Daily Report

Project:	Durham Meadows Pipeline Installation	Date:	June 29, 2021
Location:	S. Main Street and the Shared Access Driveway, Middletown	Day of Week:	Tuesday
Project #:	AECOM: 6061487	Report No:	274
Contractor:	Ludlow Construction	Page:	1 of 11

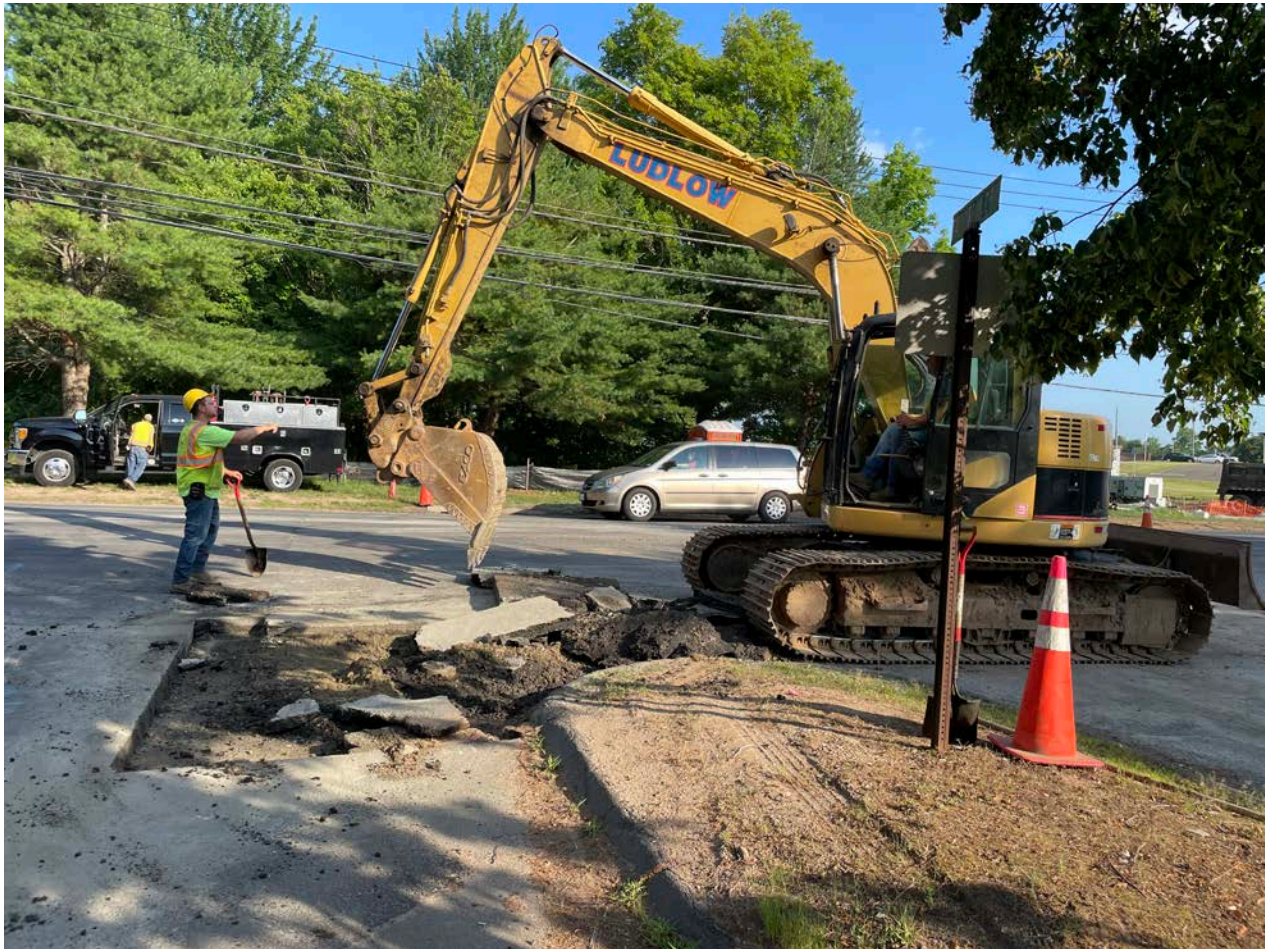
Picture 1: Ludlow removing asphalt from a trench cut overcut at the intersection of Talcott Ridge Drive and S. Main Street, Middletown. View to the west.

0719: Ludlow is setting up at the intersection of Talcott Ridge Drive and the northbound lane of S. Main Street, Middletown, as they begin to remove asphalt from trench overcuts as part of permanent paving activities.

0748: Ludlow continues to excavate pavement and concrete from the footprints of trench overcuts at the intersection of Talcott Ridge Drive and the northbound lane of S. Main Street. Ludlow is also removing a 1" copper blowoff line at the intersection.

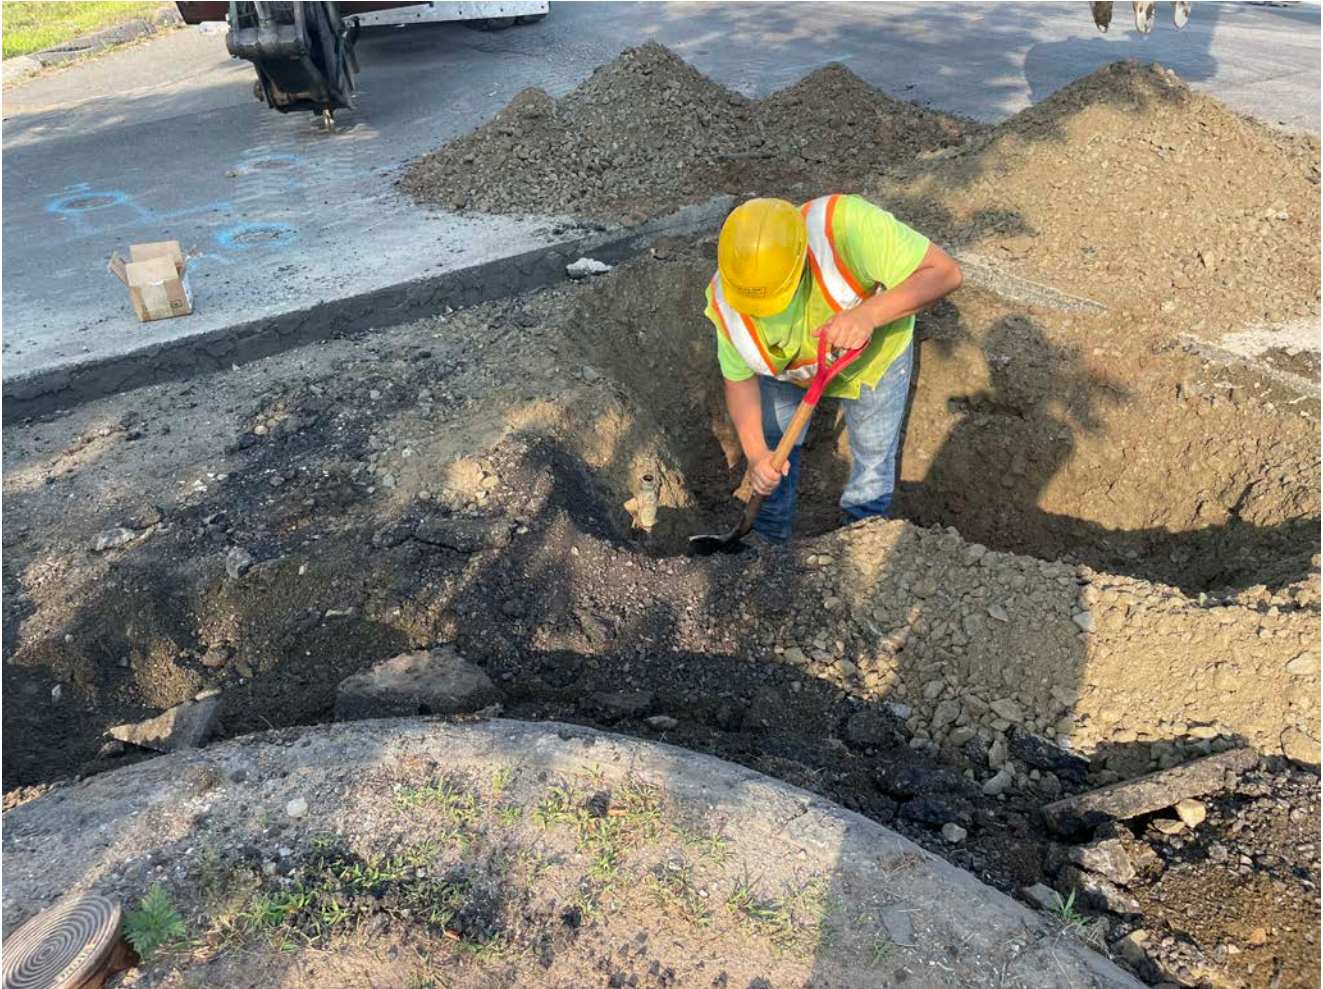
Picture 2: Ludlow hand digging around a 1" copper blow off pipe that they plan to remove today. View to the southwest.

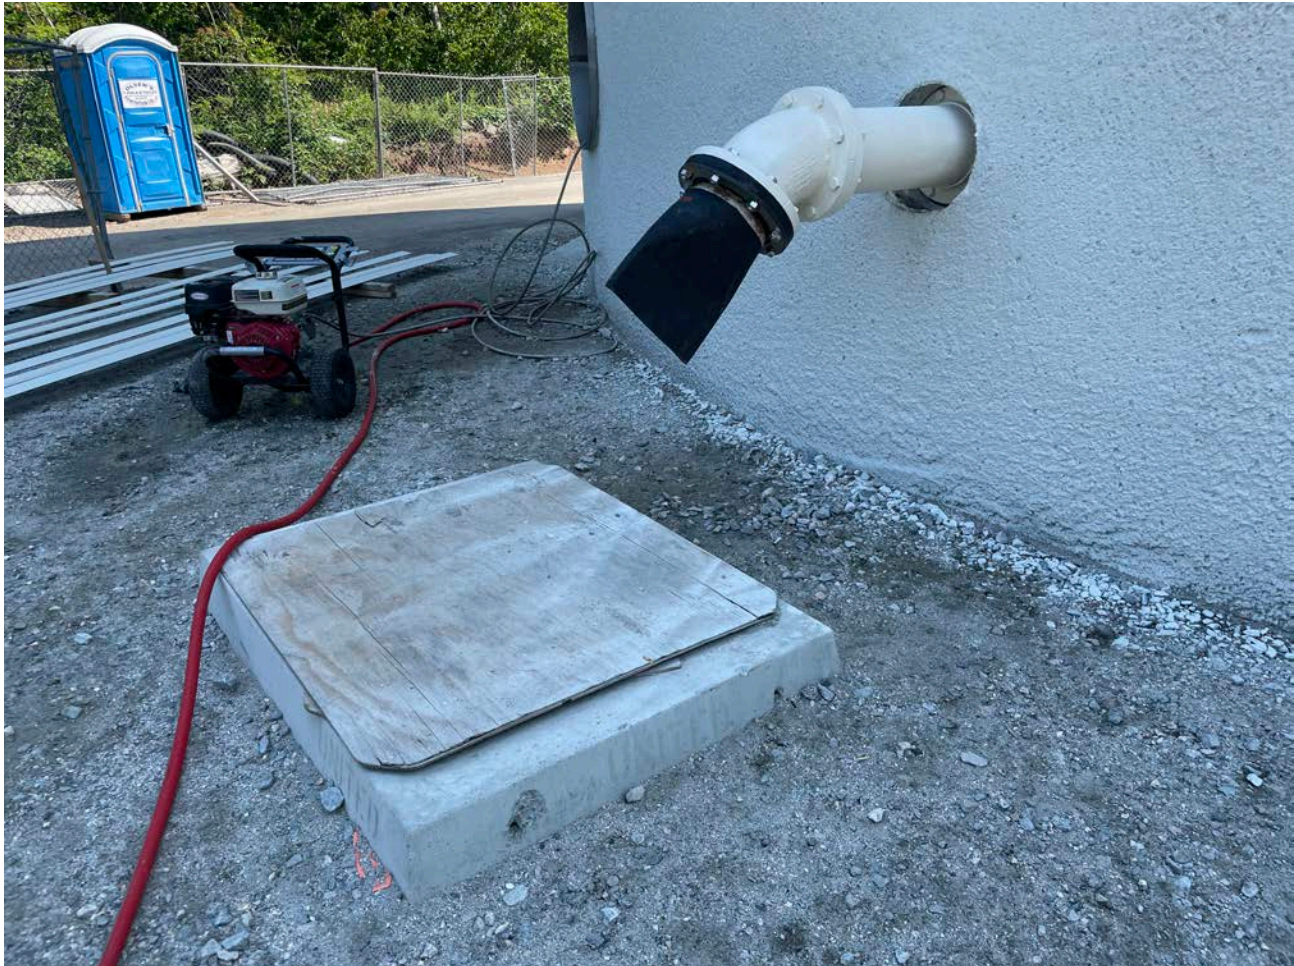
Picture 3: Overflow pipe on the exterior of the water tank located east of the Shared Access Road that DN Tanks painted. View to the north.

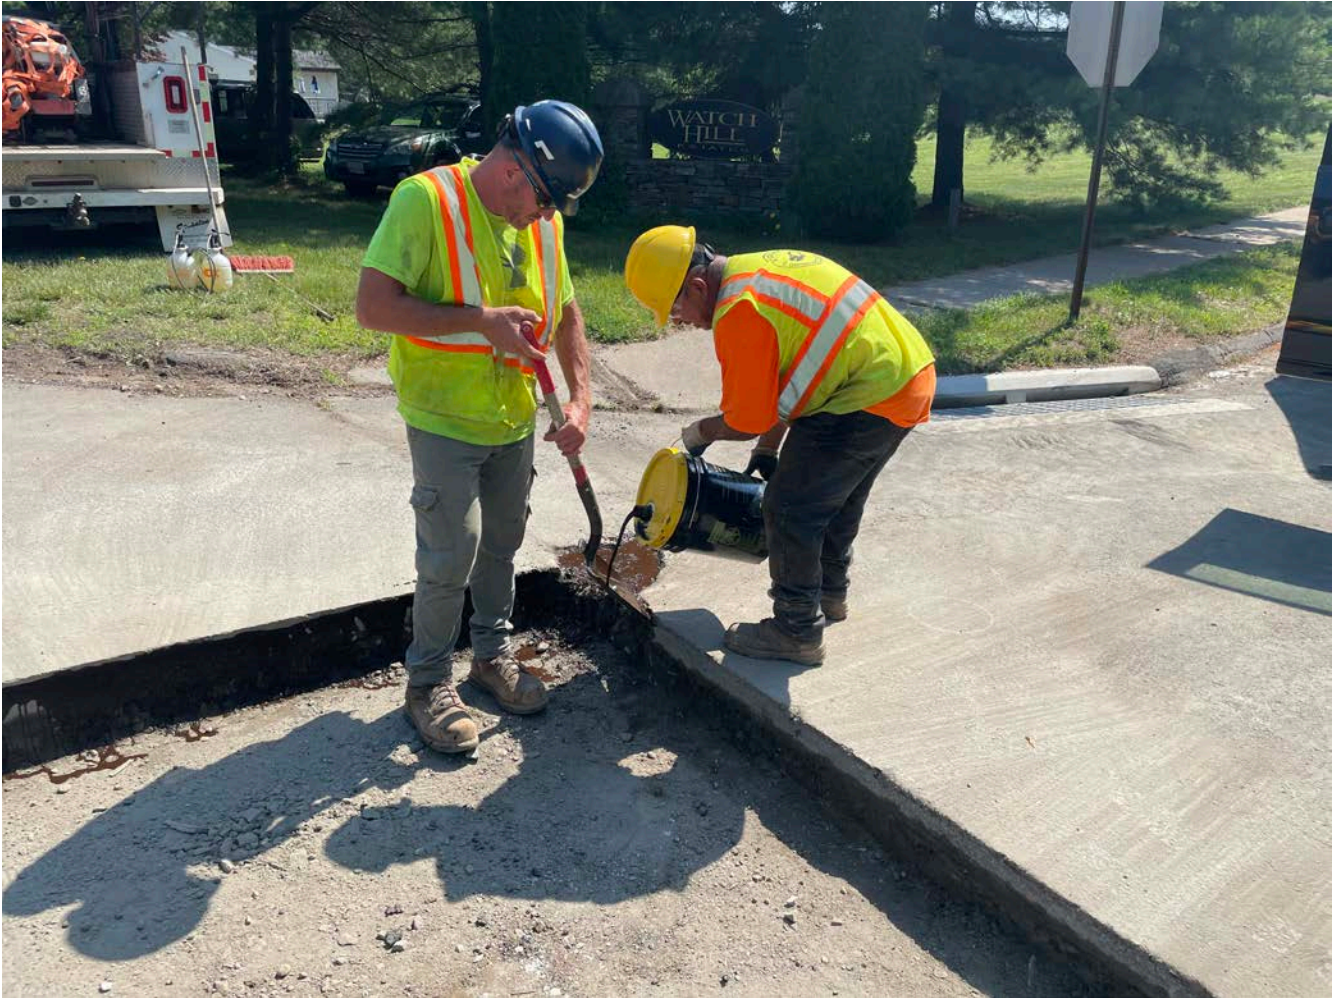
Picture 4: Ludlow placing tack coat on the edges of cut pavement as part of permanent paving activities at the intersection of Talcott Ridge Drive and S. Main Street, Middletown. View to the southwest.

1132: Ludlow has removed asphalt and concrete from all trench overcuts that they are performing permanent paving activities at today. Ludlow is starting to apply tack coat to the edges of cut pavement on the trench overcuts.

1208: Ludlow continues to apply tack coat to the edges of cut pavement on the trench overcuts.

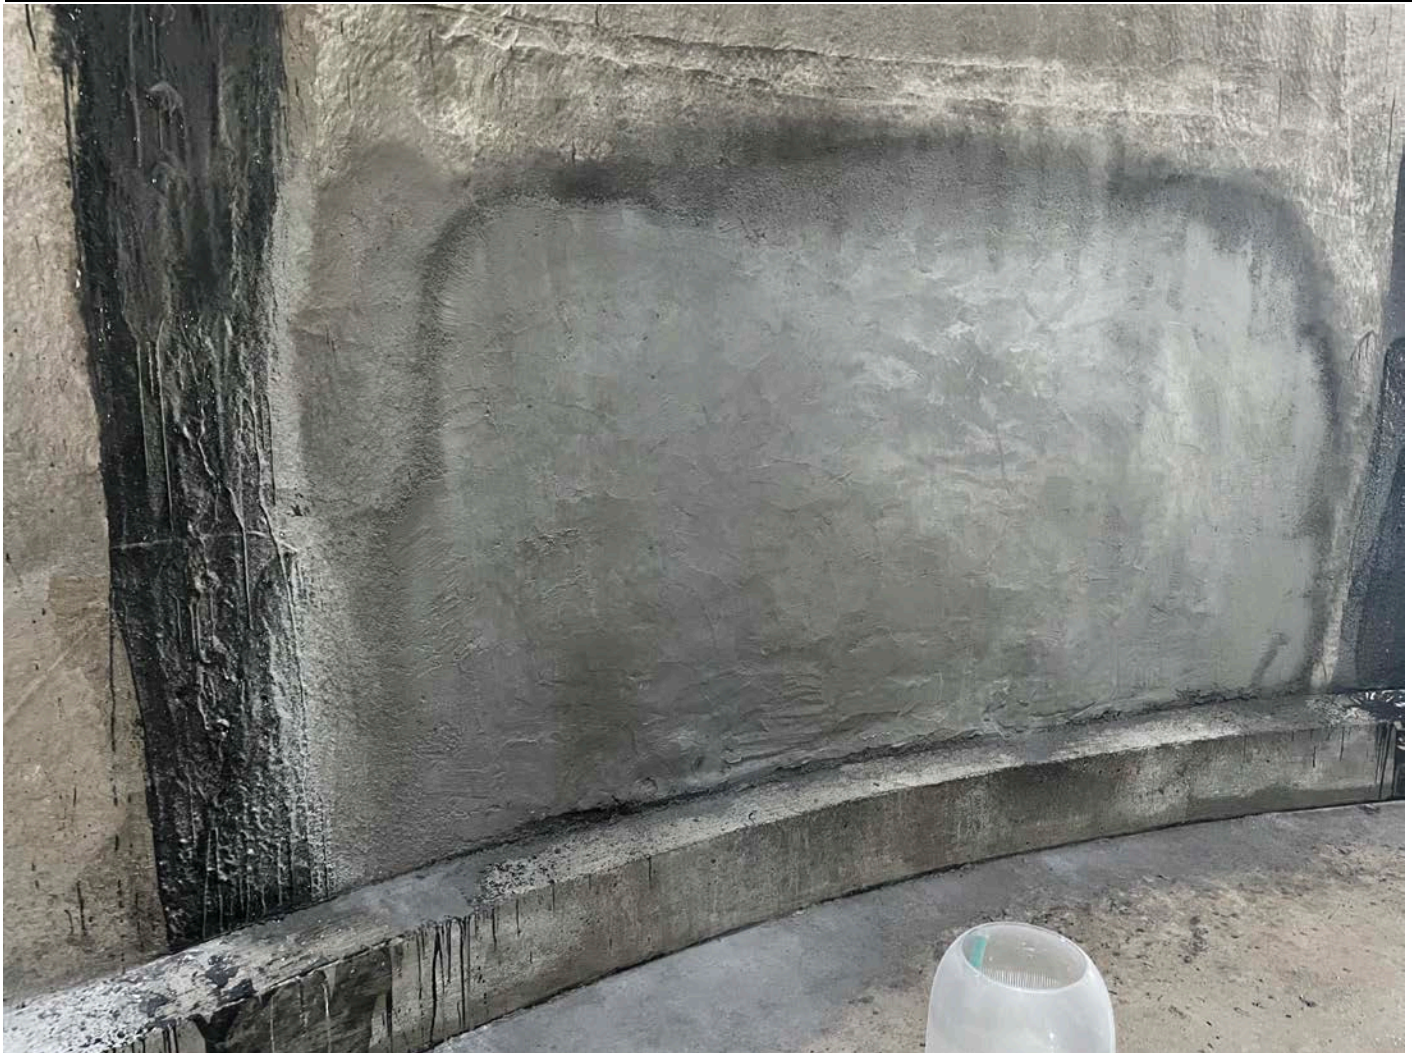
Picture 5: Non-shrink grout that DN Tanks mortared over the repaired portion of the water tank where a temporary access was once located. View to the east.

1214: AECOM inspects the inside of the water tank where DN Tanks used non-shrink grout (Tamms Structural Mortar) to patch over some rough areas of shotcrete that was used to patch over a temporary entrance on the northeast side of the water tank.

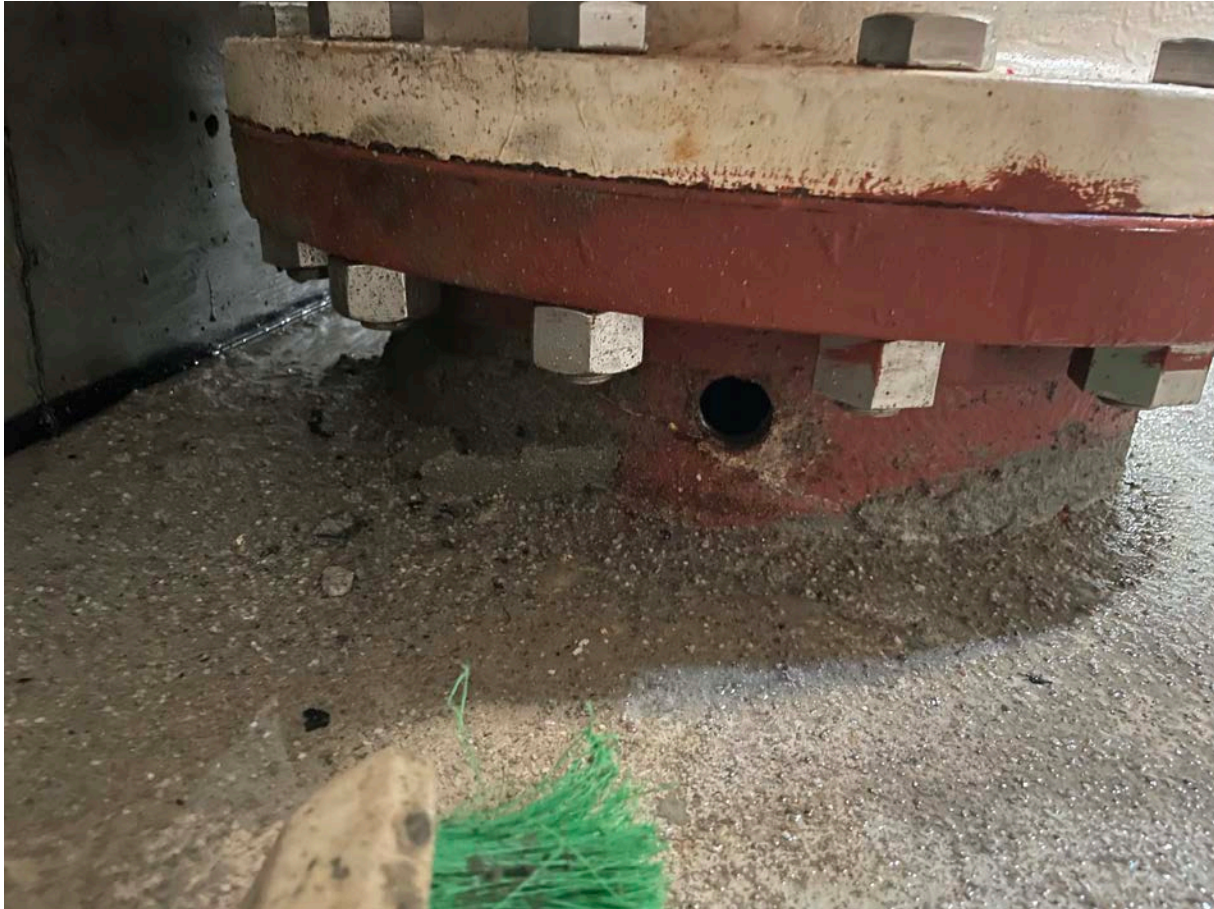
Picture 6: Hole left in the base of the inlet of the water tank where Ludlow removed a 1" stub used for pressure testing. DN Tanks stated that this hole will not be capped. View to the west.

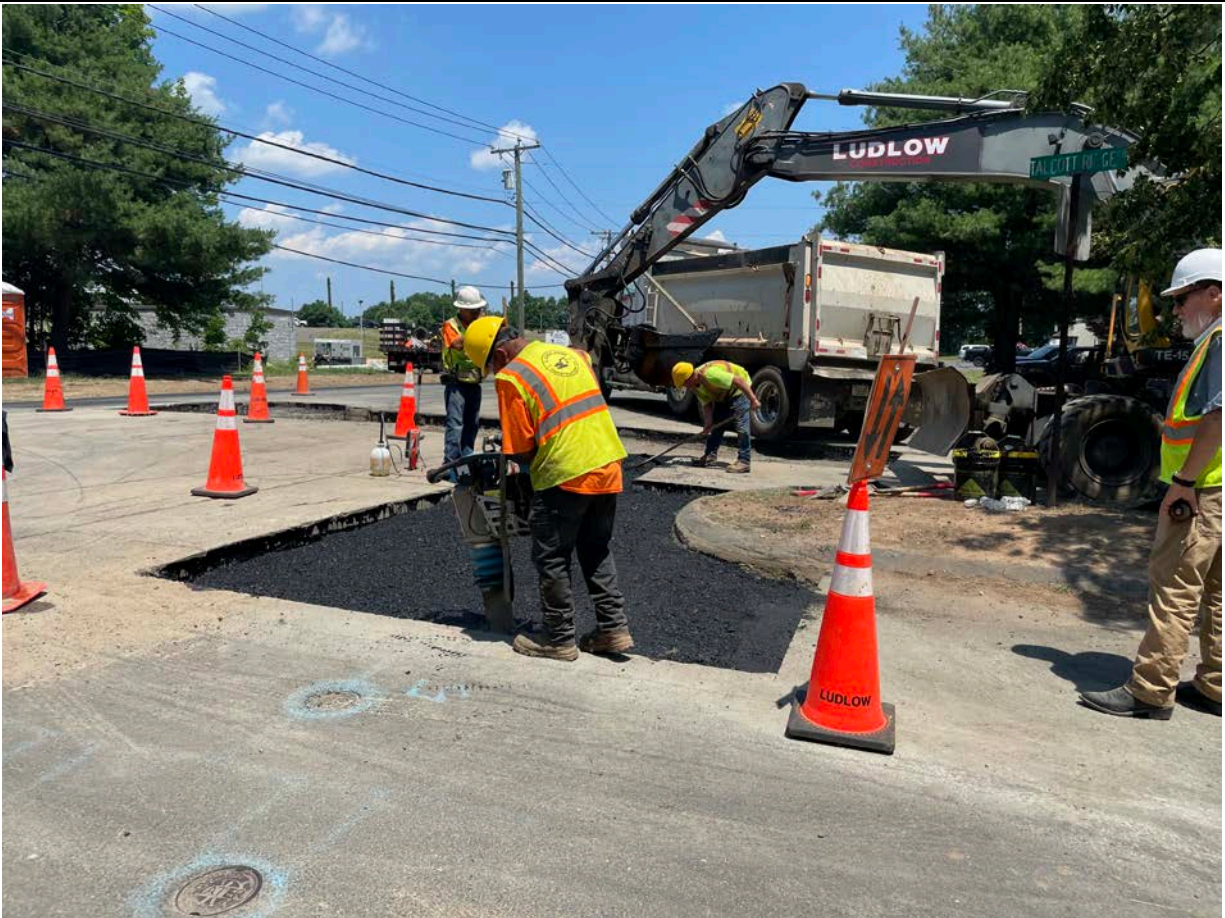
Picture 7: Ludlow using a jumping jack to compact asphalt along the edge of a trench overcut on S. Main Street as part of permanent paving activities. View to the north.

1222: Ludlow is beginning to place the first lift of asphalt on trench overcuts located at the intersection of Talcott Ridge Drive and the northbound lane of S. Main Street. Ludlow is using a jumping jack to compact the asphalt where it meets the edge of cut pavement, and a compacting roller to compact the rest of the asphalt.

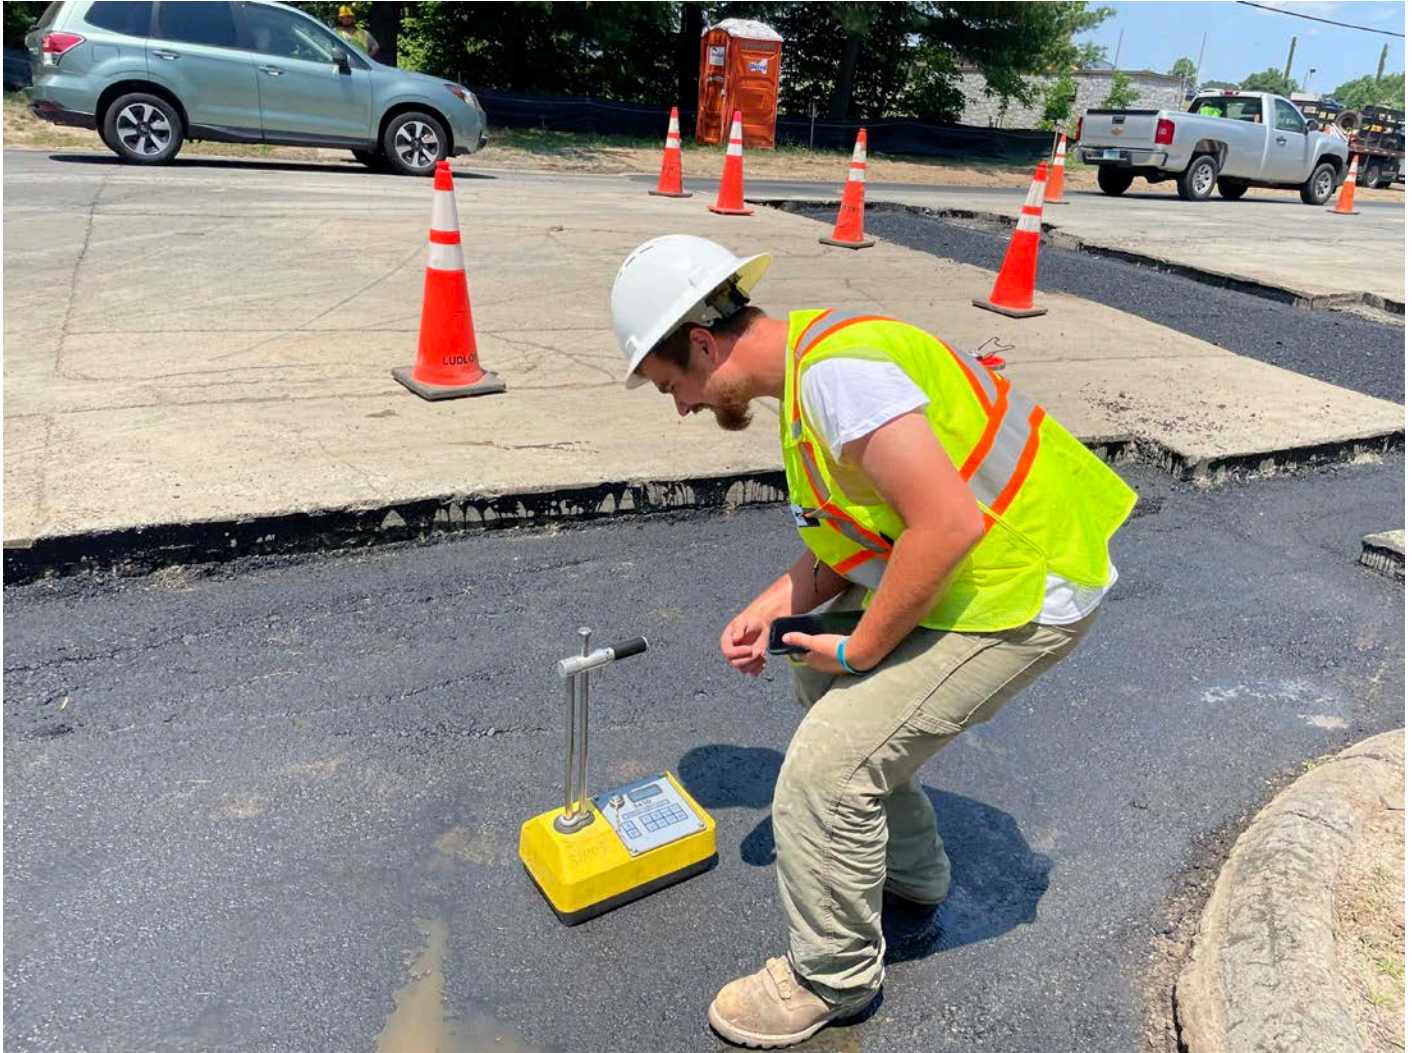
Picture 8: JTC testing compaction on the first lift of asphalt that was placed on the trench overcuts on the northbound lane of S. Main Street, Middletown. View to the west.

1236: JTC just collected compaction data from the first lift of asphalt that was placed and rolled at the trench overcuts located at the intersection of Talcott Ridge Drive and S. Main Street.

1256: JTC continues to take compaction readings from the first lift of asphalt that they placed and rolled.

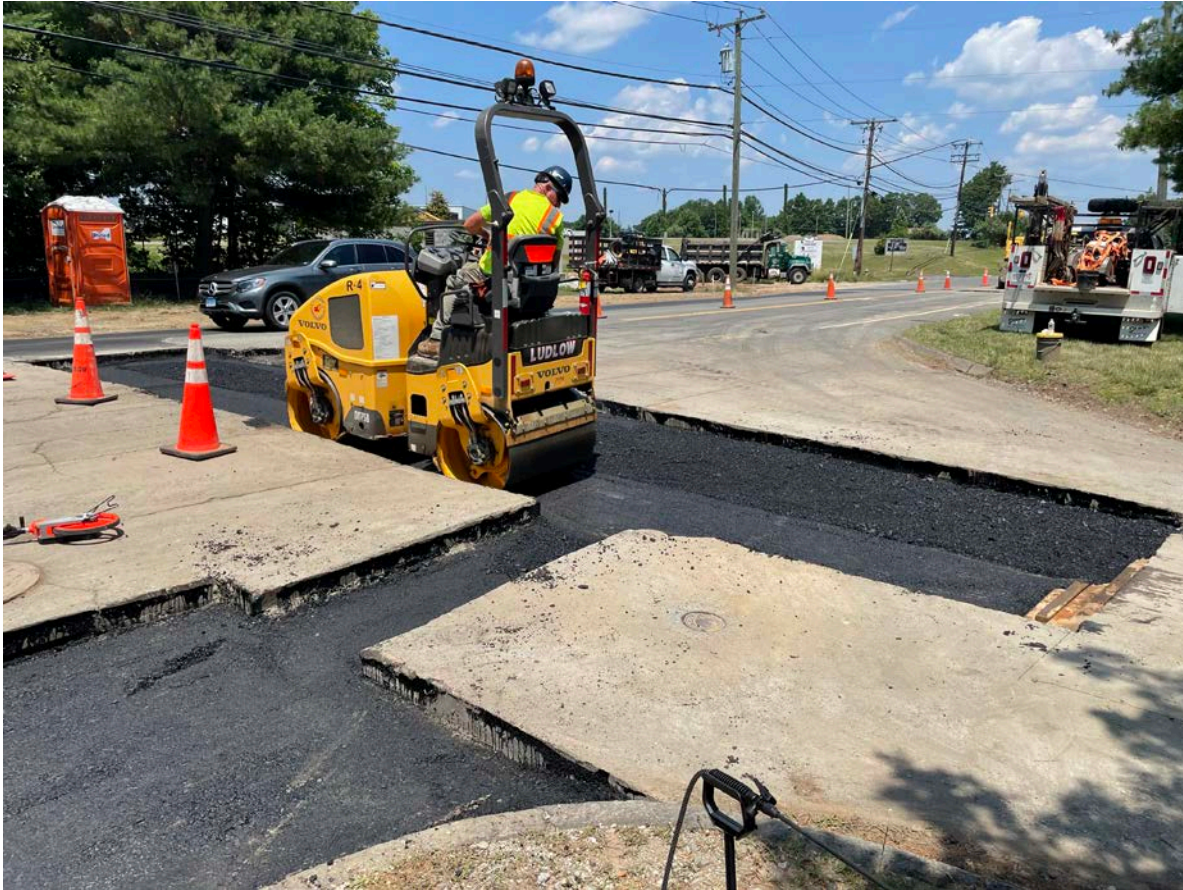
Picture 9: Ludlow rolling the first lift of asphalt on trench overcuts on the northbound lane of S. Main Street, Middletown. View to the north.

1301: Ludlow is placing a second lift of asphalt at the trench overcuts at the intersection of Talcott Ridge Drive and the northbound lane of S. Main Street. As the USACE confirmed with Ludlow yesterday, asphalt is being placed in the following sequence: first lift is 4" of superpave 1.0 (1"), the second lift is 3" of superpave 1.0 (1"), and 2" of superpave 0.5 (0.5").
