## Daily Report

<b>Project:</b>	Durham Meadows Pipeline Installation	<b>Date:</b>	August 12, 2021
<b>Location:</b>	Main Street, Durham; S. Main Street and the Shared Access Driveway, Middletown	<b>Day of Week:</b>	Thursday
<b>Project #:</b>	AECOM: 6061487	<b>Report No:</b>	301
<b>Contractor:</b>	Ludlow Construction	<b>Page:</b>	1 of 17

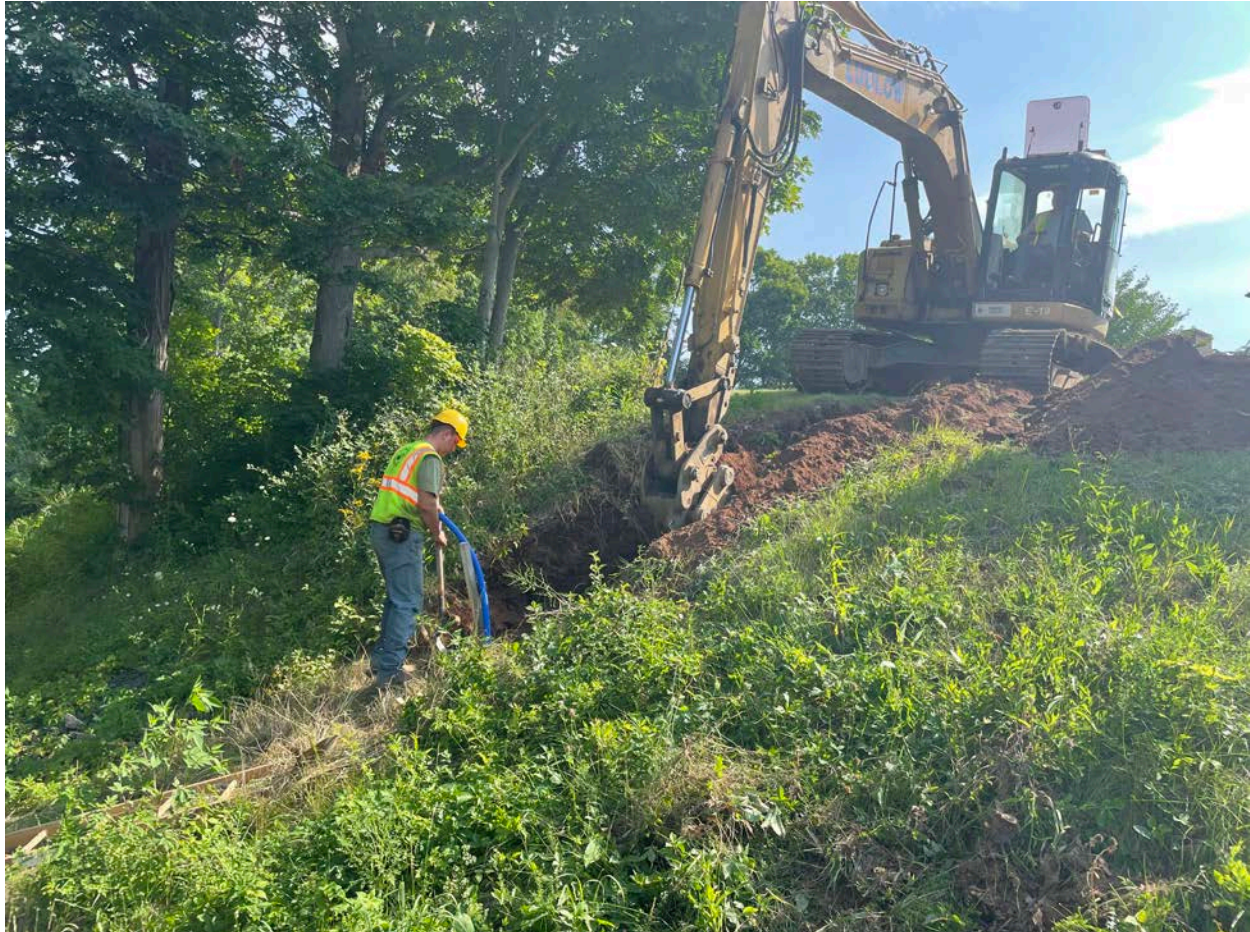
Picture 1: Ludlow excavating at 10 Johns Way next to Maple Avenue for the installation of a 1.5" copper water service line. View to the northeast.

0931: Ludlow starts to excavate at the edge of Maple Avenue, moving east towards 10 Johns Way for the installation of a 1.5" copper water service line. Ludlow indicates that the insertion point on the north side of the house conflicts with an oil tank on the inside of the residence. They plan to pass the 1.5" copper water service line through an existing penetration on the north side of the residence's foundation that is currently being used by the home's well water line.

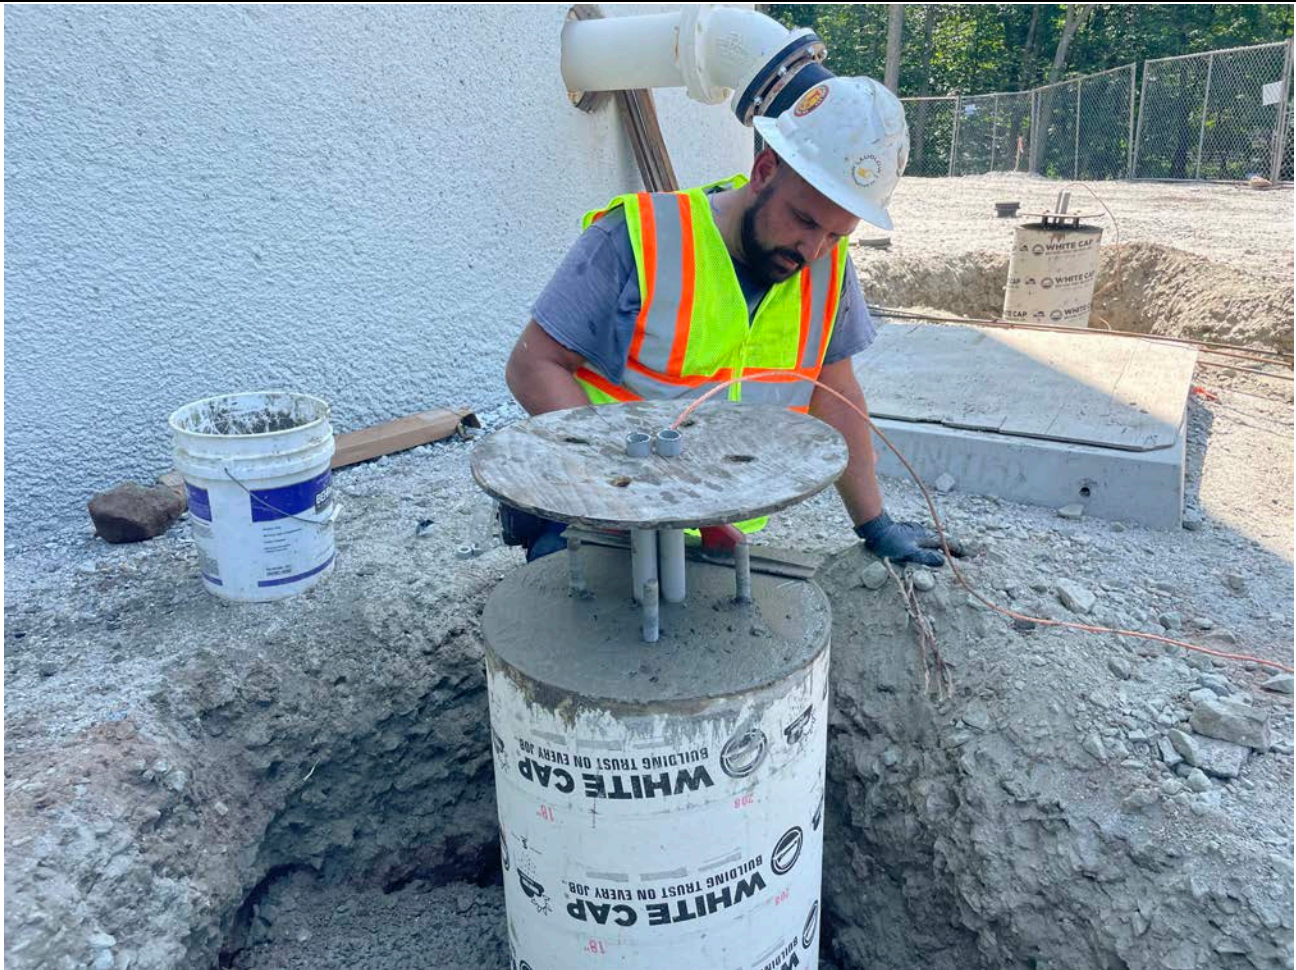
Picture 2: Ludlow leveling concrete that was placed into the sonotubes for the light pole bases at the water tank work zone located east of the Shared Access Driveway in Middletown today. View to the south.

1010: CT Ready Mix begins to place concrete over portions of the utility duct bank trench and into the three sonotubes that were previously set in place next to the water tank located east of the Shared Access Driveway.

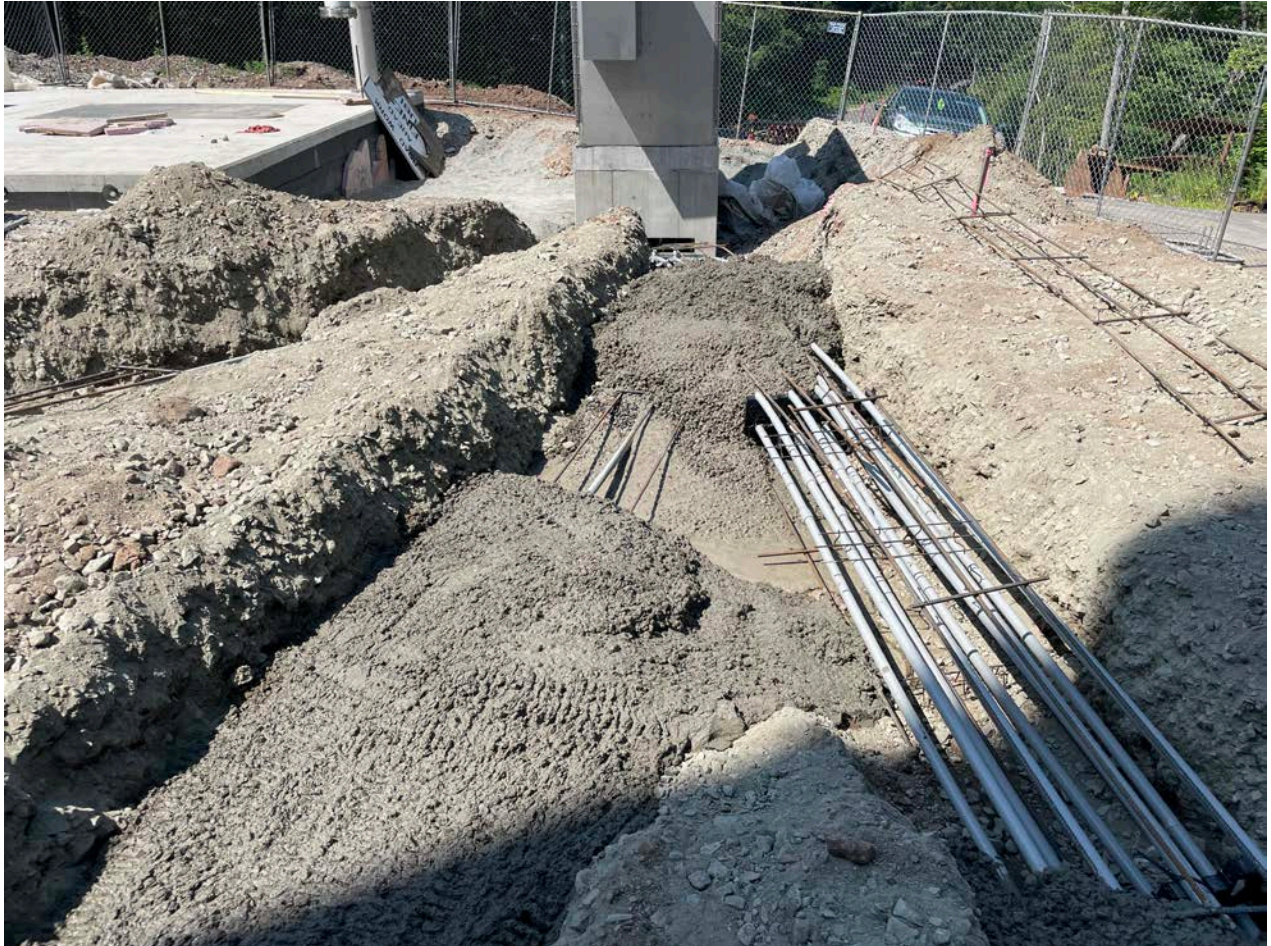
**Picture 3: 4000 PSI concrete that was placed over sections of the utility duct bank today on the west side of the water tank located east of the Shared Access Driveway in Middletown. View to the west.**

1005: CT Ready Mix delivers a load of 4000 PSI concrete to the water tank work zone for placement in the utility duct bank trenches and into the three sonotube light pole bases. JTC is present to collect field quality data and 5 concrete cylinder samples. JTC reports the following data for the concrete:

- Loading time: 0900 hours
- Arrival temperature: 81°F
- Air entrainment: 3.3%
- Slump: 6.5"

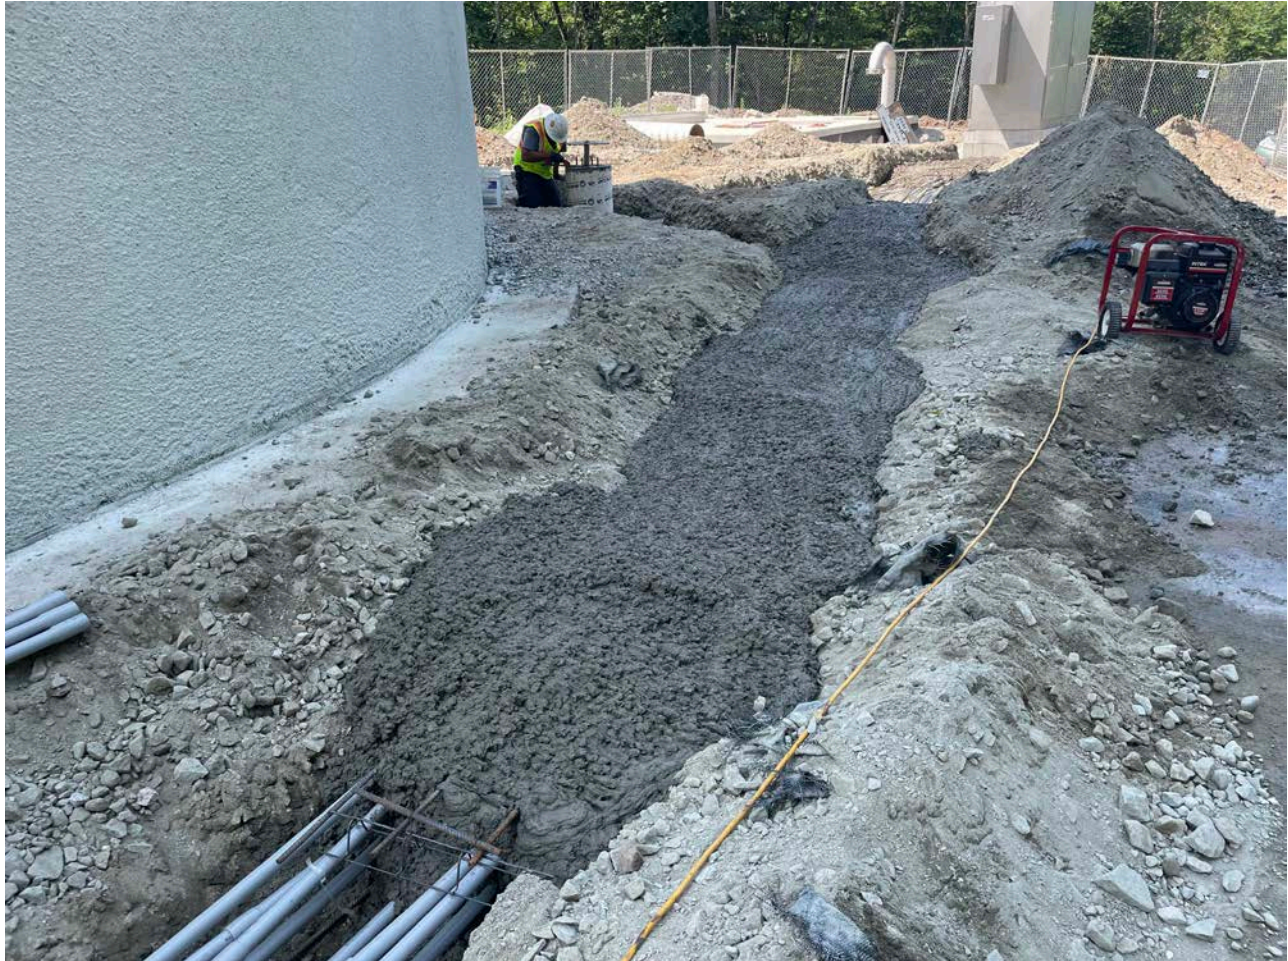
**Picture 4: 4000 PSI concrete that was placed over sections of the utility duct bank today on the west side of the water tank located east of the Shared Access Driveway in Middletown. View to the south.**

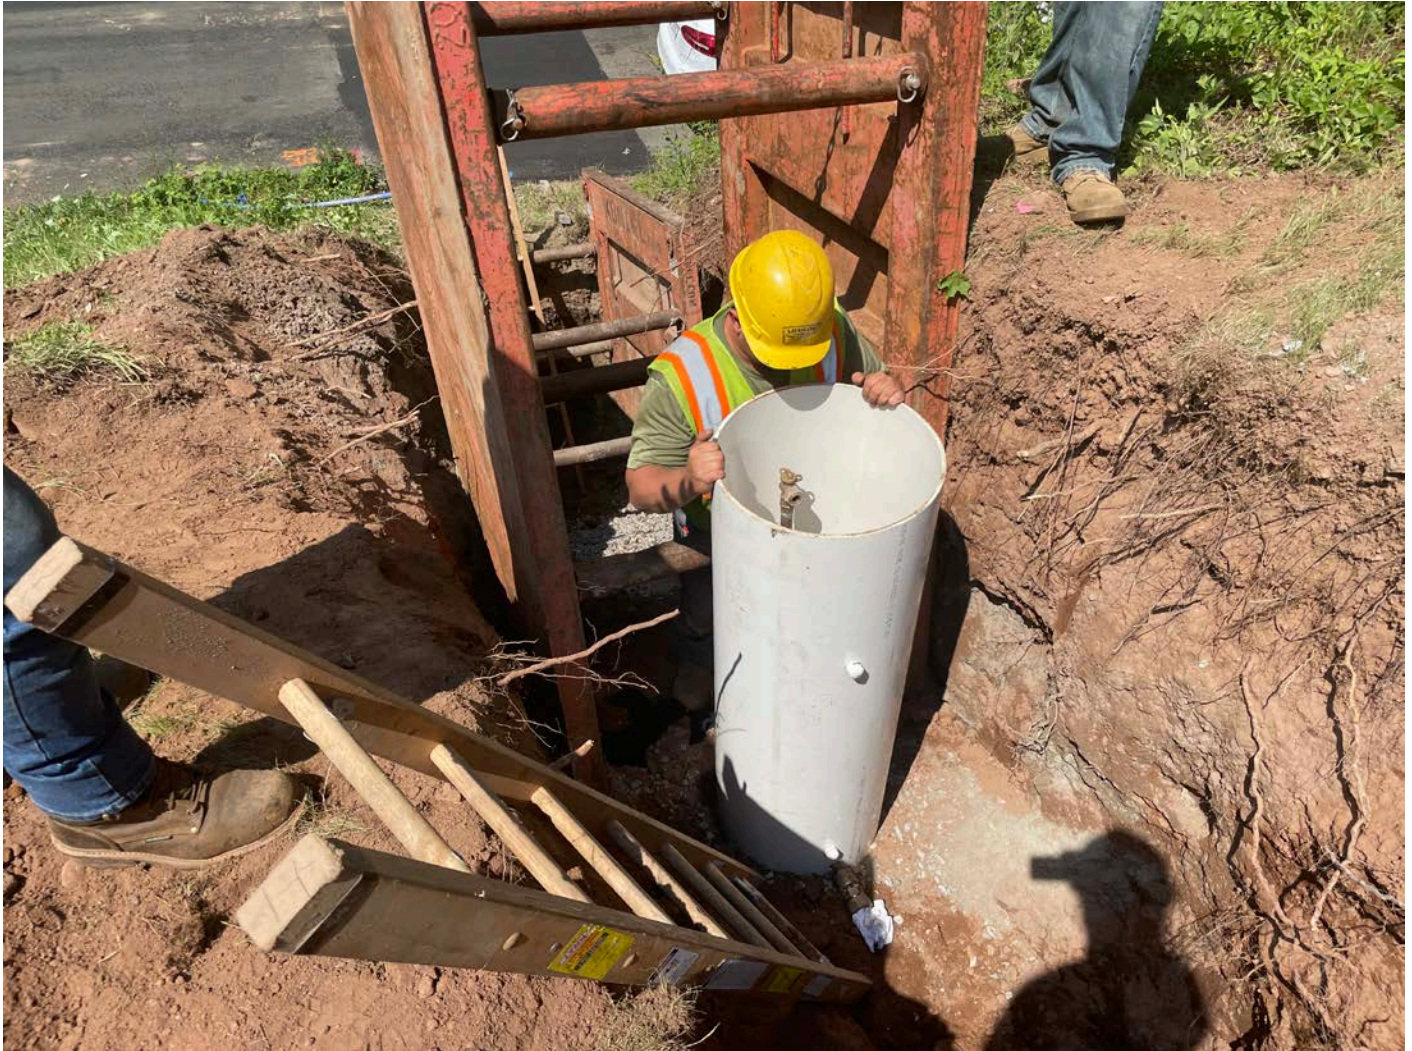
Picture 5: Ludlow setting meter pit in place in the trench that they excavated for the installation of a 1.5” copper water service line at the 10 Johns Way, Durham, residence. View to the northwest.

1145: Ludlow places the meter pit into the trench they have excavated at the 10 Johns Way residence.

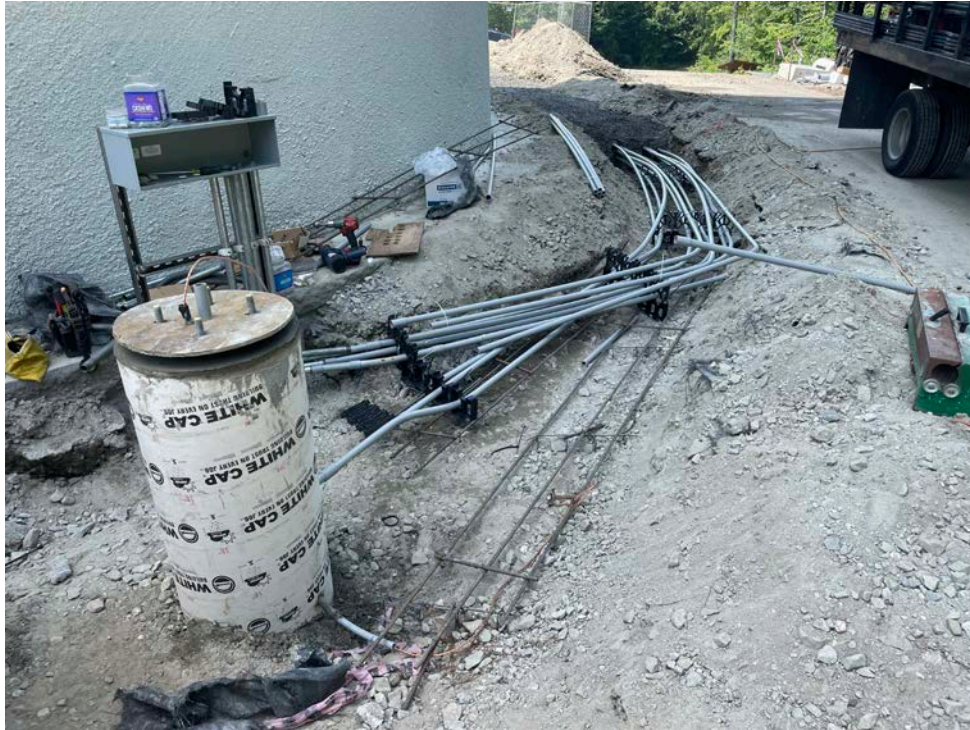
Picture 6: View of progress of the conduit installation on the north side of the water tank located east of the Shared Access Driveway in Middletown. View to the west.

1236: A&R Electrical continues to work on the placement of conduits at the water tank work zone located east of the Shared Access Driveway in Middletown.

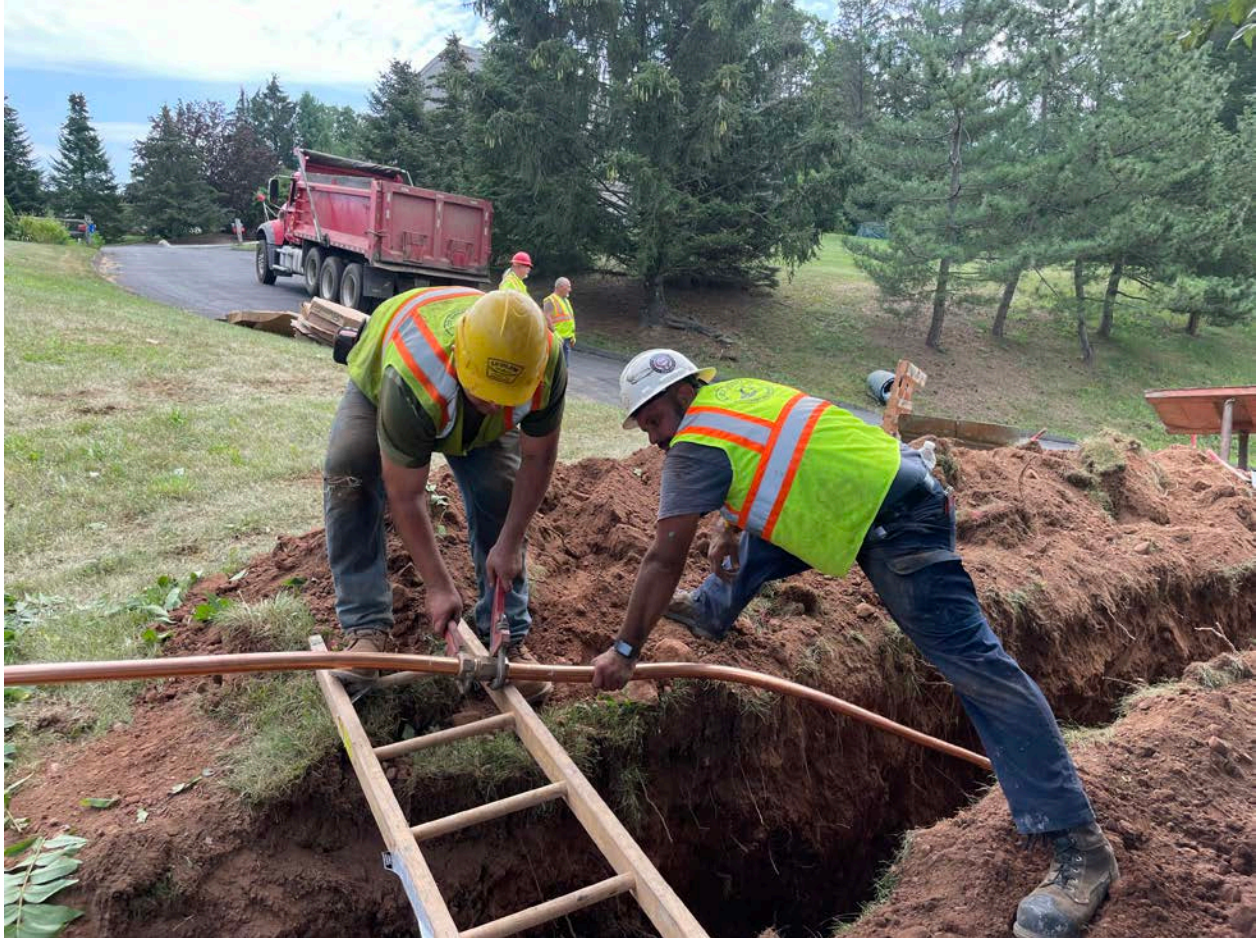
Picture 7: Ludlow joining two sections of 1.5" copper water service line at the residence located at 10 Johns Way, Durham. View to the east.

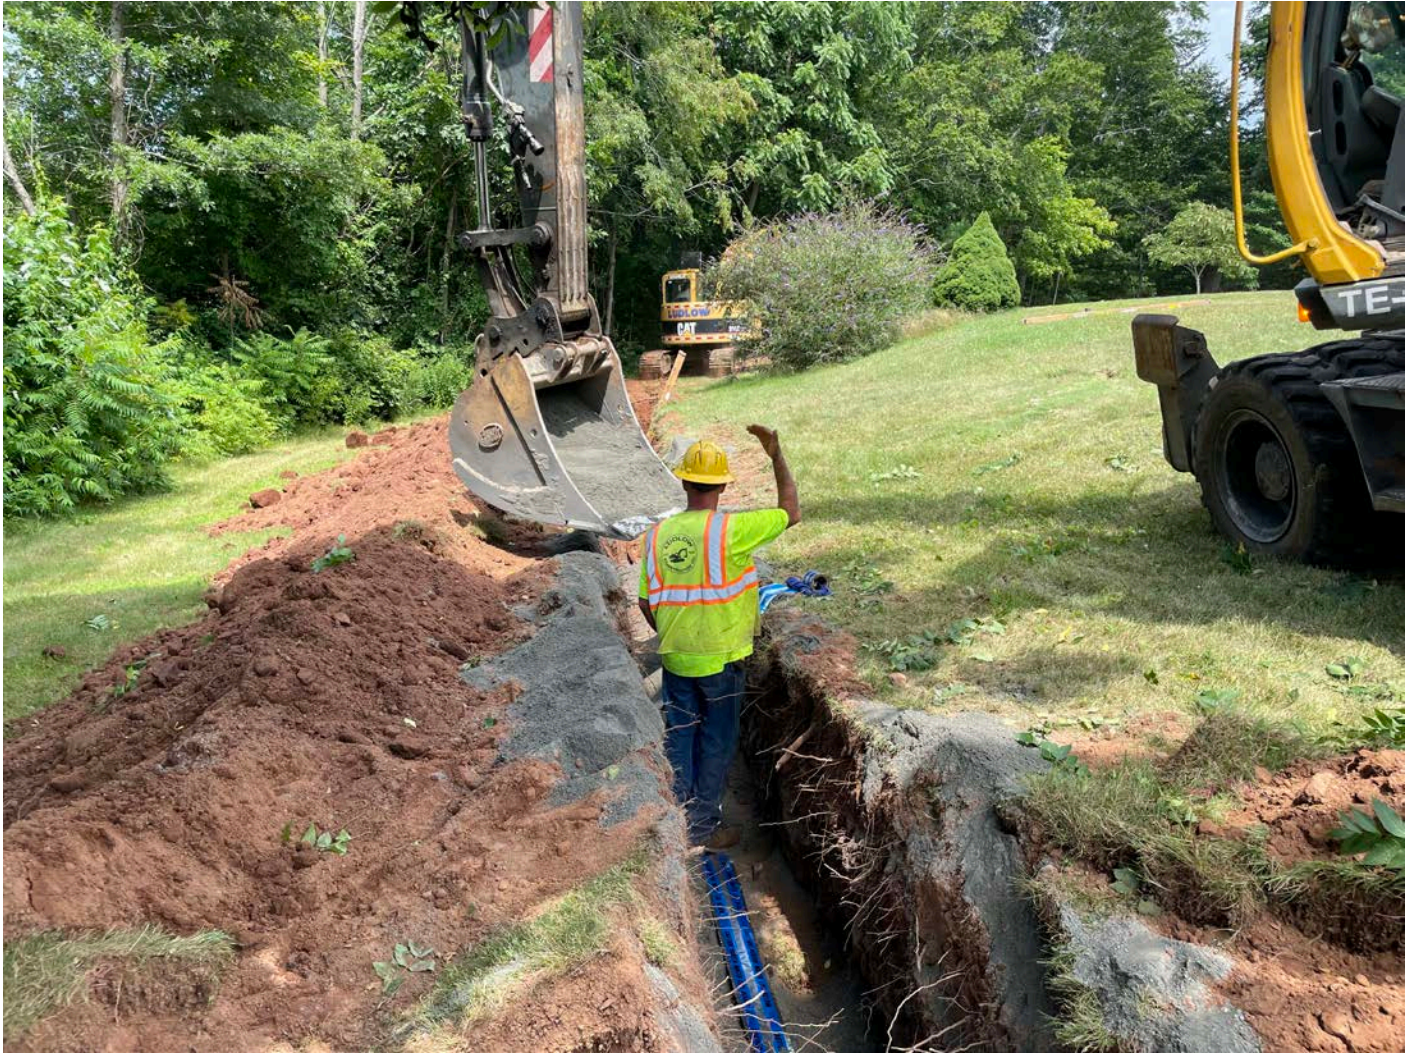
Picture 8: Ludlow placing sand and caution tape over 1.5" copper water service line at the residence located at 10 Johns Way, Durham. View to the north.

1344: Ludlow is using a jumping jack to compact native fill they have placed over the sand and caution tape that was placed over the 1.5" copper water service line at 10 Johns Way, Durham. The fill is being placed in 1' lifts.

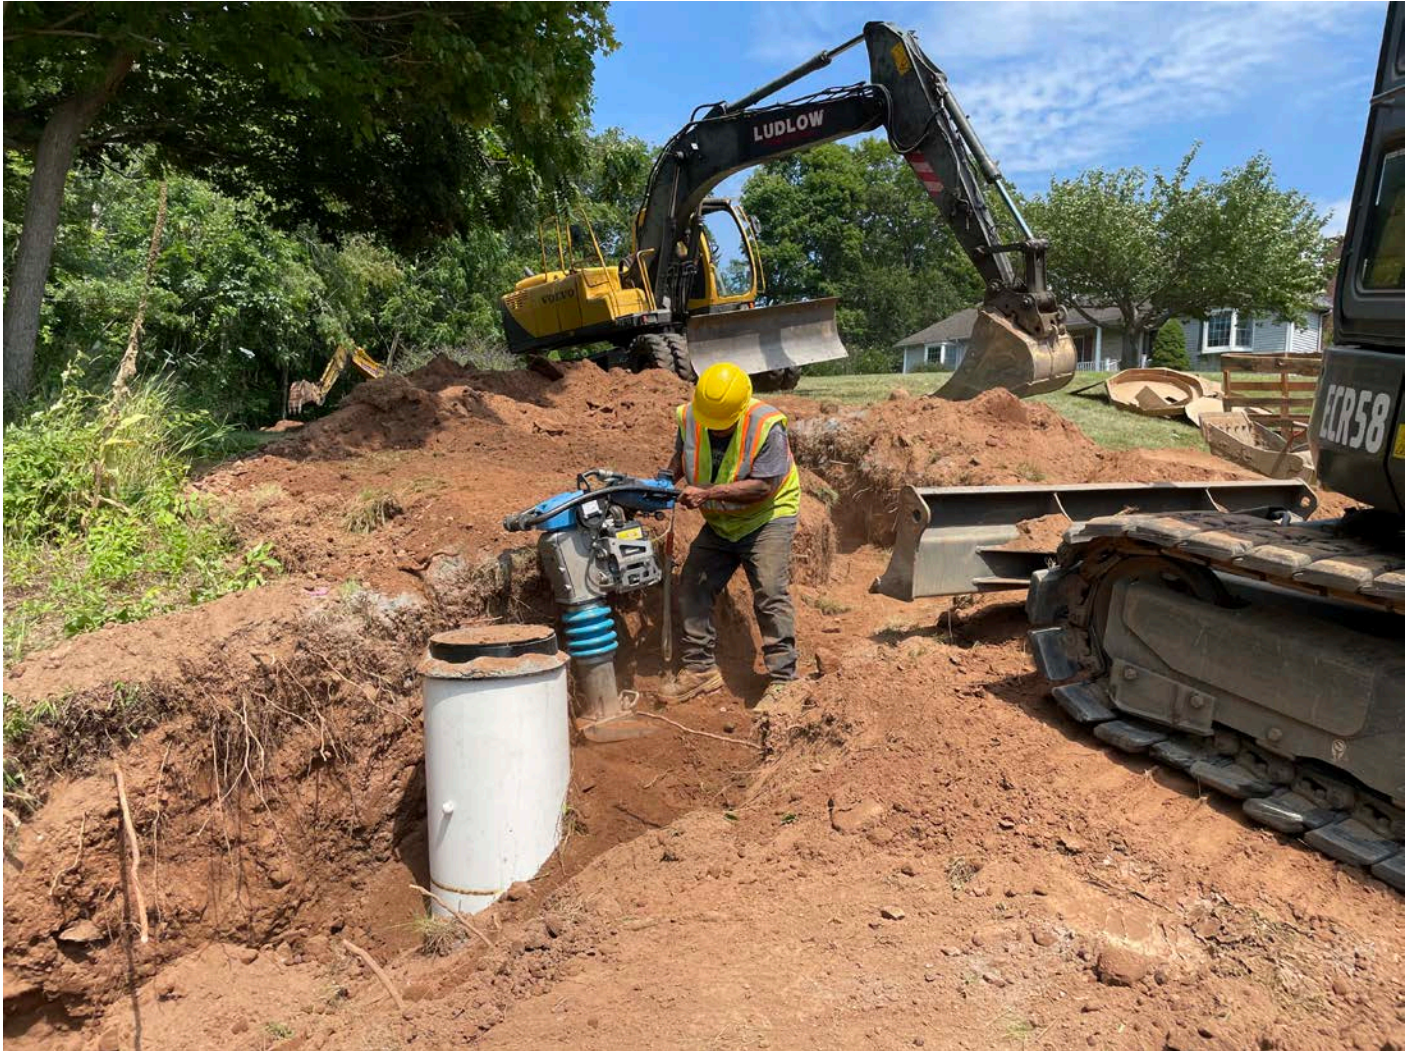
Picture 9: Ludlow compacting fill over 1.5" copper water service line they installed at the residence located at 10 Johns Way, Durham. View to the northeast.

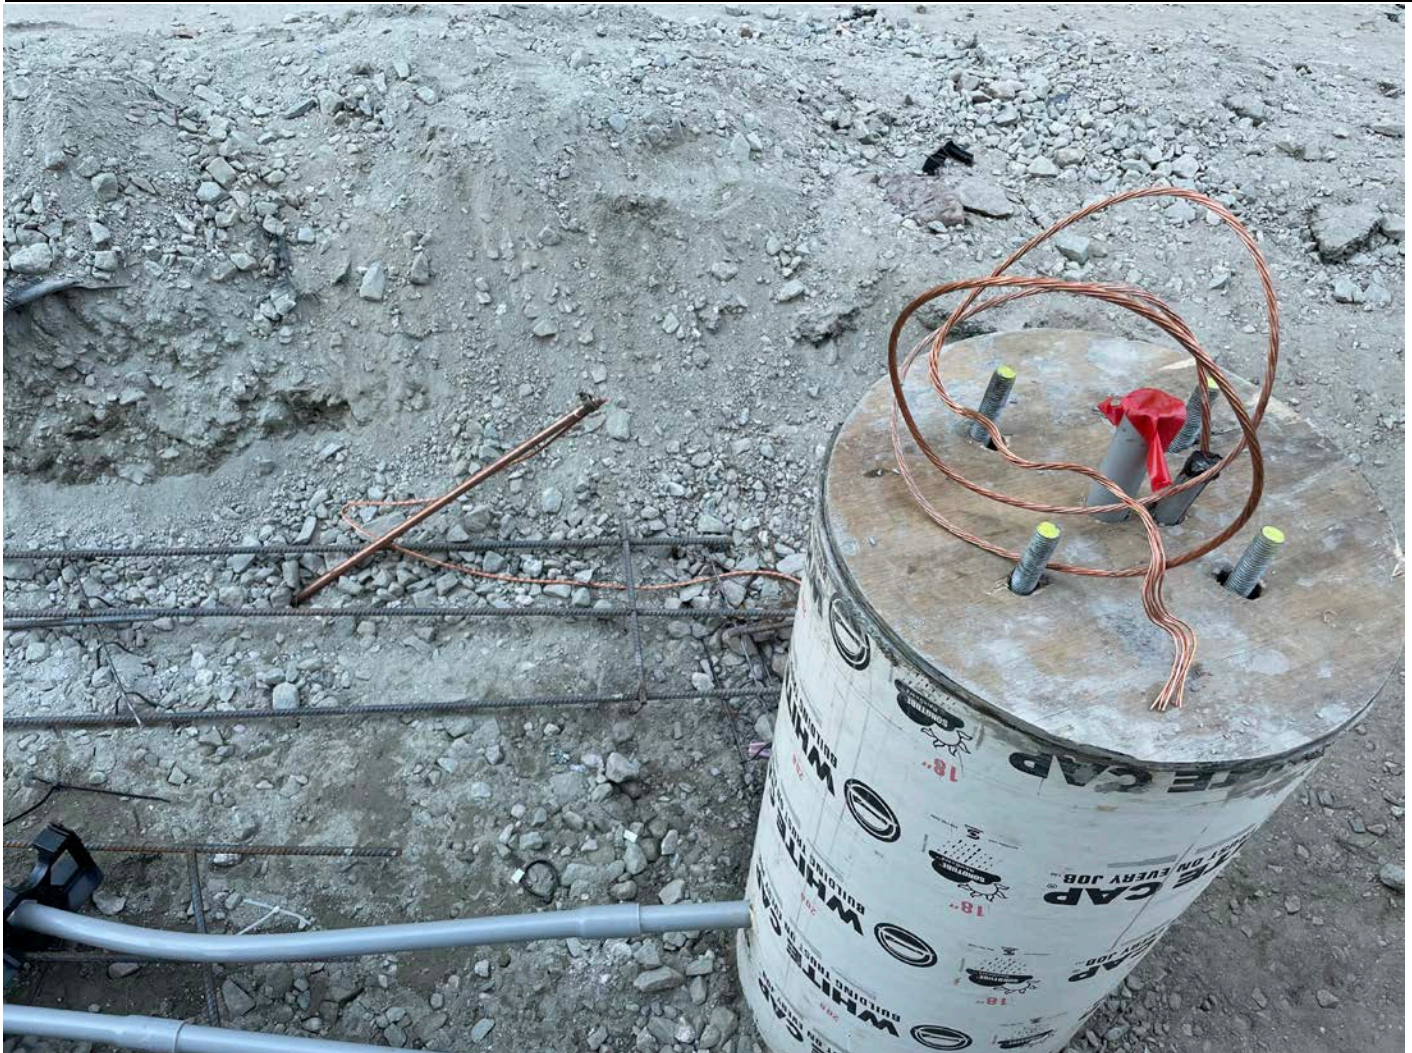
Picture 10: Ground line that A&R Electrical installed on the northeast side of the water tank located east of the Shared Access Driveway in Middletown.

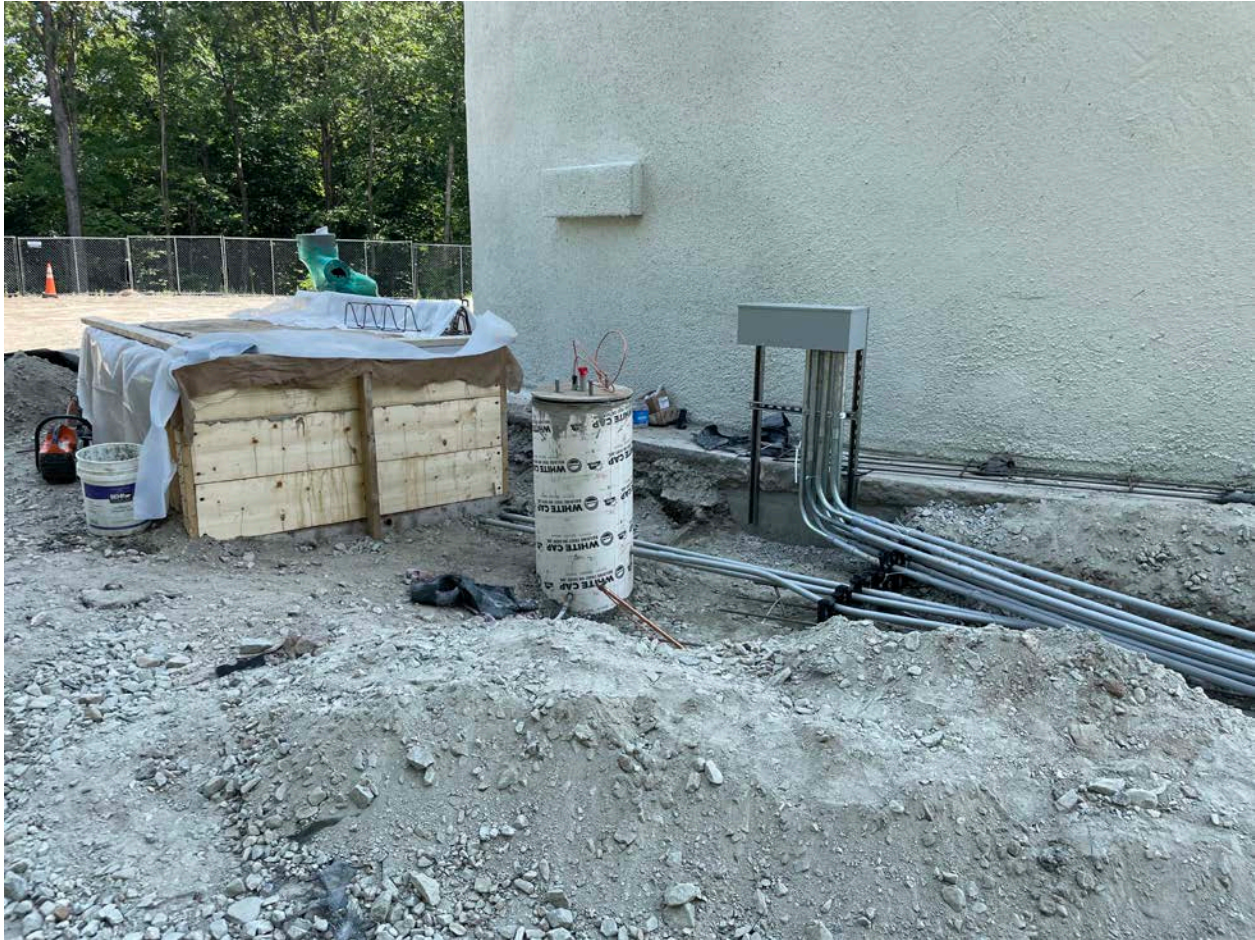
Picture 11: Overview of blower enclosure pad and conduit that has been installed on the northeast side of the water tank located east of the Shared Access Driveway. View to the south.

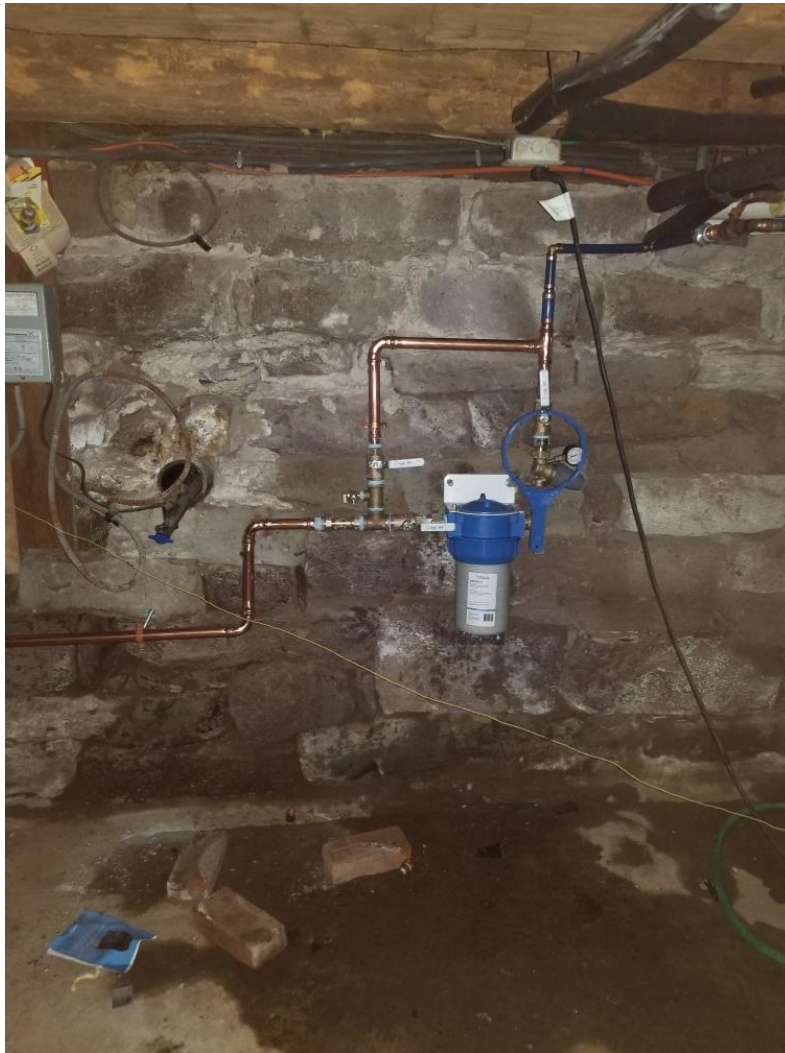
Picture 12: Final water service components that Fazzino Plumbing installed today at the residence located at 248 Main Street, Durham.

0956: Fazzino Plumbing finishes the installation of final water service components at the residence located at 248 Main Street, Durham.

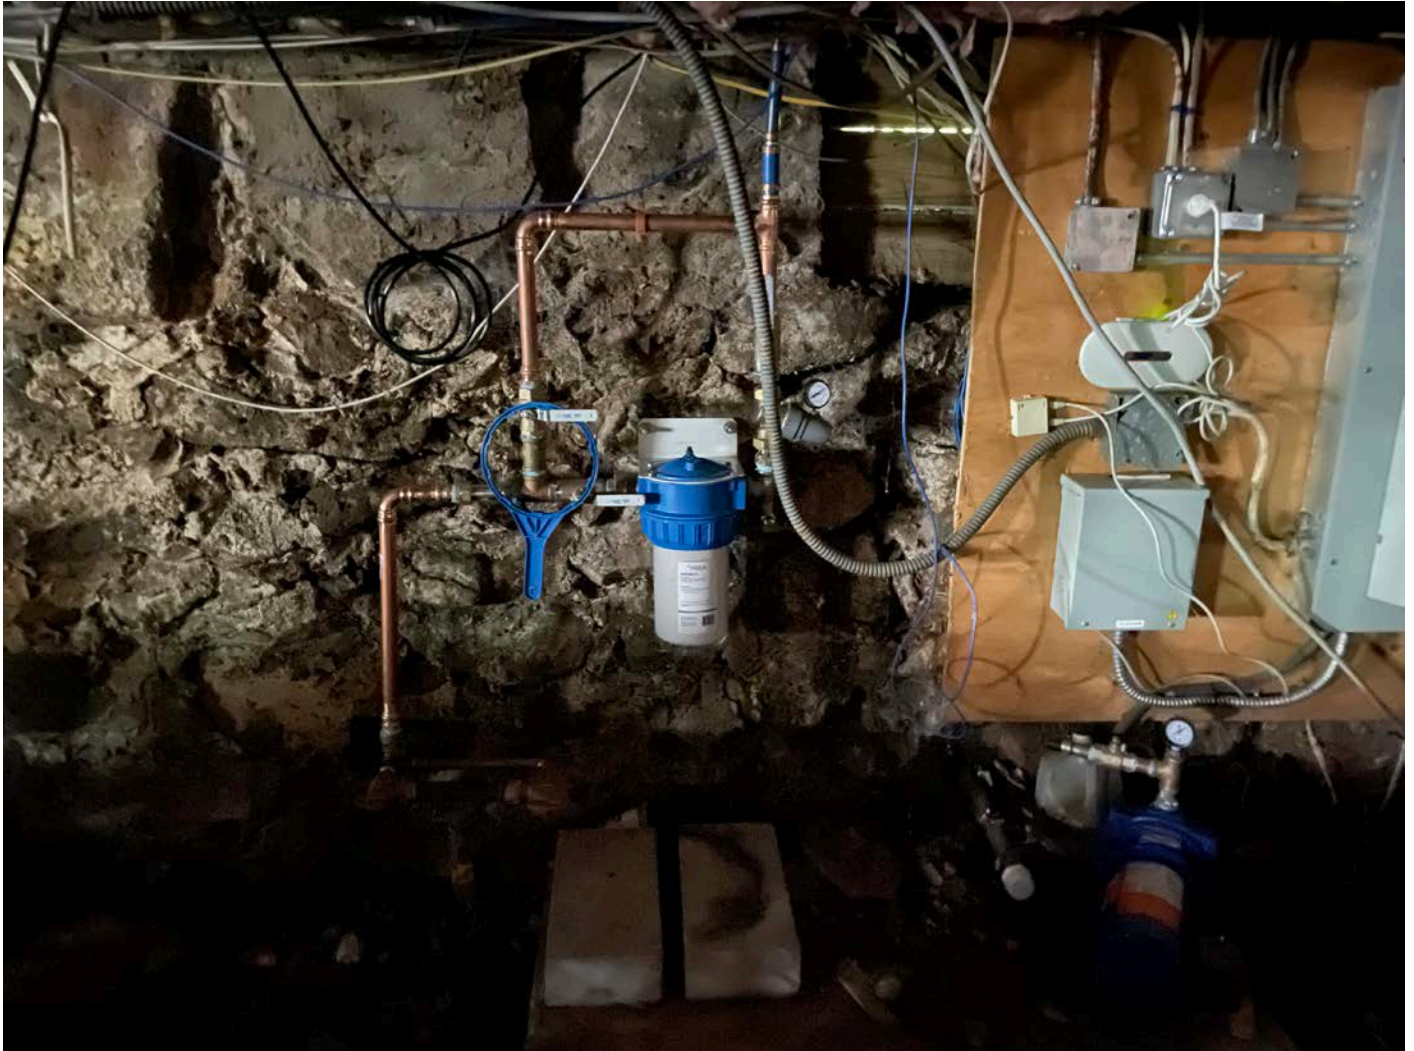
Picture 13: Final water service components that Fazzino Plumbing installed today at the residence located at 265 Main Street, Durham.

1105: Fazzino Plumbing continues to work on installing final water service components at the residence located at 265 Main Street, Durham.

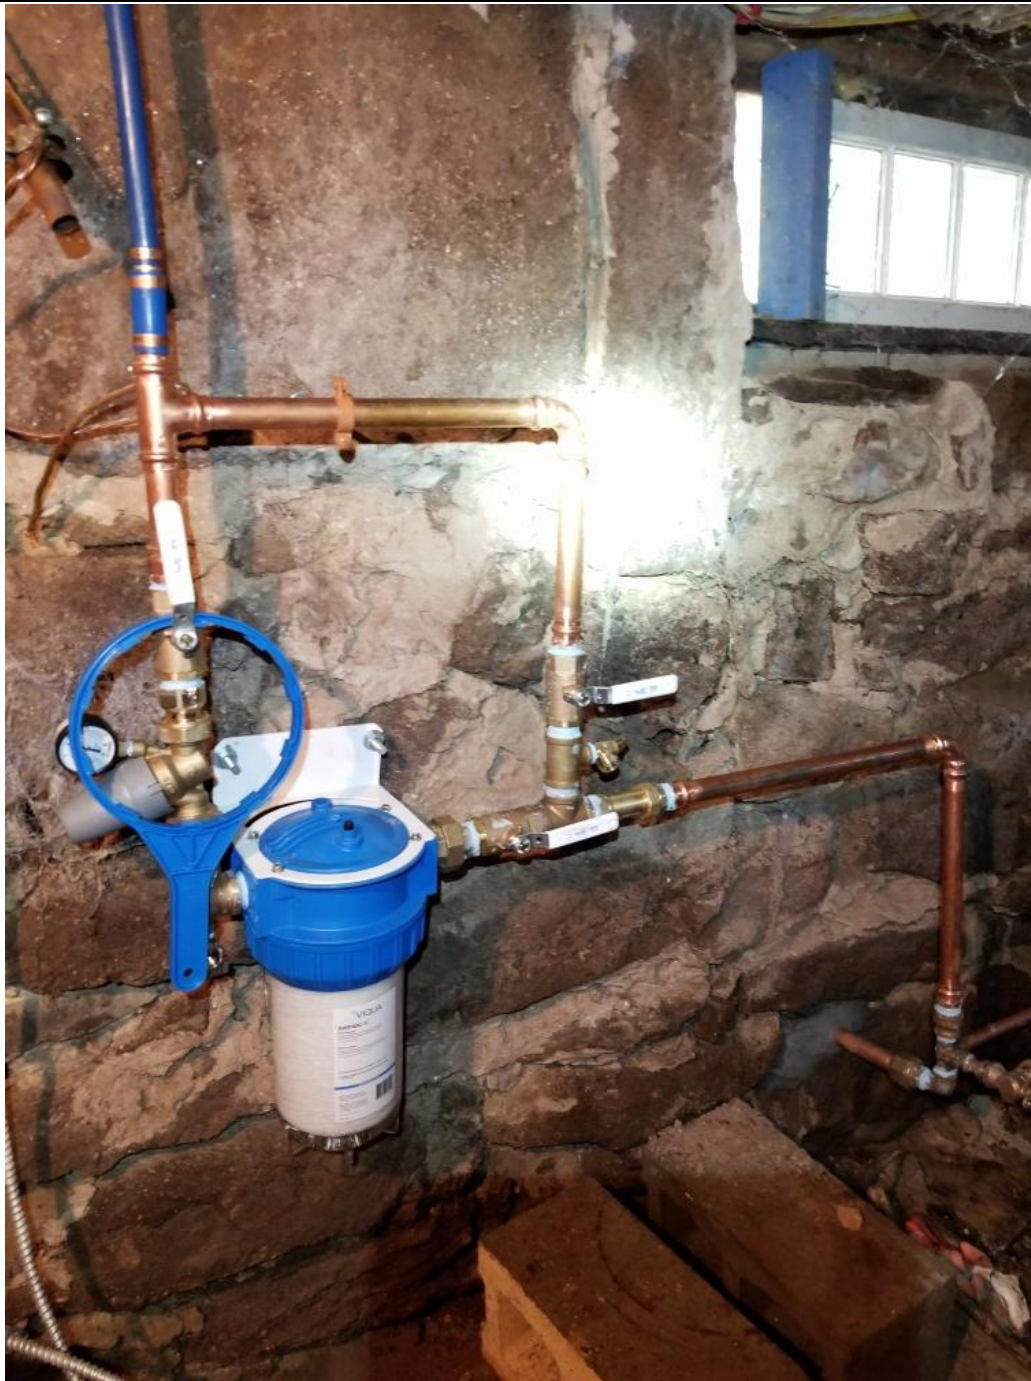
Picture 14: Final water service components that Fazzino Plumbing installed today at the residence located at 267 Main Street, Durham.

1355: Fazzino Plumbing finishes the installation of final water service components at the residence located at 267 Main Street, Durham.
