Daily Report

Project:	Durham Meadows Pipeline Installation	Date:	September 28, 2021
Location:	Main Street, Durham; Shared Access Driveway, Middletown	Day of Week:	Tuesday
Project #:	AECOM: 6061487	Report No:	331
Contractor:	Ludlow Construction	Page:	1 of 17

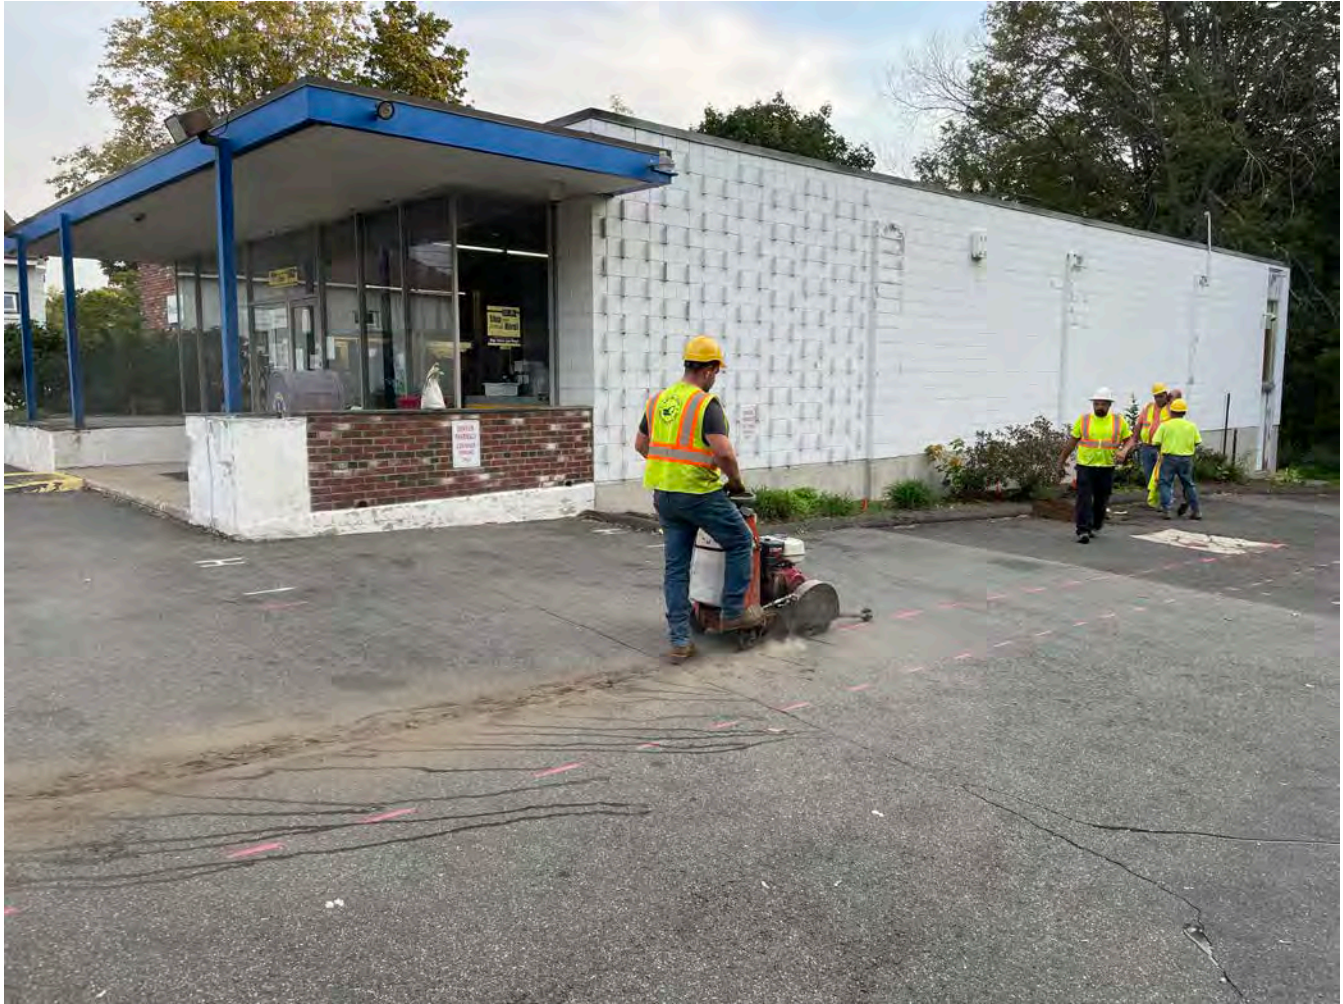
Picture 1: Ludlow saw cutting pavement in the driveway of the 321 Main Street property for the installation of a 1" copper water service line. View to the northeast.

0725: Ludlow has mobilized to the 321 Main Street property to install a 1" copper water service line. Ludlow is currently saw cutting a footprint for a trench in the asphalt parking lot, working east from the curb stop.

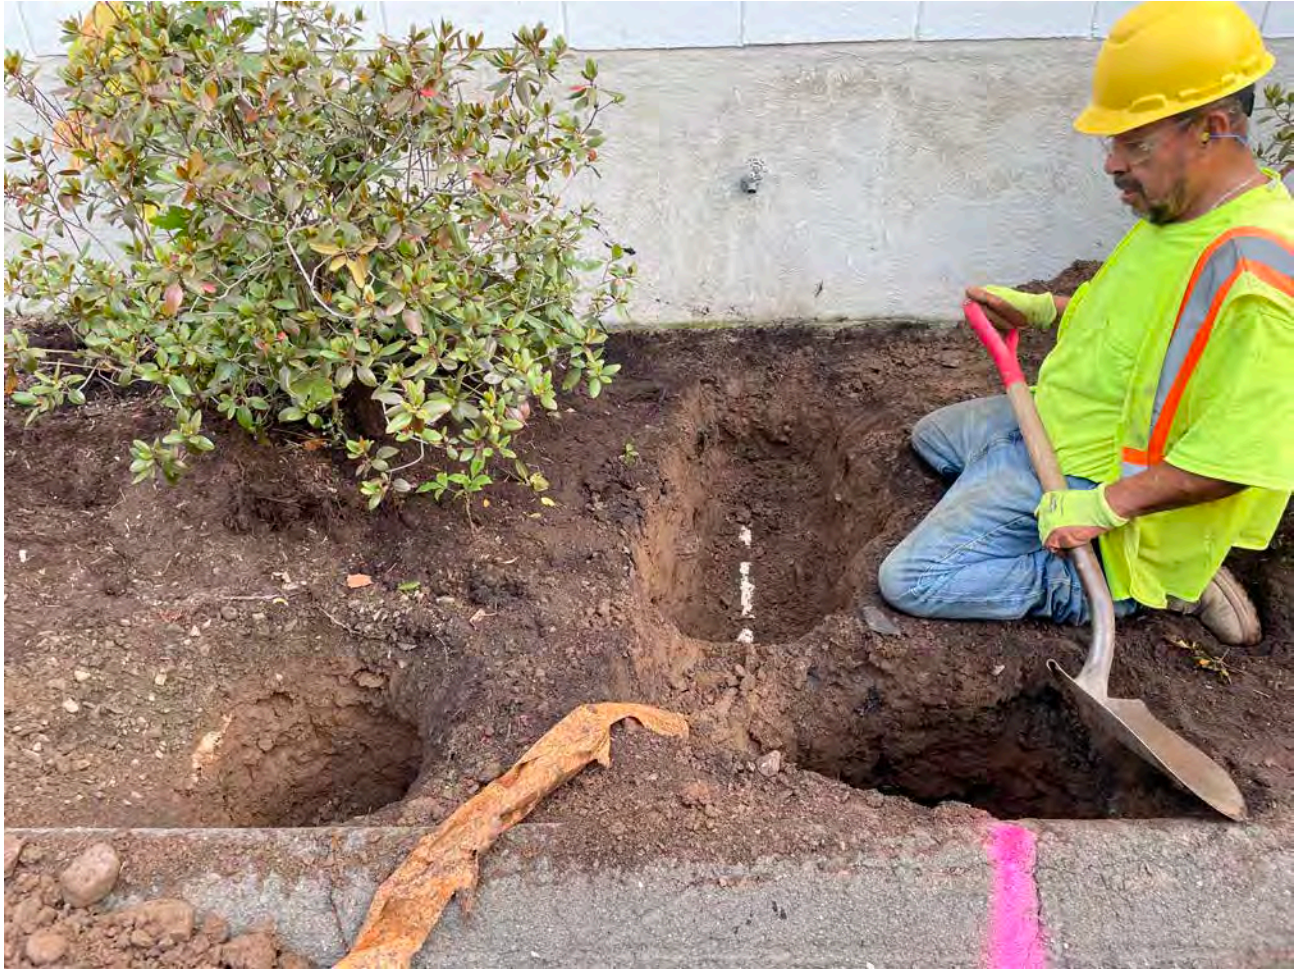
Picture 2: Ludlow hand excavating on the south side of the 321 Main Street building to identify the location of utilities prior to the installation of a 1" copper water service line. View to the north.

0834: Ludlow has removed almost all of the asphalt from the footprint of the trench they will excavate for the installation of a 1" copper water service line at the 321 Main Street, Durham, property. Ludlow is currently hand-digging on the south side of the 321 Main Street building to daylight existing electric and water lines.

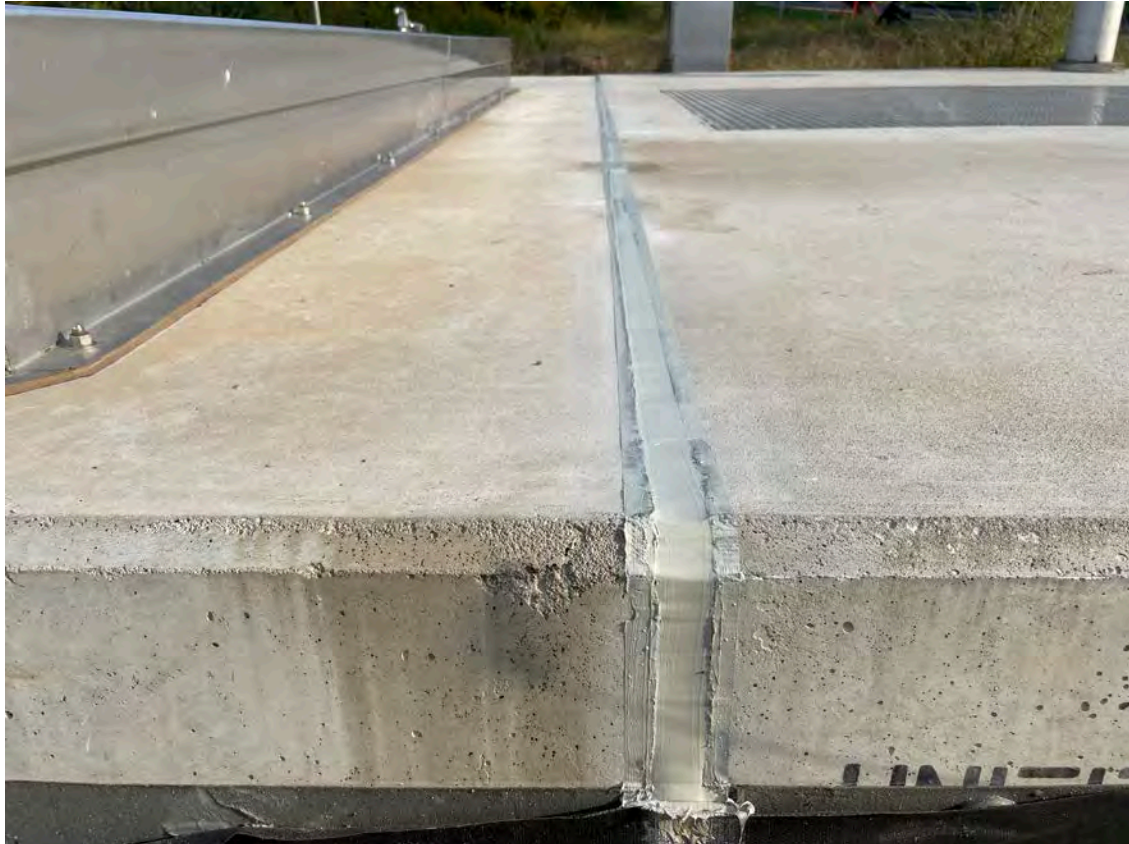
Picture 3: New caulking that United Concrete applied to the seam between the two halves of the PRV vault roof. View to the north.

0738: United Concrete is working at the PRV vault where they are removing caulking between the two sections to the vault roof in order to replace it.

0824: United Concrete continues working on removing the existing caulk between the two sections of the PRV vault roof for replacement.

0902: United Concrete has departed the PRV vault after re-caulking the seam between the two sections of the vault roof.

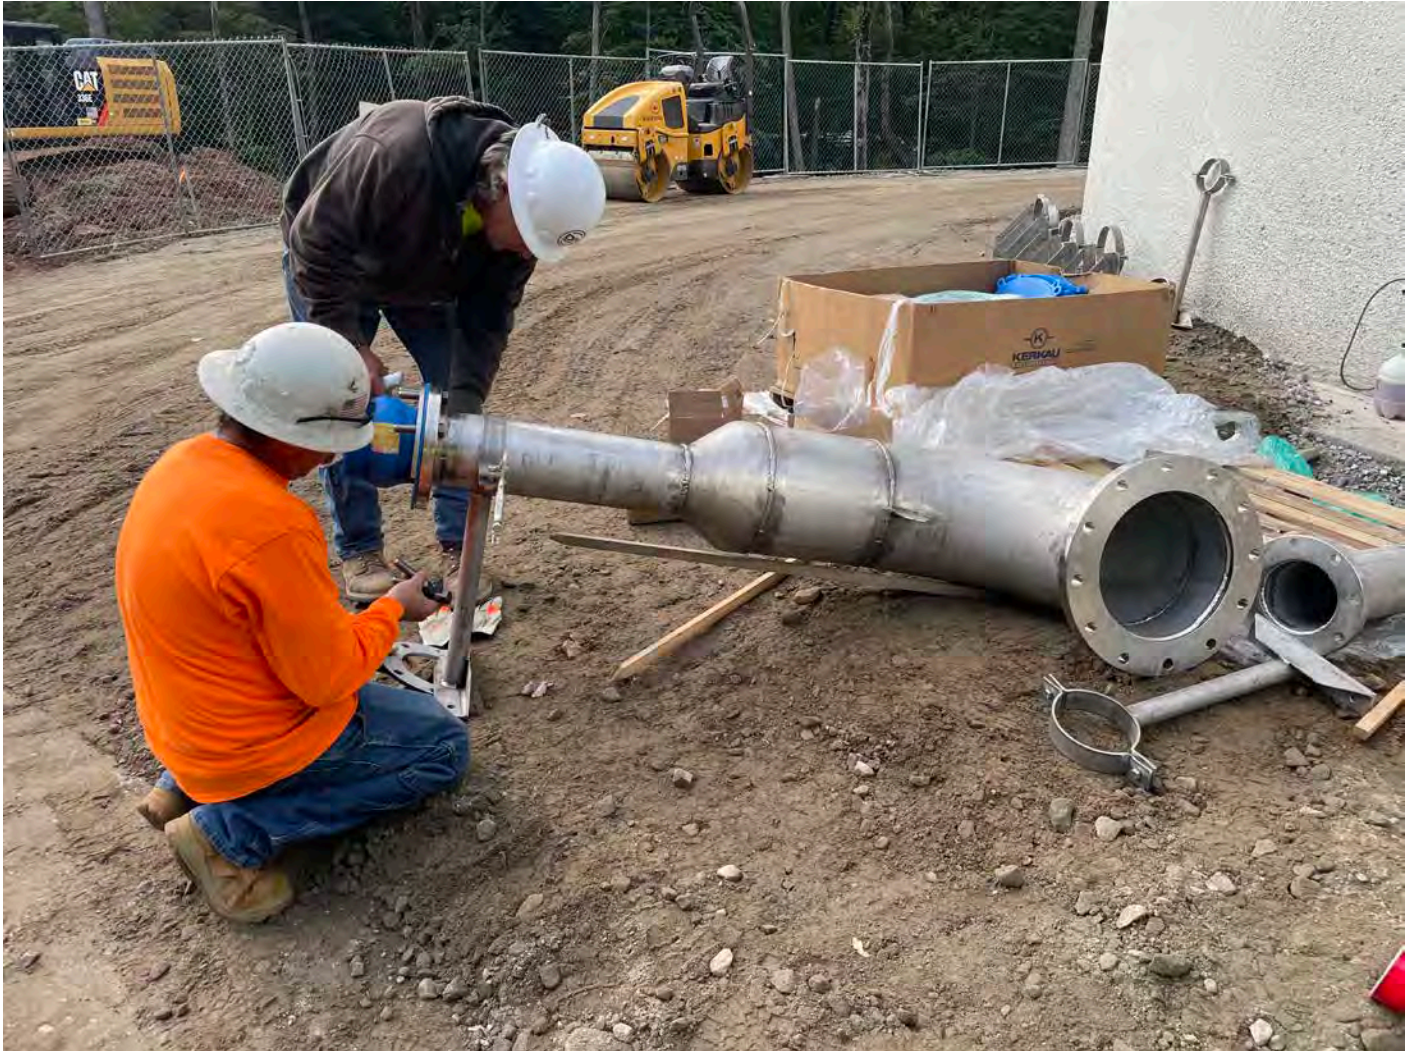
Picture 4: DN Tanks assembling sections of the air duct that will be installed on the northeast side of the water tank located east of the Shared Access Driveway in Middletown. View to the south.

0912: DN Tanks is assembling a portion of the stainless steel air duct (the FL elbow and reducer) that will connect to the blower located on the northeast side around of the water tank.

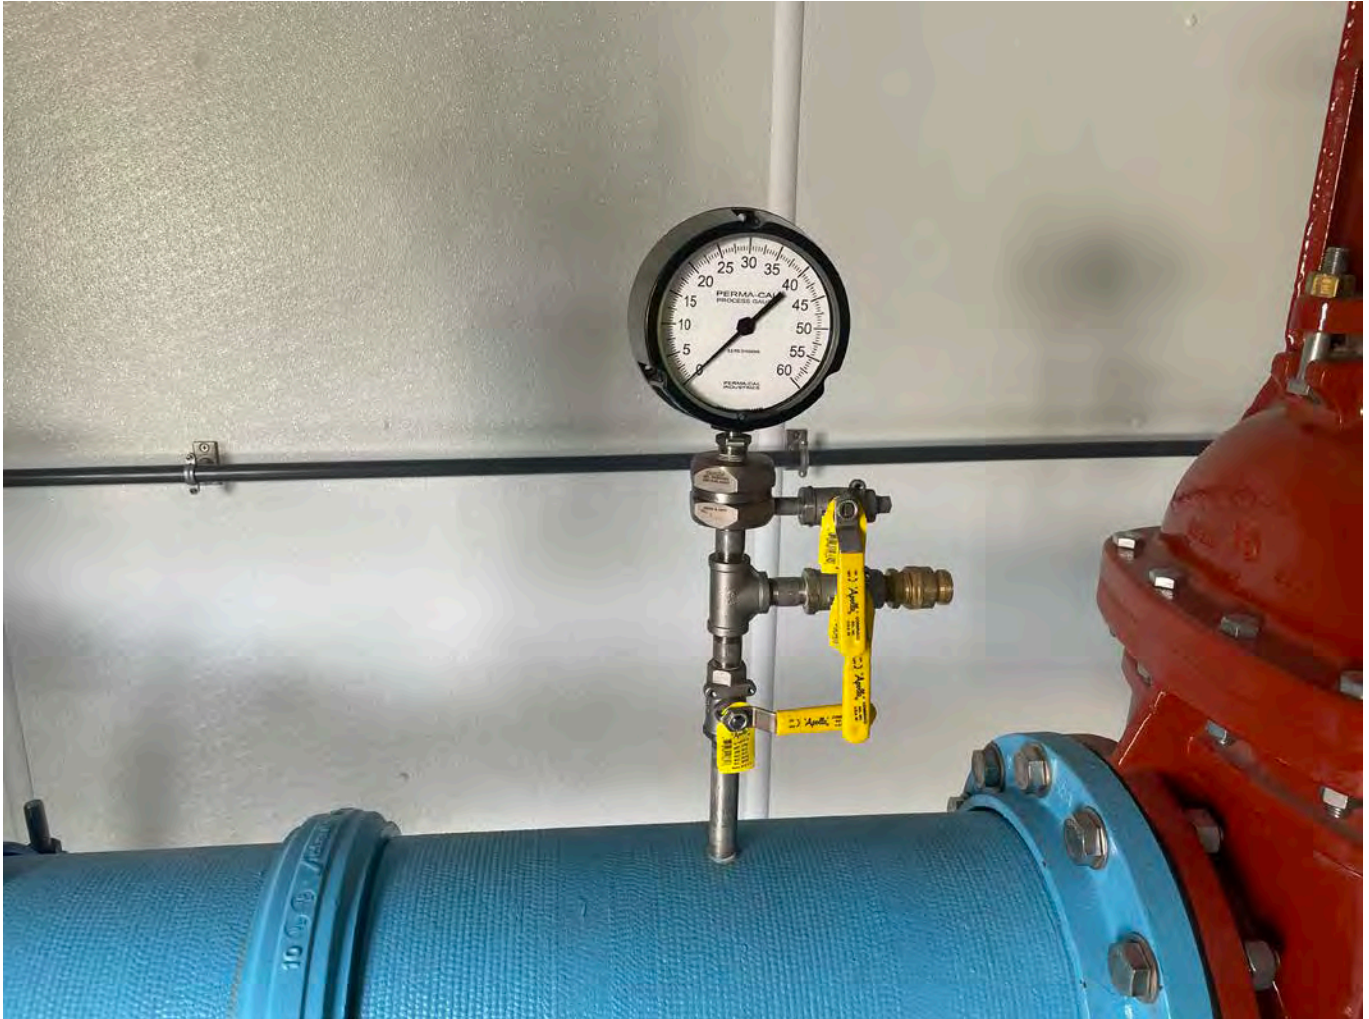
Picture 5: 60 PSI gauge that United Concrete will change out today with a 150 PSI gauge on the 16" DIP waterline located inside of the water meter building located at Station 126+80.

0925: United Concrete is working at the water meter building. They will be exchanging the 60 PSI gauge on the 16" DIP waterline with a 150 PSI gauge; pouring concrete around three penetrations in the vault floor; enlarging a hole around a 1/2" PVC conduit that passes through the fiberglass grate located in the northeast corner of the vault; and spot painting over areas of unpainted concrete. United Concrete will use a 5500 PSI Sacrete mix for patching holes in the bottom of the building.

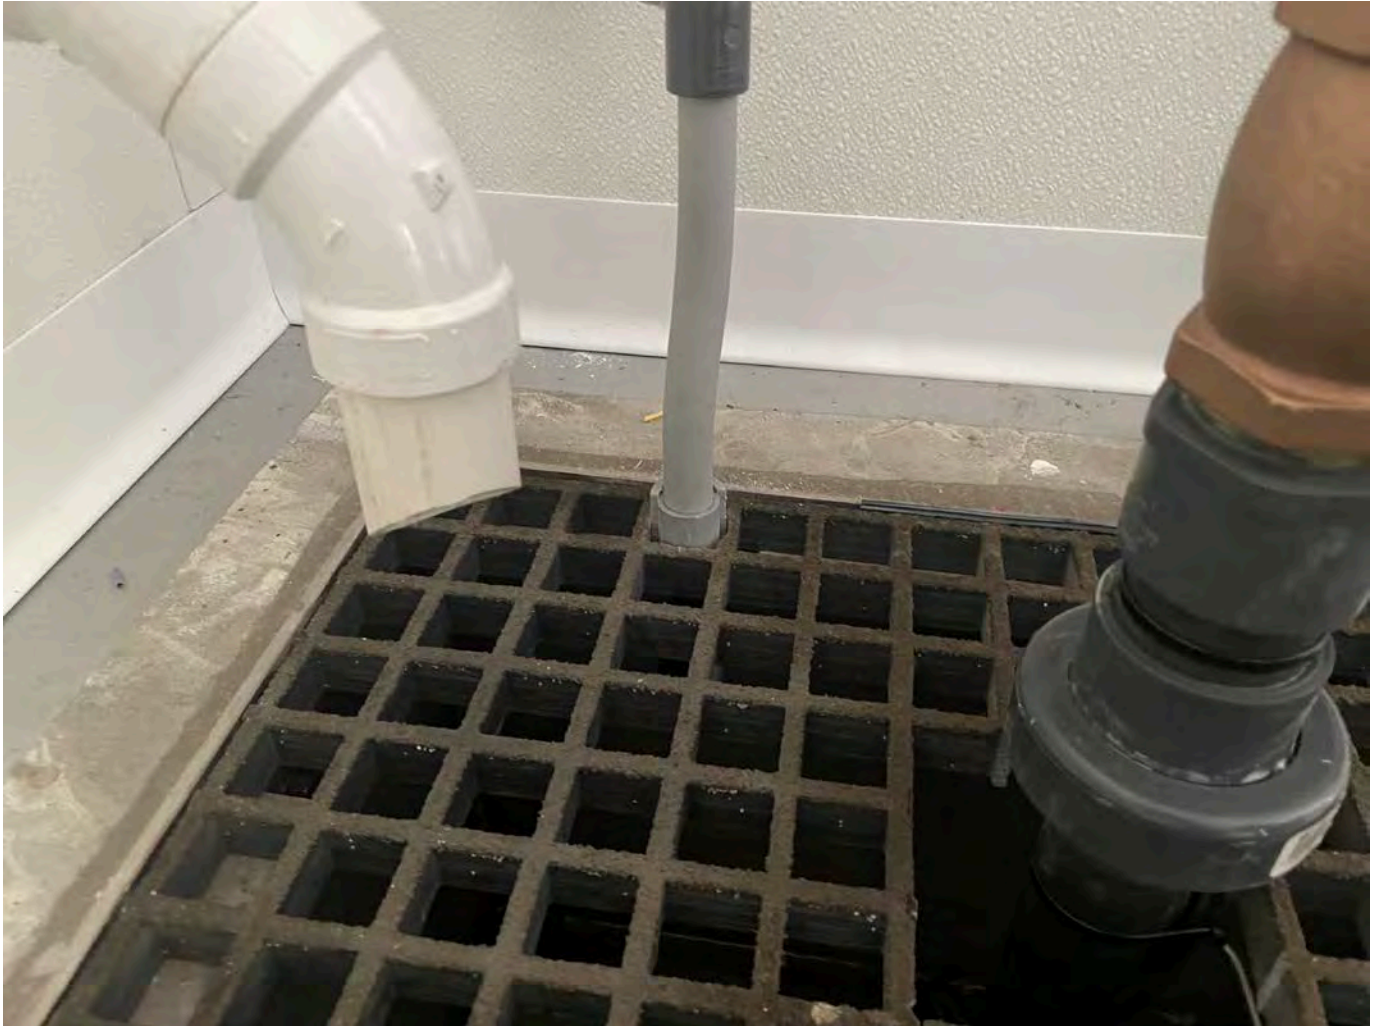
Picture 6: Gray 1/2 PVC conduit that was installed through the fiberglass grate at the northeast corner of the water meter vault located at Station 126+80. United Concrete will cut a larger hole in the grate around the PVC conduit. View to the east.

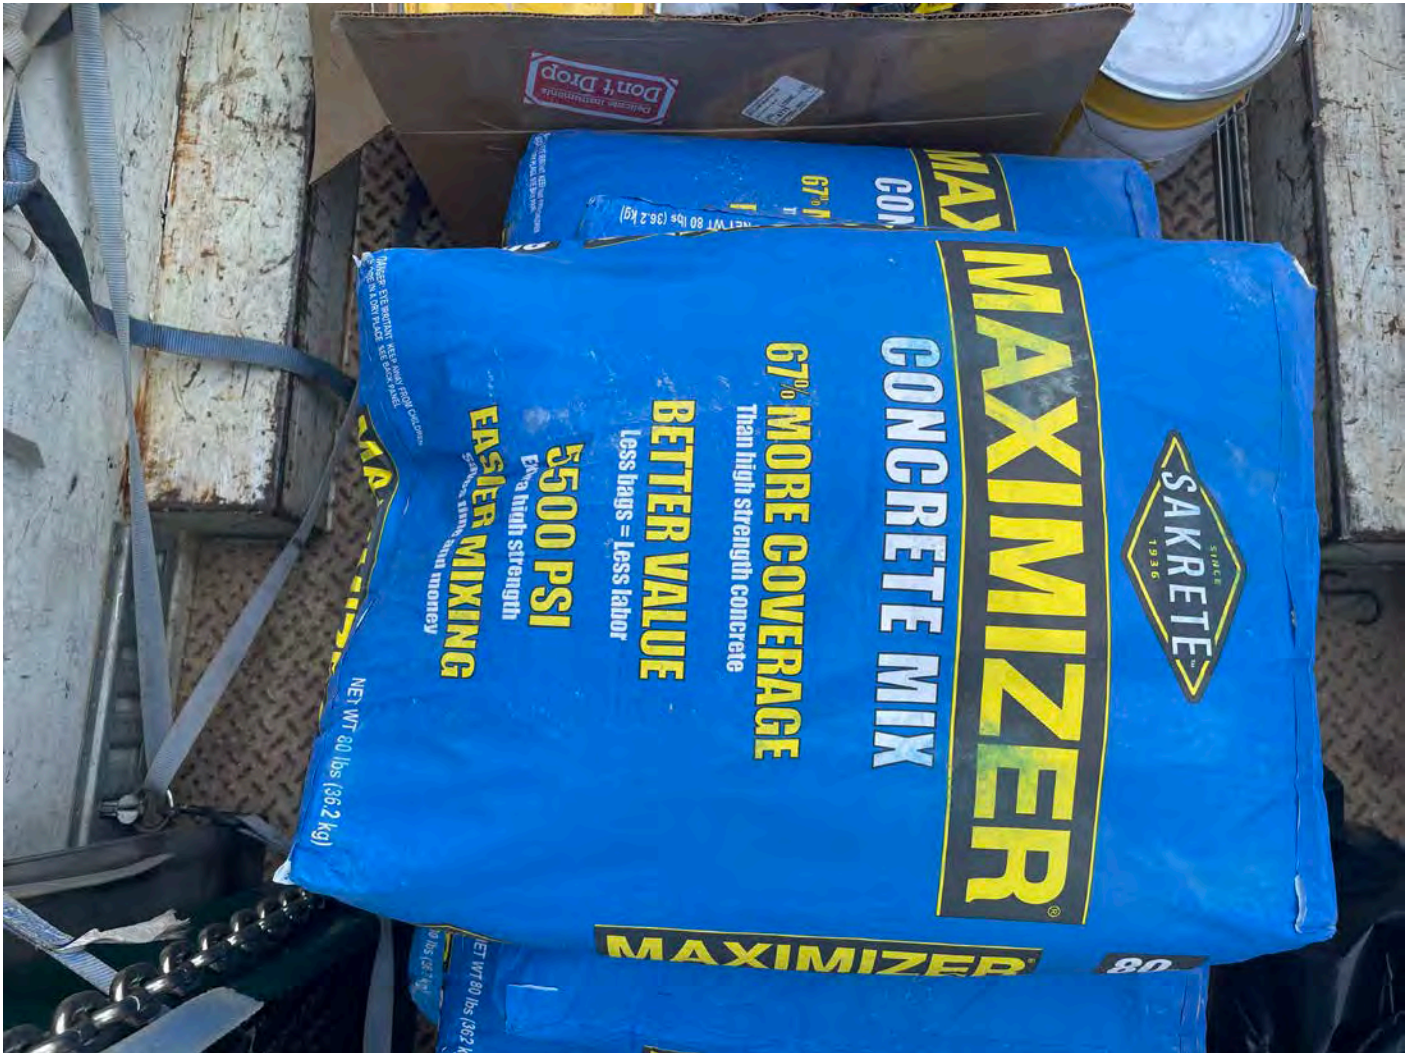
Picture 7: 5500 PSI concrete mix that United Concrete used to fill cut-outs in the water meter building floor.

1031: United Concrete continues to work at the water meter building. United Concrete has filled in two of the three floor cutouts (the two that are located on the west side of the building's interior) with 5500 PSI concrete, and is currently filling the cutout at the southeast corner of the vault's interior where the 16" DIP water line penetrates the building's floor.

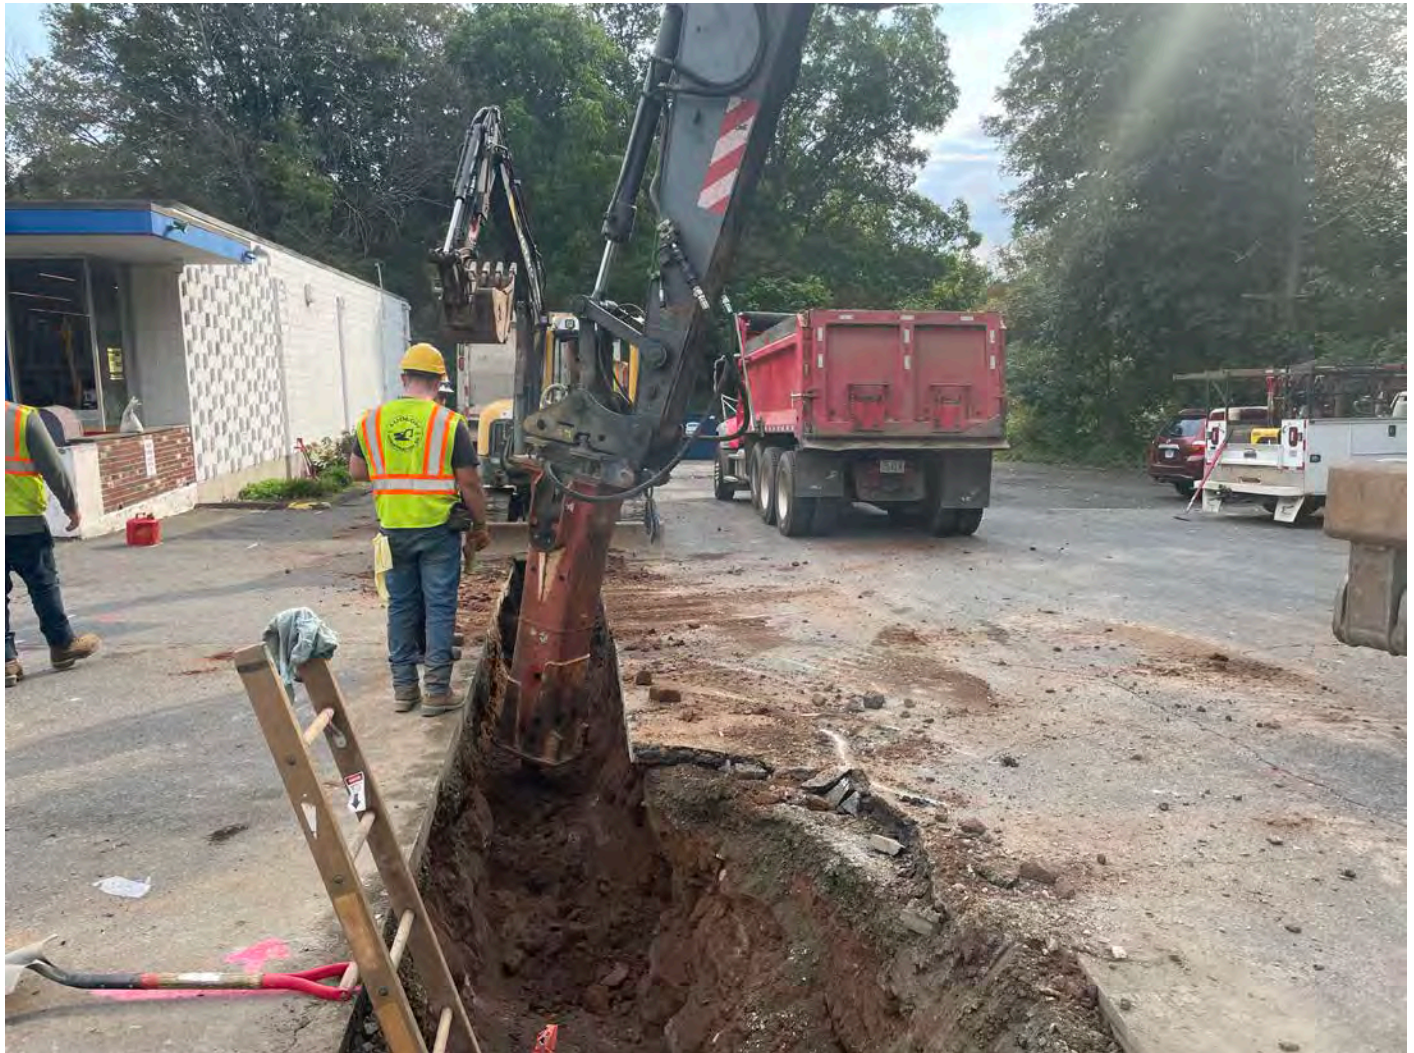
Picture 8: Ludlow hammering rock that they encountered while excavating a trench for the installation of a 1" copper water service line at the 321 Main Street property in Durham. View to the east.

0940: Ludlow is using the excavator equipped with a hammer to break up rock in the trench they are excavating at the 321 Main Street property for the installation of a 1" copper waterline.

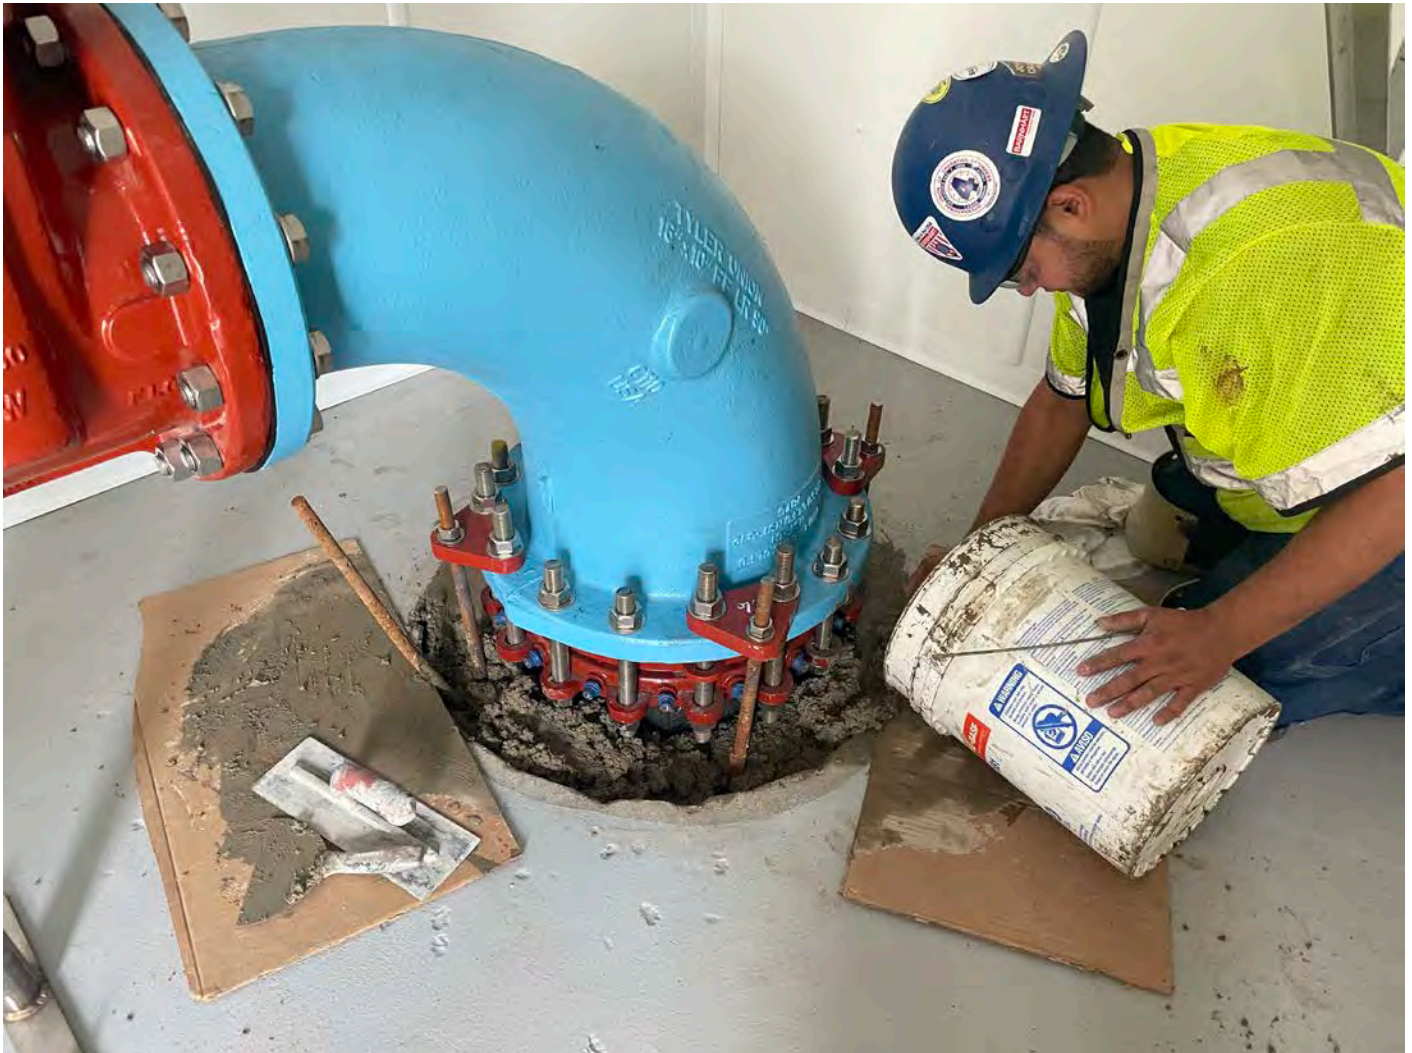
Picture 9: United Concrete placing 5500 PSI concrete around the penetration in the floor of the water meter building where the 16" water line passes through the floor. View to the southeast.

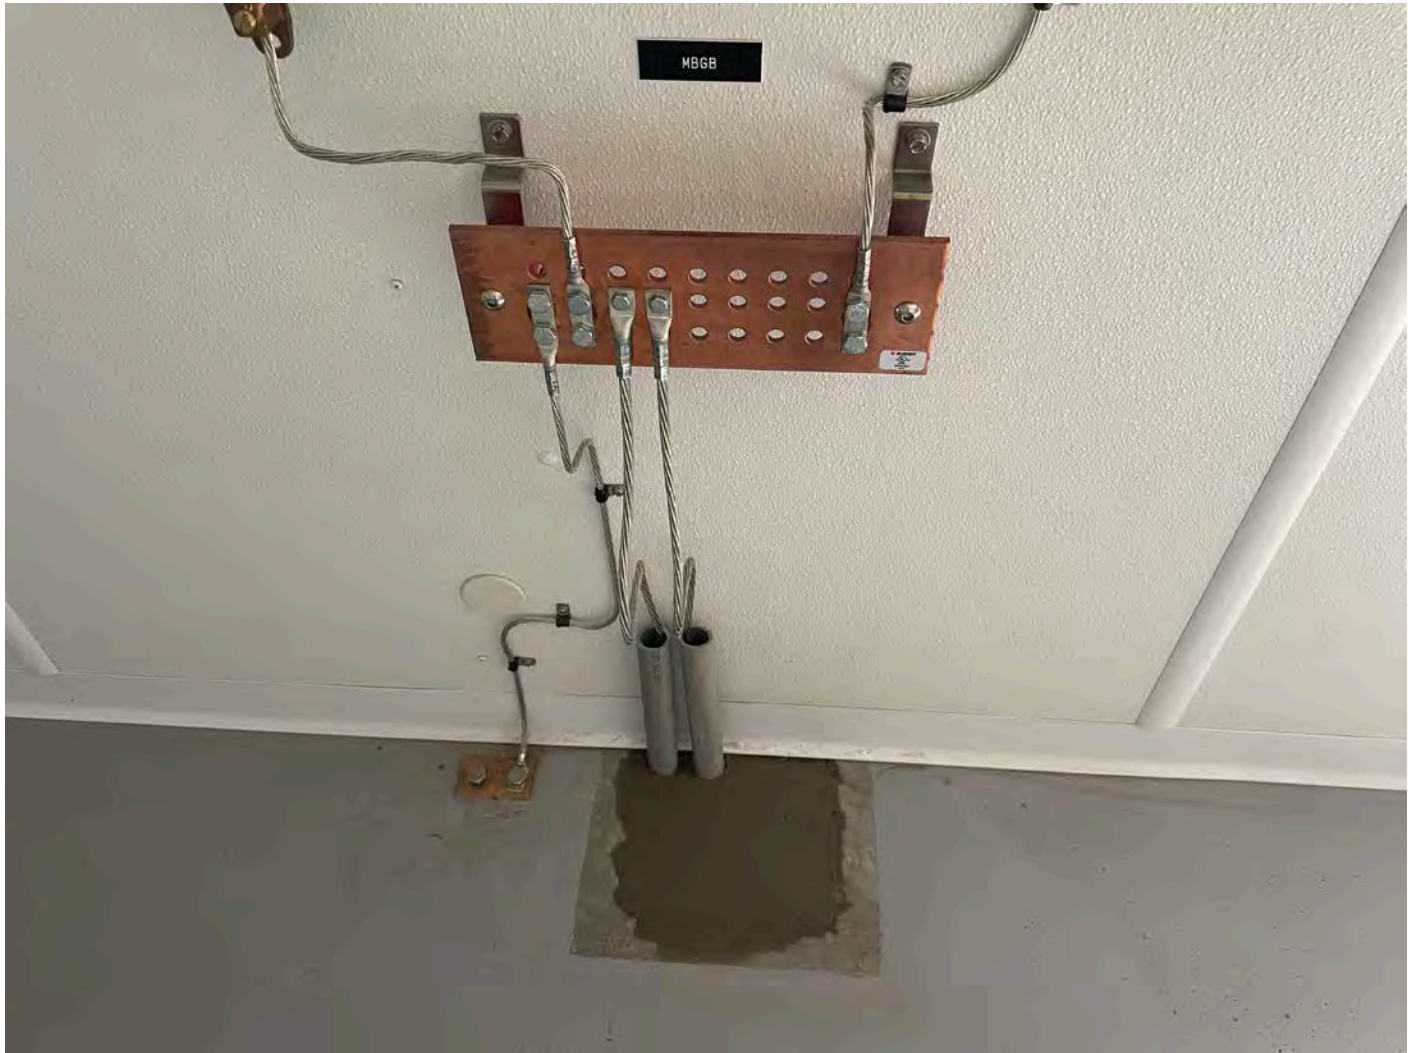
Picture 10: 5500 PSI concrete that United Concrete placed around a penetration in the floor on the west side of the water meter vault. View to the west.

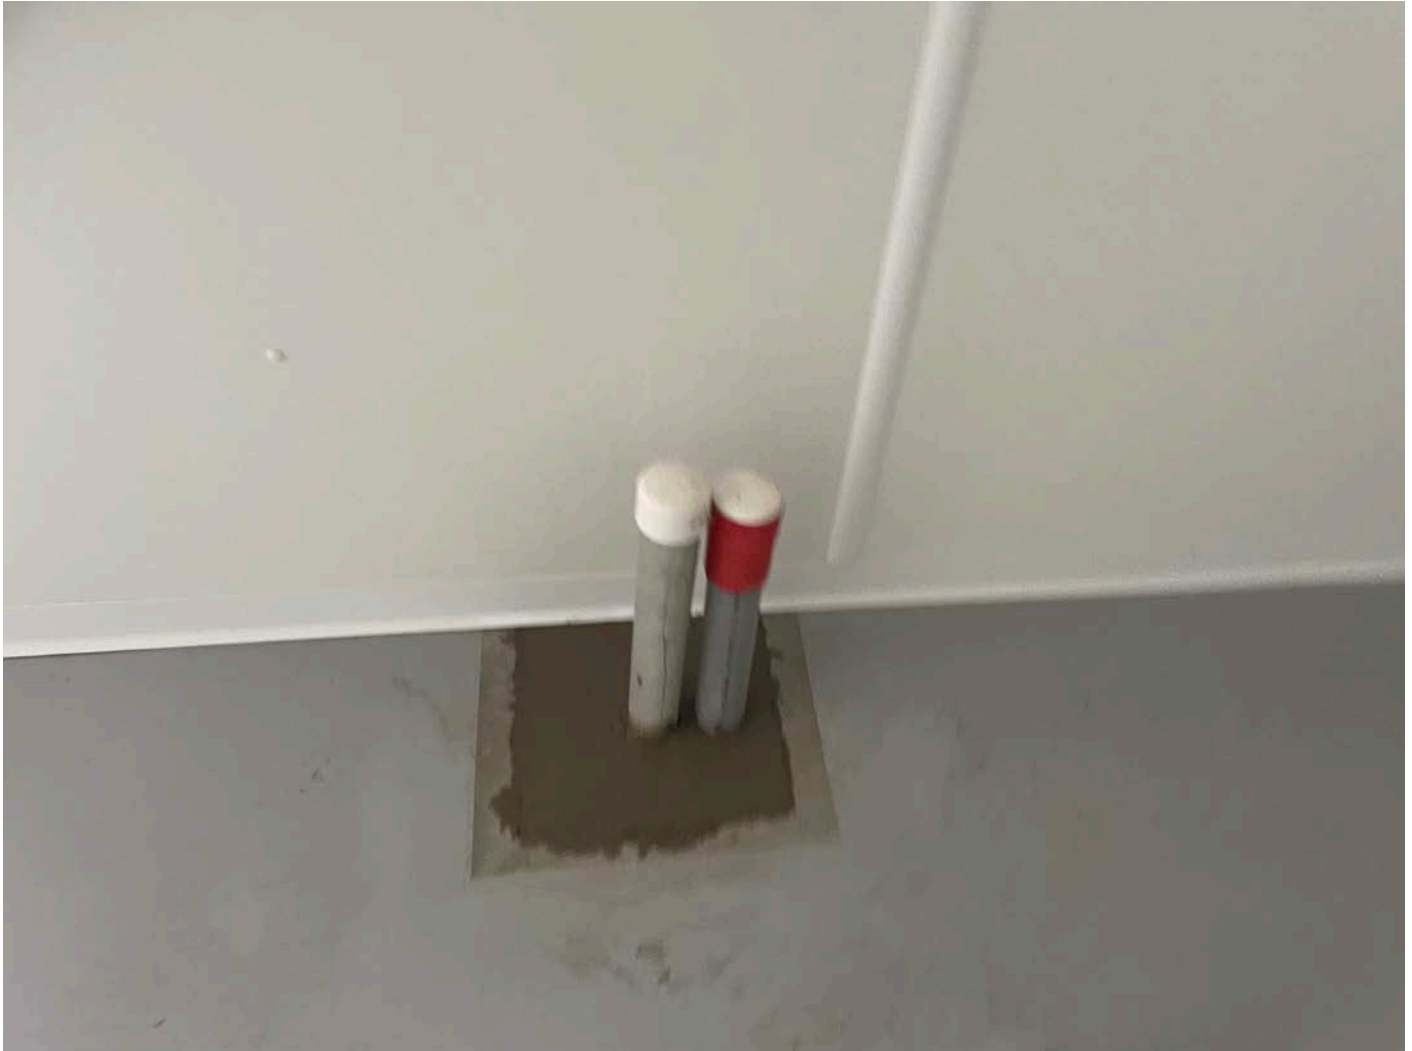
Picture 11: 5500 PSI concrete that United Concrete placed around another penetration in the floor on the west side of the water meter vault. View to the west.

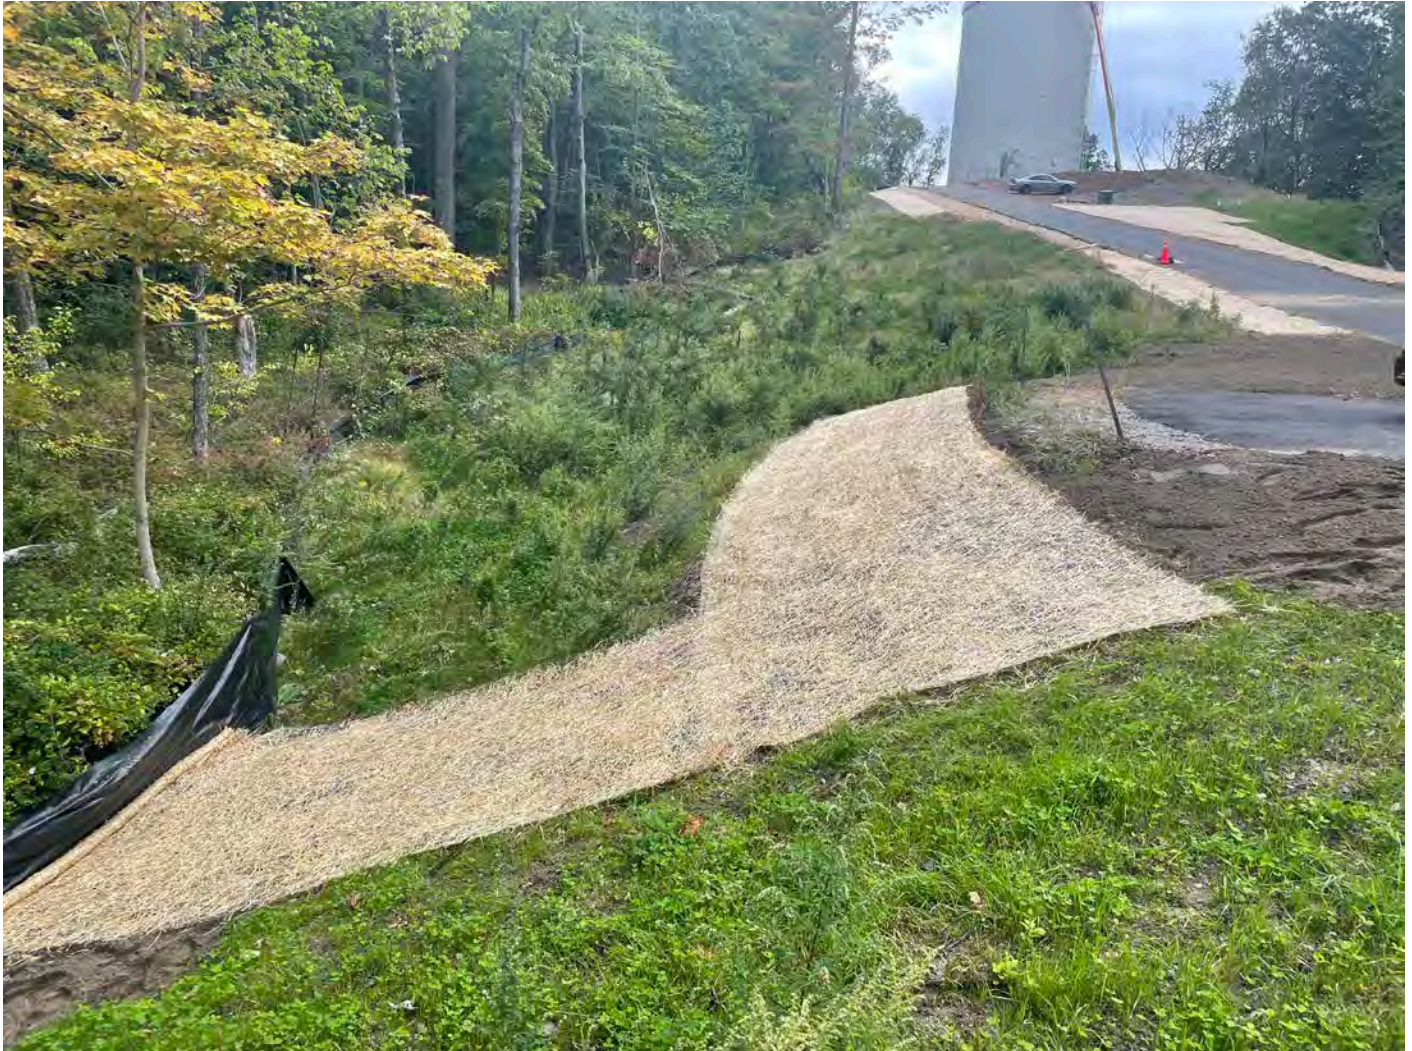
Picture 12: Straw erosion control mats that Ludlow placed on the north side of the turnout located at Station 14+00 on the Shared Access Driveway in Middletown. View to the east.

0920: Ludlow continues to place straw matting on the south side of the Shared Access Driveway where they placed loam and seed yesterday between Stations 12+00 and 13+40. The mat is manufactured by North American Green (DS 150).

1046: Ludlow continues to place straw mat on the north and south side of the Shared Access Driveway where they placed fresh loam and grass seed yesterday.

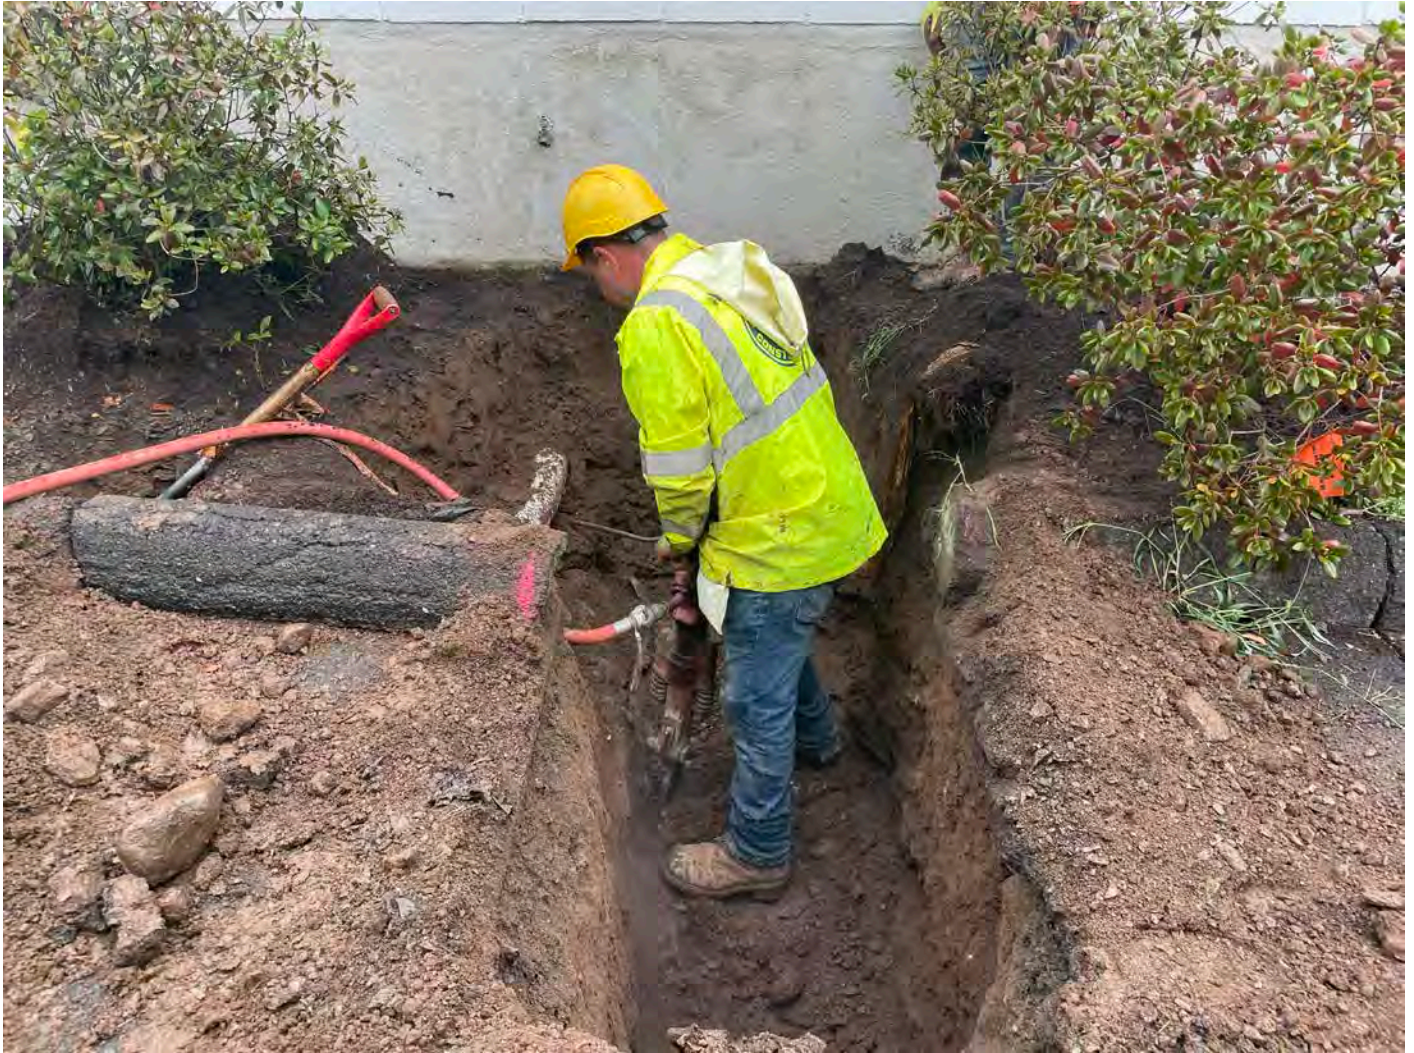
Picture 13: Ludlow jackhammering rock on the south side of the 321 Main Street building for the installation of a 1" copper water service line. View to the north.

1235: Ludlow is jackhammering rock approximately 4' south of the southern foundation of the 321 Main Street building. Ludlow has installed approximately 50' of 1" copper water service line from the curb stop moving eastwards. Ludlow has covered the installed pipe with 6" of sand with caution tape placed over the sand. Heavy rain is currently falling.

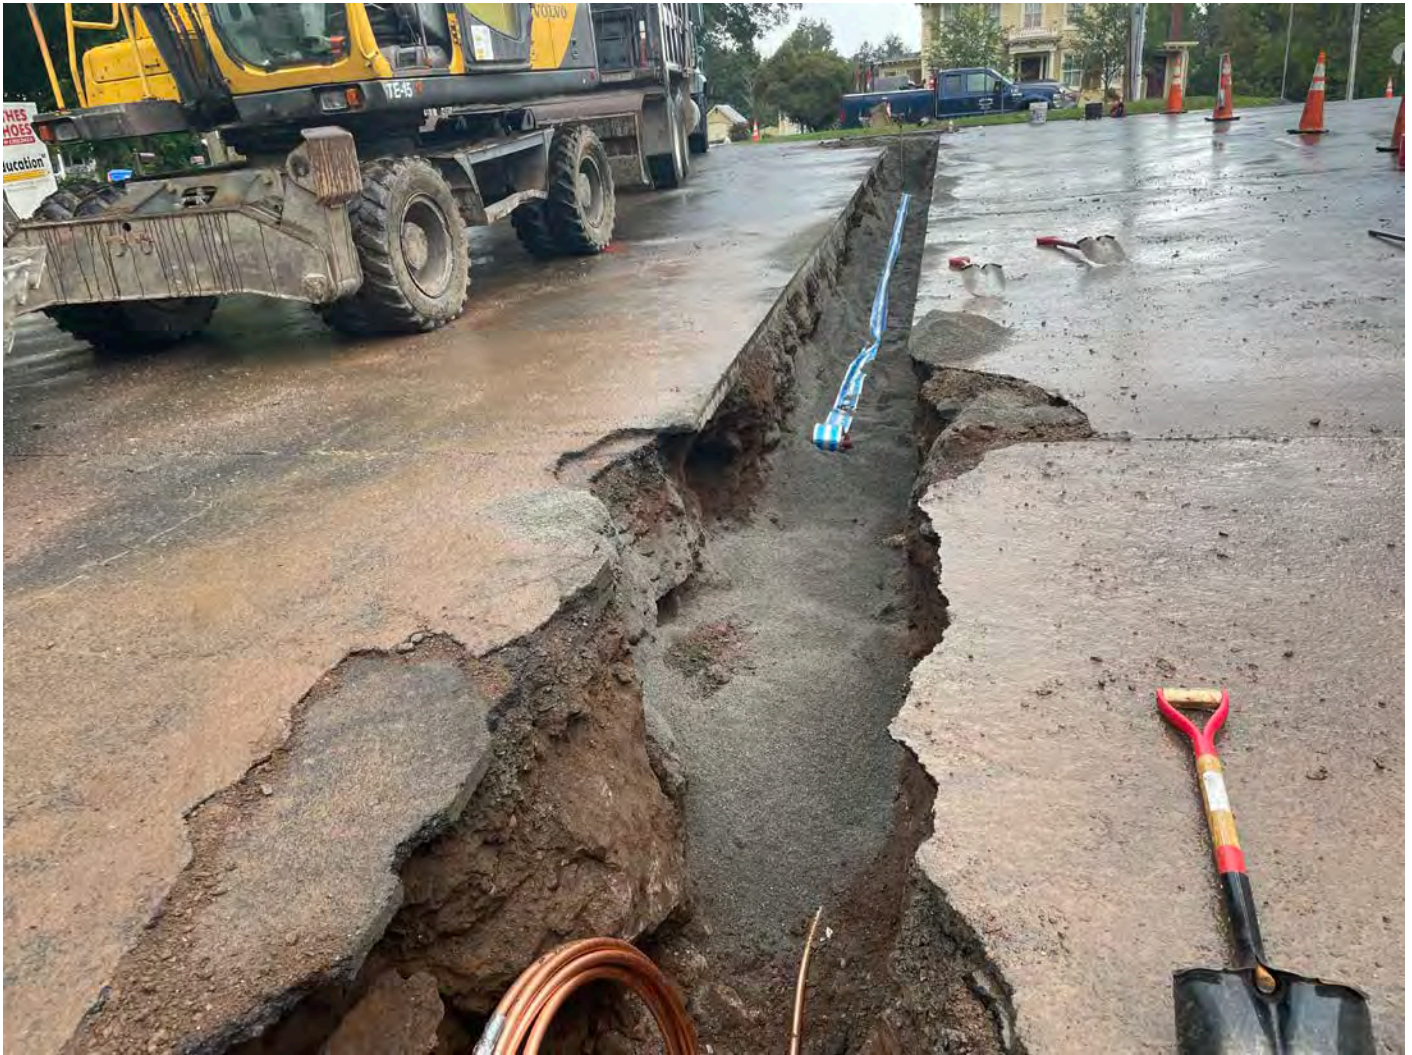
Picture 14: Sand and caution tape that Ludlow has placed over 1" copper water service line at the 321 Main Street property. View to the west.

1356: Ludlow continues to place sand, caution tape, and fill over the 1" copper water service line they have installed at the 321 Main Street property.
