Daily Report

Project:	Durham Meadows Pipeline Installation	Date:	September 29, 2021
Location:	Main Street, Durham; Shared Access Driveway, Middletown	Day of Week:	Wednesday
Project #:	AECOM: 6061487	Report No:	332
Contractor:	Ludlow Construction	Page:	1 of 15

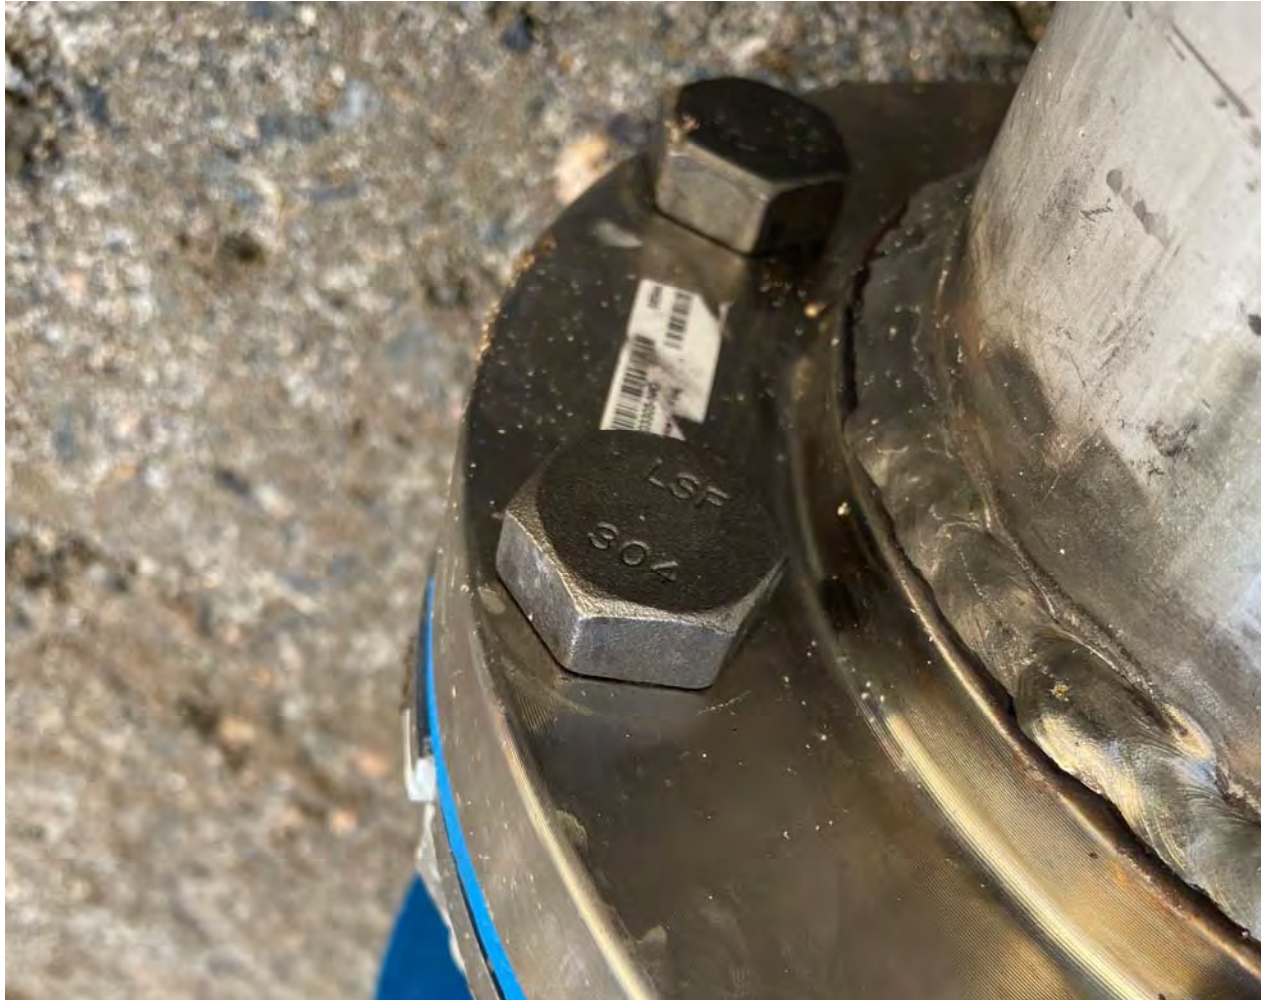
Picture 1: 304 stainless steel bolts used to connect sections of 12" stainless steel air duct piping on the northeast side of the water tank located east of the Shared Access Driveway.

0942: DN Tanks is beginning to assemble the air duct and attach it to the side of the tank on the northeast side of the water tank. 304 stainless steel bolts are being used to make the connections between sections of the stainless steel air duct piping.

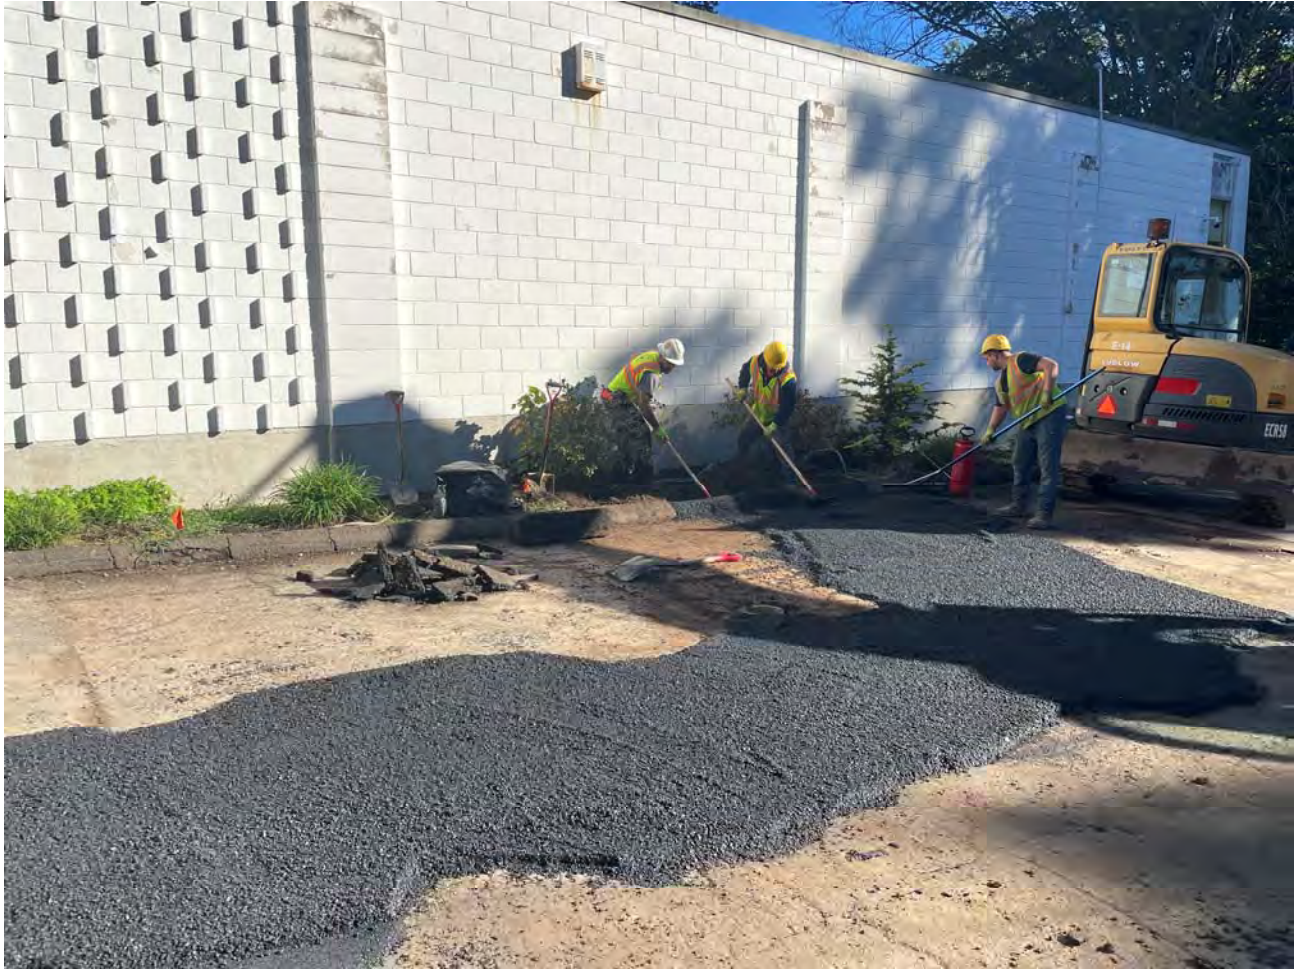
Picture 2: Ludlow raking out asphalt they placed on the south side of the 321 Main Street building over the trench they are backfilling after having installed a 1" copper water service line. View to the northeast.

0906: Ludlow begins to place and compact asphalt over the trench they excavated yesterday at the 321 Main Street property for the installation of a 1" copper water service line.

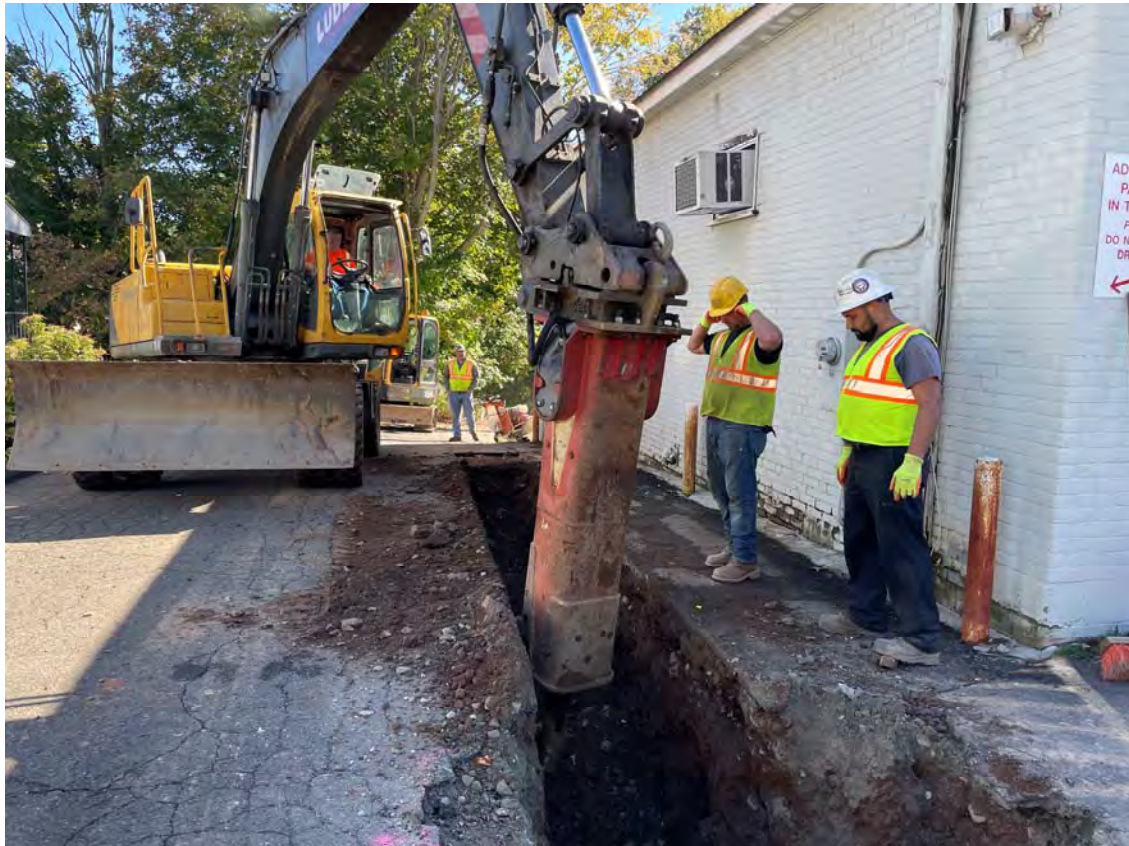
Picture 3: Ludlow hammering rock on the north side of the 325 Main Street building as they work to install a 1" copper water service line. View to the east.

1221: Ludlow is using a hammer attached to the excavator to break up rock in the trench that they are excavating on the north side of the 325 Main Street building for the installation of a 1" copper water service line.

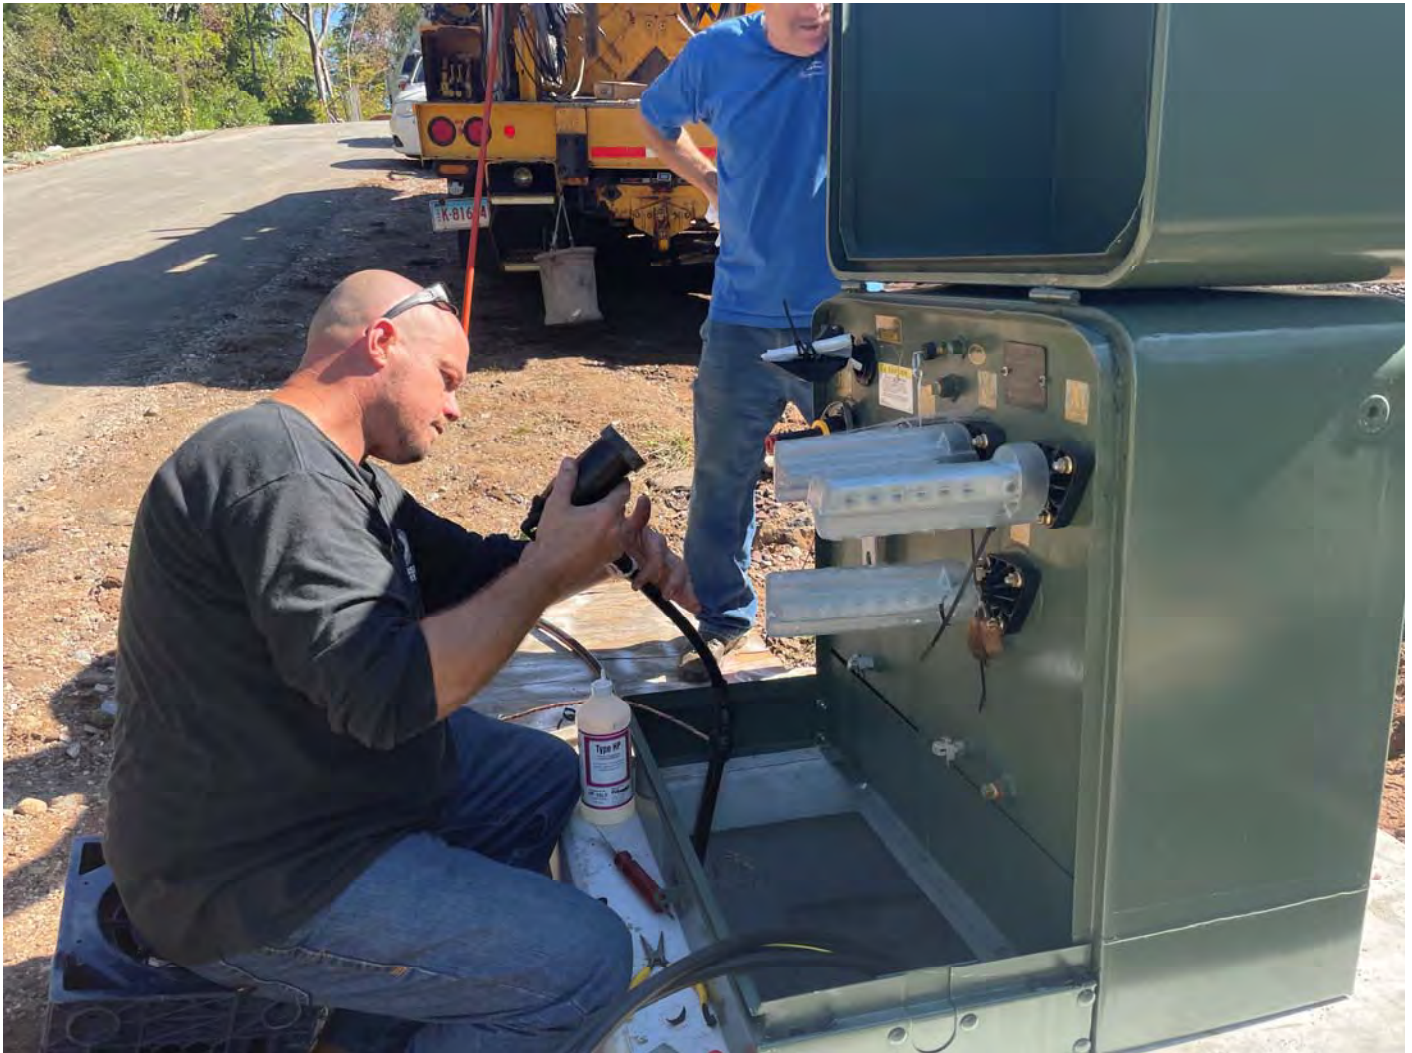
Picture 4: Eversource connecting a primary line to the transformer located at Station 12+00 on the Shared Access Driveway in Middletown. View to the east.

1143: Eversource is connecting primary and secondary power lines to the transformer located at Station 12+00.

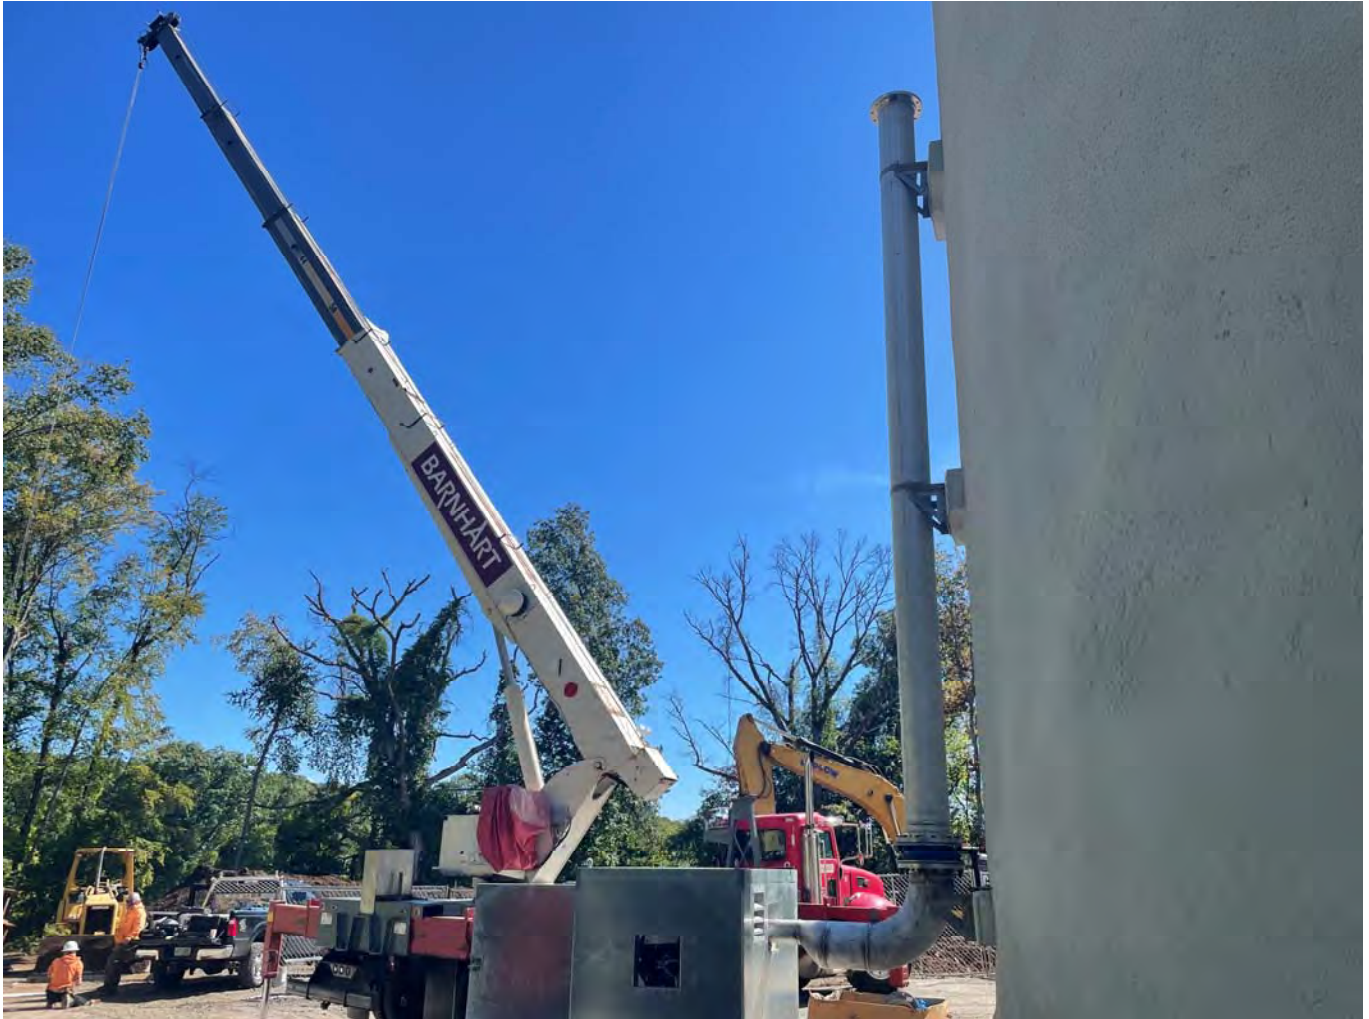
Picture 5: 20' section of 12" stainless steel air duct that DN Tanks has attached to the southwest side of the blower and the northeast side of the water tank located east of the Shared Access Driveway in Middletown. View to the southeast.

1151: DN Tanks continues to connect mounting brackets to the northeast side of the water tank in order to mount the 12" stainless steel air vent. DN Tanks has already connected a 20' section of the 12" air vent on top of the 90° elbow that is attached to the southwest side of the blower.

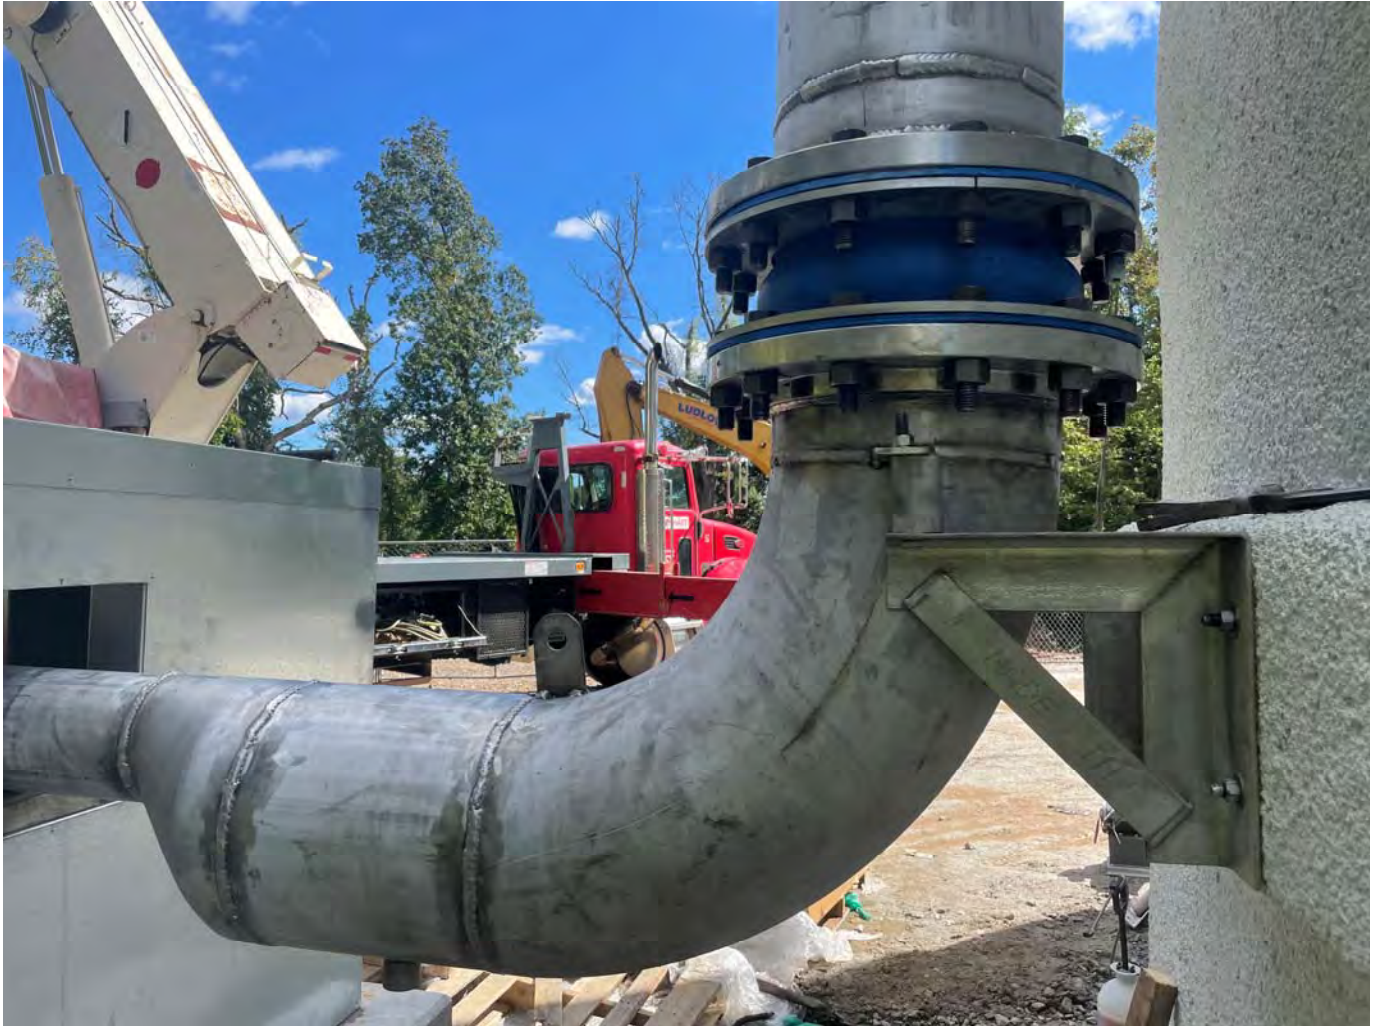
Picture 6: Stainless steel elbow exiting the southwest side of the blower, connected to 12" stainless steel air duct with a 12" Garlock Style 8400 expansion joint. View to the southeast.

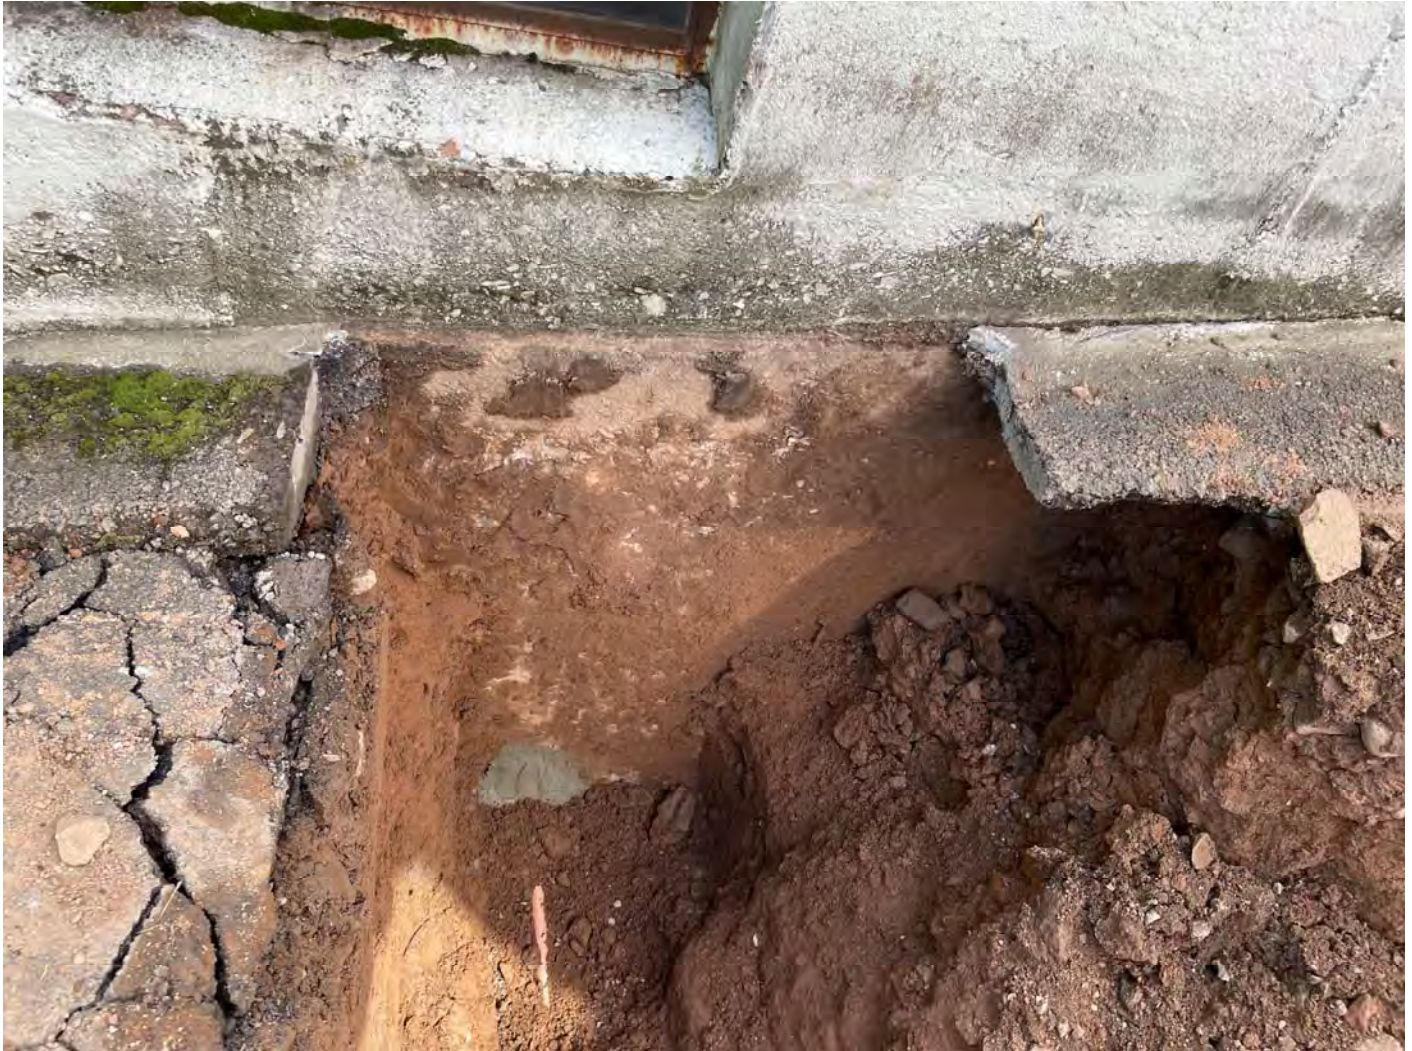
Picture 7: Poured concrete foundation that Ludlow has exposed on the north side of the 325 Main Street, Durham, building as they work to install a 1" copper water service line. View to the south.

1315: Ludlow has installed a 1" copper water service line at the 325 Main Street property from the curb stop to the penetration into the north side of the property's foundation. The penetration into the poured concrete foundation was made 5' 5" west of the building's northeast corner. Ludlow is currently placing sand over the 1" copper water service line.

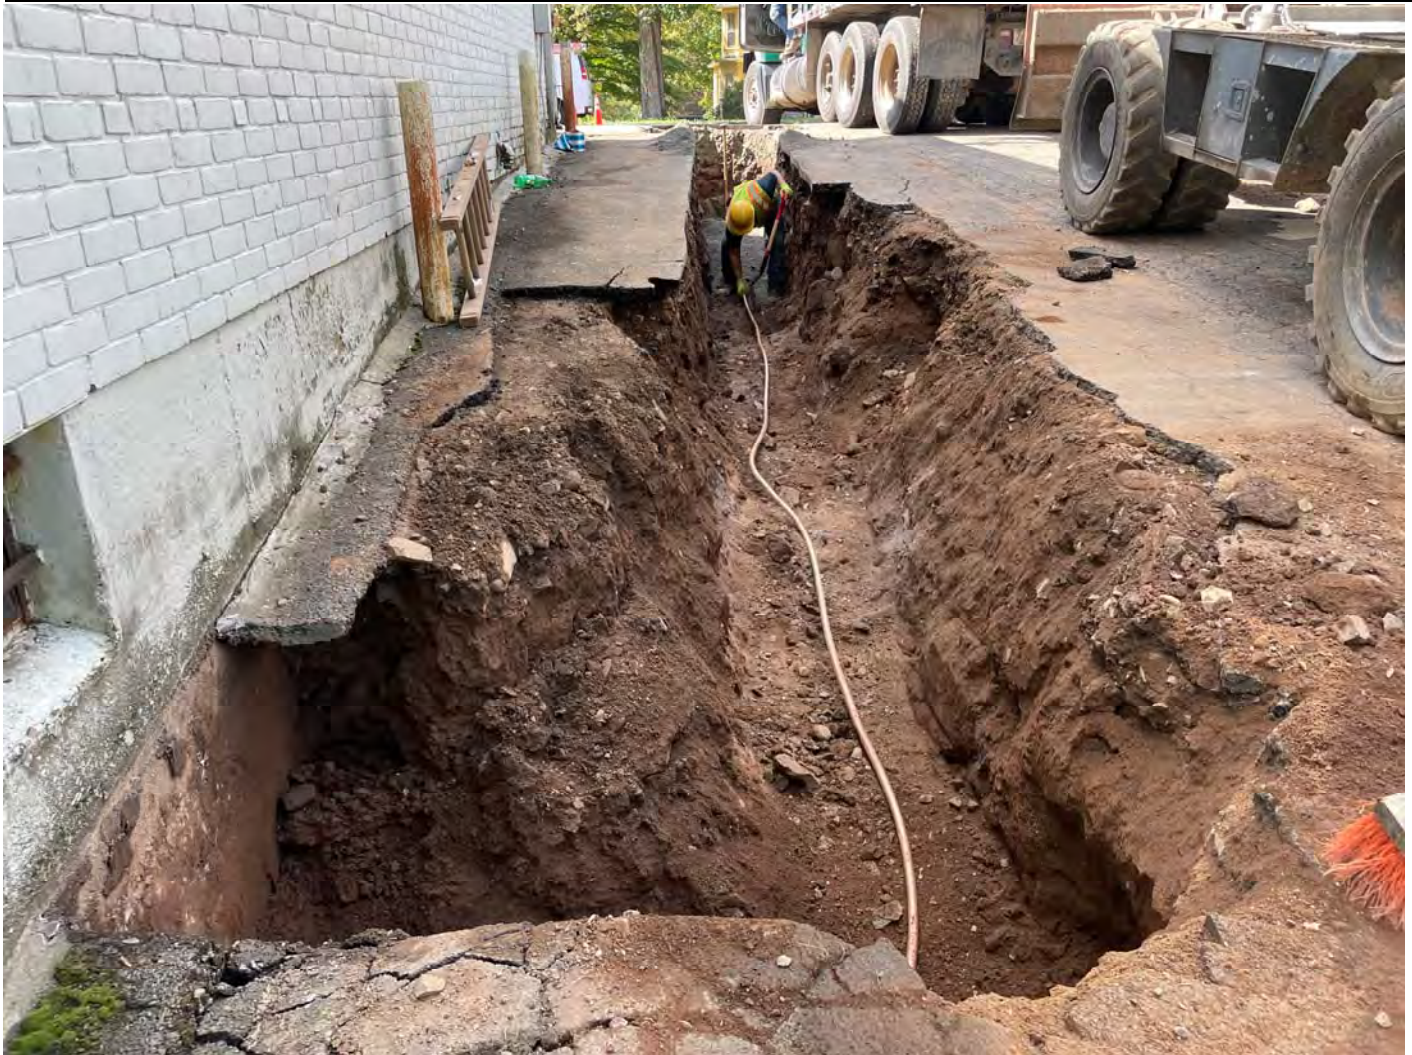
Picture 8: 1" copper water service line that Ludlow has installed on the north side of the 325 Main Street, Durham, building. View to the west.

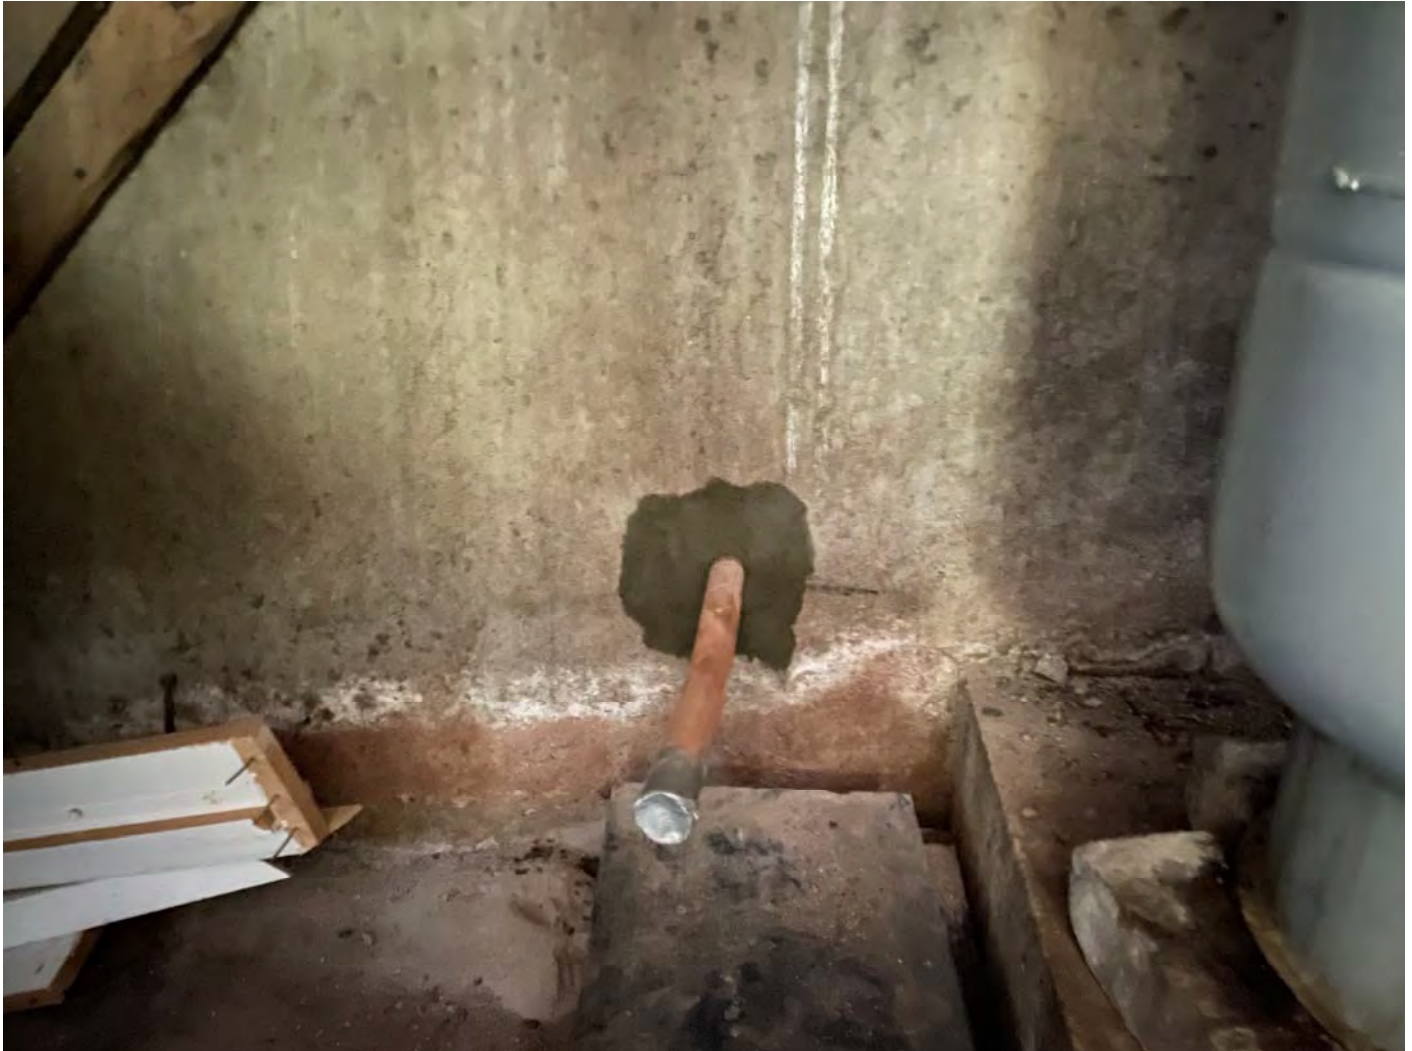
Picture 9: 1" copper water service line that Ludlow has installed through the northern foundation of the 325 Main Street building and has secured with non-shrink grout. View to the north.

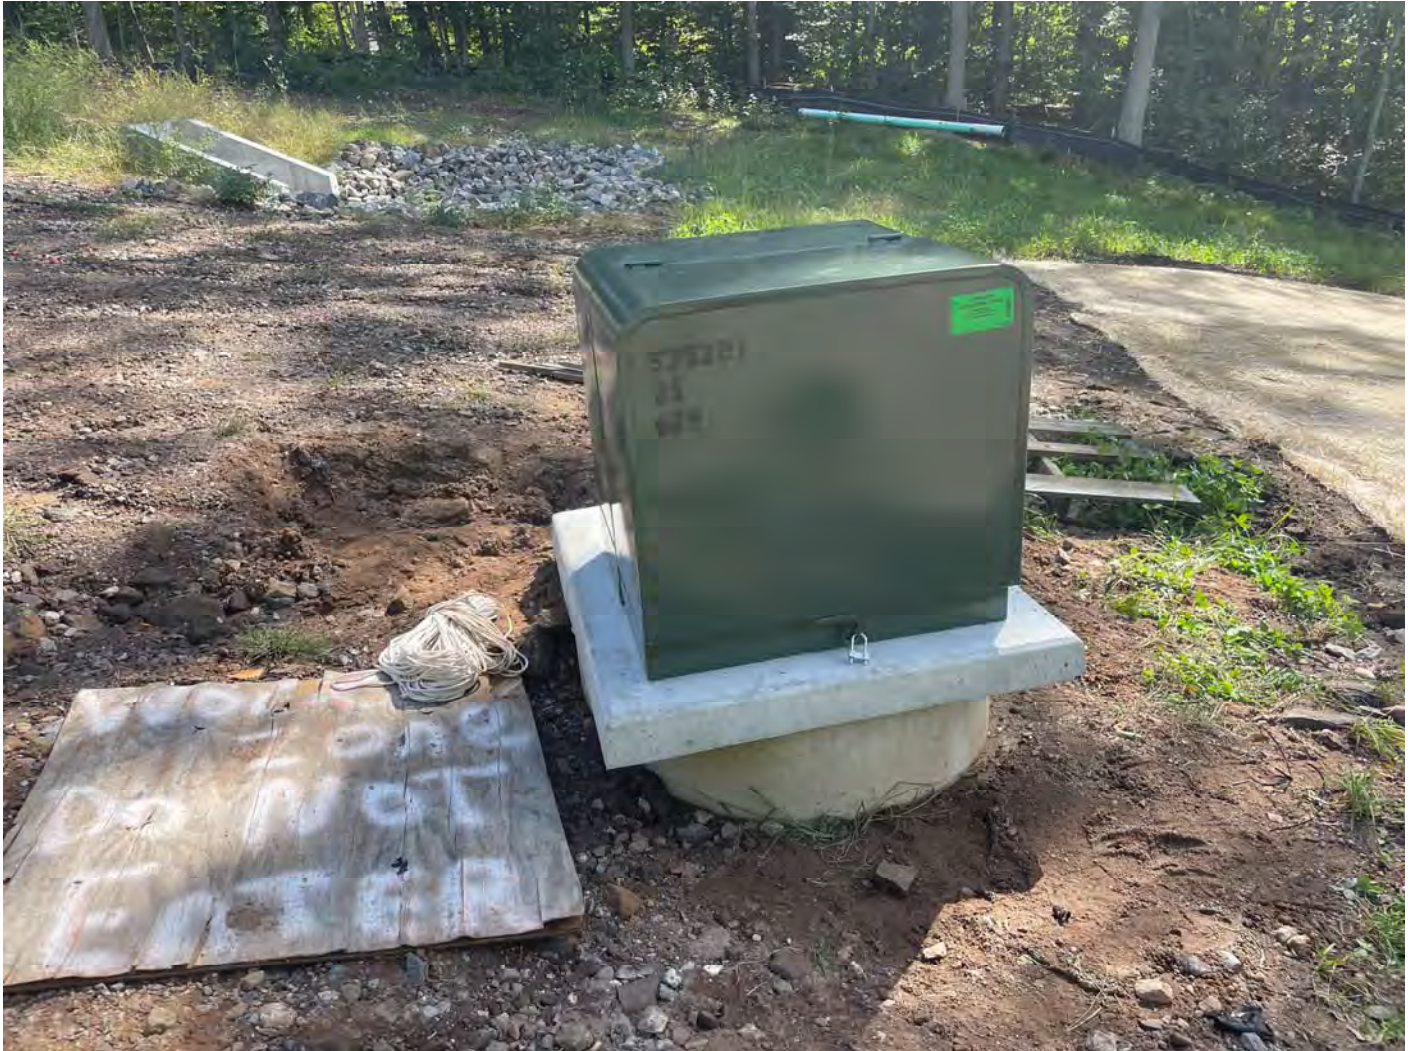
Picture 10: Transformer set in place by Eversource at Station 12+00. View to the south.

1114: Eversource has set the transformer at Station 12+00 onto the transformer slab.

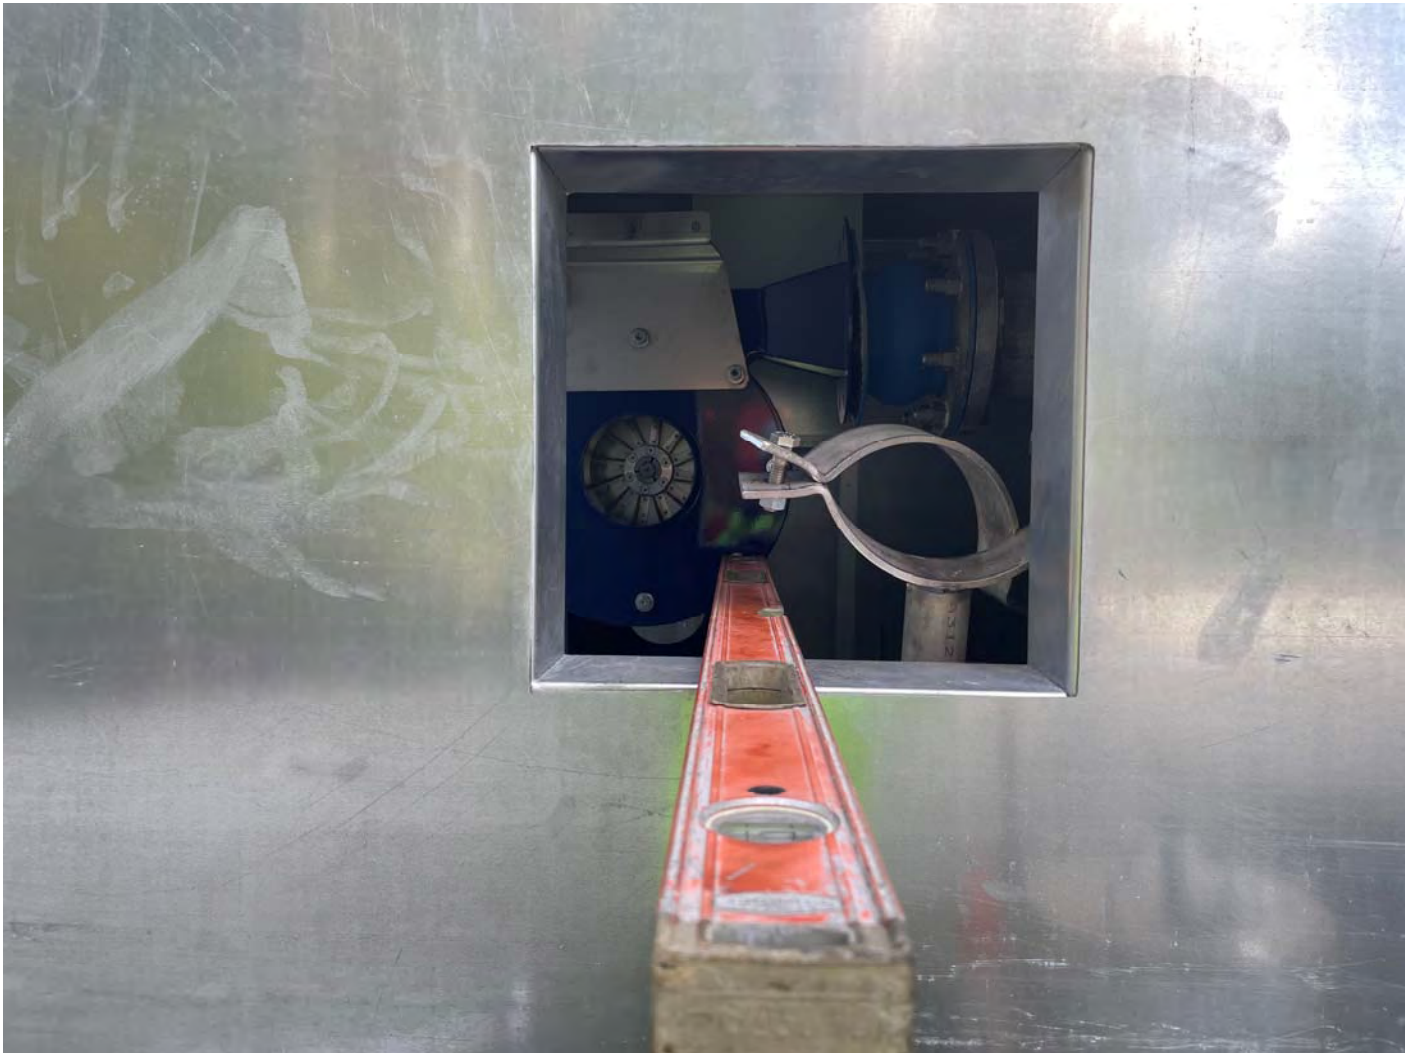
Picture 11: View into the blower enclosure on its west side. View to the east.

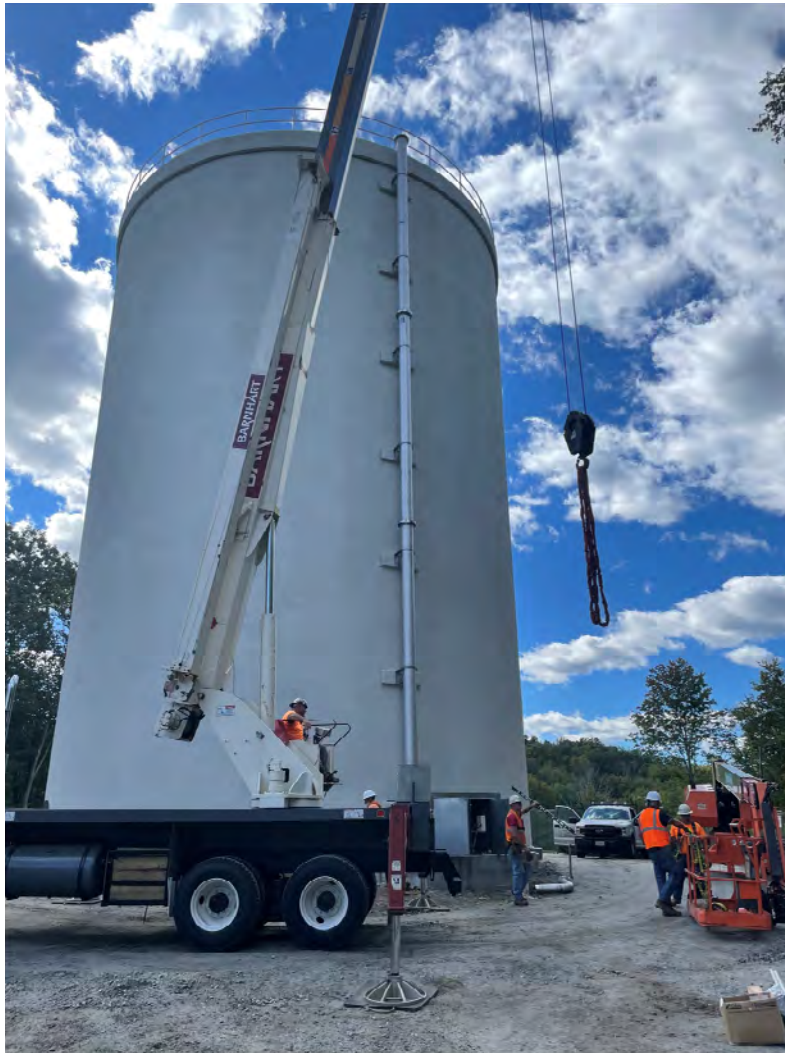
Picture 12: View of the water tank located east of the Shared Access Driveway in Middletown, with 12” stainless steel air duct installed and secured in place by DN Tanks today. View to the west.

1342: DN Tanks has placed the third of three 20' sections of 12" stainless steel air duct pipe on the northeast side of the water tank located east of the Shared Access Driveway in Middletown.
