## Daily Report

<b>Project:</b>	Durham Meadows Pipeline Installation	<b>Date:</b>	October 6, 2021
<b>Location:</b>	Maiden Lane, Durham; S. Main Street and the Shared Access Driveway, Middletown	<b>Day of Week:</b>	Wednesday
<b>Project #:</b>	AECOM: 6061487	<b>Report No:</b>	337
<b>Contractor:</b>	Ludlow Construction	<b>Page:</b>	1 of 18

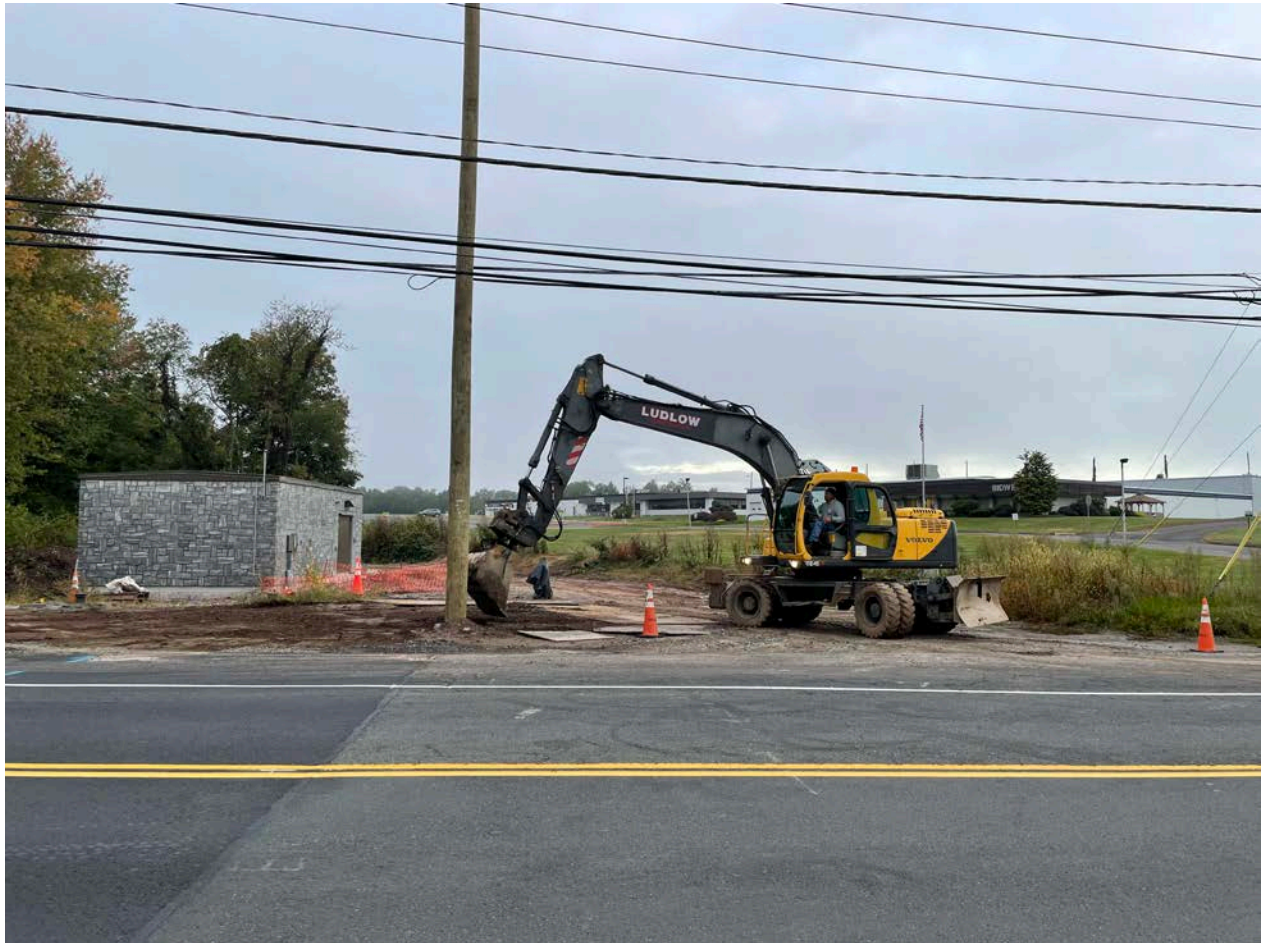
Picture 1: Ludlow grading fill at the booster station located at Station 750+63 on S. Main Street in Middletown. View to the west.

Ludlow performed minor earth work at the booster station located at Station 750+63, grading fill on the east side of the building.

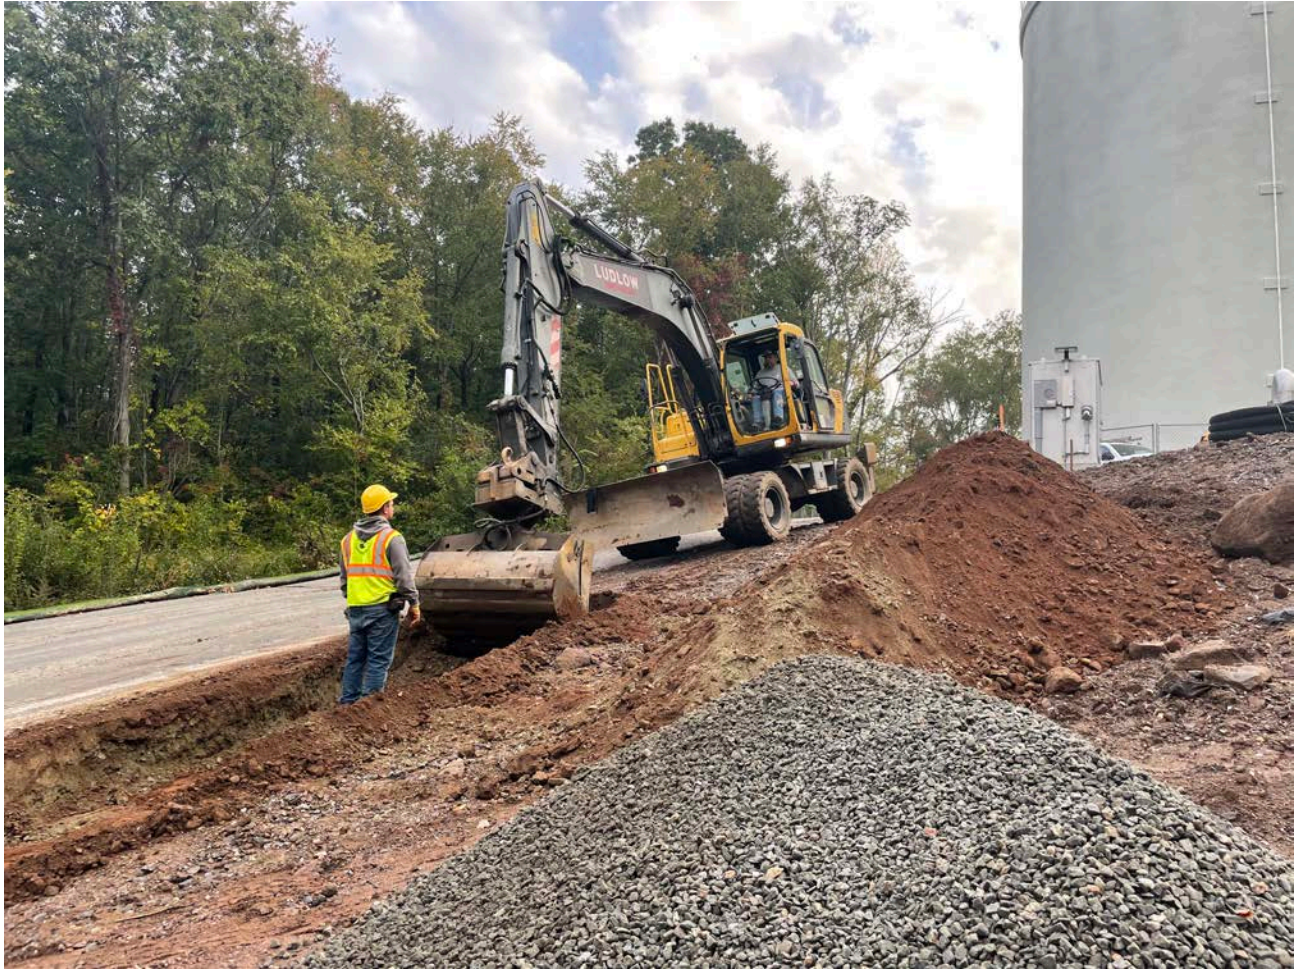
**Picture 2: Ludlow excavating on the south side of the Shared Access Driveway between Stations 10+83 and 11+34 as they prepare to construct a retaining wall. View to the northeast.**

0803: Ludlow excavates at Station 11+34 as they begin to shape the slope for the construction of a VERSA-LOK retaining wall.

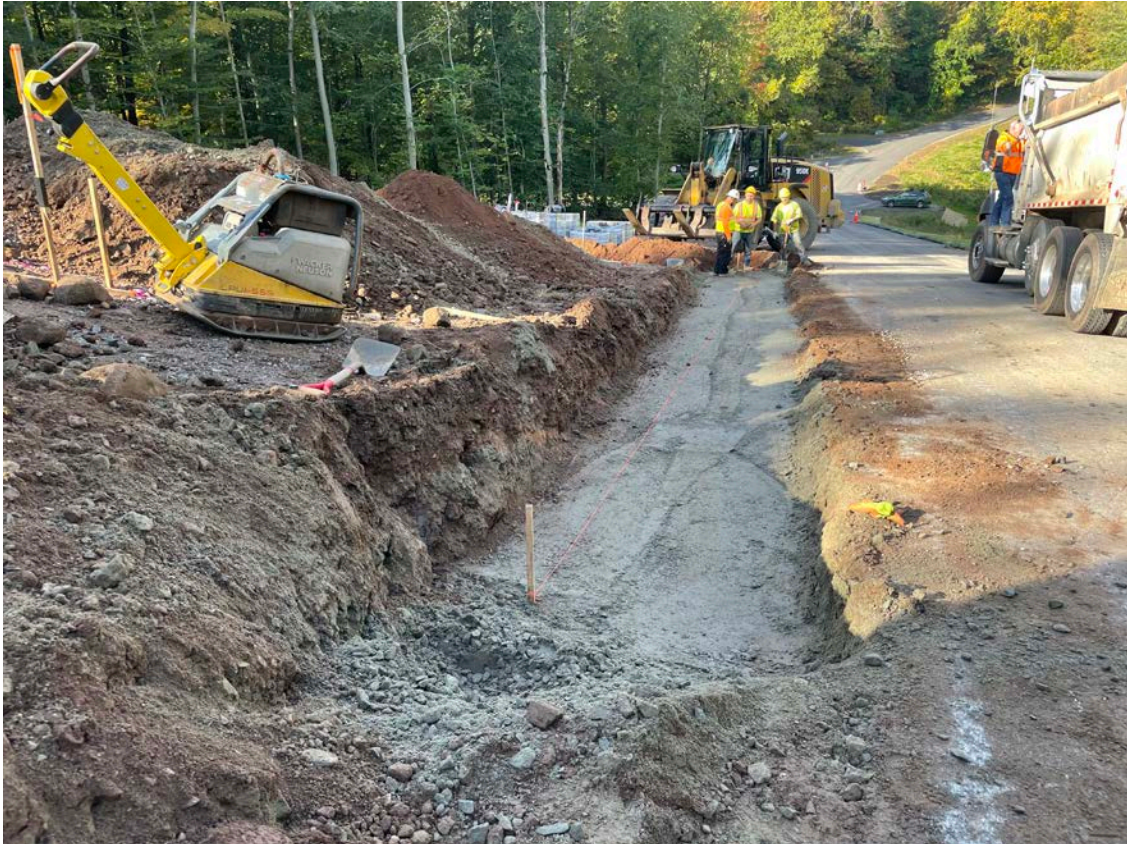
**Picture 3: Base that Ludlow has compacted on the south side of the Shared Access Driveway between Stations 10+83 and 11+34 for the placement of VERSA-LOK blocks for the construction of a retaining wall. View to the west.**

0917: Ludlow has excavated and compacted fill on the south side of the Shared Access Driveway between Stations 10+83 and 11+34. Ludlow is using a plate compactor on the fill that will underlie the retaining wall.

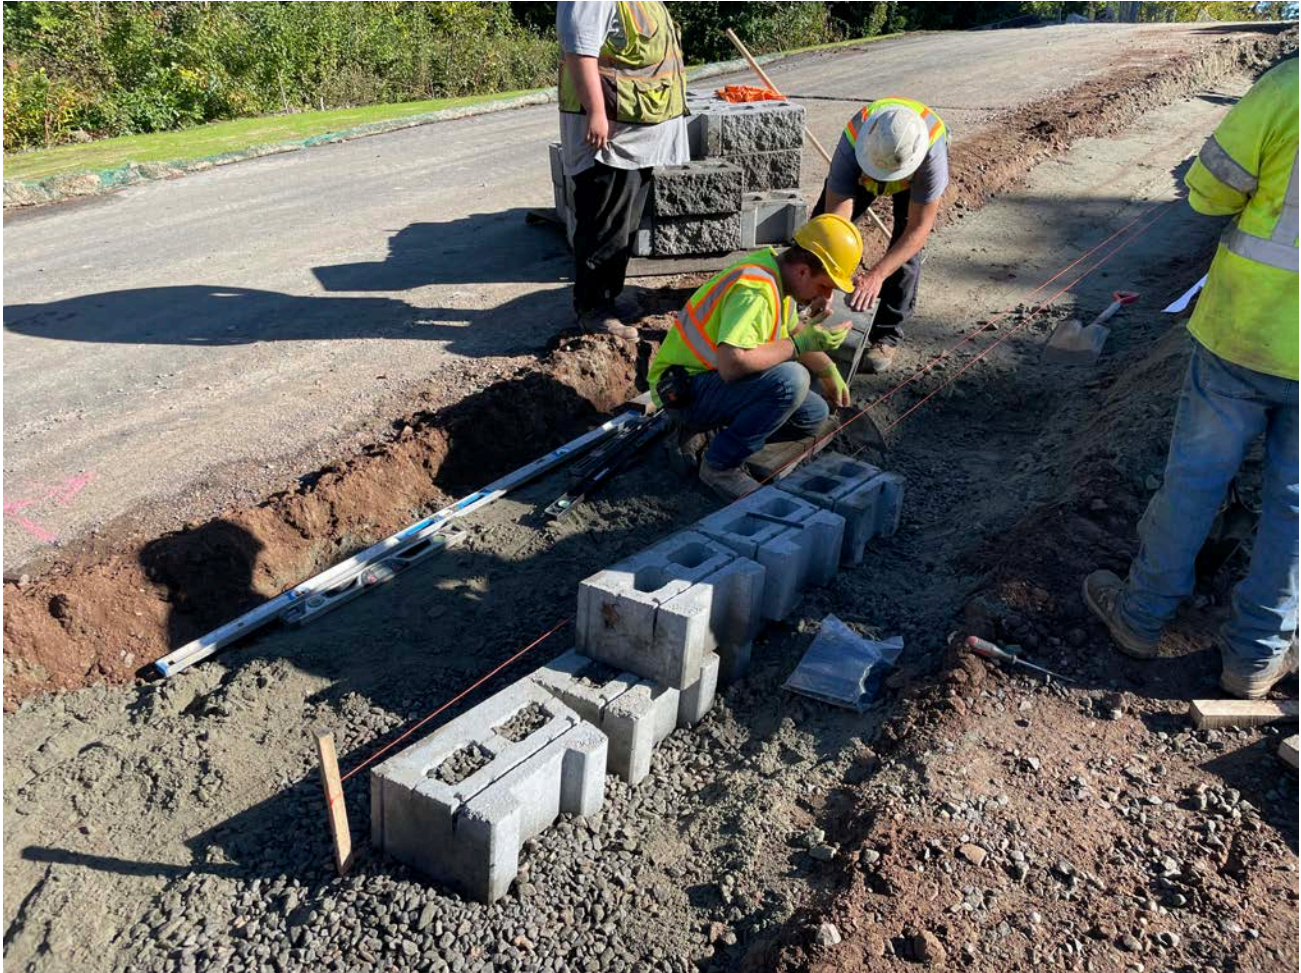
Picture 4: Ludlow placing VERSA-LOK blocks for the construction of a retaining wall on the south side of the Shared Access Driveway between Stations 10+83 and 11+34. View to the northeast.

1014: Ludlow is placing VERSA-LOK blocks as they begin to construct the retaining wall on the south side of the Shared Access Driveway. The hollow pockets in the block are being filled with 3/4" stone. Ludlow is also using a thin layer of the 3/4" stone as a base to set the blocks upon.

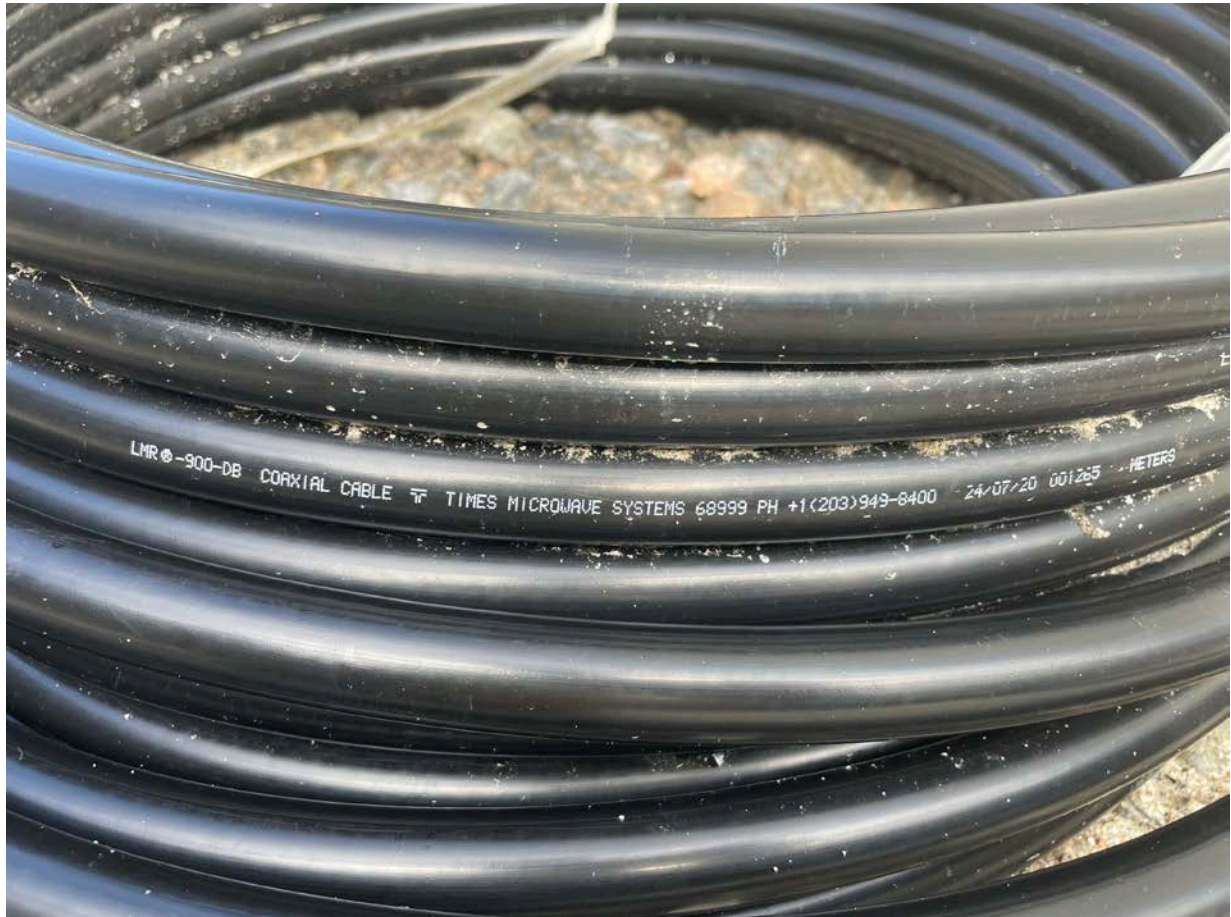
**Picture 5: Coaxial cable for the tank radio antenna that was placed inside of the 2" conduit that was installed on the west side of the water tank at the Shared Access Driveway in Middletown.**

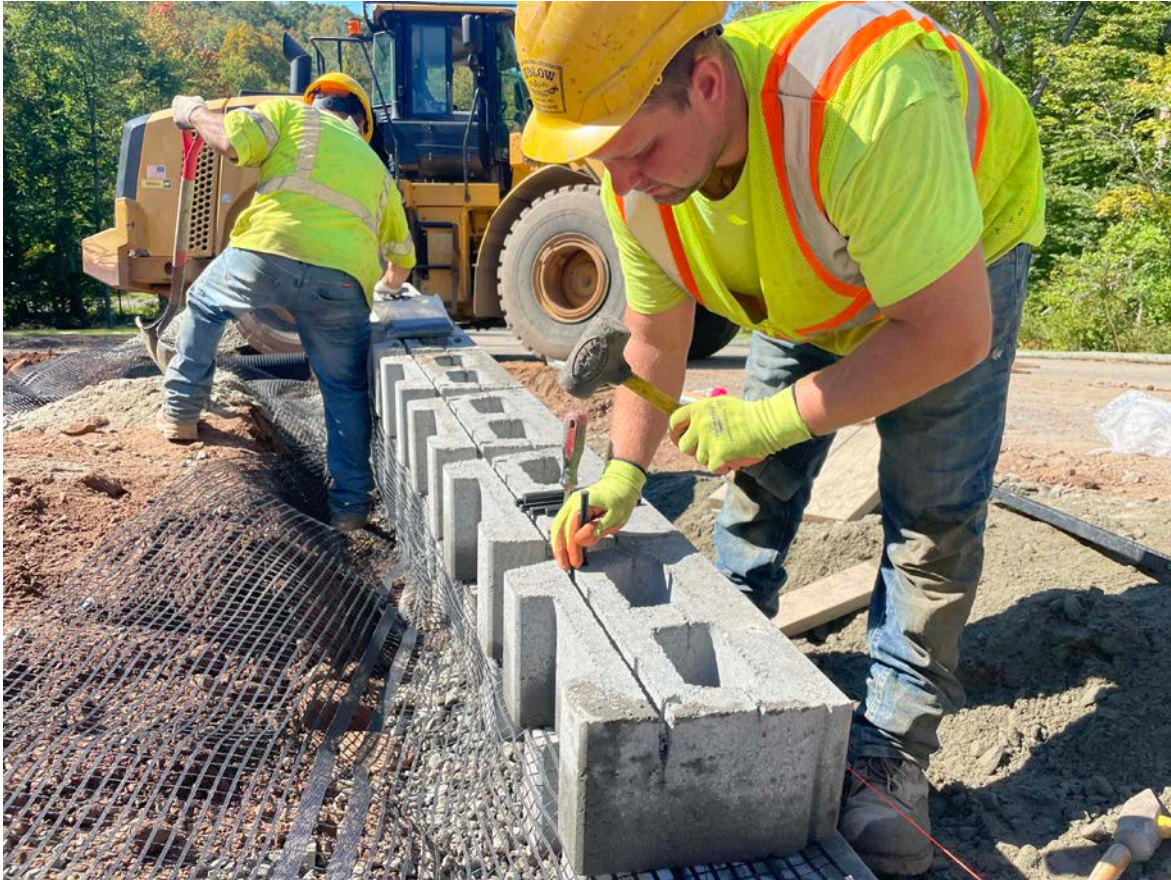
Picture 6: Ludlow securing VERSA-LOK blocks together with plastic pins as they construct a retaining wall on the south side of the Shared Access Driveway between Stations 10+83 and 11+34. View to the west.

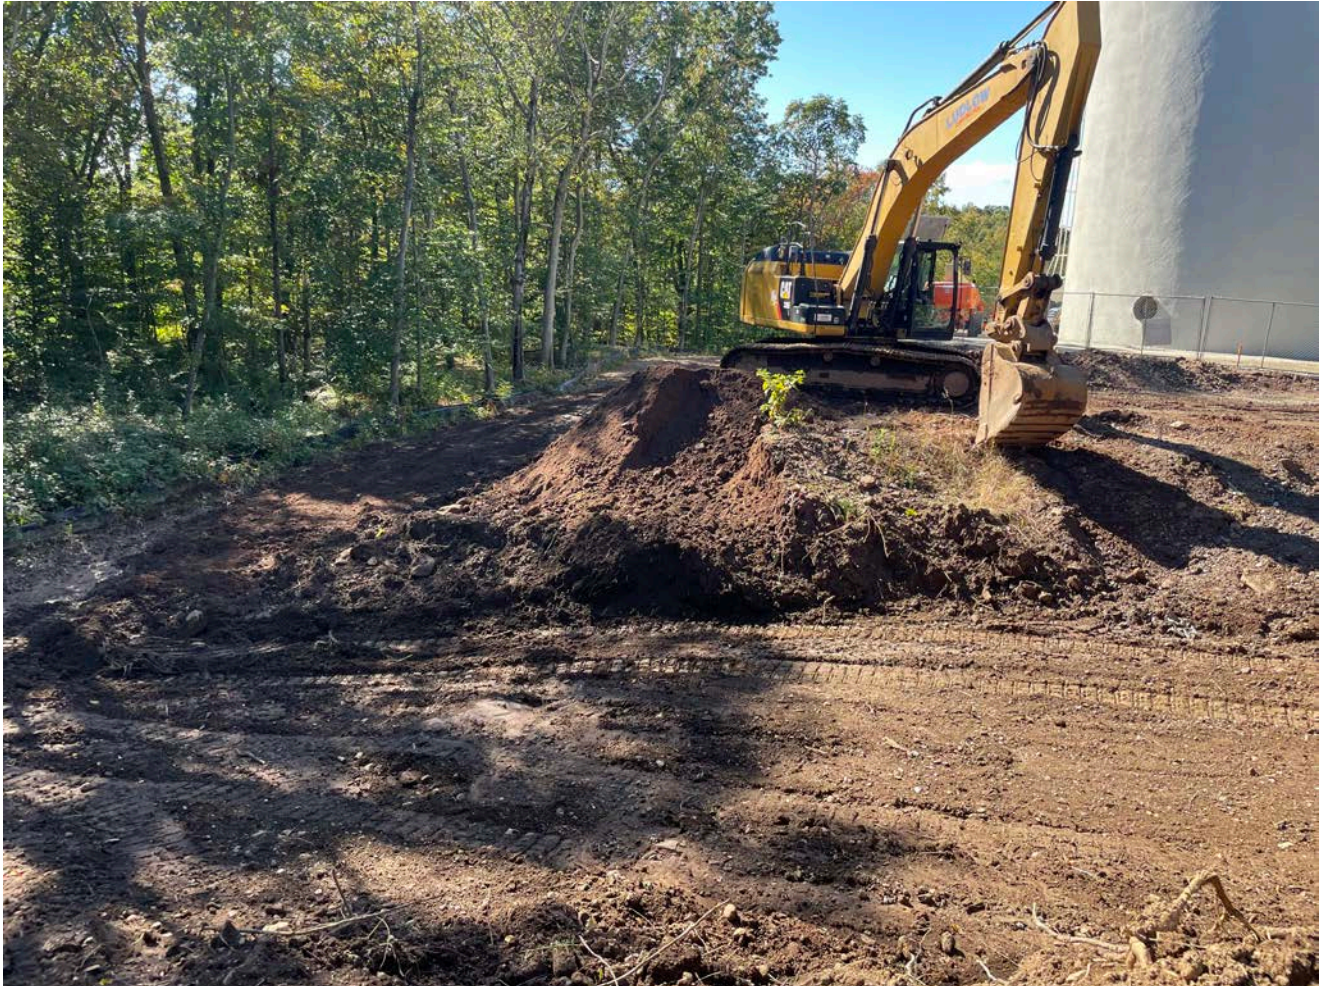
**Picture 8: Ludlow excavating fill on the slope located to the southeast of the water tank. Ludlow is loading the excavated soil into a dump truck for off-site removal. View to the west.**

1233: Ludlow continues earth work on the slope located east and southeast side of the water tank. They are excavating soil, live loading it into a dump truck, and trucking it off-site.

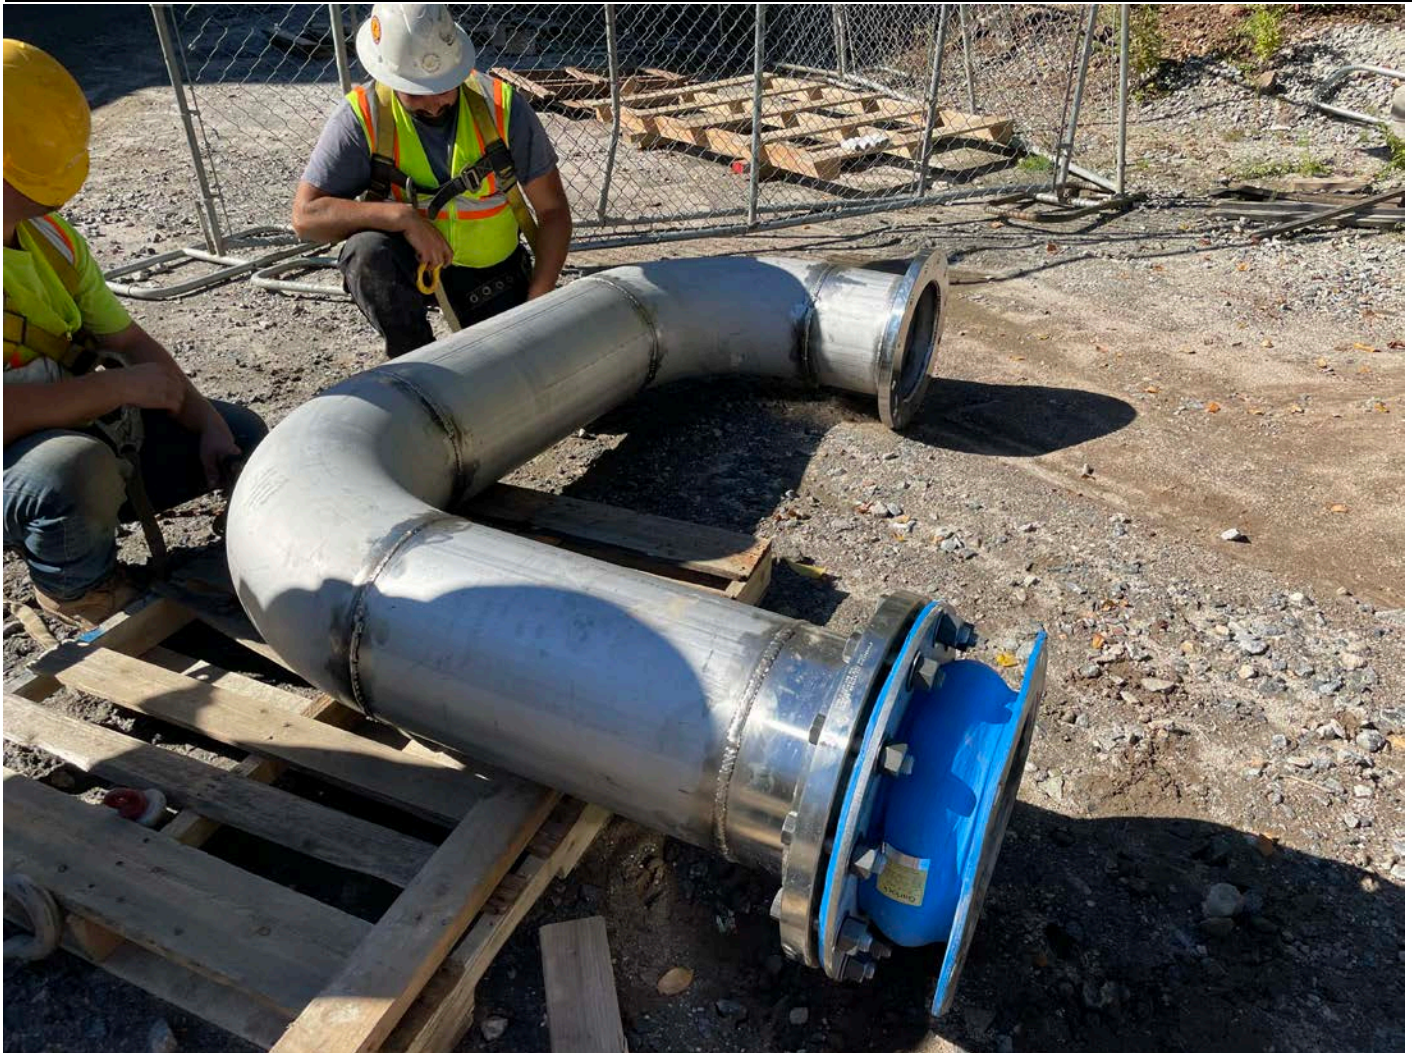
**Picture 9: Section of 12" stainless steel air duct that Barnhart will lift with a crane to place on top of 12" stainless steel air duct that was previously installed on the northeast side of the water tank.**

1418: Barnhart is in the process of staging the crane for today's lift of a section of 12" stainless steel air duct.

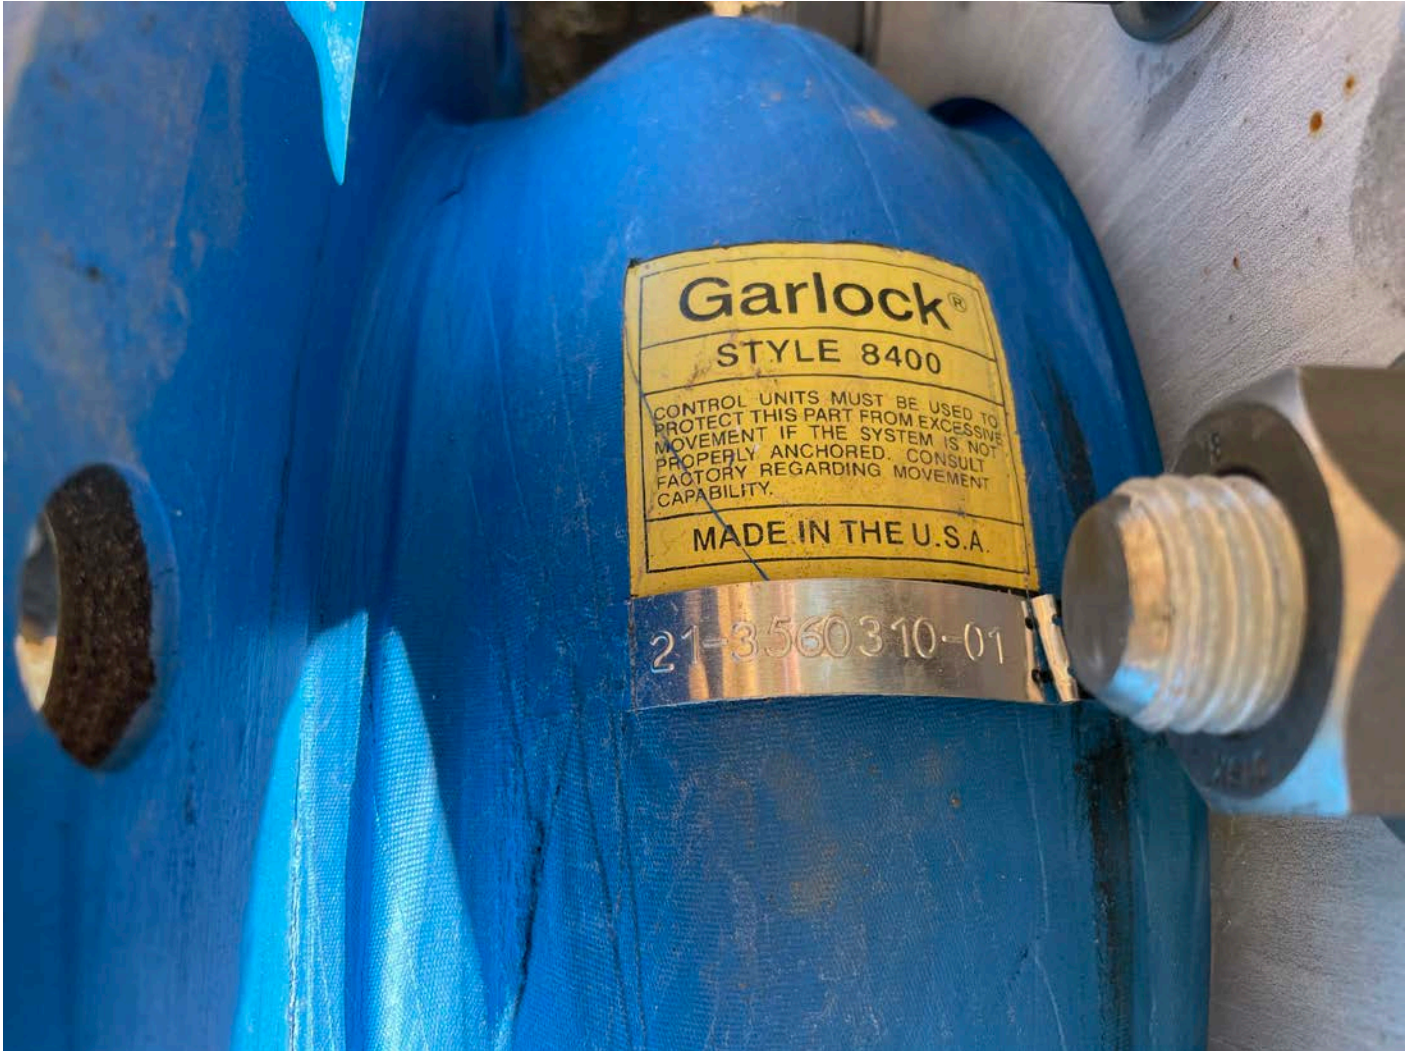
Picture 10: Expansion joint that was installed today, attached to the section of 12” stainless steel air duct that was installed on top of 12” stainless steel air duct that was previously-installed on the northeast side of the water tank.

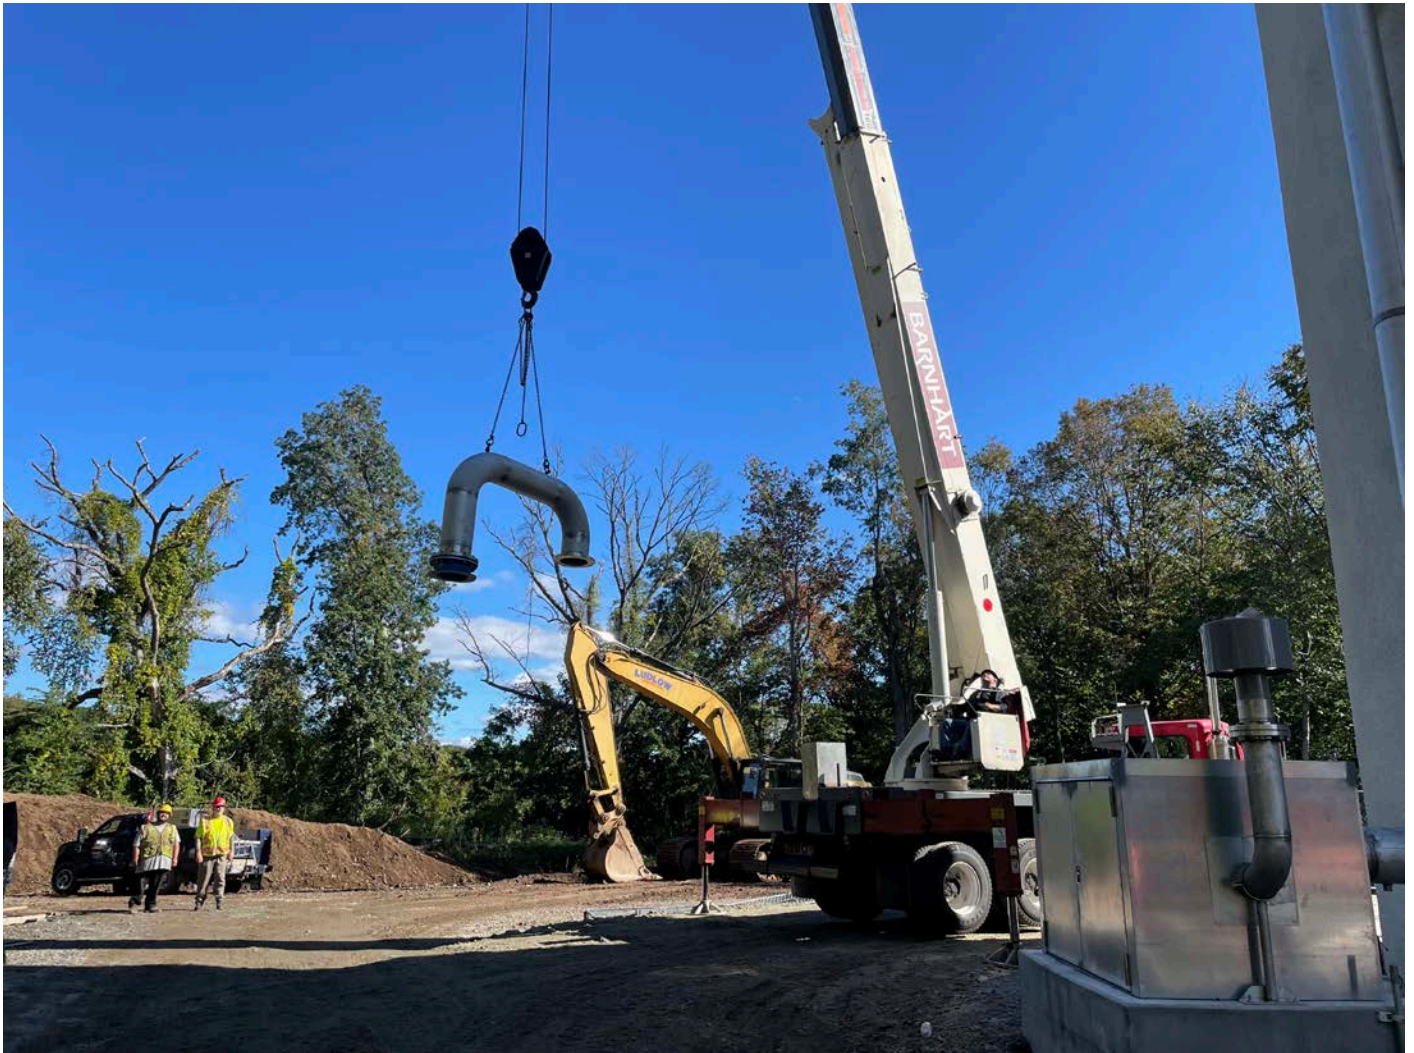
Picture 11: Barnhart lifting a section of 12” stainless steel air duct that will be installed on top of 12” stainless steel air duct that was previously installed on the northeast side of the water tank.

1445: Barnhart has lifted the section of 12" stainless steel air duct and is positioning it into place while two Ludlow laborers using a boom lift prepare to bolt it to the top of the section of 12" air duct that was previously installed on the northeast side of the water tank.

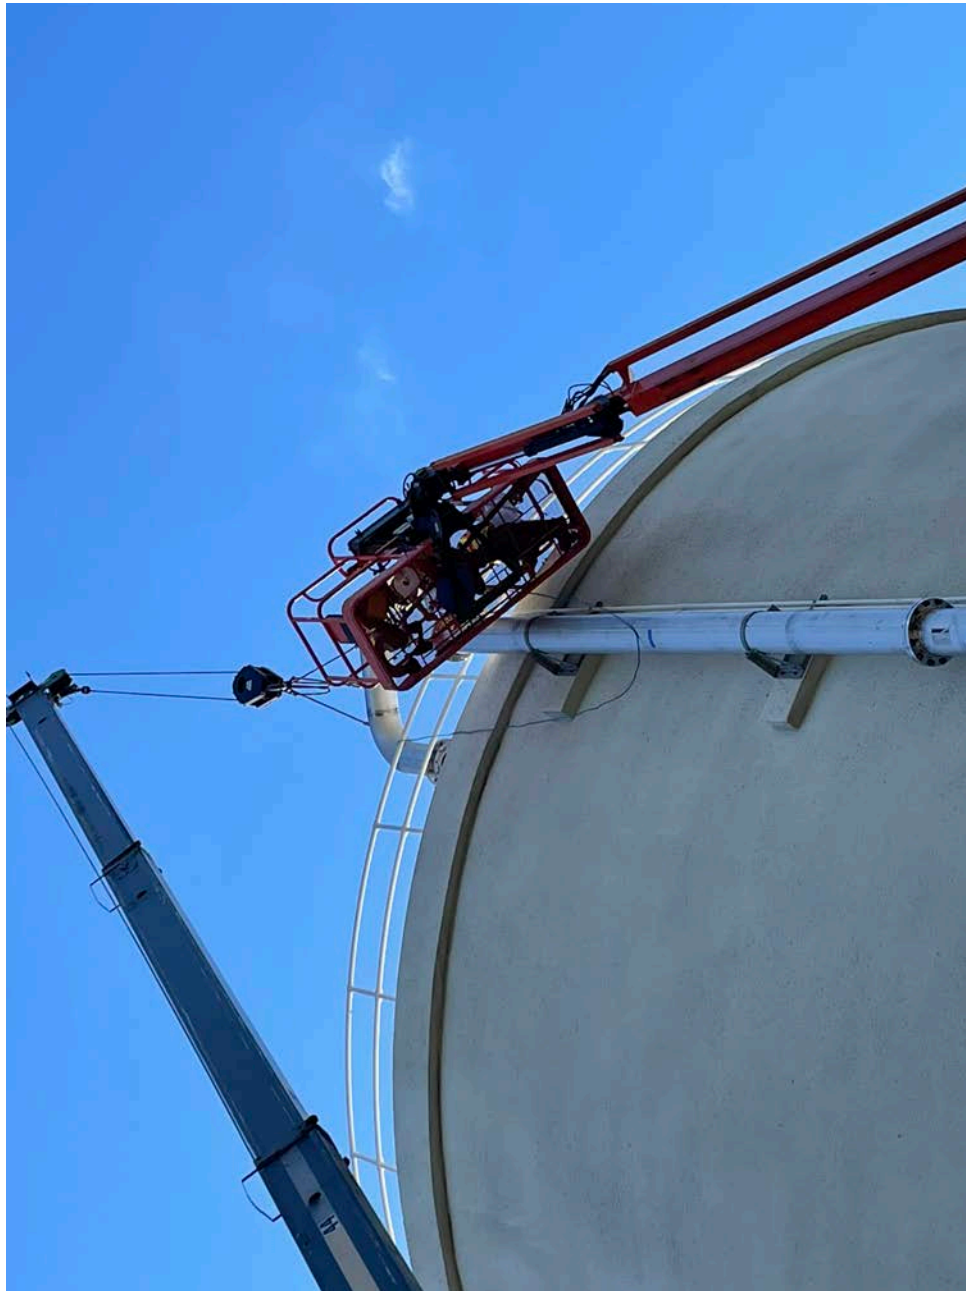
**Picture 12: Ludlow installing a section of 12” stainless steel air duct on top of 12” stainless steel air duct that was previously installed on the northeast side of the water tank.**

1507: Ludlow is in the process of bolting the section of 12" stainless steel air duct that Barnhart has lifted to the 12" air duct that was previously installed on the northeast side of the water tank.

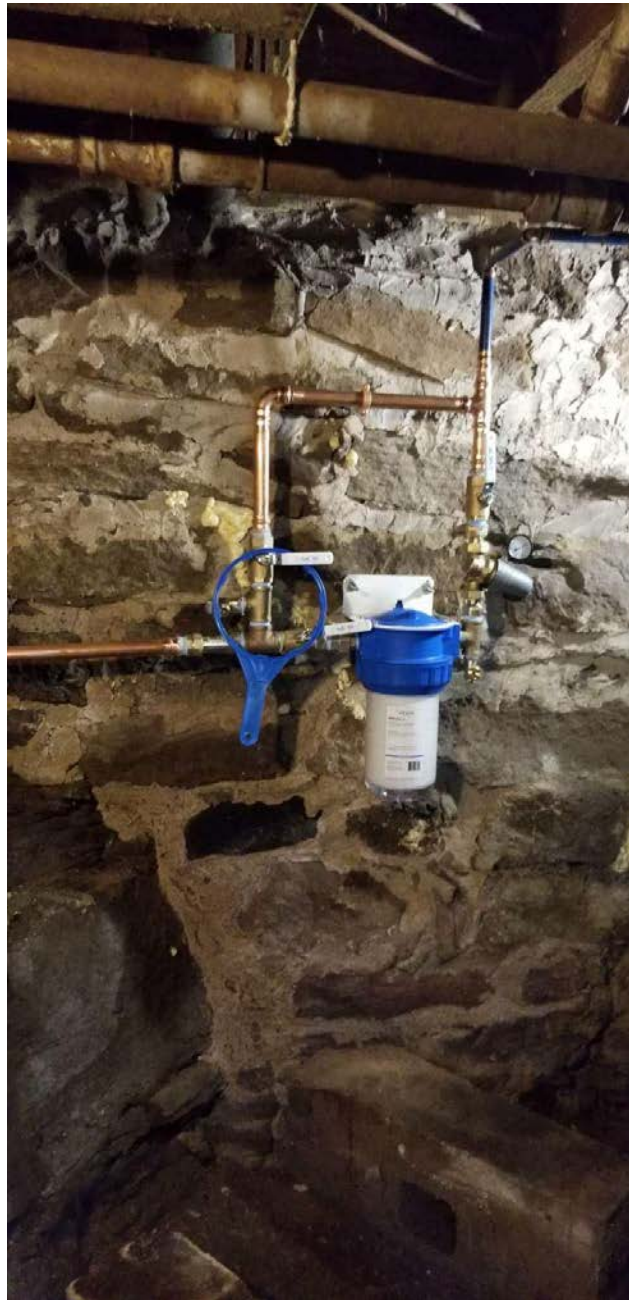
**Picture 13: Final water service components that Fazzino Plumbing installed at the 308 Main Street, Durham, residence.**

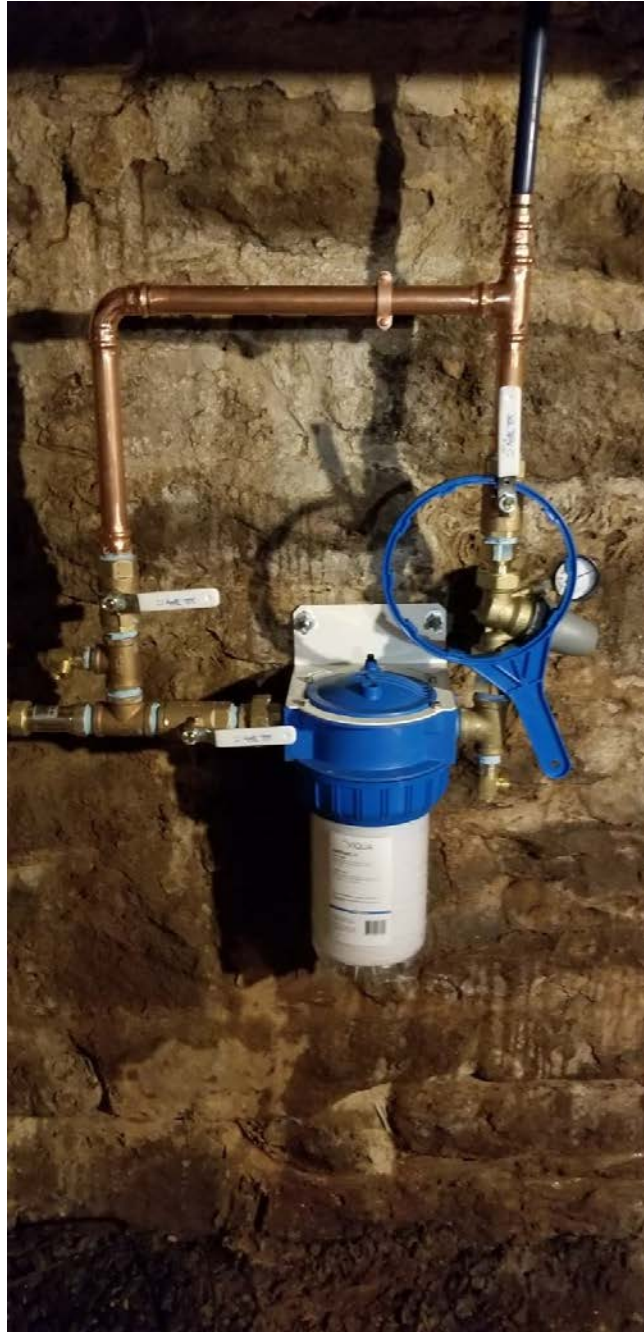
Picture 14: Final water service components that Fazzino Plumbing installed at the 316 Main Street, Durham, residence.

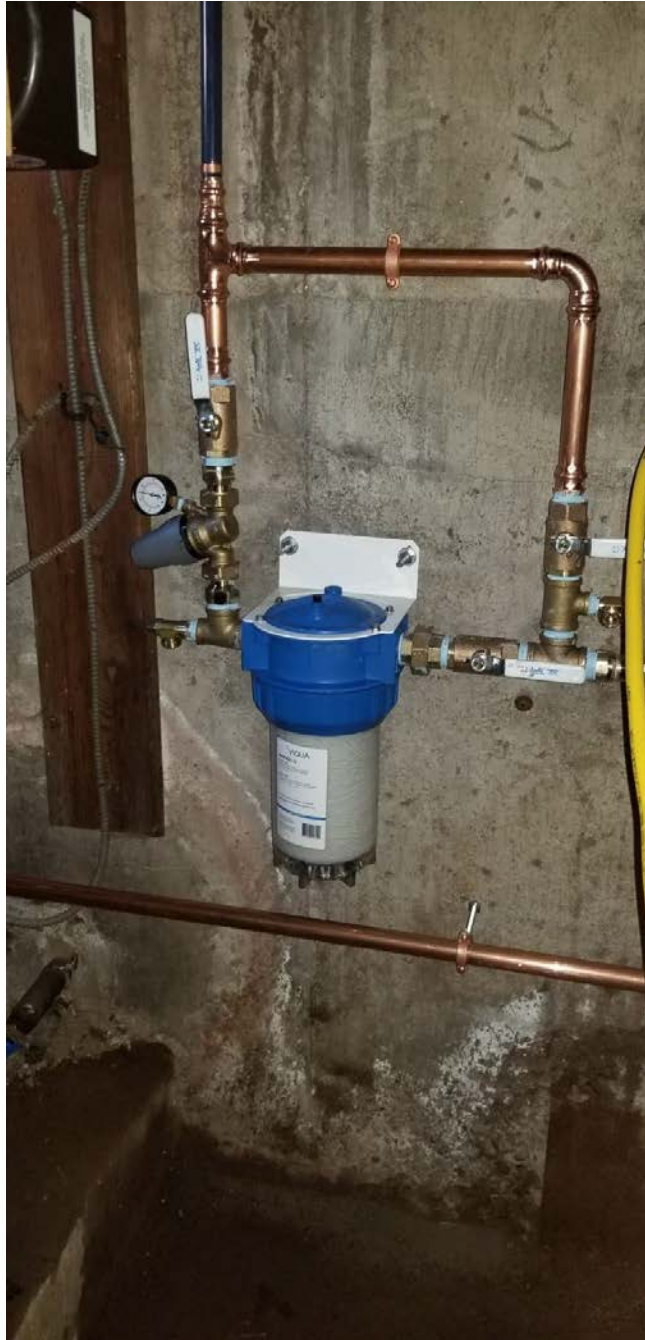
**Picture 15: Final water service components that Fazzino Plumbing installed at the 321 Main Street, Durham, residence.**
