Daily Report

Project:	Durham Meadows Pipeline Installation	Date:	October 8, 2021
Location:	Maiden Lane, Durham; Shared Access Road, Middletown	Day of Week:	Friday
Project #:	AECOM: 6061487	Report No:	339
Contractor:	Ludlow Construction	Page:	1 of 14

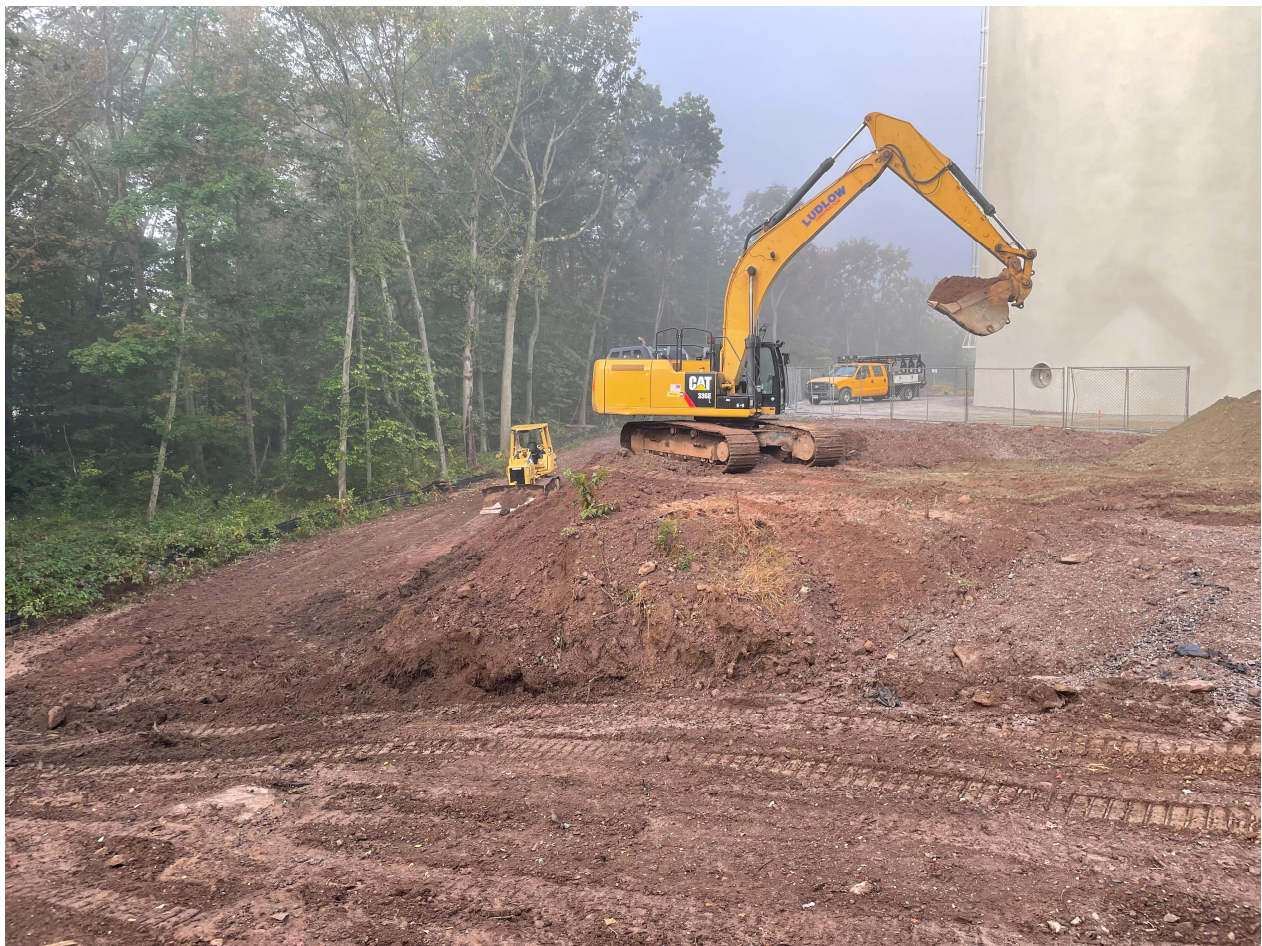
Picture 1: Ludlow shaping the slope to the southeast of the water tank located east of the Shared Access Road in Middletown. View to west.

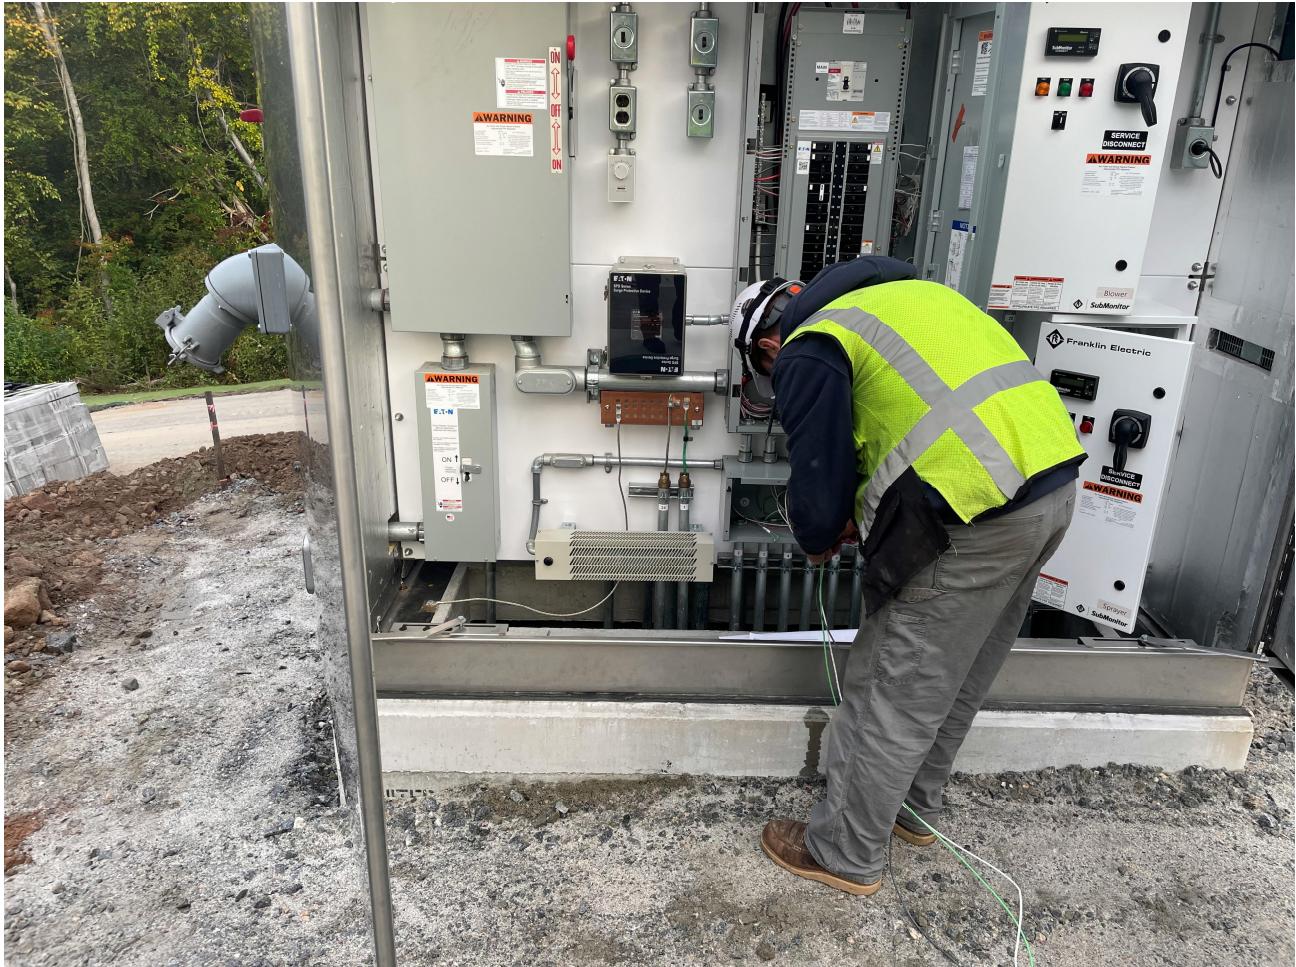
Picture 2: A&R Electrical working inside of the electrical enclosure located on the north side of the altitude vault at the water tank work zone. View to the north.

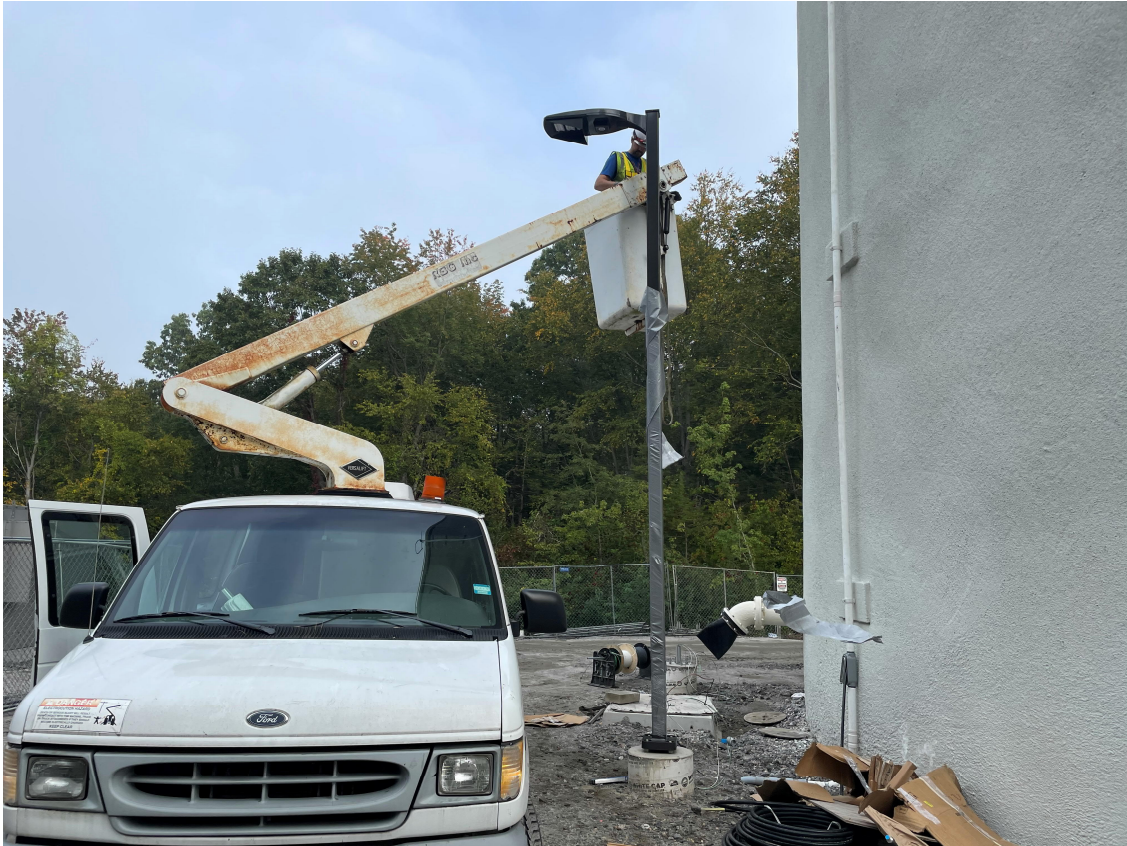
Picture 3: A&R Electrical working on a light pole they just installed on the west side of the water tank. View to the north.

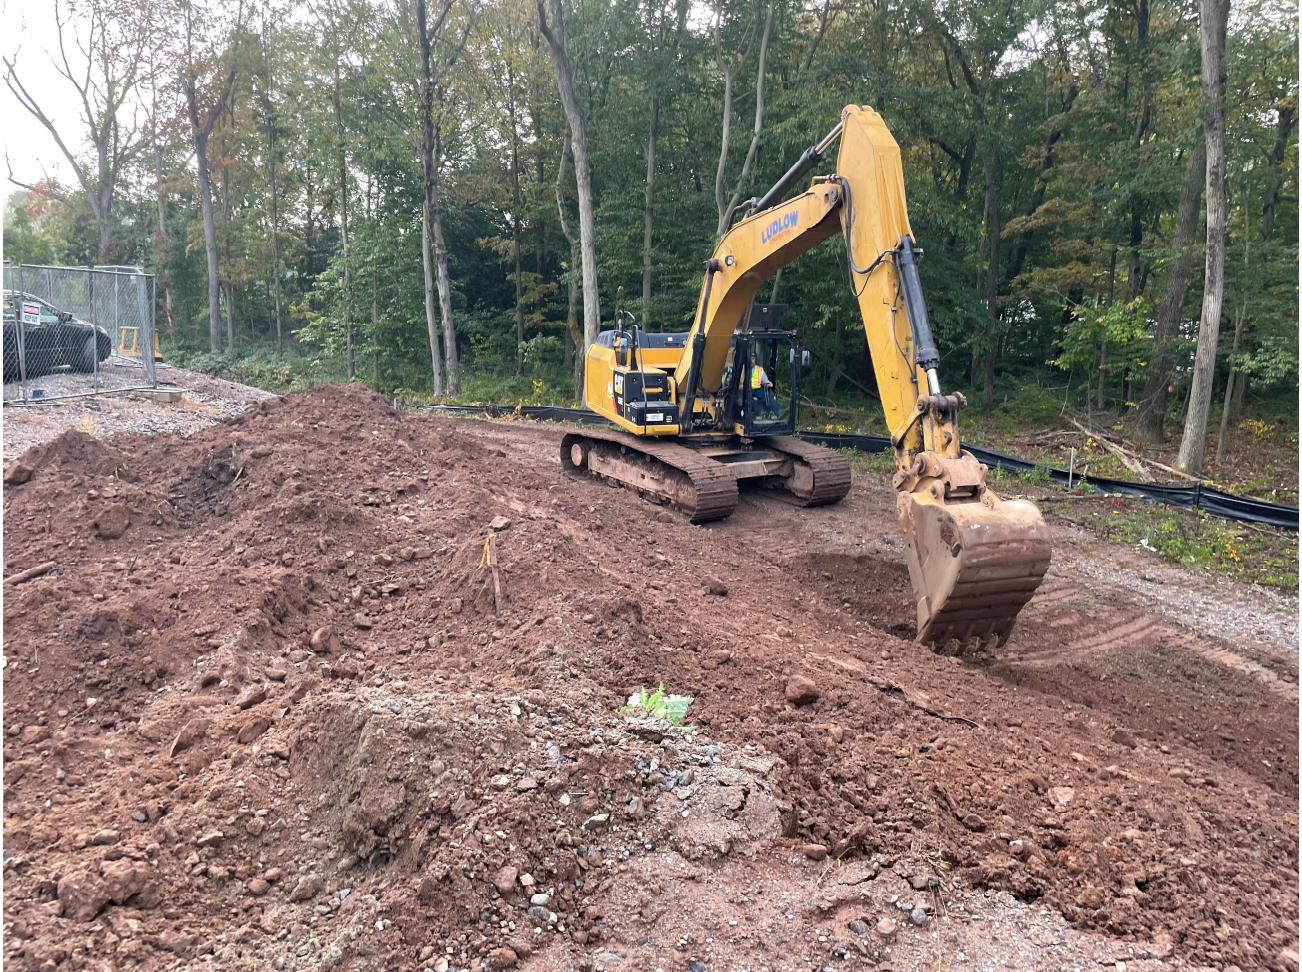
Picture 4: Ludlow shaping the slope to the southwest of the water tank located east of the Shared Access Road in Middletown. View to east.

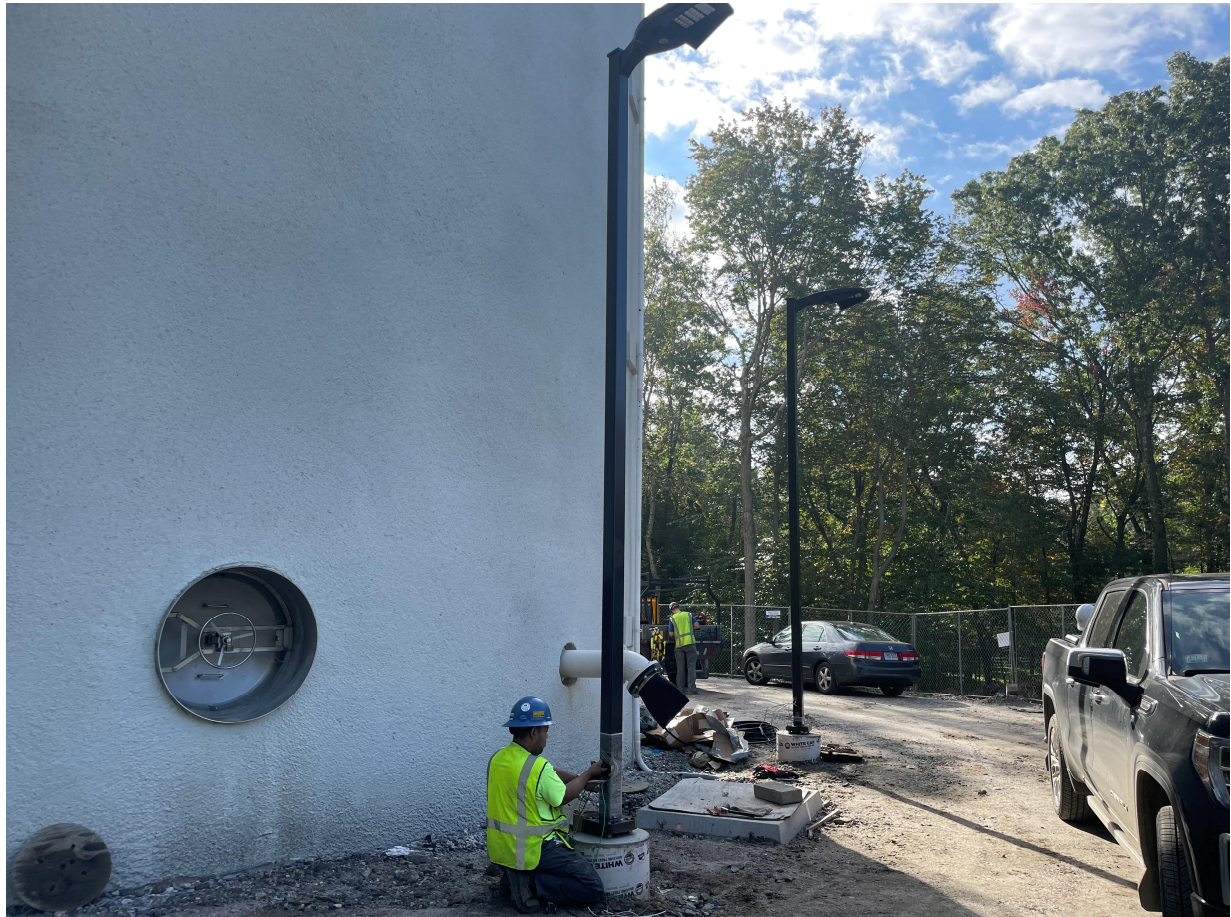
Picture 5: A&R Electrical wiring a light pole they just installed on the west side of the water tank. View to the southeast.

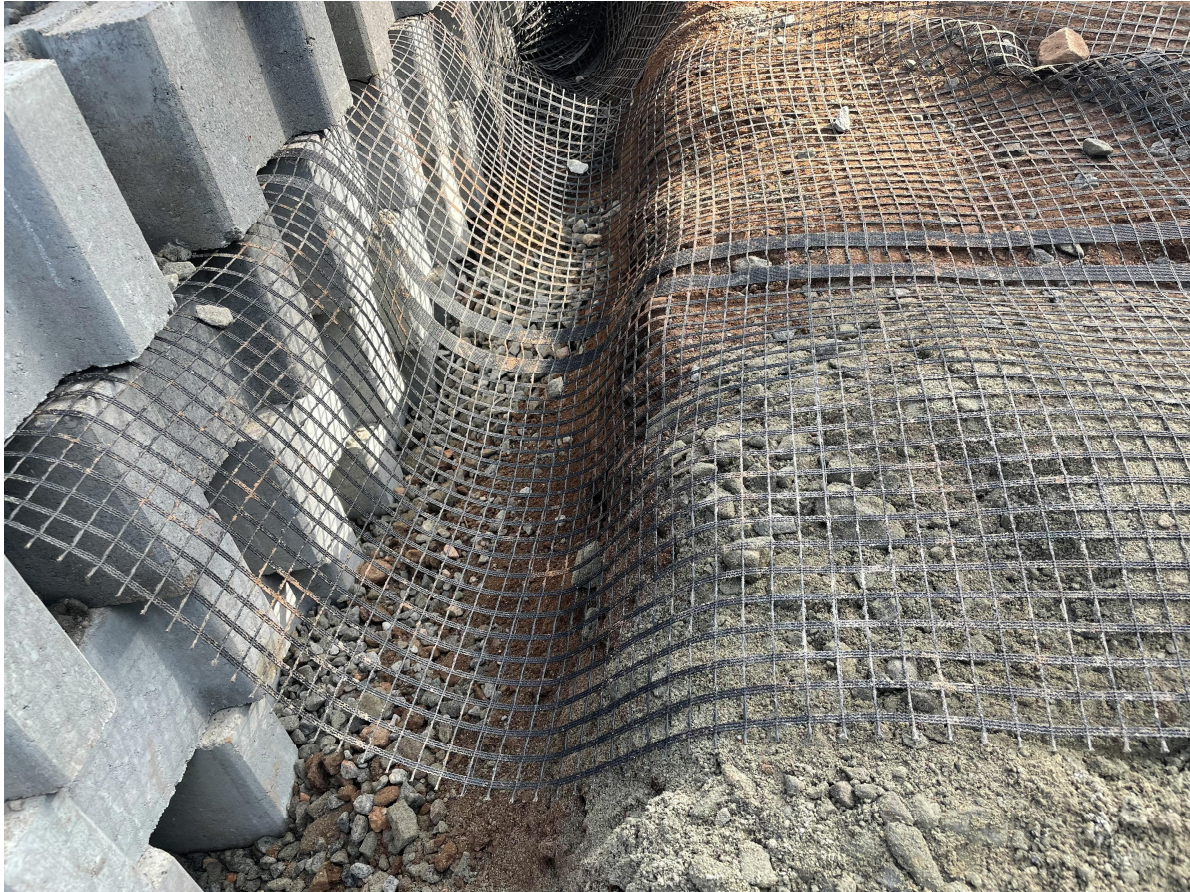
0709: Ludlow is mobilizing to the water tank work zone to resume work on the retaining wall located between Stations 10+83 and 11+34. Ludlow is currently disassembling the wall so they spin the geogrid fabric they placed on October 6, 2021 90°, which will orient the fabric for maximum strength.

Picture 6: Geogrid that Ludlow placed on the south side of the retaining wall they are constructing between Stations 10+83 and 11+34 on the south side of the Shared Access Road. View to the east.

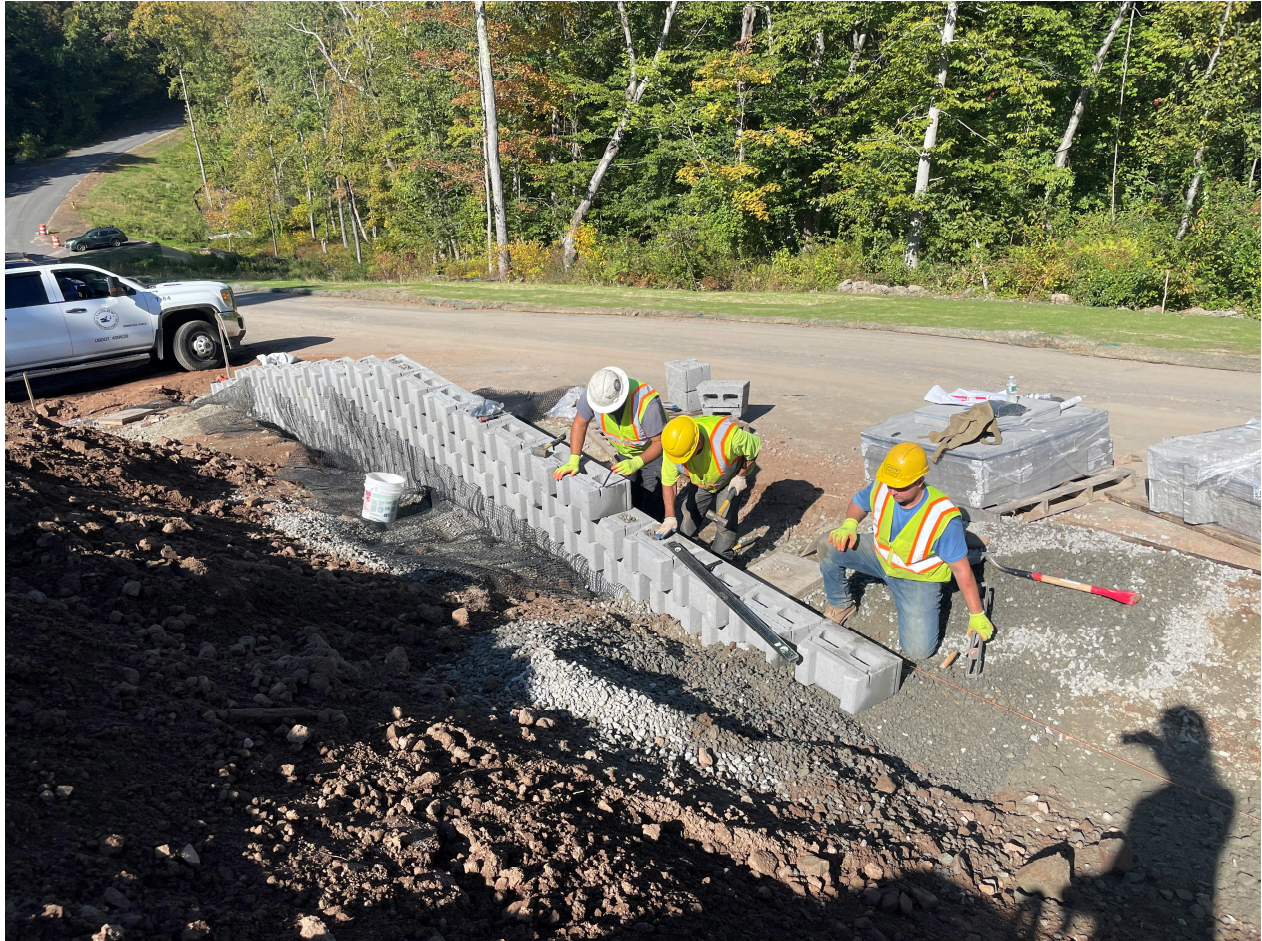
Picture 7: Ludlow constructing a retaining wall between Stations 10+83 and 11+34 on the south side of the Shared Access Road. View to the west.

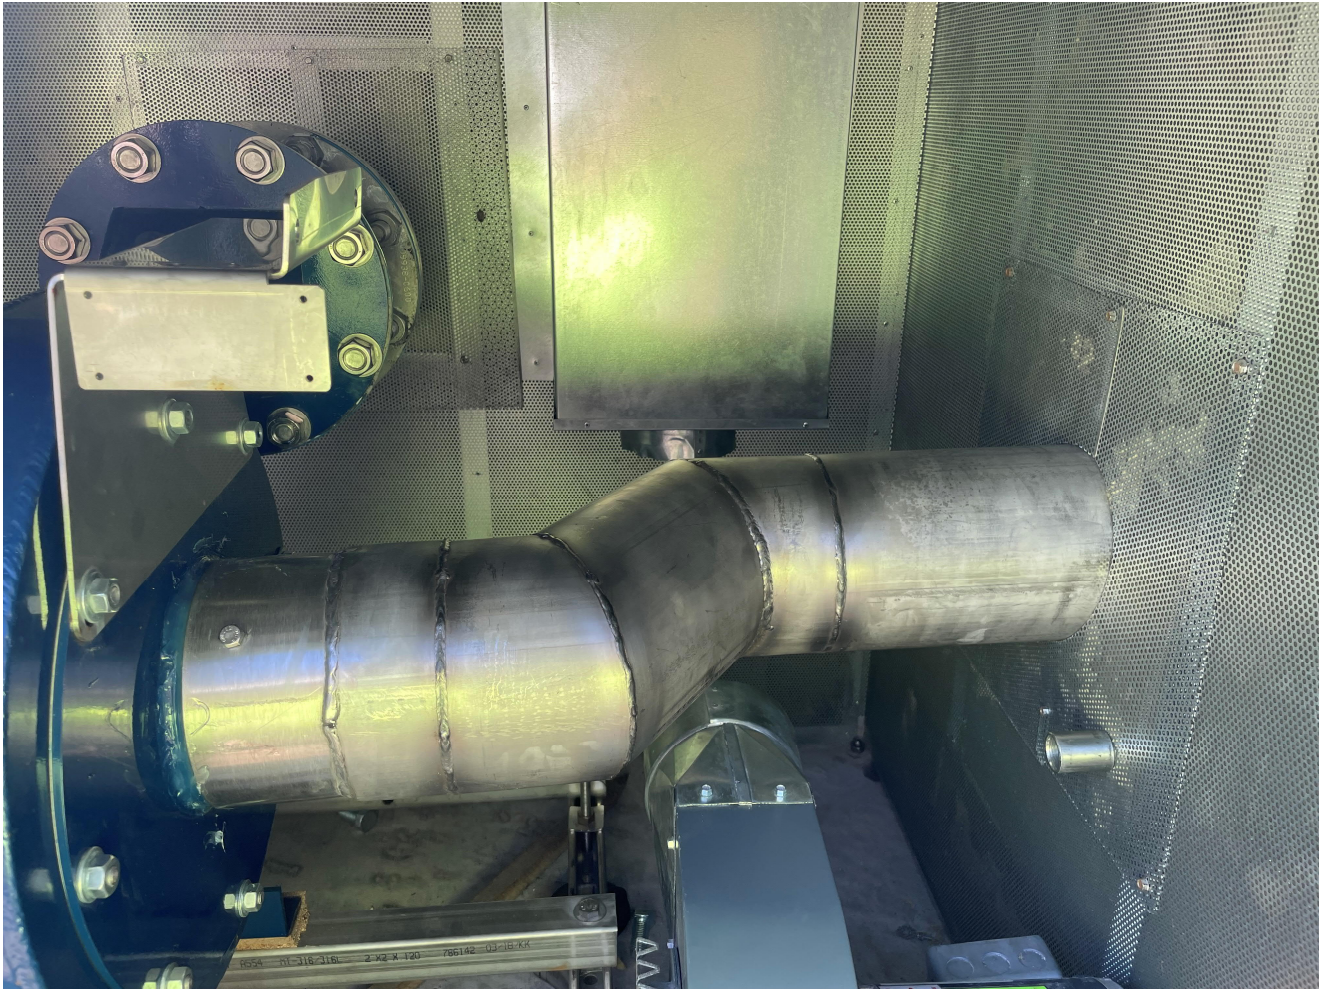
Picture 8: Stainless steel duct that Ludlow's subcontractor fabricated for placement on the blower located inside of the blower cabinet on the northeast side of the water tank. View to the south.

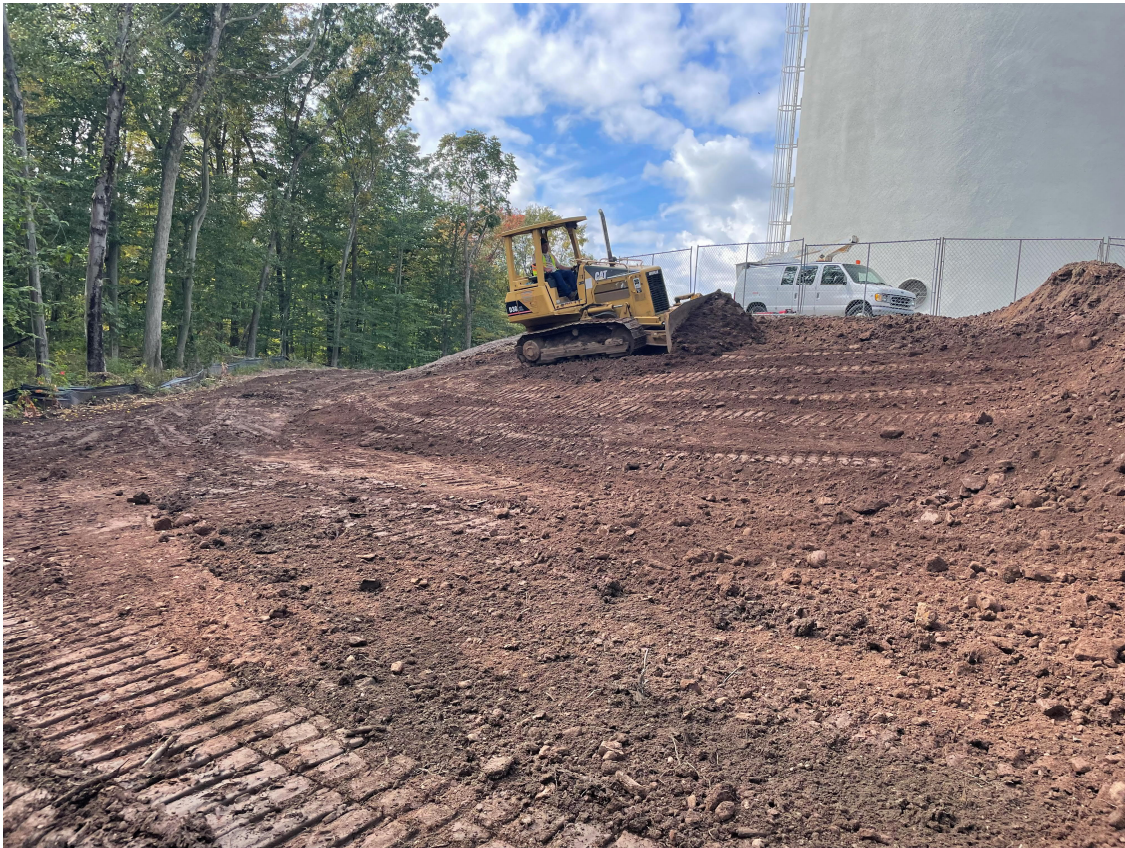
Picture 9: Ludlow shaping the slope to the southeast of the water tank located east of the Shared Access Road in Middletown. View to west.

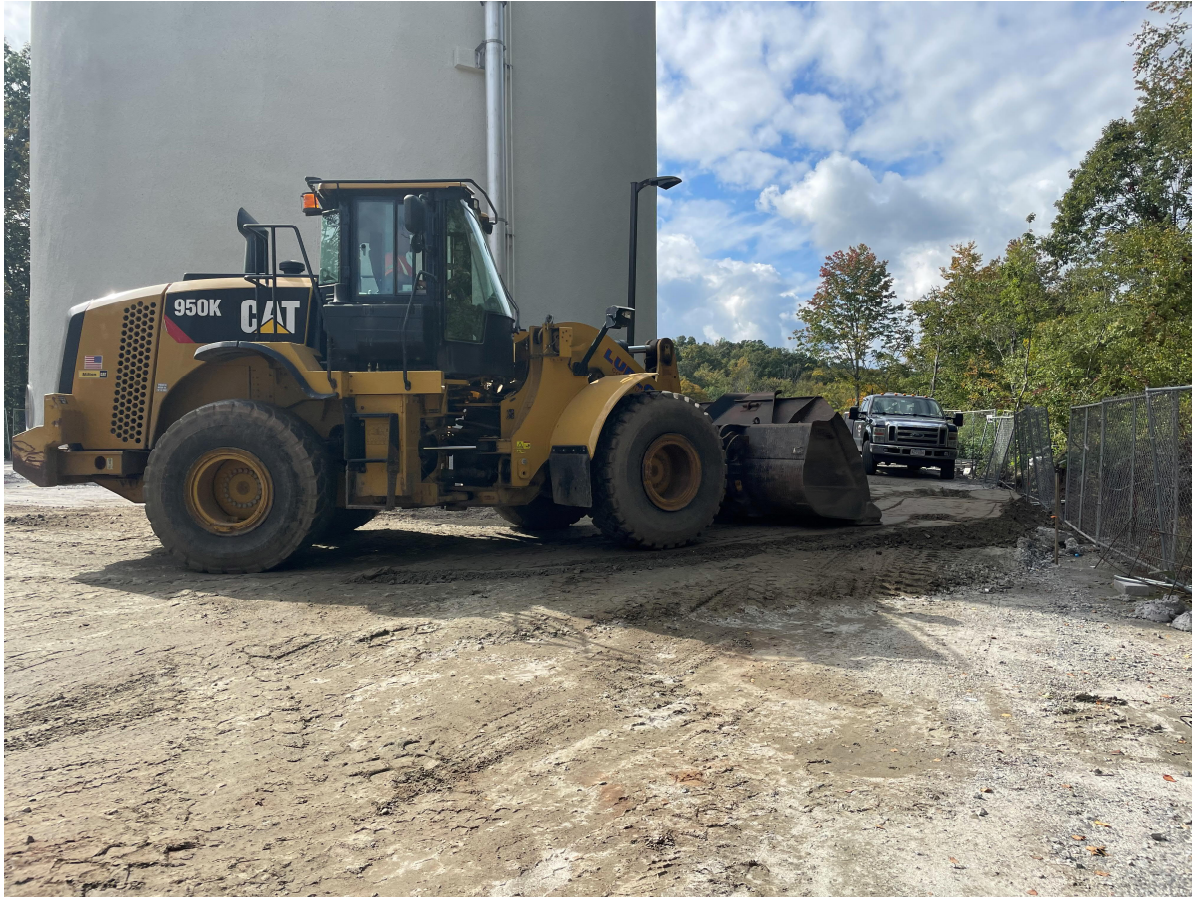
Picture 10: Ludlow grading 1.5'-minus gravel on the northeast side of the water tank. View to the west.

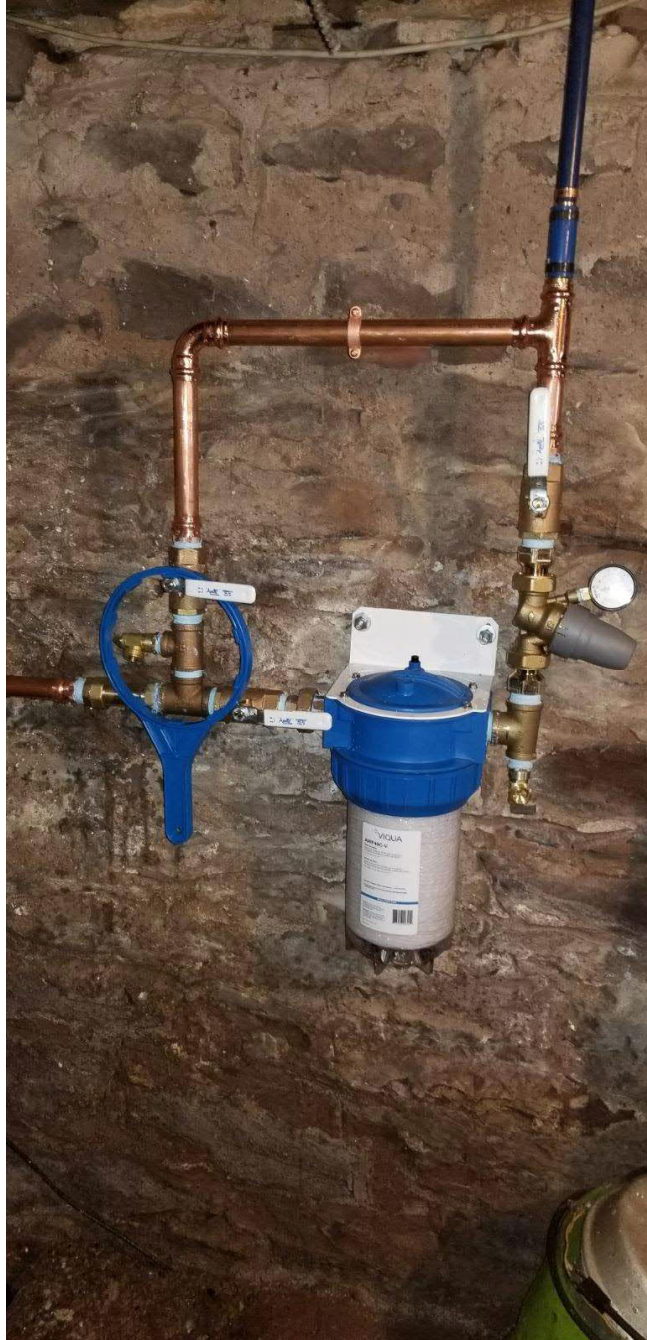
Picture 11: Final water service components that Fazzino Plumbing installed at the 29 Maiden Lane, Durham, residence.

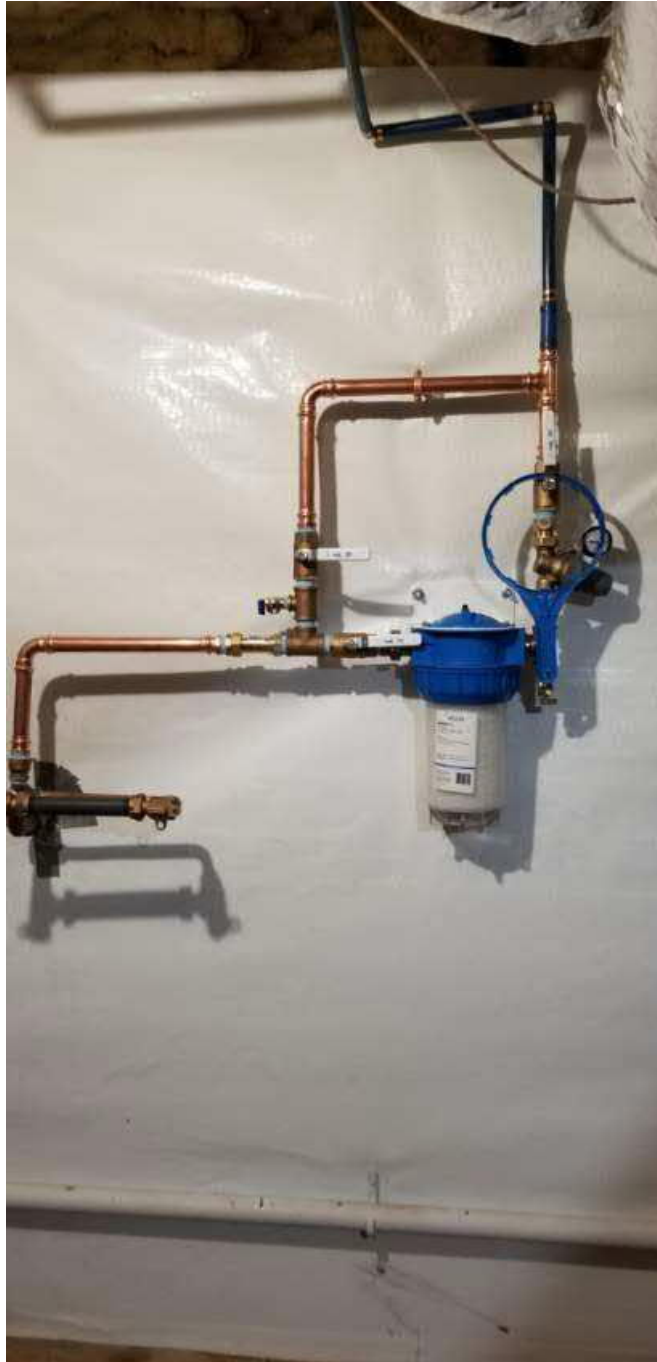
1338: Fazzino Plumbing just finished with the installation of a 1" copper water service line at the 35 Maiden Lane residence.

Picture 12: Final water service components that Fazzino Plumbing installed at the 35 Maiden Lane, Durham, residence.
