Daily Report

Project:	Durham Meadows Pipeline Installation	Date:	October 12, 2021
Location:	Main Street, Durham; Shared Access Road, Middletown	Day of Week:	Tuesday
Project #:	AECOM: 6061487	Report No:	341
Contractor:	Ludlow Construction	Page:	1 of 15

Ludlow installed a meter pit, catch basin, and drain lines at the 224 Talcott Ridge Drive property, and performed earth work next to the water tank located east of the Shared Access Road in Middletown.

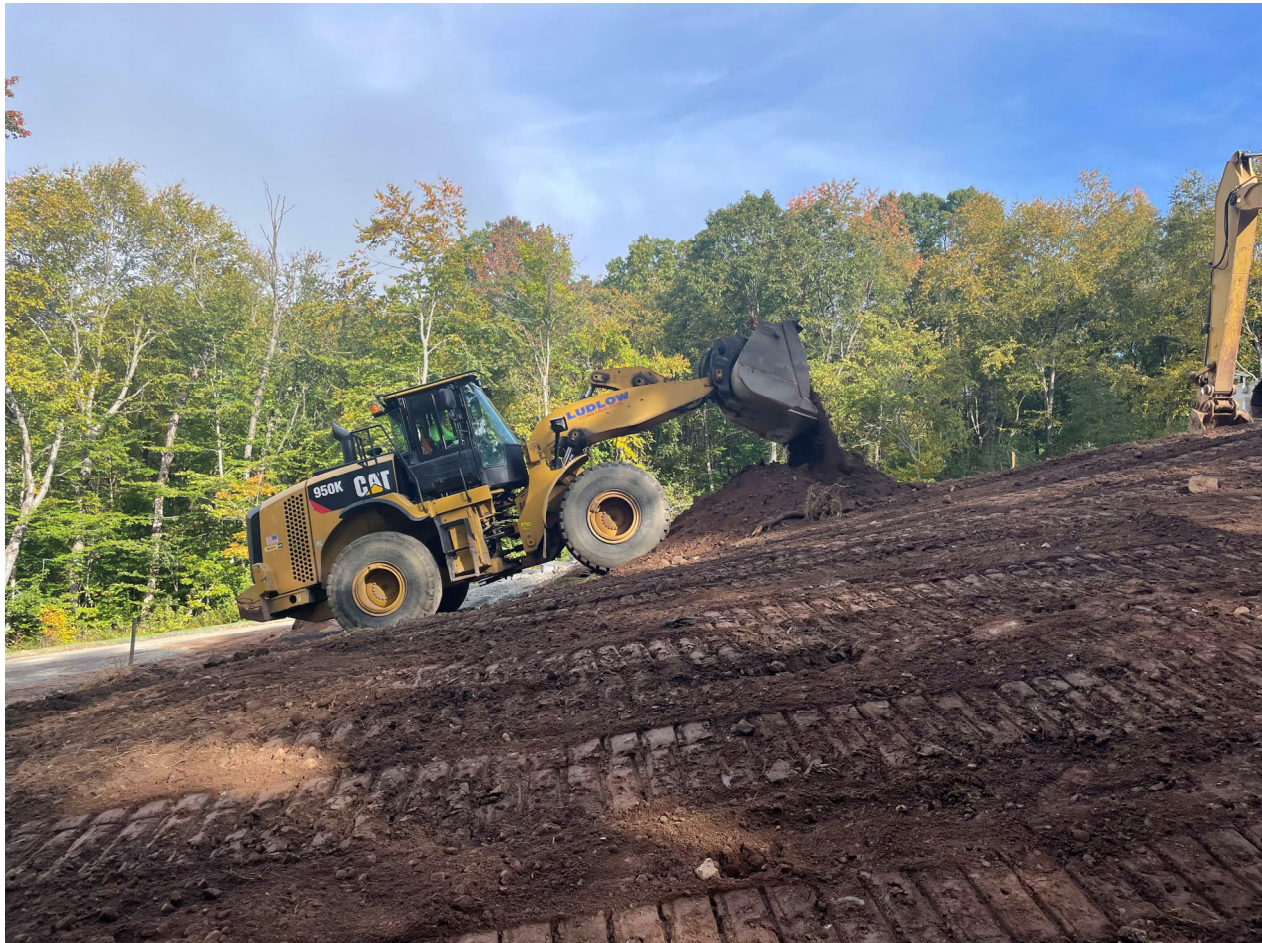
Picture 1: Ludlow placing fill on the slope located on the west side of the water tank. View to north.

0958: Ludlow is placing fill on the slope located on the west side of the water tank and south of the retaining wall.

1021: Ludlow continues to place fill on the west side of the water tank, south of the retaining wall located between Stations 10+83 and 11+34.

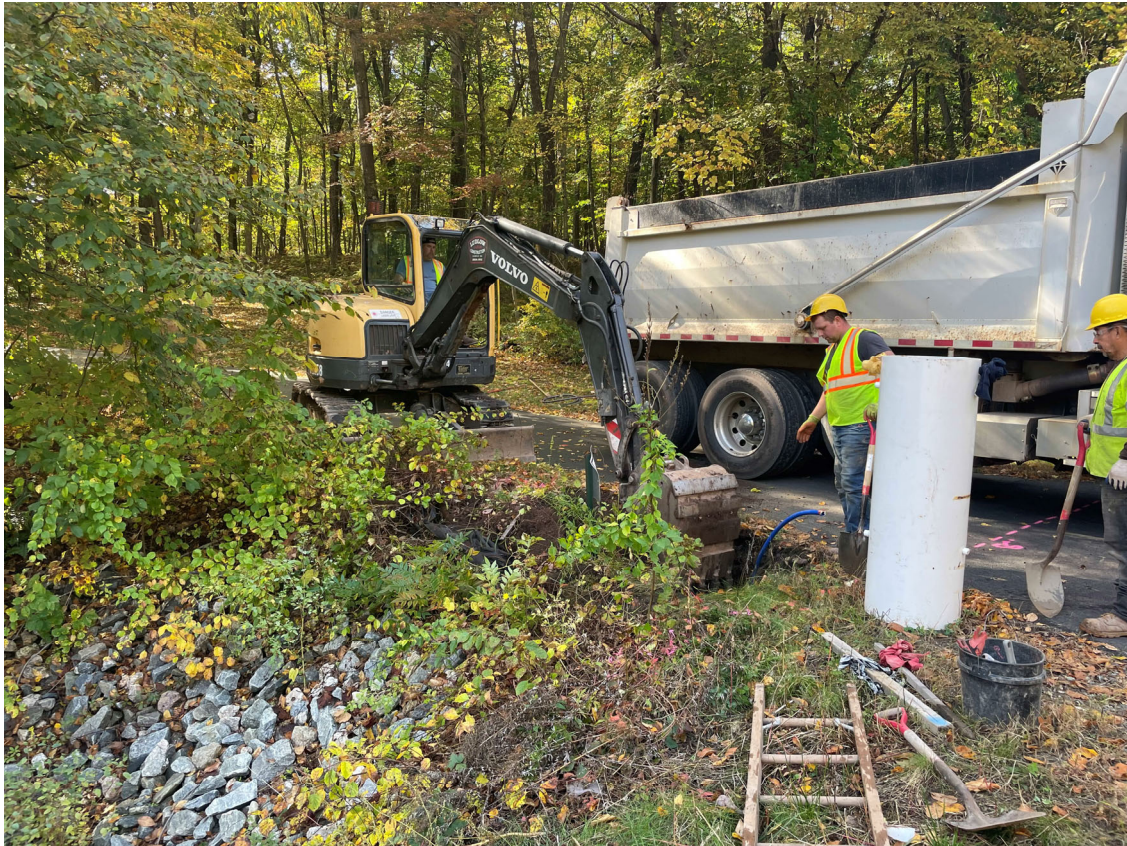
Picture 2: Ludlow excavating on the south side of the curb stop for 224 Talcott Ridge Drive for the installation 1" copper water service line that will run to a meter pit they will install approximately 8' south of the curb stop. View to southwest.

1124: Ludlow begins to excavate south of the curb stop at the 224 Talcott Ridge Drive residence for the installation of a meter pit.

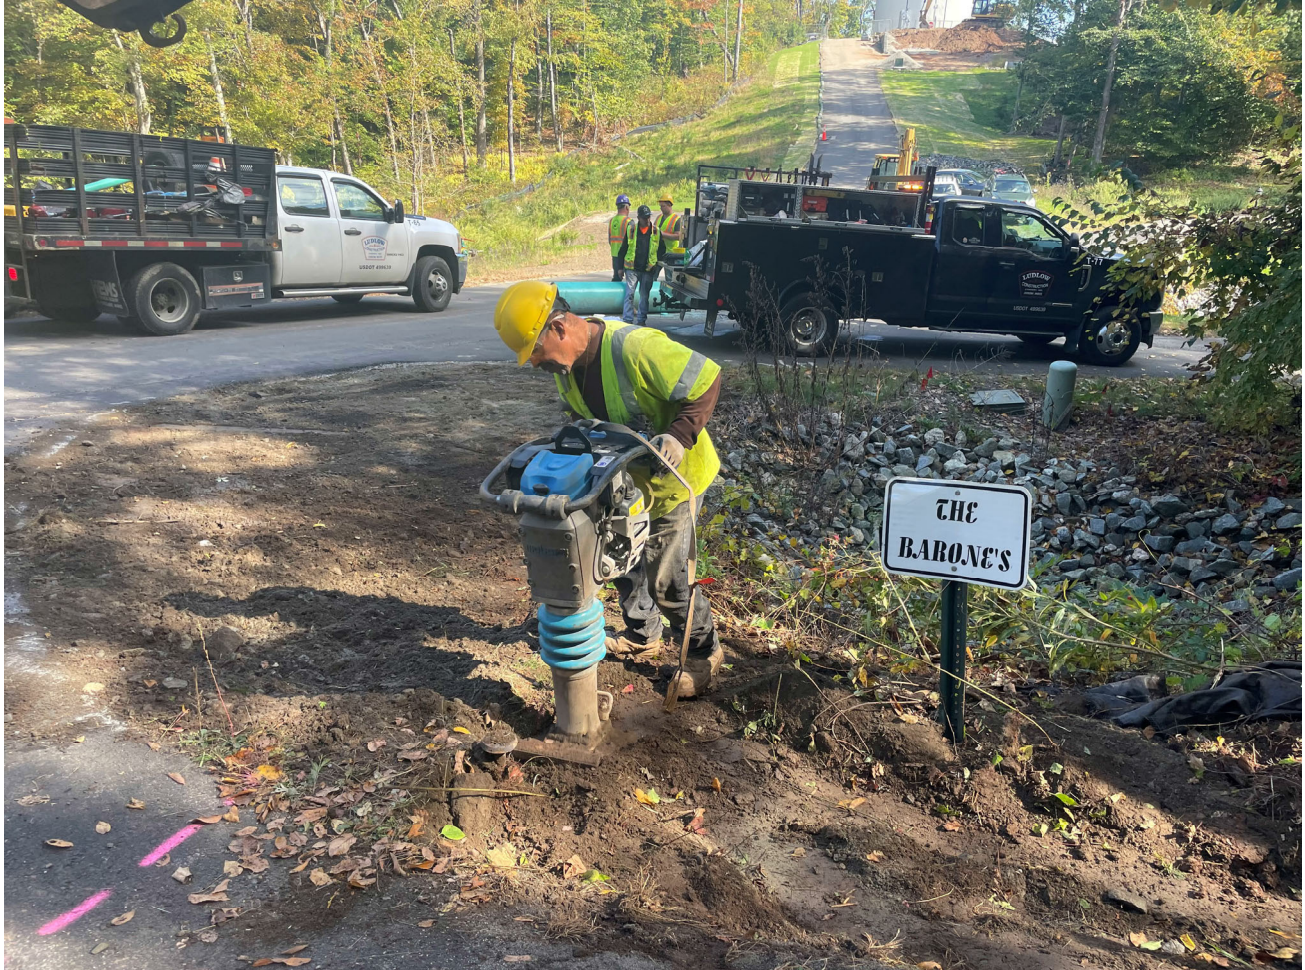
Picture 3: Ludlow compacting soil next to the curb stop for the 224 Talcott Ridge Drive after installing a 1" copper water service line on the south side of the curb stop. View to the northeast.

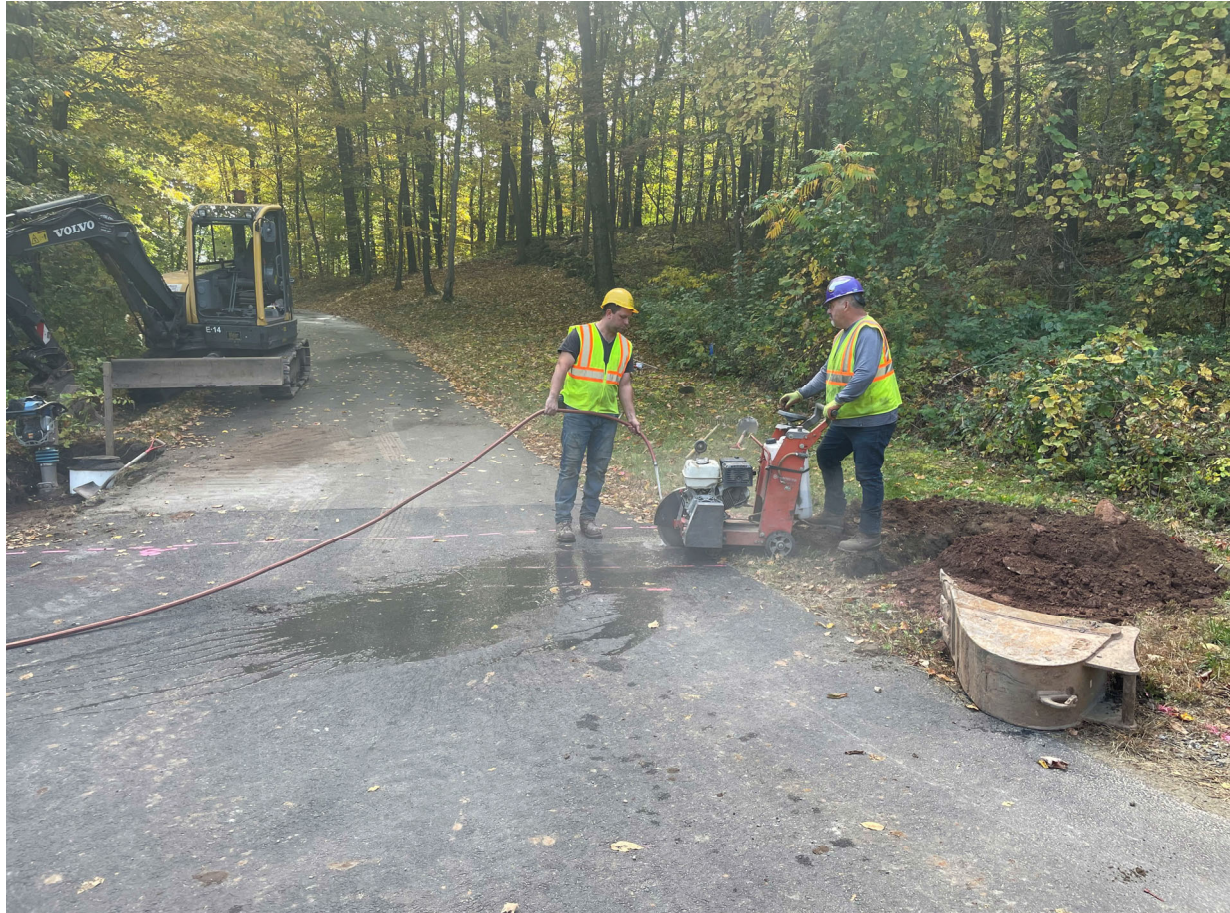
Picture 4: Ludlow saw cutting asphalt on the driveway for the 224 Talcott Ridge Drive property as they prepare to excavate a trench. View to the south.

1231: Ludlow begins to saw cut the asphalt driveway for the 224 Talcott Ridge Drive driveway for the installation of an 8" section of PVC that will be installed east-to-west where the east end of the pipe will daylight into the adjoining plunge bowl between the driveways for 216 and 224 Talcott Ridge Drive. The west end of the 8" PVC will be located inside of the 18" PVC riser that Ludlow will install as part of a catch basin on the west side of the driveway.

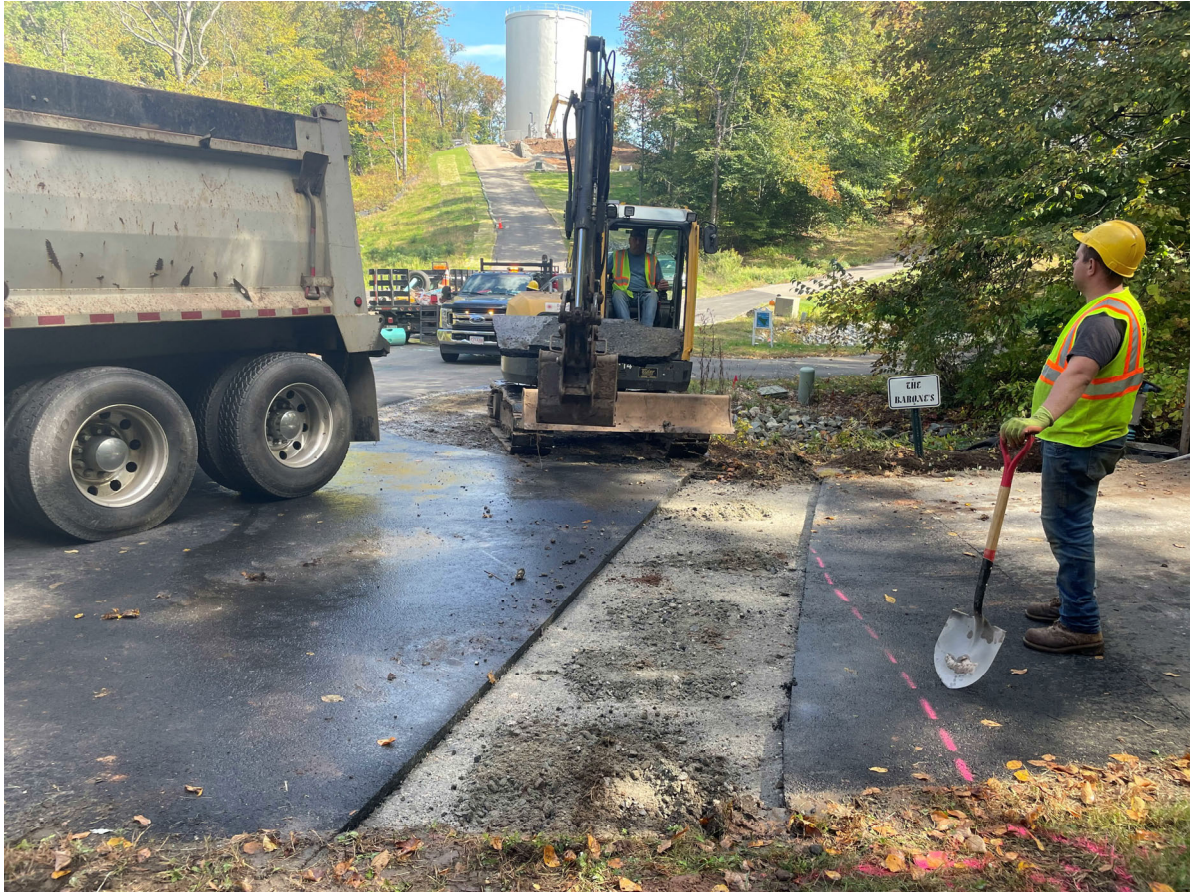
Picture 5: Trench footprint on the driveway for the 224 Talcott Ridge Drive property where Ludlow has removed asphalt as they prepare to excavate a trench. View to the east.

1244: Ludlow has removed a strip of asphalt between the curb stop and the catch basin they preparing to install on the west side of the 224 Talcott Ridge Drive driveway.

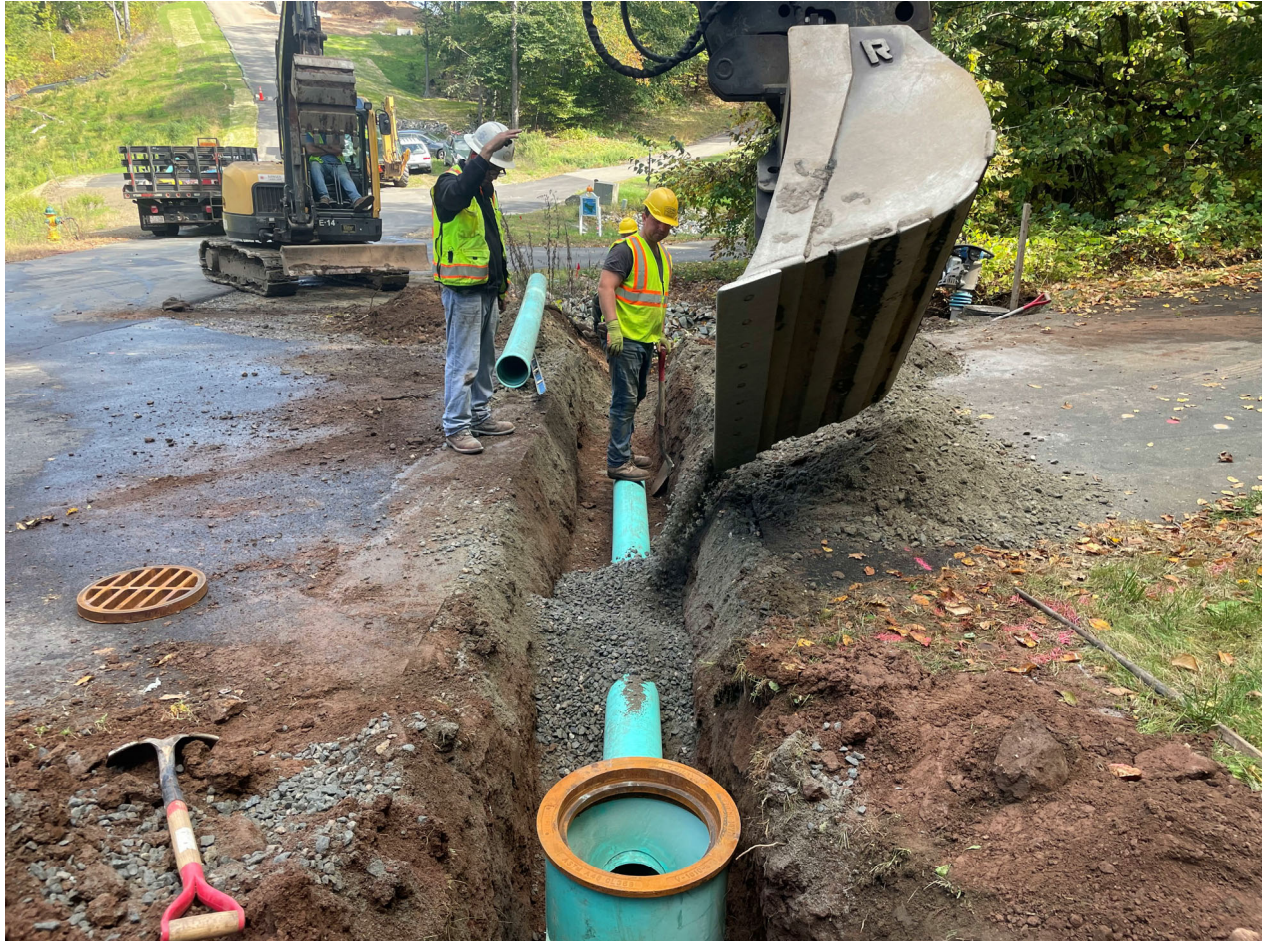
Picture 6: Ludlow placing $\frac{3}{4}$ " stone over a section of 8" PVC pipe they have placed in the trench they excavated across the driveway for the 224 Talcott Ridge Drive property. The west side of the 8" PVC pipe terminates in the 18" PVC riser of a catch basin they just installed. View to the east.

1333: Ludlow placed approximately 6" of ¾" stone over the 8" PVC pipe that they have placed in the trench that's been excavated across the driveway for the 224 Talcott Ridge Drive property. Ludlow is currently placing a section of filter fabric over the ¾" stone.

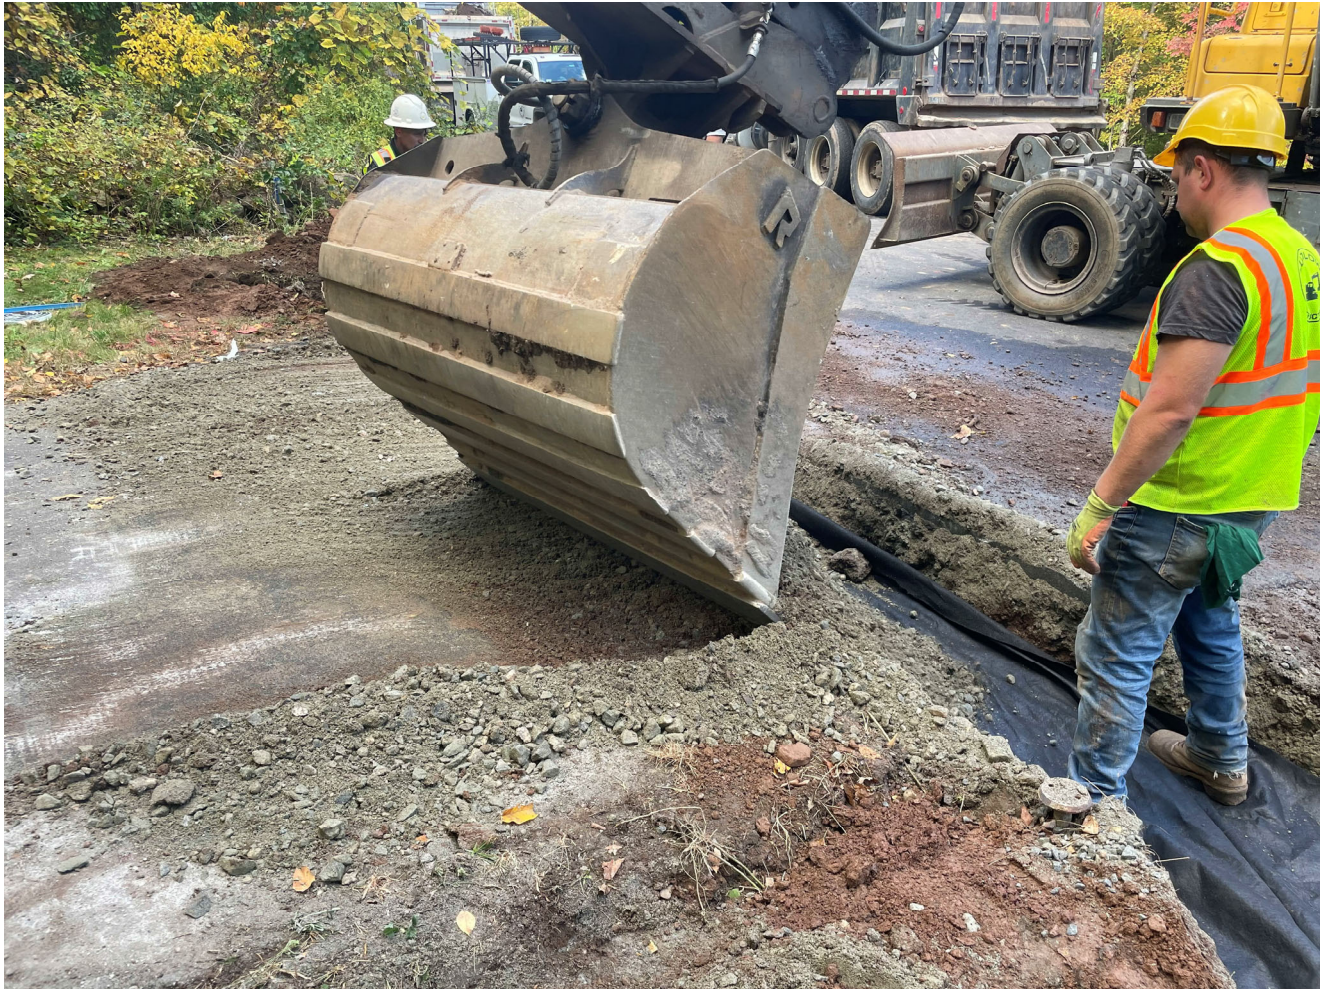
Picture 7: Ludlow placing fill over a section of filter fabric that was placed over ¾" stone that was placed over the 8" PVC pipe that Ludlow placed in the trench on the driveway for the 224 Talcott Ridge Drive property. View to pipe the northwest.

1335: Ludlow is placing fill from the trench excavation over the filter fabric they just placed over the ¾" stone that covers the 8" PVC pipe they just installed across the driveway for the 224 Talcott Ridge Drive property.

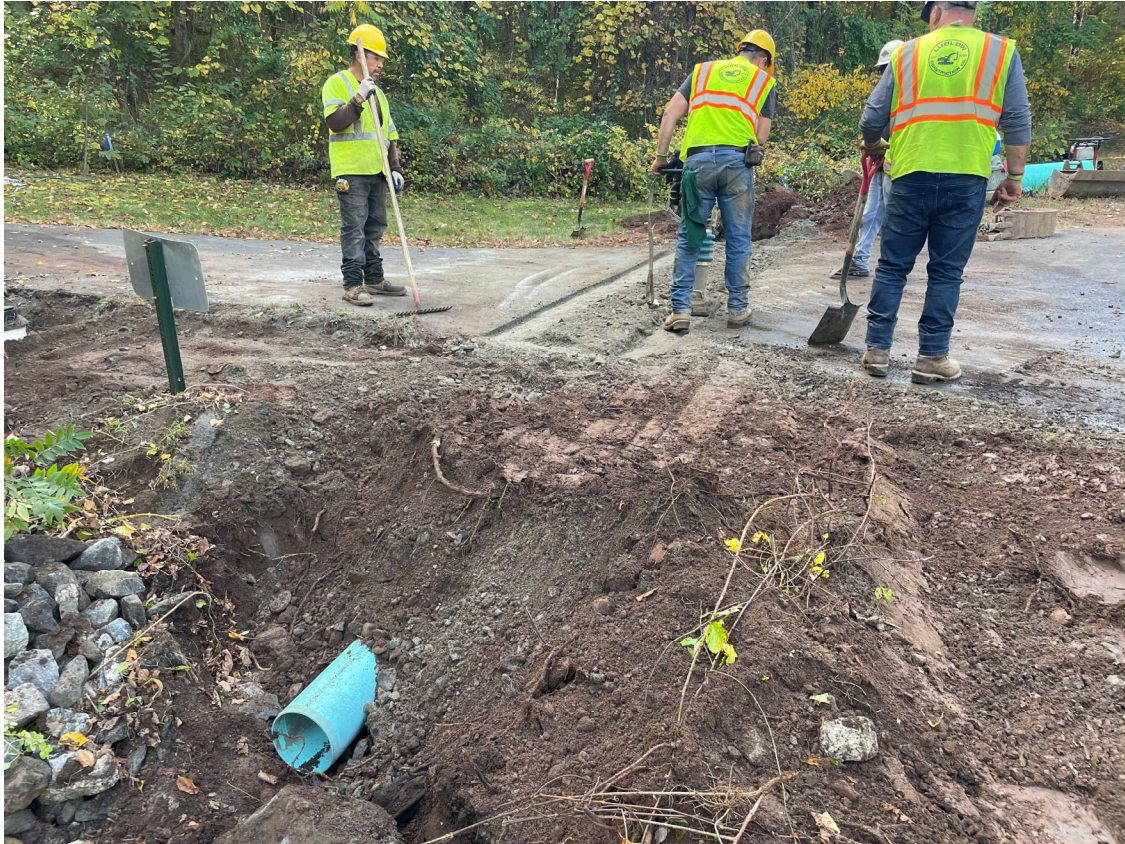
Picture 8: View of backfilled trench after Ludlow installed a section of 8" PVC pipe across the driveway for the 224 Talcott Ridge Drive property. The east side of the 8" PVC pipe discharges to the plunge bowl located on the east side of the driveway entrance. View to west.

1337: Ludlow is using a jumping jack to compact the fill they just placed over the filter fabric in the trench at the 224 Talcott Ridge Drive driveway.

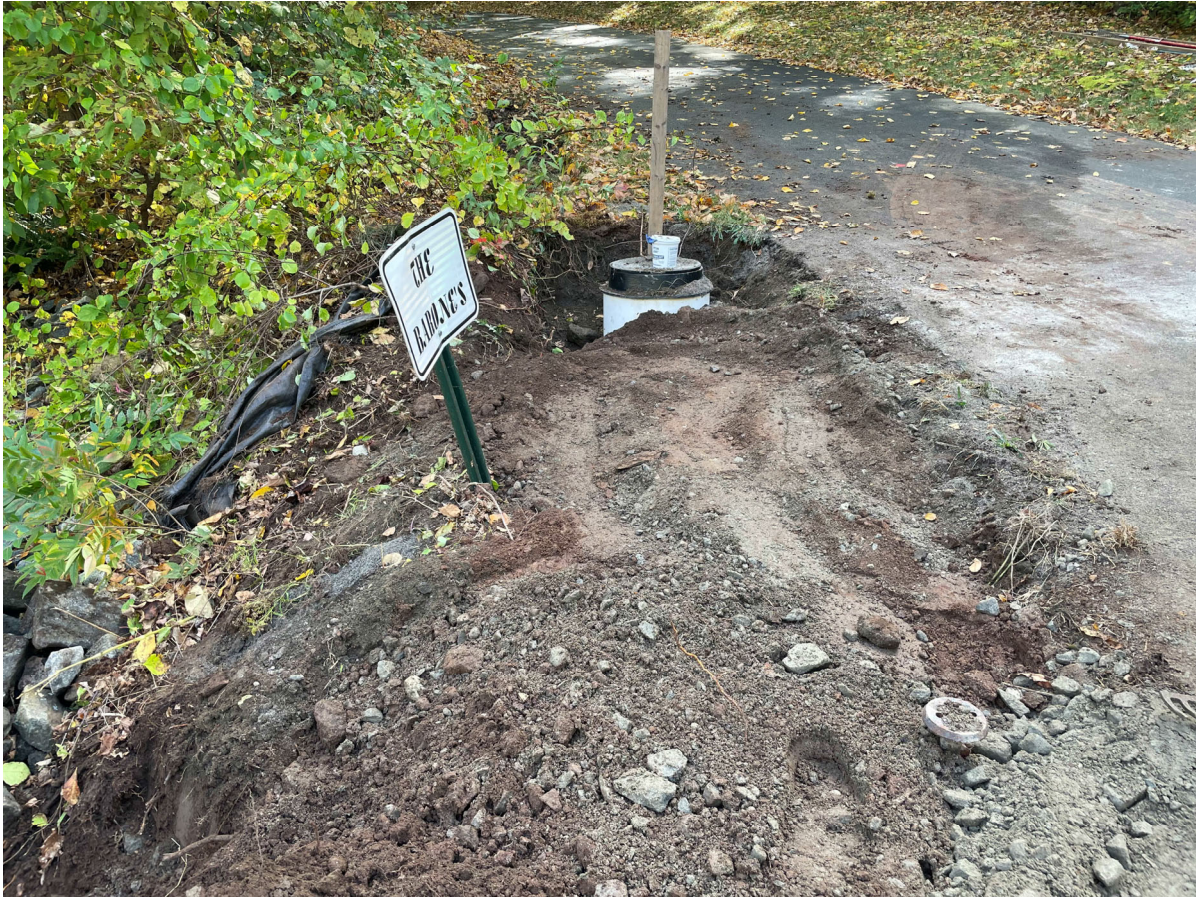
Picture 9: Meter pit that Ludlow installed 8' north of the curb stop for the 224 Talcott Ridge Drive property. View to the south.

1207 Ludlow has installed a meter pit approximately 8' south of the curb stop for the 224 Talcott Ridge Drive property.

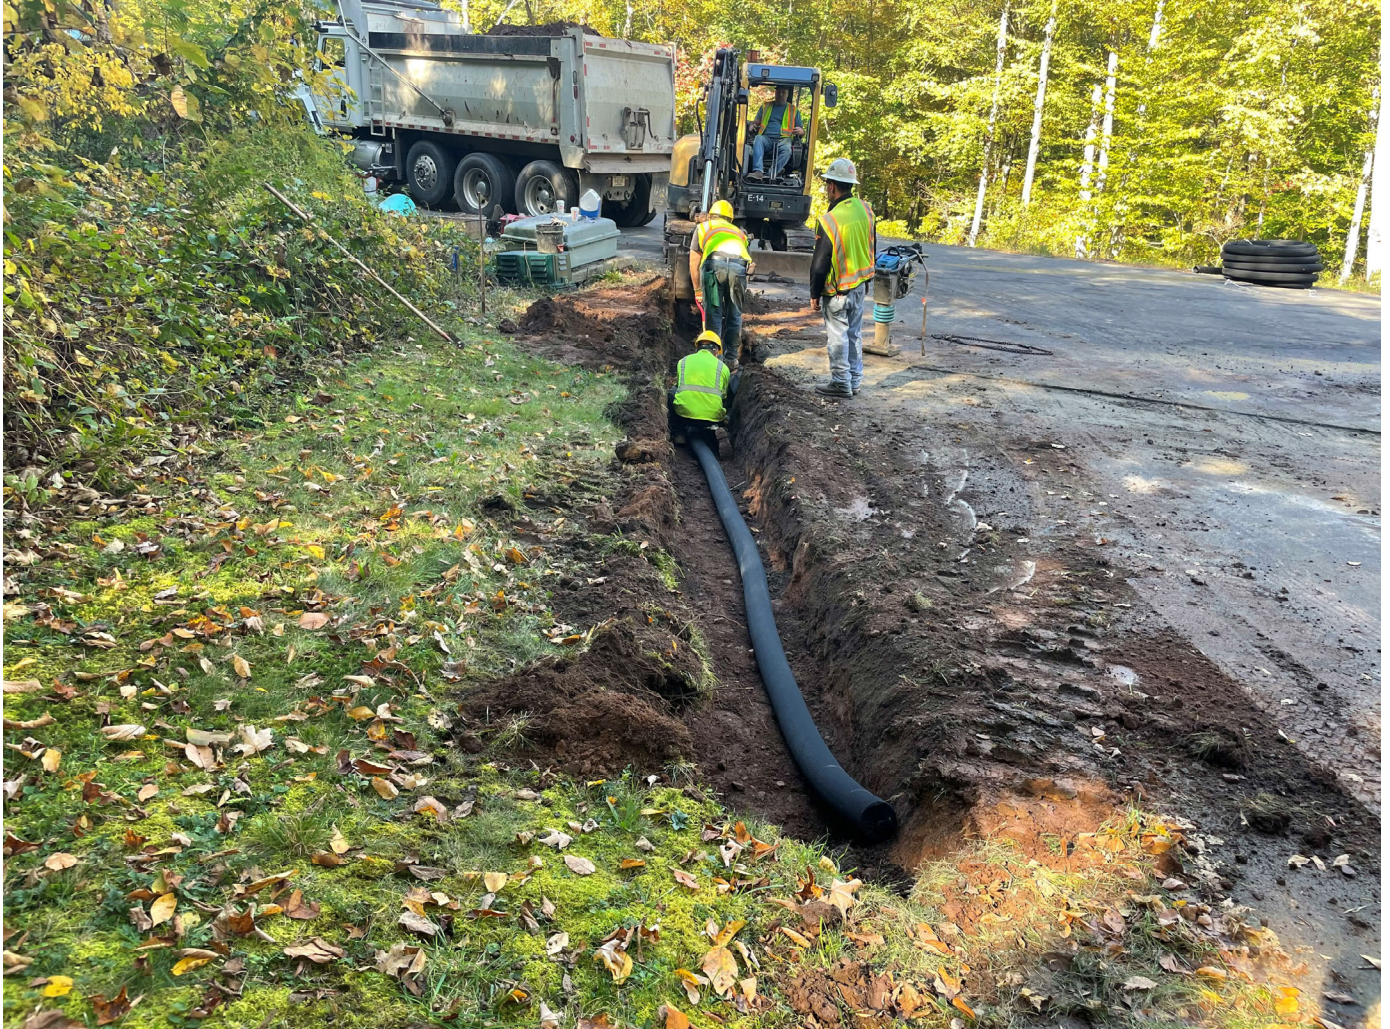
Picture 10: Ludlow placing a section of 4" corrugated, perforated plastic pipe (encased on a filter sock) in a trench they excavated on the west side of the driveway for the 224 Talcott Ridge Drive property. View to the north.

1356: Ludlow is excavating a trench approximately 18" deep on the west edge of the driveway for 224 Talcott Ridge Drive property for the installation of a section of 4" plastic perforated corrugated pipe that will be part of a drainage system. The north end of the 4" plastic pipe will terminate inside of the 18" PVC of the catch basin that Ludlow just installed on the west side of the driveway.

1402: Ludlow is placing 4" plastic perforated corrugated pipe into the trench they just excavated on the west edge of the driveway for the 224 Talcott Ridge Drive property.

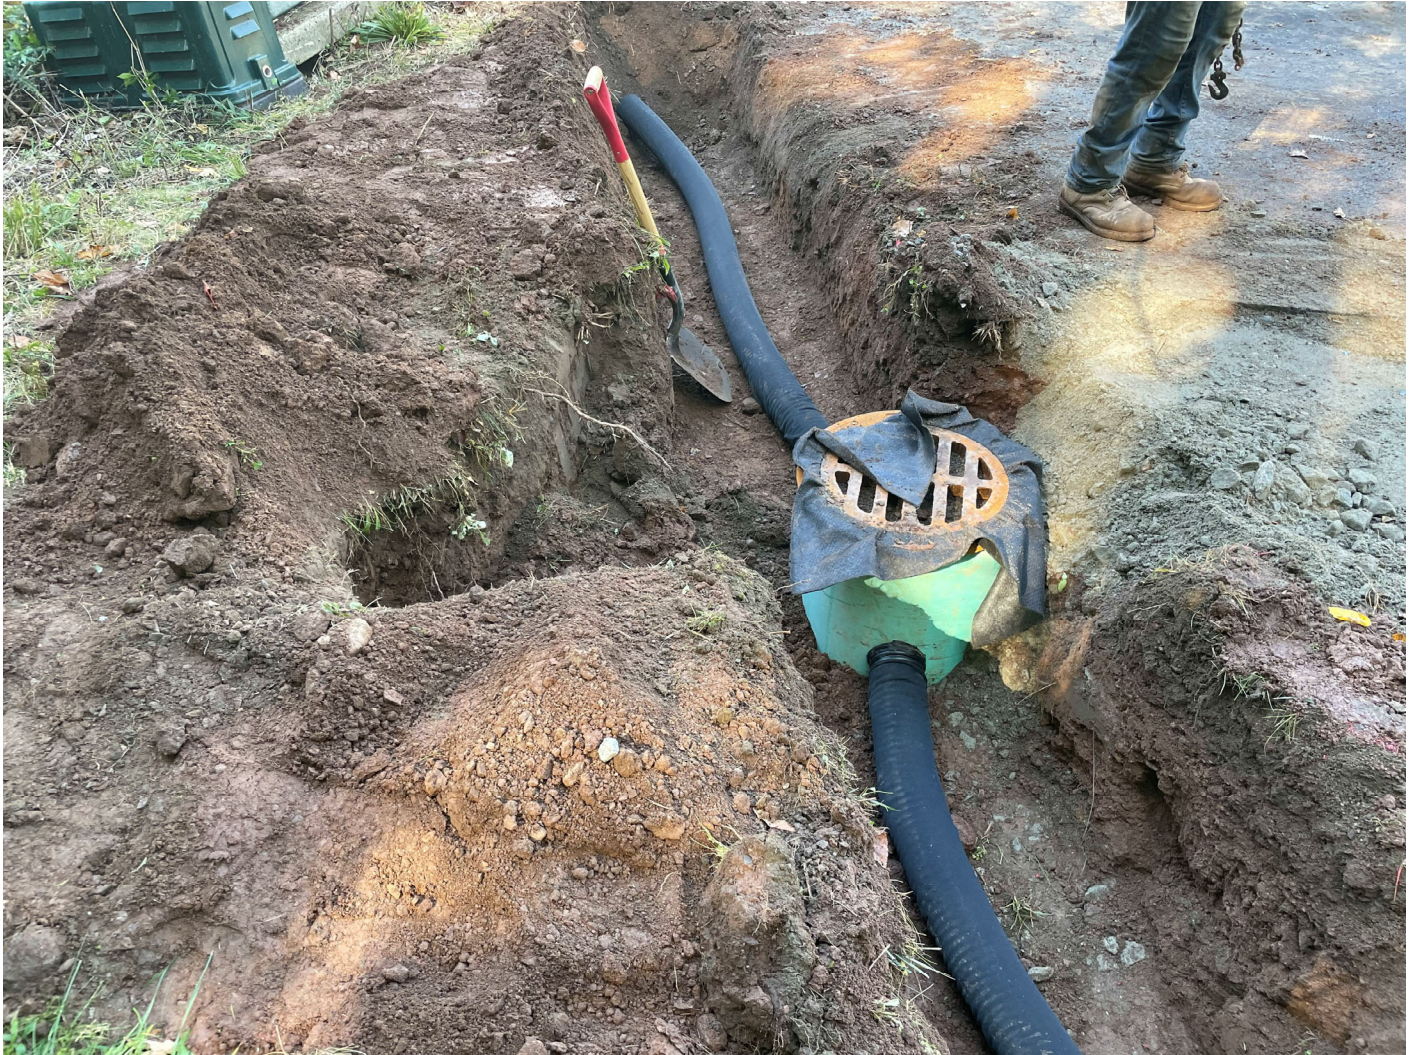
Picture 11: 4" corrugated, perforated plastic pipe (encased on a filter sock) that Ludlow placed in a trench they excavated on the west side of the driveway for the 224 Talcott Ridge Drive property. The sections of pipe connect to the 18" PVC riser of the catch basin that Ludlow installed on the west side of the driveway. View to the north.

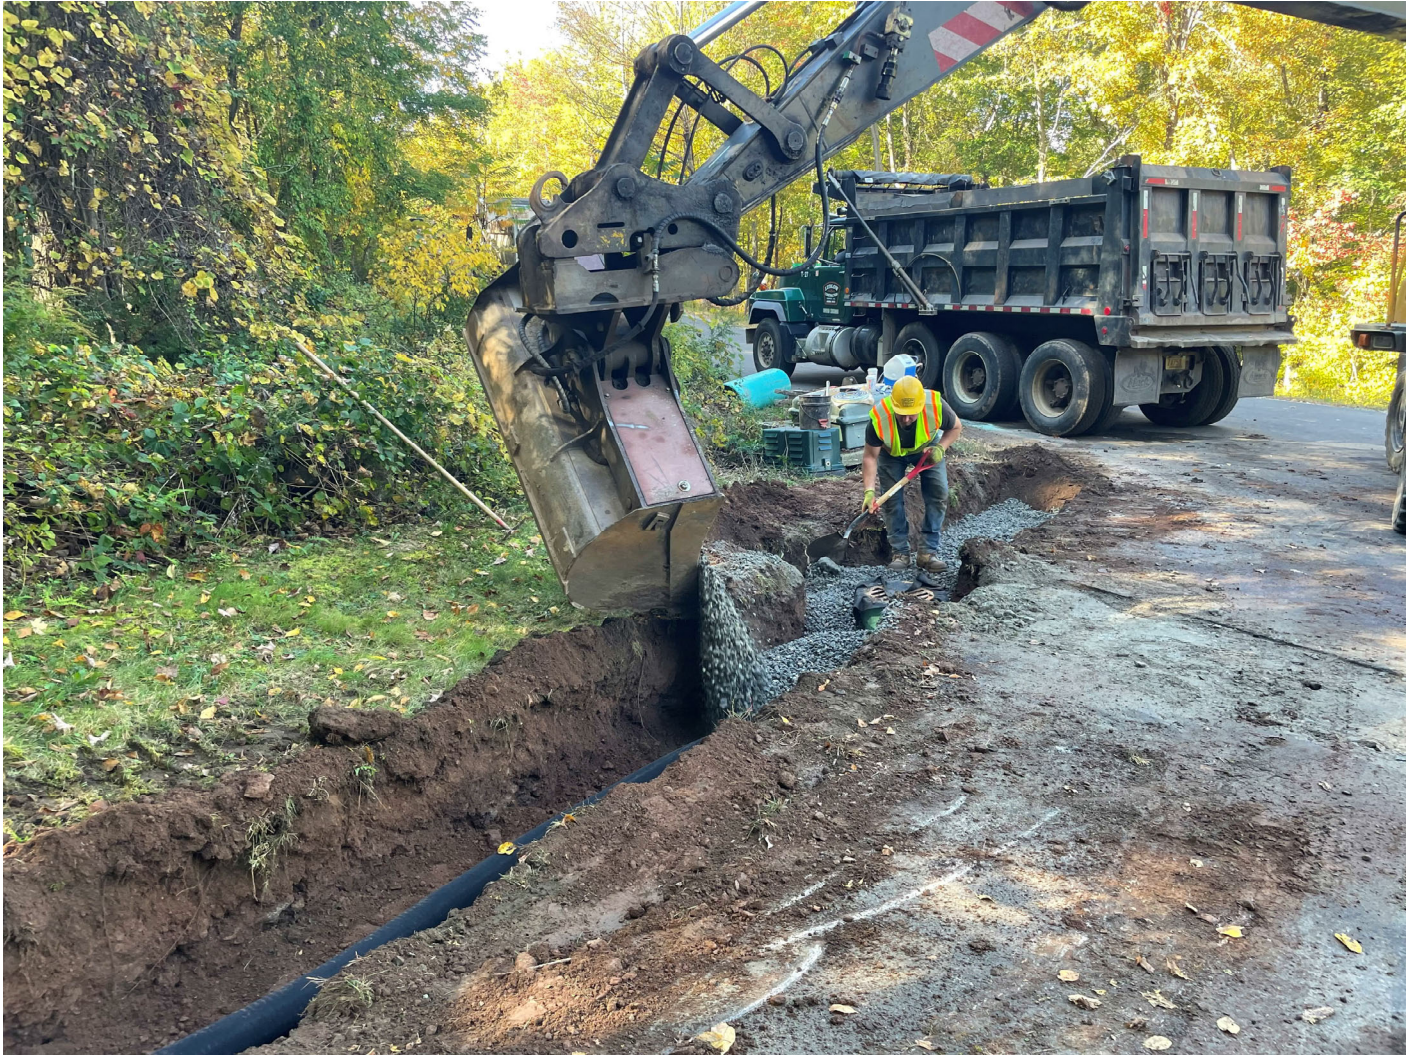
Picture 12: Ludlow placing 3/4" stone over 4" corrugated, perforated plastic pipe (encased on a filter sock) that Ludlow placed in a trench they excavated on the west side of the driveway for the 224 Talcott Ridge Drive property. View to the northwest.

1413: Ludlow is placing ¾" stone over the 4" plastic perforated pipe they placed in the trench on the west side of huge 224 Talcott Ridge Drive driveway. Ludlow also ran approximate 8" of the perforated pipe on the north side of the catch basin. That is also being covered or ¾" stone.
