Daily Report

Project:	Durham Meadows Pipeline Installation	Date:	October 22, 2021
Location:	Main Street, Durham; Shared Access Driveway, Middletown	Day of Week:	Friday
Project #:	AECOM: 6061487	Report No:	349
Contractor:	Ludlow Construction	Page:	1 of 14

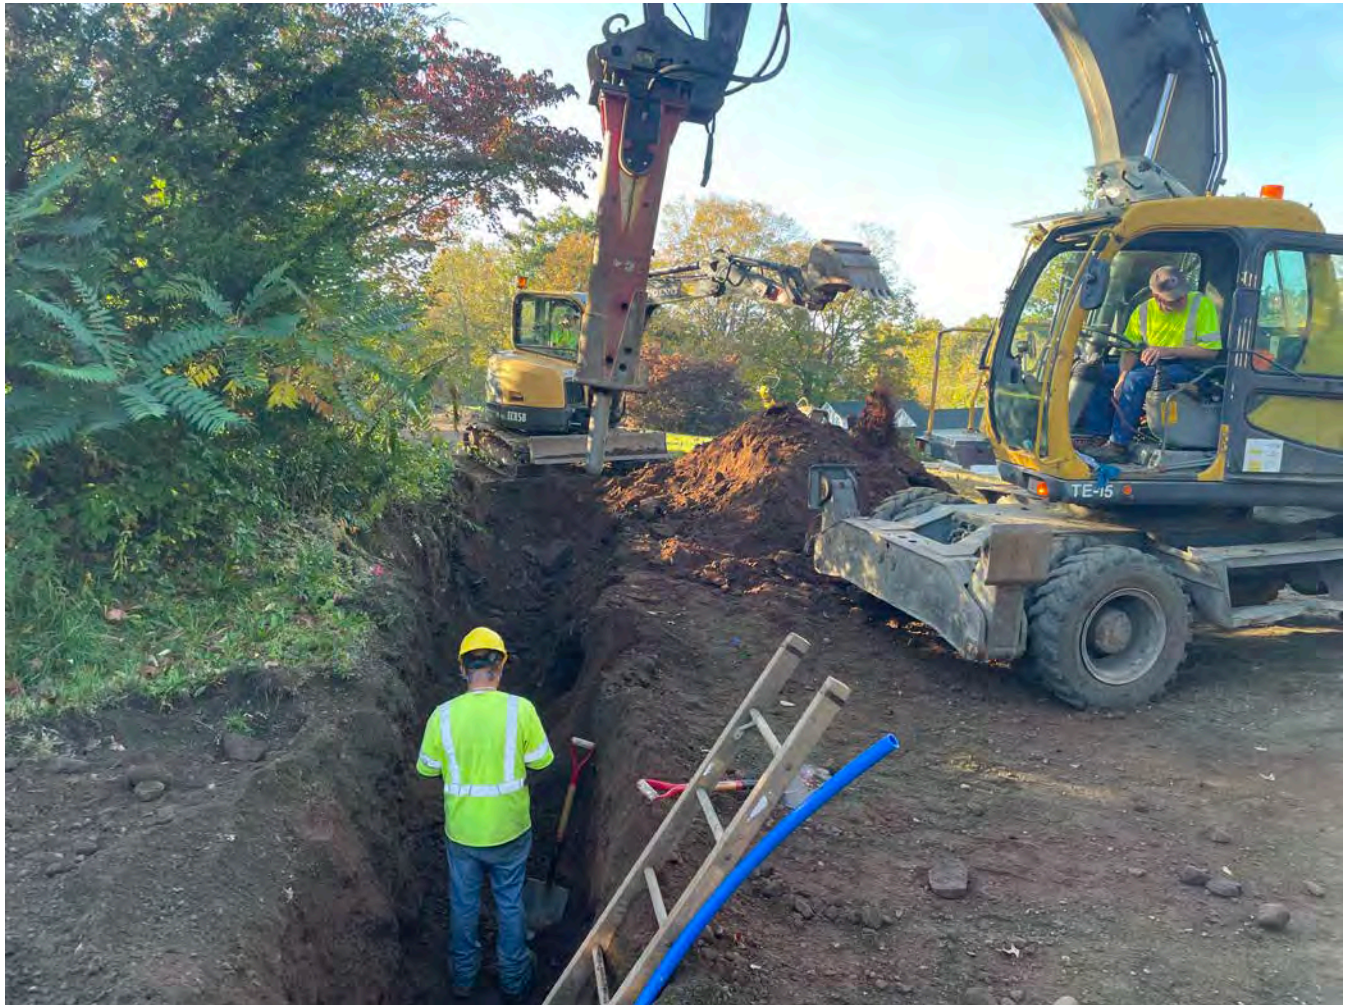
Picture 1: Ludlow preparing to hammer rock they encountered while excavating a trench for the installation of a 1.5" copper water service line at the 175 Main Street, Durham, property. View to the south.

0807: Ludlow has encountered rock approximately 20' south of the 175 Main Street property curb stop. Ludlow is preparing to hammer the rock using a Volvo EW170 excavator.

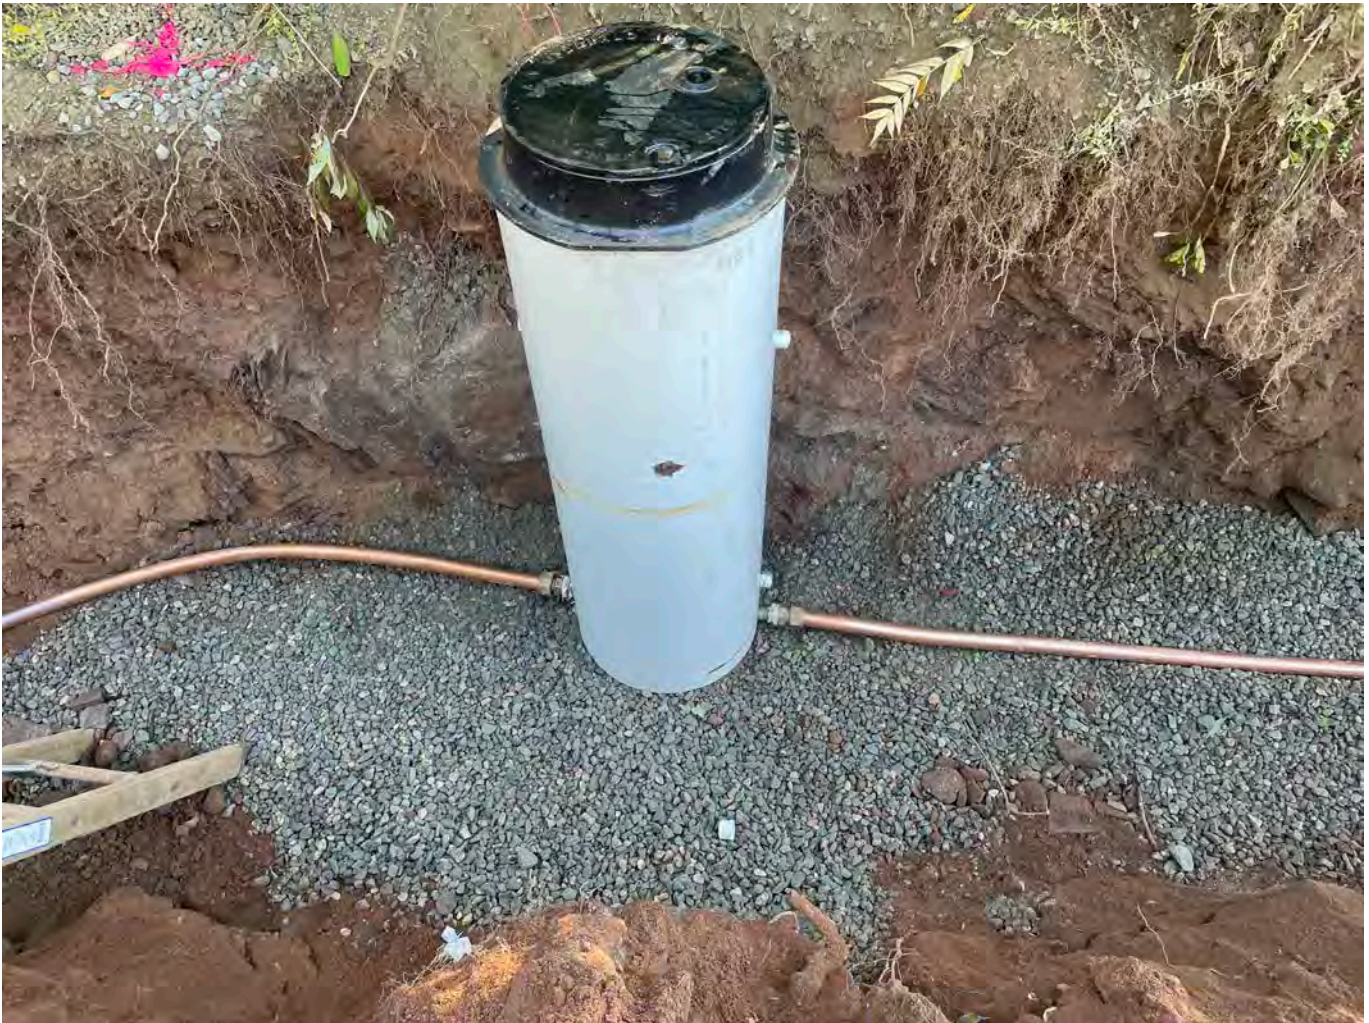
Picture 2: Meter pit that Ludlow installed at the 175 Main Street property, with 1.5" copper pipe installed on the north and south sides of the PVC riser. View to the east.

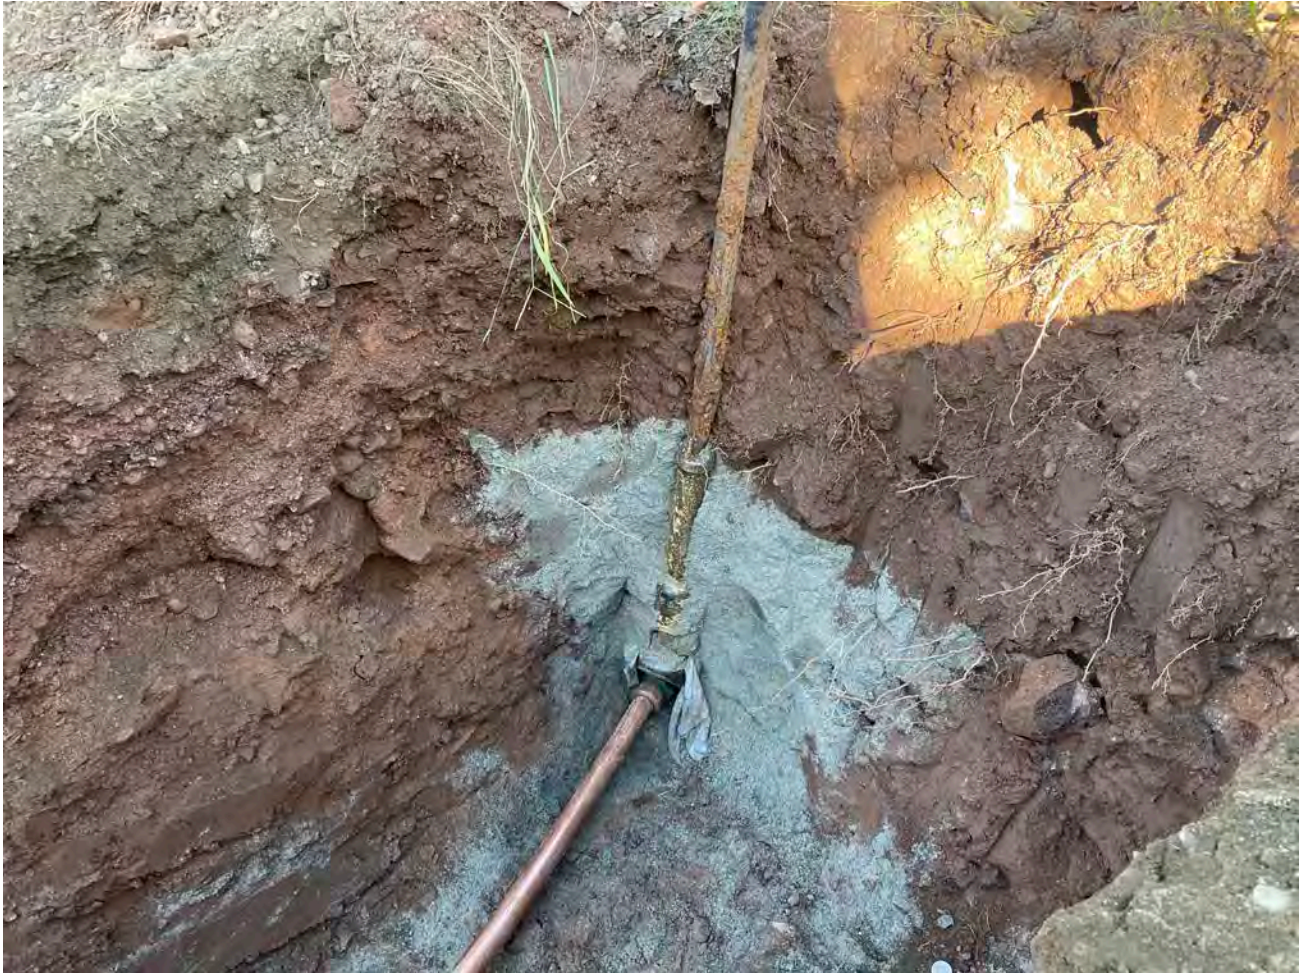
Picture 3: Curb stop that Ludlow installed at the 175 Main Street property, with 1.5" copper pipe installed on the south side of the curb stop. View to the northwest.

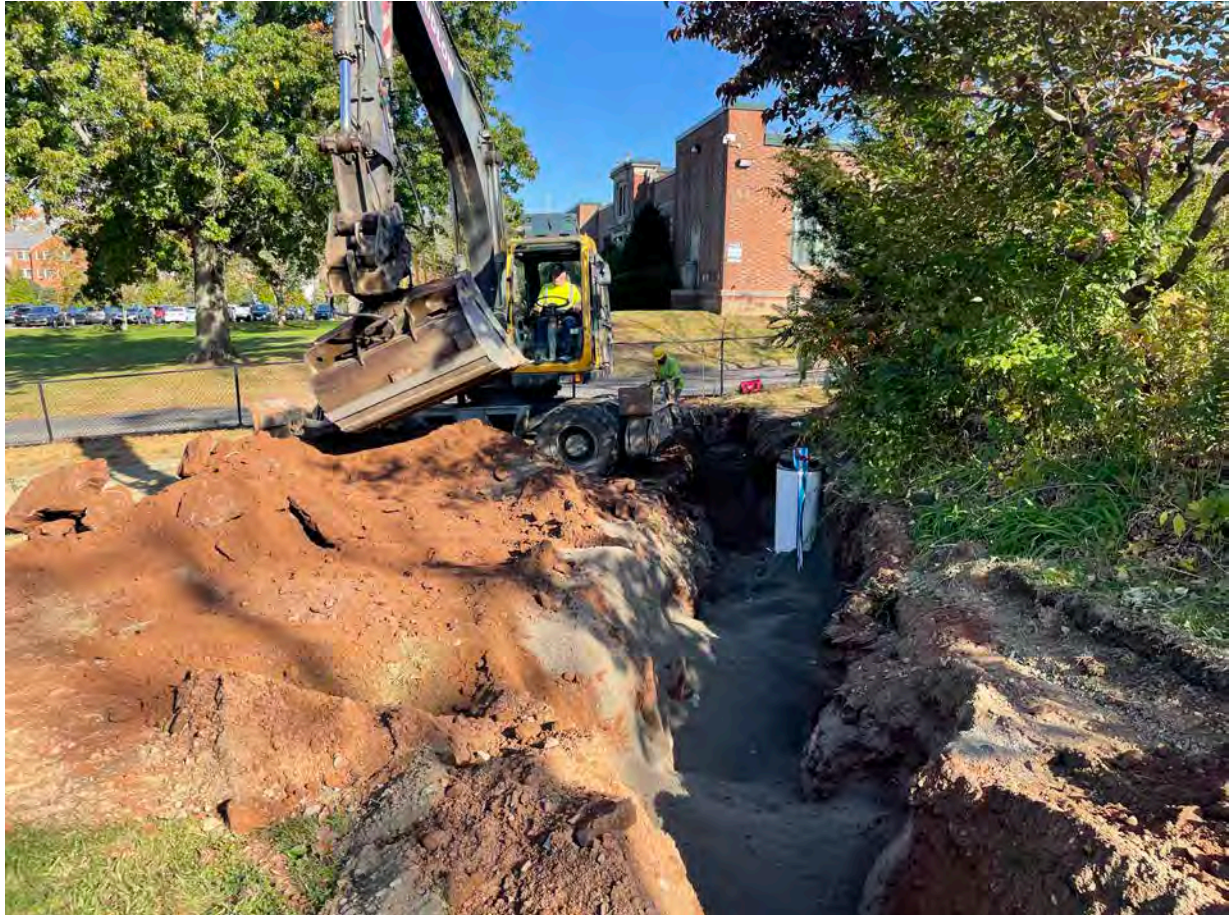
Picture 4: Ludlow backfilling over the 1.5” copper pipe they installed at the 175 Main Street property. View to the north.

1048: Ludlow is placing a 1.5" copper water service line into the trench they excavated down the driveway of the 175 Main Street residence. On the north side of the excavation, Ludlow is backfilling over the 1.5" copper line with 6" of sand, followed by caution tape, followed by native fill.

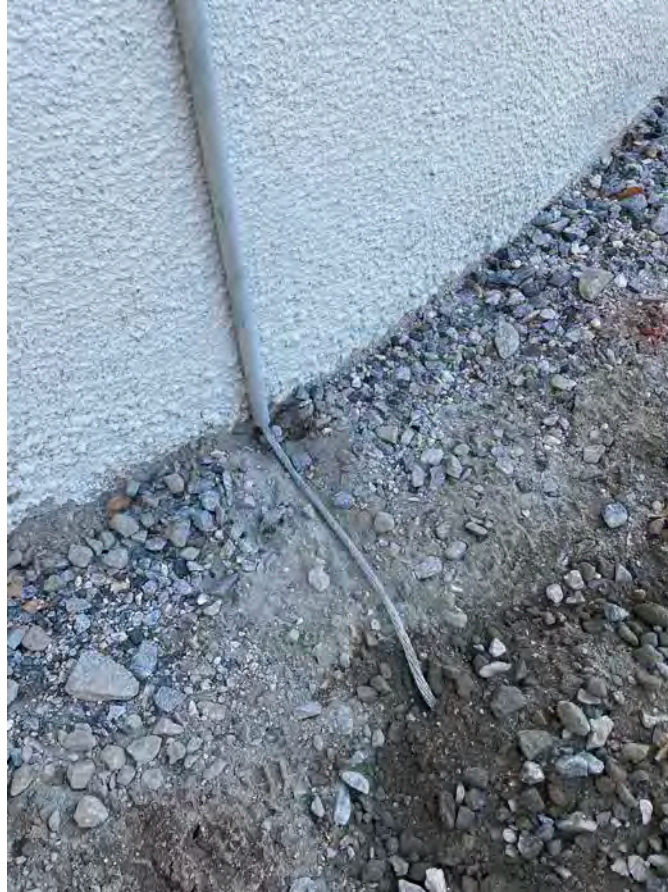
Picture 5: Grounding wire that B&B Lightning Protection installed on the side of the water tank and tied into the existing subsurface grounding wires around the perimeter of the tank. Water tank work zone located east of the Shared Access Driveway. View to south.

B&B Lightning Protection returned to the water tank to finish the installation of grounding lines for the lightning protection system on the tank. They were not able to finish yesterday because they had to use glue instead of bolts to attach cable fasteners to the top of the water tank.

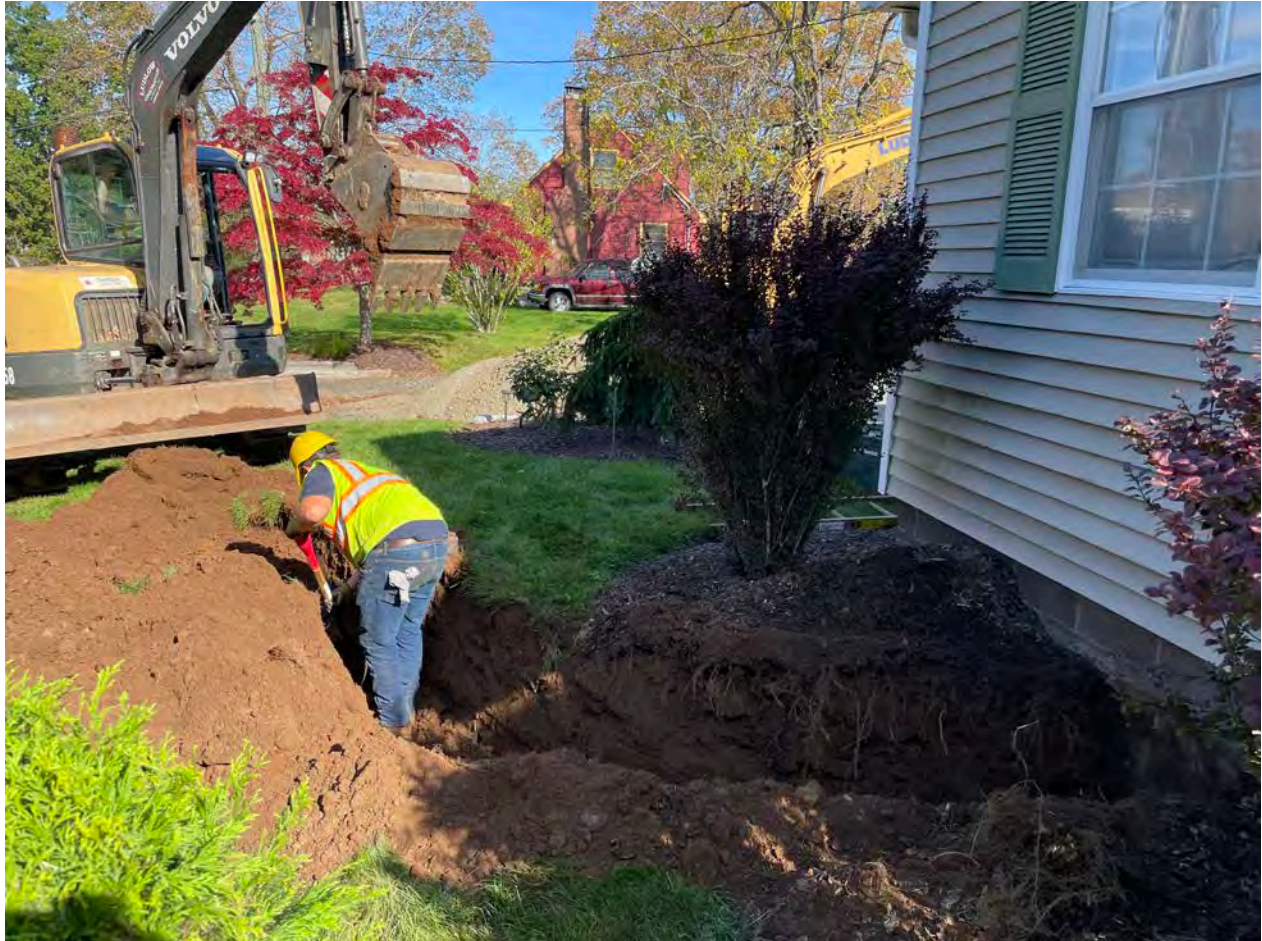
Picture 6: Ludlow excavating a trench northward for the installation of a 1.5" copper water service line at the 175 Main Street property. View to the north.

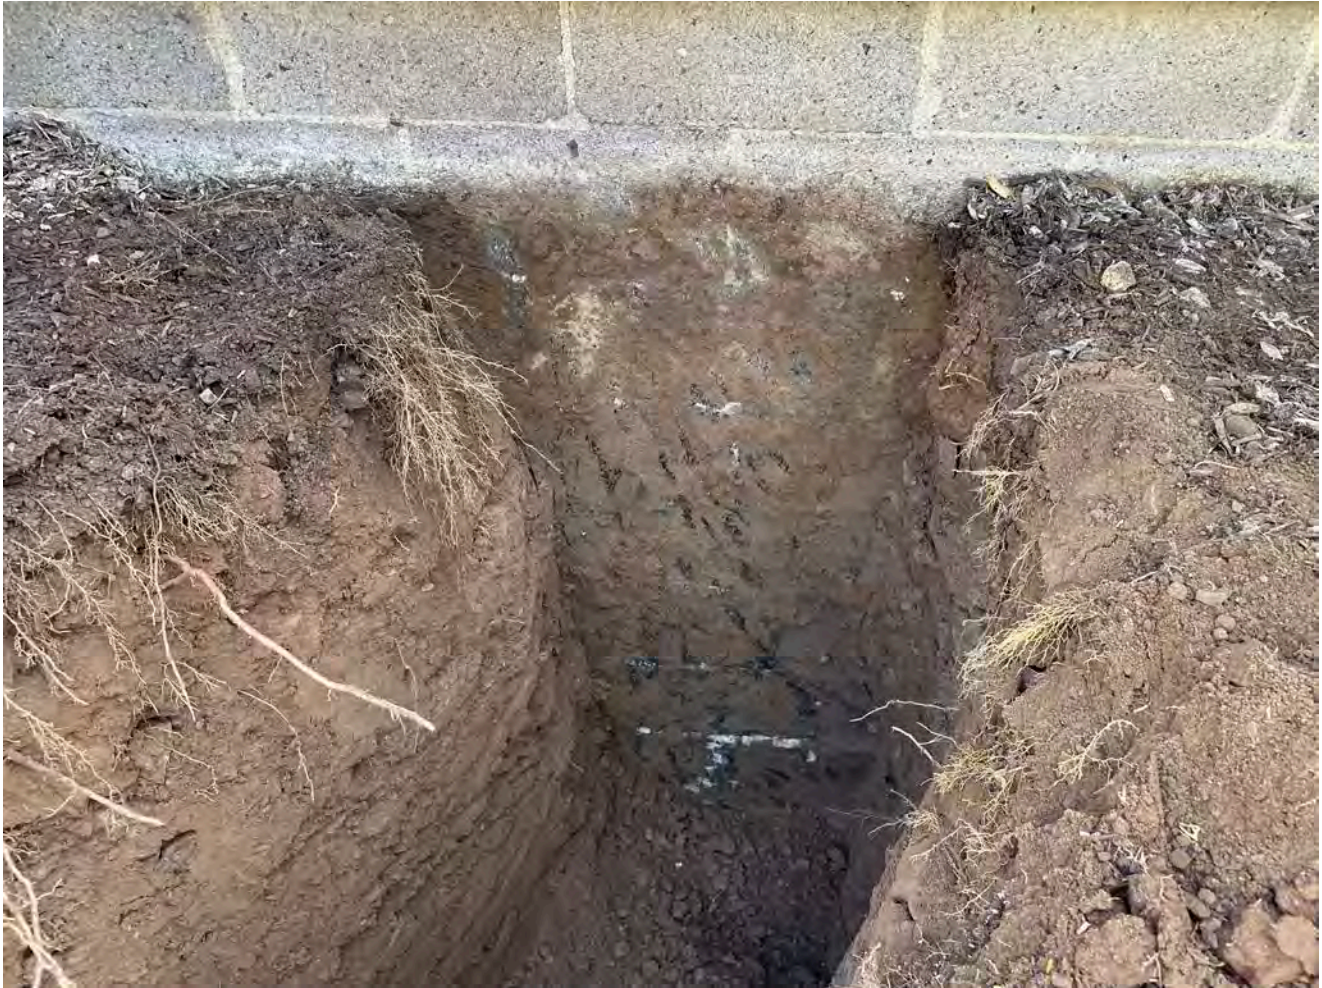
Picture 7: Cinder block foundation of the 175 Main Street residence that Ludlow daylighted on the west side of the house. View to the east.

1033: Ludlow has begun to excavate on the west side of the 175 Main Street residence in order to daylight the cinder block foundation. Ludlow has already excavated a separate portion of the trench south of the curb stop to within 50' of the 175 Main Street residence.

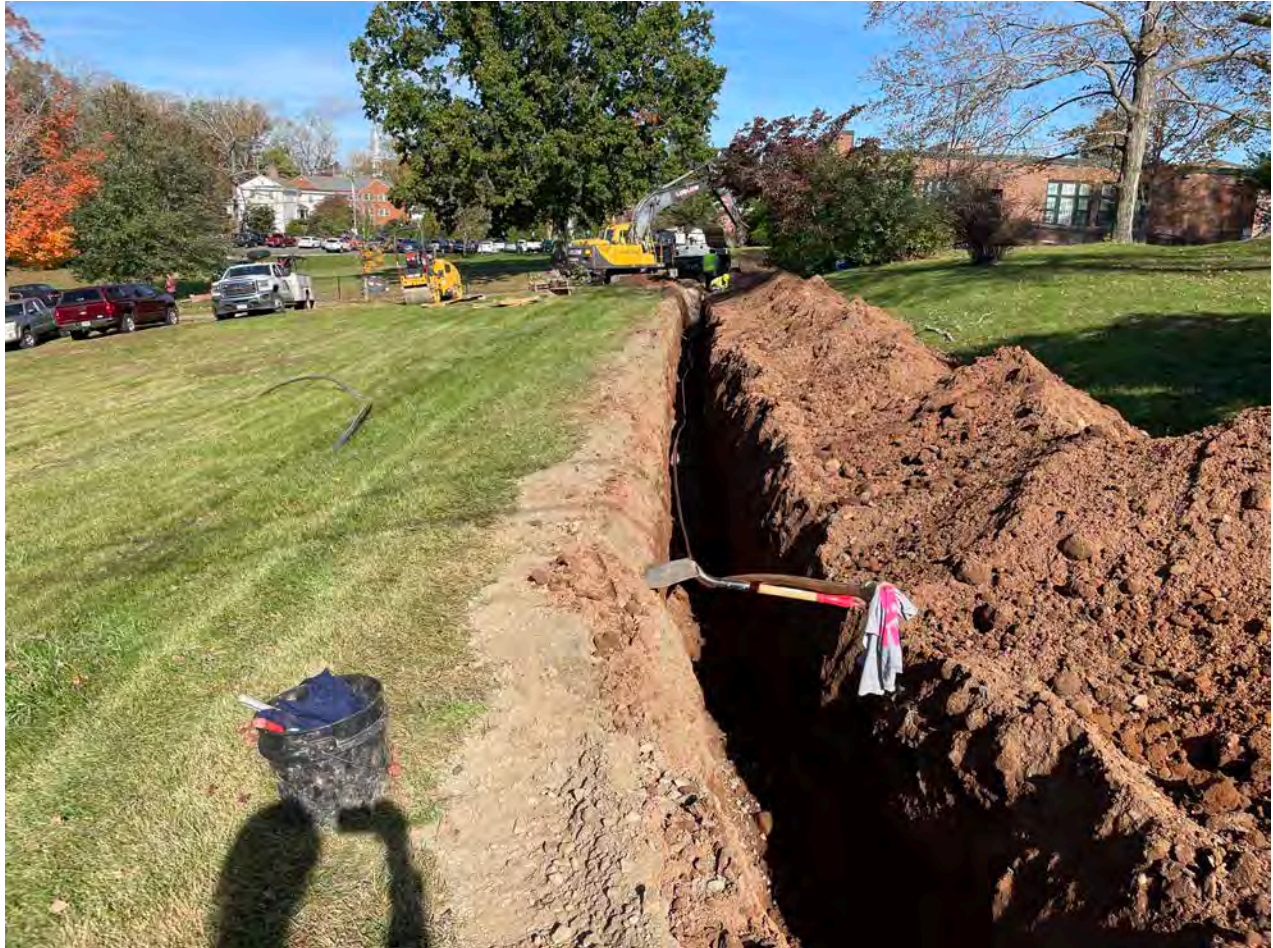
Picture 8: Ludlow in the process of installing a 1.5" copper water service line for the 175 Main Street residence. View to the north.

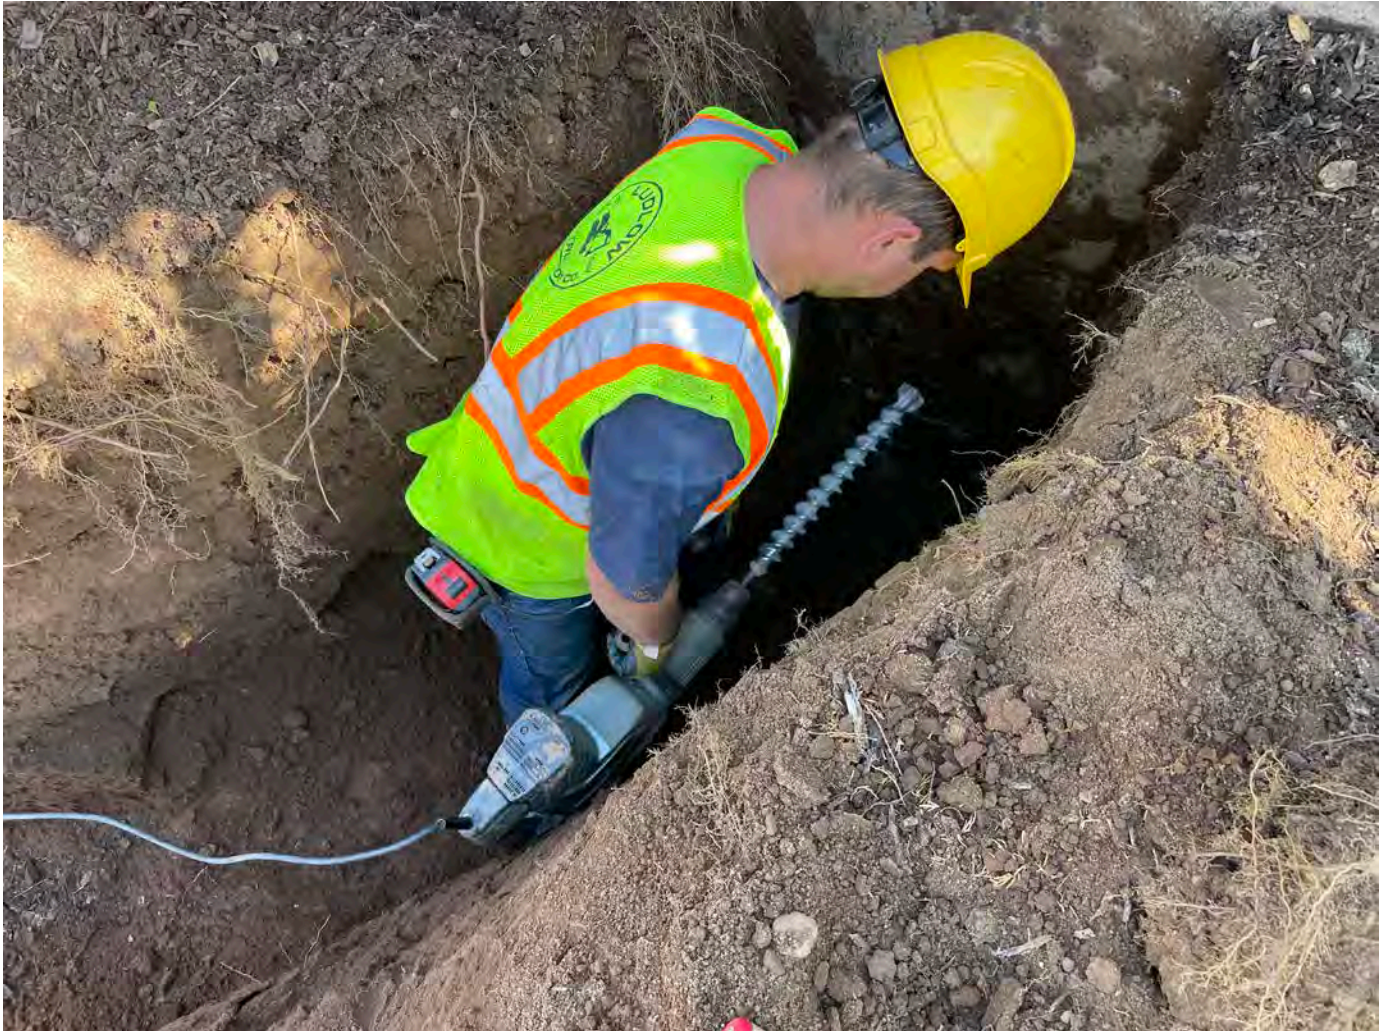
Picture 9: Ludlow preparing to penetrate the cinder block foundation of the residence located at 175 Main Street for the installation of a 1.5" copper water service line. View to northeast.

1138: Ludlow prepares to penetrate the foundation on the west side of the 175 Main Street residence by drilling through it with a rotary hammer.

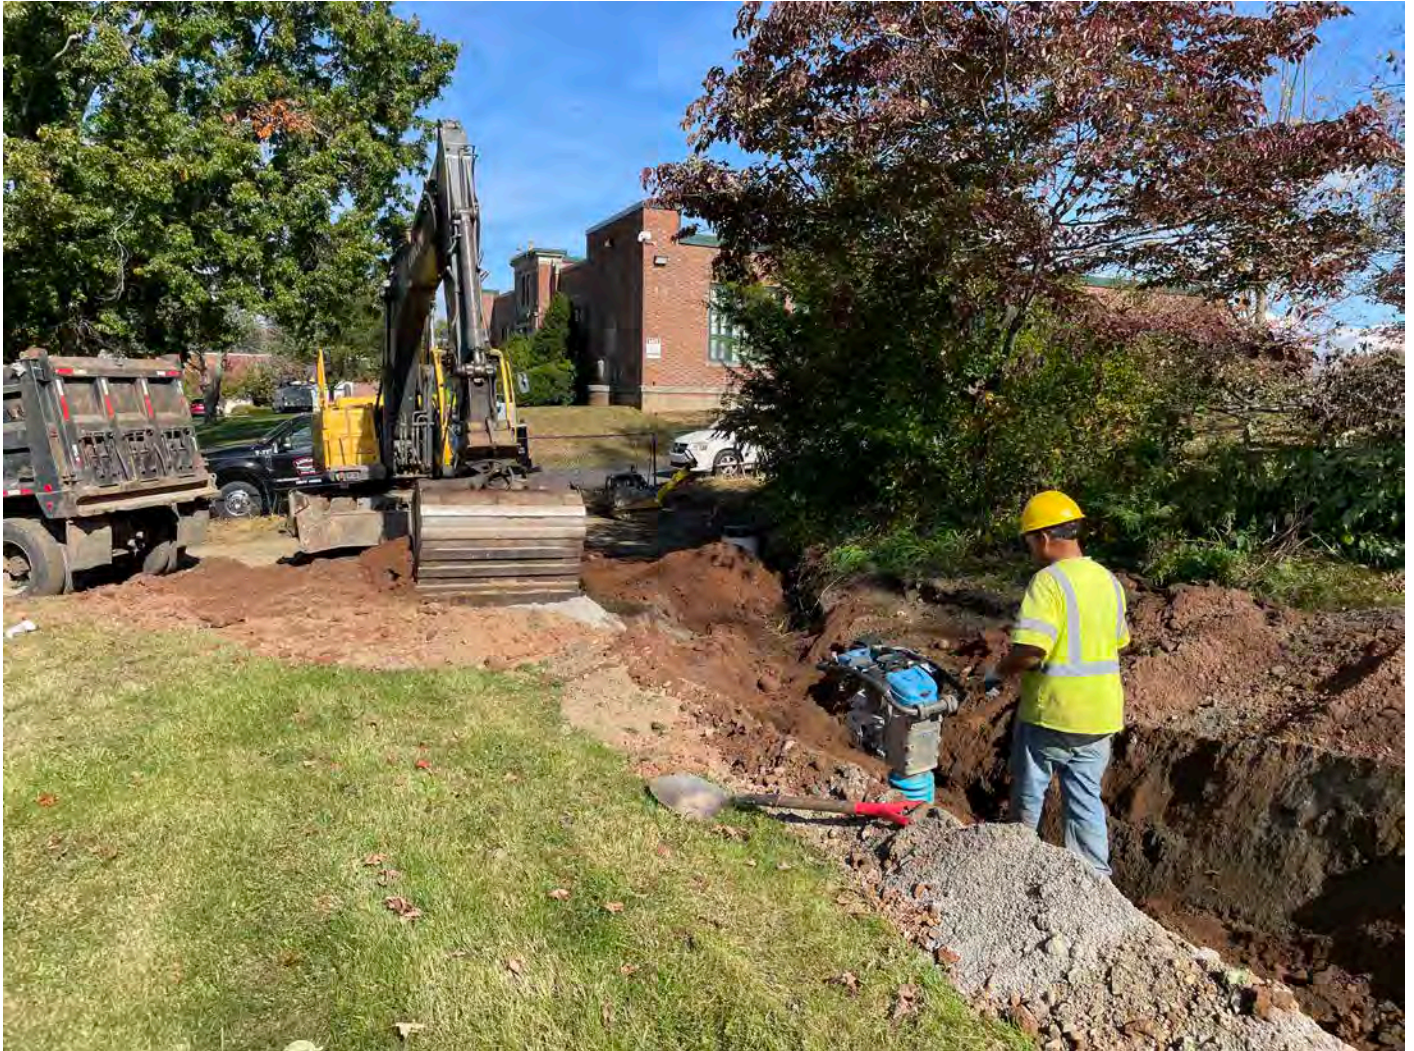
Picture 10: Ludlow compacting fill with a jumping jack they just placed over sand and caution tape as they backfill the trench where they installed a 1.5" copper water service line at the 175 Main Street property. View to northeast.

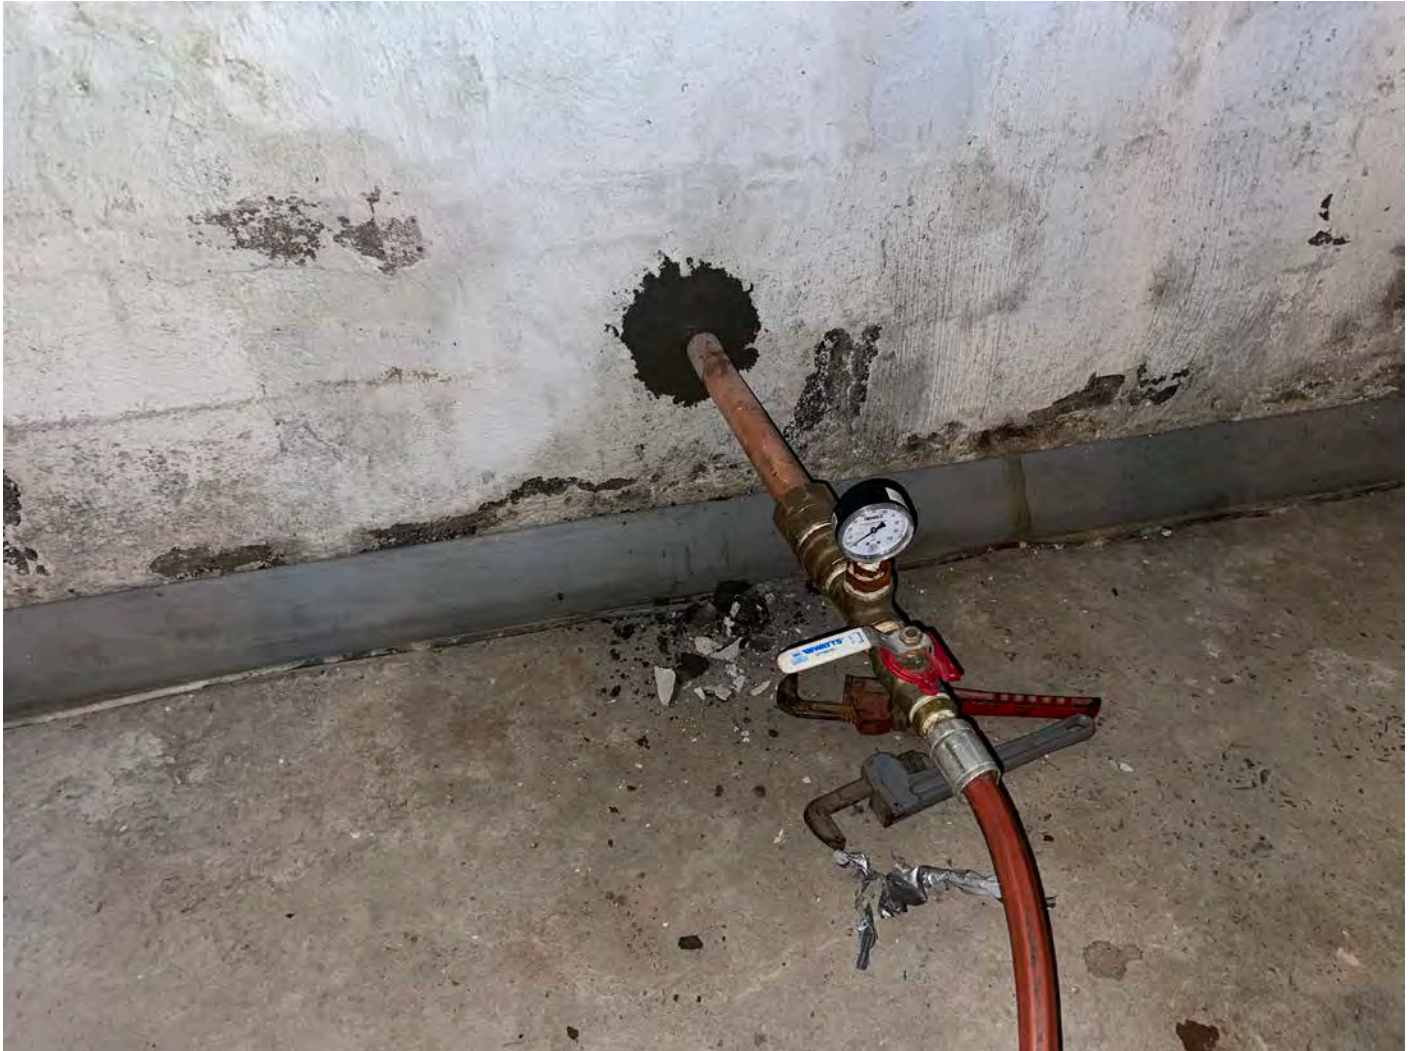
Picture 11: Pressure gauge that Ludlow placed on the 1.5" copper water service line they installed through the western foundation of the 175 Main Street residence. View to northwest.

1311: Ludlow is using non-shrink grout to secure the 1.5" copper water service line in place where it penetrates the western foundation of the residence located at 175 Main Street. Ludlow has set up a pressure gauge on the 1.5" copper water service line on the interior of the 175 Main Street residence to perform a pressure test.

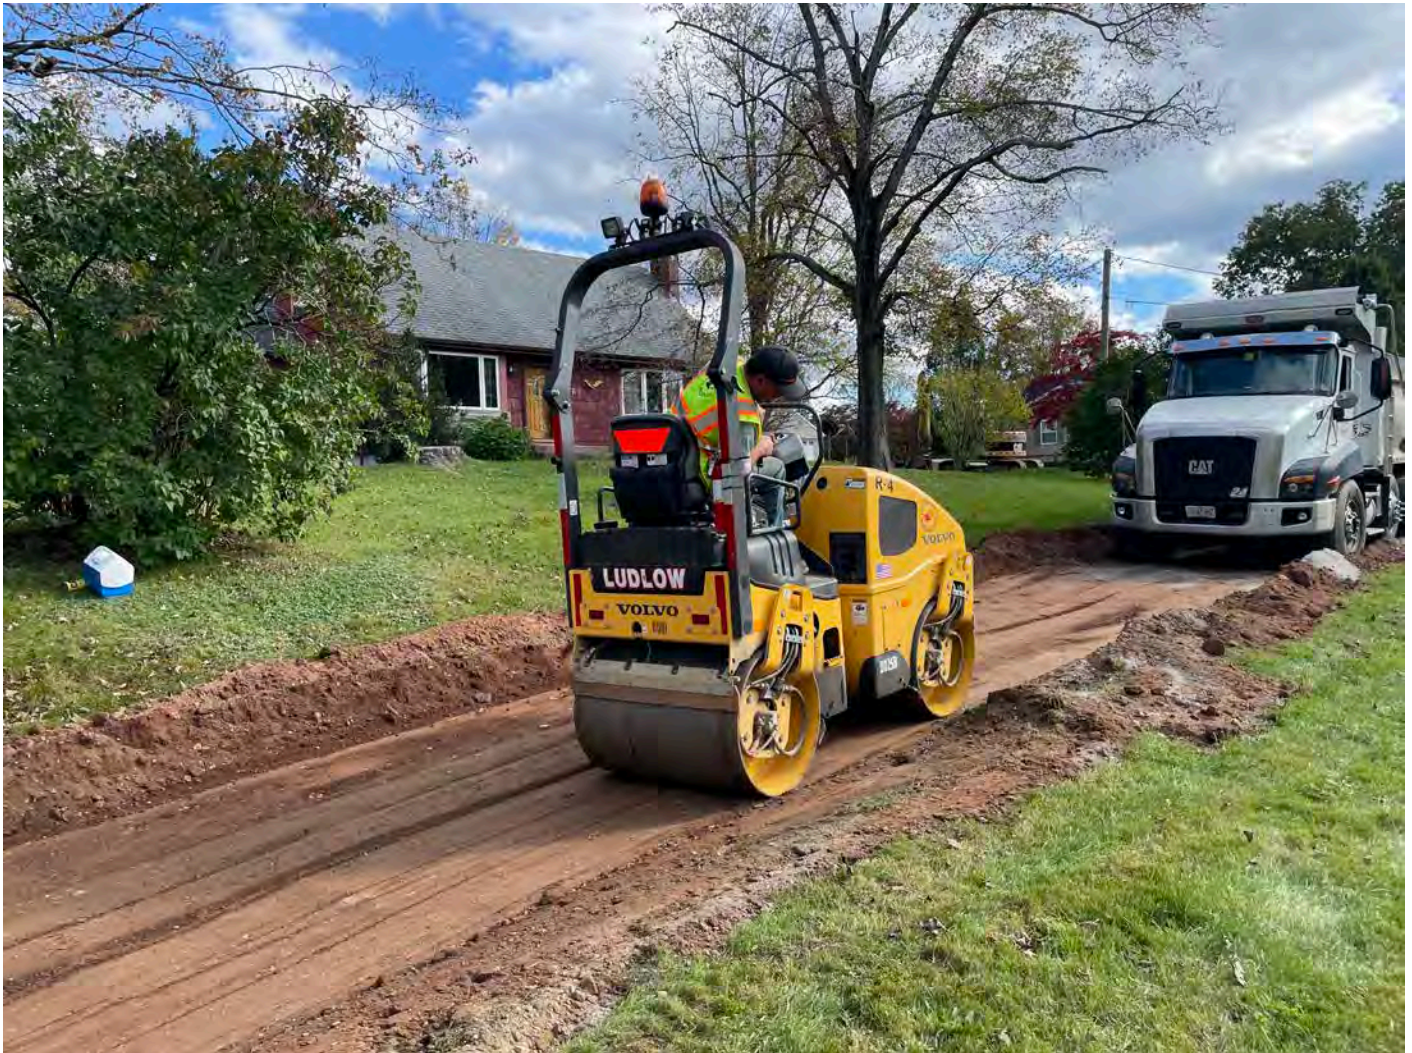
Picture 12: Ludlow compacting gravel they replaced on the driveway for the 175 Main Street property. View to southeast.
