## Daily Report

<b>Project:</b>	Durham Meadows Pipeline Installation	<b>Date:</b>	November 16, 2021
<b>Location:</b>	Maple Avenue, Durham	<b>Day of Week:</b>	Tuesday
<b>Project #:</b>	AECOM: 6061487	<b>Report No:</b>	364
<b>Contractor:</b>	Ludlow Construction	<b>Page:</b>	1 of 12

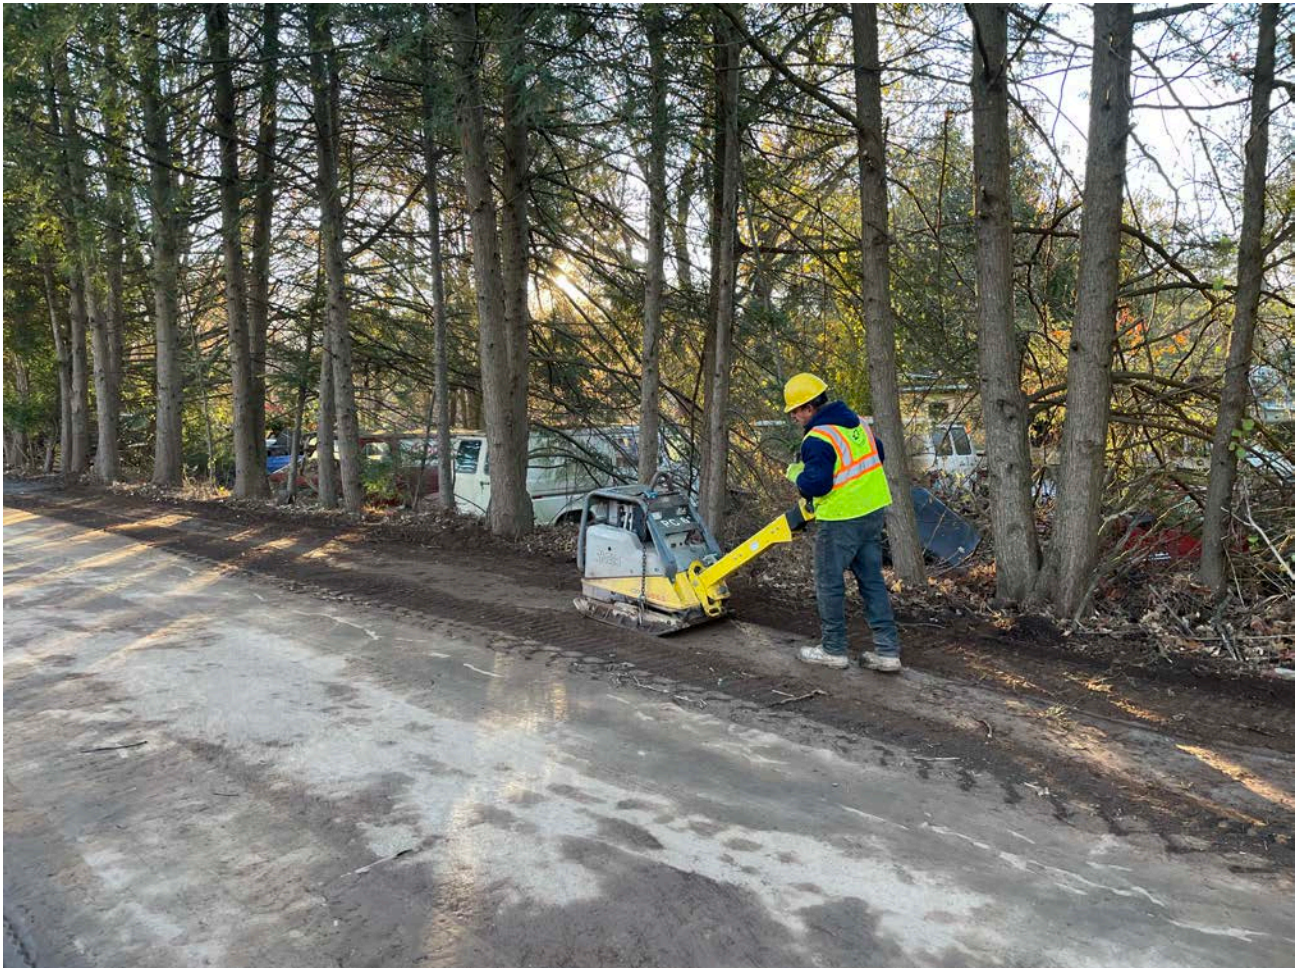
**Picture 1: Ludlow compacting native fill that was backfilled over the 1.5" copper water service line that they installed on the south side of the driveway at the 228 Maple Avenue property. View to the southeast.**

0733: Ludlow is using a plate compactor on a 1' lift of native fill that they have placed on the south side of the driveway at 228R Maple Avenue as they continue to backfill the trench they excavated for the installation of a 1.5" copper water service line.

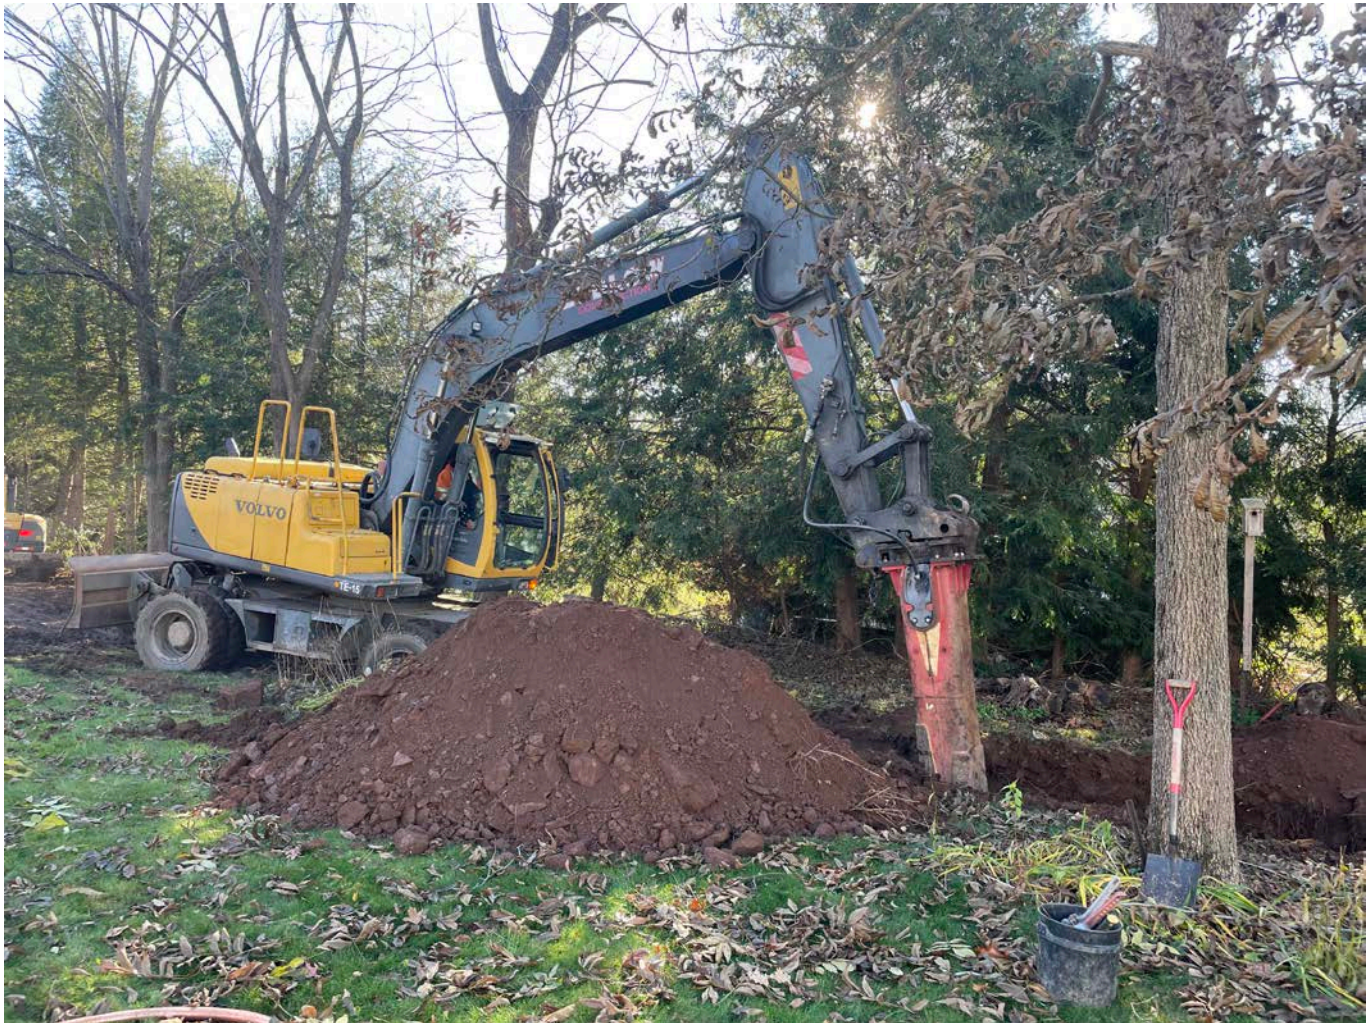
**Picture 2: Ludlow hammering rock in the trench they are excavating for the installation of a 1.5" copper water service line at the 228 Maple Avenue property in Durham. View to the southeast.**

0859: Ludlow is using large Volvo excavator equipped with a hammer to break up rock in the trench they are excavating approximately 30 feet west of the driveway at 228R Maple Avenue property.

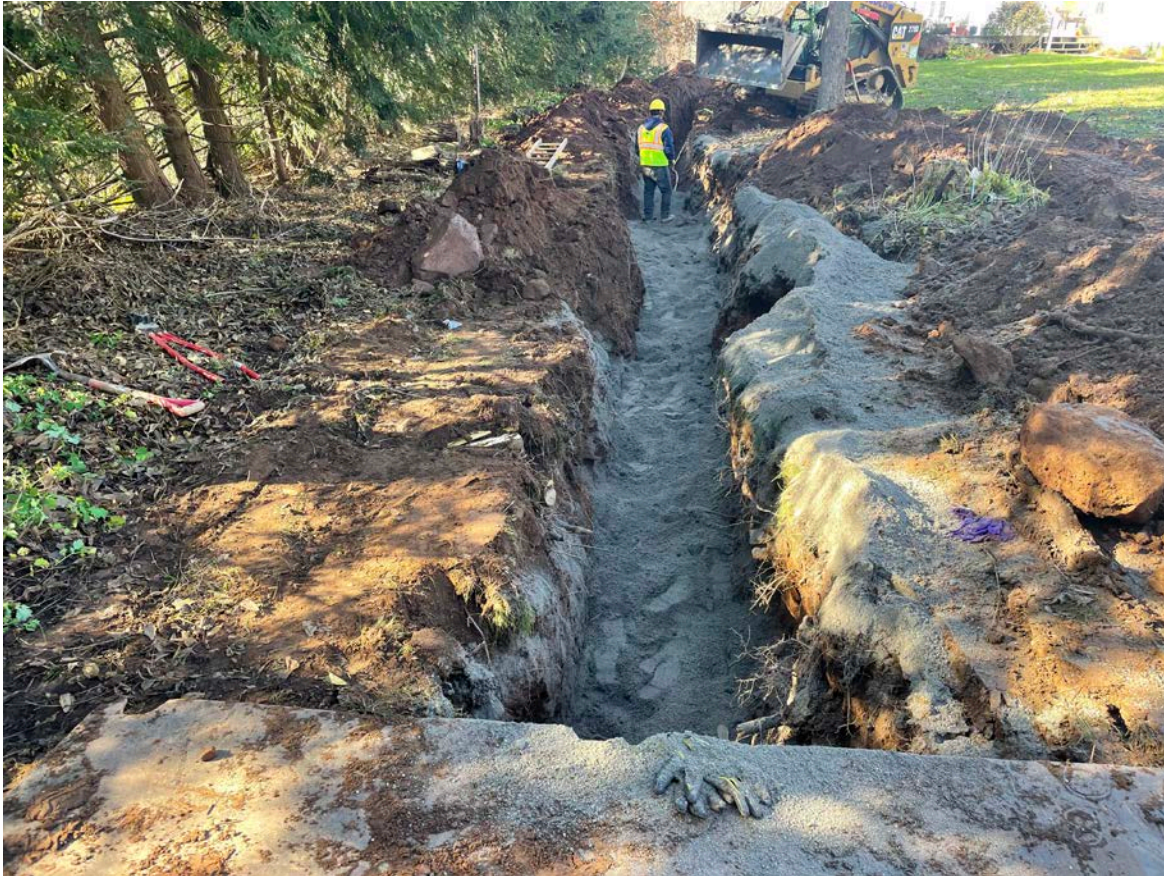
Picture 3: Ludlow placing sand over 1.5" copper water pipe that they installed at the 228R Maple Avenue property. View to the west.

1020: Ludlow has installed all of the 1.5" copper water service line required to bring service into the 228R Maple Avenue residence. Ludlow is currently backfilling over the copper pipe with 6" of sand.

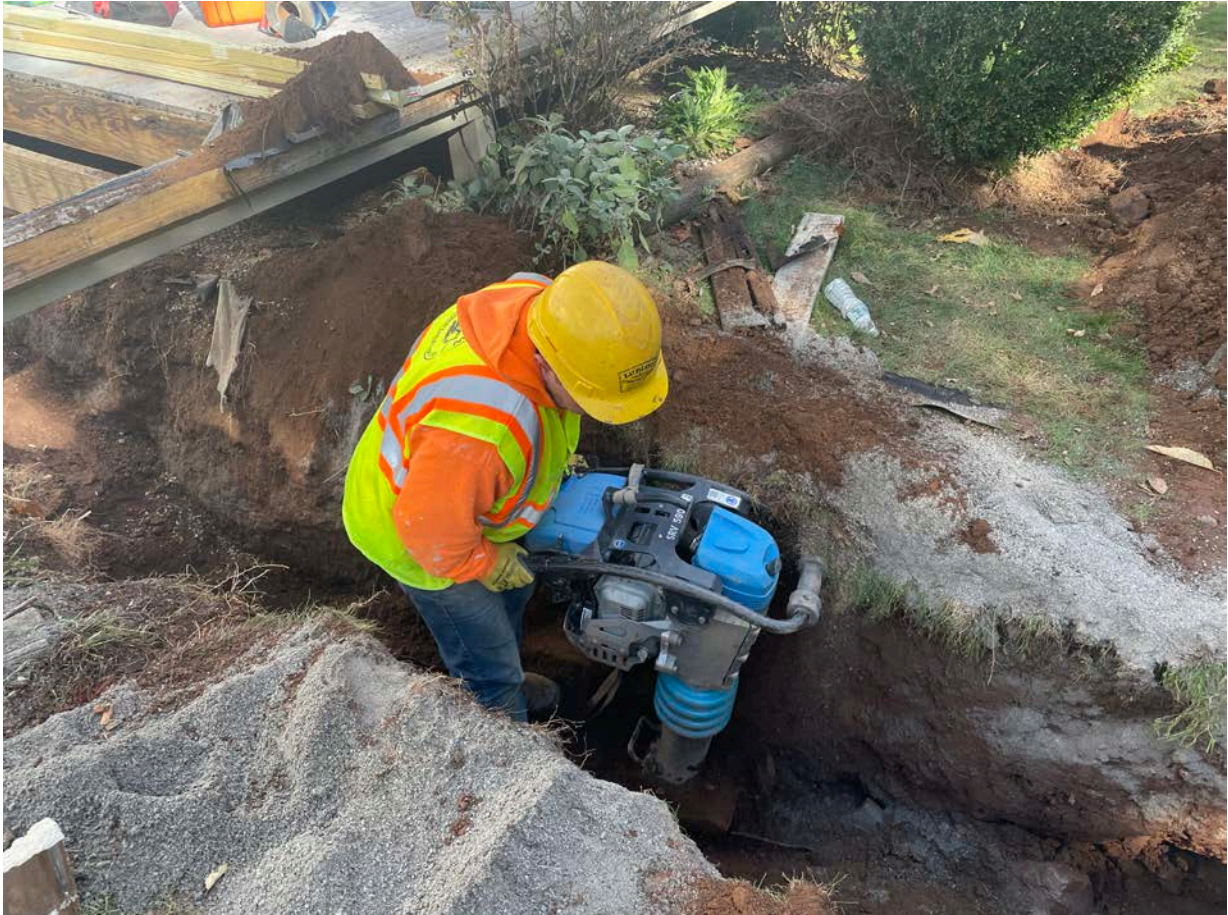
**Picture 4: Ludlow compacting native fill that they placed over the 1.5" copper water service line they installed on the south side of the 228R Maple Avenue residence. View to the northeast.**

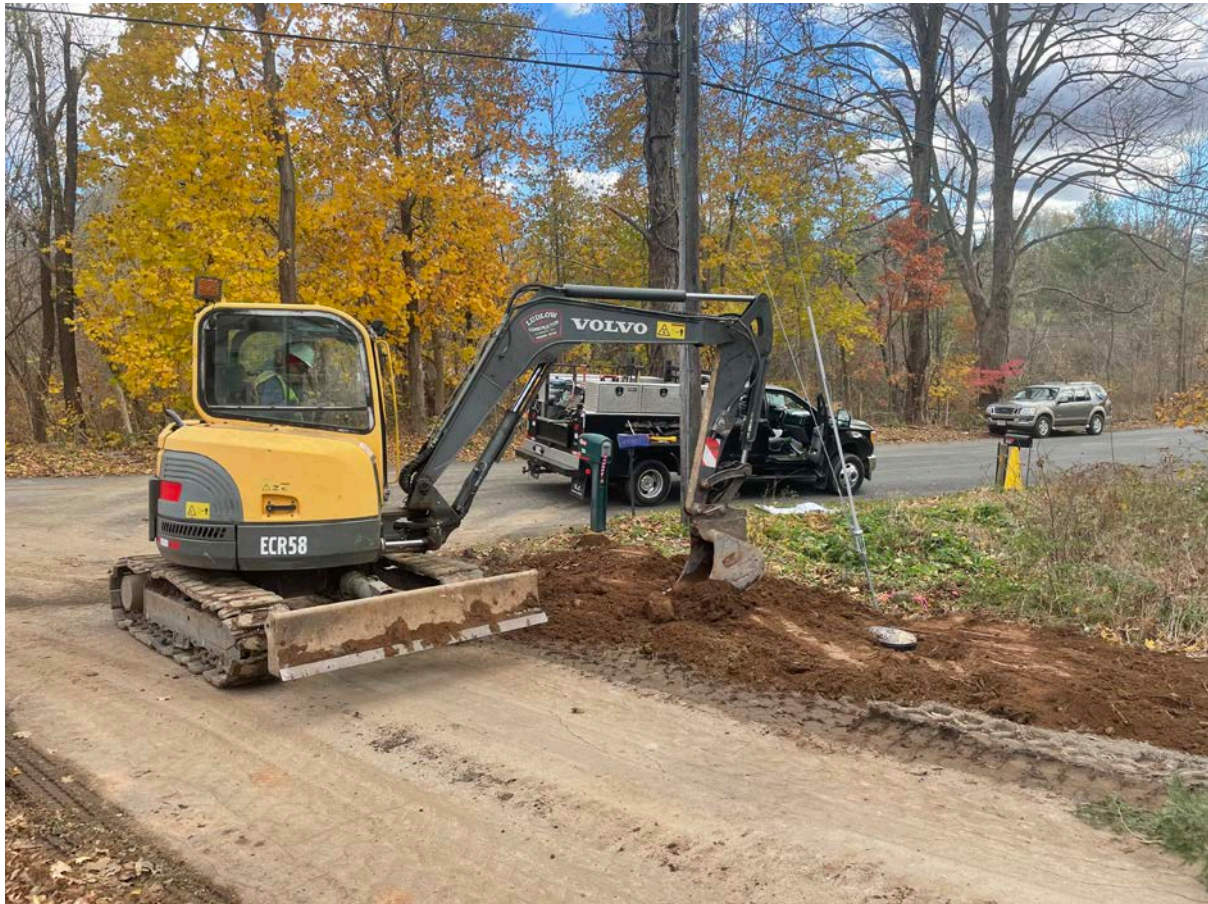
Picture 5: Ludlow placing loam next to the meter pit for the 228R Maple Avenue property. View to the southeast.

1251: Ludlow is placing and grading loam around the meter pit for the 228R Maple Avenue property.

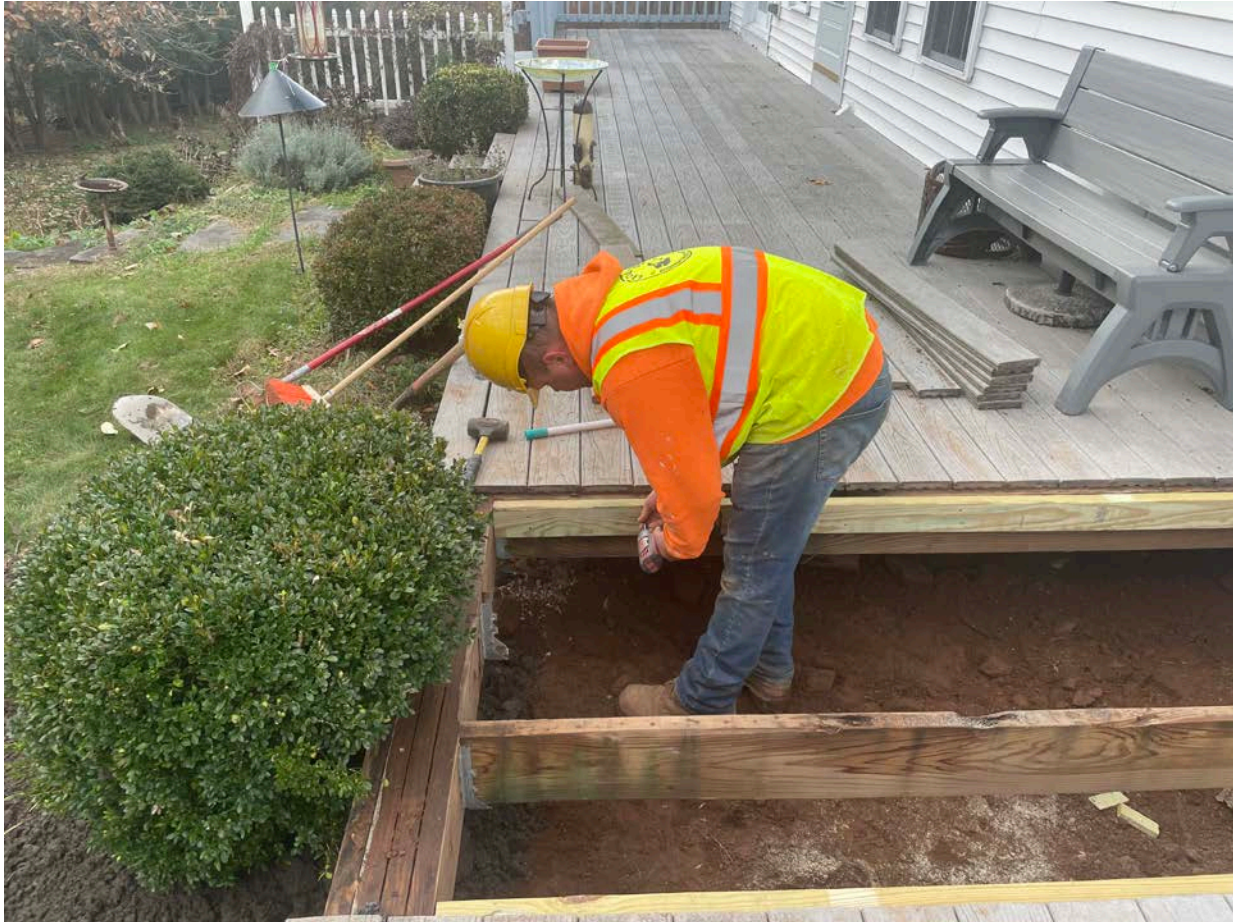
Picture 6: Ludlow attaching a 2x4 to one of the joists of the deck located on the south side of the 228R Maple Avenue residence to provide additional support when the deck slats are replaced. View to the west.

1326: Ludlow is screwing a 2x4 onto an existing joist of the deck located on the south side of the 228R Maple Avenue residence to provide additional support for the plastic composite deck slats that Ludlow will soon screw back into place.

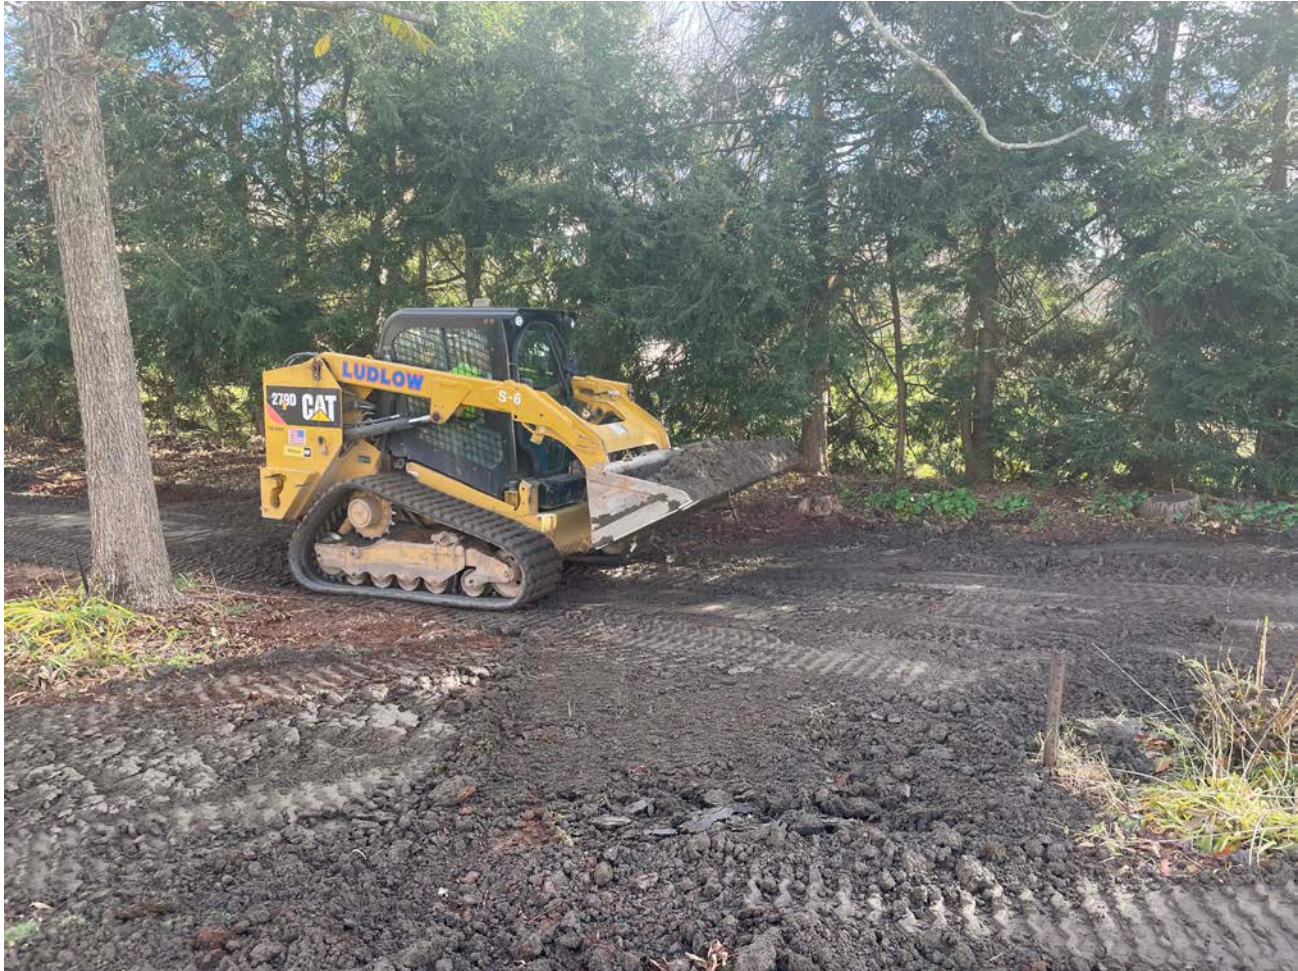
Picture 7: Ludlow placing loam to the west of the driveway at the 228R Maple Avenue property. View to the southwest

1319: Ludlow is placing and grading loam on the west side of the driveway where they are restoring the areas that were disturbed during the installation of a 1.5" copper water service line.

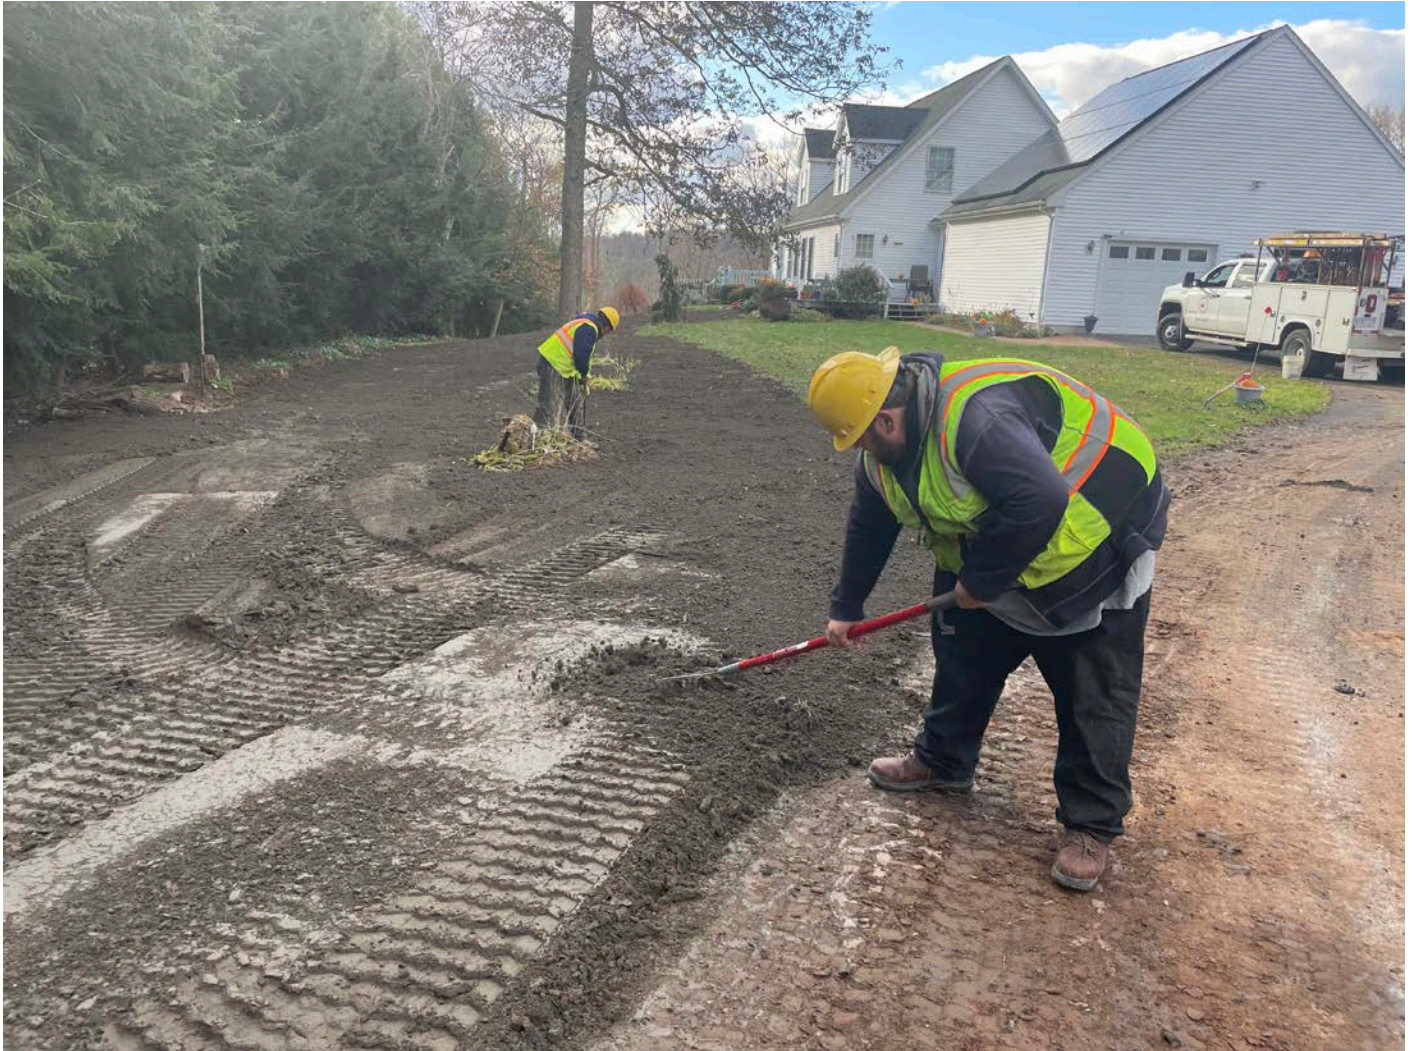
Picture 8: Ludlow raking out freshly placed loam to the west of the driveway for the 228R Maple Avenue property. View to the west.

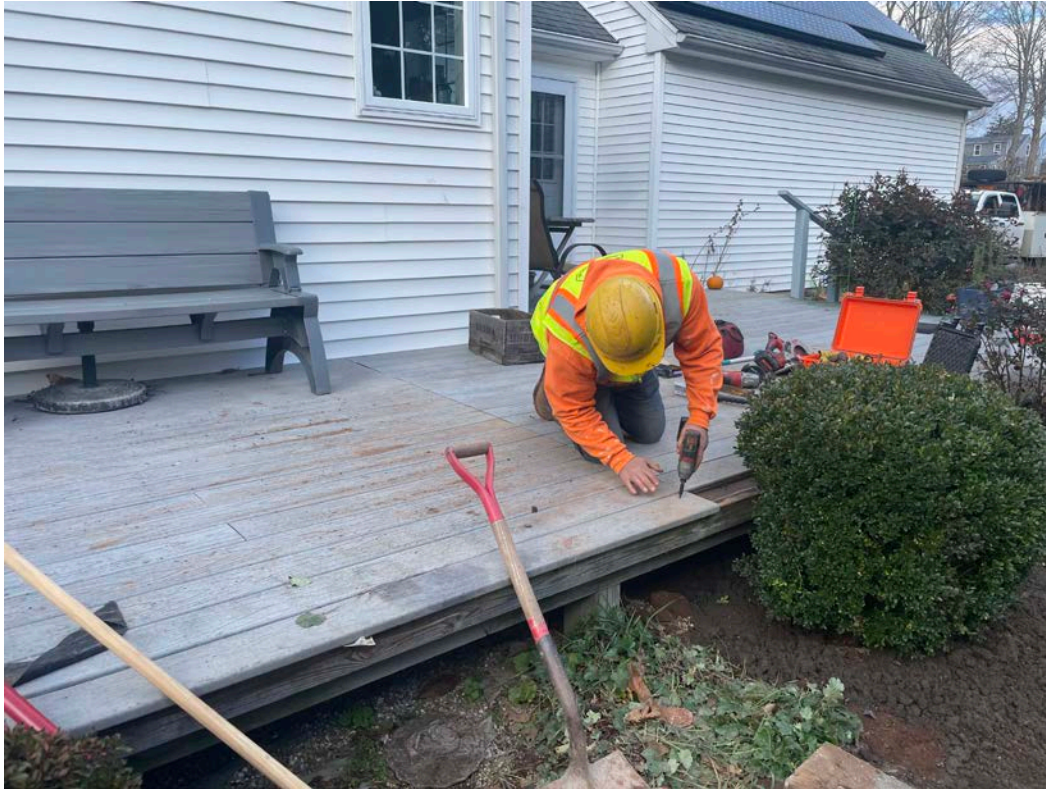
**Picture 9: Ludlow replacing deck slats on the south side of the 228R Maple Avenue residence after they installed a 1.5" copper water service line. View to the east.**

1405: Ludlow continues to place loam on the south side of the driveway for the 228R Maple Avenue property to restore the areas that were disturbed during the installation of the 1.5" copper water service line. Ludlow continues to reassemble the section of the deck located on the south side of the 228R Maple residence that was disassembled to allow for the installation of a 1.5" copper water service line.

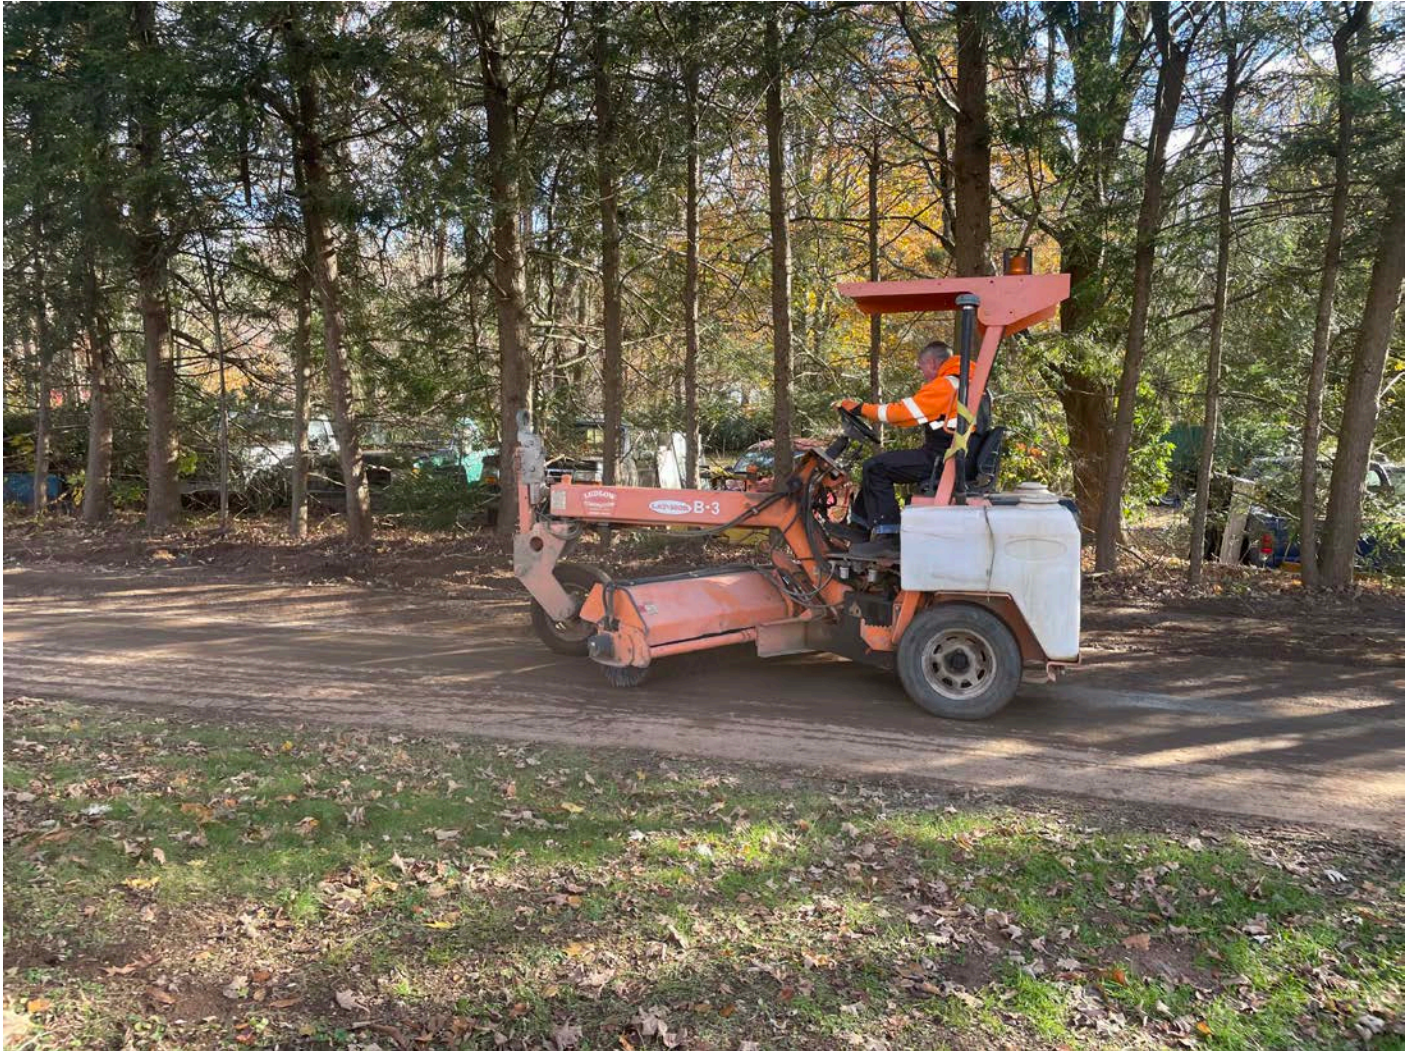
Picture 10: Ludlow cleaning the driveway at the 228R Maple Avenue property with a Broce Broom. View to the south.

1424: Ludlow is using a Broce Broom to clean dirt off the driveway at the 228R Maple Avenue property.
