## Daily Report

<b>Project:</b>	Durham Meadows Pipeline Installation	<b>Date:</b>	November 24, 2021
<b>Location:</b>	Talcott Lane, Durham; S. Main Street and the Shared Access Driveway, Middletown	<b>Day of Week:</b>	Wednesday
<b>Project #:</b>	AECOM: 6061487	<b>Report No:</b>	370
<b>Contractor:</b>	Ludlow Construction	<b>Page:</b>	1 of 12

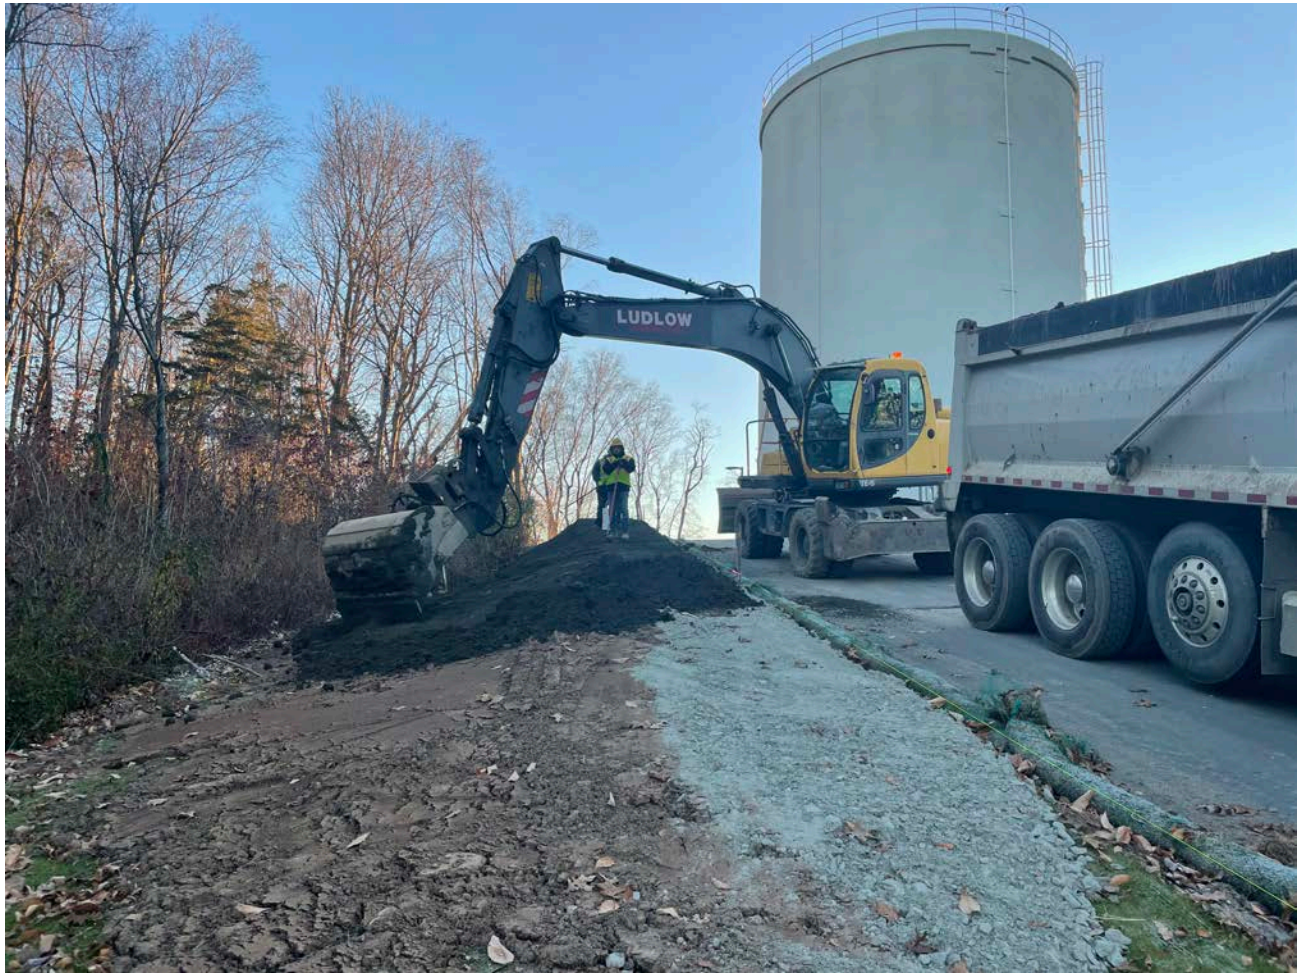
**Picture 1: Ludlow placing loam on top of the 1.25"-minus gravel they placed and compacted yesterday on the north side of the water tank located east of the Shared Access Driveway in Middletown. View to the east.**

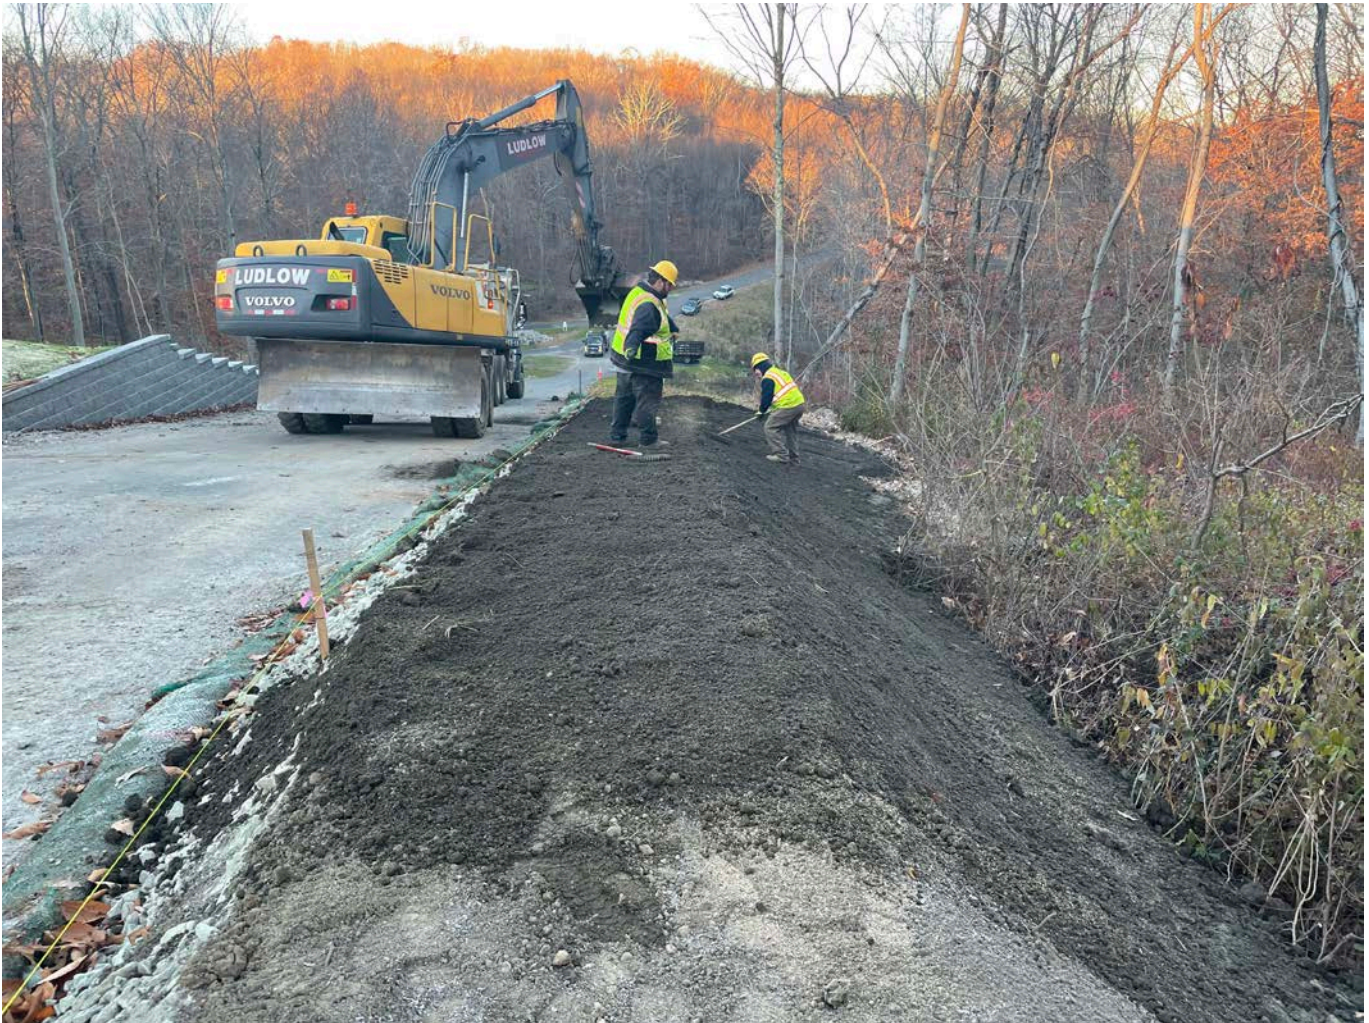
Picture 2: Ludlow placing grass seed on top of the loam they placed between Stations 10+50 and 11+75 on the north side of the Shared Access Driveway in Middletown. View to the west.

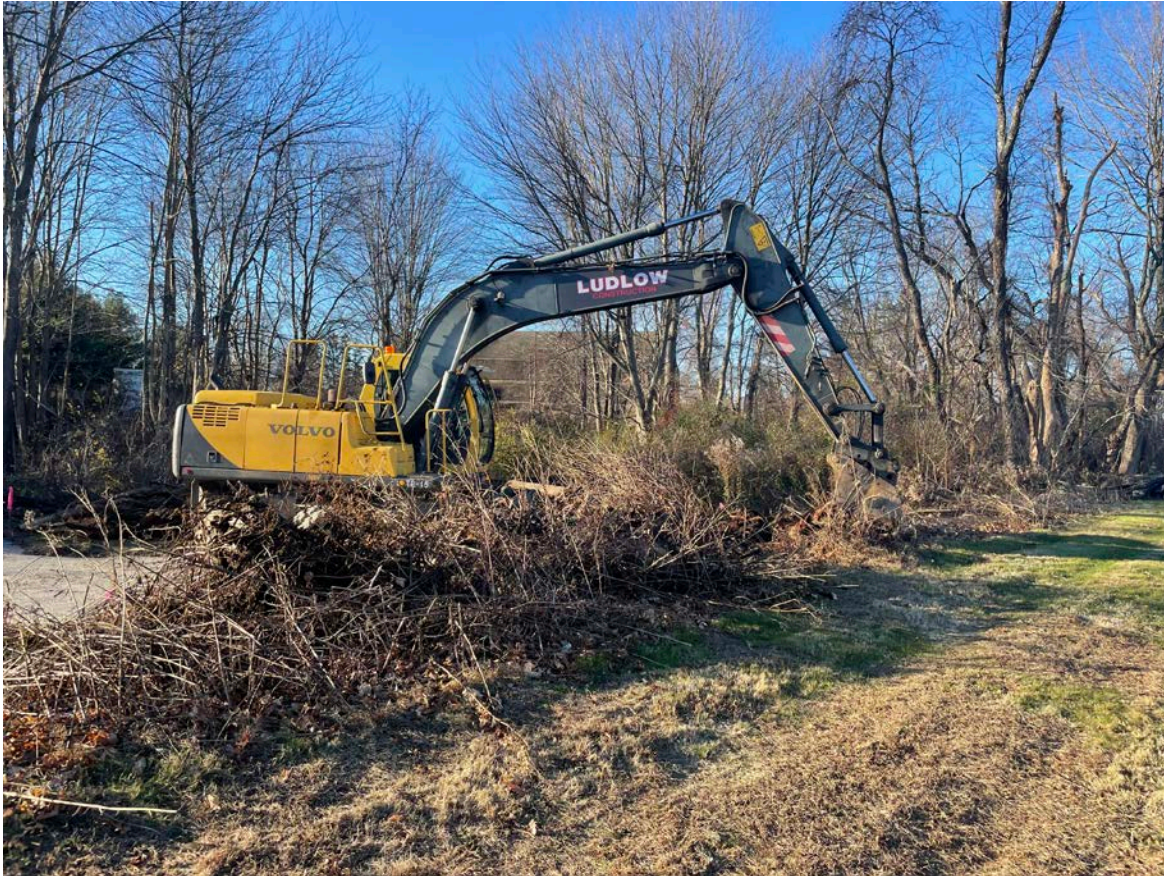
**Picture 3: Ludlow excavating brush and tree stumps at the northwest corner of the booster station work zone located at Station 750+63 in Middletown. View to the west.**

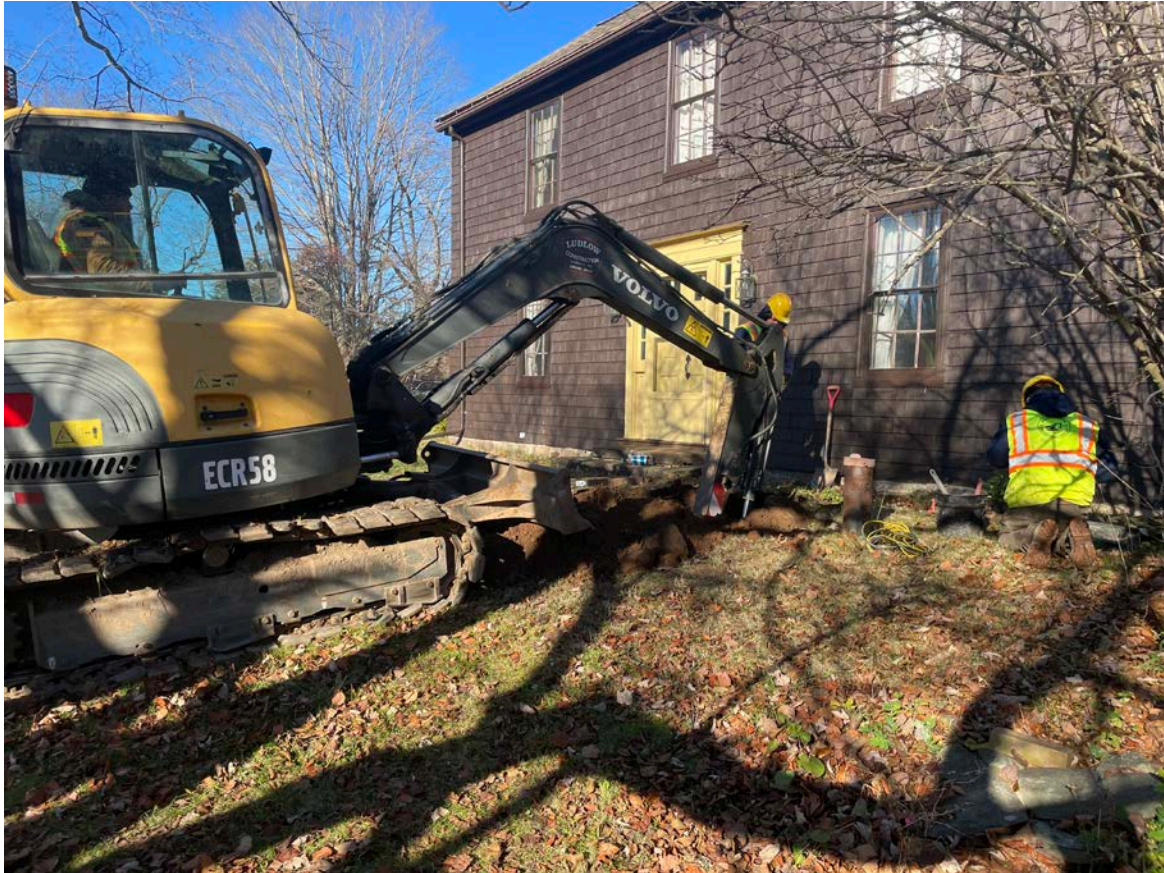
Picture 4: Ludlow excavating a trench on the south side of the 25 Talcott Lane residence for the installation of a 1" copper water service line. View to the northwest.

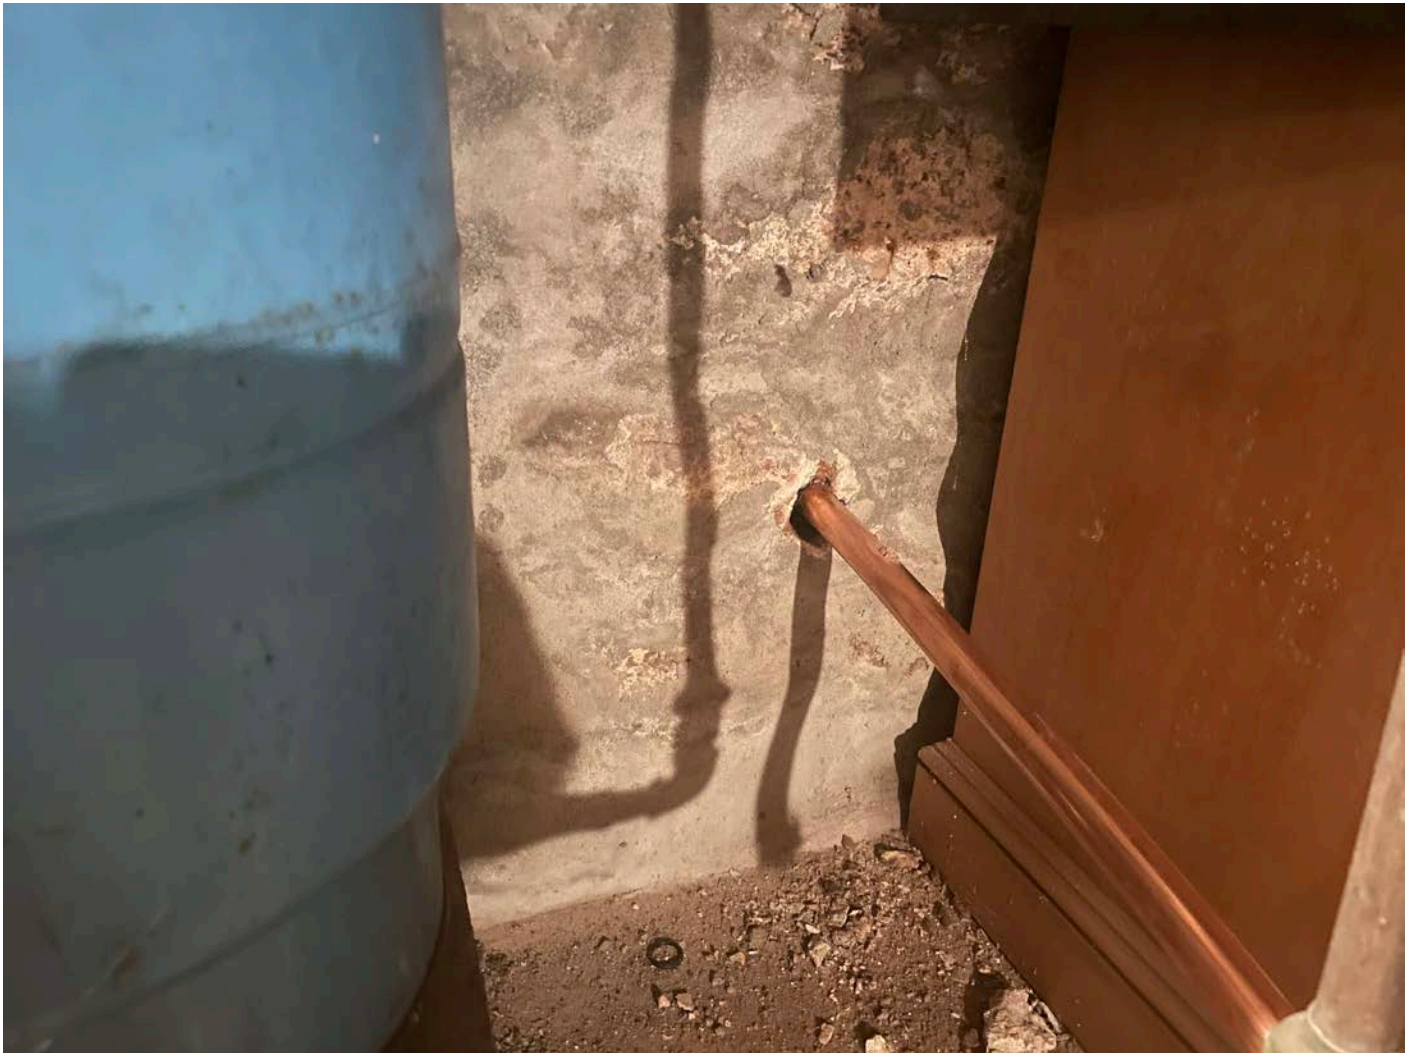
1118: Ludlow has passed the 1" copper water service line through the southern foundation of the 25 Talcott Lane residence and has secured it in place on both sides of the foundation with non-shrink grout.

Picture 5: 1" copper water service line that Ludlow installed through the southern foundation of the 25 Talcott Lane residence. View to the south.

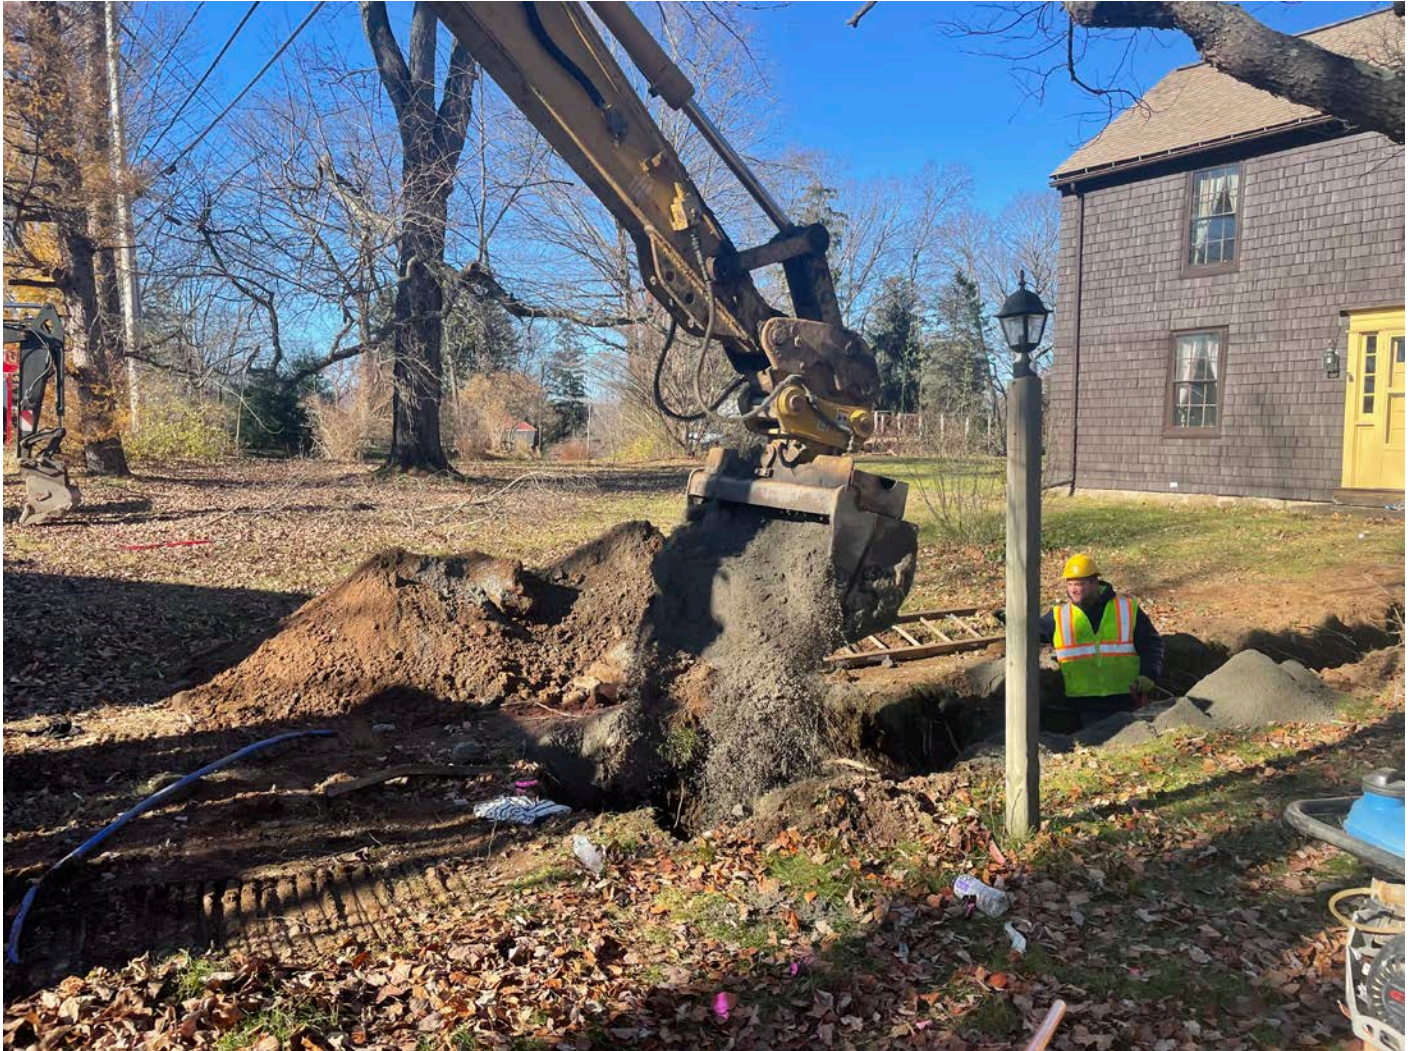
Picture 6: Ludlow placing sand over the 1” copper water service line they just installed at the 25 Talcott Lane property. View to the northwest.

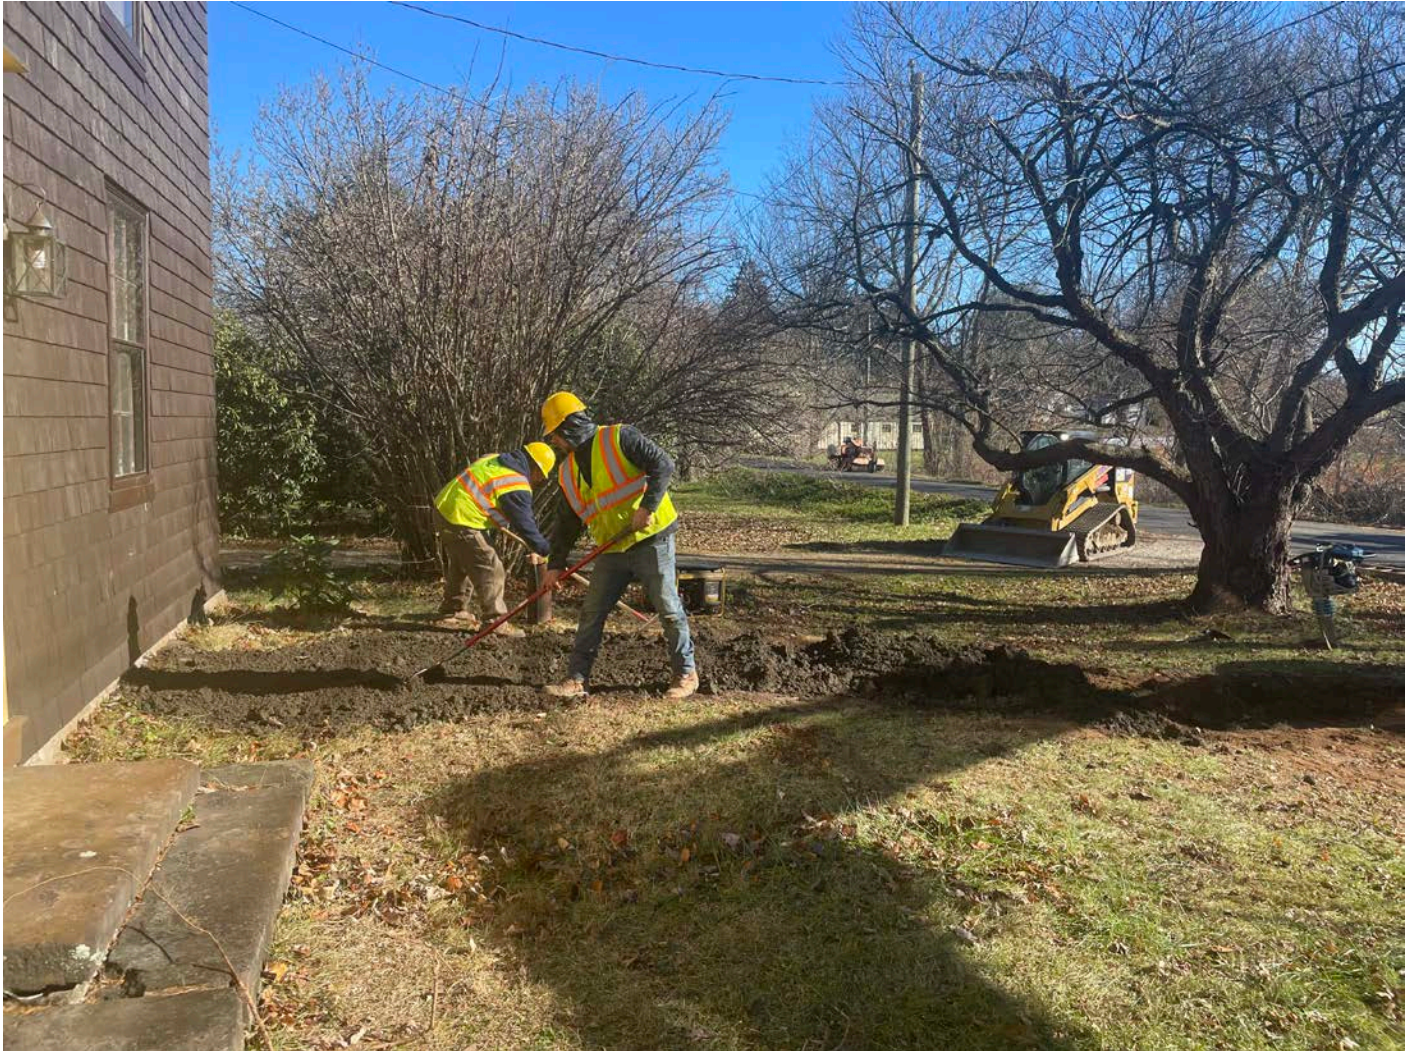
**Picture 7: Ludlow raking out loam that was placed to restore those areas of the 25 Talcott Lane property that were disturbed during the installation of a 1" copper water service line. View to the east.**

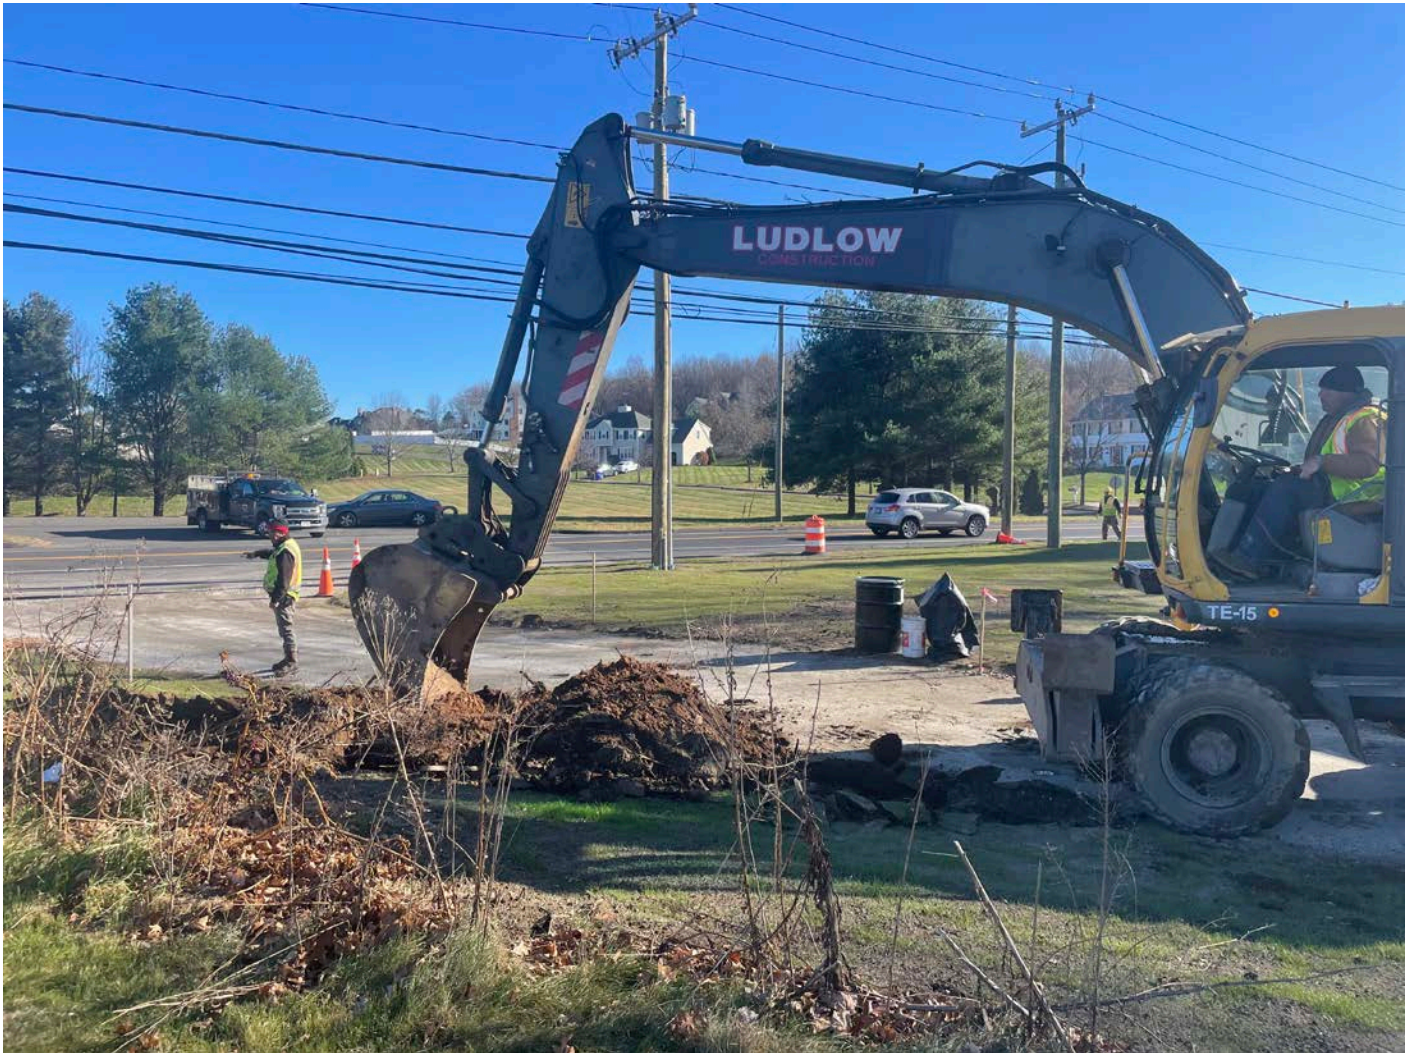
**Picture 8: Ludlow excavating a tree stump from the north side of the booster station work zone located at Station 750+63 in Middletown. View to the southeast.**

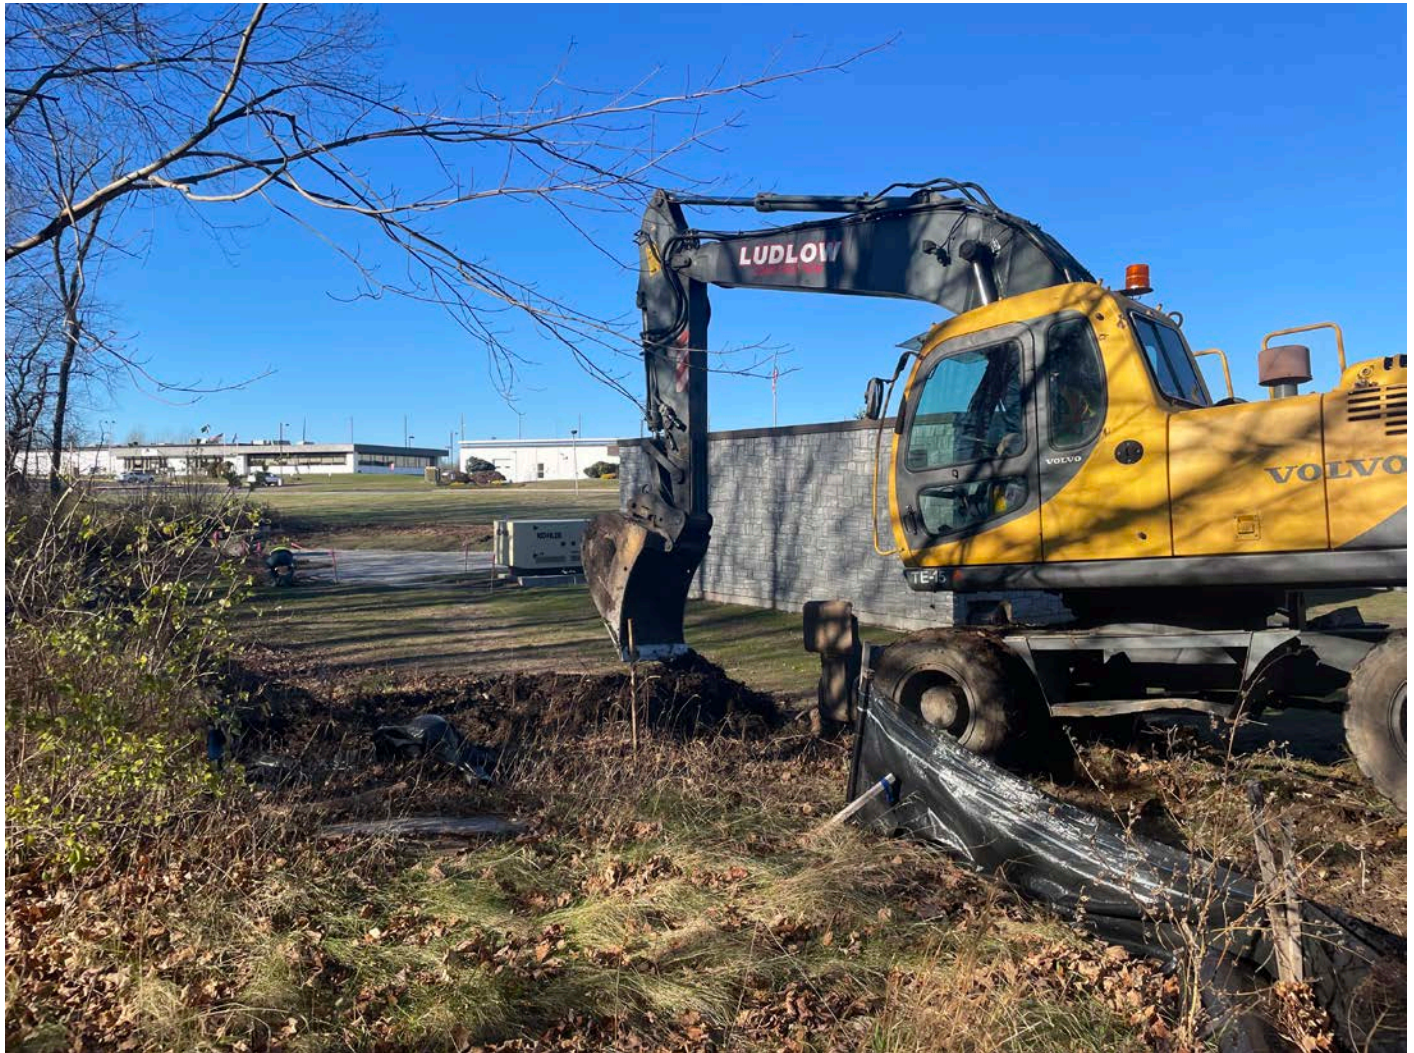
**Picture 9: Ludlow excavating brush at the southeast corner of the booster station work zone located at Station 750+63 in Middletown. View to the northwest.**
