Daily Report

Project:	Durham Meadows Pipeline Installation	Date:	December 6, 2021
Location:	Maiden Lane, Durham	Day of Week:	Monday
Project #:	AECOM: 6061487	Report No:	376
Contractor:	Ludlow Construction	Page:	2 of 12

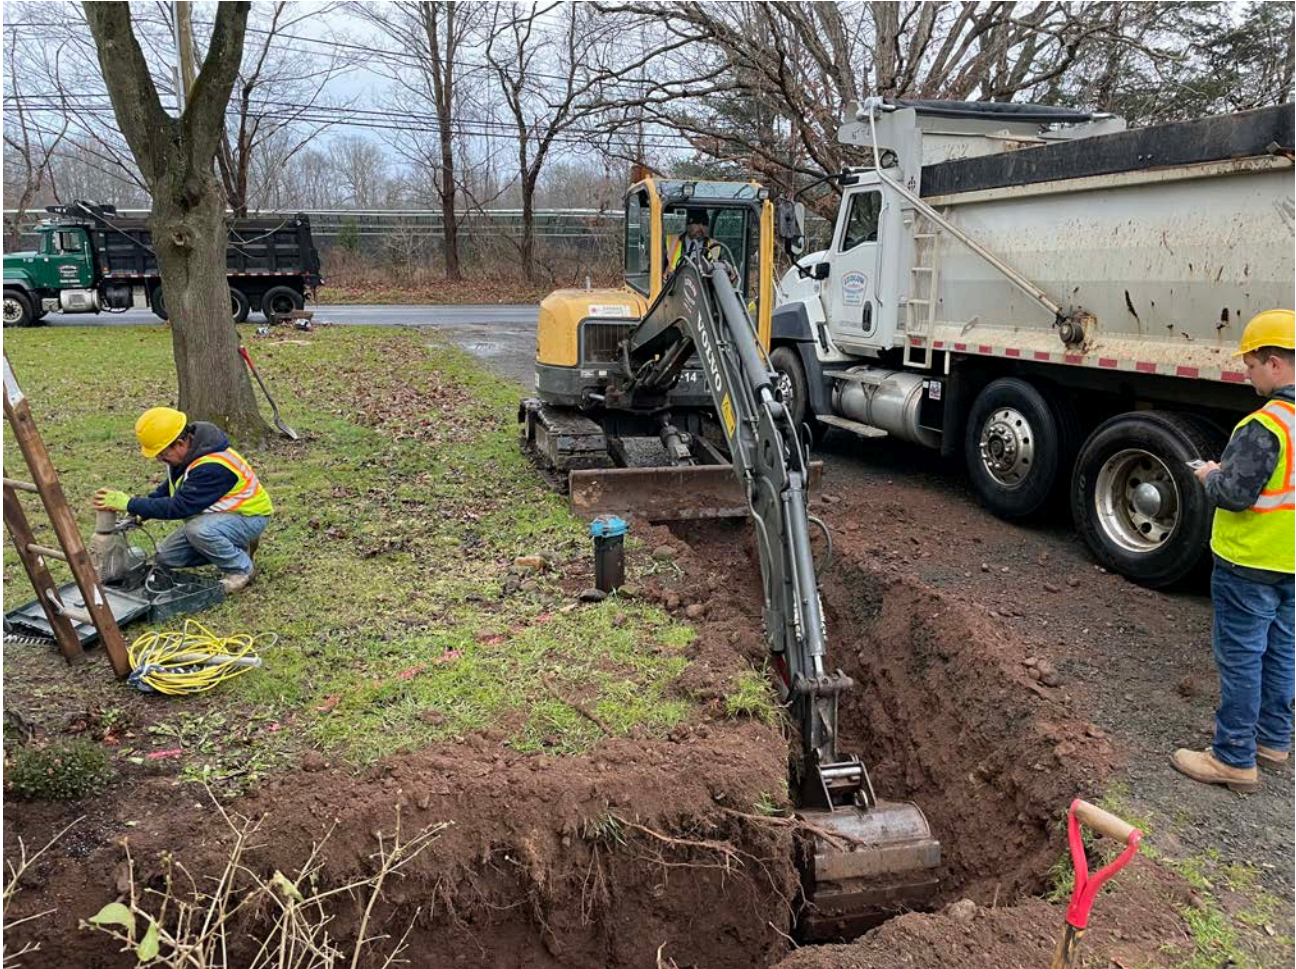
Picture 1: Ludlow excavating a trench for the installation of a 1" copper water service line at the 78 Maiden Lane property. View to the south.

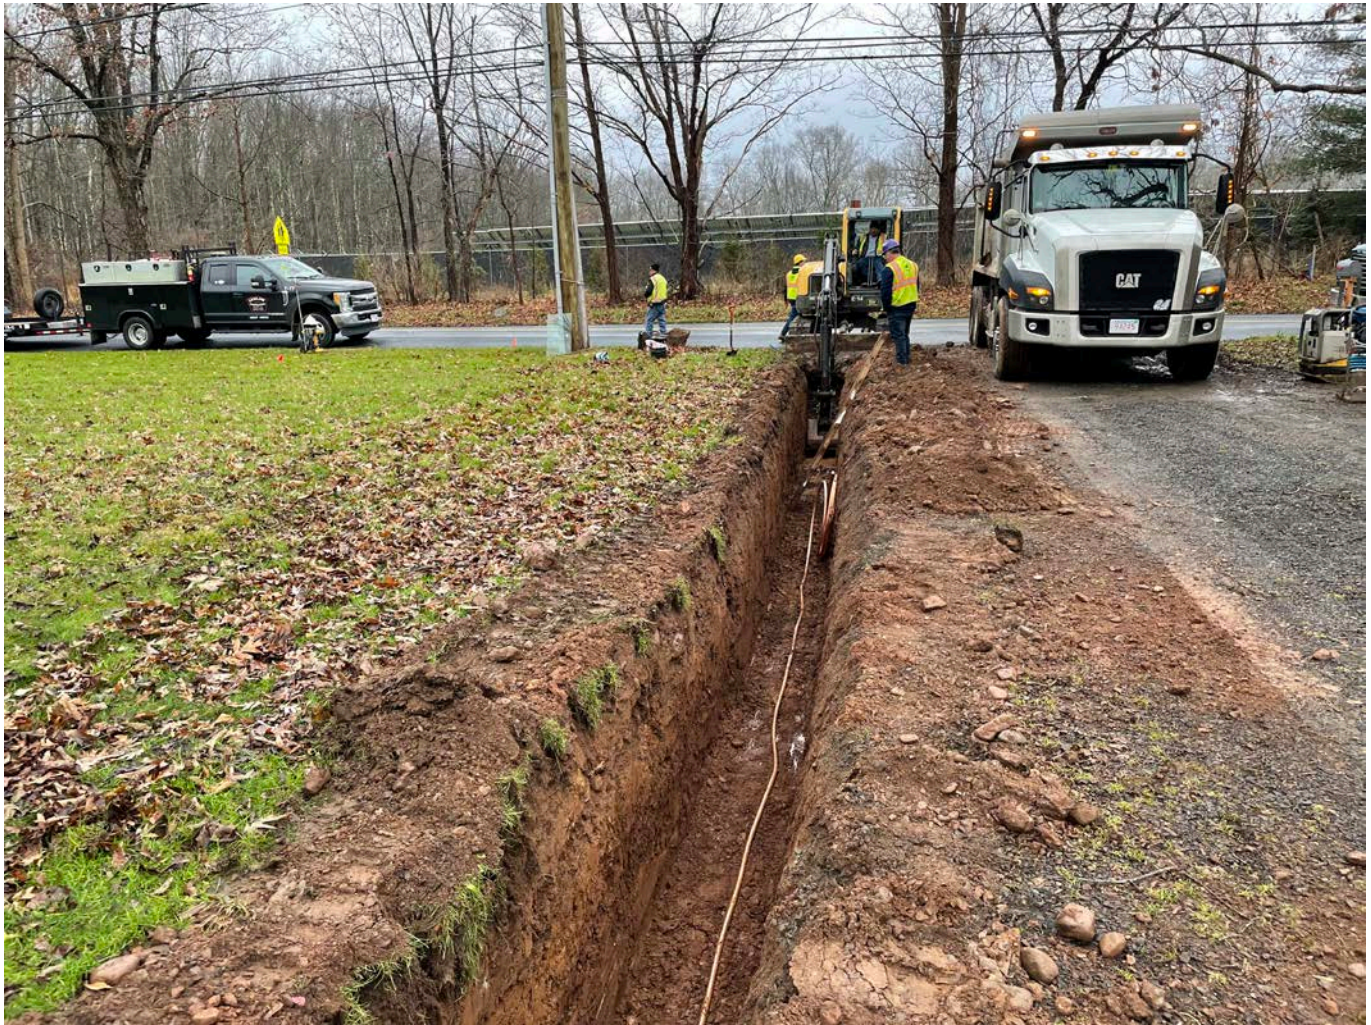
Picture 2: Ludlow excavating a trench for the installation of the 1" copper water line shown in the foreground. View to the south.

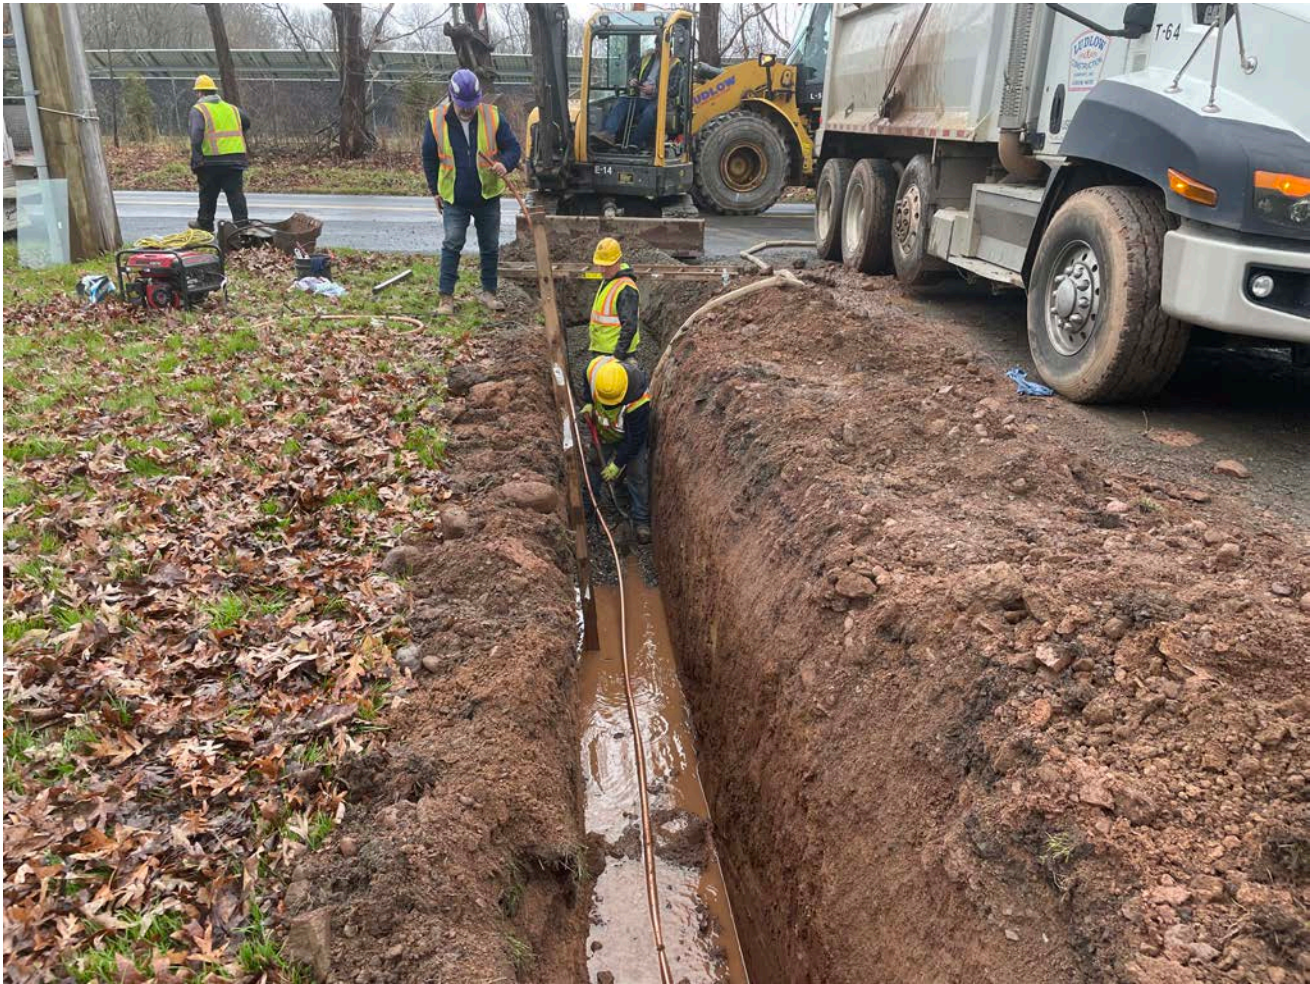
Picture 3: Ludlow placing a pump that has been set in $\frac{3}{4}$ " gravel in the trench they are working in at the 78 Maiden Lane property as they install a 1" copper water service line. View to the south.

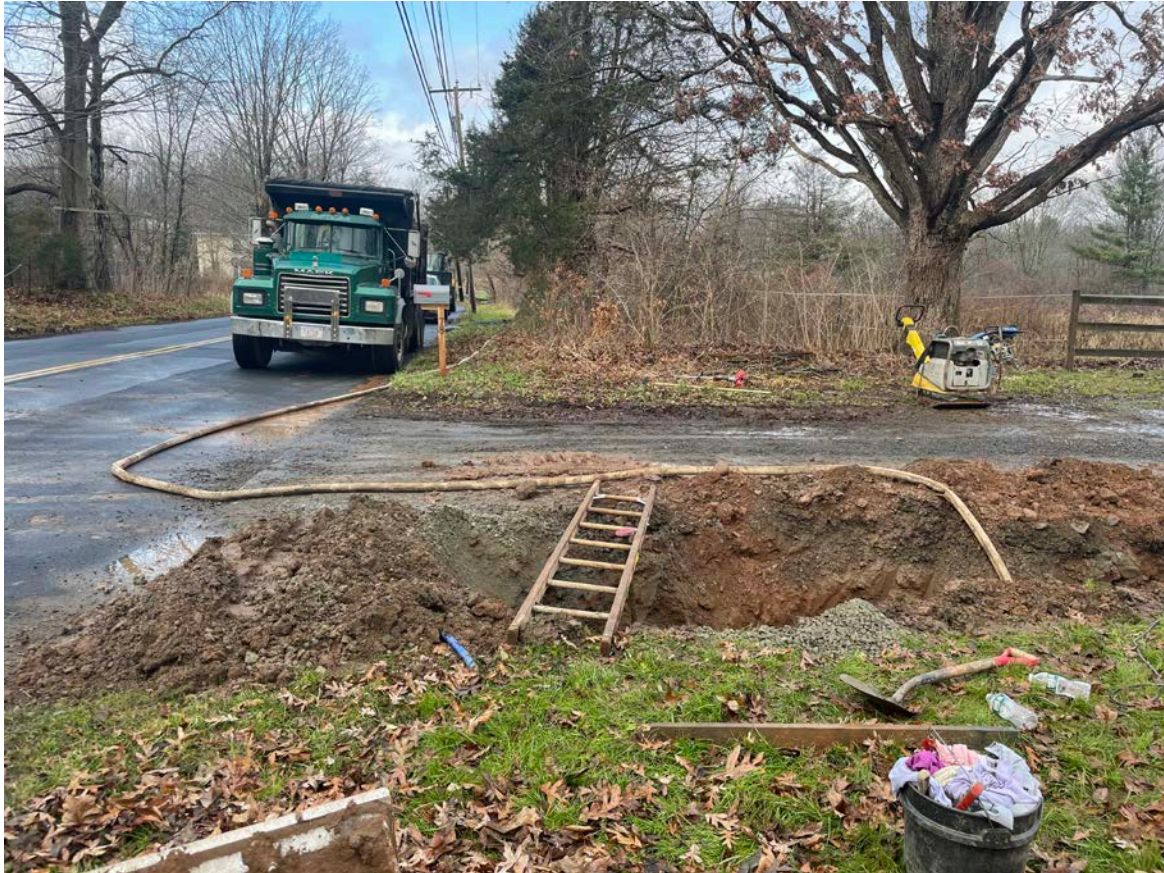
0932: Ludlow has encountered water in the trench they are excavating at the 78 Main Lane property for the installation of a 1" copper water service line. Ludlow is pumping the water out of the trench and into a silt bag that was placed on the north side of Maiden Lane to the west of the driveway. Ludlow has connected 1" copper pipe to the curb stop for the 78 Maiden Lane residence and has inserted it through the west side of the home's foundation.

Picture 4: Ludlow pumping water from the trench they excavated at 78 Maiden Lane into a silt bag placed west of the driveway and north of Maiden Lane. View to the west.

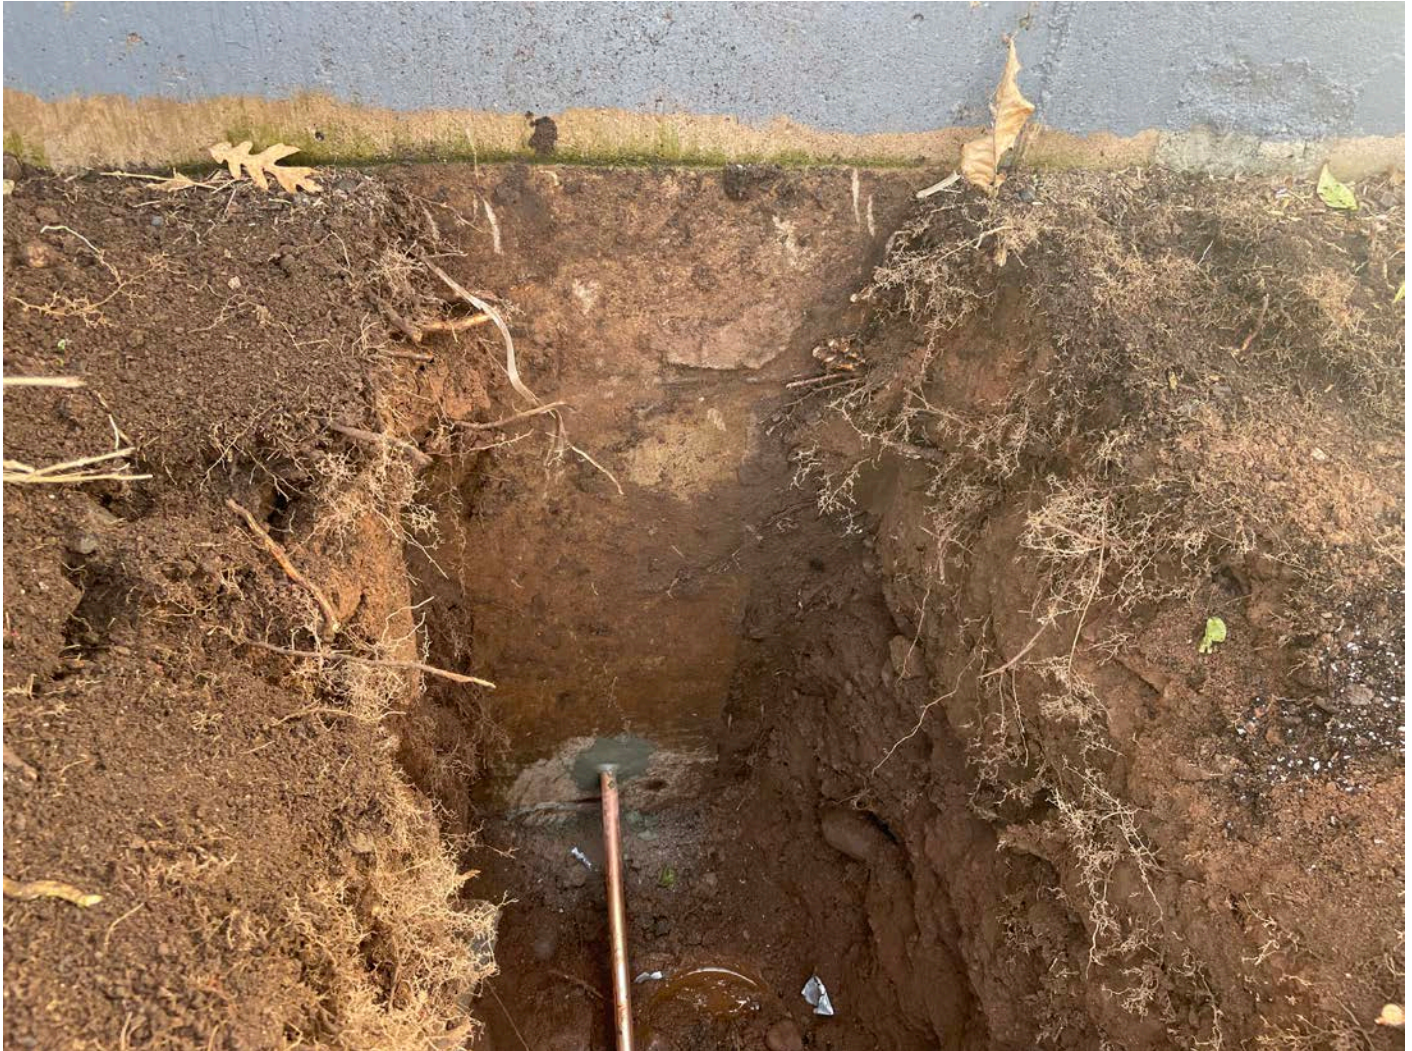
Picture 5: 1" copper water service line that Ludlow has secured in place as it passes through the western foundation of the 78 Maiden Lane residence. View to the east.

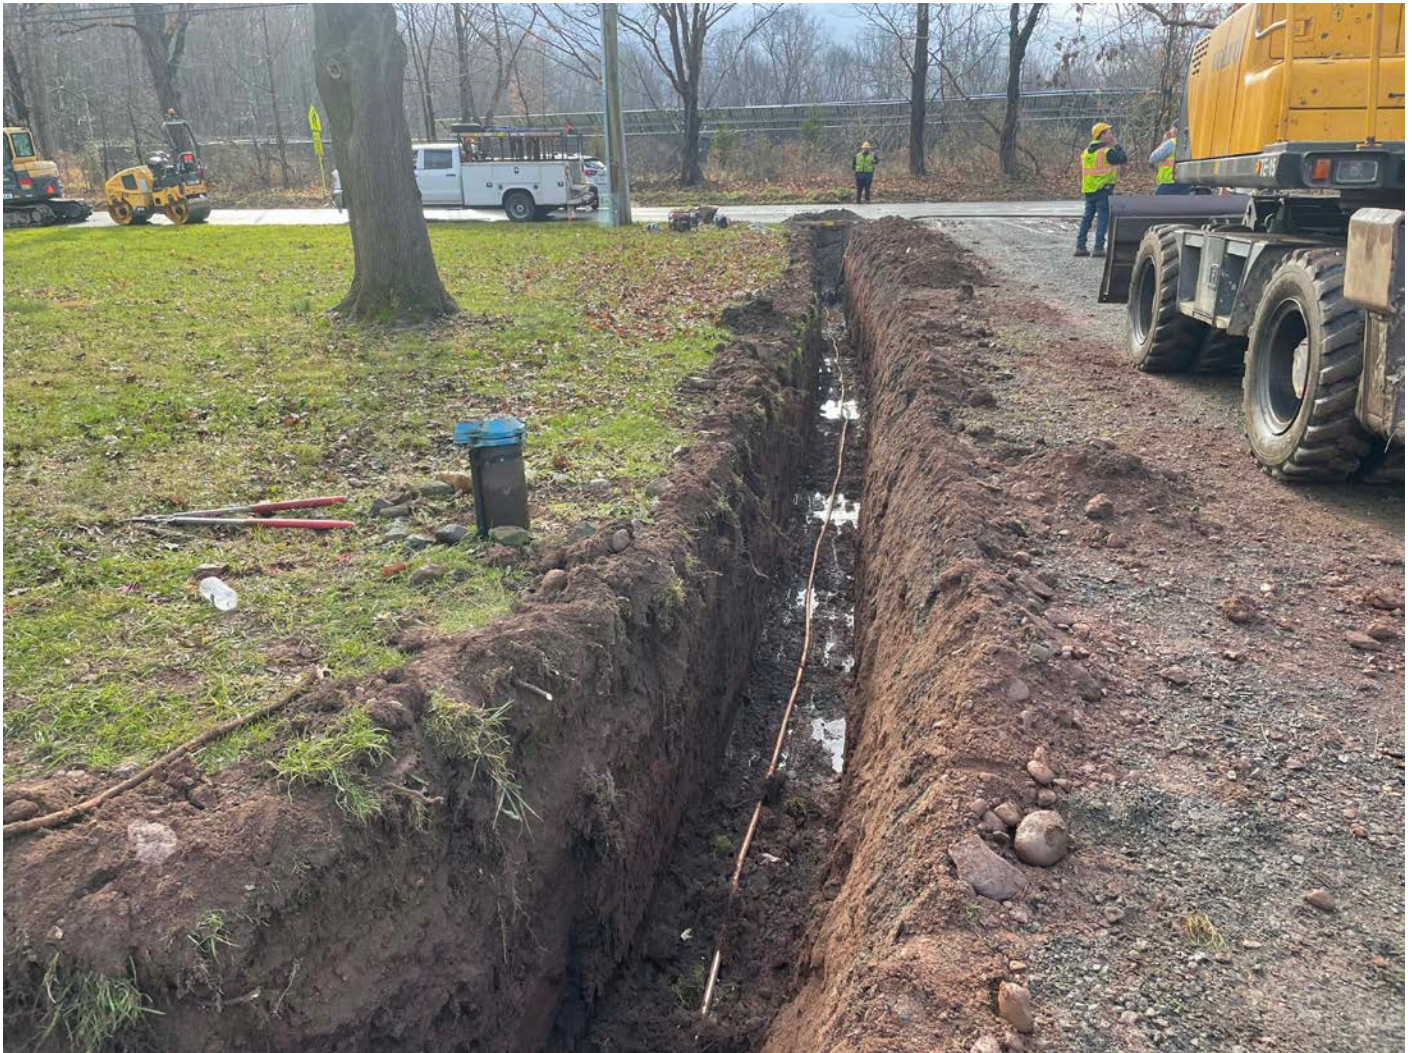
Picture 6: 1" copper water service line that Ludlow has connected to the curb stop at the south end of the trench at the 78 Maiden Lane property. View to the south.

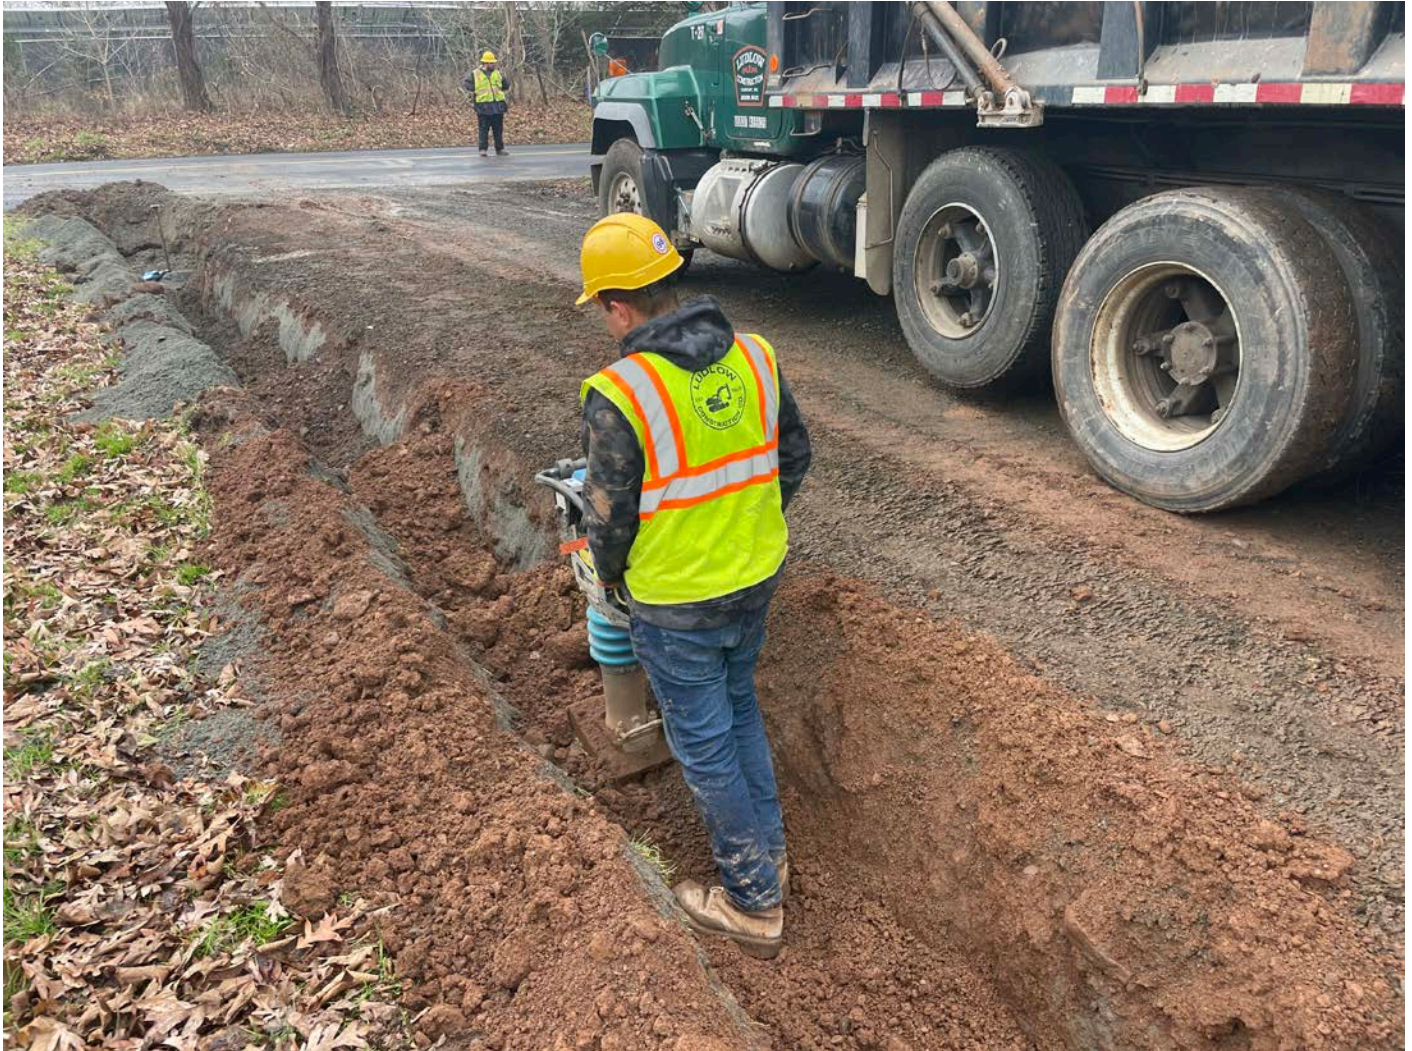
1130: Ludlow has placed sand and caution tape over the 1" copper water service line they just installed at the 78 Maiden Lane property and have begun to backfill the trench with native fill in 1' foot lifts. Ludlow is compacting the fill between the placement of each lift with a jumping jack.

Picture 7: Ludlow using a jumping jack to compact the native fill being used to backfill the trench that Ludlow excavated at the 78 Maiden Lane property. View to the south.

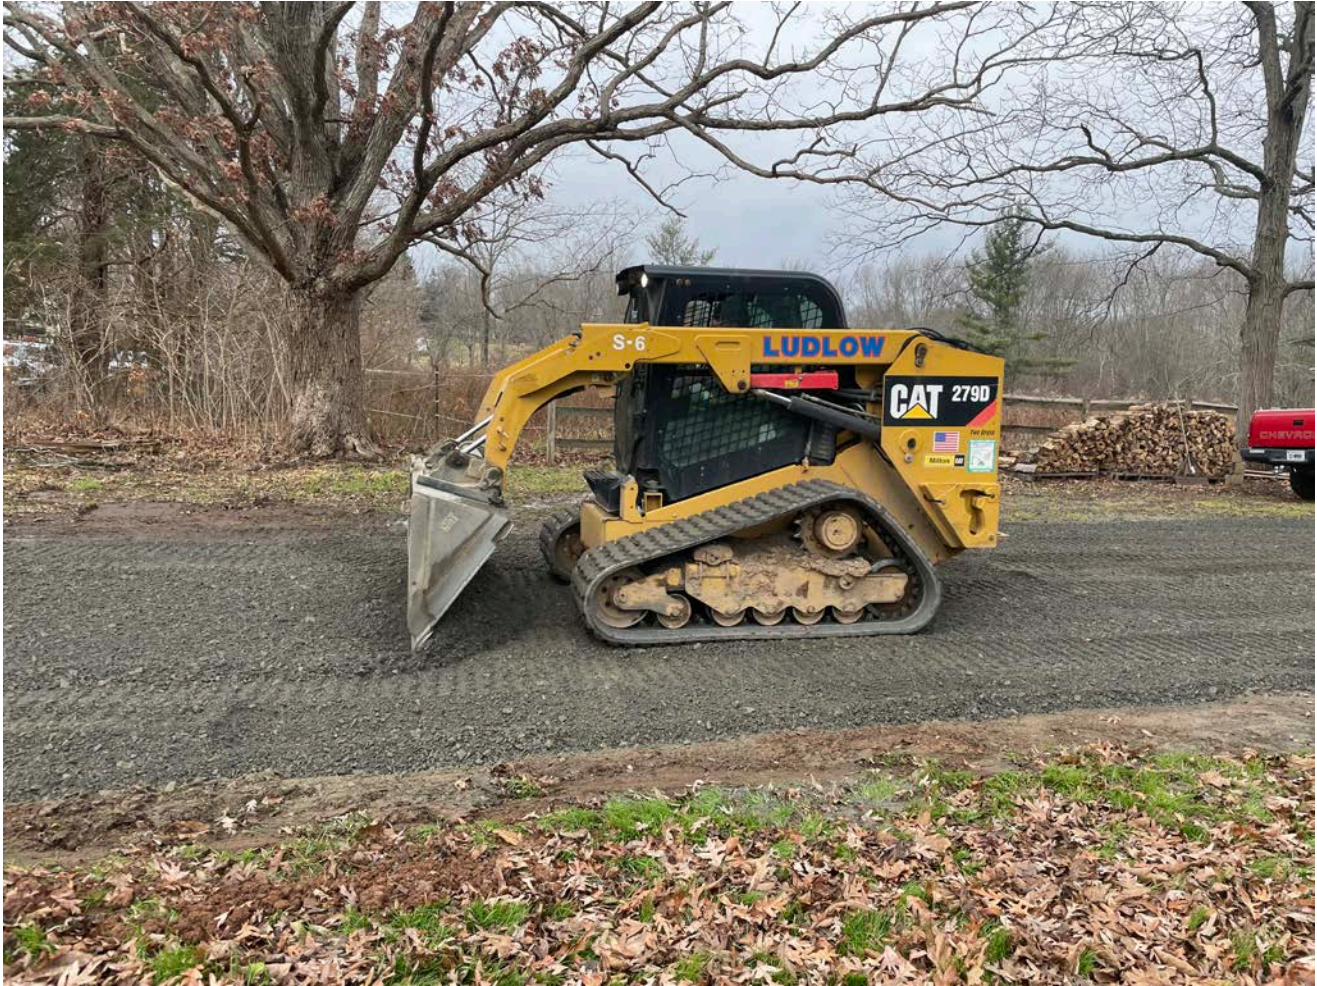
1238: Ludlow is placing and grading ¾" processed gravel on the driveway of 78 Maiden Lane to restore it after it was disturbed during the installation of a 1" copper water service line at the residence.

Picture 8: Ludlow grading the $\frac{3}{4}$ " processed gravel they used to restore the driveway at the 78 Maiden Lane property after they installed a 1" copper water service line. View to the west.

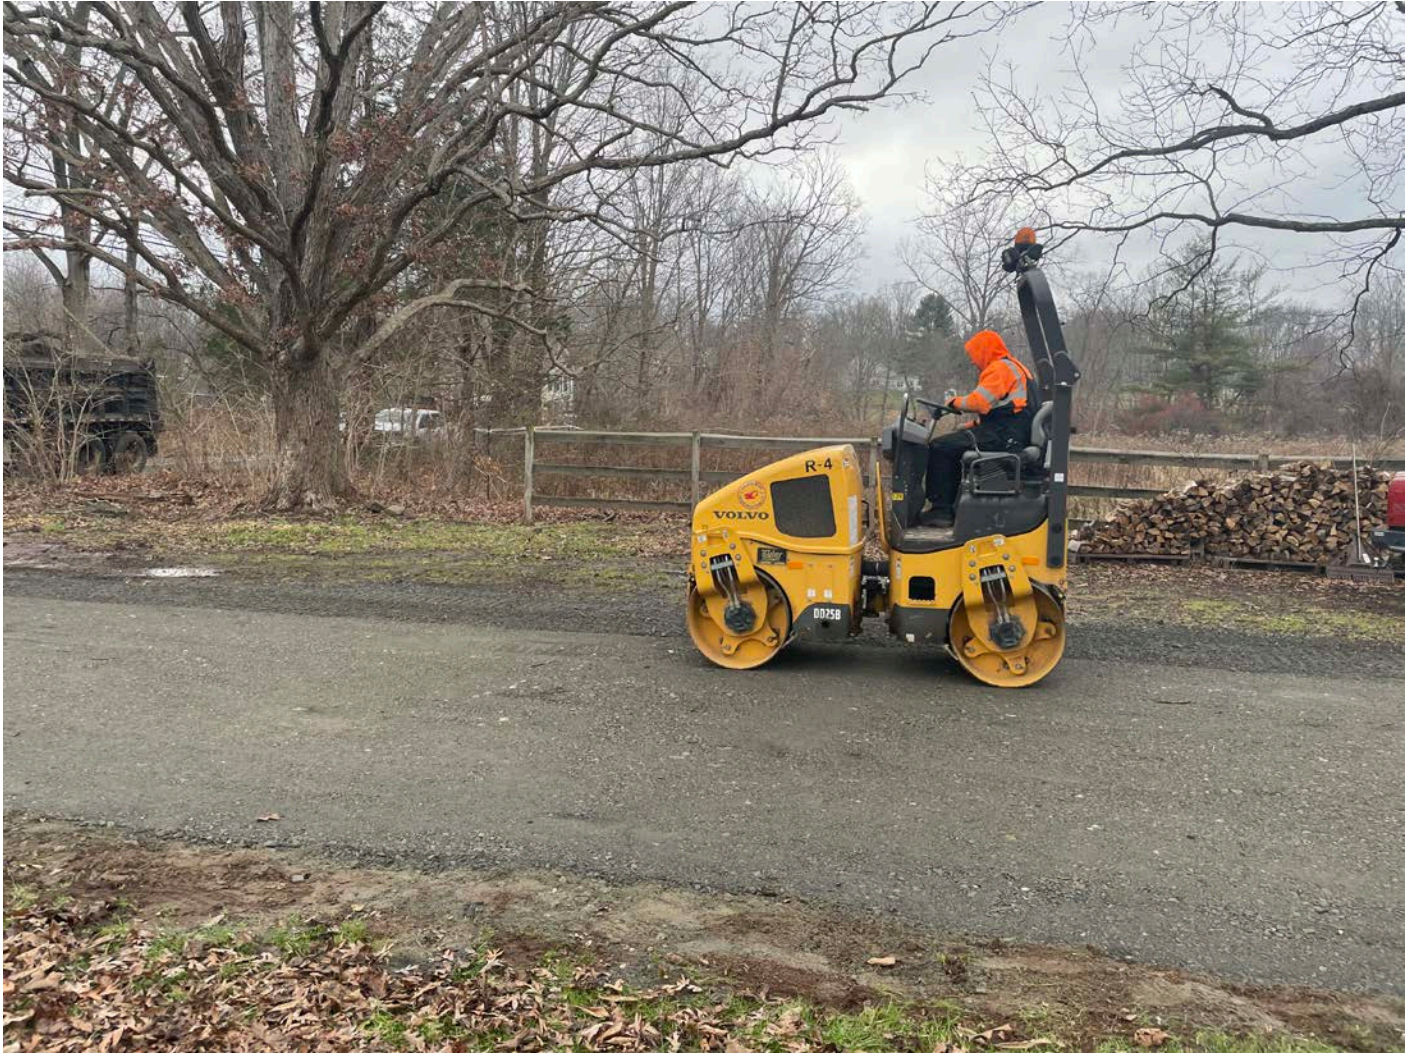
1303: Ludlow has finished placing ¾" process gravel on the driveway of 78 Maiden Lane and has begun to compact it with a rolling compactor.

Picture 9: Ludlow compacting the ¾" processed gravel they used to restore the driveway at the 78 Maiden Lane property after they installed a 1" copper water service line. View to the southwest.

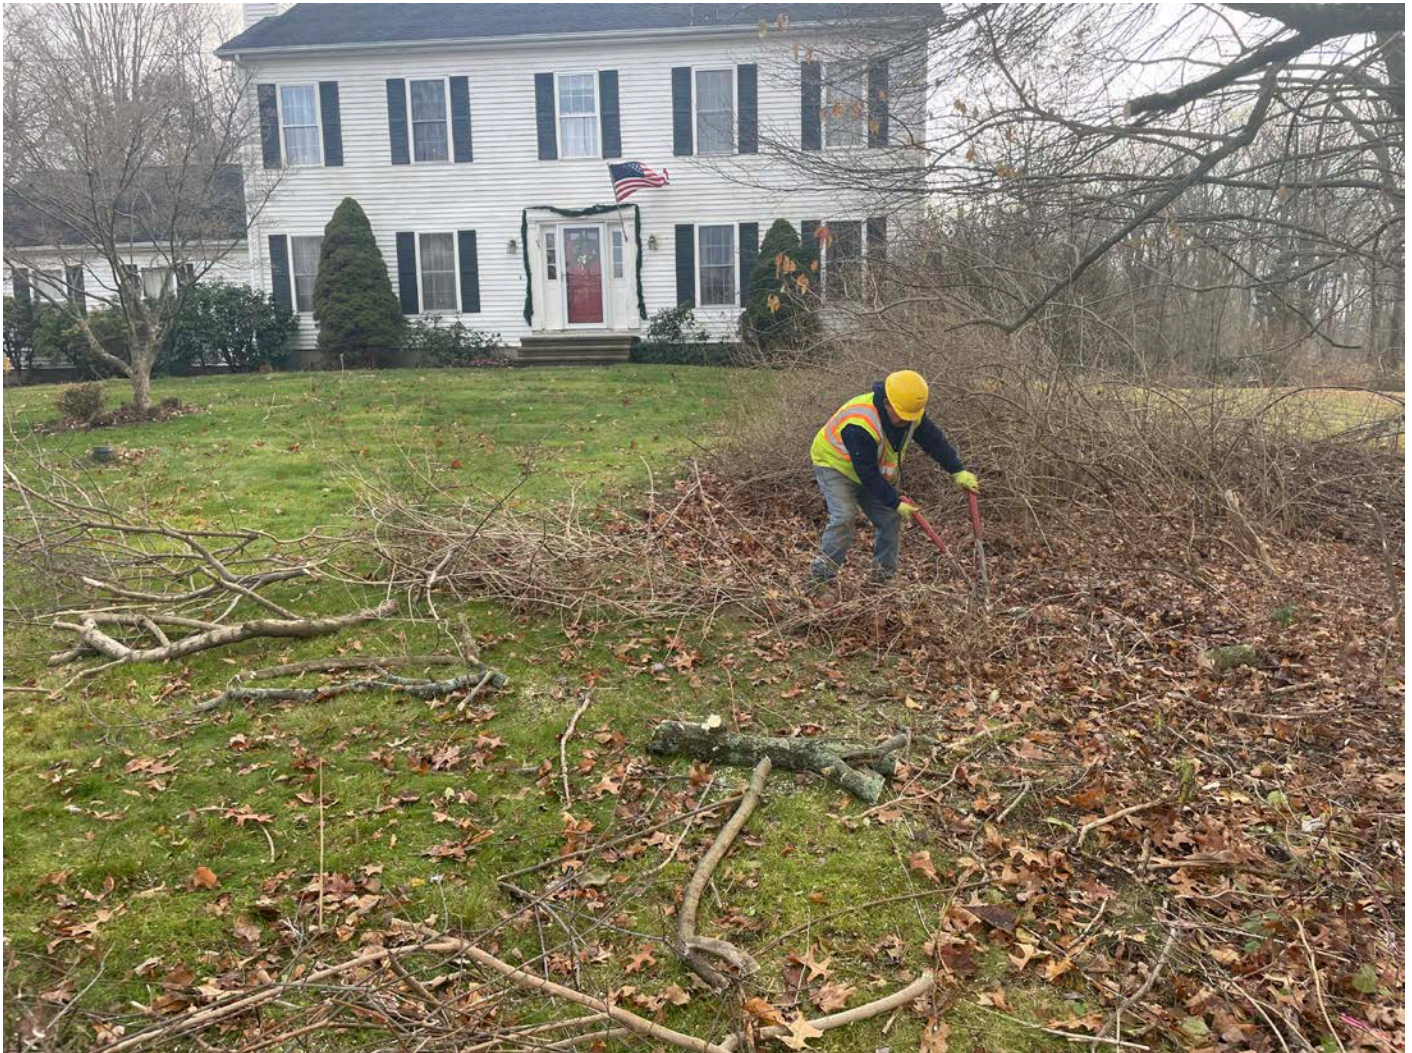
1406: Ludlow is clearing a minor amount of brush and tree limbs at 105 Maiden Lane to clear a path for the installation of a copper water service line tomorrow.

Picture 10: Ludlow clearing brush at the 105 Maiden Lane property as they begin to clear a path for the installation of a copper water service line. View to the south.
