## Daily Report

<b>Project:</b>	Durham Meadows Pipeline Installation	<b>Date:</b>	December 7, 2021
<b>Location:</b>	Maiden Lane, Durham	<b>Day of Week:</b>	Tuesday
<b>Project #:</b>	AECOM: 6061487	<b>Report No:</b>	377
<b>Contractor:</b>	Ludlow Construction	<b>Page:</b>	1 of 14

### Daily Activities – Installation of water lines, Main Street, Durham

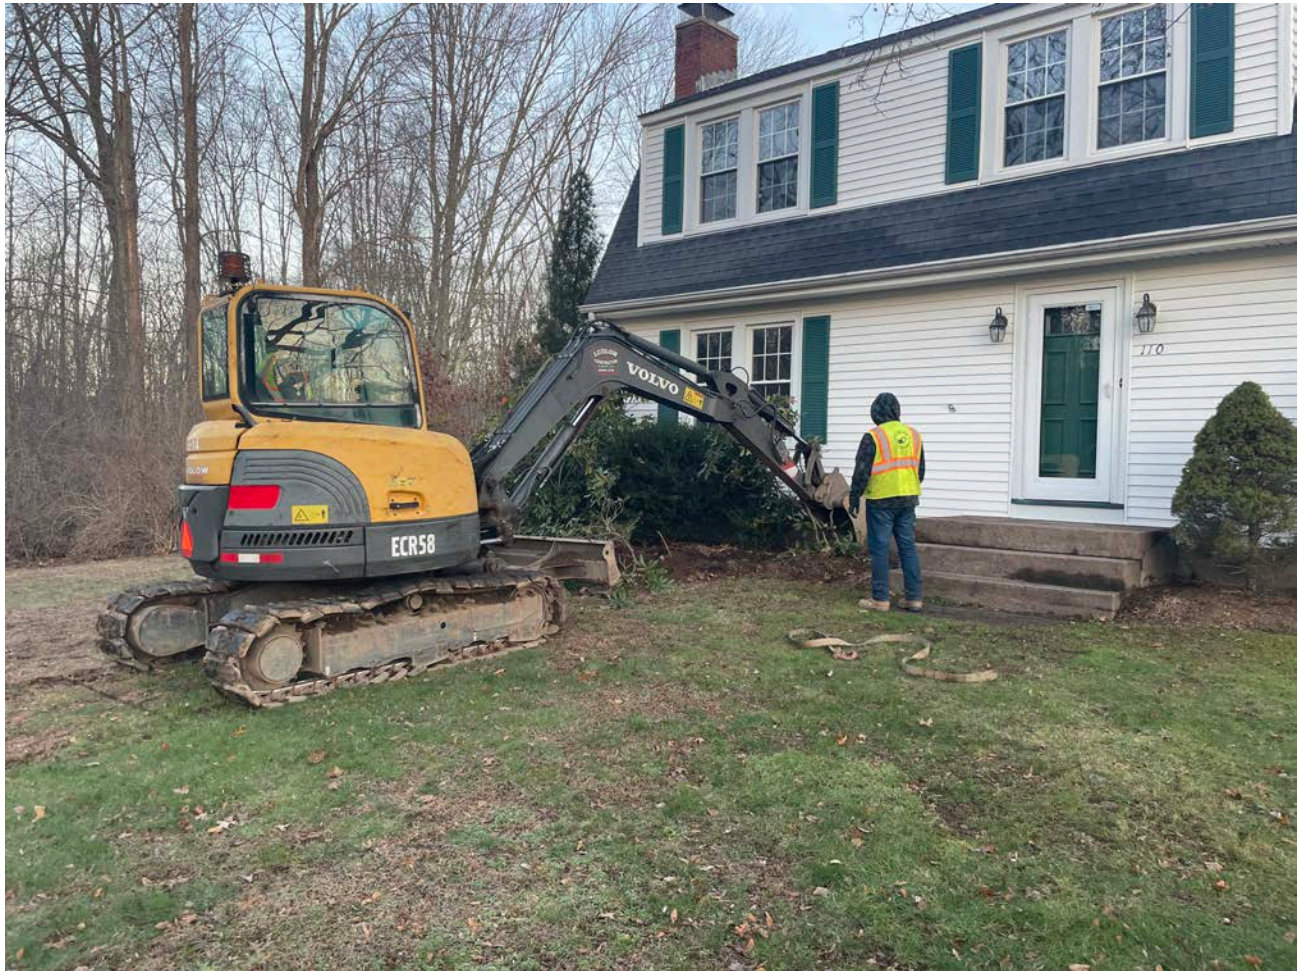
**Picture 1: Ludlow prepares to begin excavating a trench for the installation of a 1" copper water service line on the south side of the 110 Maiden Lane residence. View to the northwest.**

0719: Ludlow has begun to excavate on the south side of the 110 Maiden Lane residence as they begin to install activities for a 1" copper water service line.

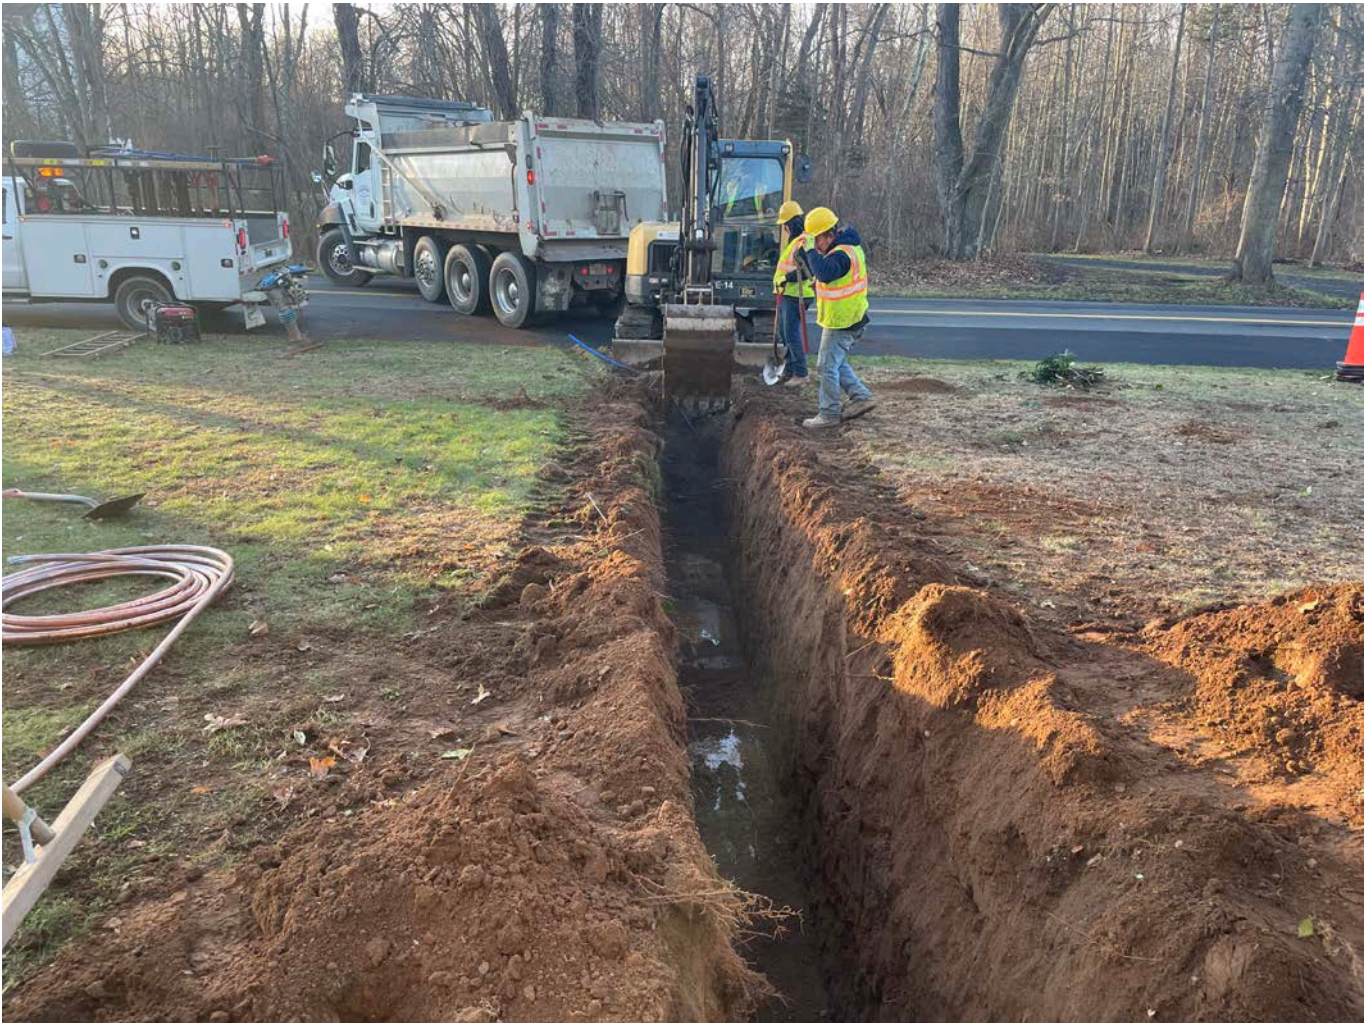
**Picture 2: Ludlow excavating a trench for the installation of a 1" copper water service line on the south side of the 110 Maiden Lane residence. View to the south.**

0749: Ludlow continues excavating at the 110 Maiden Lane property, starting at the southern foundation and moving south towards the curb stop. Ludlow has encountered water at the bottom of the trench.

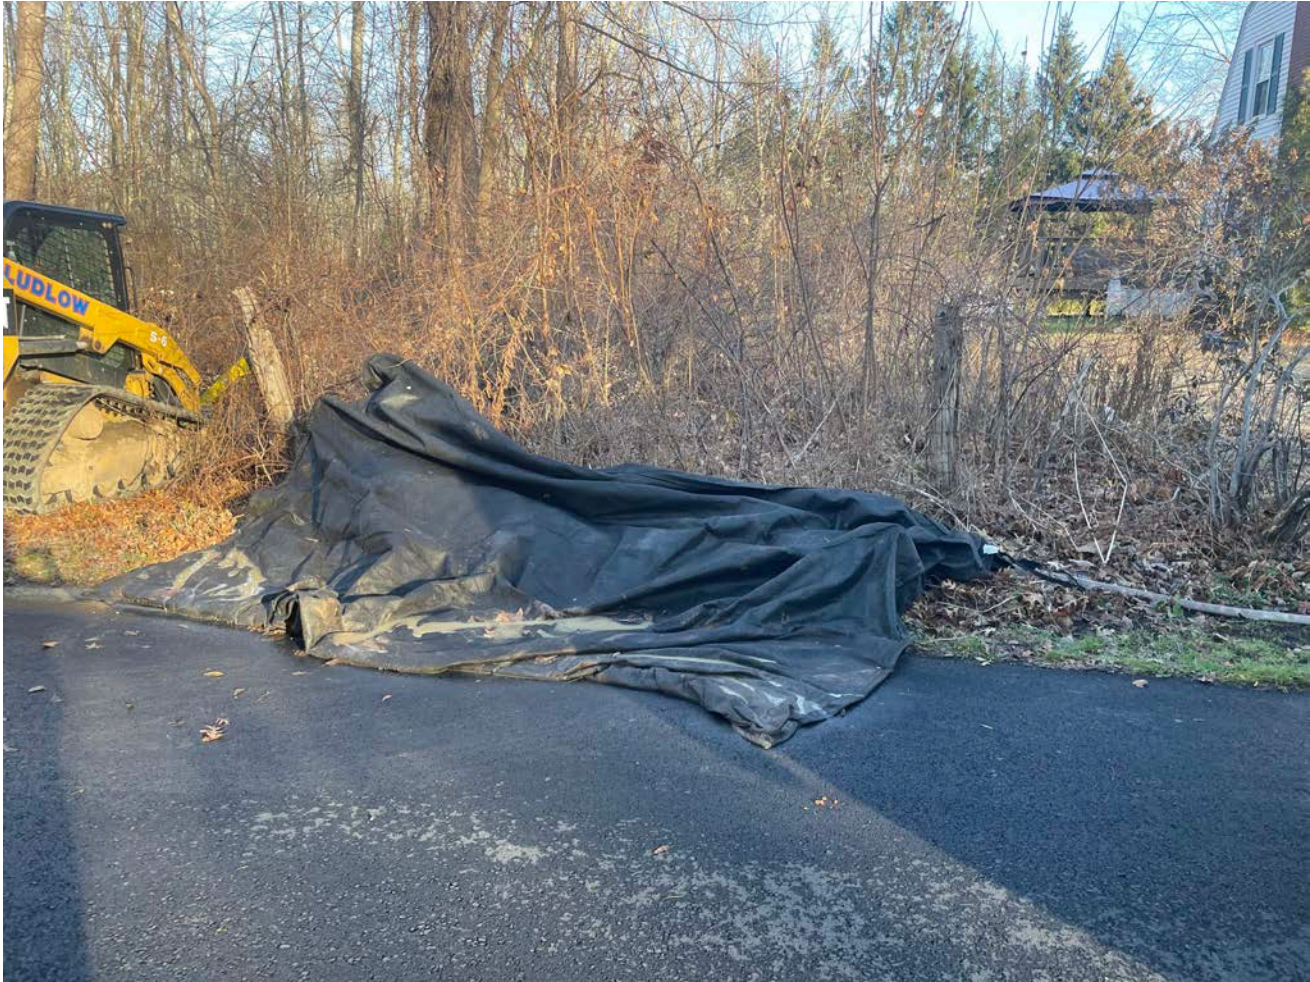
**Picture 3: Silt bag that Ludlow placed on the north side of Maiden Lane to discharge water being pumped from the trench they are excavating at the 110 Maiden Lane property for the installation of a 1" copper water service line. View to the north.**

0811: Ludlow is setting up to pump water out of the trench they are working in at the 110 Maiden Lane property. Ludlow is running the discharge hose from the pump into a silt bag they have placed on the north side of Maiden Lane and, west of the residence.

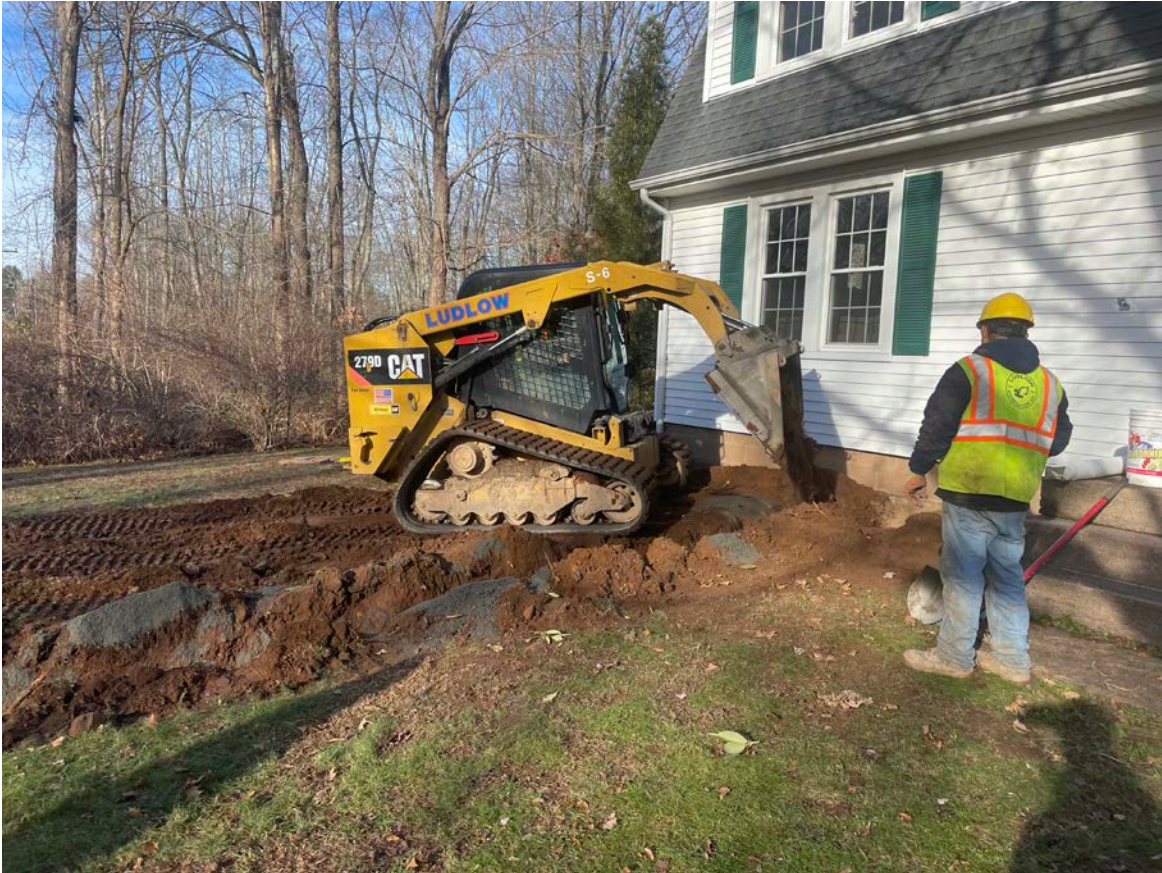
Picture 4: Ludlow placing sand over the 1" copper water service line they installed at the 110 Maiden Lane property. View to the west.

0913: Ludlow begins to place sand above and below the 1" copper water service line they just installed at the 110 Maiden Lane property.

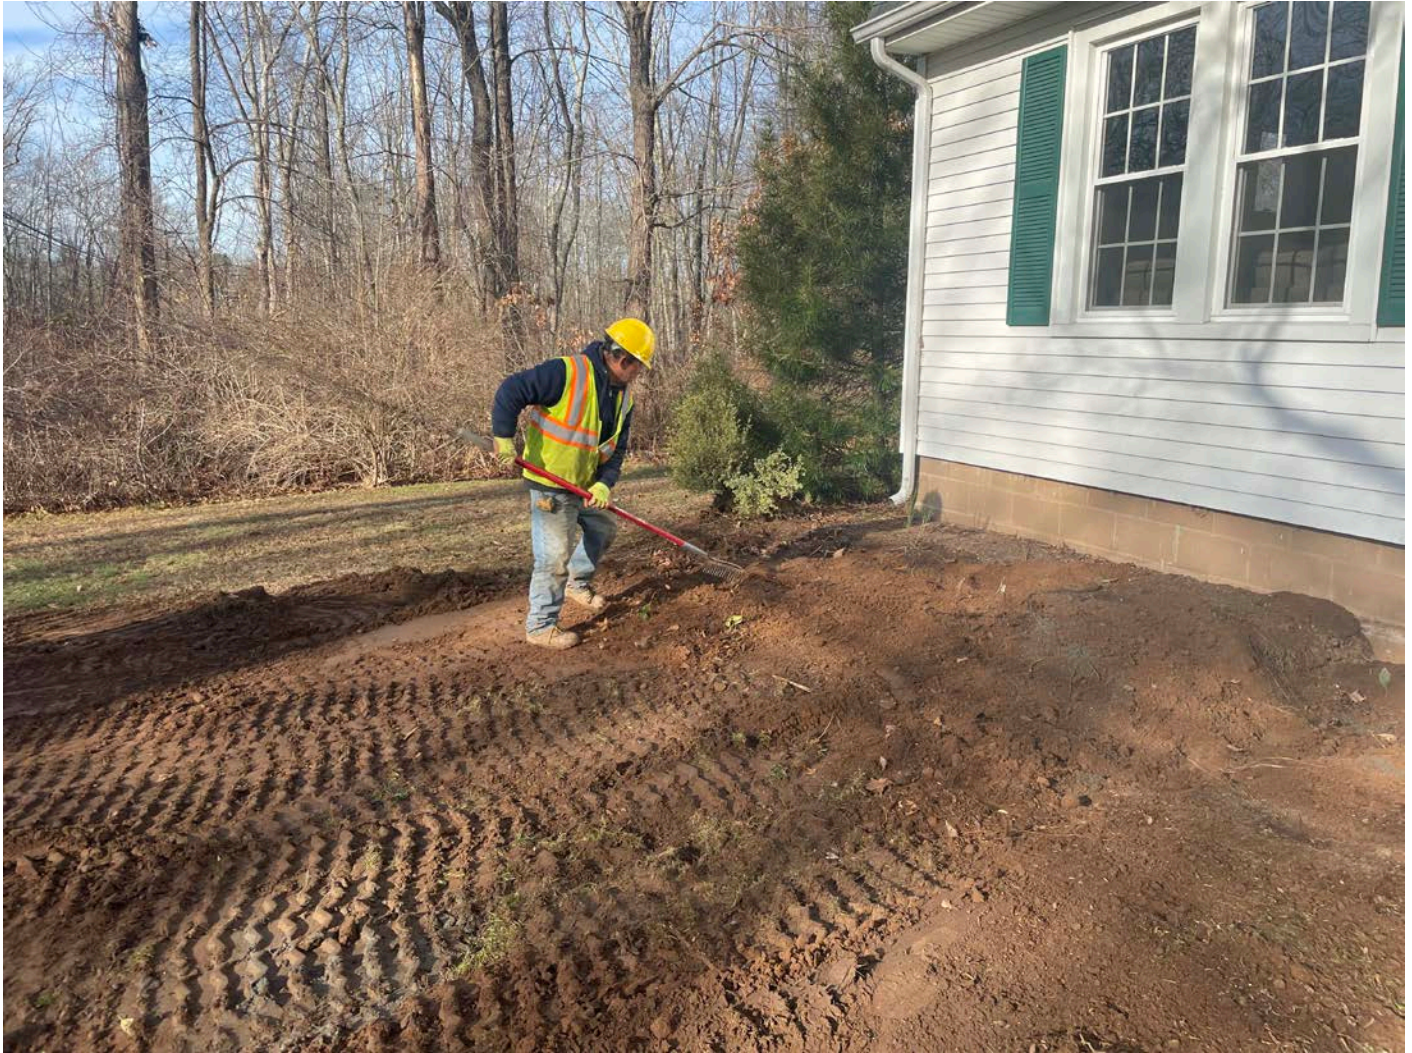
**Picture 5: Ludlow raking out loam that they placed on the southside of the 110 Maiden Lane residence to restore those areas that were disturbed by the installation of a 1" copper water service line. View to the west.**

1018: Ludlow has placed loam over the areas disturbed during the installation of a 1" copper water service at the 110 Maiden Lane property.

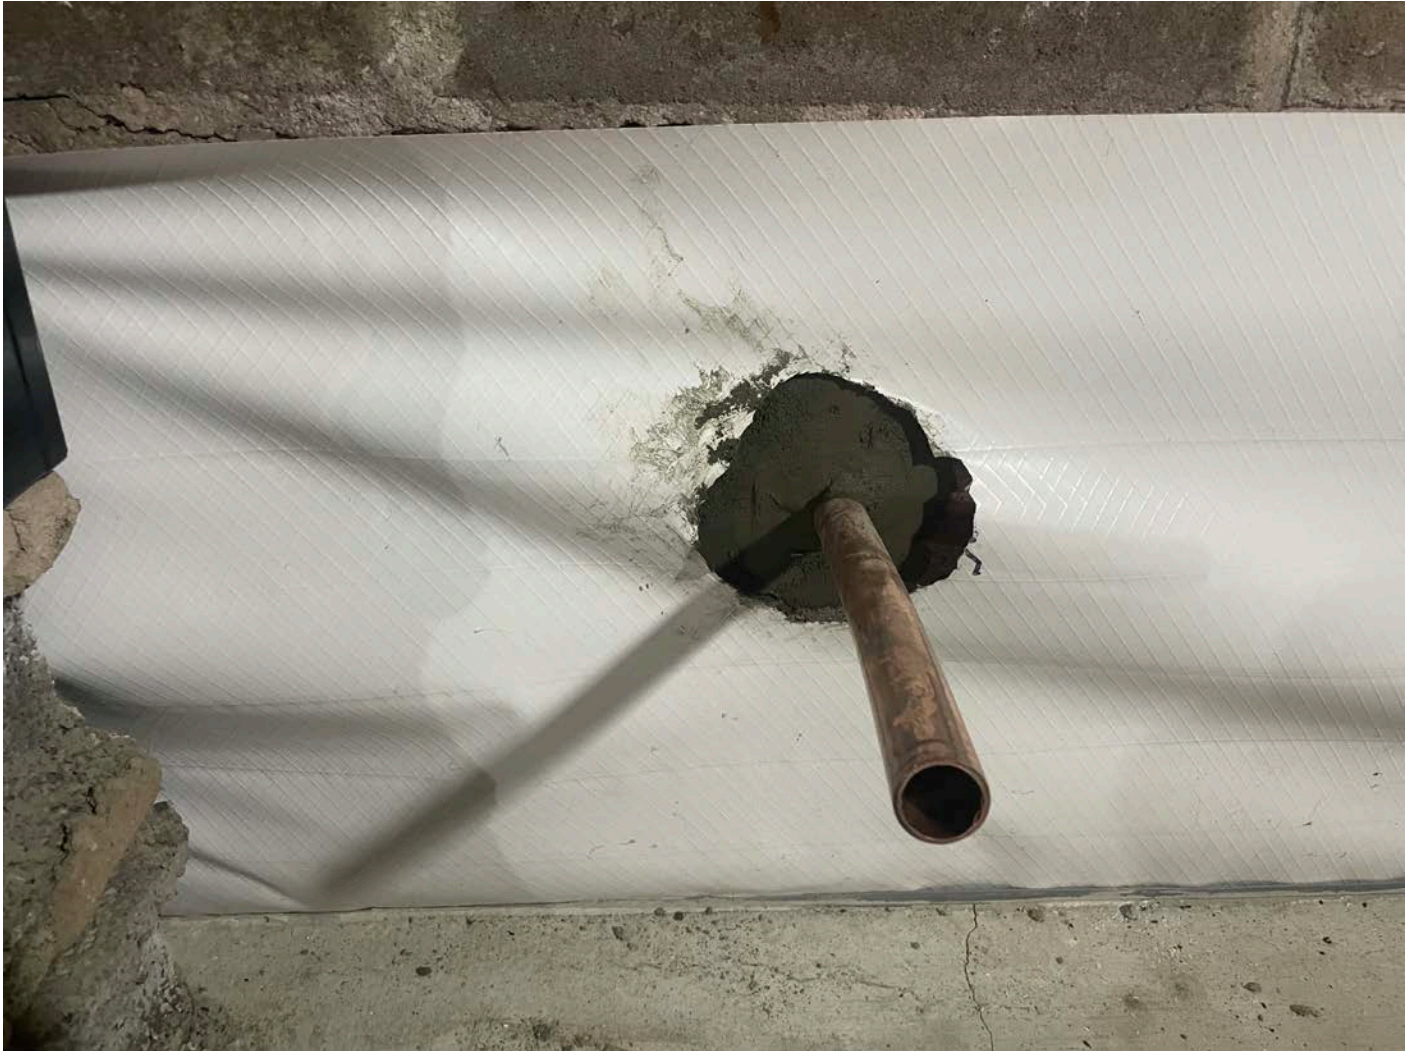
Picture 6: 1" copper water service line that Ludlow inserted through the southern foundation of the 110 Maiden Lane residence and secured in place with non-shrink grout. View to the south.

0857: Ludlow used a rotary hammer to penetrate the south side of the concrete block foundation of the 110 Maiden Lane residence. The penetration point is 136" east of the home's southwest corner and is 50" below surface grade. Ludlow has inserted the 1" copper water line through the penetration.

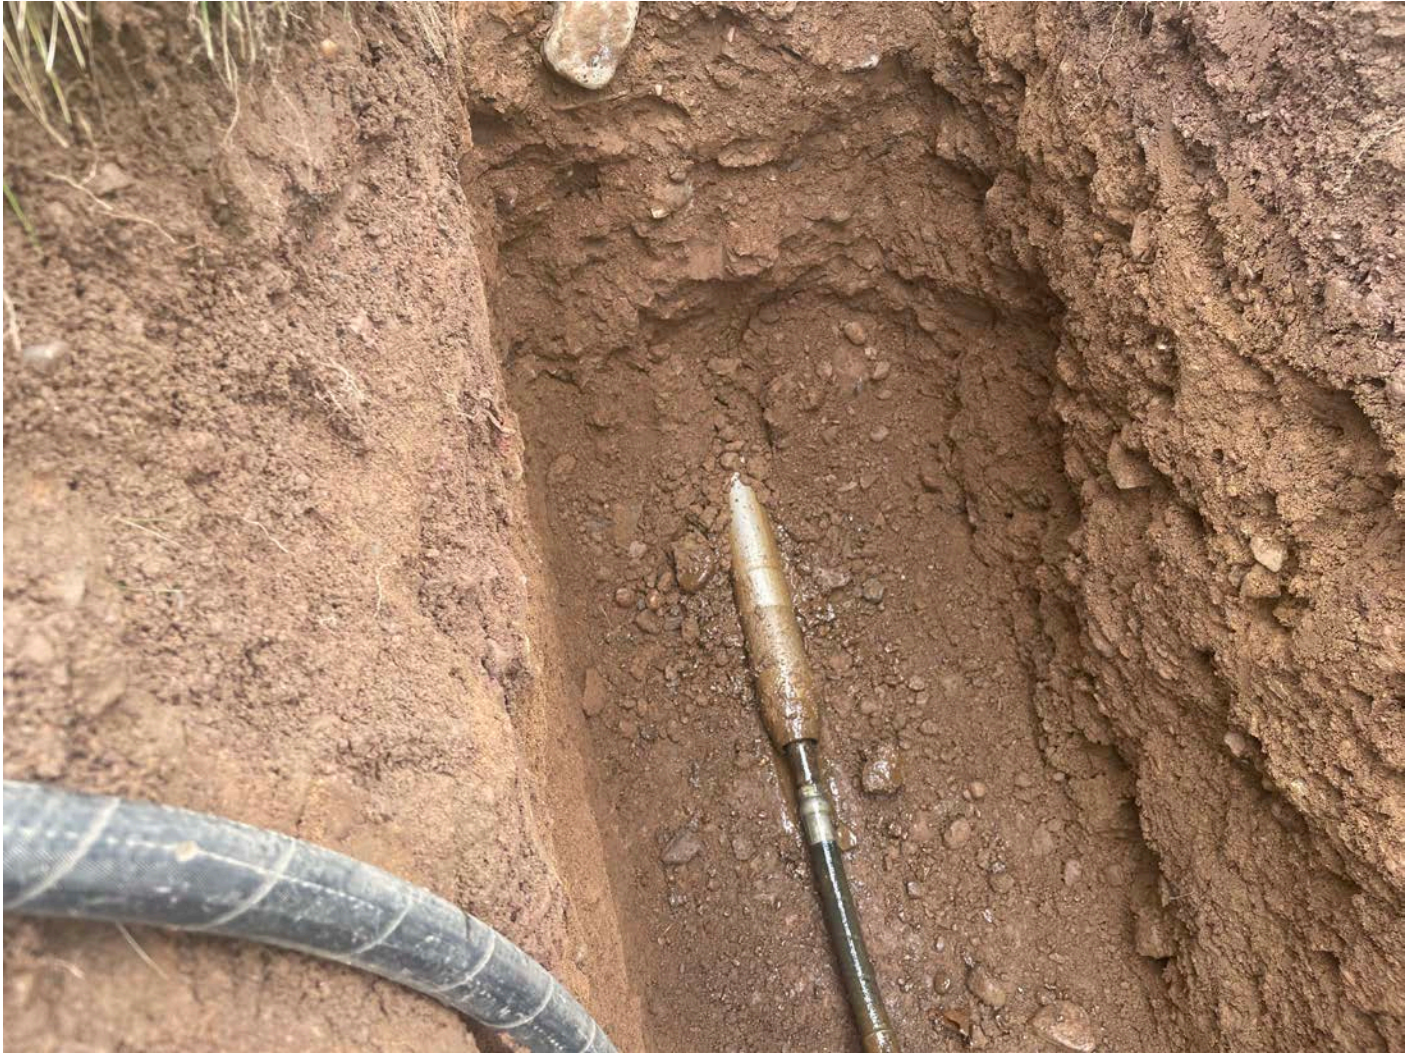
**Picture 7: Pneumatic mole that Ludlow is using to make a hole beneath the sidewalk of the 105 Maiden Lane residence for the installation of a 1" copper water service line. View to the north.**

1143: Ludlow is using a pneumatic mole to punch a hole beneath the sidewalk on the north side of the 105 Maiden Lane residence. Ludlow has also daylighted the poured-concrete foundation of the residence.

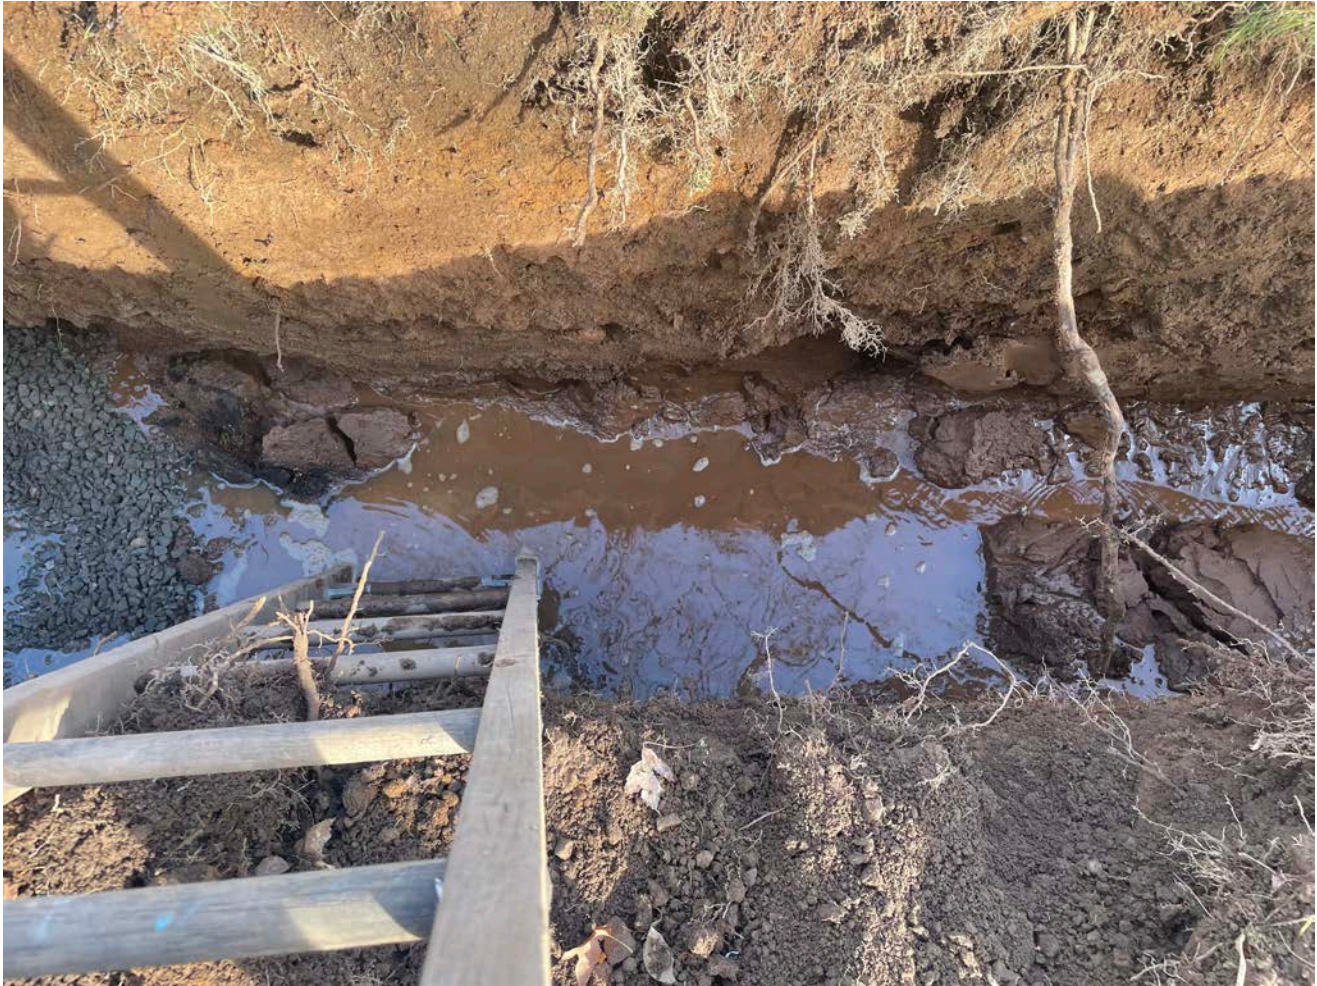
Picture 8: Water that was observed in the bottom of the trench that Ludlow is excavating at the 105 Maiden Lane property for the installation of a 1" copper water service line.

1220: Ludlow has almost completed the trench they need to install a 1" copper water service line for the 105 Maiden Lane residence. Ludlow is setting a pump up on the north side of the trench next to the curb stop to remove water that has collected in the trench. Ludlow is discharging the water into a silt bag they placed west of the 105 Maiden Lane property and south of Maiden Lane. Ludlow is currently attaching the 1" copper water line to the curb stop. Ludlow has inserted the copper line through the penetration they made on the north side of the residence's foundation with a rotary hammer. The penetration point is located 81" east of the east side of the home's concrete stairs and 53" below surface grade. Ludlow has excavated the trench is 60" deep.

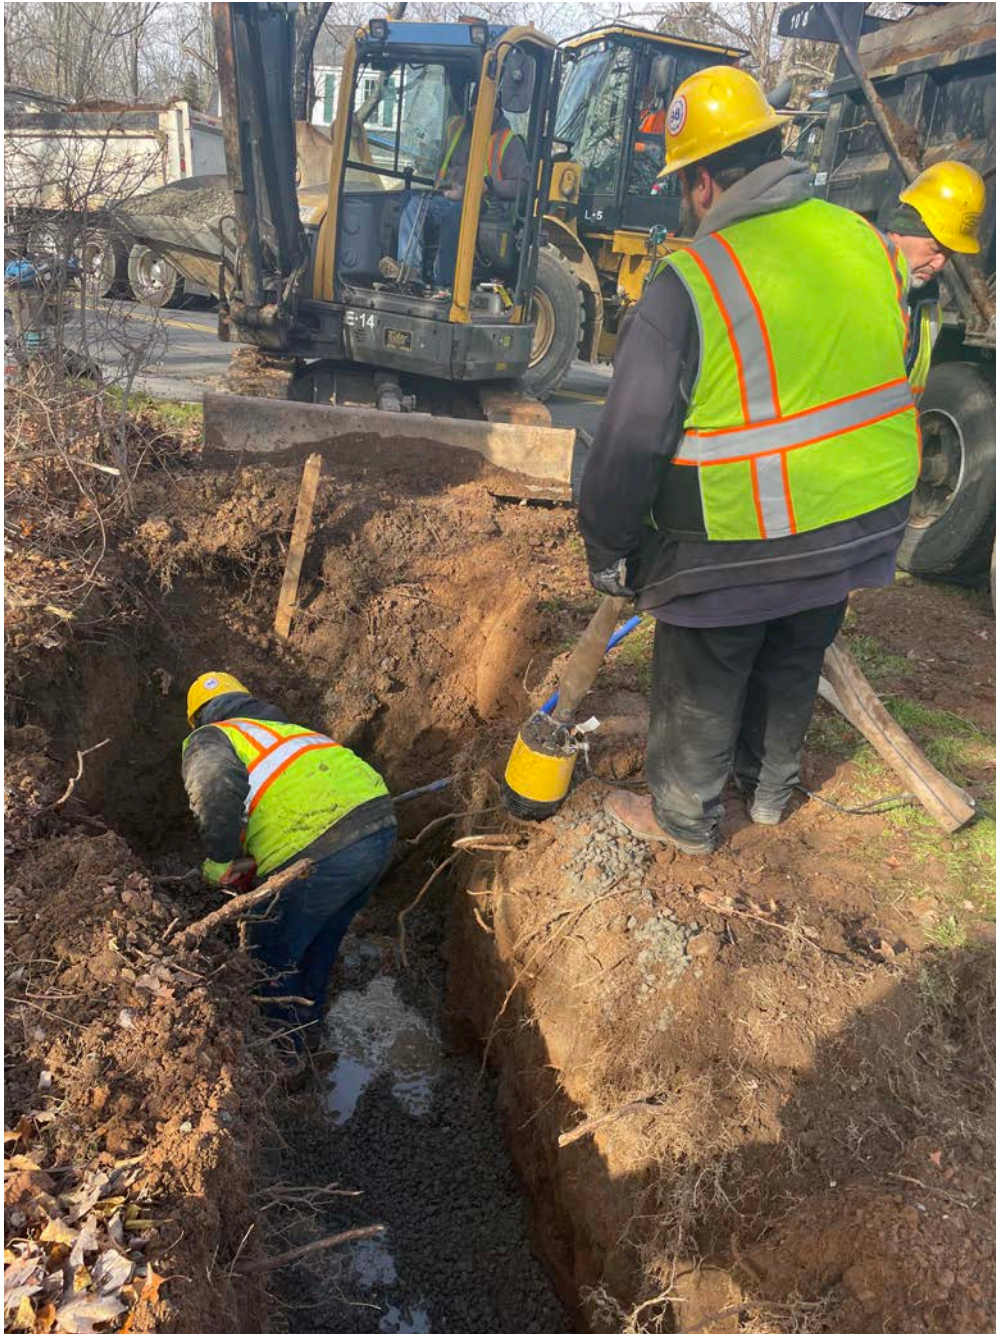
Picture 9: Ludlow preparing to set a pump in the trench they excavated at the 105 Maiden Lane property for the installation of a 1" copper water service line. View to the southwest.

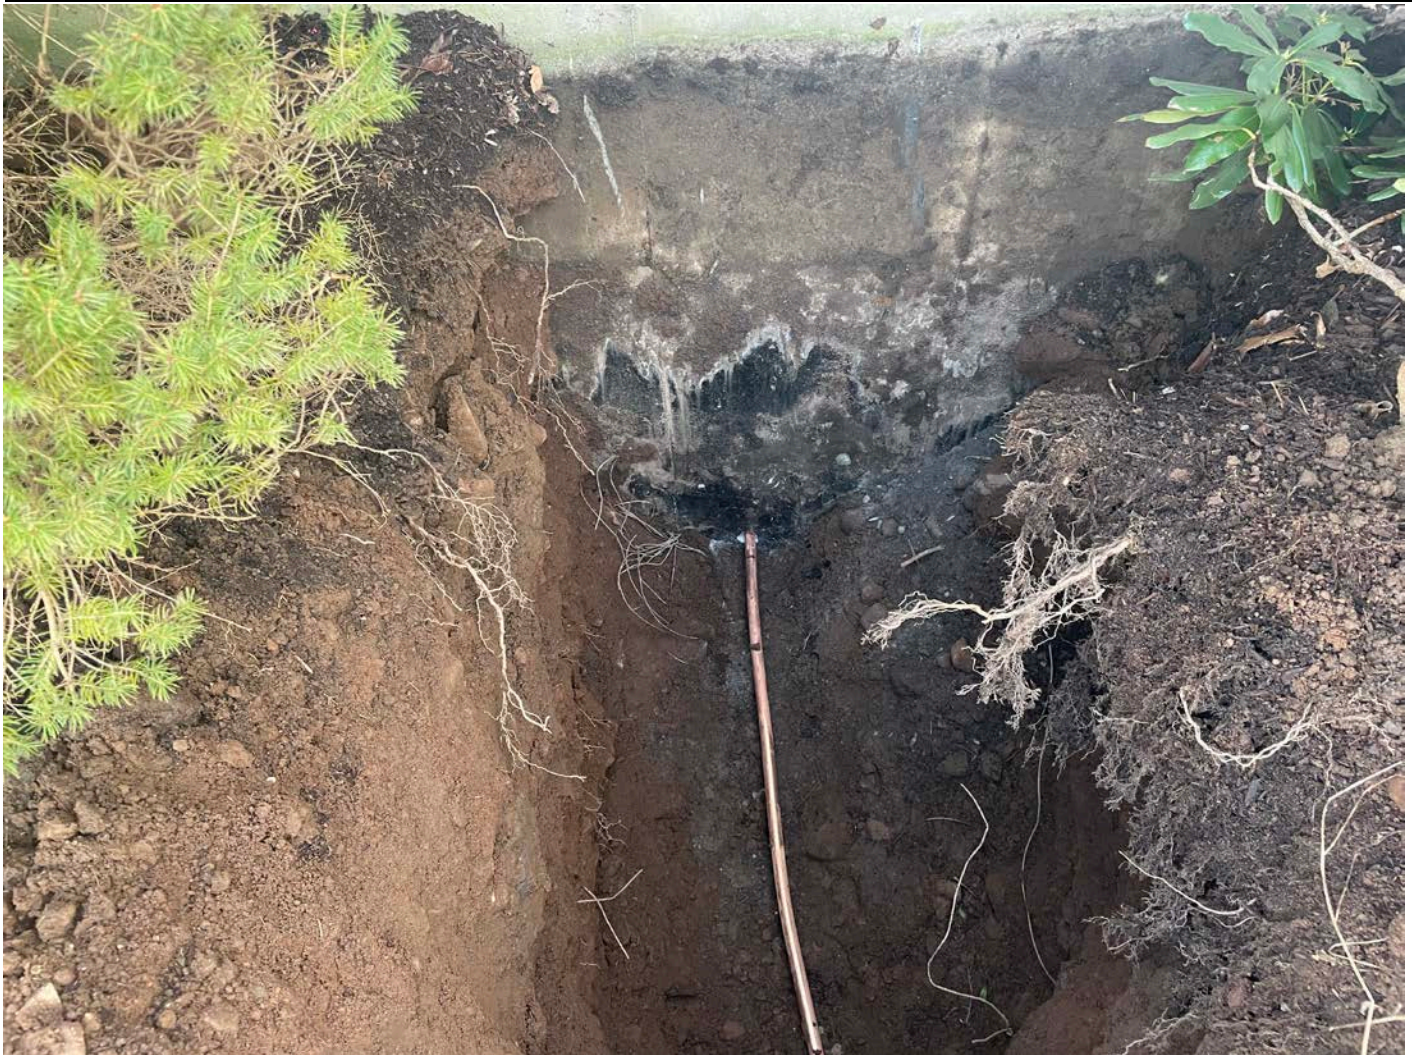
**Picture 10: 1" copper water service line that Ludlow has passed through the penetration they made on the northern foundation of the 105 Maiden Lane residence and secured in place with non-shrink grout. View to the north.**

1254: Ludlow is using non-shrink grout to secure the 1" copper water line in place where Ludlow passed it through the penetration they made on the northern foundation of the 105 Maiden Lane residence.

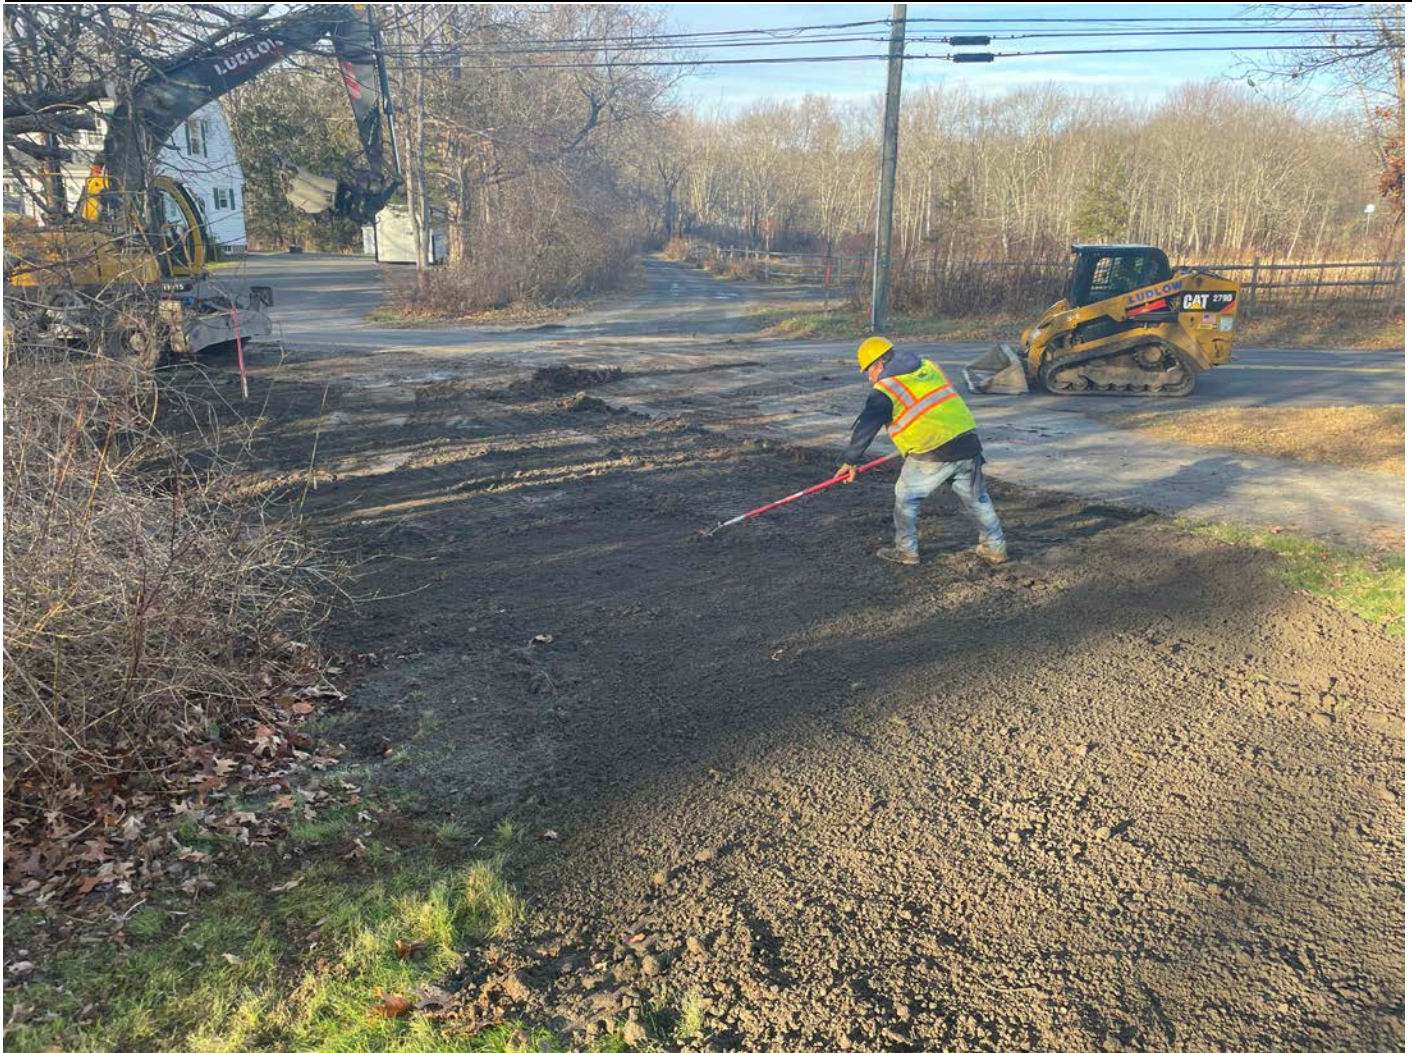
**Picture 11: Ludlow raking loam at the 105 Maiden Lane property as they work to restore those portions of the property that were disturbed by the installation of a 1" copper water service line. View to the north.**

1421: Ludlow is placing and grading loam at the 105 Maiden Lane property as they work to restore those portions of the property that were disturbed during the installation a 1" copper water service line.

1432: Ludlow is continuing to place, grade, and rake out loam at the 105 Maiden Lane property as they work to restore those portions of the property that were disturbed during the installation a 1" copper water service line. Ludlow has also begun to place grass seed on the raked-out loam.
