## Daily Report

<b>Project:</b>	Durham Meadows Pipeline Installation	<b>Date:</b>	December 8, 2021
<b>Location:</b>	Main Street, Maiden Lane, and Pickett Lane, Durham; S. Main Street, Middletown	<b>Day of Week:</b>	Wednesday
<b>Project #:</b>	AECOM: 6061487	<b>Report No:</b>	378
<b>Contractor:</b>	Ludlow Construction	<b>Page:</b>	1 of 15

### Pipe Connections, Installations, and Other Work

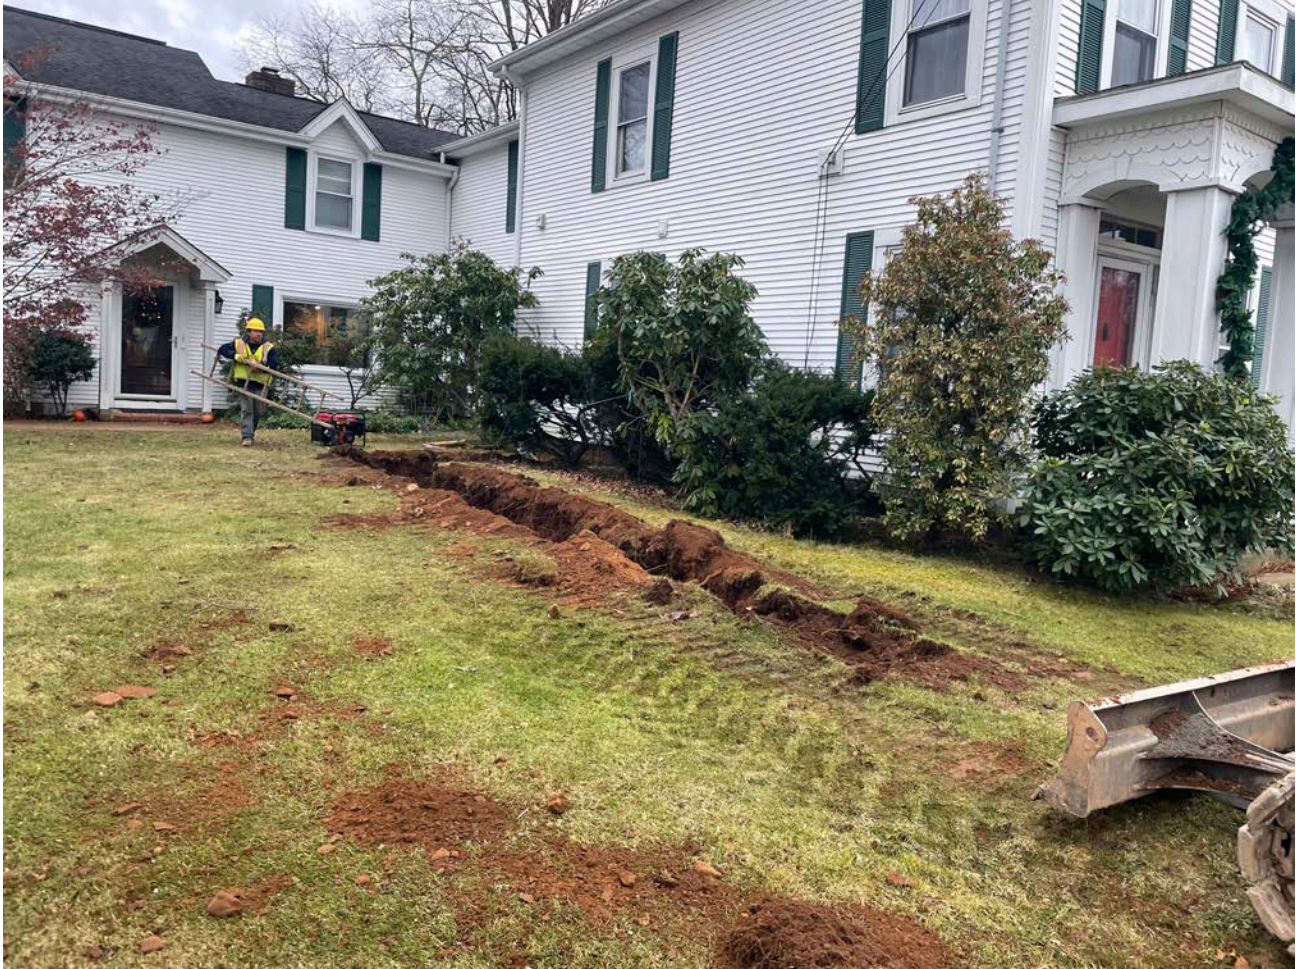
**Picture 1: Ludlow excavating a trench for the installation of a 1" copper water service line on the east side of the 123 Maiden Lane residence. View to the southwest.**

0719: Ludlow has begun to excavate on the east side of the 123 Maiden Lane residence where they are daylighting the fieldstone foundation.

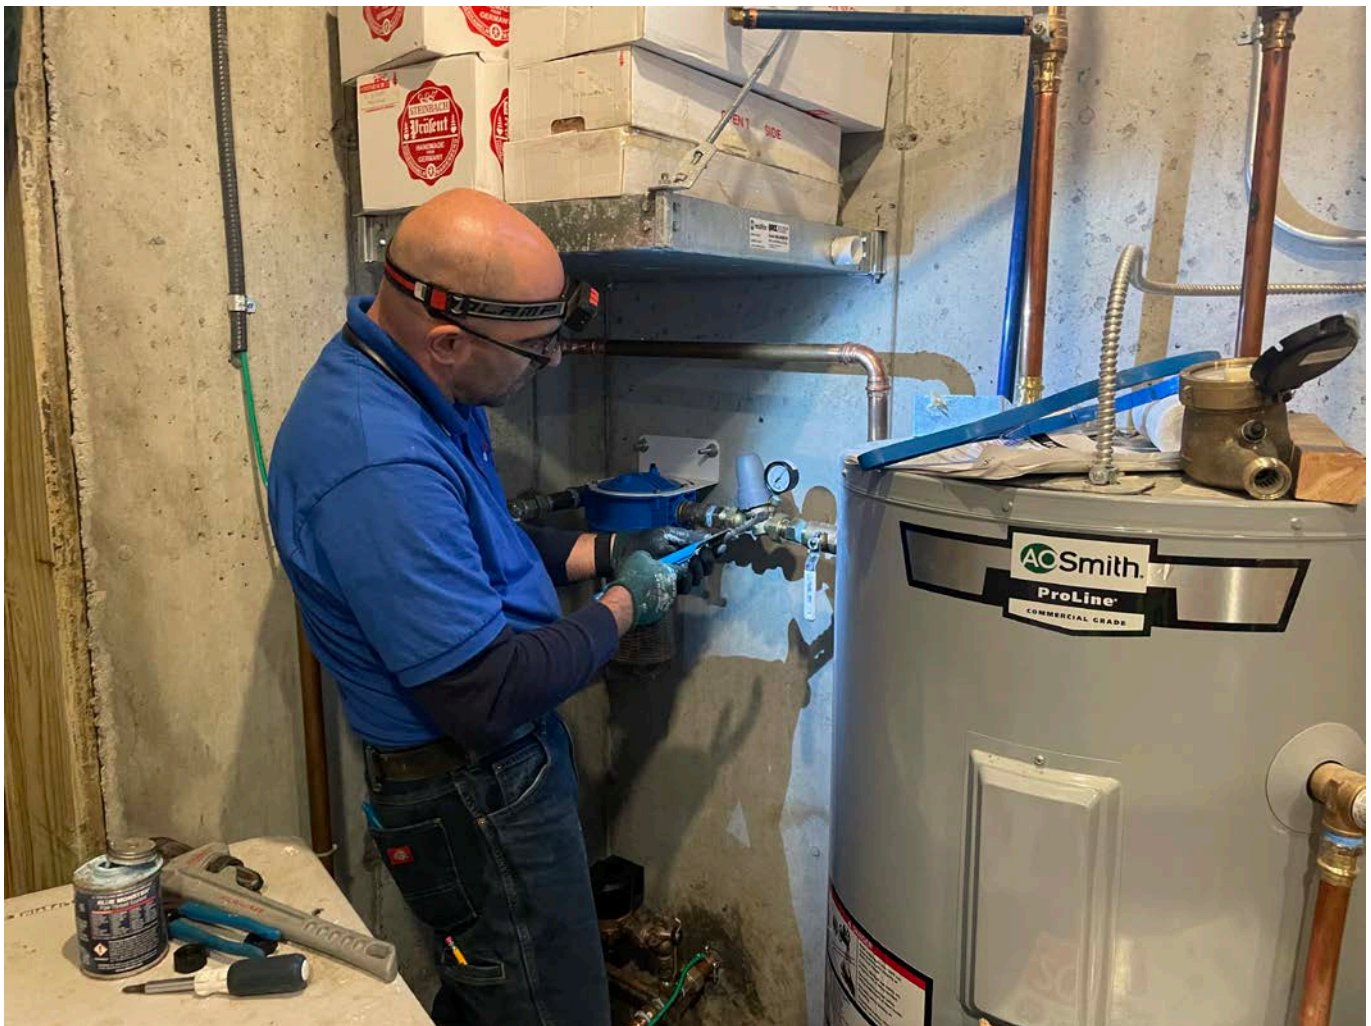
**Picture 2: Fazzino Plumbing replacing brass tees that were part of the final water service components that were previously installed at the 174 Main Street residence.**

0750: Fazzino Plumbing mobilizing to the 174 Main Street, Durham, property to replace they three brass tees that were part of the water service components that Fazzino previously installed.

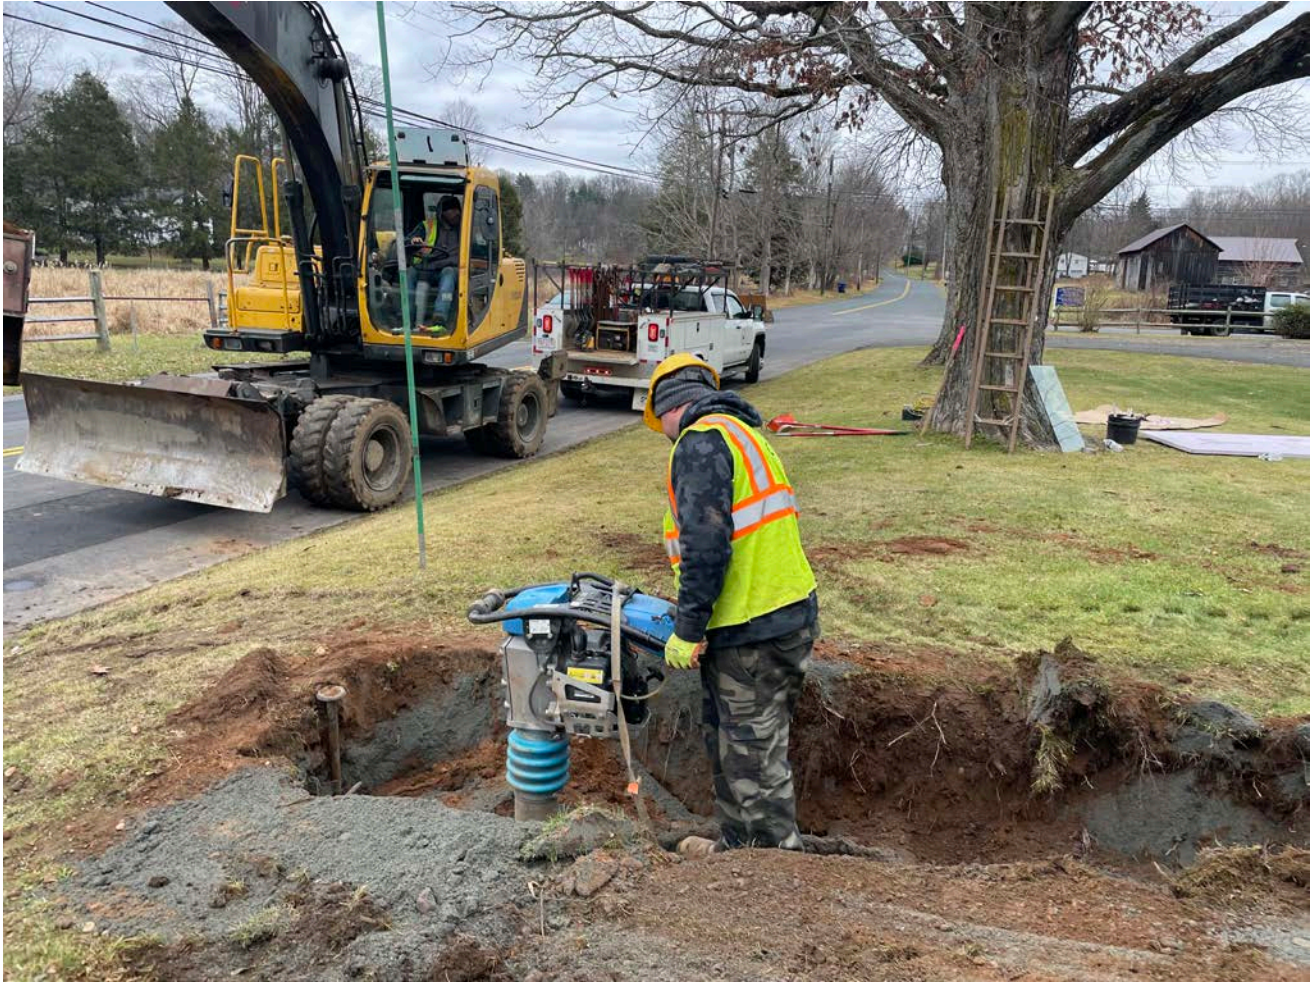
Picture 3: Ludlow compacting native fill in the trench they are backfilling at the 123 Maiden Lane property after the installation of a 1" copper water service line. View to the east.

0908: Ludlow continues to place and compact native fill over the sand and caution tape they placed over the 1" copper water service line at the 123 Maiden Lane property. The fill is being placed in 1' lifts and is being compacted with a jumping jack.

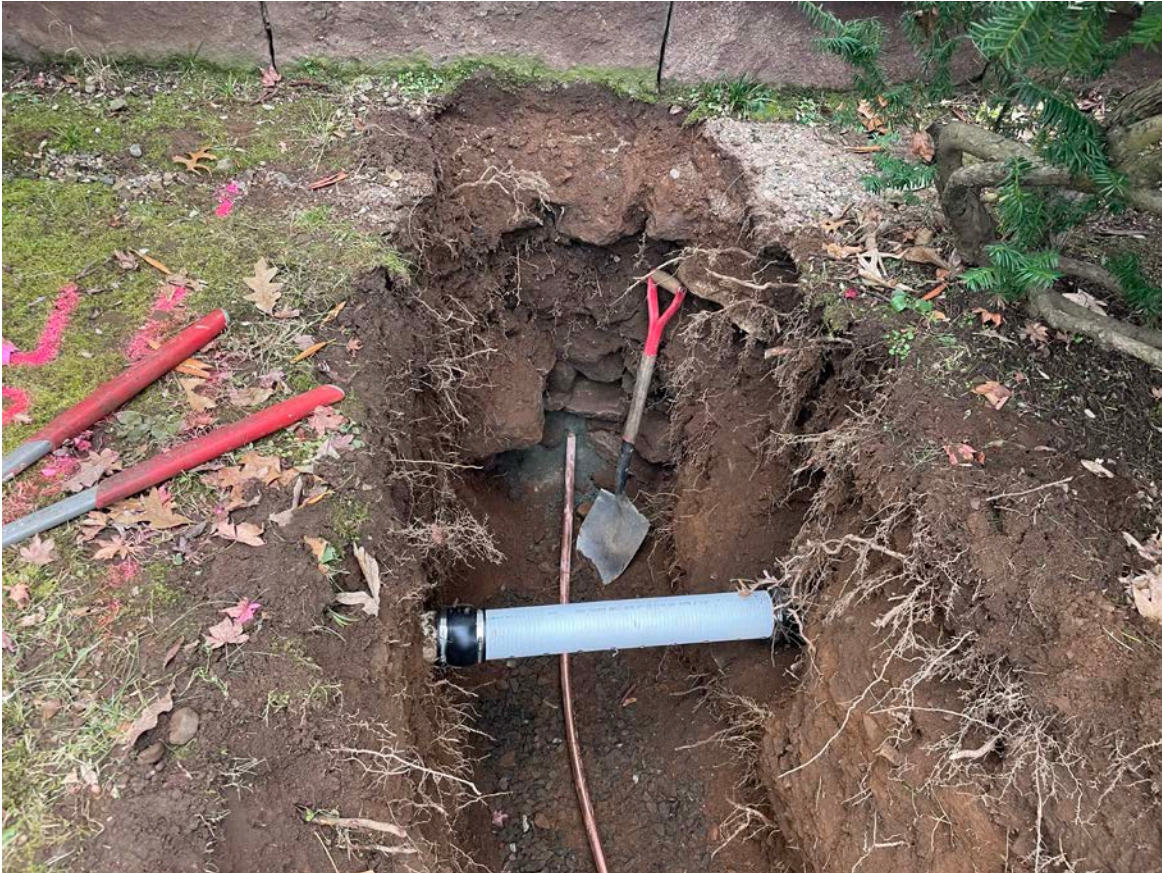
Picture 4: Ludlow has also repaired a 4" perforated PVC drain pipe on the east side of the 123 Maiden Lane residence's foundation with a new piece of perforated PVC and two Fernco boots. View to the west.

0832: Ludlow begins to backfill over the 1" copper water service line they just installed at the 123 Maiden Lane property. Ludlow has also repaired a 4" perforated PVC drain pipe on the east side of the home's foundation with a new piece of perforated PVC and two Fernco boots. Ludlow has also used non-shrink grout to secure the 1" copper water service line where it penetrates the field stone foundation of the residence.

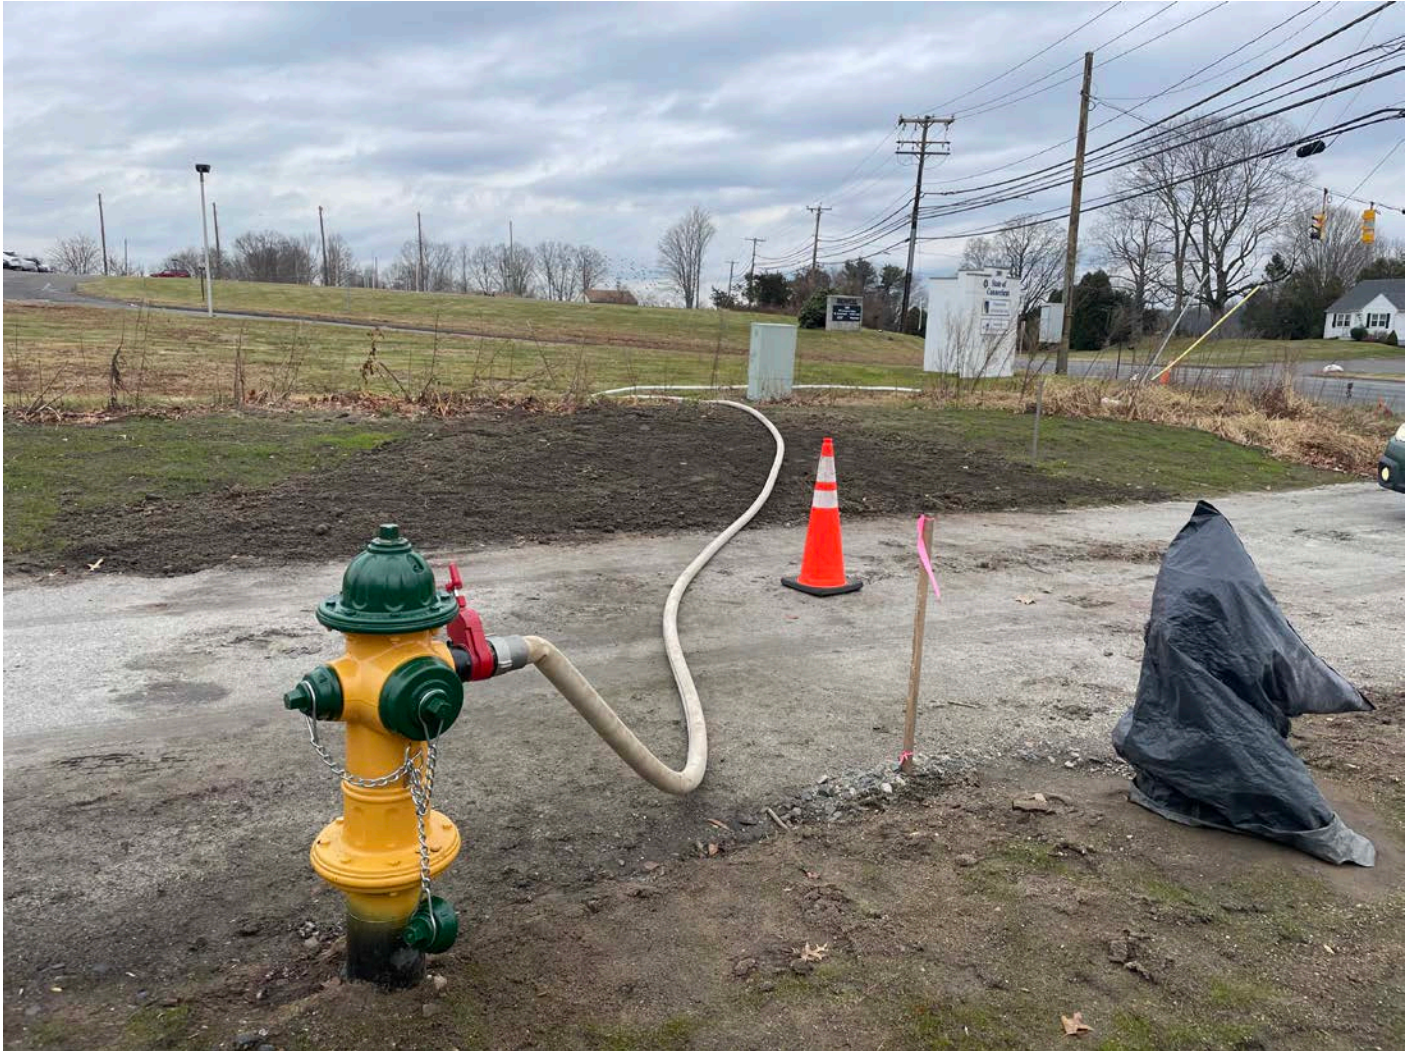
**Picture 5: Ludlow purging the 8" DIP waterlines located on the east side of the booster station. The purged water is being directed into a storm drain located on the north side of the booster station driveway. View to the northeast.**

0744: Ludlow is working at the booster station flushing the 8" DIP water lines. The water is being flushed out of one of the hydrants at the booster station (the one located furthest west) and is being discharged into a catch basin located immediately north of the booster station driveway on the west side of Route 17.

0914: Ludlow continues to purge the 8" DIP water lines located on the east side of the booster station. One of the lines being flushed is the 8" DIP water line that Ludlow installed previously on Talcott Ridge Drive.

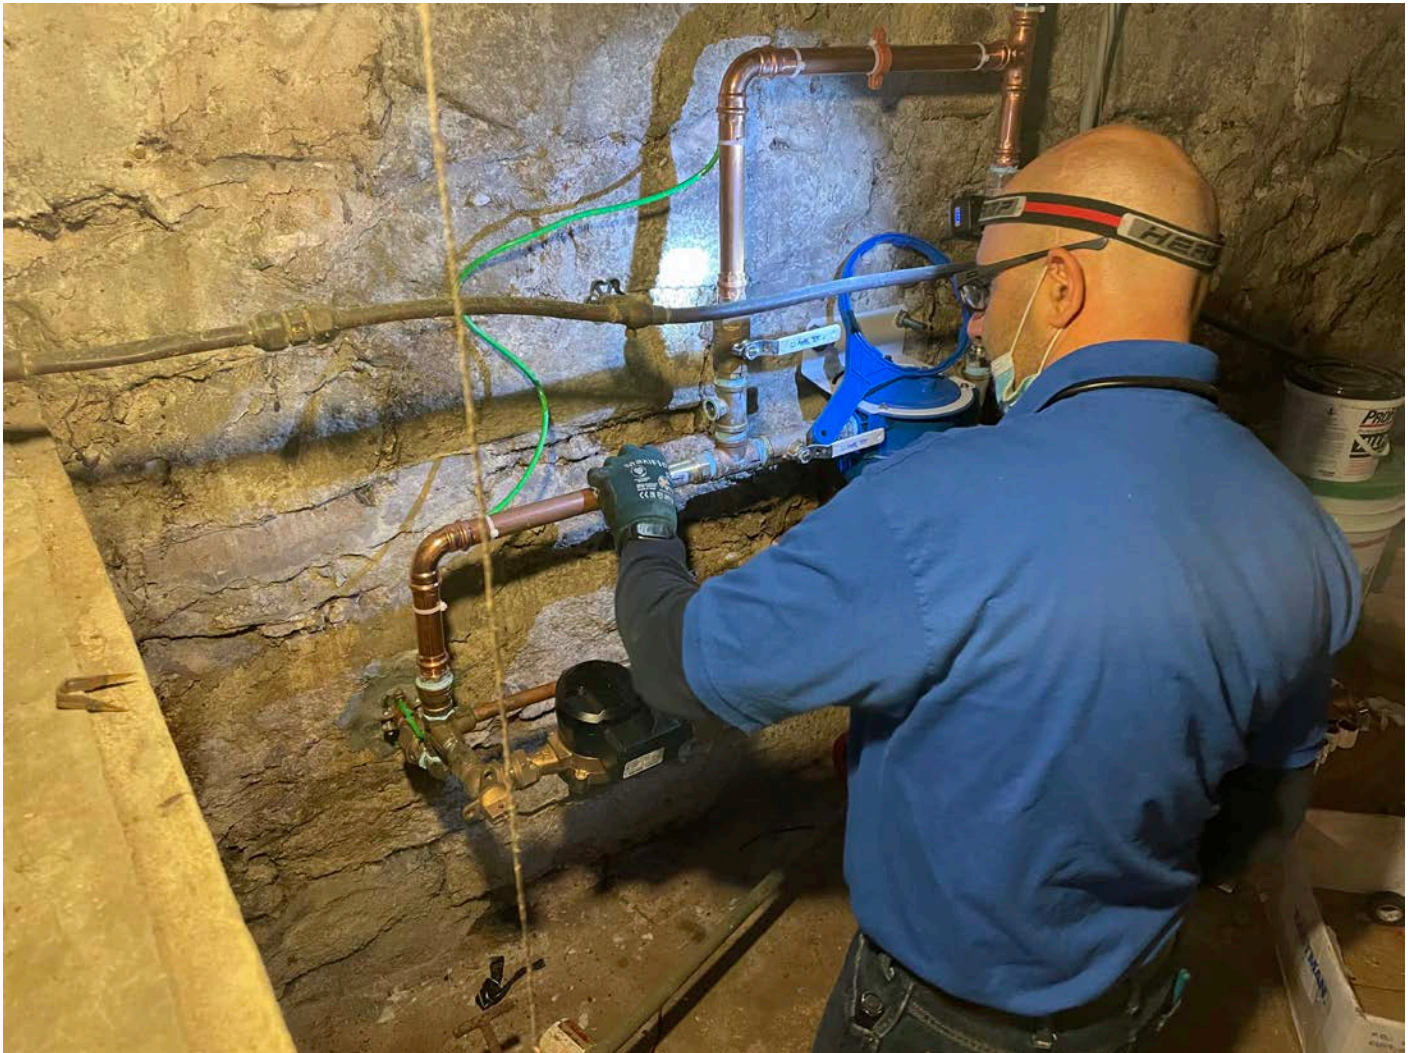
**Picture 6: Fazzino Plumbing replacing brass tees that were part of the final water service components that were previously installed at the 265 Main Street residence.**

1026: Fazzino plumbing continues to work on replacing the brass tees of the water system components they previously installed at the 265 Main Street, Durham, residence.

1039: Fazzino Plumbing is finishing up changing out tees at the 265 Main Street residence.

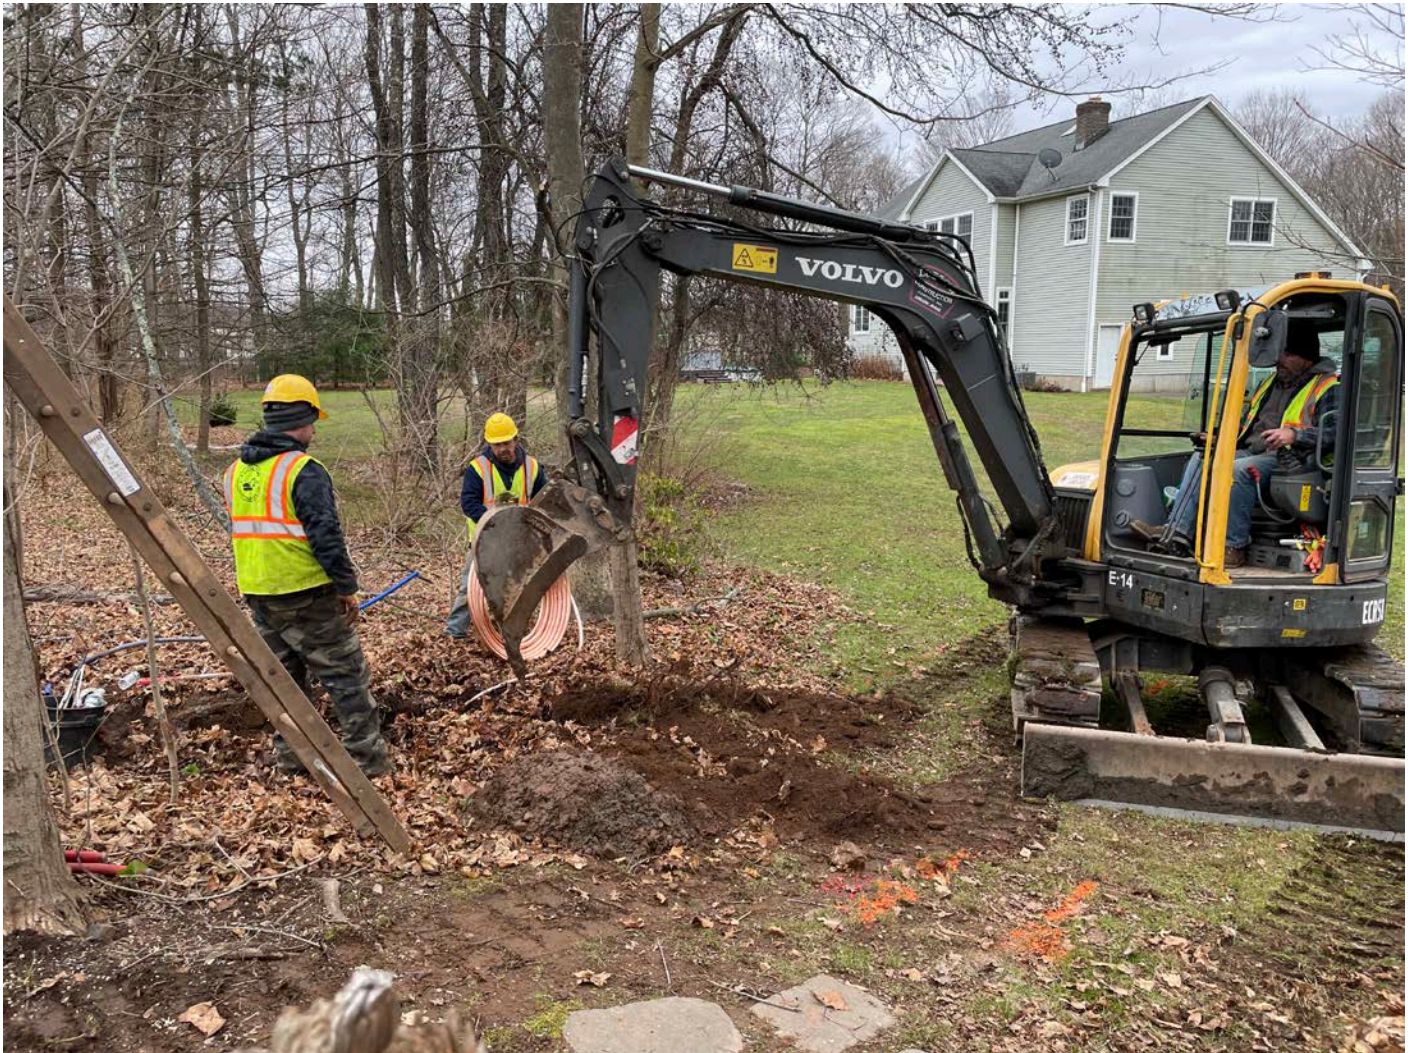
Picture 7: Ludlow beginning to excavate on the west side of the curb stop of the 93R Maiden Lane residence for the installation of a 1" copper water service line. View to the southwest.

1122: Ludlow has staged on Pickett Lane, Durham, and has begun to excavate on the west side of the 93R Maiden Lane property for the installation of a 1" copper water service line.

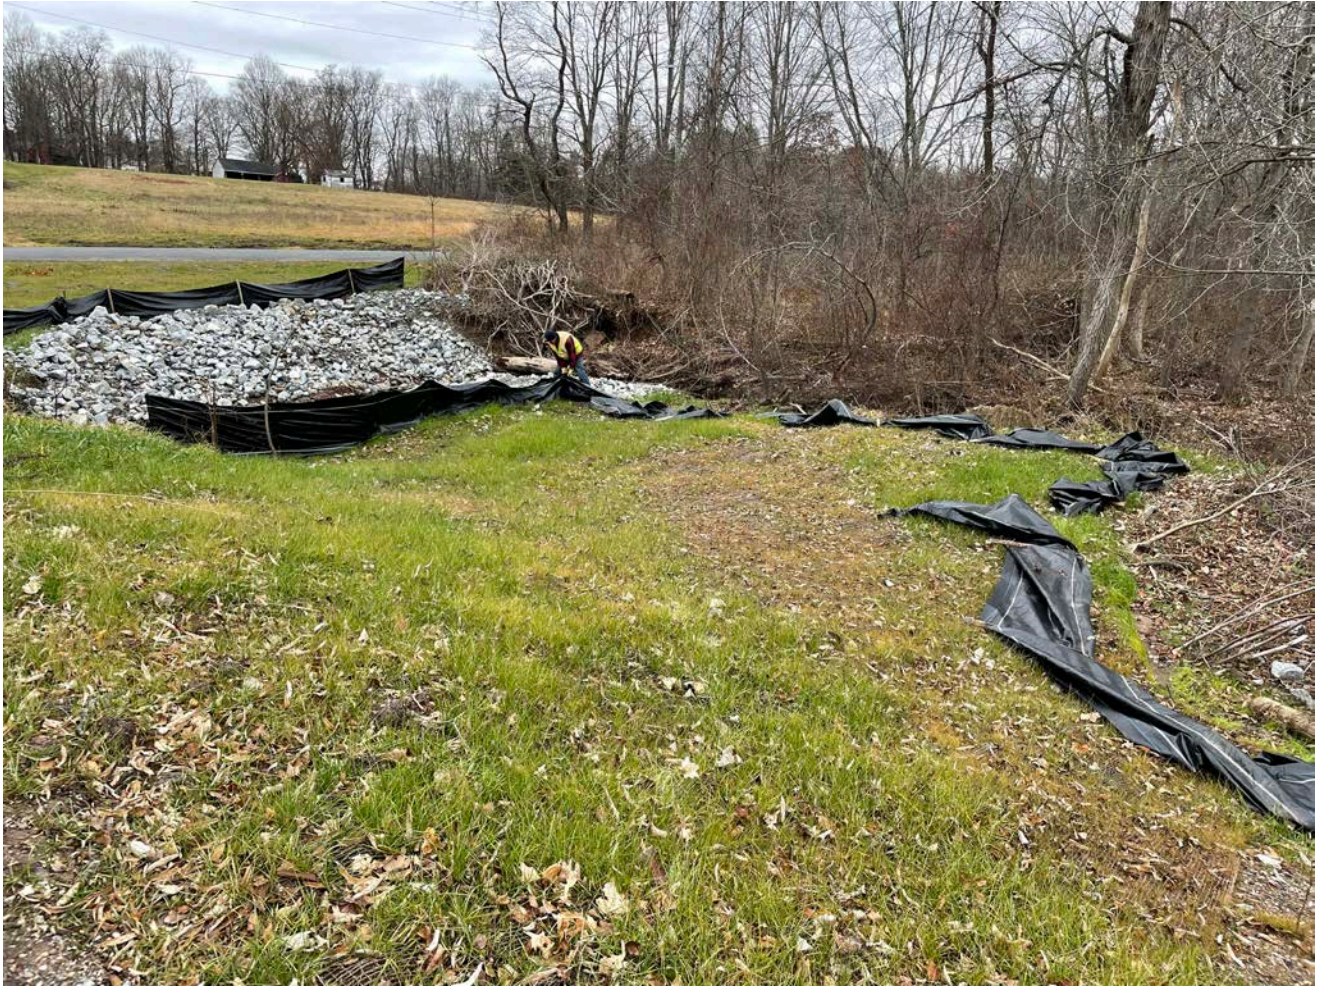
**Picture 8: Ludlow removing the silt fence they previously placed on either side of Ball Brook on the north side of Maiden Lane during the Maiden Lane stream crossing.**

1200: Ludlow is removing the silt fence they previously placed on either side of Ball Brook on the north side of Maiden Lane during the installation of the water line on Maiden Lane.

1301: Ludlow continues removing the silt fence they previously placed on either side of Ball Brook on the north side of Maiden Lane during the Maiden Lane stream crossing.

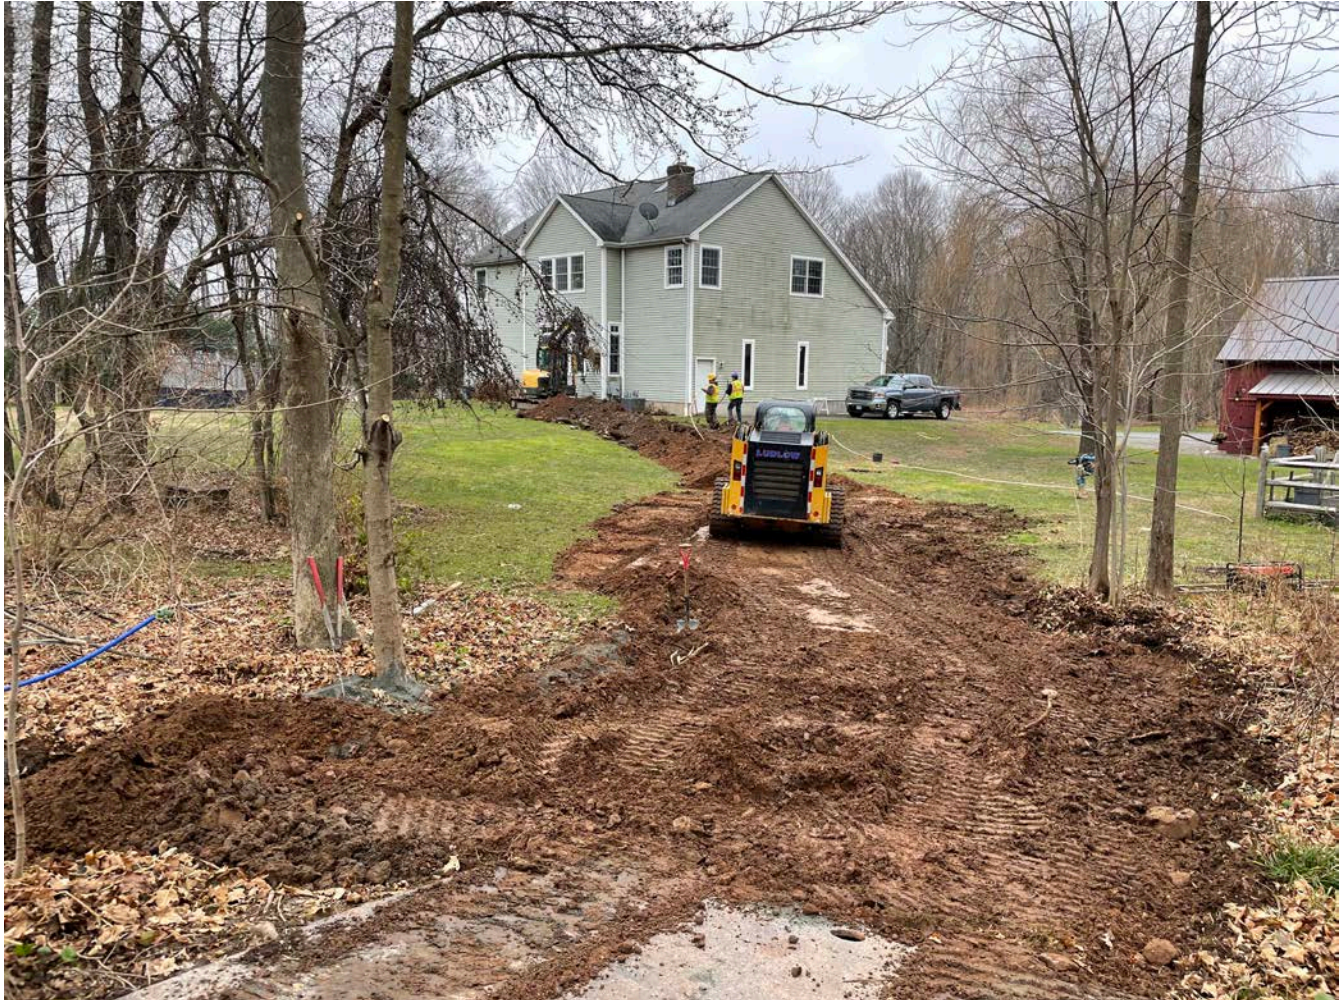
**Picture 9: Ludlow backfilling over the of the 1” copper water service line that they are installing at the 93R Maiden Lane residence. View to the southwest.**

1306: Ludlow has begun to backfill over the 1" copper water service line they are installing at the 93R Maiden Lane property.

1338: Ludlow continues to place sand and caution tape over the 1" copper water service line they are installing at the 93R Maiden Lane property.

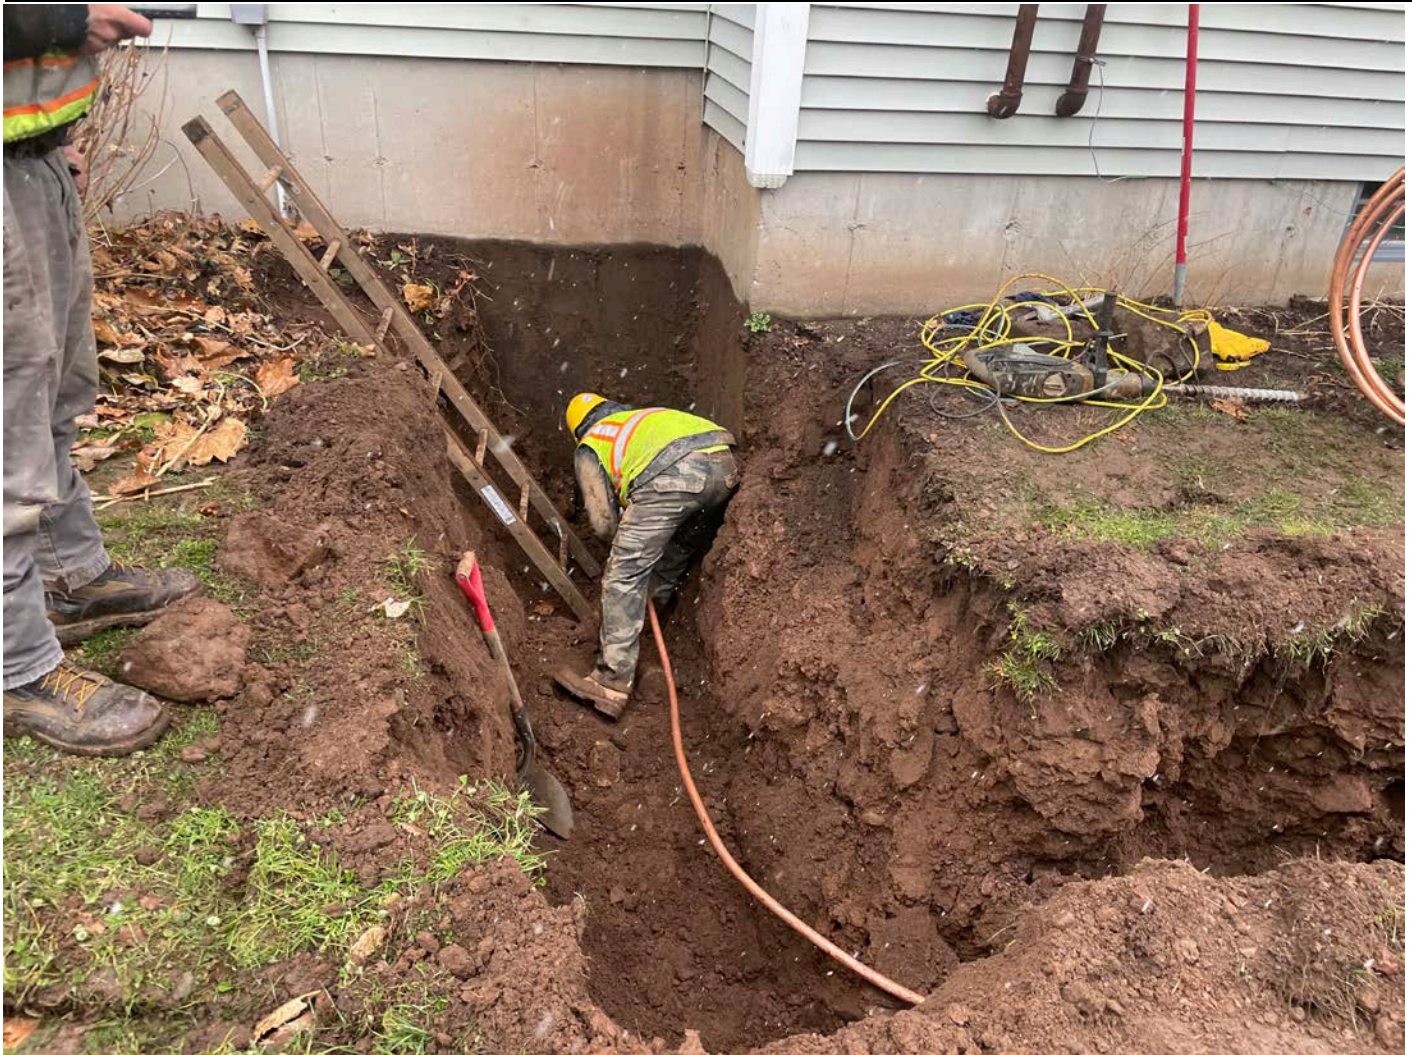
**Picture 10: Ludlow inserting 1" copper water service line through a hole they drilled on the east side of the foundation for the 93R Maiden Lane residence. View to the west.**

1401: Ludlow has penetrated the poured-concrete foundation of 93R Maiden Lane residence with a rotary hammer and is currently inserting the 1" copper water service line through the hole. The penetration is located 48' below the surface grade and 20' north of the residence's southeast corner.

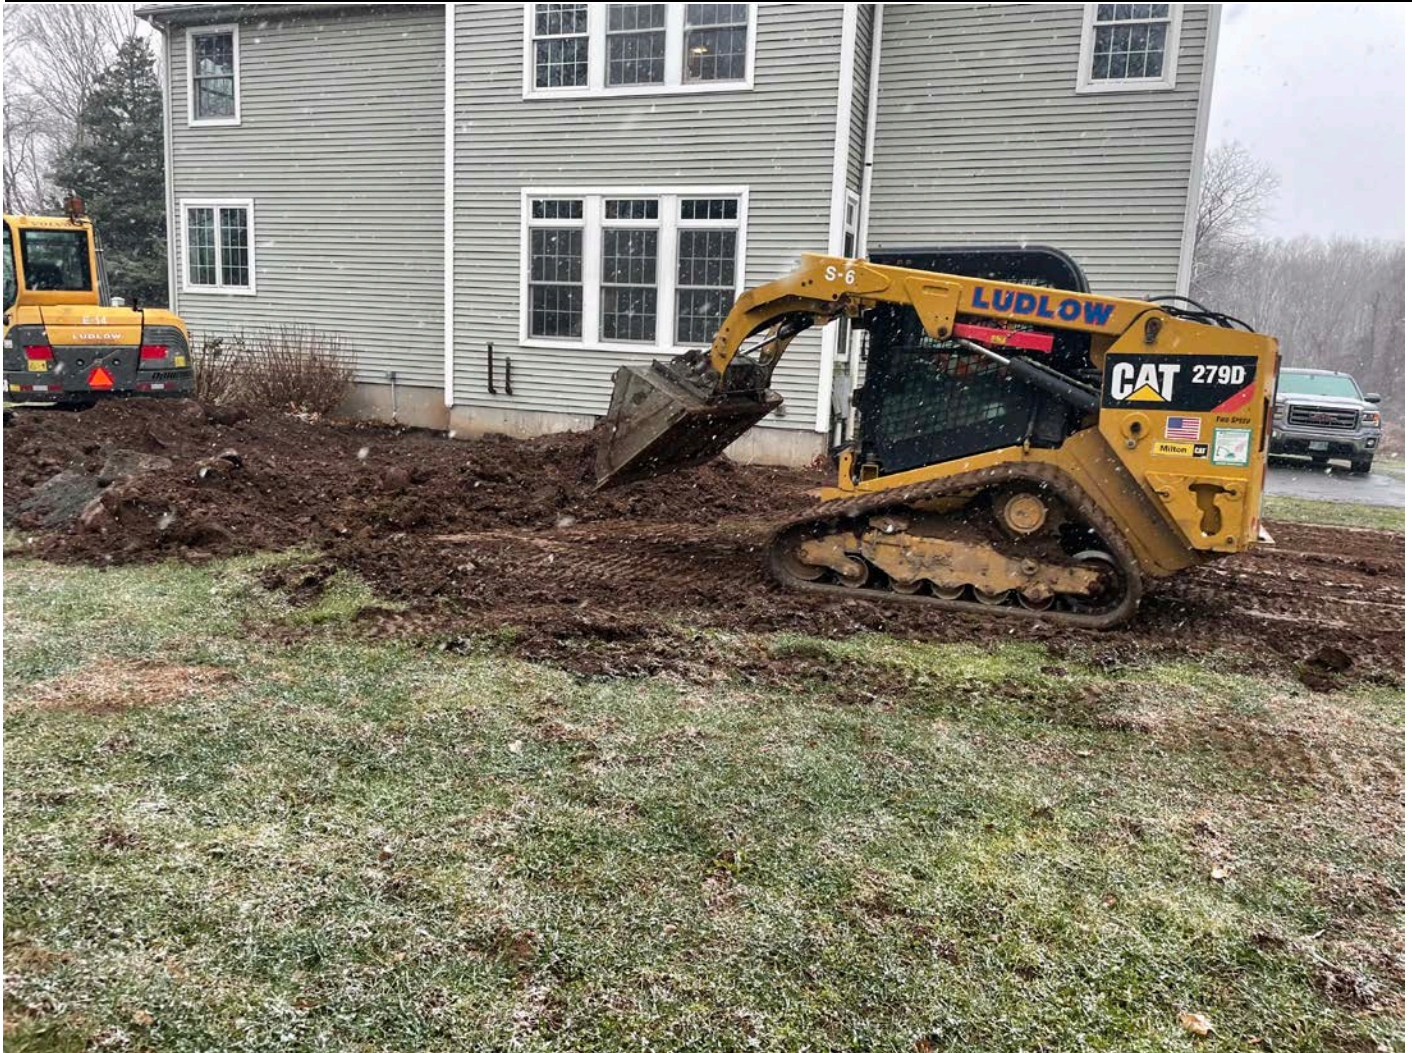
Picture 11: Ludlow grading fill they placed over the 1" copper water service line they installed at the 93R Maiden Lane property. View to the southwest.

1437: Ludlow has finished backfilling the trench at 93R Maiden Lane after installing a 1" copper water service line. Ludlow is currently performing some rough grading over the trench footprint and will return tomorrow to restore the yard with loam and grass seed.
