Daily Report

Project:	Durham Meadows Pipeline Installation	Date:	December 16, 2021
Location:	Shared Access Driveway and Talcott Ridge Drive, Middletown	Day of Week:	Thursday
Project #:	AECOM: 6061487	Report No:	384
Contractor:	Ludlow Construction	Page:	1 of 17

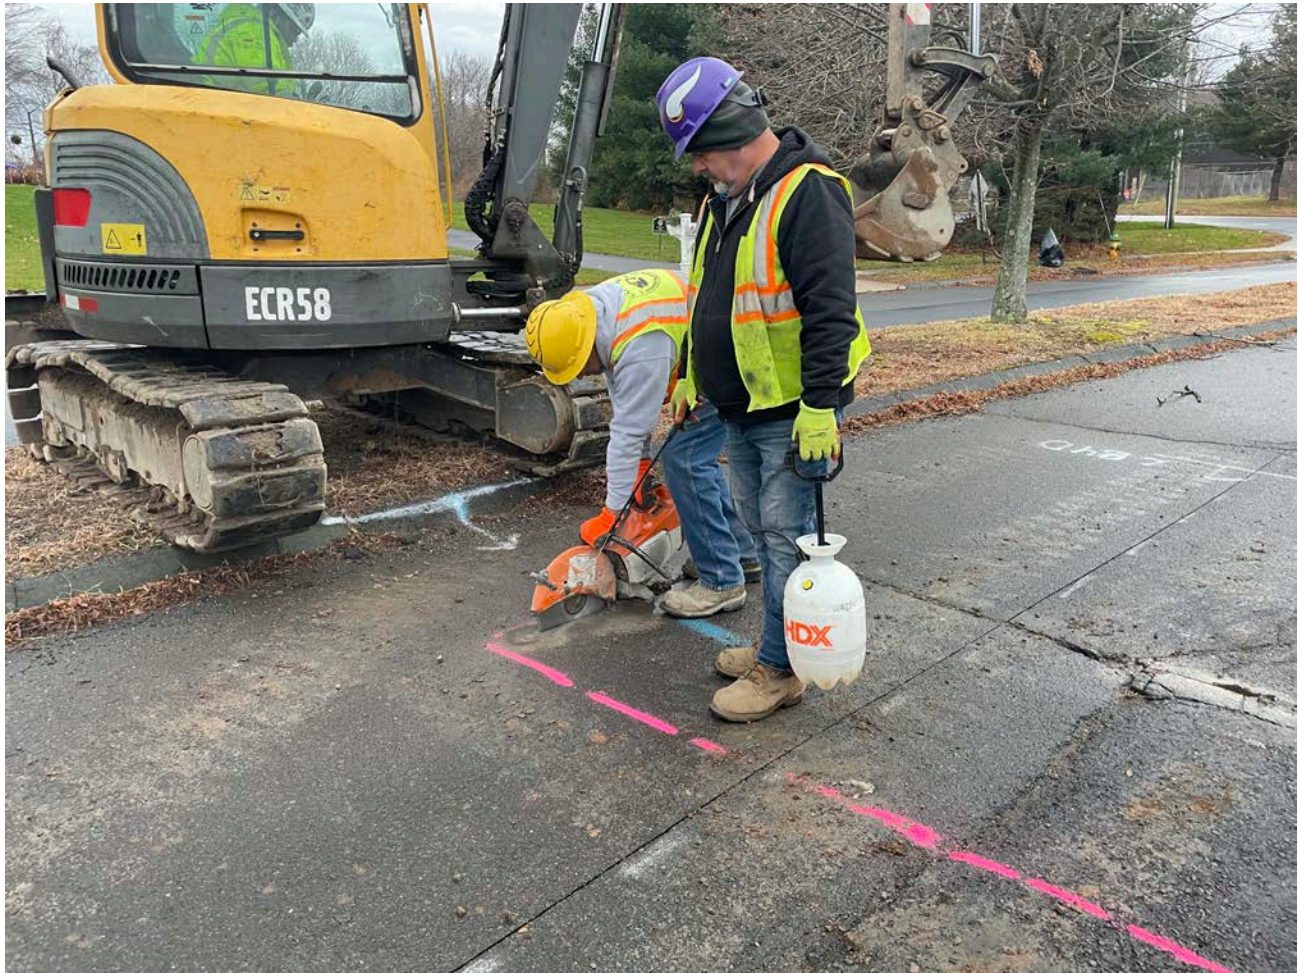
Picture 1: Ludlow saw-cutting pavement at Station 753+68 as they prepare to migrate water service for the 9 Talcott Ridge Drive residence from the old City waterline to the new 8" DIP line that Ludlow installed. View to the southwest.

0732: Ludlow begins to saw-cut the footprint of a trench at Station 753+68 on the westbound lane of Talcott Ridge Drive as they start to migrate water service for the 9 Talcott Ridge Drive residence from the old City waterline to the new 8" DIP line that Ludlow installed.

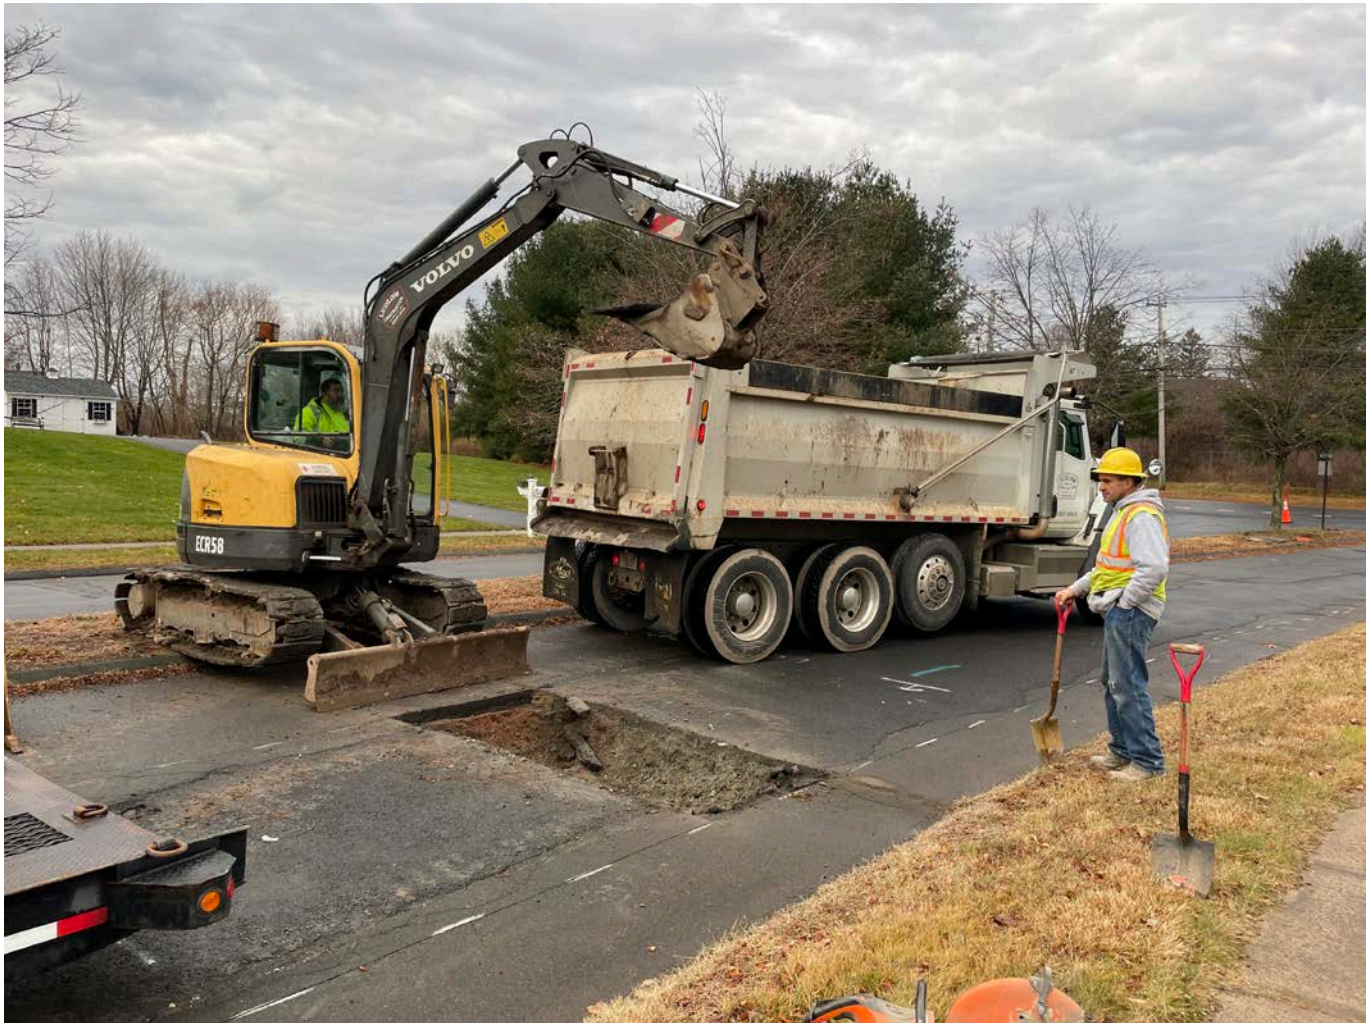
Picture 2: Ludlow excavating at Station 753+68 as they prepare to migrate water service for the 9 Talcott Ridge Drive residence from the old City waterline to the new 8" DIP line that Ludlow installed. View to the southwest.

0826: Ludlow continues to excavate a trench what are the westbound lane of Talcott Ridge Drive across from 9 Talcott Ridge Dr.

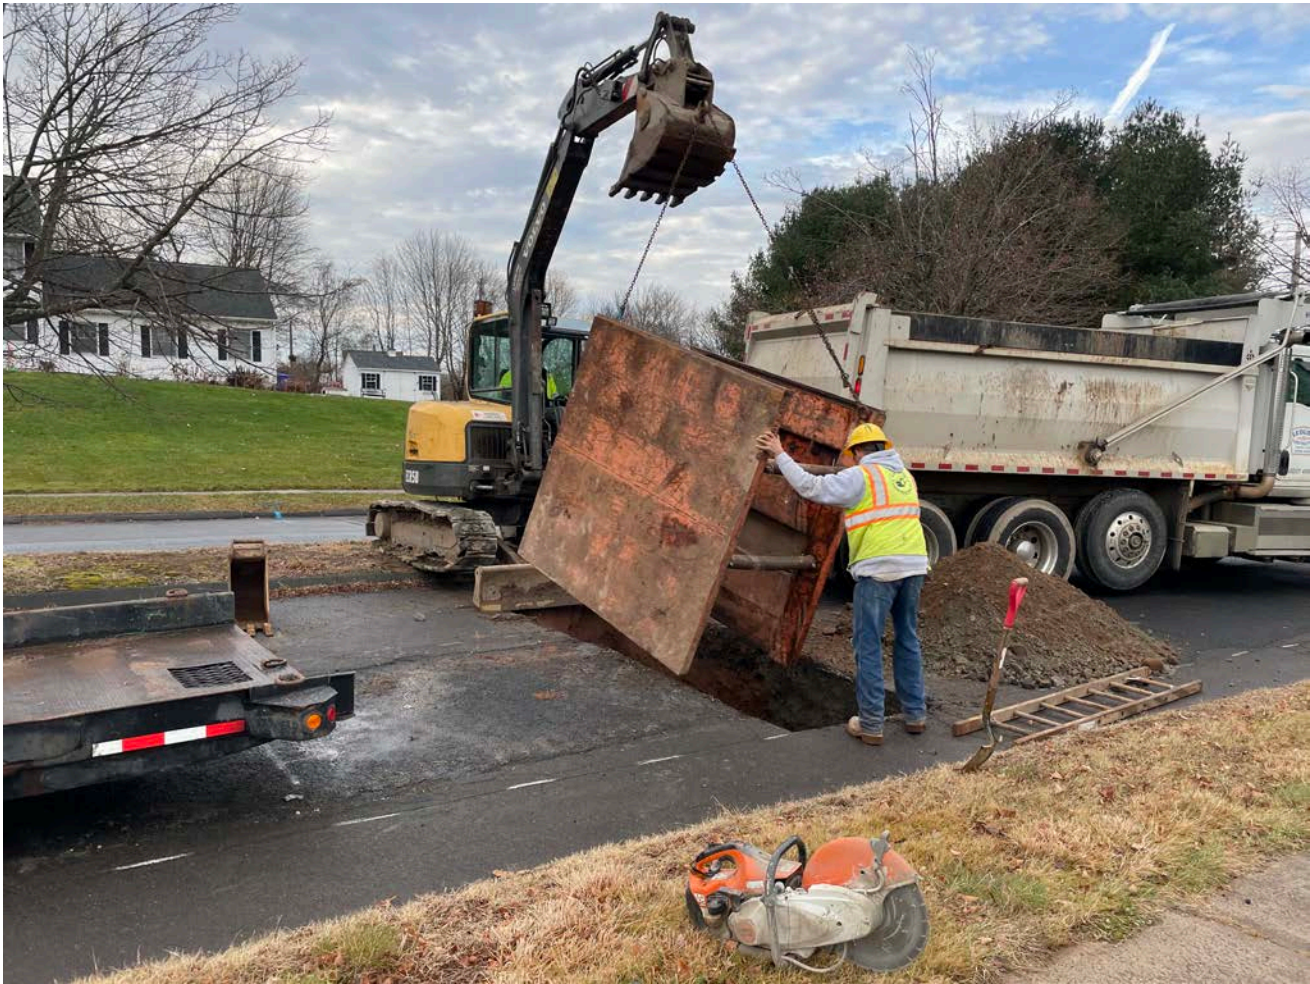
Picture 3: Ludlow placing a trench box in the excavation they made at Station 753+68 as they prepare to migrate water service for the 9 Talcott Ridge Drive residence from the old City waterline to the new 8" DIP line that Ludlow installed. View to the southwest.

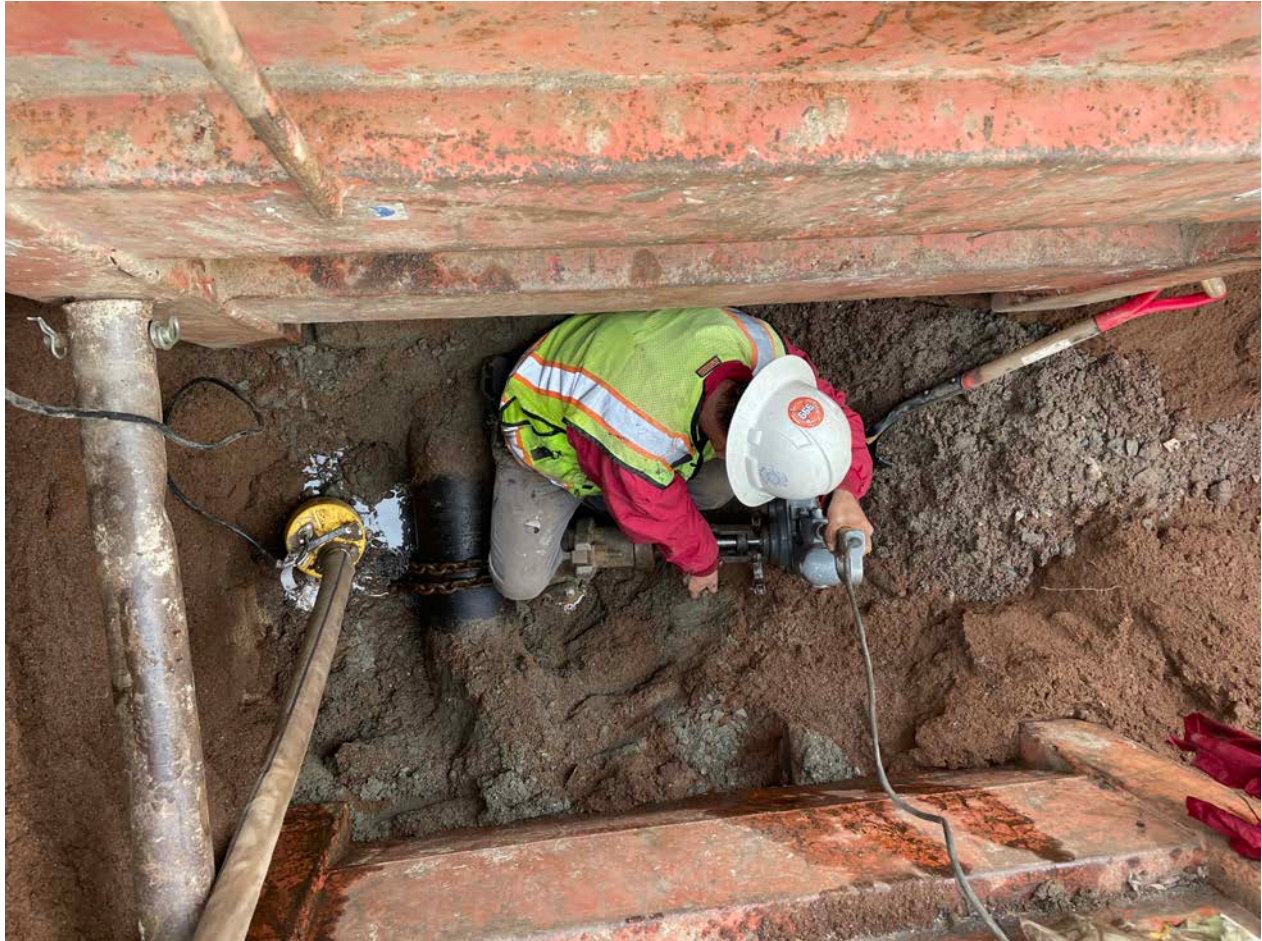
Picture 4: Ludlow tapping the new 8" DIP line that Ludlow previously installed on the westbound lane of Talcott Ridge Drive for the installation of a corporation stop.

0927: Ludlow has begun to tap the 8" DIP water line they daylighted at Station 753+68 on the westbound lane of Talcott Ridge Drive.

0946: Ludlow just finished tapping the 8" DIP water line on the westbound lane of Talcott Ridge Drive.

0952: Ludlow begins the installation of a 1" corp stop on the 8" DIP water line at Station 753+68.

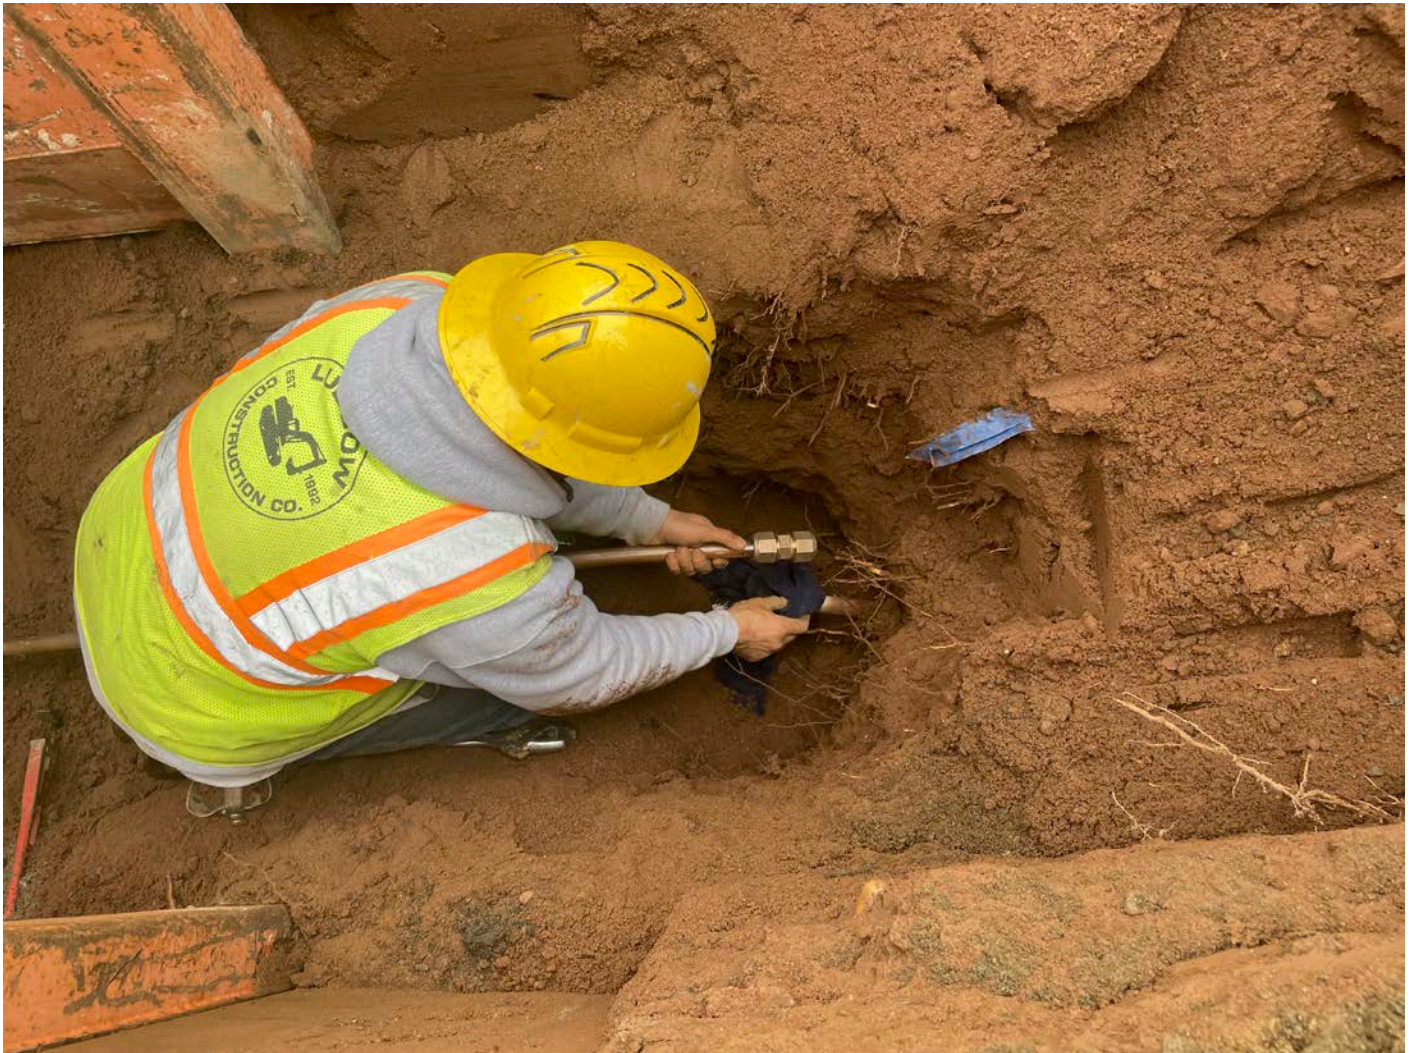
Picture 5: Ludlow connecting a 1" copper water service line they just attached to the 8" DIP line that Ludlow previously installed on the westbound lane of Talcott Ridge Drive to the 9 Talcott Ridge Drive residence service line.

1053: Ludlow is backfilling over the section of 1" copper pipe they used to migrate the water service for the 9 Talcott Ridge Drive residence to the new 8" DIP waterline on Talcott Ridge Drive. Ludlow has placed 6" of sand beneath the copper pipe and 12" of sand above it, followed by the placement of caution tape.

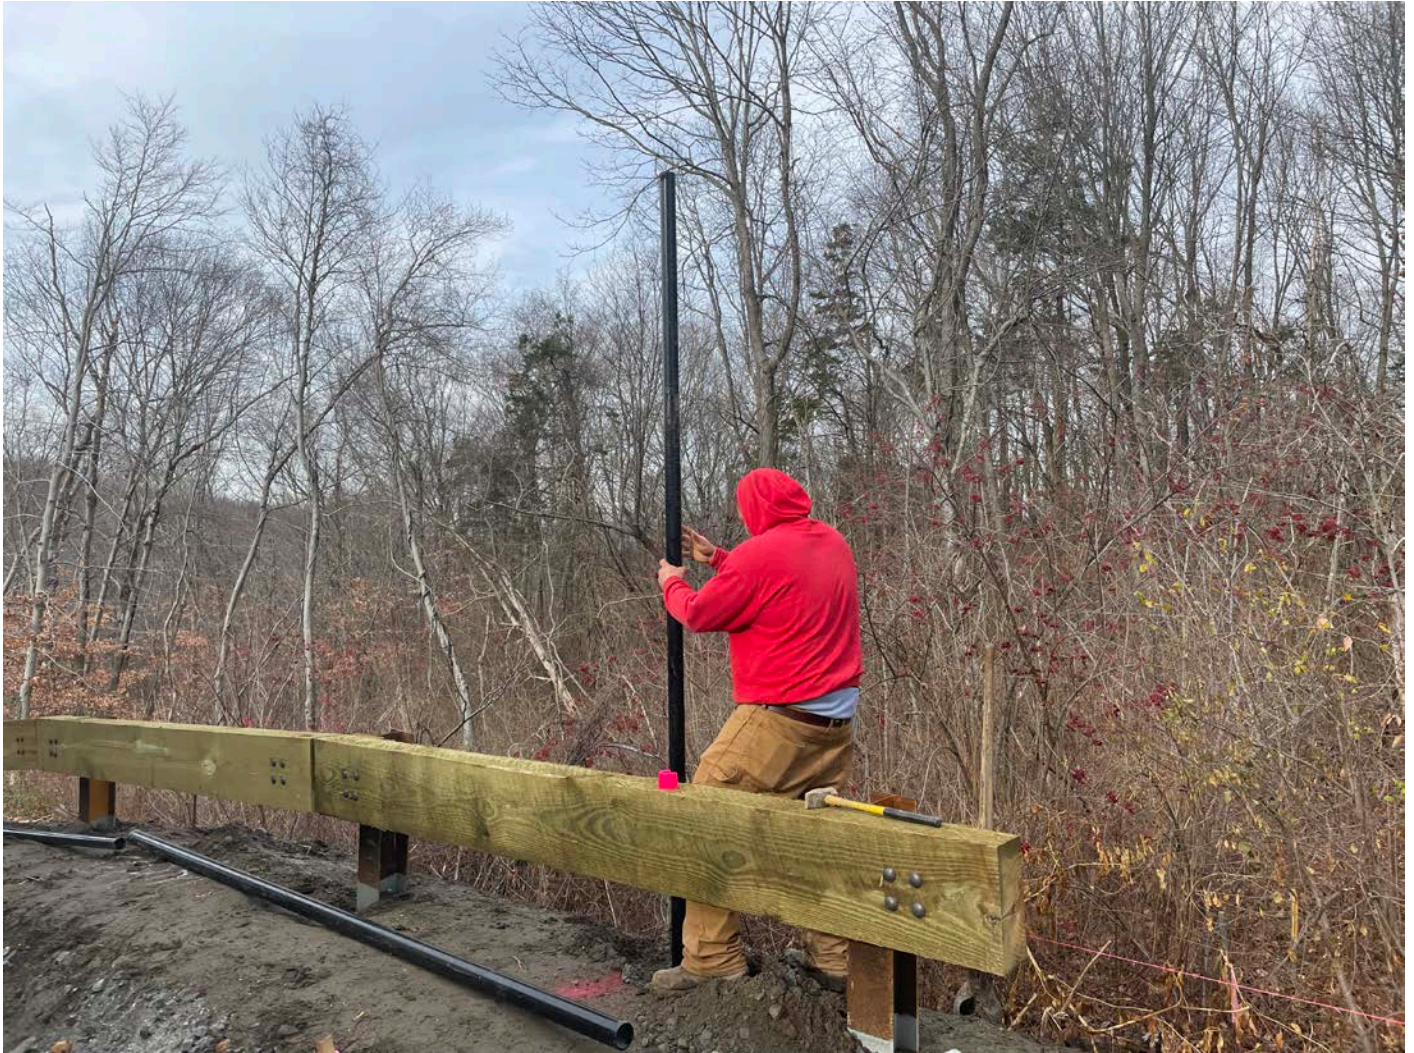
Picture 6: Eagle Fence and Guardrail installing a fence post at Station 10+50 on the north side of the Shared Access Driveway in Middletown.

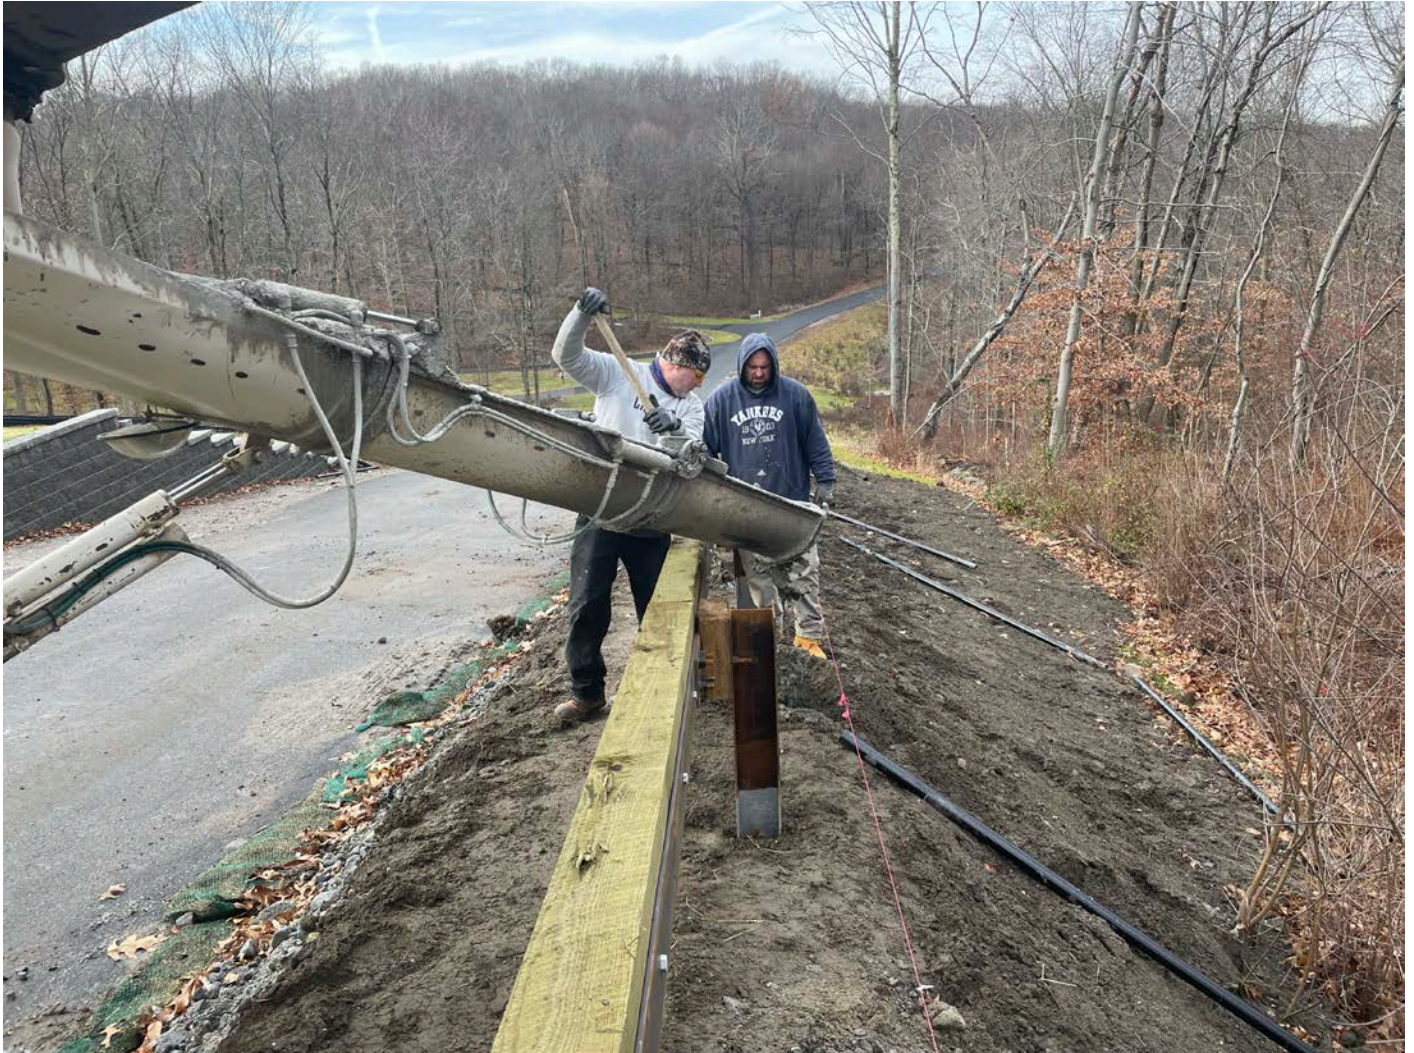
Picture 7: Eagle Fence and Guardrail guiding a Tilcon concrete truck as it places concrete into the holes that Eagle made for the installation of fence posts around the water tank and altitude valve vault located east of the Shared Access Driveway in Middletown.

1034: Tilcon begins to place concrete in the holes that Eagle Fence and Guardrail excavated on the north side of the Shared Access Driveway for the installation of fence posts.

1137: Eagle Fence and Guardrail continues to direct the Tilcon concrete truck to place concrete in the holes that were excavated for the installation of fence posts

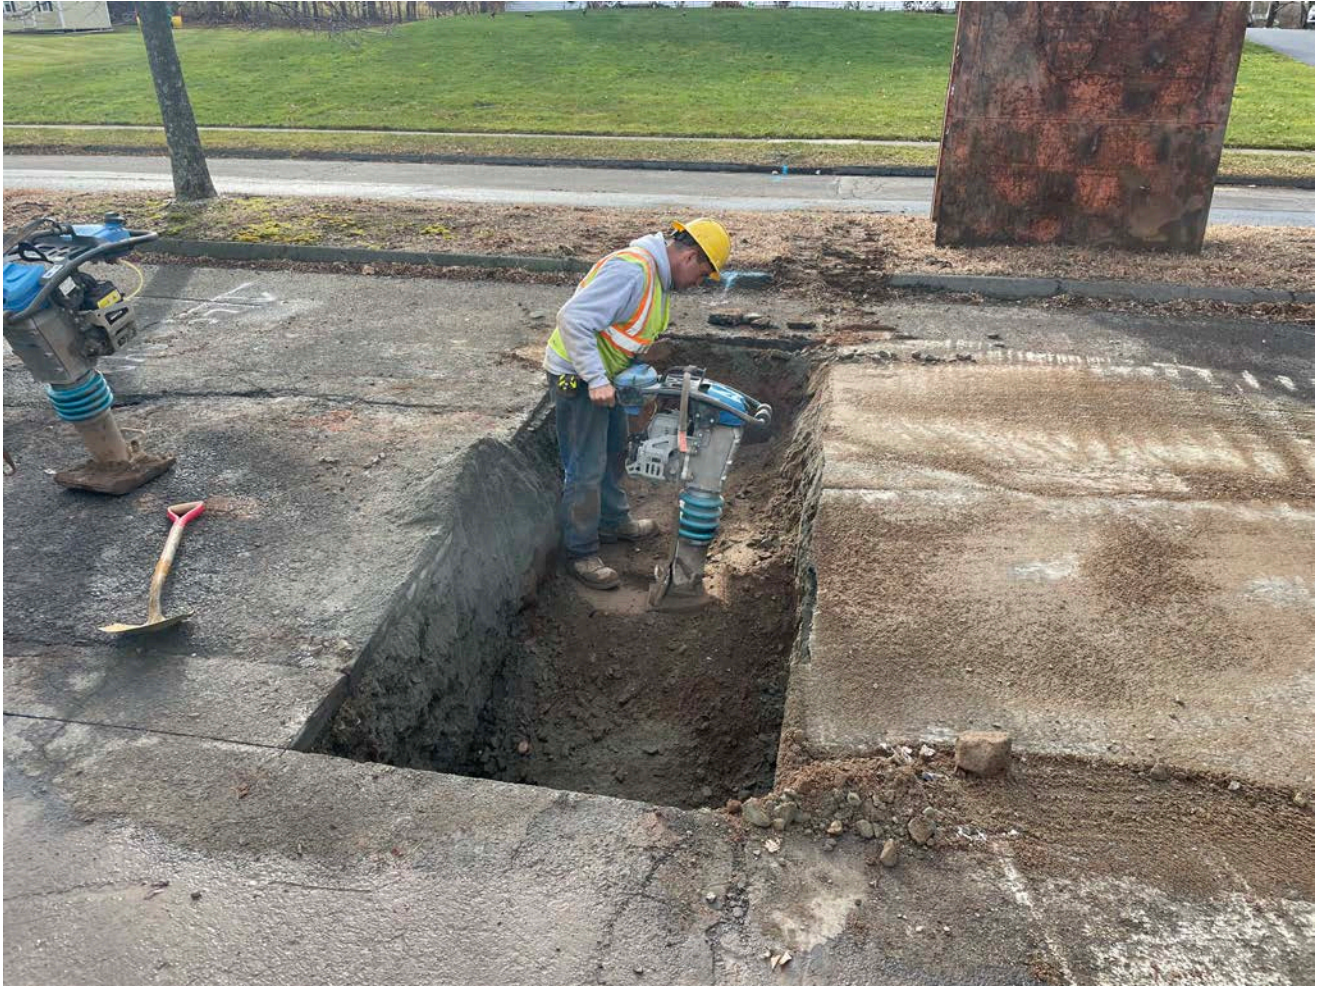
Picture 8: Ludlow compacting backfill they placed in 1' lifts at Station 753+68 on the westbound lane of Talcott Ridge Drive in Middletown. View to the south.

1109: Ludlow continues backfilling the trench at Station 753+68 with 1.25"-minus gravel placed in 1' lifts. Ludlow is compacting the fill with a jumping jack. Ludlow has begun to saw-cut the footprint of a trench at Station 754+13 in order to migrate water service from the older City water line to the 8" DIP water line that Ludlow previously installed.

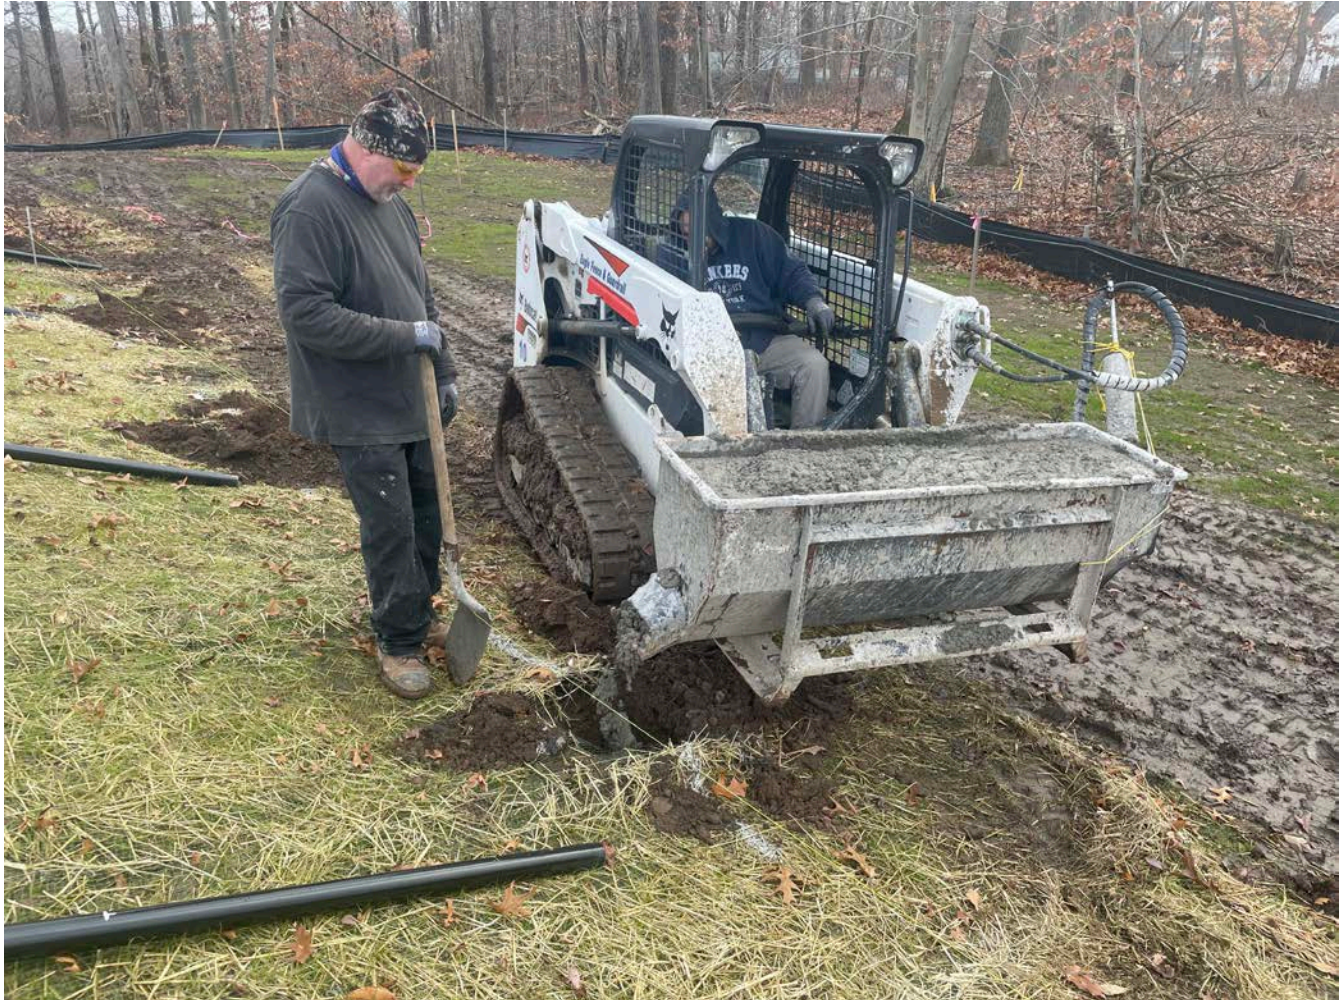
Picture 9: Eagle Fence and Guardrail placing concrete into the holes they made for the installation of fence posts at the water tank work zone. View to the southeast.

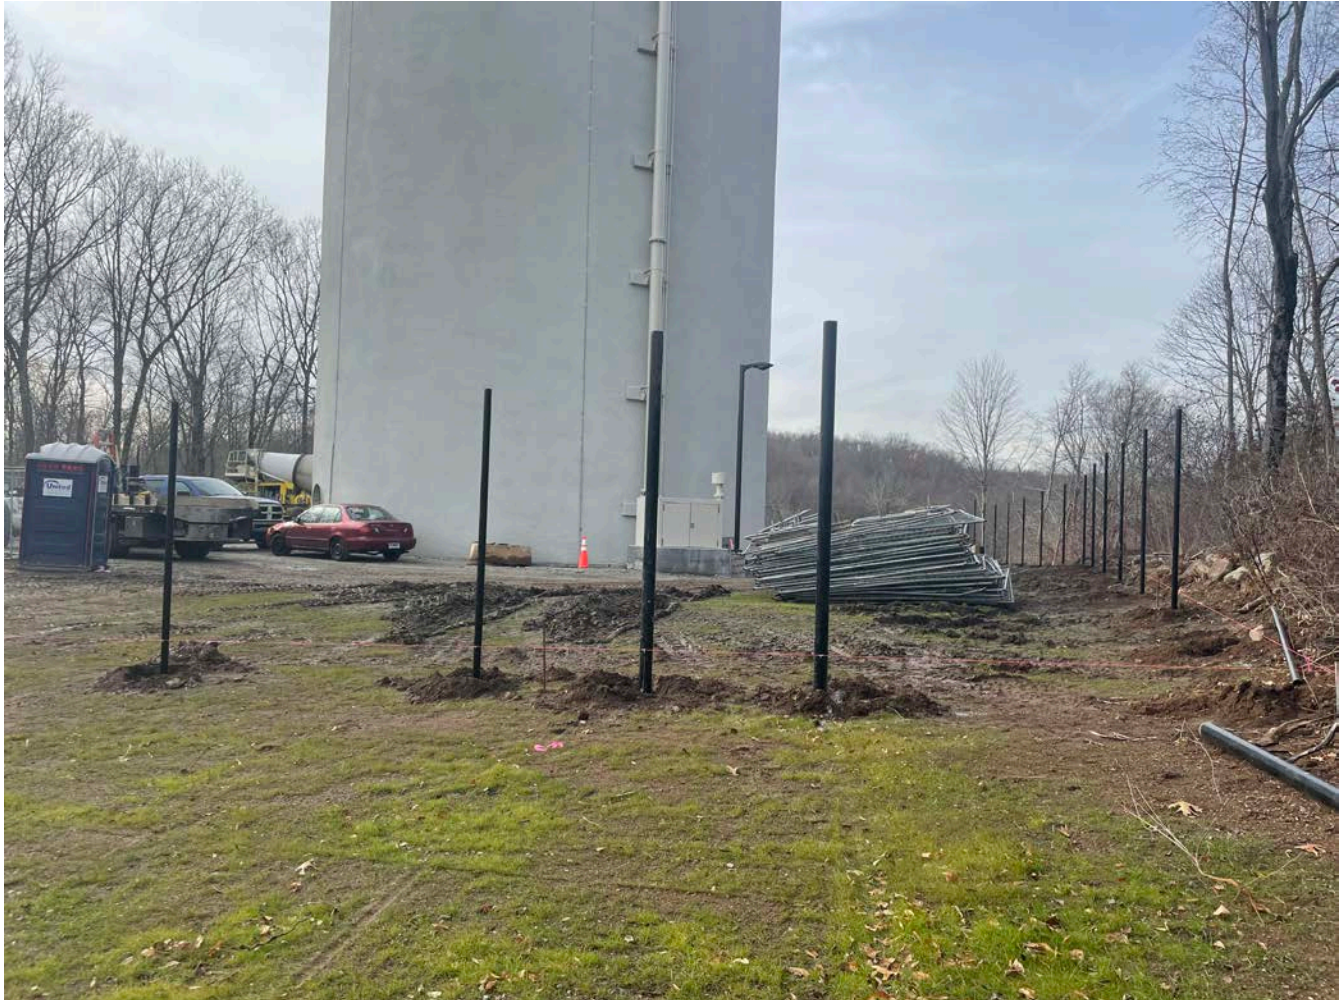
Picture 10: View of the fence posts that Eagle Fence and Guardrail have set into place on the east and north side of the water tank located east of the Shared Access Road in Middletown. View to the west.

1259: Eagle Fence and Guardrail has cemented all fence posts in place and is beginning to backfill over the cement with soil.

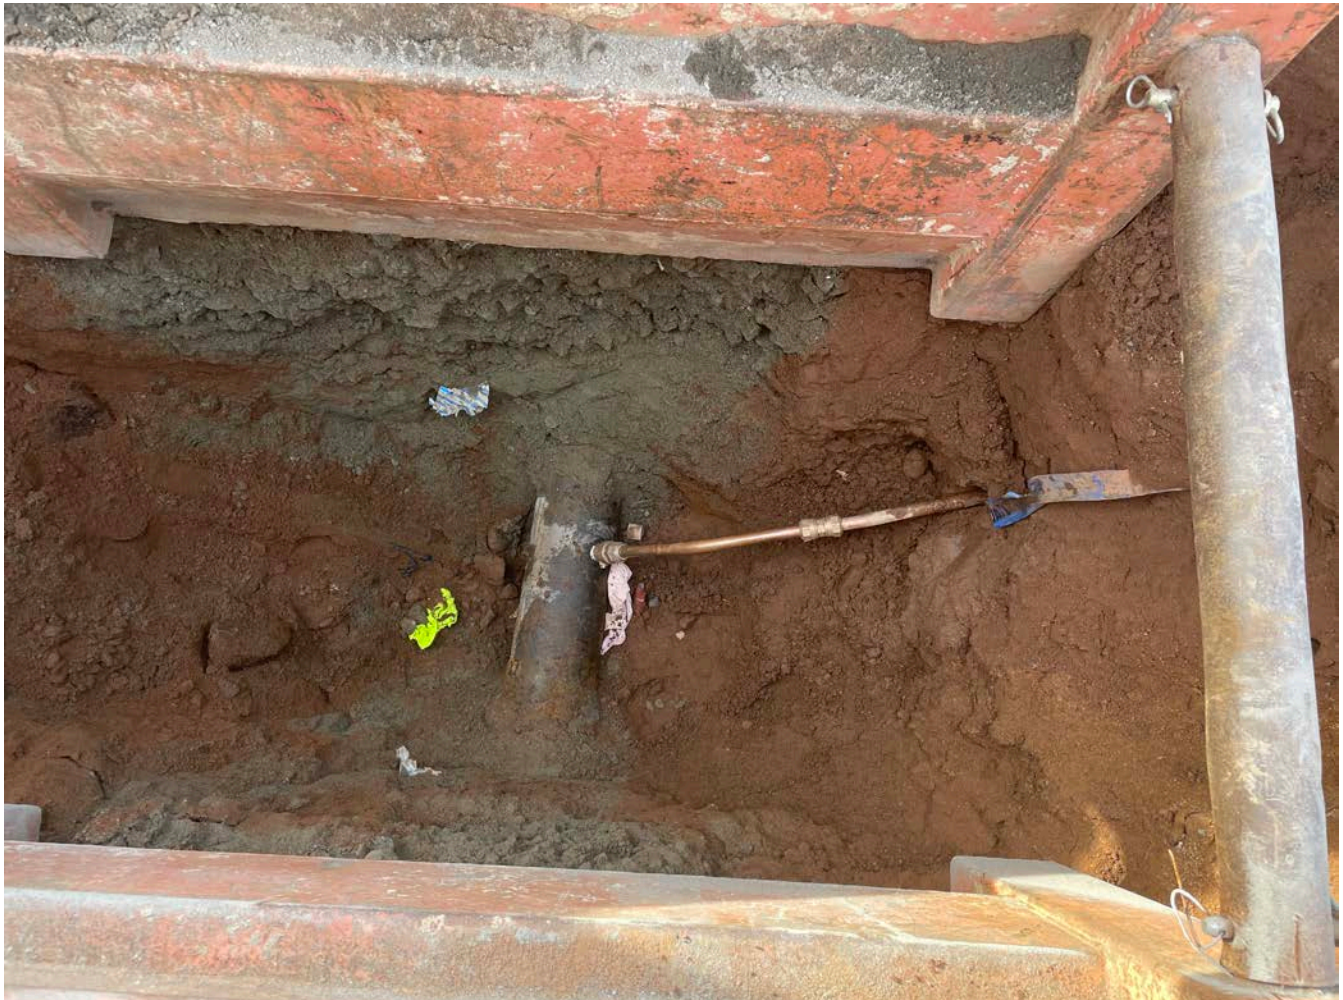
Picture 11: Connection that Ludlow made between the curb stop at Station 754+13 and the 8" DIP water line that Ludlow previously installed on Talcott Ridge Drive.

1326: Ludlow has finished connecting the curb stop located at Station 754+13 to the 8" DIP water line that they previously installed.

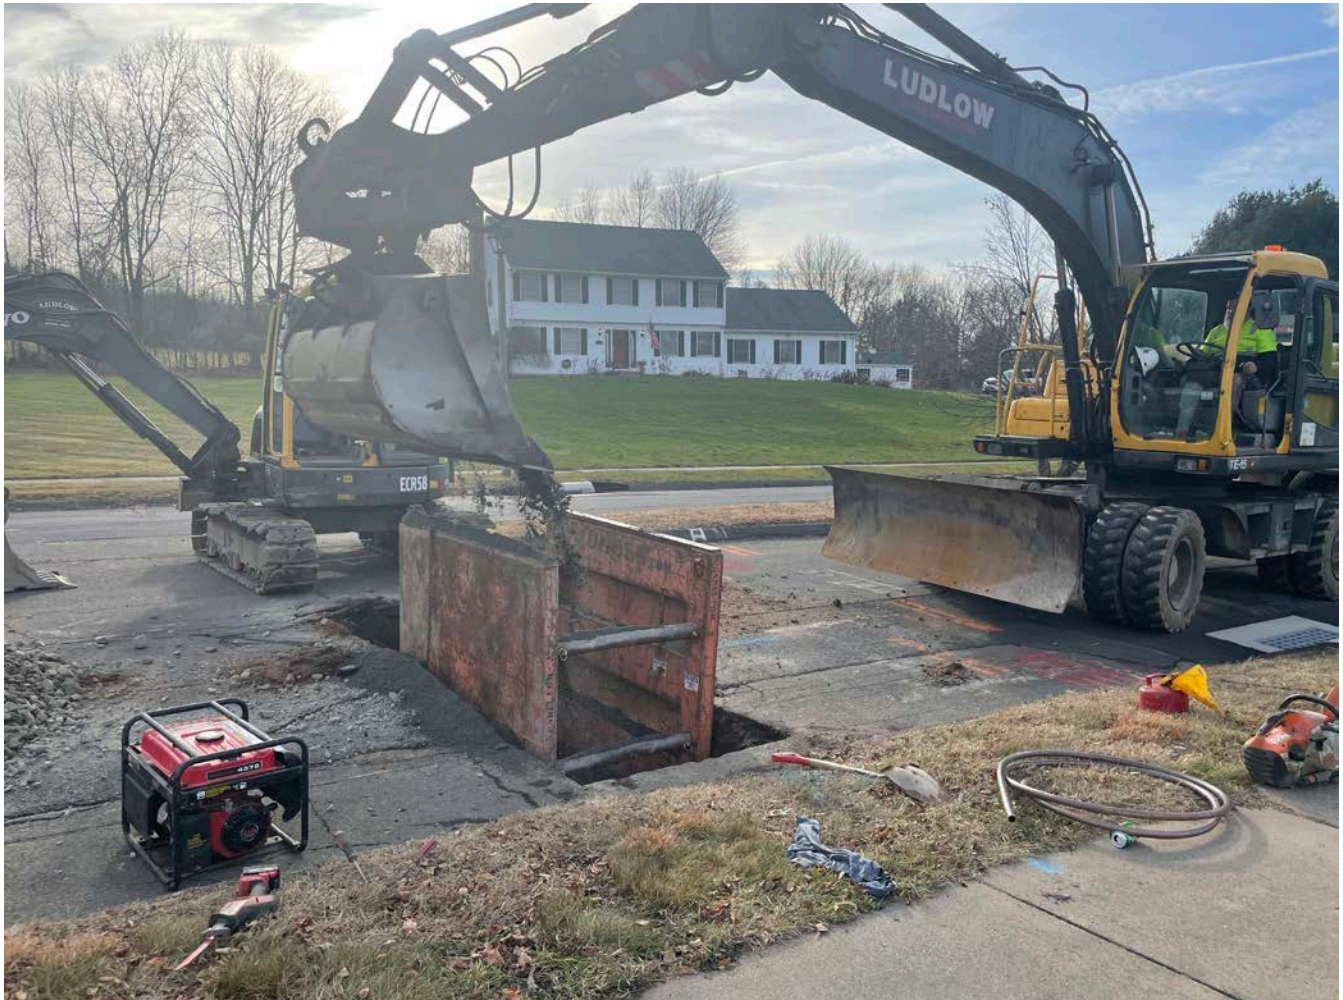
Picture 12: Ludlow placing sand over the 1" copper line they used to connect the curb stop at Station 754+13 to the 8" DIP water line that Ludlow previously installed on Talcott Ridge Drive.

1333: Ludlow begins to place sand over the corporation stop and the new section of 1" copper pipe they just installed at Station 754+13 between the curb stop and the newer 8" DIP water line that Ludlow previously installed on the westbound lane of Talcott Ridge Drive.

1337: Ludlow is using a jumping jack to compact the sand that they just placed over the corporation stop and the new section of 1" copper pipe they just installed at Station 754+13.

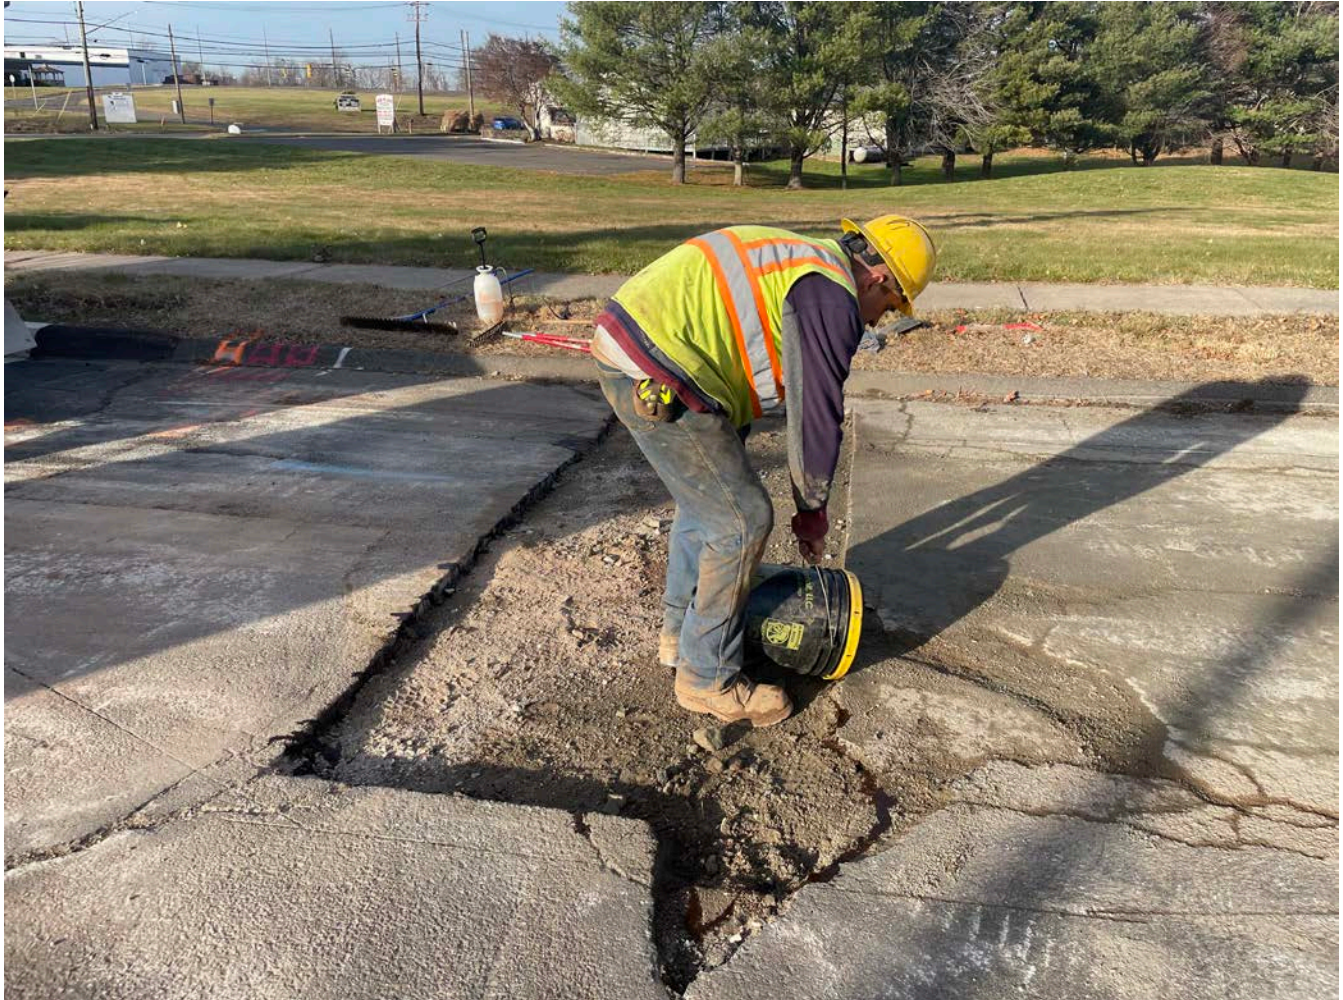
Picture 13: Ludlow placing tack coat on the cut edges of pavement where they excavated at Station 754+13 on the westbound lane of Talcott Ridge Drive. View to the northwest.

1426: Ludlow has both excavations on the westbound lane of Talcott Ridge Drive backfilled and compacted. Ludlow is waiting for the delivery of asphalt to complete the repair of the two backfilled excavations. Ludlow is placing tack coat on the cut edges of the cut pavement on both excavations.

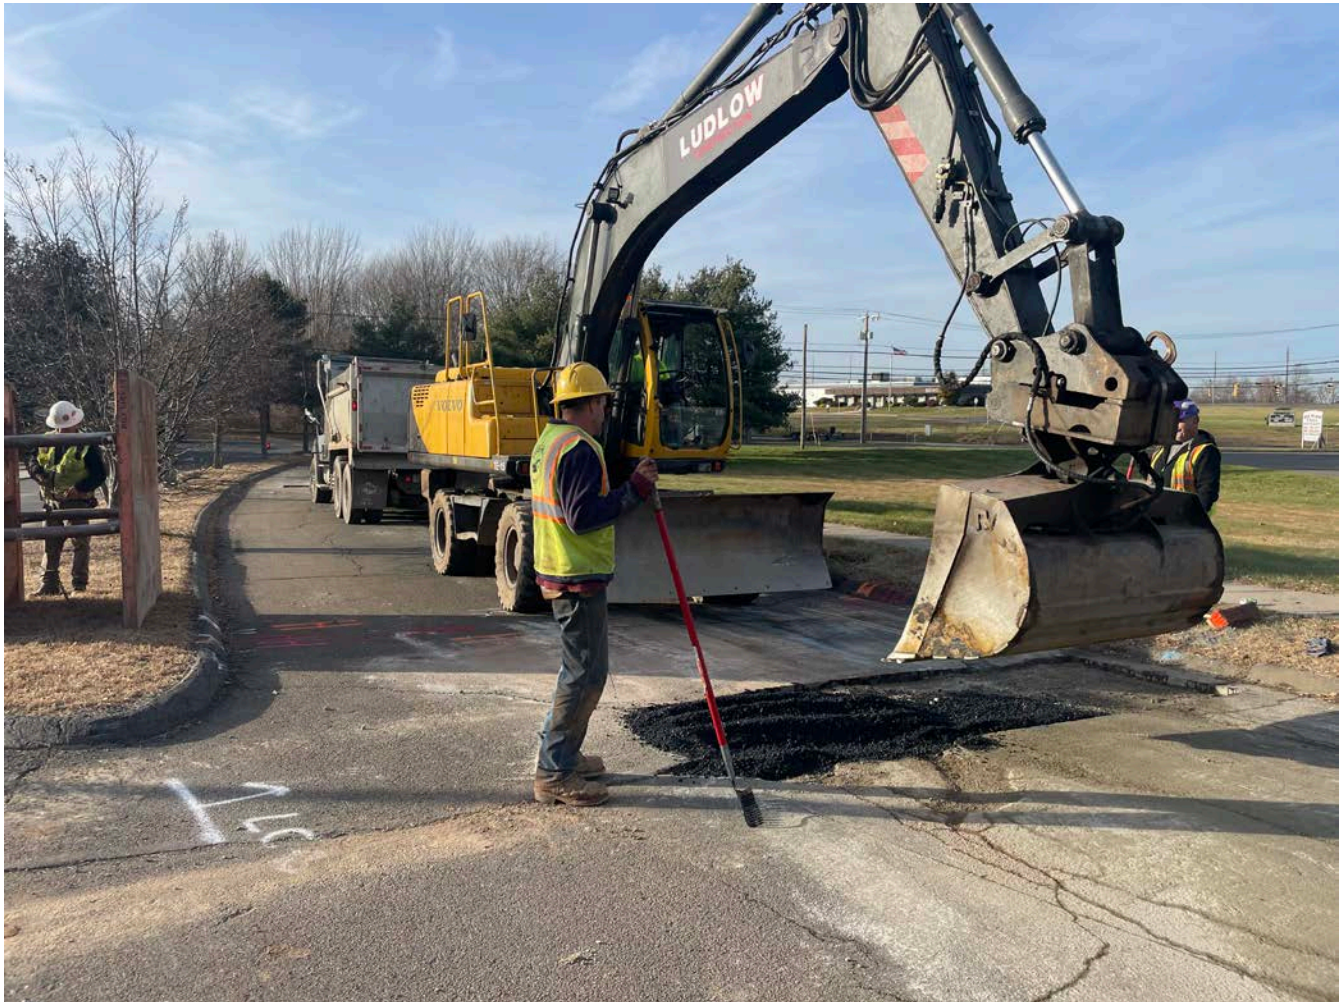
Picture 14: Ludlow placing asphalt over the backfilled trench they excavated at Station 754+13 on the westbound lane of Talcott Ridge Drive. View to the northwest.

1430: Ludlow is placing asphalt over the backfilled trenches at Stations 753+68 and 754+13 on the westbound lane of Talcott Ridge Drive.

1454: Ludlow has finished placing asphalt over both backfilled excavation at Stations 753+68 and 754+13 on the westbound lane of Talcott Ridge Drive. The asphalt patches were compacted using a rolling compactor.
