## Daily Report

<b>Project:</b>	Durham Meadows Pipeline Installation	<b>Date:</b>	April 8, 2022
<b>Location:</b>	S. Main Street, Durham	<b>Day of Week:</b>	Friday
<b>Project #:</b>	AECOM: 6061487	<b>Report No:</b>	400
<b>Contractor:</b>	Ludlow Construction	<b>Page:</b>	1 of 10

### Daily Activities – Booster station start-up, S. Main Street, Middletown

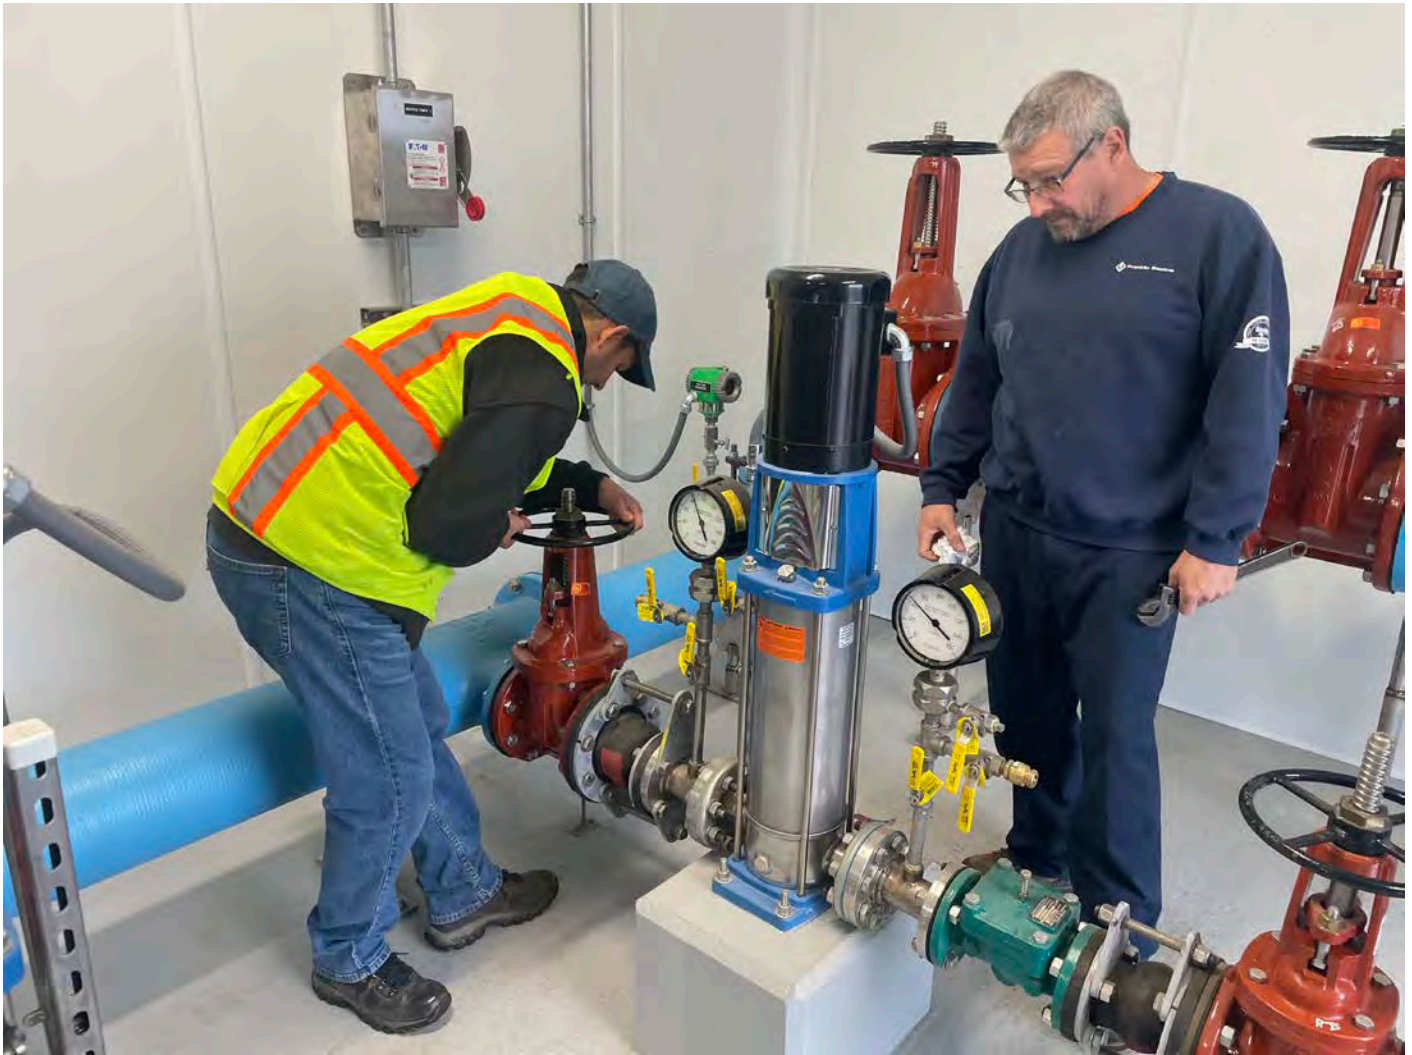
Picture 1: Ludlow opening water line valve inside of the booster station located on S. Main Street in Middletown. View to the southwest.

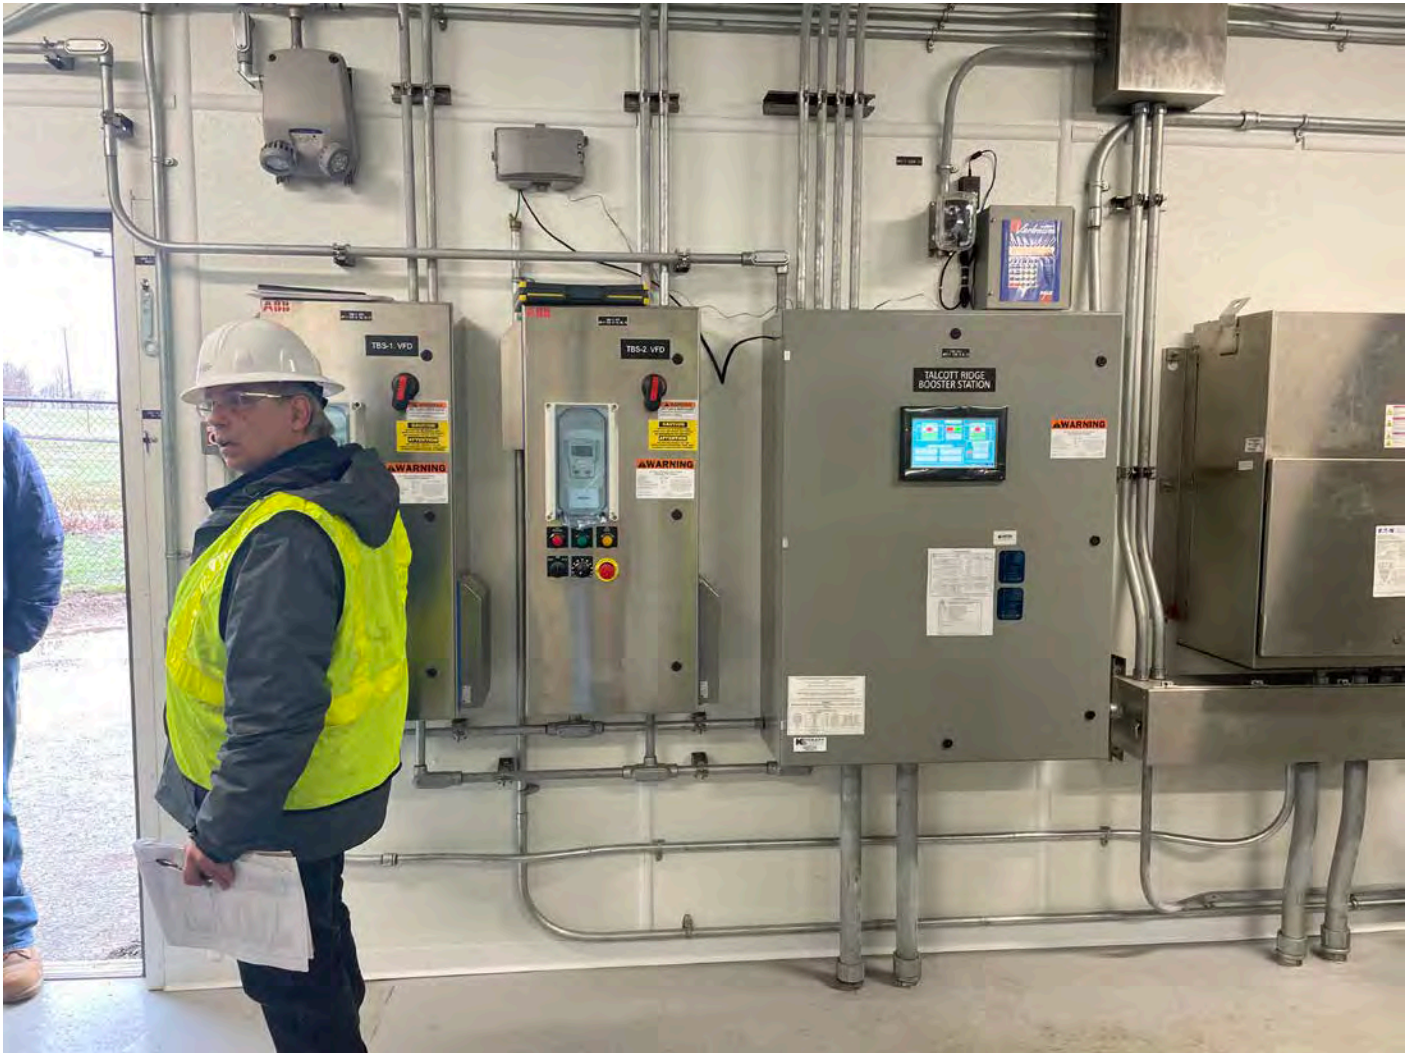
Picture 2: Variable frequency drives (left) and control panel (center) located on the north side of the booster station located on S. Main Street in Middletown. View to the north.

1000: United Concrete and Knapp Engineering continue to work at the booster station as part of start-up activities. Knapp Engineering is troubleshooting a communication problem between the VFDs and the control panel. VFD manufacturer's representative is not on-site.

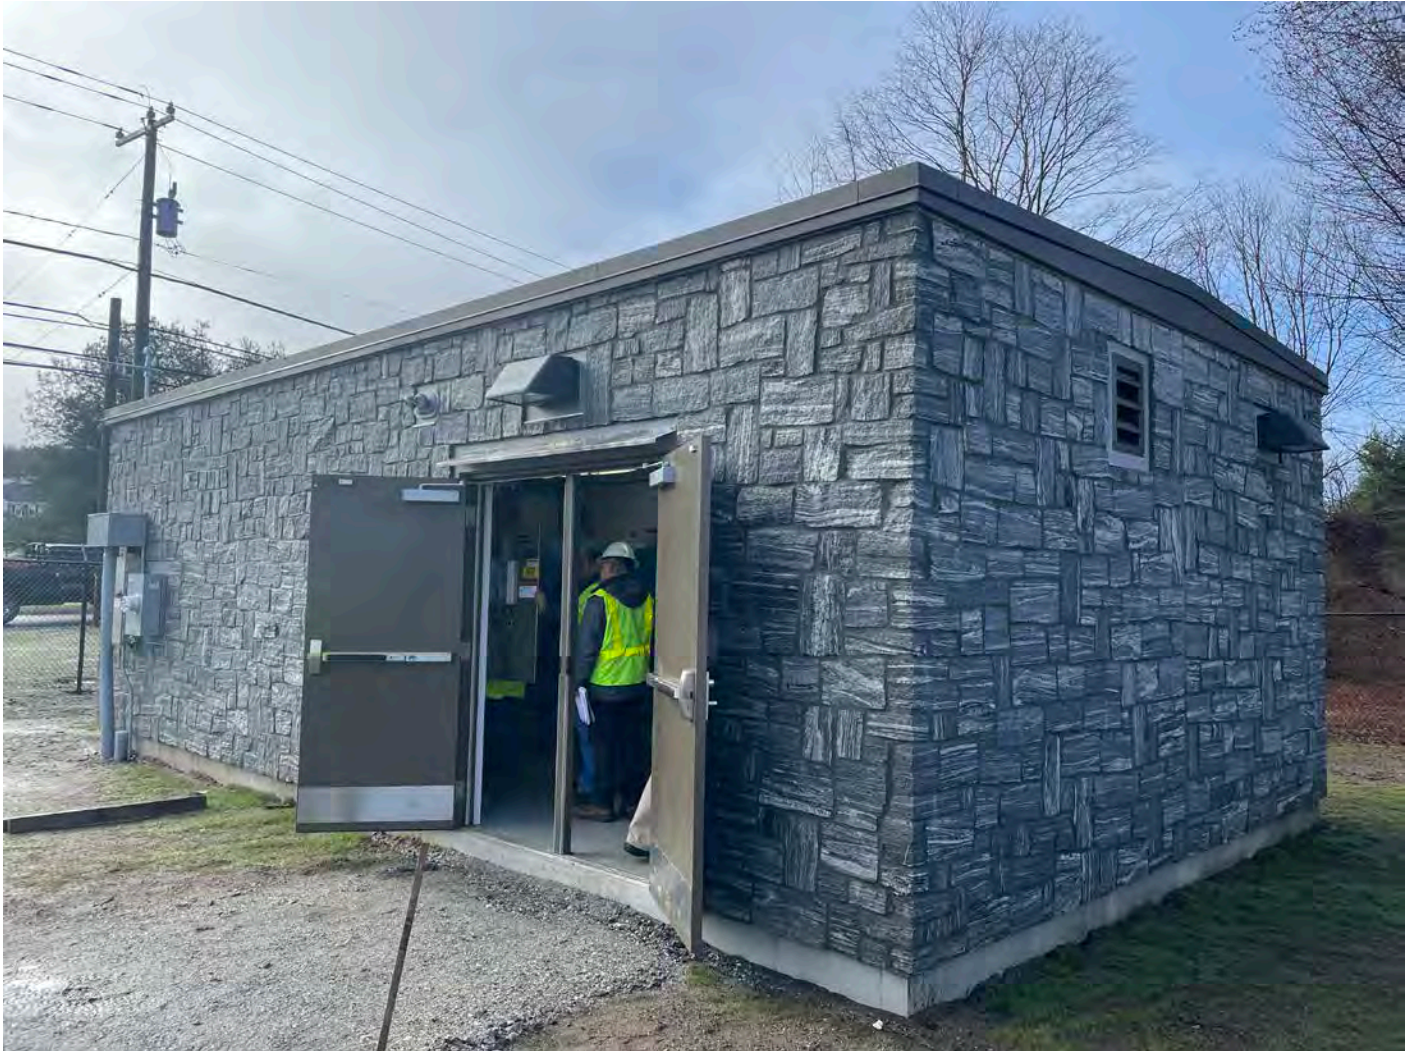
Picture 4: Exterior view of the booster station located on S. Main Street in Middletown. View to the southeast.

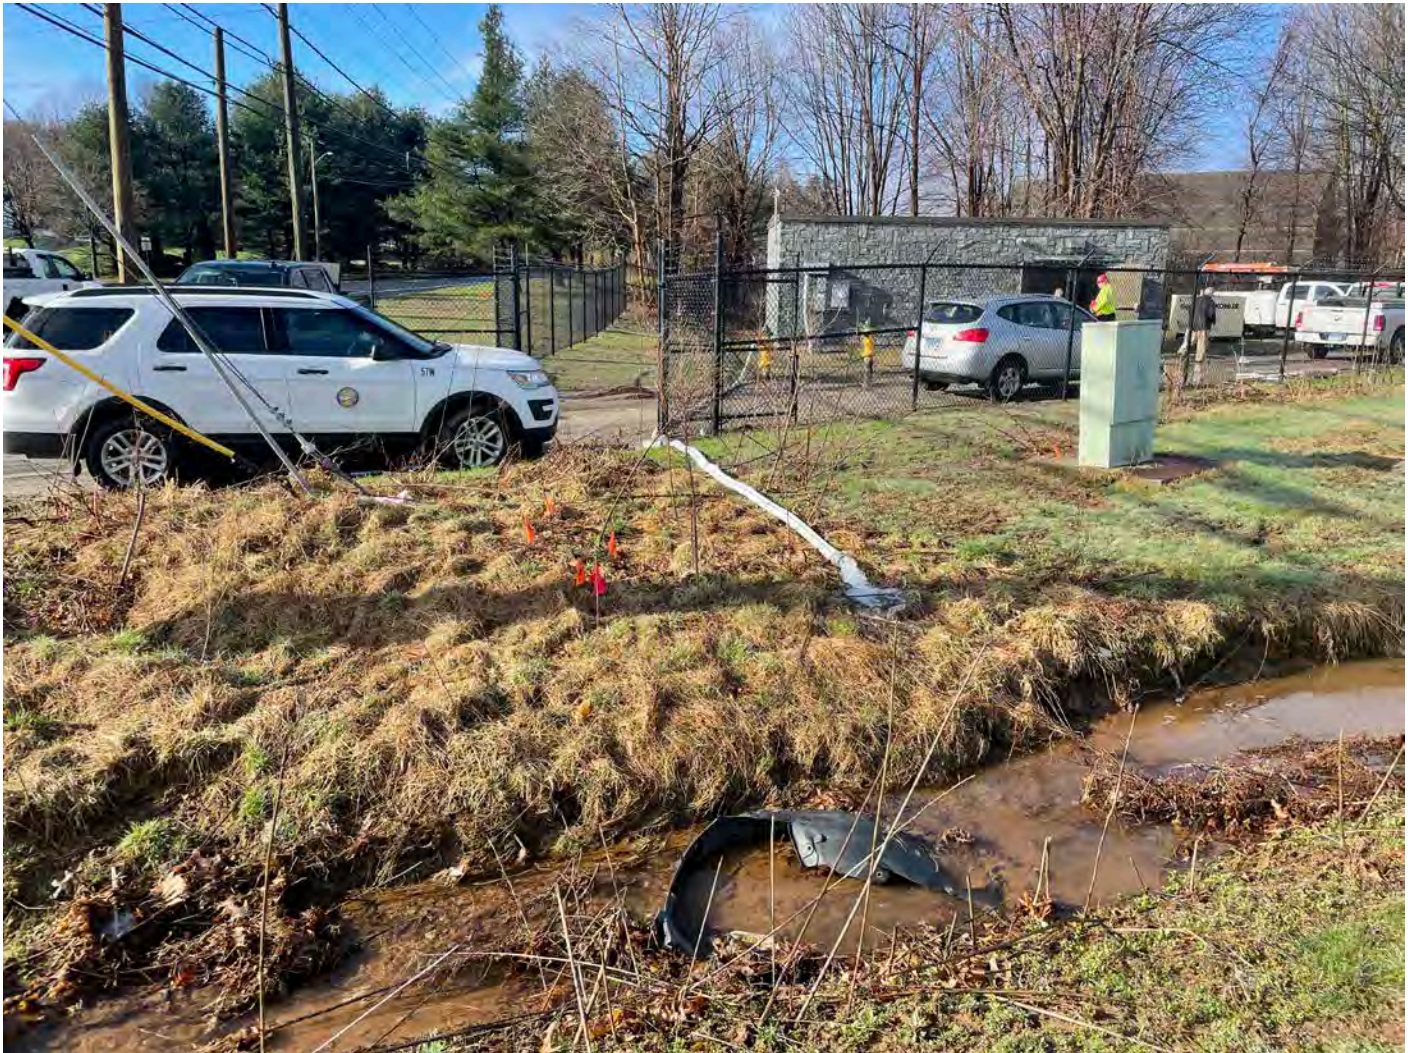
**Picture 5: Potable water generated from start-up activities being discharged to a swale located to the north/northeast of the booster station located on S. Main Street in Middletown. View to the south.**

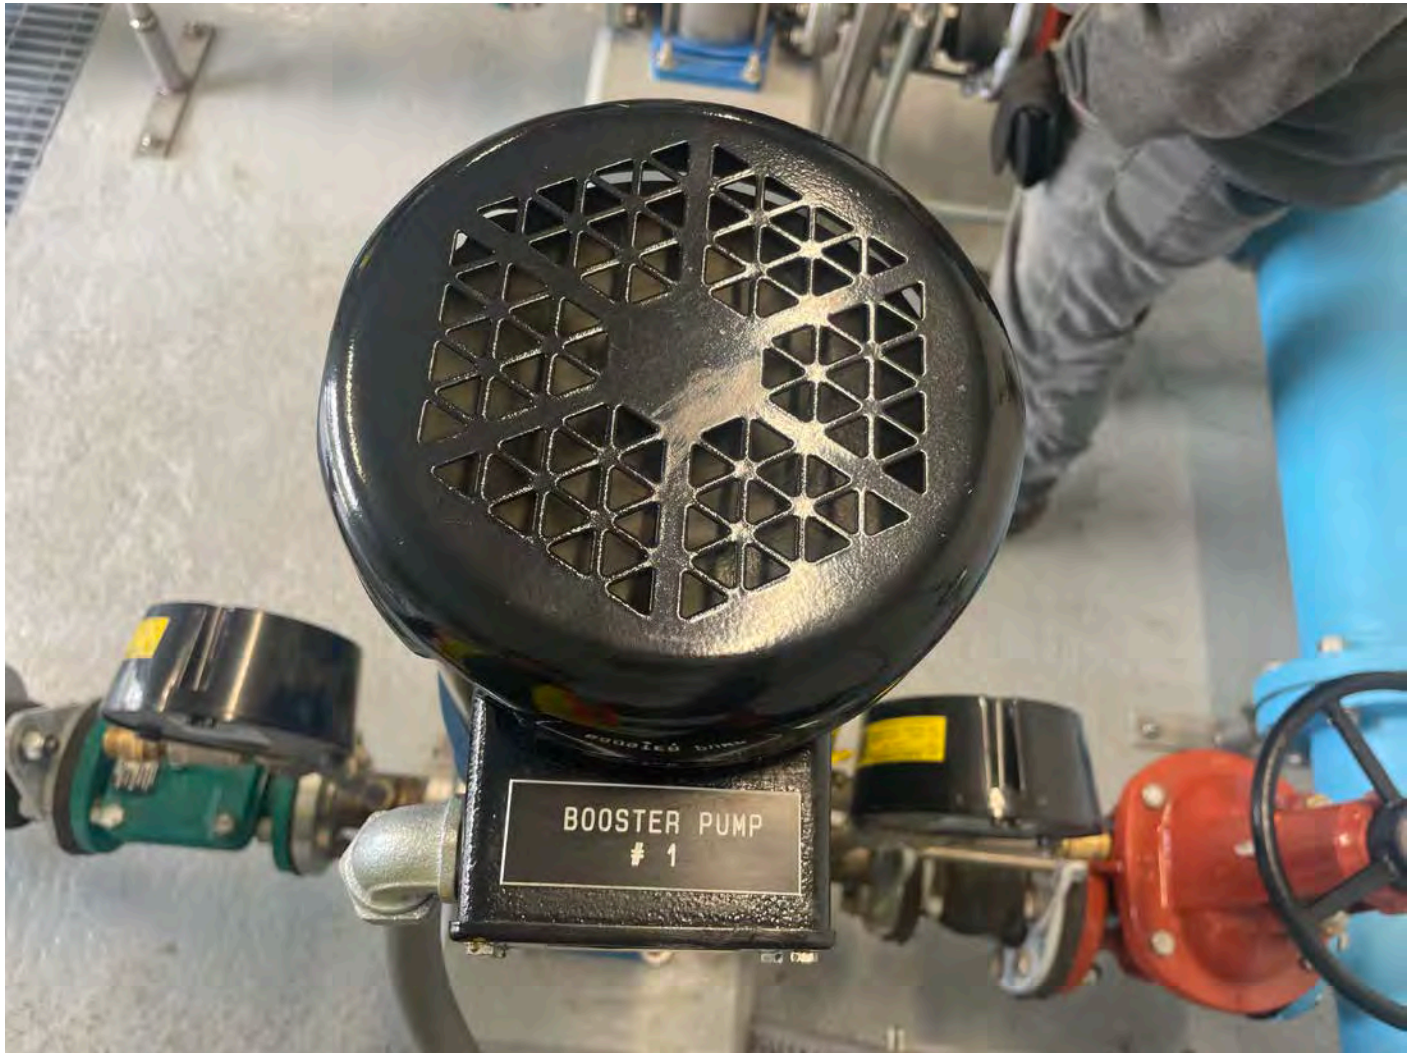
0826: United Concrete tests both pumps at the booster station. Pump Number 1 is spinning the wrong direction because the 3-phase wiring was connected to the pump incorrectly. United is currently working to correct this issue.

**Picture 6: Booster Pump #1, which was spinning in the opposite direction due to some wiring issues. This problem was solved before the project team left the booster station for the day.**

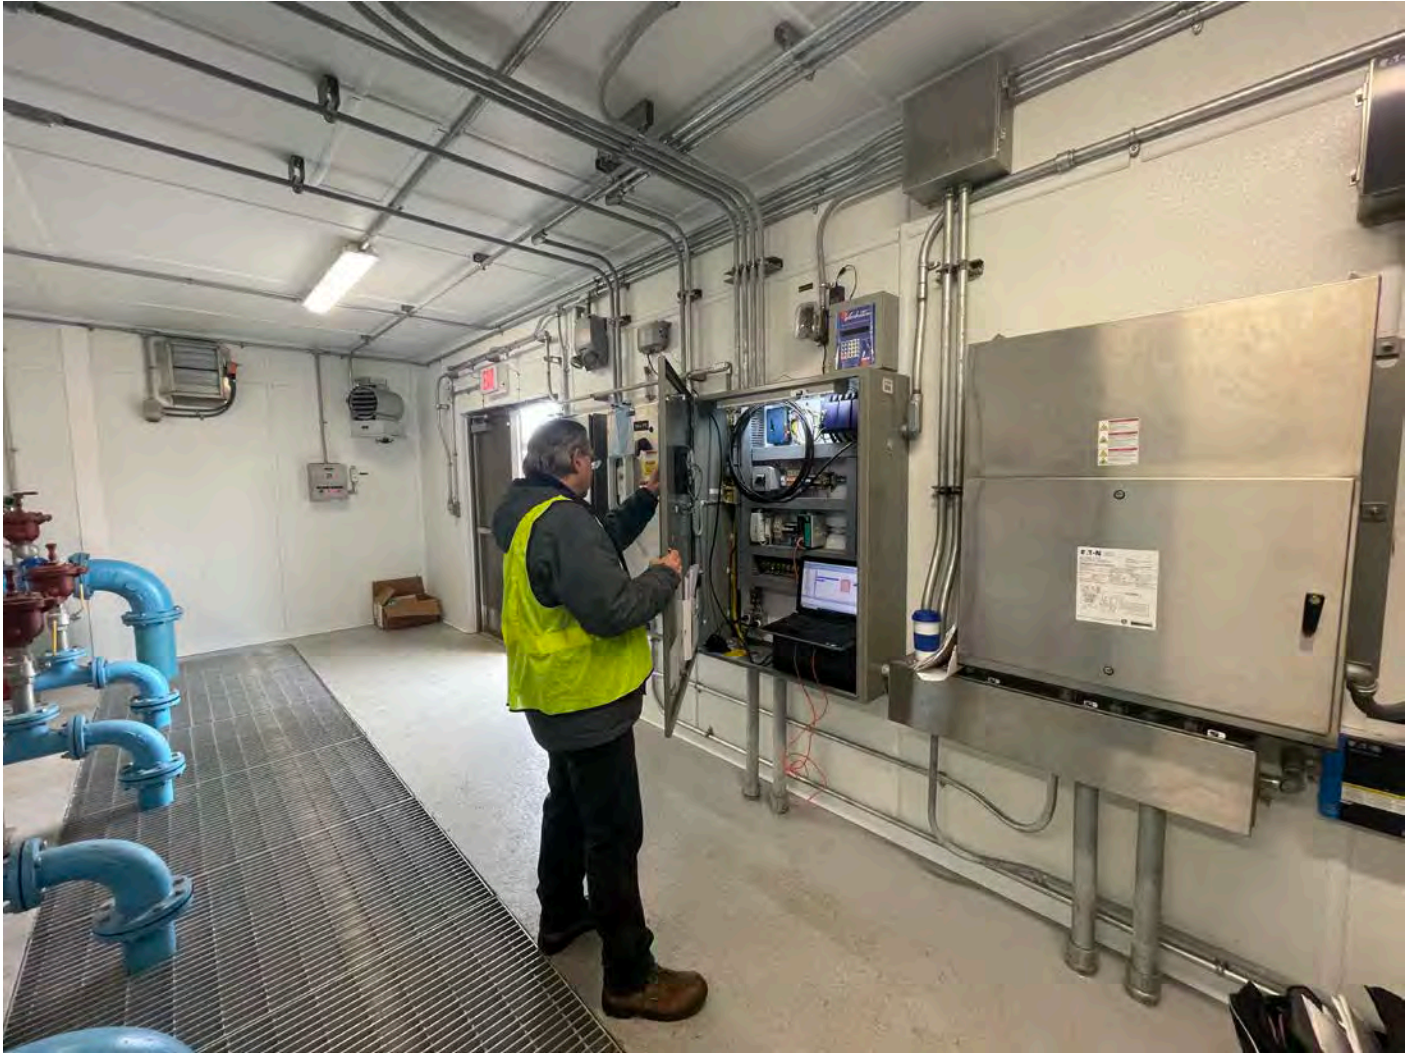
Picture 7: Knapp Engineering working on the control panel located on the north side of the booster station located on S. Main Street in Middletown. View to the northwest.
