Daily Report

Project:Durham Meadows Pipeline InstallationDate:May 26, 2022Main Street, Durham; Shared Access Road, Talcott RidgeDay of Week:Thursday

Project #: AECOM: 6061487 **Report No:** 434

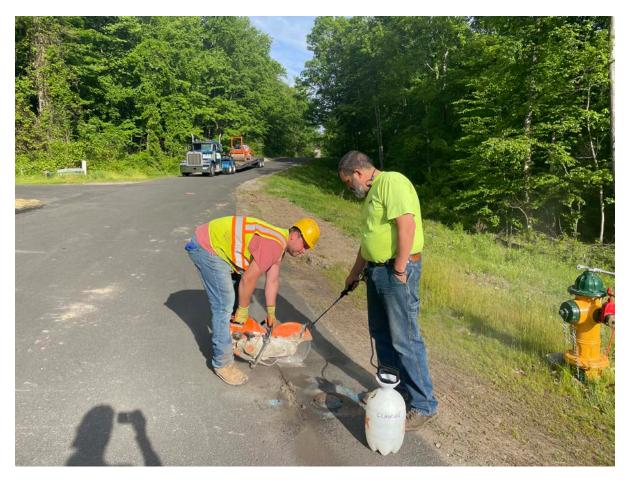
Picture 1: Ludlow saw-cutting pavement around a roadbox located at Station ~14+70 on the north side of the Shared Access Driveway as they prepare to raise it ahead of an upcoming paving event. View to the west.

0749: Ludlow is saw-cutting asphalt around a road box located at Station ~14+30 on the Shared Access Driveway as they prepare to raise it by several inches.

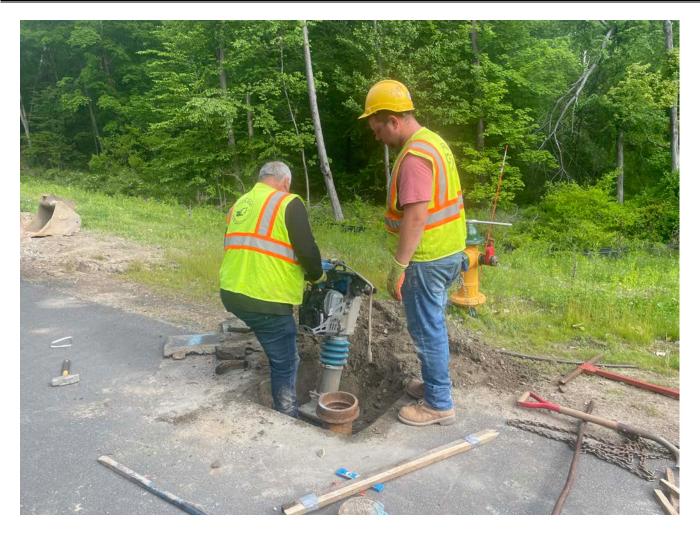
Picture 2: Ludlow compacting soil around the roadbox located at Station ~14+70 after Ludlow raised it by several inches ahead of an upcoming paving event. View to the north.

0835: Ludlow is backfilling around the road box located at Station ~14+70 and is using jumping jack to compact the fill.

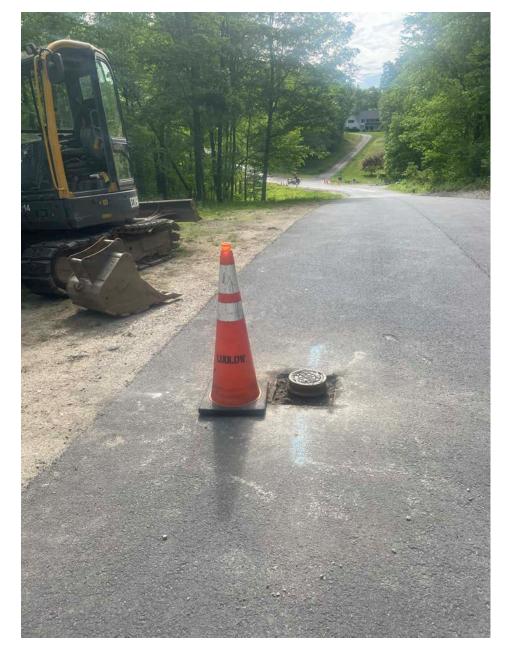
Picture 3: Roadbox located at Station 17+91 on the north side of the Shared Access Driveway that Ludlow raised ahead of an upcoming paving event. View to the east.

0932: Ludlow has finished raising the roadboxes located at Stations ~14+70 and 17+91 Ludlow is using a Broce Broom to clean Talcott Ridge Drive.

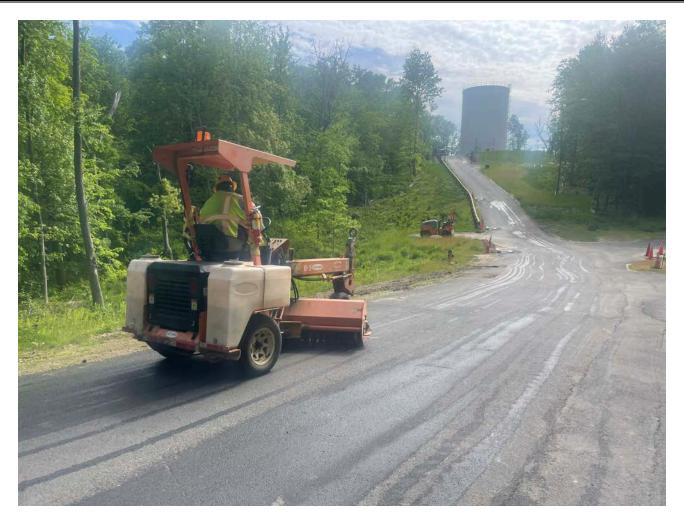
Picture 4: Ludlow using a Broce Broom to clean the Shared Access Driveway in Middletown. View to the east.

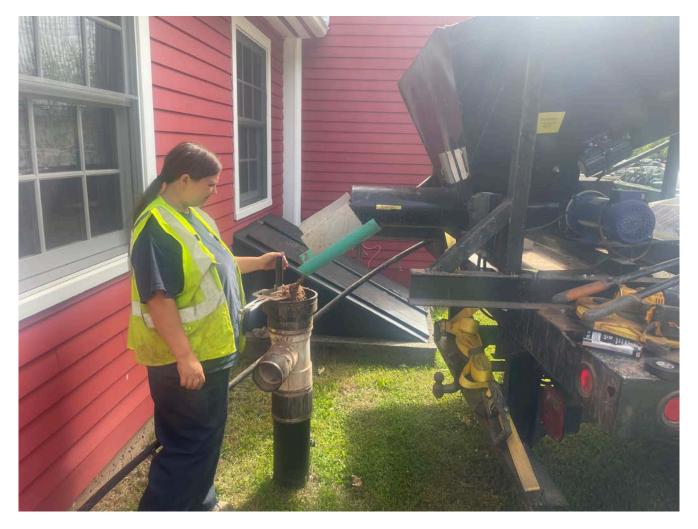
Picture 5: Grela placing sand into the well located on the south side of the 216 Main Street, Durham, residence as part of well decommissioning activities. View to the east.

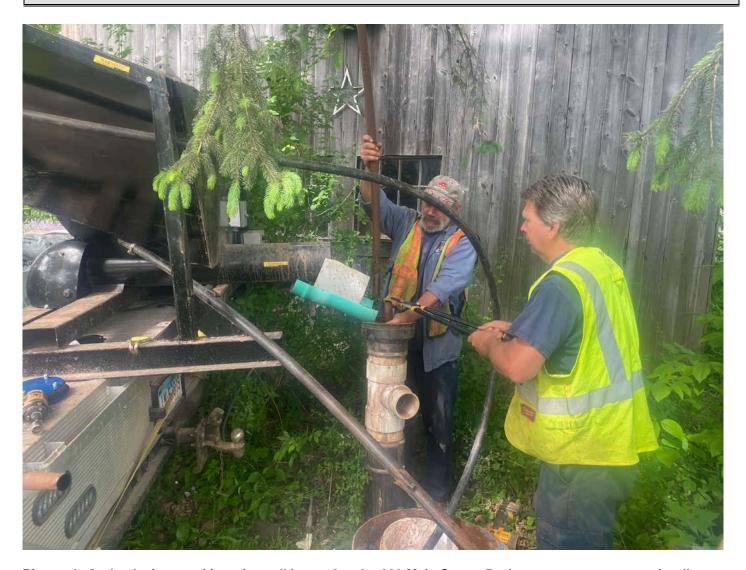
Picture 6: Grela placing sand into the well located at the 208 Main Street, Durham, property as part of well decommissioning activities. View to the southwest.

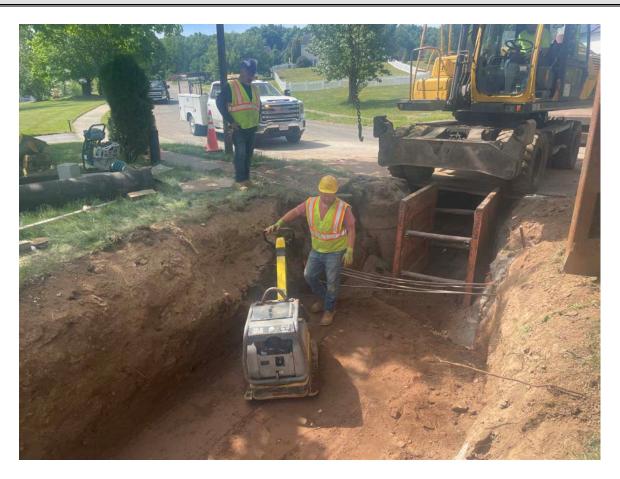
Picture 7: Ludlow compacting fill that is being placed in 1' lifts over the 12" DIP they installed at Station 40+41 on Talcott Ridge Drive, Middletown. View to the southeast.

1023: Ludlow is backfilling over the 12" DIP they installed at Station 40+41. Ludlow has placed fill in 1' lifts and is compacting it with a plate compactor

1219: Ludlow continues to backfill over the 12" DIP they installed at Station 40+41. Fill is being placed in 1 foot lengths and compacted with a plate comp actor.

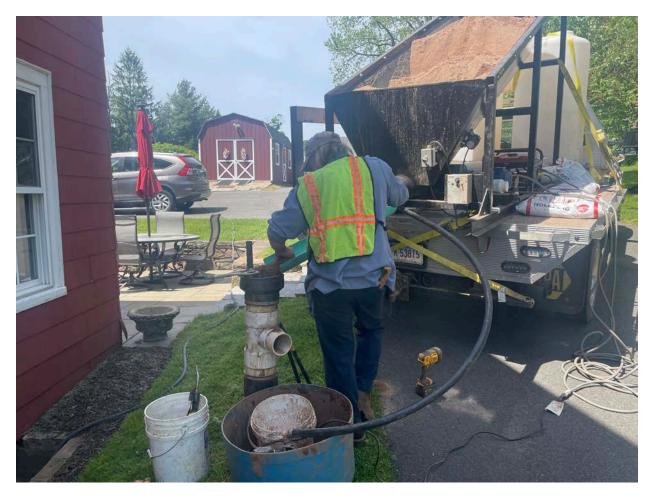
Picture 8: Grela placing sand into the well located on the north side of the 186 Main Street, Durham, property as part of well decommissioning activities. View to the west.

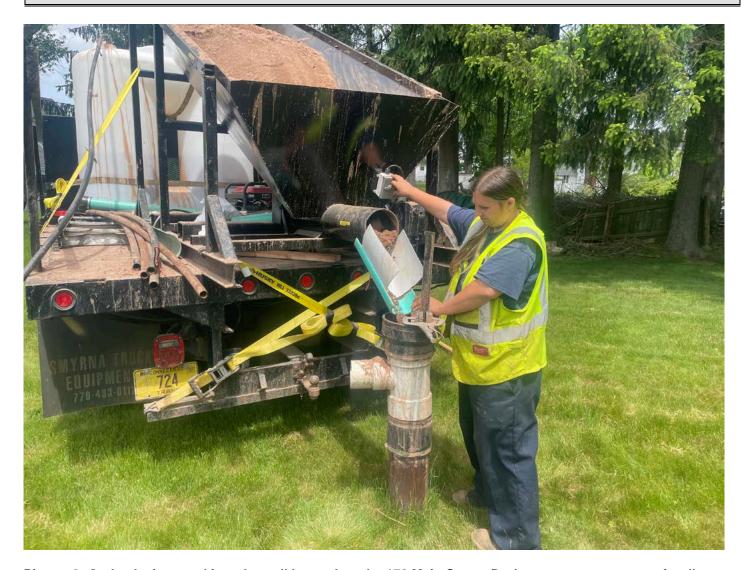
Picture 9: Grela placing sand into the well located on the 176 Main Street, Durham, property as part of well decommissioning activities. View to the northwest.

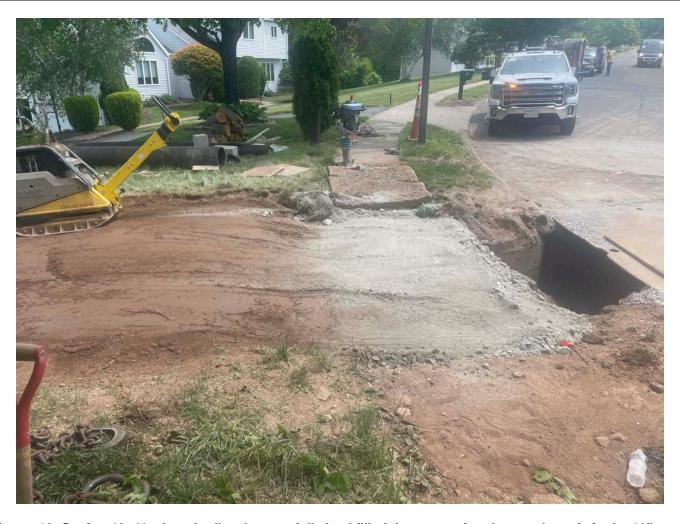
Picture 10: Station 40+41 where Ludlow has partially backfilled the excavation they made to tie in the 12" water line coming in from Round Hill Road to the 16" DIP waterline that Ludlow installed on Talcott Ridge Drive. View to the west.

1255: Ludlow continues to backfill over the 12" DIP they installed at Station 40+41. Ludlow used -3" gravel as backfill under the footprint of the sidewalk. The area north of the sidewalk has been backfilled and compacted. Ludlow is currently backfilling the portion of the excavation located south of the sidewalk (on Talcott Ridge Drive).

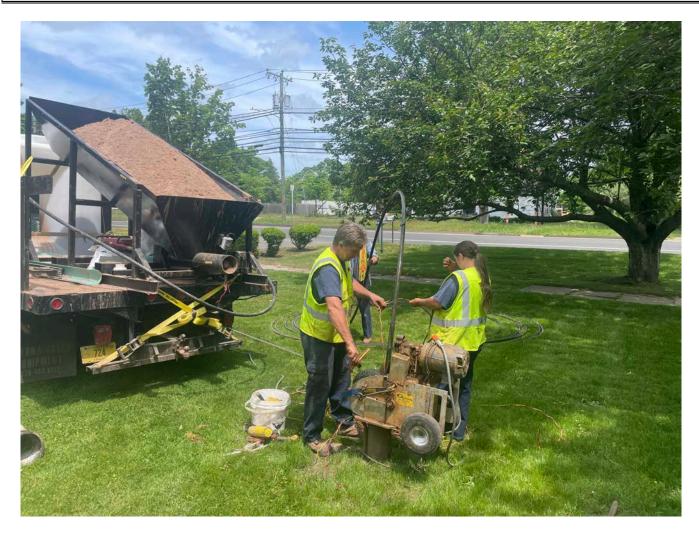
Picture 11: Grela placing sand into the well located on the 272 Main Street, Durham, property as part of well decommissioning activities. View to the east.

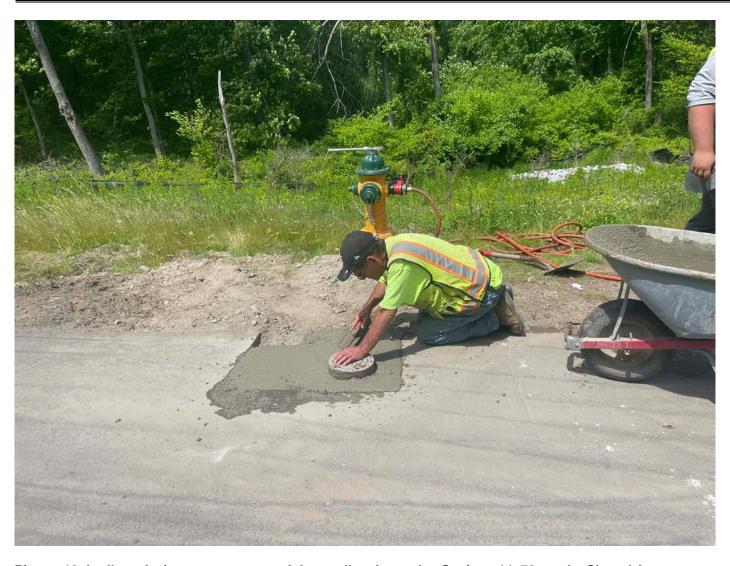
Picture 12: Ludlow placing concrete around the roadbox located at Station ~14+70 on the Shared Access Driveway in Middletown. View to the north.
