## Daily Report

<b>Project:</b>	Durham Meadows Pipeline Installation	<b>Date:</b>	May 27, 2022
<b>Location:</b>	Main Street, Durham; Shared Access Driveway, Talcott Ridge Drive, Middletown	<b>Day of Week:</b>	Friday
<b>Project #:</b>	AECOM: 6061487	<b>Report No:</b>	435
<b>Contractor:</b>	Ludlow Construction	<b>Page:</b>	1 of 20

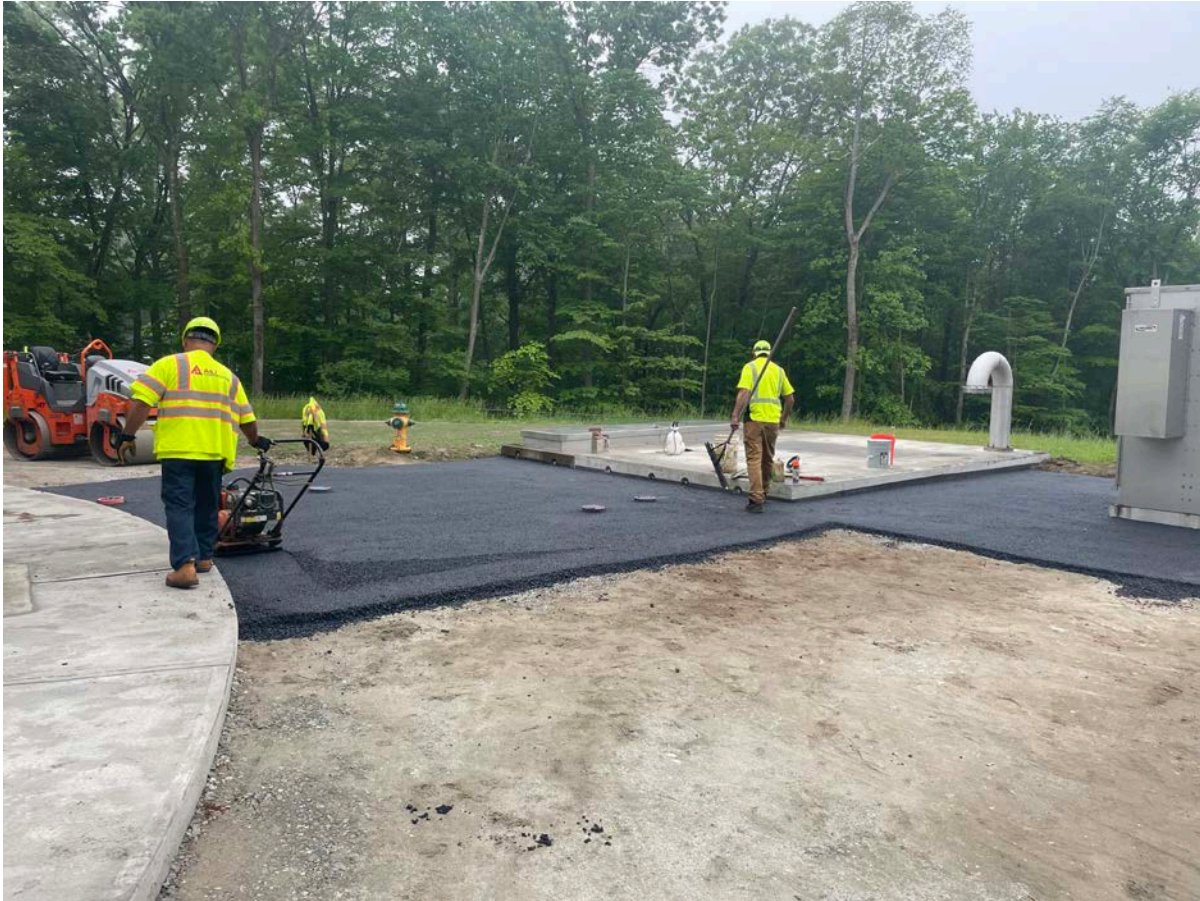
**Picture 1: A&J Construction placing the first lift of asphalt around the electrical enclosure located on the west side of the water tank located on the east side of the Shared Access Driveway. View to the southwest.**

0836: A&J Construction begins placing the first lift of asphalt around the electrical enclosure located to the east of the water tank.

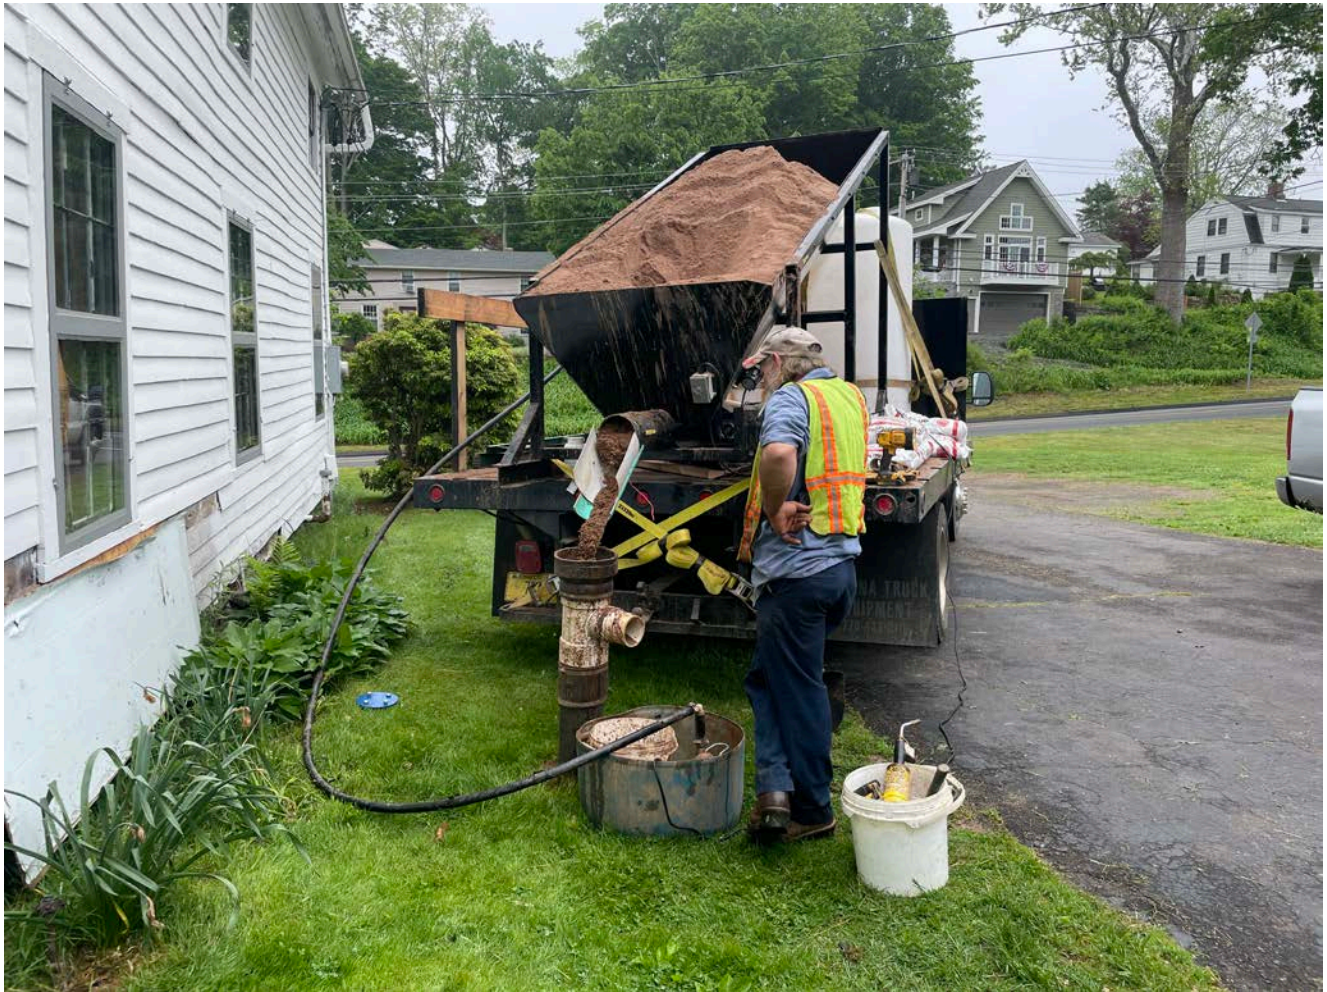
**Picture 2: Grela placing sand into the well located on the north side of the 167 Main Street, Durham, residence as part of well decommissioning activities. View to the west.**

1038: Grela is placing bentonite chips in the well located at 177R Main Street. Grela continues to place sand into the well located at the 167 Main Street property.

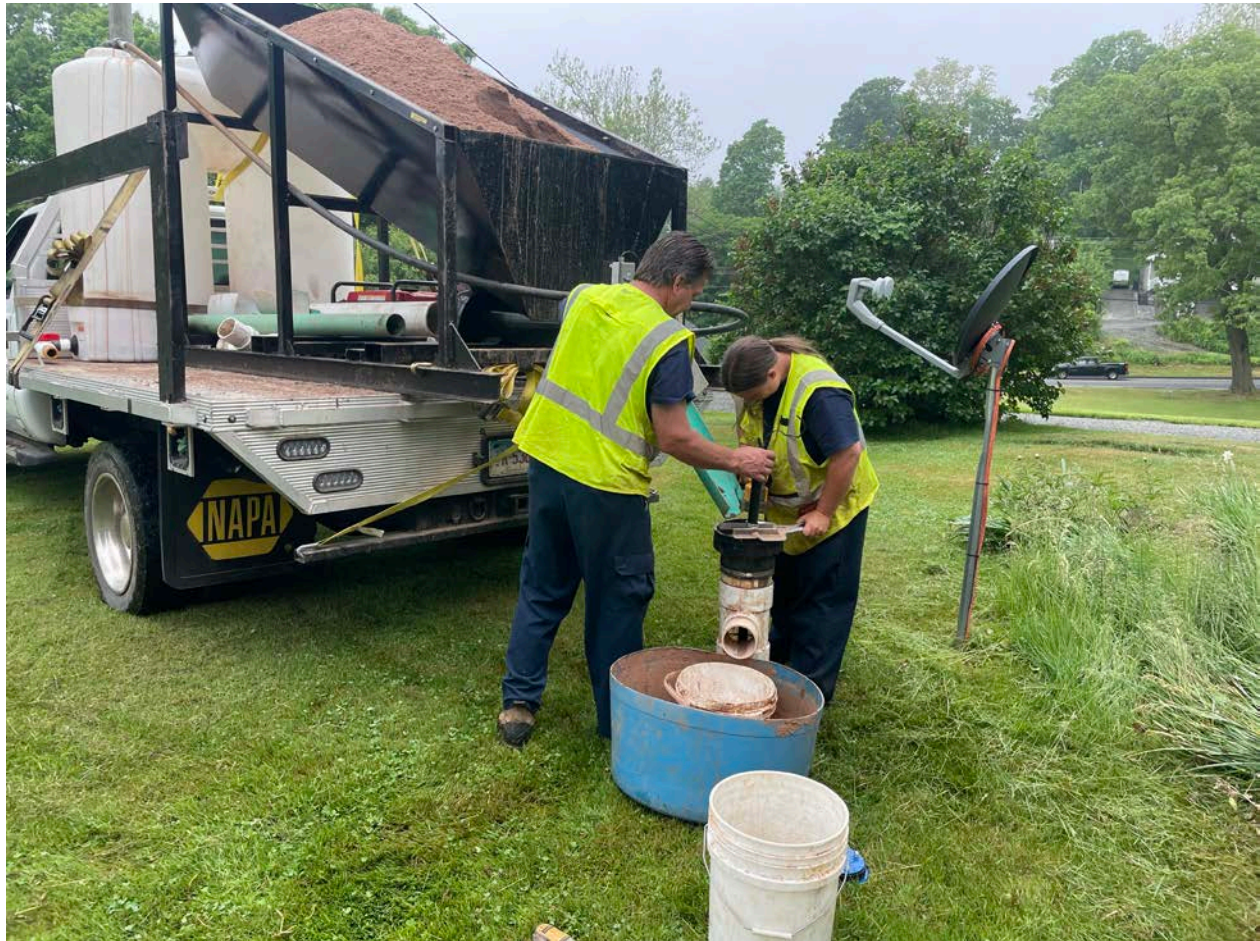
Picture 3: Grela placing sand into the well located on the south side of the 177R Main Street, Durham, residence as part of well decommissioning activities. View to the west.

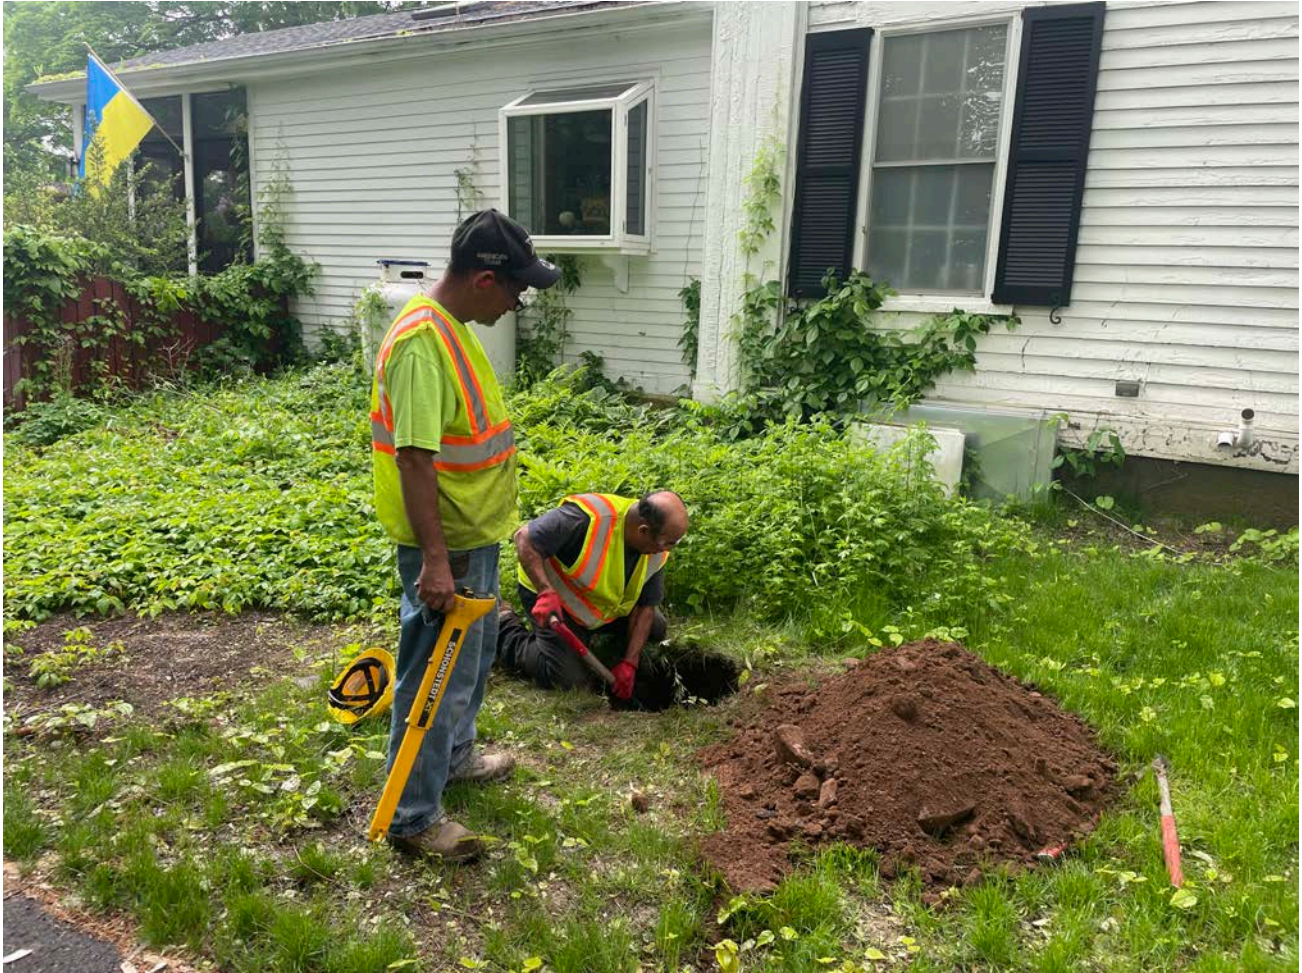
Picture 4: Ludlow locating the well on the north side of the 313 Main Street residence. View to the southeast.

1107: Grela and Ludlow just located the dug well located on the north side of the 313 Main Street residence.

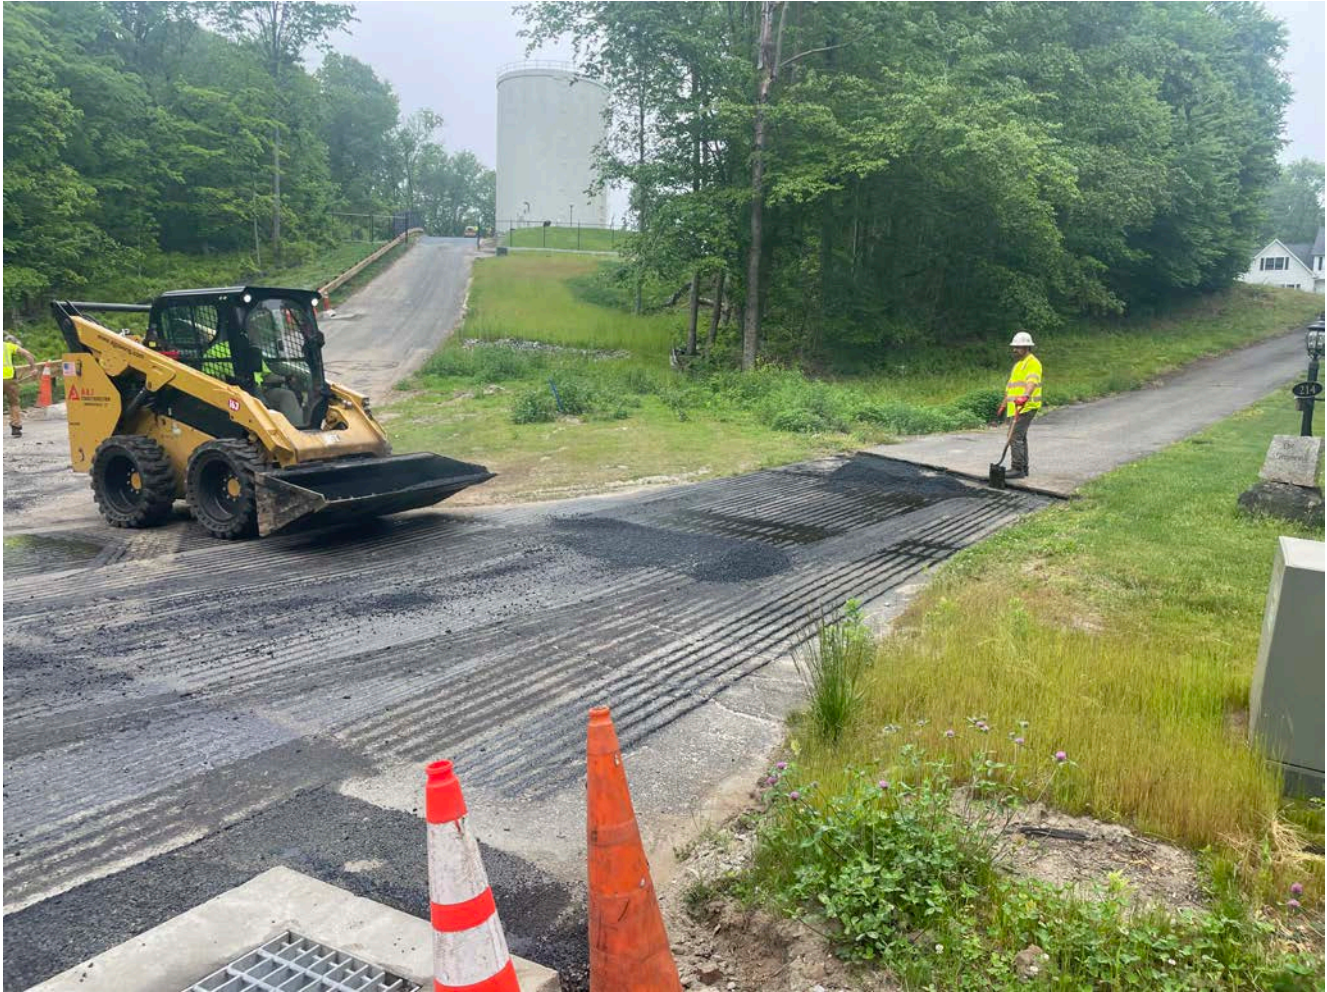
Picture 5: A&J Construction about to place asphalt on the driveway apron for the 224 Talcott Ridge Drive property after having placed tack coat. View to the east.

1121: A&J Construction has completed paving the driveway aprons for the 214, 216, and 224 Talcott Ridge Drive properties. In addition, A&J Construction has paved a portion of the driveway of the 216 Talcott Ridge Drive property under separate contract with the property owner. A&J Construction has just placed tack coat from ~Stations 11+00 to 14+00.

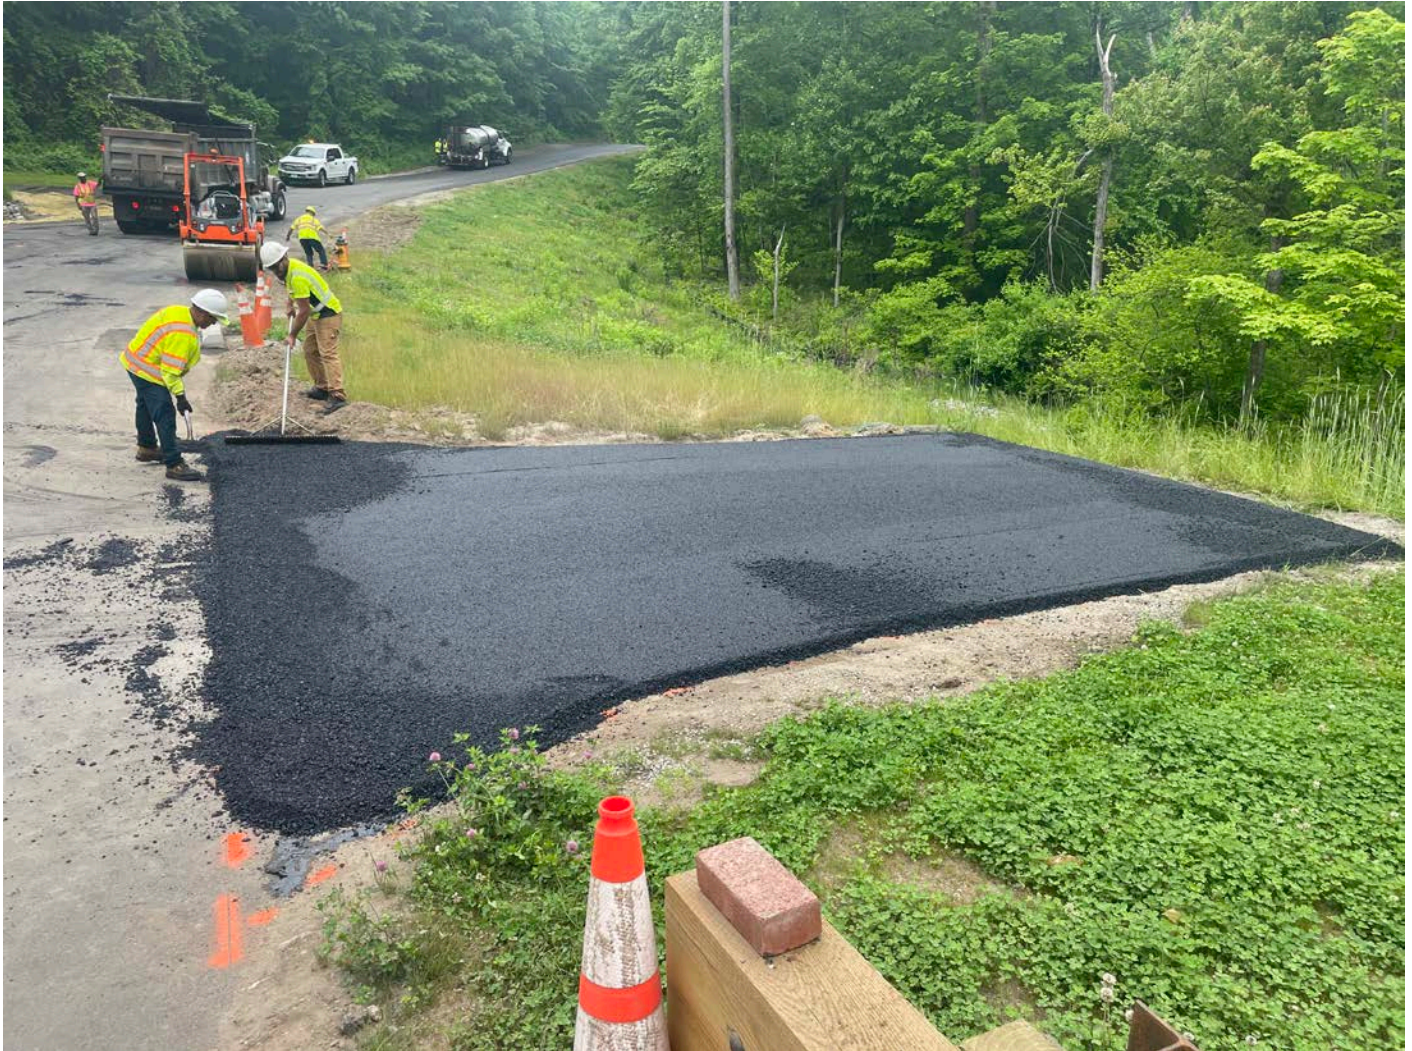
Picture 6: The turn out located at Station ~14+00 on the Shared Access Driveway where A&J Construction just placed a lift of asphalt. View to the west.

0953: A&J Construction is placing tack coat on the driveway apron for 214 Talcott Ridge Drive. A&J Construction has placed the first lift of asphalt on the vehicle turn out located at ~Station 14+15.

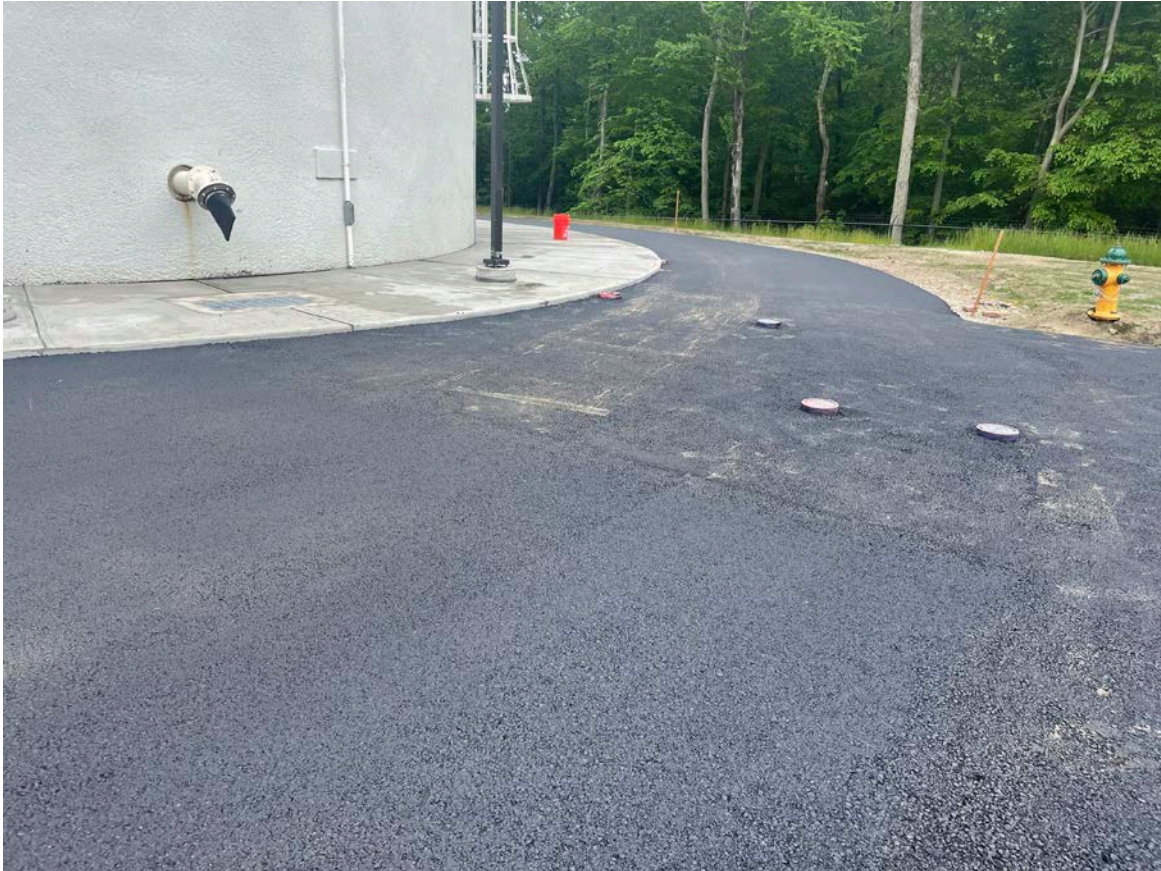
Picture 7: The south side of the water tank where A&J Construction just placed the first of two lifts of asphalt. View to the south.

0956: A&J Construction has placed the first lift of asphalt around the water tank up to Station 11+40.

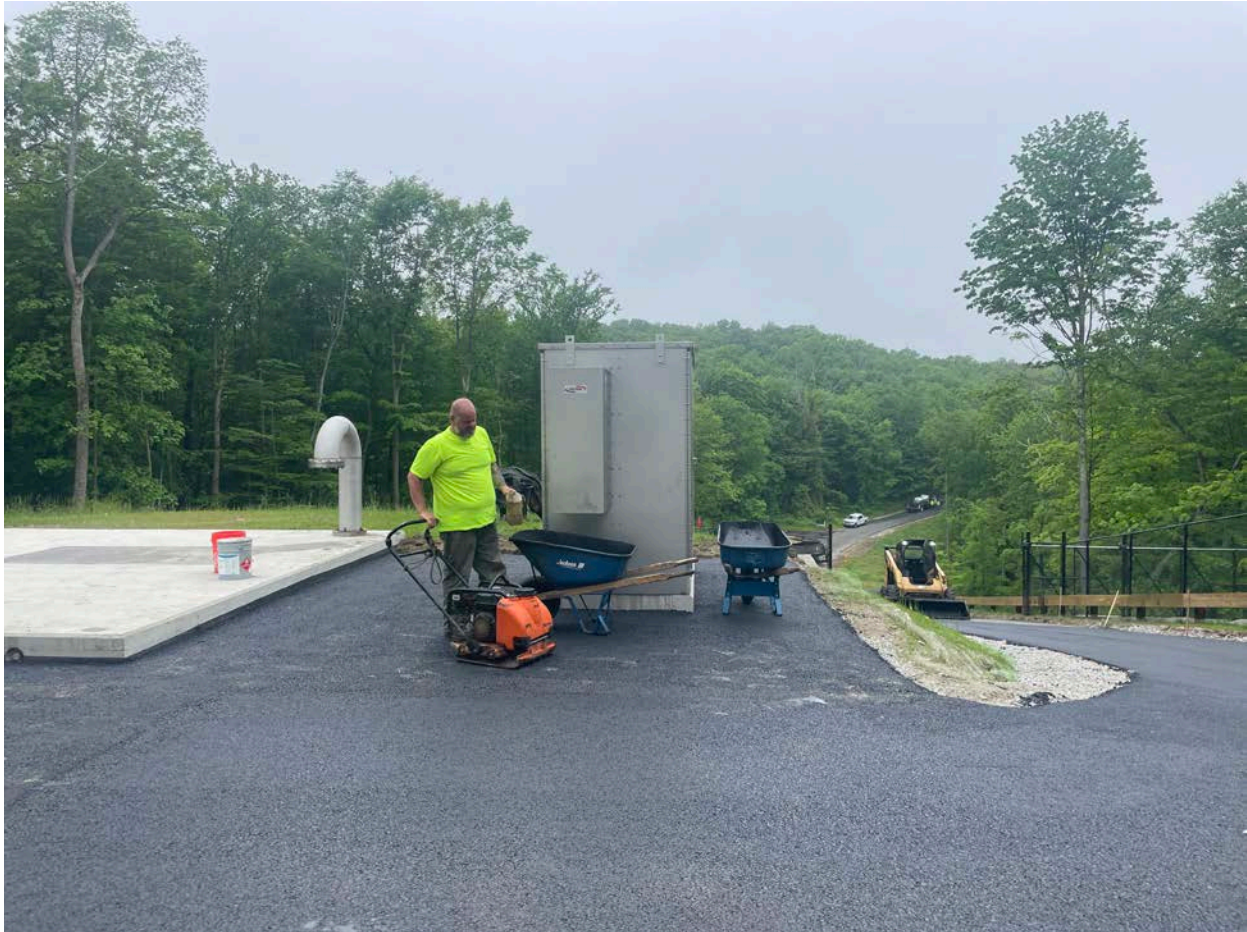
**Picture 8: The electrical enclosure located on the south side of the water tank where A&J Construction just placed the first of two lifts of asphalt. View to the west.**

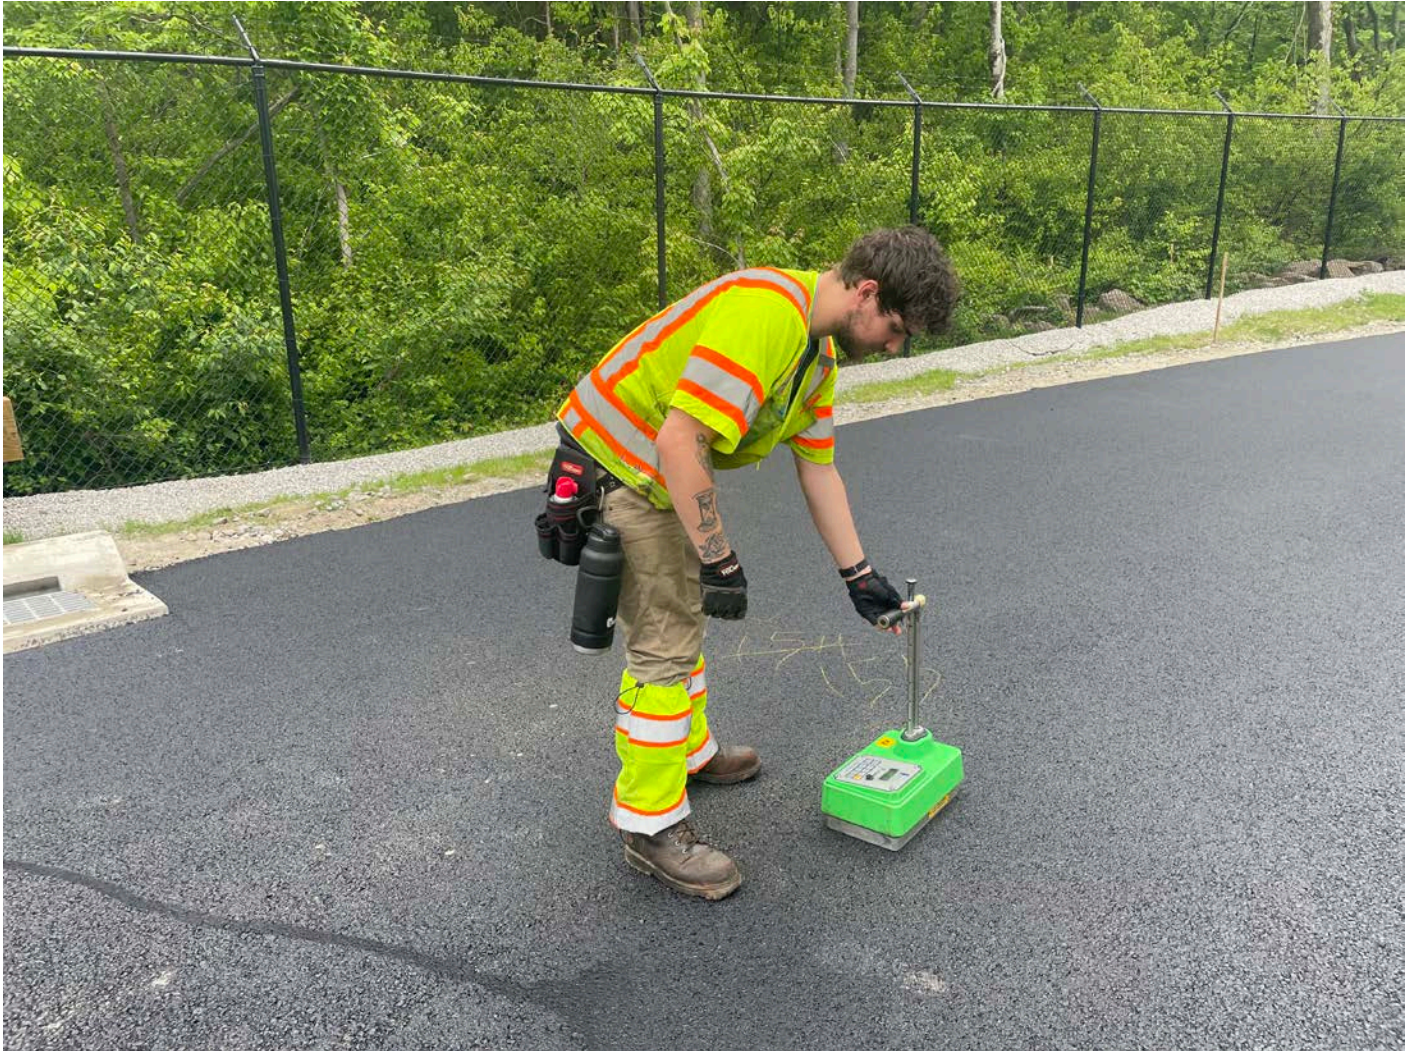
Picture 9: Advanced Testing checking temperature and compaction on the asphalt that A&J Construction placed at Station ~10+50 on the Shared Access Driveway. View to the northeast.

1005: Advanced Testing is performing temperature and compaction field testing on the asphalt that A&J Construction has placed at the water tank work zone. The Advanced Testing representative indicates that the asphalt is arriving on site at or above the required temperature, and that compaction results are within specifications.

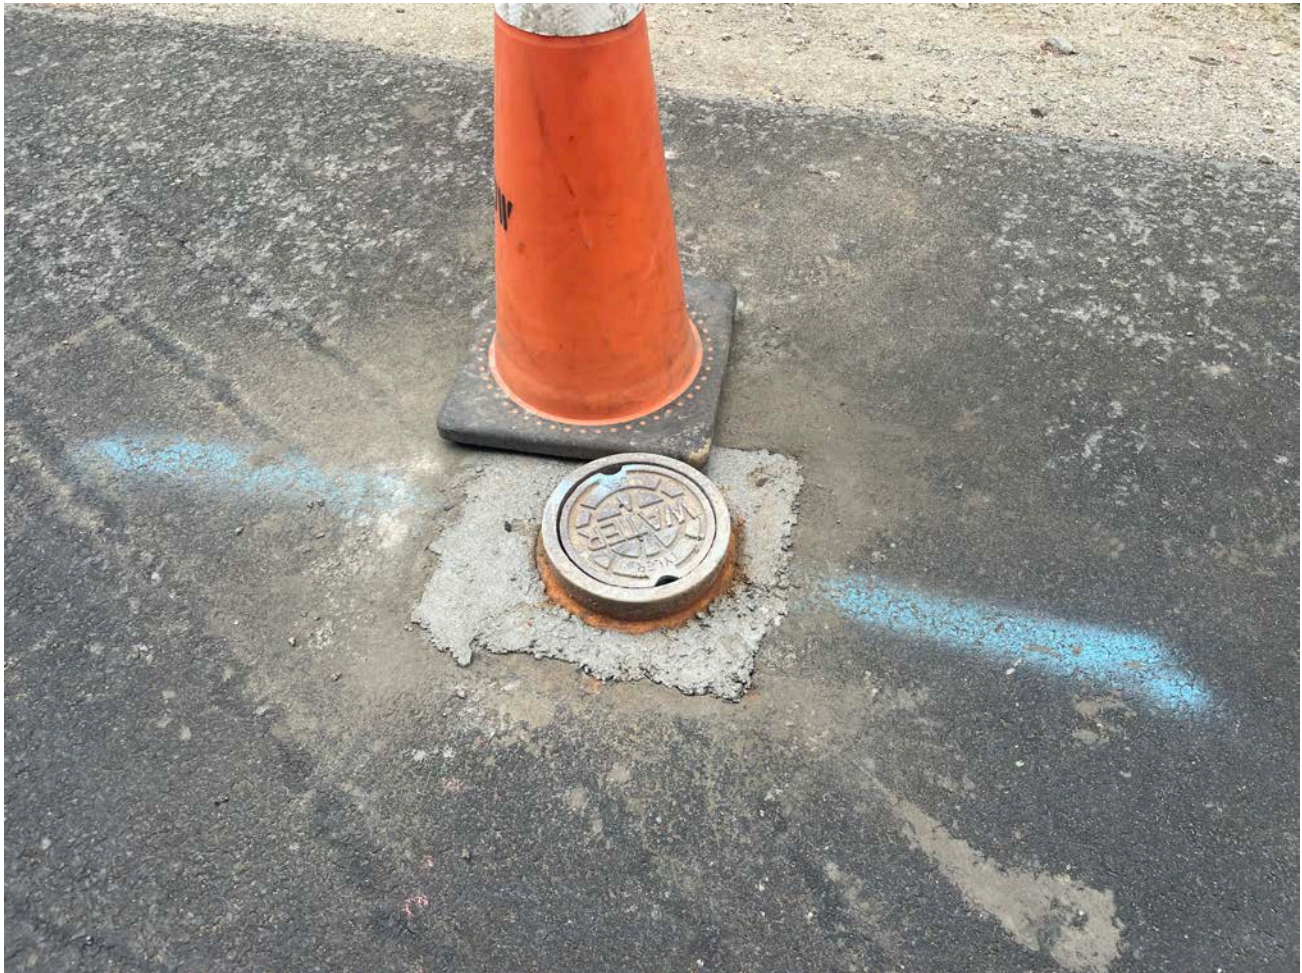
Picture 10: Station 17+91 where Ludlow placed concrete around a road box they raised. View to the northwest.

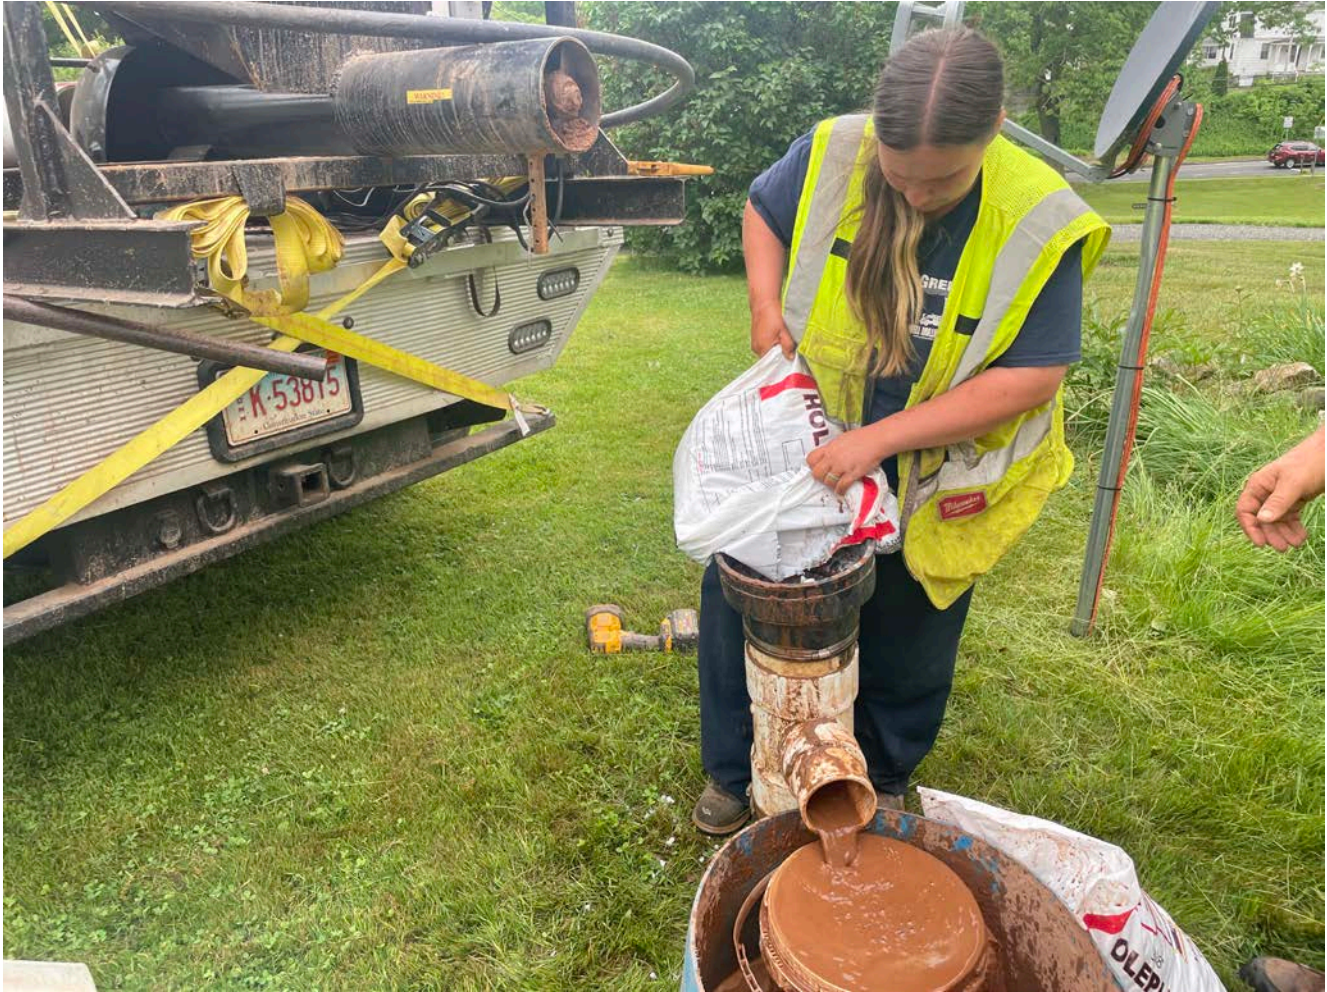
Picture 11: Grela placing sand into the well located on the 177R Main Street, Durham, property as part of well decommissioning activities. View to the west.

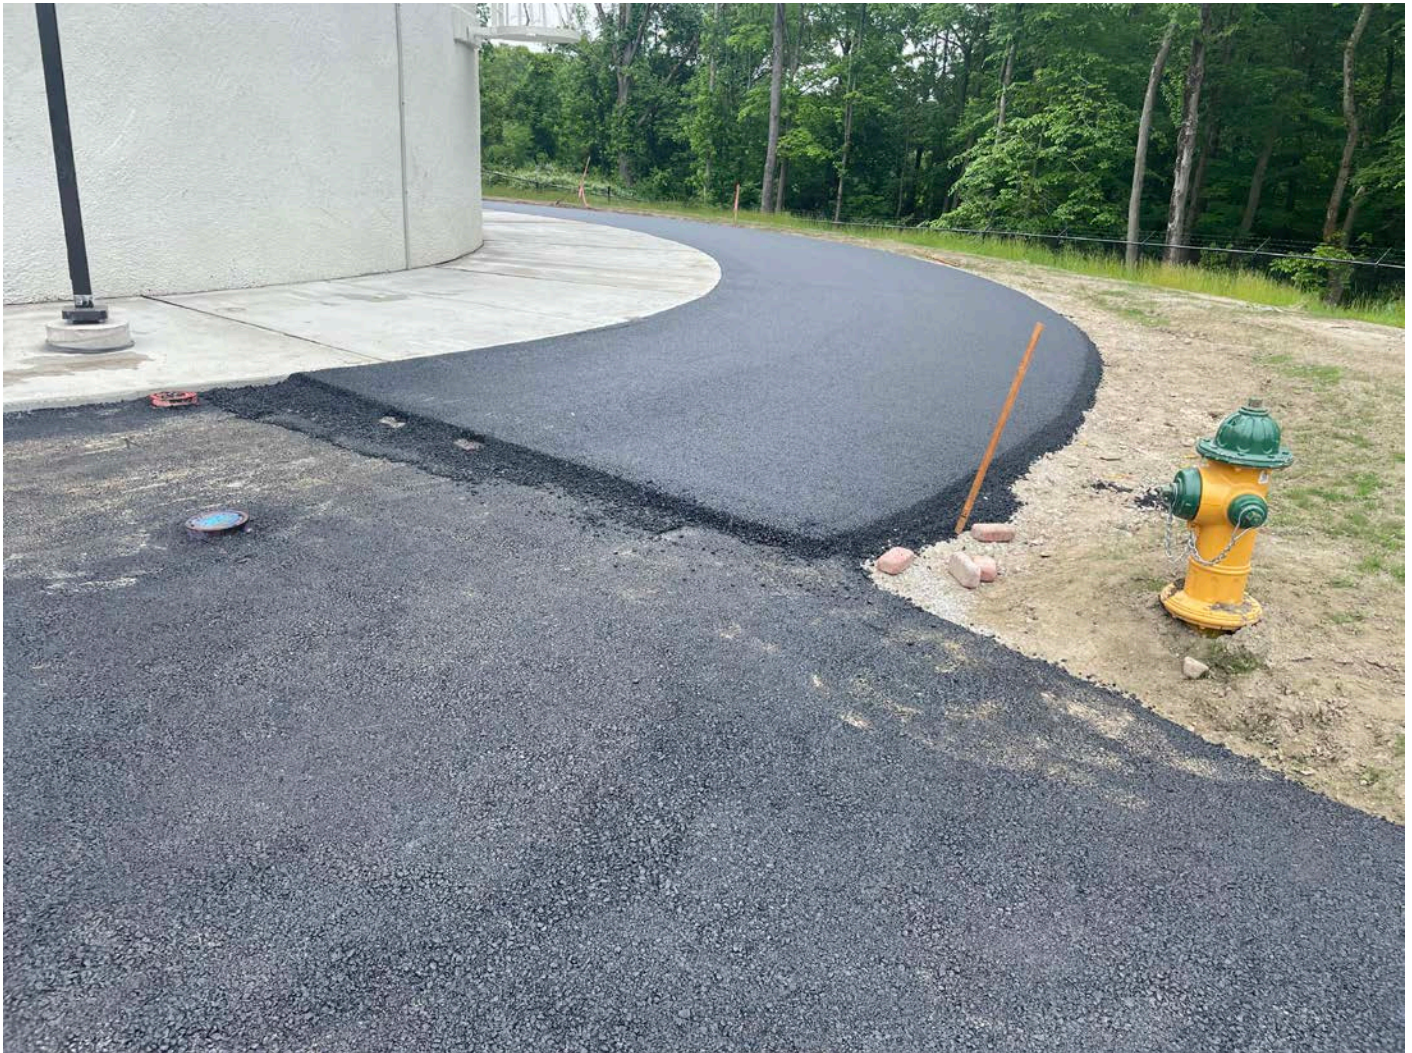
Picture 12: The south side of the water tank where A&J Construction is in the process of placing the second of two lifts of asphalt. View to the southeast.

1025: A&J Construction is placing the second lift of asphalt around the water tank and up to Station 11+40.

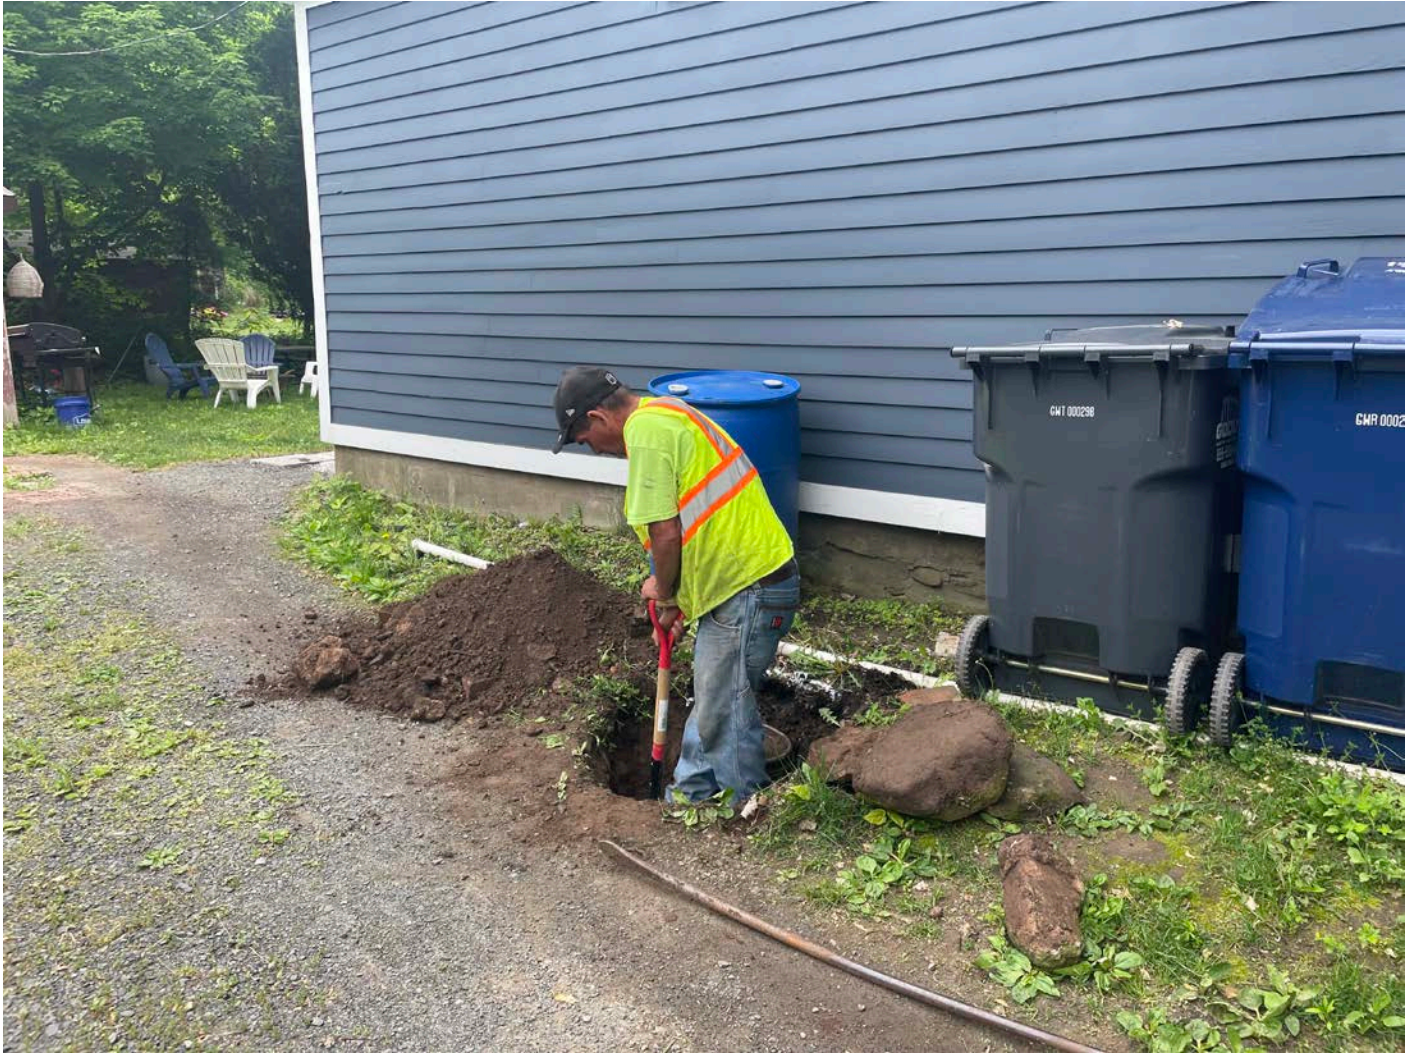
Picture 13: Ludlow excavating around the well casing on the north side of the 271 Main Street residence. View to the southeast.

1153: Ludlow is removing soils from around the well casing at the 271 Main Street property in order to provide Grela space to cut the casing 2' below surface grade.

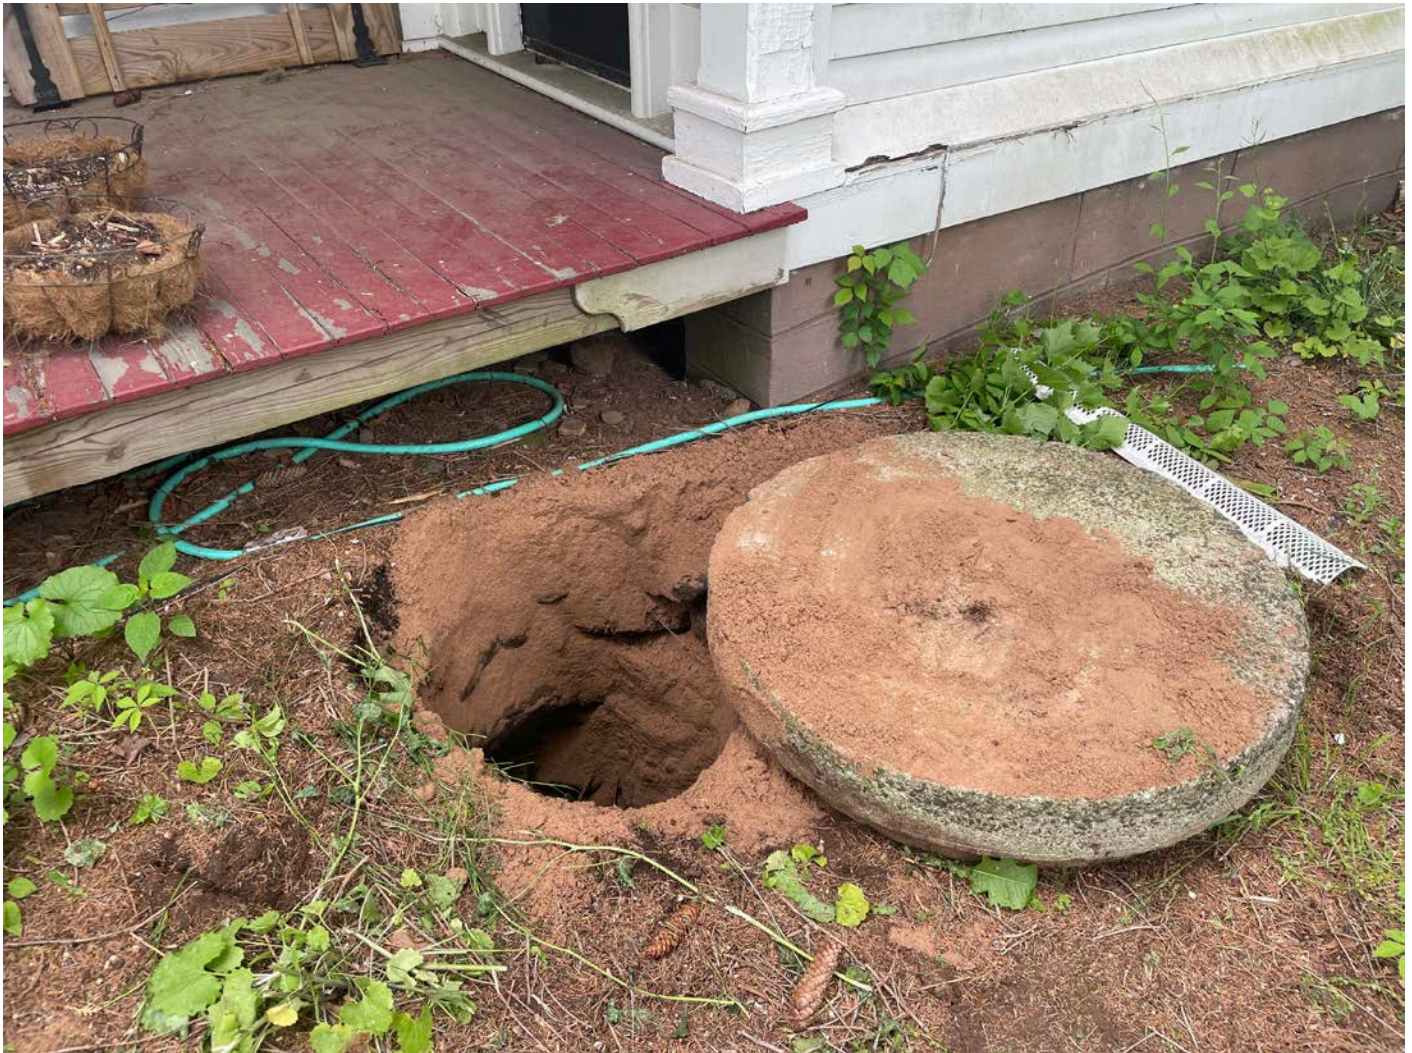
Picture 14: The dug well located on the south side of the 313 Main Street residence that Ludlow daylighted in order to allow Grela to decommission the well. View to the north.

1157: Grela is placing sand into the dug well located on the south side of the 313 Main Street residence. Grela is also placing sand down the well located on the north side of the 313 Main Street residence as part of decommissioning activities.

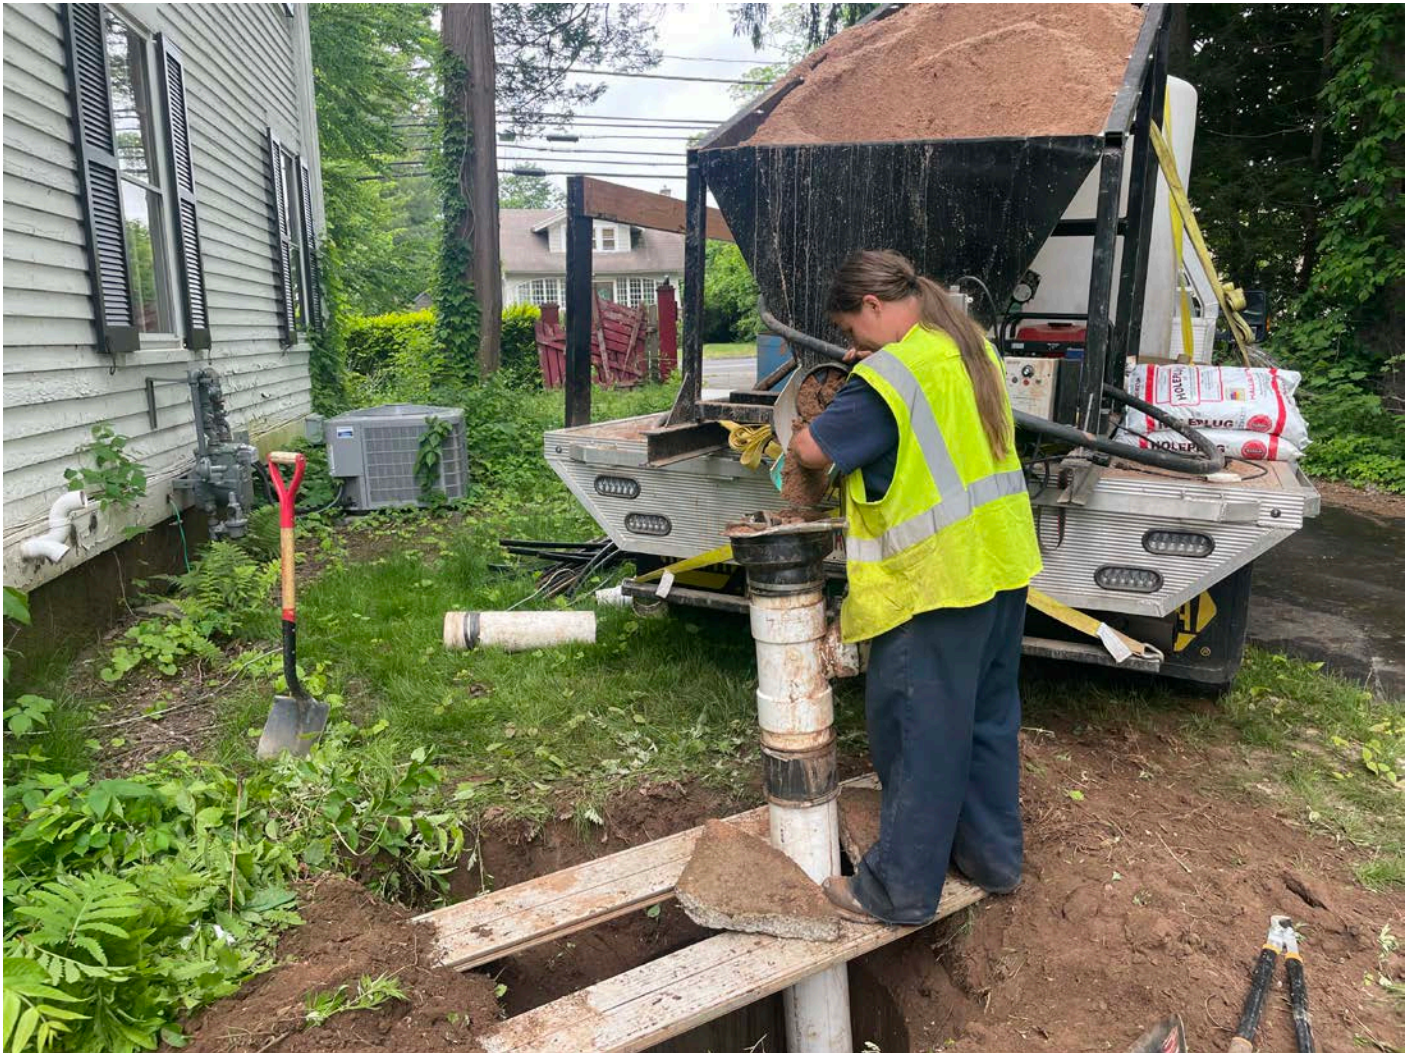
Picture 15: Grela placing sand into the well located on the north side of the 313 Main Street residence as part of decommissioning activities. View to the west.

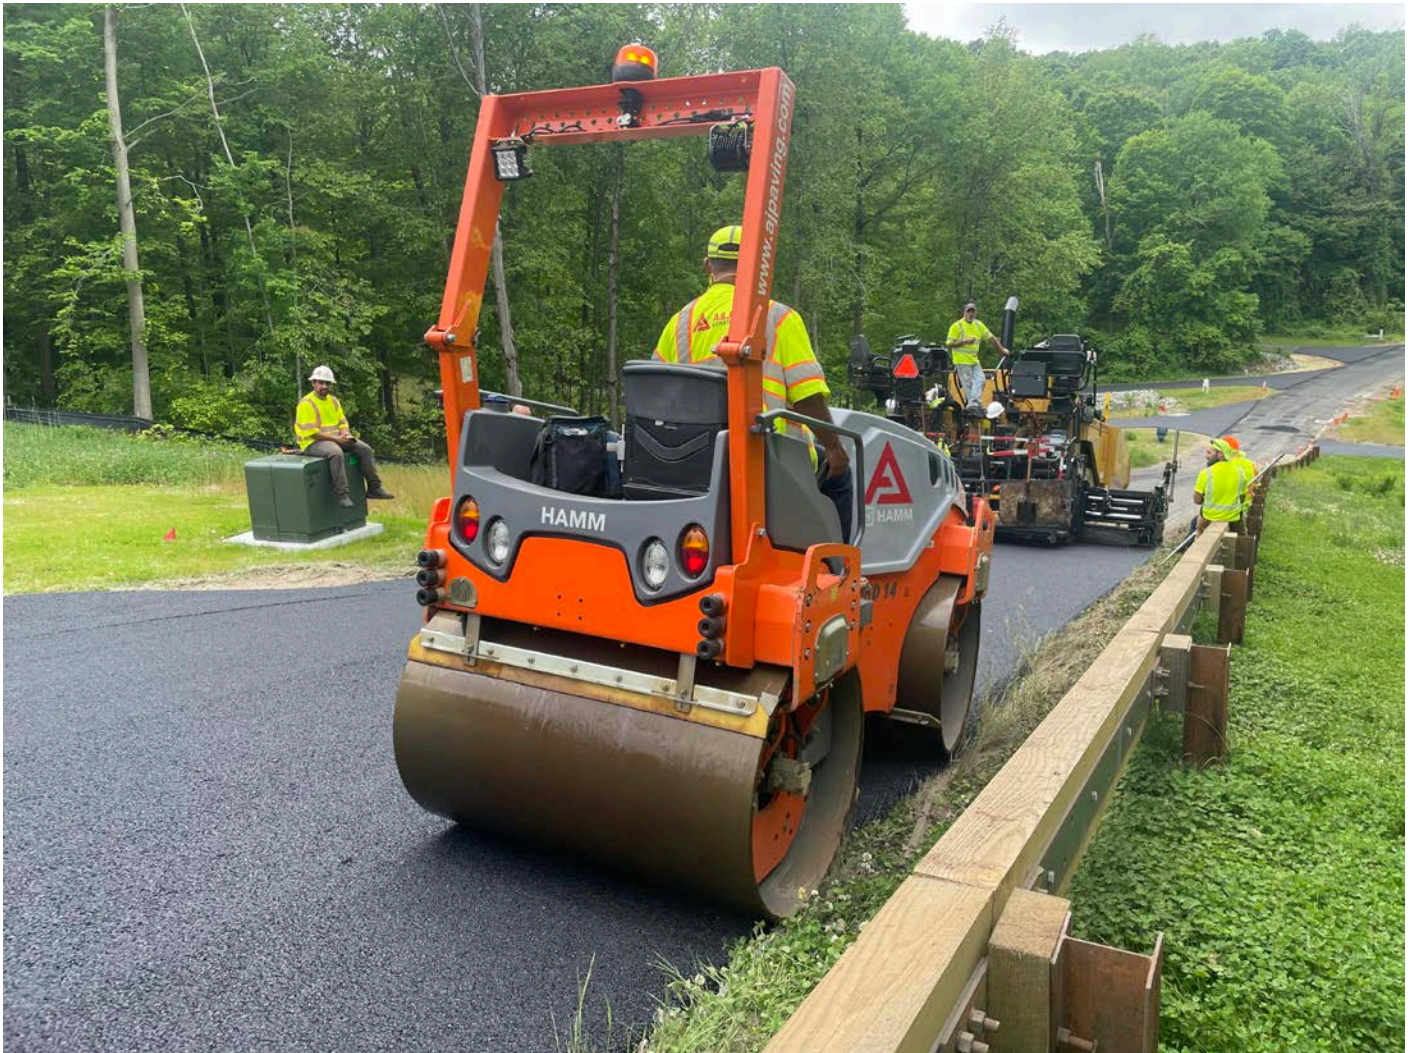
Picture 16: A&J Construction placing and rolling asphalt on the Shared Access Driveway. View to the west.

1503: A&J Construction continues to place and compact asphalt on the Shared Access Driveway, working westwards towards Station 23+00.
