Daily Report

Project:	Durham Meadows Pipeline Installation	Date:	August 31, 2022
Location:	Pickett Lane, Durham	Day of Week:	Wednesday
Project #:	AECOM: 6061487	Report No:	501
Contractor:	Ludlow Construction	Page:	1 of 14

Daily Activities – Installation of water service lines, Durham

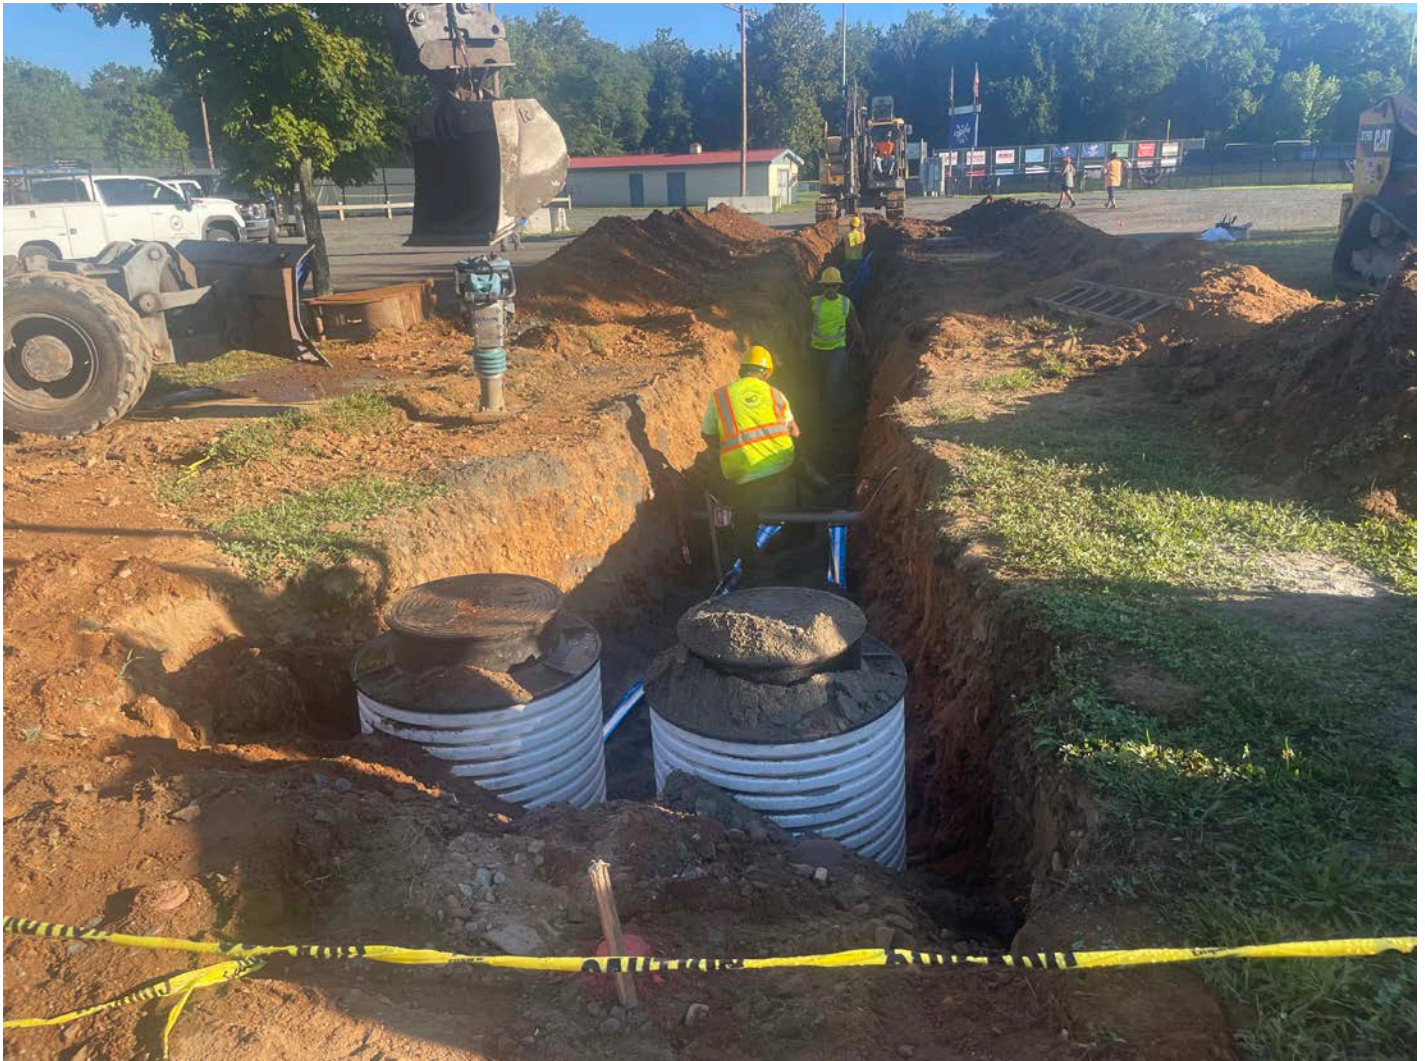
Picture 1: Ludlow installing two 1.5" polyethylene water lines to the north of the two meter vaults they installed at Station ~516+55. View to the north.

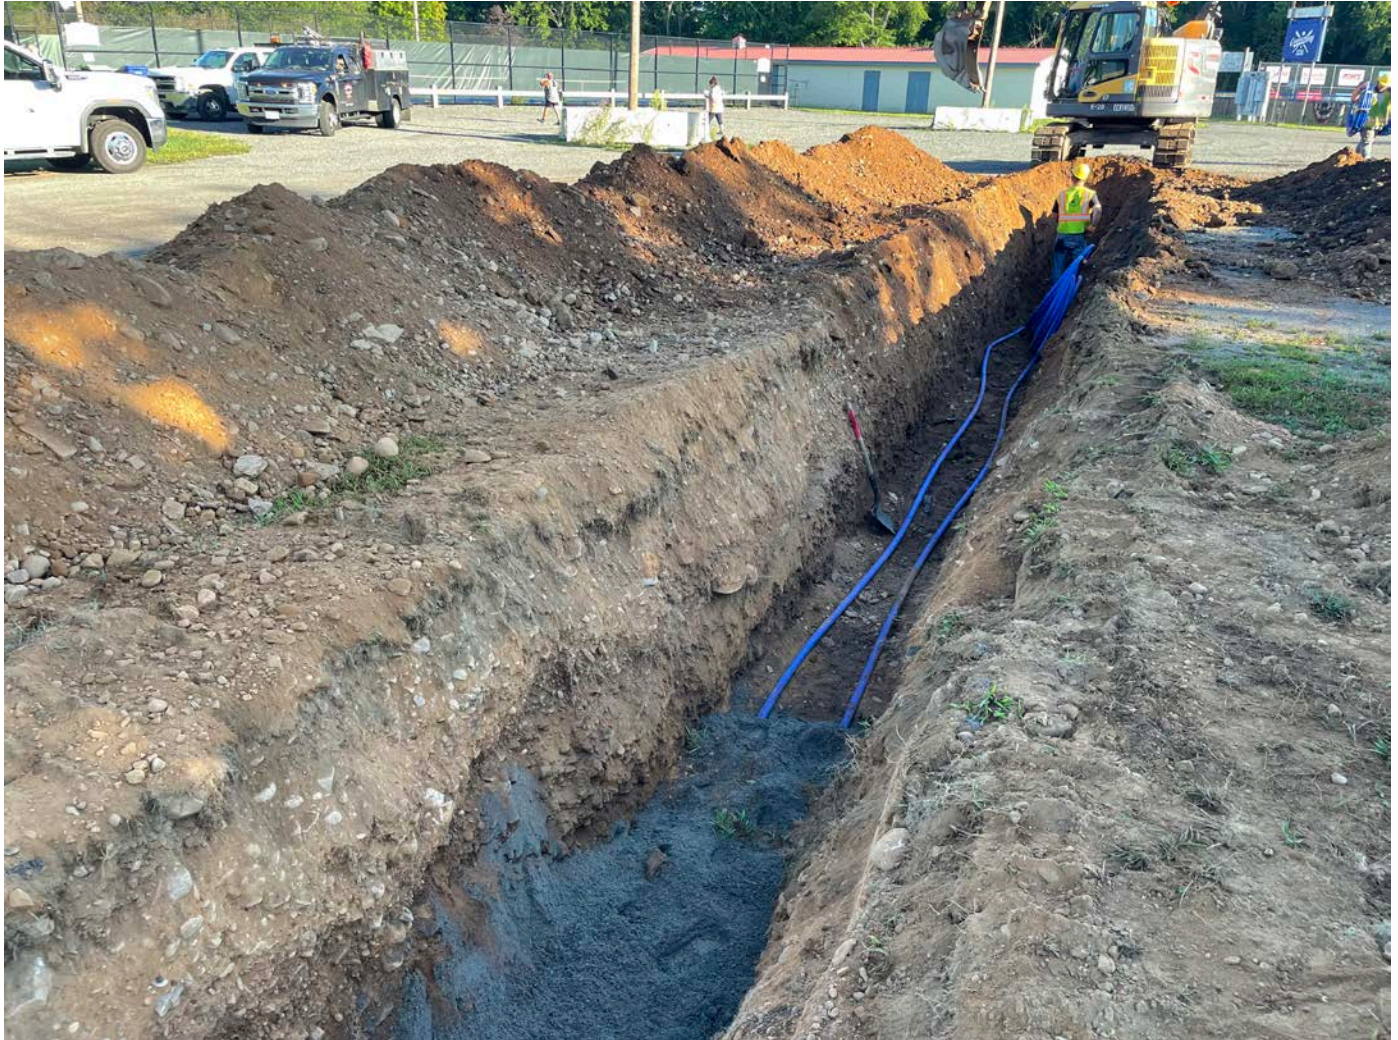
Picture 2: Ludlow installing two 1.5" polyethylene water lines to the north of the two meter vaults they installed at Station ~516+55. View to the north.

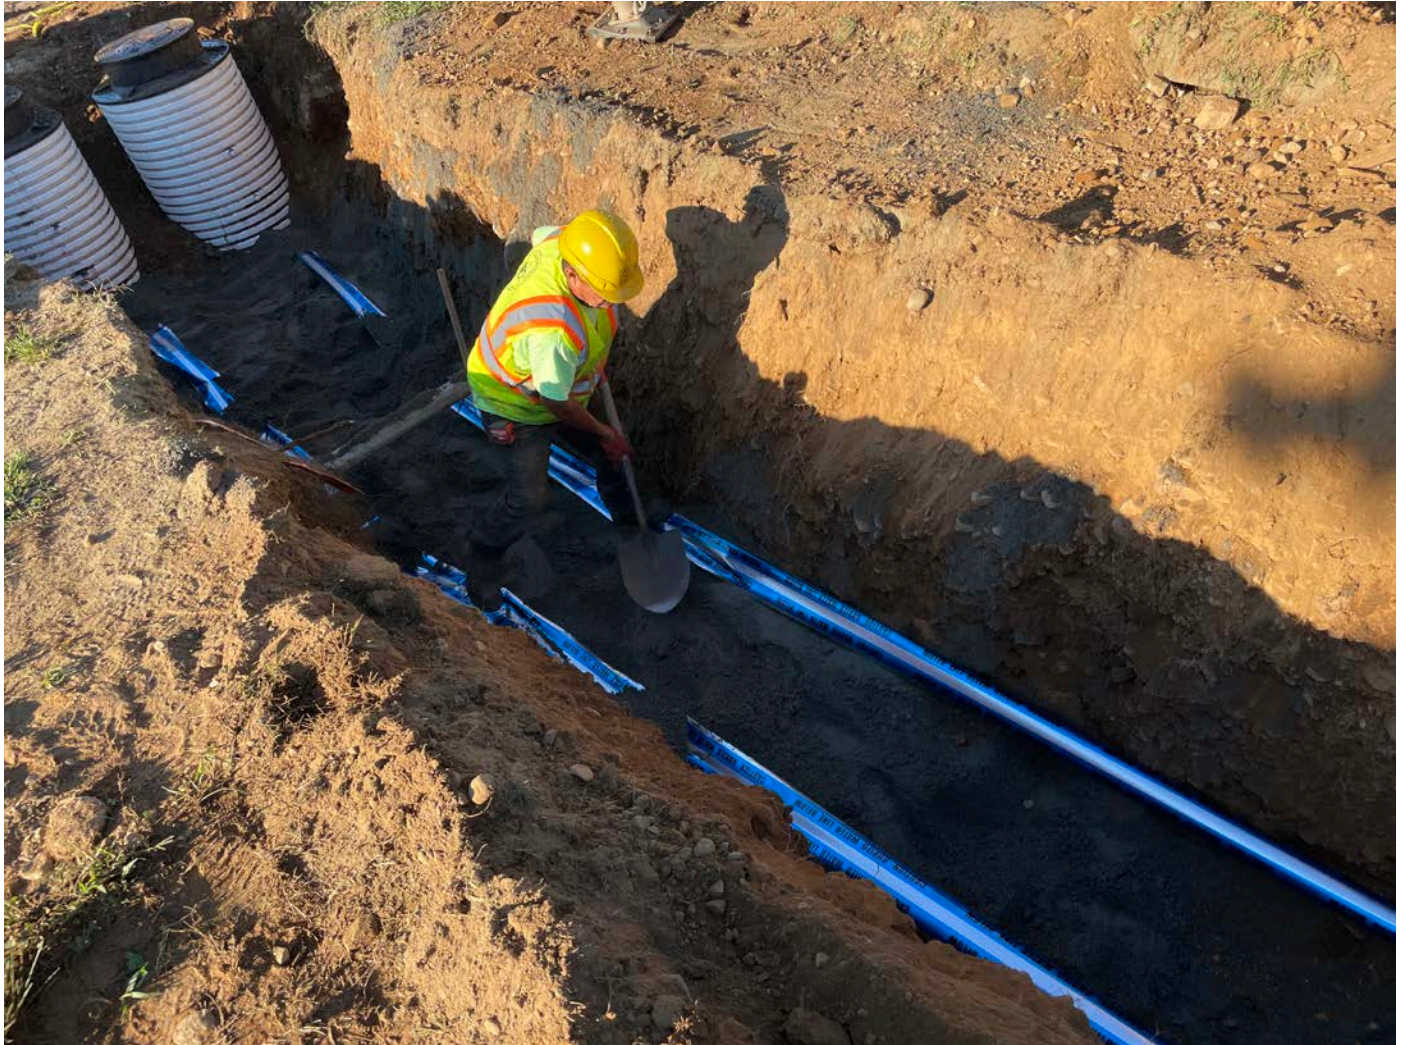
Picture 3: Ludlow placing sand followed by caution tape over the two 1.5" polyethylene water lines they are installing to the north of the two meter vaults they installed at Station ~516+55. View to the southwest.

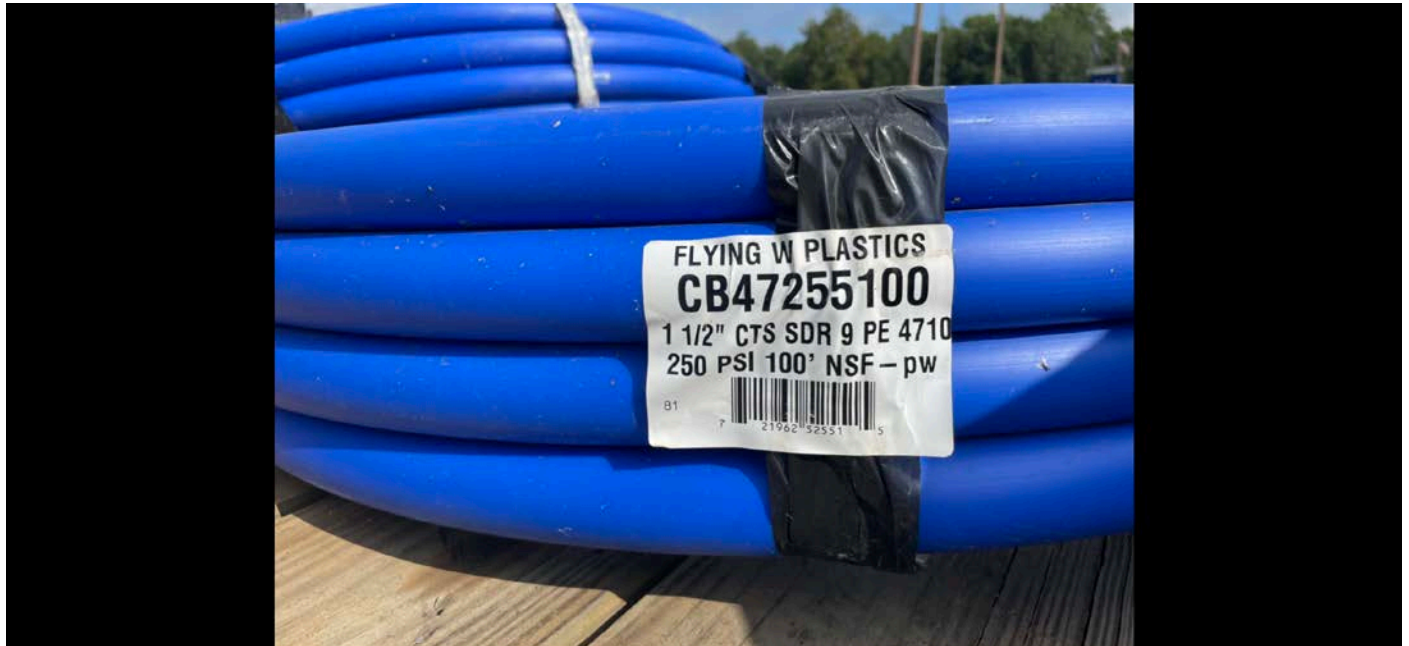
Picture 4: 1.5" polyethylene water line that Ludlow installed between the recreation center and the meter vaults located at Station ~516+55.

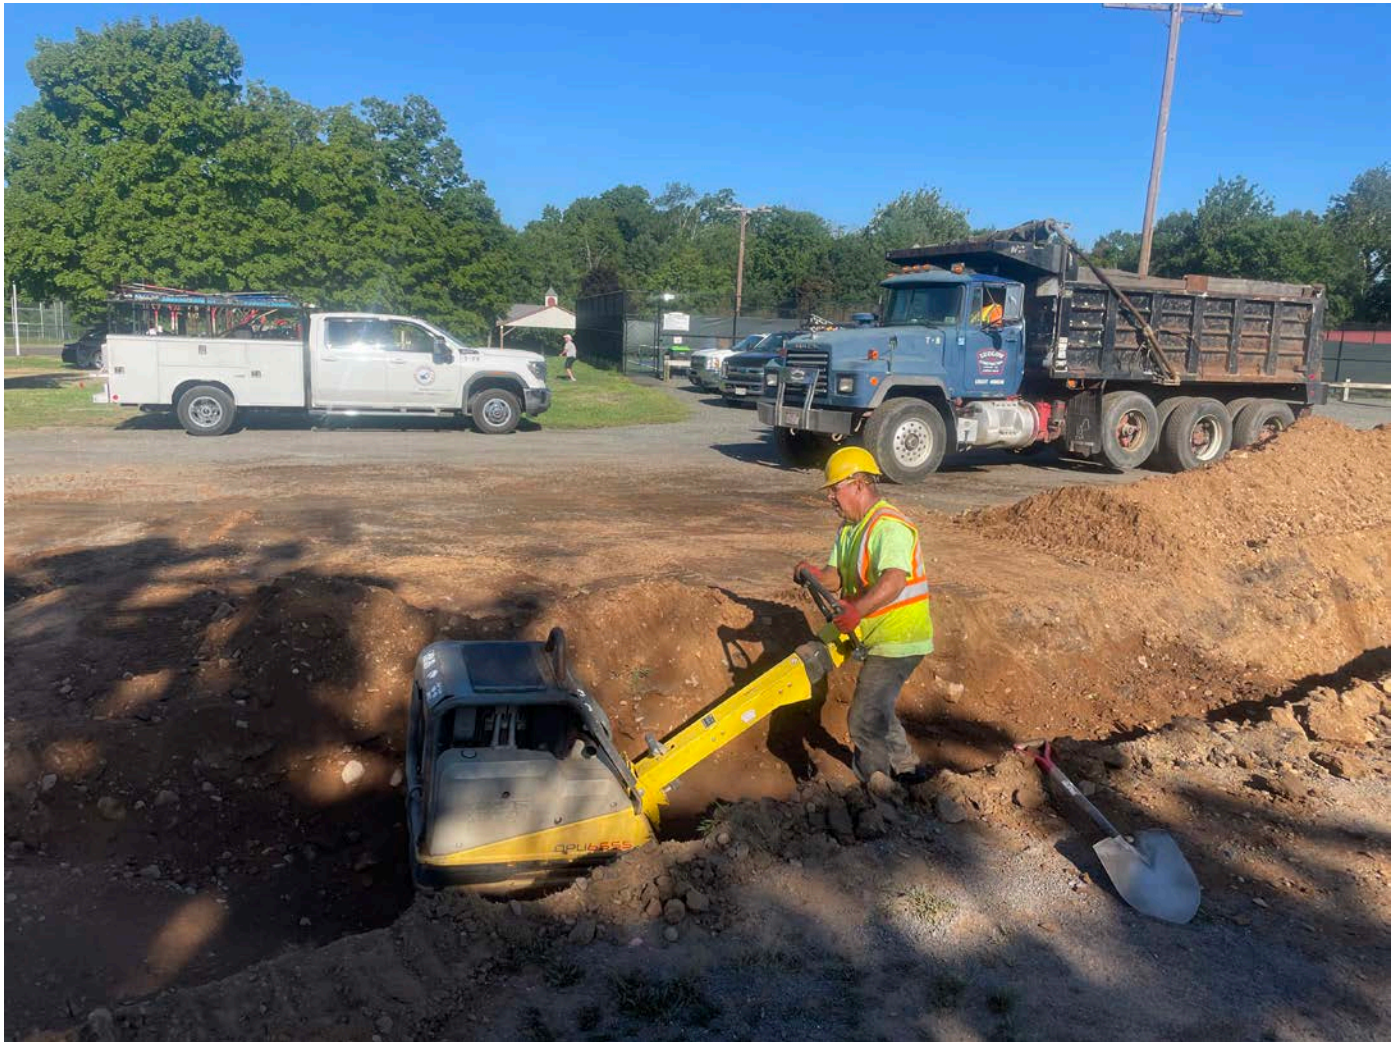
Picture 5: Ludlow compacting fill that was placed over the caution tape and sand they placed on top of the two 1.5" polyethylene water lines that Ludlow installed to the north of the two meter vaults they installed at Station ~516+55. View to the west.

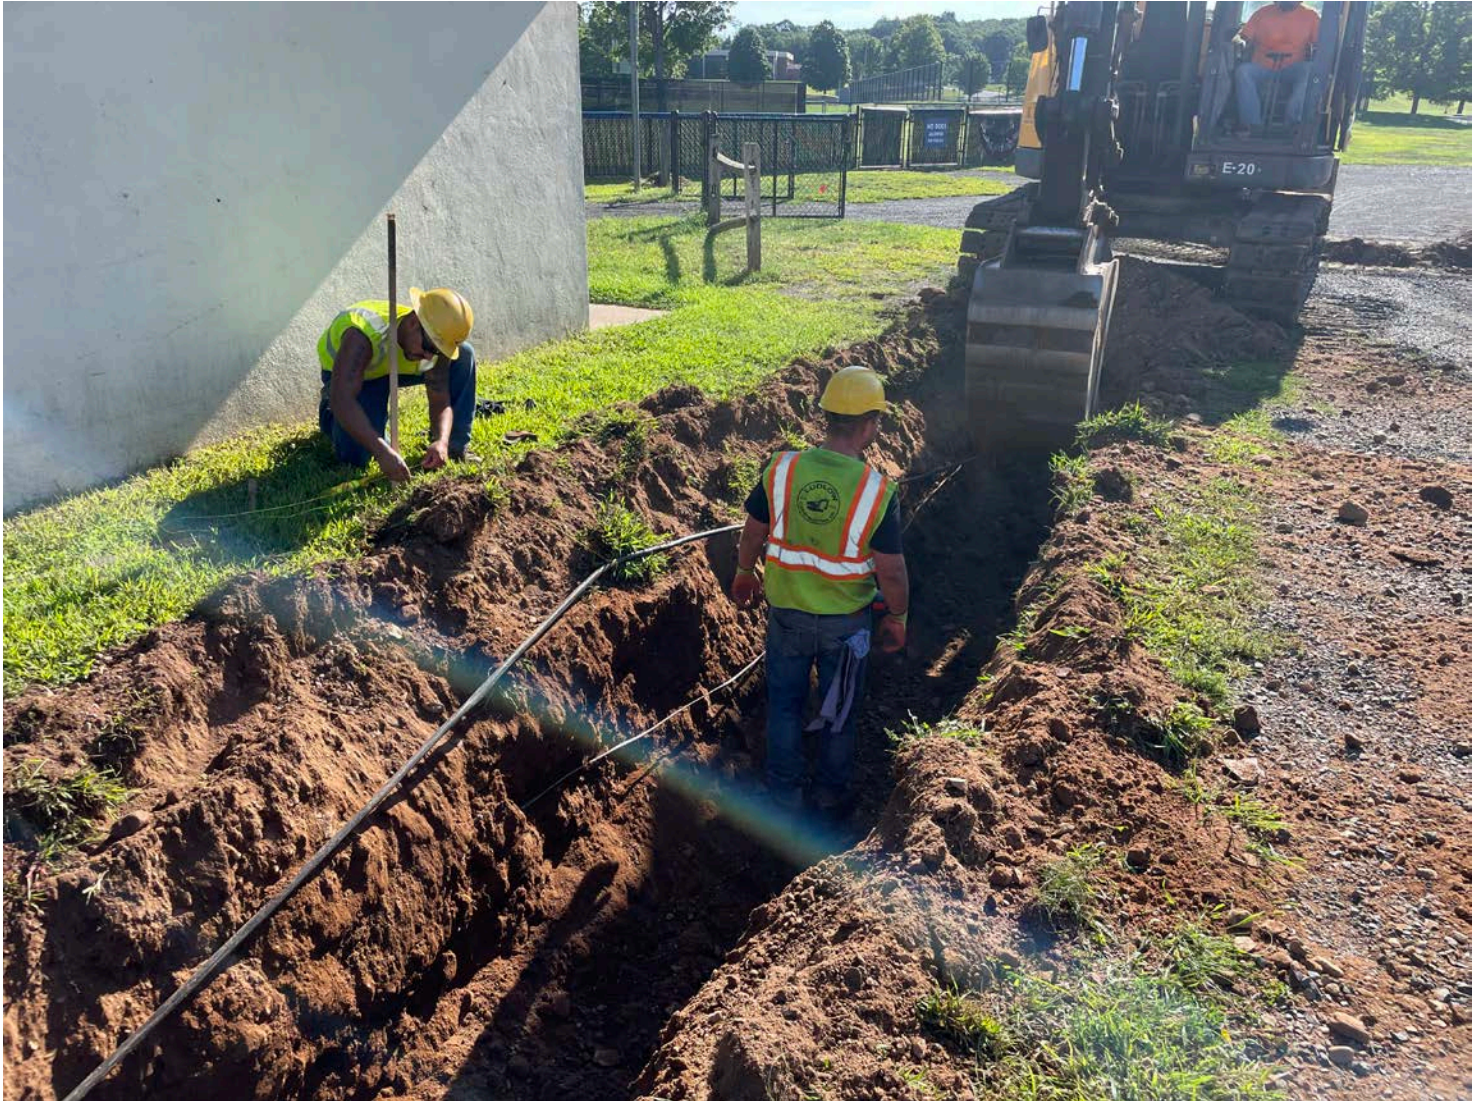
Picture 6: Ludlow excavating on the south side of the recreation center in order to install two 1.5” polyethylene water lines at the recreation center. View to the east.

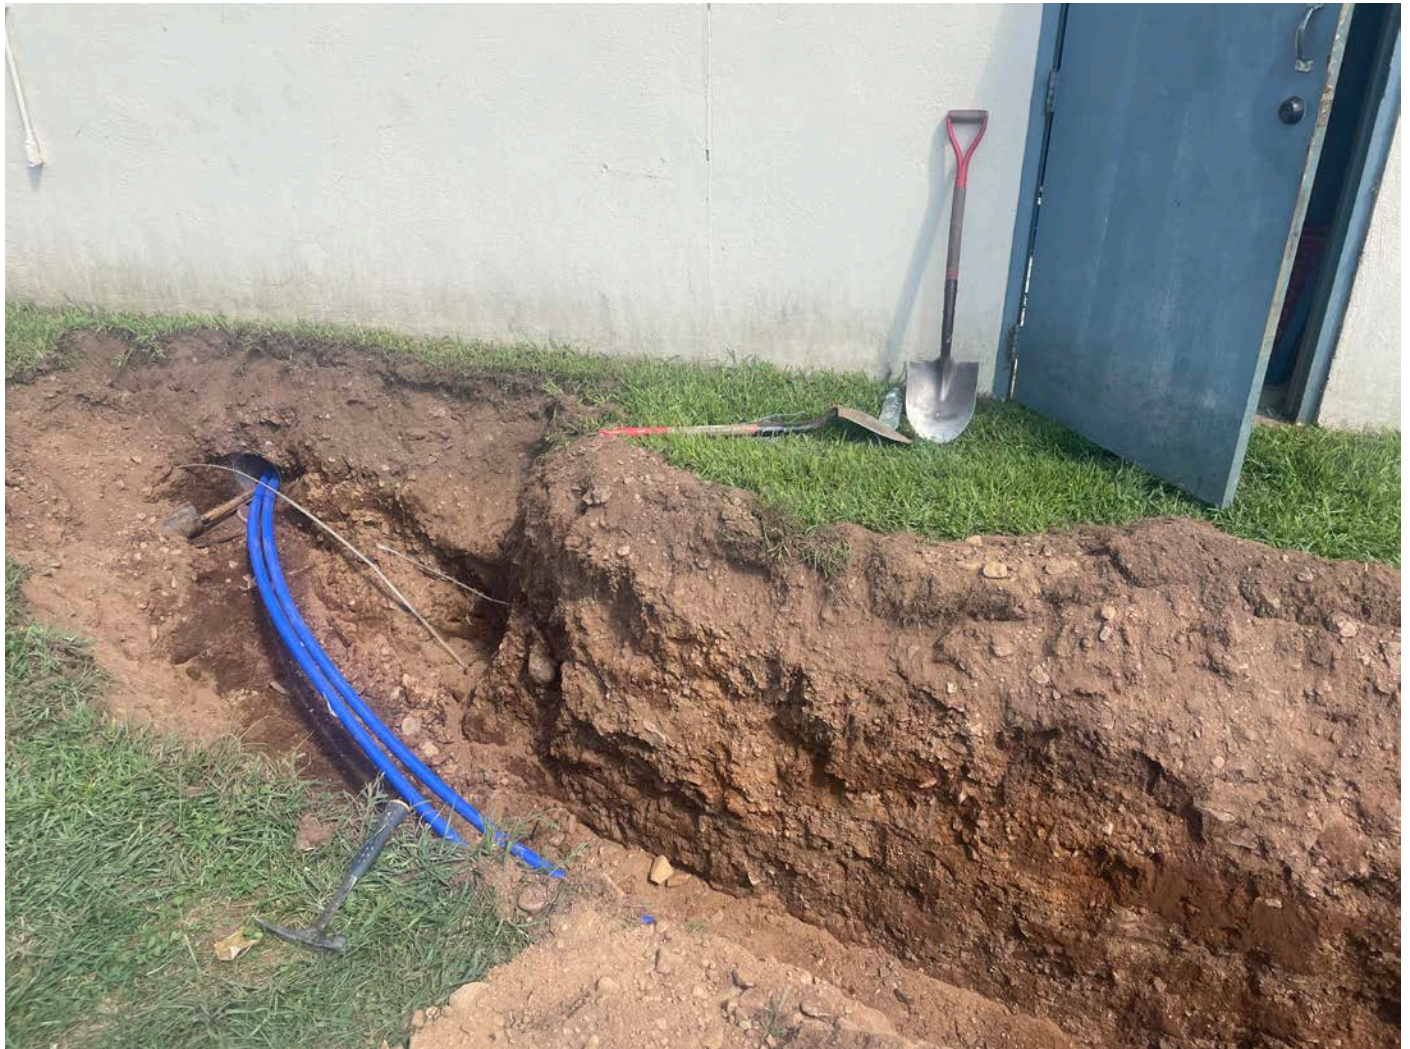
Picture 7: View of the two 1.5" polyethylene water lines that Ludlow installed, where it was run into the south side of the recreation center located on Pickett Lane. View to the northwest.

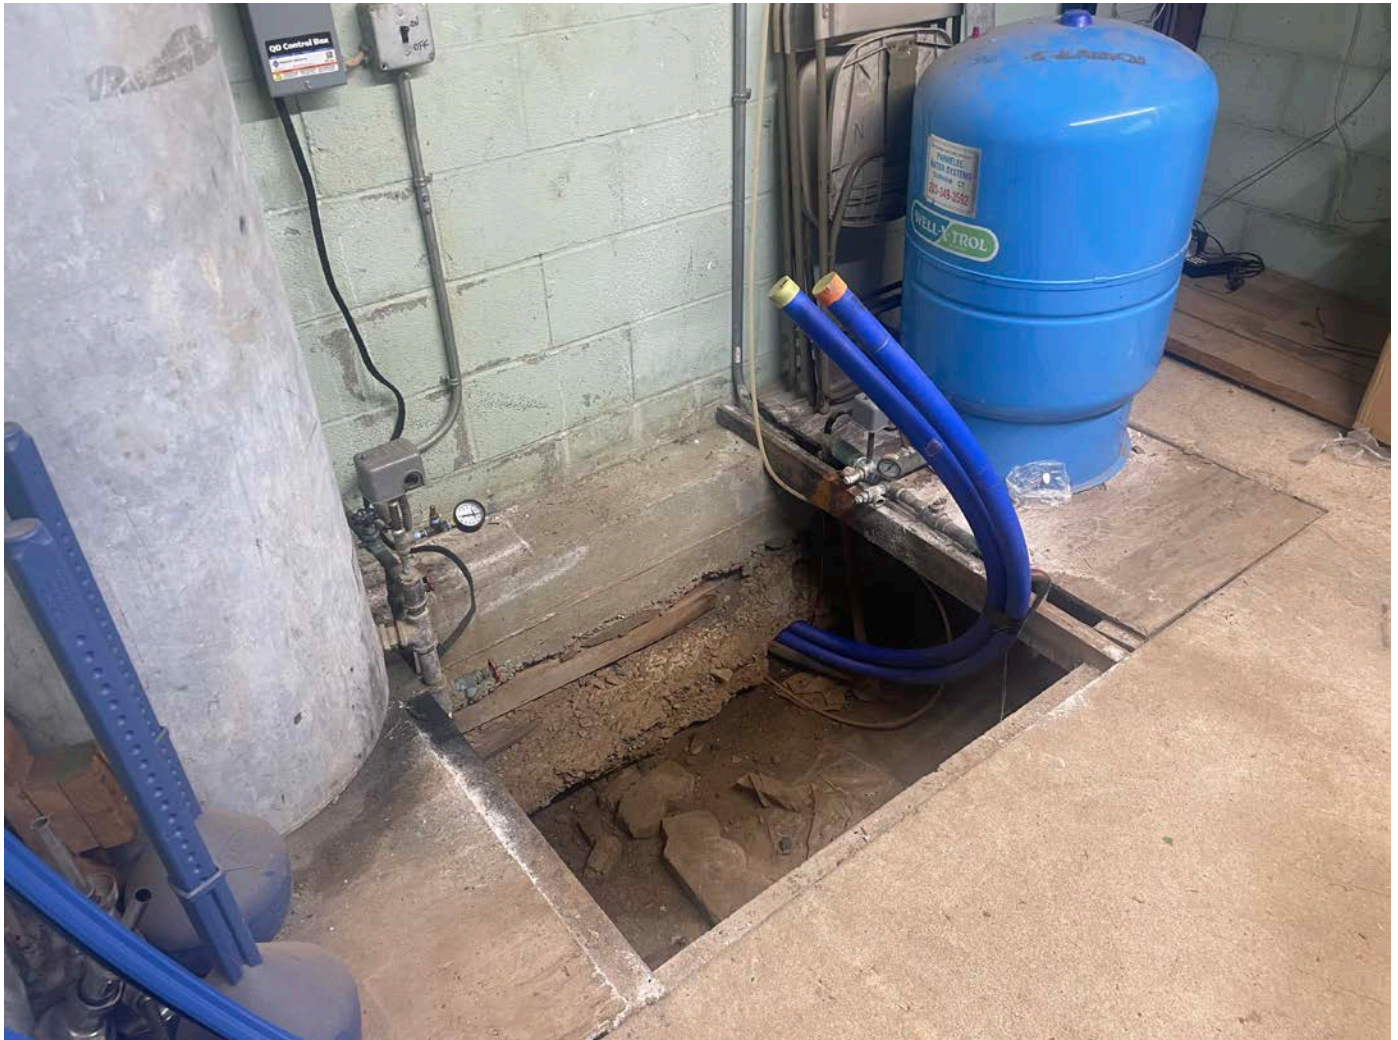
Picture 8: View from the inside of the recreation center where Ludlow ran two 1.5" polyethylene waters. View to the southwest.

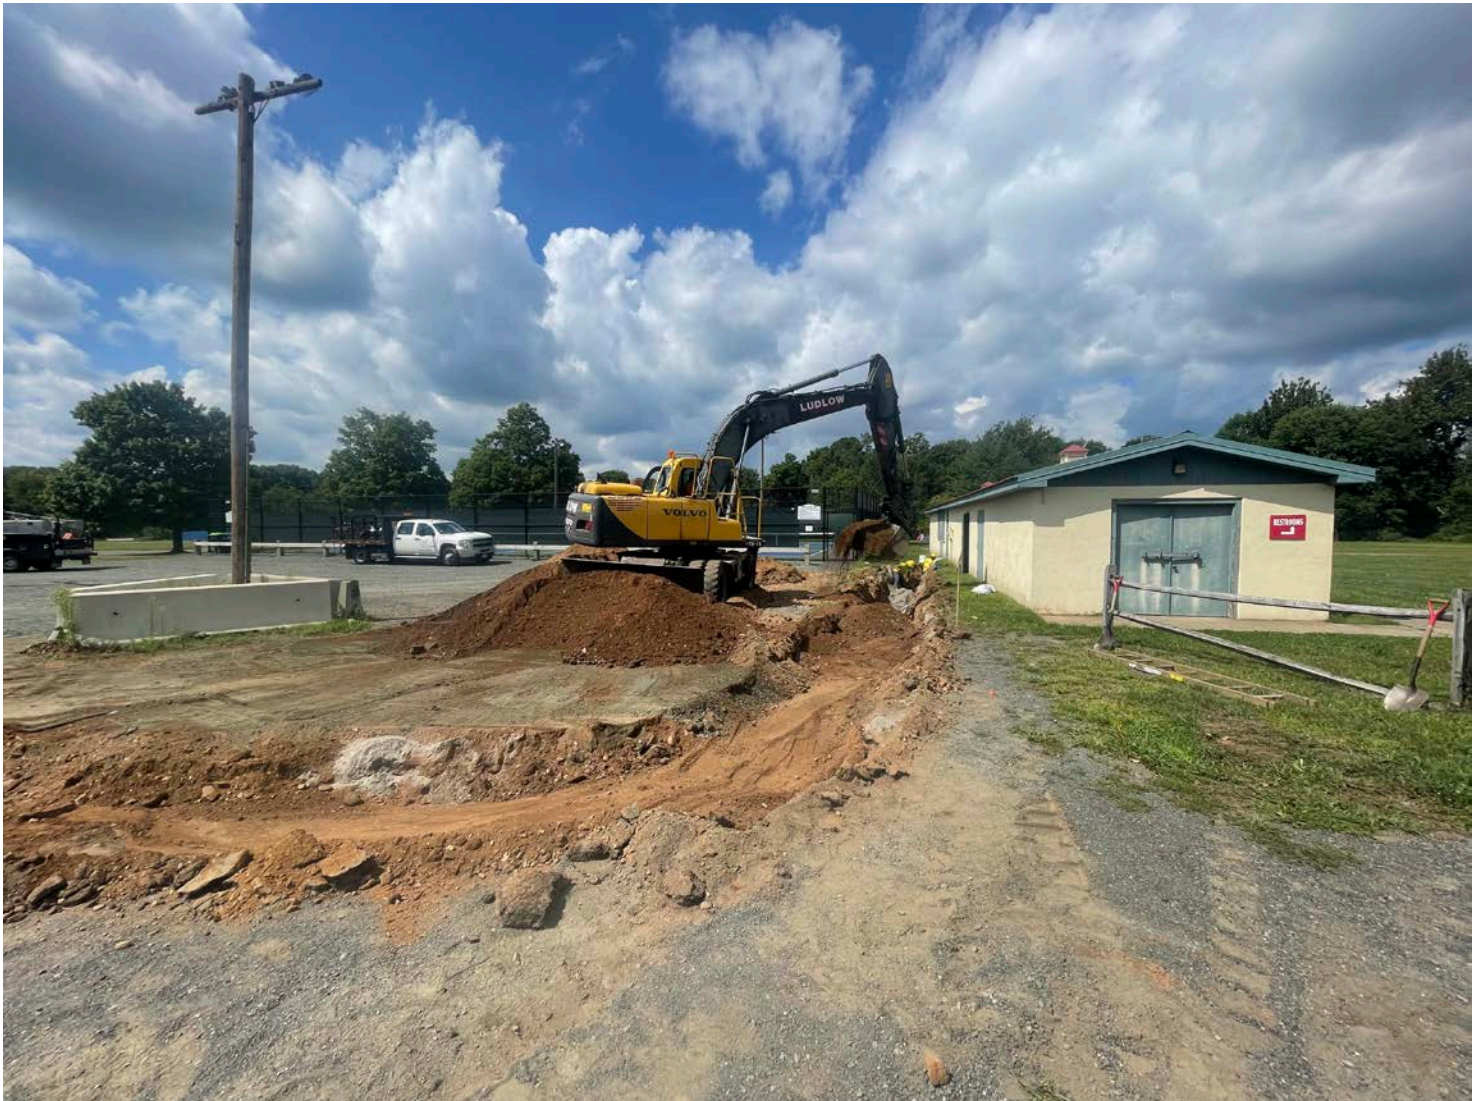
Picture 9: Ludlow placing native fill over the sand they placed over the two 1.5” polyethylene water lines that they Ludlow installed on the south side of the recreation center located on Pickett Lane. View to the west.

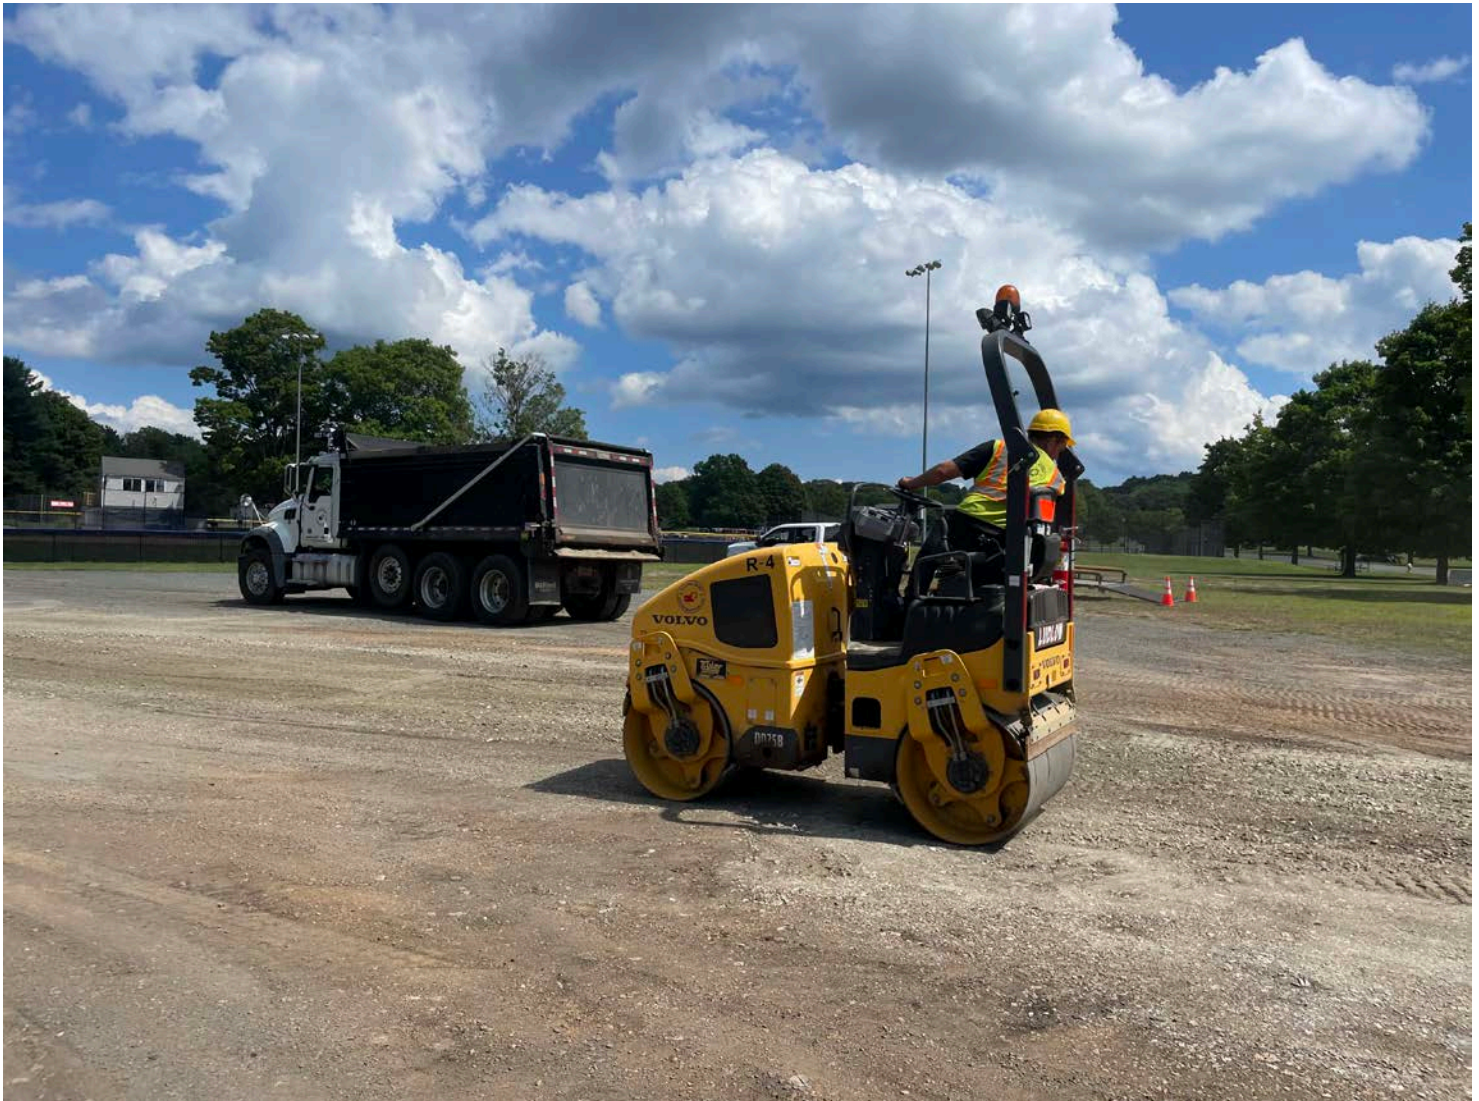
Picture 10: Ludlow compacting the fill they backfilled over the sand and caution tape that was placed over the two 1.5" polyethylene water lines that they installed today. View to the east.

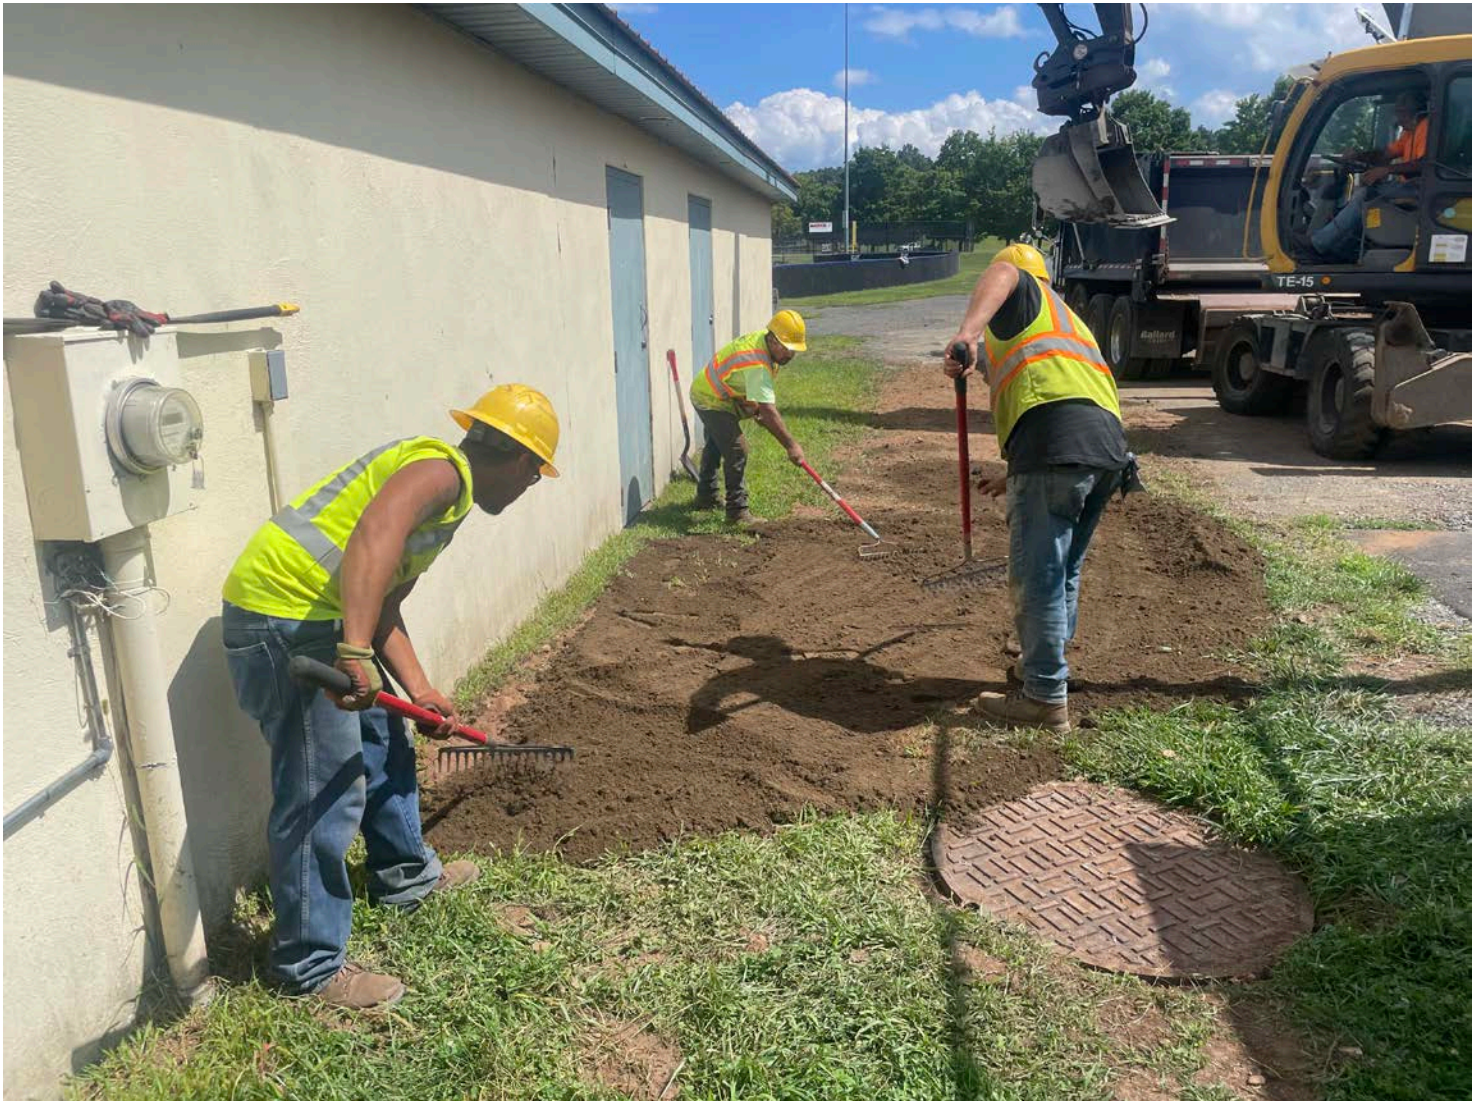
Picture 11: Ludlow placing loam and grass seed on the south side of the recreation center located on Pickett Lane after they installed two 1.5" polyethylene water lines. View to the east.

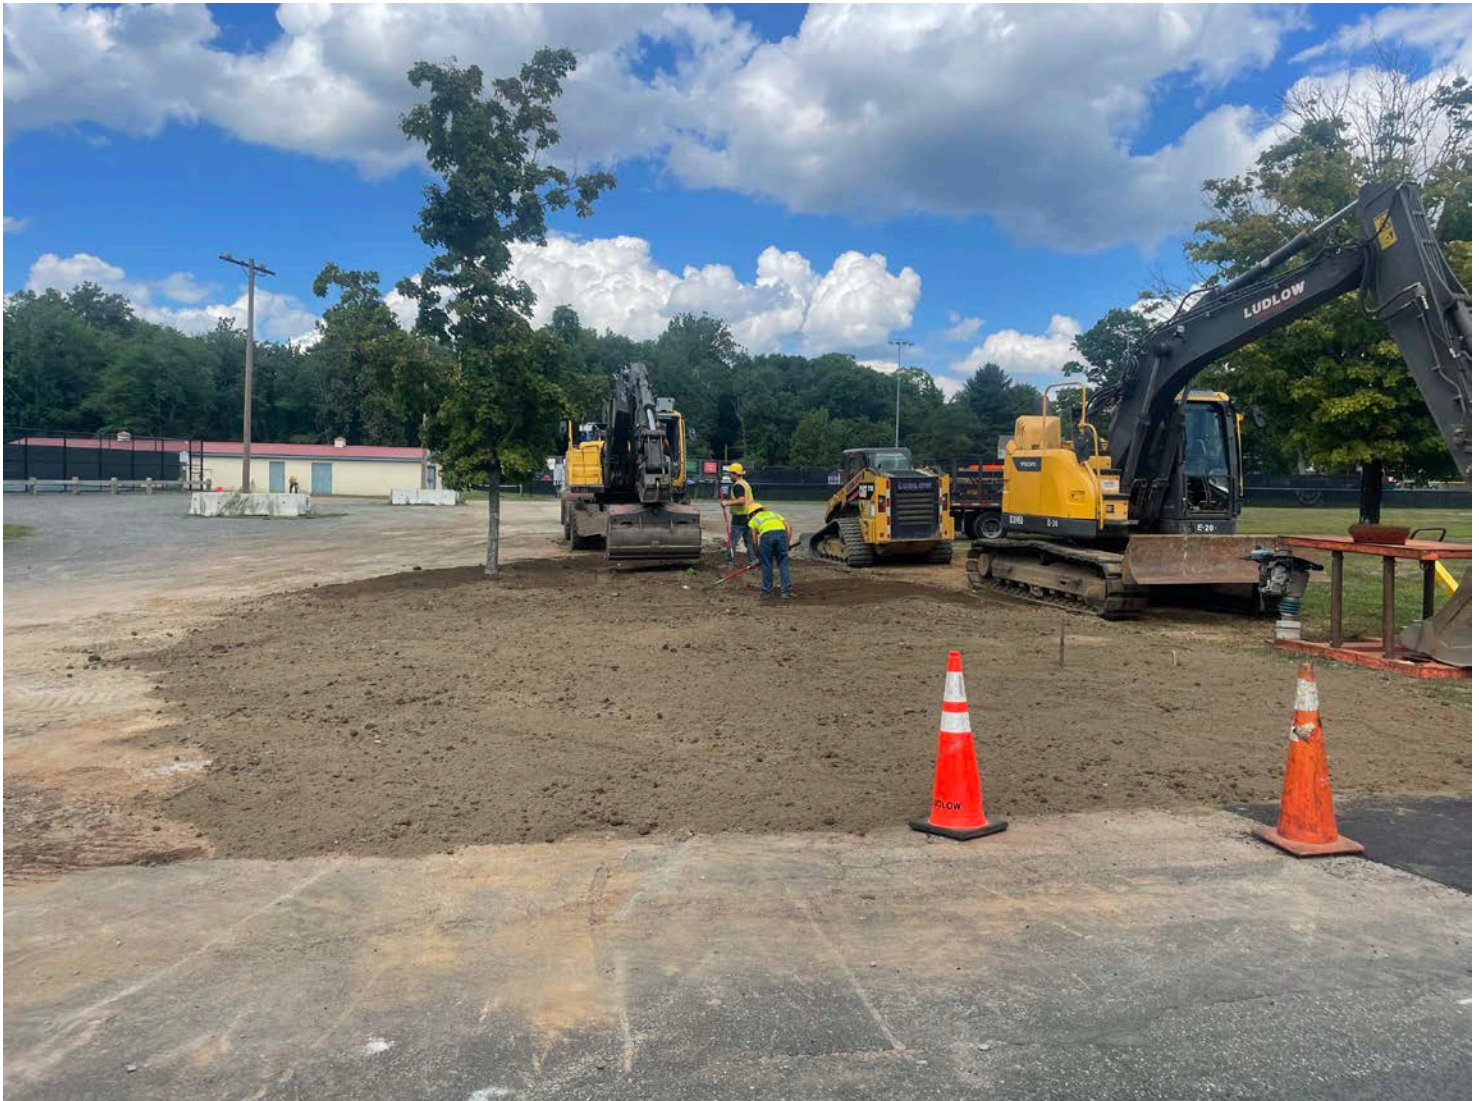
Picture 12: Ludlow placing loam and grass seed on the north side of Pickett Lane after they installed two 1.5” polyethylene water lines. View to the north.
