## Daily Report

<b>Project:</b>	Durham Meadows Pipeline Installation	<b>Date:</b>	September 19, 2022
<b>Location:</b>	Main Street, Maple Avenue, and Pickett Lane, Durham; S. Main Street, Middletown	<b>Day of Week:</b>	Monday
<b>Project #:</b>	AECOM: 6061487	<b>Report No:</b>	512
<b>Contractor:</b>	Ludlow Construction	<b>Page:</b>	2 of 12

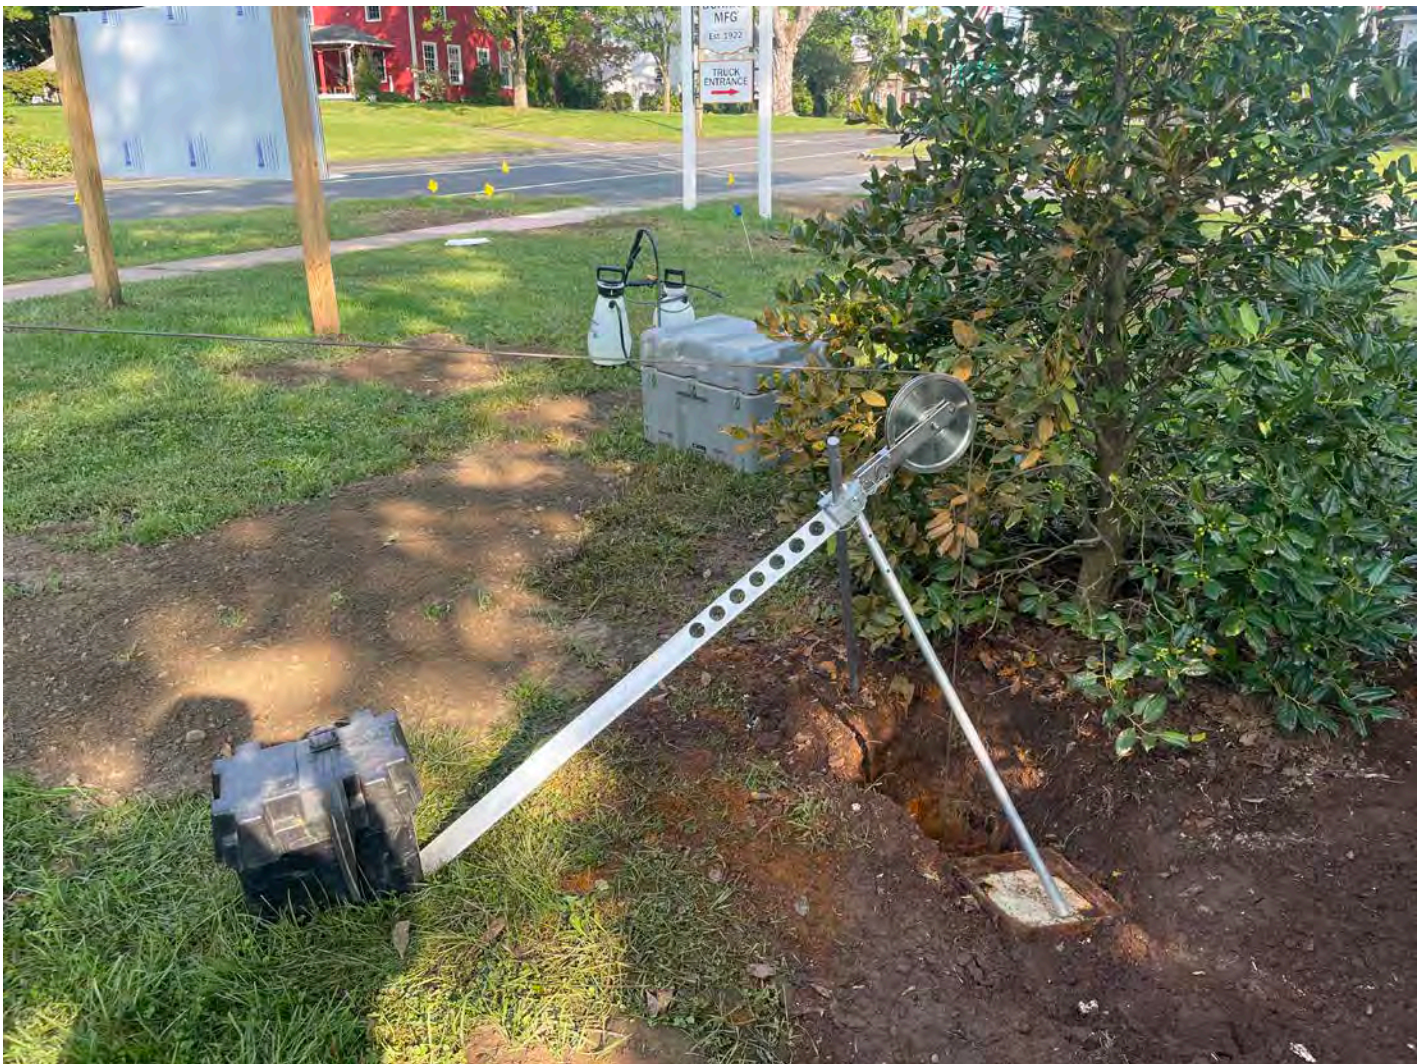
Picture 1: Geophysical Applications setting up on well DMC-2 to resume borehole assessment activities. View to the northwest.

0835: Geophysical Application mobilizes back to the Durham Manufacturing facility to continue logging well number DMC-2.

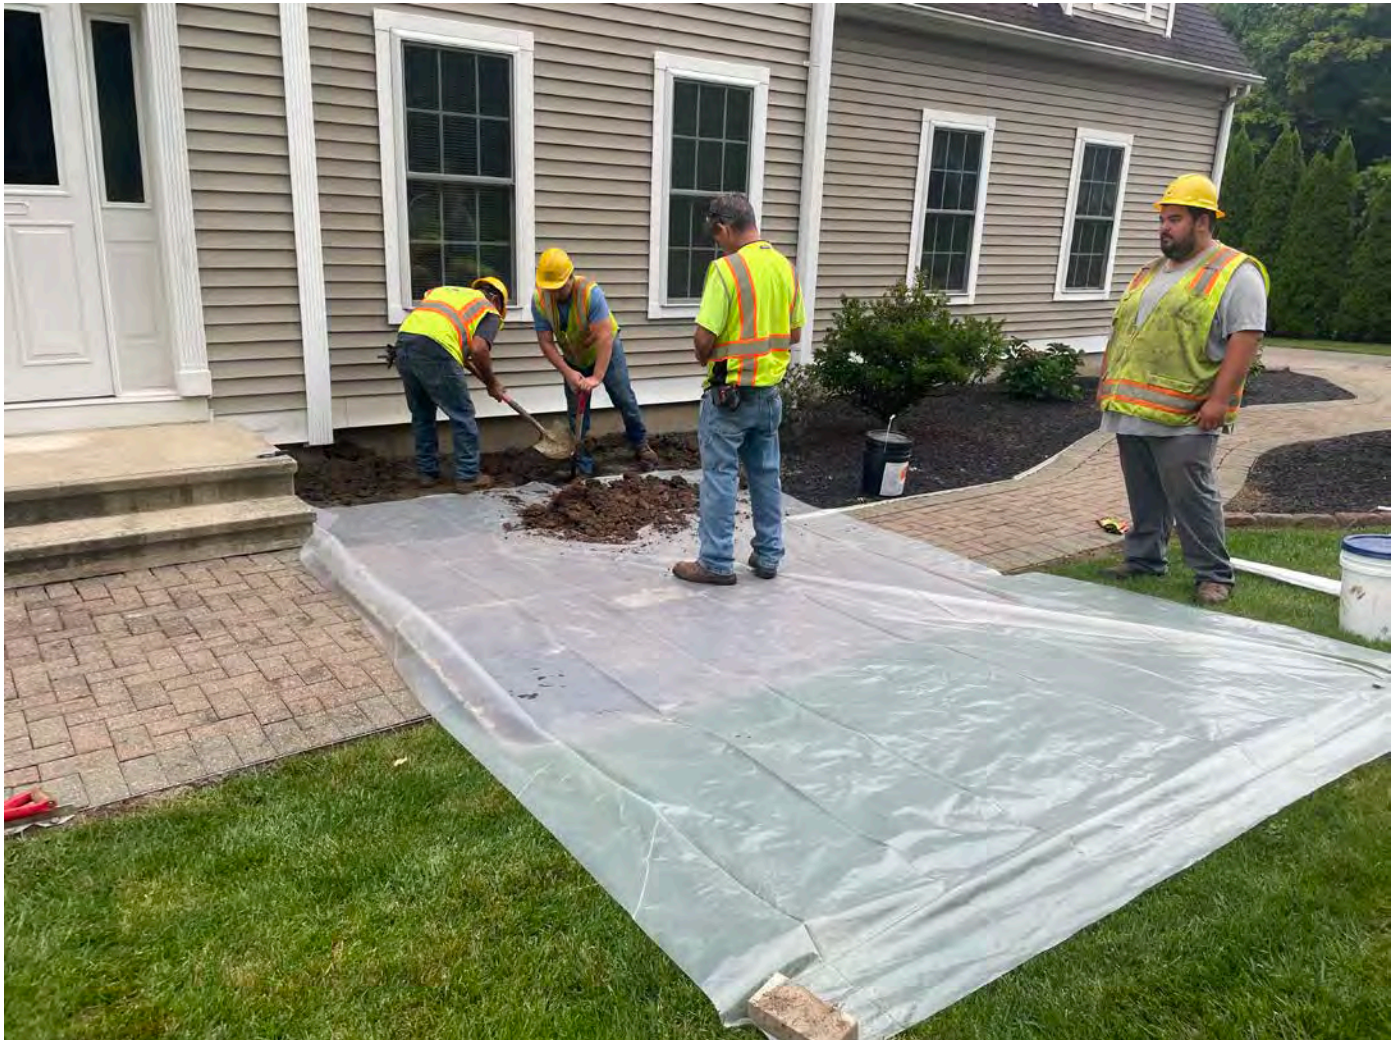
Picture 2: Ludlow hand-excavating on the east side of the 166 Maple Avenue residence to daylight where the 1" copper water service line penetrates the foundation in order to address a minor leak in the basement of the house. View to the northwest.

0843: Ludlow is chipping the concrete around where the 1" copper water service line penetrates the eastern foundation of the 166 Maple Avenue residence o make a clean patch where Ludlow will apply a seal of hydraulic cement.

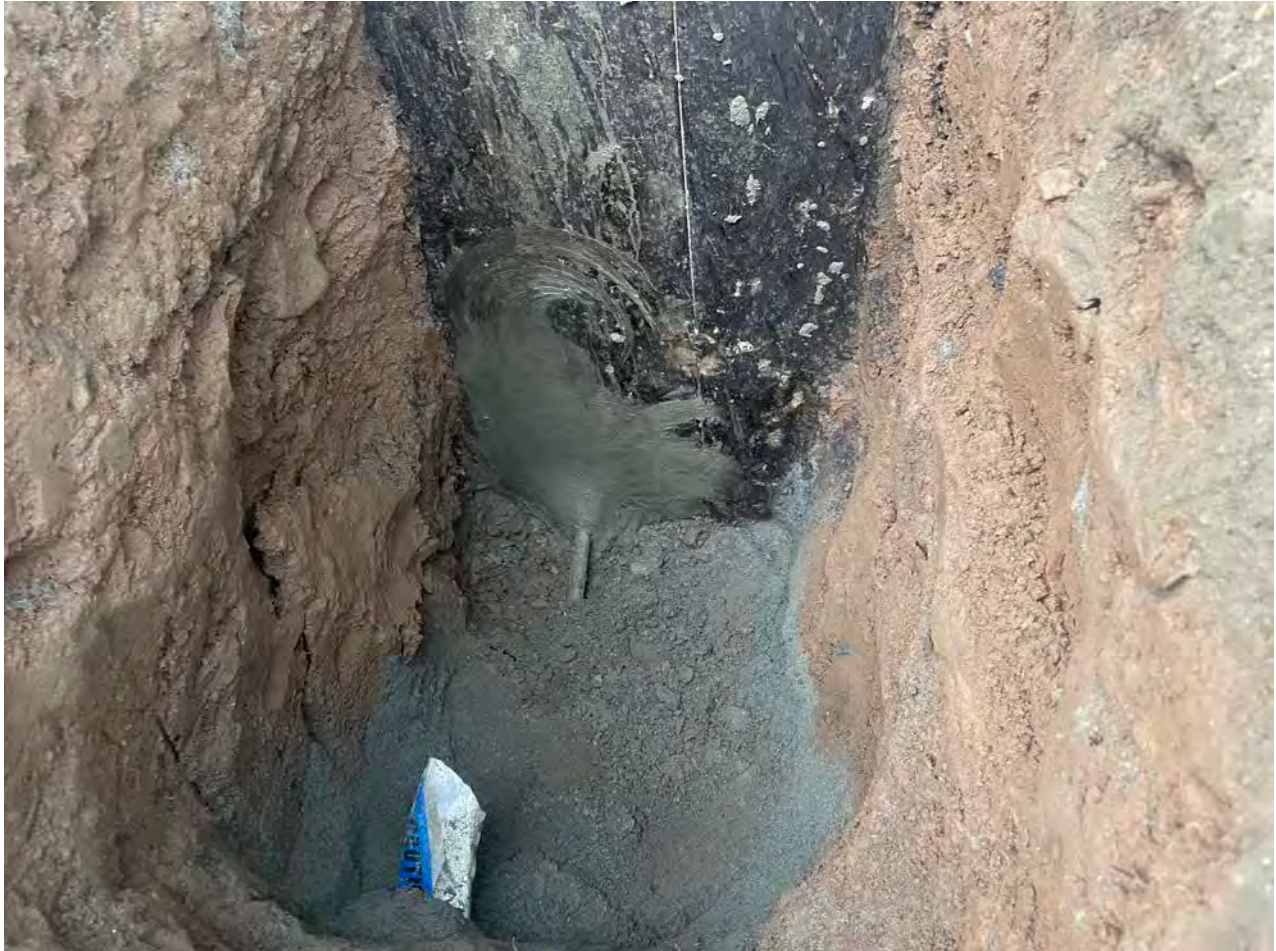
**Picture 3: The east side of the 166 Maple Avenue residence where Ludlow has daylighted the 1” copper water service line that penetrates the home’s foundation. Ludlow has placed a patch of hydraulic cement around the area where the copper line penetrates the foundation. View to the west.**

0911: Ludlow has just placed a patch of hydraulic cement around the 1" copper water service line where it penetrates the eastern foundation of the 166 Main Street residence.

0947: Ludlow is waiting for the hydraulic cement to cure before they coat it with foundation sealant.

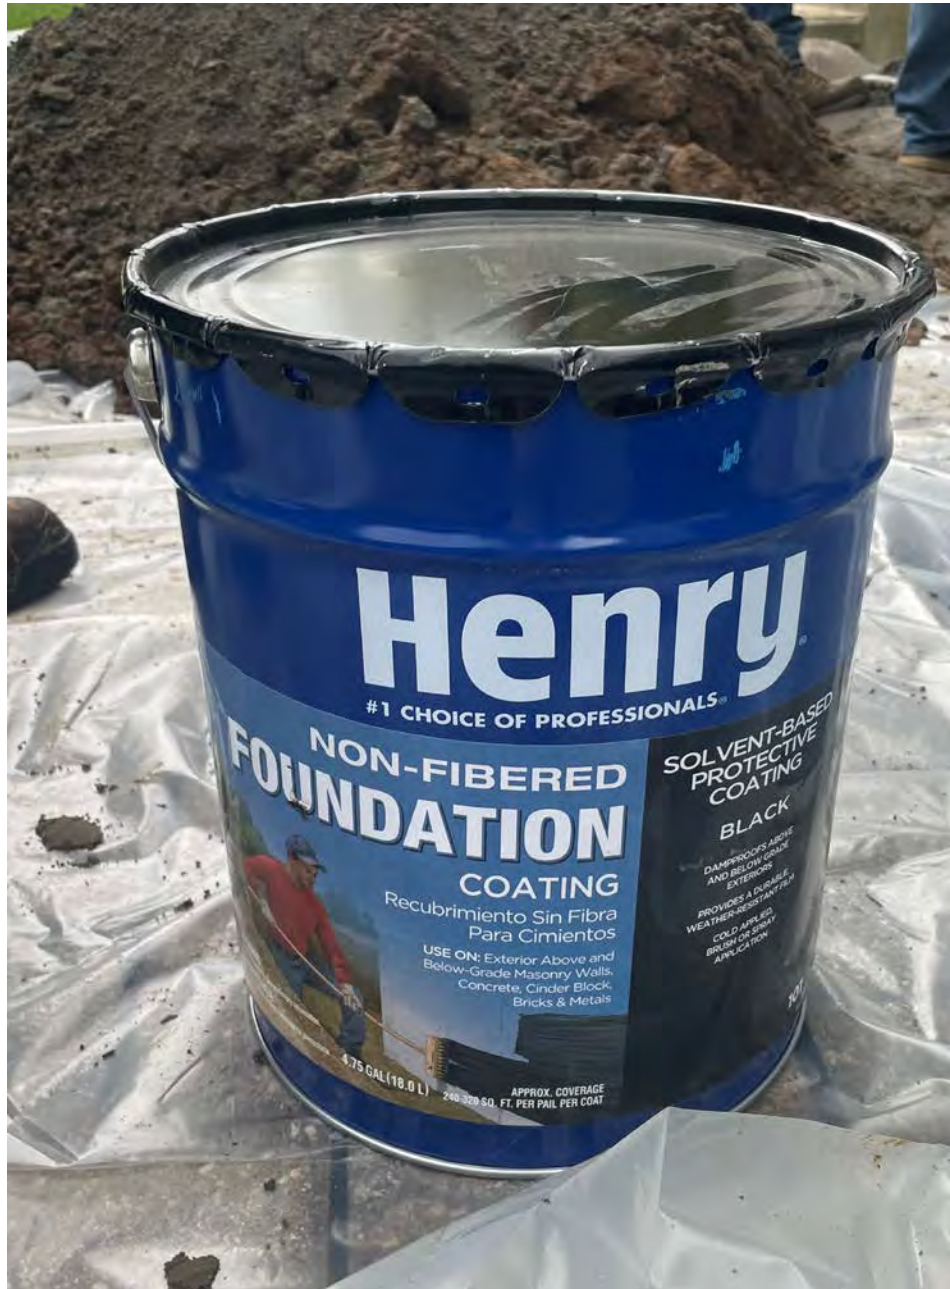
Picture 4: The foundation coating that Ludlow applied to the area they placed a cement patch at the 166 Maple Avenue residence where the 1" copper water service line penetrates the foundation.

1038: Ludlow is applying Henry non-fiber foundation coating to the section of the foundation above and below where the 1" copper water service line penetrates the eastern foundation of the 166 Maple Avenue residence.

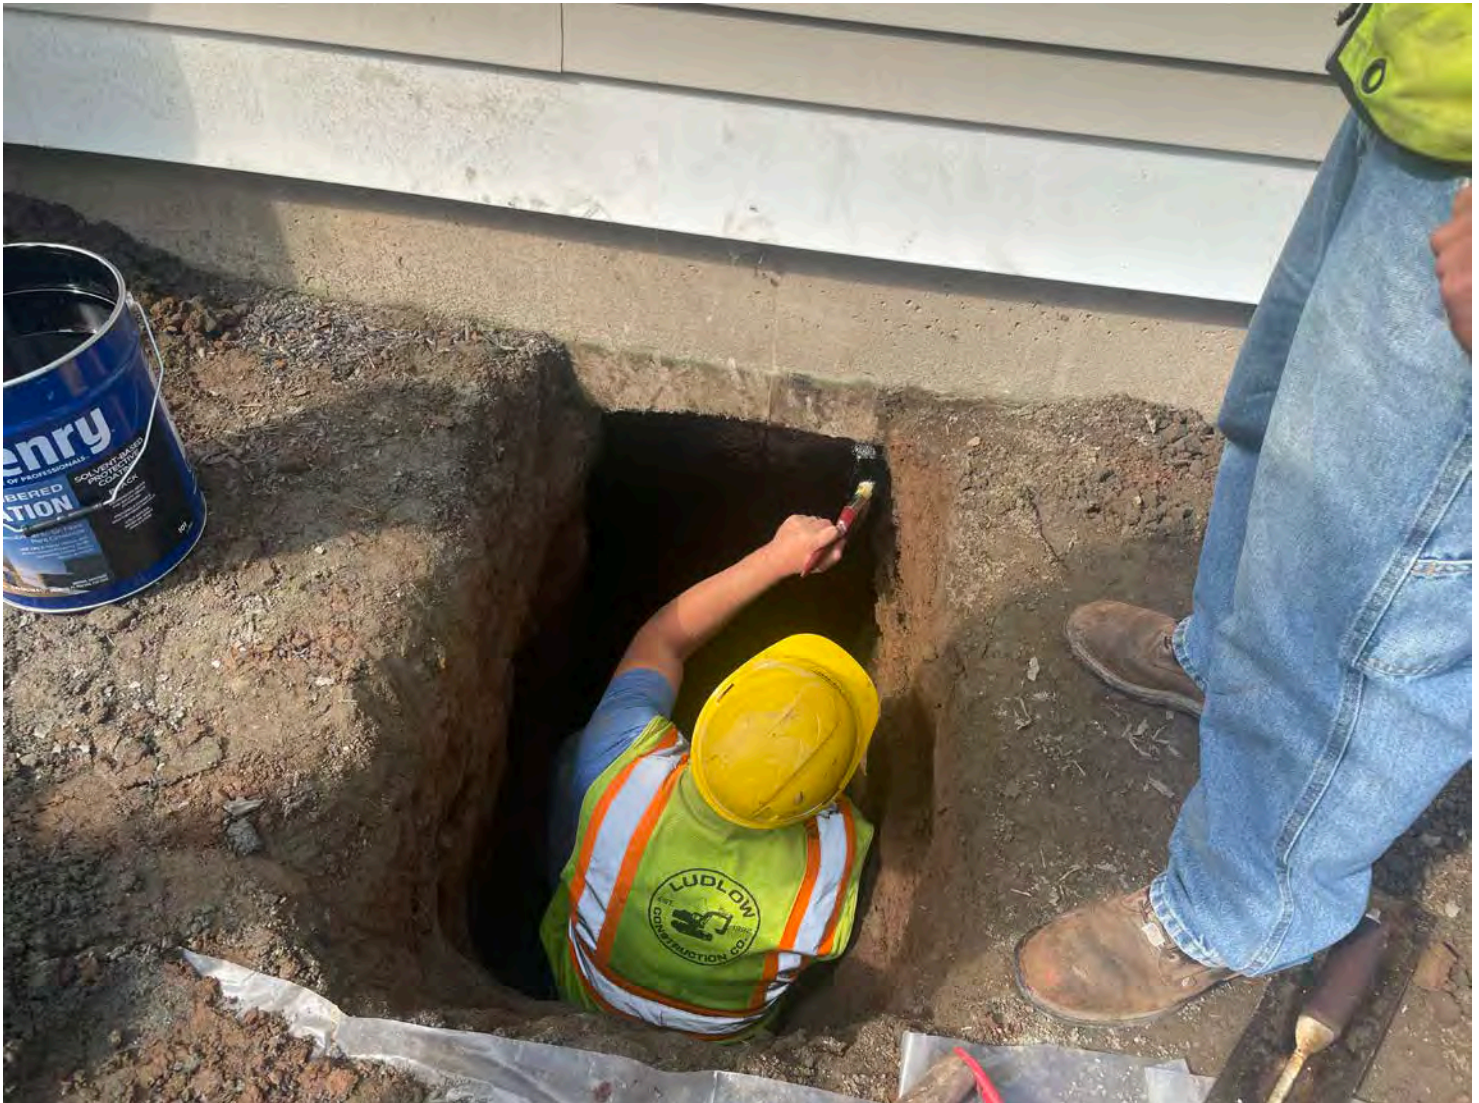
Picture 5: Ludlow applying foundation coating to the area they placed a cement patch at the 166 Maple Avenue residence where the 1" copper water service line penetrates the foundation. View to the west.

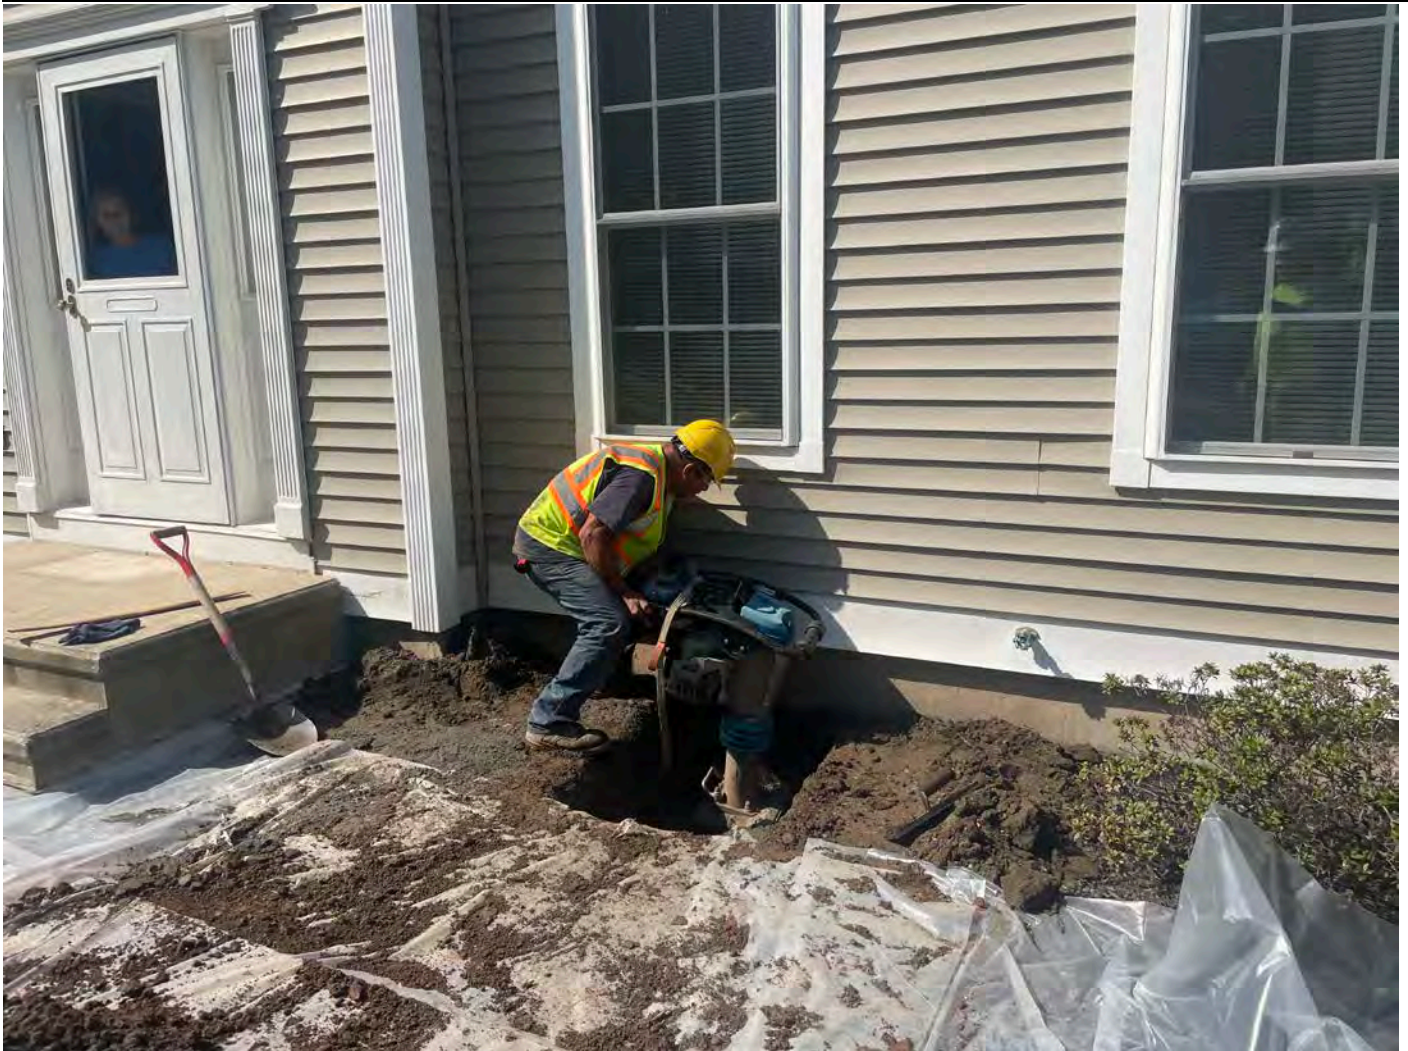
Picture 6: Ludlow compacting backfill on the east side of the 166 Maple Avenue residence after they repaired a small leak where the 1" copper water service line penetrates the east side of the home's foundation. View to the southwest.

1055: Ludlow tests their leak repair by dumping 5 gallons of water into the excavation on the east side of the foundation where they applied hydraulic cement and foundation sealer. No leaking was observed where the 1" copper pipe enters the west side of the foundation, as observed from inside of the home's basement.

1059: Ludlow begins to backfill the excavation on the east side of the foundation of the 166 Maple Avenue residence.

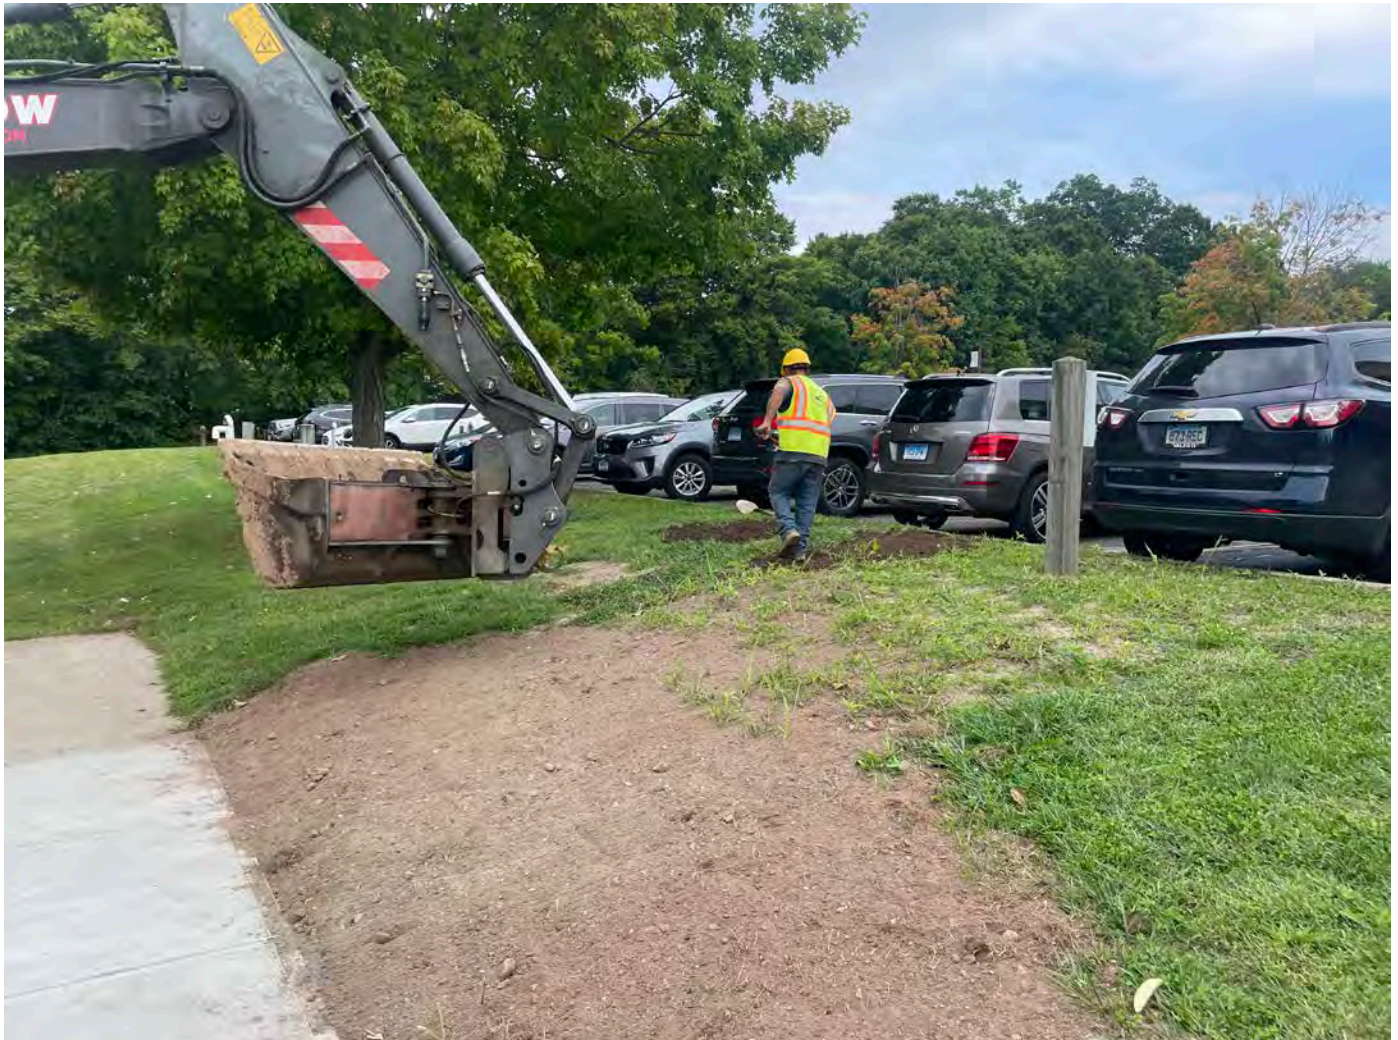
Picture 7: Ludlow placing loam on the portions of the lawn that were disturbed during the installation of a water service line at the CRHS. View to the northeast.

1219: Ludlow is placing loam on portions of the lawn at the Coginchaug Regional High School in Durham that were disturbed during trench over cut repaving activities and sidewalk repair activities.

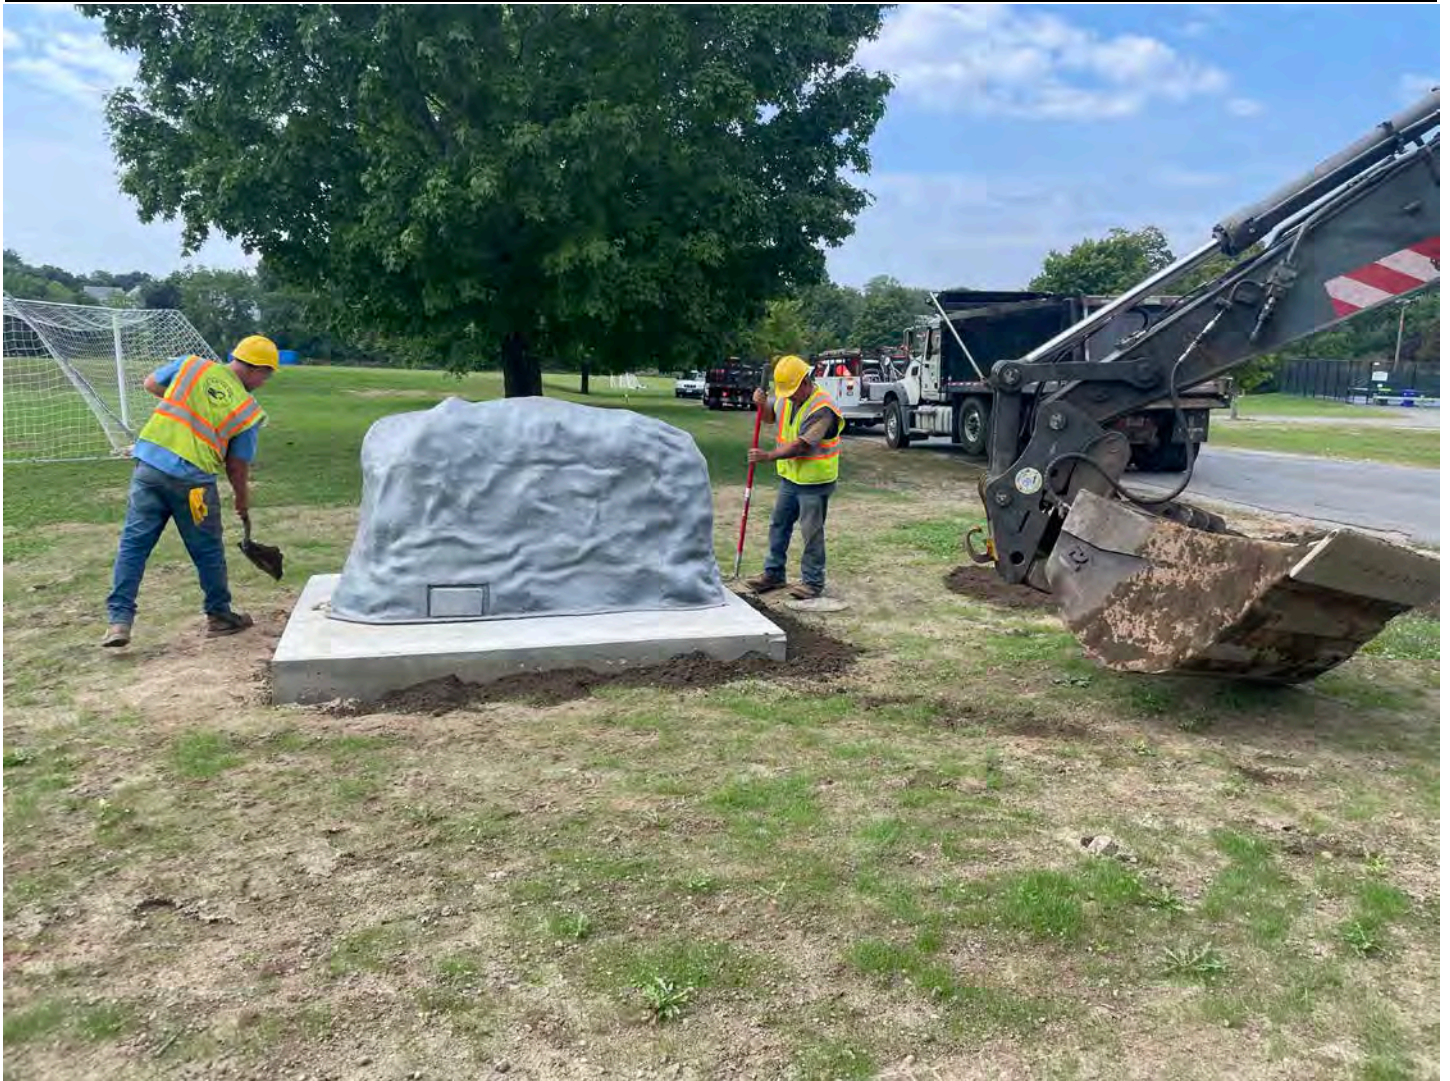
**Picture 8: Ludlow placing loam around the backflow preventer located on the south side of Pickett Lane, Durham, near Station 517+73. View to the west.**

1235: Ludlow is placing loam and grass seed around the backflow preventer located at Station 517+73, on the south side of Pickett Lane, Durham.

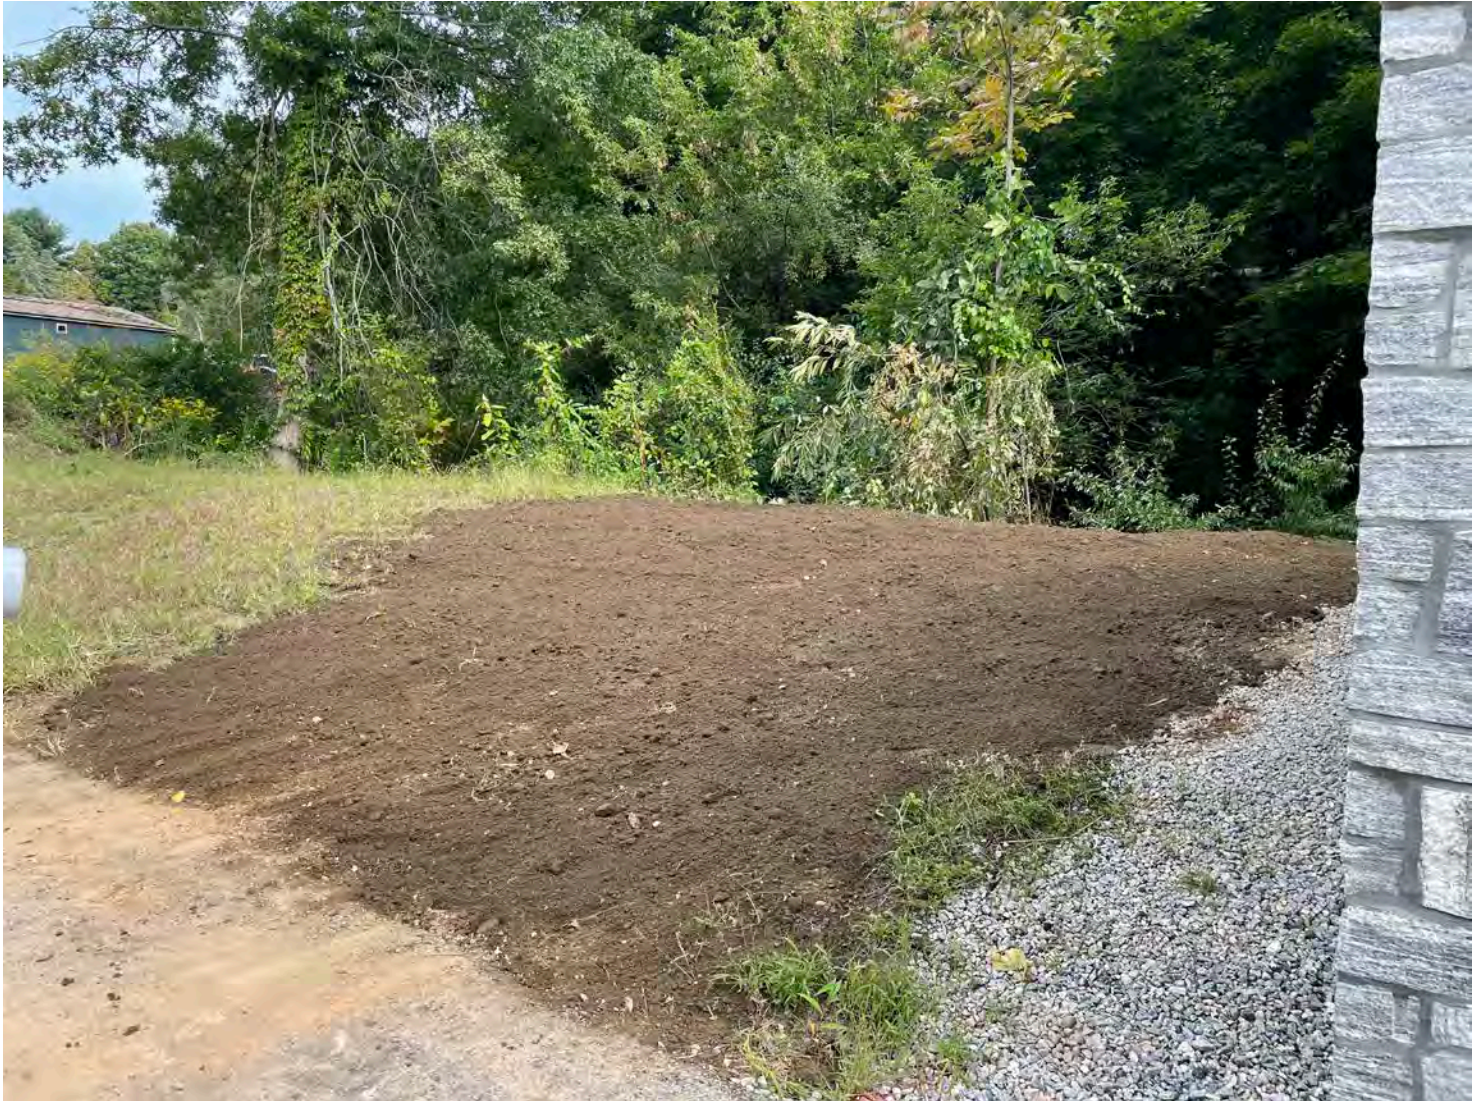
**Picture 9: Loam and grass seed that Ludlow placed on the north side of the Water Meter Building located on S. Main Street in Middletown. View to the northeast.**

1403: Ludlow is placing loam and grass seed on the north side of the Water Meter Building on S. Main Street in Middletown.
