#### **Daily Report**

#### Daily Activities – Installation of a gate valve, Booster Station, Middletown

<b>7 1</b>		
Project:	Durham Meadows Pipeline Installation	Date:	October 7, 2022
Location:	Pickett Lane and Maiden Lane, Durham; S. Main Street and the Shared Access Road, Middletown	Day of Week:	Friday
Project #:	AECOM: 6061487	Report No:	525
Contractor:	Ludlow Construction	Page:	2 of 14

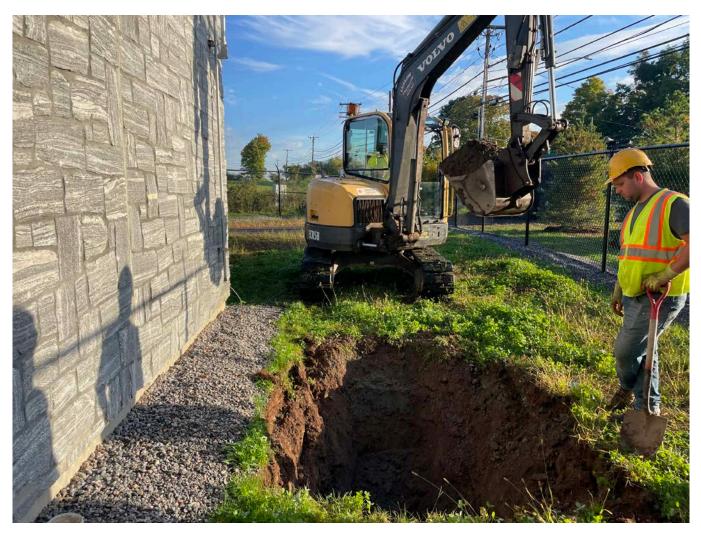
Picture 1: Ludlow excavating on the east side of the Booster station to install a gate valve on the 8" DIP discharge line. View to the north.

00758: Ludlow is excavating on the east side of the Booster Station to daylight the existing 8" DIP discharge line in order to install an 8" gate valve.

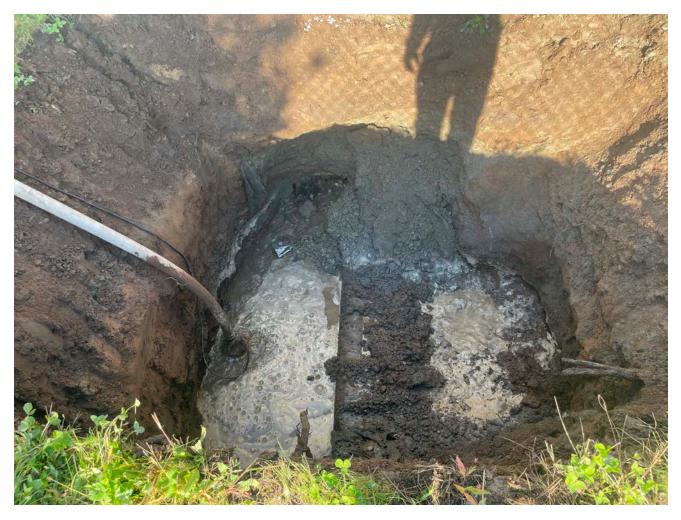
Picture 2: A pump that Ludlow set into the excavation they made while daylighting the 8" discharge line located on the east side of the Booster Station. View to the west.

0859: Ludlow has enlarged the excavation on the east side of the Booster Station and has encountered ground water is flowing into the excavation from underneath the building. Ludlow has set a pump in the excavation and is discharging the groundwater along the fence line located on the south side of the building.

0916: Ludlow has placed a second pump into the excavation located on the east side of the Booster Station and is discharging the water to the south side of the building along the fence line. Ludlow has exposed the 8" DIP discharge line on the east side of the building.

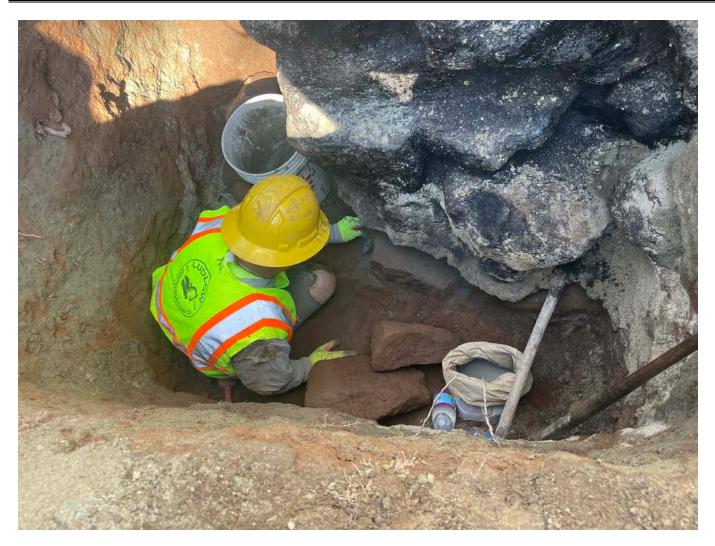
Picture 3: Ludlow placing portland cement on the southwest exterior of the foundation of the 24 Maiden Lane, Durham, residence. View to the north.

1030: Ludlow continues to apply portland cement to the southwest corner of the foundation of the 24 Maiden Lane residence.

1252: Ludlow has finished applying portland cement followed by hydraulic cement to the southwest corner of the foundation of the 24 Maiden Lane residence.

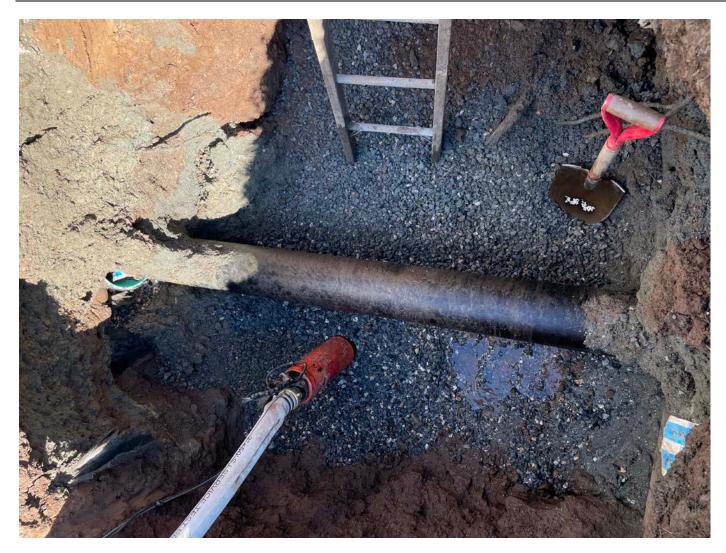
Picture 4: 8" DIP line that Ludlow daylighted on the east side of the Booster Station as they prepare to install an 8" gate valve. View to the north.

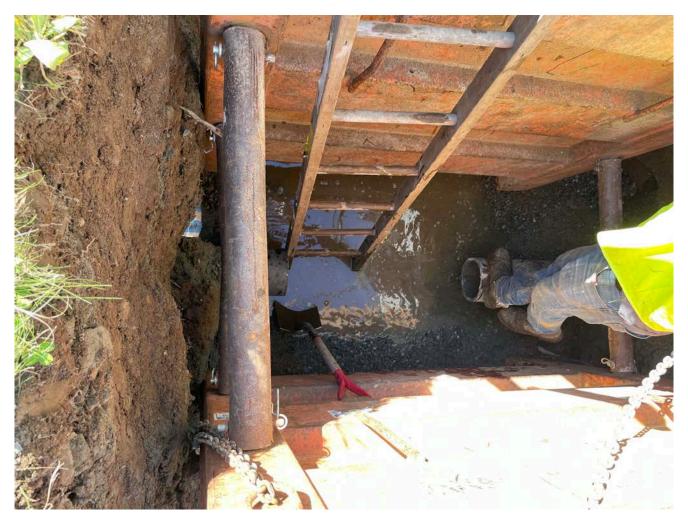
Picture 5: 8" DIP line that Ludlow daylighted on the east side of the Booster Station after having cut out a section of the pipe in order to install an 8" gate valve. View to the south.

1112: Ludlow has cut out a section of the 8" DIP discharge line located on the east side of the Booster Station.

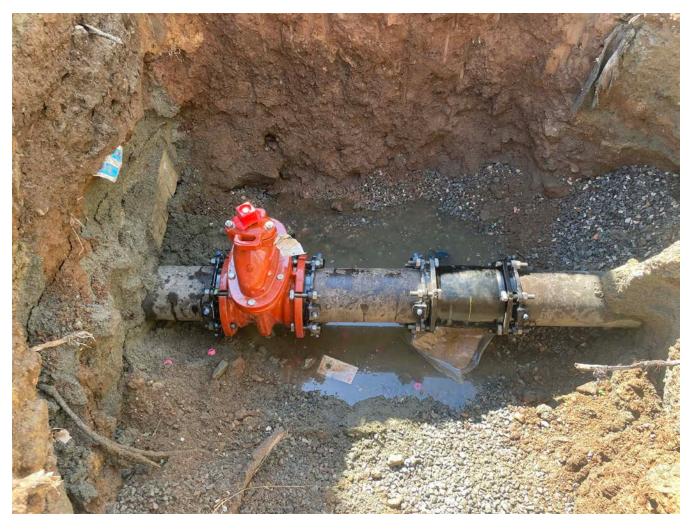
Picture 6: 8" gate valve that Ludlow installed on the 8" discharge line located on the east side of the Booster Station. View to the south.

1209: Ludlow is in the process of installing an 8" gate valve on the east side of the Booster Station, using Megalug connections on both sides of the valve to secure it in place.

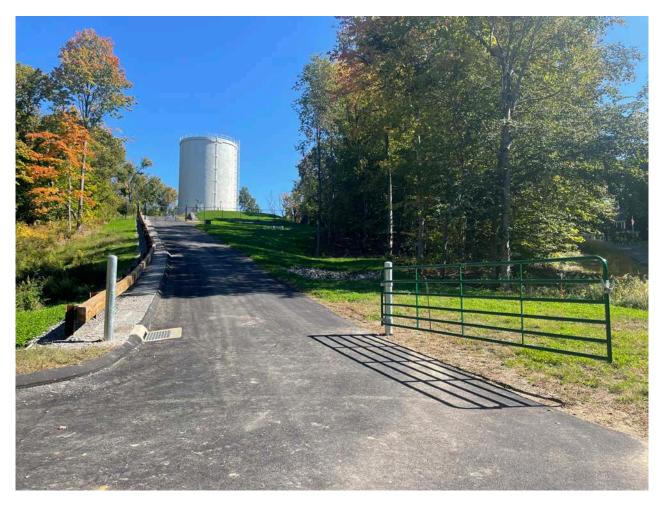
Picture 7: Fence that Eagle Fence finished installing near Station 14+00 on the Shared Access Road in Middletown. View to the east.

- Ludlow placed flowable fill around the catch basin they installed on the southeast corner of the intersection of Pickett Lane and Main Street, and in the trench connecting the catch basin to the manhole they installed on 177R Main Street property.
- Eagle Fence installed a gate on the Shared Access Road at Station ~14+00. According to Ludlow, Eagle Fence installed the gate hinges on Wednesday.

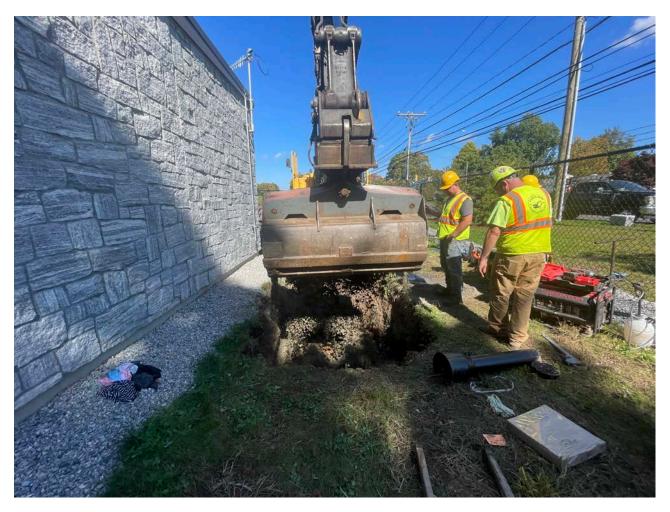
Picture 8: Ludlow placing 1.25" processed gravel over the sand they placed on the 8" gate valve they installed on the east side of the Booster Station. View to the north.

1308: Ludlow is placing 1.25" processed gravel over the sand they placed on top of the 8" valve.

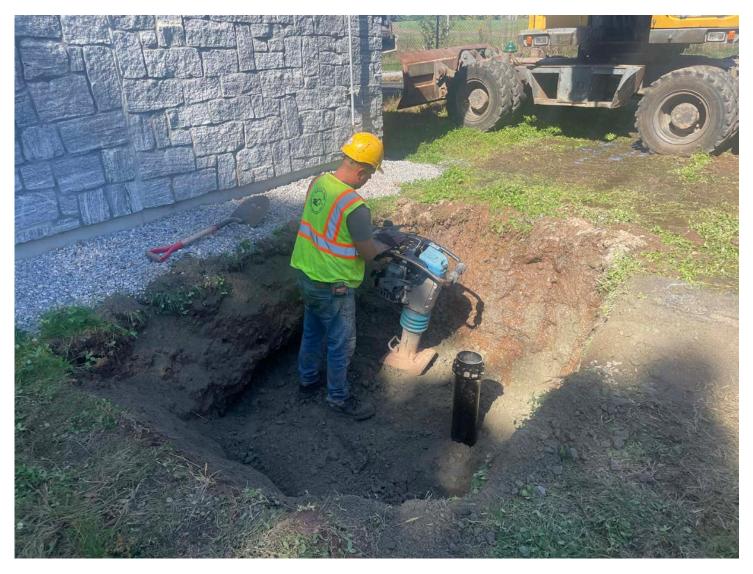
Picture 9: Ludlow compacting the 1.25" processed gravel they placed east side of the Booster Station. View to the northwest.

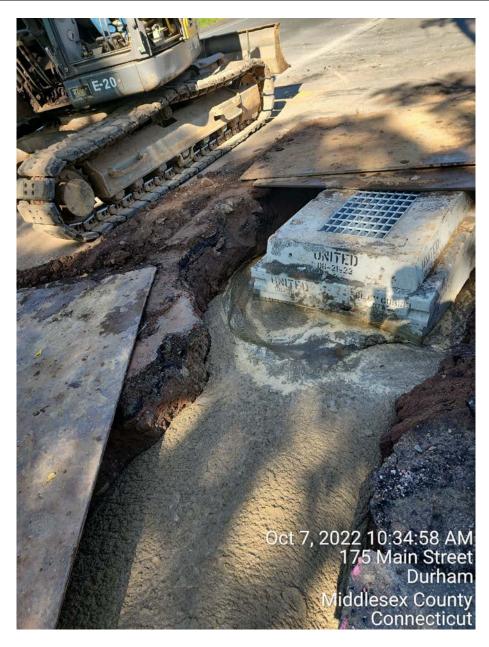
Picture 10: Flowable fill that Ludlow placed around the catch basin they installed on Pickett Lane and in the trench connecting the catch basin to the manhole they installed on 177R Main Street property. View to the north.

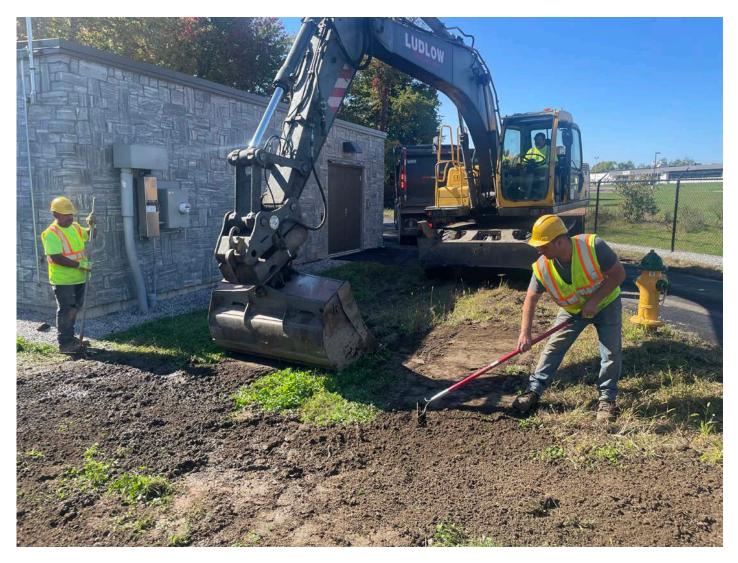
Picture 11: Ludlow placing loam and grass seed on those areas that were disturbed during the installation of an 8" gate valve on the east side of the Booster Station. View to the west.

1348: Ludlow is placing loam and grass seed on those areas of the Booster Station work zone that were disturbed during the installation of the 8" gate valve.
