Daily Report

Project: October 21, 2022 **Durham Meadows Pipeline Installation** Date:

Report No: 535 Project #: AECOM: 6061487

Contractor: Ludlow Construction

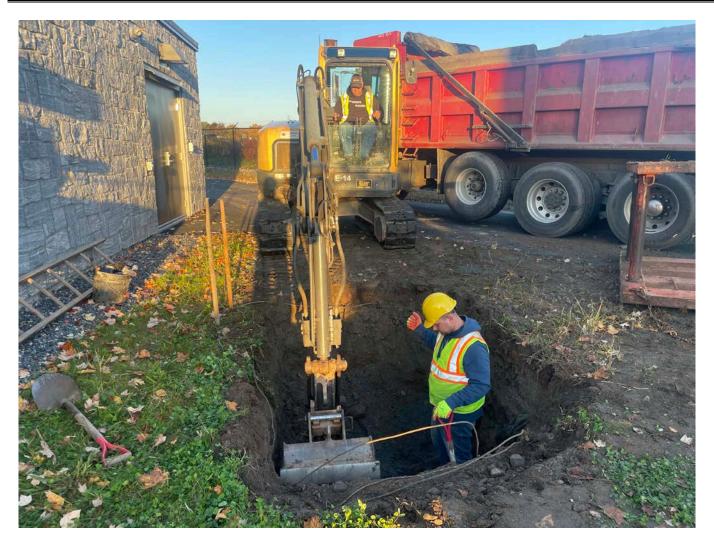
0739: Ludlow is excavating on the north side of the Booster Station as they prepare to install an 8" gate valve. A small amount of water has appeared below the invert of the 8" DIP line that they daylighted during excavation activities. Ludlow has set a pump into the excavation and has the discharge line set up to discharge the groundwater to the south side of the Booster Station.

Picture 1: Ludlow excavating on the north side of the Booster Station located on S. Main Street, Middletown, as they work to install an 8" DIP gate valve. View to the west.

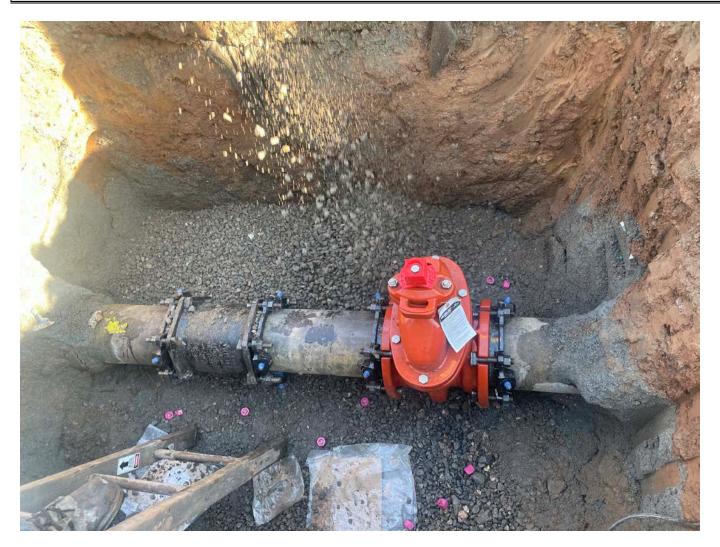
0909: Ludlow begins to place ¾" stone beneath, and on the sides of, the 8" gate valve they just installed on the north side of the Booster Station.

0912: Ludlow has placed 6" of $\frac{3}{4}$ " stone below the 8" DIP they daylighted on the north side of the Booster Stations , and have placed additional $\frac{3}{4}$ " gravel on the side of the DIP approximately 4" higher than the pipe's invert. Ludlow placed filter fabric on either side of the pipe on top of the stone.

Picture 3: Ludlow placing additional $\frac{3}{4}$ " stone under and on the sides of the 8" DIP gate valve they just installed on the north side of the Booster Station. View to the north.

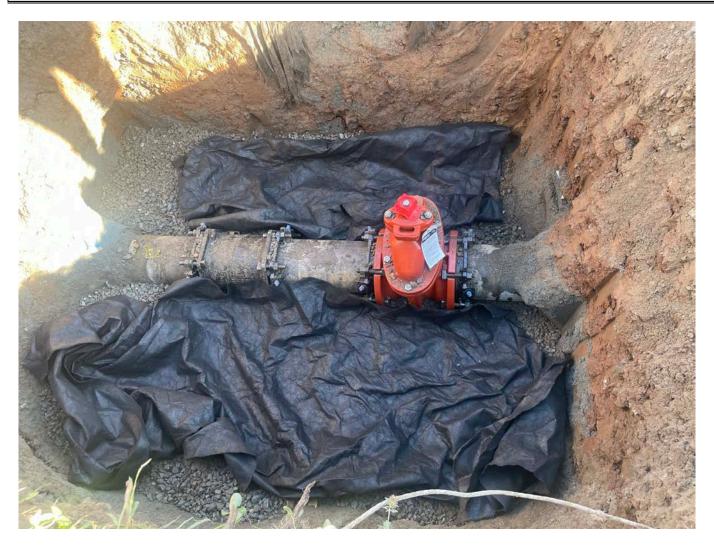
Picture 4: Filter fabric that Ludlow placed on the north and south sides of the 8" DIP gate valve they just installed on the north side of the Booster Station. View to the north.

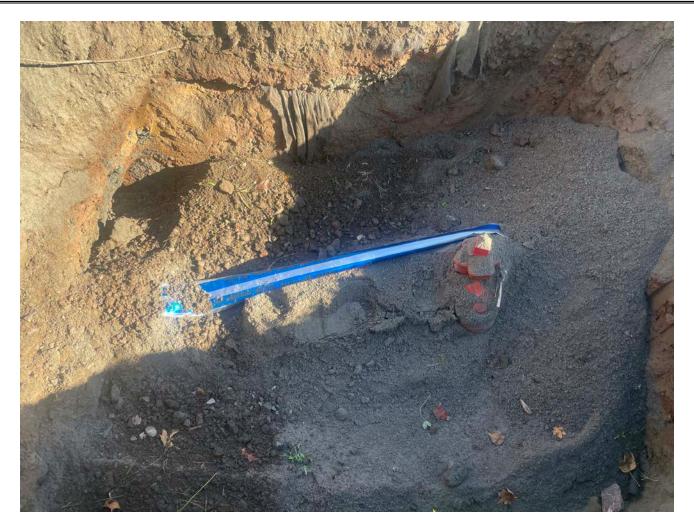
Picture 5: Sand and caution tape that Ludlow placed over the filter fabric and 8" DIP gate valve that they just installed on the north side of the Booster Station. View to the north.

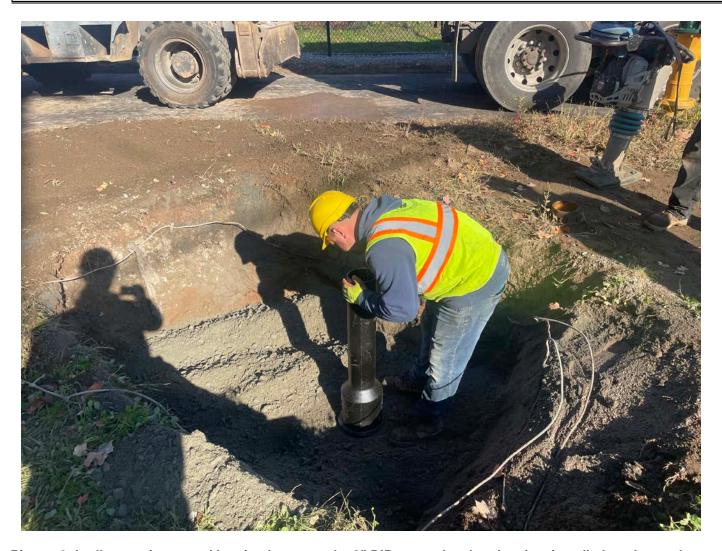
Picture 6: Ludlow setting a road box in place over the 8" DIP gate valve that they just installed on the north side of the Booster Station. View to the northwest.

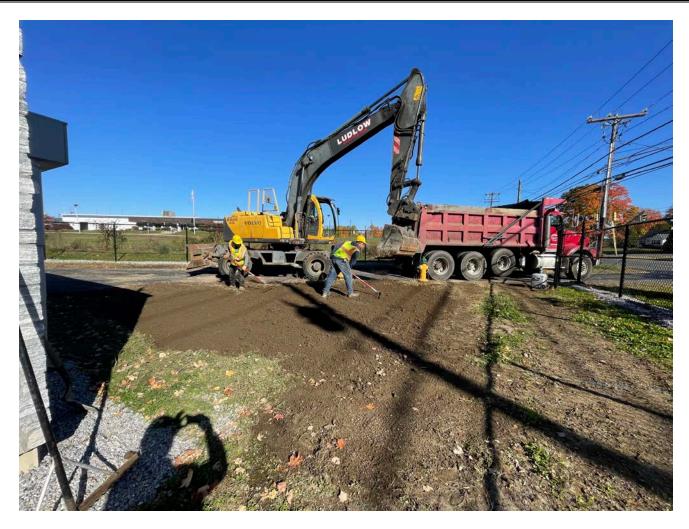
1036: Ludlow is spreading loam and placing grass seed on the north side of the Booster Station after having backfilled over the 8" gate valve they installed. Ludlow is also dressing up north edge of the Booster Station driveway with loam and grass.

Picture 8: Ludlow placing loam and grass seed on the north side of the Booster Station on those areas of lawn that were disturbed during the installation of an 8" gate valve. View to the north.

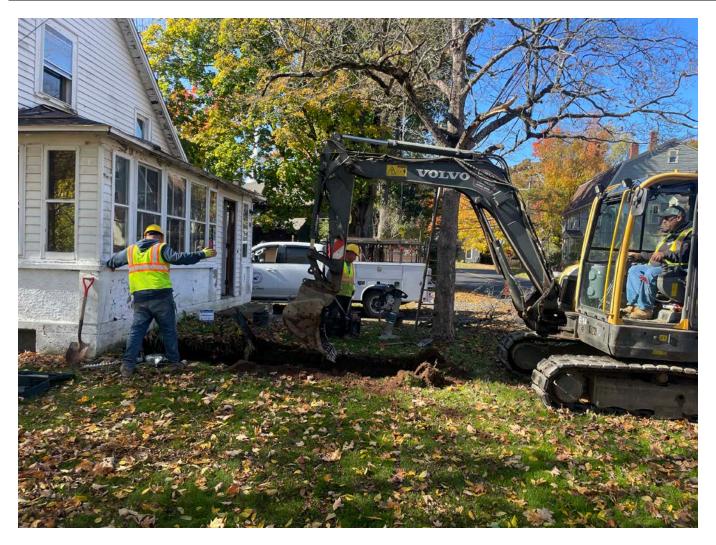
1119: Ludlow has begun to excavate on the north side of the 11 Maiden Lane, Durham, property where they are going to install a 1" copper water line from the property's curb stop to the inside of the home's basement.

Picture 9: Ludlow excavating on the north side of the 11 Maiden Lane, Durham, residence as they prepare to run a 1" copper water service line from the curb stop to the interior of the residence's basement. View to the west.

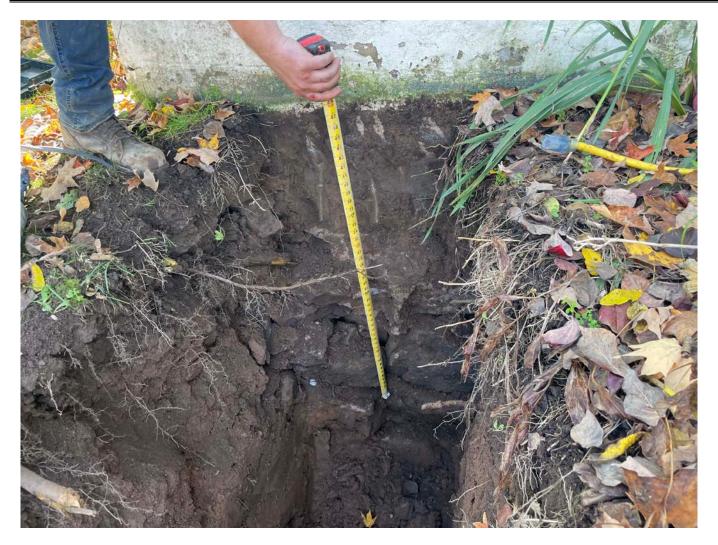
Picture 10: Ludlow measuring where they will penetrate the north side of the field stone foundation of the 11 Maiden Lane residence with a 1" copper water service line. View to the south.

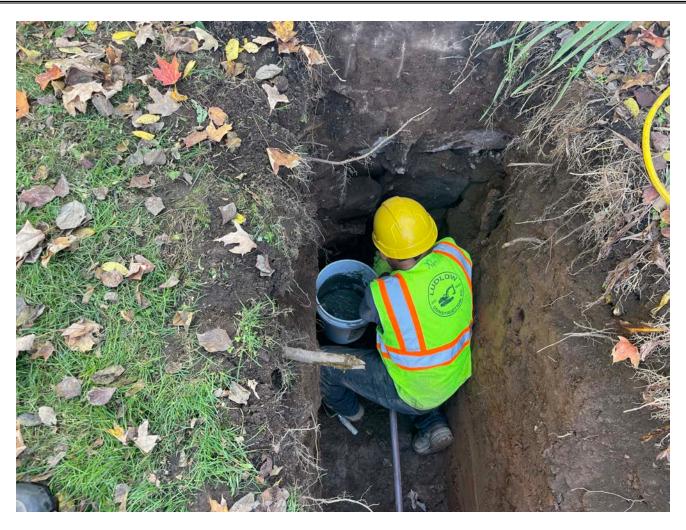
1211: Ludlow has finished installing a 1" copper water service line between the 11 Maiden Lane curb stop and the inside of the home's basement. Ludlow is currently securing the pipe in place with hydraulic cement.

Picture 11: Ludlow using hydraulic cement to secure the 1" copper water service line that they ran through the north side of the foundation of the 11 Maiden Lane residence. View to the south.

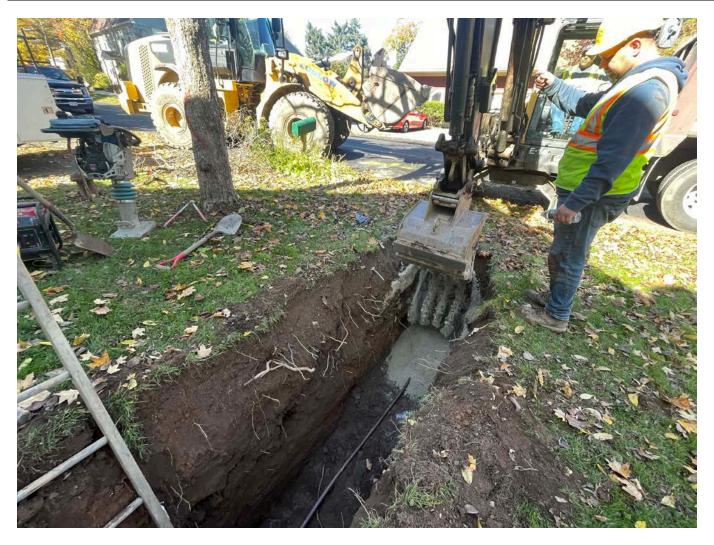
1221: Ludlow is placing sand above and below the 1" copper water service line they installed at the 11 Maiden Lane property.

Picture 12: Ludlow placing sand over and under the 1" copper water service line that they ran from the curb stop located on the north side of the 11 Maiden Lane residence into the basement of the home. View to the northwest.

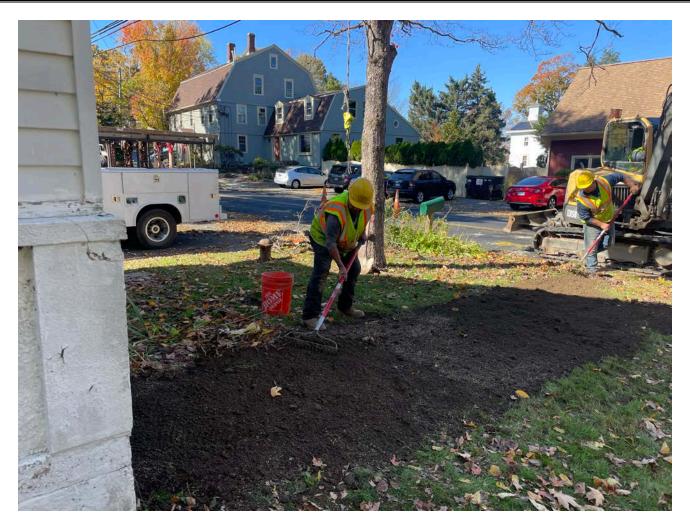
1313: Ludlow has finished backfilling the trench they excavated during the installation of a 1" copper water service line at the 11 Middle Lane property. Ludlow is currently placing loam and grass seed on those areas that were disturbed by the excavation.

Picture 13: Ludlow placing loam and grass seed on those areas of the lawn at the 11 Maiden Lane property that were disturbed during the installation of a section of 1" copper water service line. View to the northwest.

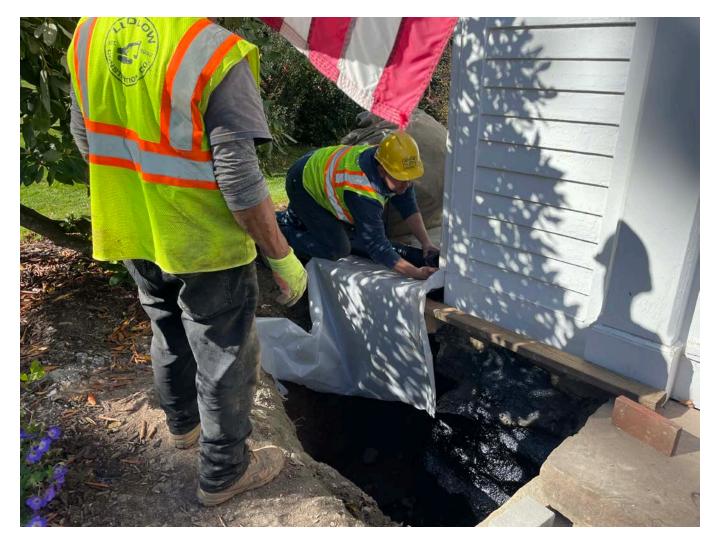
- Rain for Rent removed the frak tank from the 281 Main Street, Durham, property.
- Ludlow covered the open excavation on southwest corner of the 24 Maiden Lane residence with poly sheeting.
- Ludlow performed general housekeeping activities at the 281 Main Street, Durham, property.

Picture 14: Ludlow covering the open excavation of the southwest corner of the 24 Maiden Lane, Durham, residence with poly sheeting for the weekend to allow the second coat of foundation coating they applied to the field stone foundation time to air out. View to the northwest.
