**AREA 1 PRELIMINARY SITE CHARACTERIZATION
SUMMARY
PER- AND POLYFLUOROALKYL SUBSTANCES
(PFAS) REMEDIAL INVESTIGATION**

FORMER FORT DEVENS ARMY INSTALLATION, DEVENS, MA

JUNE 2020

Prepared by:
KOMAN Government Solutions, LLC
293 Boston Post Road West, Suite 100
Marlborough, MA 01752
Contract No.: W912WJ-18-C-0011

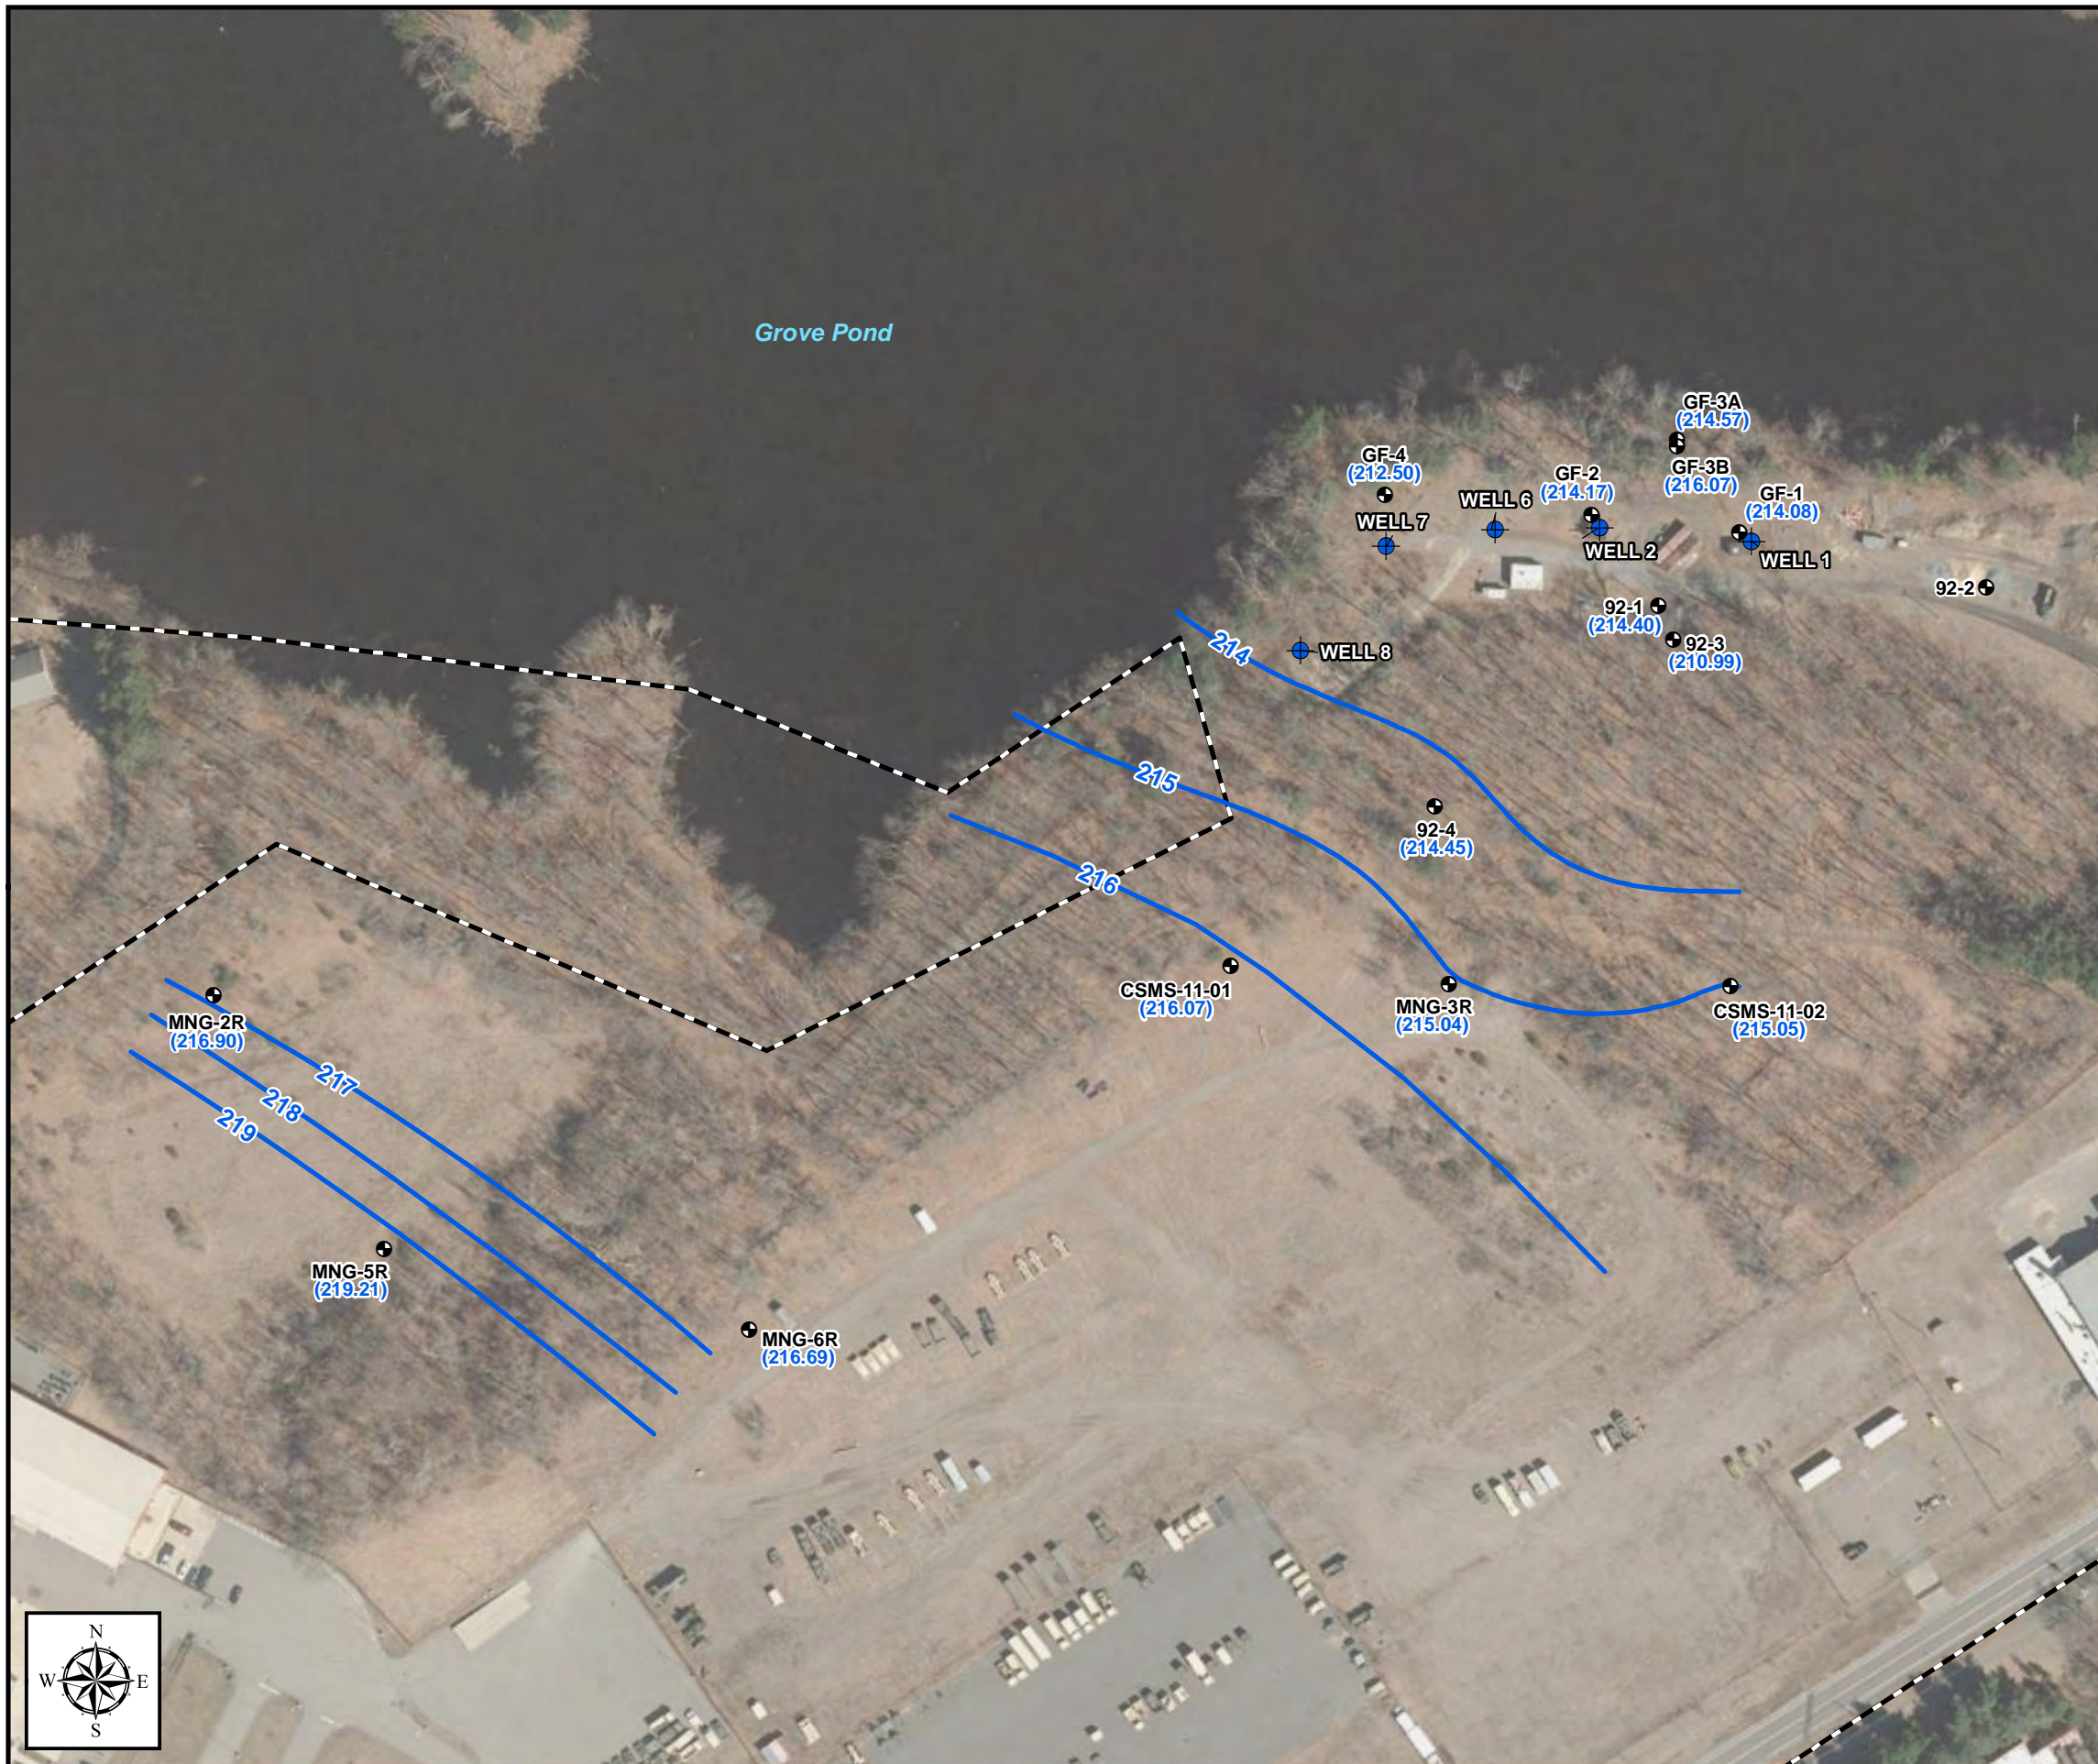
Figure
2-5

An Area 1 synoptic water level monitoring event, that encompassed all of the Grove Pond area piezometers and monitoring wells, was conducted on March 12, 2020 (Figure 2-5 and 2-6).

Groundwater results are presented on Figure 6-2 and in and in cross section (Figures 6-3 through 6-7). Soil sampling results are summarized on Figure 6-8. Surface water and sediment sampling results are summarized on Figure 6-9. Area and sitewide groundwater contours are presented on Figures 2-3, 2-4, 2-5 and 2-6. All of the results are presented in Appendix H. The discussions below are focused on results with respect to the media specific criteria (Table 1-1).

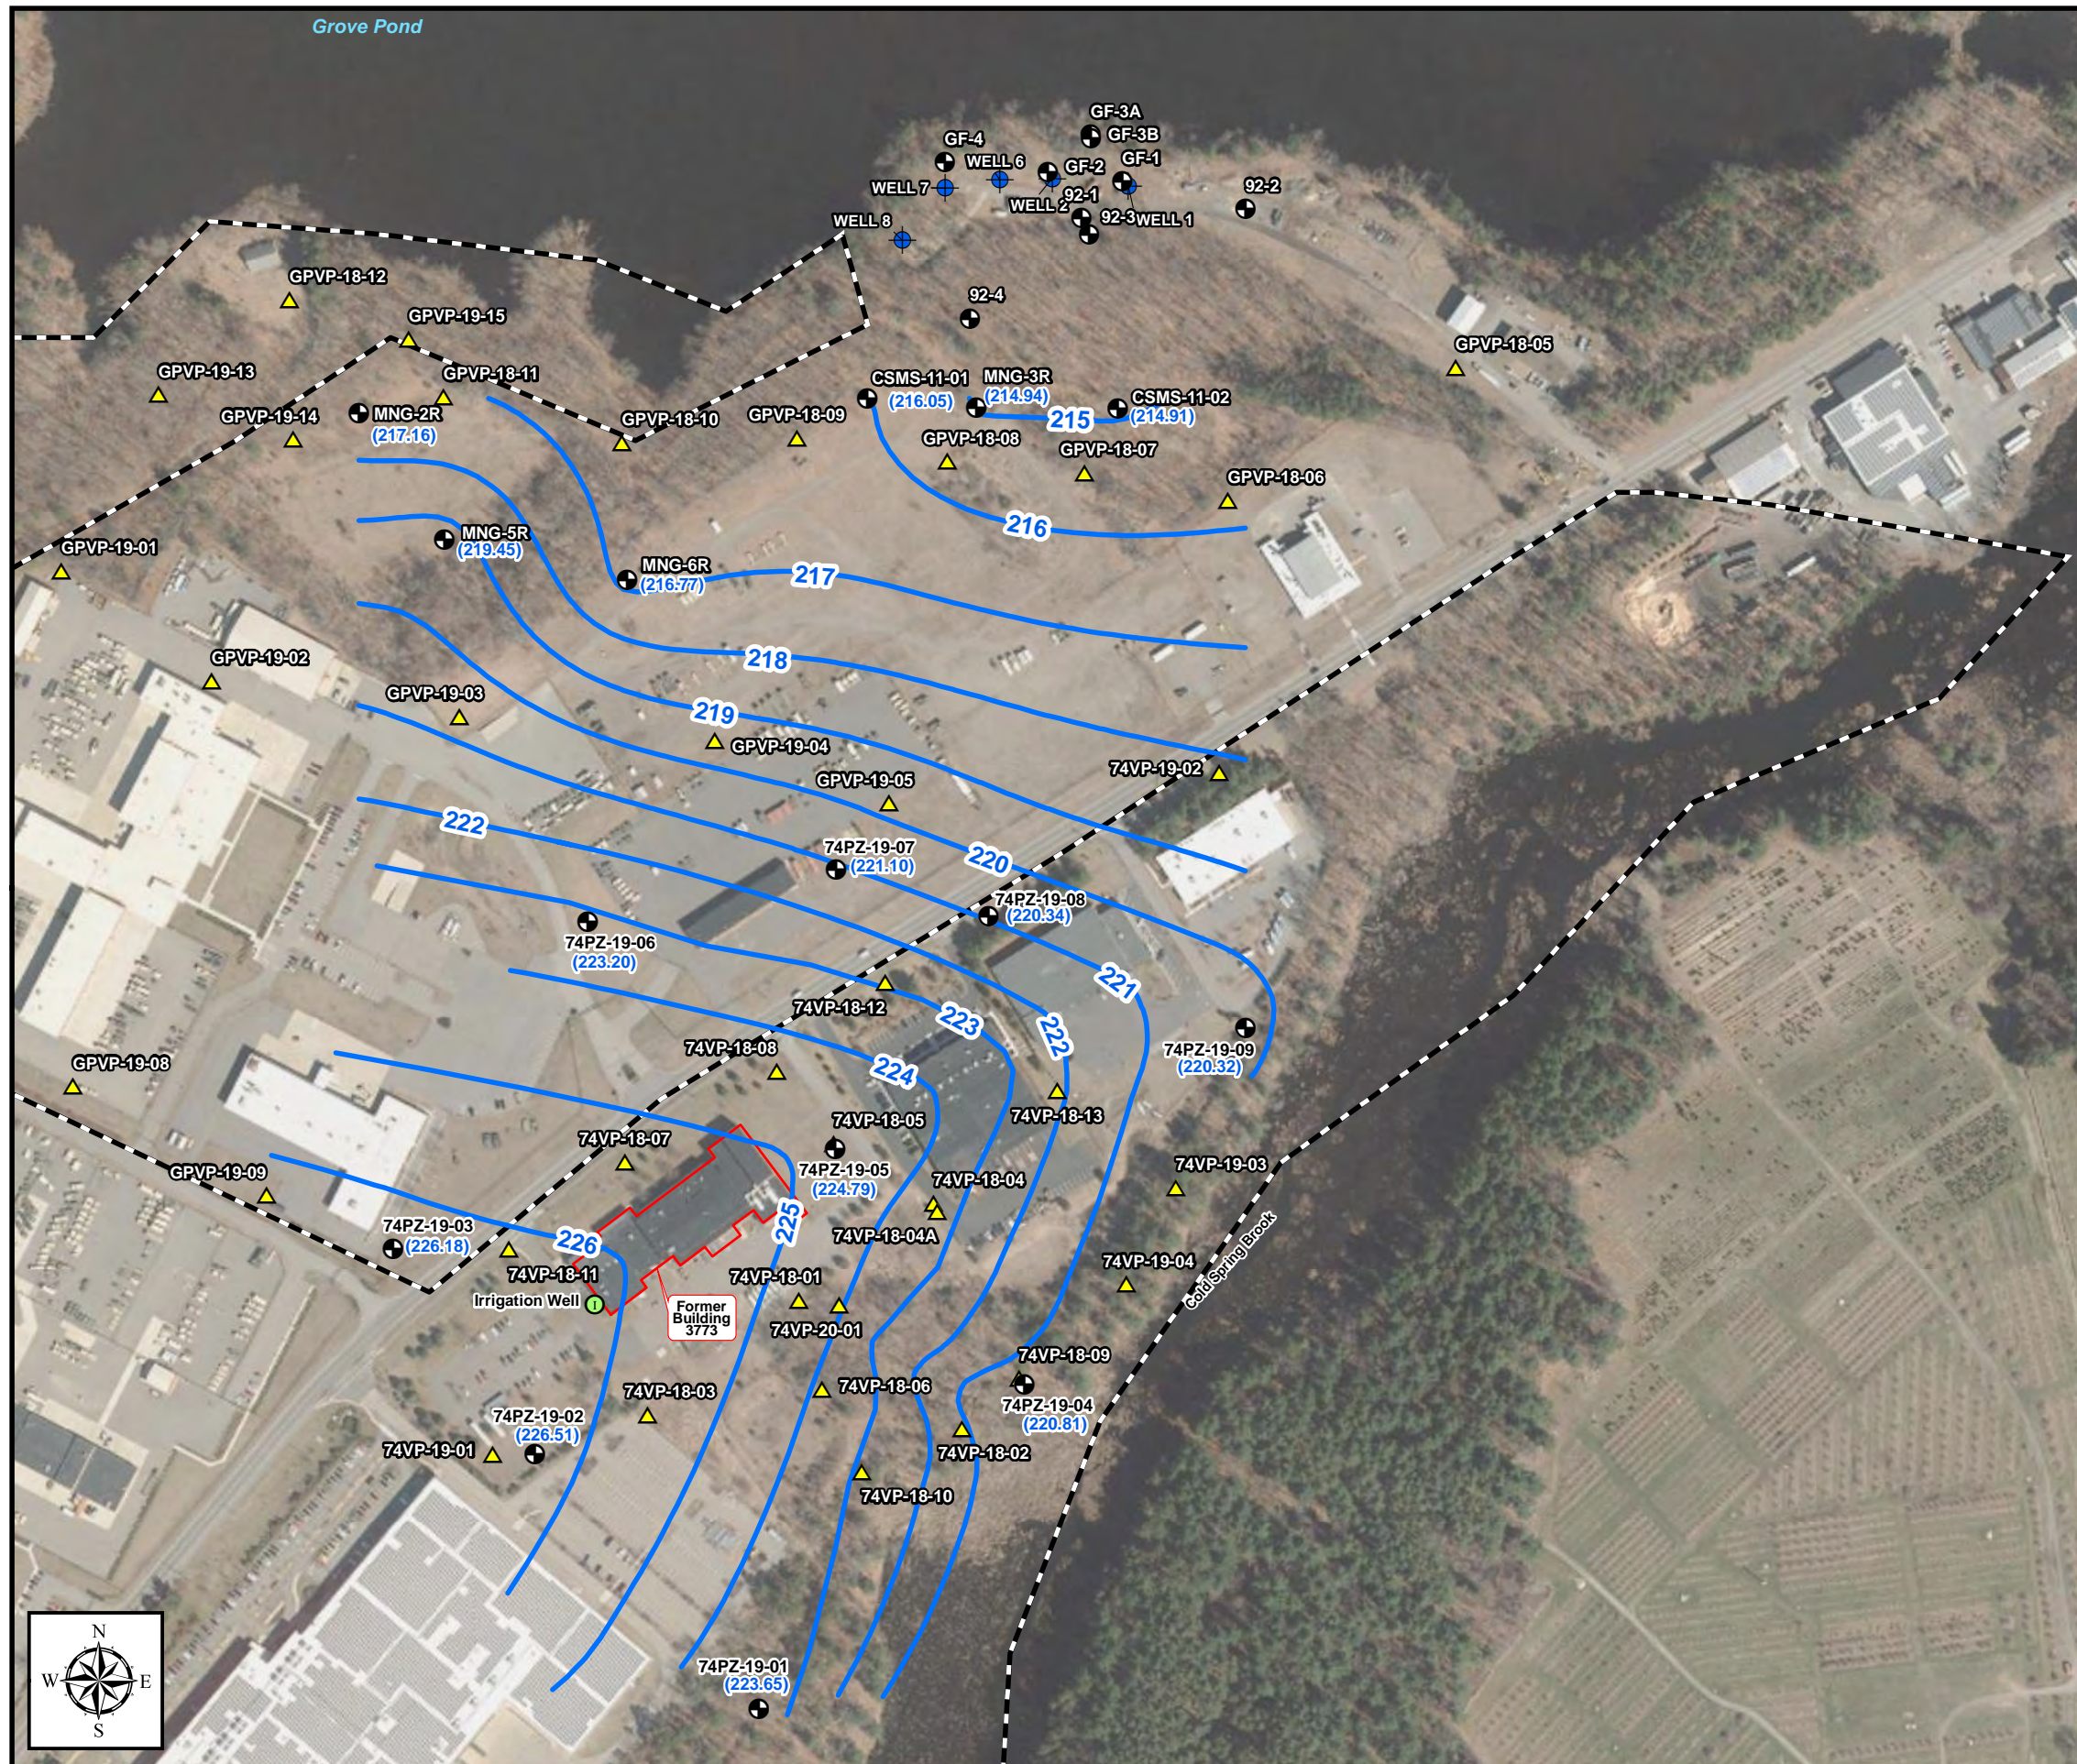
Figure
2-6

- Public Water Supply Well
- Monitoring Well/Piezometer
- Vertical Profiling Location
- Irrigation Well (Approximate Location)
- Groundwater Contours (March 19, 2019)
Contour Elevation is in Ft NAVD88
- Groundwater Elevation
- Former Fort Devens Boundary

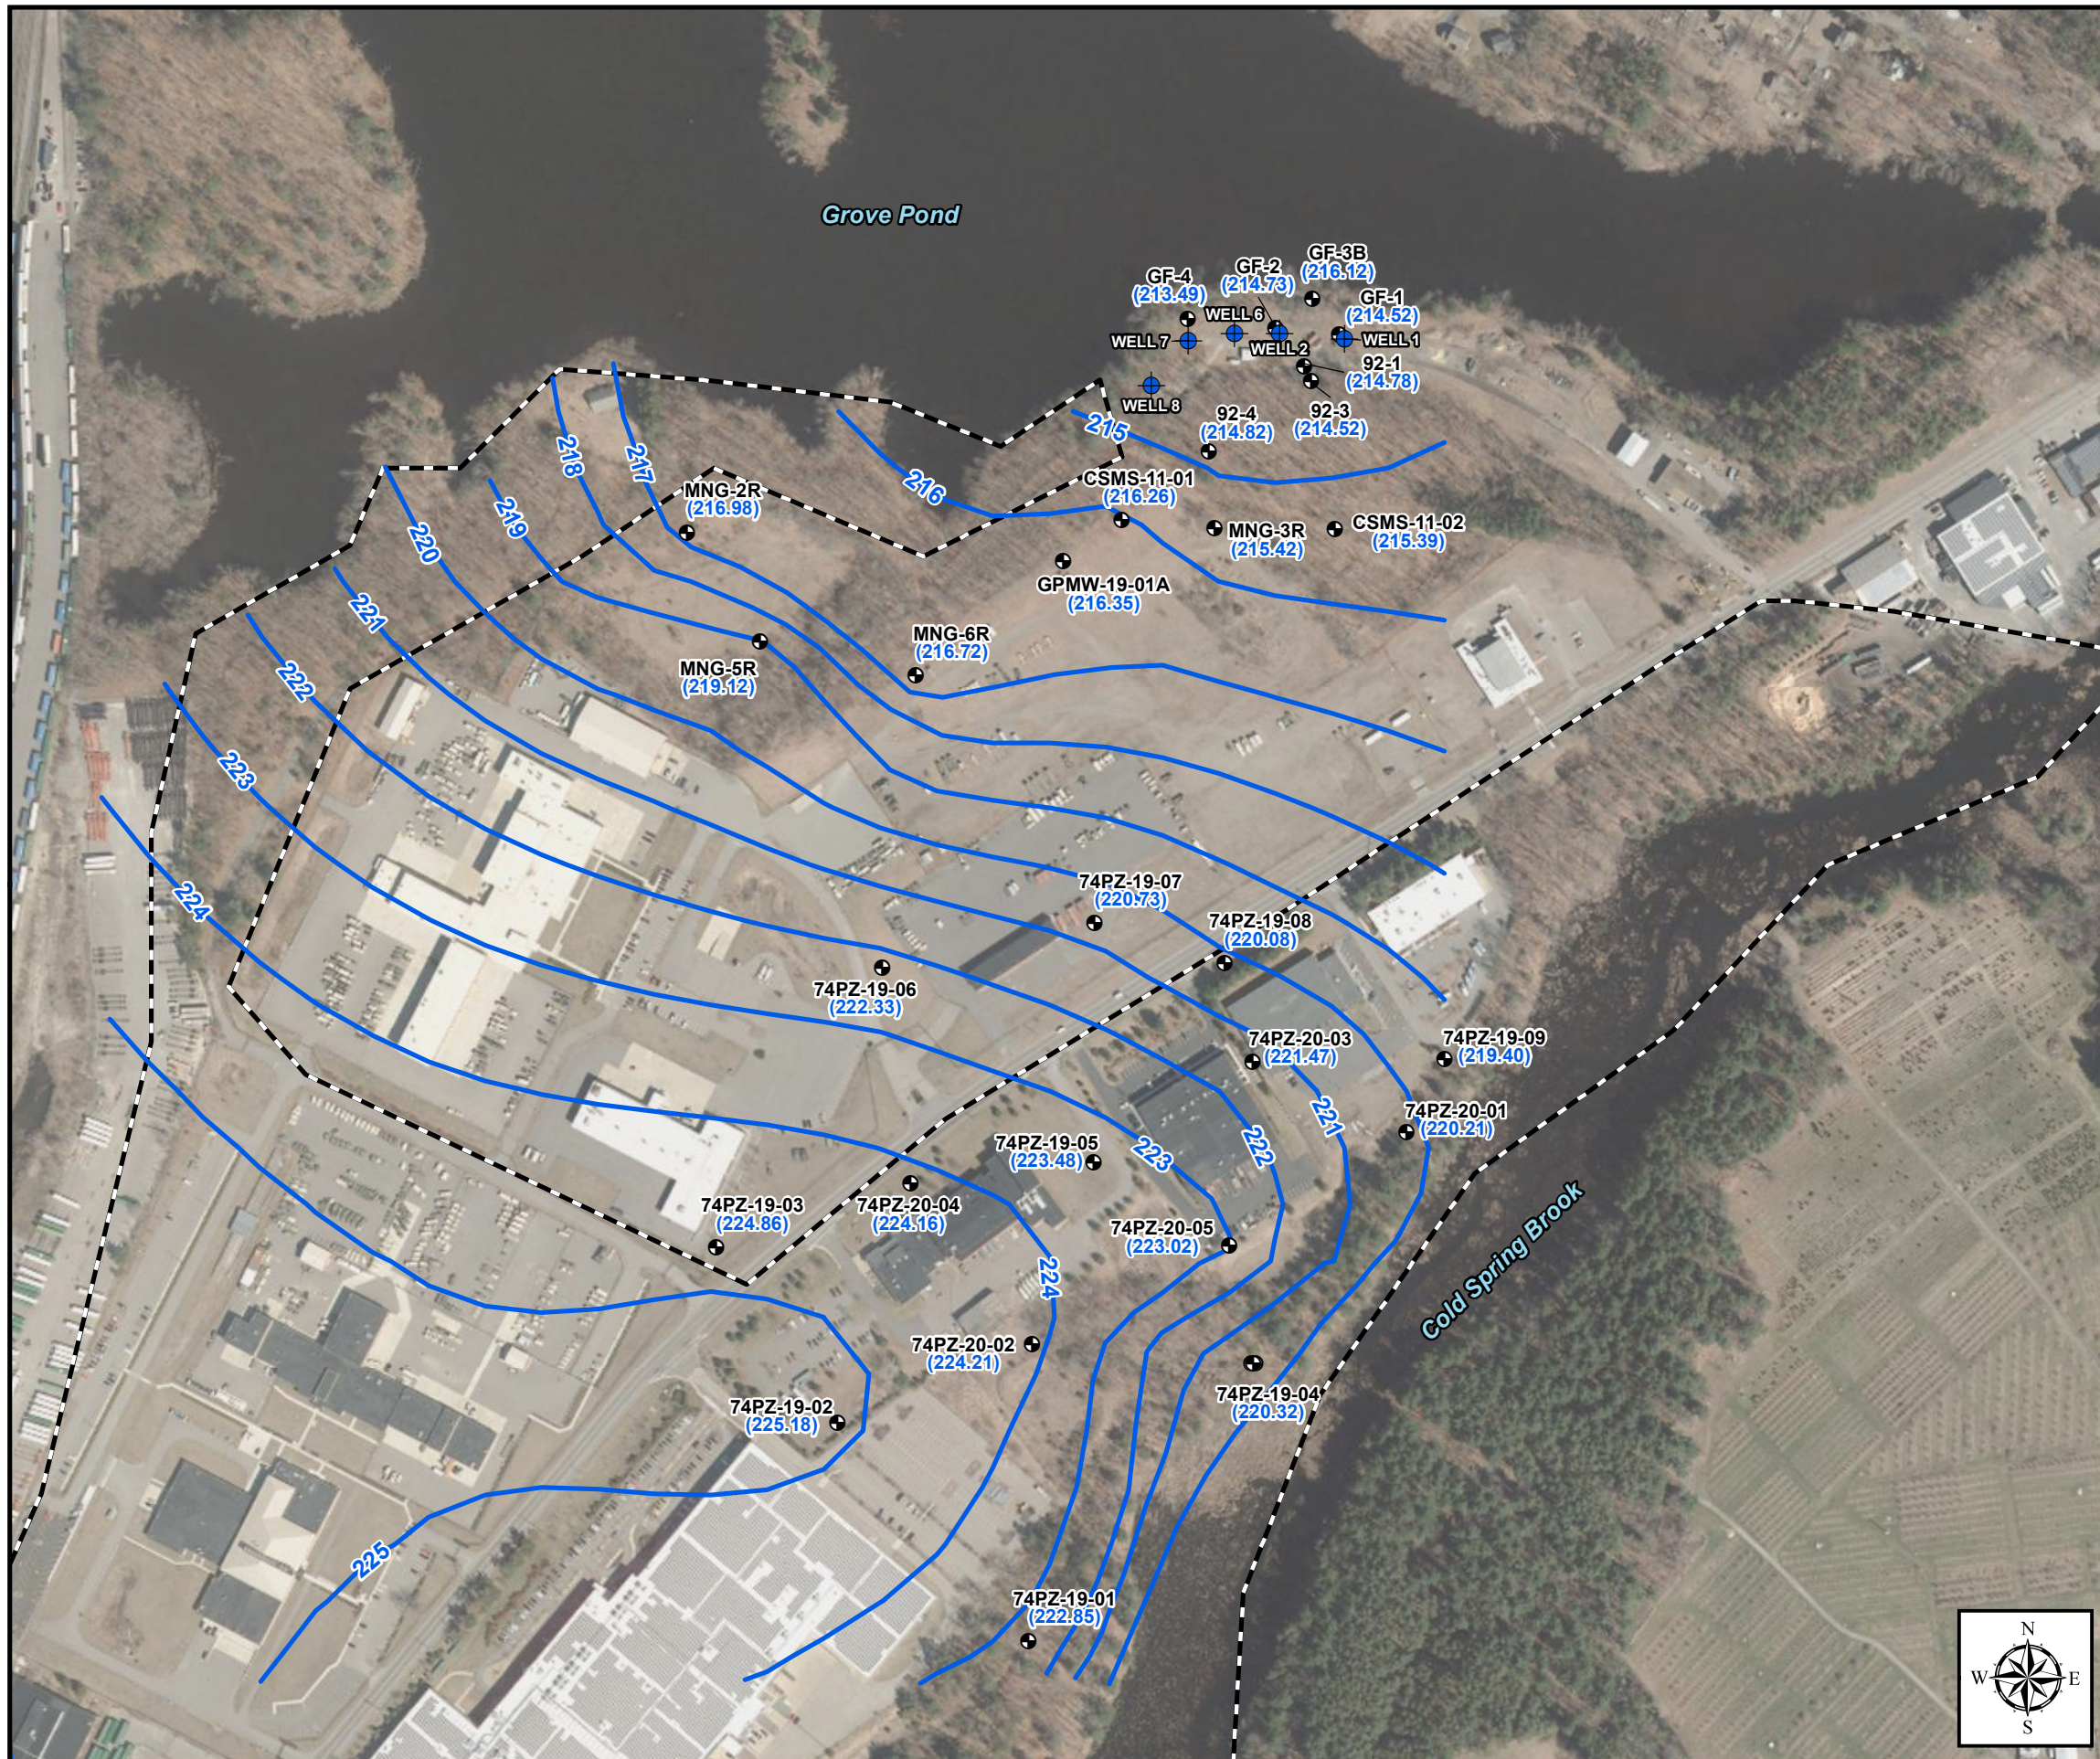
Figure
2-9

A synoptic water level event was conducted on January 2-3, 2020 (Figure 2-8). A separate Area 1 synoptic water level monitoring event, that encompassed all of the area piezometers and monitoring wells, was conducted on March 13, 2020 (Figure 2-9).

Groundwater results are presented on Figure 7-5 and in and in cross section (Figures 7-6 and 7-7). Soil sampling results are summarized on Figure 7-8. Surface water and sediment sampling results are summarized on Figure 7-11. Groundwater contours are presented on Figures 2-8 and 2-9. All of the results are presented in Appendix H. The discussions below are focused on results with respect to the media specific criteria (Table 1-1).

An Area 1 synoptic water level monitoring event, that encompassed all of the area piezometers and monitoring wells, was conducted on March 13, 2020 (Figure 2-9).

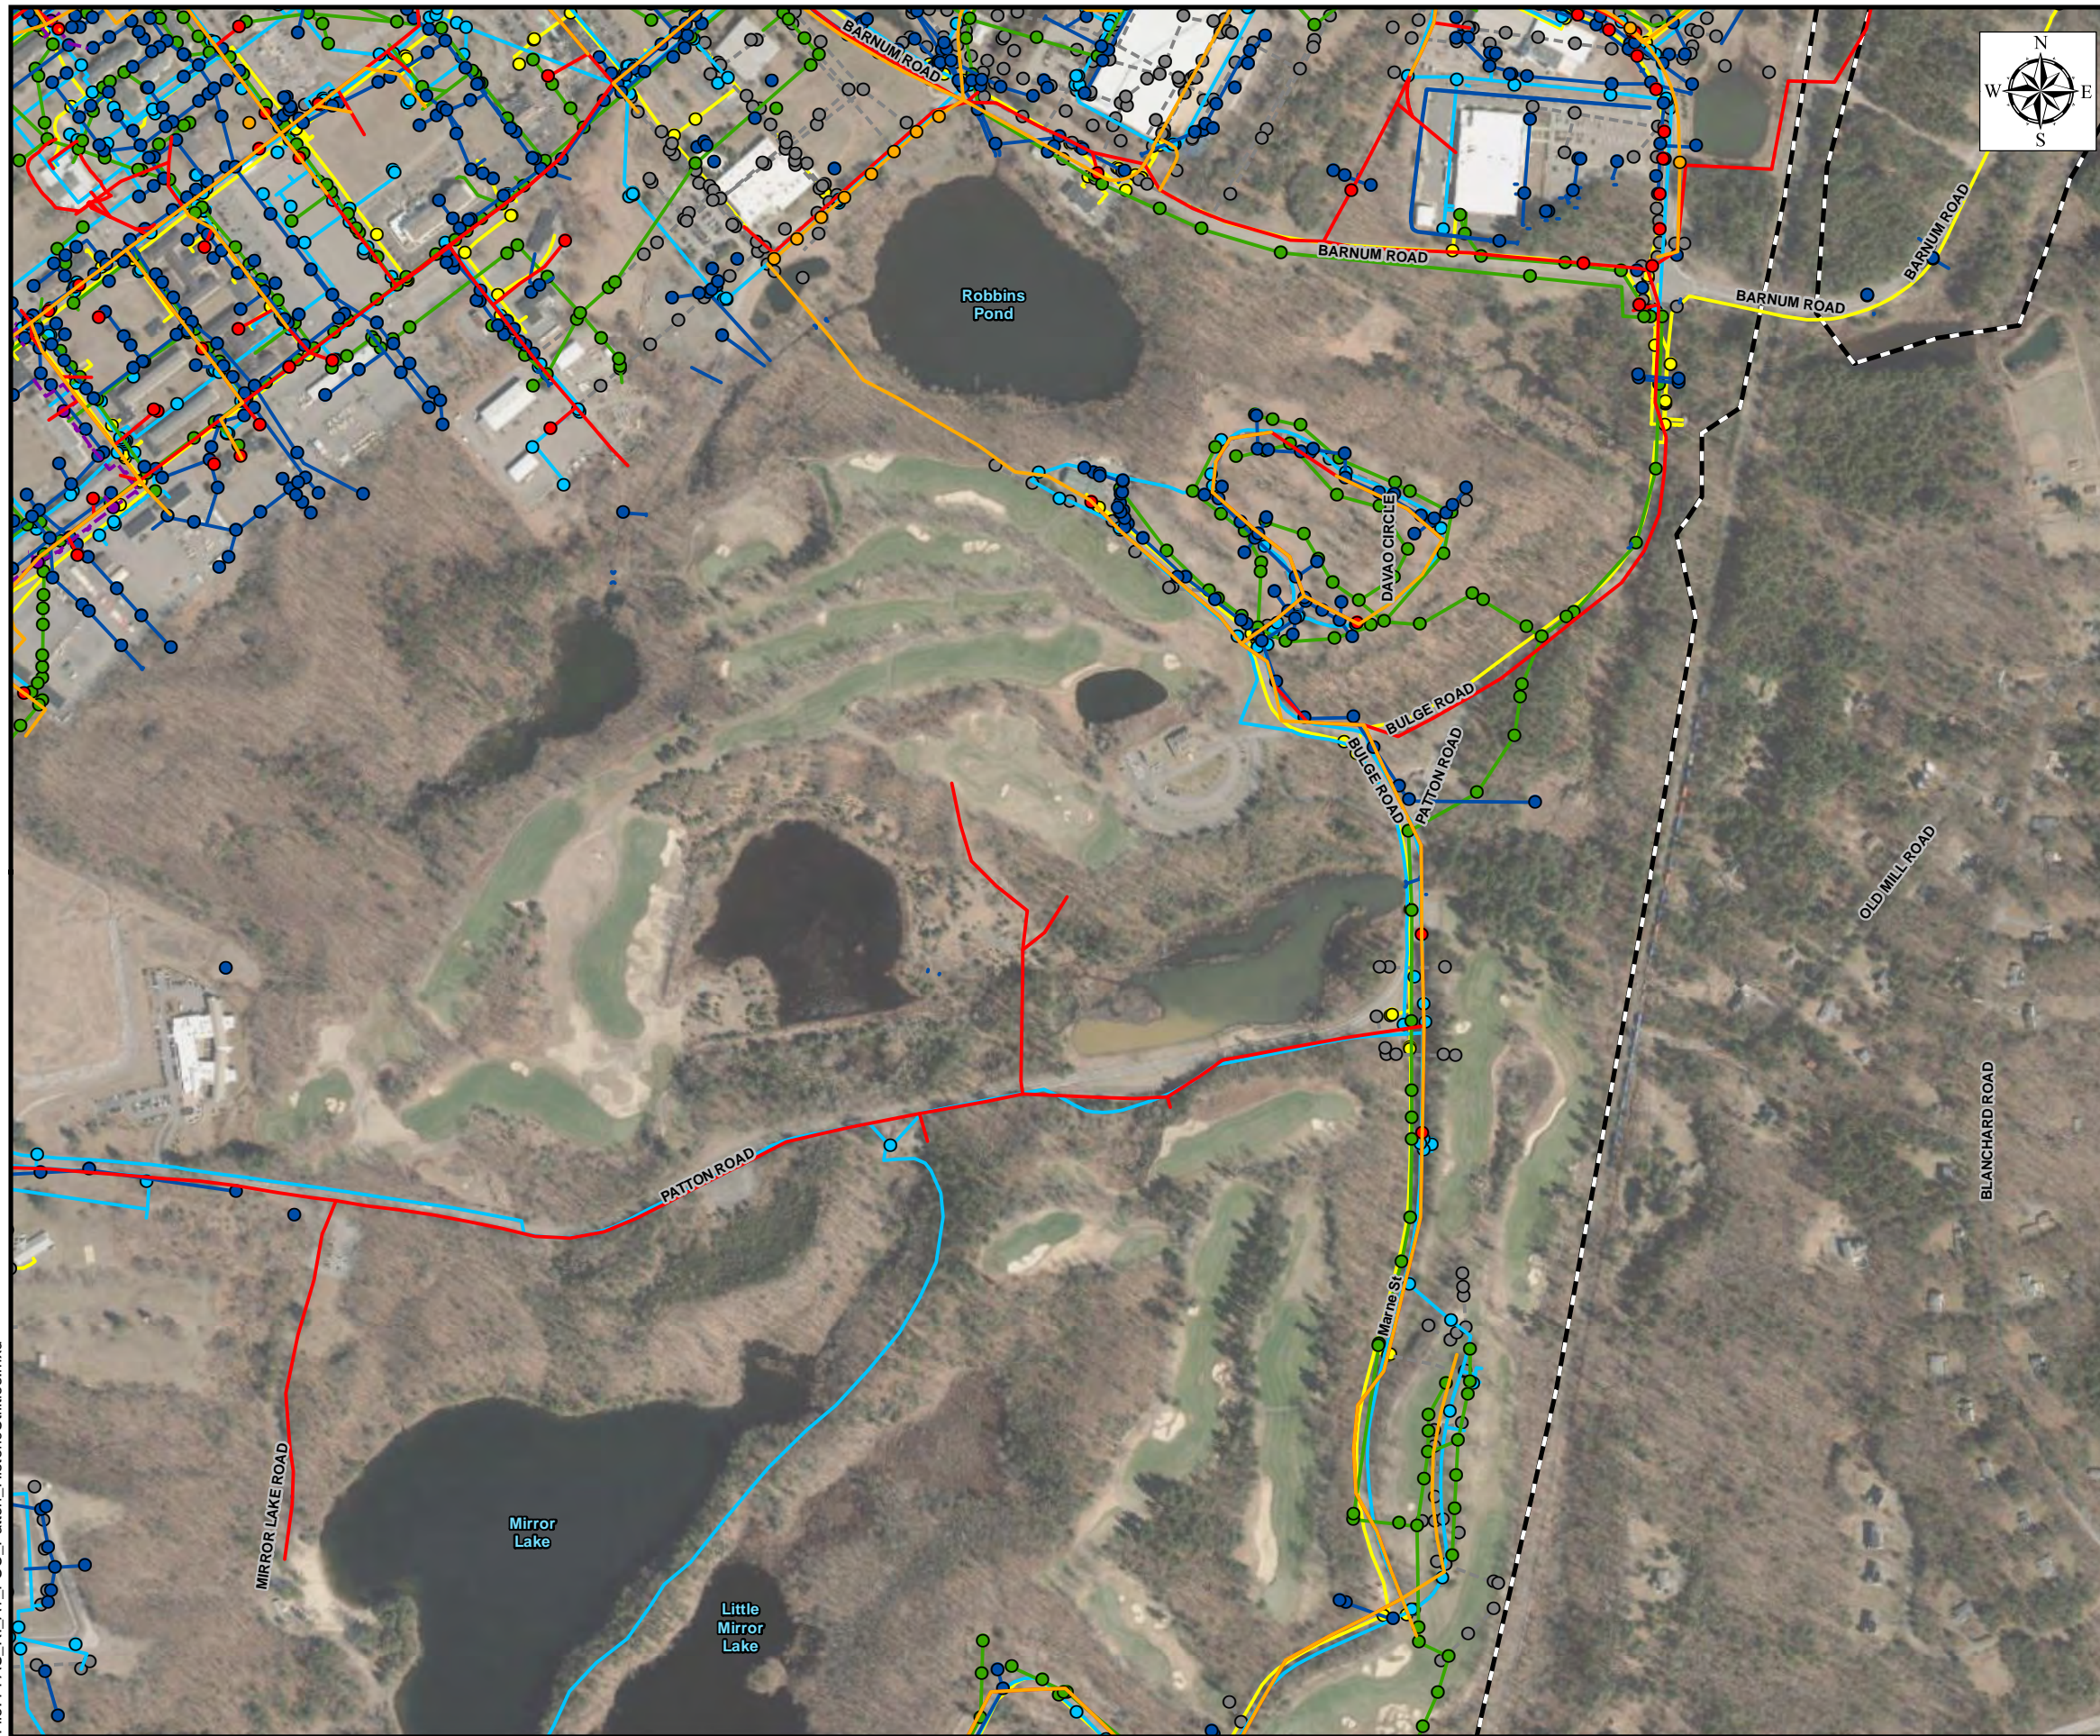
Figure
7-1

MassDevelopment operates the Patton water supply well as part of the Devens municipal water supply. The Patton well screen is set at 61 to 83 ft bgs and is operated at 330 gpm. The well is located just south of Patton Road, north of Mirror Lake (Figure 7-1).

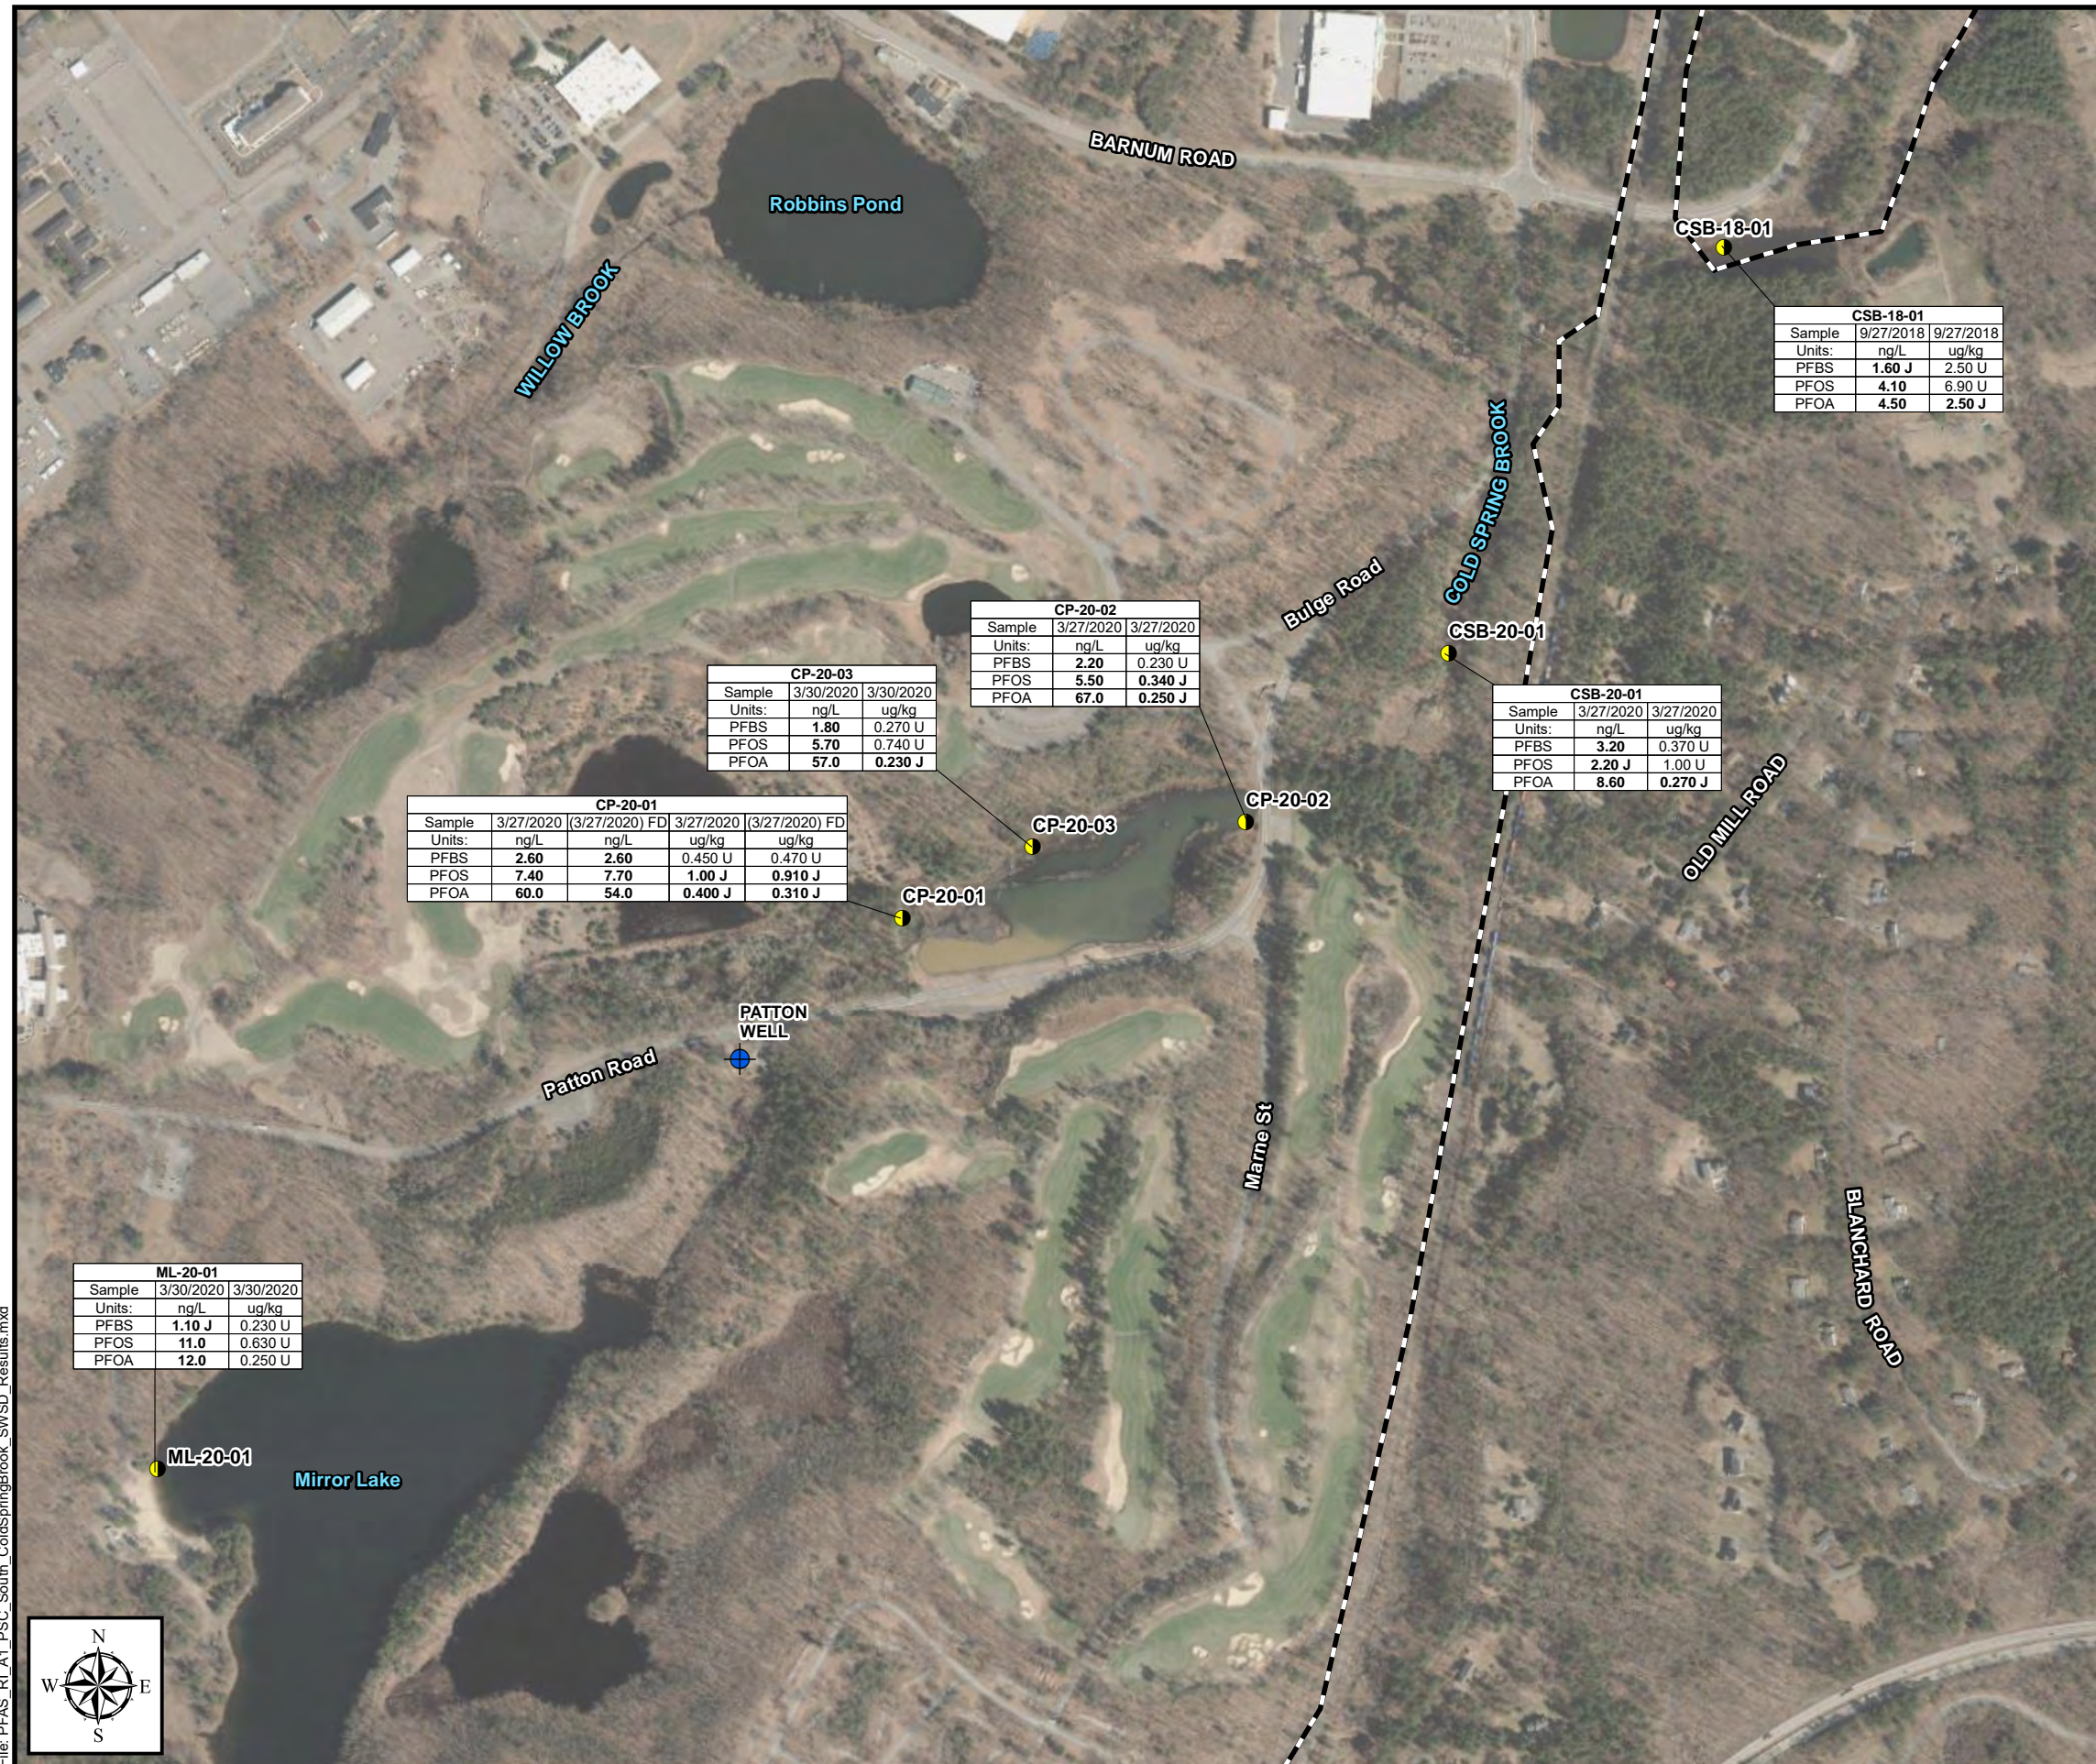
Figure
7-8

At AOC 40, four soil borings were advanced to a maximum depth of 21.5 ft bgs. Three of the locations had one or more sample intervals with detections of PFAS compounds greater than the S-1/GW-1 standards (Figure 7-8, Appendix H). At PWXB-19-04, PFAS compounds were not detected at concentrations greater than the S-1/GW-1 standards. Five of the PFAS compounds with S-1/GW-1 standards were detected at concentrations above the S-1/GW-1 standards. The locations west of the debris removal area at AOC 40 had lower PFAS concentrations and only one sample had PFDA at a concentration that was greater than the S-1/GW-1 standards. The two soil borings east of the debris removal area only had one soil sample collected at each location due to the shallow water table. The maximum concentrations of the five PFAS compounds with concentrations above the S-1/GW-1 standards detected at AOC 40 are below:
