**AREA 1 PRELIMINARY SITE CHARACTERIZATION
SUMMARY
PER- AND POLYFLUOROALKYL SUBSTANCES
(PFAS) REMEDIAL INVESTIGATION**

FORMER FORT DEVENS ARMY INSTALLATION, DEVENS, MA

JUNE 2020

Prepared by:
KOMAN Government Solutions, LLC
293 Boston Post Road West, Suite 100
Marlborough, MA 01752
Contract No.: W912WJ-18-C-0011

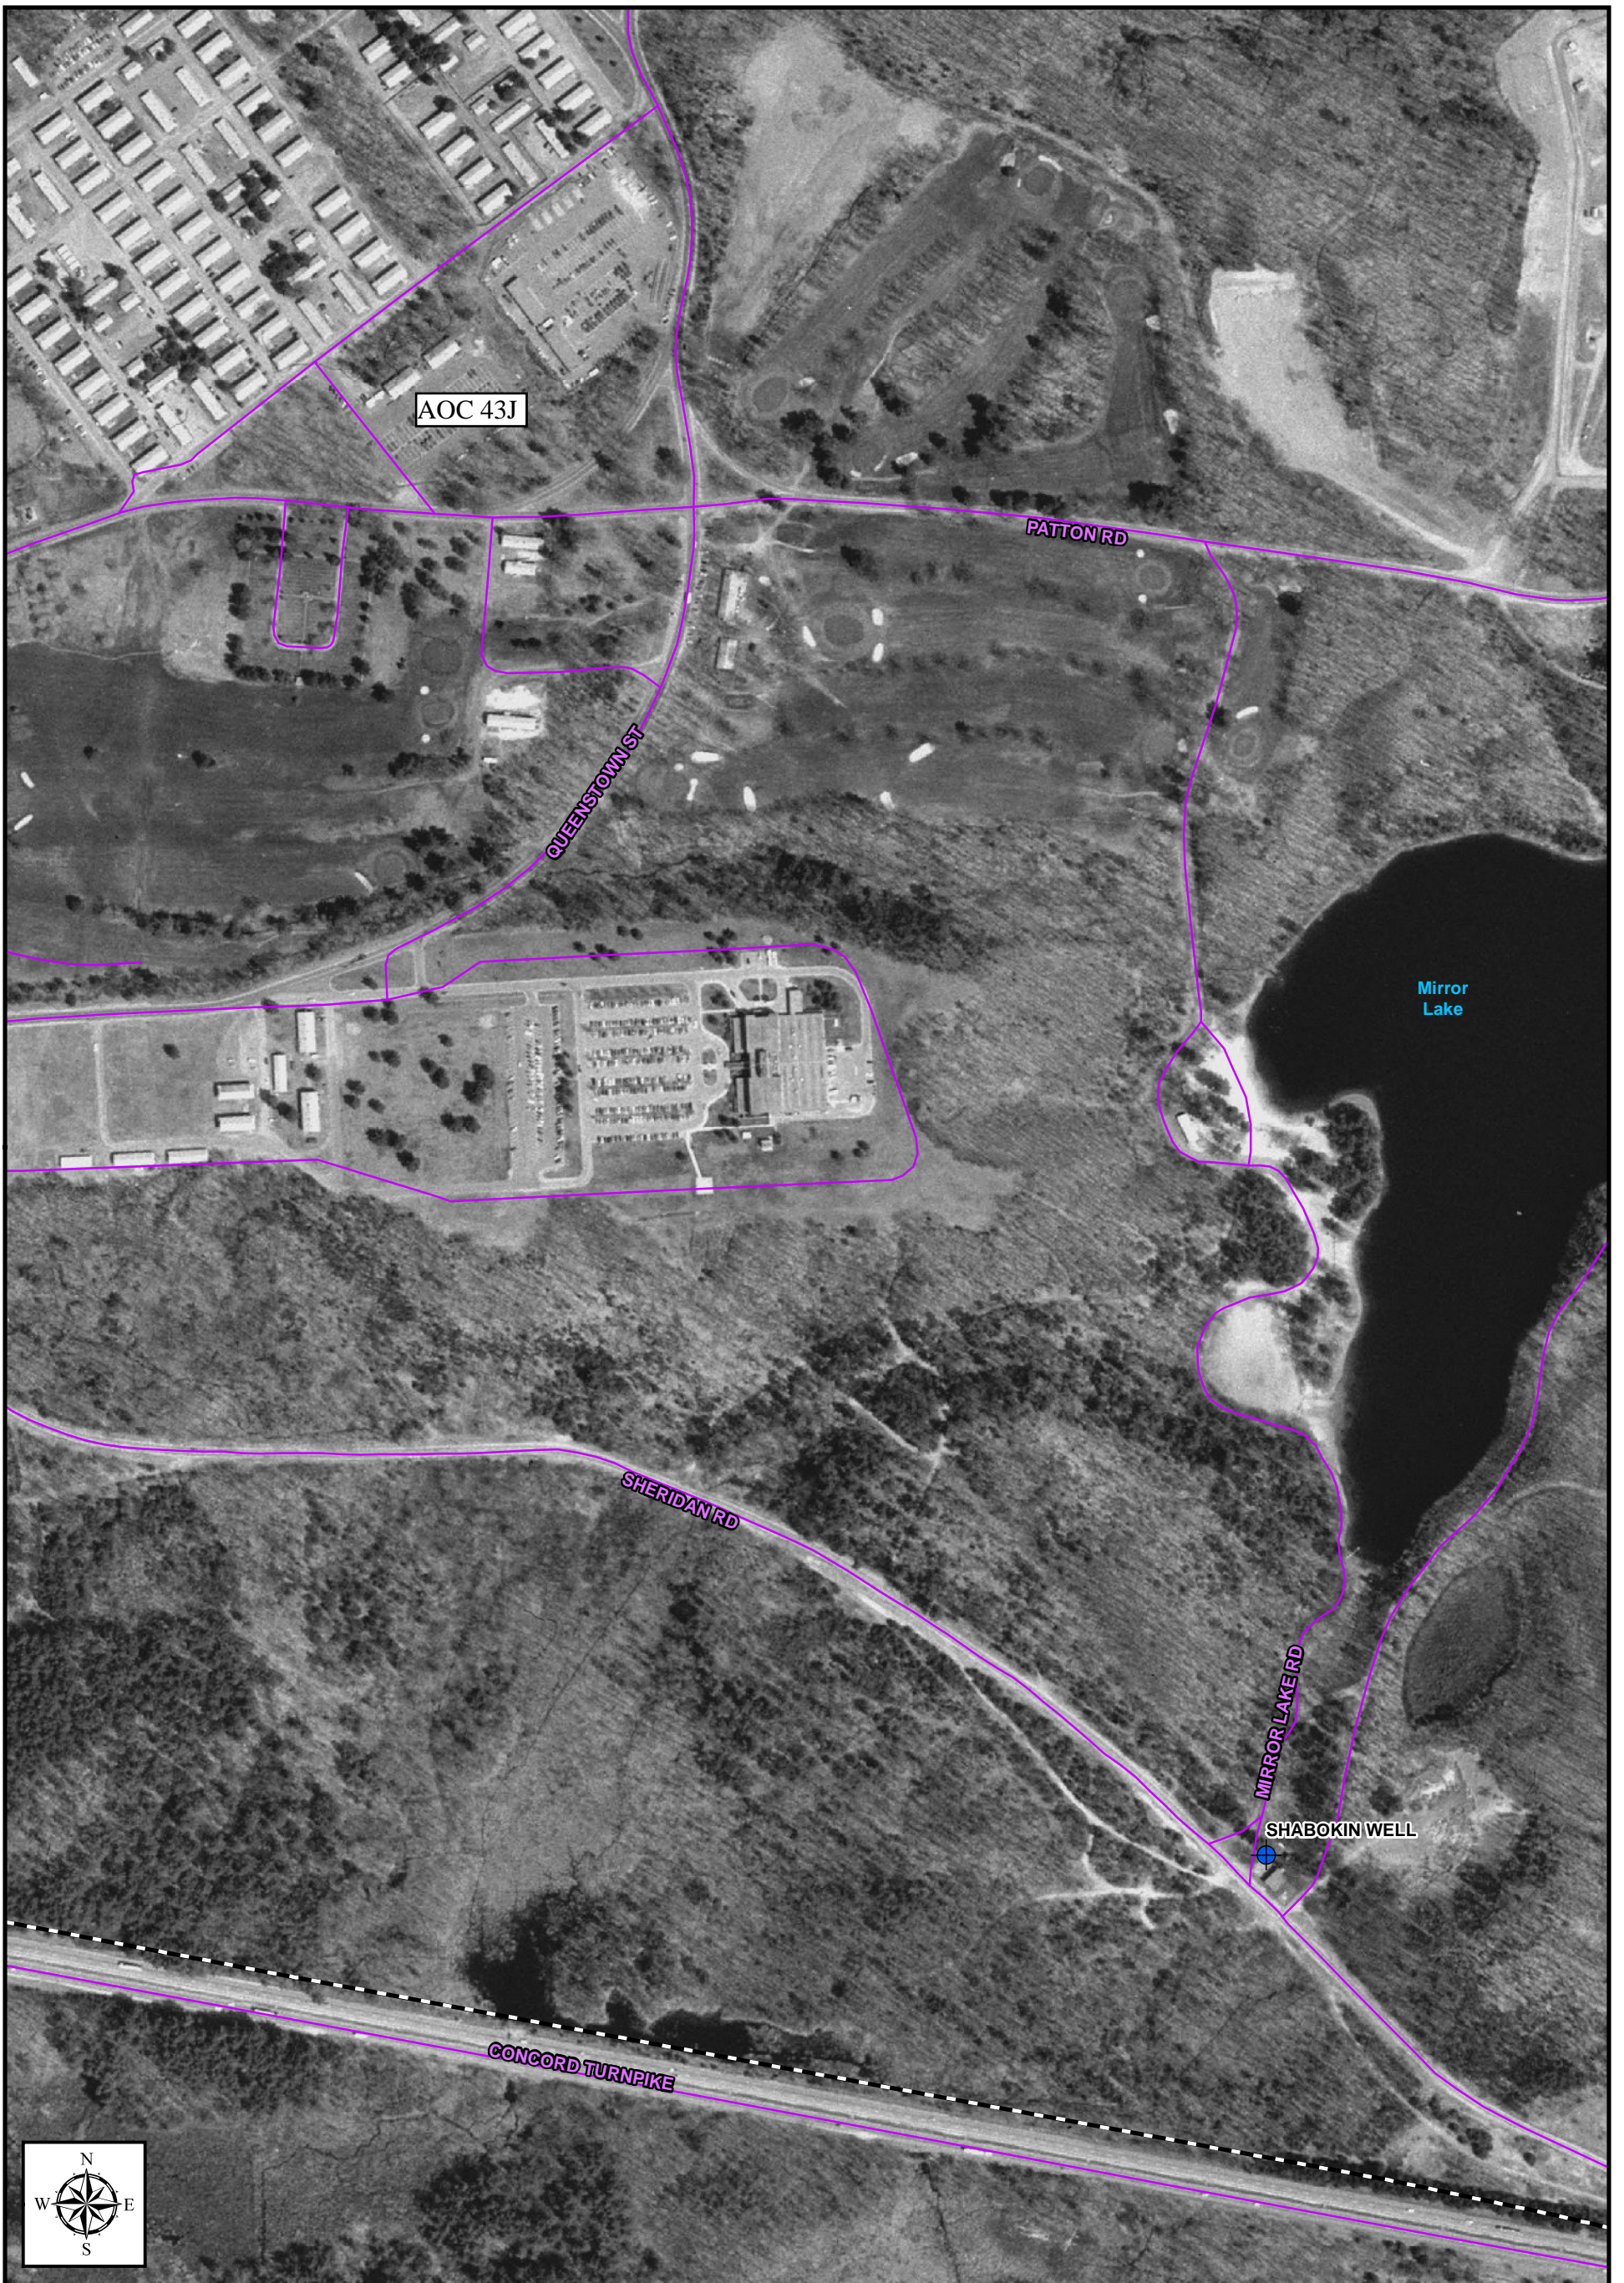
All of the detections in surface water and sediment in Cold Spring Brook, Cold Spring Brook Pond, and Mirror Lake were below the EPA SSSLs for PFAS at former Fort Devens (Table 1-1). The sampling locations and data are summarized on Figure 7-9 and the data are presented in Appendix H.

PFAS compounds were detected in the surface water upstream (CSB-18-01) (Figure 7-9) of where AOC 75 is discharging suggesting there are other PFAS impacts to Cold Spring Brook upstream of AOC 75. PFAS was detected in surface water downstream (CSB-18-02) of where AOC 75 is discharging but at lower concentrations than at CSB-20-02 and -03. The data indicates there is a limited area of higher PFAS concentrations in the brook, resulting from PFAS impacted groundwater discharging to the brook, and the PFAS impacted surface water at AOC 75 mixes with other surface water inputs resulting in lower concentrations downstream.

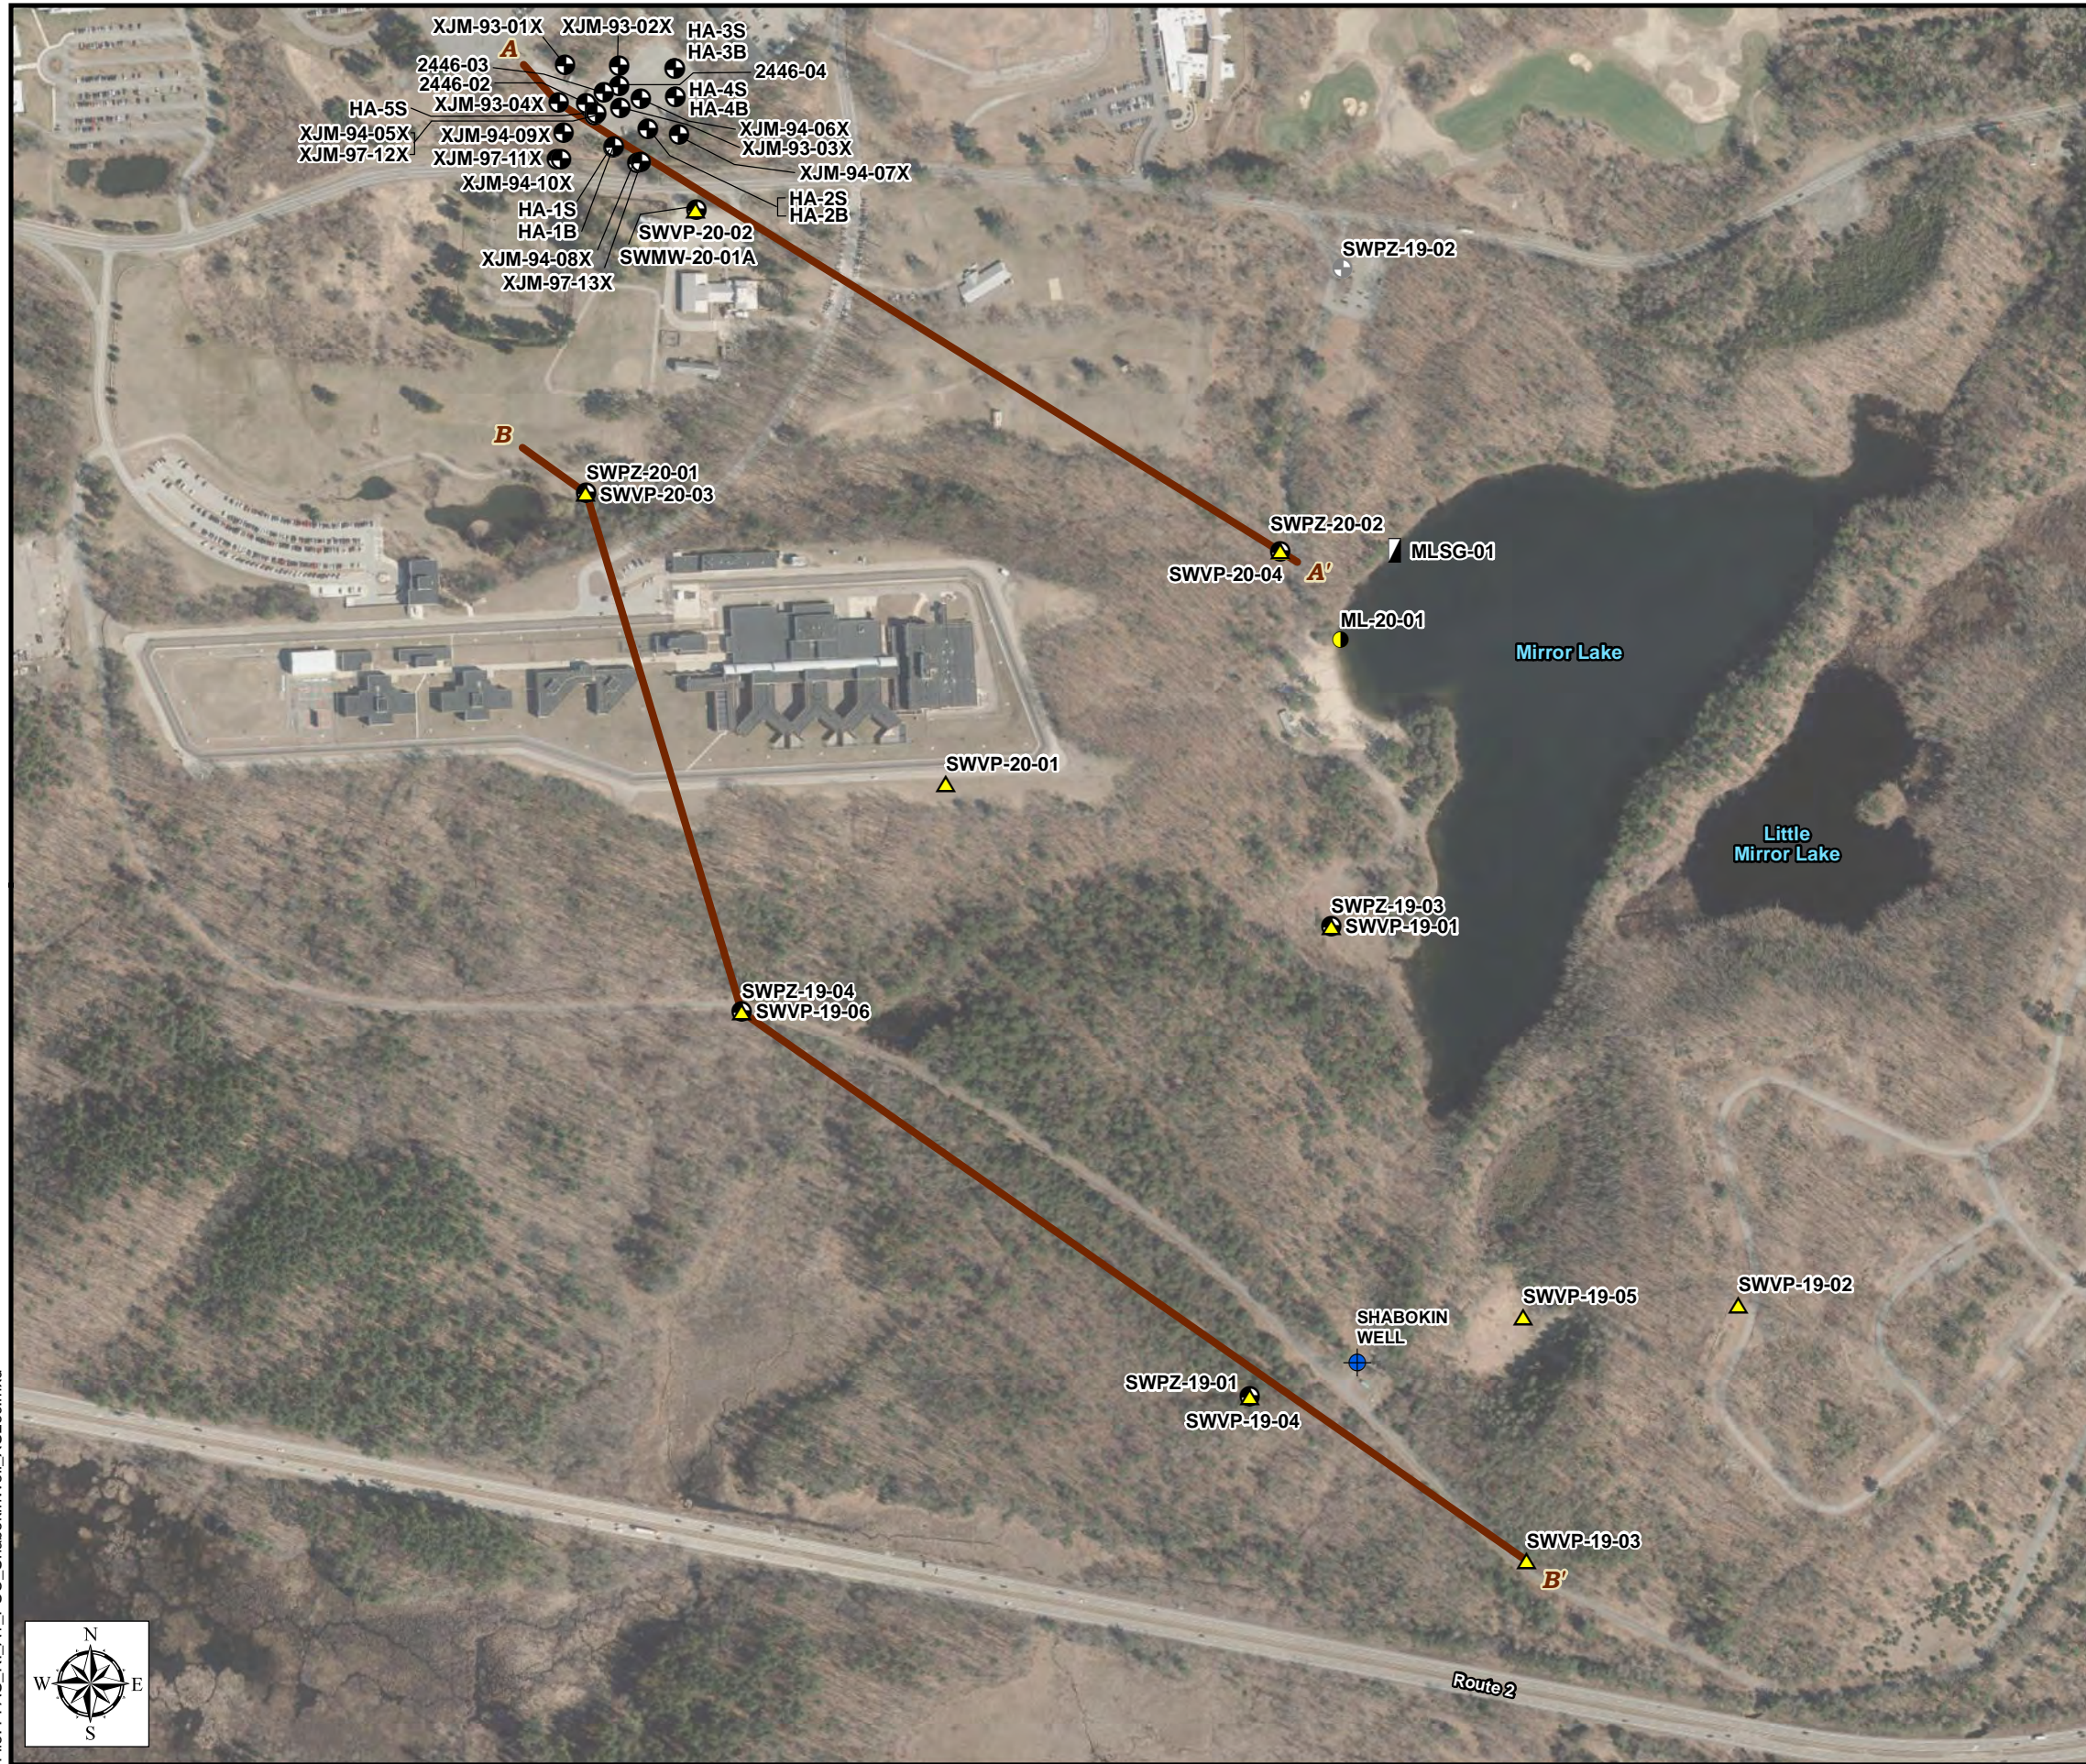
Groundwater analytical results are presented on Figure 8-5 and in cross section (Figures 8-6 through 8-8). All of the results are presented in Appendix H. The discussions below are focused on results with respect to the media specific criteria (Table 1-1).

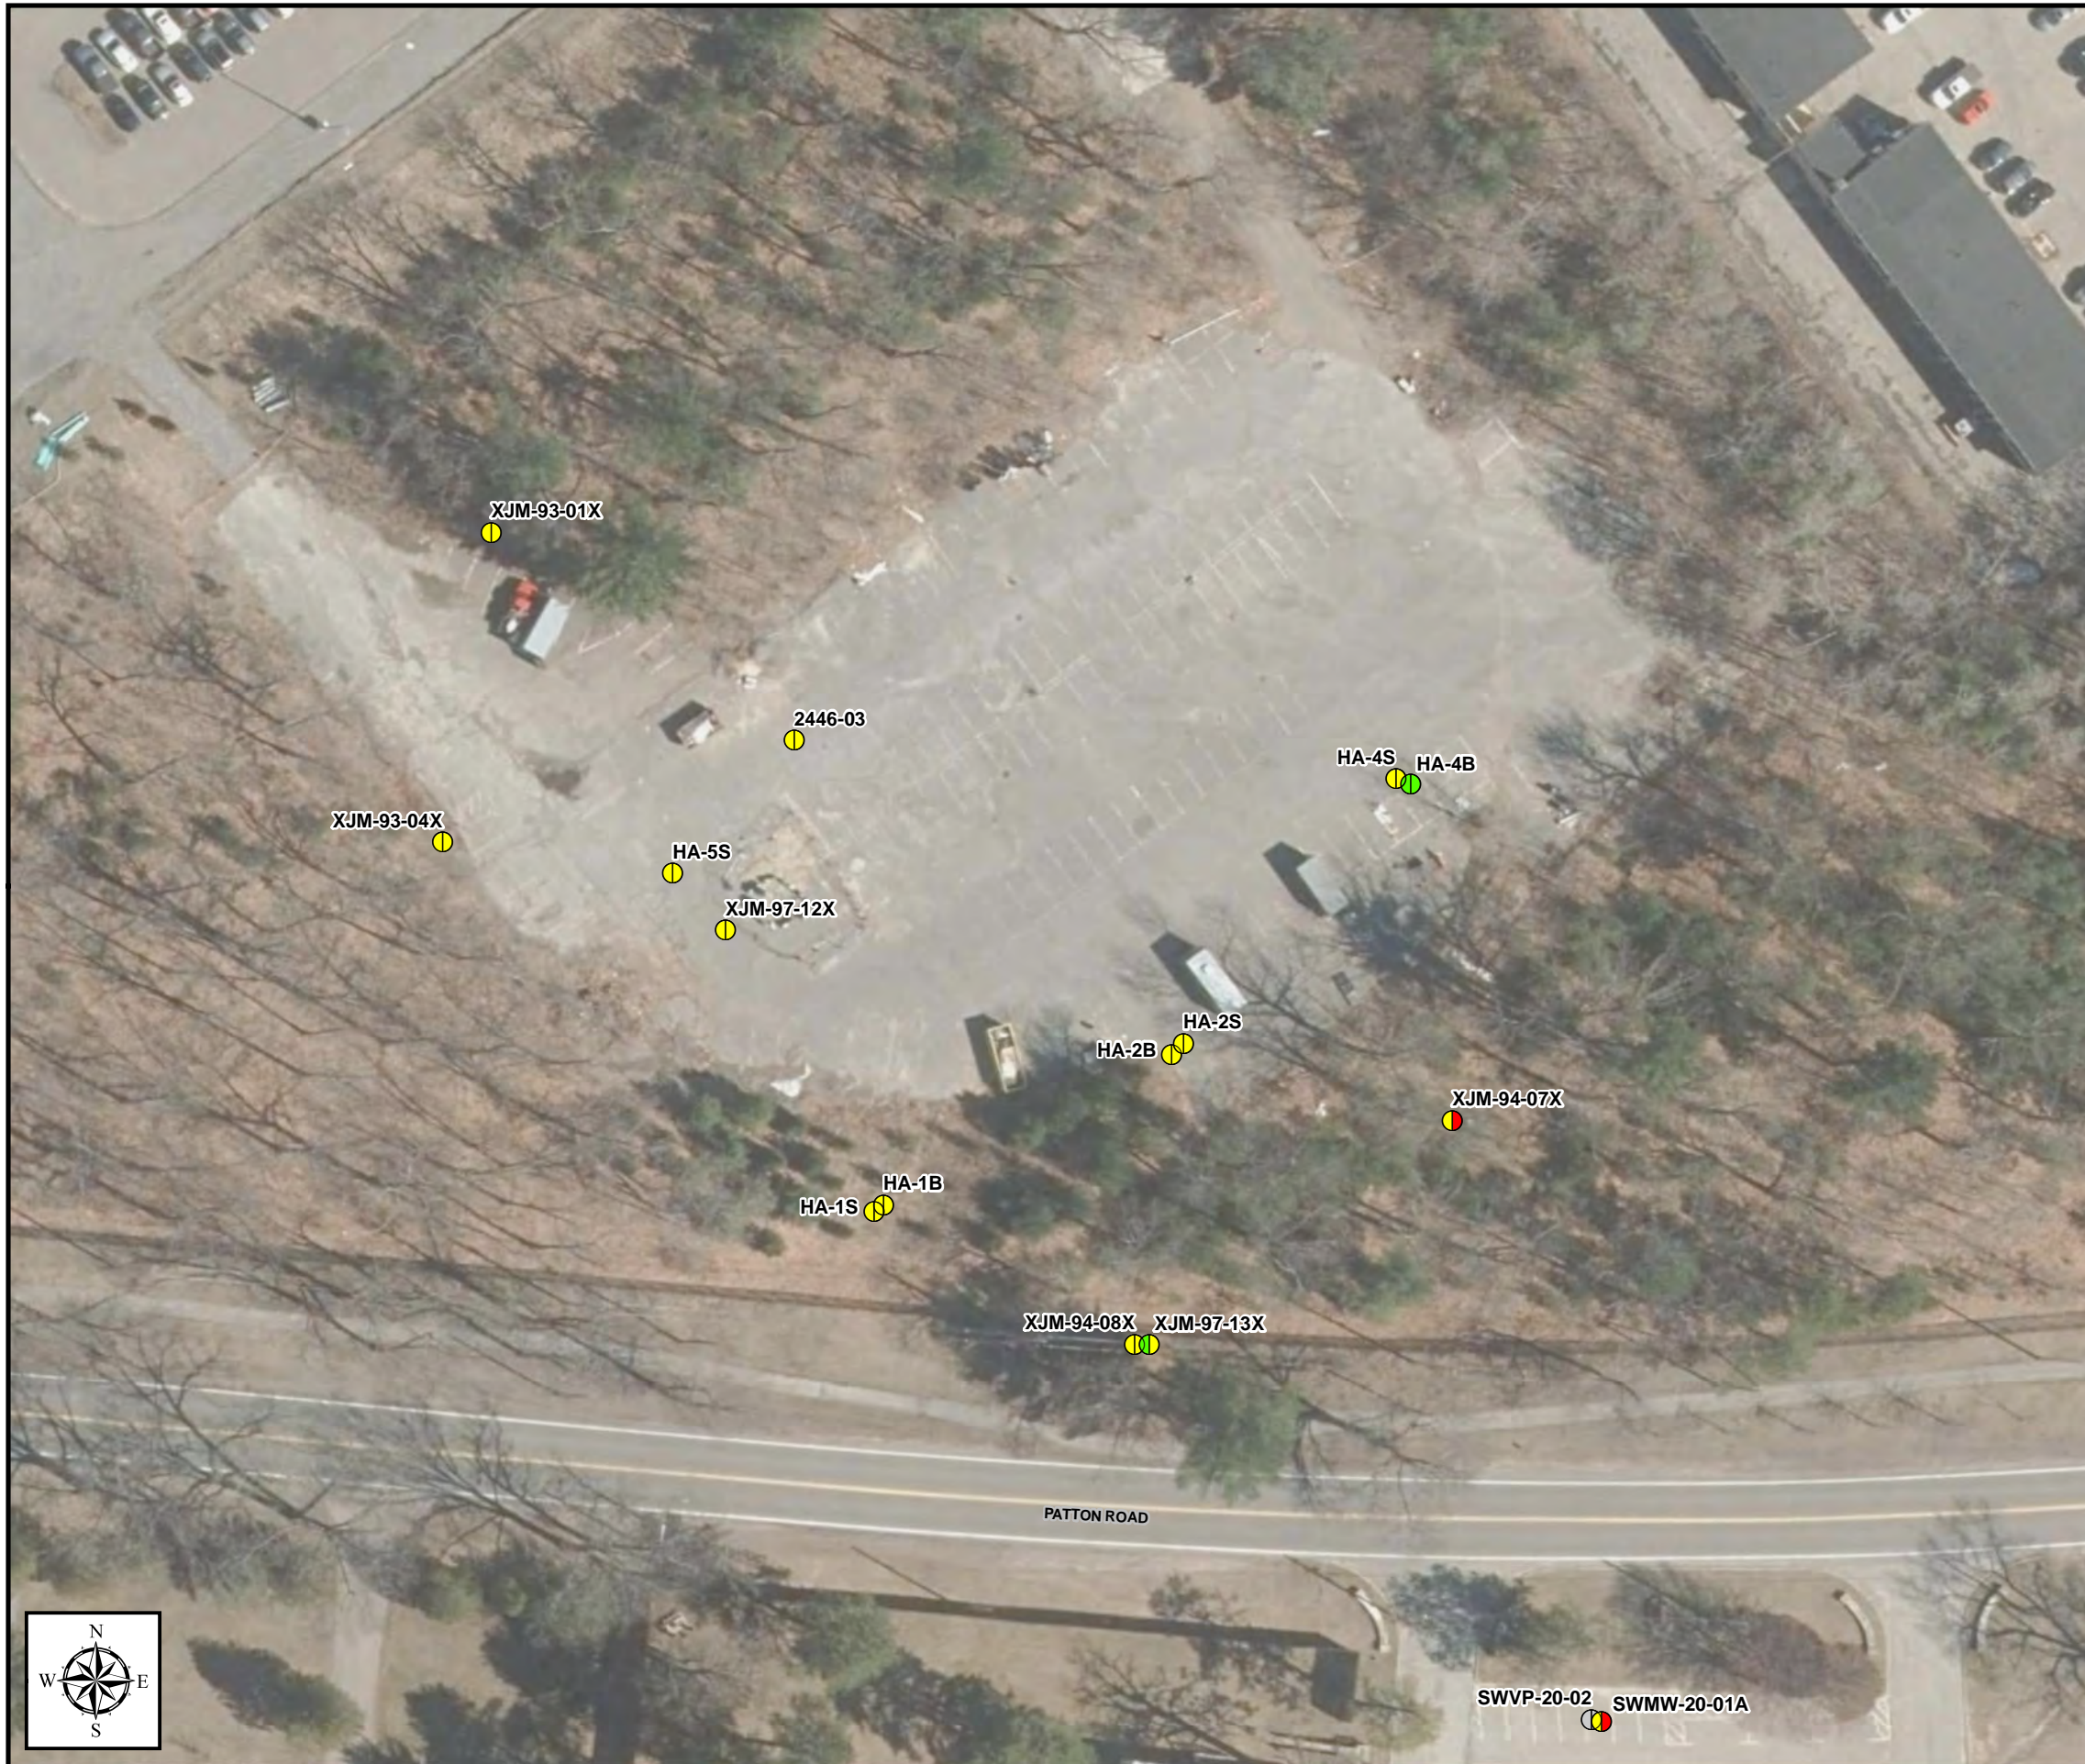
The RI field investigation at AOC 43J included sampling existing monitoring wells. The work was completed in general accordance with the *Area 2 Field Sampling Plan Addendum to Remedial Investigation Work Plan for Per- and Polyfluoroalkyl Substances (PFAS)* (KGS, 2018c). Field activities were added as the data was received and reviewed. Sampling locations are presented on Figure 9-1 and summarized in Table 9-1. The results are discussed in Section 9.5.

Groundwater samples were collected from existing monitoring wells at AOC 43J in December 2018 through January 2019 in accordance with the *Area 2 Field Sampling Plan Addendum to Remedial Investigation Work Plan for Per- and Polyfluoroalkyl Substances (PFAS)* (KGS, 2018c) (Table 9-1, Figure 9-1).

AOC 43J was first identified as a possible source of contamination in 1988 (Argonne National Laboratory, 1992). The Army identified several leaking USTs which held gasoline, waste oil, and diesel. At the time of base closure in 1996, the area around AOC 43J was used as a vehicle storage yard and maintenance facility (former Buildings T-2446 and T-2479) for a Special Forces Unit of the Army. The former maintenance facility used a 1,000-gallon UST for storage of maintenance wastes. This UST was located just south of former Building T-2446 (Figure 9-1) (Haley and Aldrich, 2017).
