**FINAL
NO FURTHER ACTION DECISION UNDER CERCLA
STUDY AREA 43D
PATCH ROAD HISTORIC GAS STATION**

FORT DEVENS, MASSACHUSETTS

JULY 1996

ABB ABB Environmental
Services, Inc.

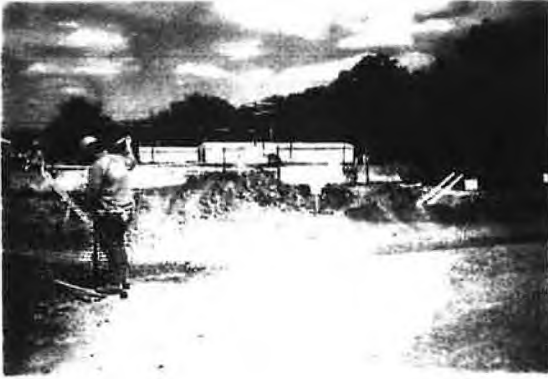
Opening Excavation - Securing Area

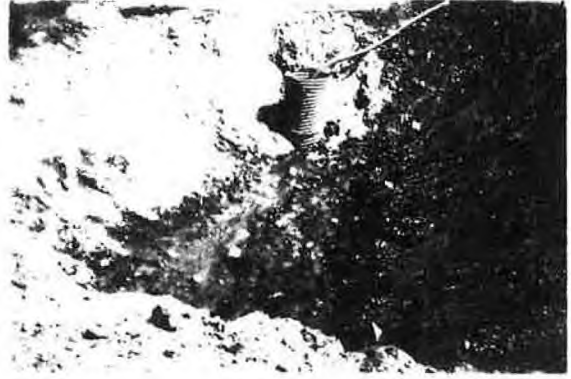
Dewatering Sump

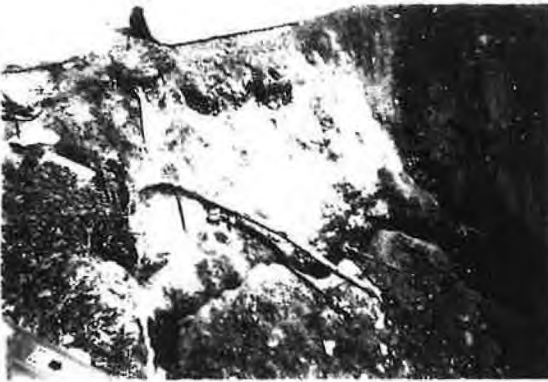
Storm Sewer Line Exposed

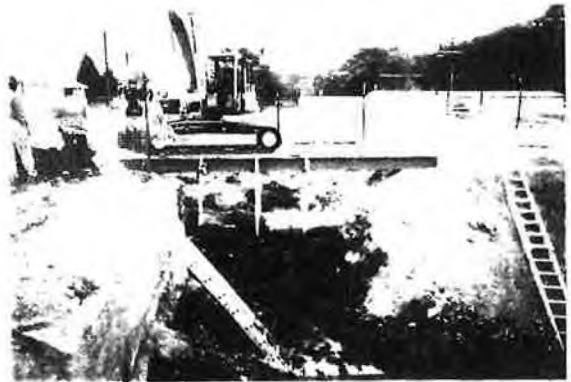
Supported Storm Line

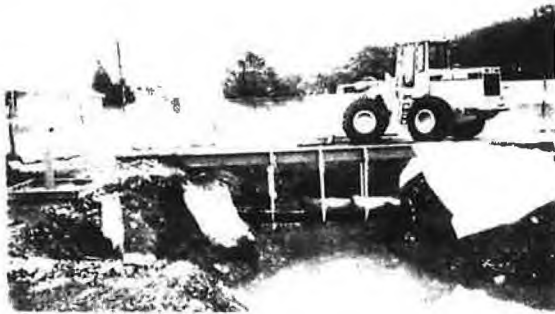
Foundation Removed

section of concrete broke off during excavation and it was discovered that the structure was a frost wall sitting on footings with a concrete slab on top. The wall of the structure facing the excavation collapsed during removal activities leaving the top slab and other sidewall slabs. The slab was removed from the top in order to excavate the remaining contaminated soil. Screening samples were collected in this area and the results indicated TPH concentrations below the action level.

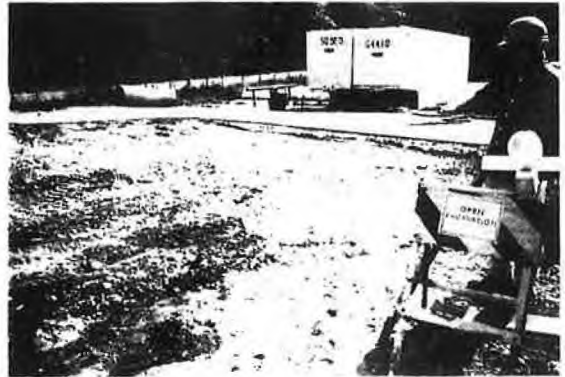
Backfilled to Rough Grade

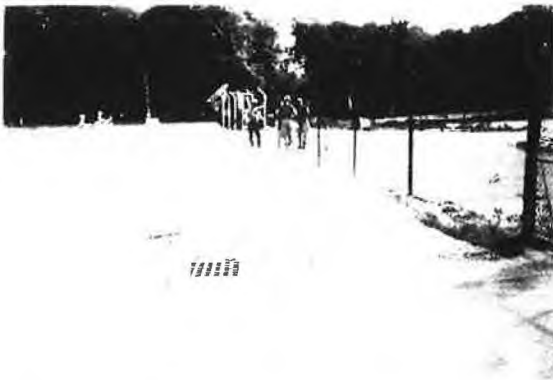
SA 43D Restored to Original Contours

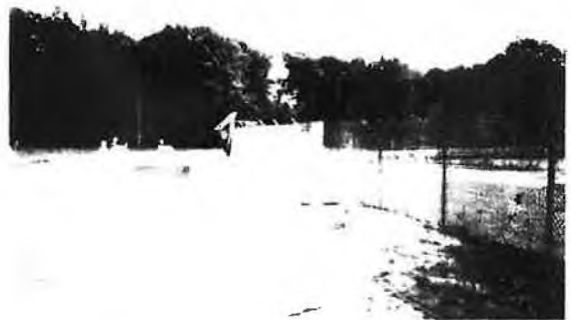
Existing Chain Link Fence Re-installed
