**FINAL  
NO FURTHER ACTION DECISION UNDER CERCLA  
STUDY AREA 49  
BUILDING 3602 LUST SITE**

**FORT DEVENS, MASSACHUSETTS**

**CONTRACT NO DACA33-91-D-0006  
DELIVERY ORDER NO. 21**

**OCTOBER 1996**

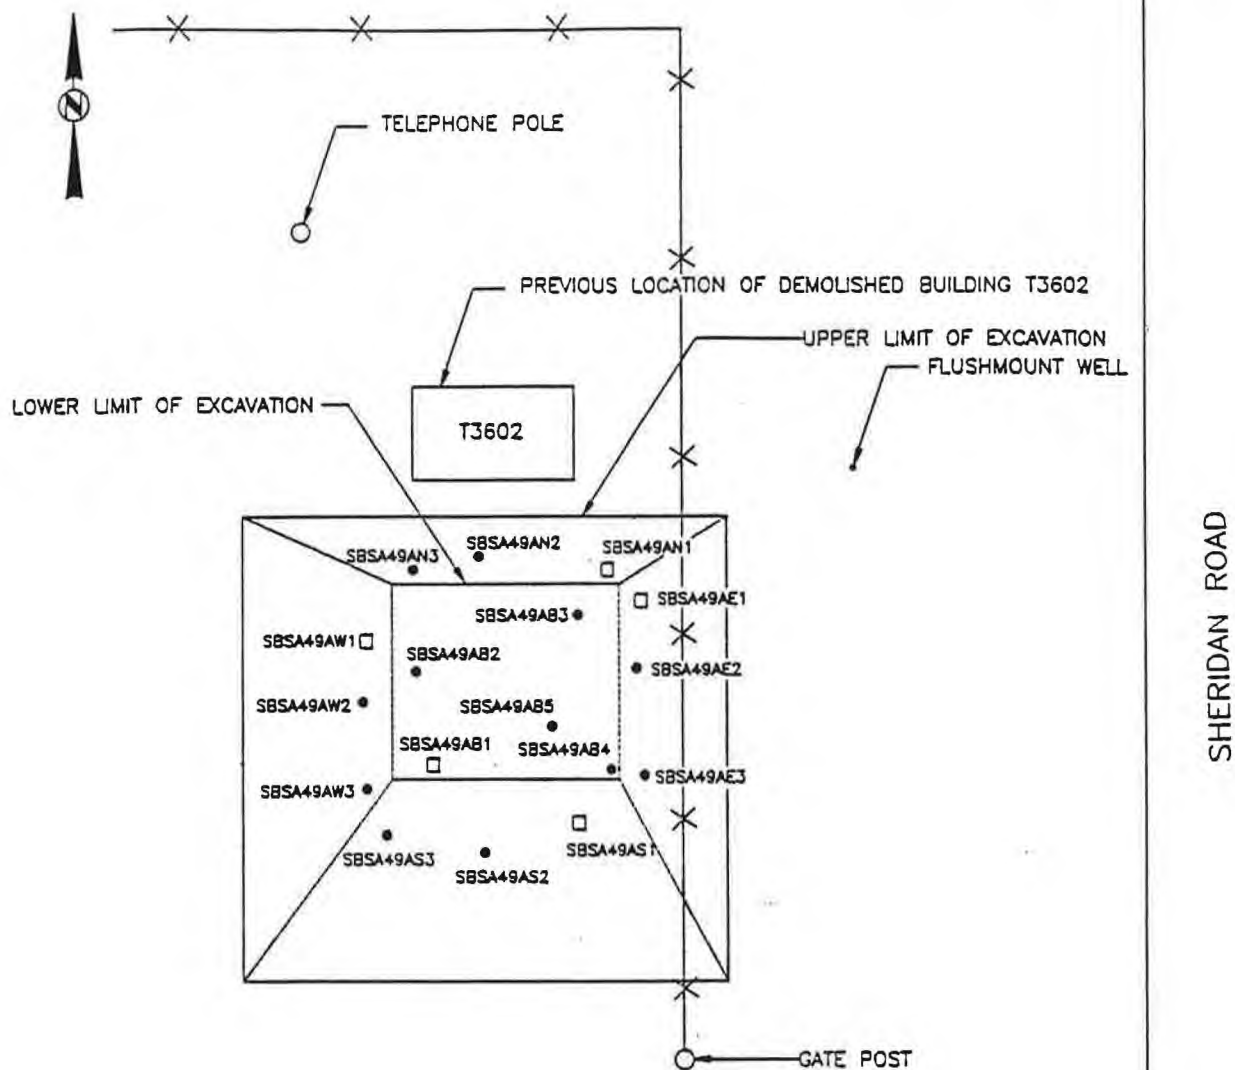
CONFIRMATORY COMPOSITE SAMPLE NUMBERS	DISCRETE SAMPLE LOCATIONS
SBSA49SNC	SBSA49AN1 SBSA49AN2 SBSA49AN3
SBSA49AWC	SBSA49AW1 SBSA49AW2 SBSA49AW3
SBSA49ASC	SBSA49AS1 SBSA49AS2 SBSA49AS3
SBSA49AEC	SBSA49AE1 SBSA49AE2 SBSA49AE3
SBSA49ABC	SBSA49AB1 SBSA49AB2 SBSA49AB3 SBSA49AB4 SBSA49AB5

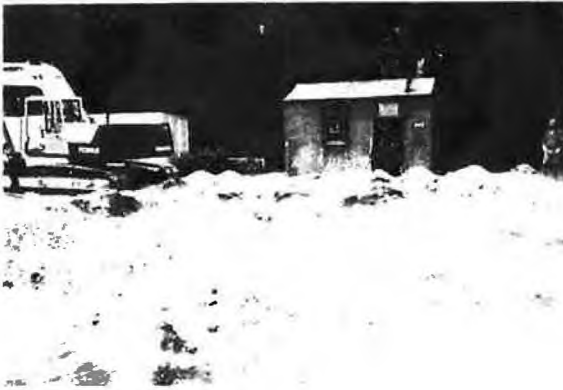
Opening Previous Excavation

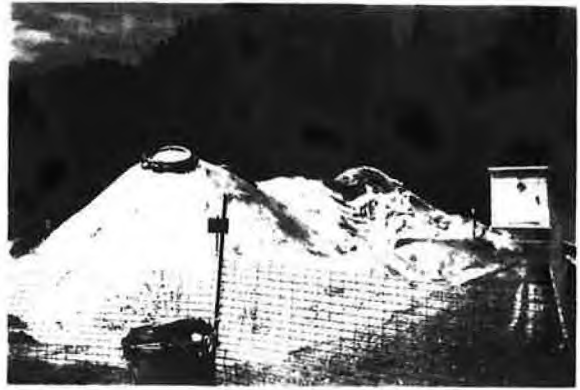
Soil Staging Cells

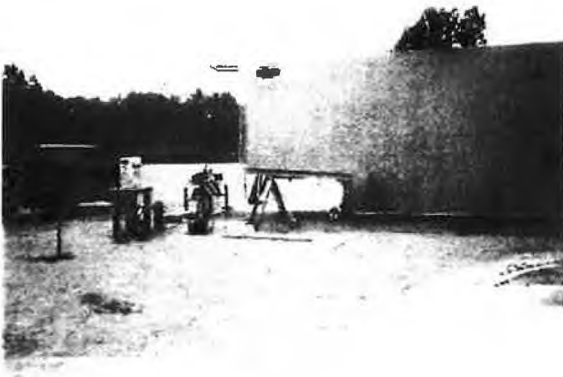
Frac Tank Storing Water from Excavation

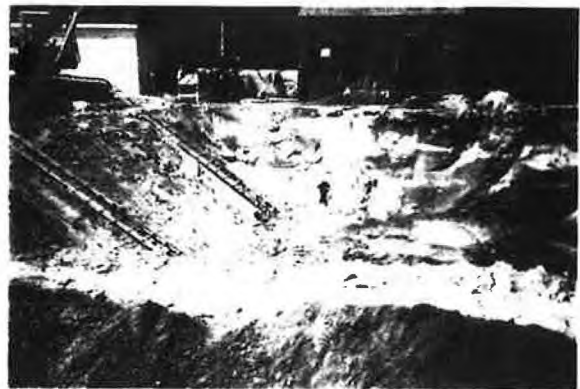
Limits of Excavation

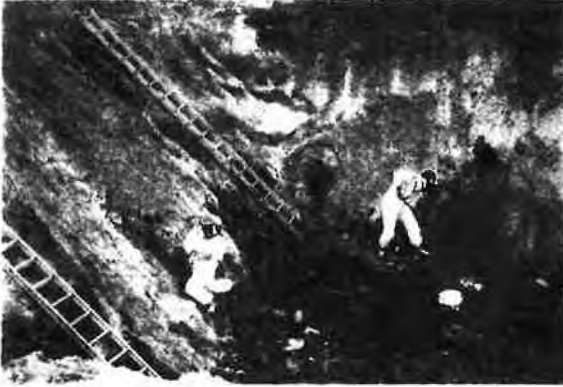
Technicians Collecting Confirmation Samples

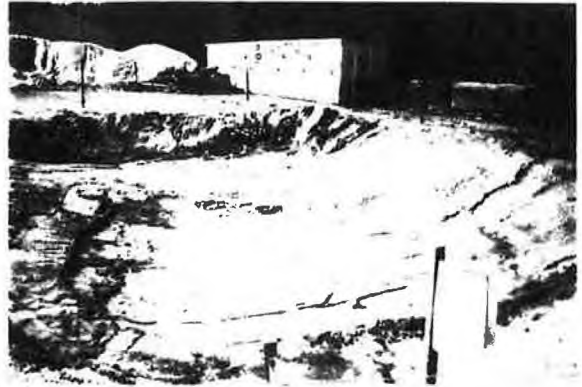
Backfilling Excavation

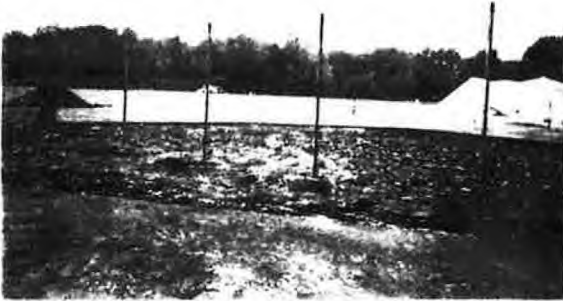
Excavation Restored to Rough Grade

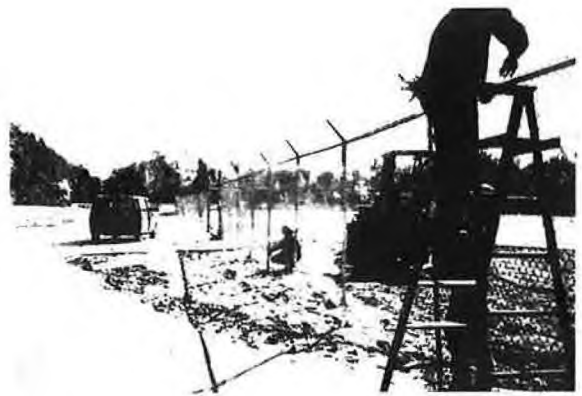
Re-installation of Existing Fence
