**FINAL  
NO FURTHER ACTION DECISION UNDER CERCLA  
STUDY AREA 56  
BUILDING 2417 LUST SITE**

**FORT DEVENS, MASSACHUSETTS**

**OCTOBER 1996**

**ABB** ABB Environmental  
Services, Inc.

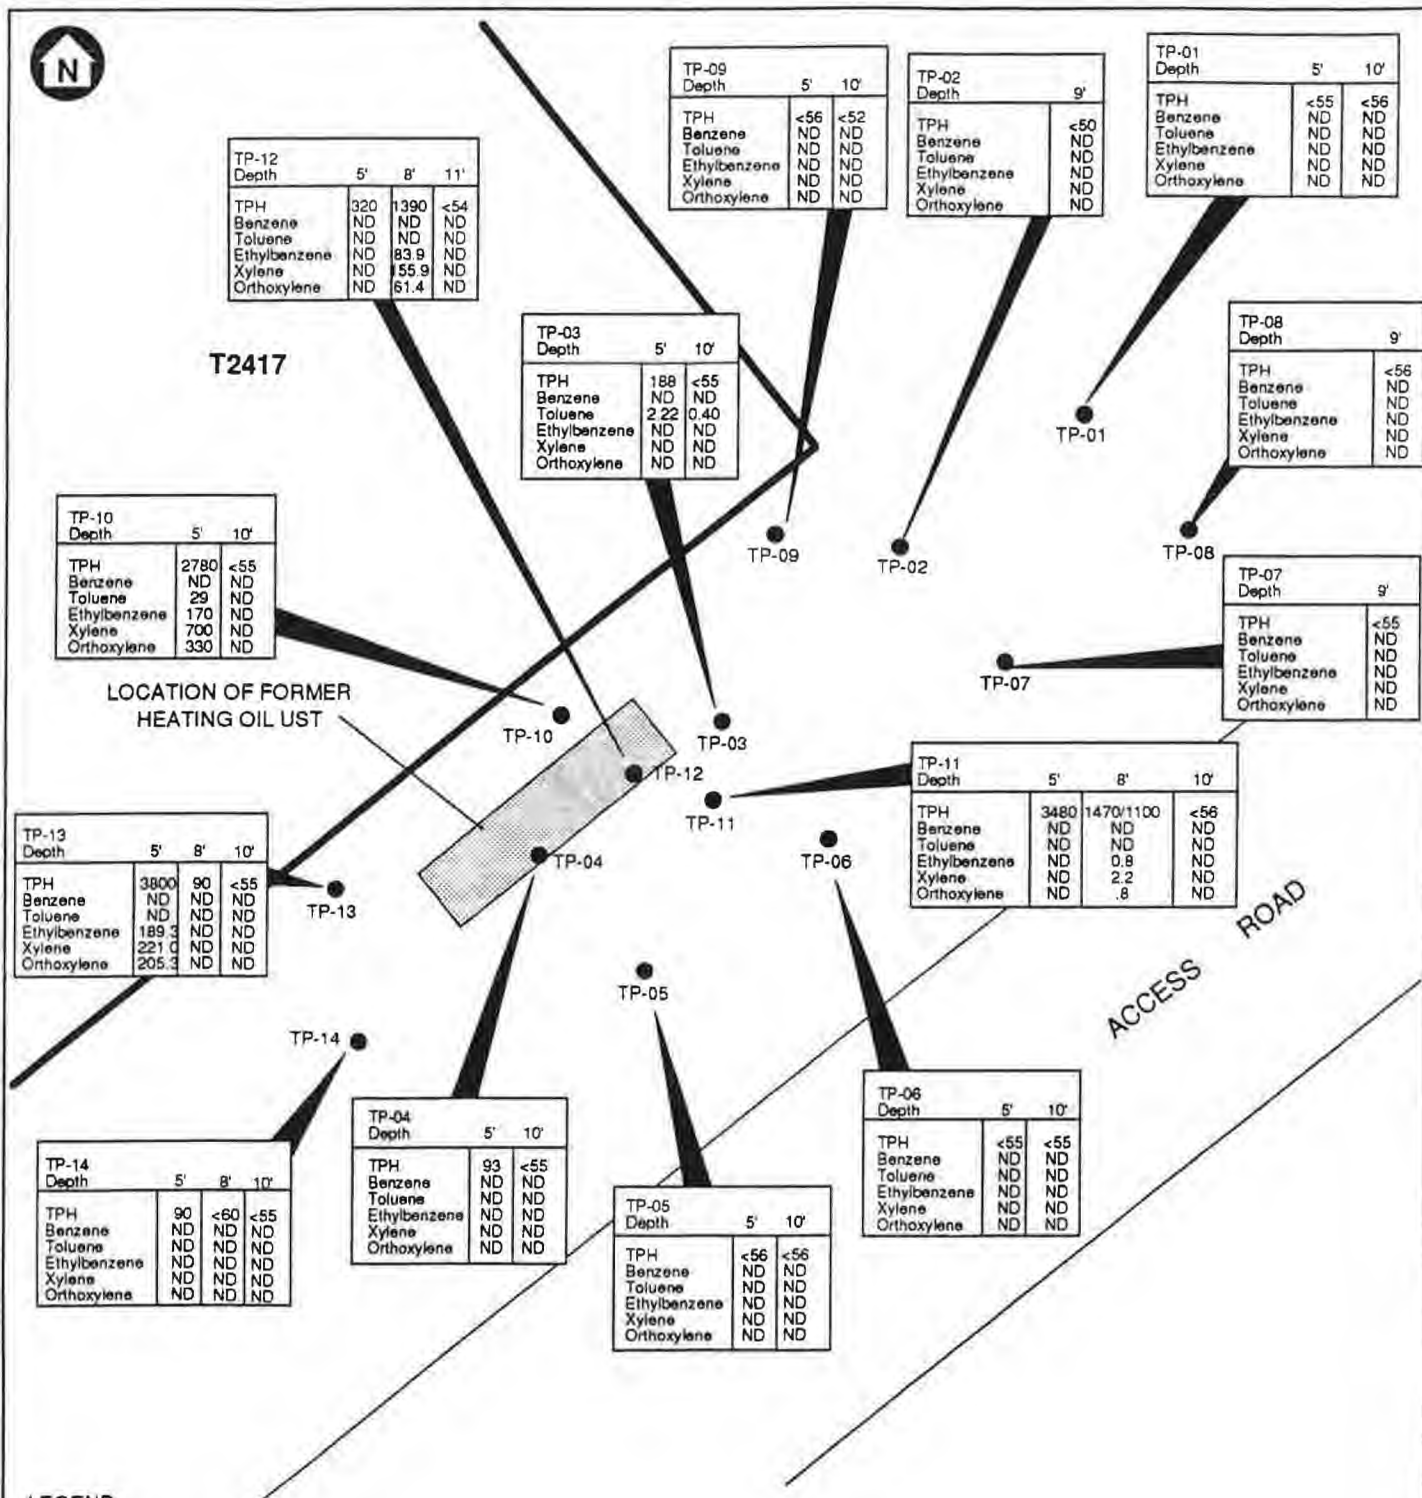
**FIGURE 4-1**  
**SITE INVESTIGATION FIELD SCREENING RESULTS, 1992**  
**NO FURTHER ACTION DECISION DOCUMENT**  
**SA 56 BUILDING 2417 LUST SITE**  
**FORT DEVENS, MA**

- TERRAPROBE LOCATION
- BTEX - BENZENE, TOLUENE, ETHYLBENZENE, XYLENE
- TPH - TOTAL PETROLEUM HYDROCARBONS
- ND - NON DETECT

Results of field screening were used to place two soil borings at the location of highest detected concentrations. Two samples were collected from each of these borings and were analyzed for VOCs and TPH to confirm field screening results and to further define geologic conditions at SA 56.

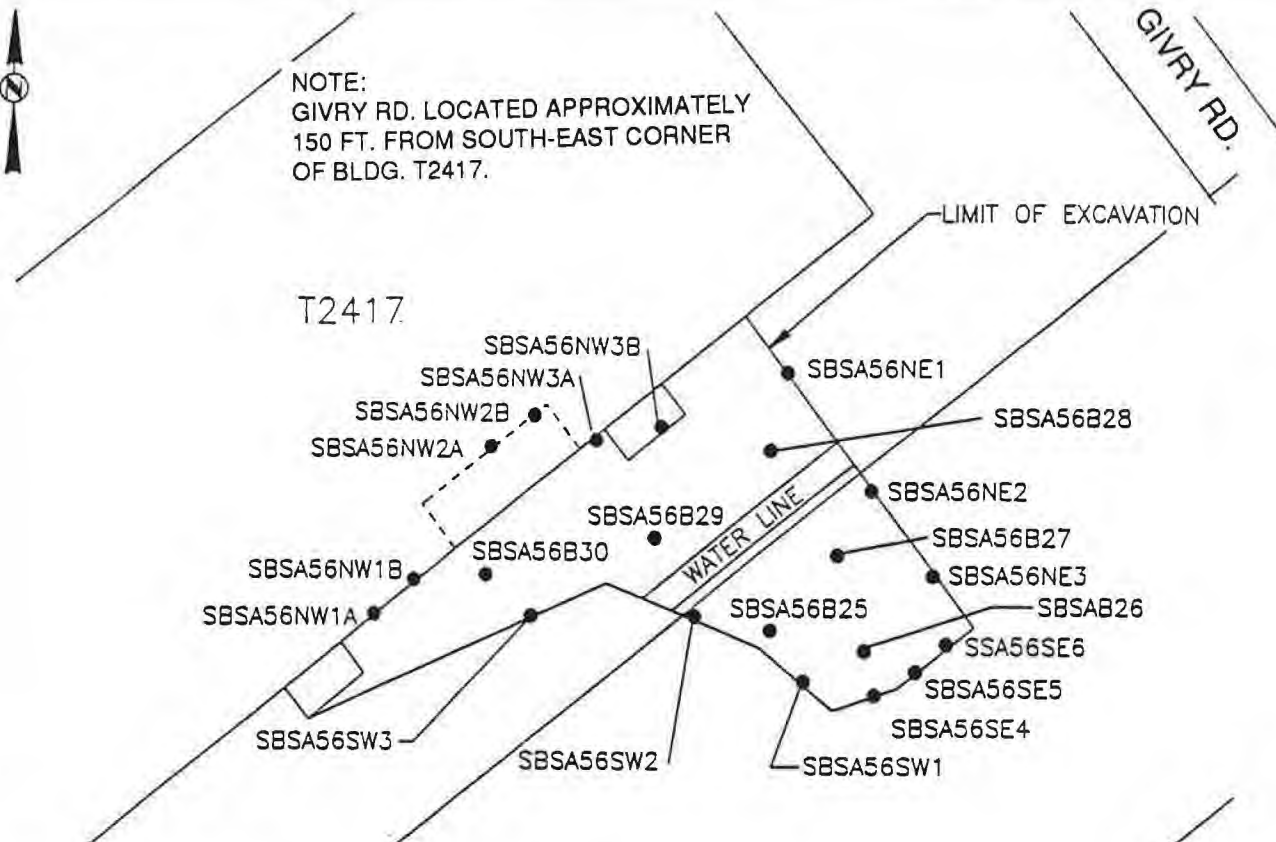
CONFIRMATORY COMPOSITE SAMPLE NUMBERS	DISCRETE SAMPLE LOCATIONS
SBSA56NWC1	SBSA56NW1A SBSA56NW1B
SBSA56NWC2	SBSA56NW2A SBSA56NW2B
SBSA56NWC3	SBSA56NW3A SBSA56NW3B
SBSA56NEC	SBSA56NE1 SBSA56NE2 SBSA56NE3
SBSA56SEC2	SBSA56SE4 SBSA56SE5 SBSA56SE6
SBSA56SWC	SBSA56SW1 SBSA56SW2 SBSA56SW3
SBSA56BC1	SBSA56B25 SBSA56B26 SBSA56B27
SBSA56BC2	SBSA56B28 SBSA56B29 SBSA56B30

--- DENOTES EXCAVATION BENEATH  
FOUNDATION

3  
4 Soil samples collected from underneath the Building 2417 foundation (northwest  
5 sidewall) indicated the presence of contamination above the TPH action level which  
6 could not be removed without potentially jeopardizing the structural integrity of the  
7 building. The USACE then directed OHM to demolish the building in order to  
8 remove the residual contamination under the building. The removal action  
9 continued until screening results indicated that TPH concentrations in residual soils  
10 did not exceed 500  $\mu\text{g/g}$  (OHM, 1996). The excavation ultimately extended to an  
11 average depth of 11 ft. A total of 1,173 tons of contaminated soil were removed;  
12 the final excavation limit is shown on Figure 4-3.

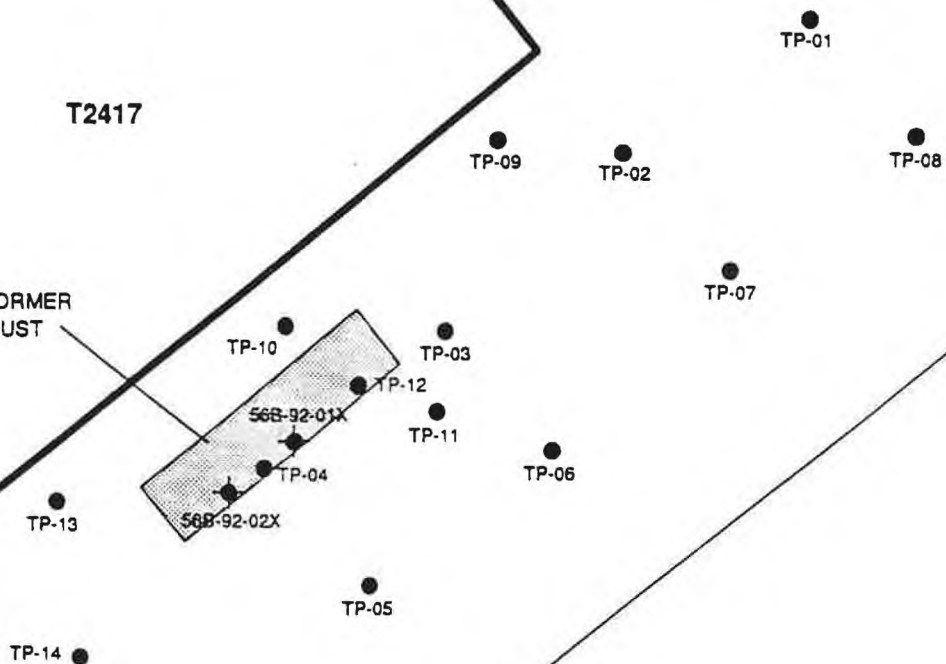
LOCATION OF FORMER  
HEATING OIL UST

- TERRAPROBE LOCATION
- ✦ SOIL BORING LOCATION

Based on the on-site screening results obtained during the TerraProbe investigation, two soil borings were installed in the "contaminated" area. Samples were collected to further define the geologic conditions at SA 56, and confirm the analytical data generated on site. Two samples were collected from each boring at depths of 7 to 9 feet and 9 to 11 feet and analyzed for volatile organic compounds (VOCs) and TPH. TPH was detected at a concentration of 1,440 mg/kg in one of the 7 to 9 feet depth samples and at 56.1 mg/kg in the other. The 9 to 11 feet samples indicated TPH concentrations of 34.1 mg/kg and 34.4 mg/kg. The only VOC detected was acetone, which is a common laboratory contaminant, at a concentration of 35 ug/kg. Figure 1-3 shows the location of the TerraProbe sampling points and borings.

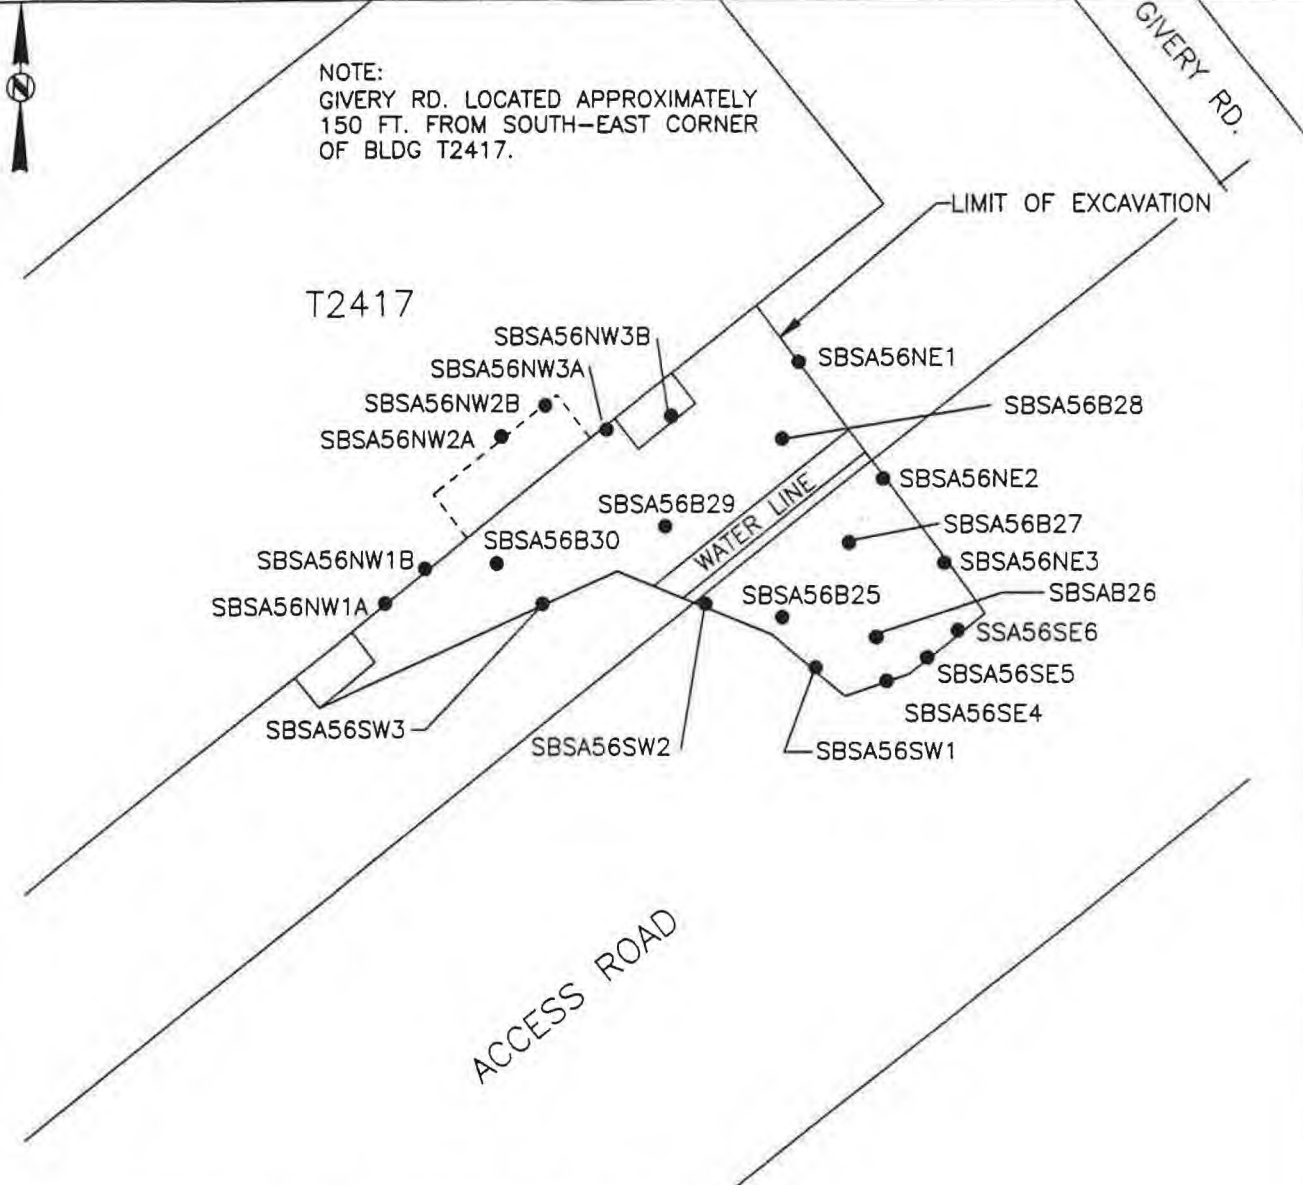
DISCRETE SAMPLE ID	CONFIRMATORY COMPOSITE SAMPLE ID
SBSA56NW1A SBSA56NW1B	SBSA56NWC1
SBSA56NW2A SBSA56NW2B	SBSA56NWC2
SBSA56NW3A SBSA56NW3B	SBSA56NWC3
SBSA56NE1 SBSA56NE2 SBSA56NE3	SBSA56NEC
SBSA56SE4 SBSA56SE5 SBSA56SE6	SBSA56SEC2
SBSA56SW1 SBSA56SW2 SBSA56SW3	SBSA56SWC
SBSA56B25 SBSA56B26 SBSA56B27	SBSA56BC1
SBSA56B28 SBSA56B29 SBSA56B30	SBSA56BC2

--- DENOTES EXCAVATION BENEATH  
FOUNDATION

Confirmation samples were collected from the bottom of the excavation and three of the sidewalls on September 22, 1994. Two composite samples were collected from the bottom of the excavation and one from each of the three sidewalls. The northwest sidewall was not sampled at this time because the removal of petroleum-contaminated material from underneath the building foundation was not complete. On October 4, 1994, three composite samples were collected from the northwest sidewall. Figure 2-1 provides the confirmatory sample locations. Three subsamples were composited from each of the three sidewalls and two bottom composite samples. Laboratory results for the sample collected from the southeast sidewall exceeded the TPH action level of 500 mg/kg and as a result this sidewall was resampled on October 3, 1994. Limited hand excavation was conducted prior to resampling the southeast sidewall because it was unclear whether the problem was attributed to the off-site data or to superficial contamination on the face of the sidewall.

Building 2417 was demolished on October 3, 1994 and additional excavation and screening was conducted on the sidewall below the building foundation to remove residual petroleum contamination above the action level. On October 4, 1994, three composite samples were collected from the northwest sidewall. Figure 2-1 provides the confirmatory sample locations. The composite samples were analyzed for TPH and semivolatile compounds. In addition to meeting the TPH action level, OHM was required to meet action levels of 4 mg/kg, 0.7 mg/kg, and 700 mg/kg for naphthalene, 2-methyl naphthalene and phenanthrene, respectively in accordance with the MCP.

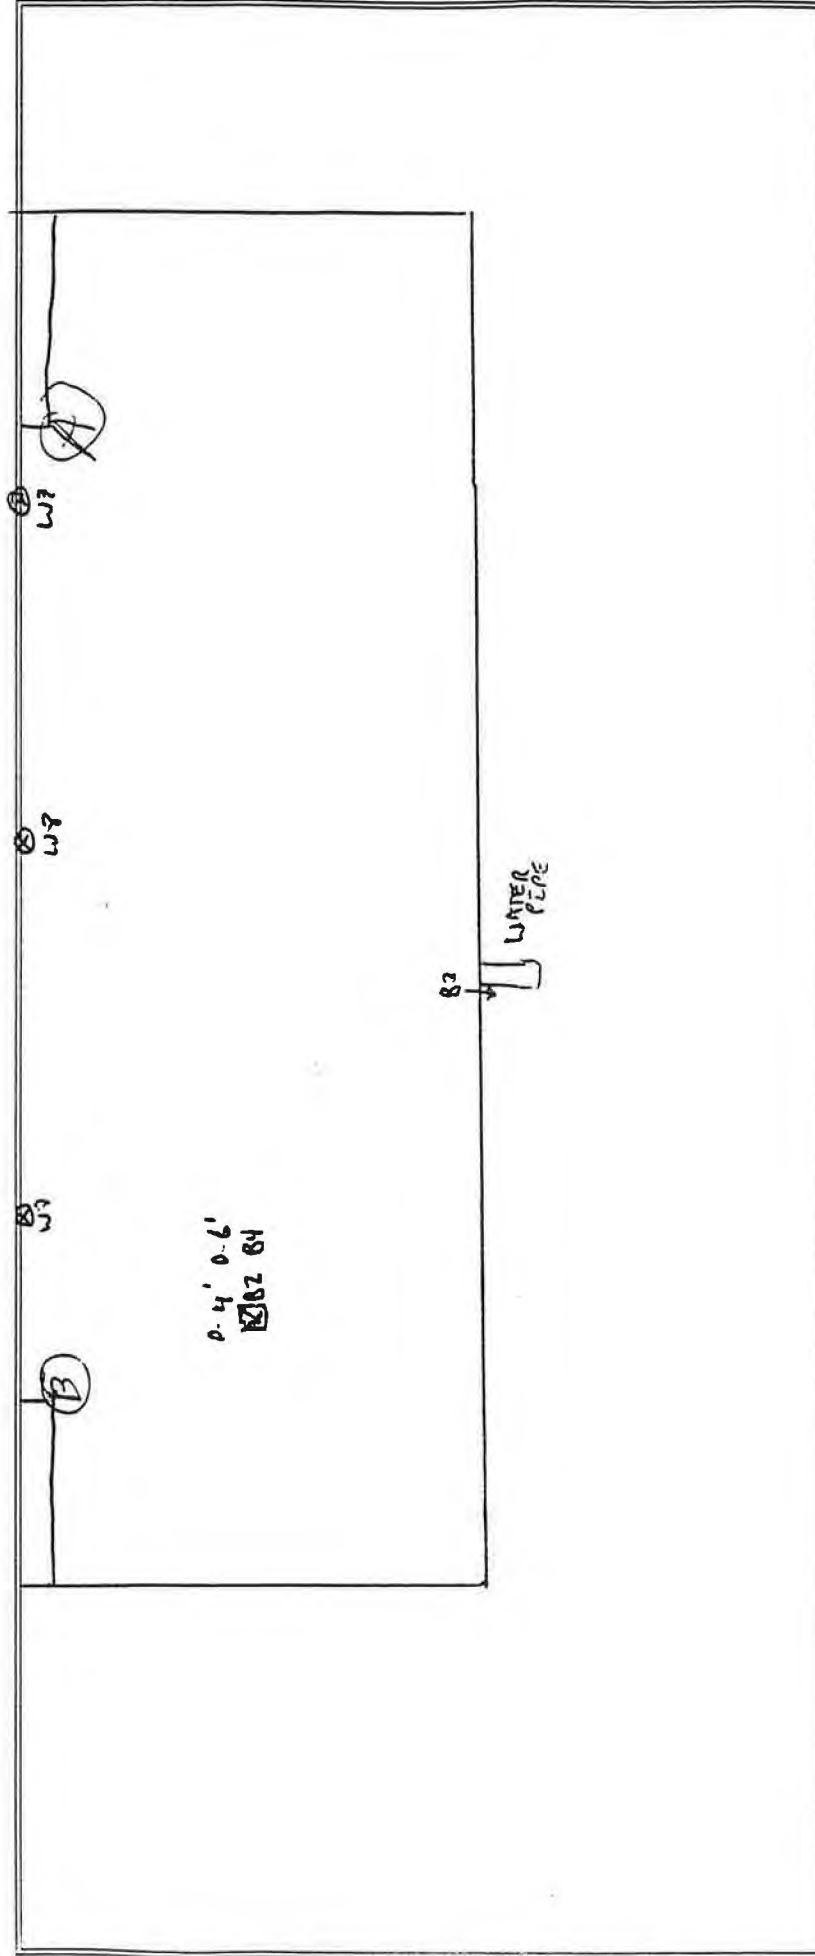
- \* NOTE  
B3 is a bottom sample. The water main was located manually by digging with a shovel. AT THIS POINT IN TIME the sample location was even with the excavation bottom and was hence labeled B3

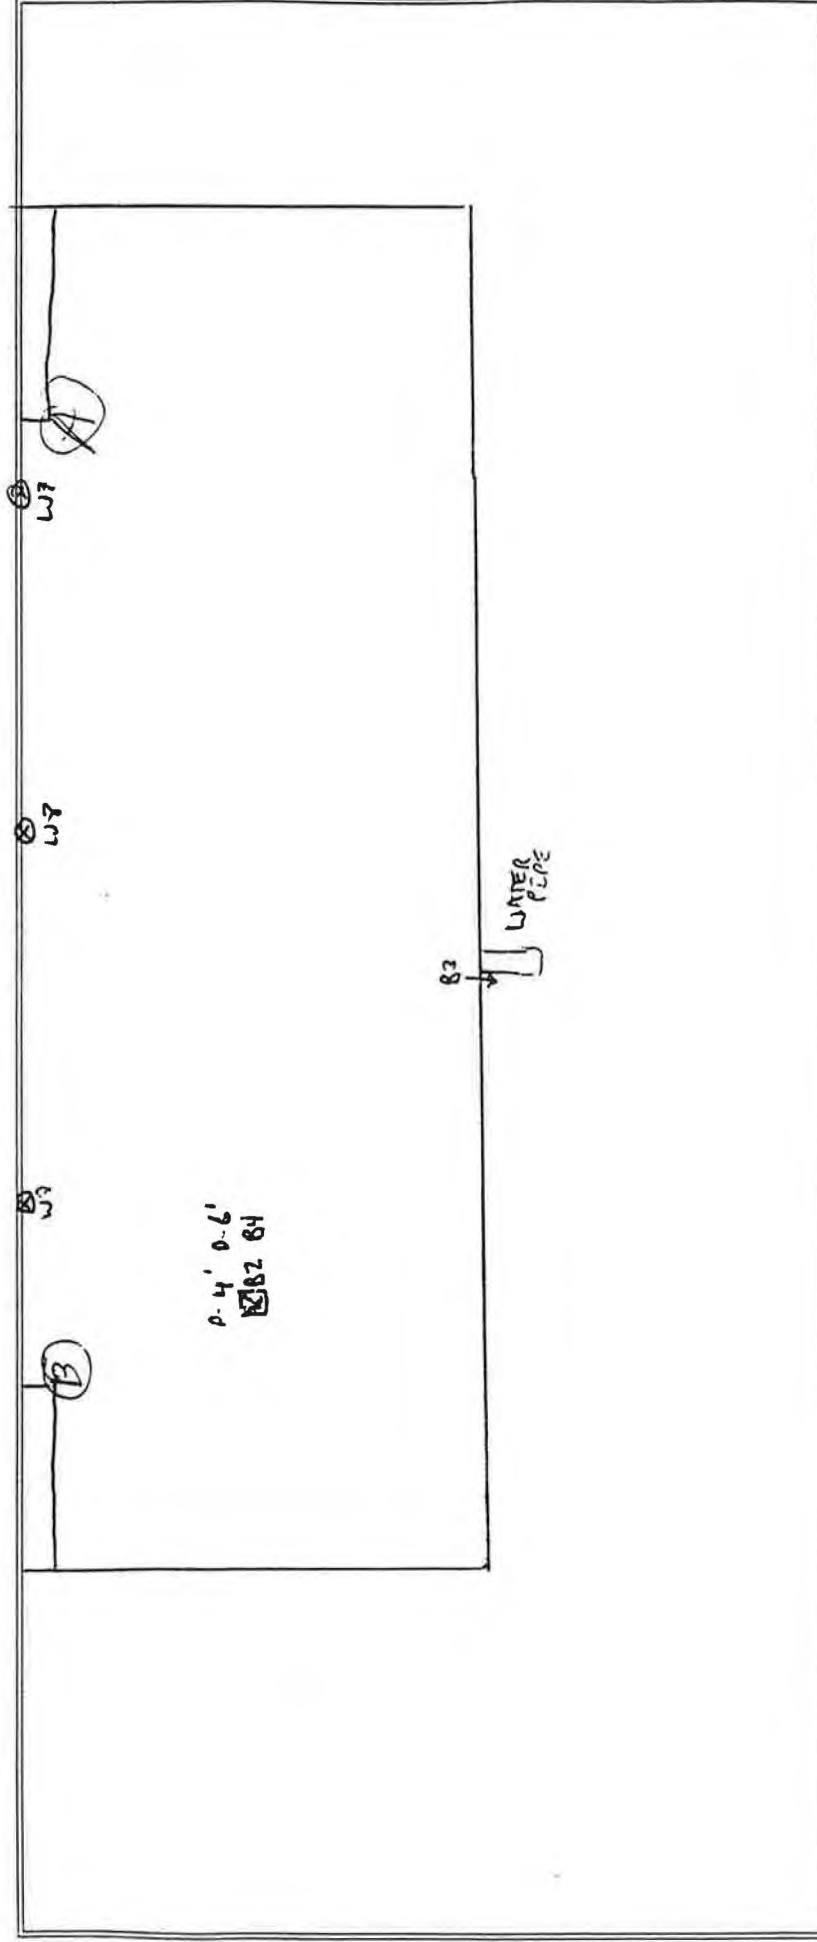
\* NOTE  
B3 is a bottom sample. The water main was located manually by digging with a shovel. AT THIS POINT IN TIME the sample location was even with the excavation bottom and was hence labeled B3
