CLOSURE REPORT  
STUDY AREA 15  
FORT DEVENS, MASSACHUSETTS

DELIVERY ORDER No. 13  
CONTRACT No. DACA33-91-D-0006

MAY 1994

ABB Environmental Services, Inc.  
Wakefield, Massachusetts  
Project Number 7136-01

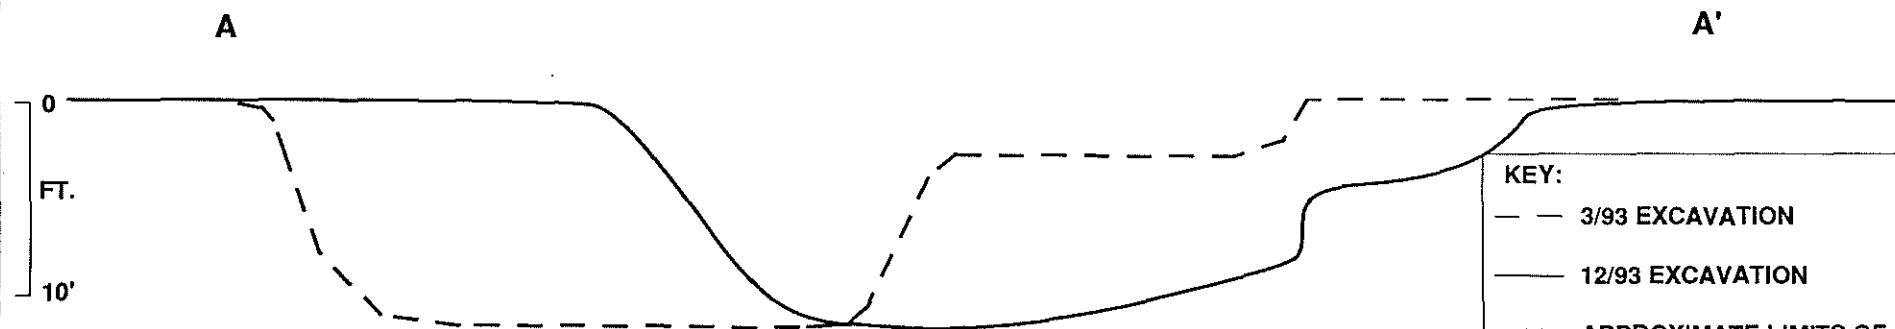
PLAN VIEW

Field observations noted during both excavation efforts indicated that the burn pit existed in the form of a 50-foot long by 20-foot wide north-south trending trench (parallel to Jackson Road) with its deepest point approximately 8 feet below grade. This shape suggests the pit may have been originally excavated with a bulldozer. Most of the contaminated soil removed during the excavation effort came from a thick pocket of stained soil 6 to 8 feet below ground surface. Below this depth, slightly stained soil was present to 12 feet below ground surface, interpreted to be the result of vertical migration. The absence of significant concentrations of TPHC in soil located below the bottom of the burn pit suggests no significant downward migration of contaminants has occurred below 12 feet. Other, less significant, staining observed in the surface soils in the form of lateral stringers is likely the result of soil reworking during consecutive disposal events or post-disposal regrading of the site.

KEY:	
---	3/93 EXCAVATION
—	12/93 EXCAVATION
■	APPROXIMATE LIMITS OF DARK STAINED SOIL

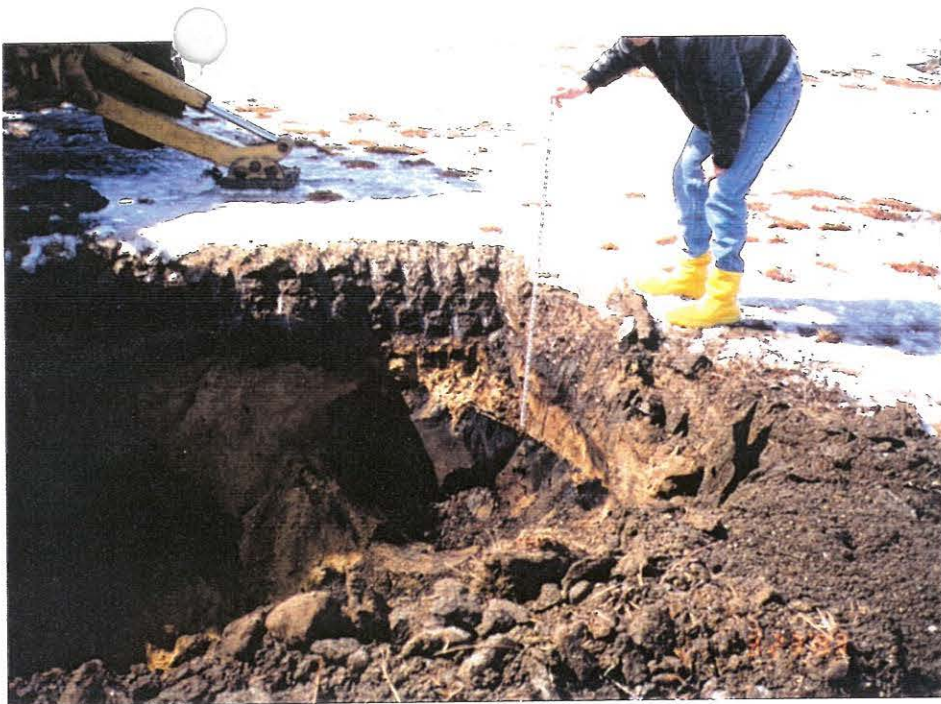
on the west wall of the excavation at a depth of roughly two feet, consistent with earlier AEHA and E&E findings. This zone of contamination appeared as a single large (2-foot-thick) stained pocket on the west wall of the excavation. As the excavation was expanded to the west, the size of the contaminated zone increased on the west wall and extended slightly onto the south wall. In addition to the large, discrete pocket of black soil, contamination was also observed to exist as thin layers or "stringers" (0.5 to one inch thick) of black soil in the uppermost 2 feet, the greatest concentration of which were located near the pocket of contamination on the west and south walls. Excavated soil was stockpiled on polyethylene plastic sheeting to the south of the excavation. A heavy, oily odor was noticed during excavation activities, but no significant VOCs were detected with a photoionization detector (PID) in air over the excavation. TPHC screening results on samples collected at this stage of the excavation revealed that the stained soil was contaminated and there was a clear correlation between the degree of staining and the concentration of TPHC (Table 1).

**1. Contamination at 2-foot depth on west wall - March 23**

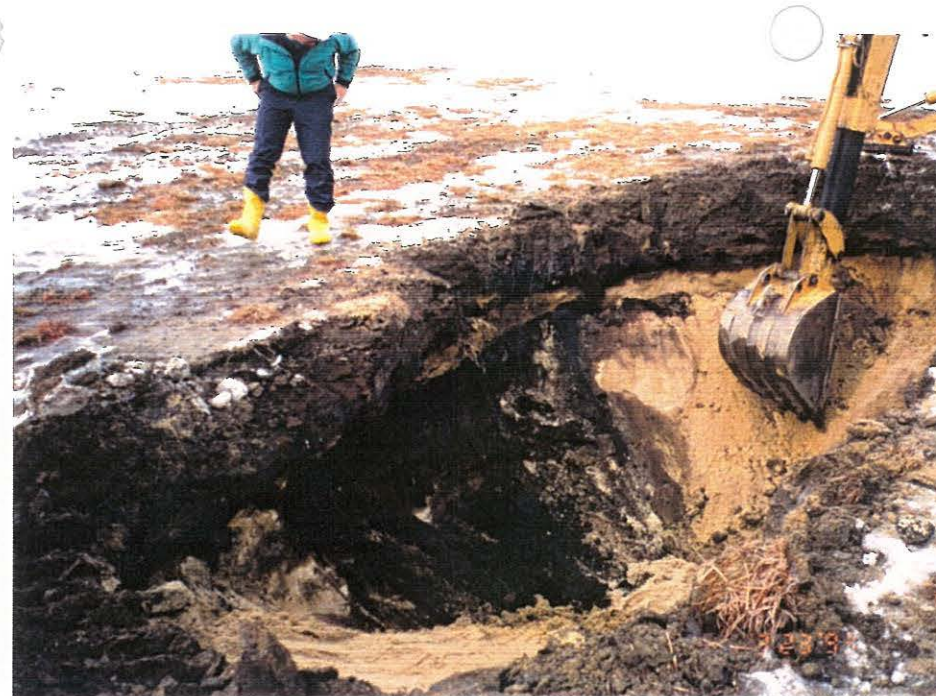
**2. Extent of stained soil on west wall - March 23**

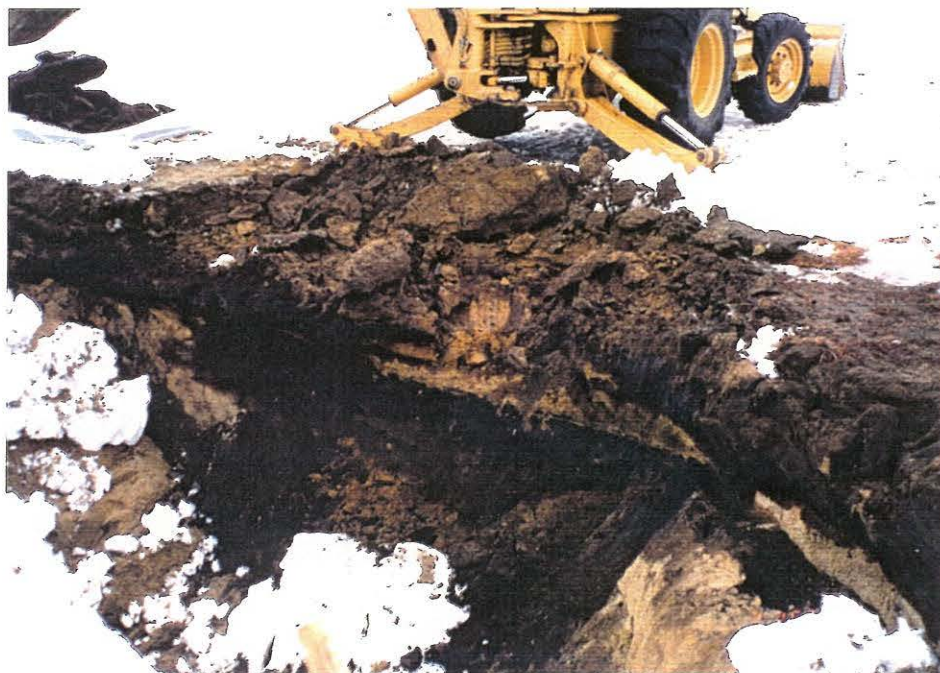
**3. Start of westward excavation - March 25**

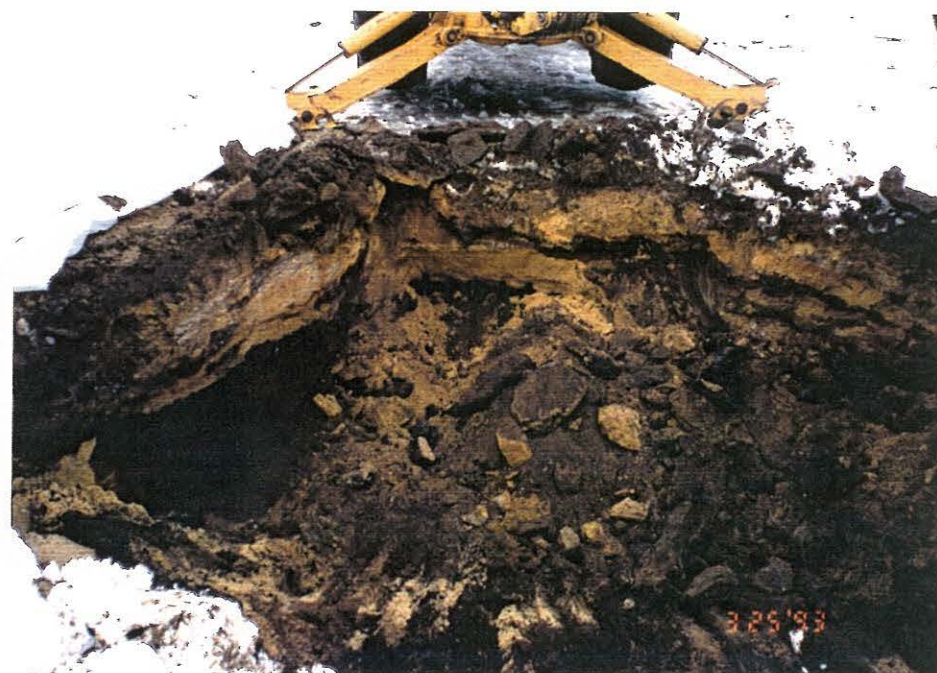
**4. Continued excavation of west wall - March 25**

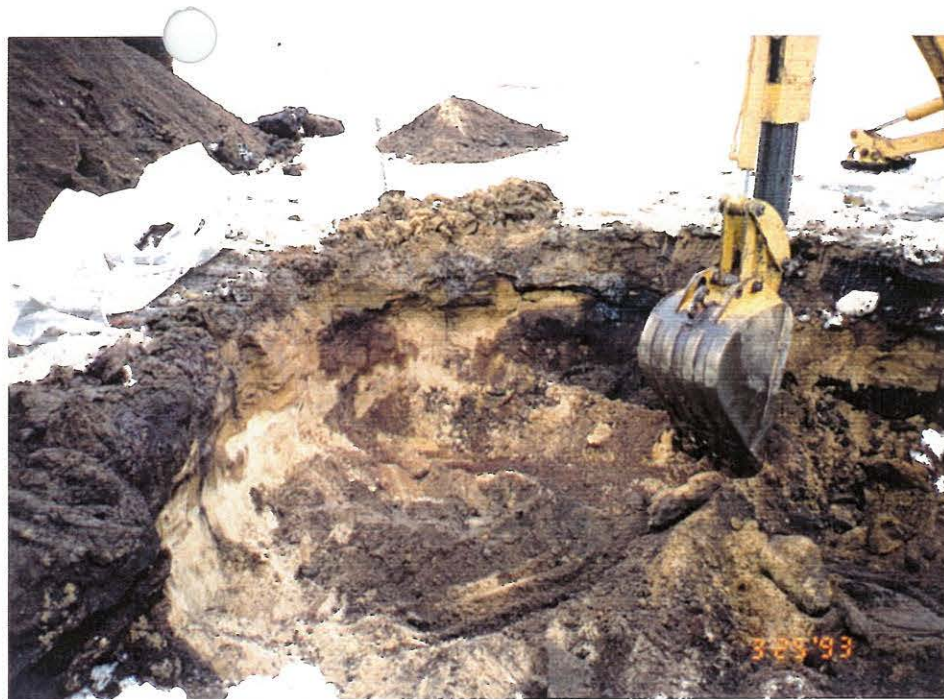
5. Clean soil on south end of west wall - March 25

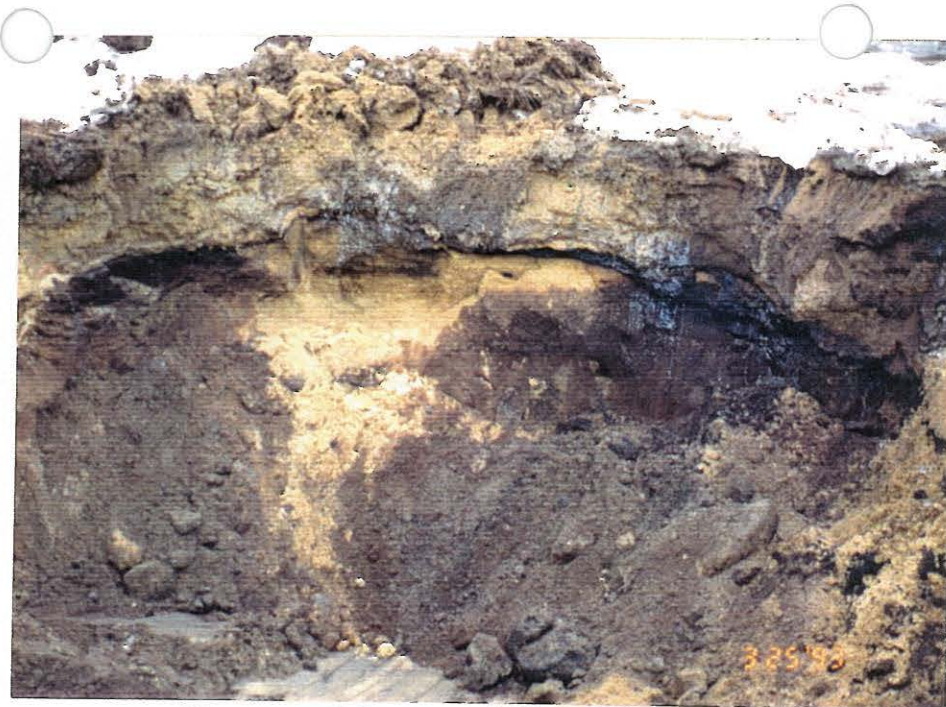
6. Close-up of Photograph No. 5 - March 25

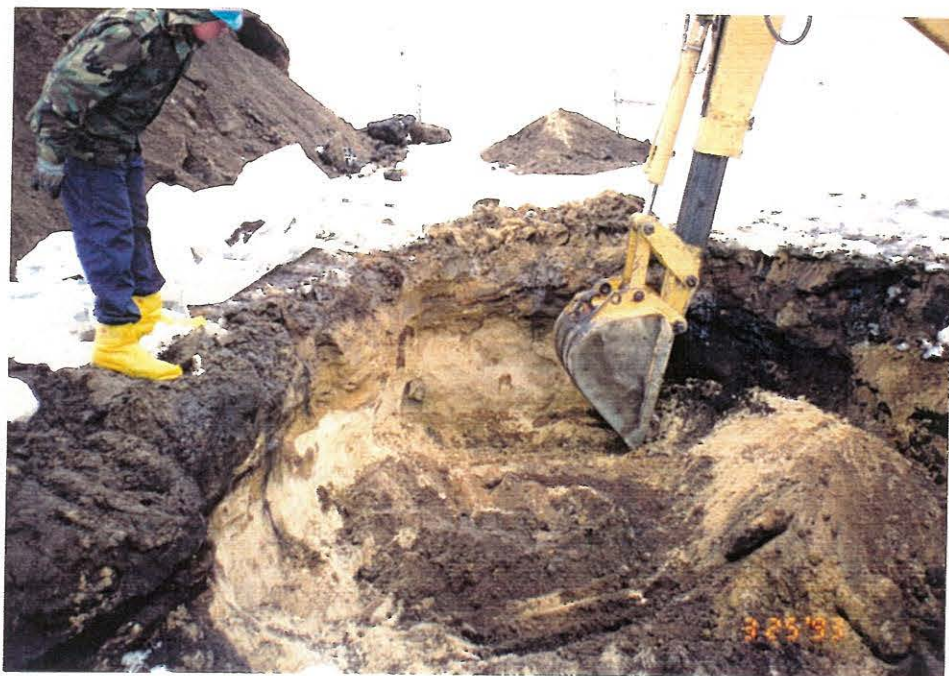
7. Continued excavation of west wall - March 25

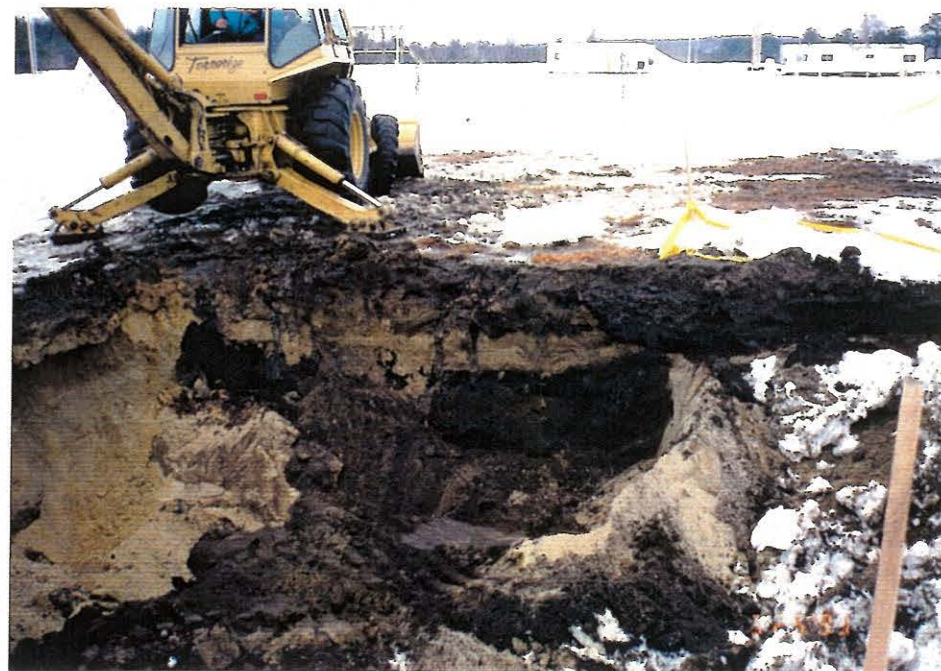
8. Contamination exposed on north wall - March 25

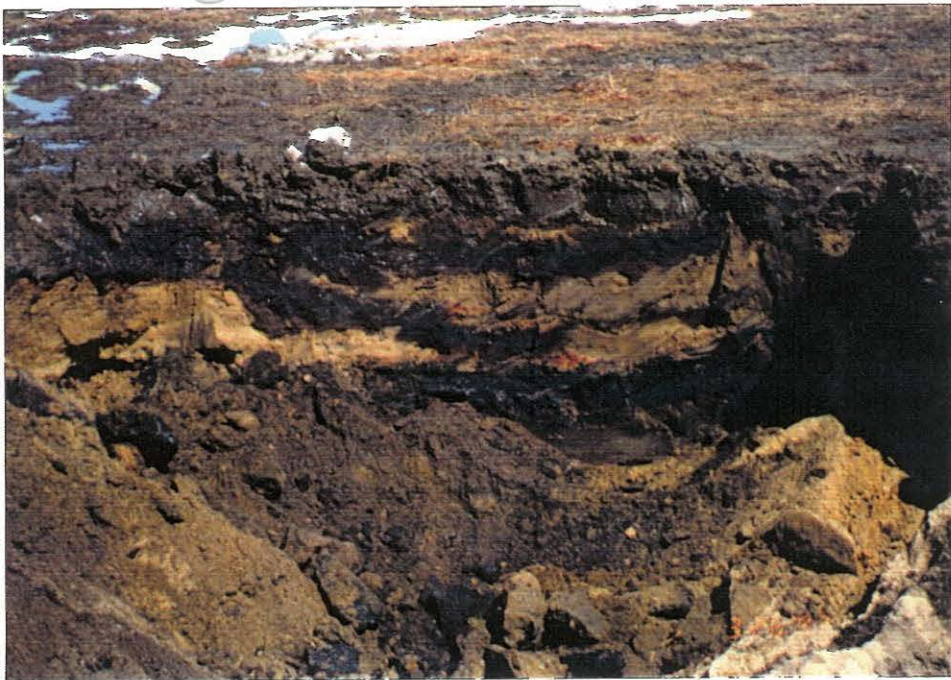
On March 26, 1993, digging continued in a northerly direction. Stained soil was observed in a more variable distribution. The contamination was less homogeneous, consisting of multiple layers of bands of black material, 0.5 to one foot thick, coalescing and separating, with dark to light brown stained layers in between. Distinct visual contrasts between clean and contaminated soil were noted laterally within the excavation. Excavated soil was stockpiled to the east and west of the excavation during this phase of digging. Various bits of debris were observed in the excavated soils including: a can, small bottle, brass shell casing, and scrap metal. At this stage of excavation, approximately 120 cubic yards of contaminated soil had been removed, approaching the quantity of soil excavation which could be included within the limits of the existing contracting mechanism. The decision was made to continue excavating to the north in a 3-foot-deep test trench to define the northern

9. Continued excavation on north wall - March 26

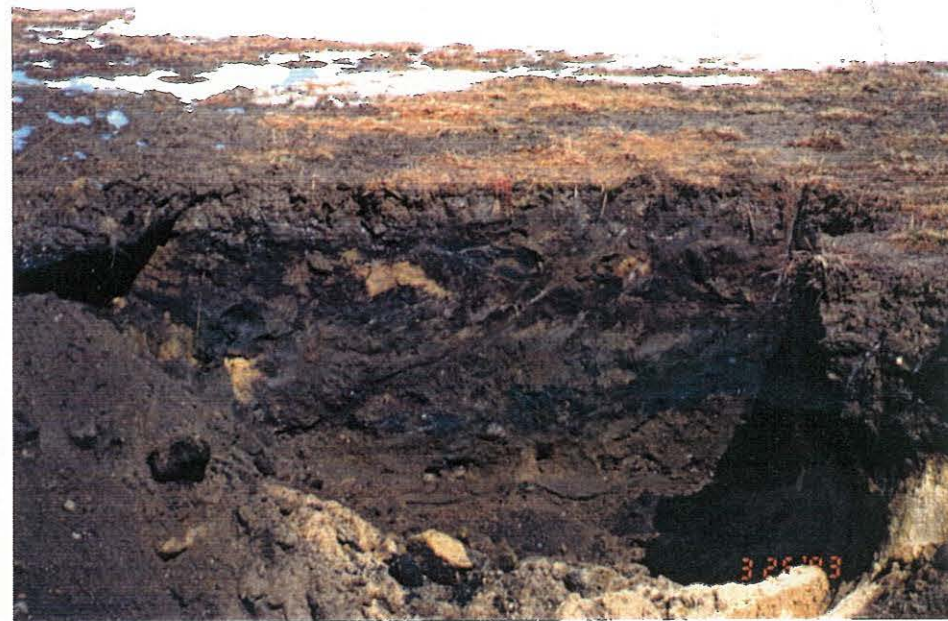
10. Coalescing bands on north wall - March 26

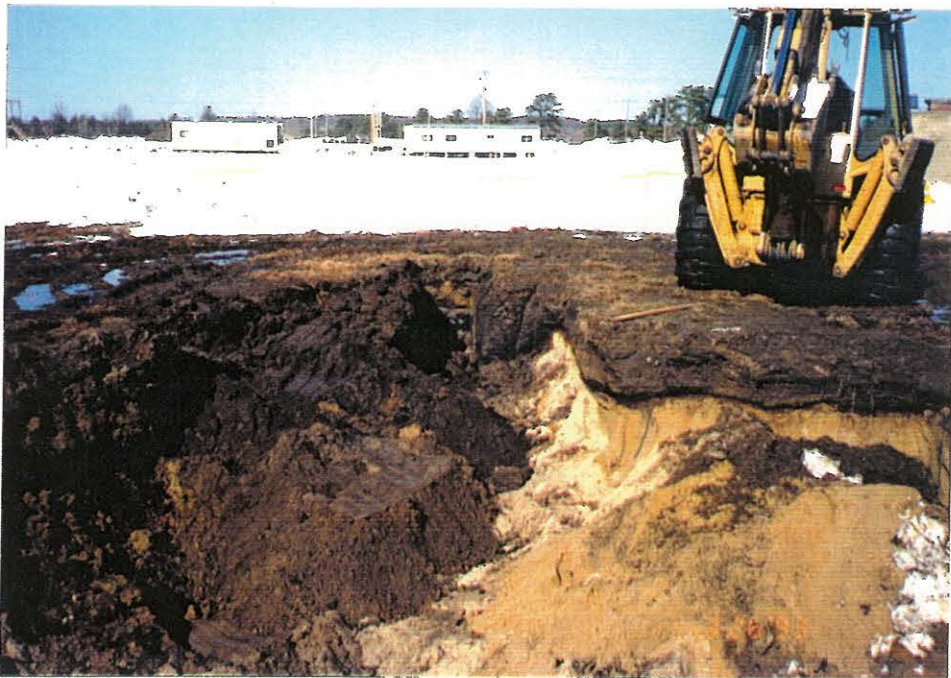
11. Northern test trench started - March 26

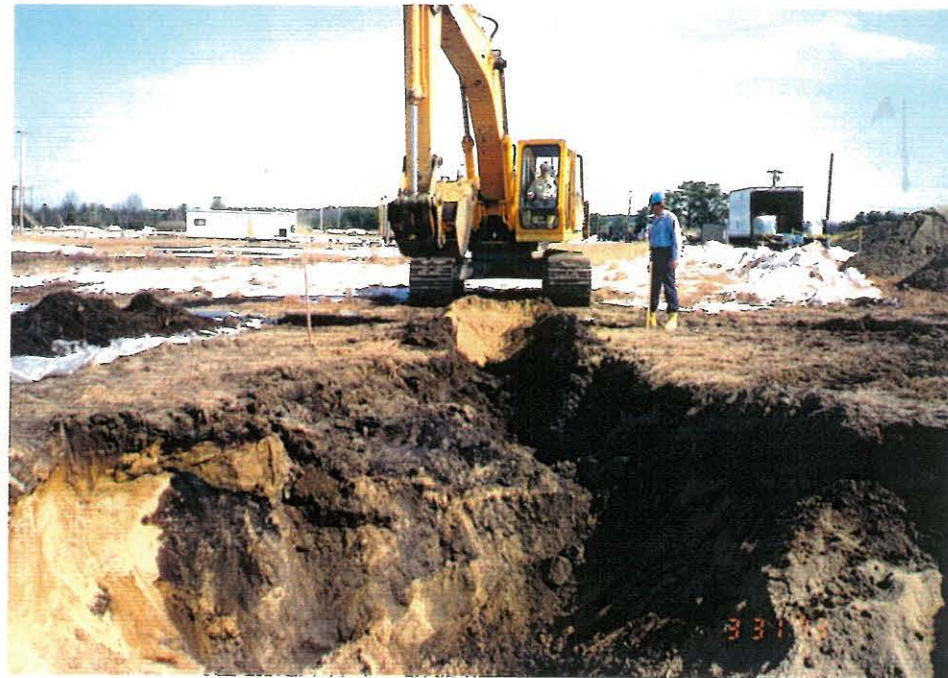
12. Clean soil at end of test trench - March 31

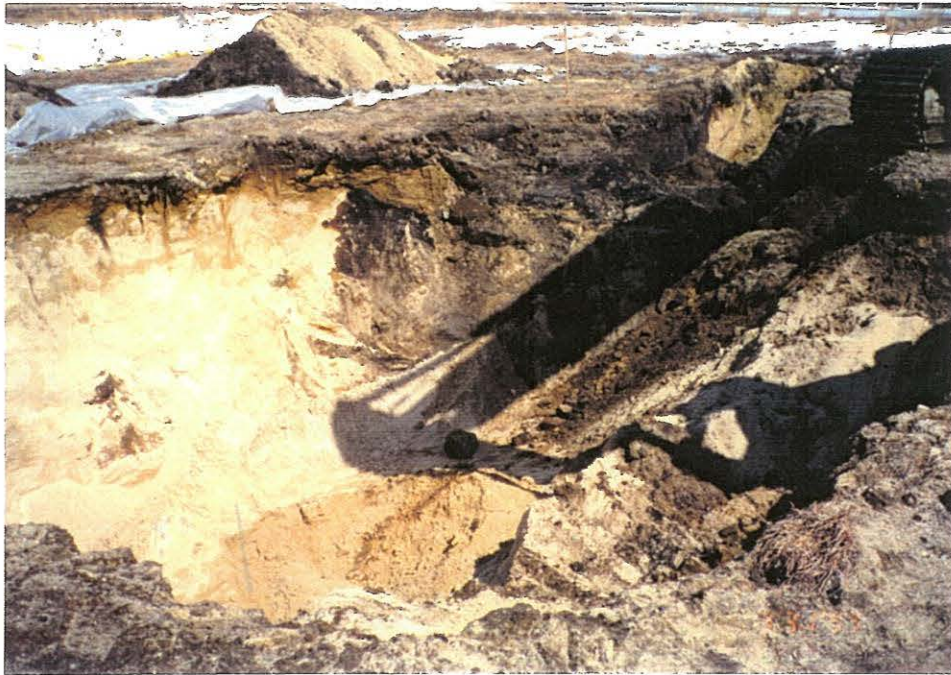
**13. Remaining contamination on west wall - March 31**

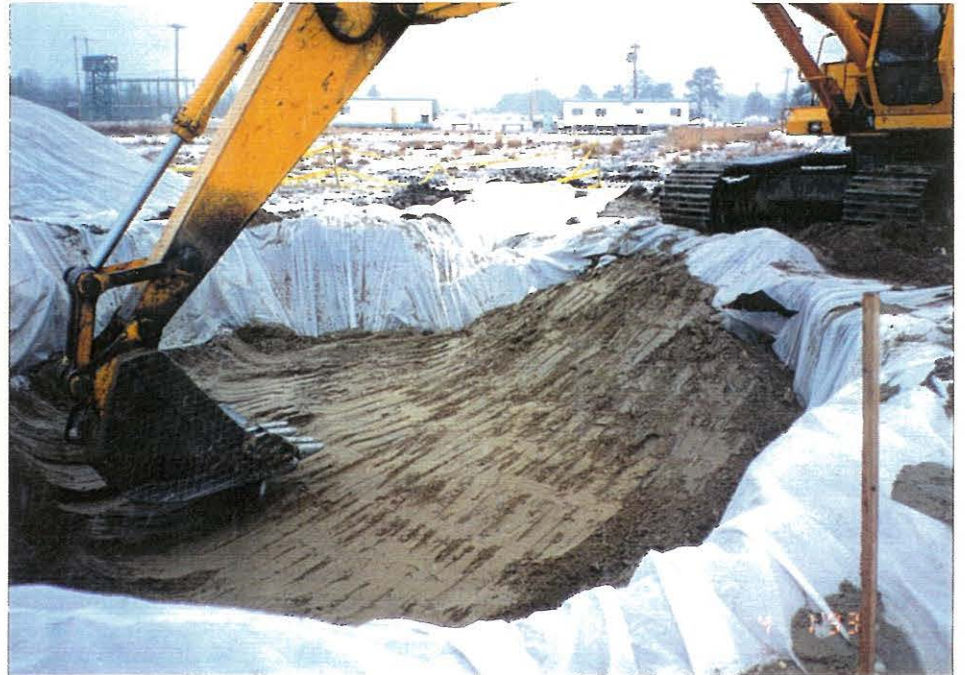
**14. Backfilling and compaction - April 1**

Because the removal efforts had to be suspended until a subsequent removal contract could be procured, backfilling was begun on April 1, 1993. The deepest portions of the excavation were backfilled first with clean fill material. Polyethylene plastic sheeting was draped over the northern slope of the excavation to a depth of approximately 10 feet to prevent mixing of clean fill with visually contaminated soil observed there. Plastic sheeting was also draped over the remaining sides of the excavation to a depth of five feet. The remainder of the excavation was then backfilled to grade with clean fill material. The limits of the excavation were marked with wooden stakes for future reference. Soil samples were collected from each of the three excavated soil stockpiles for analysis of Resource Conservation and Recovery Act hazardous waste characteristics to evaluate disposal/treatment options. The results of these analyses are presented in Appendix C-1. To reduce the potential for leaching of contaminants, the stockpiles of stained soil were covered with polyethylene plastic sheeting until arrangements could be made for removal off-site.

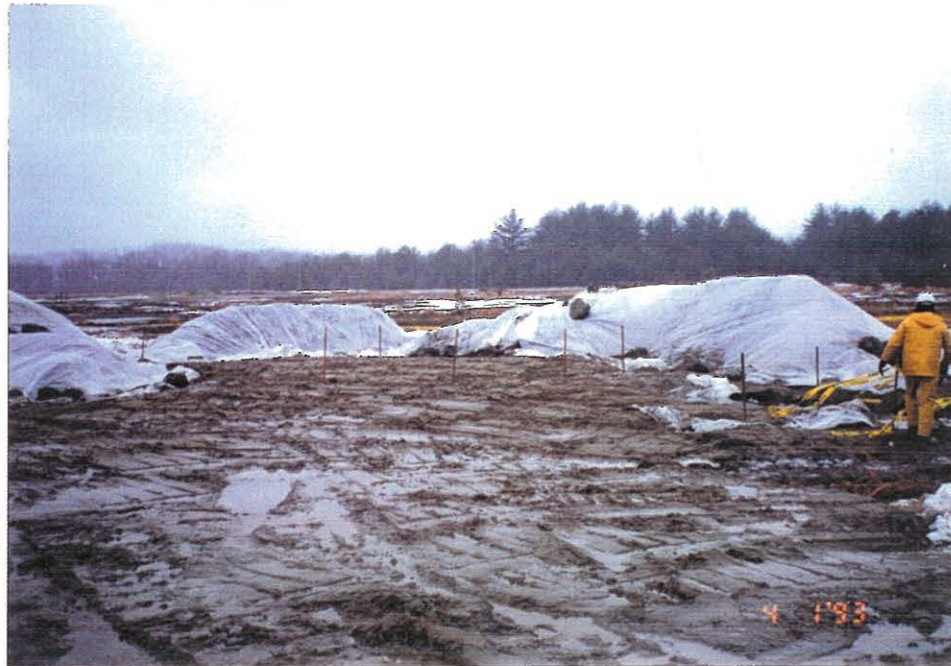
**15. Backfilling complete - April 1**

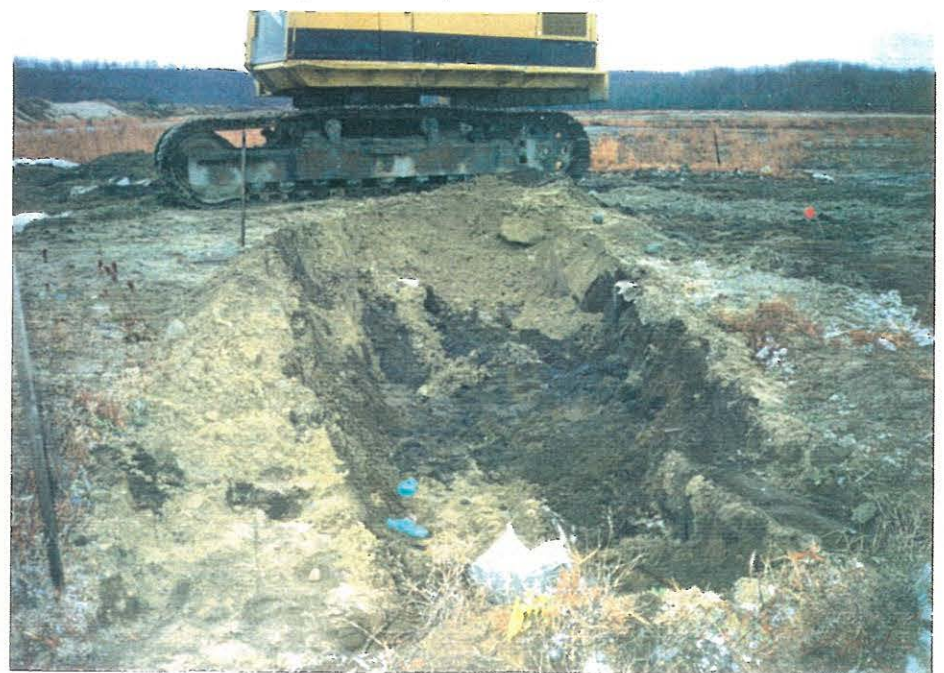
**16. Start of excavation activities - December 14**

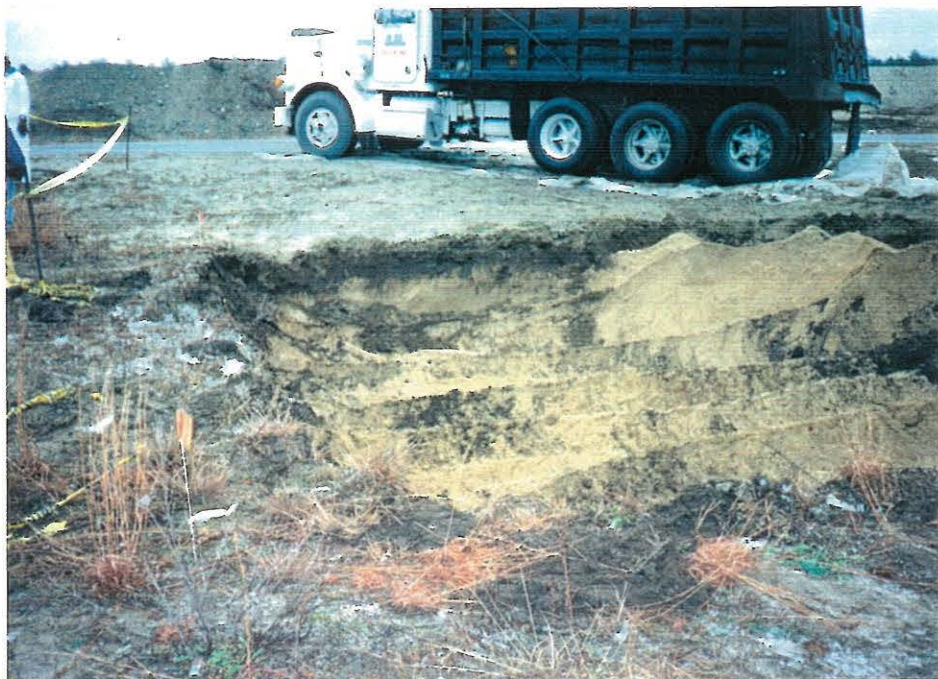
17. Excavation at the 2- to 4-foot depth - December 14

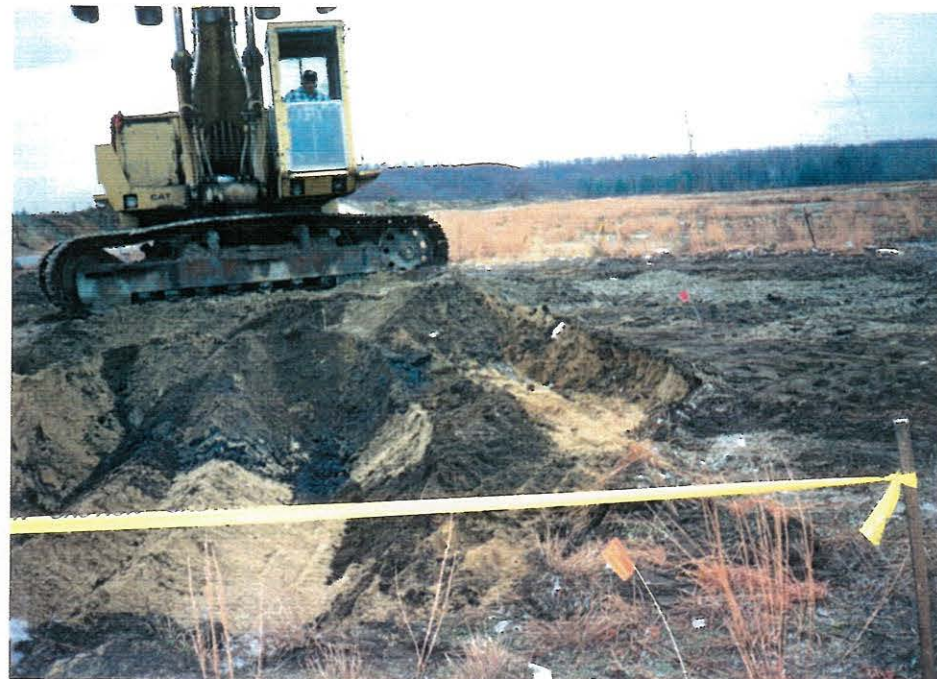
On December 14, the excavation reached a depth of approximately 10 feet in the southern half of the new excavation. The north wall and the northern 30 feet of the east and west walls and the floor were free of stained soil. Additional soil removal continued in the southernmost portion of the excavation. Seven soil samples were collected for field screening from the unstained zones within the excavation. Soil samples were screened in ABB-ES' Fort Devens field office for the presence of VOCs by headspace analysis using a PID and for TPHC by NDIR. The analytical method used in field screening for TPHC was adapted from EPA method 418.1. The results of field screening are presented in Table 2. Headspace readings in the seven samples ranged from 1 to 10 ppm, and TPHC concentrations were less than 50 mg/kg dry weight. The results continued to support the correlation between concentrations of TPHC and the degree of soil staining noted in the March 1993 removal effort.

18. Stained soil encountered on south side - December 14

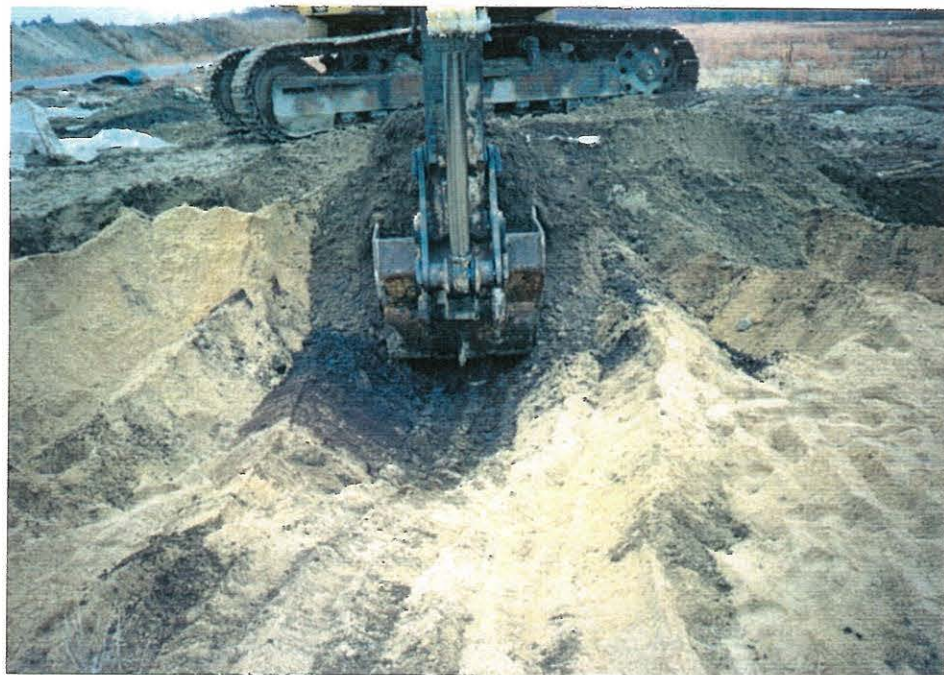
19. Close-up of Photograph No. 18 - December 14

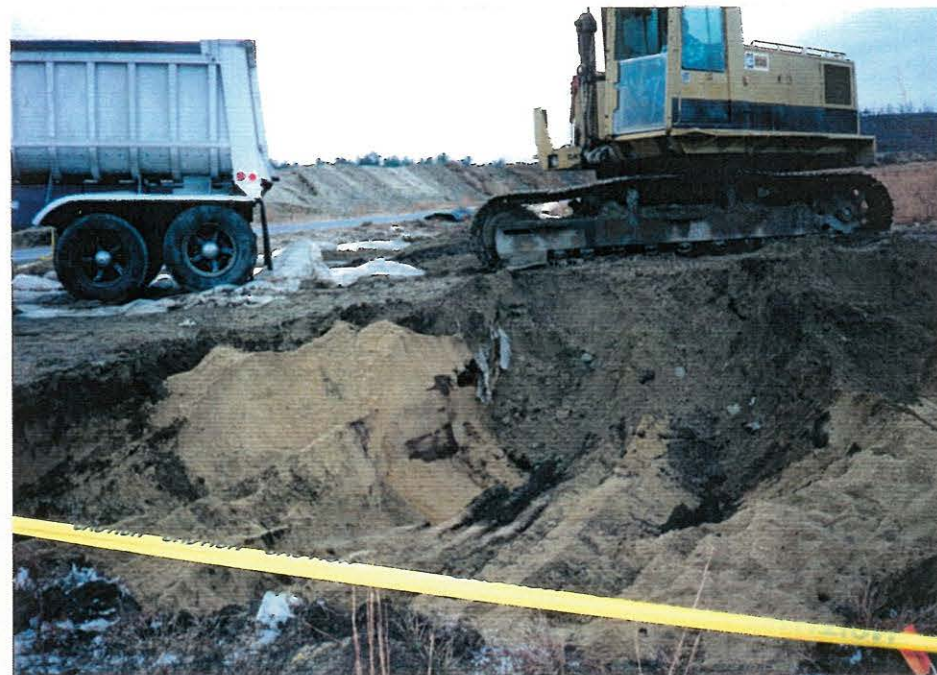
20. Limits of soil staining on east wall - December 14

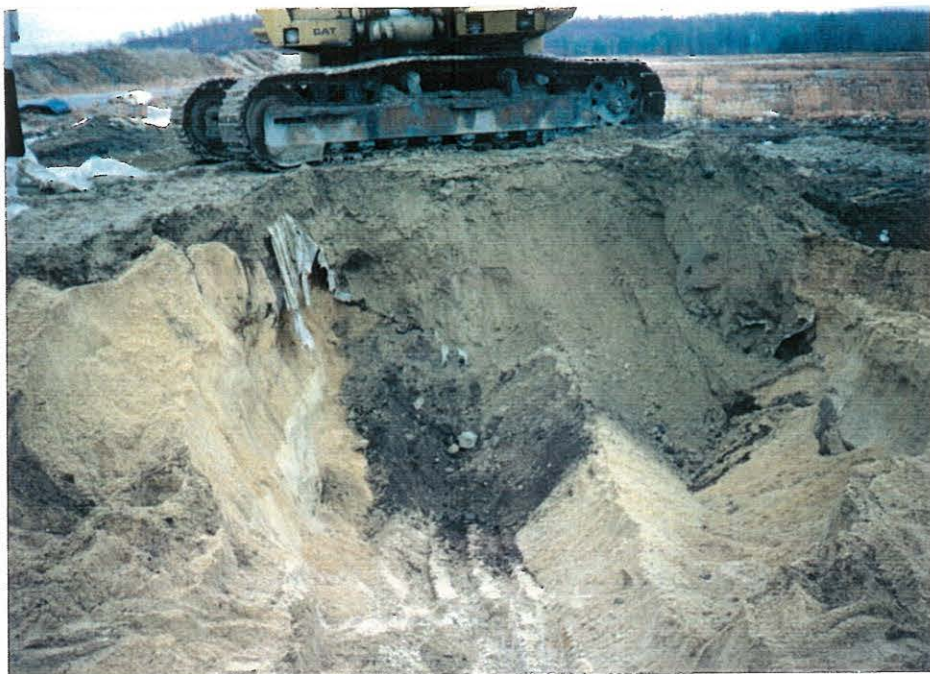
**21. Plastic sheeting encountered on south wall - December 14**

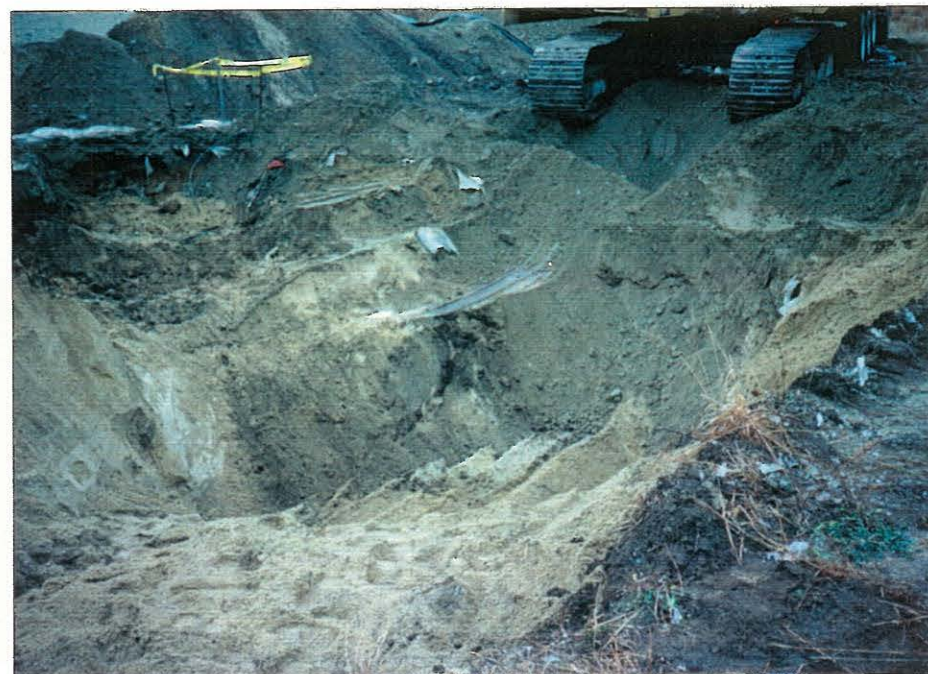
**22. East wall excavation - December 14**

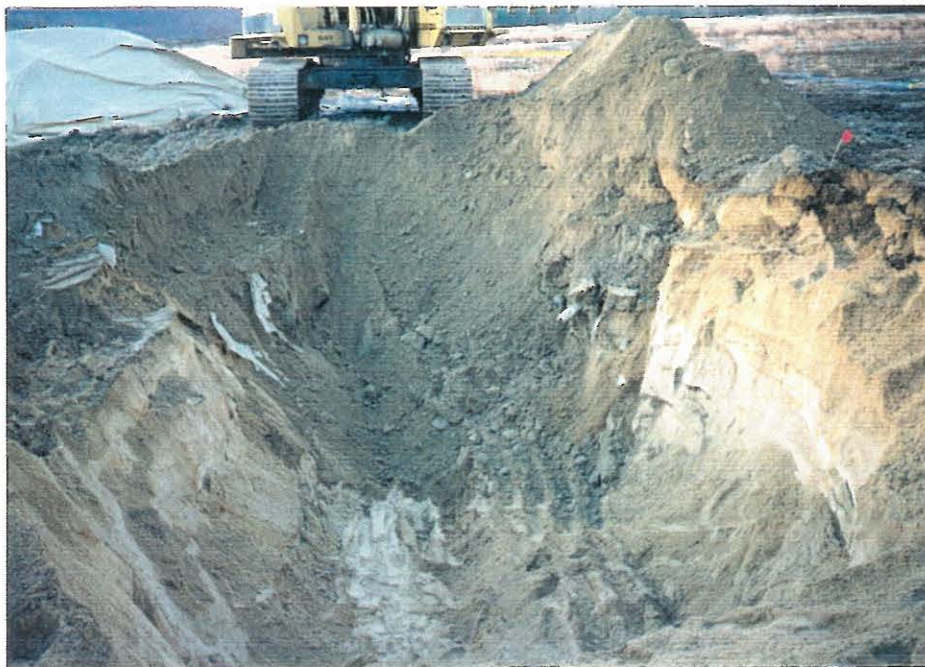
**23. South view, east and west walls clean - December 16**

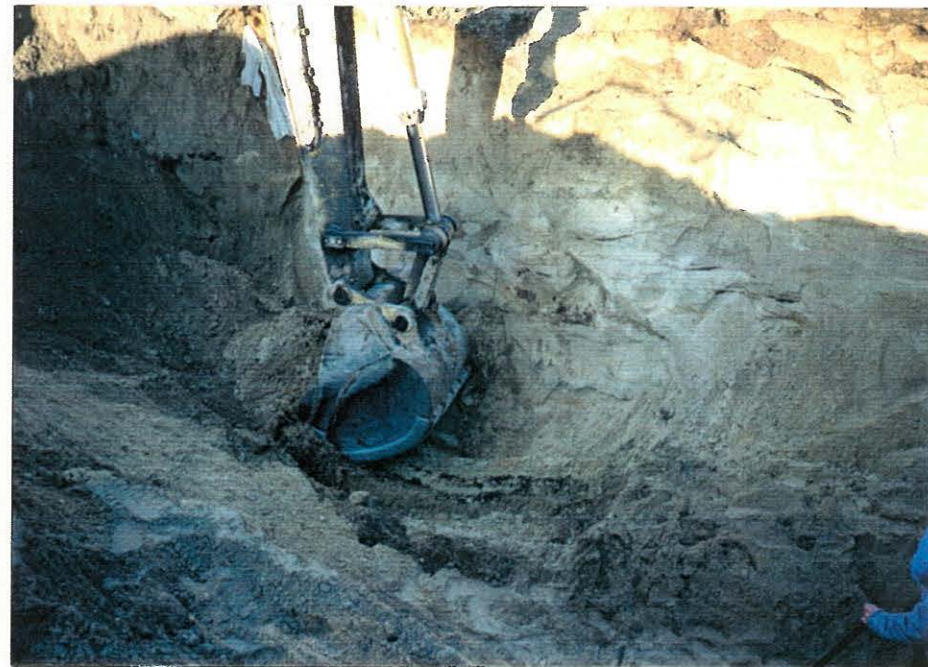
**24. Removal of stained soil from bottom - December 16**

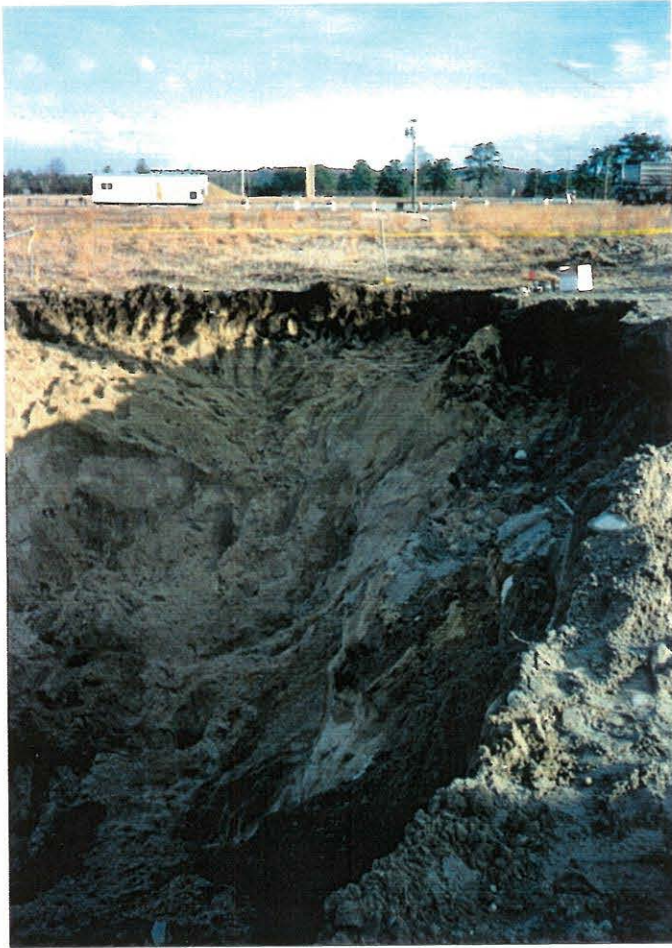
25. North view with removal complete - December 16

The backfilling was completed on December 16, 1993. Fill was added to bring the excavation up to grade. Excess fill materials and debris were removed from the site restoring SA 15 to the extent practical to its original condition.
