FINAL CLOSURE REPORT
STUDY AREA 37D
FORT DEVENS, MASSACHUSETTS

U.S. Army Corps of Engineers
New England Division
Waltham, Massachusetts
Contract Number DACW45-89-D-0506

OHM Remediation Services Corp.
Hopkinton, Massachusetts

August 4, 1995
OHM Job 16208

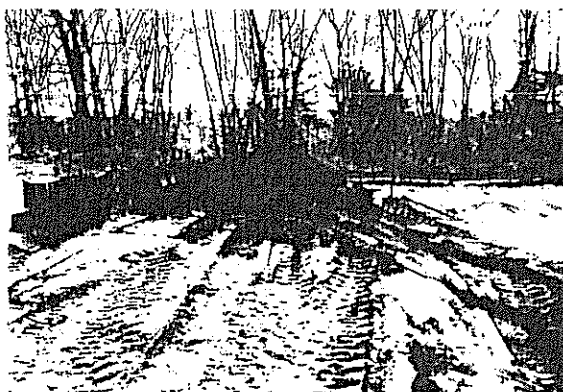
Loadout of contaminated soil

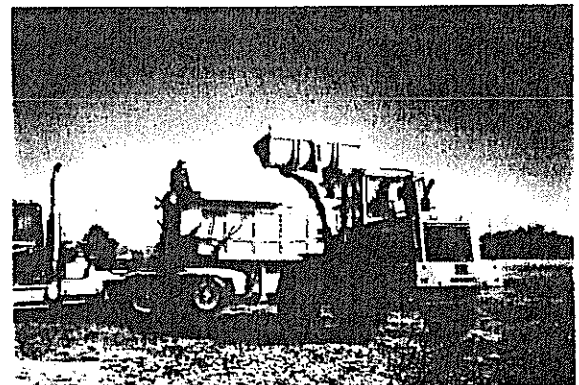
Loadout of contaminated soil
