# **Final 2004 ANNUAL REPORT**

## **WETLAND & UPLAND HABITAT RESTORATION AND LONG TERM ADAPTIVE MONITORING AND MAINTENANCE PROGRAM**

### **AREA OF CONTAMINATION (AOC) 57 DEVENS, MASSACHUSETTS**

**January 2007**

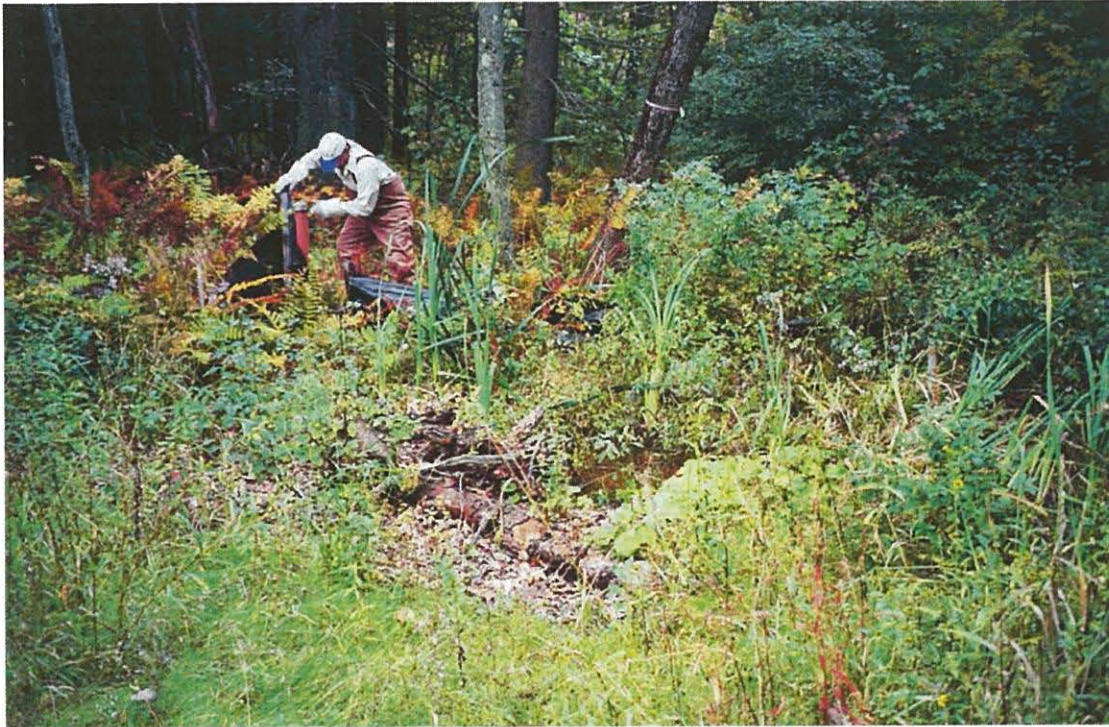
AOC 57 – Area 2: Restoration Work – Silt Fence Removal (July 2004)

Silt fence was removed from the edge of the wetland. There were a few areas where the silt fence was buried. Removal of the silt fence in these areas would have disrupted the wetland so the support poles were broken and the fencing was cut at the surface of the ground. Fence was collected and placed at the top of the site for off-site removal. This restoration also more than satisfies the 75% criterion. A small clump of *Phragmites* was noted just east of the second monitoring well from the east. Purple loosestrife was observed but not removed due to time restraints. Plant cover for both the wetland and the upland was similar to Site 3. There was significant erosion onto Site 2 as a result of construction activity above the site. This construction was associated with the building of a large silt basin just west and upland of the wetland restoration. The access road created to construct this structure diverts amounts of upland drainage onto the upland slope of AOC 57, Site 2. Although there was a small amount of erosion visible at previous

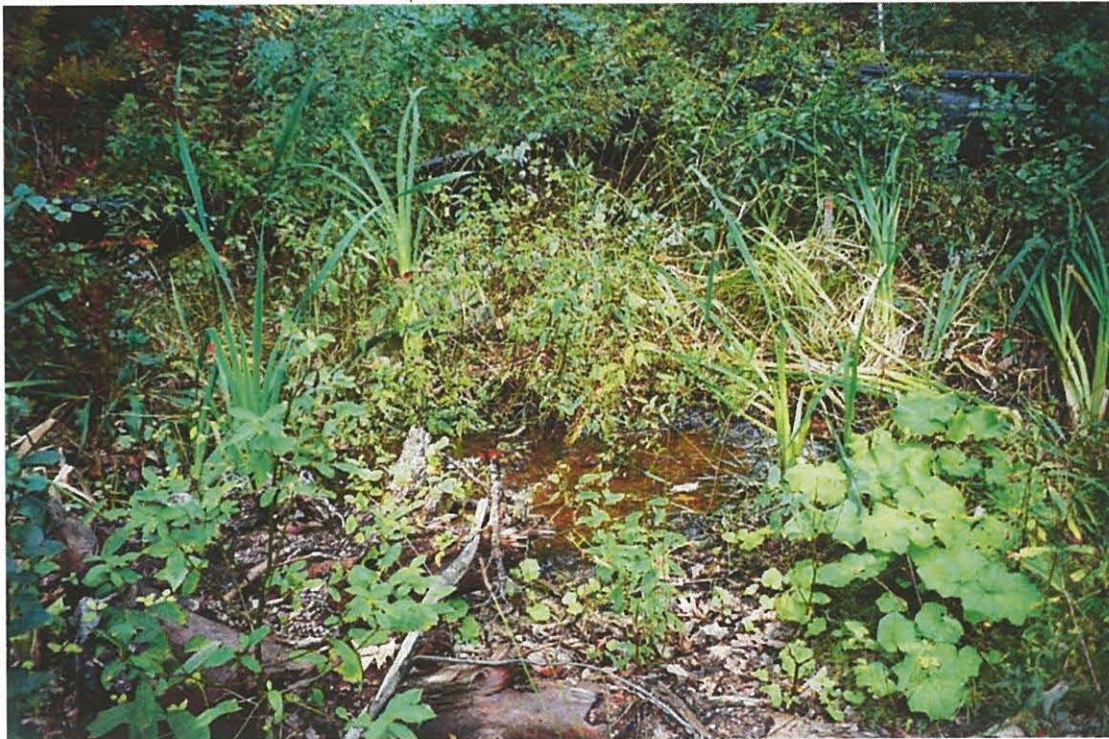
Area 2 consists of an upland site that slopes downward to the restored wetland. Based on the 2004 inspections, the upland site met the Performance Standards. Seven red maples are at the base of the slope where the upland grades into the wetland. Thirty-four white oaks have survived on the upland slope. Ground cover on the slope consisted of rabbit's foot clover, cow thistle and other grasses and herbs. Plant wanderers and colonizers from off site were observed to be reseeding the area with tree species like red maple and black birch along with colonizing shrubs such as sweet fern are growing into the site. During the June-August observations, there was a small amount of erosion limited to the rock-lined drainage swale at the east side of the restoration. A silt barrier was present at the top of the slope. During the 2004 observations, silt from the adjacent upgradient unvegetated upland area from construction activities related to the storm water detention pond being constructed for MassDevelopment had started to top the silt barrier and flow down the restored slope. This uncontrolled erosion and sedimentation resulted in additional erosion within the drainage swale and deposition of fine silt within the wetland and covering of vegetation.

AOC 57 – Area 2: Edge of Wetland With Layer of Fine Silt (July 2004)

It is imperative that the uncontrolled drainage and resulting erosion and sedimentation from the upland area (up gradient of AOC 57) from construction activities related to the storm water detention pond be diverted from flowing onto AOC 57 Area 2. If this condition persists, the wetland will continue to be filled with fine silt, negatively impacting the vegetation along with compromising restored wetland values and functions.

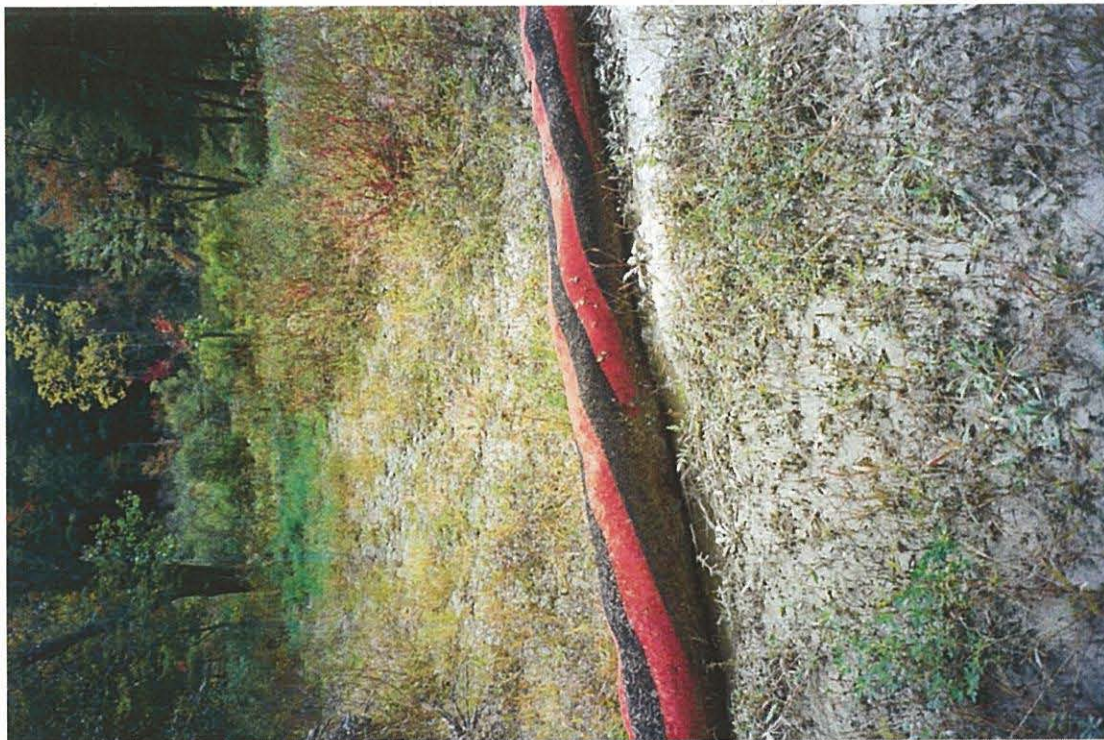
AOC 57 – Area 2: Silt Barrier/ Siltation (July 2004)

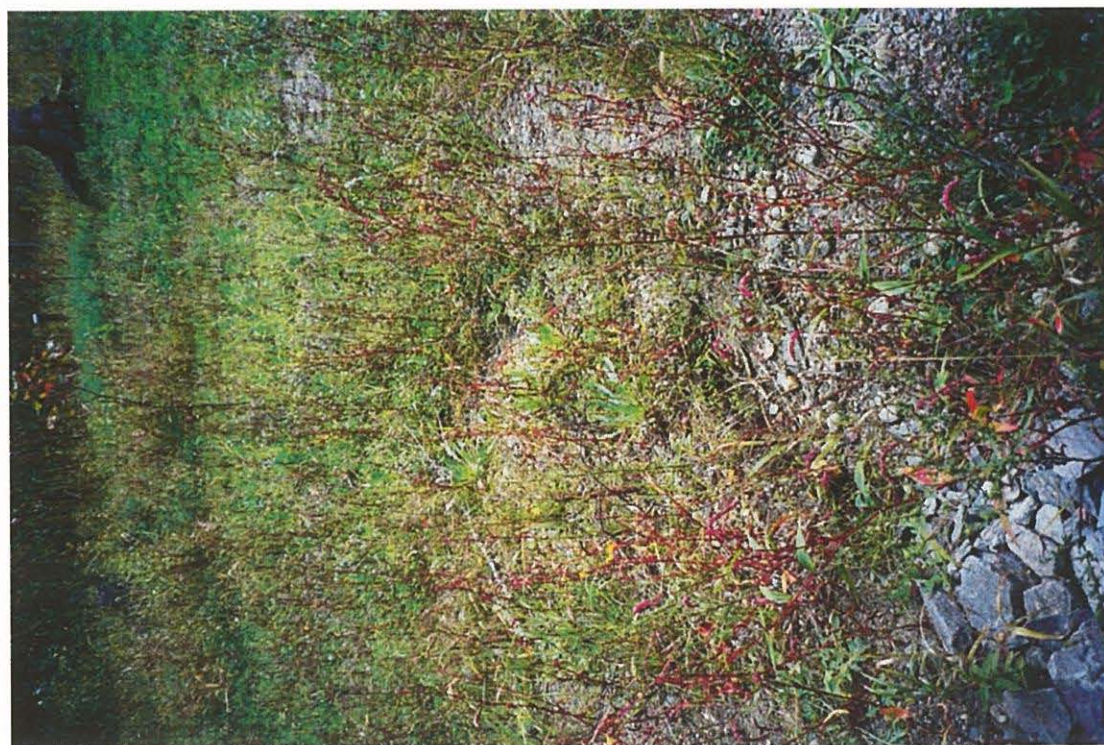
**Upland-** There has been a degradation of the upland restoration site due to current construction activity north and west of AOC57 immediately adjacent to Area 2. A large silt basin is in the final stages of construction upland/up-gradient of AOC 57. The activity of heavy equipment modifying the topography and spilling of materials such as clay liner, has directed the flow of surface water toward the straw filled conical silt barrier. AOC57 Area 2 is vulnerable because of the topography. The recent heavy and frequent rain has overtopped the silt barrier and eroded the upper end of the site. About six inches of substrate has been eroded down the slope into the wetland area. A thin layer of recently deposited silt was observed within the wetland. This erosion is limited to the eastern portion of the site.

AOC 57 – Area 2: Siltation on Upland Slope (July 2004)

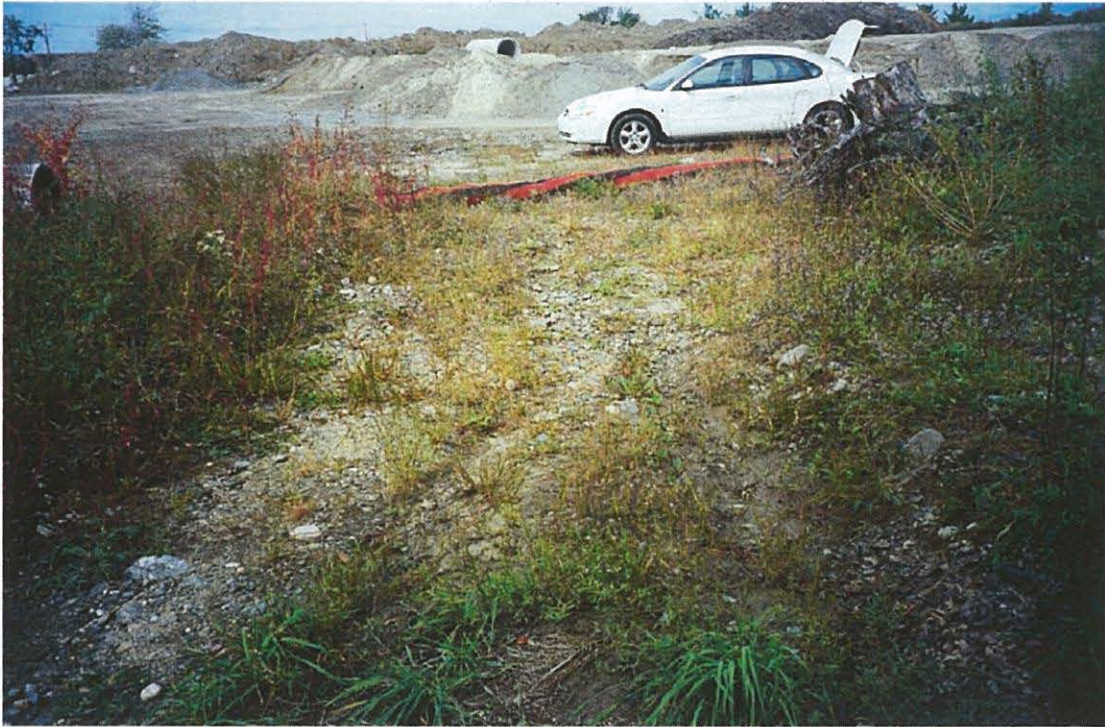
AOC 57 – Area 2: Silt Barrier/ Siltation on Upland Slope (July 2004)

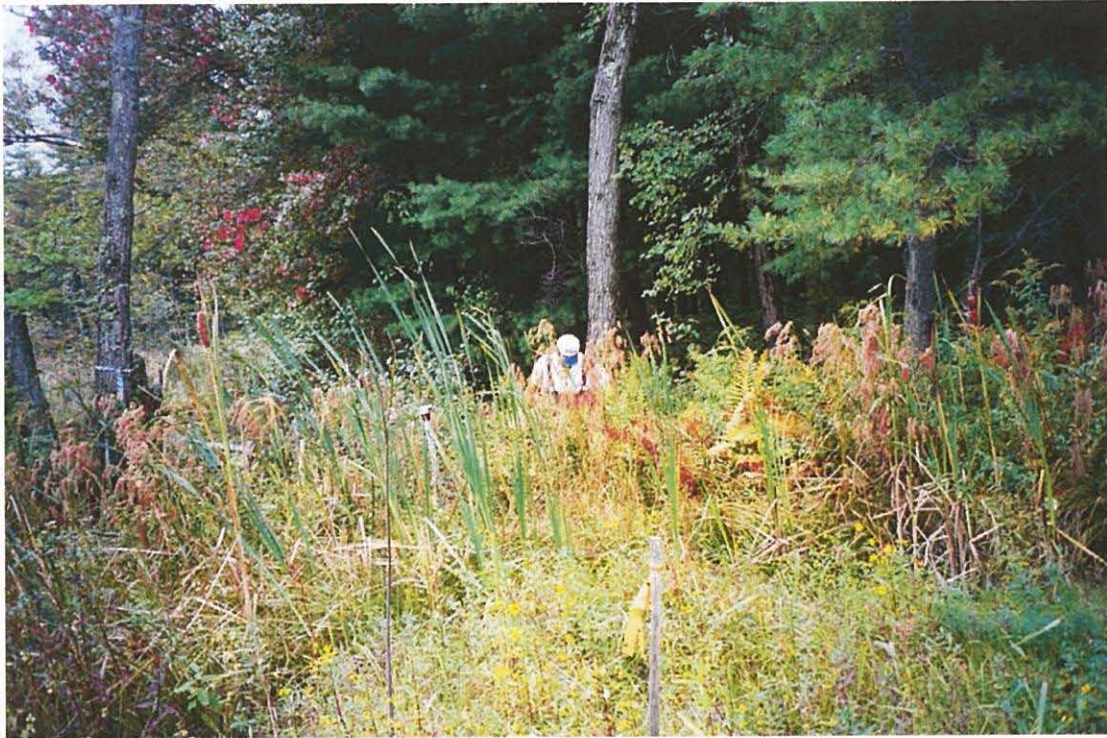
AOC 57 – Area 3: Restoration Work, Silt Fence Removal (July 2004)

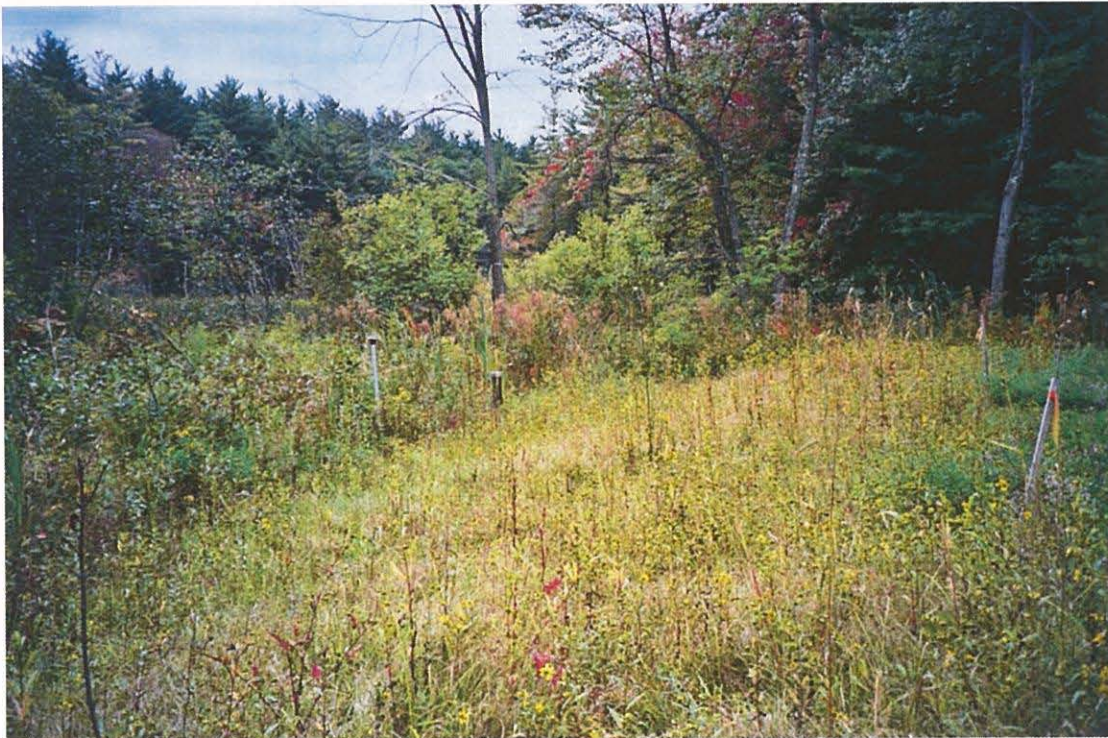
AOC 57 – Area 3: Wetland Transition Area (July 2004)

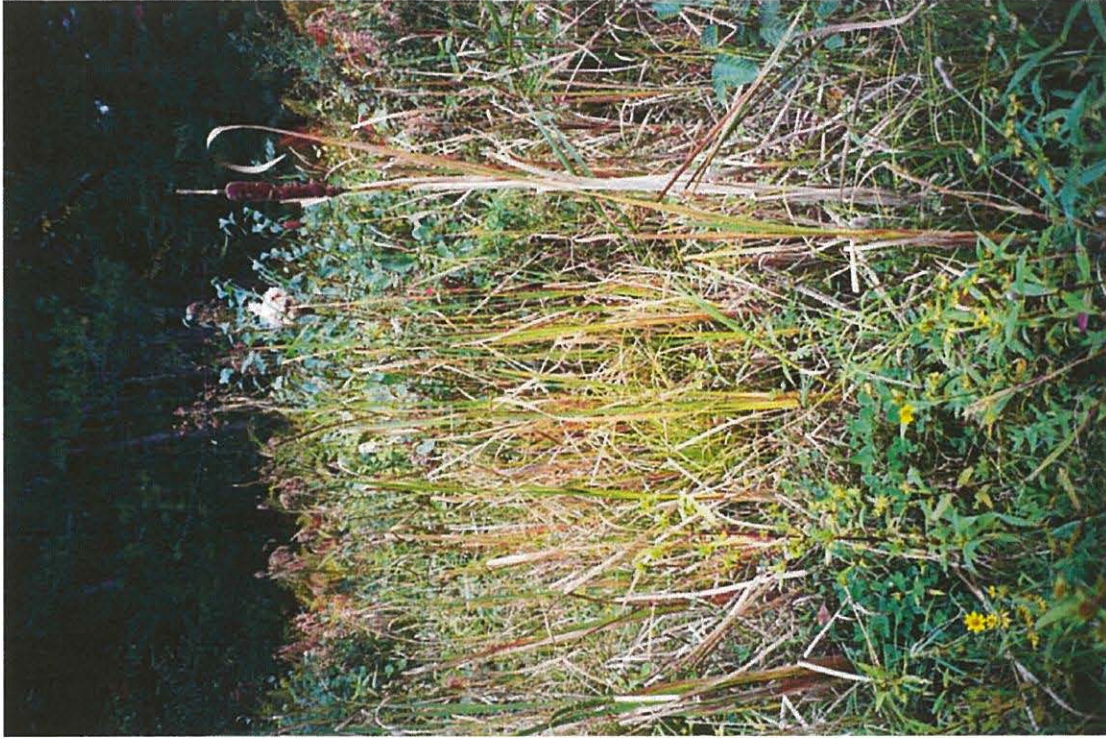
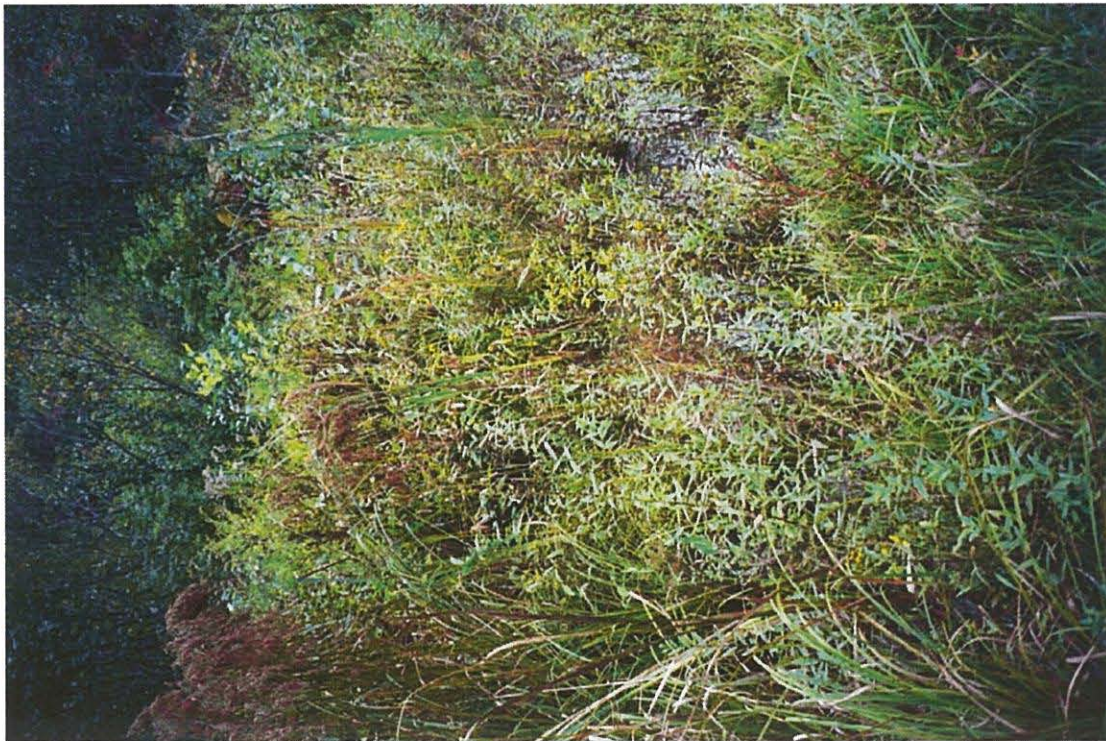
**Wetland-** The wetland restoration complies with the requirement of 75% native wetland cover, with only miniscule areas of the wetland lacking cover. No *Phragmites* was recorded at this site, although clumps of purple loosestrife are scattered throughout the restoration area and the existing, surrounding wetland. All the silt fencing and stakes were removed from the site, gathered for removal and disposal (to be arranged with NCRO).

AOC 57 – Area 3: Wetland Vegetation (July 2004)
