# **AREA 1 PRELIMINARY SITE CHARACTERIZATION SUMMARY PER- AND POLYFLUOROALKYL SUBSTANCES (PFAS) REMEDIAL INVESTIGATION**

**FORMER FORT DEVENS ARMY INSTALLATION, DEVENS, MA**

**JUNE 2020**

**Prepared by:**  
*KOMAN Government Solutions, LLC*  
**293 Boston Post Road West, Suite 100**  
**Marlborough, MA 01752**  
**Contract No.: W912WJ-18-C-0011**

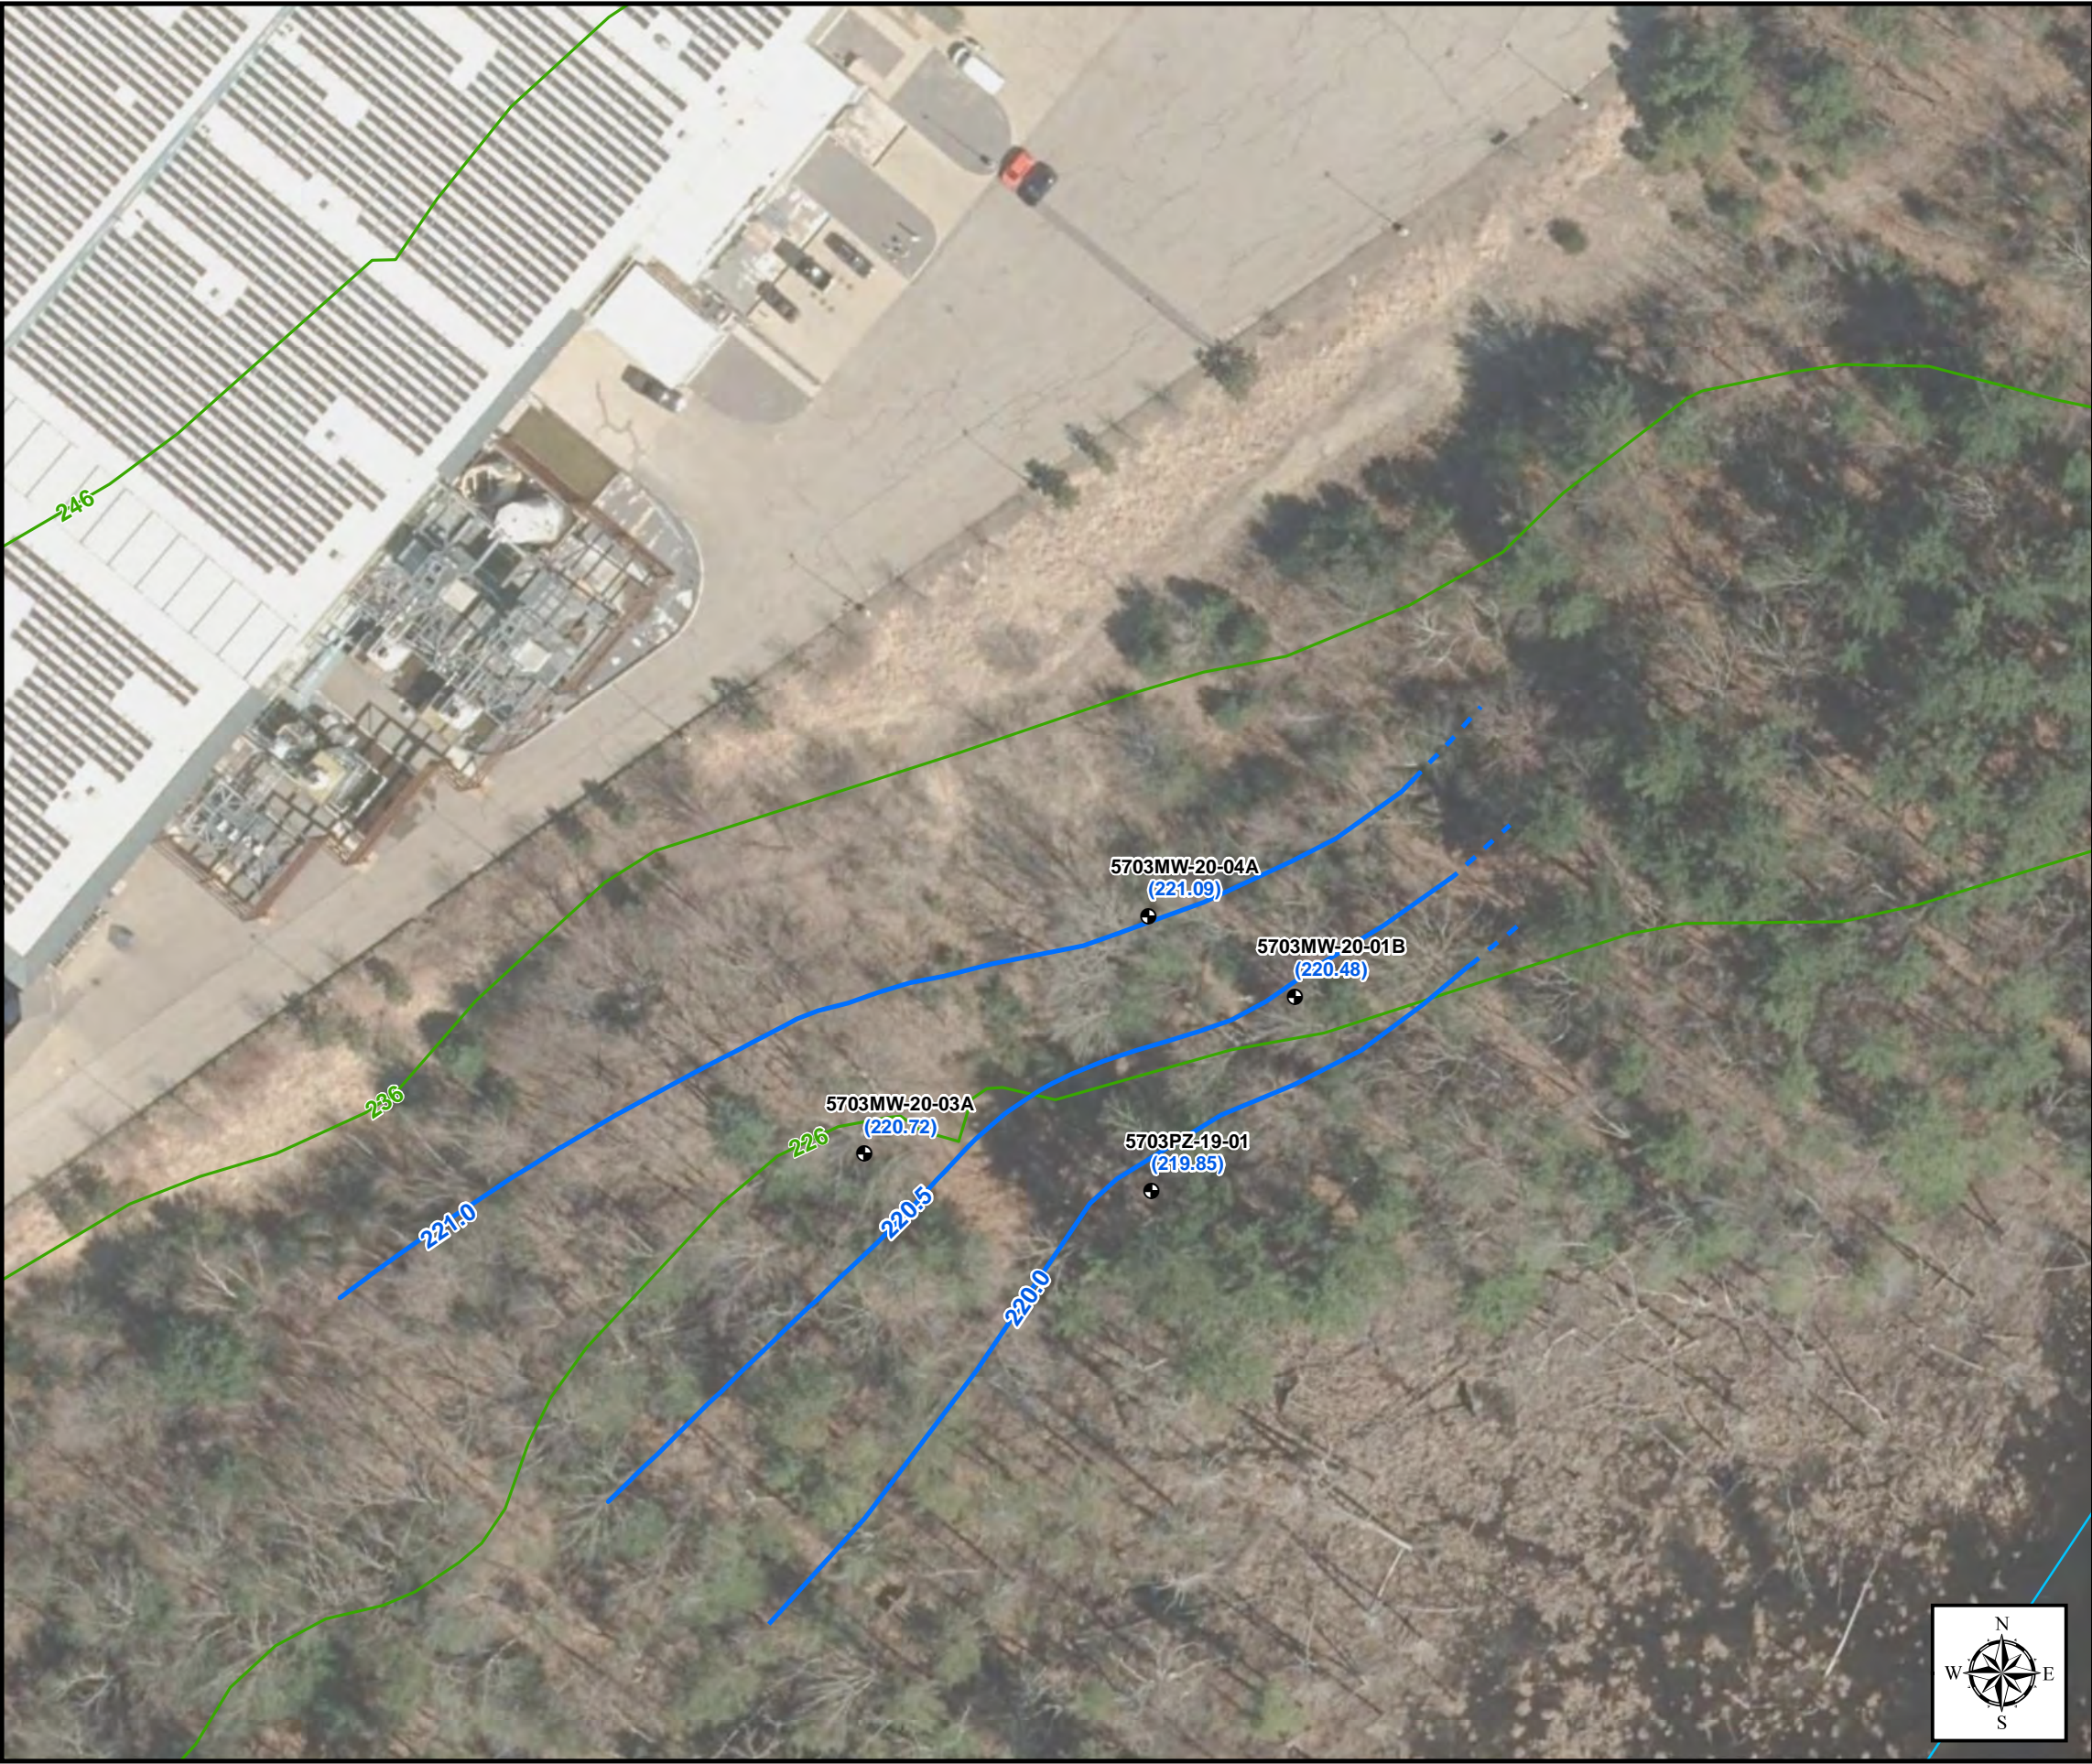
Deep Water Table Elevation Area of Contamination 57 - Area 3 March 2020 Devens PFAS RI - Area 1 PSCS			
Former Fort Devens Army Installation Devens, Massachusetts			
KOMAN Government Solutions, LLC 293 Boston Post Road West, Suite 100, Marlborough, MA 01752			
0 30 60 Feet	Date: 05/27/2020	Figure 2-15

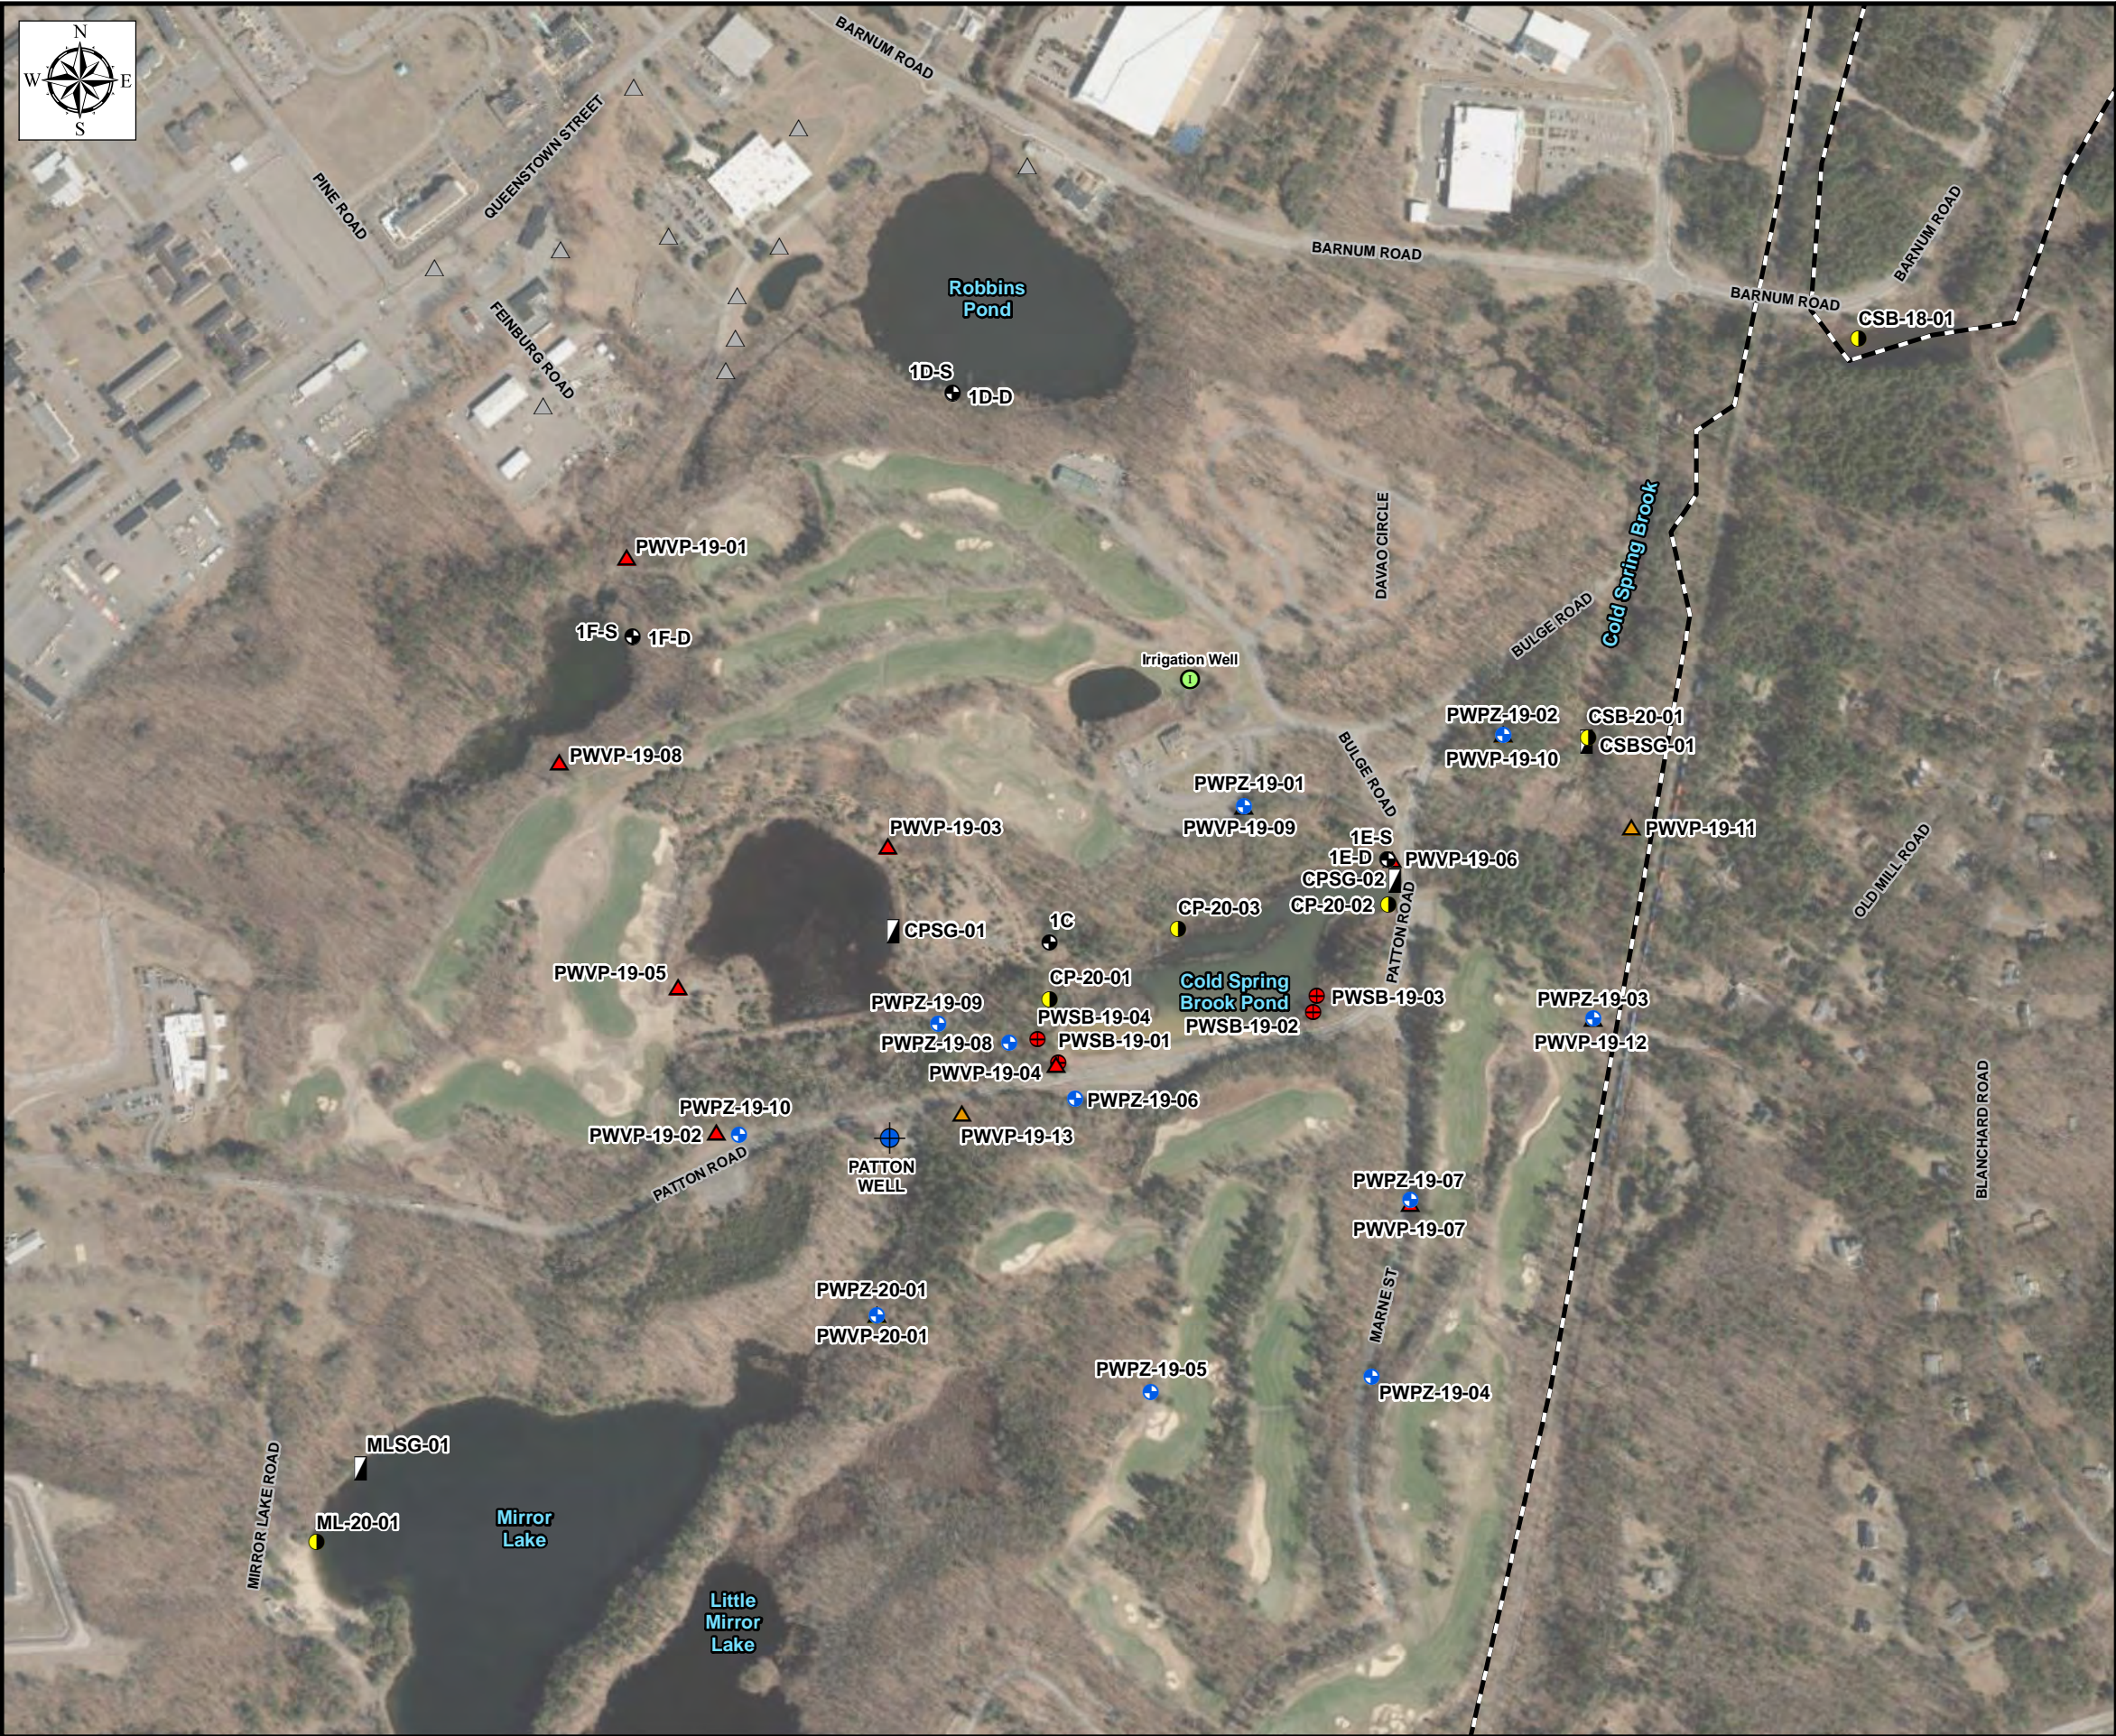
Patton Well Area/AOC 40 Field Activities Devens PFAS RI - Area 1 PSCS			
Former Fort Devens Army Installation Devens, Massachusetts			
KOMAN Government Solutions, LLC 293 Boston Post Road West, Suite 100, Marlborough, MA 01752			
0 200 400 Feet	Date: 05/27/2020	Figure 7-4
