Final Debris Removal Activities Summary Report

**Area of Contamination 50 – Debris Pile C
Former Fort Devens Army Installation
Devens, Massachusetts**

Contract No. W912WJ-19-D-0014

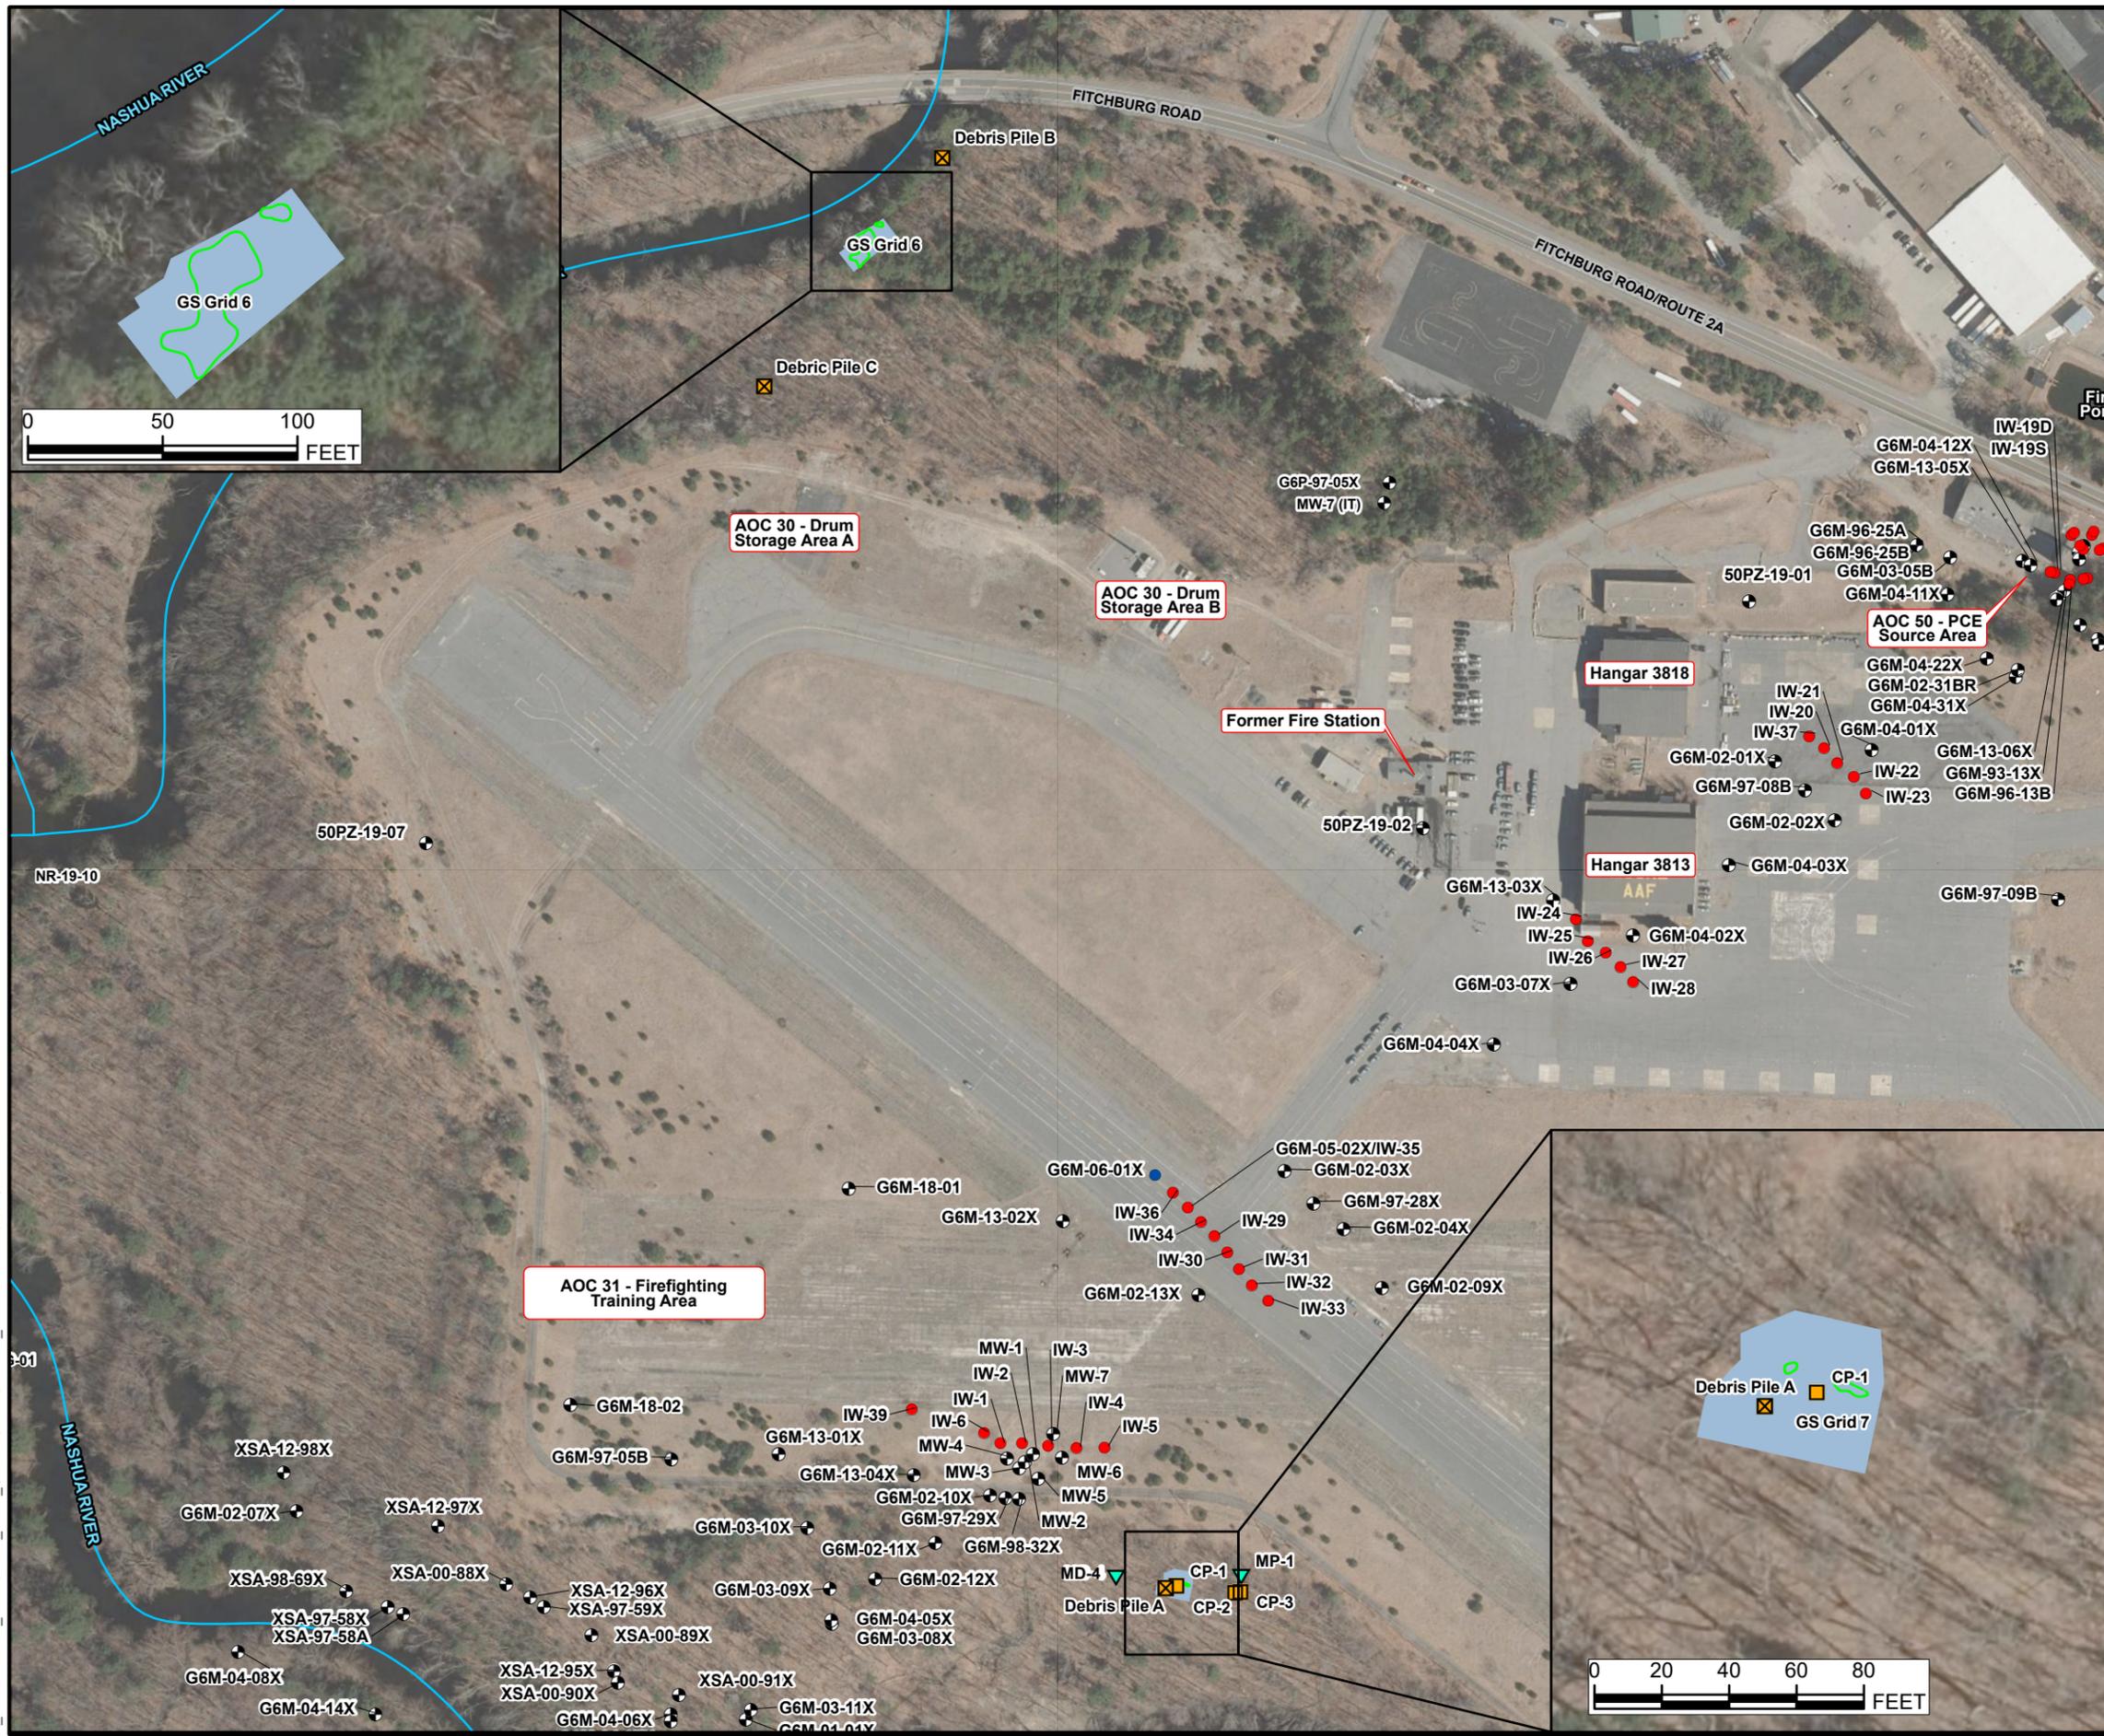
Figure 2

AOC 50 Debris Piles

On March 30, 2020, two previously identified debris areas in AOC 50 (identified as “Debris Pile A” and “Debris Pile B”) were observed to contain assorted empty metal drums, containers, and paint cans (**Figure 2**). The United States Department of the Army (Army) completed removal of these debris piles between November 29, 2021, through December 1, 2021, and the results are summarized in the Final Debris Removal Activities Report (S-A JV 2022).

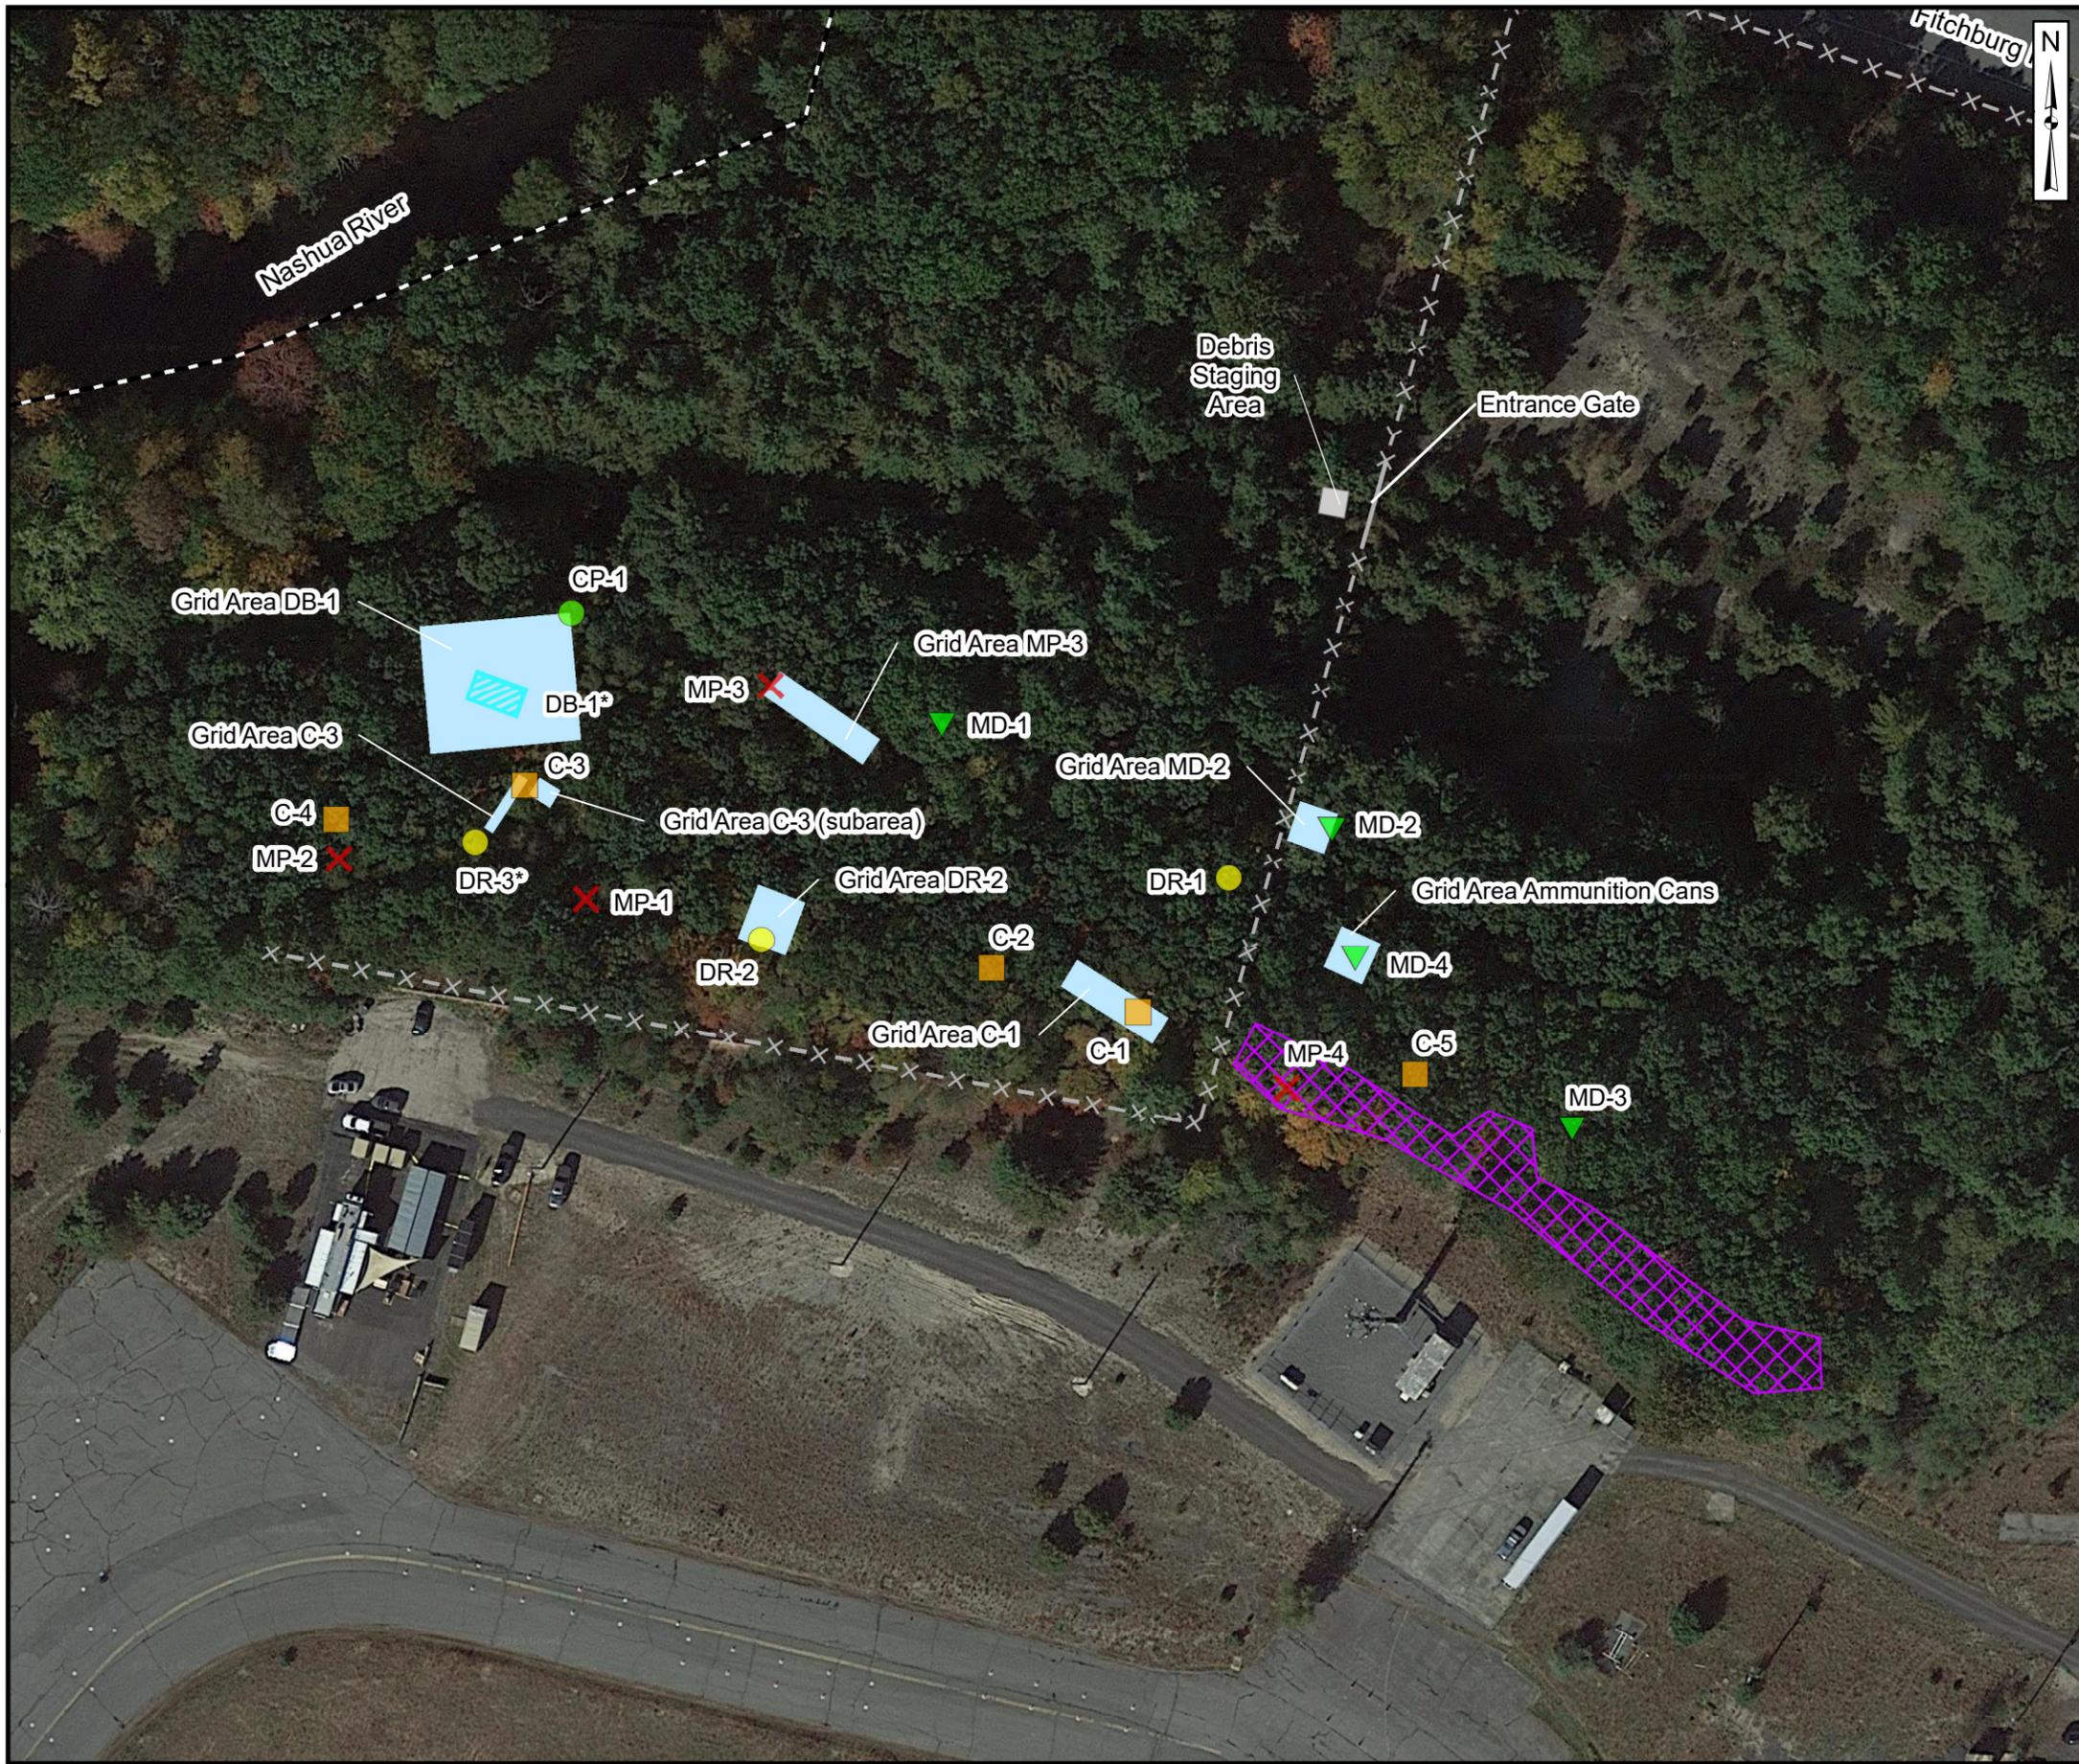
Figure 3

1. DB = Surface Debris Area
2. CP = Car Part
3. C = Metal Container
4. DR = Metal Drum
5. MD = Metal Debris
6. MP = Metal Pipe
7. *Construction debris was not removed. Hillside Debris Piles contain wood construction debris; Location DB-1 contains brickwork; and Location DR-3 contains a brick-lined chimney.

AOC 50 Debris Pile C Area

Debris removal at Debris Pile C was conducted on June 21, 2023, and June 22, 2023. **Table 1** presents a summary of the debris removed. **Figure 3** shows the location and type of debris removed. Field photographs displaying the debris removed are provided in **Appendix A**.

During the removal process, four metal ammunition cans and what appeared to be an expired smoke cannister, were observed on the ground surface (identified as MD-4; see **Figure 3**). The Ft. Devens Fire Department Chief was notified to visually inspect the items. The Ft. Devens Fire Department Chief then notified the Massachusetts State Police explosives team to inspect the items. The explosives technician inspected the items and performed a field x-ray of the ammunition boxes which appeared to be filled with concrete. The items were determined to be inert and safe for disposal, and the items were removed.

The geophysical survey was conducted at eight debris locations in Debris Pile C. A total of seven debris locations were not surveyed. Five debris locations (hillside debris piles area, C-5, MD-3, MP-1, and MP-2) were not surveyed due to the steep terrain, two debris locations (C-4 and DR-1) were not surveyed due to the presence of ground nesting bees which swarmed on approach, and two debris locations (MD-1 and C-2) were not surveyed as they were single-item debris locations. Within each geophysical survey grid, GPR and EM were conducted in approximately 5-foot by 5-foot transects. No GPR data were acquired at Grid Area DR-2 due to the steep terrain, and no EM data were acquired at Grid Area MD-2 due to the chain-link fence along the western edge of the grid area. The transects were marked in the field using pink pin flags and/or spray paint. The geophysical grid locations are shown on **Figure 3**.

- Seven areas of buried metal objects or caches of objects are present in Grid Area DB-1, Grid Area C-3, Grid Area DR-2, and Grid Area C-1 (**Figure 3**). The nature of the objects could not be determined based on the geophysical data.
- Grid Area C-3 (subarea), Grid Area MP-3, Grid Area MD-2, and Grid Area Ammunition Cans (**Figure 3**) have no significant amounts of buried metal.
- Small unidentified buried objects and possible utility segments or linear structures are present in the grid areas.

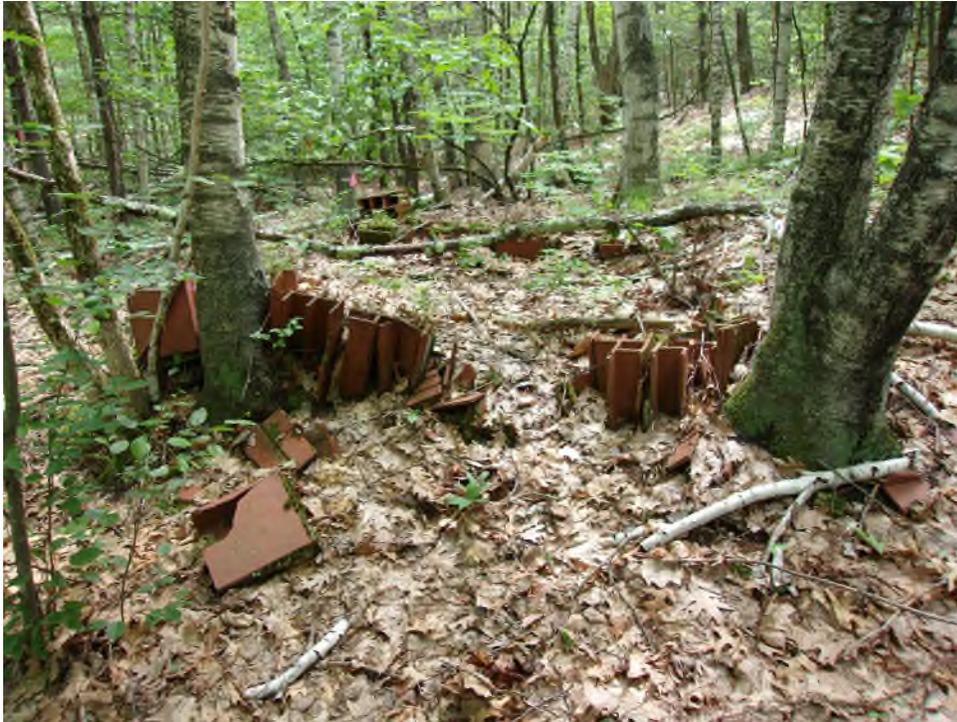
Photograph: 1

Description:
Mixed debris – brickwork, cans, bottles, glass, and other miscellaneous debris at DB-1. Brickwork was not removed.

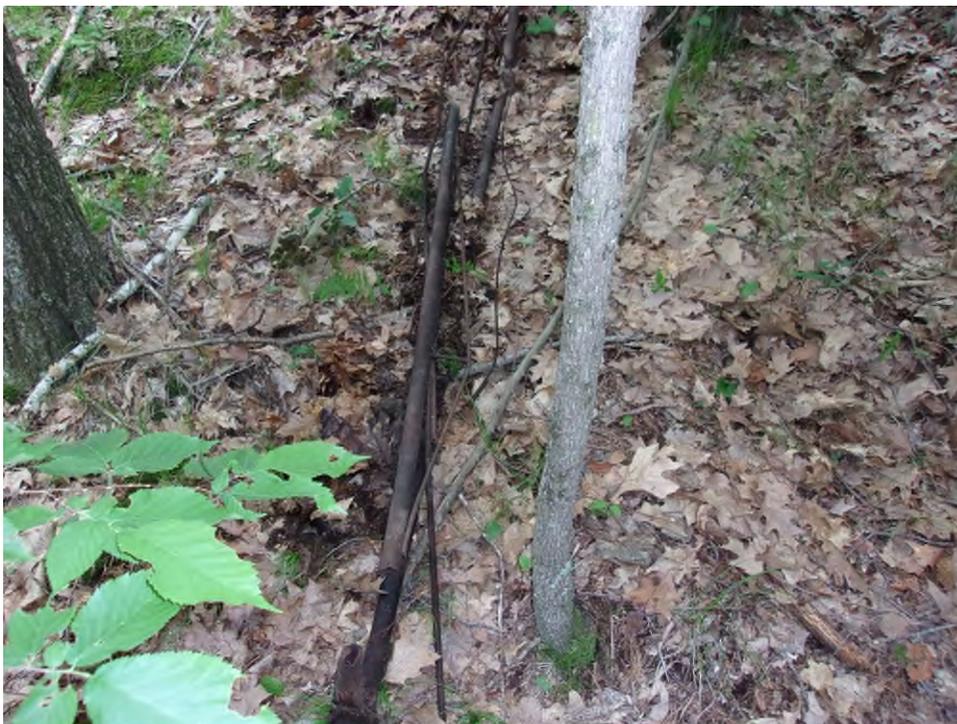
Photograph: 2

Description:
1.5" metal pipe (center of image) at MP-2

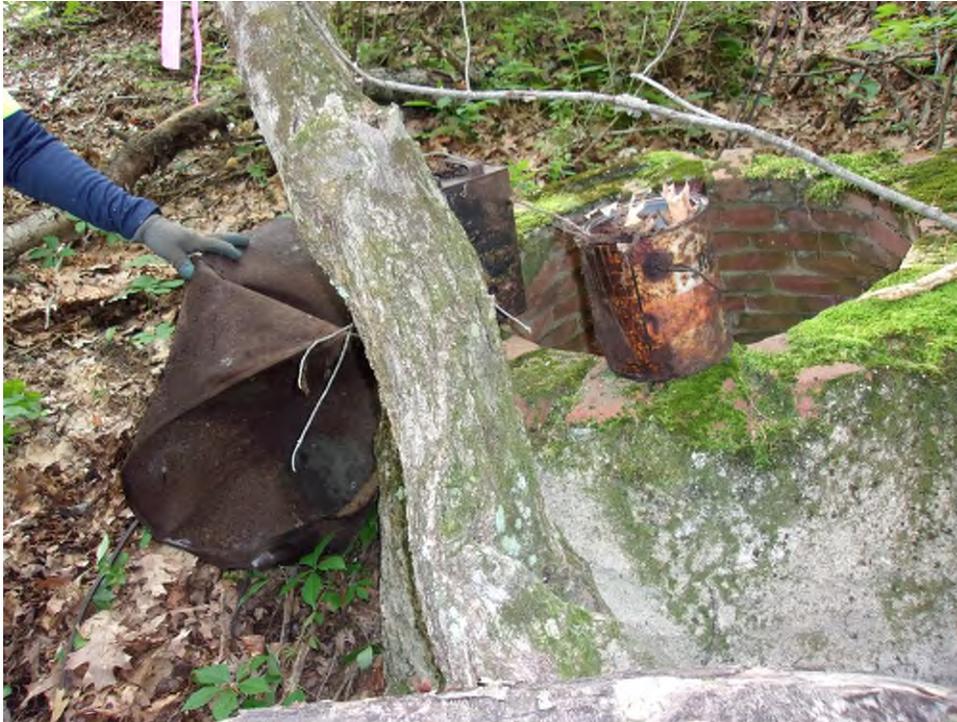
Photograph: 3

Crushed drum, metal cans, metal strapping, oil can, and brick-lined chimney at DR-3. Brick-lined chimney was not removed.

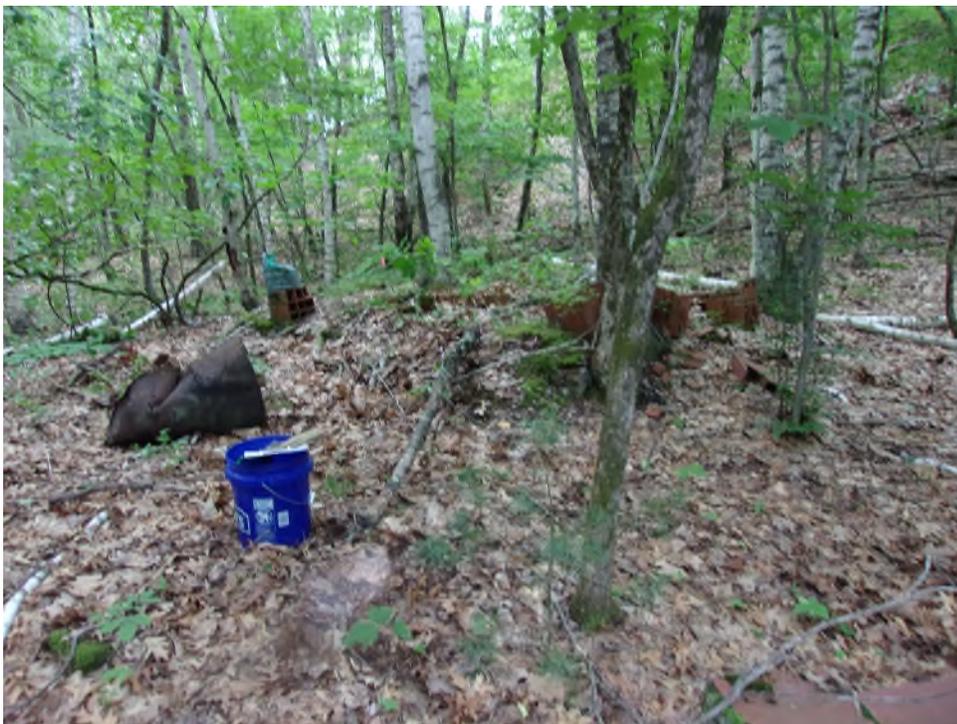
Photograph: 4

Temporary debris staging near DB-1

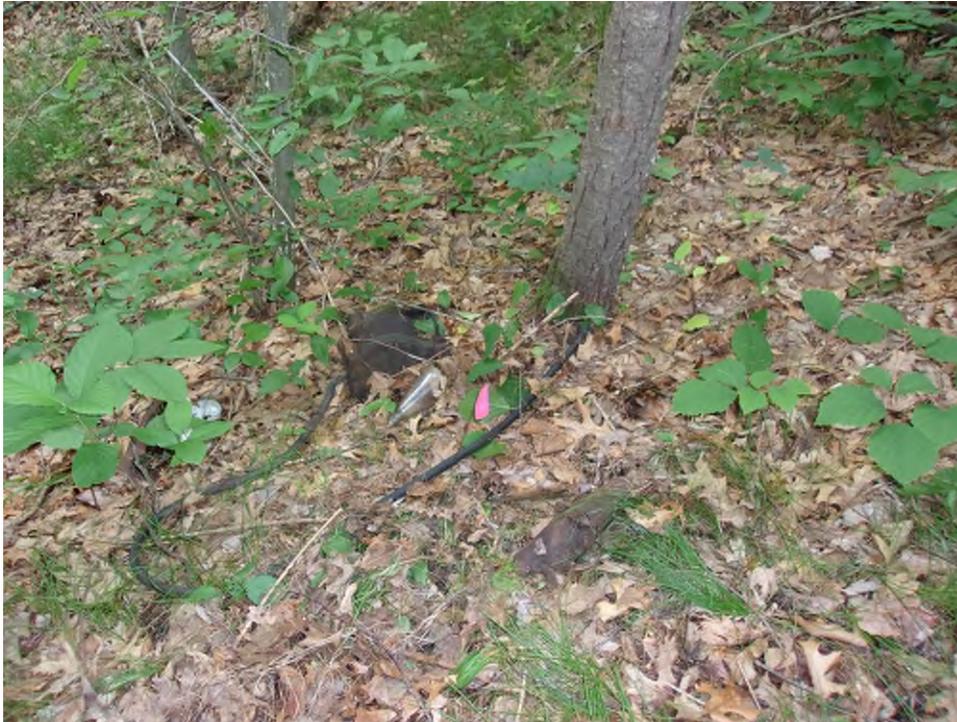
Photograph: 5
Description: Rusted metal can and lightbulb at C-4
Location: AOC 50
Date: 6/21/2023

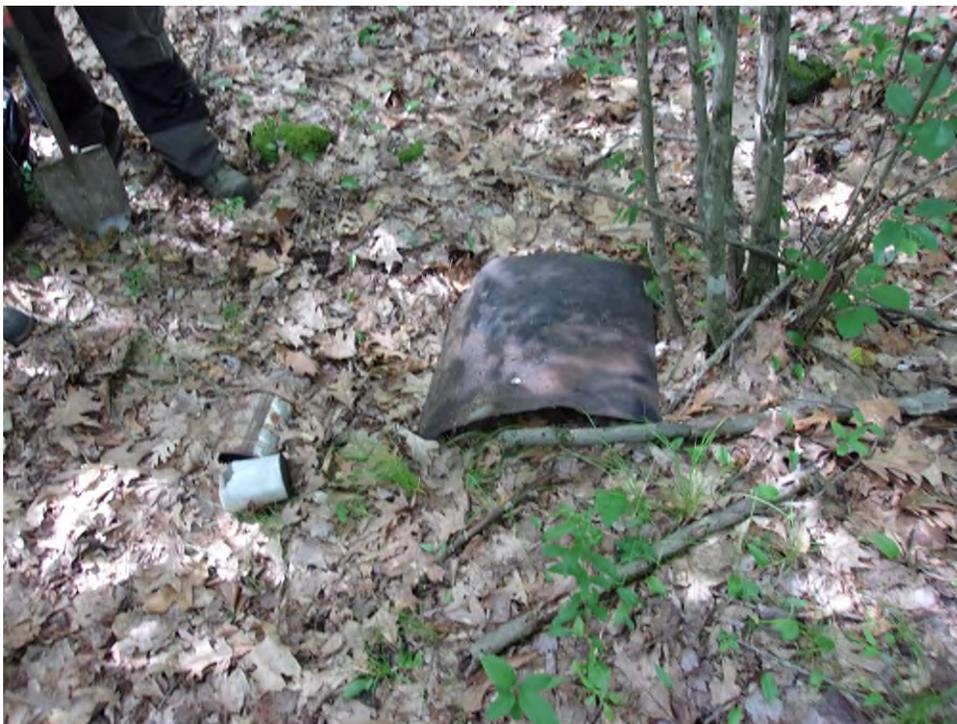
Photograph: 6
Description: 3' x 4' sheet metal and metal cans at MP-3
Location: AOC 50
Date: 6/21/2023

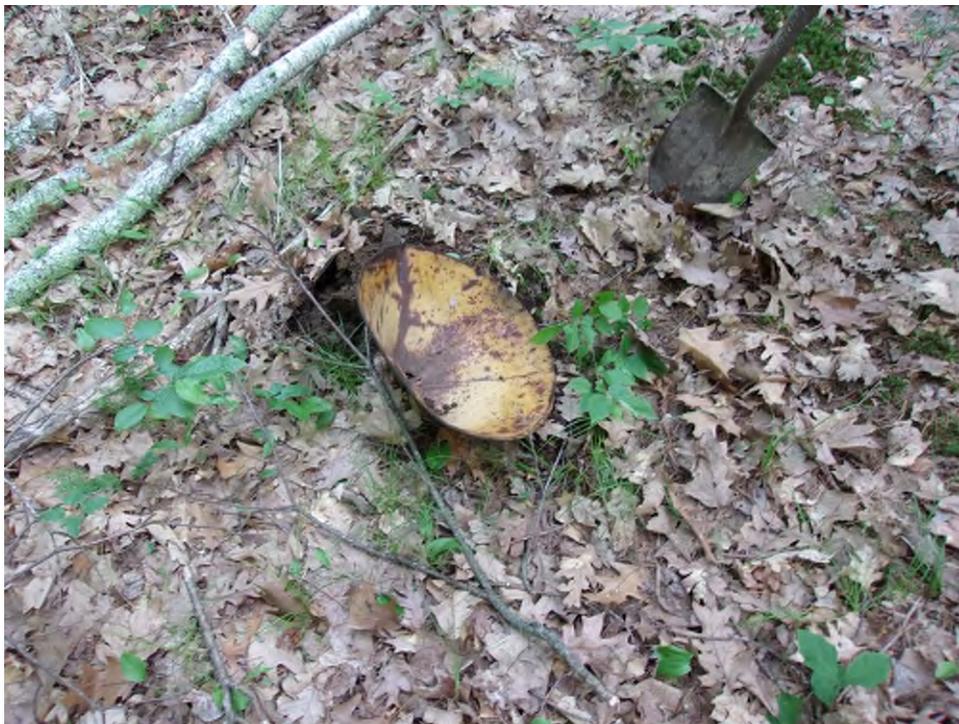
Photograph: 7
Description:
Metal funnel at MD-2
Location: AOC 50
Date: 6/21/2023

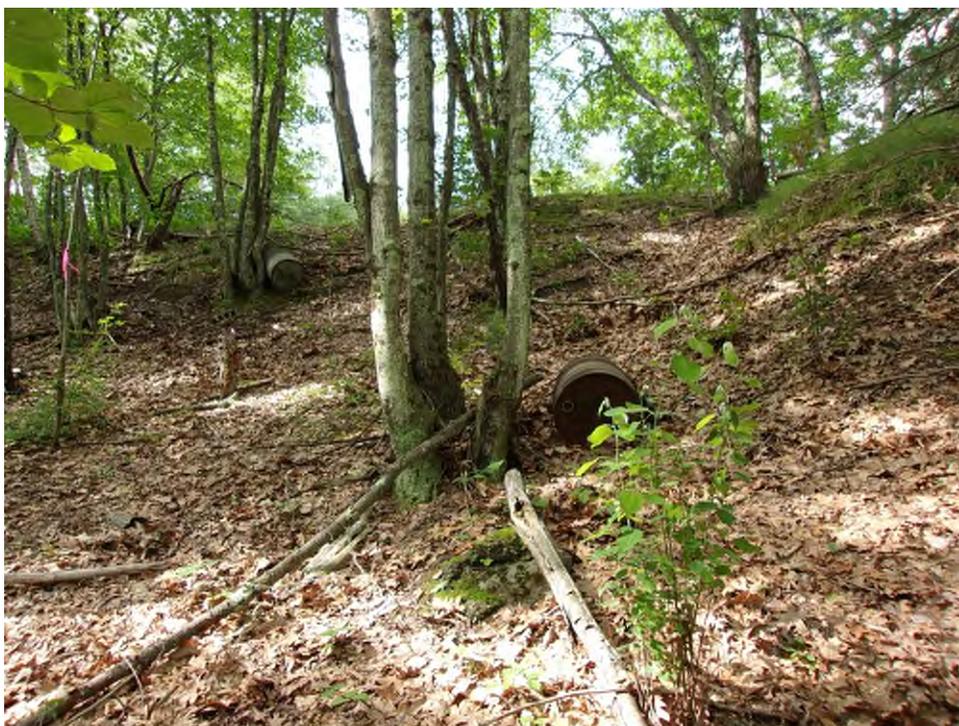
Photograph: 8
Description:
Two 55-gallon drums
on hill slope at DR-2
Location: AOC 50
Date: 6/21/2023

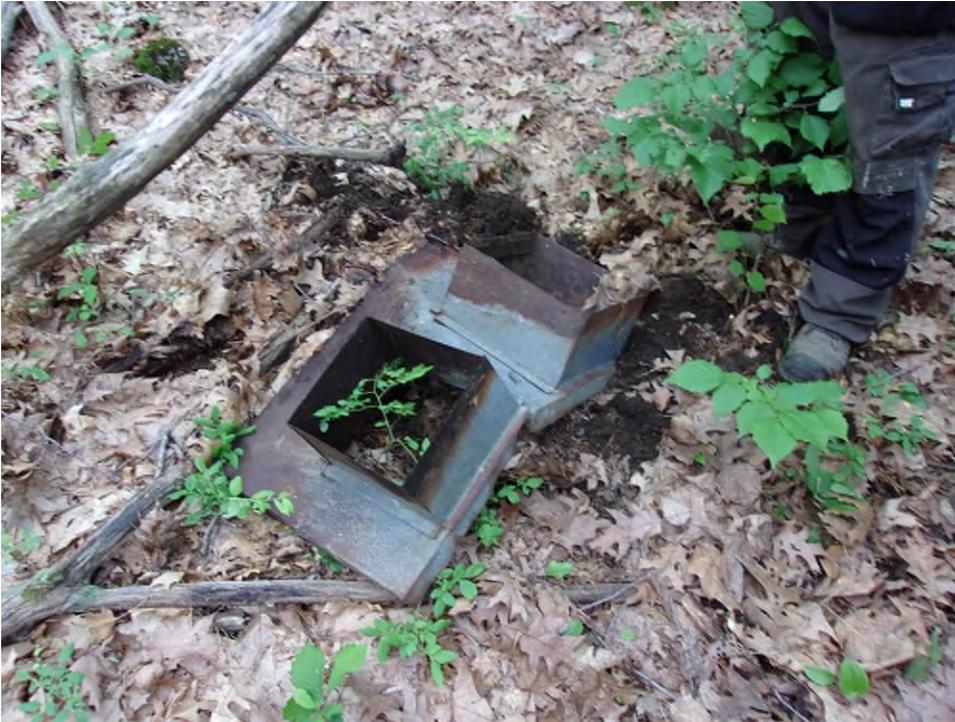
Photograph: 9

Galvanized steel ductwork at MD-1

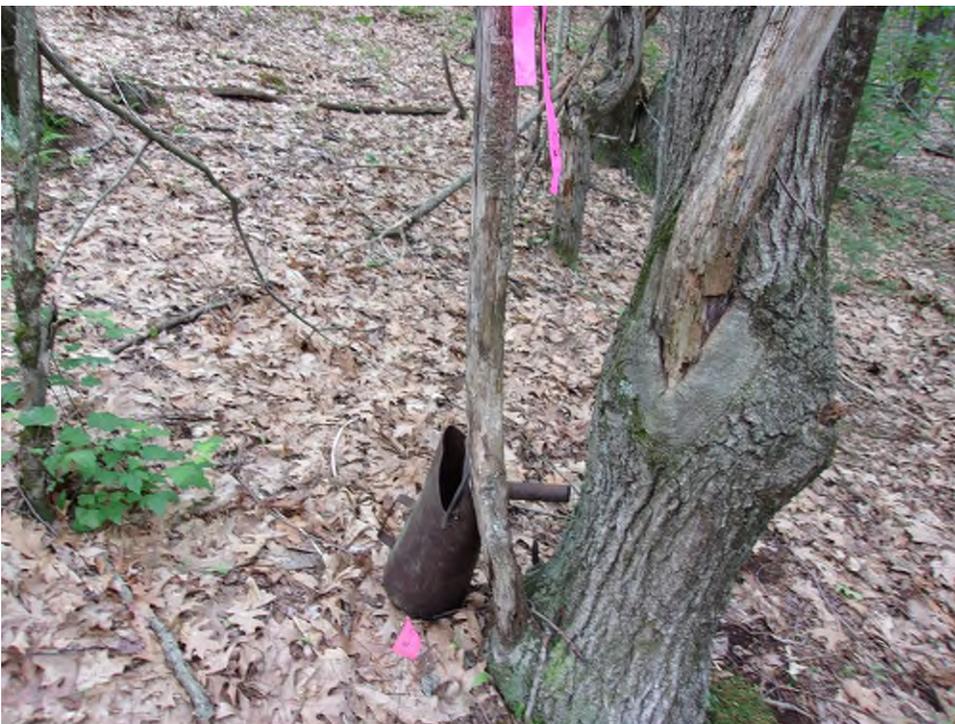
Photograph: 10

20-inch rusted metal can with handle at C-2

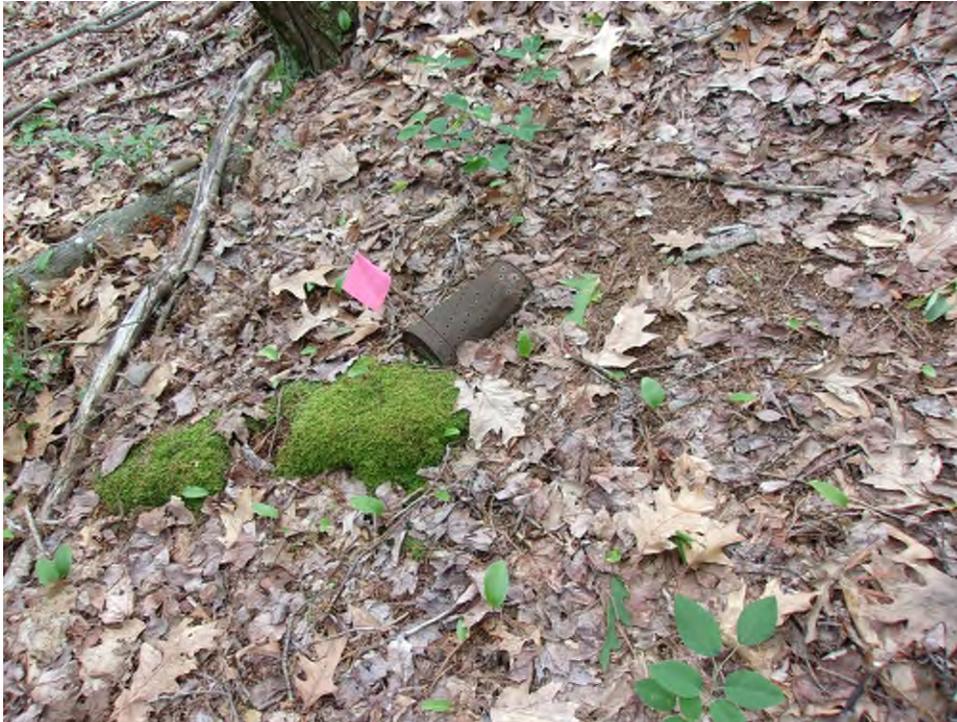
Photograph: 11

Description:
12-inch perforated
metal can at C-1

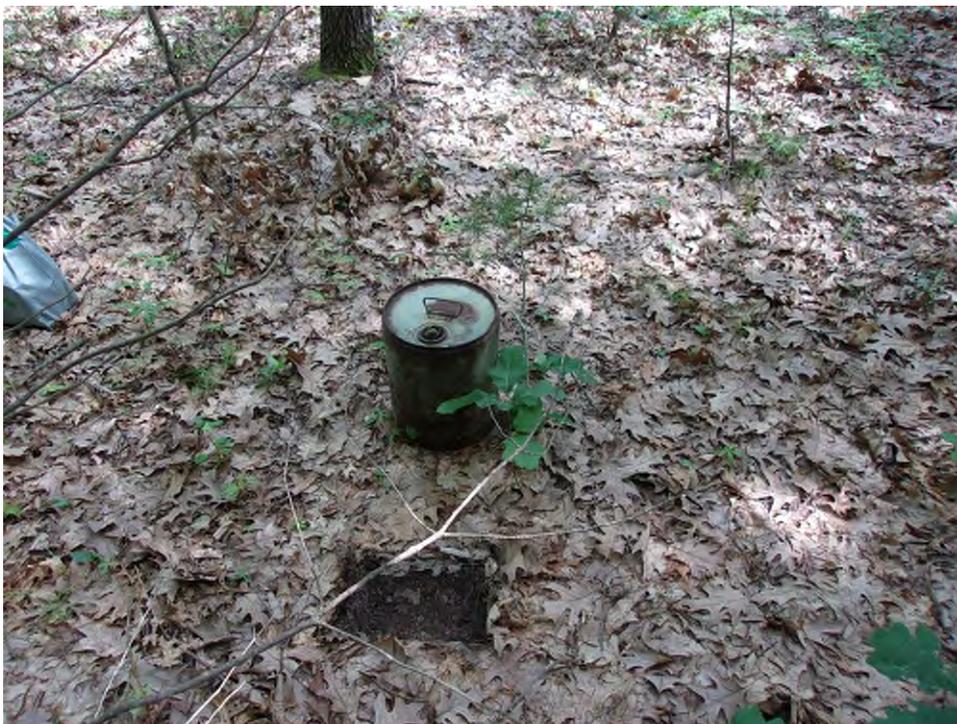
Photograph: 12

Description:
5-gallon metal can at
DR-1

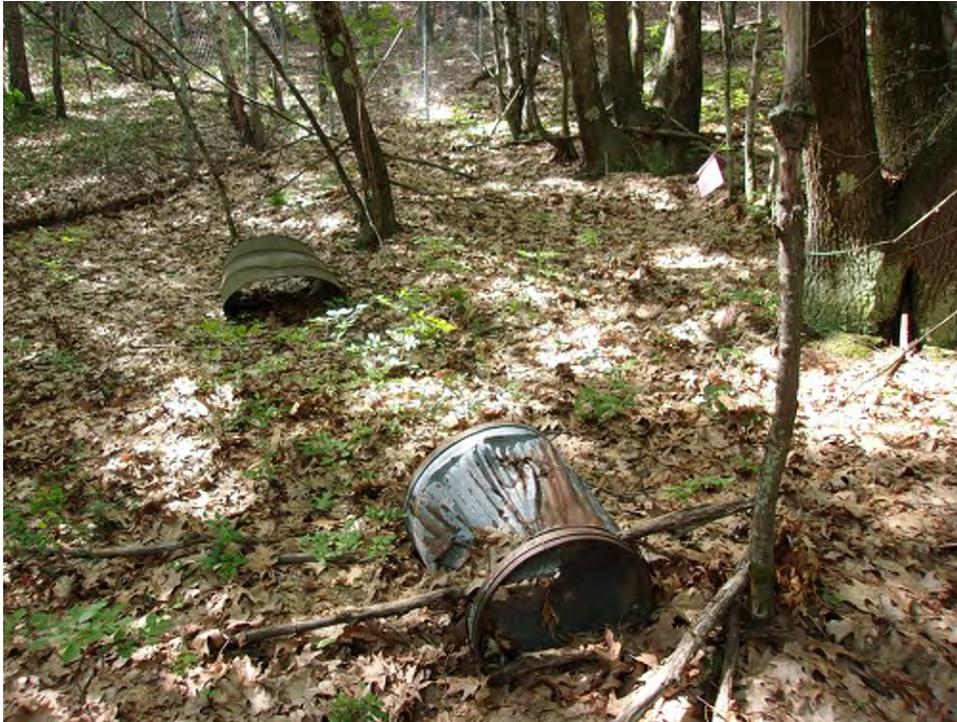
Photograph: 13

55-gallon open-ended metal drum and 30-gallon galvanized metal trash can at DR-1

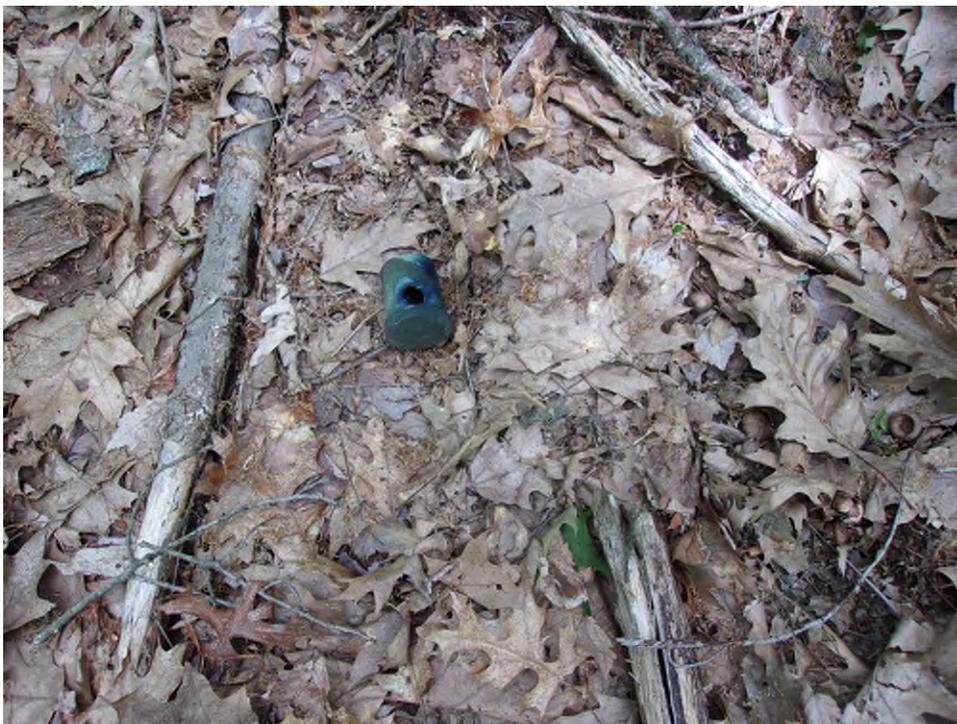
Photograph: 14

Burnt metal can (possible expired smoke cannister) at MD-4

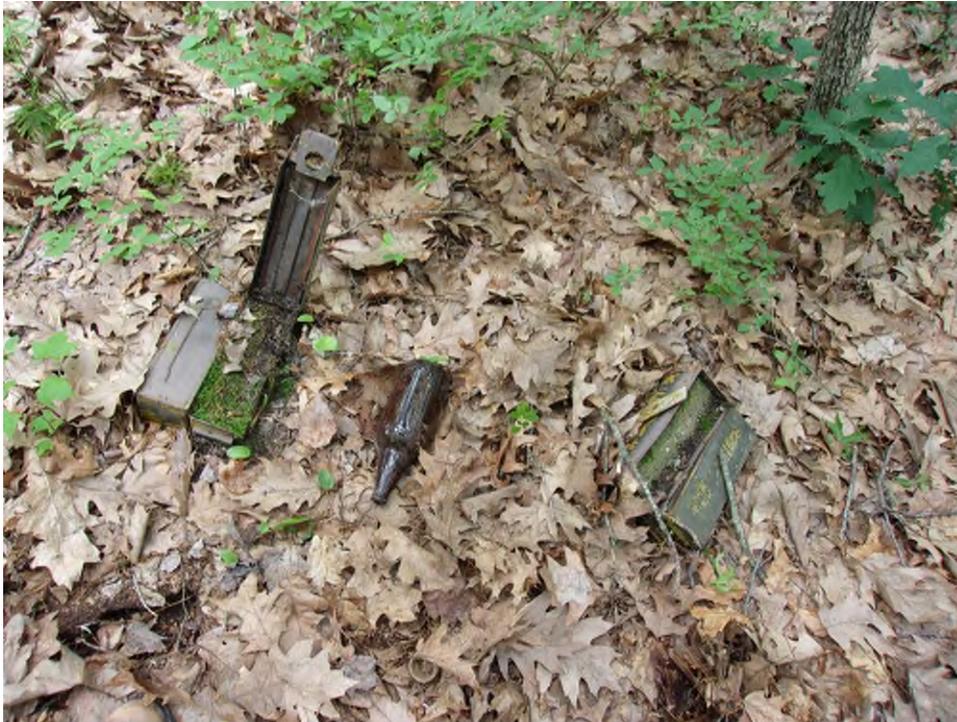
Photograph: 15

Description:
Four concrete-filled metal ammunition cans and glass bottle at MD-4

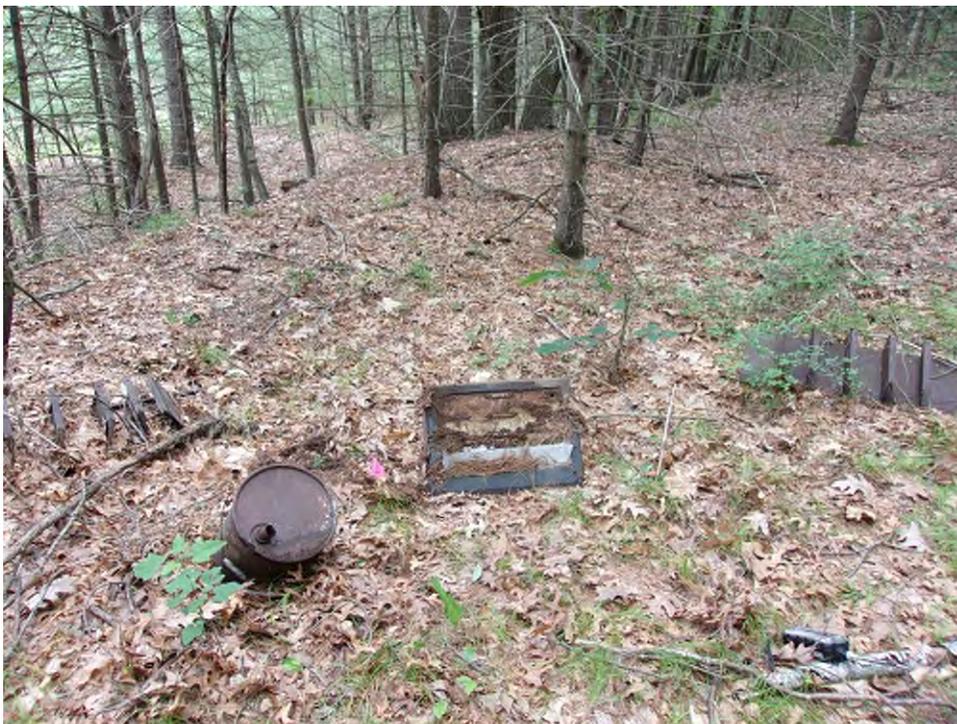
Photograph: 16

Description:
Miscellaneous metal debris at DB-1

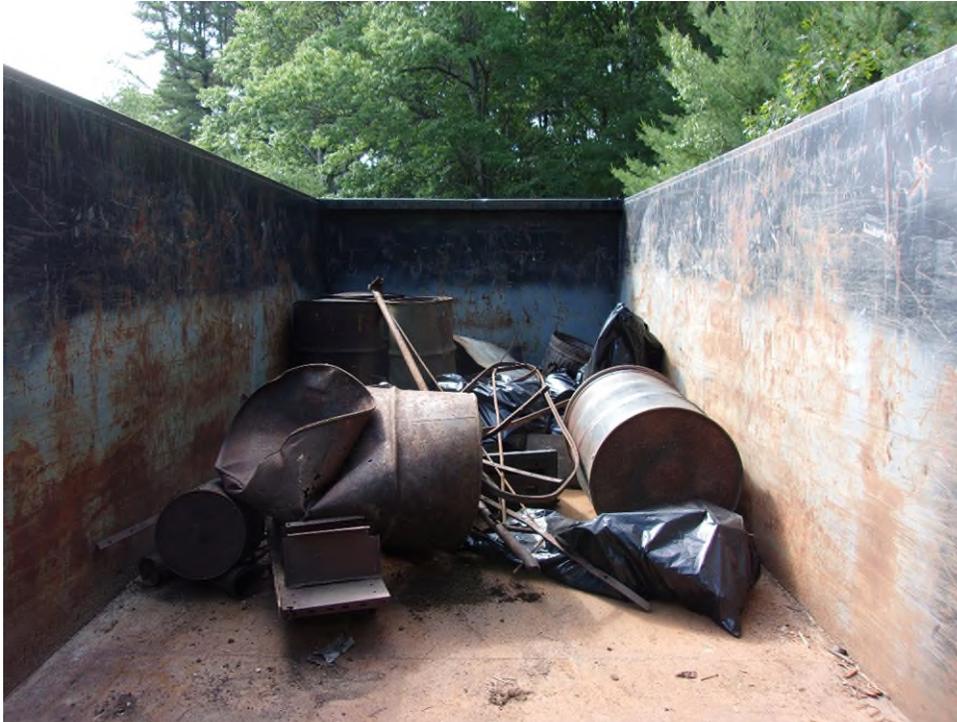
Photograph: 17

Description:
Collected debris placed
in roll-off container

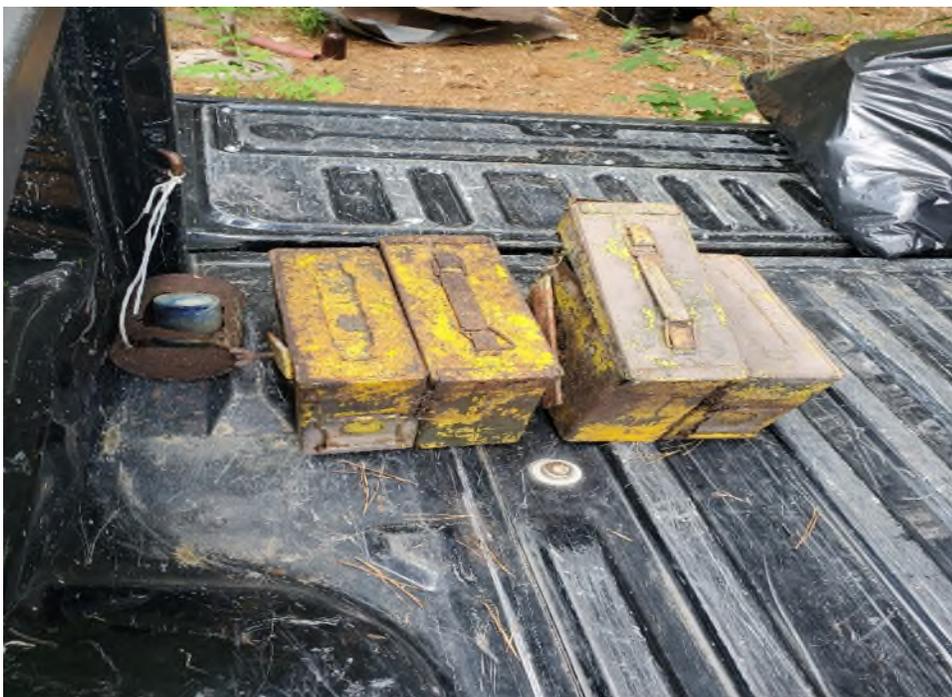
Photograph: 18

Description:
Four concrete-filled
metal ammunition cans
removed from MD-4

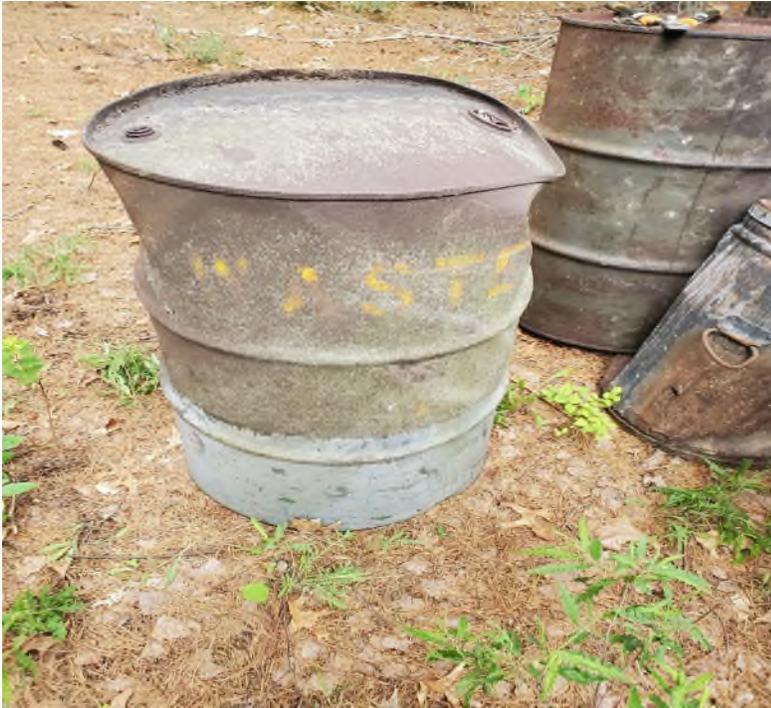
Photograph: 19

Empty waste oil drum removed from DR-2

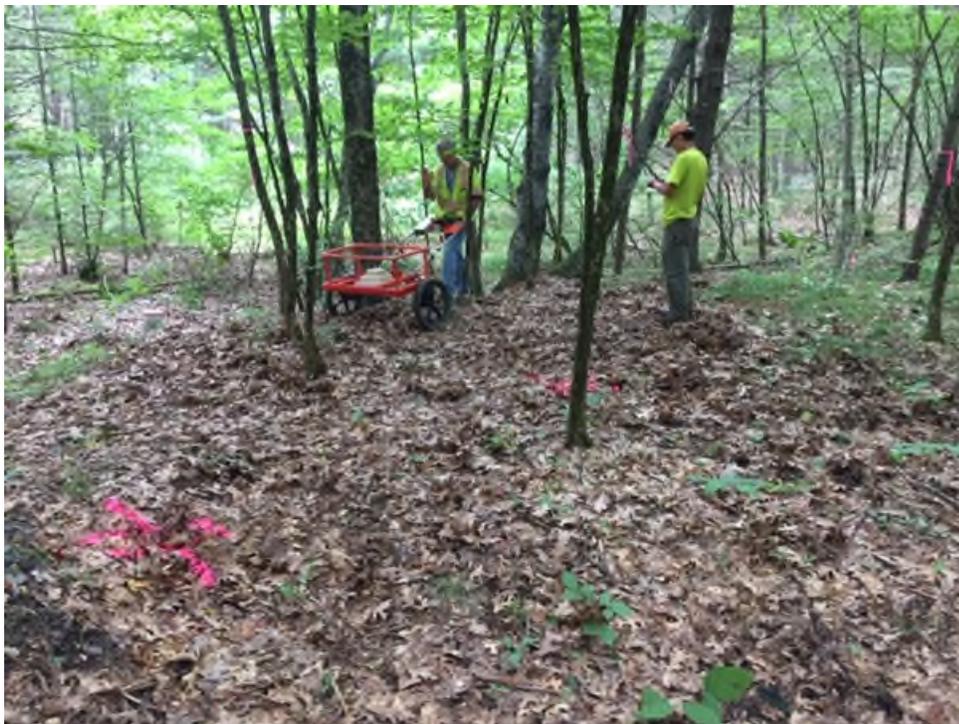
Photograph: 21
Description:
EM survey in Grid Area
DB-1
Location: AOC 50
Date: 7/27/2023

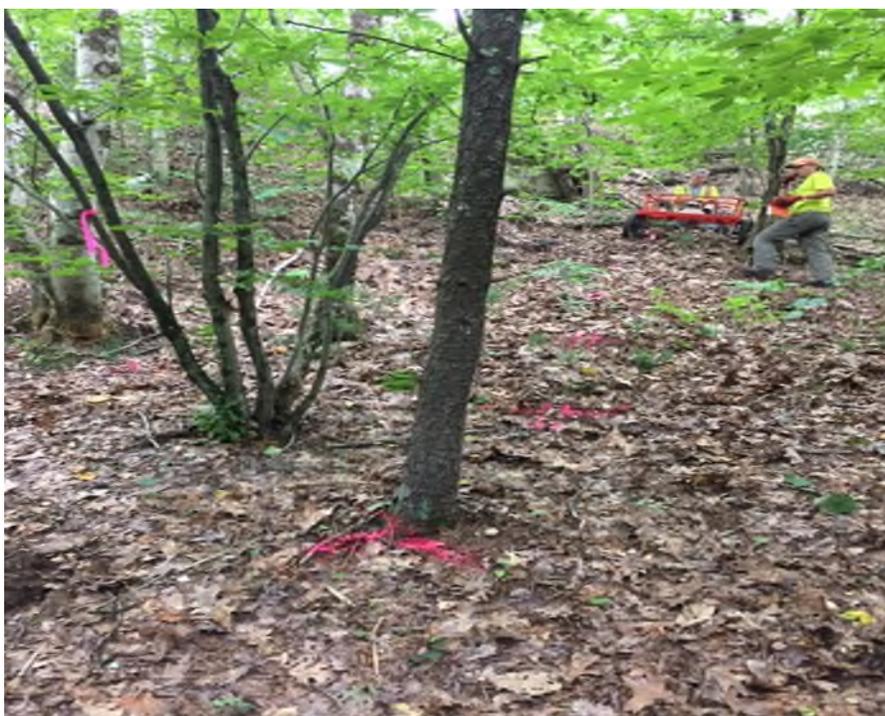
Photograph: 22
Description:
EM survey in Grid Area
C-3 and Grid Area C-3
(subarea)
Location: AOC 50
Date: 7/27/2023
