Final Debris Removal Activities Summary Report

**Area of Contamination 50 – Debris Pile C
Former Fort Devens Army Installation
Devens, Massachusetts**

Contract No. W912WJ-19-D-0014

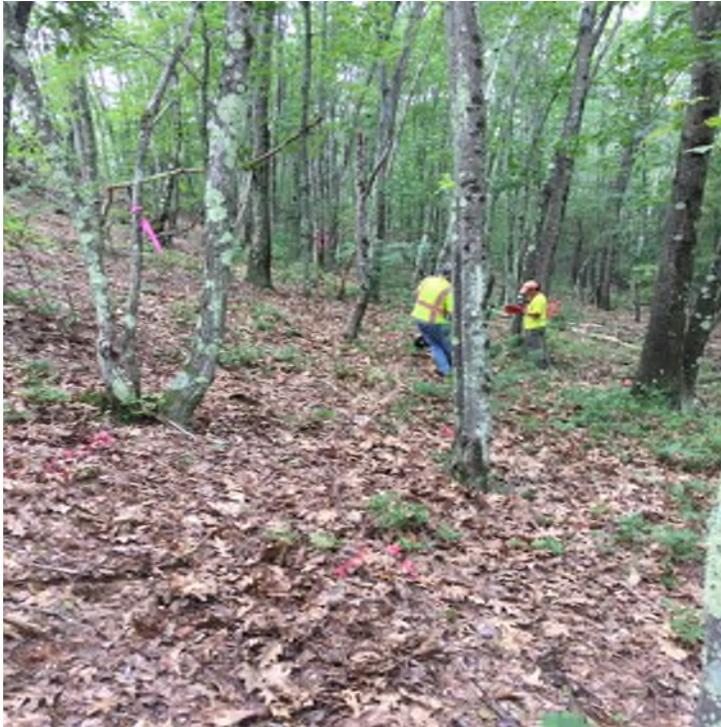
Photograph: 25

Description:
Establishing
geophysical grid for
Grid Area C-1

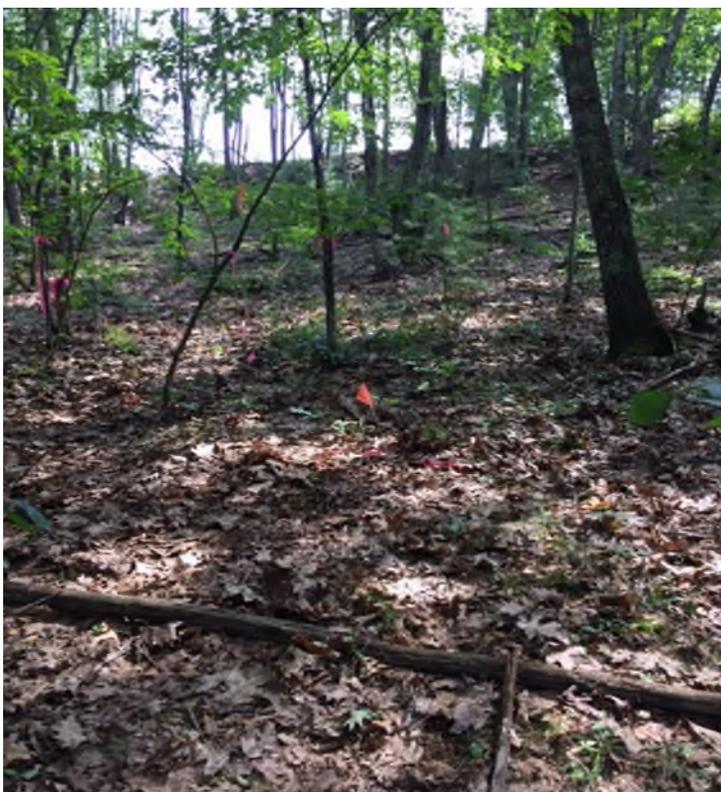
Photograph: 26

Description:
Geophysical grid for
Grid Area Ammunition
Cans

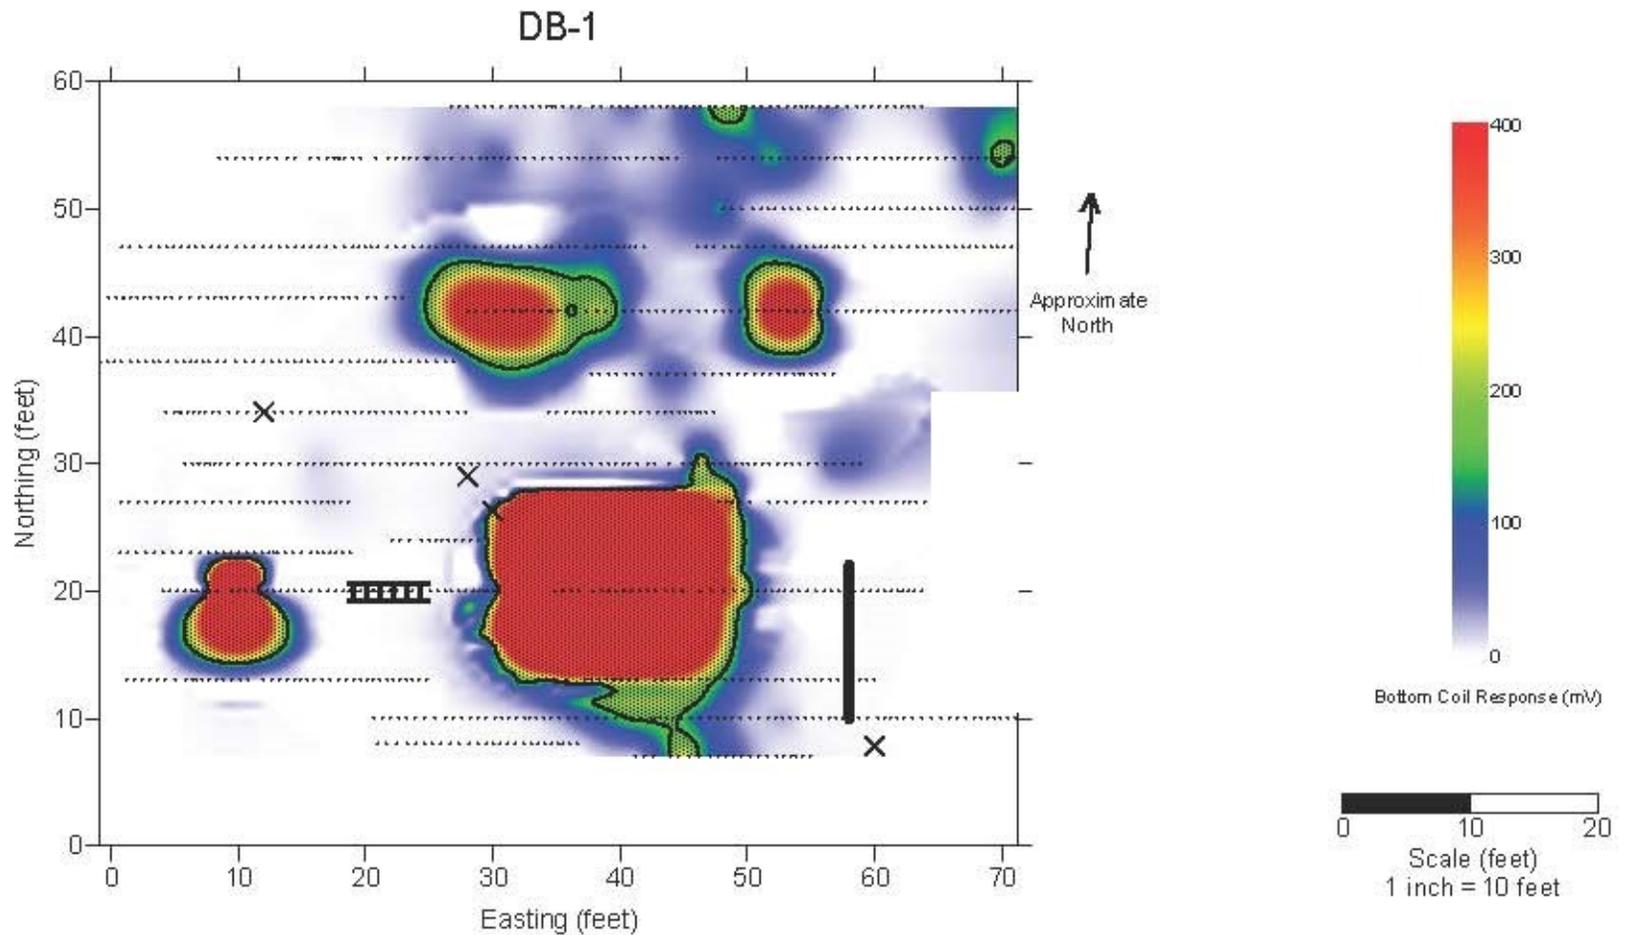
Figure 3
DB-1 Integrated Interpretation
Debris Pile Removal Report
Devens, Massachusetts

Several moderate-to high-amplitude EM anomalies (green to red areas in Figures 3, 4, 5 and 6) are present in the AOCs and are inferred to have been caused by buried metal. These moderate- to high-amplitude EM anomalies are shown as black stippled areas in the interpretation Figures 3, 4, 5, and 6. We note that the size and amplitude of one EM anomaly in DB-1 area is large enough to be caused by drums, caches of drums, or other metal debris.

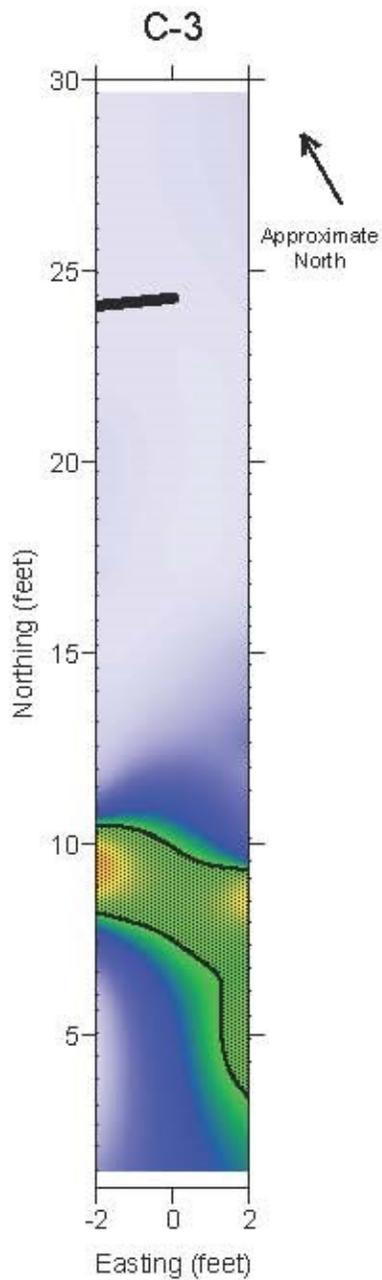
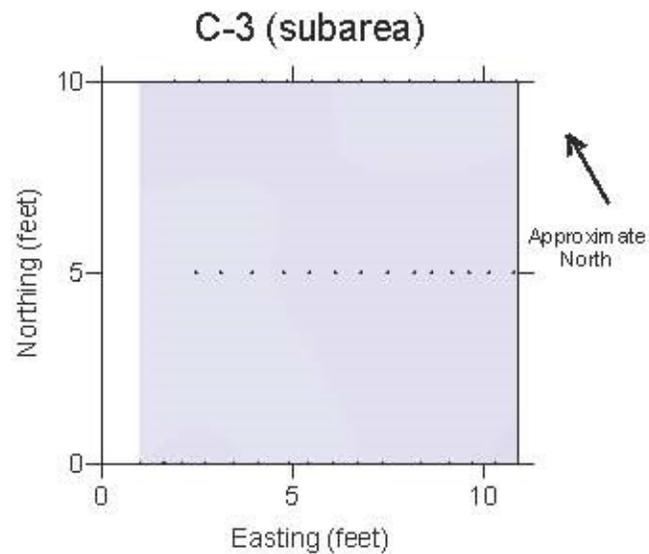
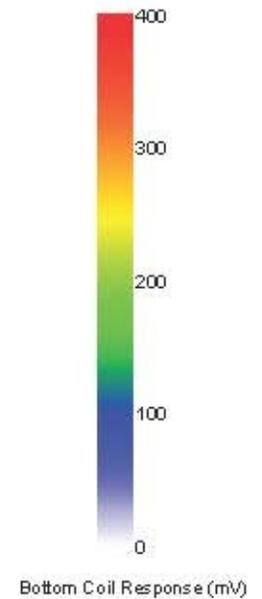
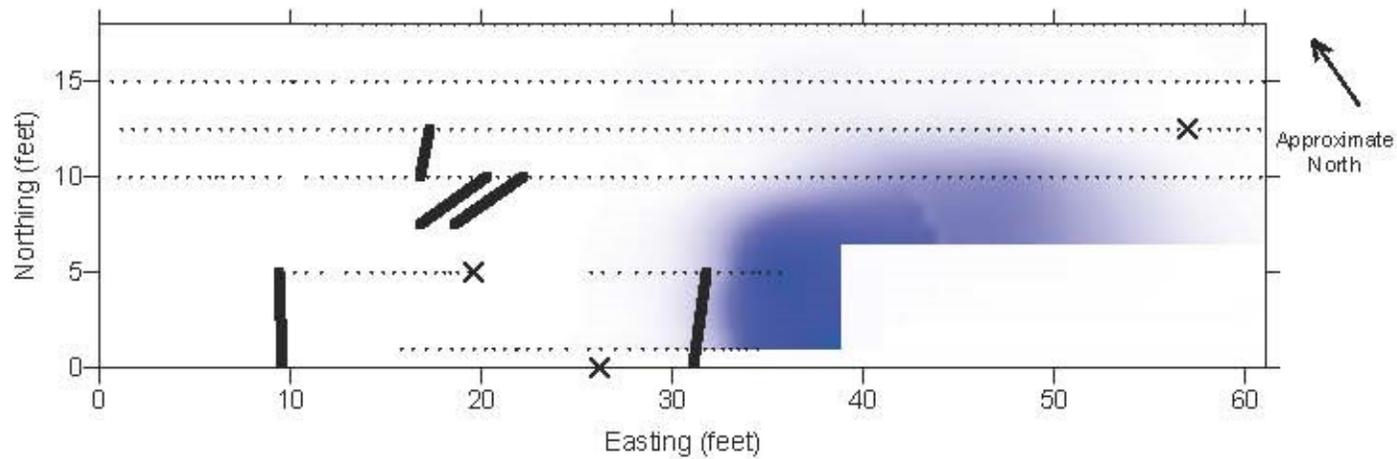
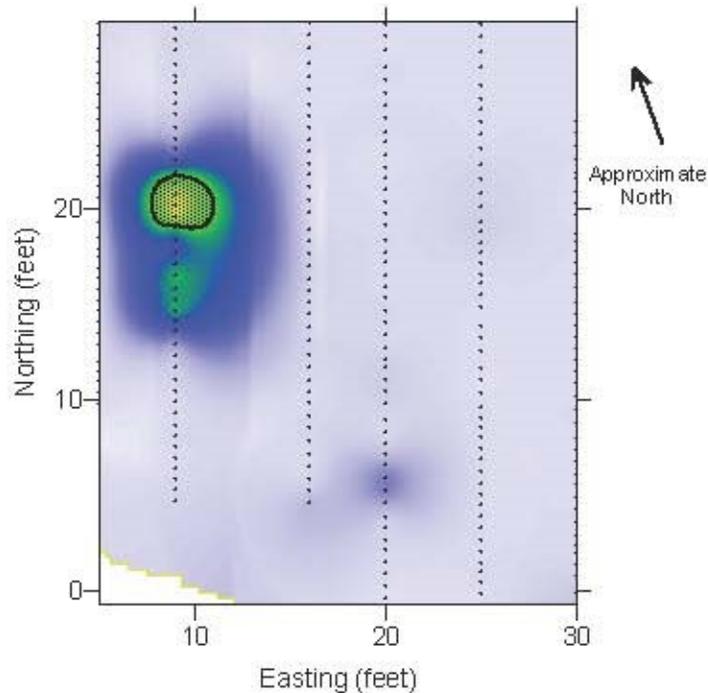
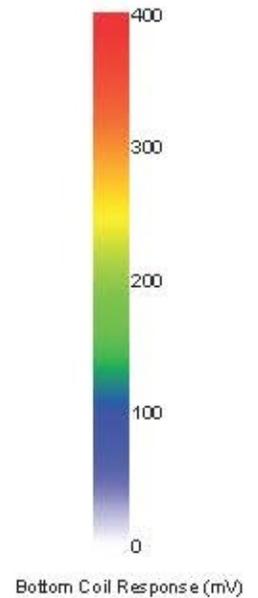
Note: No targets detected in C-3 (subarea).

Note: No GPR at DR-2 due to steep slope.
