Technical Report
Volume 4
Underground Storage Tank Closures
UST Nos. 0022 - 0024
Fort Devens, Massachusetts

ATEC File: 37.07.91.00451
Contract No. DAK31-91-D-0015

RE: Technical Report
Underground Storage Tank Closures
UST Nos. 0022 - 0024
Fort Devens, Massachusetts
ATEC File: 37.07.91.00451

UST Nos. 0022 - 0024

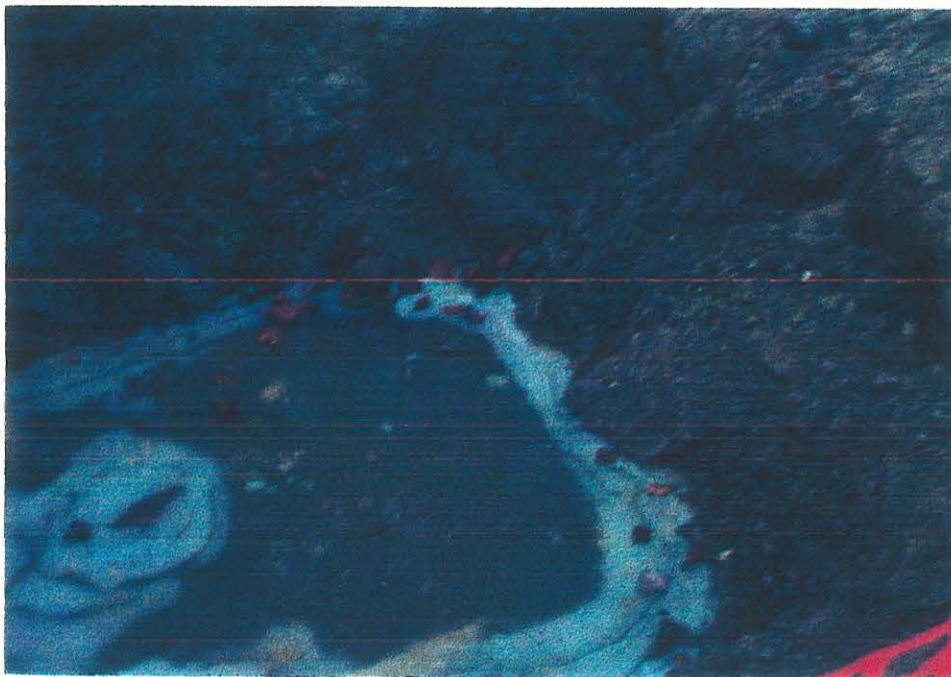
A-4

A-4: Excavation as viewed from east, facing west.

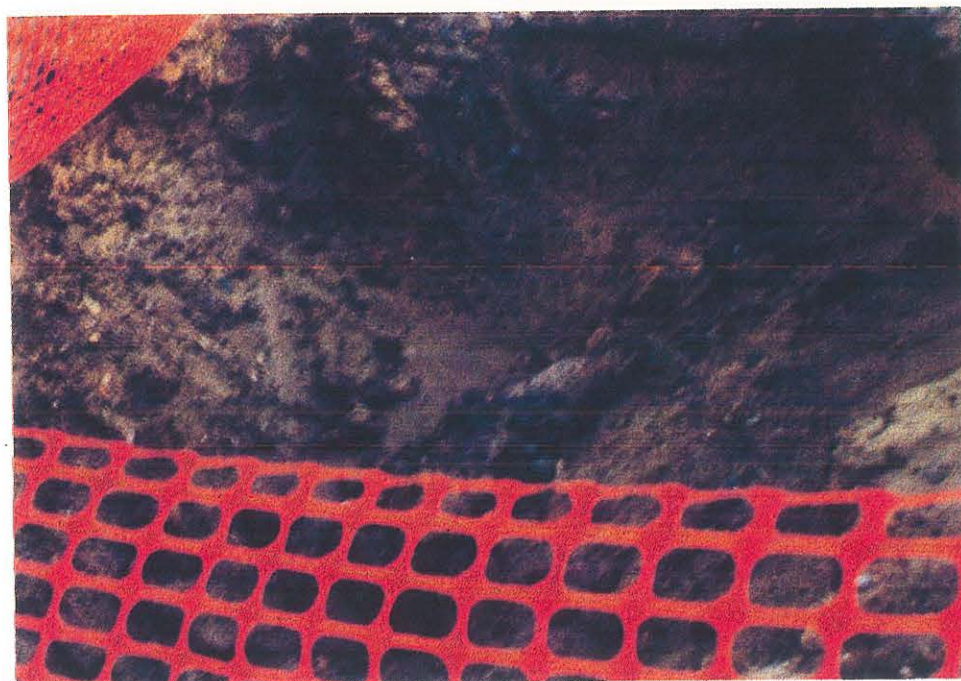
A-4

A-4: Excavation as viewed from north, facing south.

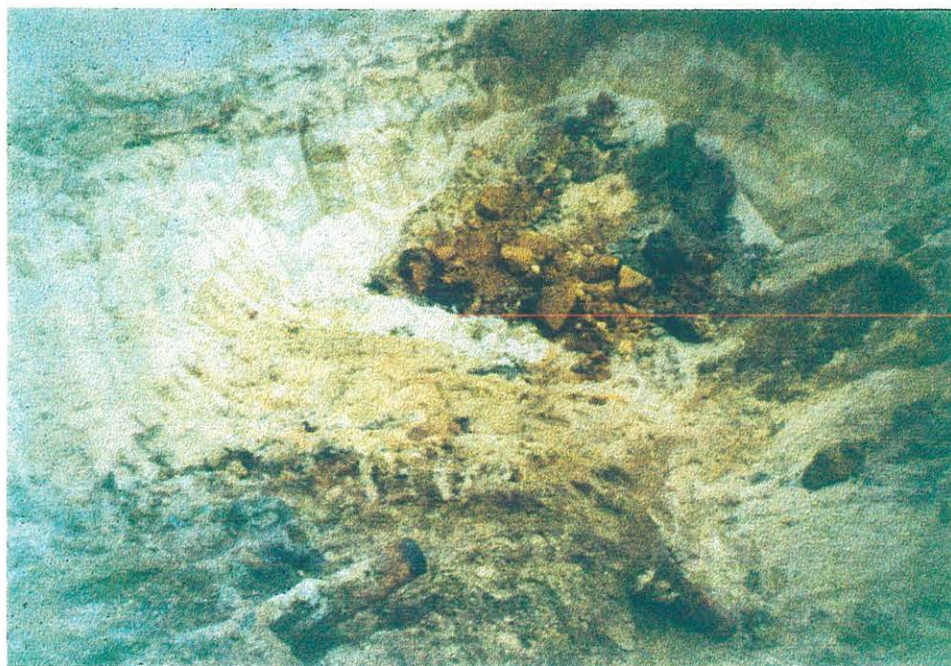
A-6 Remedial excavation as viewed from the south facing north.
