**Technical Report
Volume 7
Underground Storage Tank Closure
UST Nos. 0032 - 0034
Fort Devens, Massachusetts**

RE: Technical Report, Volume 7
Underground Storage Tank Closure
UST Nos. 0032 - 0034
Fort Devens, Massachusetts
ATEC File: 37.07.91.00451

This Post-Removal Report details the results of the closure of one 1,000-gallon, single wall, steel, Underground Storage Tank (UST) referenced as UST No. 0032, located at property known as Building 2432, Fort Devens, Massachusetts (the site). The purpose of the closure was to excavate the UST and evaluate the potential for the presence of oil and hazardous material at the site. The closure of this UST was conducted on January 14, 1992.

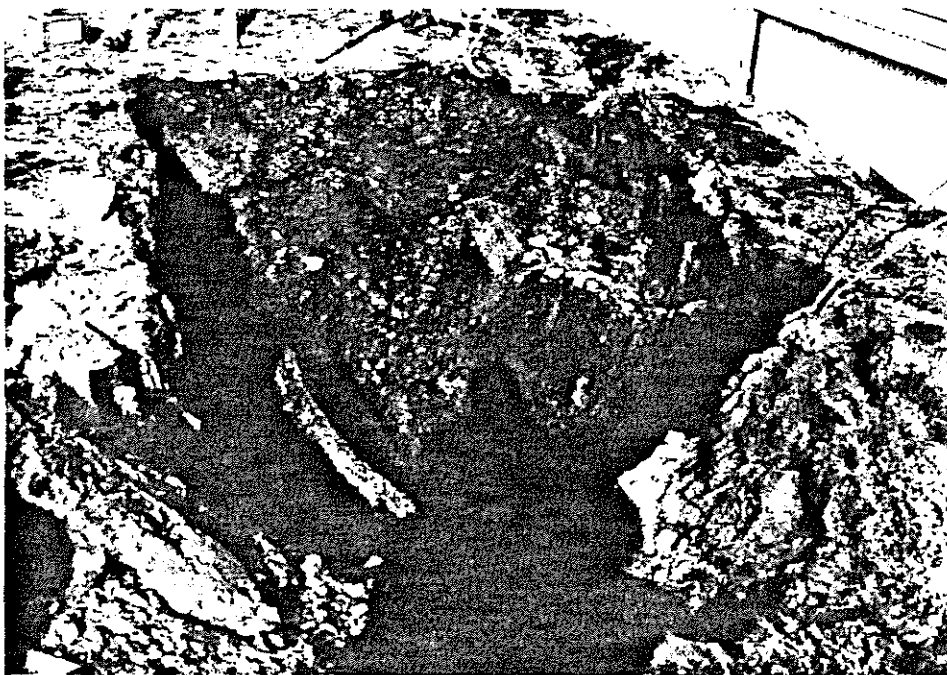
A-4

A-4: Excavation as viewed from south, facing north.
