Final Debris Removal Activities Summary Report

**Area of Contamination 57, 74, and 50
Former Fort Devens, Massachusetts**

May 2022

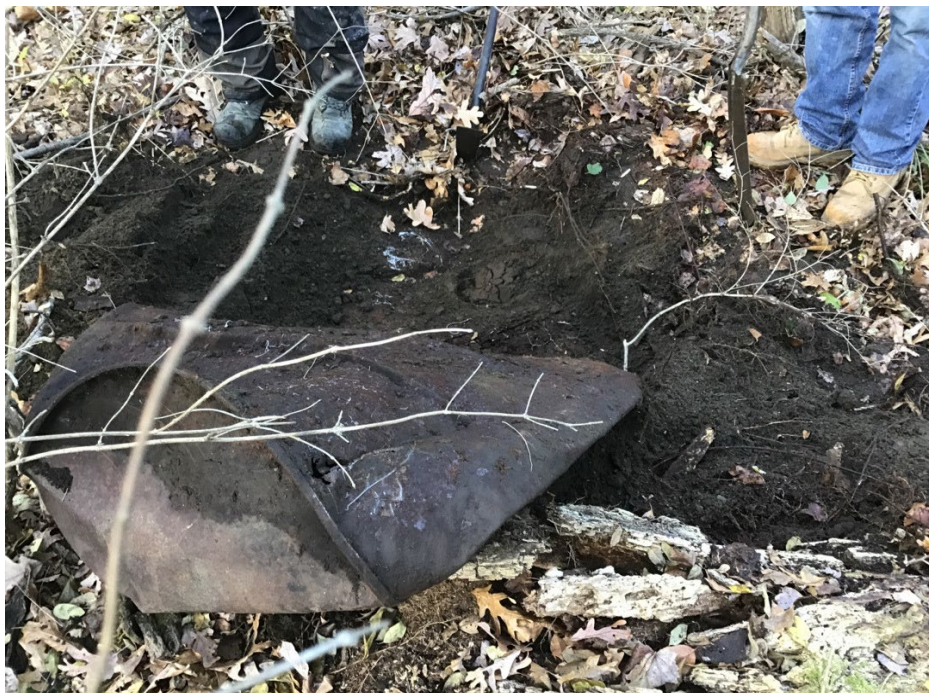
Photograph: 7

D-1: Drum after exposed. No observed soil staining.

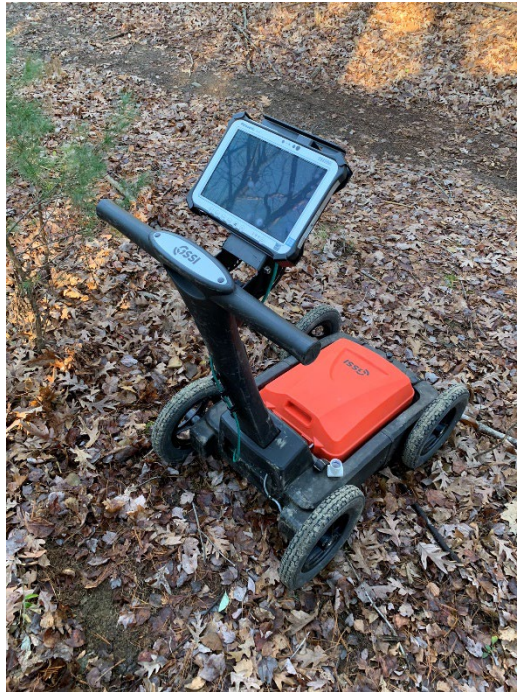
Photograph: 17

Description:
GSSI UtilityScan DF
GPR.

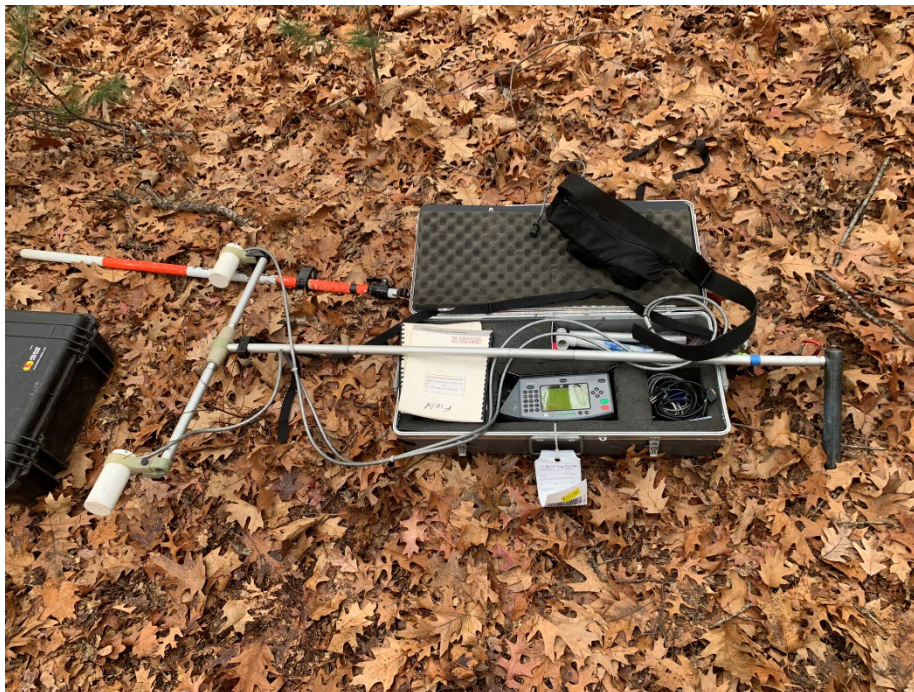
Photograph: 18

Description:
Geometrics G858-G
magnetometer.

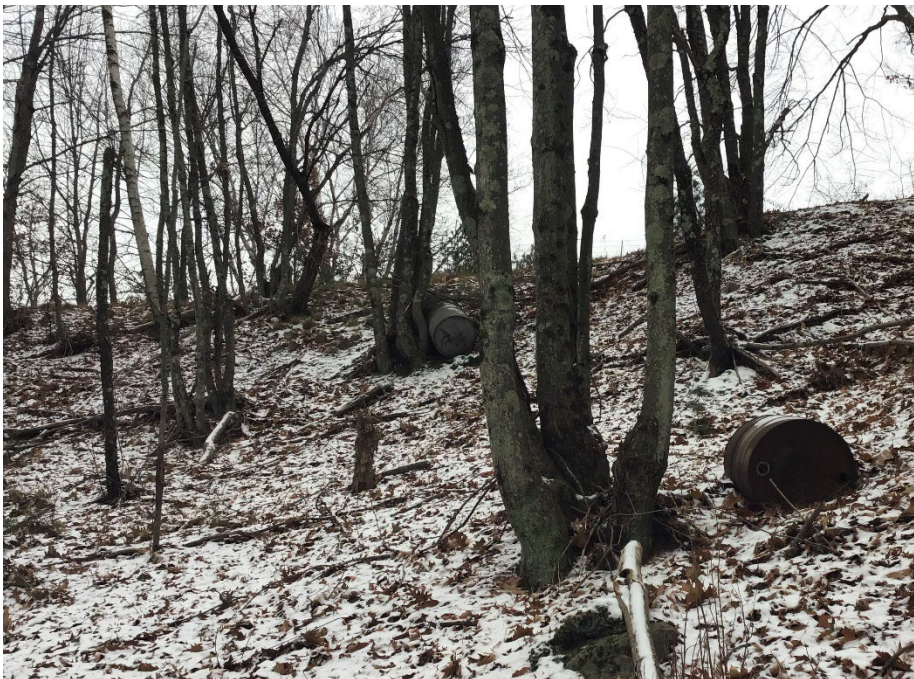
Photograph: 26

Debris Area C: Steel drums observed on slope.

During the geophysical survey, surficial debris was observed south of the Debris Pile B area at AOC 50. The debris consisted of 55-gallon drums, containers, building debris, and automotive parts. The location was identified as Debris Pile C. The debris pile location was marked in the field and is depicted on **Figure 4**. Surficial debris from this area was not removed during this mobilization. The USEPA and Massachusetts Department of Environmental Protection (MassDEP) were notified of the discovery of additional debris by email on December 14, 2021.
