Site Inspection Report for Fort Devens, Ayer, MA

DERP FUDS Project No. **D01MA058701**

December 2011

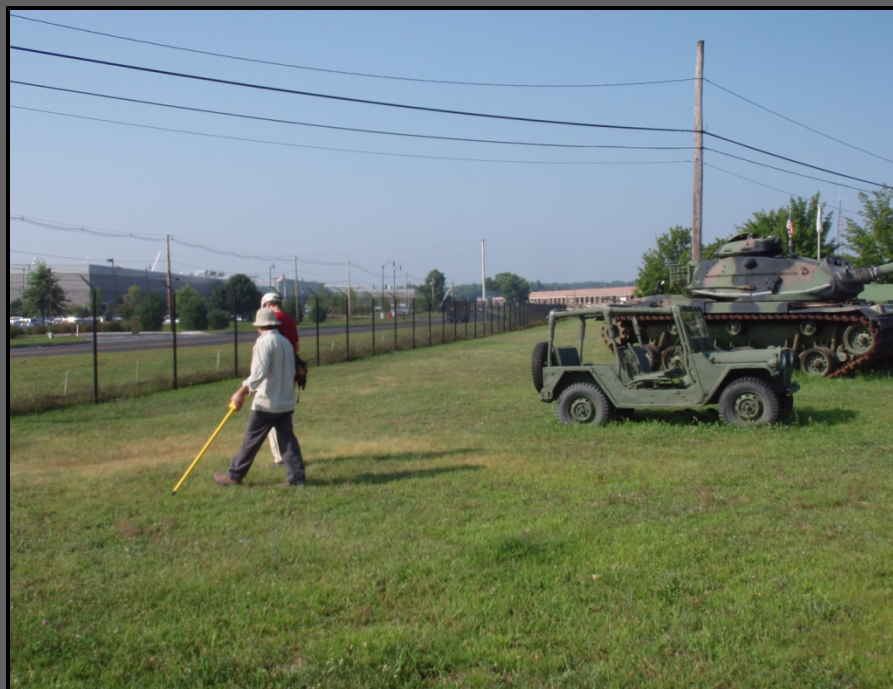
Photograph No.: E.1 Date: 08/18/09 Time: 09:27 AM

Comments: Conducting QR within MRS 1 –
Massachusetts National Guard property.

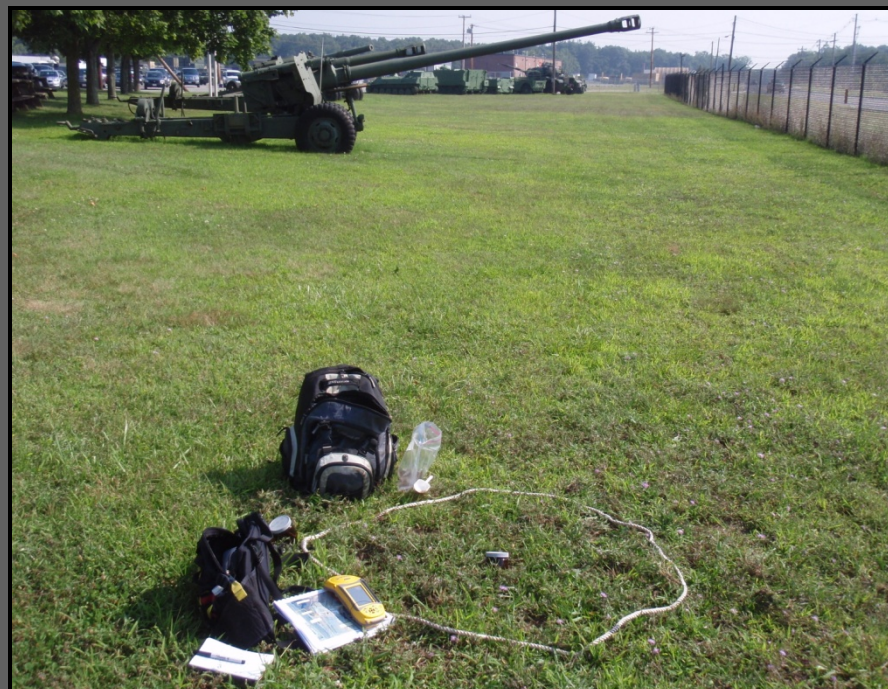
Photograph No.: E.2 Date: 08/18/09 Time: 09:40 AM

Comments: Sample DEV-MR1-SS-01-03. Taken
within MRS 1, Mass National Guard
property.

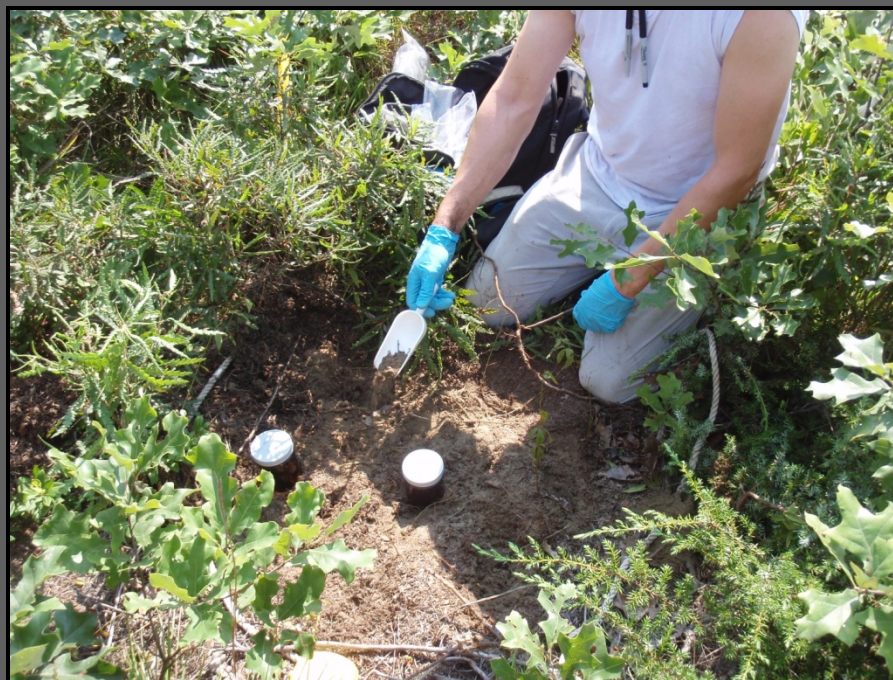
Photograph No.: E.3 Date: 08/18/09 Time: 10:33 AM

Comments: Collecting surface soil sample DEV-MR1-SS-01-01, northwestern MRS 1.

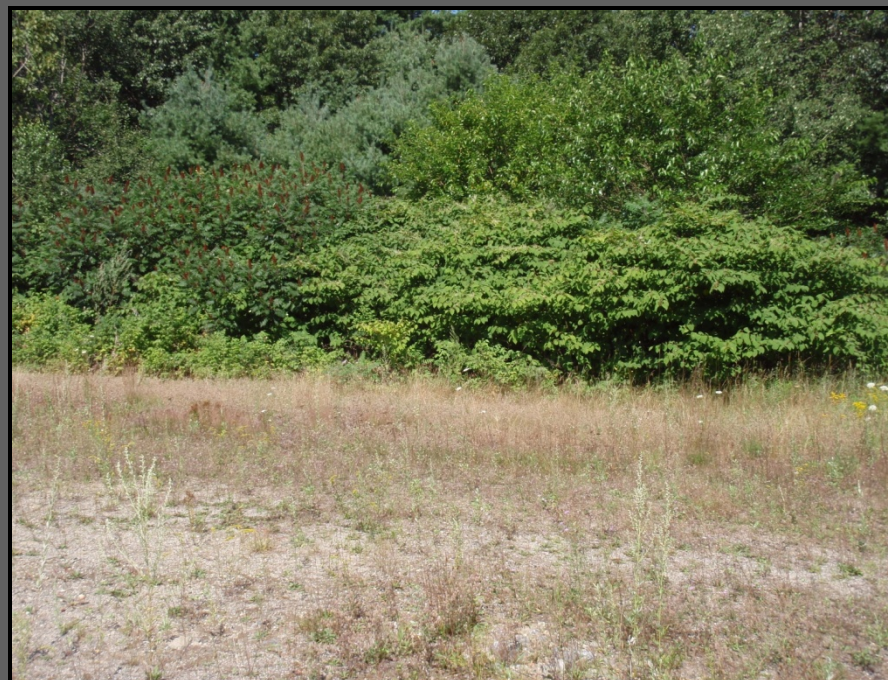
Photograph No.: E.4 Date: 08/19/09 Time: 10:45 AM

Comments: The area of the firing point, MRS 2 – 1000” Rifle and Machine Gun Range

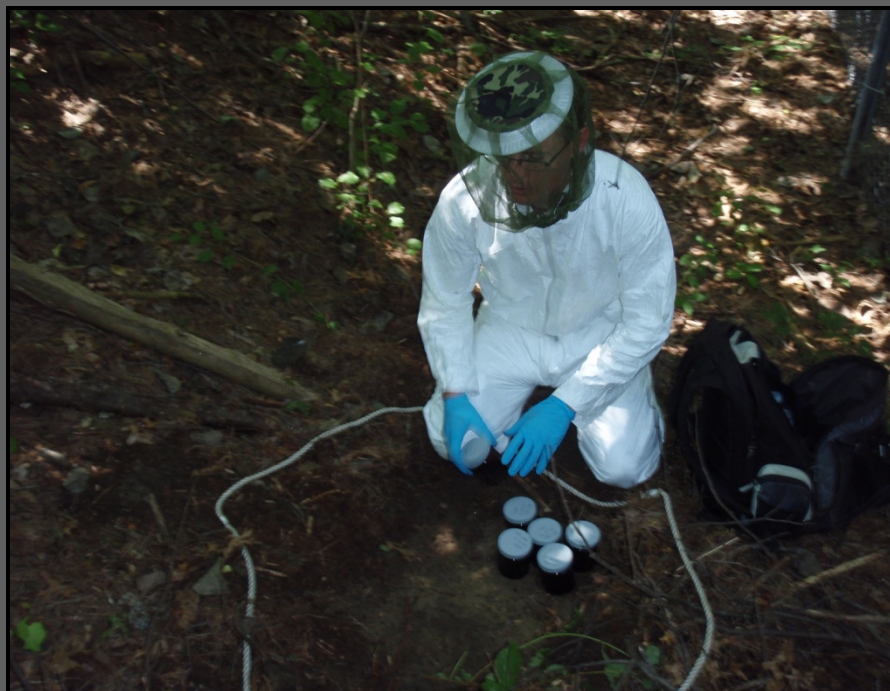
Photograph No.: E.5 Date: 08/19/09 Time: 11:20 AM

Comments: Collection of surface soil sample DEV-MR2-SS-01-05 at the firing point of the 1000" Rifle and Machine Gun Range.

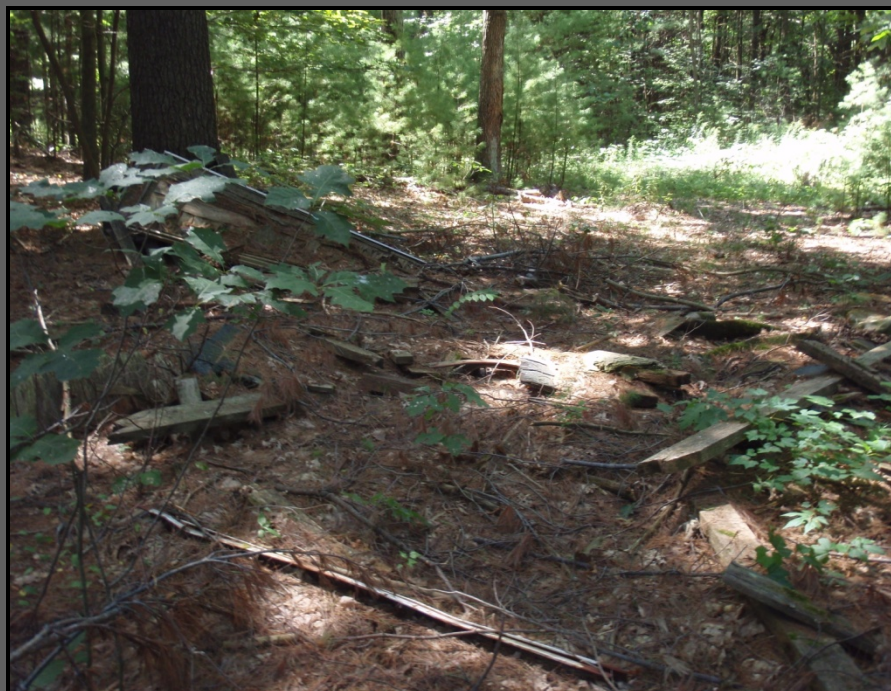
Photograph No.: E.6 Date: 08/19/09 Time: 12:15 PM

Comments: Wood remnants located in the MRS 2 – Training Area.

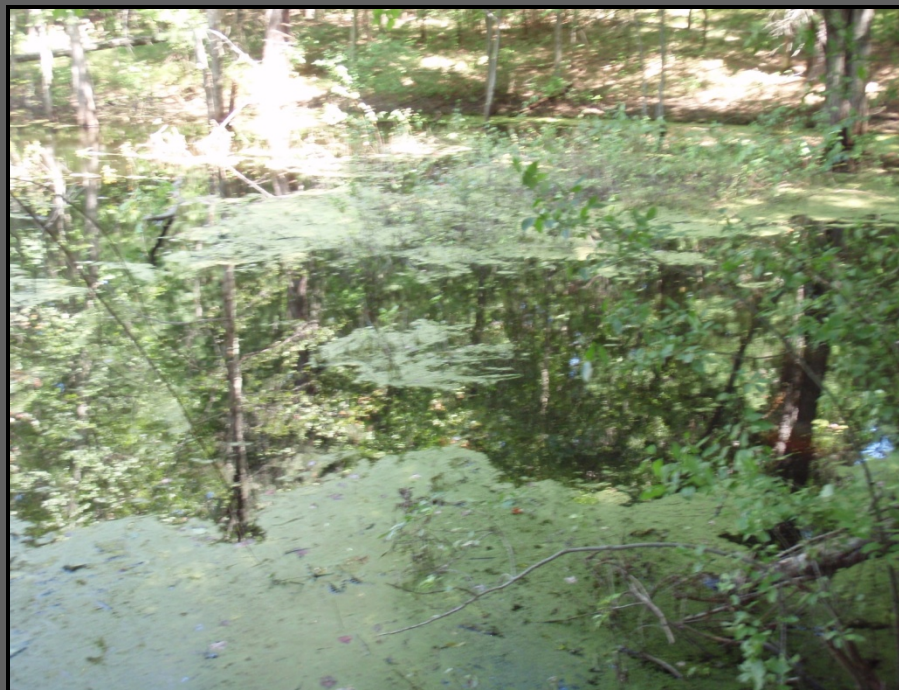
Photograph No.: E.7 Date: 09/19/09 Time: 12:30 PM

Site:	Fort Devens		
Photographer:	T. Belanger		
Location of Photograph:	MRS 2		
GPS Coordinates:	N <u>4715679.73</u>	E <u>286289.08</u>	
(UTM Zone 19N)			
Direction of Photo:	East		
Comments:	Pond located in the training area, MRS 2.

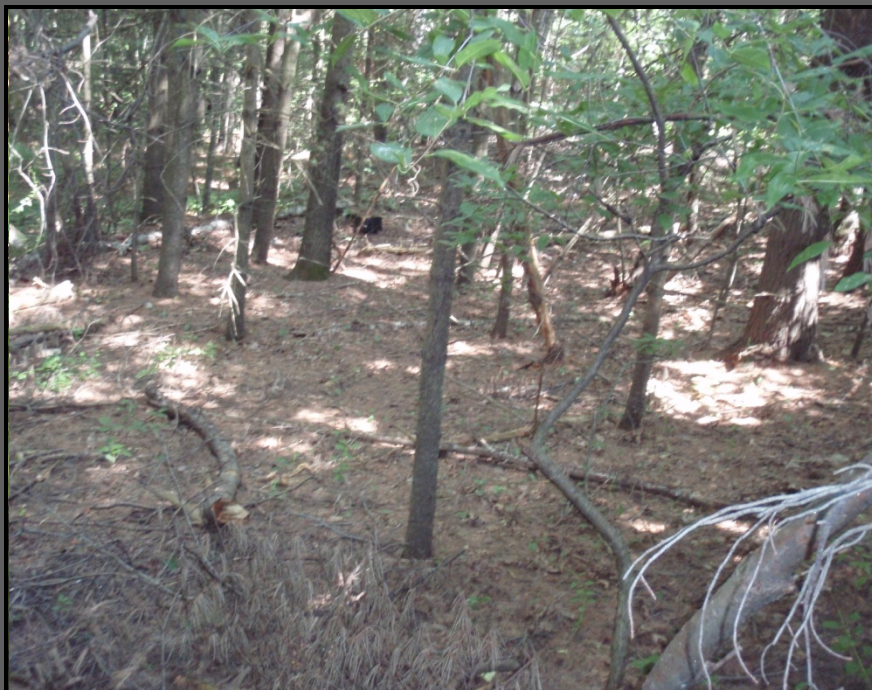
Photograph No.: E.8 Date: 09/19/09 Time: 1:05 PM

Site:	Fort Devens		
Photographer:	T. Belanger		
Location of Photograph:	MRS 2		
GPS Coordinates:	N <u>4715604.55</u>	E <u>286178.57</u>	
(UTM Zone 19N)			
Direction of Photo:	South		
Comments:	Former training area, MRS 2.

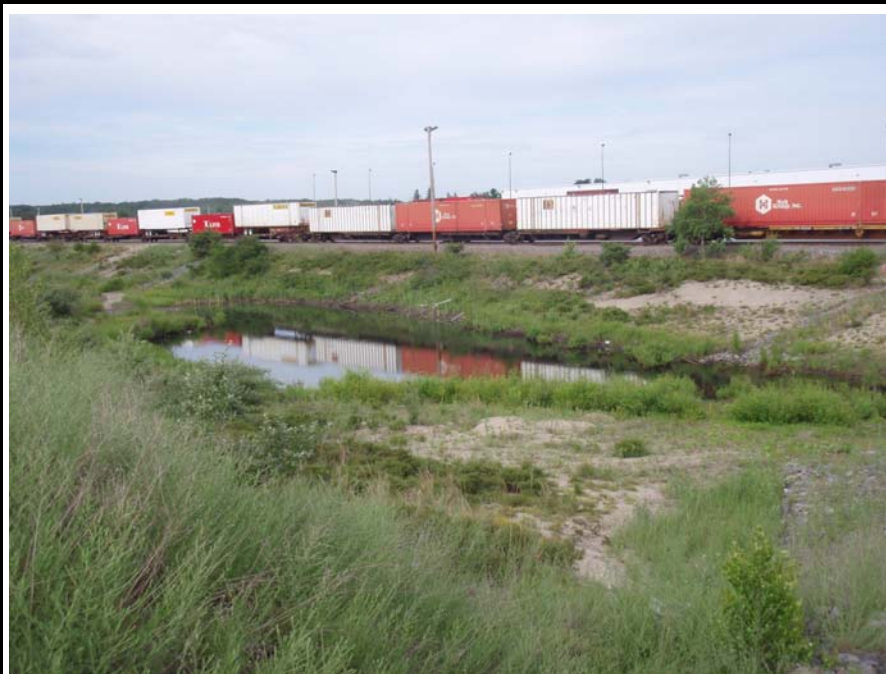
Photograph No.: E.9 Date: 06/22/2010 Time: 10:35 AM

Site: Fort Devens
Photographer: T. Belanger
Location of Photograph: PanAm property at MRS 1
GPS Coordinates: N 4715567.75 E 286291.12
(UTM Zone 19N)
Direction of Photo: West
Comments: PanAm Railroad property and small pond, MRS 1.

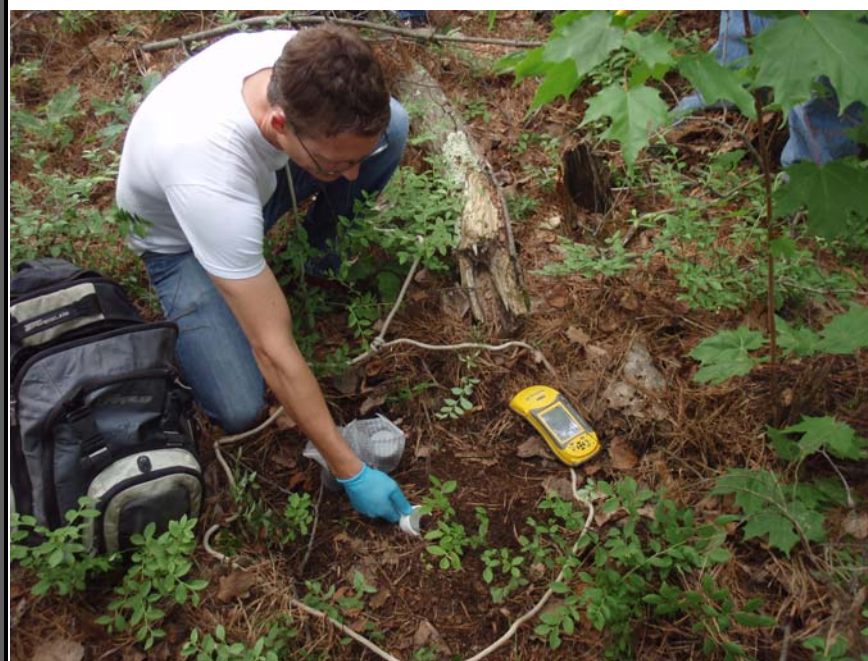
Photograph No.: E.10 Date: 06/22/2010 Time: 12:05 PM

Site: Fort Devens
Photographer: T. Belanger
Location of Photograph: PanAm property at MRS 1
GPS Coordinates: N 4715512.06 E 2862722.43
(UTM Zone 19N)
Direction of Photo: North
Comments: Collection of surface soil sample DEV-PA-SS-01-04, MRS 1.
