Muddy River Flood Damage Reduction Project  
Phase 2 Construction Activities Next 90 Days  
December 2023

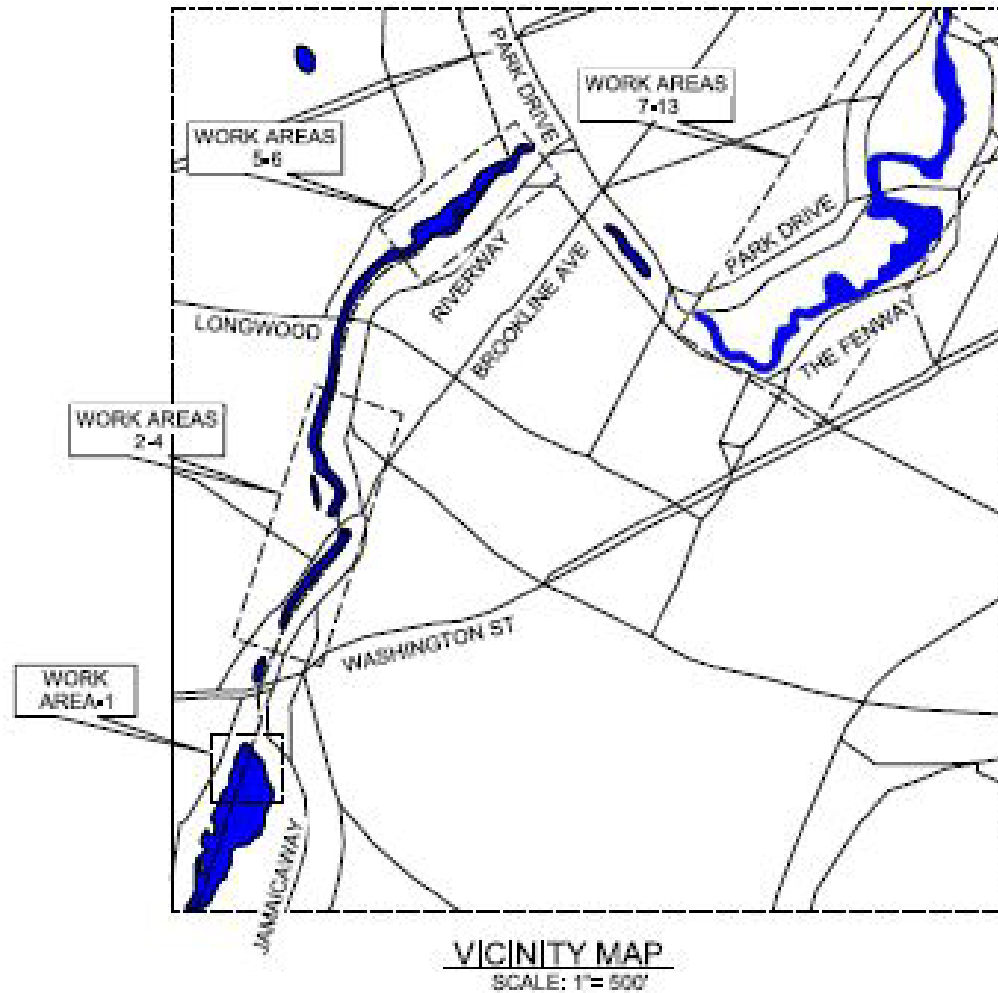
**EXTENTS OF PROJECT WORK AREA FOR PHASE 2 CONSTRUCTION**

- Dredging of the Muddy River is divided into 12 work areas as shown in the Vicinity Map, with 6 work areas upstream of the Riverway and 6 work areas downstream of Ave. Louis Pasteur.

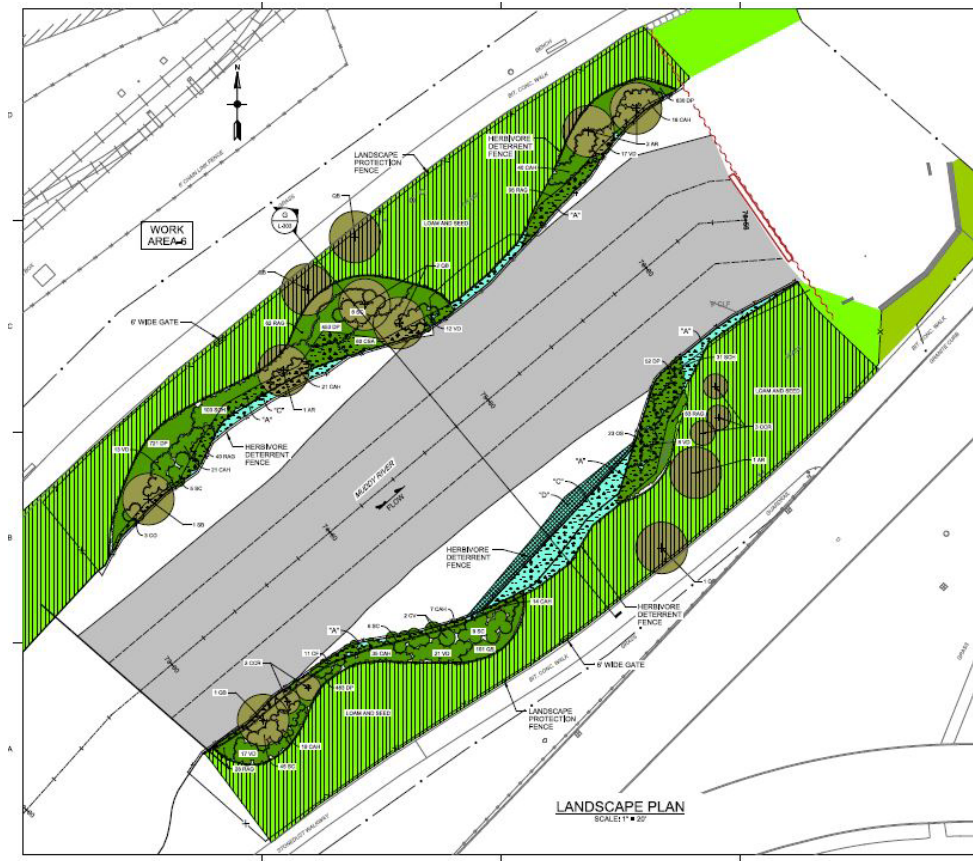
**REPRESENTATIVE FIGURE OF FLOOD CONTROL CHANNEL AND PROPOSED IMPROVEMENTS**

General: The Muddy River Flood Damage Reduction Phase 2 Construction Project is located in the footprint generally between Leverett Pond to Boylston Street in Boston and Brookline. The major project components involve dredging 1 to 8' of sediment for flow conveyance in the Back Bay Fens and the Riverway sections of the Muddy River. It also includes excavation of the sandbar and island at Leverett Pond. Work also includes the removal of *phragmites* from the wetland and riparian areas which affect flow conveyance. After removal of river sediments and *phragmites*, preservation and restoration of the historic park shoreline in construction areas will consist of planting emergent wetland plants and restoring riparian vegetation in upland areas by planting trees and shrubs. This Notice is intended to identify the general construction activities that will be performed in the next 90 days. A figure that shows a typical flood control channel and the proposed improvements is at the end of this report.
