Muddy River Flood Damage Reduction Project  
Phase 2 Construction Activities Next 90 Days  
April 2021

## EXTENTS OF PROJECT WORK AREA FOR PHASE 2 CONSTRUCTION

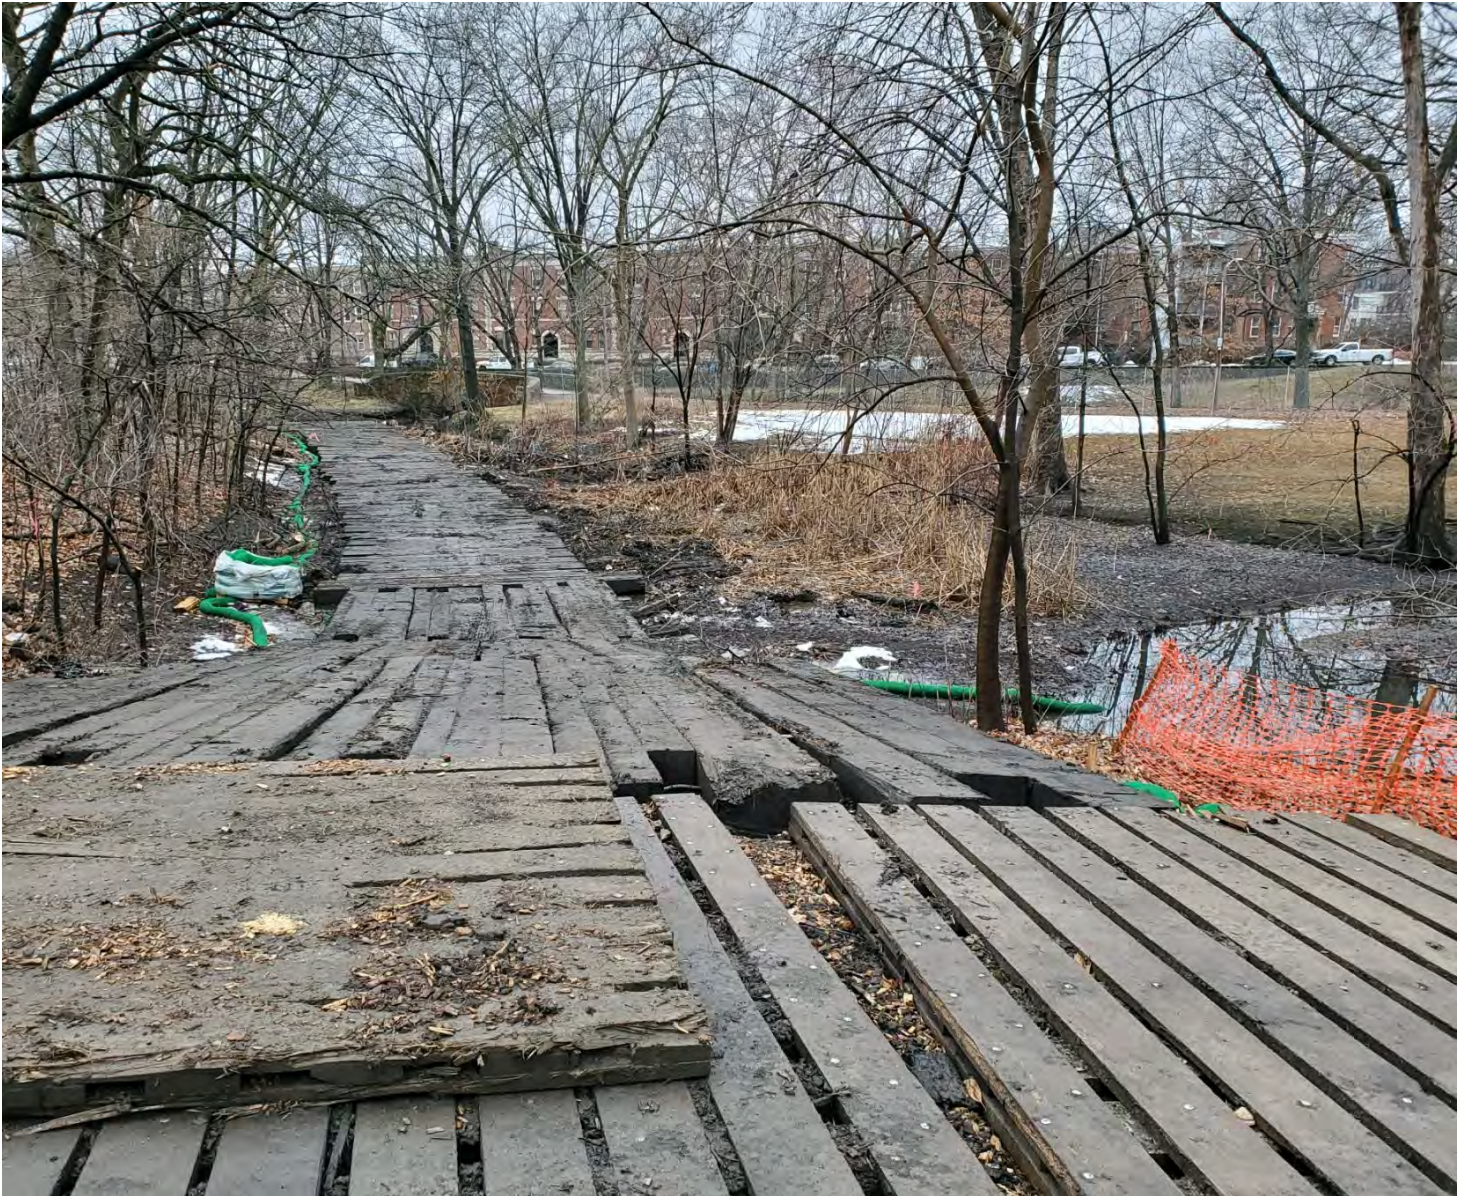
Work Area #3 – section of river at Brookline Avenue, Riverway, and Netherlands Road (near Beth Israel Deaconess Hospital) – looking upstream. Temporary timber matting road for equipment access – installed before dredging activities started.

- **Work Area #3** – section of river at Brookline Avenue, Riverway, and Netherlands Road – near Beth Israel Deaconess Hospital – the contractor completed dredging this section late-March. Surveying will be done shortly to confirm new flood risk management cross sections. Since that time, materials and equipment in this area have been relocated to Work Area #4 for dredging and in preparation for planting and restoration, which will begin following the plantings of Work Area #2. Maintenance of the planting will begin immediately during the two-year plant guarantee period.

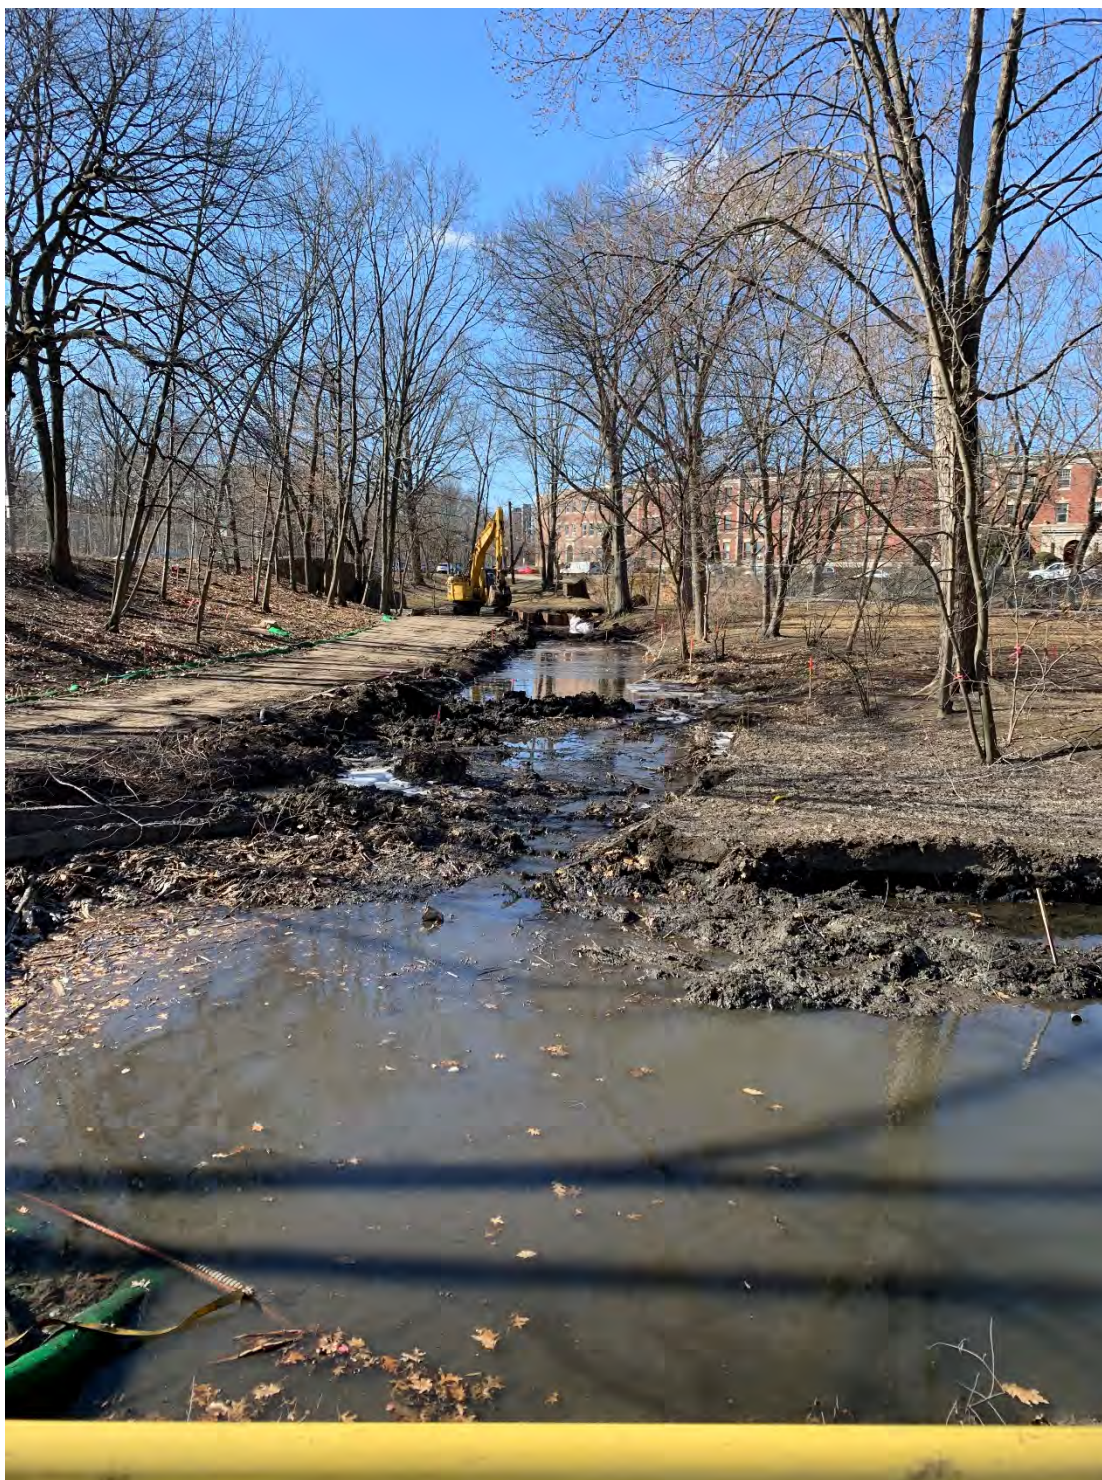
Work Area #3 – section of river at Brookline Avenue, Riverway, and Netherlands Road (near Beth Israel Deaconess Hospital) – looking upstream – photo during dredging for the flood risk management channel.

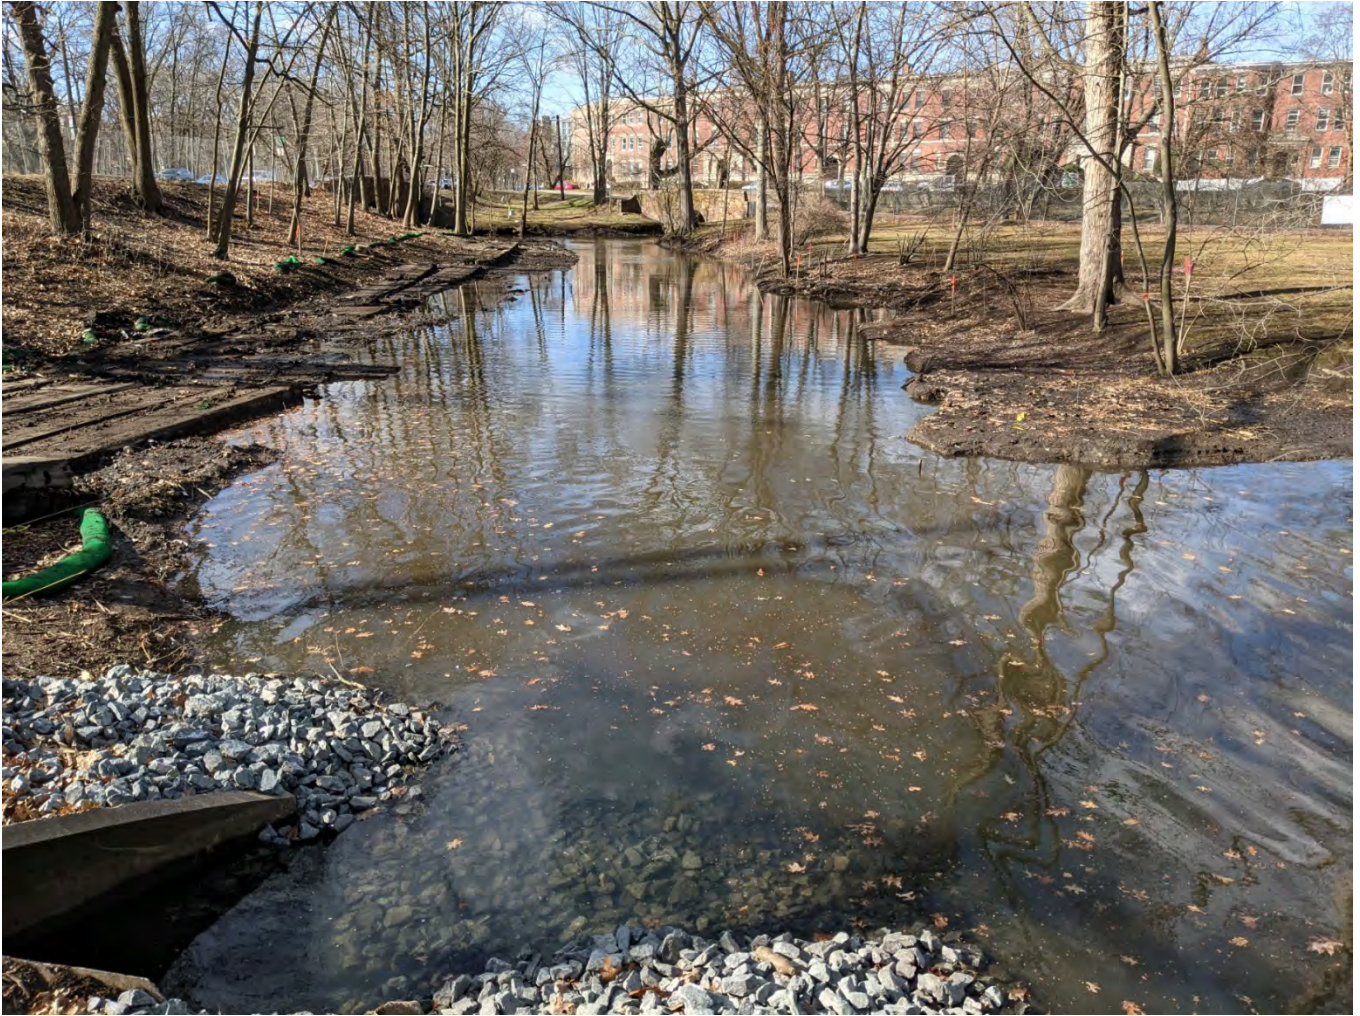
Work Area #3 – section of river at Brookline Avenue, Riverway, and Netherlands Road (near Beth Israel Deaconess Hospital) – looking upstream – dredging completed.

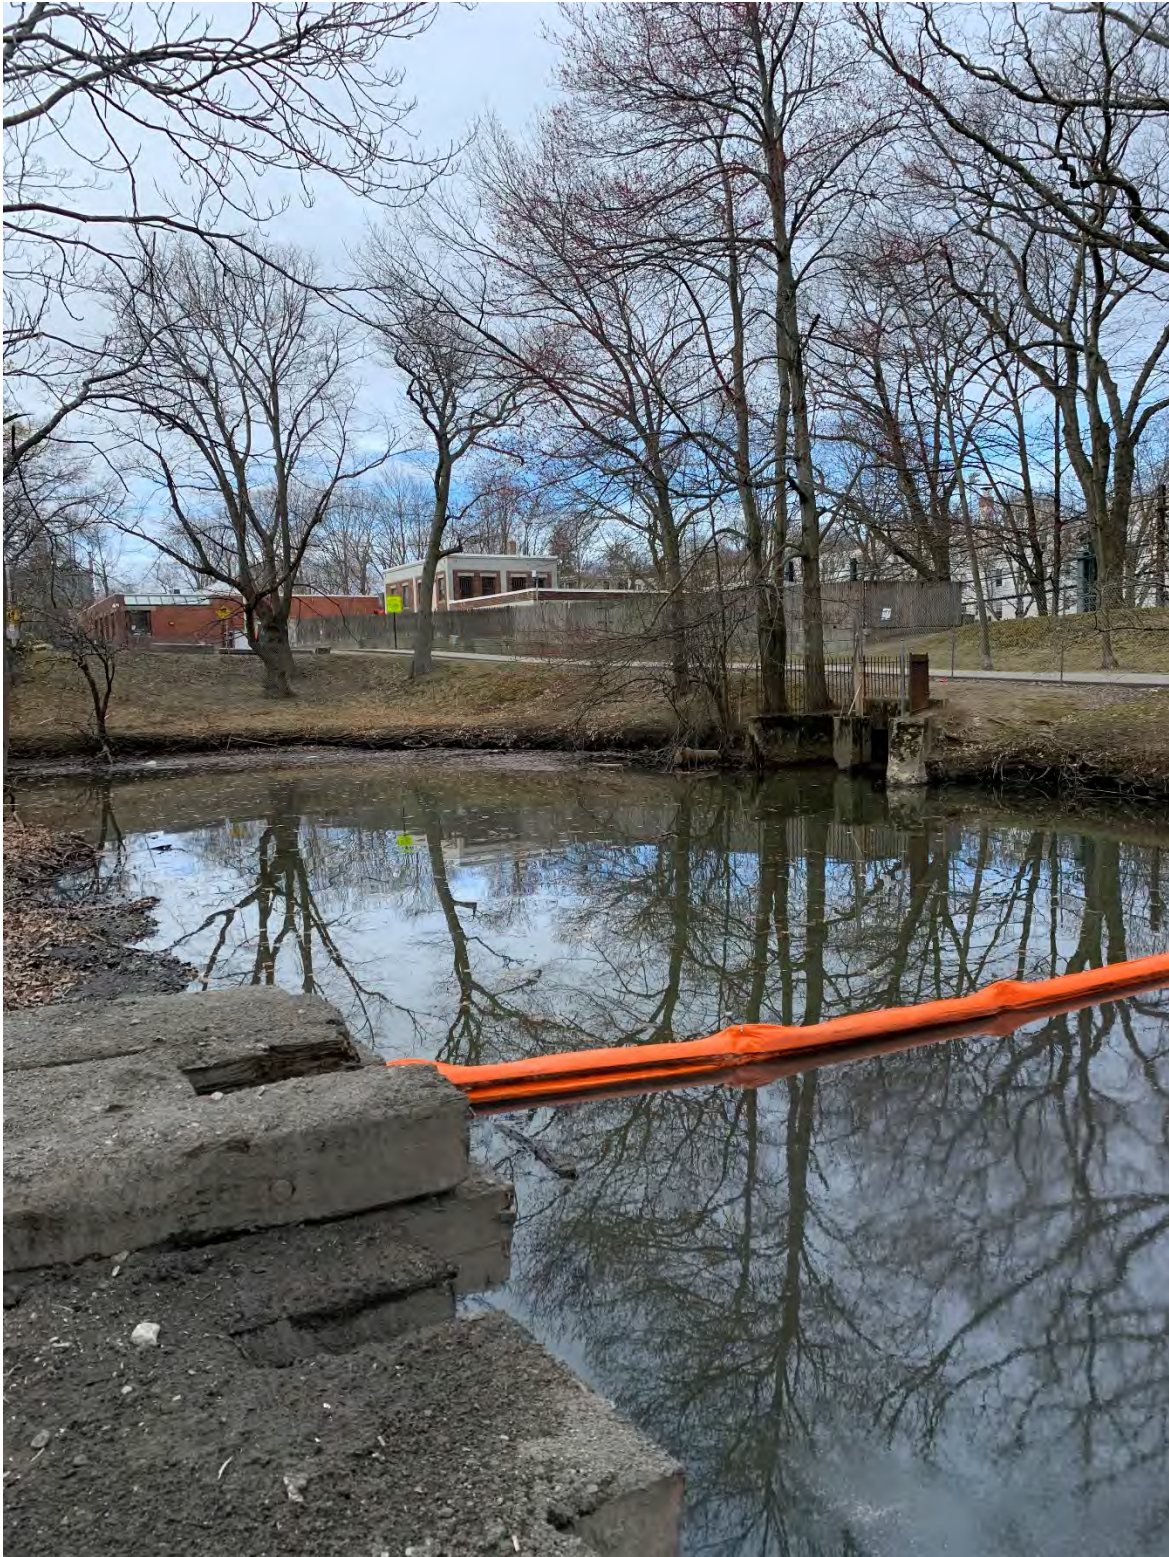
Work Area #4 - section of river immediately downstream of Work Area #3, across Netherlands Road – looking upstream.  
Flood risk management channel dredged in front of the culvert headwall.

- **Work Area #4** – section of river immediately downstream of Work Area #3, across Netherlands Road – the contractor completed dredging this section last week. Surveying will be done shortly to confirm new flood risk management cross sections. Starting after Patriots Day, materials and equipment in this area will be relocated to Work Area #1 for dredging and in preparation for planting and restoration, which will begin following the plantings of Work Area #3. Maintenance of the planting will begin immediately during the two-year plant guarantee period.

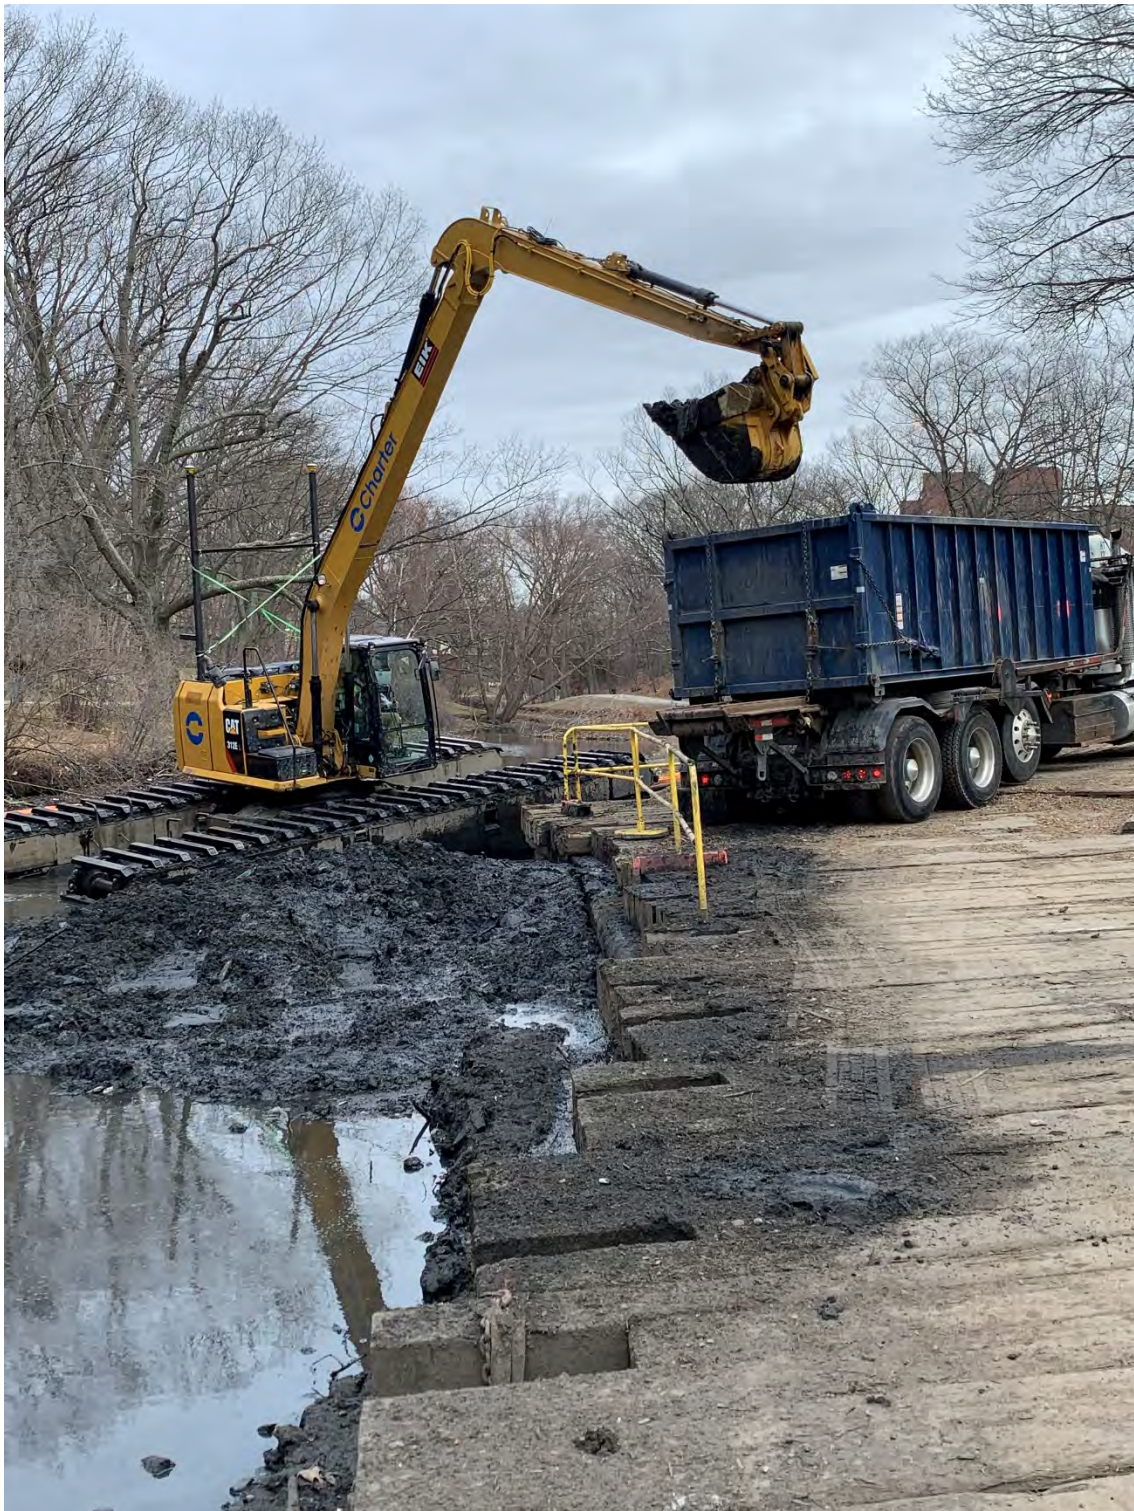
Work Area #4 - section of river immediately downstream of Work Area #3, across Netherlands Road – looking downstream. Amphibious excavator dredging the sediment and loading into truck for disposal.

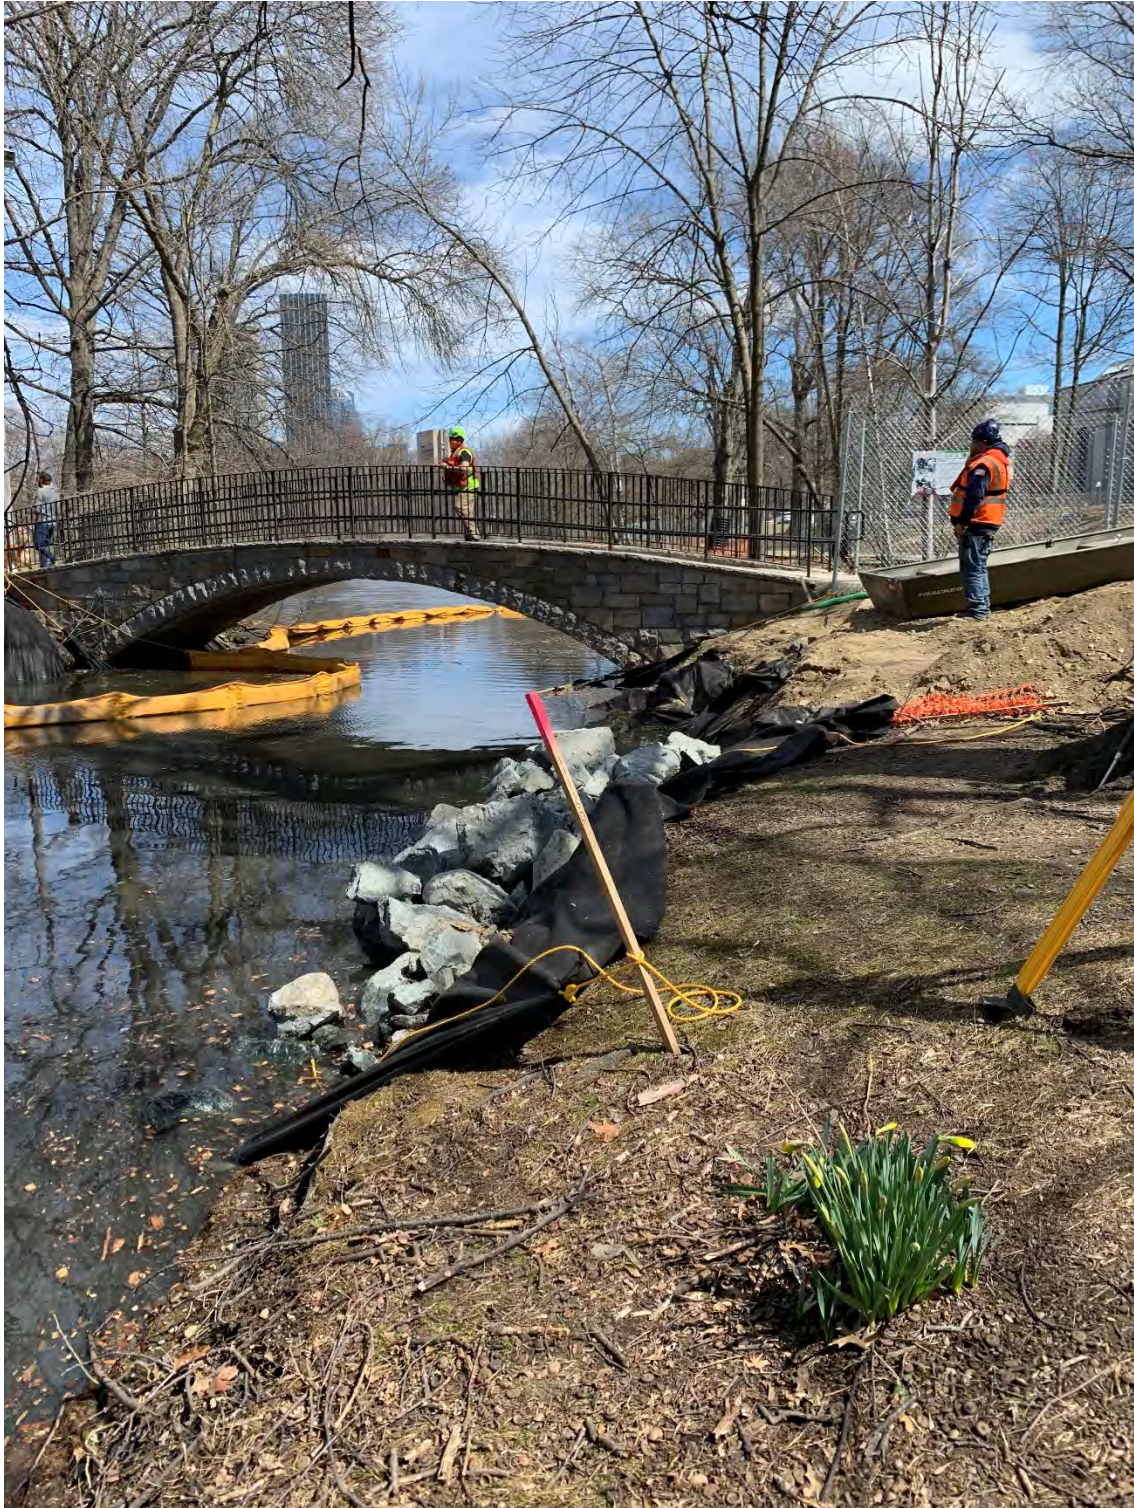
Work Area #9 – footbridge by the Museum of Fine Arts and Clemente Field – looking downstream. Dredging is complete at the footbridge and contractor is armoring the bridge abutment with stone protection.

- **Work Area #9** – section of river immediately downstream of Work Area #8 – the contractor began dredging this section early March and will be complete by the end of next week. Planting and restoration of Work Area #9 will begin following the plantings of Work Area #8. Maintenance of the planting will begin immediately during the two-year plant guarantee period.

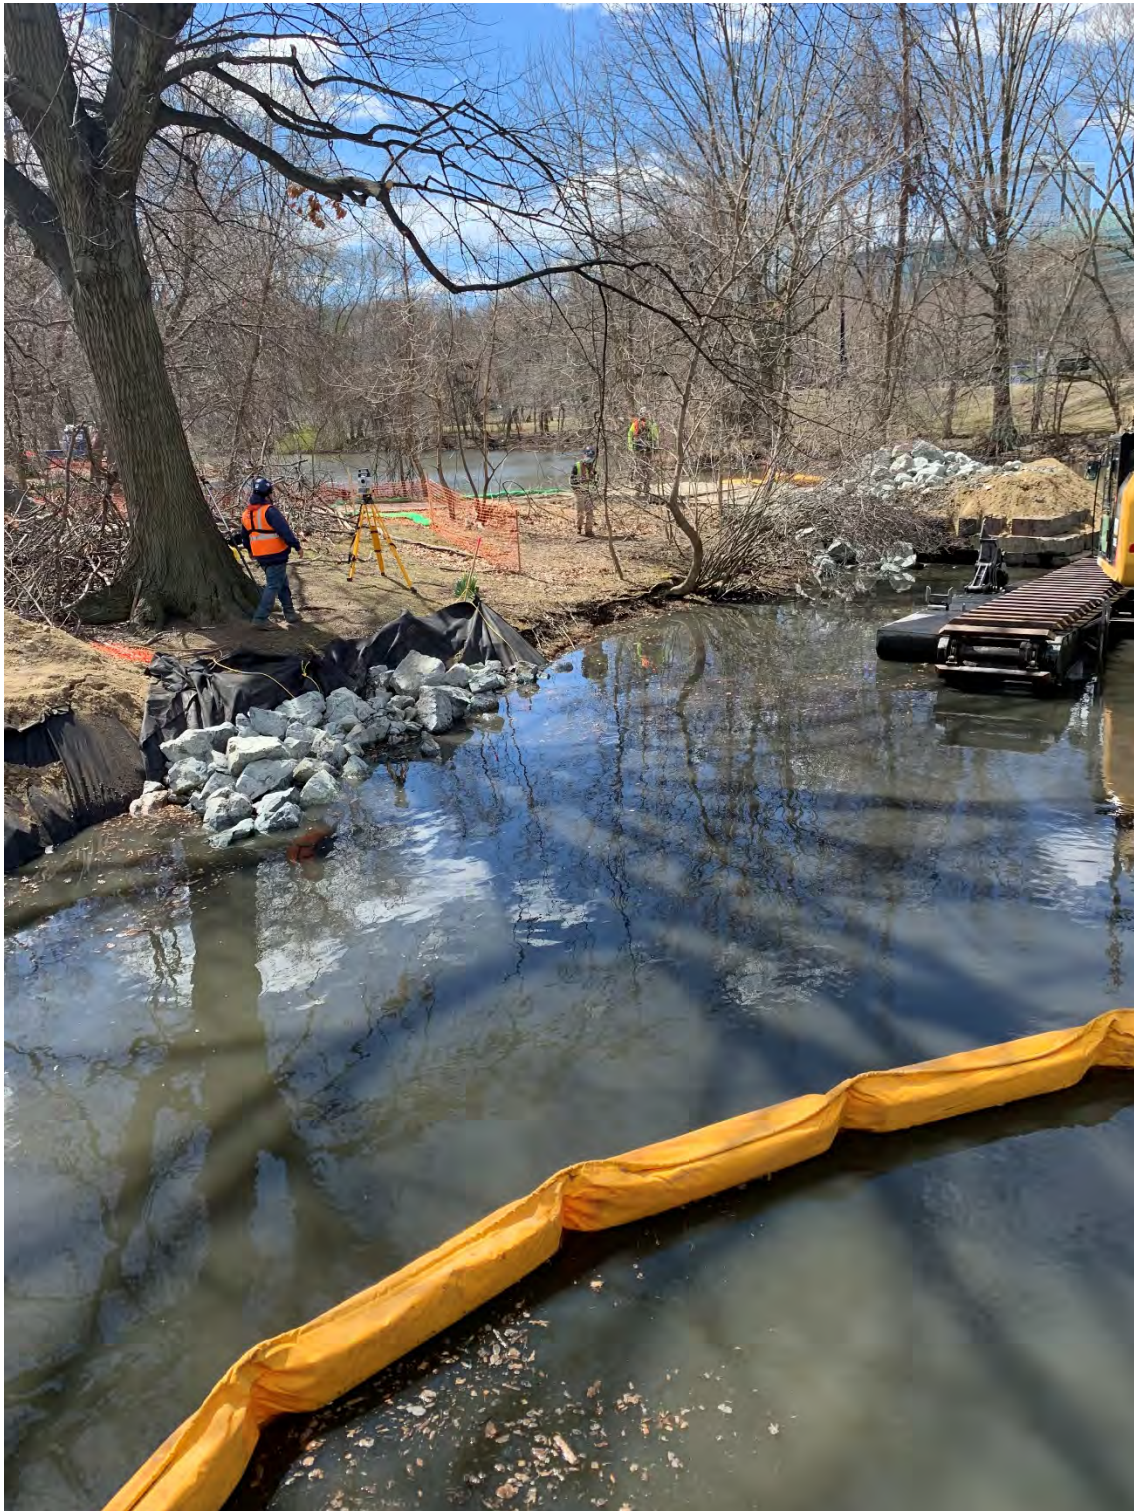
Work Area #9 – view from the footbridge by the Museum of Fine Arts and Clemente Field – looking upstream. Stone protection being installed on the bank for 40' upstream of the bridge abutment.

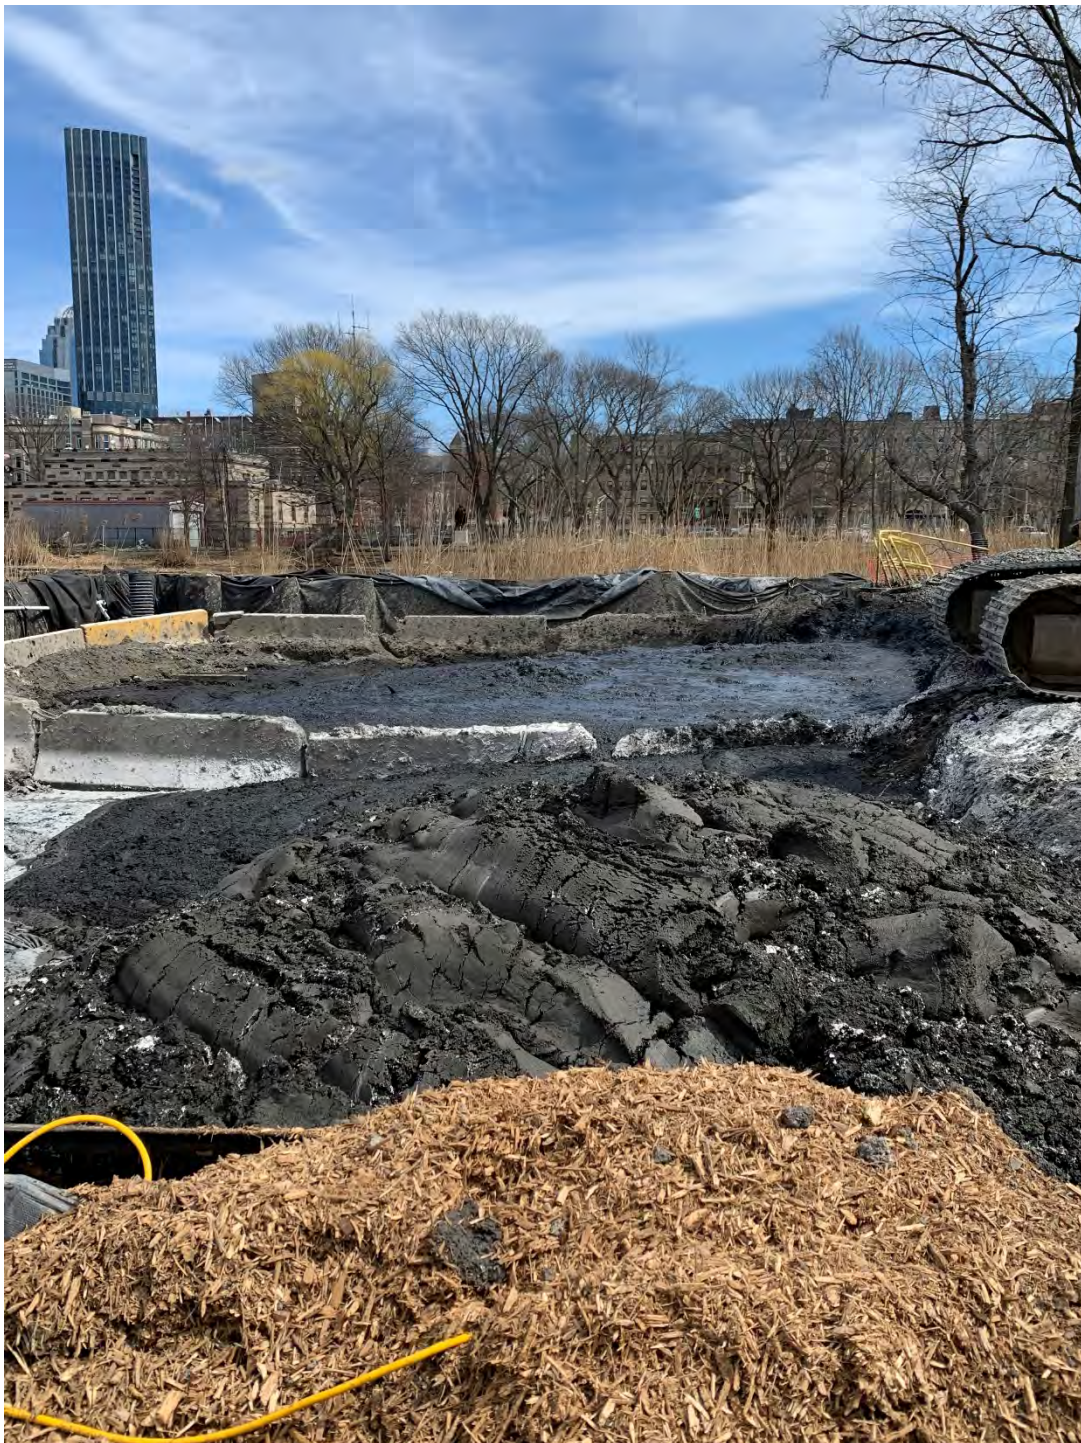
Sediment storage bin at Work Area #11 – sediment processing area – wettest material in the furthest bin and processed/drier material in the closer bin. Fibrous mulch and calciment used for sediment stabilization.

- **Work Areas #11 and #12** – Victory Gardens Area – Temporary construction fence installation at the Victory Gardens began mid-January to allow for the construction of processing bins of the Central Processing Facility on the left bank of Work Area #11, to supplement the already constructed bins on the right bank near the Duck House. This was required due to the increase of daily dredged material production, necessitating additional bins to store the dredged sediment while it is dewatered and stabilized before the processed sediment is loaded and transported to the final disposal facility. These work areas will continue to see periodic activity as dredged material storage is required. However, dredging in the section of the river in these areas will likely begin much later this year or early in 2022.
