Muddy River Flood Damage Reduction Project  
Phase 2 Construction Activities Next 90 Days  
June 2022

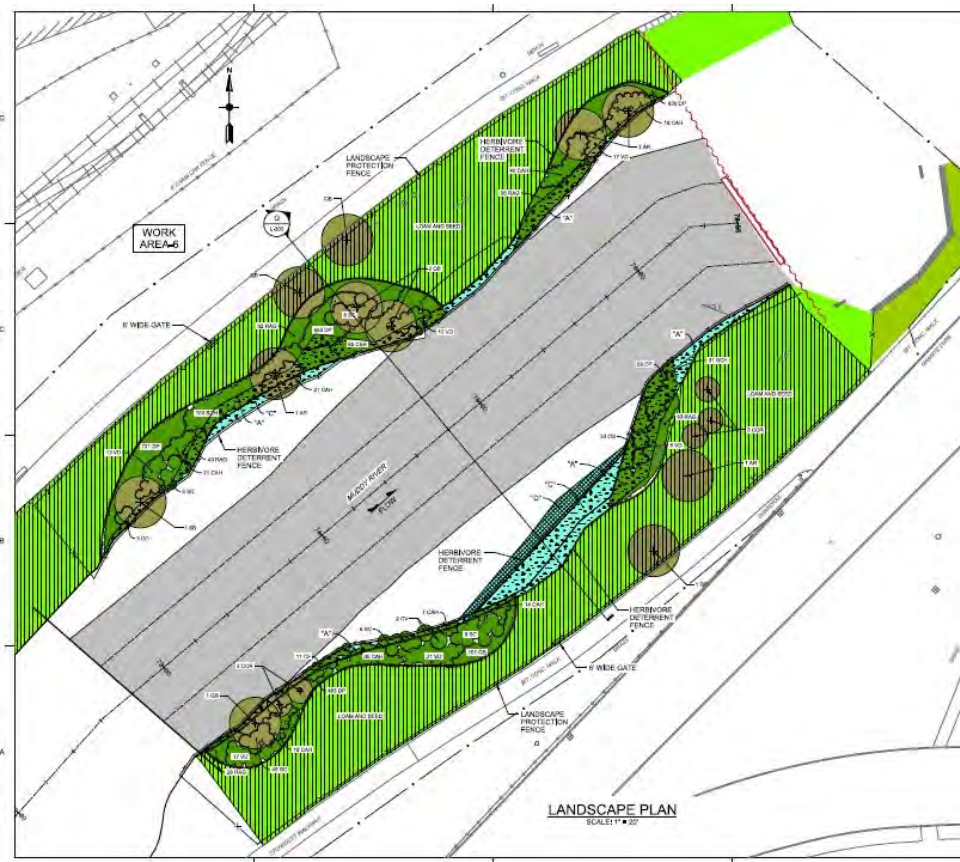
**REPRESENTATIVE FIGURE OF FLOOD CONTROL CHANNEL AND PROPOSED IMPROVEMENTS**

General: The Muddy River Flood Damage Reduction Phase 2 Construction Project is located in the footprint generally between Leverett Pond to Boylston Street in Boston and Brookline. The major project components involve dredging 1 to 8' of sediment for flow conveyance in the Back Bay Fens and the Riverway sections of the Muddy River. It also includes excavation of the sandbar and island at Leverett Pond. Work also includes the removal of *phragmites* from the wetland and riparian areas which affect flow conveyance. After removal of river sediments and *phragmites*, preservation and restoration of the historic park shoreline in construction areas will consist of planting emergent wetland plants and restoring riparian vegetation in upland areas by planting trees and shrubs. This Notice is intended to identify the general construction activities that will be performed in the next 90 days. A figure that shows a typical flood control channel and the proposed improvements is at the end of this report.

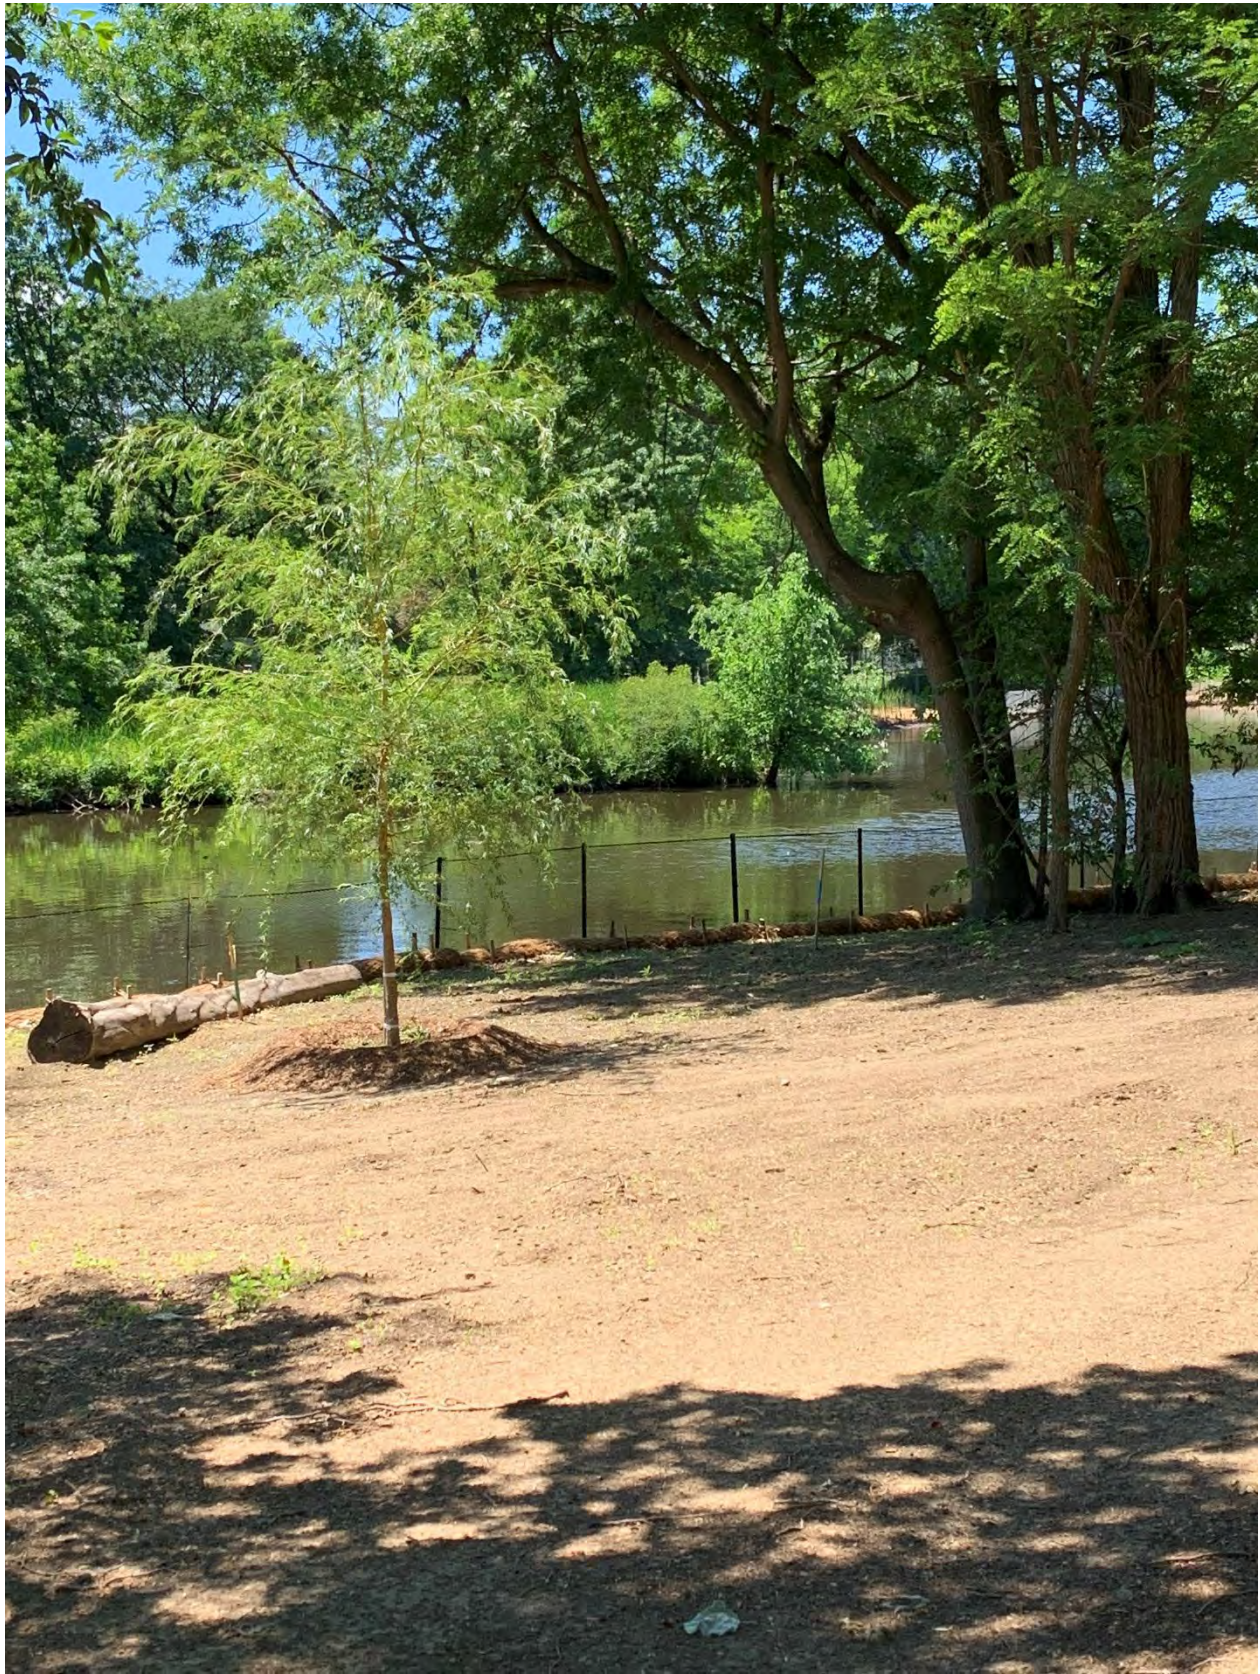
Work Area #10 – section of river immediately downstream of Work Area #9 which ends at Agassiz Road – herbivore fence, coir log, habitat log, and plantings installed as part of the restoration.

- **Work Area #10** – section of river immediately downstream of Work Area #9 which ends at Agassiz Road – the contractor completed dredging this section mid-December 2021. Surveying was done between July 2021 to January 2022 to confirm new flood risk management cross sections. The sediment processing bins were removed as part of the dredging efforts. Since that time, a review of the as-dredged conditions has taken place to confirm plant locations and topsoil quality to optimize planting success. Installation of herbivore fence, coir logs, and loam was completed mid-May. Trees and shrub beds were planted between early- into mid-May. Stonedust path restoration was completed mid-June. Maintenance of the planting will begin immediately during the two-year plant guarantee period.

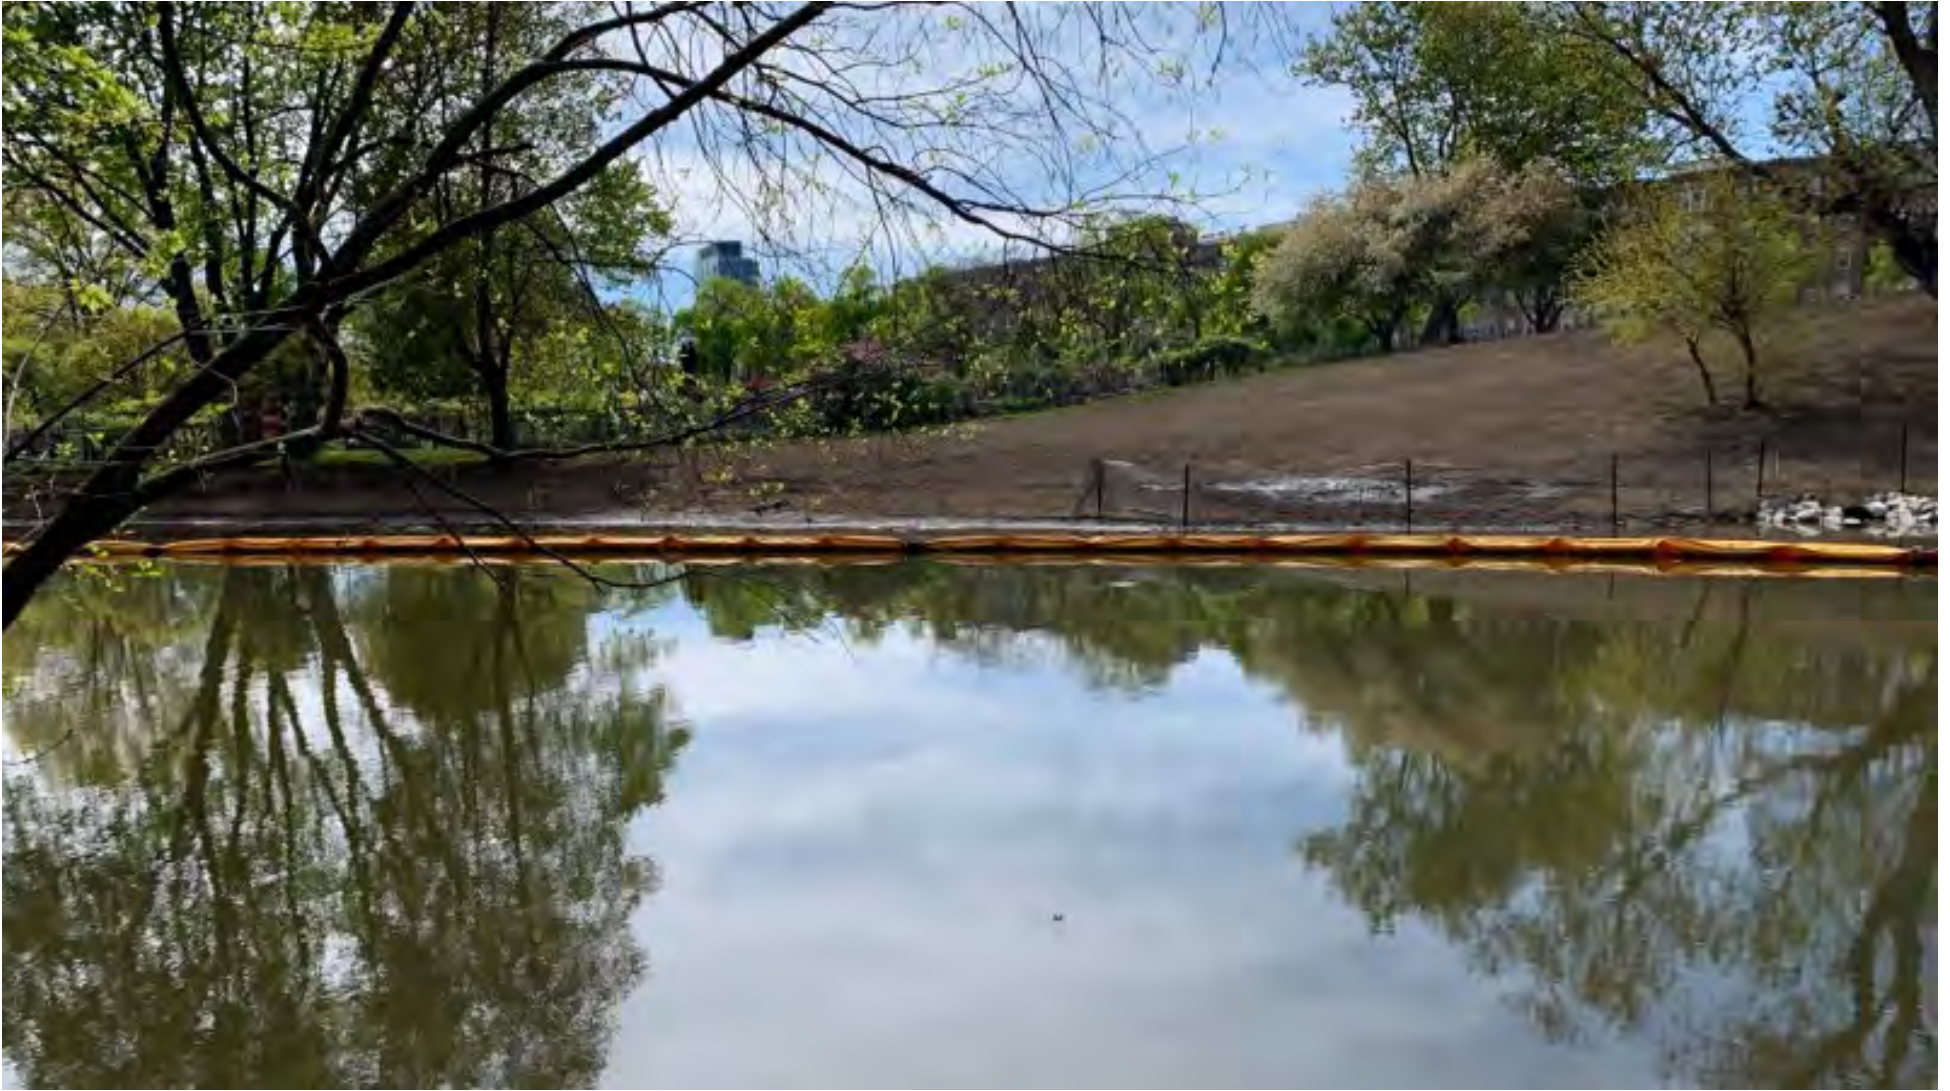
Work Area #12 – section of river upstream of Boylston Street Bridge. Area loamed and herbivore fence installed. Continue to prepare the area for plantings to be installed in the Fall 2022 window.

- **Work Areas #11 and #12** – Victory Gardens Area – dredging in the section of the river downstream of Agassiz Road Bridge began in late-December 2021 and was completed mid-May 2022. Installation of herbivore fence, coir logs, and preparation of wetland shelves began in mid-June and will continue into July. Planting and restoration of Work Areas #11 and #12 is expected to take place in the Fall 2022 to coincide with the planting window. Maintenance of the planting will begin immediately during the two-year plant guarantee period.

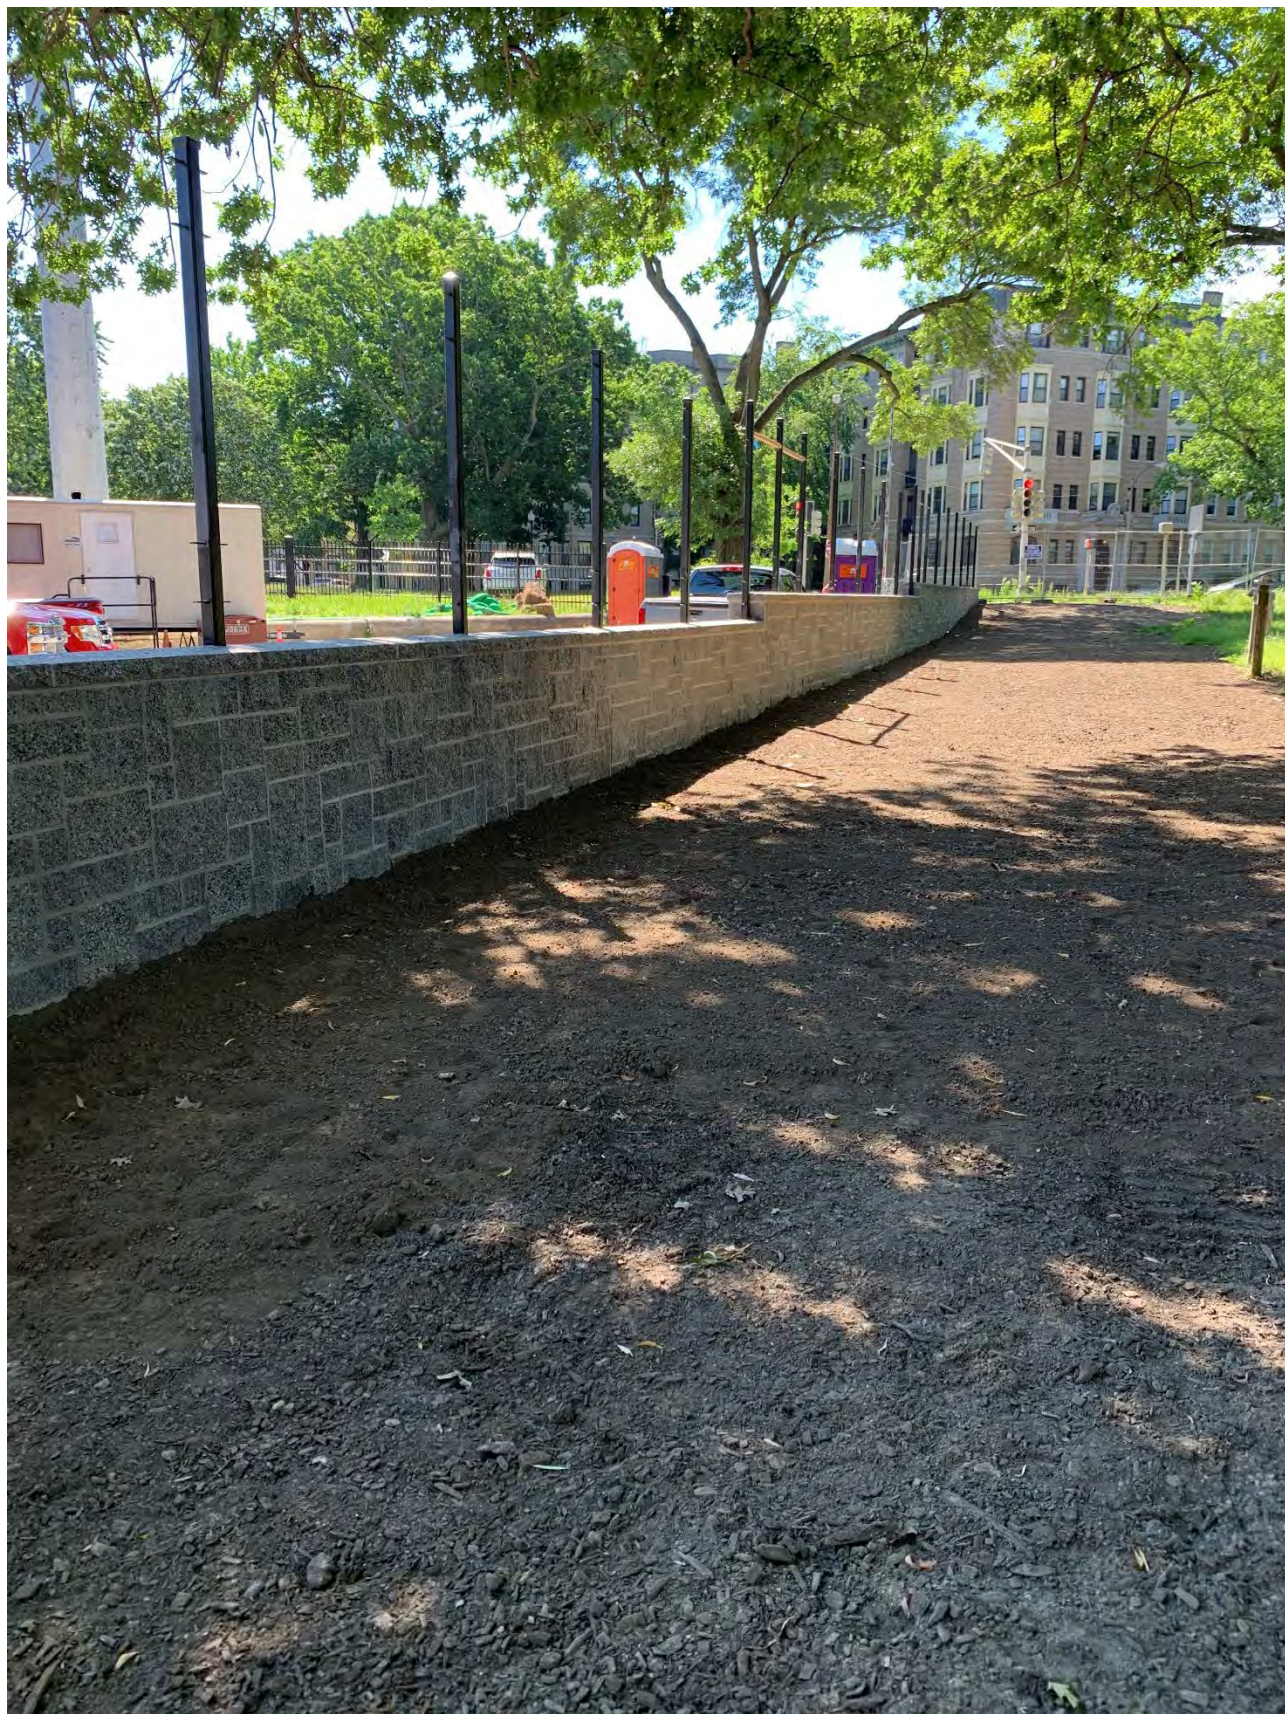
Work Area #13 – Boston Fire Department Building in the vicinity of the Fenway and Agassiz Road – granite veneer and capstone installed. Site backfilled at the south section of the constructed floodwall. Note the security fence post installed on top of the floodwall.

- **Work Area #13** – Boston Fire Department Building in the vicinity of the Fenway and Agassiz Road – the pumps were installed December in the new pump station, as well as the new electrical panels in the existing fire department building. Granite veneer installation resumed in early April and all granite has been installed for the façade as well as the capstone. The new security fence posts have also been installed. Security fencing and security lights will be installed on top of the floodwall once the backfill and parking lot reconstruction is complete – expect to be mid- to late-July.

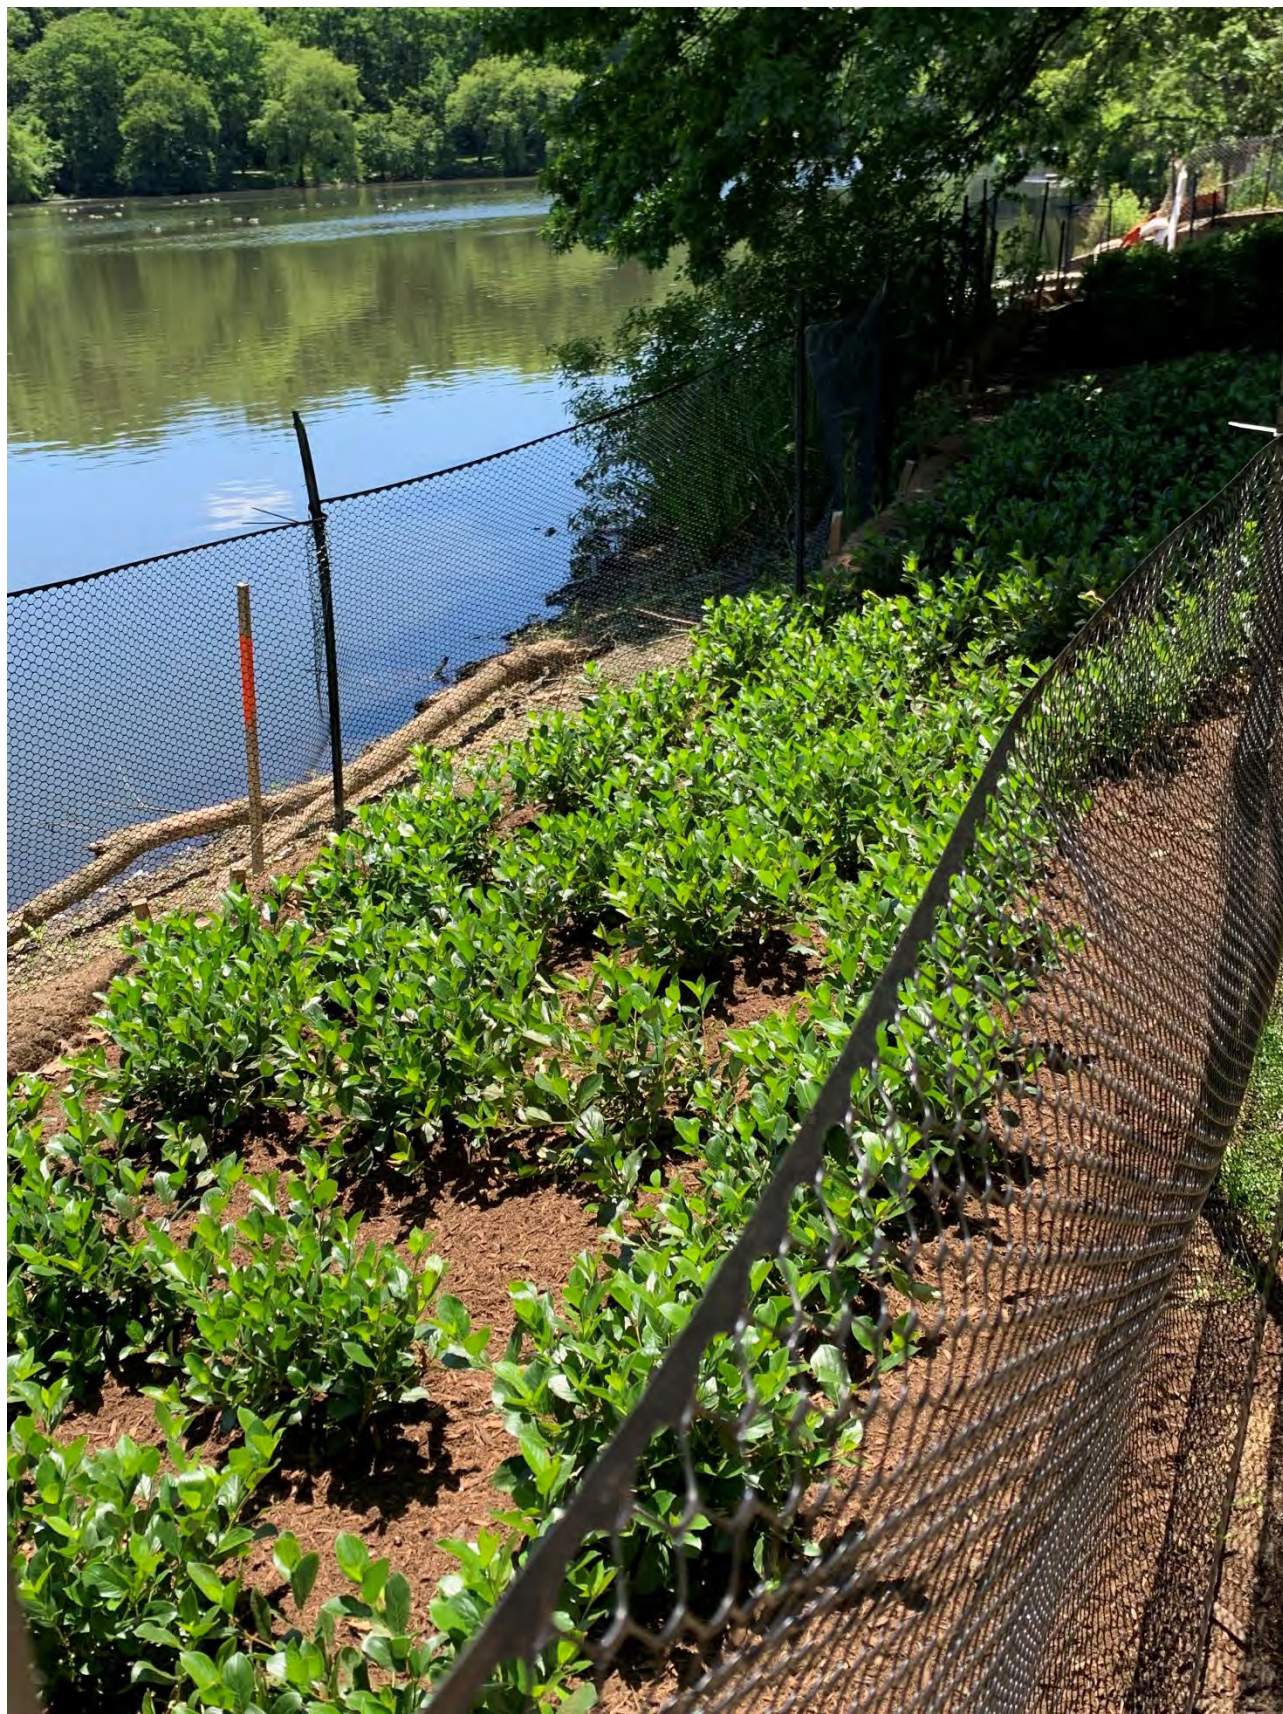
Work Area #1 – Leverett Pond – plantings installed during the Spring 2022 planting window.

- **Work Area #1** – Leverett Pond – The contractor completed dredging the revised footprint in June 2021. Surveying was done in mid-July 2021 to confirm new flood risk management cross sections. The additional dredging work at the Village Brook Outfall requested by the Sponsors was completed and equipment demobilized mid-March 2022. Installation of herbivore fence and coir logs and preparation of shrub beds were completed in April. Trees and shrub beds were planted between early May into mid-June and seed for the lawn areas will

go down this week. Landscape protection fence installation will begin this week and continue into the first part of July. Maintenance of the planting will begin immediately during the two-year plant guarantee period.

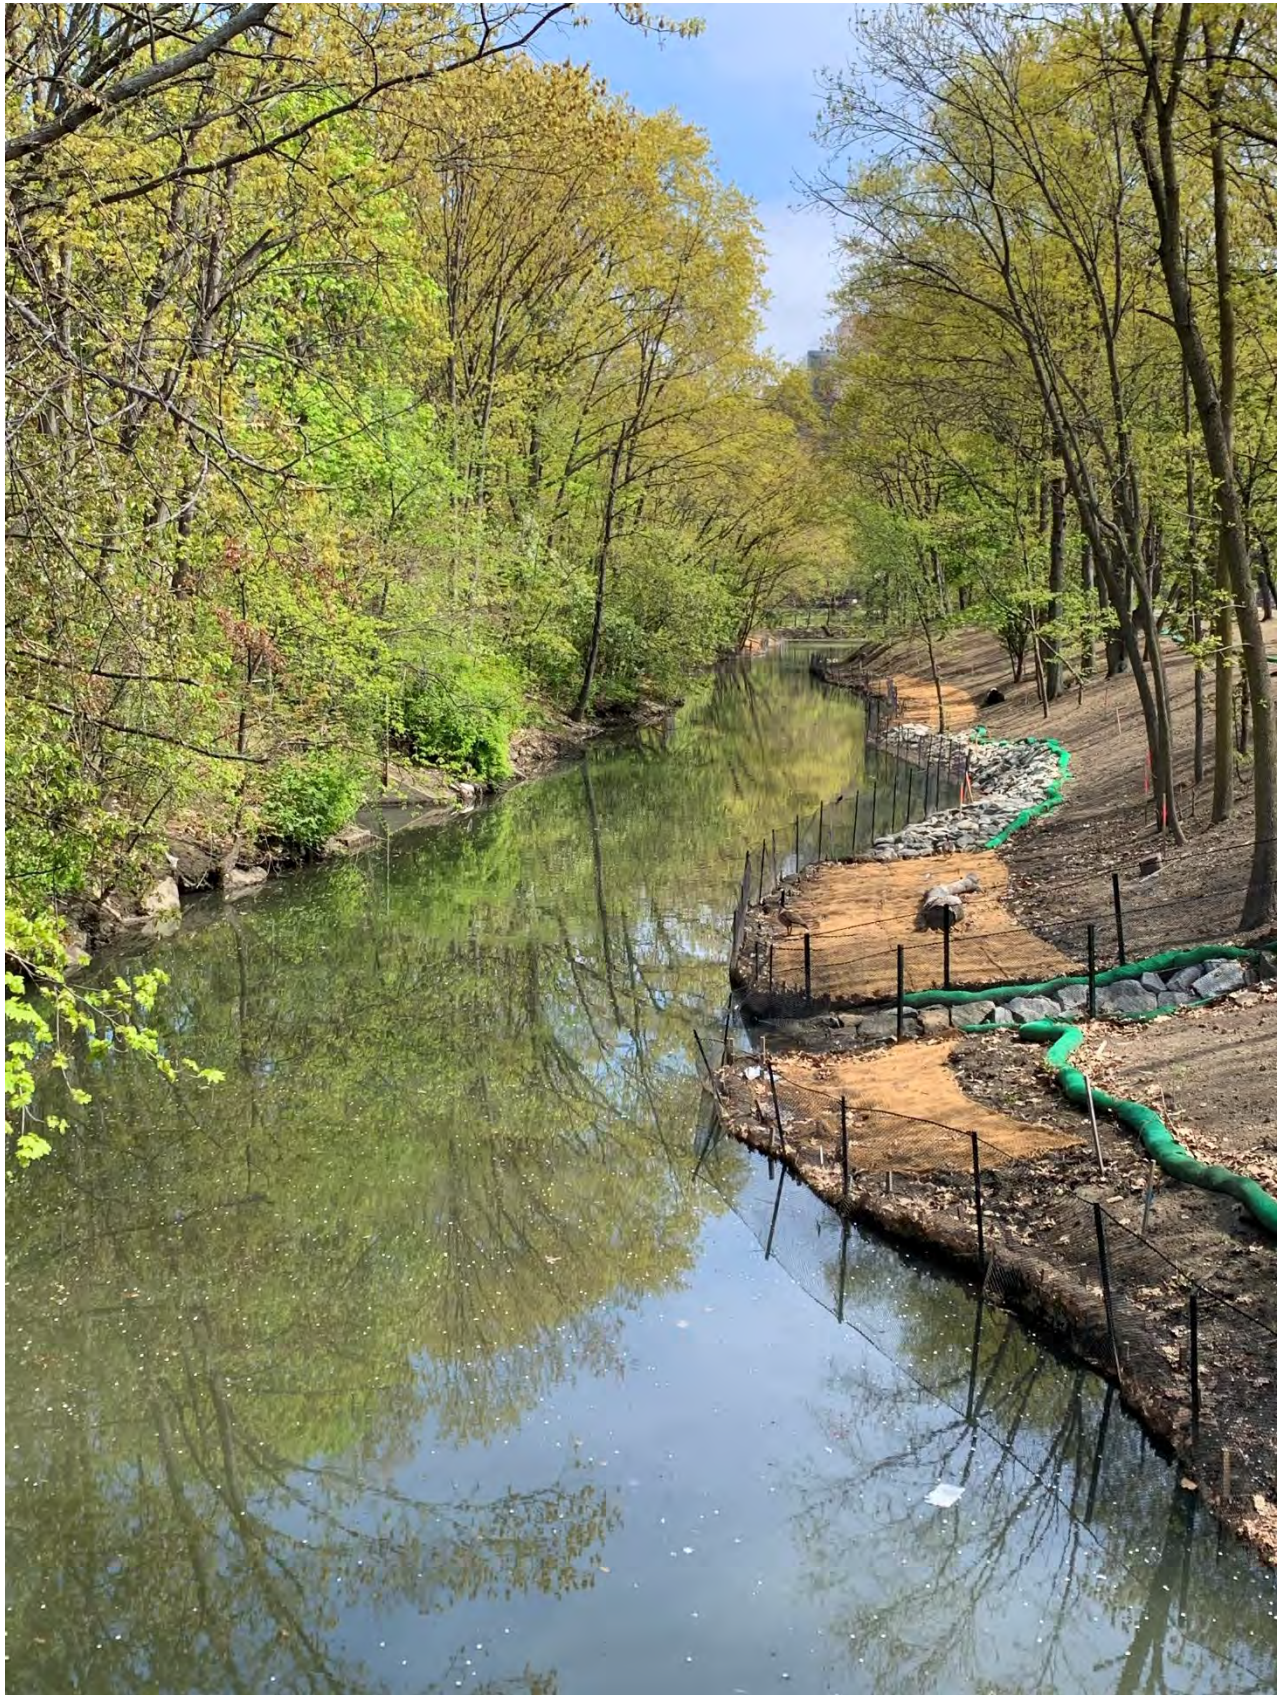
Work Area #2 – section of river at Brookline Avenue and the Riverway – near Beth Israel Deaconess Hospital – bank cleared; wetland shelf constructed; herbivore fence and coir log installed; and loam placed – ready for plants to be installed. Mid-May 2022.

- **Work Area #2** – section of river at Brookline Avenue and the Riverway – near Beth Israel Deaconess Hospital – the contractor completed dredging this section mid-February 2021. Surveying was done in February to confirm new flood risk management cross sections. Since that time, a review of the as-dredged conditions has taken place to confirm plant locations and topsoil quality to optimize planting success. A collapsed drain was repaired this past winter which deferred planting of Work Area #2 to Spring 2022. Installation of herbivore fence, coir logs, and preparation of wetland shelves and shrub beds were completed in April. Trees and shrub beds were planted between early May into early June and seed for the lawn areas will go down this week. Maintenance of the planting will begin immediately during the two-year plant guarantee period.

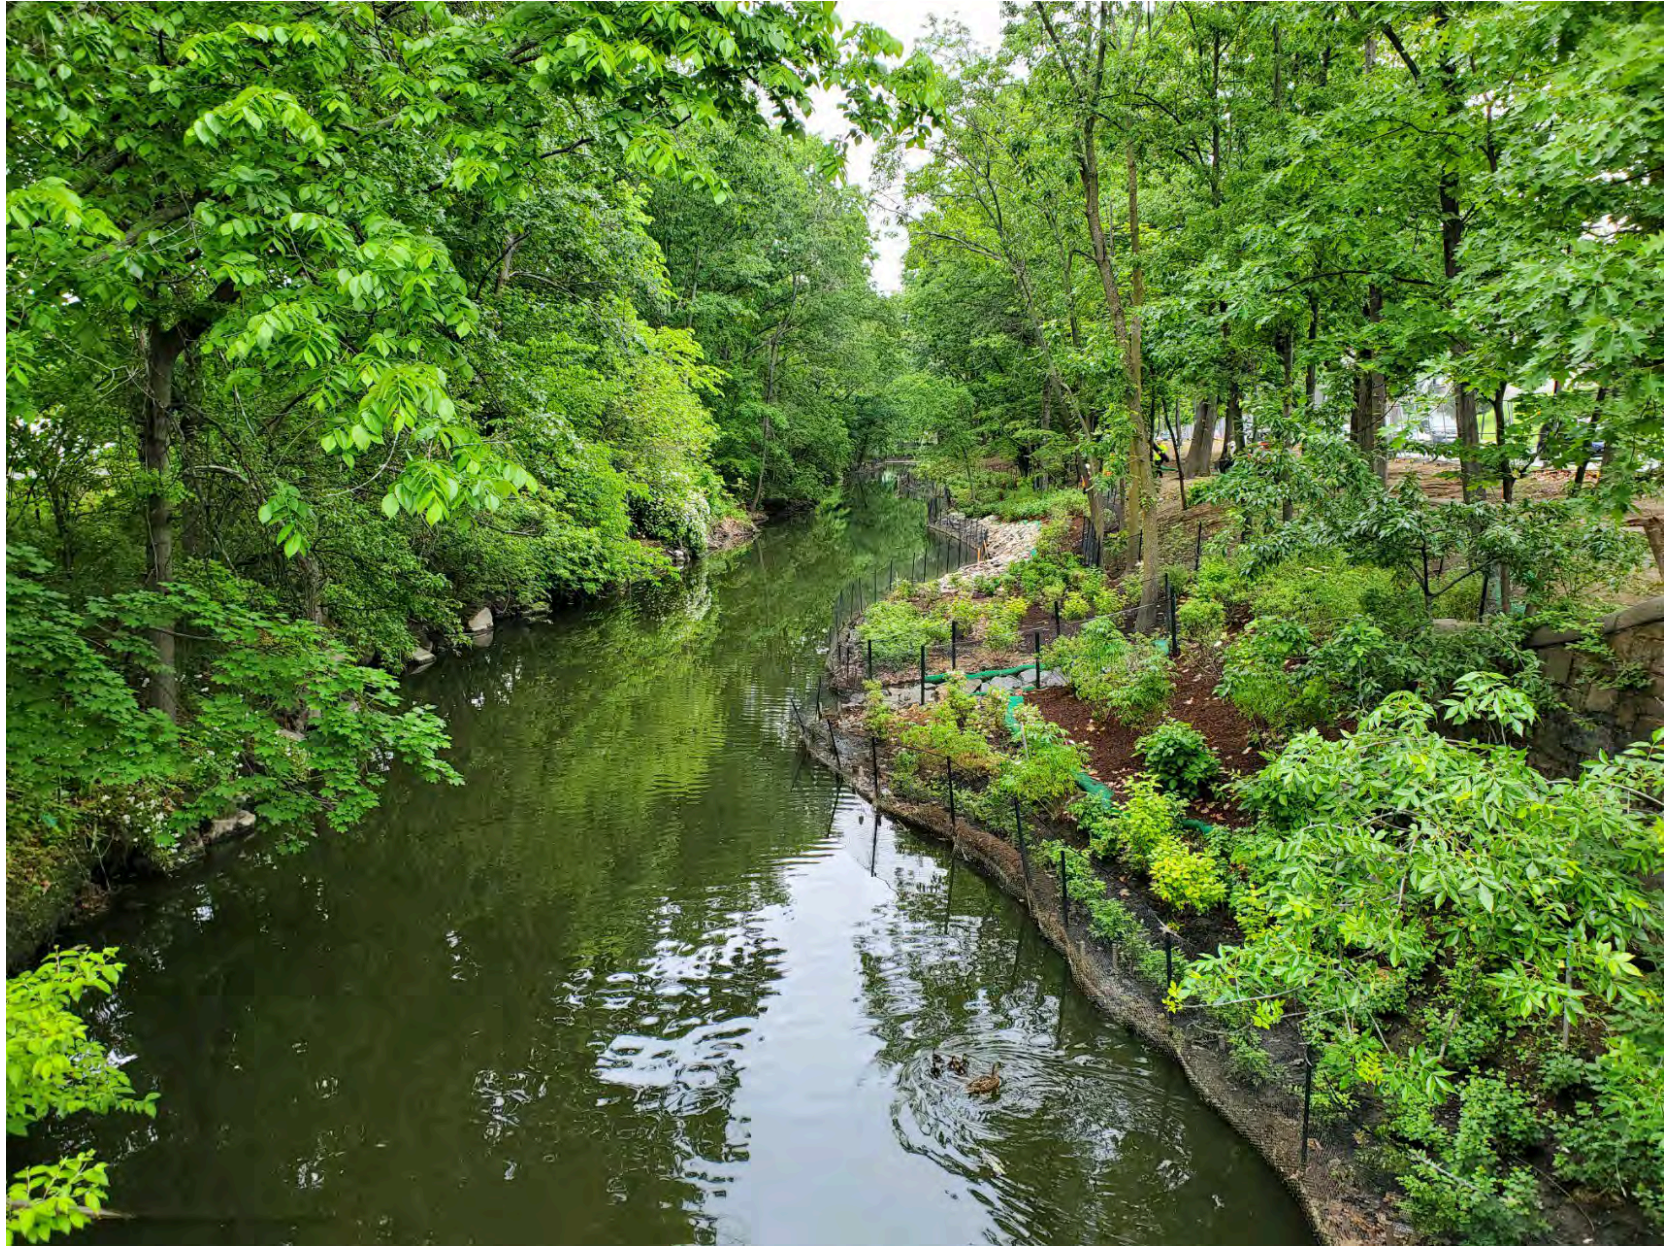
Work Area #2 – section of river at Brookline Avenue and the Riverway – near Beth Israel Deaconess Hospital – bank area planted. Early-June 2022.

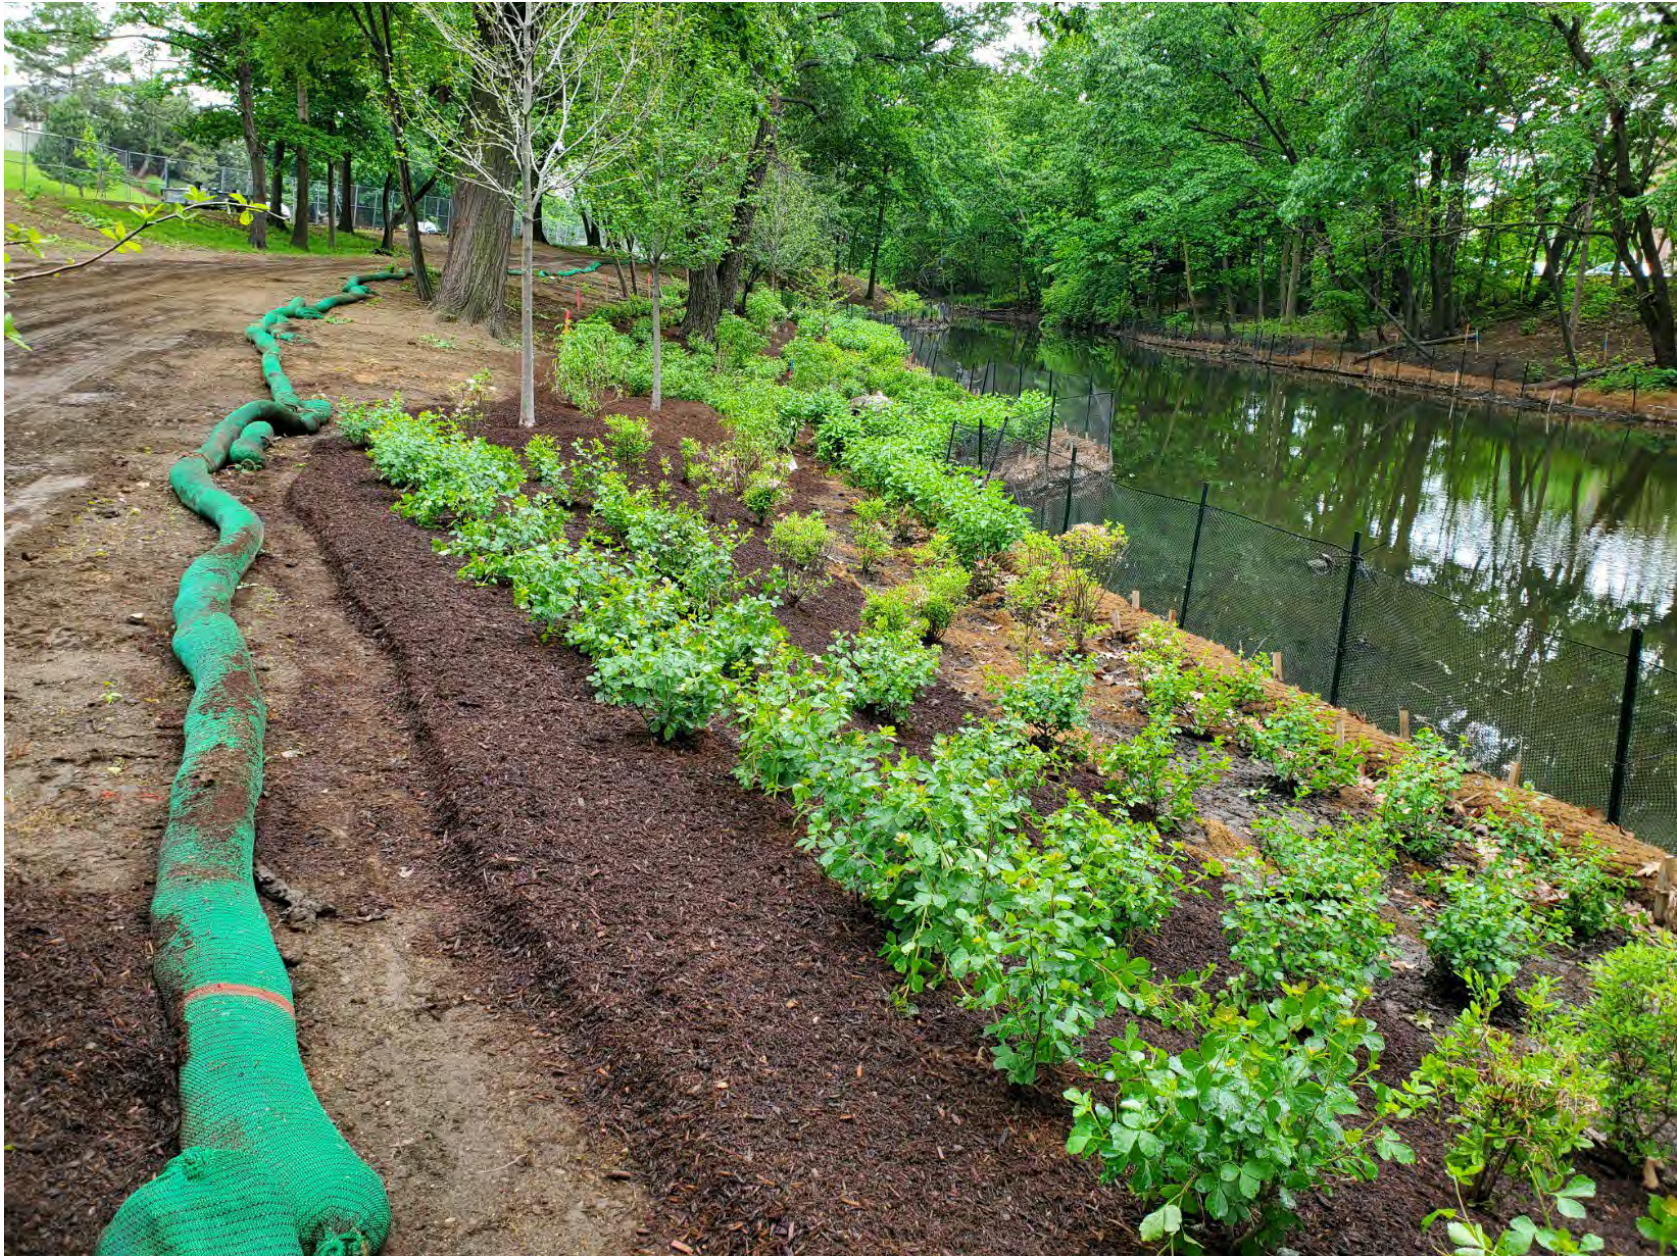
Work Area #2 – section of river at Brookline Avenue and the Riverway – near Beth Israel Deaconess Hospital – bank area planted. Early-June 2022.

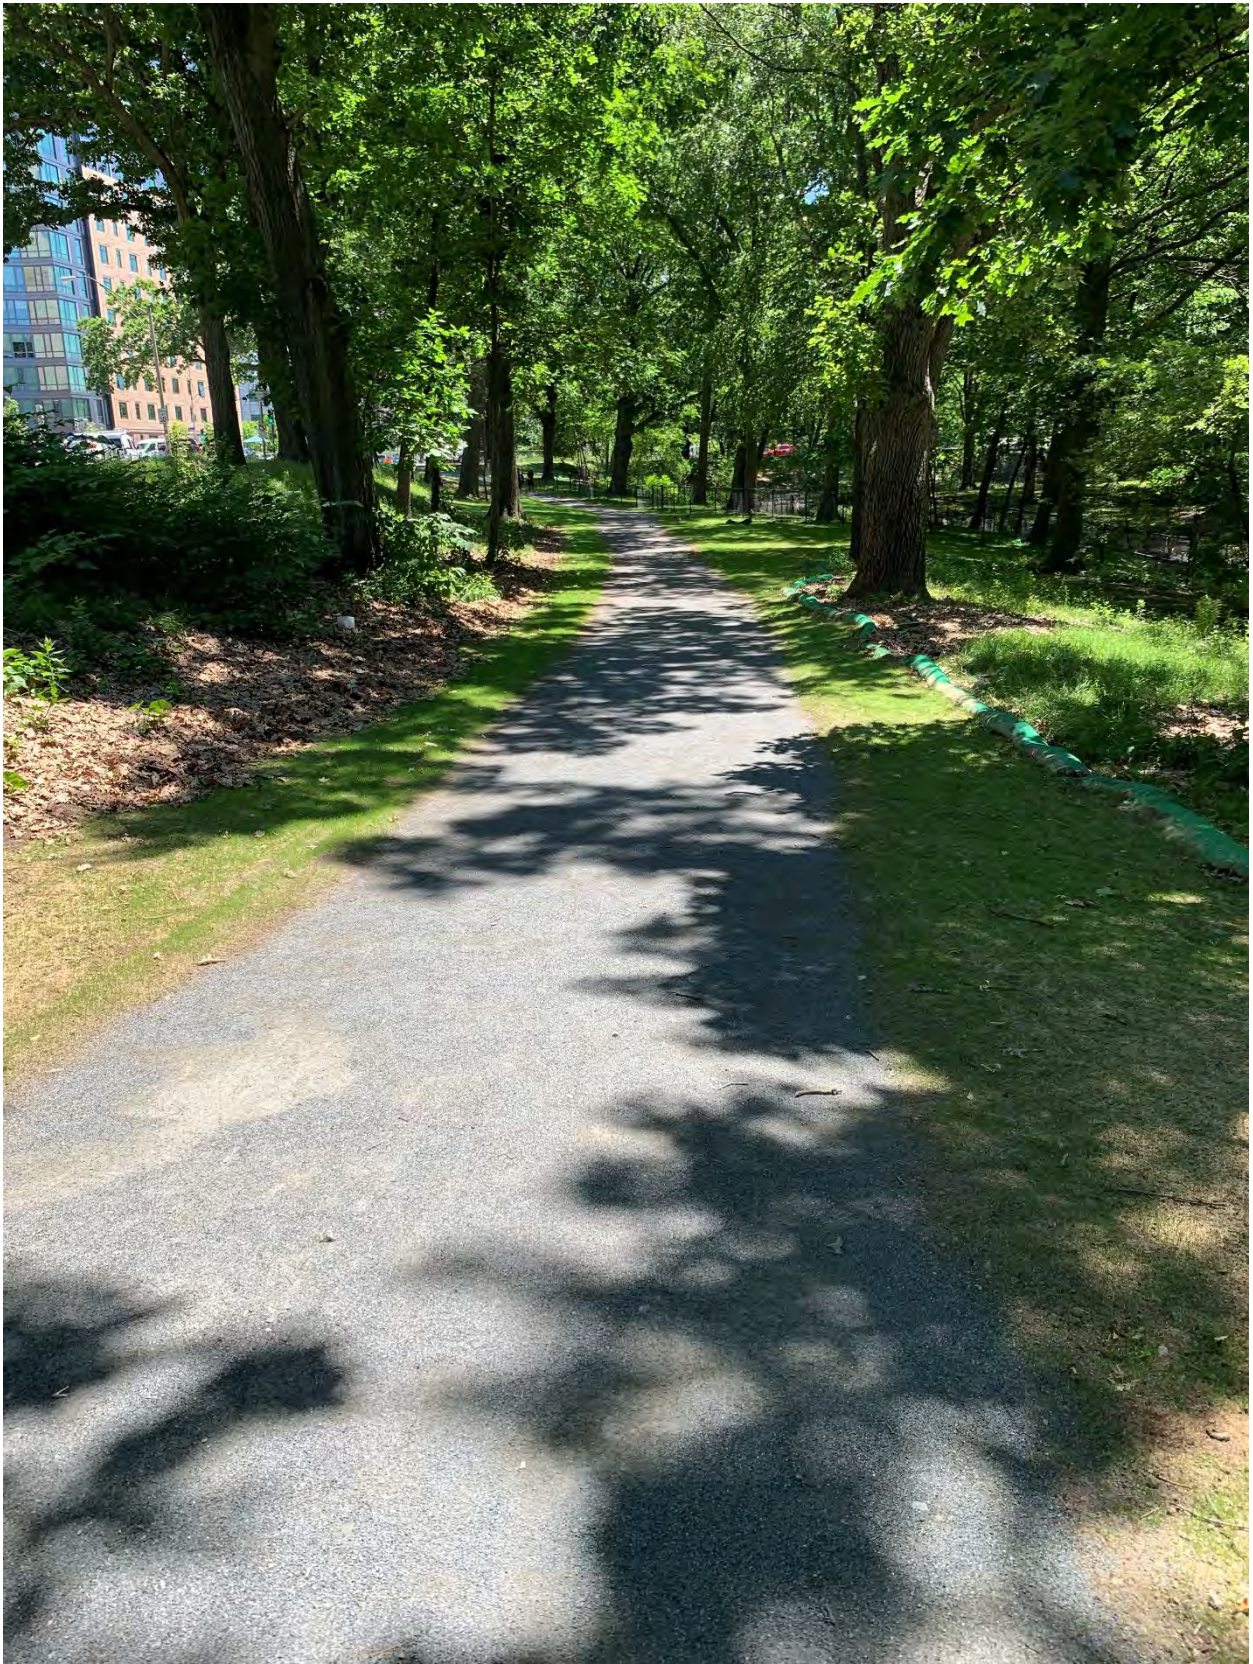
Work Area #3 – section of river at Brookline Avenue, the Riverway, and Netherlands Road – near Beth Israel Deaconess Hospital – stonedust pathway constructed and banks planted as part of the restoration.

- **Work Area #3** – section of river at Brookline Avenue, the Riverway, and Netherlands Road – near Beth Israel Deaconess Hospital – the contractor completed dredging this section late-March 2021. Surveying was done in May to confirm new flood risk management cross sections. Since that time, a review of the as-dredged conditions has taken place to confirm plant locations and topsoil quality to optimize planting success. All trees, upland planting, and seeding were completed in October 2021. Stonedust path restoration and landscape protection fence installation took place in mid-May. Wetland plants were installed late-May. Maintenance of the planting will continue to October 2023 during the two-year plant guarantee period.

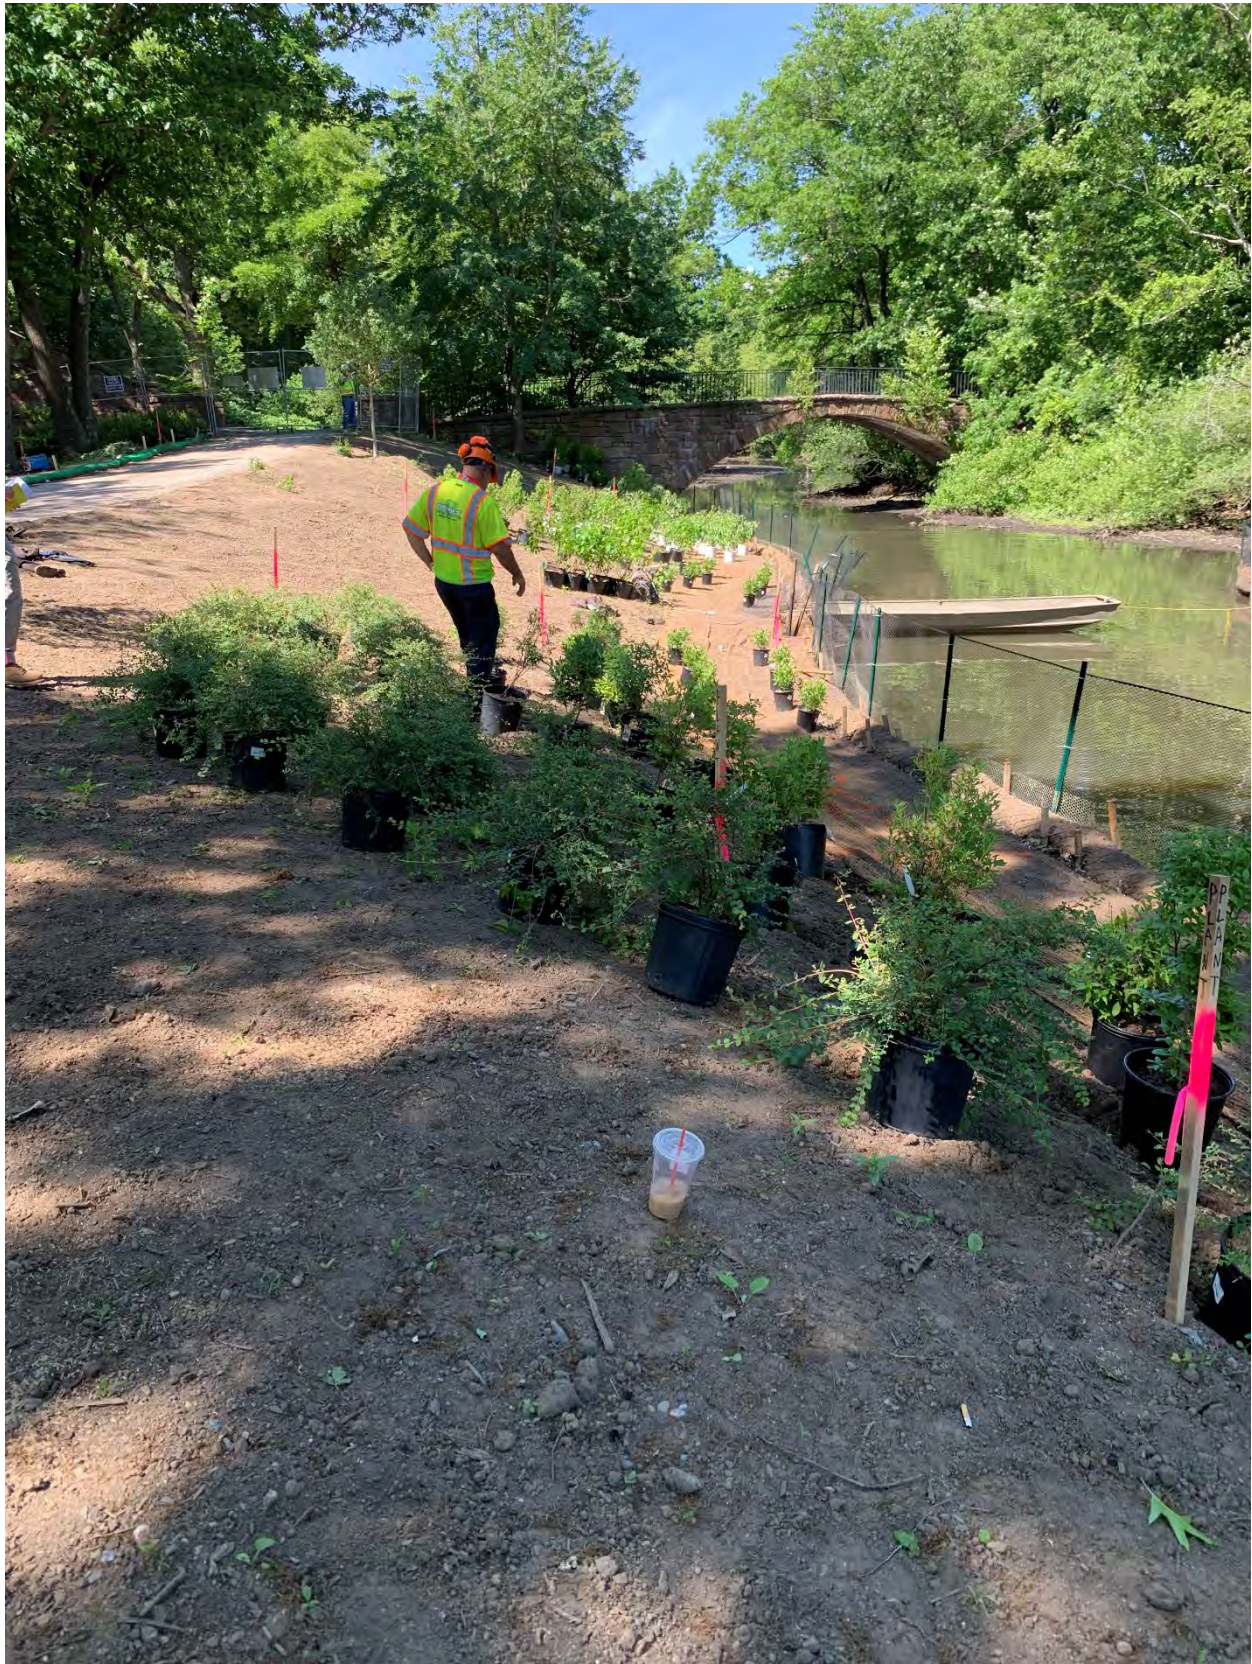
Work Area #5 – section of river by Short Street Bridge – looking upstream at the bridge. Flood risk management channel dredged through the peninsula late April which created an island in the Muddy River. Plantings being installed early June on the bank.

- **Work Areas #5 and #6** – section of river by Short Street Bridge to Back Bay Yard – near the intersection of Park Drive and Riverway – as the dredging activities resumes in the upstream stretches of the river, temporary construction fencing was installed in early March 2022. Mobilization of equipment and dredging of Work Area #5 took place late-April. Trees and shrubs were planted between early- to mid-June. Maintenance of the planting will begin immediately during the two-year plant guarantee period. In Work Area #6, dredging outside the MWRA easement area began late May and will continue into July. Expectation is to receive MWRA permit to dredge over the existing sewer lines to complete dredging this Fall. Planting and restoration of Work Area #6 will be determined once the MWRA permit is received and the schedule assessed to see where the dredging and planting work will fall.
