Muddy River Flood Damage Reduction Project  
Phase 2 Construction Activities Next 90 Days  
June 2022

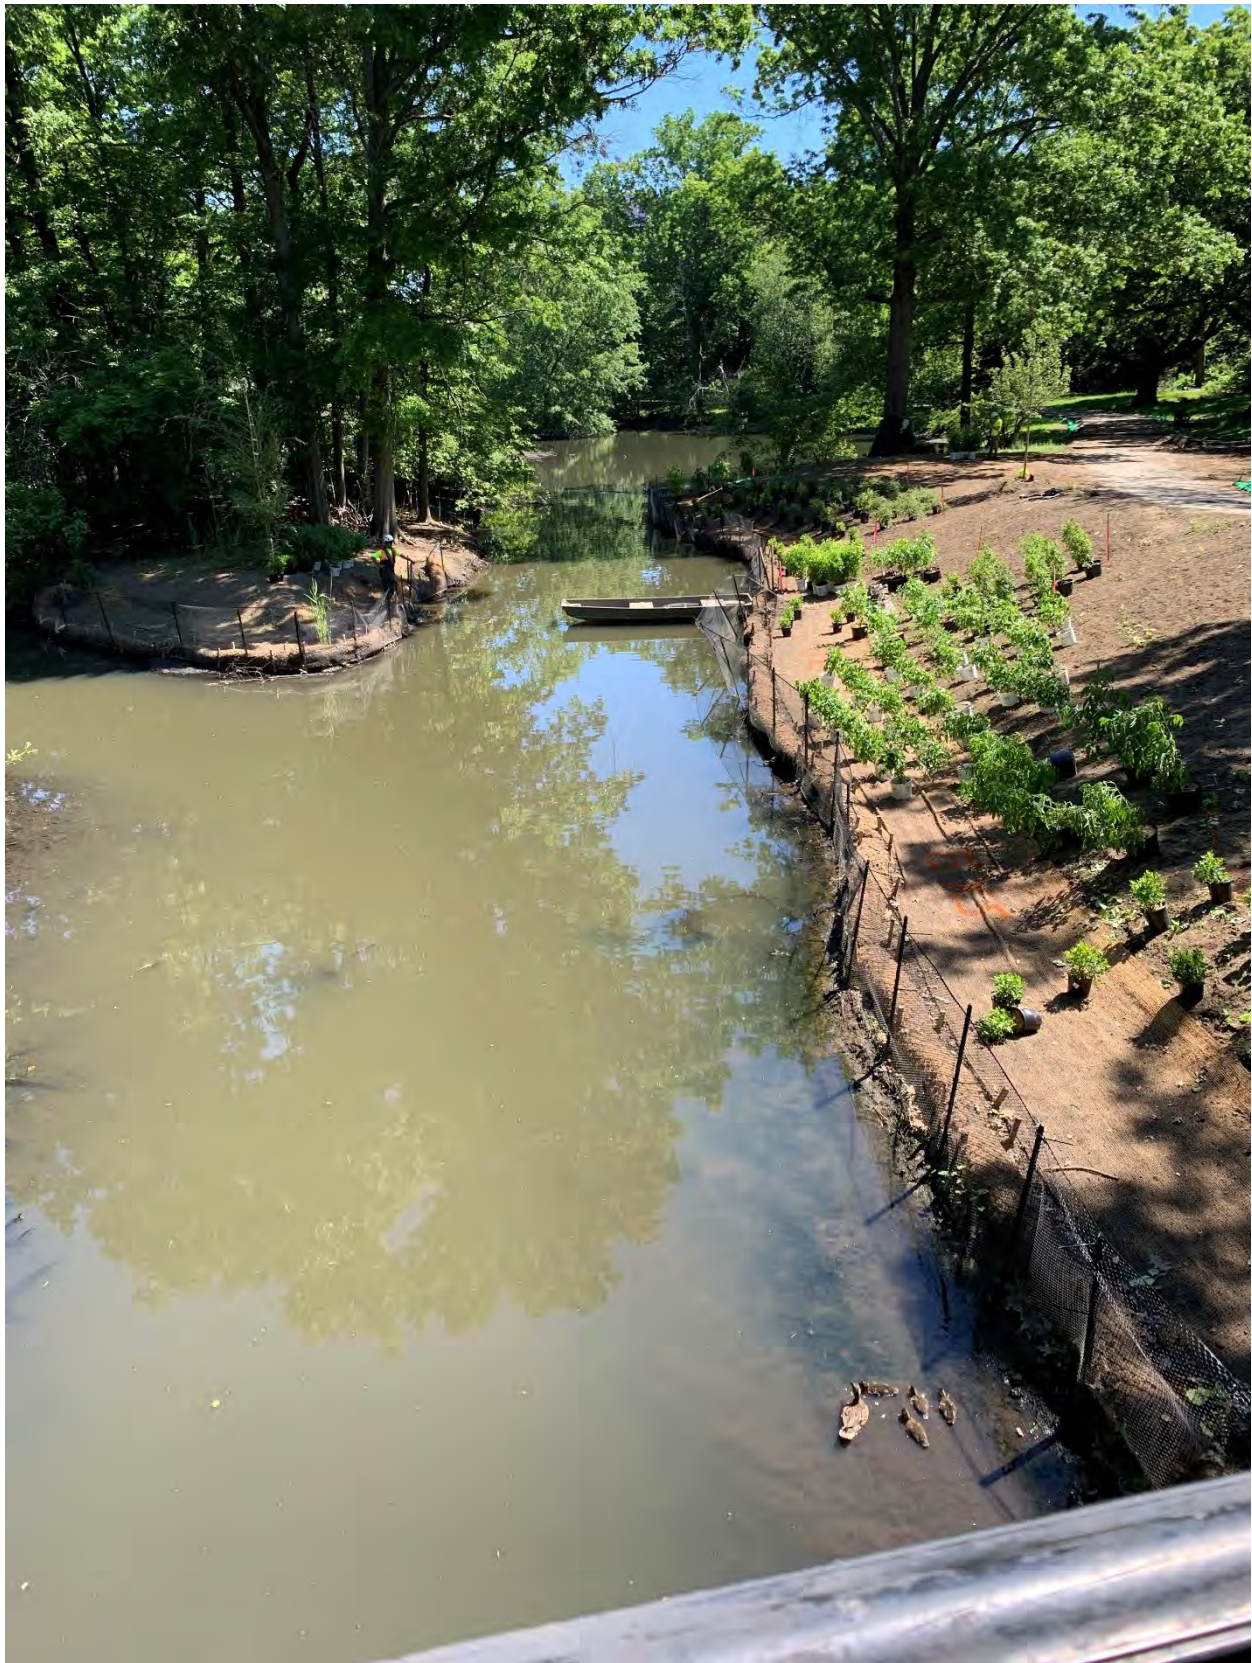
Work Area #5 – section of river by Short Street Bridge – looking downstream from the bridge at the newly created island. Plantings being installed early June on the bank and on the island.

- **Work Areas #5 and #6** – section of river by Short Street Bridge to Back Bay Yard – near the intersection of Park Drive and Riverway – as the dredging activities resumes in the upstream stretches of the river, temporary construction fencing was installed in early March 2022. Mobilization of equipment and dredging of Work Area #5 took place late-April. Trees and shrubs were planted between early- to mid-June. Maintenance of the planting will begin immediately during the two-year plant guarantee period. In Work Area #6, dredging outside the MWRA easement area began late May and will continue into July. Expectation is to receive MWRA permit to dredge over the existing sewer lines to complete dredging this Fall. Planting and restoration of Work Area #6 will be determined once the MWRA permit is received and the schedule assessed to see where the dredging and planting work will fall.

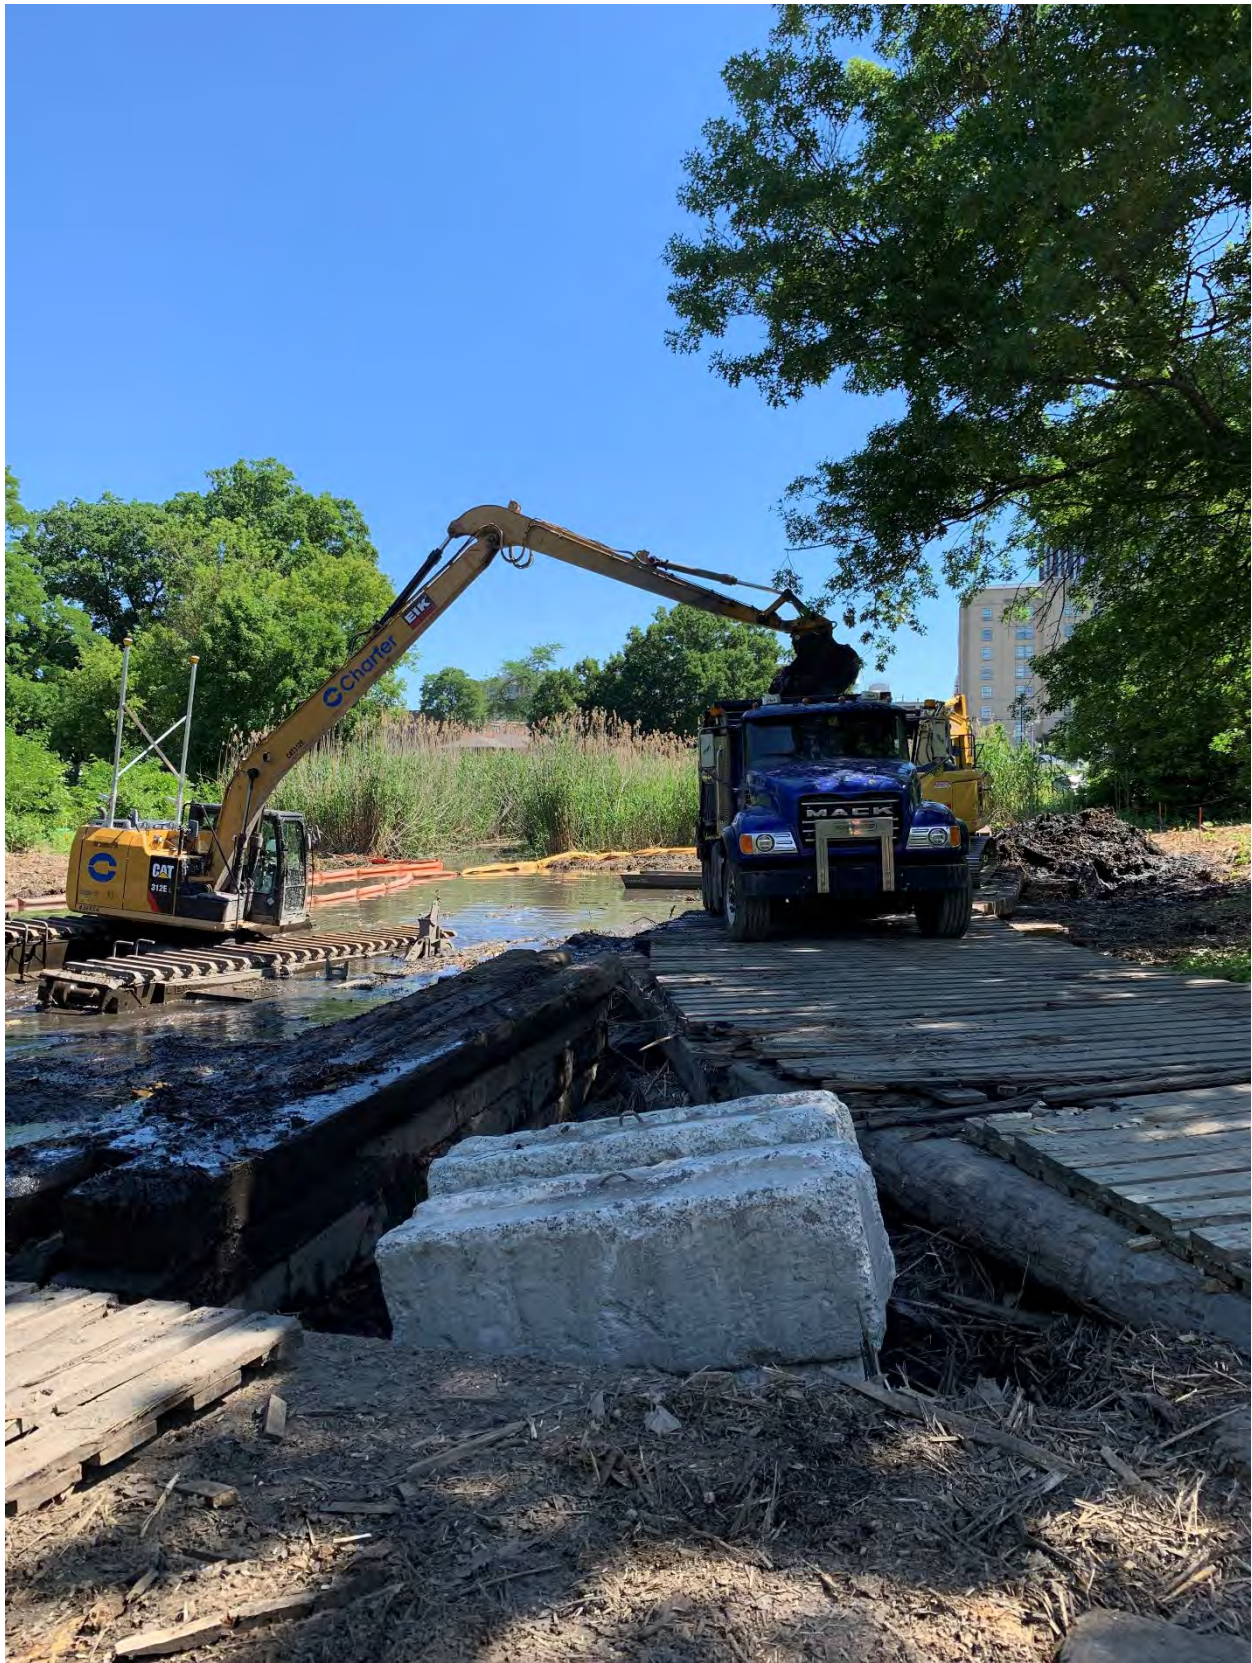
Work Area #6 – section of river by Short Street Bridge to Back Bay Yard – near the intersection of Park Drive and Riverway – upstream area outside of MWRA easement. Dredging of the flood risk management ongoing into July.
