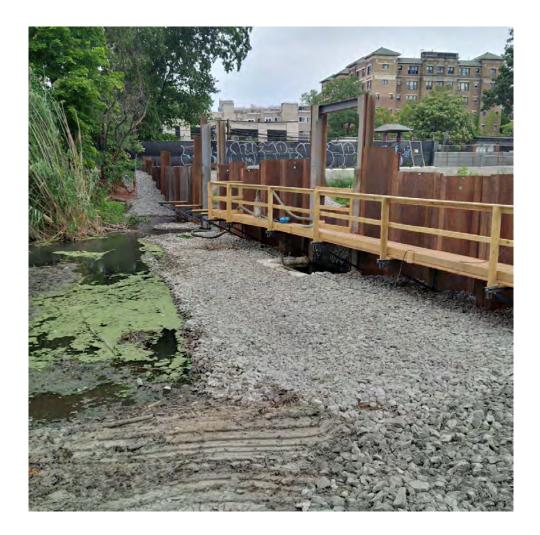
Upstream limits of Phase 1 Construction – line of steel sheeting installed as the Flow Restriction Control Structure (FRCS). Note the two weir opening in the sheeting to allow continuous flow over the structure; constructed walkway for maintenance of this structure; and scour protection of the FRCS with stone – early September 2015.

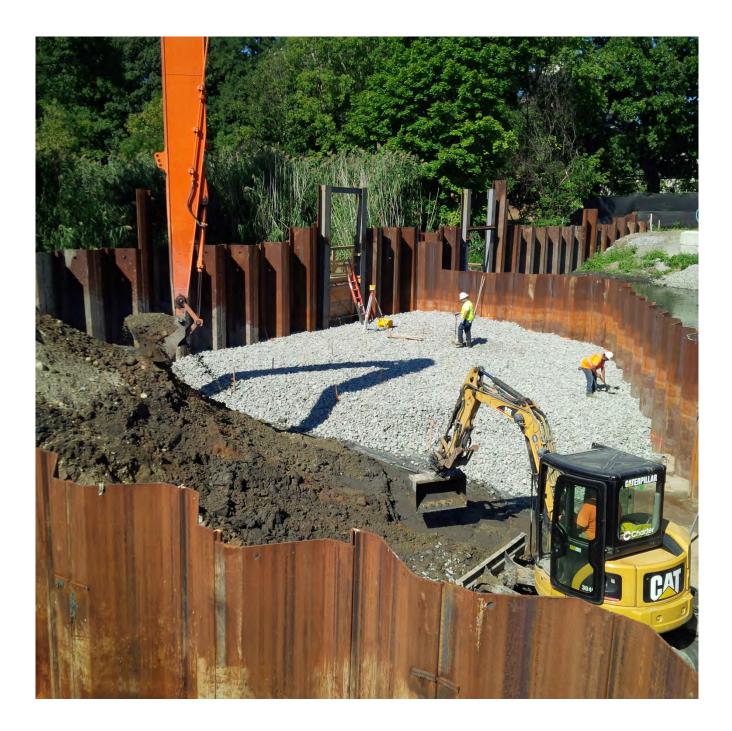
Grading and excavating of the flood risk management (FRM) channel on the southside downstream of the FRCS – mid September 2015.

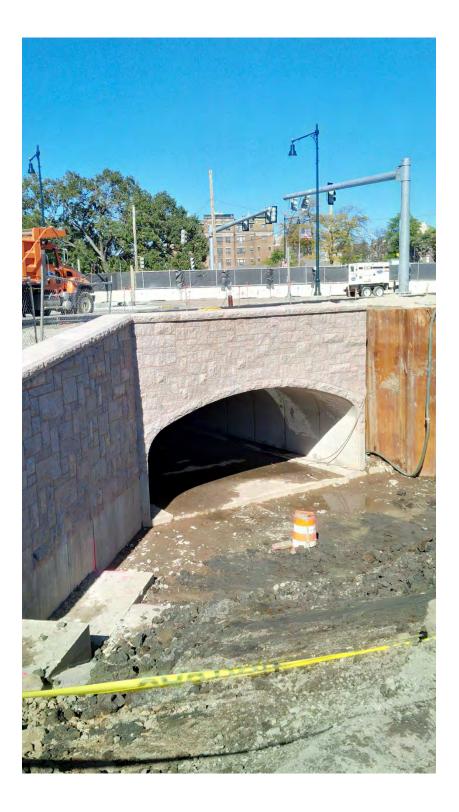
New Riverway Culvert in the former Sears Parking Lot – note the granite veneer installed on the precast culvert and the wingwall that cannot be completed until the existing twin 72" culverts are removed – mid October 2015.

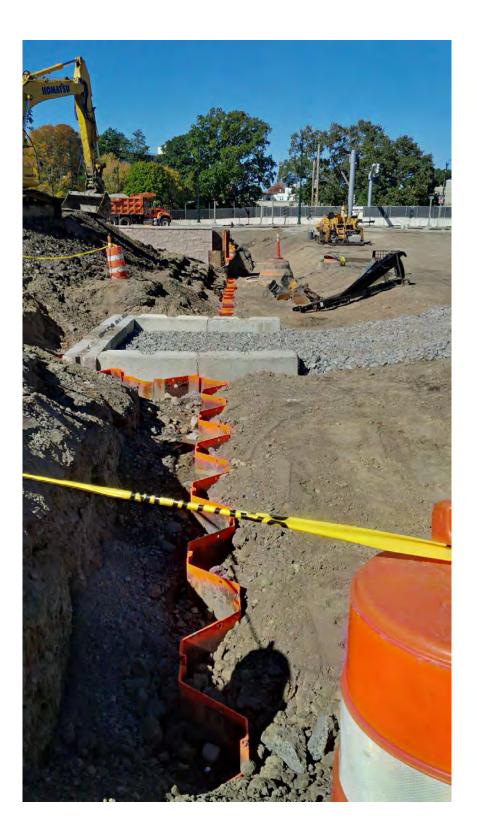
Steel sheeting installed for the river diversion in the pre-excavated trench in the former Sears Parking Lot – note the box-out for the existing storm drainage system – mid October 2015.

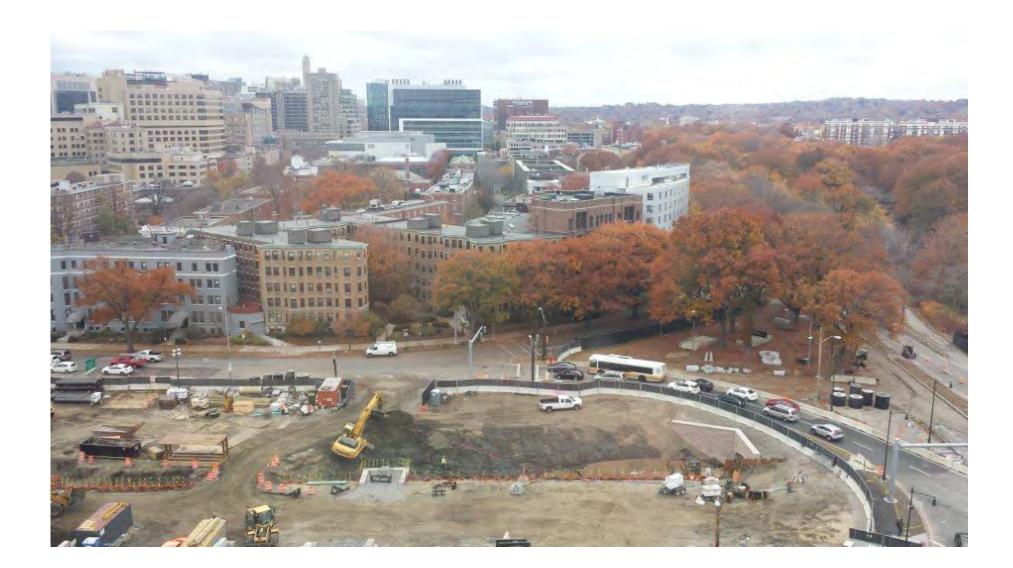
Overview of the former Sears Parking Lot – note the excavation downstream of the new Riverway Culvert to construct the new river channel to return the Muddy River to its natural state – early November 2015.

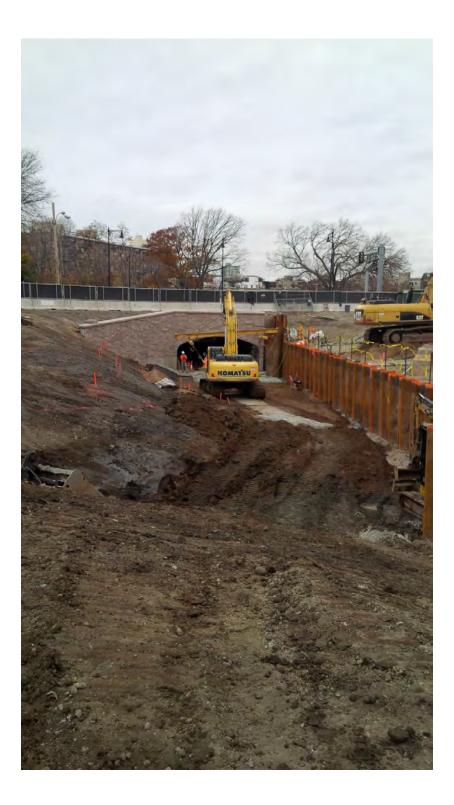
Excavation and shaping of the right (looking downstream) bank of the new river channel downstream of the new Riverway Culvert – mid November 2015.

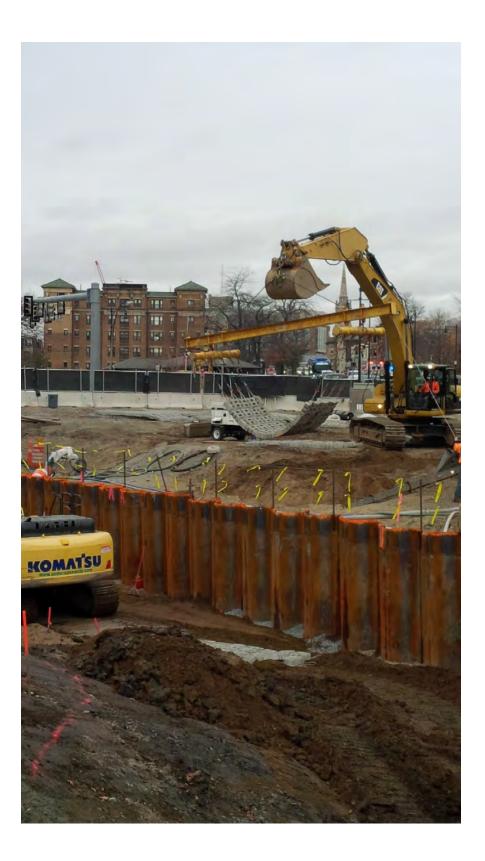
Equipment lowering sections of Articulated Concrete Blocks (ACBs) in place for scour protection downstream of the new Riverway Culvert – mid November 2015.

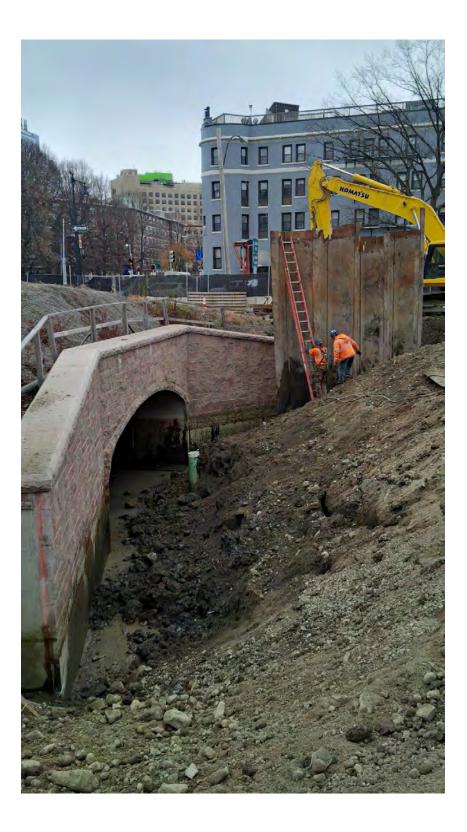
Removal of the steel sheeting support of excavation at the upstream end of the new Brookline Avenue culvert – this will allow the continued "daylighting" of the southside of the new channel – early December 2015.

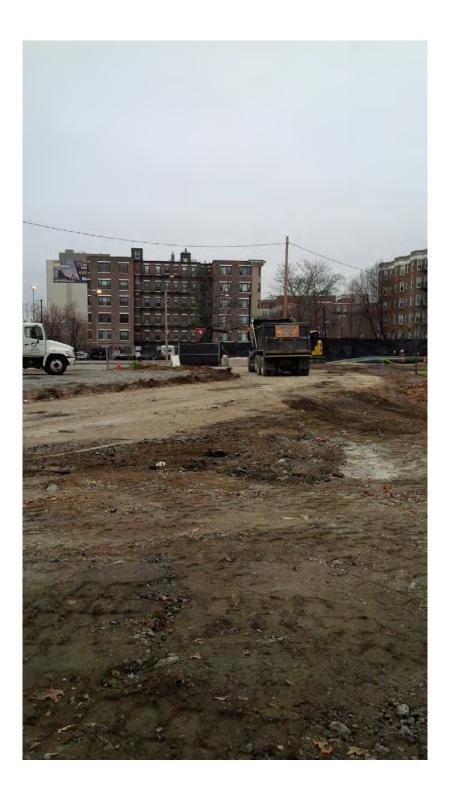
Removal of the roadway and sidewalk at the Jug Handle work area now that the roadway is permanently removed from vehicular and pedestrian traffic – mid December 2015.

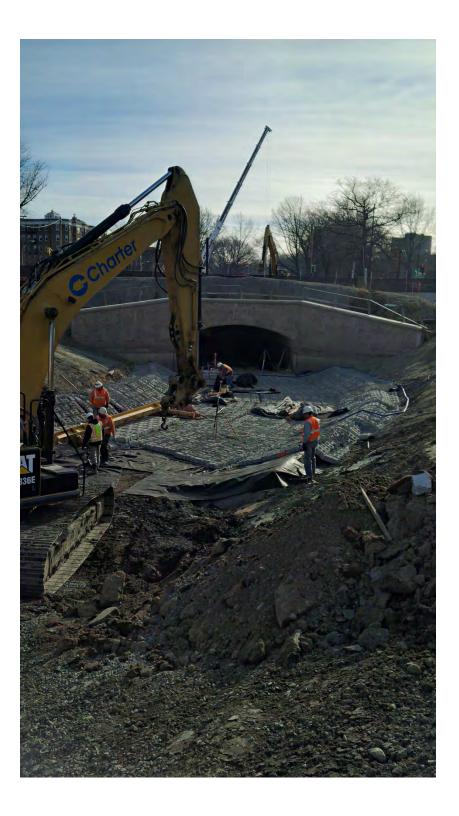
Installation of the articulated concrete blocks (ACBs) at the upstream of the Brookline Avenue culvert – early January 2016.

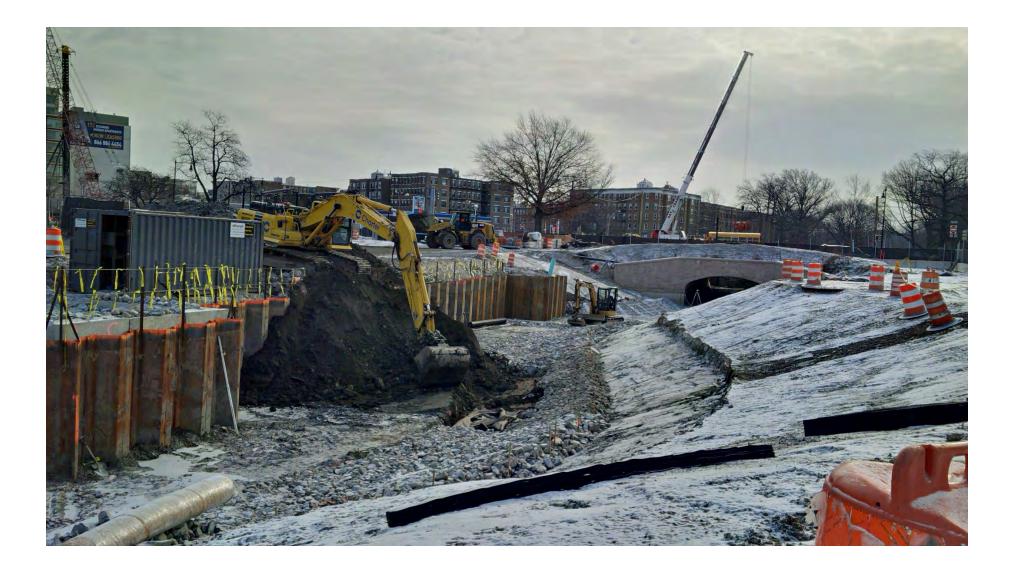
Excavating the last of the material from the southside of the former Sears Parking Lot to form the new flood risk management channel – mid January 2016.

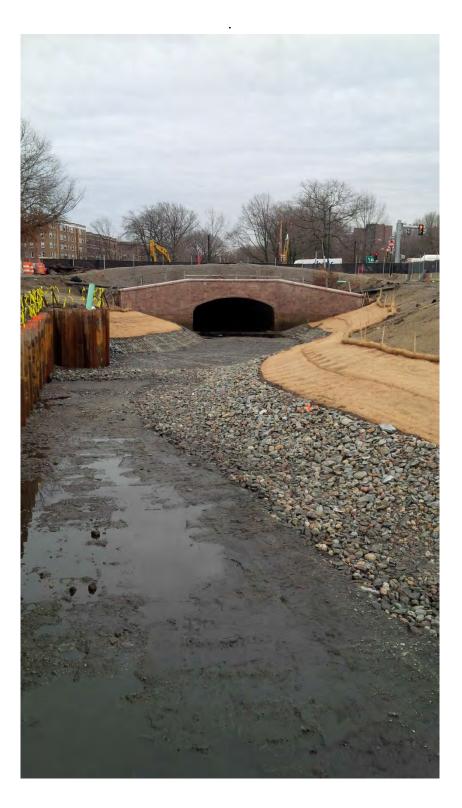
Southside of the flood risk management completed, to include ACB's for channel scour protection, and stone protection, geocells, and turf reinforcement mattress for bank protection – looking at the upstream Brookline Avenue culvert – early February 2016.

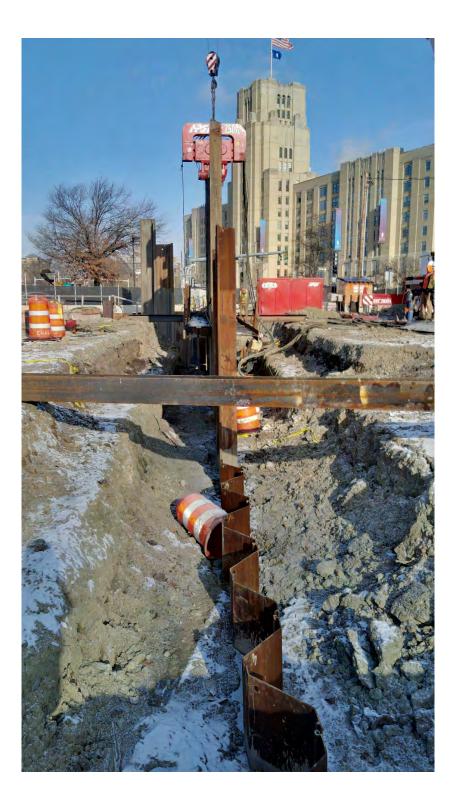
Installation of the steel sheeting support of excavation roughly in the middle of the Jug Handle work area in order to excavate for the southside of the FRM channel, while maintaining flow in the existing twin 72" culverts – mid January 2016.

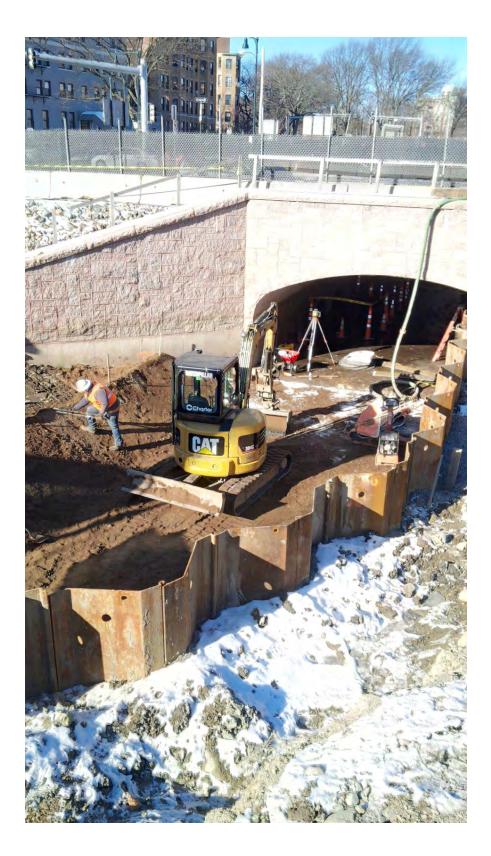
Excavating downstream of the new Brookline Avenue culvert in the Jug Handle work area – late January 2016.

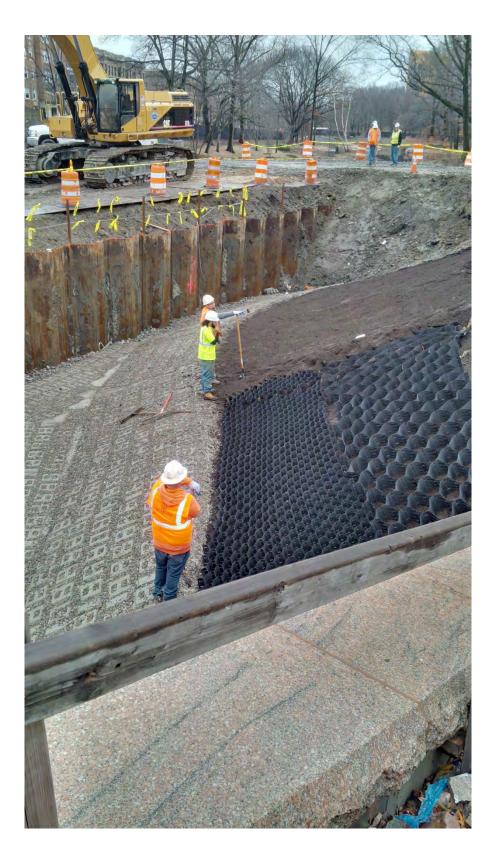
Installation of geocells and loam for bank restoration – downstream of the new Brookline Avenue culvert – early February 2016.

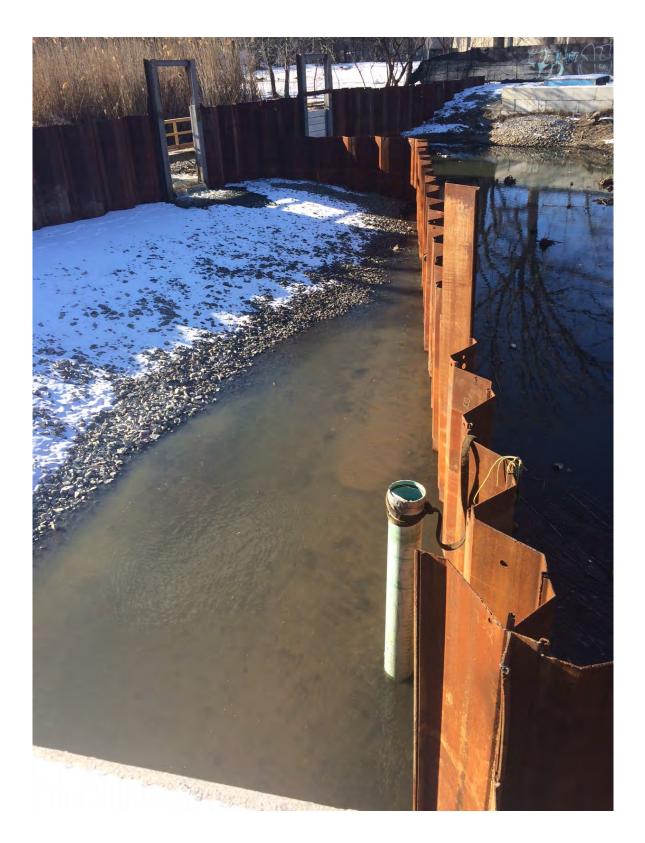
Flow through the new FRM channel on the southside, downstream of the Flow Restriction Control Structure at the Riverway – February 13, 2016.

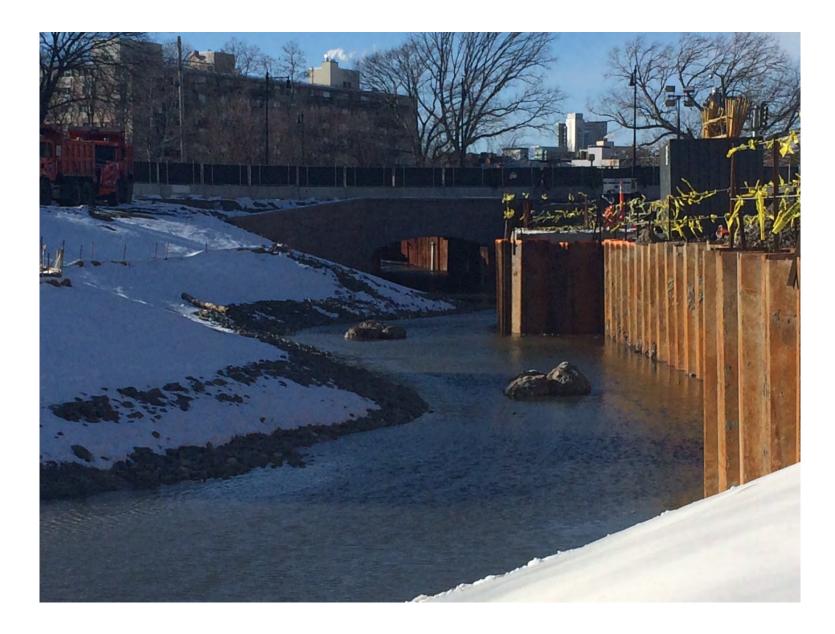
Muddy River flowing through the new FRM channel on the southside of the former Sears Parking Lot – February 13, 2016.

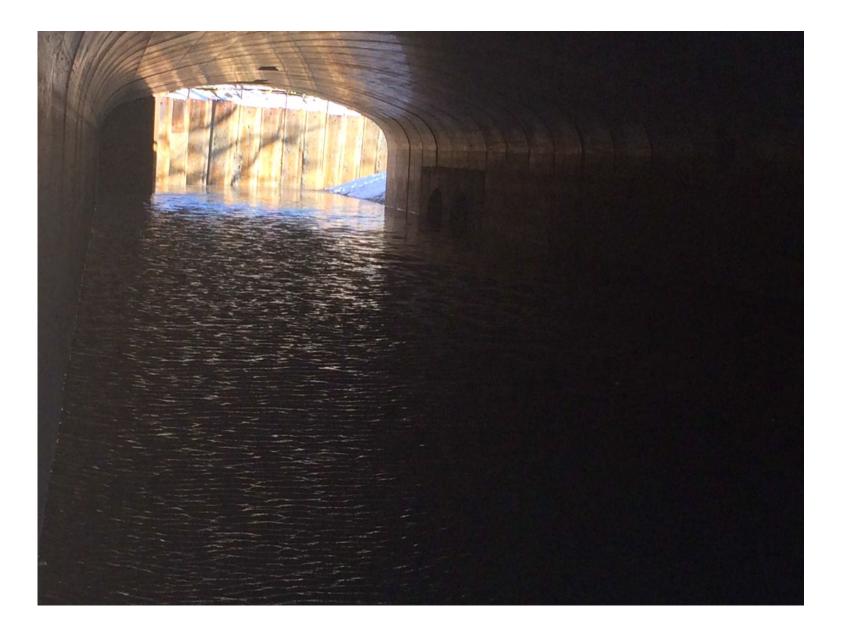
Muddy River flowing through the new Brookline Avenue Culvert – February 13, 2016.

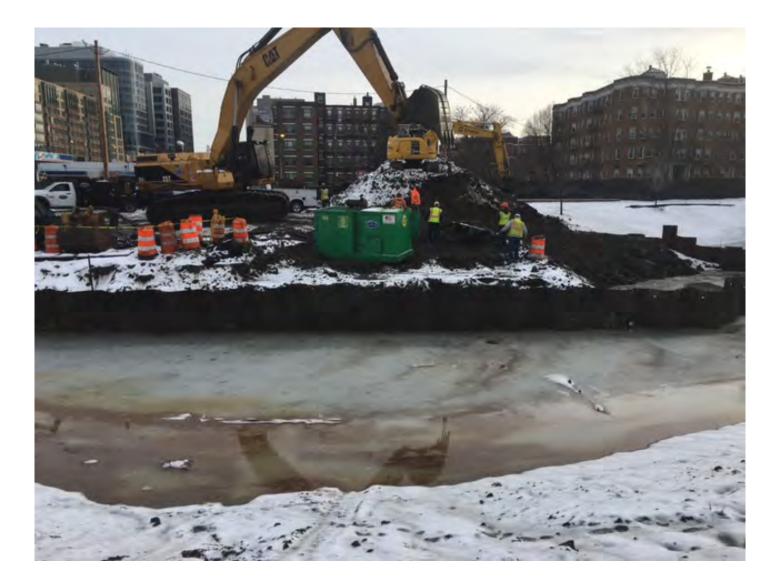
Former Jug Handle area – note the river flowing on the nearside in the new FRM channel; while excavation takes place on the far side – February 16, 2016.

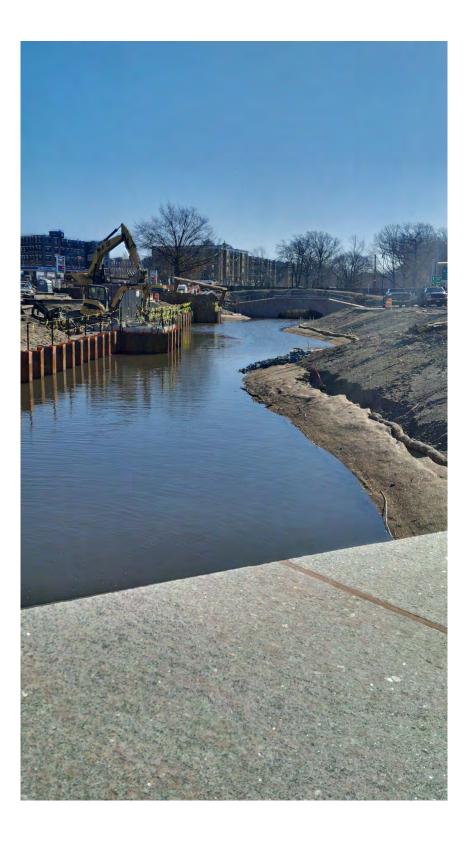
Muddy River flowing through new FRM channel on the southside of former Sears Parking Lot – view looking at new Brookline Avenue Culvert – 18 February 2016.
