MUDDY RIVER FLOOD RISK MANAGEMENT – PHASE II

Wendy Gendron
Chief, Civil Works/IIS Branch
New England District/PPMD
Date: 27 FEB 2020

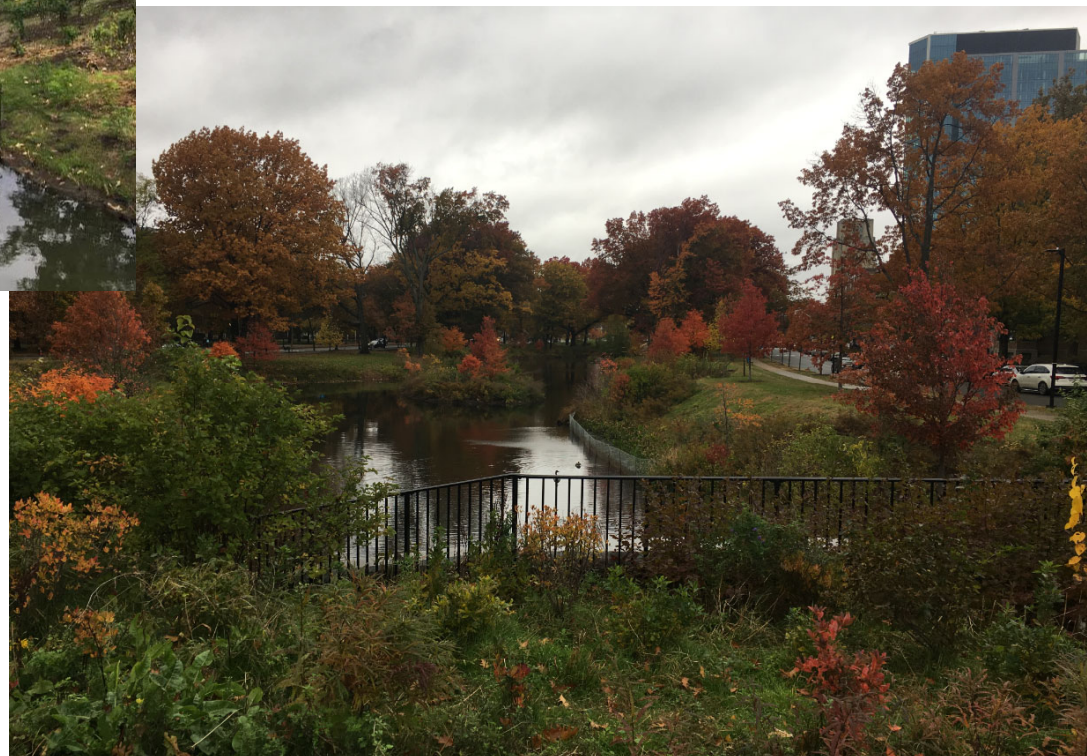
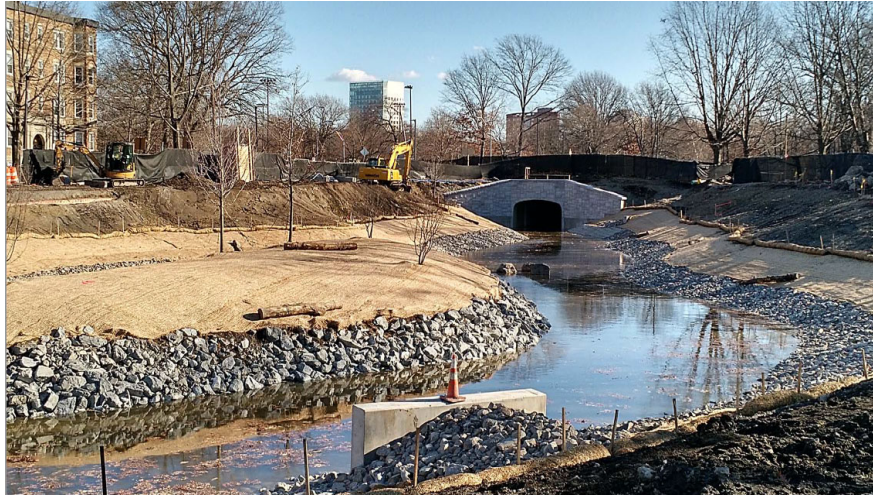
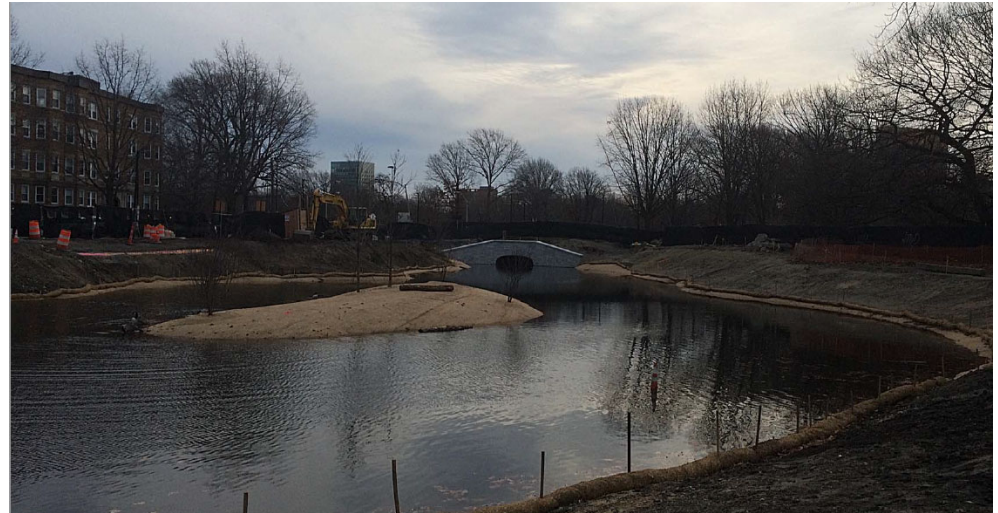
- Daylight 700 linear feet river
- Installation of larger culverts
- Improved channel capacity (dredging/excavation)
- Riparian & wetland restoration

- Looking upstream from new Fens culvert

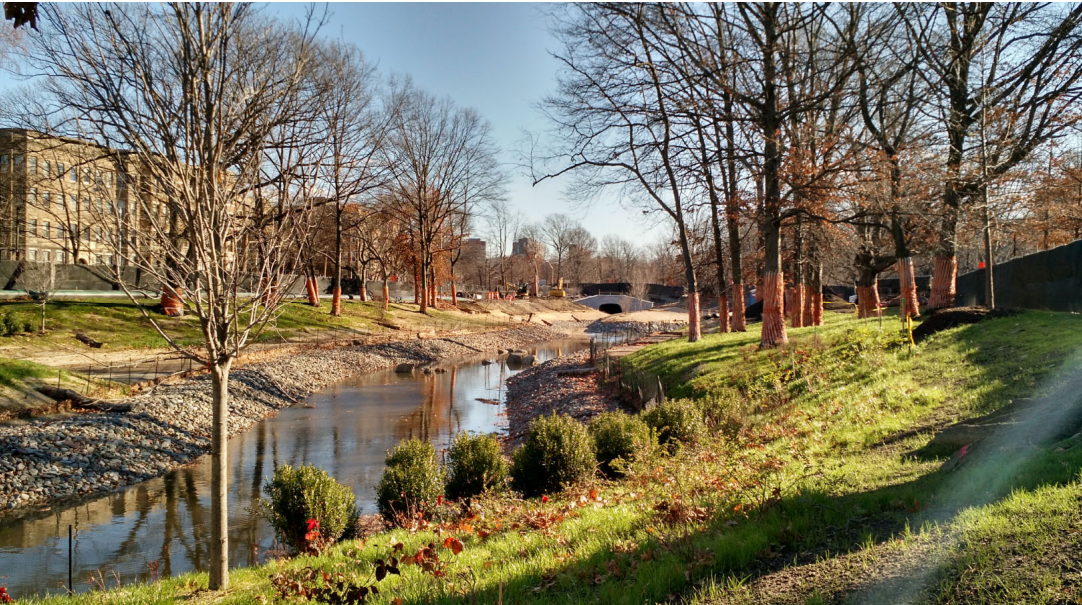
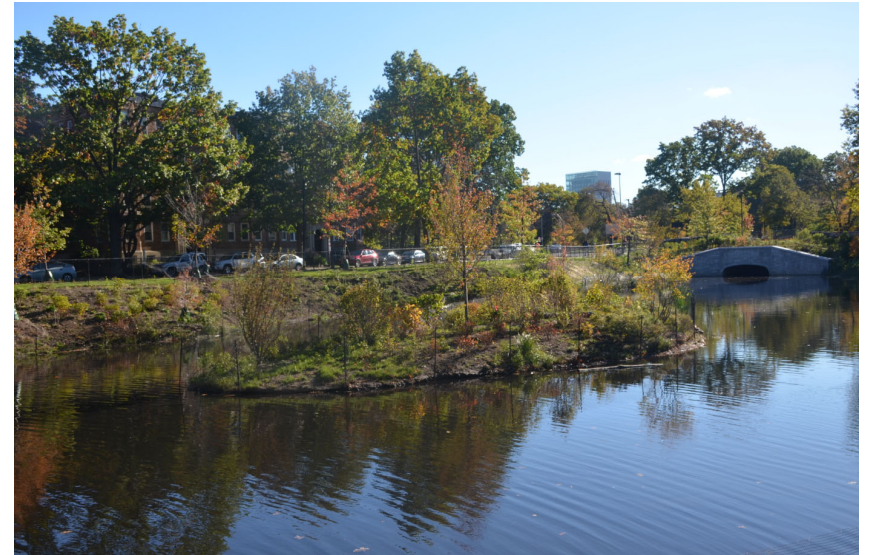
- Looking downstream toward new Fens culvert

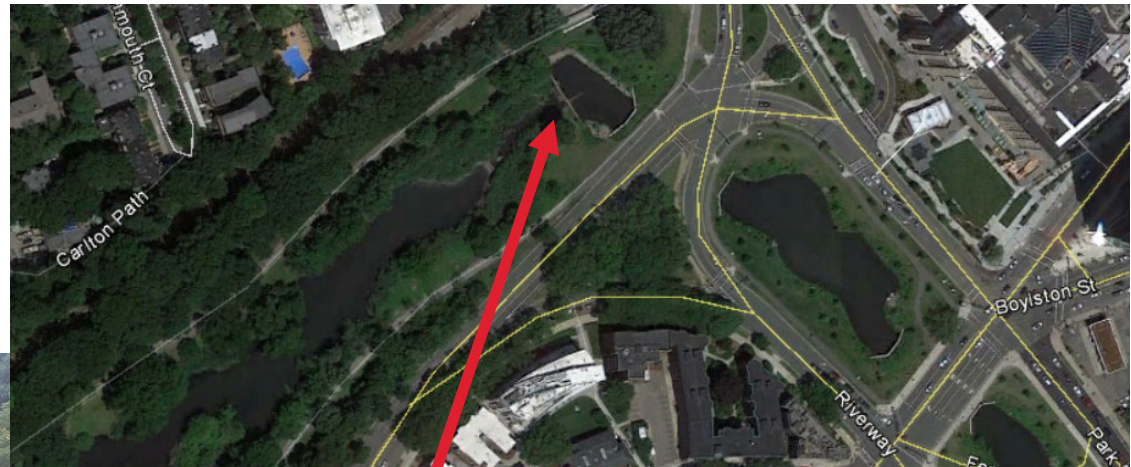
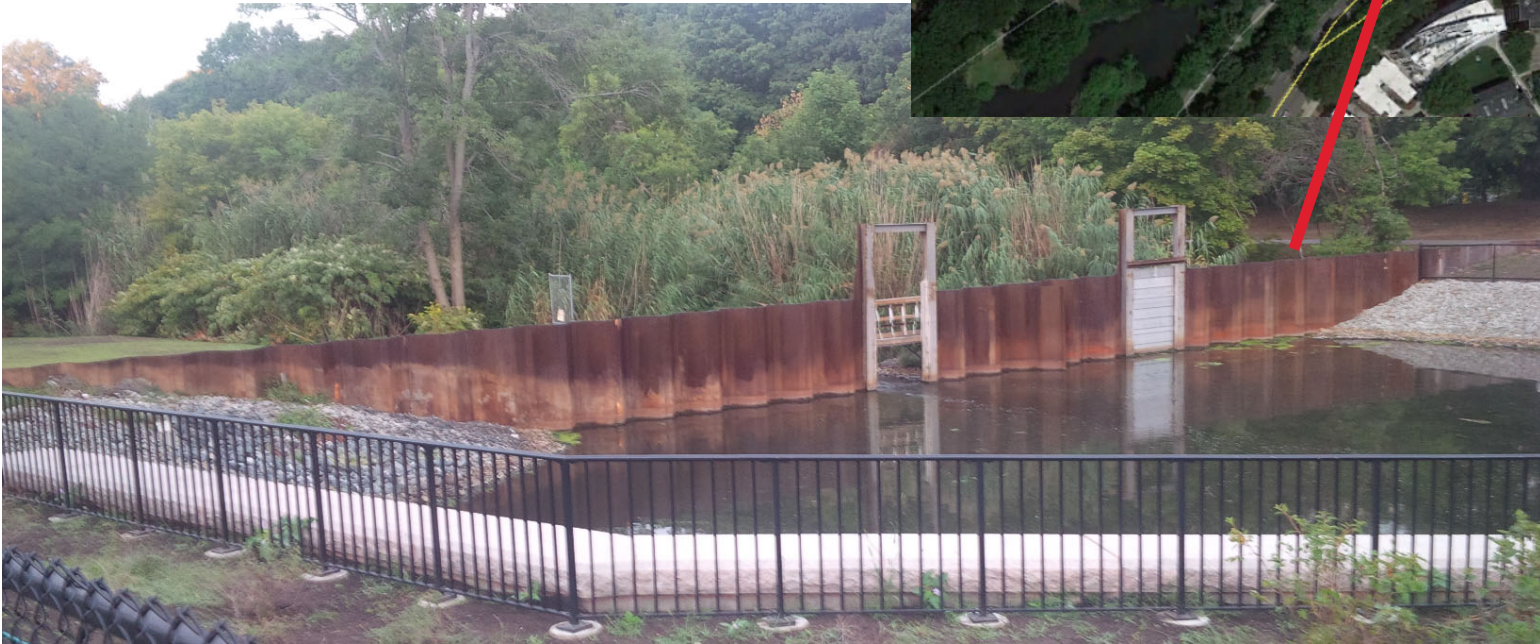
- Remove the temporary flow restriction control structure upstream of Phase 1 @ Riverway

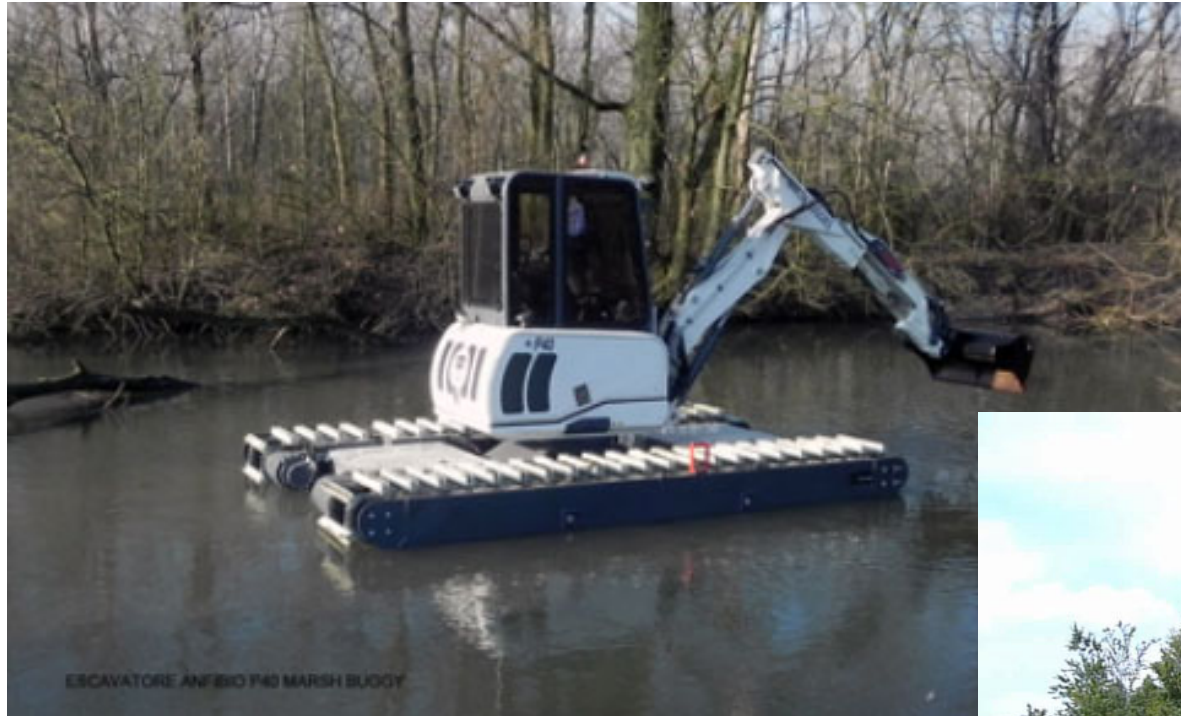
In the Wet

Marsh Buggy

Long Reach Excavator

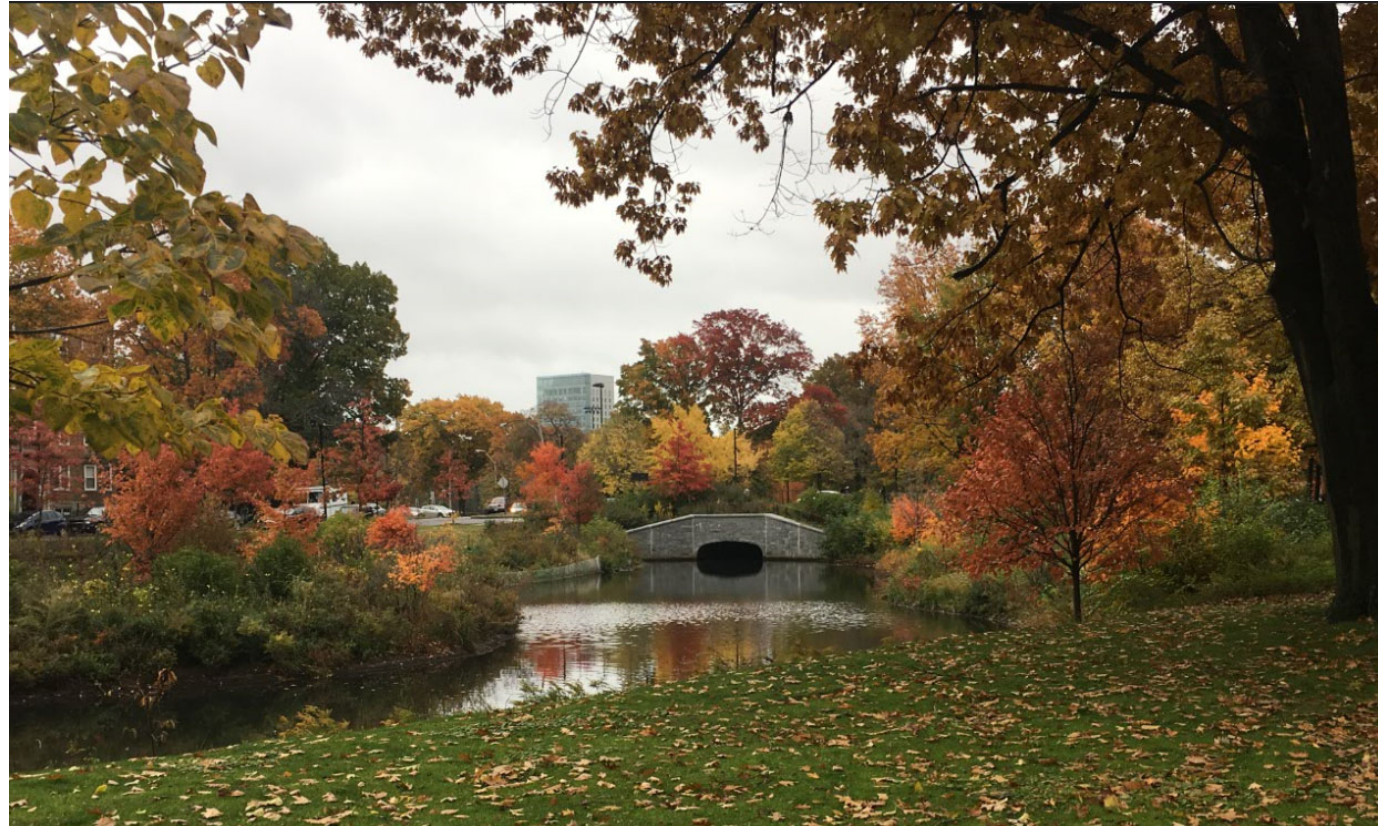
Improved water conveyance

- Water will move through the system faster
- Charles River water level still strongly influences Muddy River water level
- Dry periods may be longer
- Designed for “20-year storm”; doesn’t mean it comes around every 20 years = in any given year there is a 5% chance of a occurring
