Muddy River Flood Damage Reduction Project  
Phase 2 Construction Activities Next 90 Days  
October 2021

General: The Muddy River Flood Damage Reduction Phase 2 Construction Project is located in the footprint generally between Leverett Pond to Boylston Street in Boston and Brookline. The major project components involve dredging 1 to 8' of sediment for flow conveyance in the Back Bay Fens and the Riverway sections of the Muddy River. It also includes excavation of the sandbar and island at Leverett Pond. Work also includes the removal of *phragmites* from the wetland and riparian areas which affect flow conveyance. After removal of river sediments and *phragmites*, preservation and restoration of the historic park shoreline in construction areas will consist of planting emergent wetland plants and restoring riparian vegetation in upland areas by planting trees and shrubs. This Notice is intended to identify the general construction activities that will be performed in the next 90 days. A figure that shows a typical flood control channel and the proposed improvements is at the end of this report.

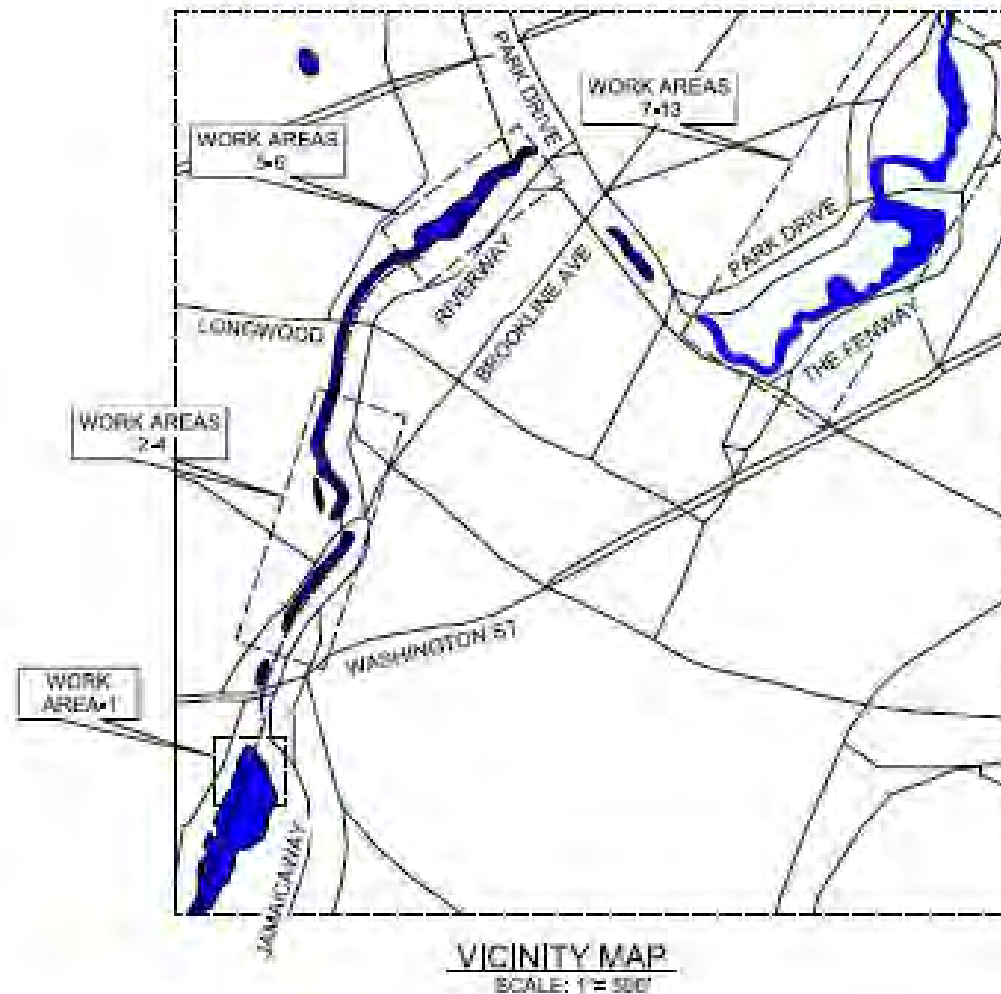
## EXTENTS OF PROJECT WORK AREA FOR PHASE 2 CONSTRUCTION

- Dredging of the Muddy River is divided into 12 work areas as shown in the Vicinity Map, with 6 work areas upstream of the Riverway and 6 work areas downstream of Ave. Louis Pasteur. At this time, the contractor continues dredging in Work Area #10.

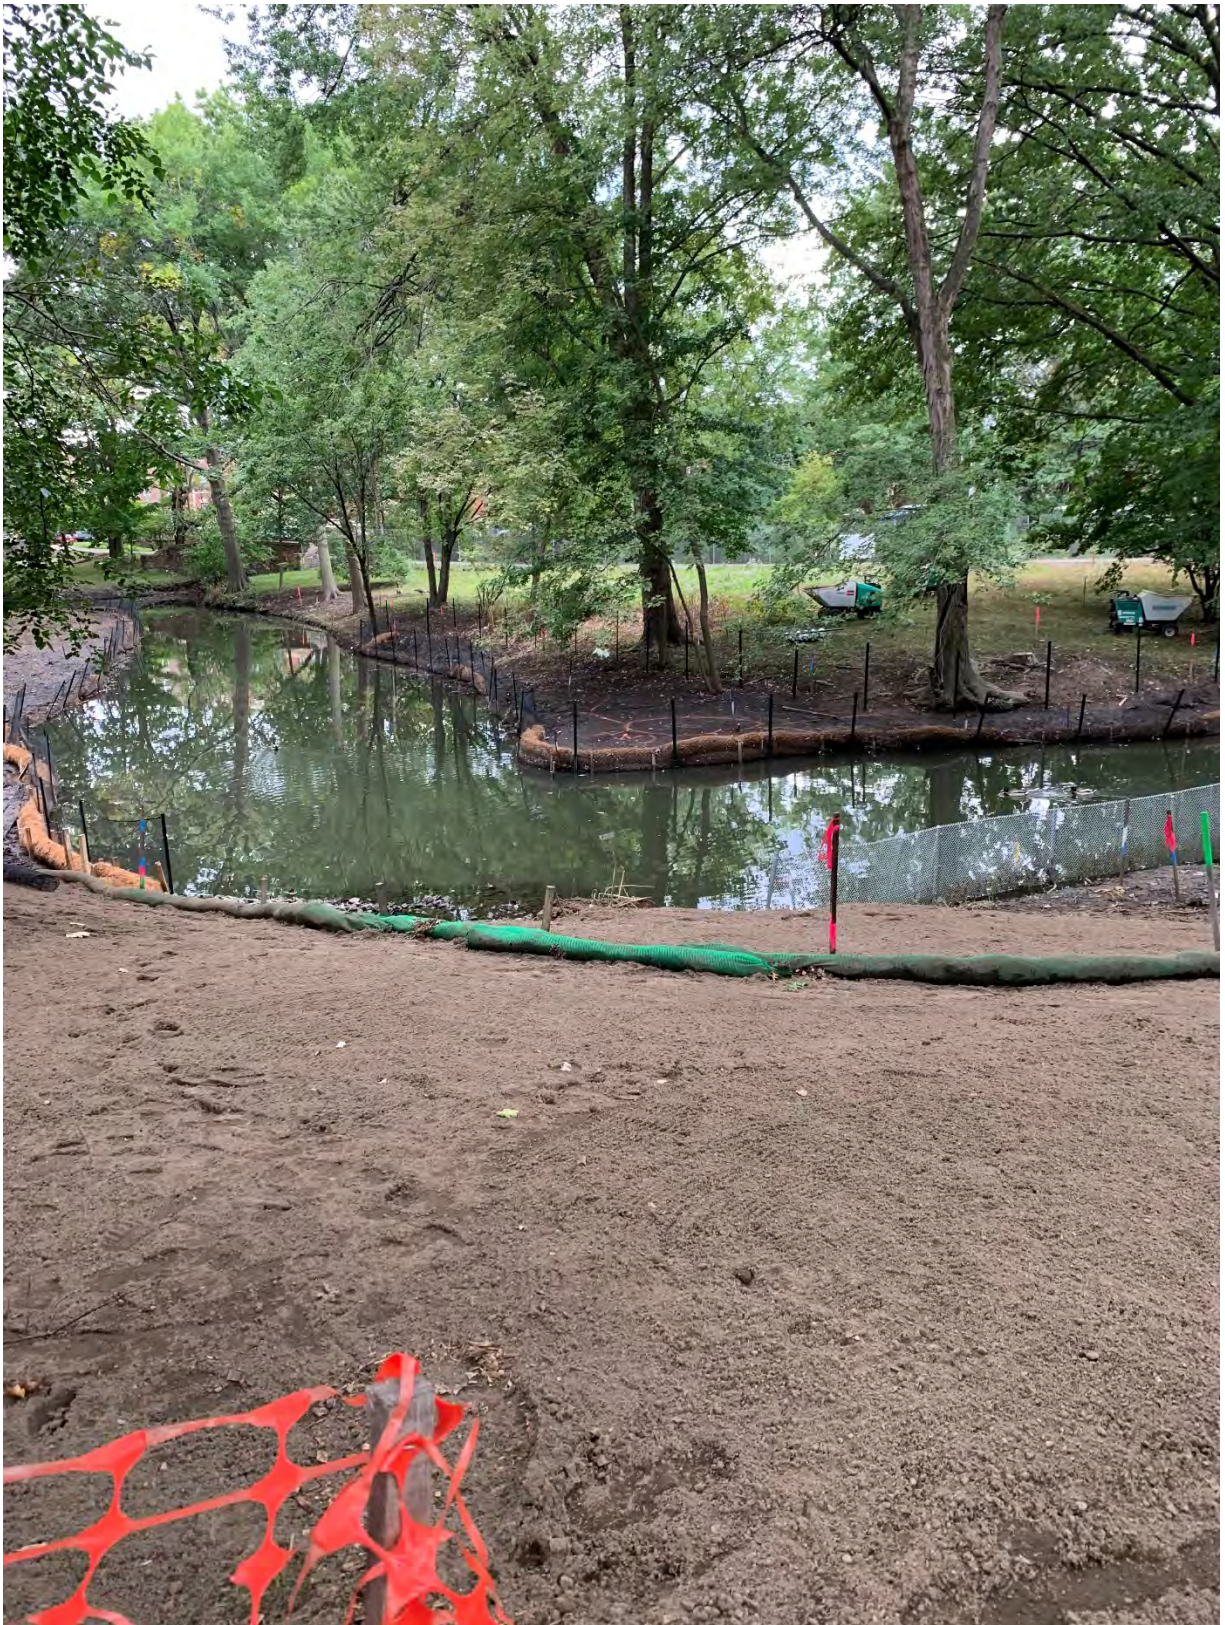
Work Area #3 – section of river at Brookline Avenue, the Riverway, and Netherlands Road – near Beth Israel Deaconess Hospital – view of graded bank on the near side and across the river is the constructed wetland shelf with coir log. Also installed is the temporary herbivore deterrent fence.

- **Work Area #3** – section of river at Brookline Avenue, the Riverway, and Netherlands Road – near Beth Israel Deaconess Hospital – the contractor completed dredging this section late-March 2021. Surveying was done in May to confirm new flood risk management cross sections. Since that time, a review of the as-dredged conditions has taken place to confirm plant locations and topsoil quality to optimize planting success. Grading of the site and wetland construction began late September. Trees and upland planting will begin later this week and continue after Columbus Day and all planting, seeding, and path restoration will be completed by October. Maintenance of the planting will begin immediately during the two-year plant guarantee period.

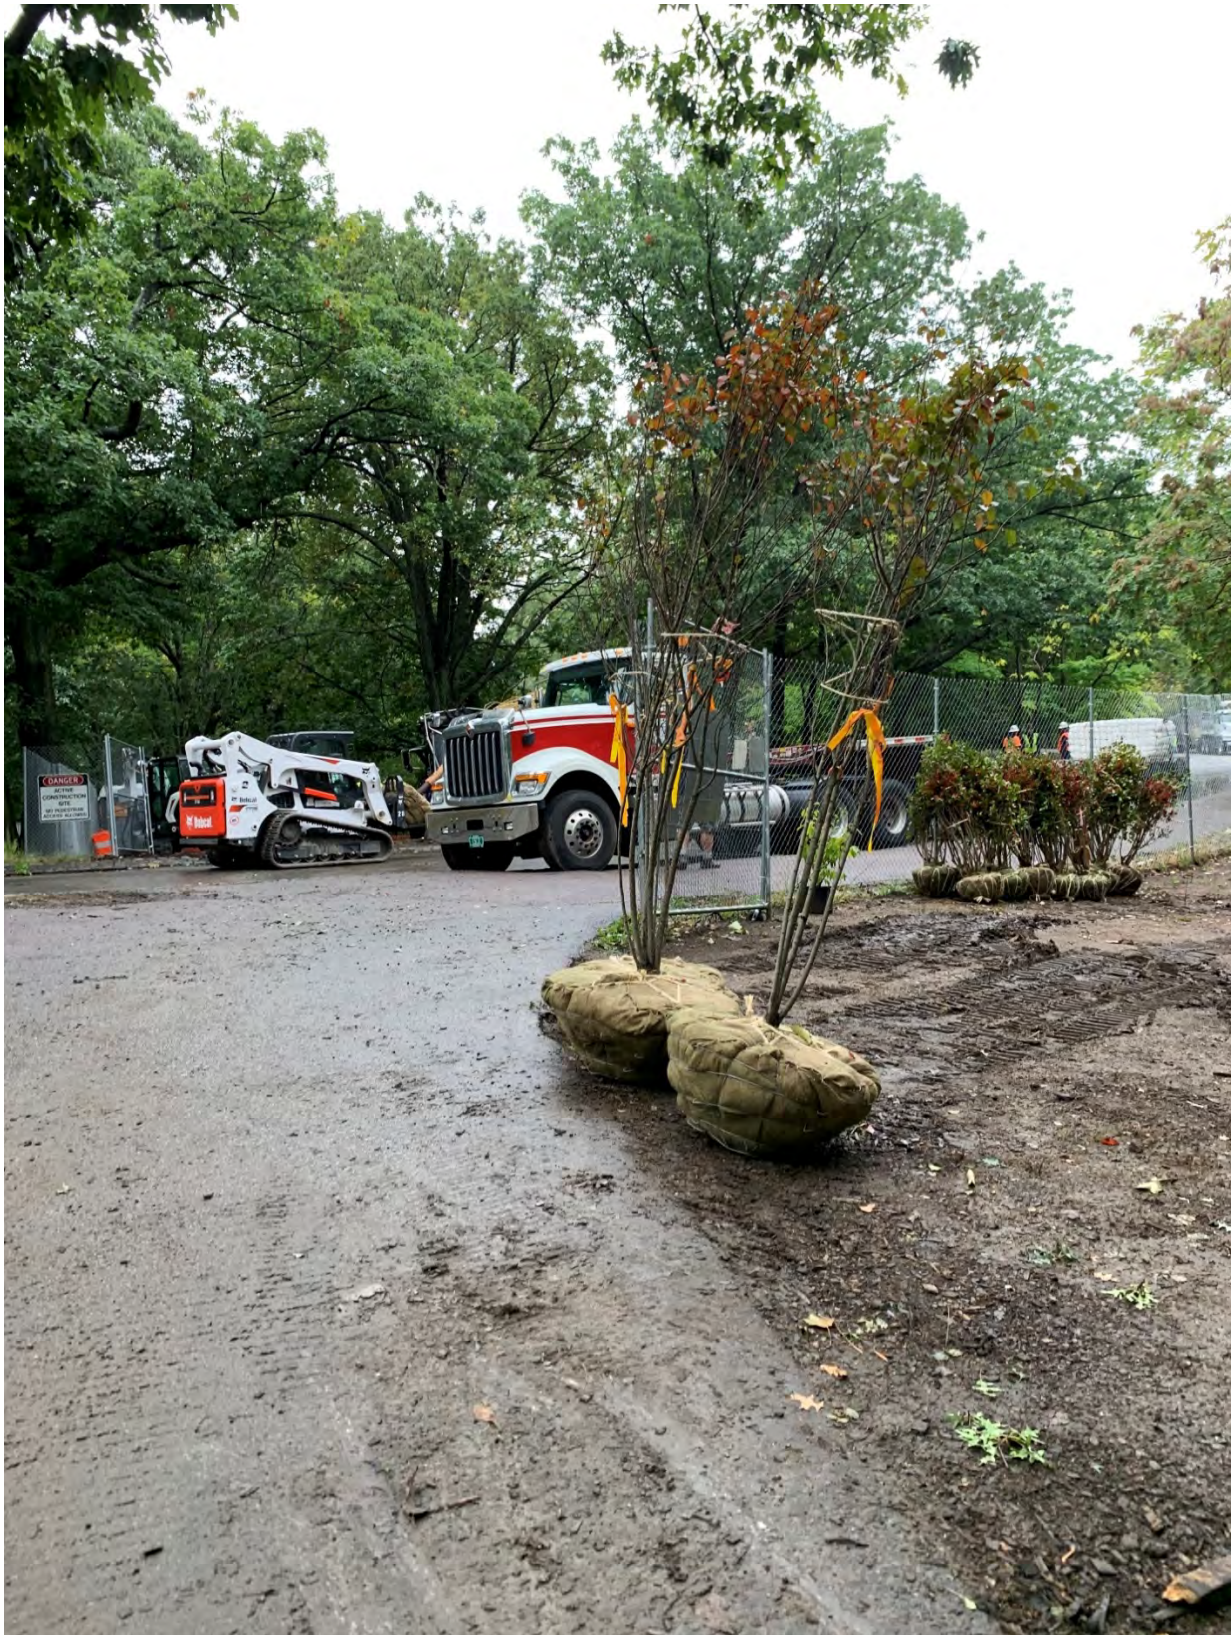
Work Area #4 – section of river immediately downstream of Work Area #3, across Netherlands Road – tree and shrub delivered to the site ready for planting.

- **Work Area #4** – section of river immediately downstream of Work Area #3, across Netherlands Road – the contractor completed dredging this section early April 2021. Surveying was done late May to confirm new flood risk management cross sections. Since that time, a review of the as-dredged conditions has taken place to confirm plant locations and topsoil quality to optimize planting success. Grading of the site and wetland construction began mid-September. Upland planting began last week and will continue with more planting and tree plantings later this week and continue after Columbus Day and all planting, seeding, and path restoration will be completed by October. Maintenance of the planting will begin immediately during the two-year plant guarantee period.

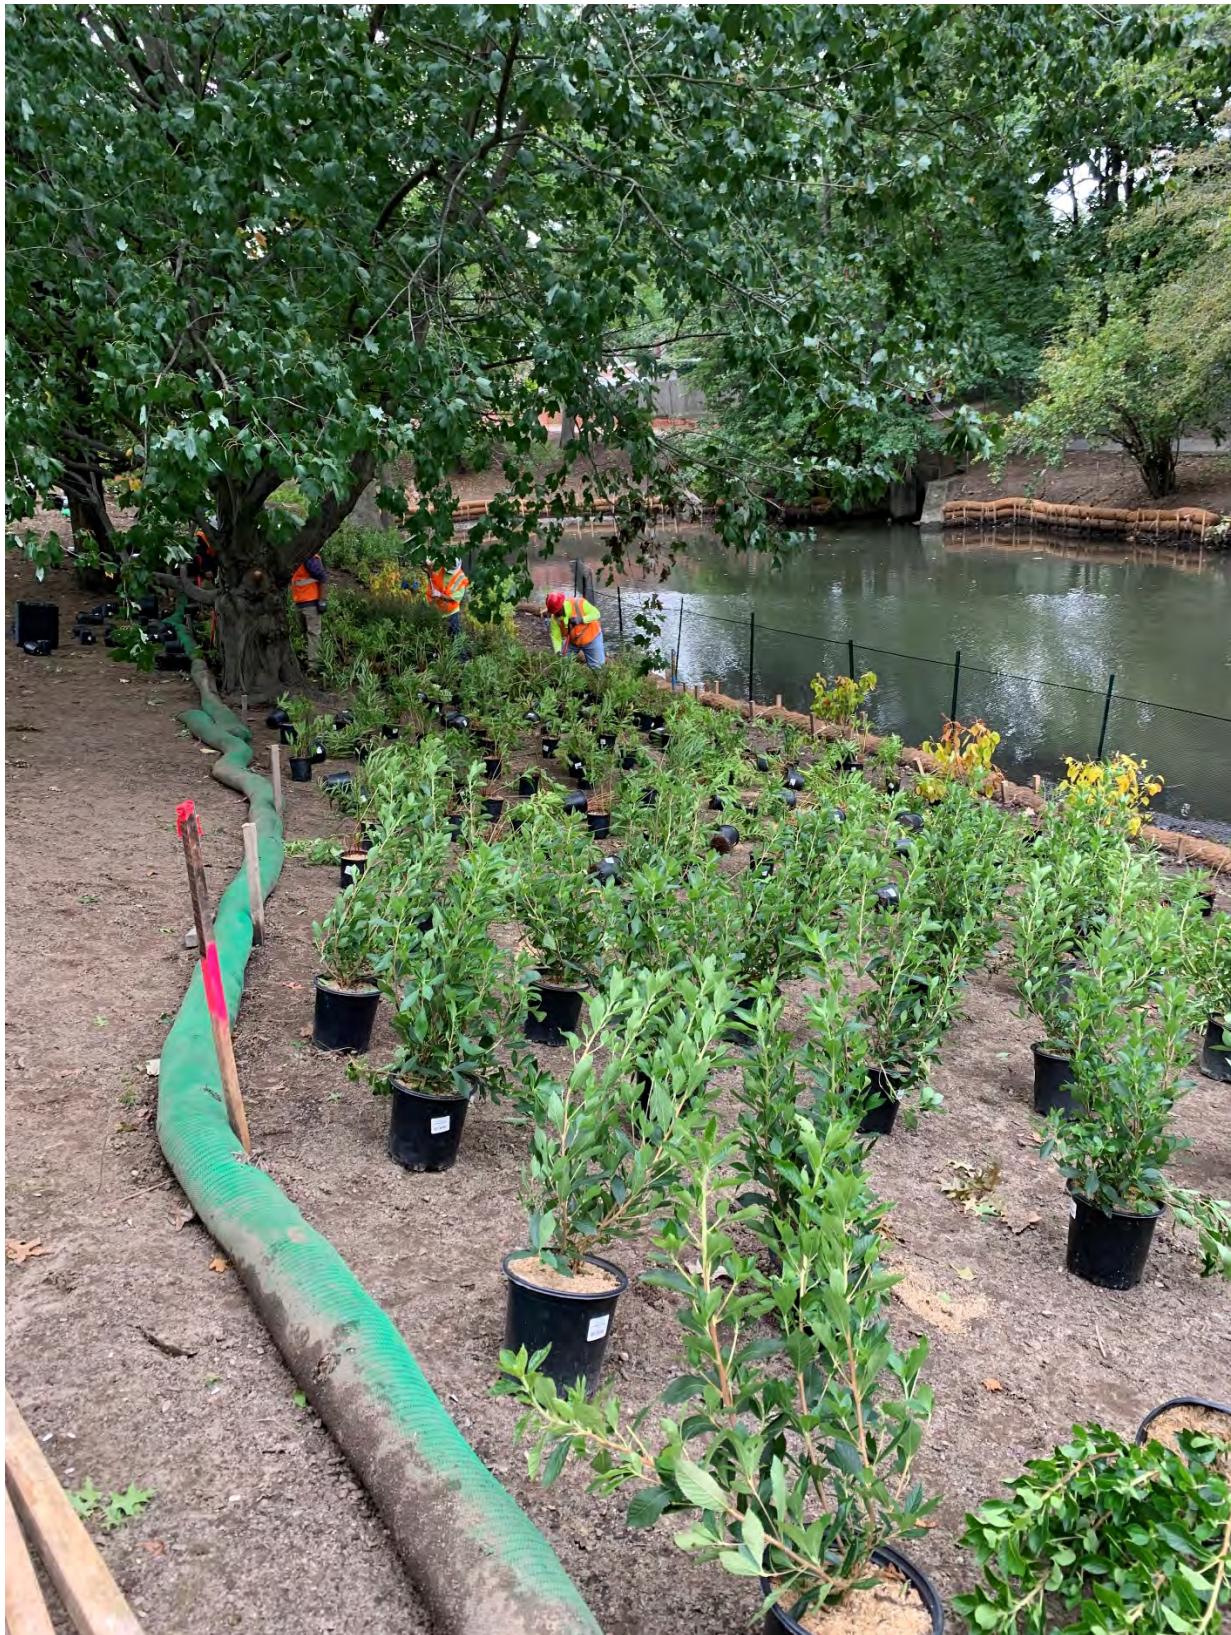
Work Area #4 – section of river immediately downstream of Work Area #3, across Netherlands Road – landscapers installing plants on the graded bank which are laid out by the landscape architect.

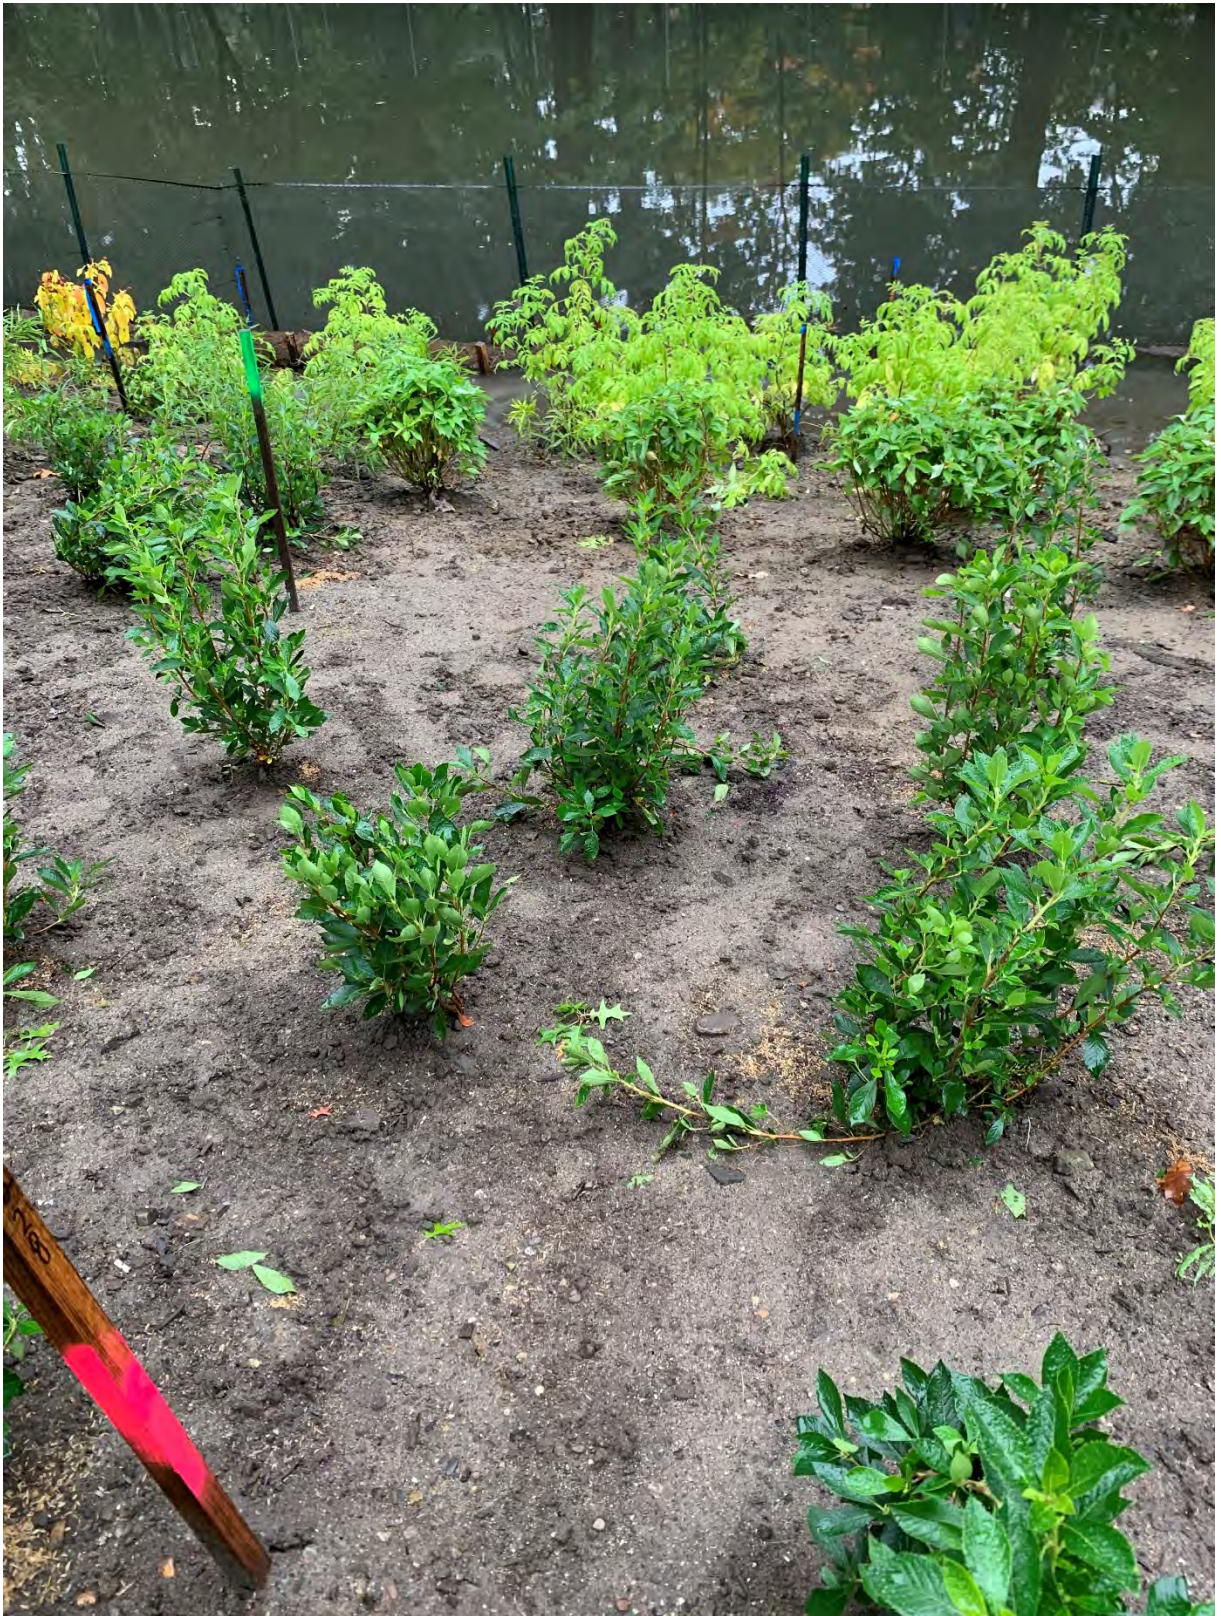
Work Area #4 – section of river immediately downstream of Work Area #3, across Netherlands Road – installed plantings. Two-year guarantee and maintenance period will begin shortly after provisional acceptance.

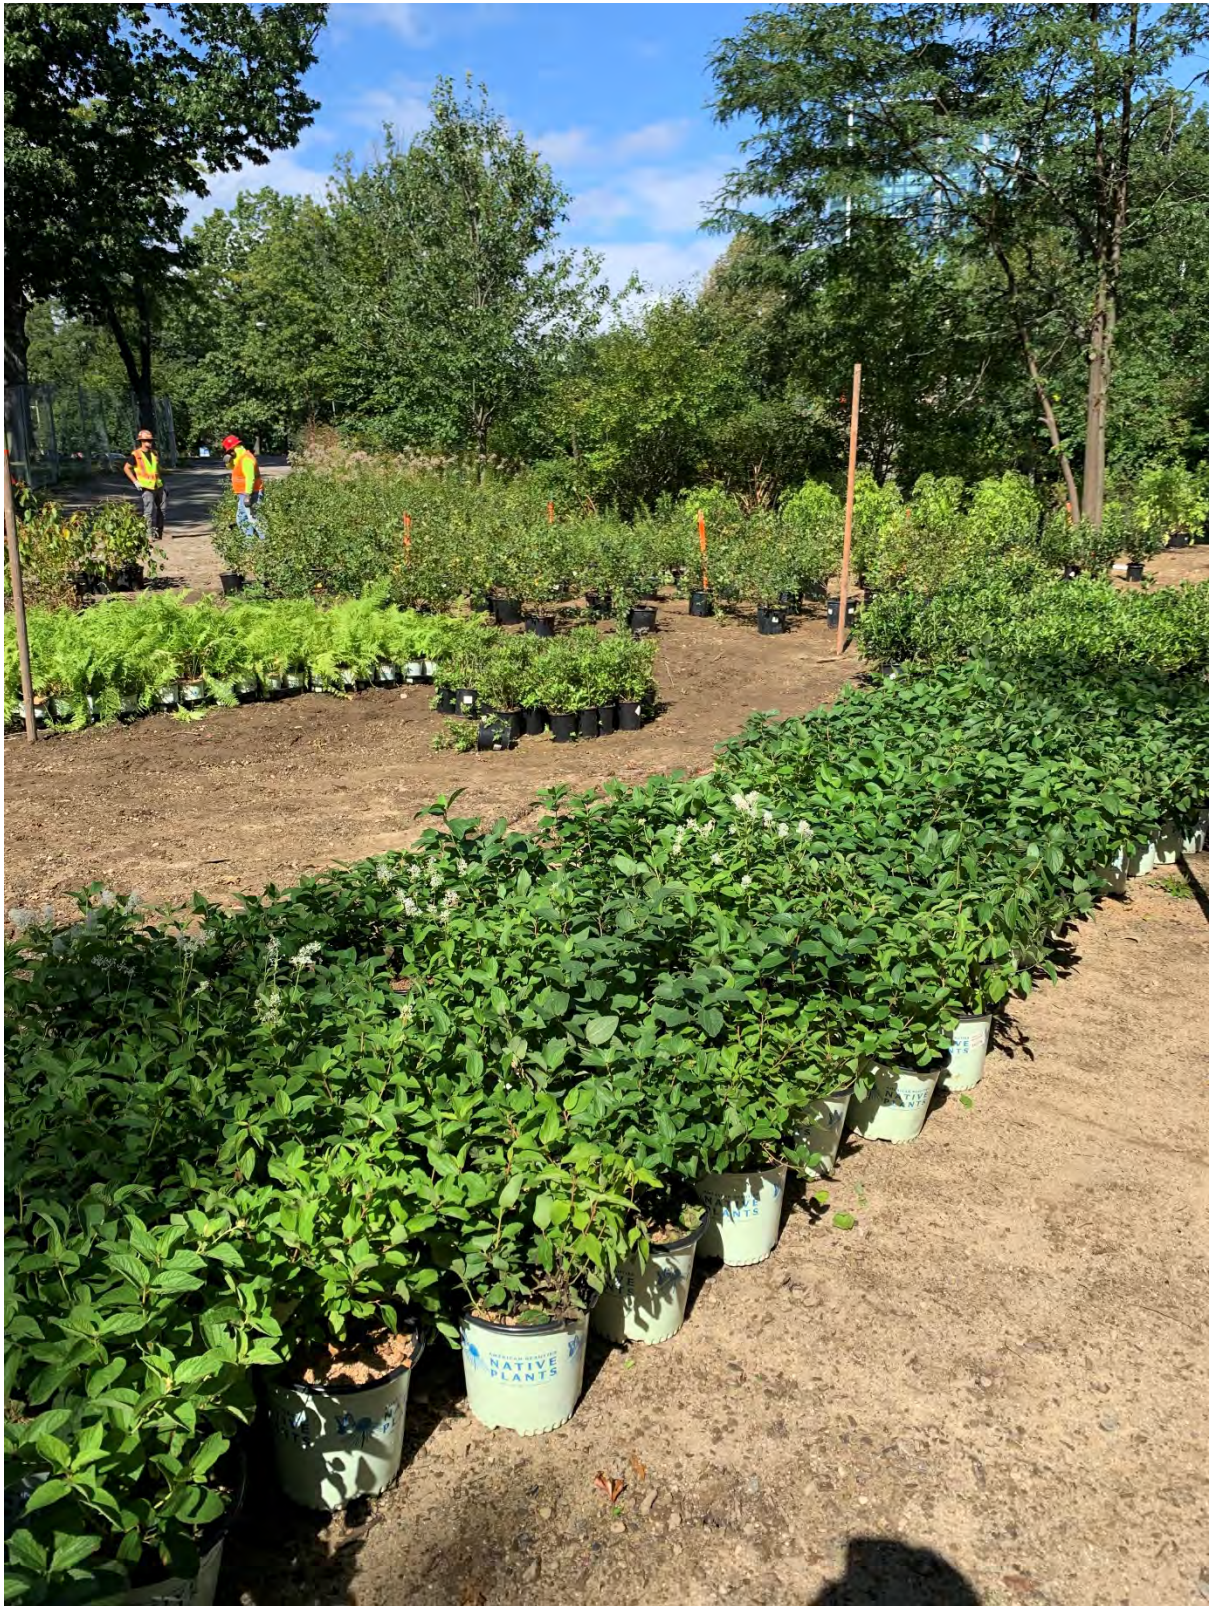
Work Area #7 – section of river immediately downstream of Avenue Louis Pasteur – shrub delivery. Note the pole which designates the new tree location.

- **Work Area #7** – section of river immediately downstream of Avenue Louis Pasteur – the contractor completed dredging this section at the end of December 2020. Surveying was done in early January to confirm new flood risk management cross sections. Since that time, a review of the as-dredged conditions has taken place to confirm plant locations and topsoil quality to optimize planting success. Grading of the site and wetland construction began early September. All upland plants have been planted. Trees will be delivered this week and will be planted by Columbus Day and all planting, seeding, and path restoration will be completed by October. Maintenance of the planting will begin immediately during the two-year plant guarantee period.

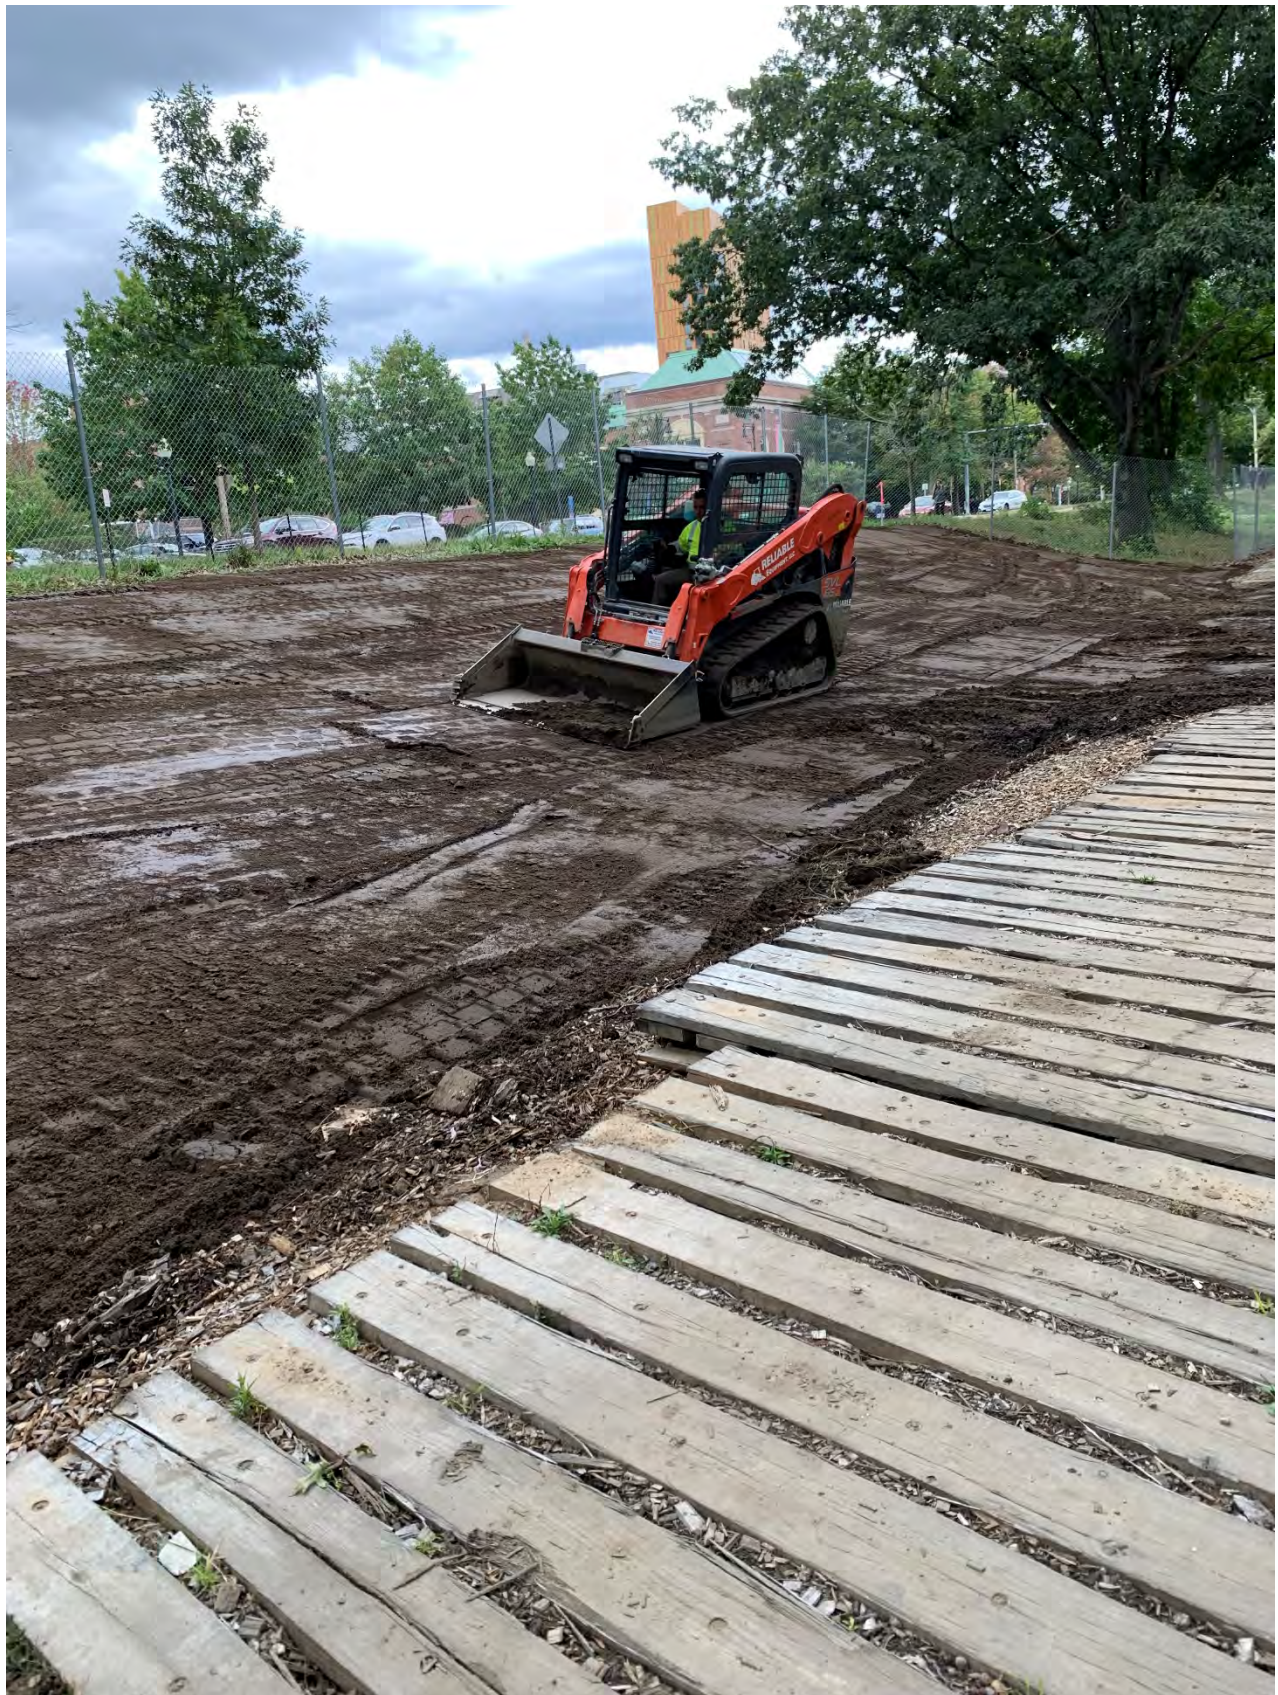
Work Area #8 – section of river downstream of Work Area #7 which is immediately downstream of Avenue Louis Pasteur  
– grading of the storage and staging area for restoration. Seed will be put down shortly.

- **Work Area #8** – section of river immediately downstream of Work Area #7 – the contractor completed dredging this section before the end of February 2021. Surveying was done in late February to confirm new flood risk management cross sections. Since that time, a review of the as-dredged conditions has taken place to confirm plant locations and topsoil quality to optimize planting success. All upland plants have been planted. Trees will be delivered this week and will be planted by Columbus Day and all planting, seeding, and path restoration will be completed by October. Maintenance of the planting will begin immediately during the two-year plant guarantee period.

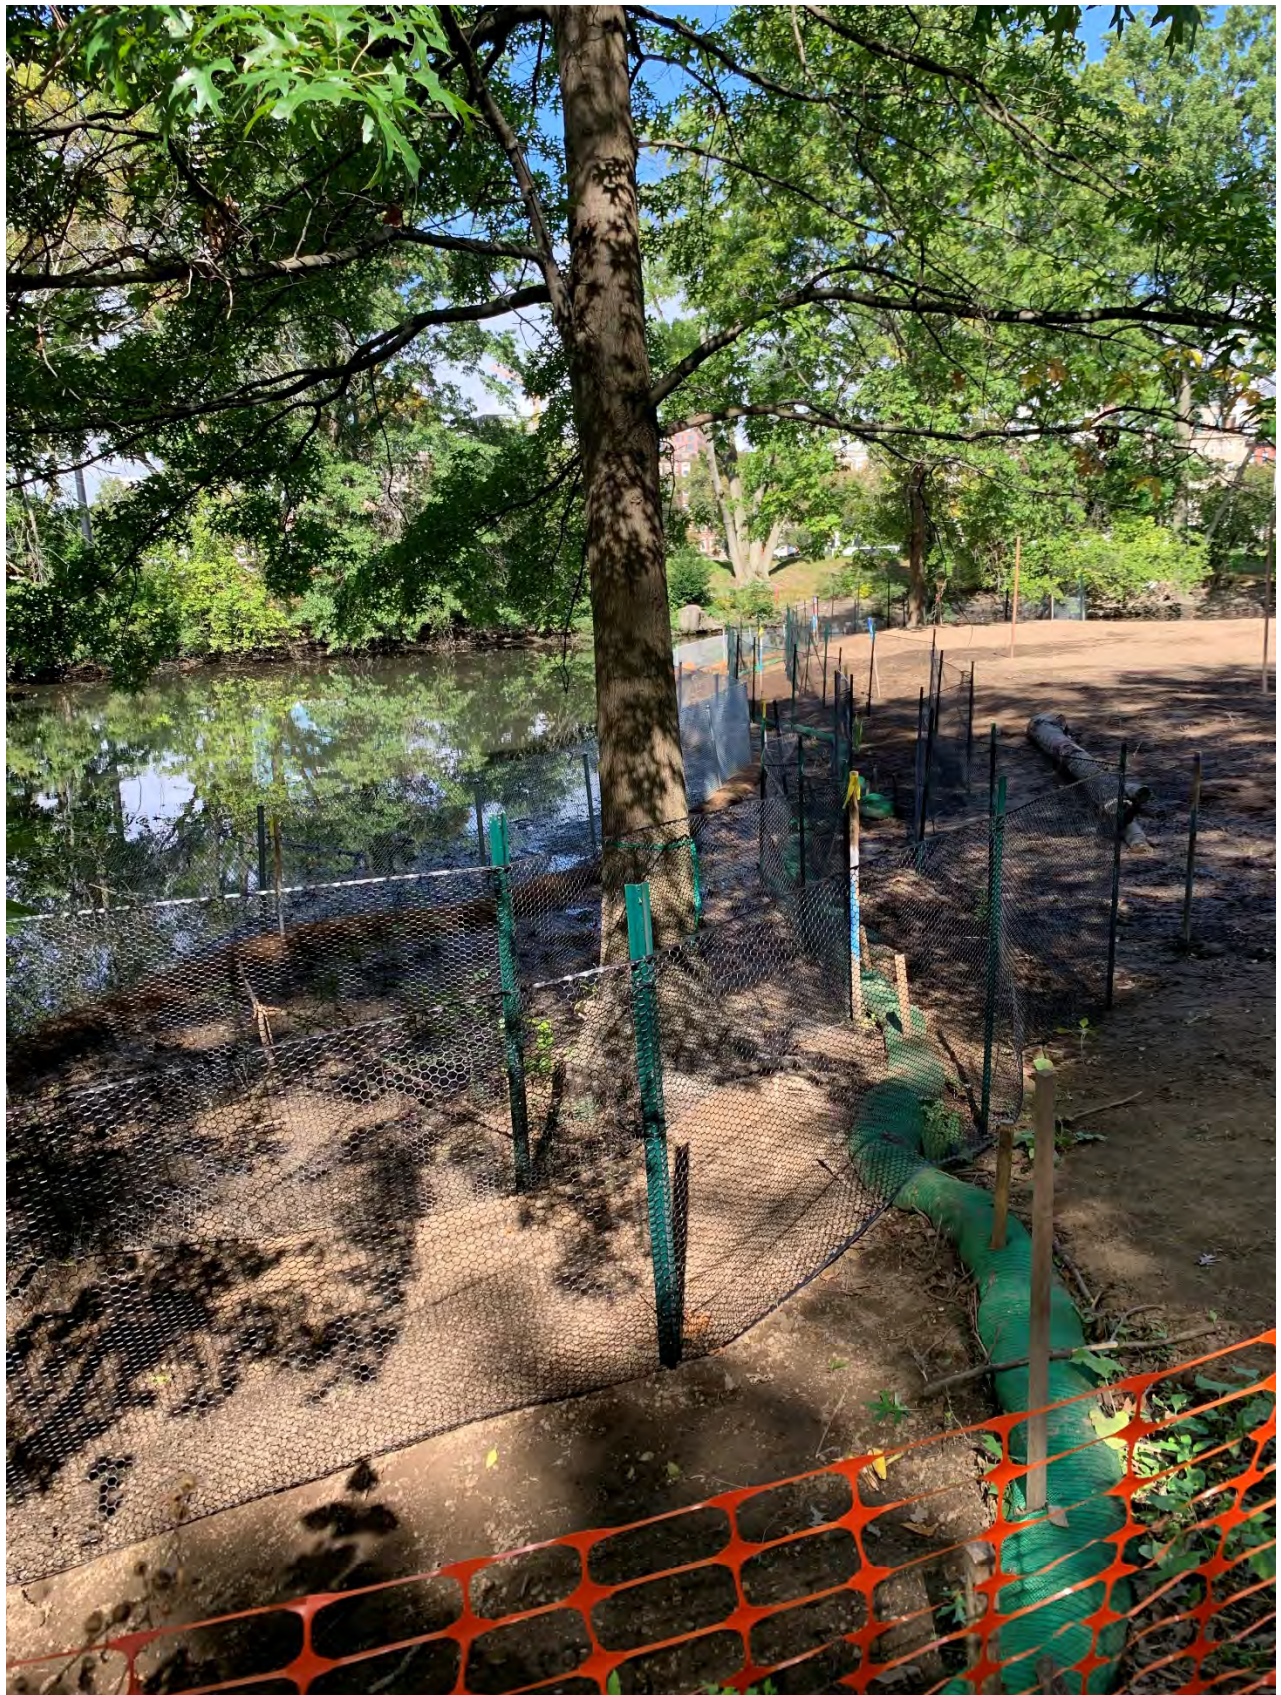
Work Area #9 – section of river immediately downstream of Work Area #8 – constructed wetland shelves A (pickerel weed emergent plants) and B (wetland seed mix). Note the layers of temporary herbivore deterrent fence and temporary in-channel carp deterrent fence to allow for plant establishing during the two-year guarantee period.

- **Work Area #9** – section of river immediately downstream of Work Area #8 – the contractor completed dredging this section mid-April 2021. Surveying was done in late June to confirm new flood risk management cross sections. Since that time, a review of the as-dredged conditions has taken place to confirm plant locations and topsoil quality to optimize planting success. All upland plants have been planted. Trees will be delivered this week and will be planted by Columbus Day and all planting, seeding, and path restoration will be completed by October. Maintenance of the planting will begin immediately during the two-year plant guarantee period.

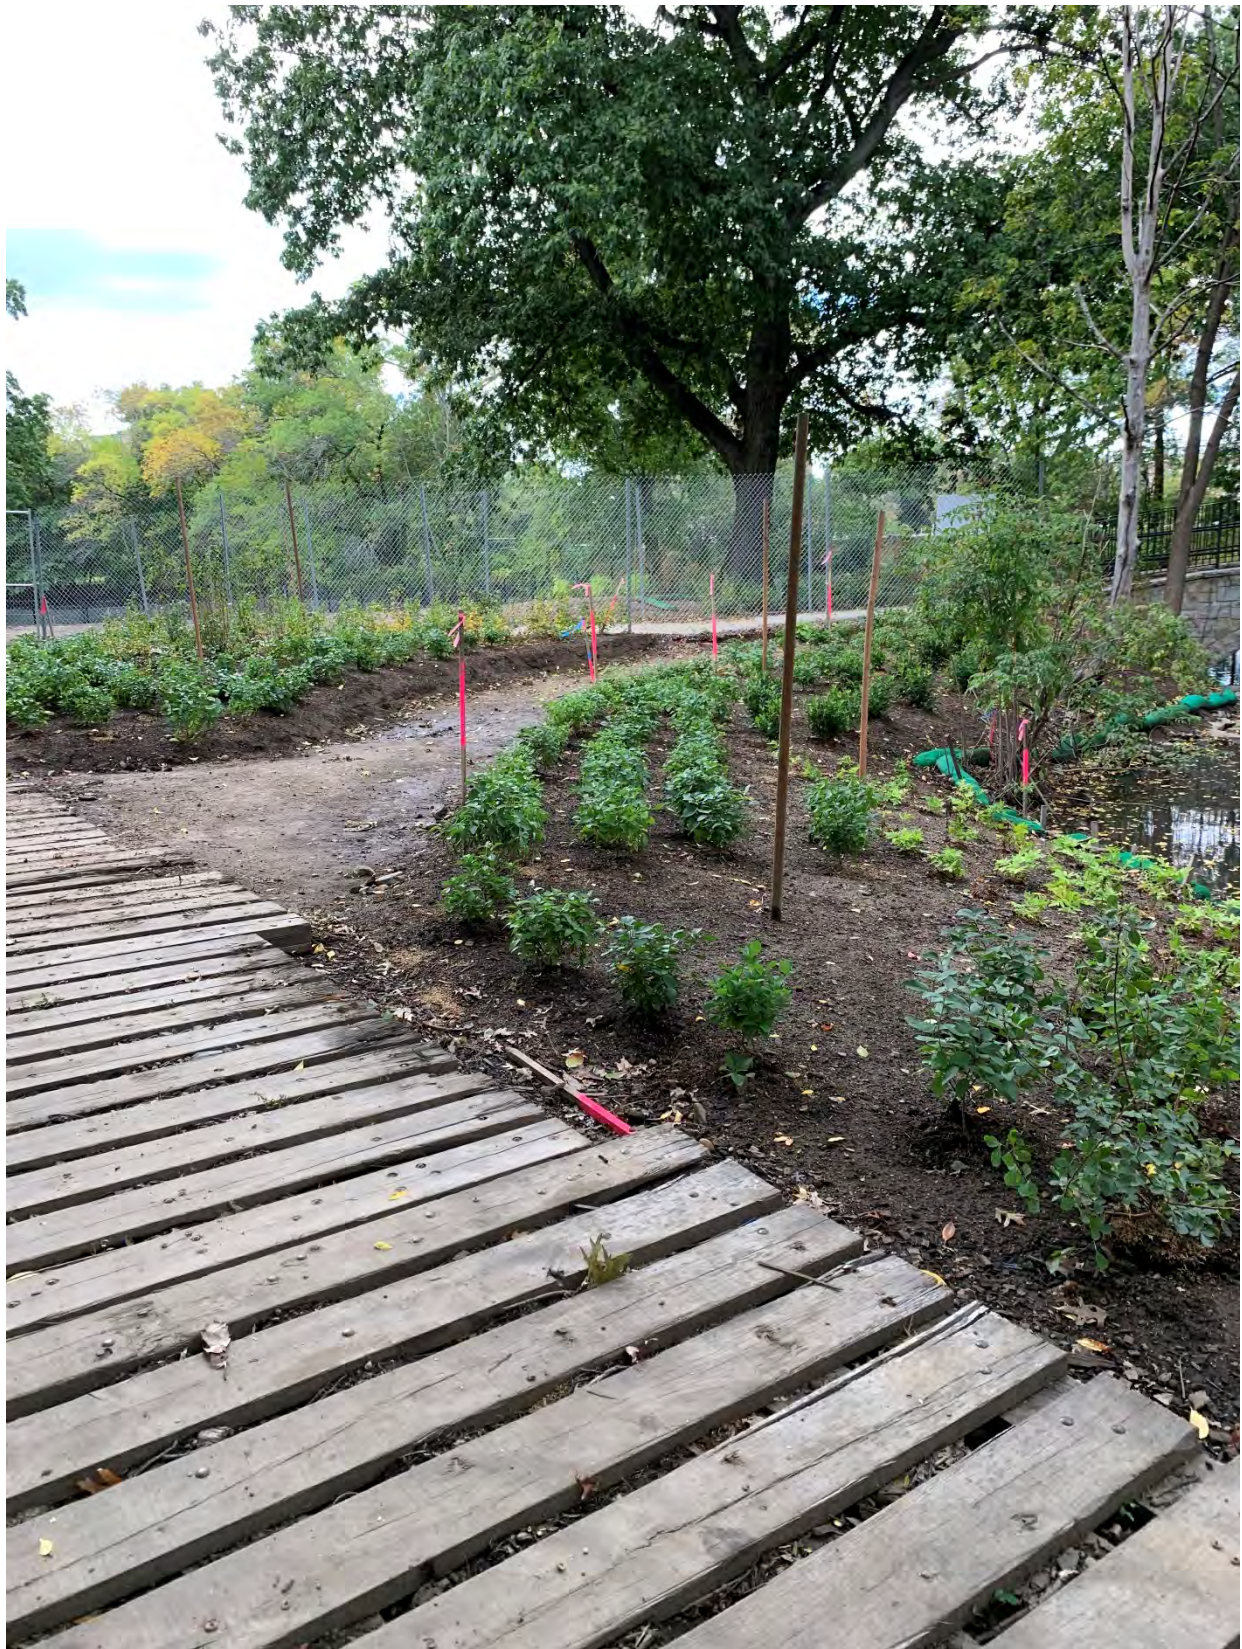
Work Area #9 – section of river immediately downstream of Work Area #8 – constructed shrub beds for restoration and the existing stonedust pathway which will also be restored. Note the long pole which designates the new tree location.

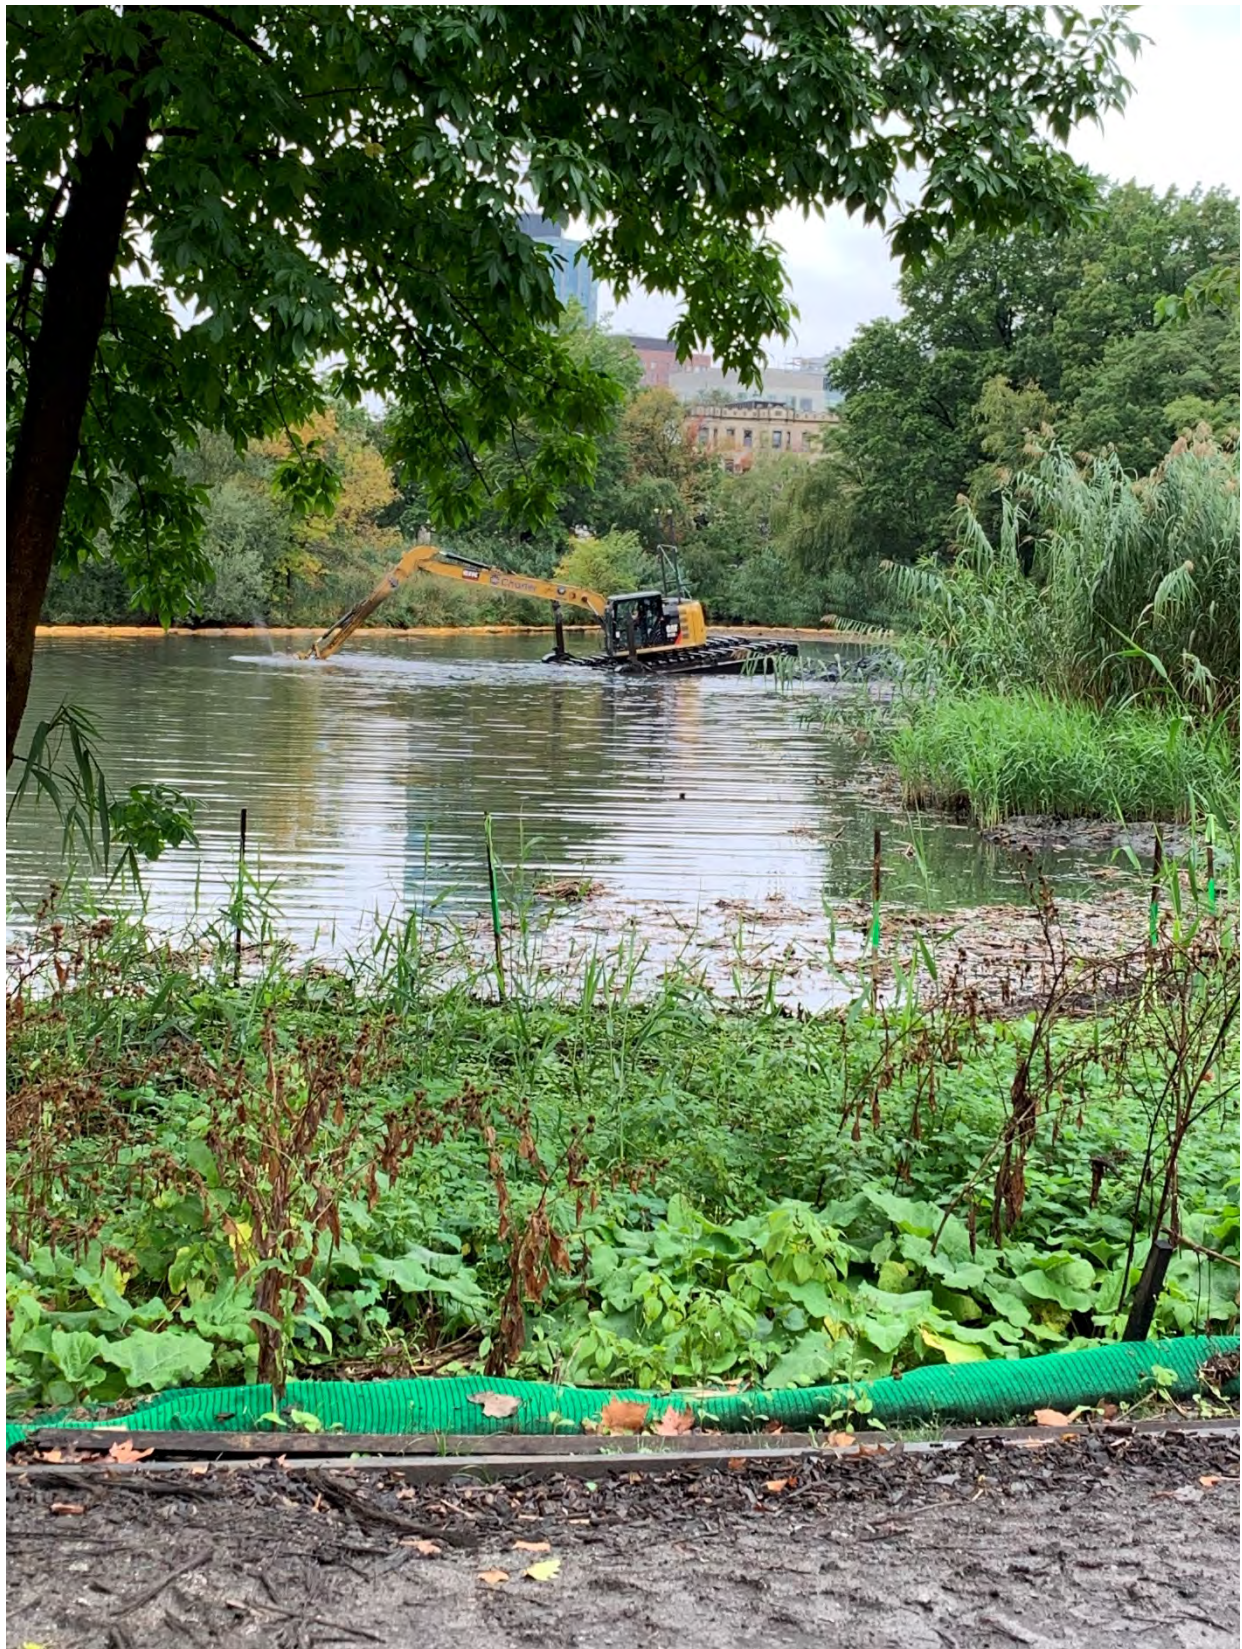
Work Area #10 – section of river immediately downstream of Work Area #9 which ends at Agassiz Road – amphibious excavator dredging the sediment from the river.

- **Work Area #10** – section of river immediately downstream of Work Area #9 which ends at Agassiz Road – dredging began in late April 2021 and will continue for several months and work will continue into next year in this work area. Work Area #10 has the largest quantity of dredged sediment to be removed at about 35,000cy. As planned, the dredge equipment (amphibious excavator) from Work Area #1 was mobilized to Work Area #10 in mid-July to supplement the dredging efforts. As we approach the narrower part of the Work Area #10 towards the Agassiz Road Bridge, the 2<sup>nd</sup> amphibious excavator will no longer be required. The plan is to divert this equipment and crew either back upstream to dredge Work Areas #5 and #6 or downstream to dredge Work Areas #11 and #12 mid- to late-November. Planting and restoration of Work Area #10 will begin once dredging is complete – expected to be Spring 2022.
