FORMER NIKE BU 51/52 BATTERY LAUNCH AREA, HAMBURG, NY

HISTORICAL PHOTOGRAPHIC ANALYSIS

FINAL REPORT
APRIL 2020

Former Nike BU-51/52 Battery Launch Area Hamburg, Erie County, NY (FUDS C02NY0079)

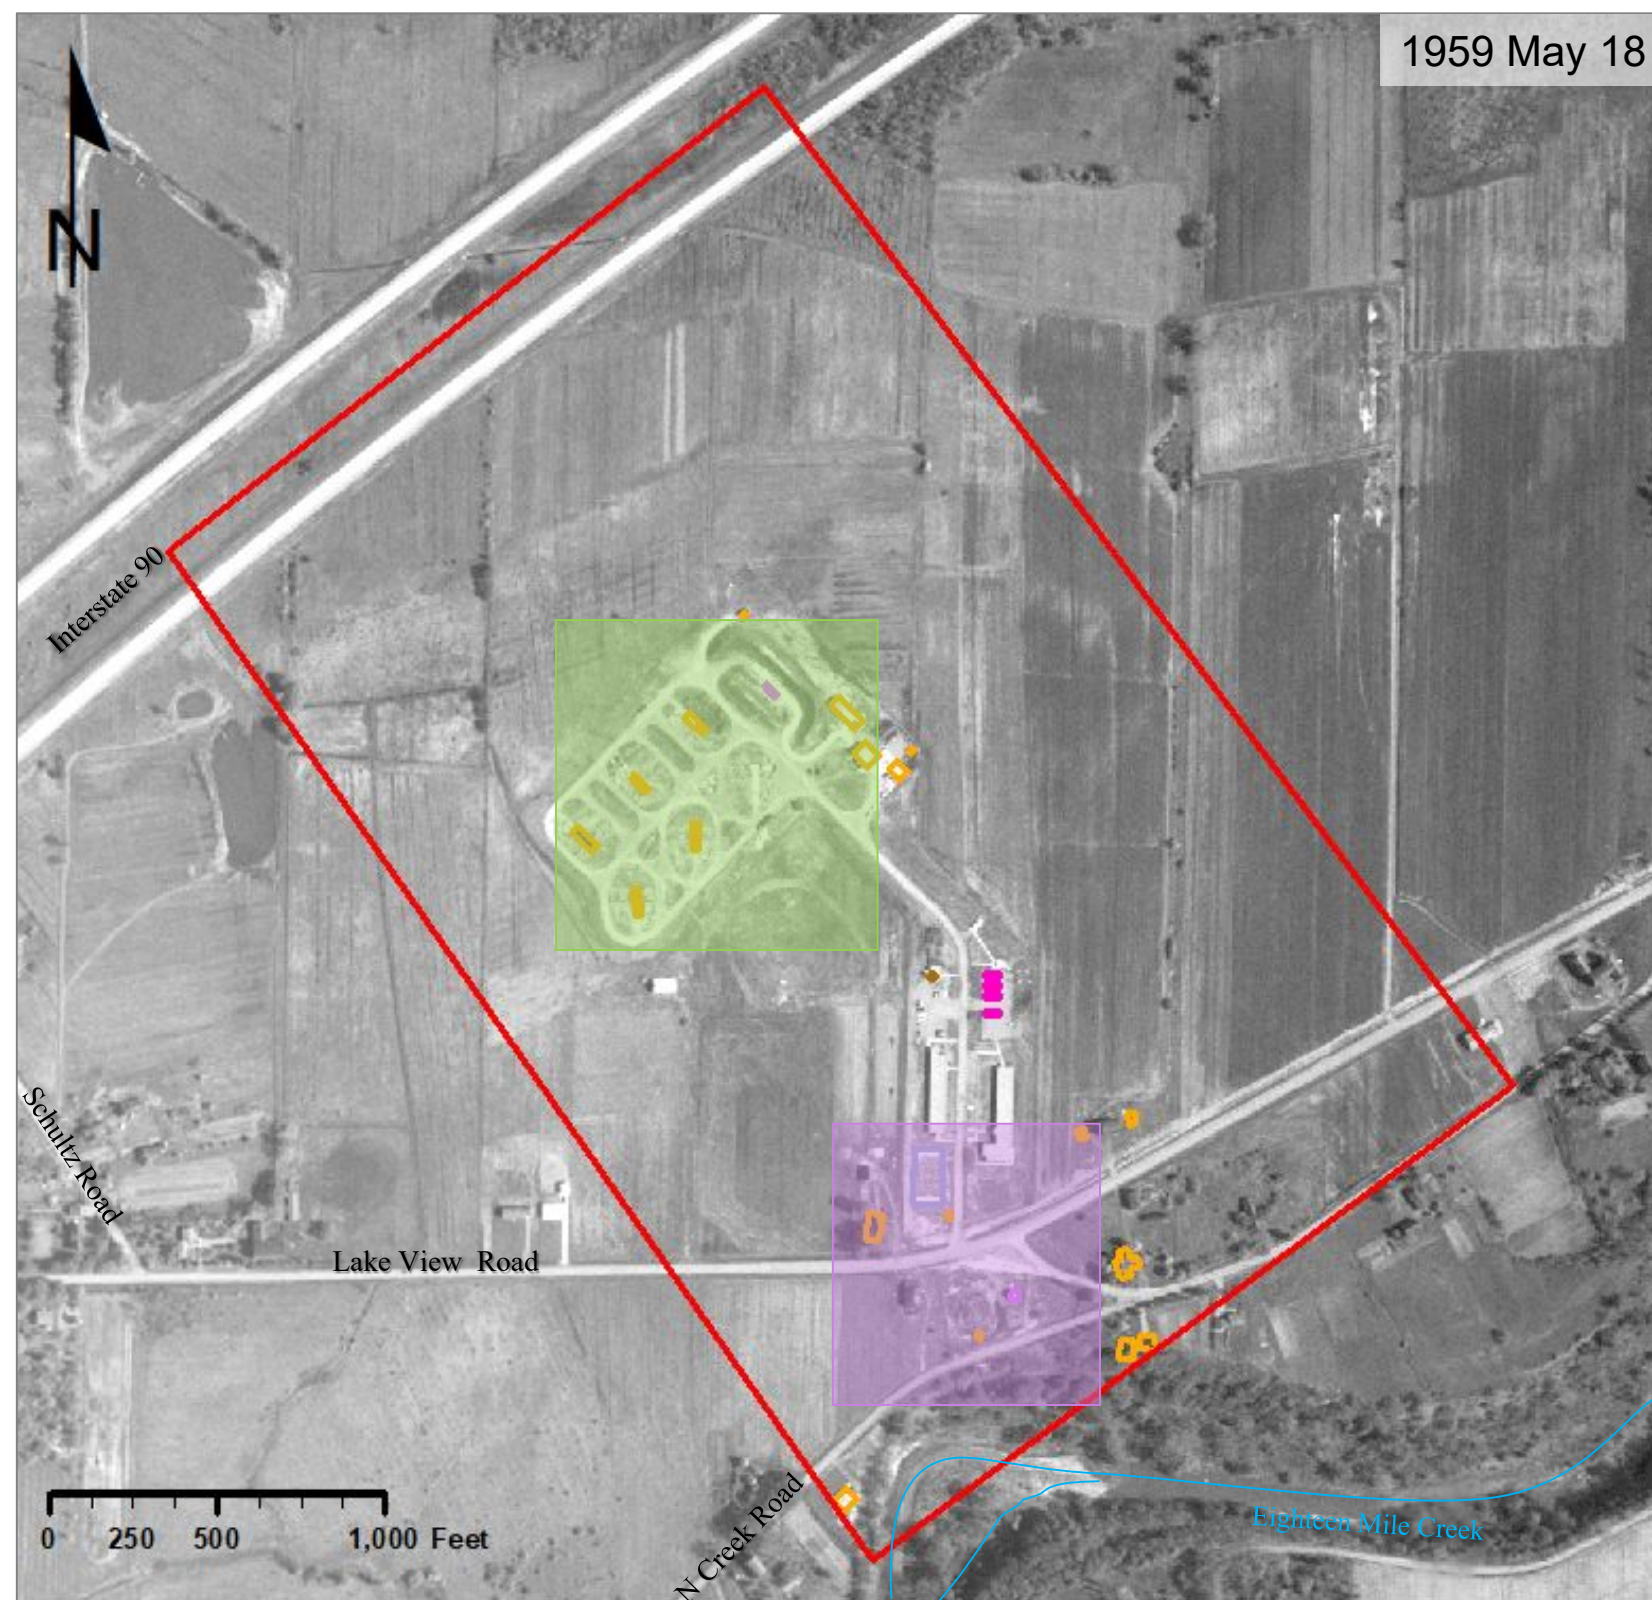
PHOTOGRAPHIC ANALYSIS: 1959

An aboveground storage tank (AST) is observed within the Acid Fueling Area.

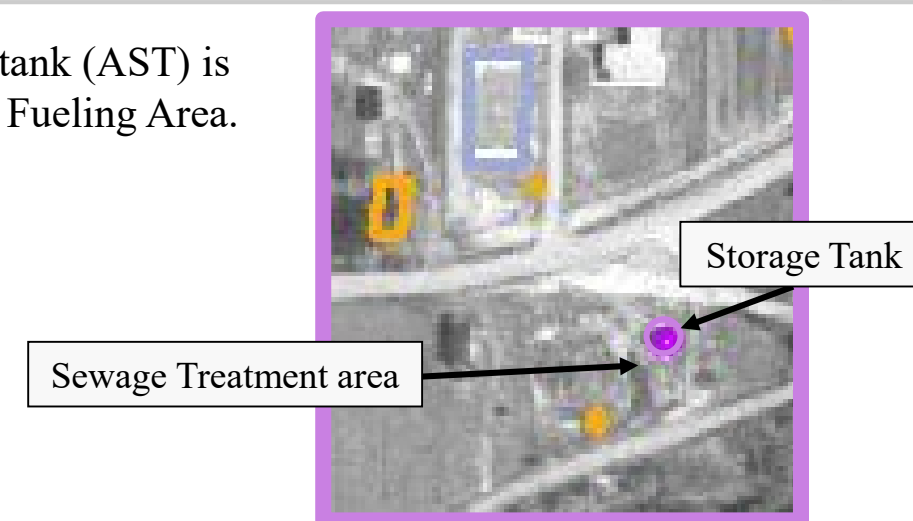
Storage Tank – Located in the Acid Fueling Area

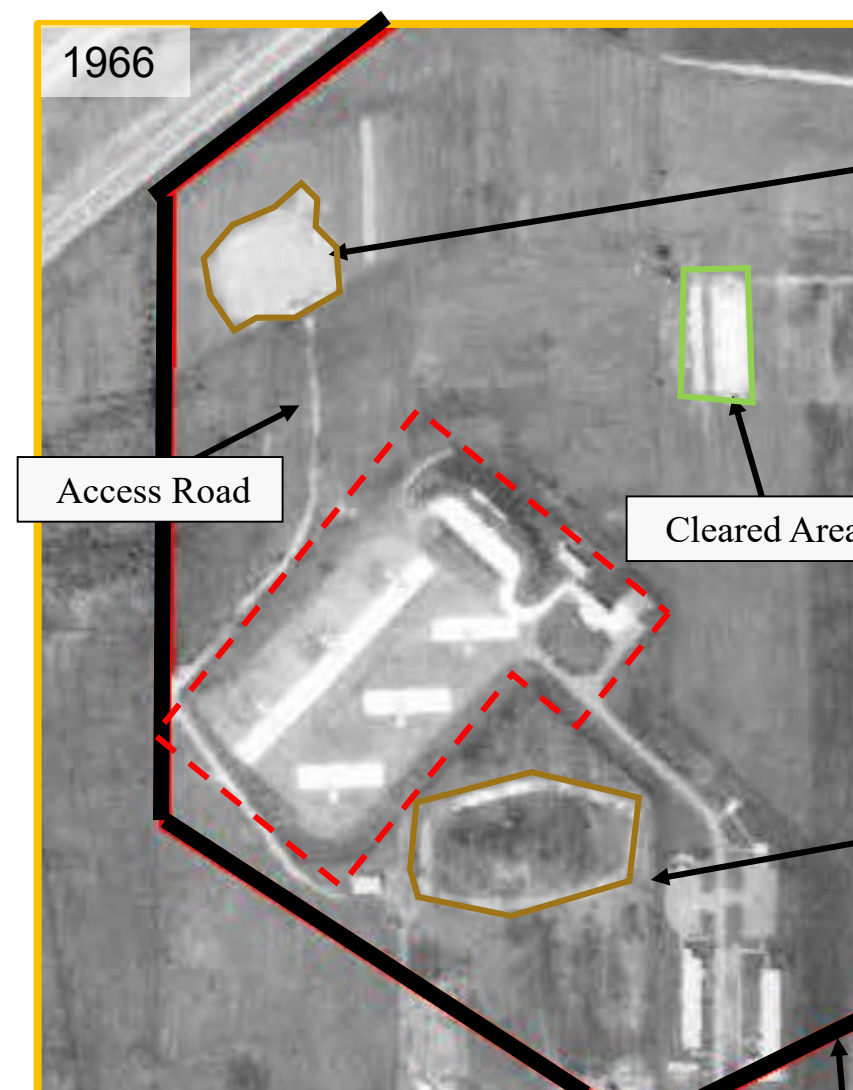
PHOTOGRAPHIC ANALYSIS: 1966, 1967

Newly cleared and disturbed area (with access road) north of the Launch Area is evident in the 1966 imagery.

- Area of Interest
- Underground Missile and Launcher Area
- Building
- Cleared Area
- Disturbed Ground

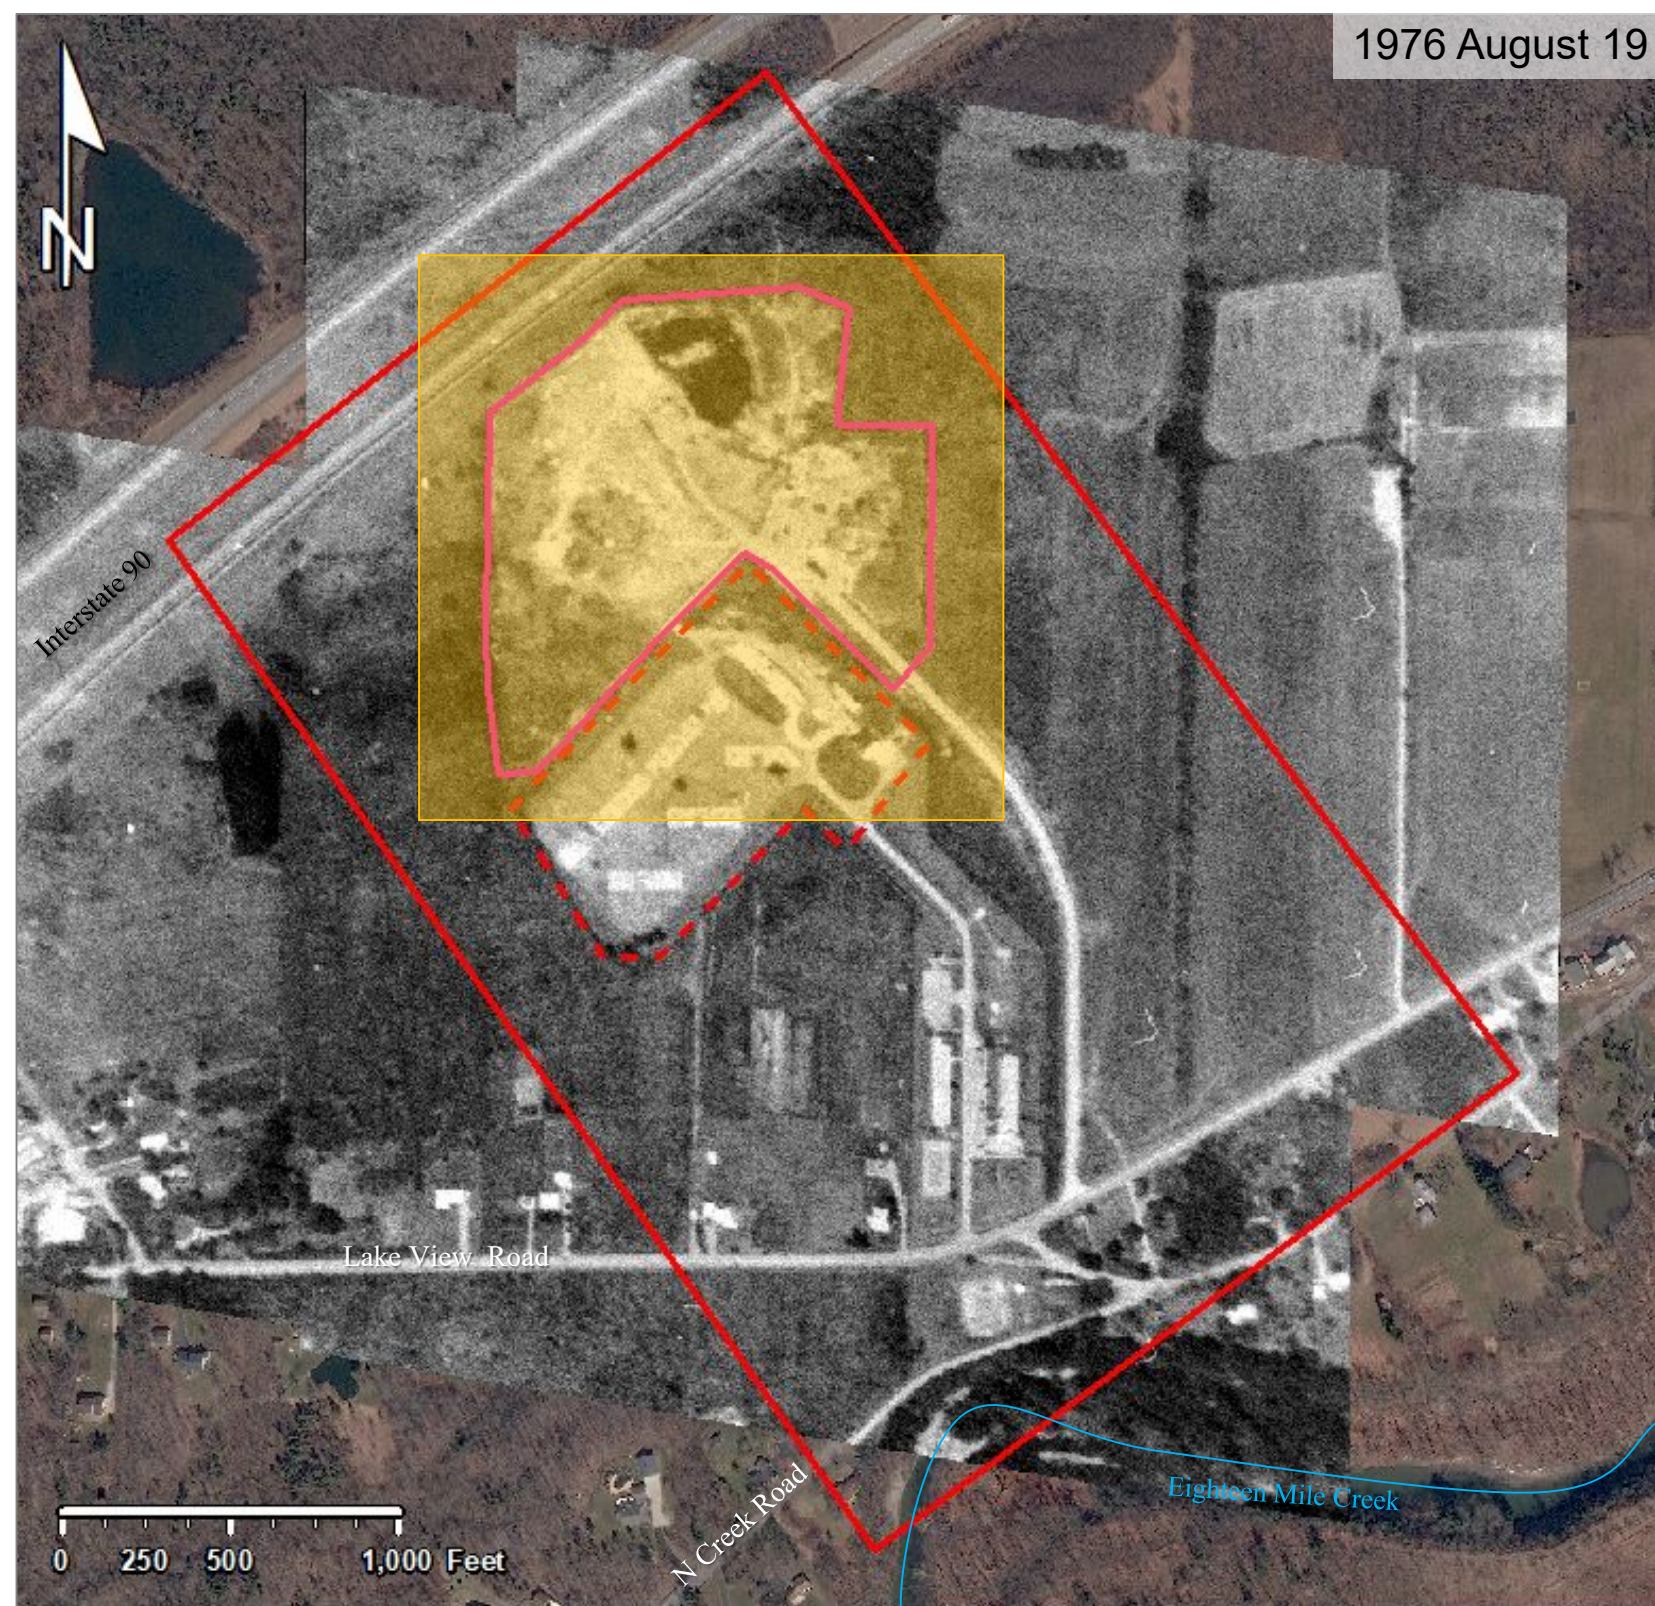
PHOTOGRAPHIC ANALYSIS: 1976

Continued activity is observed within the landfill north of the former Launch Area.

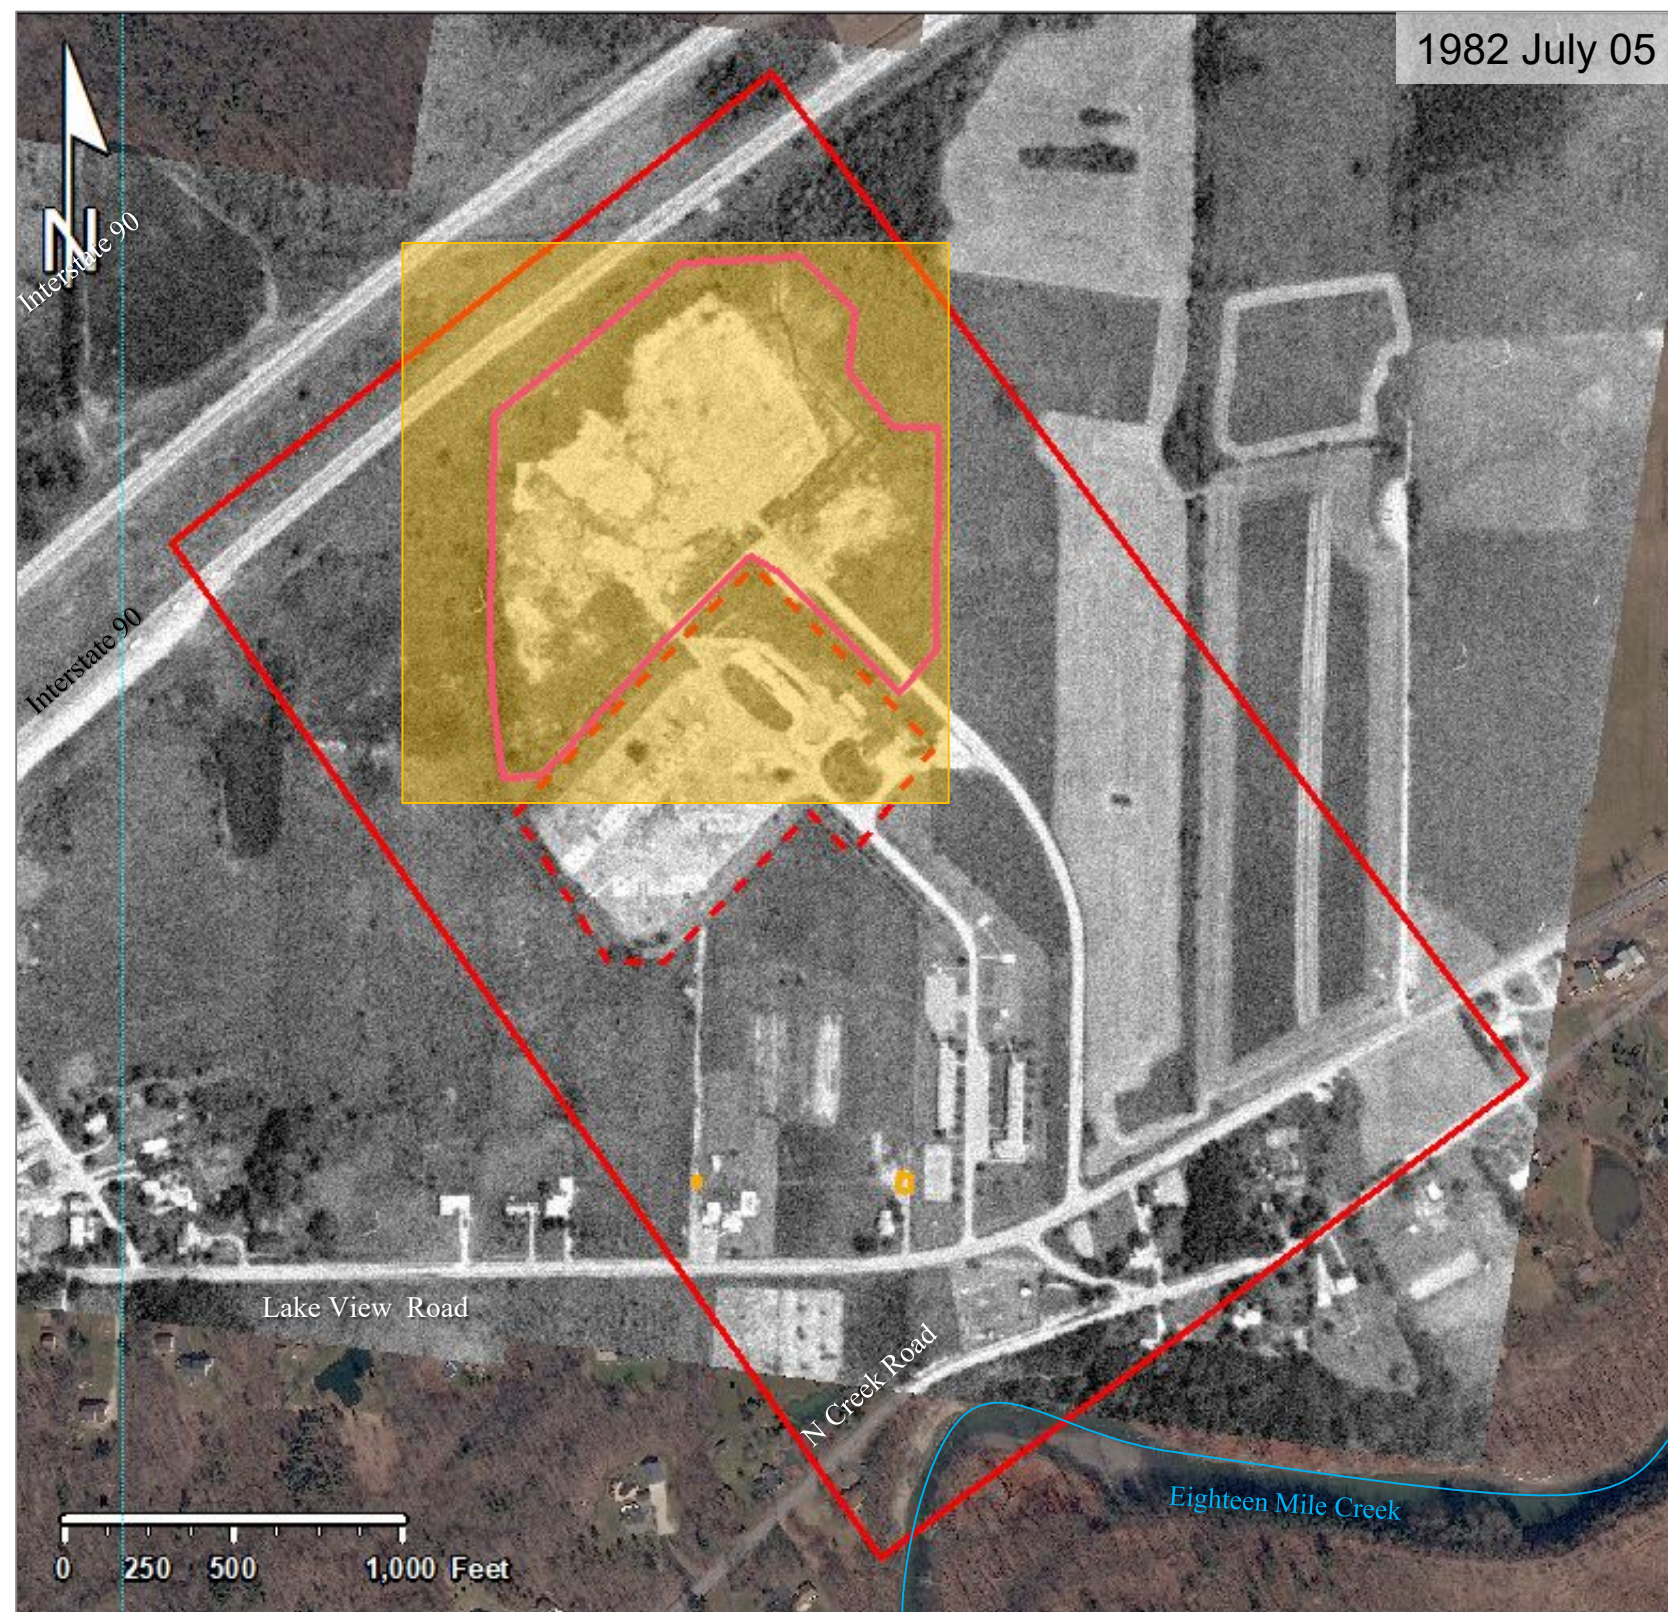
PHOTOGRAPHIC ANALYSIS: 1982

Continued use of the landfill is observed. The access roads visible in 1979 are no longer visible in 1982.

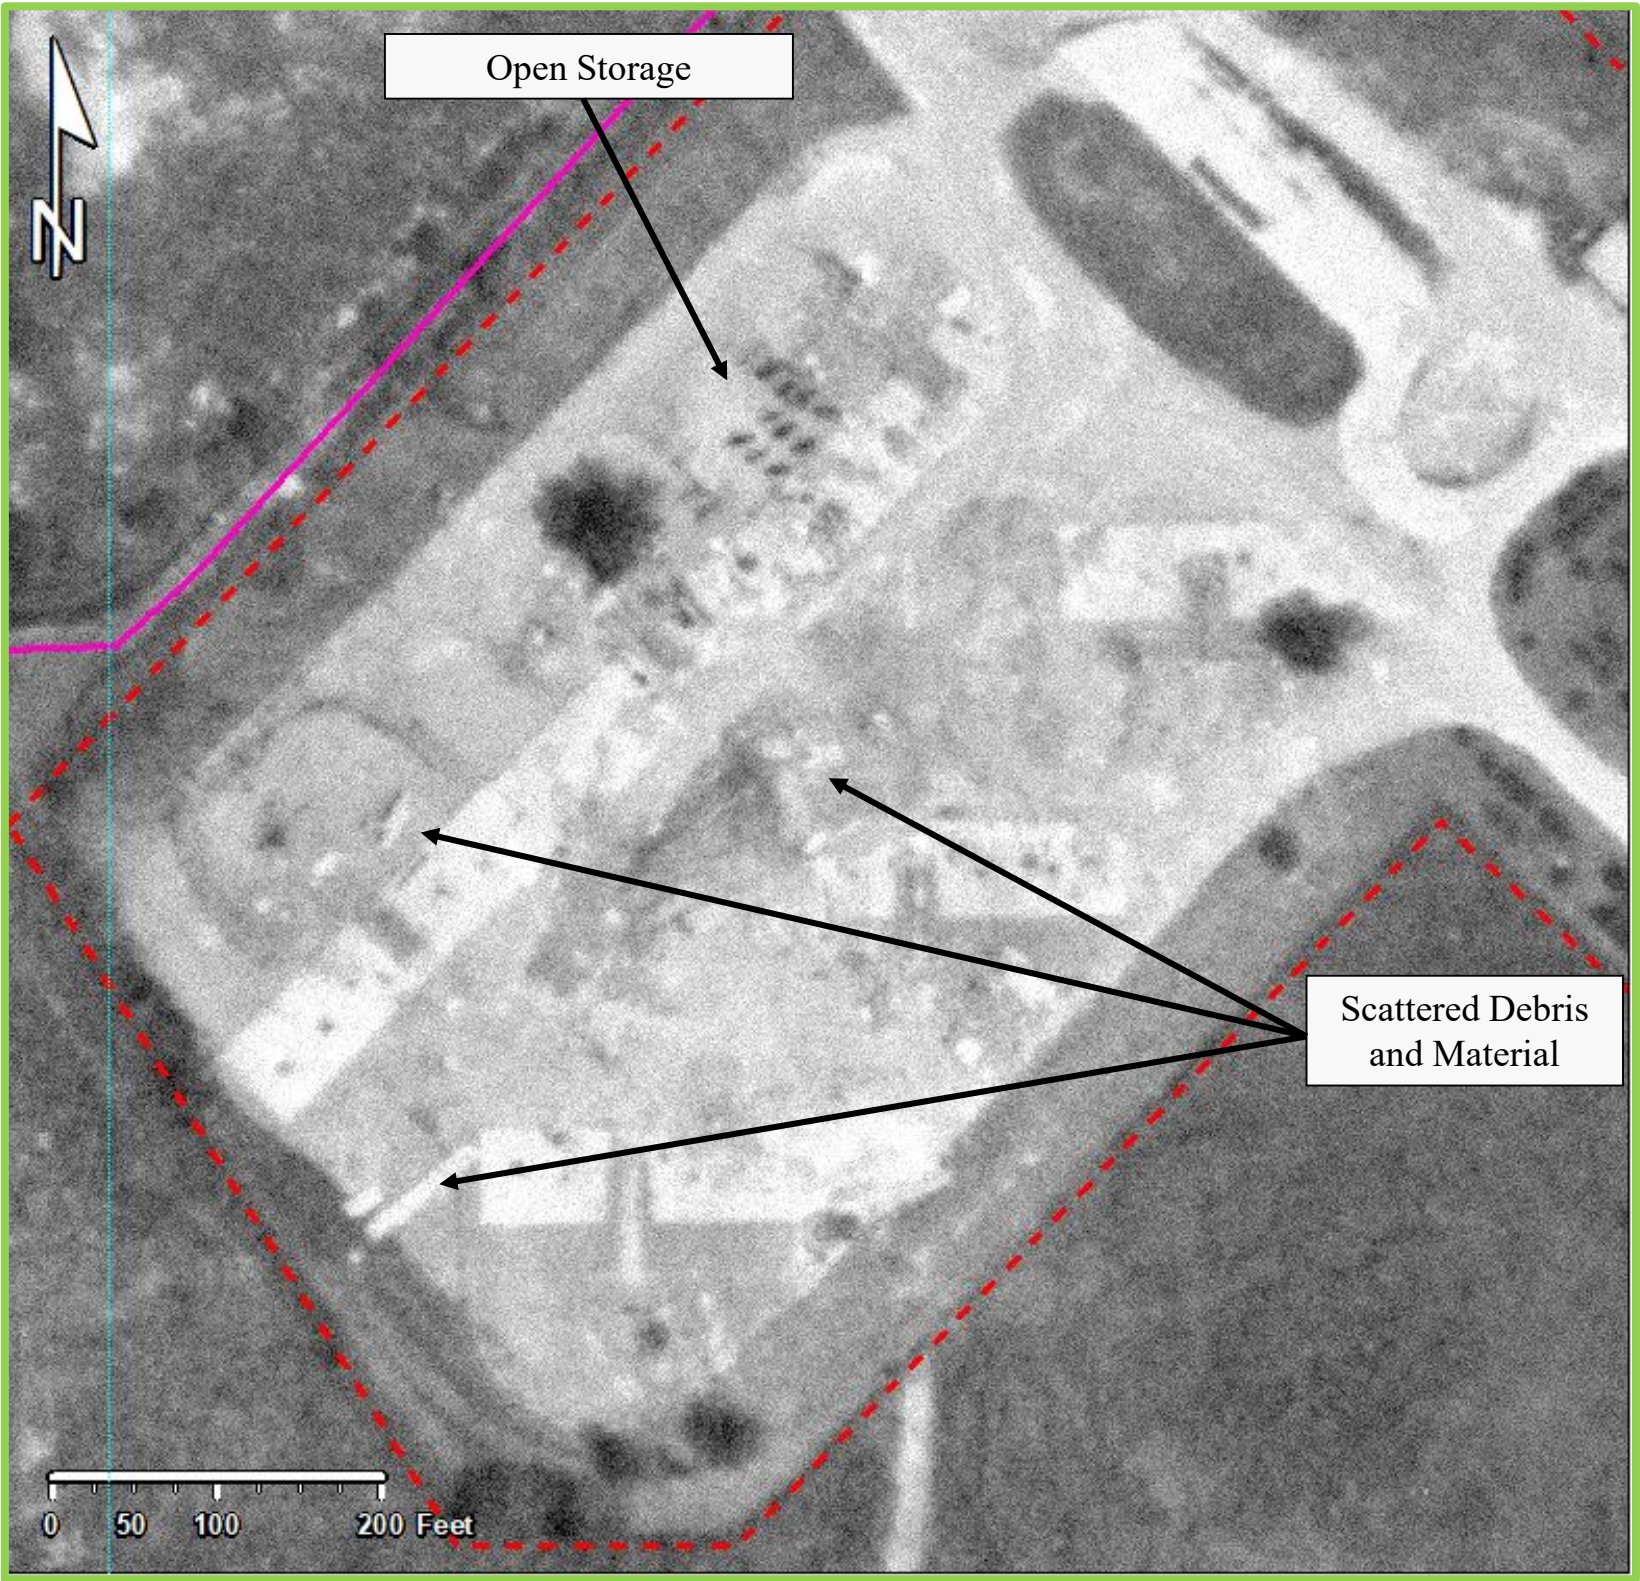
PHOTOGRAPHIC ANALYSIS: 1982 CONTINUED

Scattered debris, material, ground scars, and open storage are observed within the former Launch Area. New buildings are observed south of the former Launch Area.

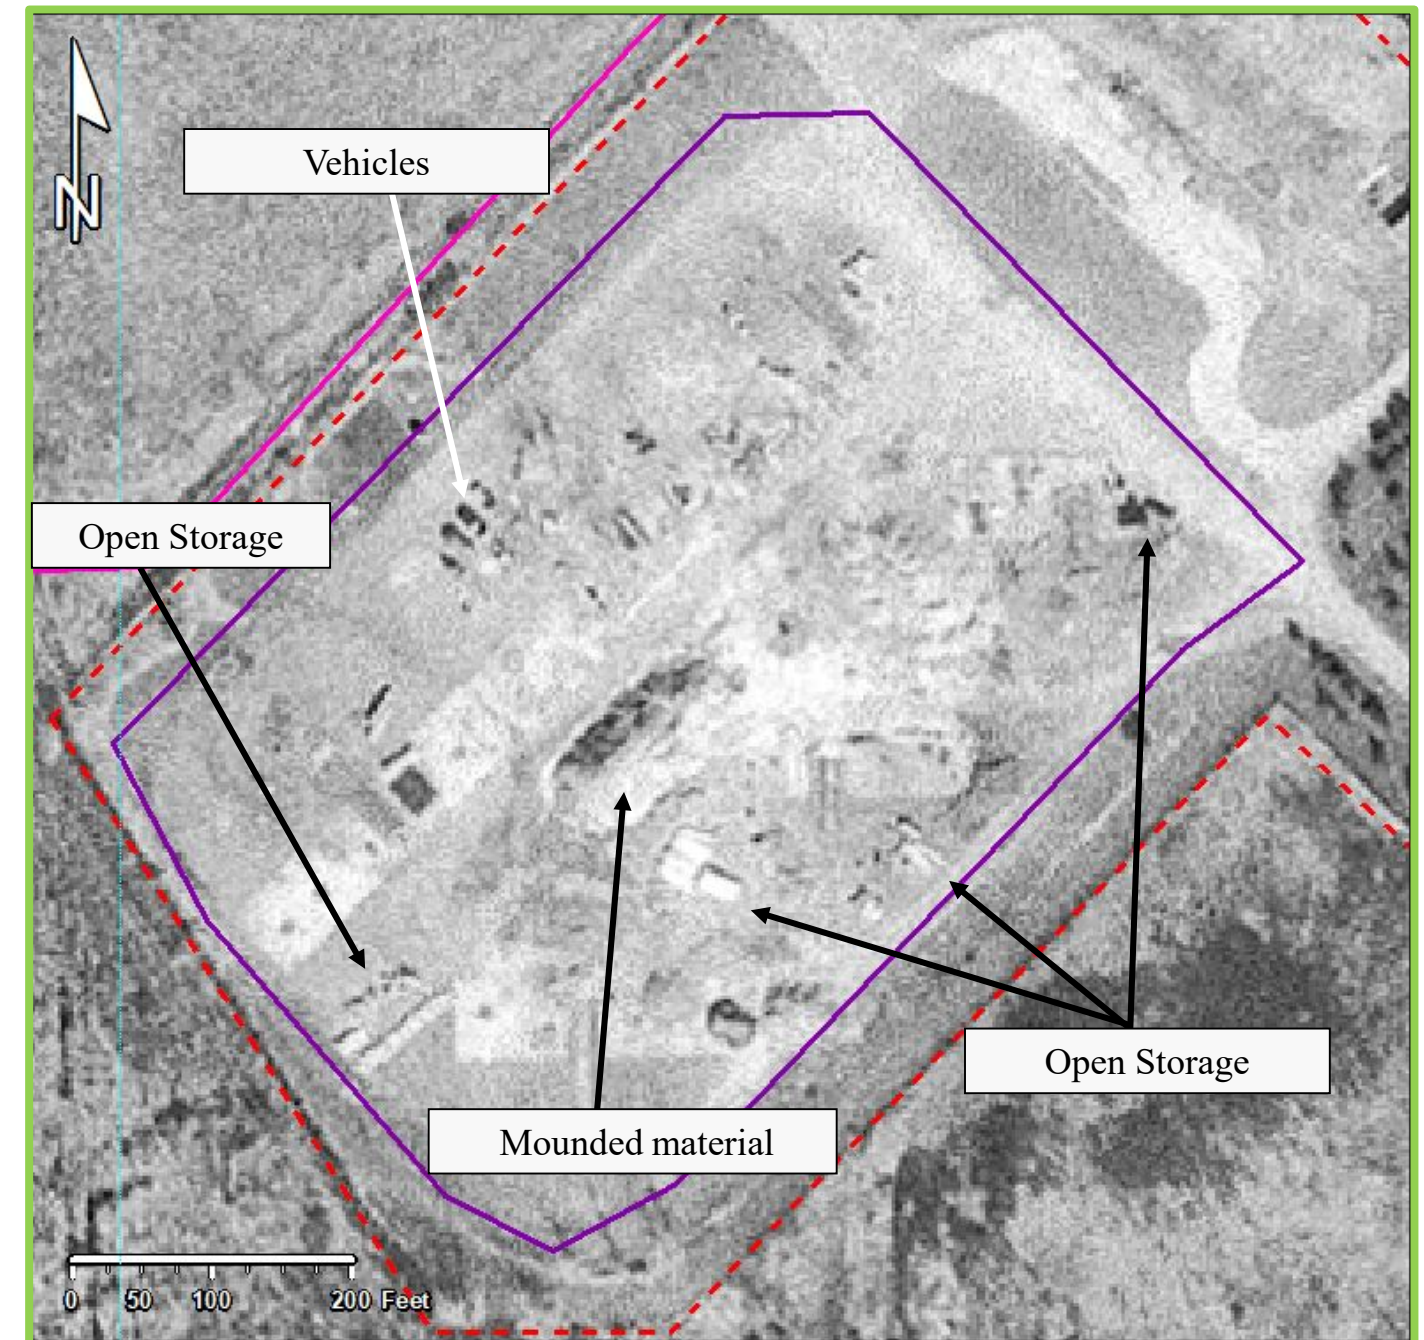
PHOTOGRAPHIC ANALYSIS: 1983 CONTINUED

Increased usage is observed within the former Launch Area. Mounded material, vehicles and open storage are visible throughout the area.

Several new buildings are observed in the southern portion of the study area.
