Reference: Summary Memo - Royal River Sediment Probing, Yarmouth, Maine

Royal River Sediment Probing

Title
Royal River Sediment Probing -
Downstream Reach

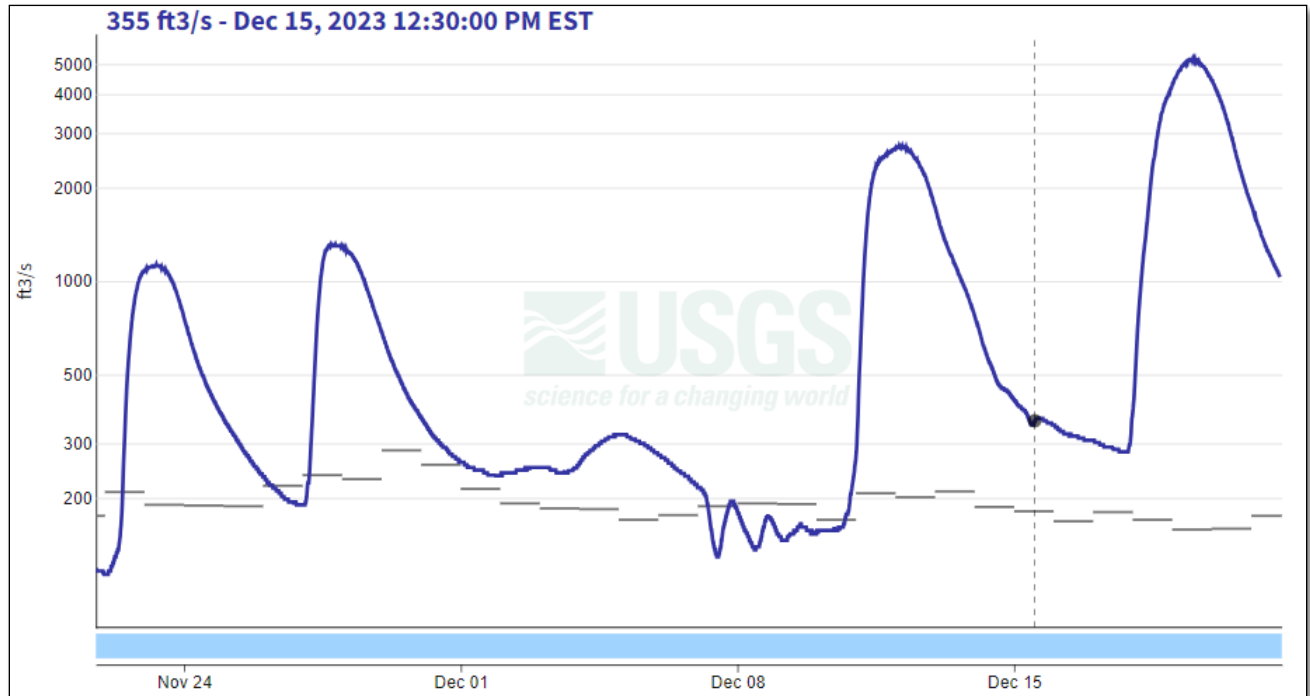
Figure 1. Discharge data from USGS streamgage “Royal River at Yarmouth, Maine – 01060000” from the period of November 21, 2023, to December 21, 2023; note grey horizontal lines represent approximately the historic median flow

The weather was mostly sunny with low and high temperatures of about 30°F to 55°F. Flows in the river were estimated at between 344 cubic feet per second (cfs) to 366 cfs during the time of the data collection based on the U.S. Geological Survey (USGS) streamgage “Royal River at Yarmouth, Maine – 01060000” (Figure 1), which is located approximately 1,000 feet (ft) downstream of Bridge Street and likely provides a reasonably close approximation of flow within the study reaches.

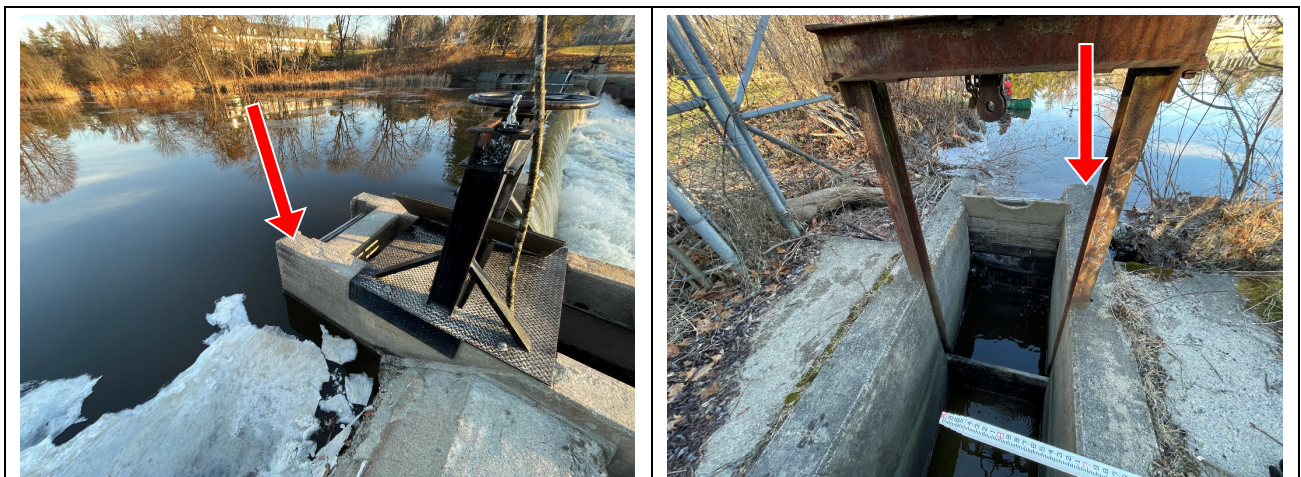
Figure 2. Locations of water surface elevation measurements for the downstream reach at Bridge Street Dam (left photo) and the upstream reach at Elm Street Dam (right photo)

Water surface elevations in the study reaches may be assumed to be equal to other water surface elevations in the same study reach due to an approximate “level-pool” condition from the backwater effects of the dams. Flow speeds were very low (<1 fps) within the impounded reaches. Therefore, a level-pool assumption could be used to rectify the depth measurements to a known vertical datum (e.g., the North American Vertical Datum of 1988 [NAVD88]). Distances were measured between the water surface elevation and the top of the fishway concrete training walls. For the downstream reach, the water surface elevation was approximately 2.20 ft below the top of the upstream right fishway concrete training wall. For the upstream reach, the water surface elevation was approximately 2.05 ft below the top of the upstream left fishway concrete training wall. Figure 2 presents the locations of these measurement points.

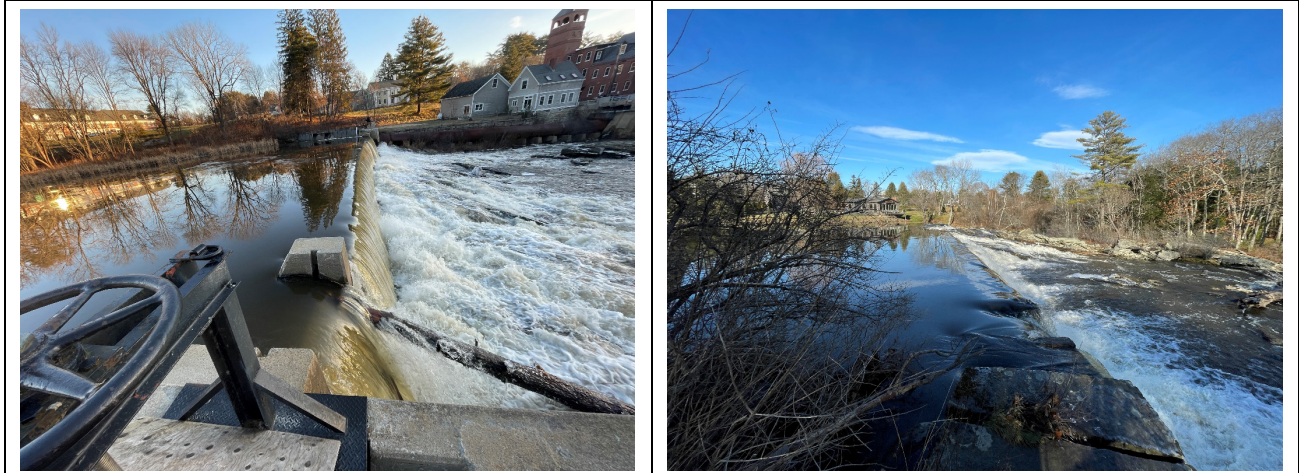
Figure 3. Overview of the Bridge Street Dam spillway (left) and the Elm Street Dam spillway (right)

Due to high flows on the day of the site visit, flows over the spillways at both dams precluded data collection near the spillways. Collecting data near the spillways was not considered safe and was therefore not included as part of this analysis. The photos in Figure 3 present an overview of the spillways during the site visit.

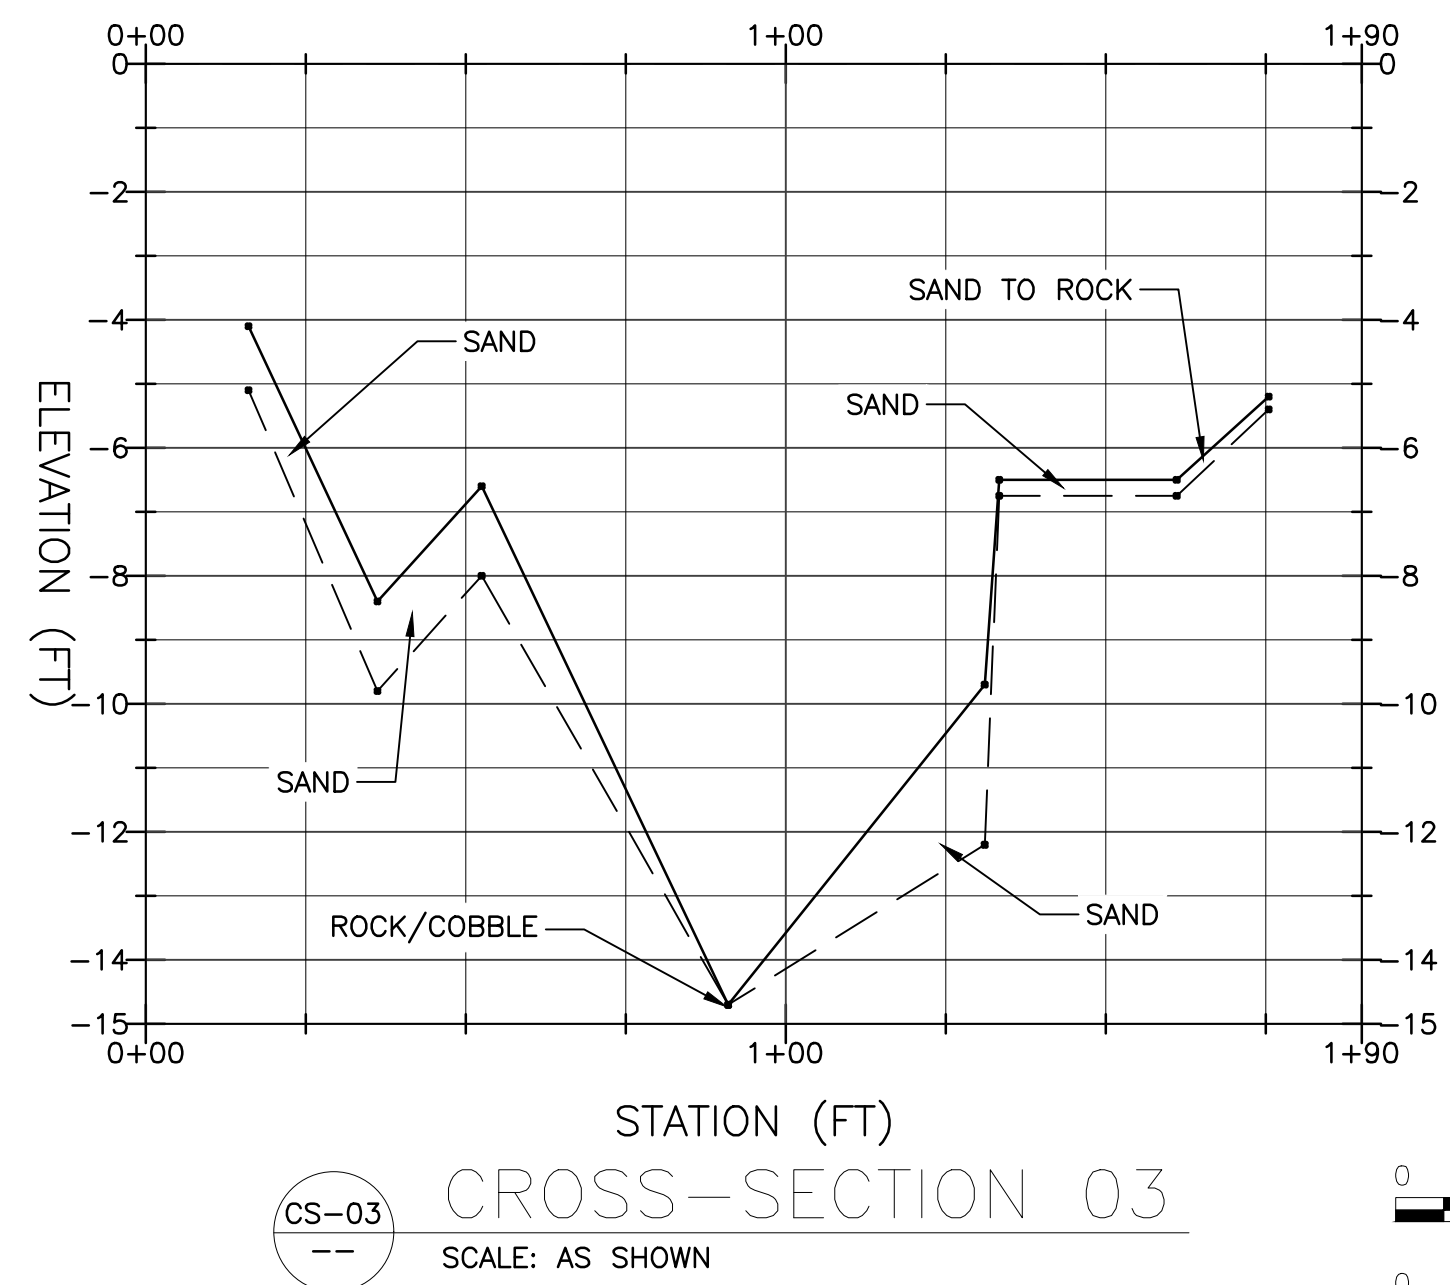
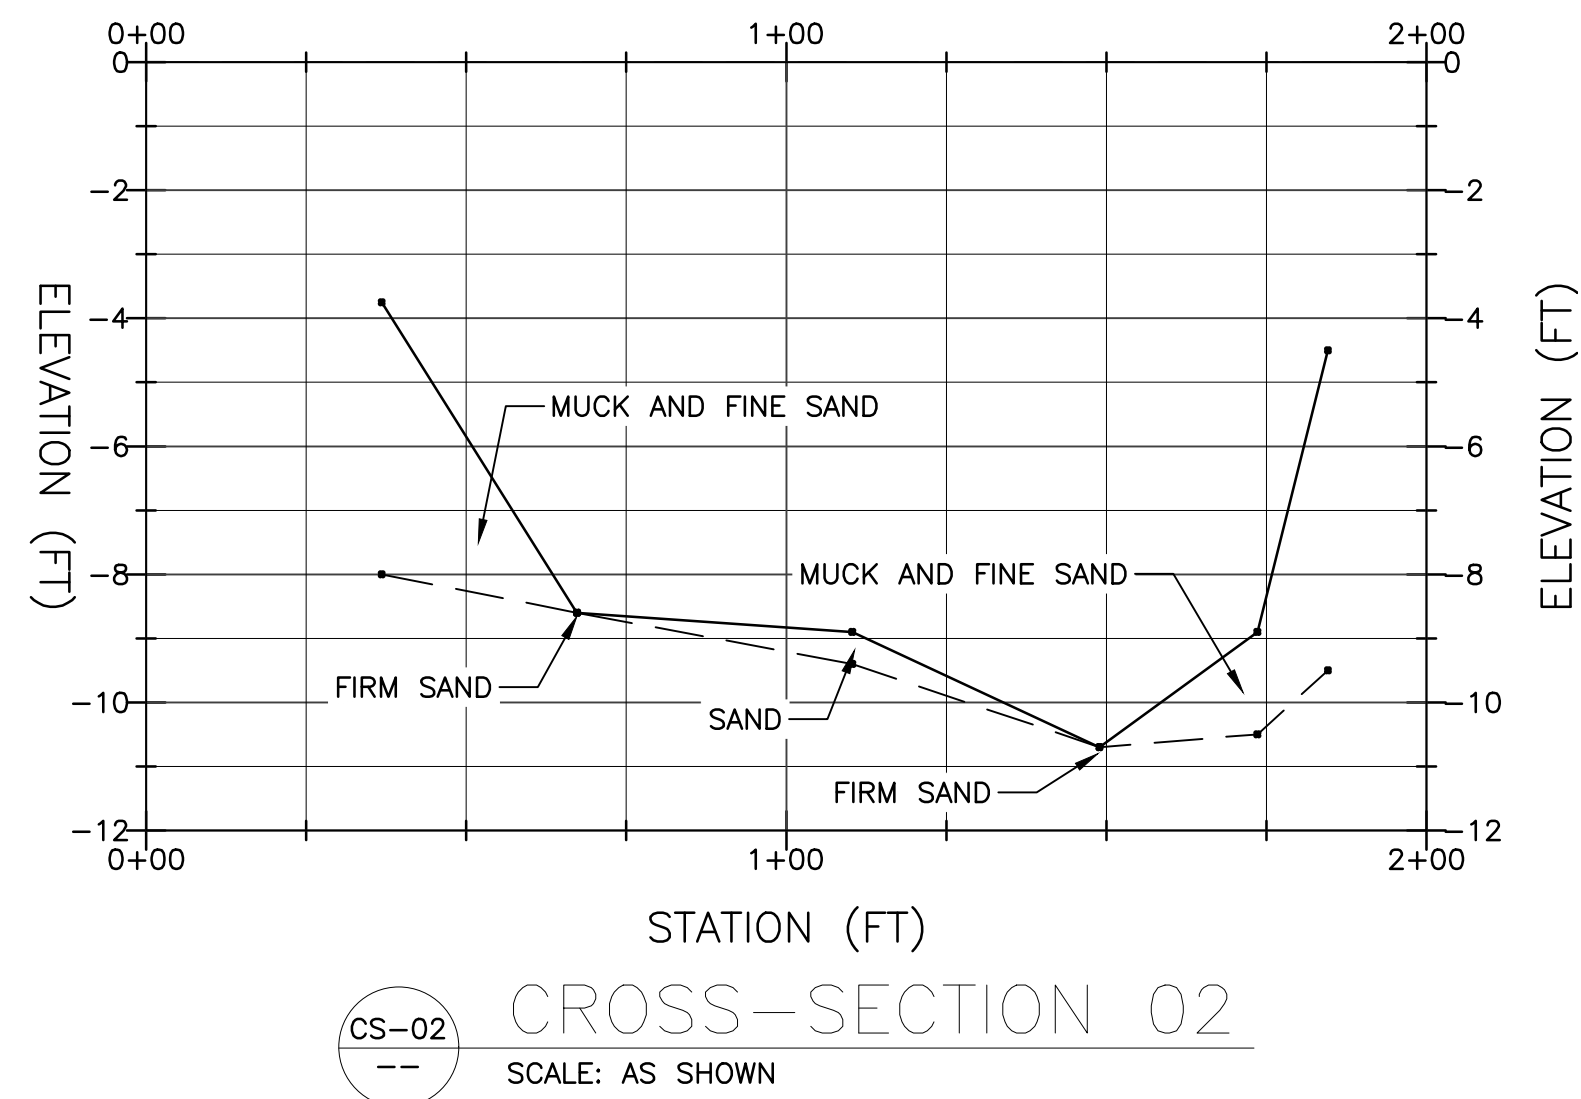
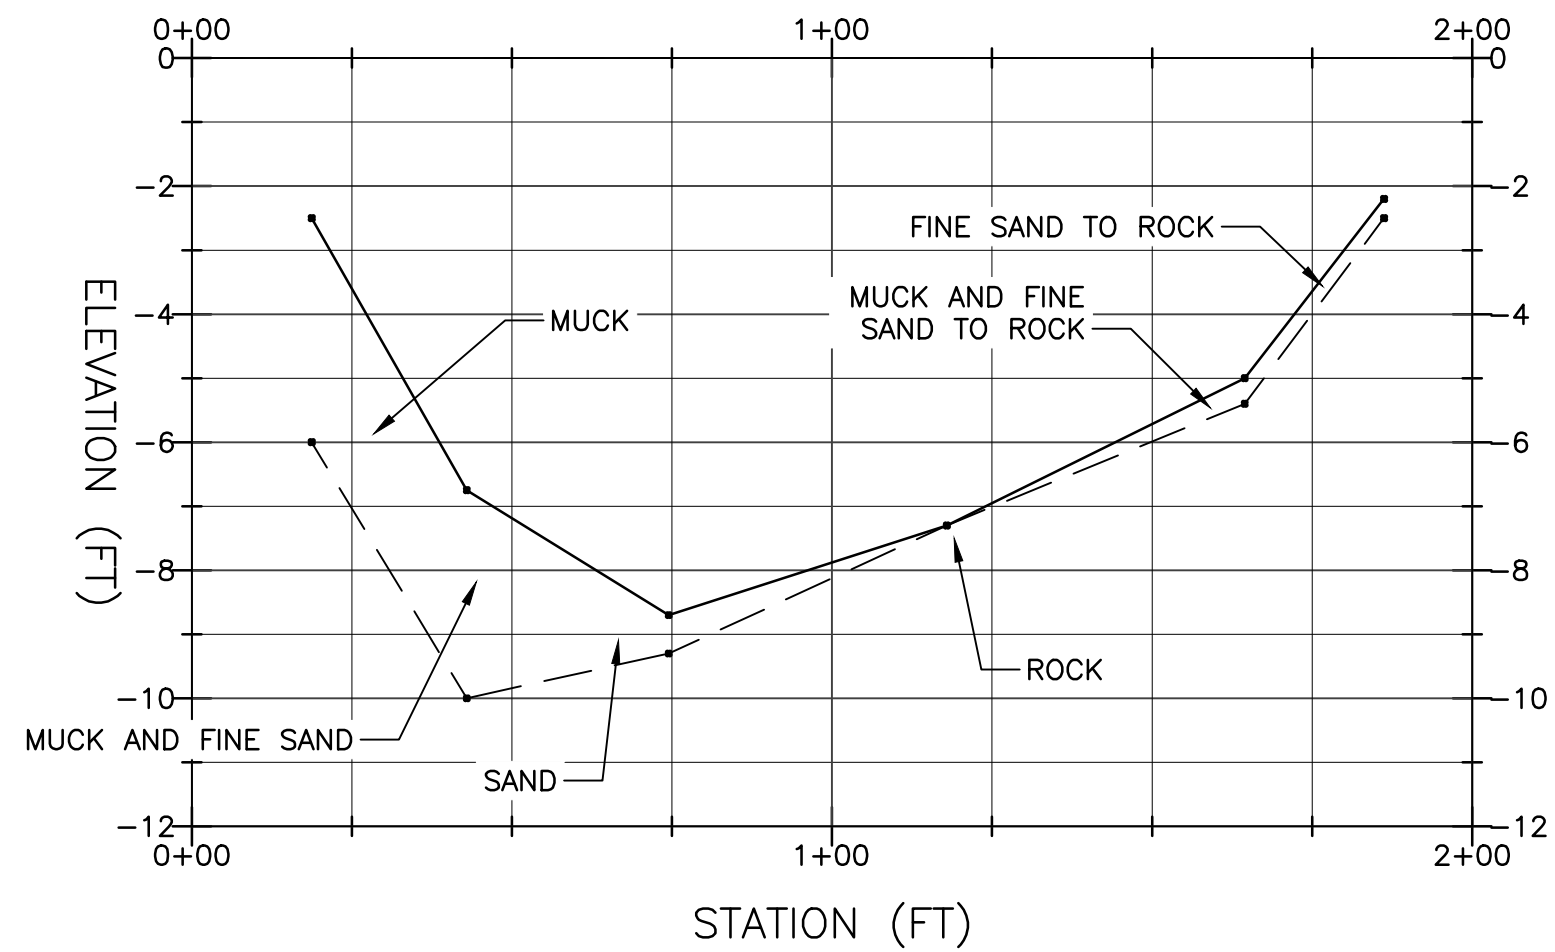
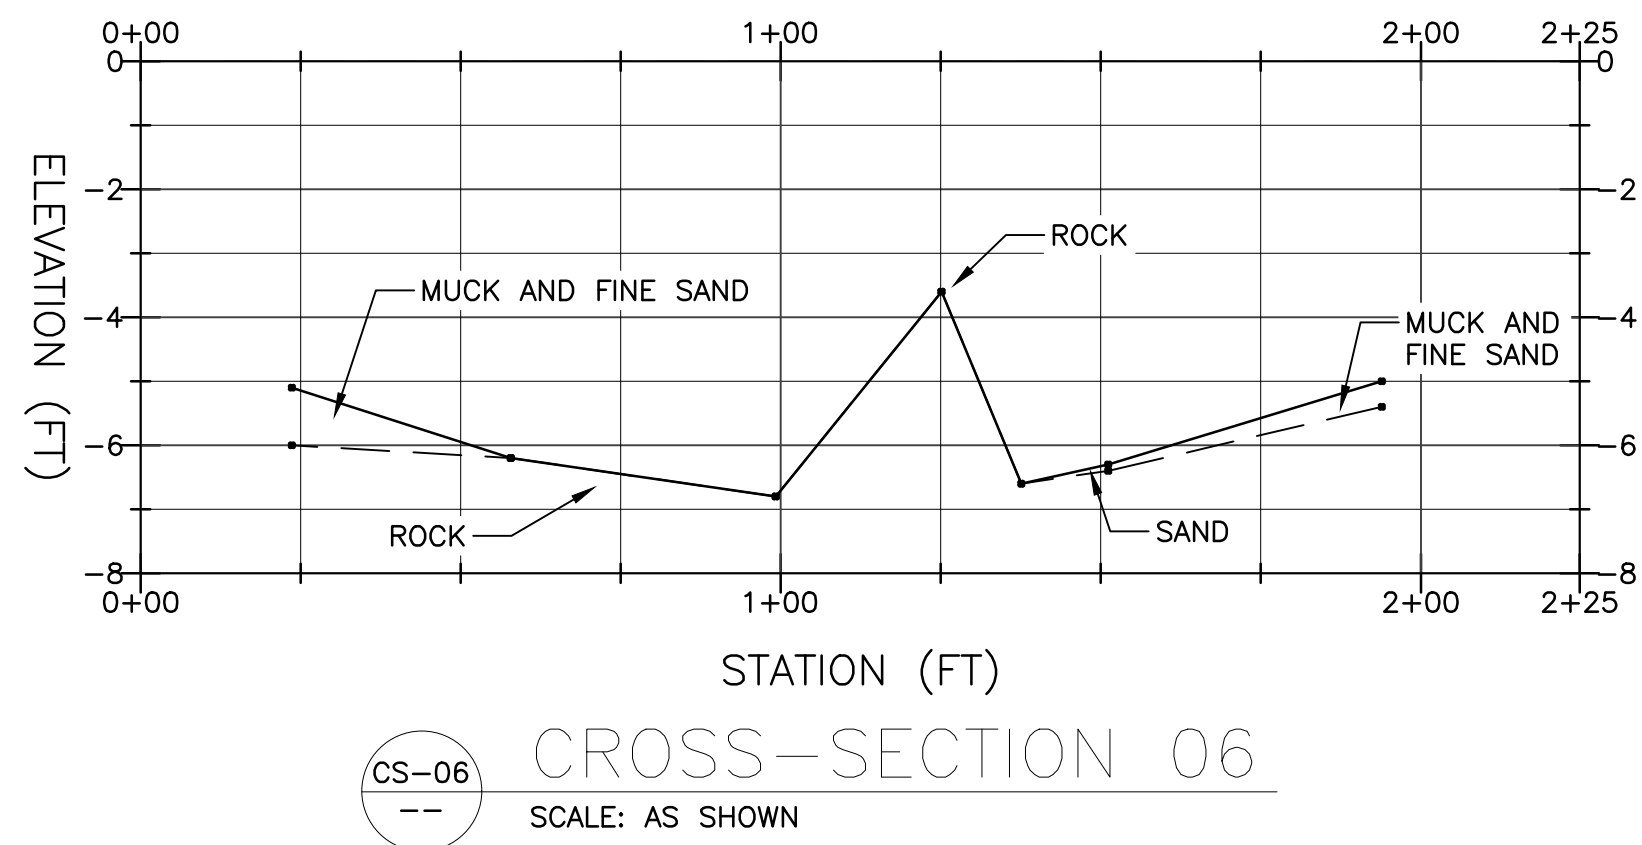
Project No. 195602899	Scale AS SHOWN
Revision 0	Sheet 1 of 2
Drawing No.	FIG-01

- CROSS-SECTION DATA WAS DEVELOPED FROM MANUAL PROBING COLLECTED BY GPS AND PERFORMED BY STANTEC ON DECEMBER 15, 2023. REFER TO THE ACCOMPANYING STANTEC MEMO FOR DETAILS RELATED TO THE DATA COLLECTION METHODS AND THE SEDIMENT PROBE SUMMARY DATA TABLE.
- AERIAL PHOTOGRAPHY IS MAINE 2012 ORTHO IMAGERY ACCESSED VIA THE NATIONAL MAP ONLINE DATA PORTAL.
- ORIENTATION OF CROSS-SECTIONS ARE BASED ON AN OBSERVER FACING DOWNSTREAM.
- TOP AND BOTTOM OF SEDIMENT PROBES WERE BASED ON DEPTHS MEASURED IN REFERENCE TO THE WATER SURFACE ELEVATION (ELEVATION = 0 FT).
- SEDIMENT PROBING DATA PRESENTED HEREIN WERE DEVELOPED BY PROJECTING THE ELEVATION DATA ONTO THE CROSS-SECTIONS DEPICTED IN THE PLAN VIEW.

Figures were developed that present the transect locations and cross-section profiles. Note that a one-to-ten (1:10) vertical exaggeration was used in the profiles to exaggerate the vertical scale. The locations of the GPS points were plotted on aerial imagery for reference. The most proximal data location points to the transects were selected for use in projecting onto the cross-section profiles and were considered to be the most representative data for the transects. Although not all the data location points were incorporated into the cross-section profiles at the transects, the raw data of these points presented in the summary table (Attachment B) can help augment the information presented in the profiles, if warranted.

The results from the sediment probing and characterization data collection efforts are presented in the representative cross-sections in Figures 1 and 2 in Attachment A to this memo. In addition, a summary table with the GPS location data and sediment depth and characterization information is presented in Attachment B to this memo. Point ID numbers for each probe location are provided in the plan views in Attachment A and can be cross-referenced to the summary table in Attachment B.
