Part 2: Overview of Dredged Material Disposal at the Proposed Penobscot Bay Site

- History of aquatic placement of dredged material
- Current techniques for placement of dredged material in the aquatic environment and tools for monitoring
- Overview of the proposed Penobscot Bay Site

Public Information Meeting – 08 April 2014: Searsport Harbor
Navigation Improvement Pre-Application Water Quality Certification

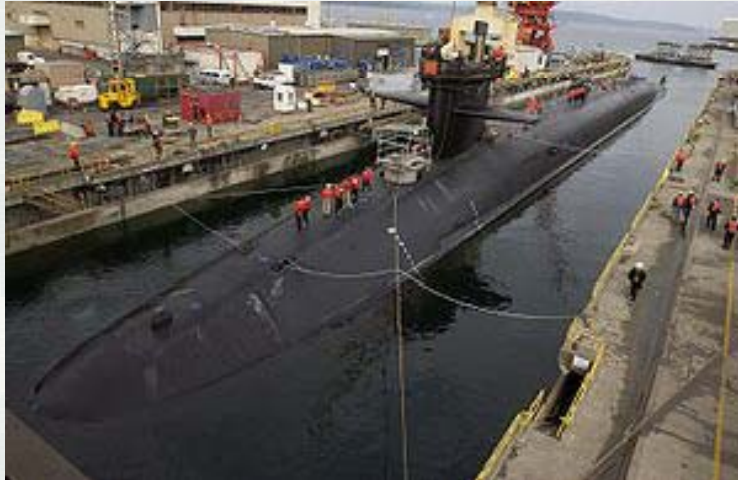
- Disposal Area Monitoring System (DAMOS) was initiated in 1977 focused on monitoring material dredged from the Trident sub base

- Targeted placement of material to minimize impacts (at buoys)
- Monitoring to track site recovery – expanded to cover sites throughout New England
- Results summarized in reports available to the public

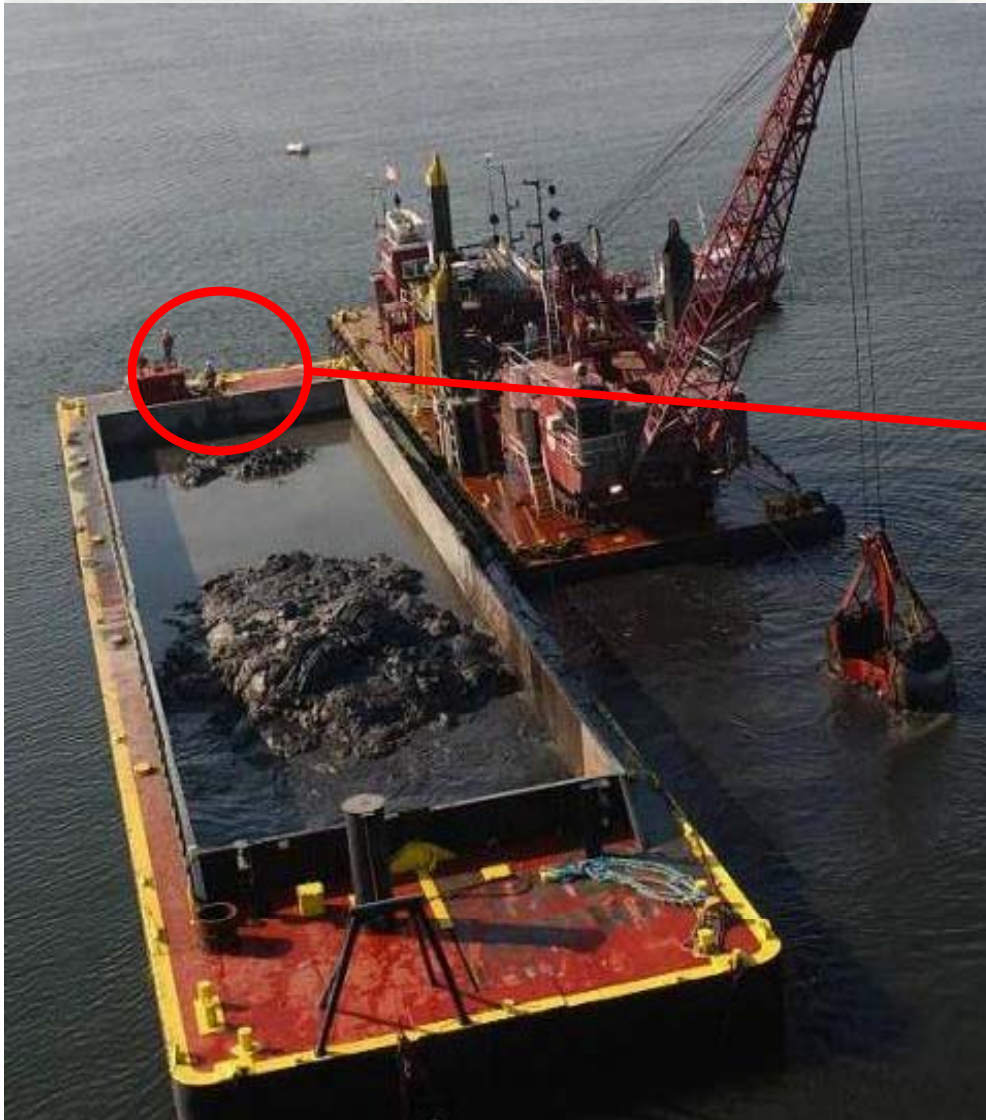
Tracking system required for all disposal

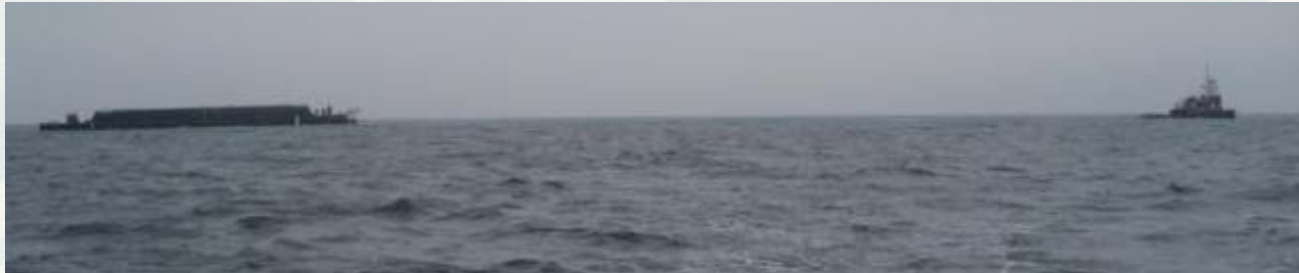
- GPS allows for tracking tug/scow over full disposal trip

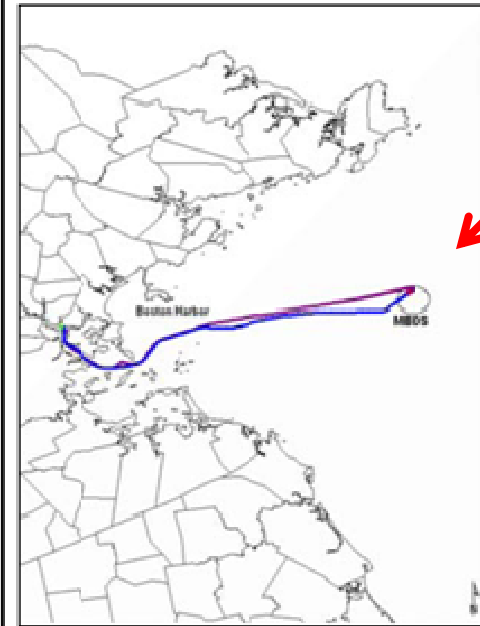
Example recorded track of scow loaded in Boston Harbor and disposed in Massachusetts Bay

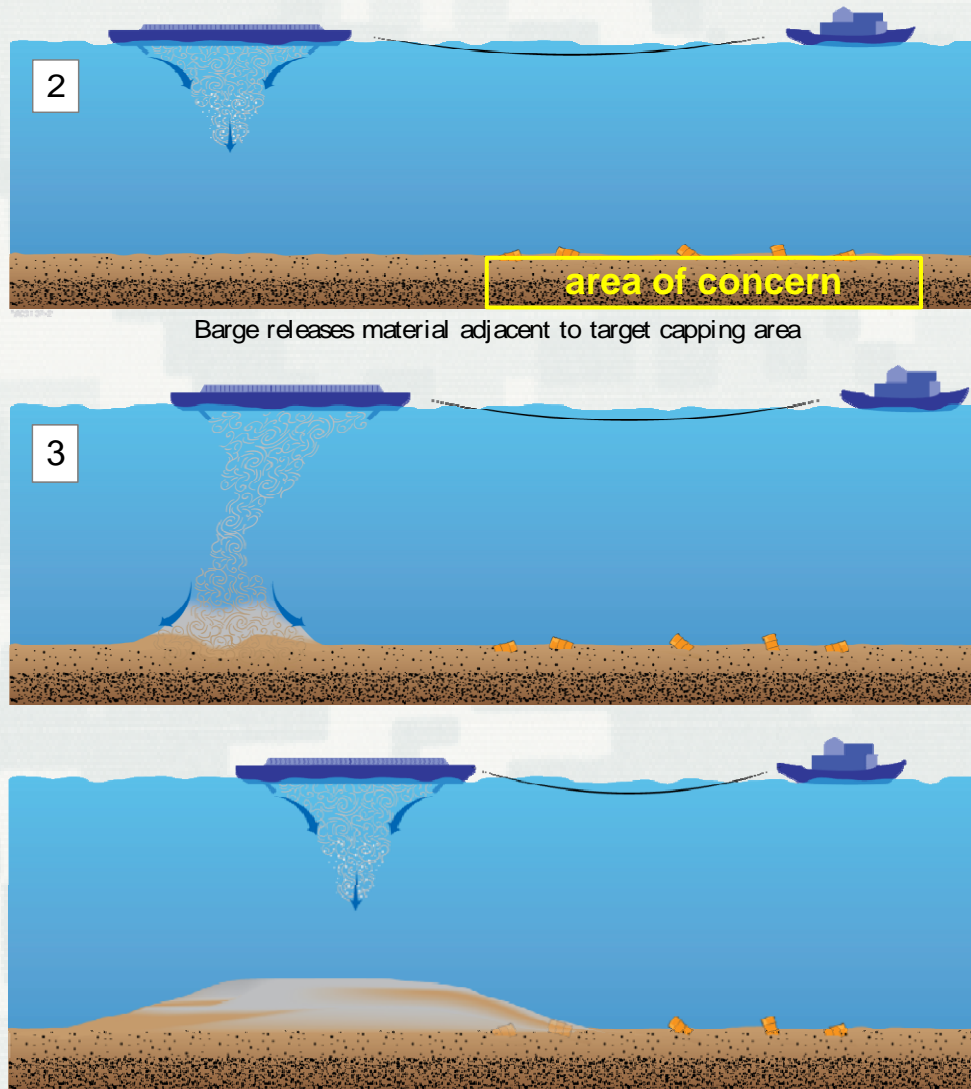
- Very sensitive fathometers allow identification of individual scow disposal events and tracking buildup of material on the bottom with multiple loads

Example from evaluation of potential capping of the historic Industrial Waste Site in Massachusetts Bay

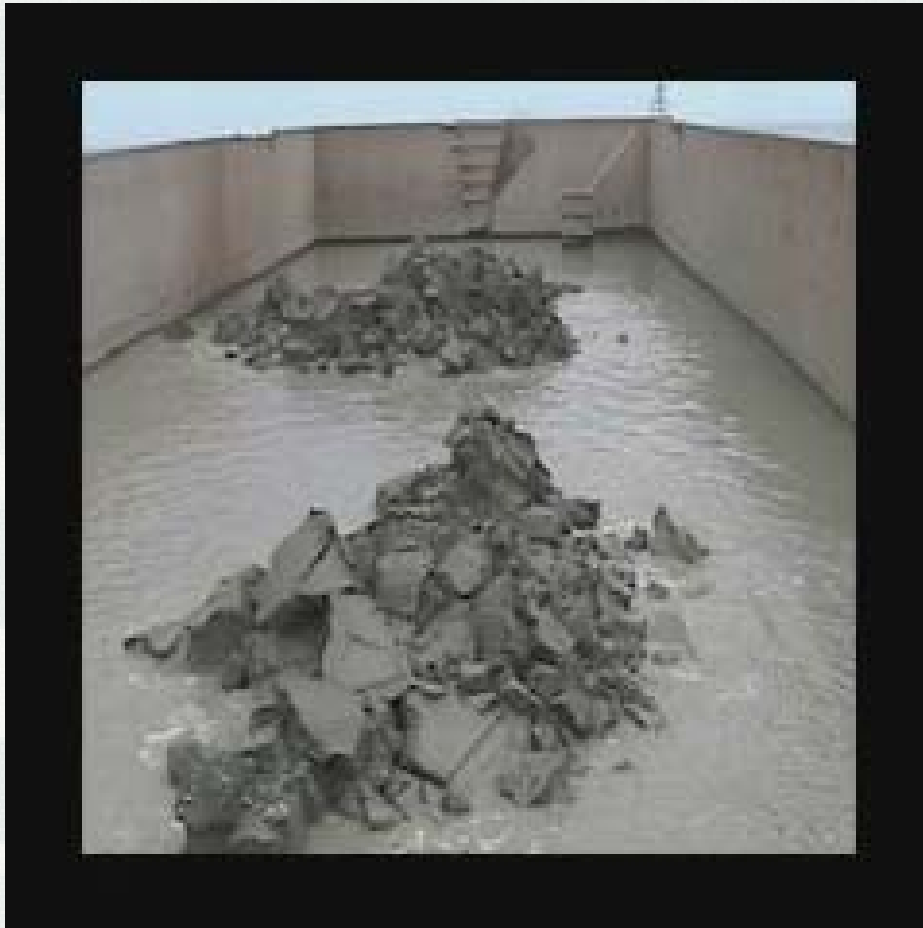
- release of 3000+ cubic yards of improvement dredged material from Boston Harbor at the Massachusetts Bay Disposal Site

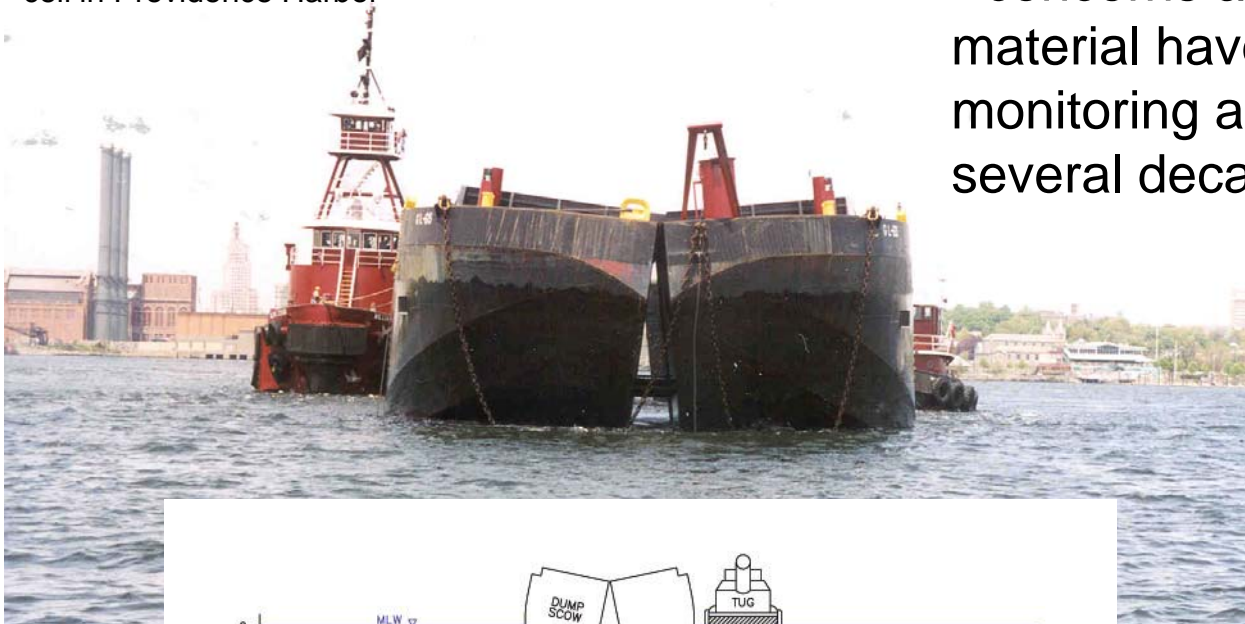
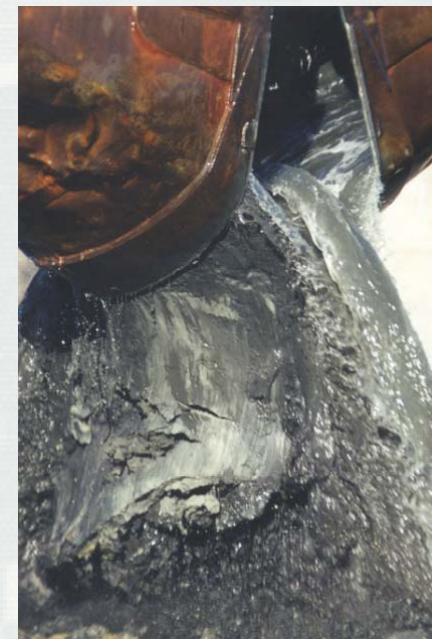
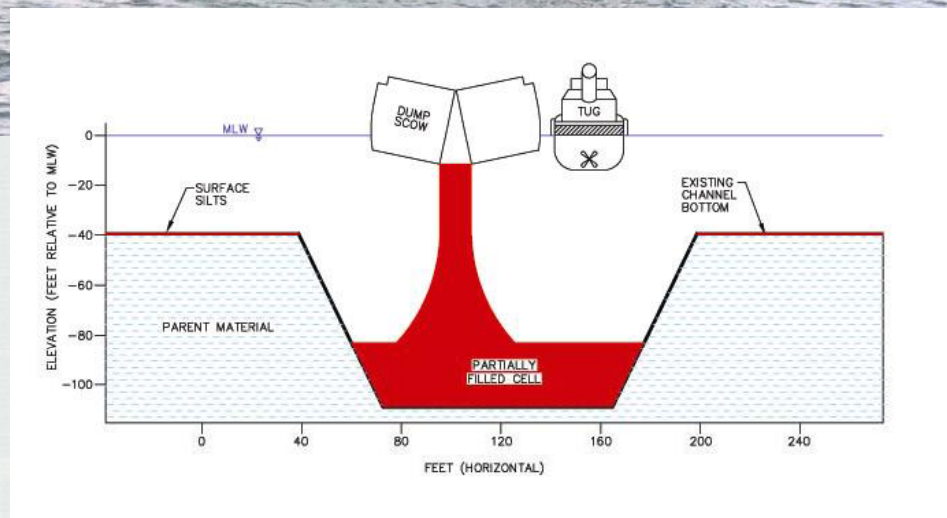
Scow releasing material over CAD cell in Providence Harbor

- schematic of placement of unsuitable material into a Confined Aquatic Disposal (CAD) cell

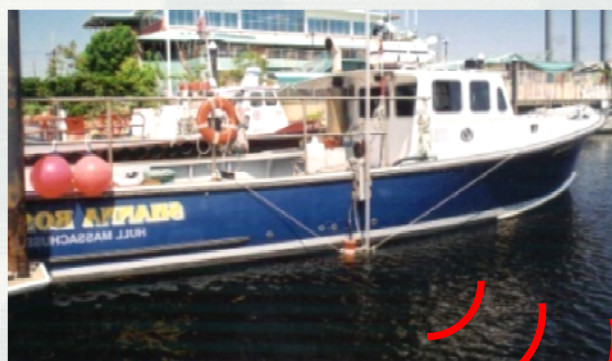
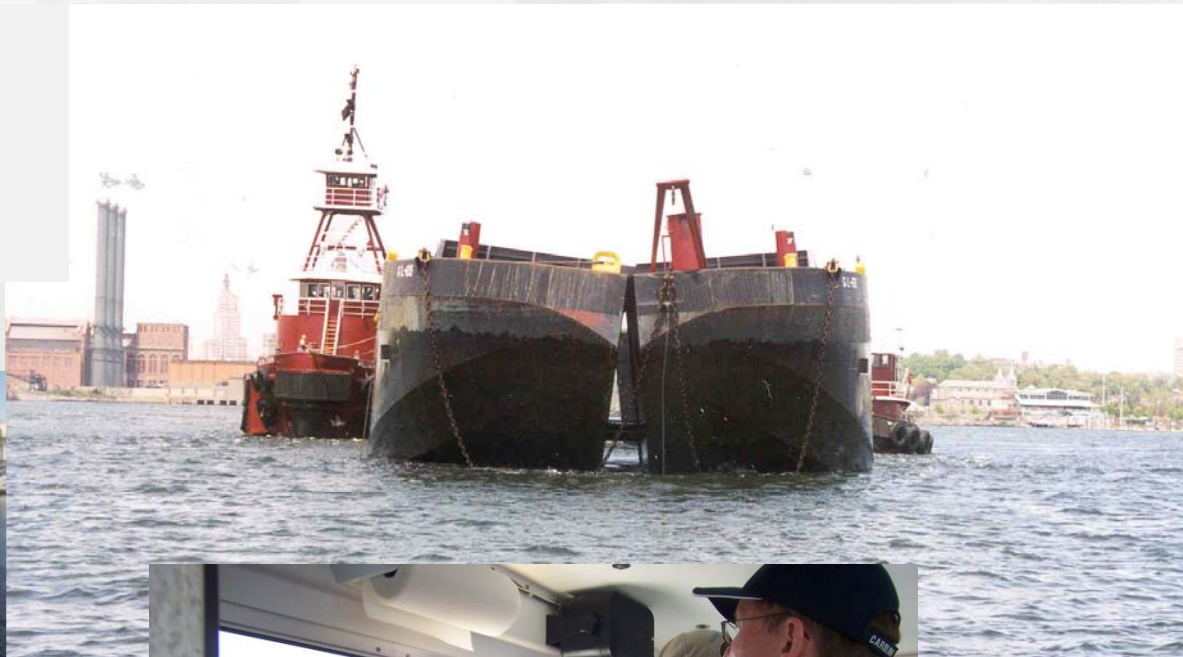
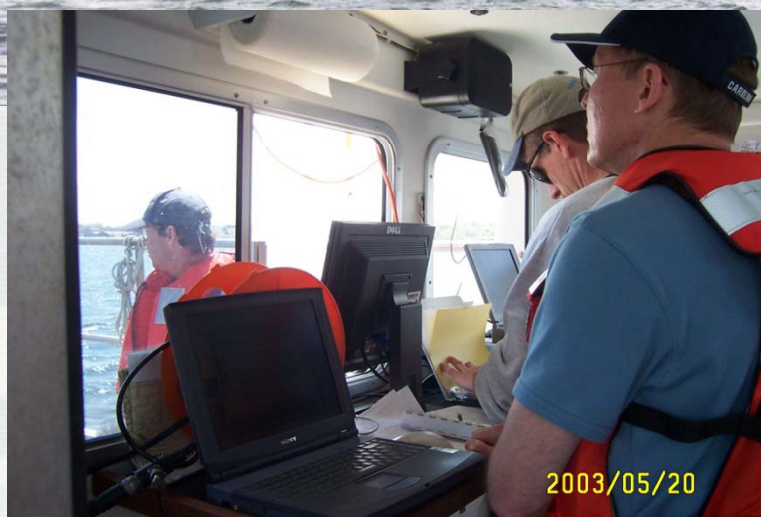
- Field measurements to identify and track plume of suspended material following scow opening

Acoustic Doppler Current Profiler used to identify suspended material and track plume movement in Providence Harbor

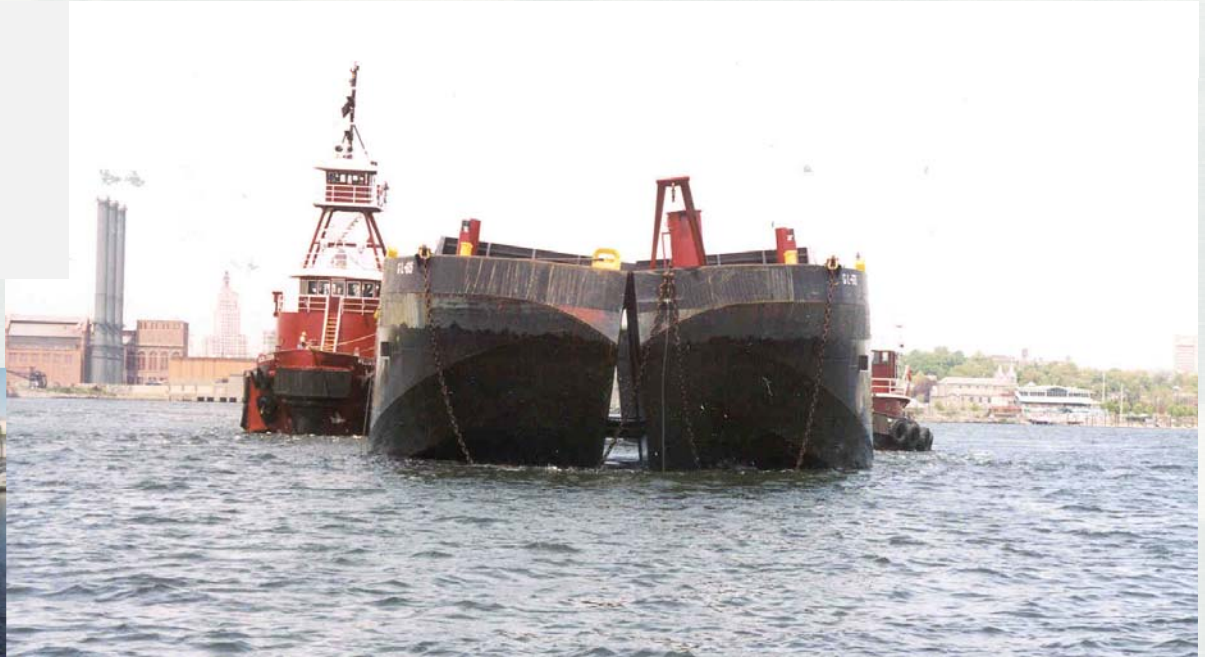
- Field measurements to identify and track plume of suspended material following scow opening

Acoustic Doppler Current Profiler used to identify suspended material and track plume movement in Providence Harbor

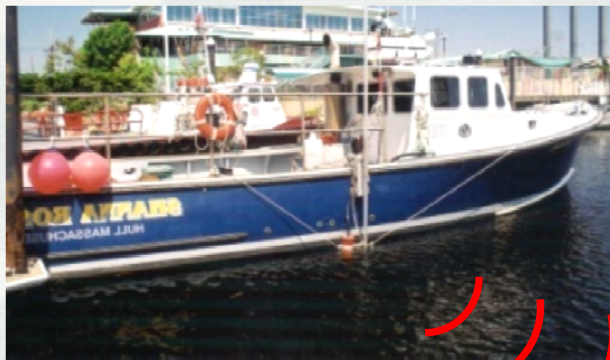
- Field measurements to identify and track plume of suspended material following scow opening

Acoustic Doppler Current Profiler used to identify suspended material and track plume movement in Providence Harbor

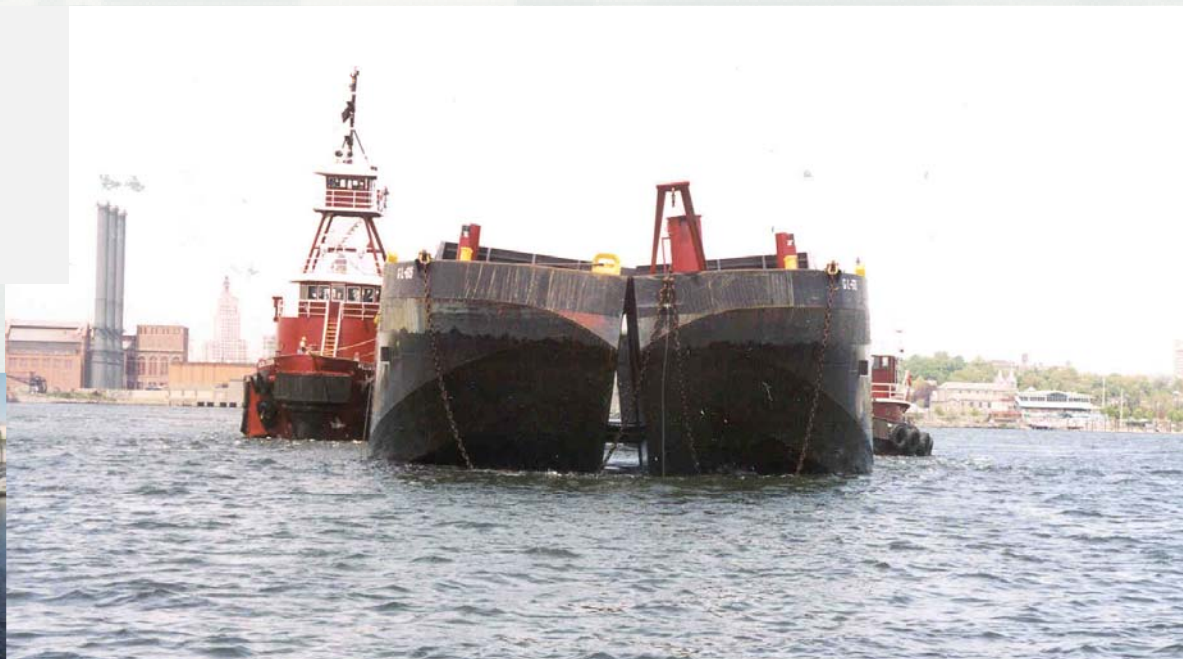
- Field measurements to identify and track plume of suspended material following scow opening

Acoustic Doppler Current Profiler used to identify suspended material and track plume movement in Providence Harbor

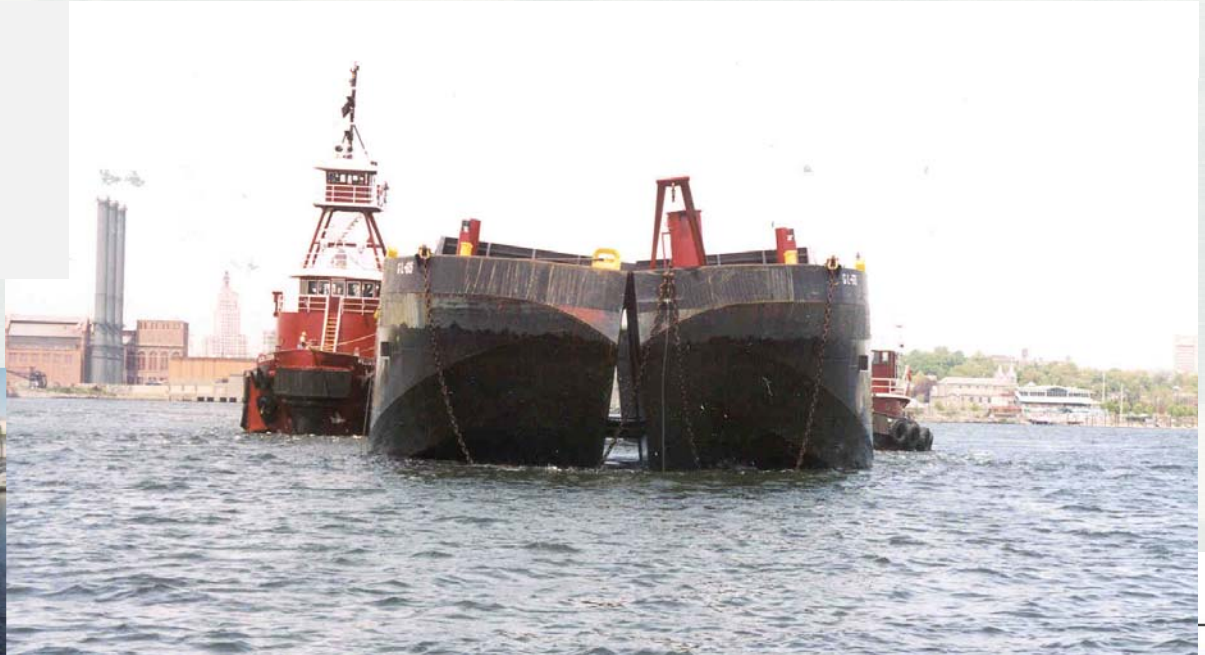
- Field measurements to identify and track plume of suspended material following scow opening

Acoustic Doppler Current Profiler used to identify suspended material and track plume movement in Providence Harbor

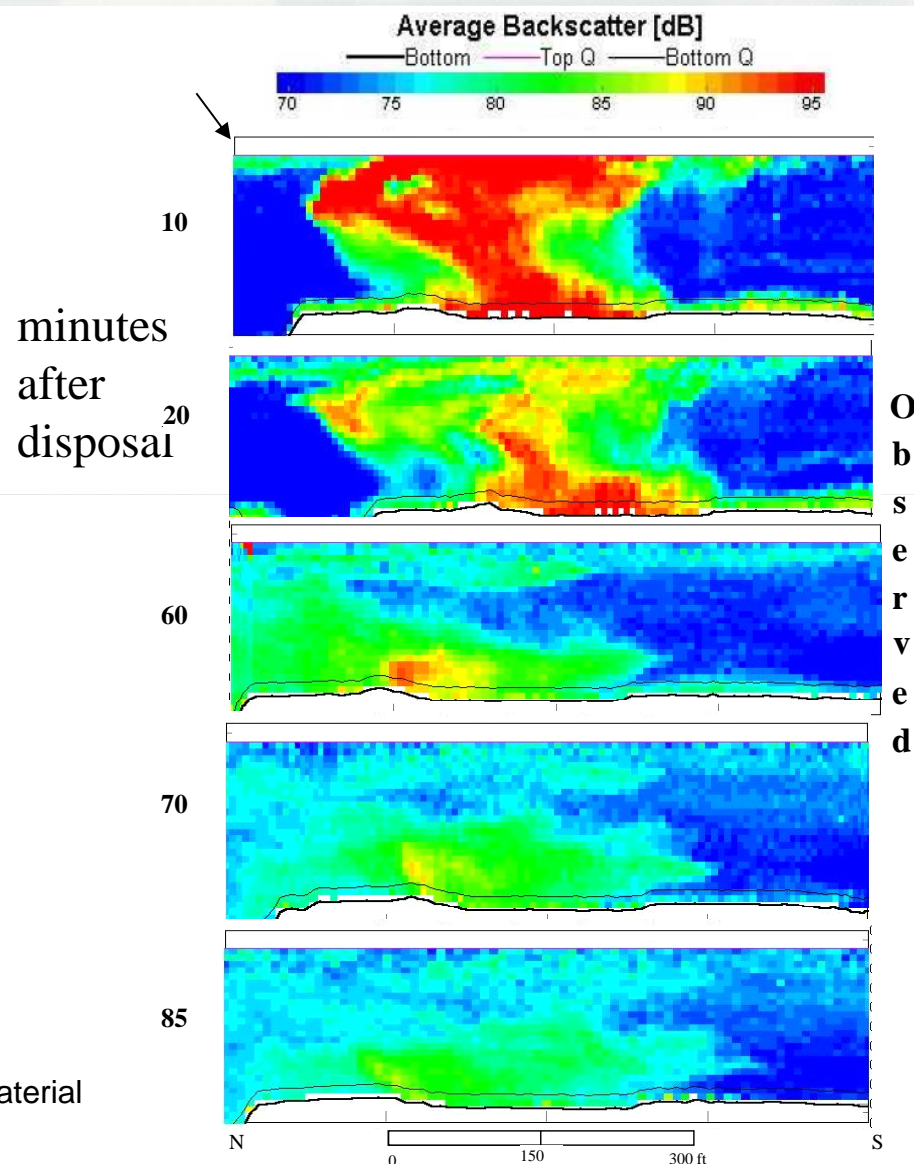
- Sequential boat-based transects show very limited duration of suspended material in the water column
- Laboratory analyses of water samples collected from the disturbed area did not identify impacts

monitoring following scow release of material
over CAD cell in Providence Harbor

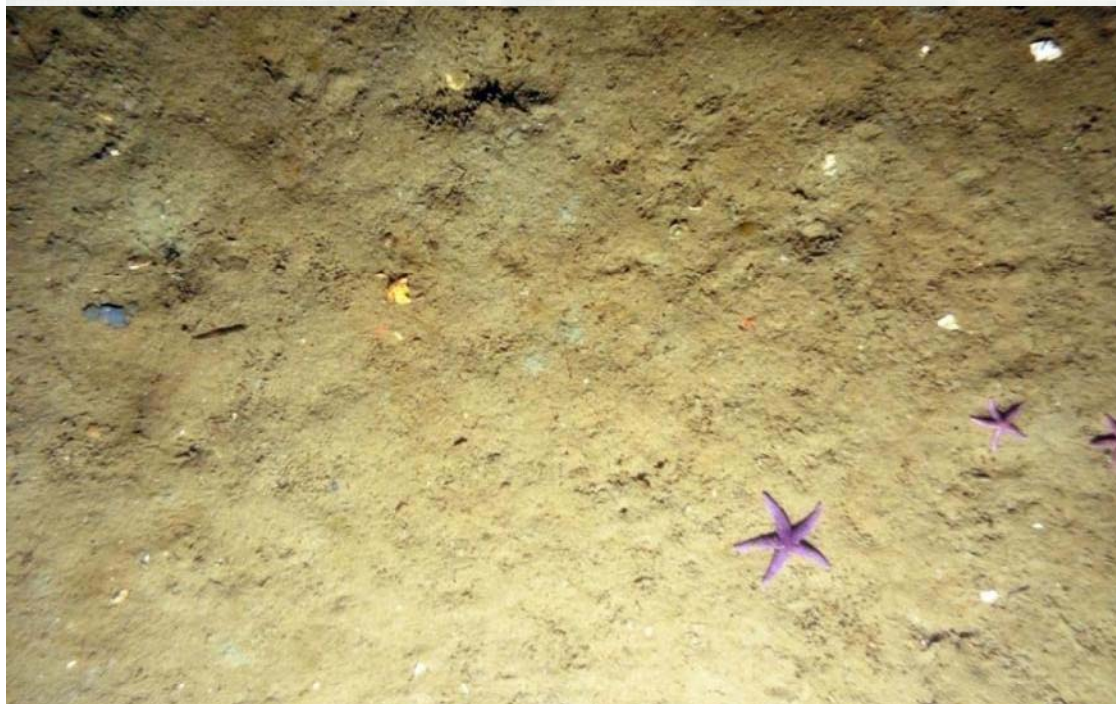
- Benthic (seabottom) impacts limited to the direct footprint of the material placement
- Following disturbance, fine-grained habitats follow a predictable sequence of recovery
- Tracking this recovery is a primary objective of the DAMOS Program (see reports #188, 191, 192, 193 for recent examples)

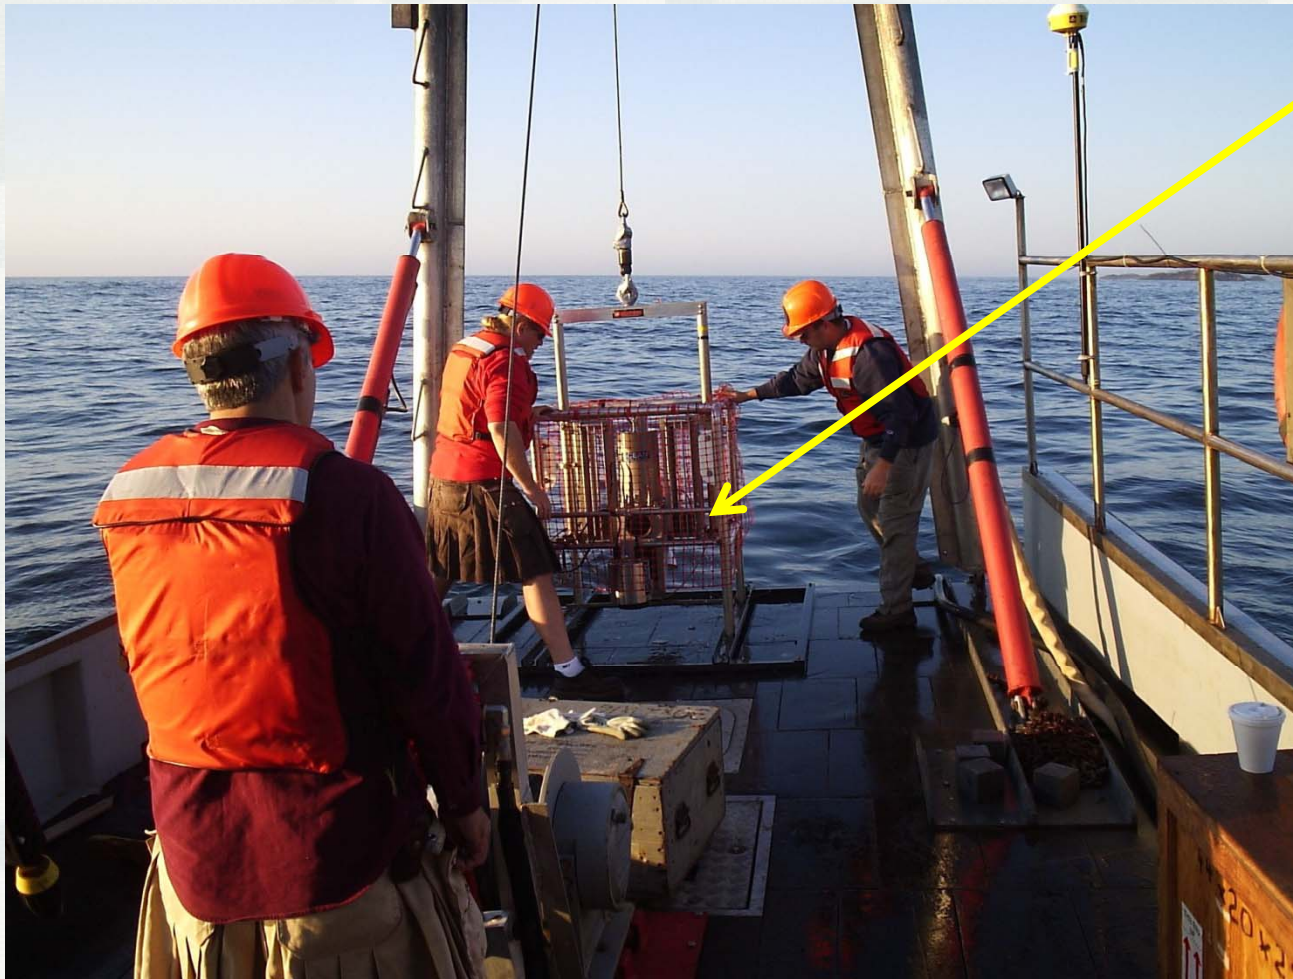
- sediment profile and plan view cameras provide images above and below the seafloor
- imaging multiple locations provides a comprehensive evaluation of a site

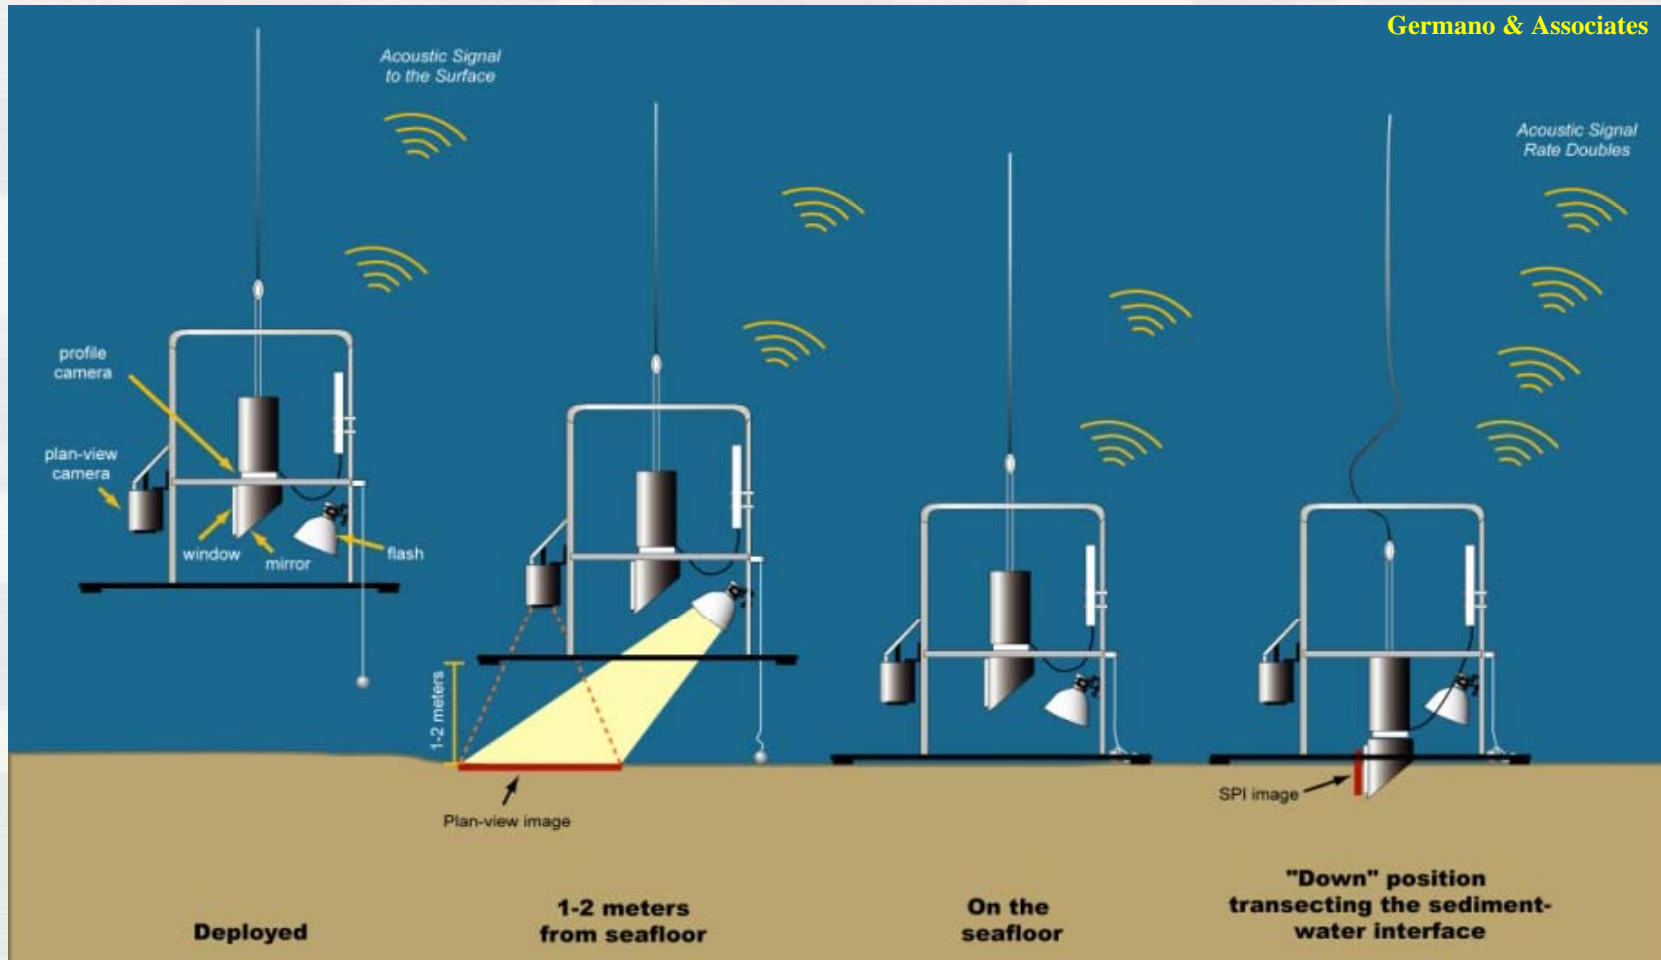
- Deployment of the seafloor imaging camera

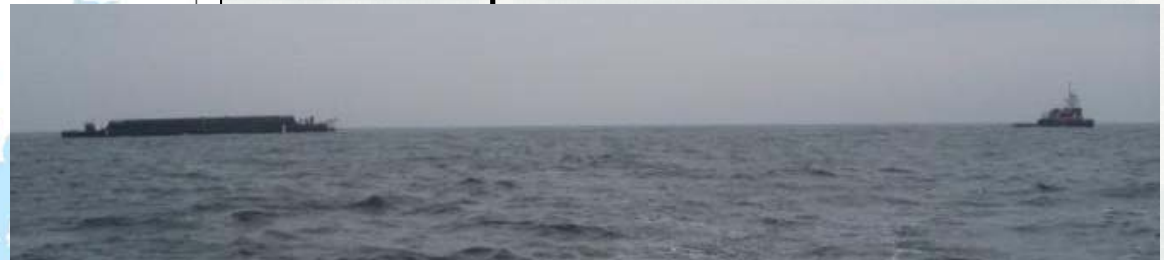
Extended haul distance to disposal site

- approximately 38 miles additional haul for each scow round trip

- additional 63 days of tug-scow traffic on the bay
- additional 260,000 gallons of diesel fuel usage

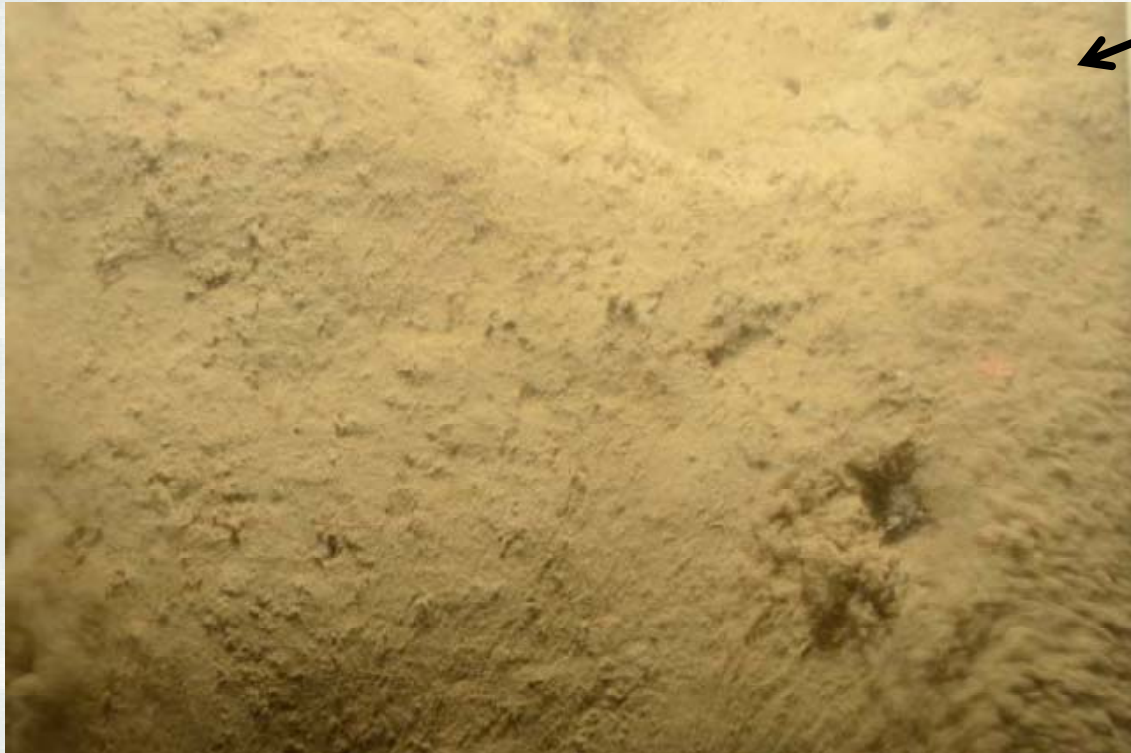
← example plan view image of seafloor in a pit within the proposed disposal area (~2 ft across)

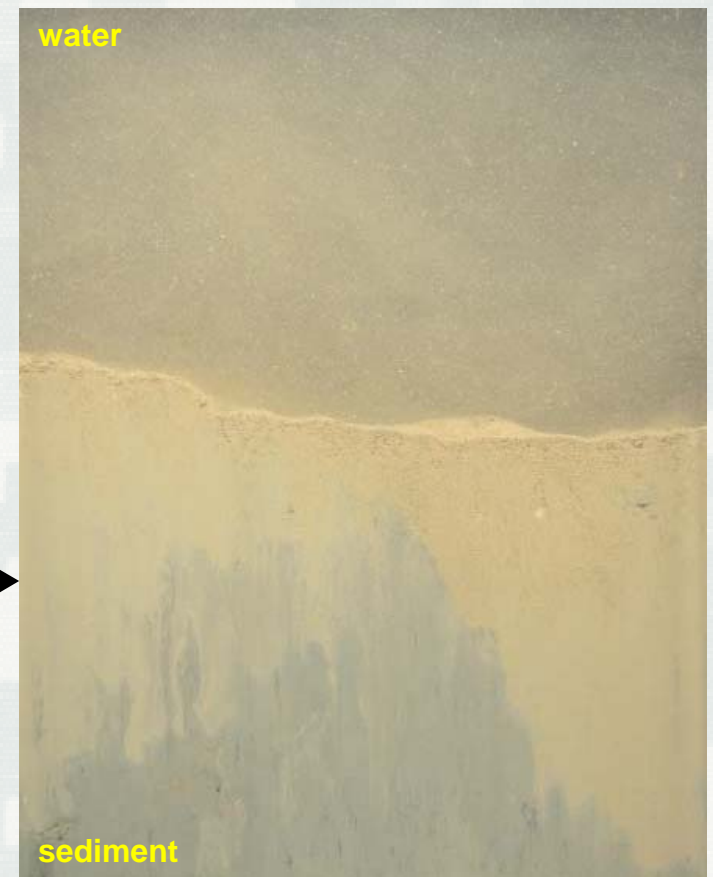
example profile view image across the sediment water interface in a pit within the proposed disposal area (~6 inches across)

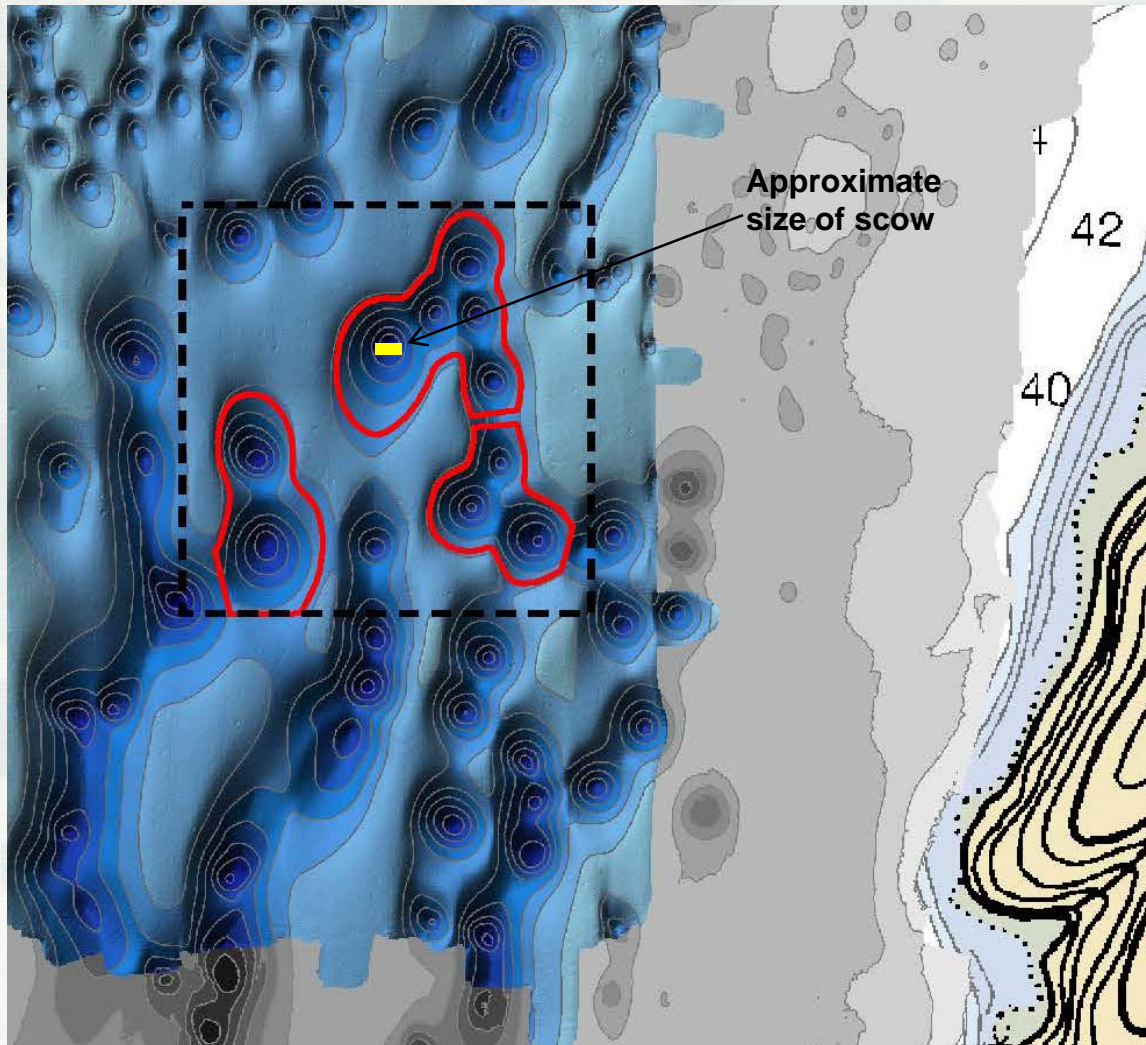
- one or two of the pit clusters will provide sufficient capacity for all the material from the project
- disposal will be targeted to cover less than $\frac{1}{4}$ of the site
