FIVE-YEAR REVIEW REPORT

FIRST FIVE-YEAR REVIEW

**WATERTOWN ARSENAL - FORMER GSA PROPERTY
FORMERLY USED DEFENSE SITE PROJECT NUMBER D01MA0019_02
TOWN OF WATERTOWN
MIDDLESEX COUNTY, MASSACHUSETTS**

3 August 2018

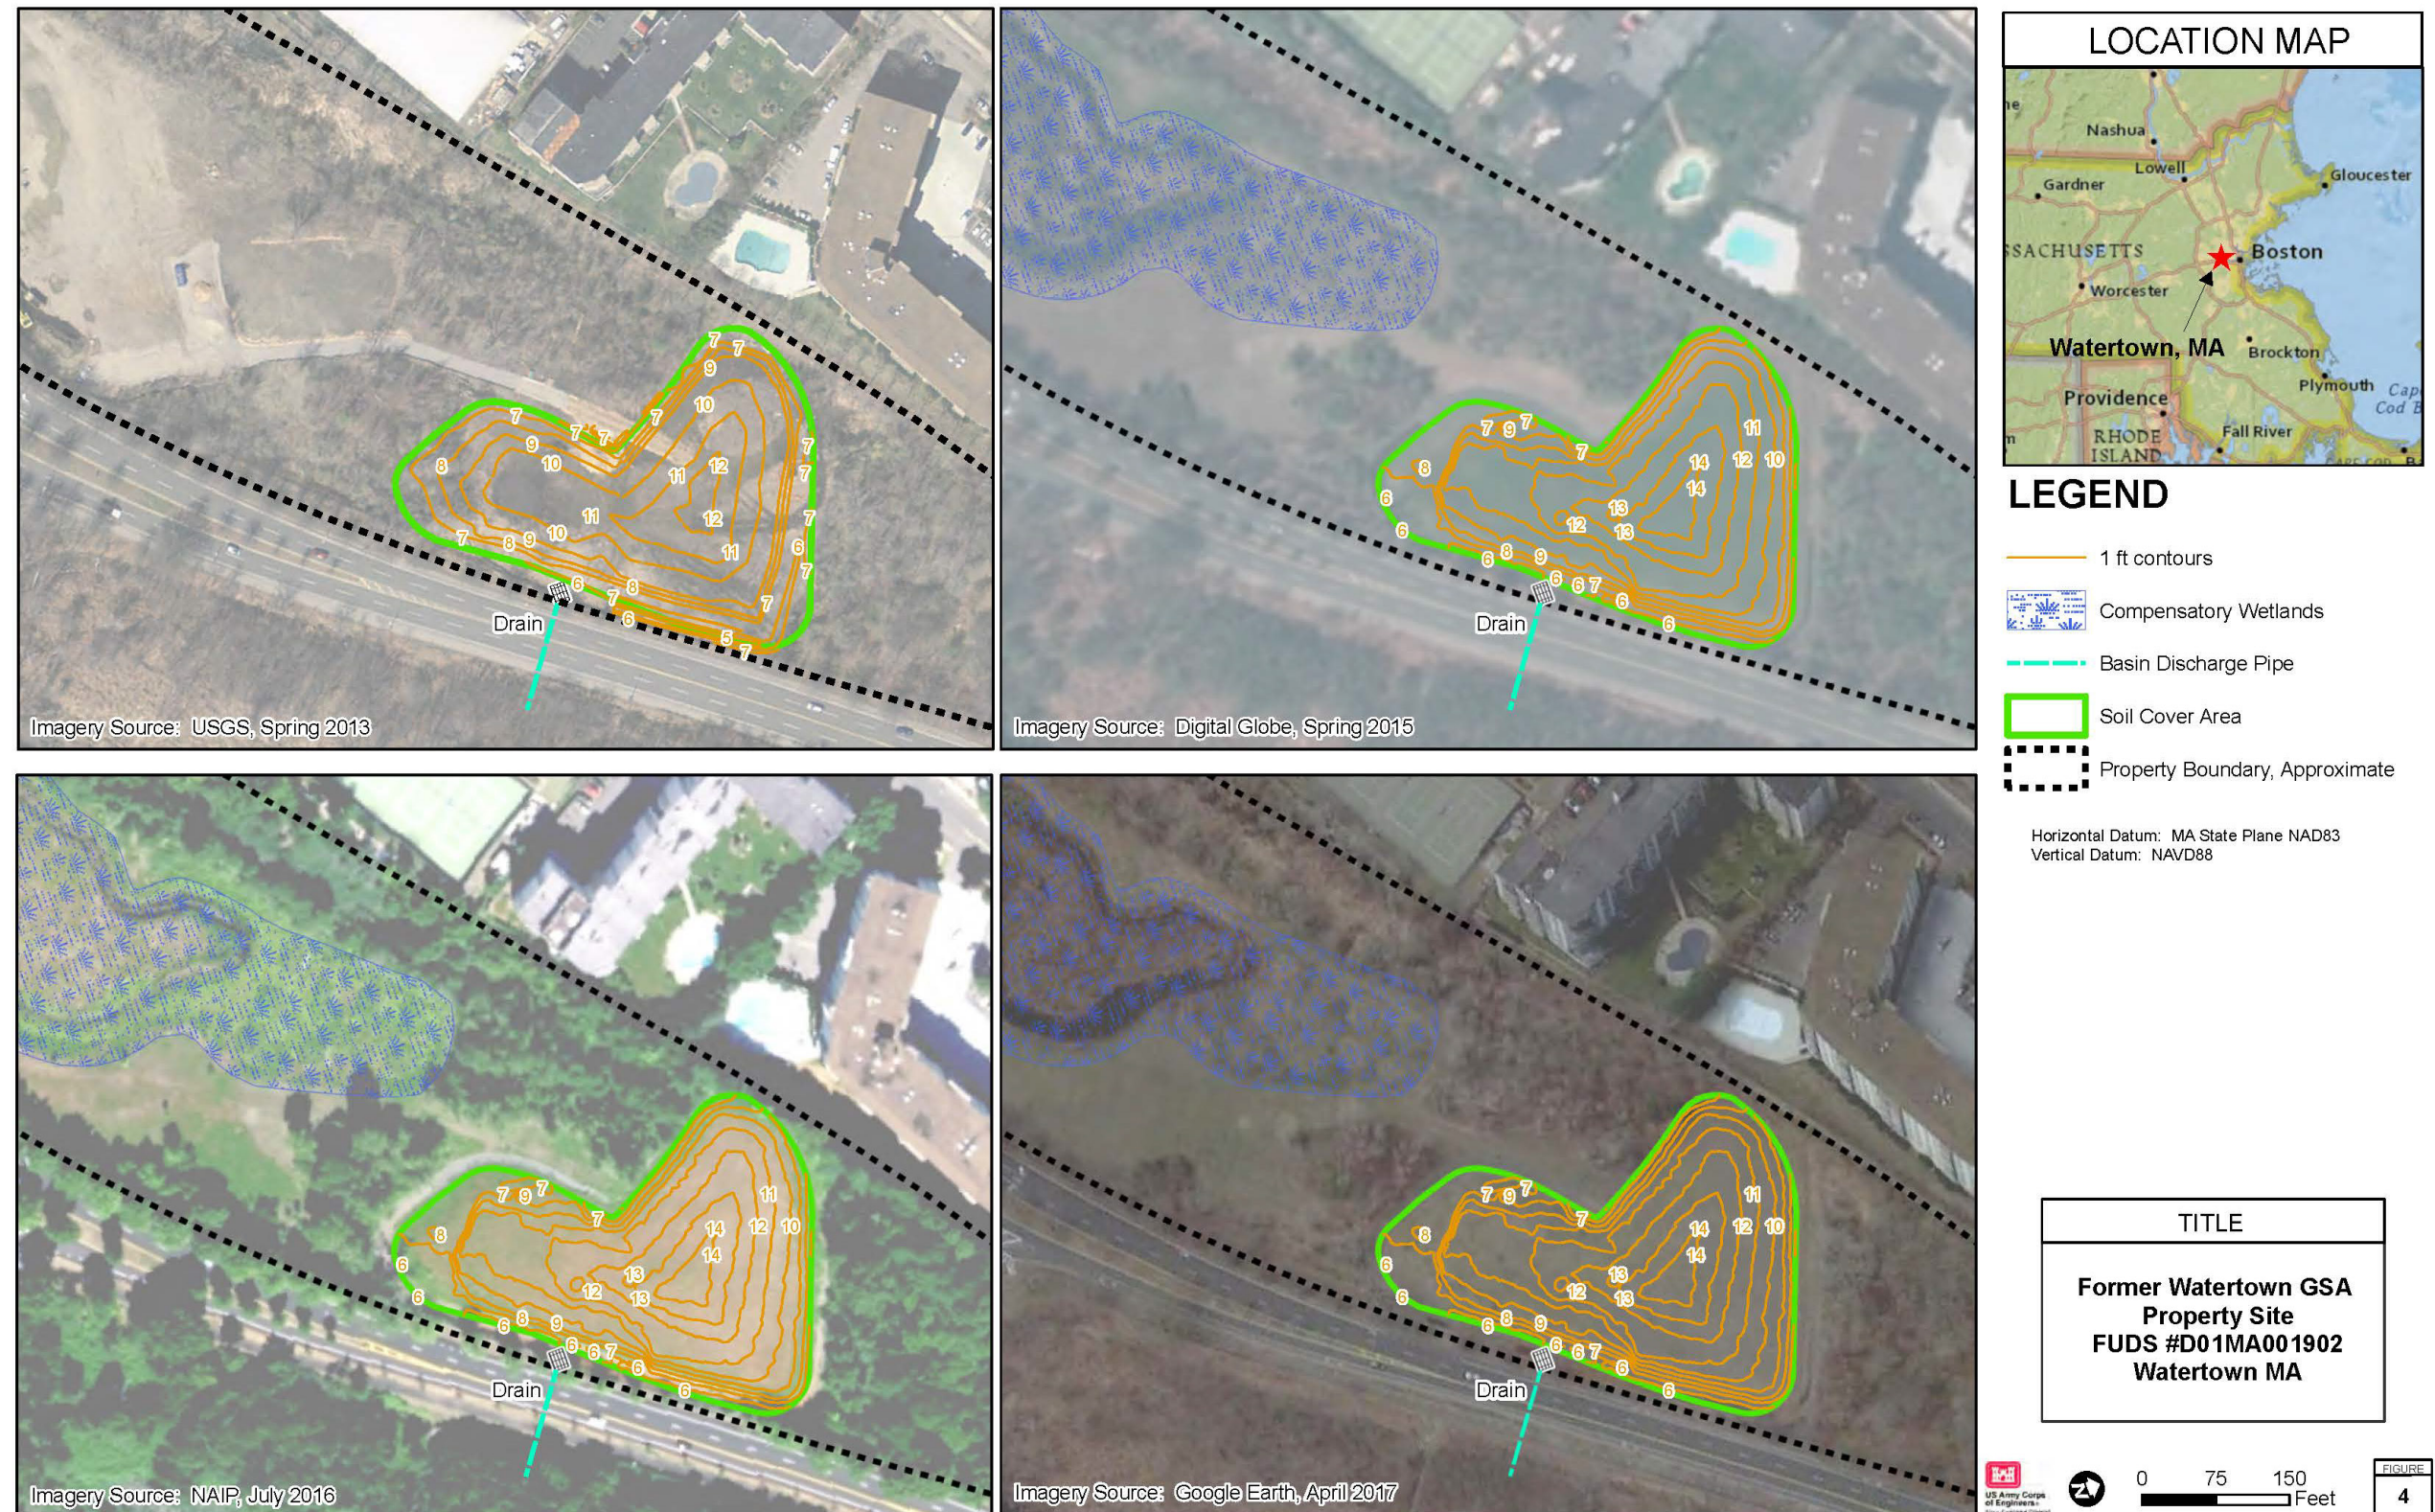
Figure 4. Changes to the soil cover area from 2013 to 2017 (Google Earth, 2017, NAIP, 2017, NOAA, 2016, Worldview Orthoimagery, 2015, USGS, 2013).

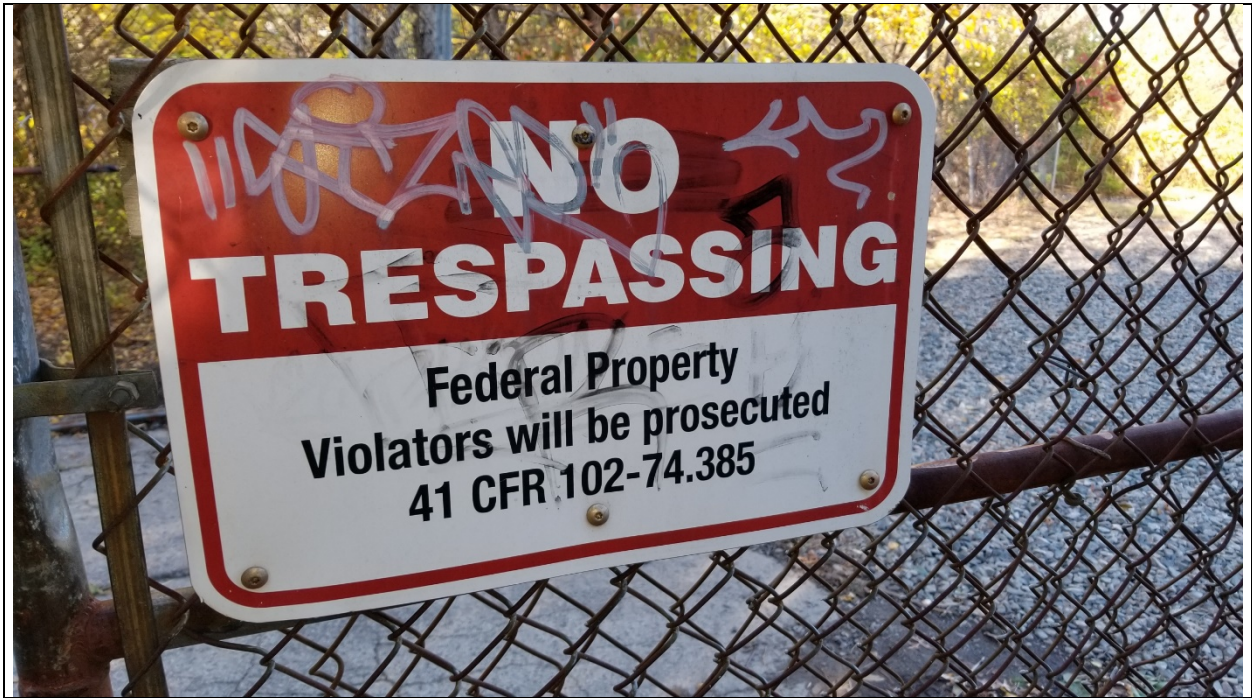
Photo 1. Legacy warning sign on access gate leading to the compensatory wetlands and soil cover (site is no longer owned by the US Government).

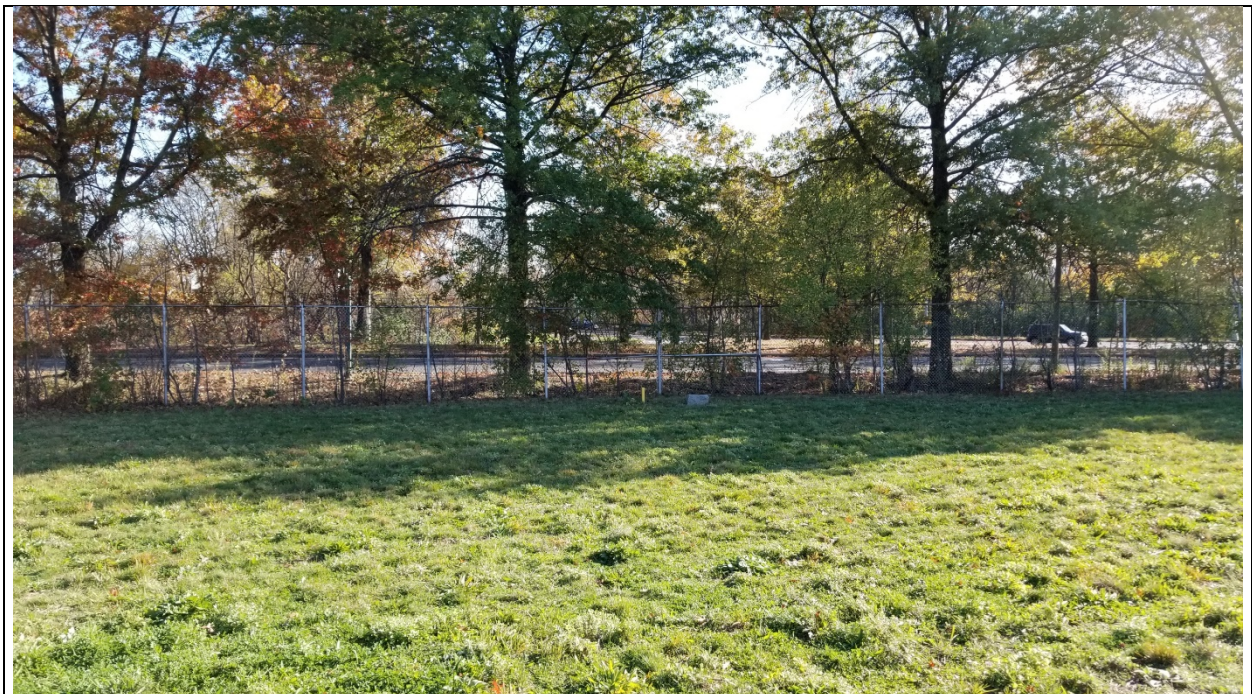
Photo 2. Fence running parallel to Greenough Avenue. Yellow stickup is part of natural gas utility.

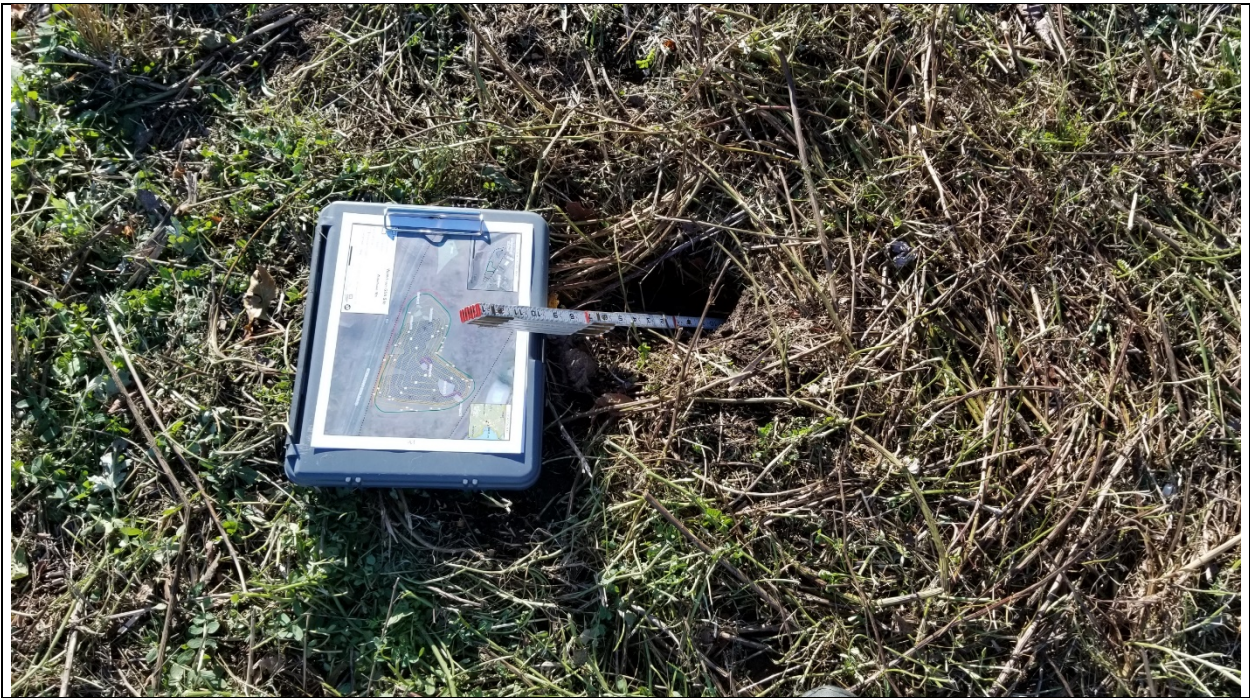
2.	Adequacy ■ ICs are adequate □ ICs are inadequate □ N/A Remarks <u>Soil cover is in good condition with no ruts or obvious settlement areas (depressions holding water). Animal burrow up to 1 ft deep and unknown horizontal extent are present, up to 6-in in diameter.</u>

Photo 3. Animal burrow, about 1.5 foot deep.

The soil cover integrity has not been compromised. The observed burrows did not contain filter fabric debris, and will be filled in 2018. The soil cover's perimeter survey markers and boulders are still in place. The site's perimeter chain link fence and gates installed by MassDCR shows no signs of vandalism or damage, and prevents public access to the eastern swale.

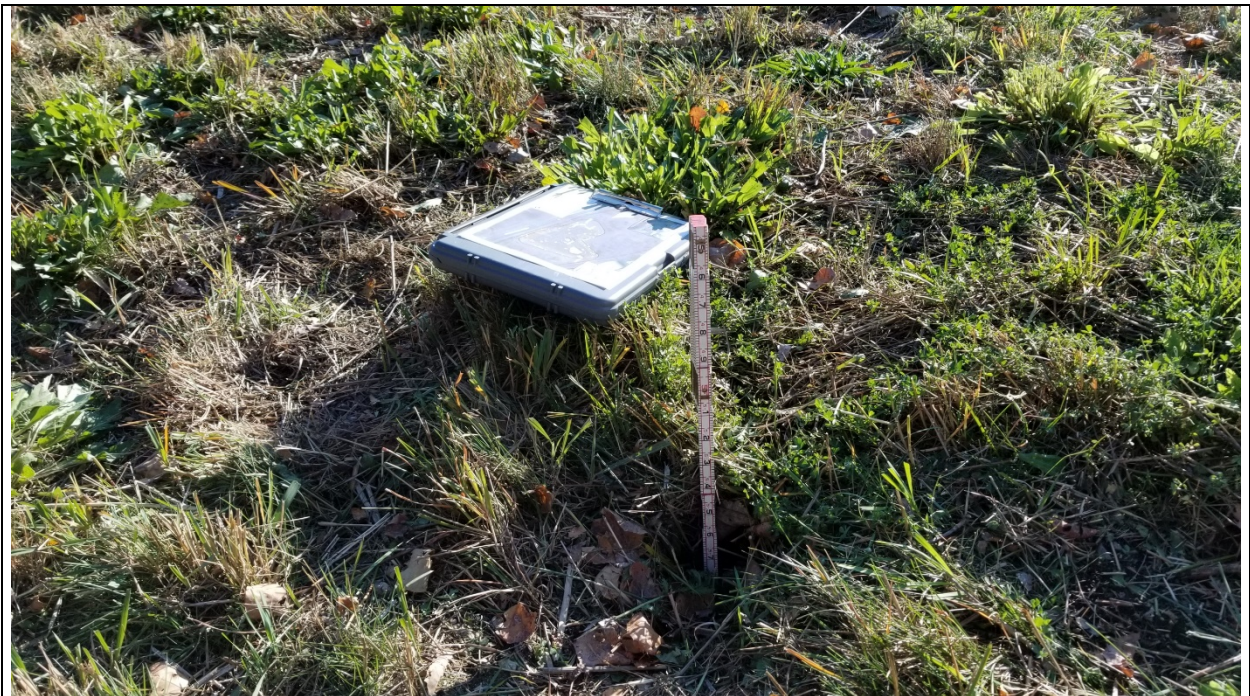
Photo 4. Animal burrow, about 0.6 foot deep.

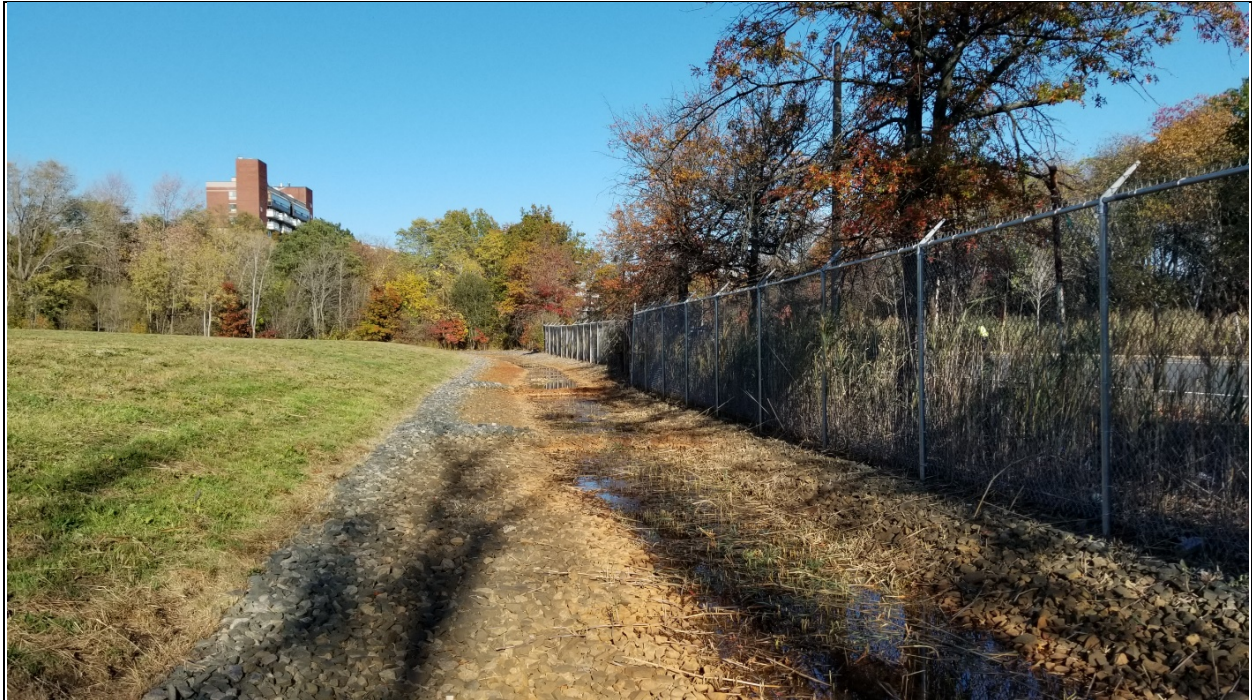
Phragmites is growing along the eastern swale's edges. Plant debris clogs the check dams and catch basin discharge grate. Persistent standing water in the swales suggests the check dams may be clogged, and provides habitat for mosquito larvae. The eastern swale's riprap channel armor is iron stained.

Photo 5. Drainage ditch looking northeast/upstream of the surface water discharge grate on the eastern swale (Photo 6 below). Note brown iron staining and Phragmites stubble (to be treated with herbicide). Greenough Boulevard is to the right.

- GERE Boundary Survey Data Documentation Errors. The boundary should be resurveyed and the GERE corrected.
- Operations & Maintenance Plan Execution. Inspection findings should be geo-referenced and tracked over time in accordance with the O&M Plan.
- Eastern Swale. Iron-staining is present in the swale and should be assessed.
- Swale Check Dams. The drainage swale's check dams retain water for several days after precipitation events and should be assessed. The check dams and receiving catch basin should be inspected and serviced if needed.

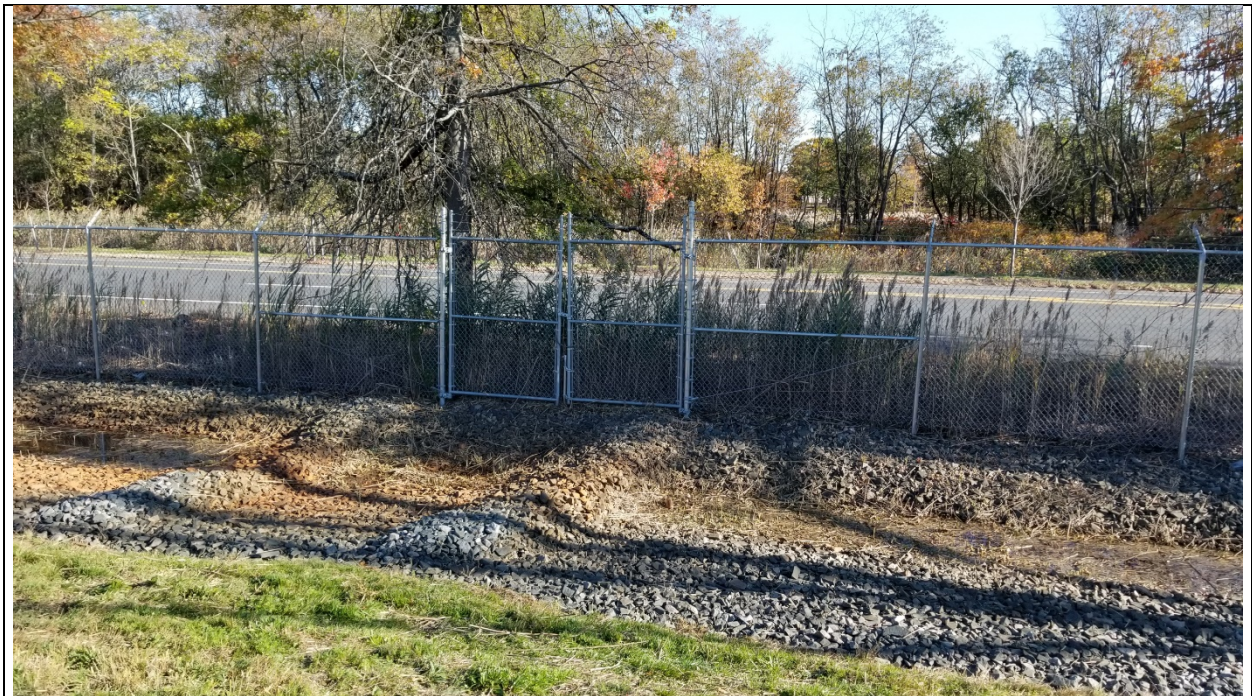
Photo 6. Fence and maintenance gate near Greenough Boulevard. Gate is next to surface water runoff drain running under the road to the Charles River. Note brown iron staining and Phragmites stubble (to be treated with herbicide). Greenough Boulevard is in the background).

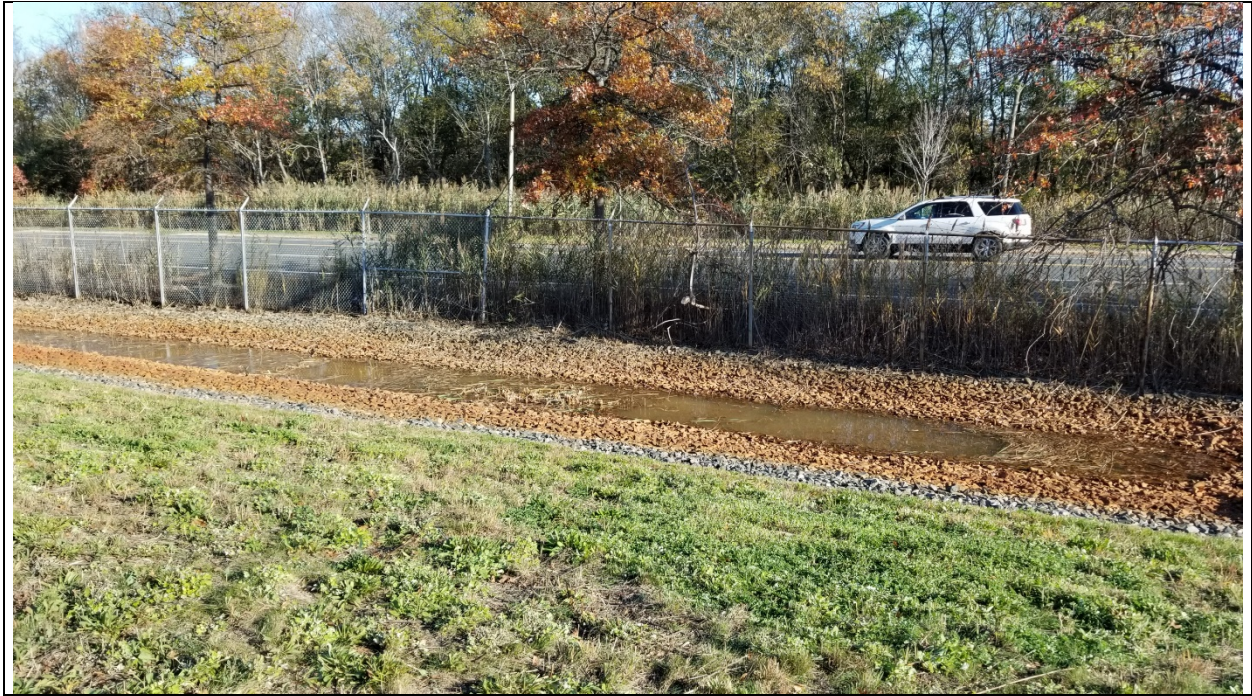
Photo 7. Upper portion of eastern swale parallel to Greenough Boulevard, showing ponded water, iron staining on the riprap/channel armor, and Phragmites stubble.
