### **INTERIM APPROVED JURISDICTIONAL DETERMINATION FORM U.S. Army Corps of Engineers**

**A. COMPLETION DATE FOR APPROVED JURISDICTIONAL DETERMINATION (AJD):** November 28, 2018

**B. ORM NUMBER IN APPROPRIATE FORMAT (e.g., HQ-2015-00001-SMJ):** NAE-2000-01240

State: Connecticut County/parish/borough: Fairfield City: Greenwich

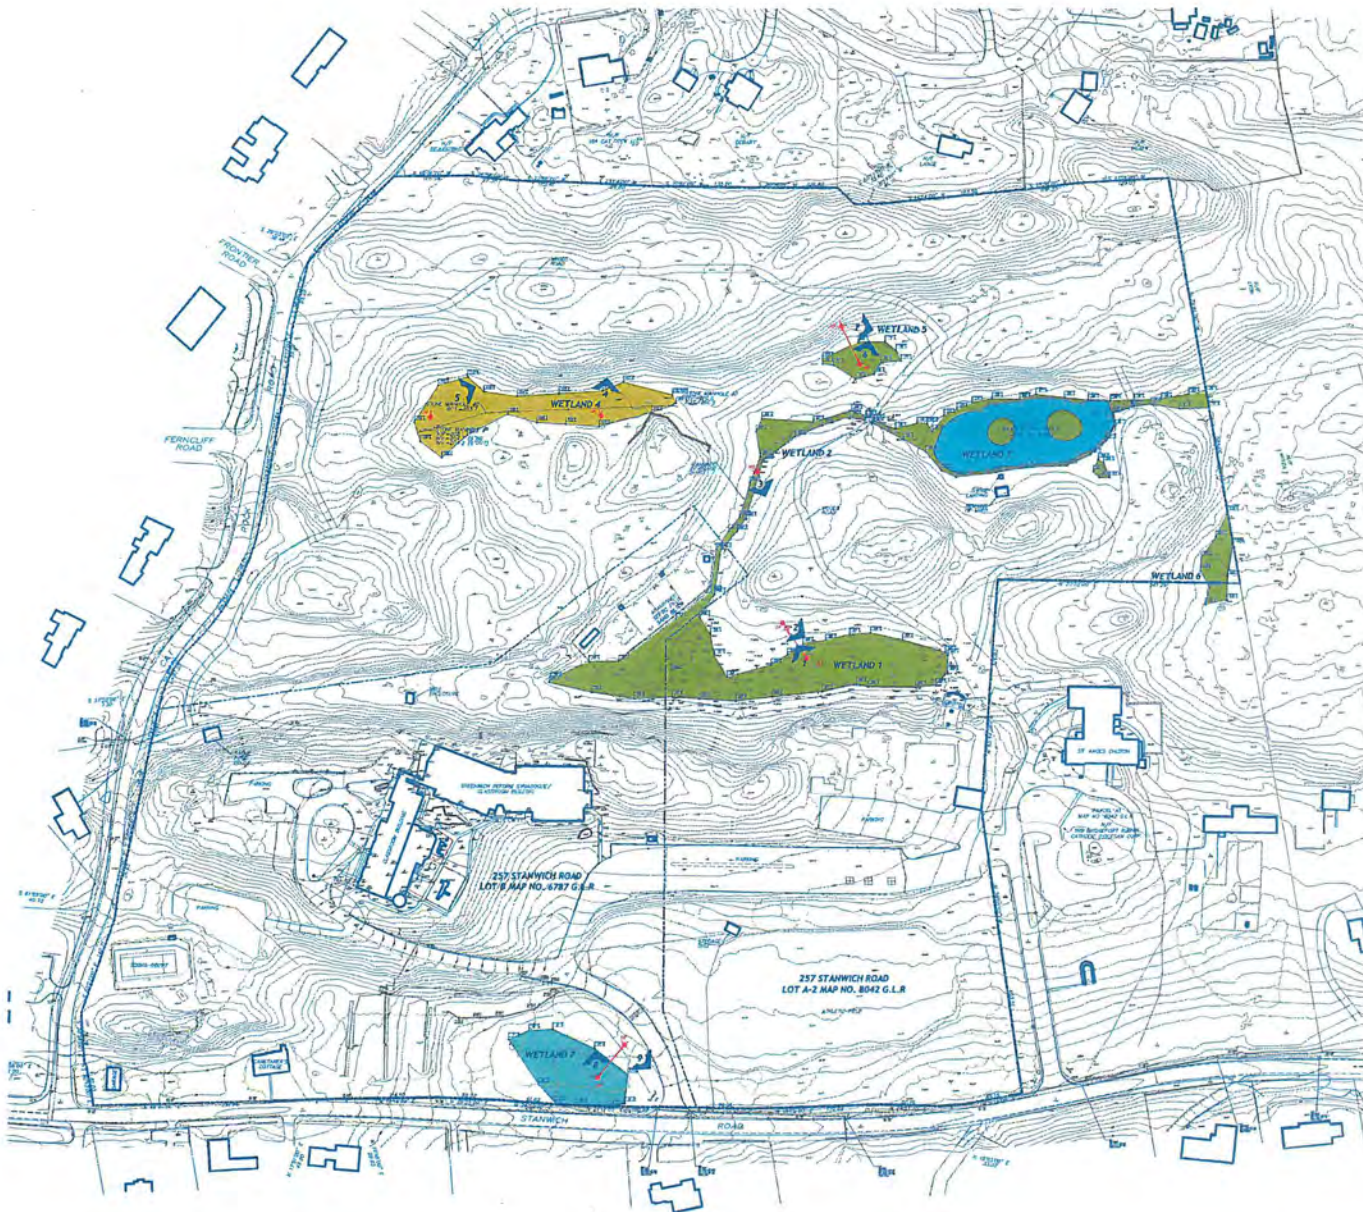
**FEDERAL WETLAND & WATERCOURSE  
DELINEATION MAP**

**WETLAND 4** - DRAINED AND DEGRADED WOODLAND WETLAND DEPRESSION TO BE RESTORED THROUGH REFORMATION AND PLANTING OF NATIVE HYDROPHITIC TREES AND SHRUBS. AREA CURRENTLY FUNCTIONS PRIMARILY AS AN UPLAND.

**WETLAND 1** - WOODLAND AND MARSH, SHALLOW DEPRESSION, DISTURBED NORTHERN AND SOUTHERN AREAS TO BE ENHANCED AND EXPANDED VIA REMOVAL OF "PRAGMATES" AND PLANTING OF NATIVE TREES, SHRUBS AND HERBS.

**WETLAND 7** - DEGRADED LAWN WETLAND SLOPE TO BE ENHANCED VIA PLANTING OF NATIVE TREES, SHRUBS AND HERBS, MICROTOPOGRAPHY IMPROVEMENTS AND INTRODUCTION OF STORMWATER.

**WETLAND 5** - WOODLAND WETLAND, SHALLOW DEPRESSION TO REMAIN UNDISTURBED.

**WETLAND 3** - SHALLOW POND AND FRINGE WOODLAND WETLAND, PROVIDES BREEDING AND DEVELOPMENT HABITAT TO OBLIGATE VERNAL POOL SPECIES (E.G., SPOTTED SALAMANDER AND WOOD FROG). AREA TO BE PROTECTED AND UNALTERED.

**WETLAND 6** - GENTLY SLOPING, WOODLAND WETLAND TO REMAIN UNDISTURBED.

**WETLAND 2** - GENTLY SLOPING, WOODLAND WETLAND TO REMAIN UNALTERED, HISTORICALLY SYSTEM ALTERED FOR INSTALLATION OF SUBSURFACE DRAIN BETWEEN WETLAND 4 AND 3.

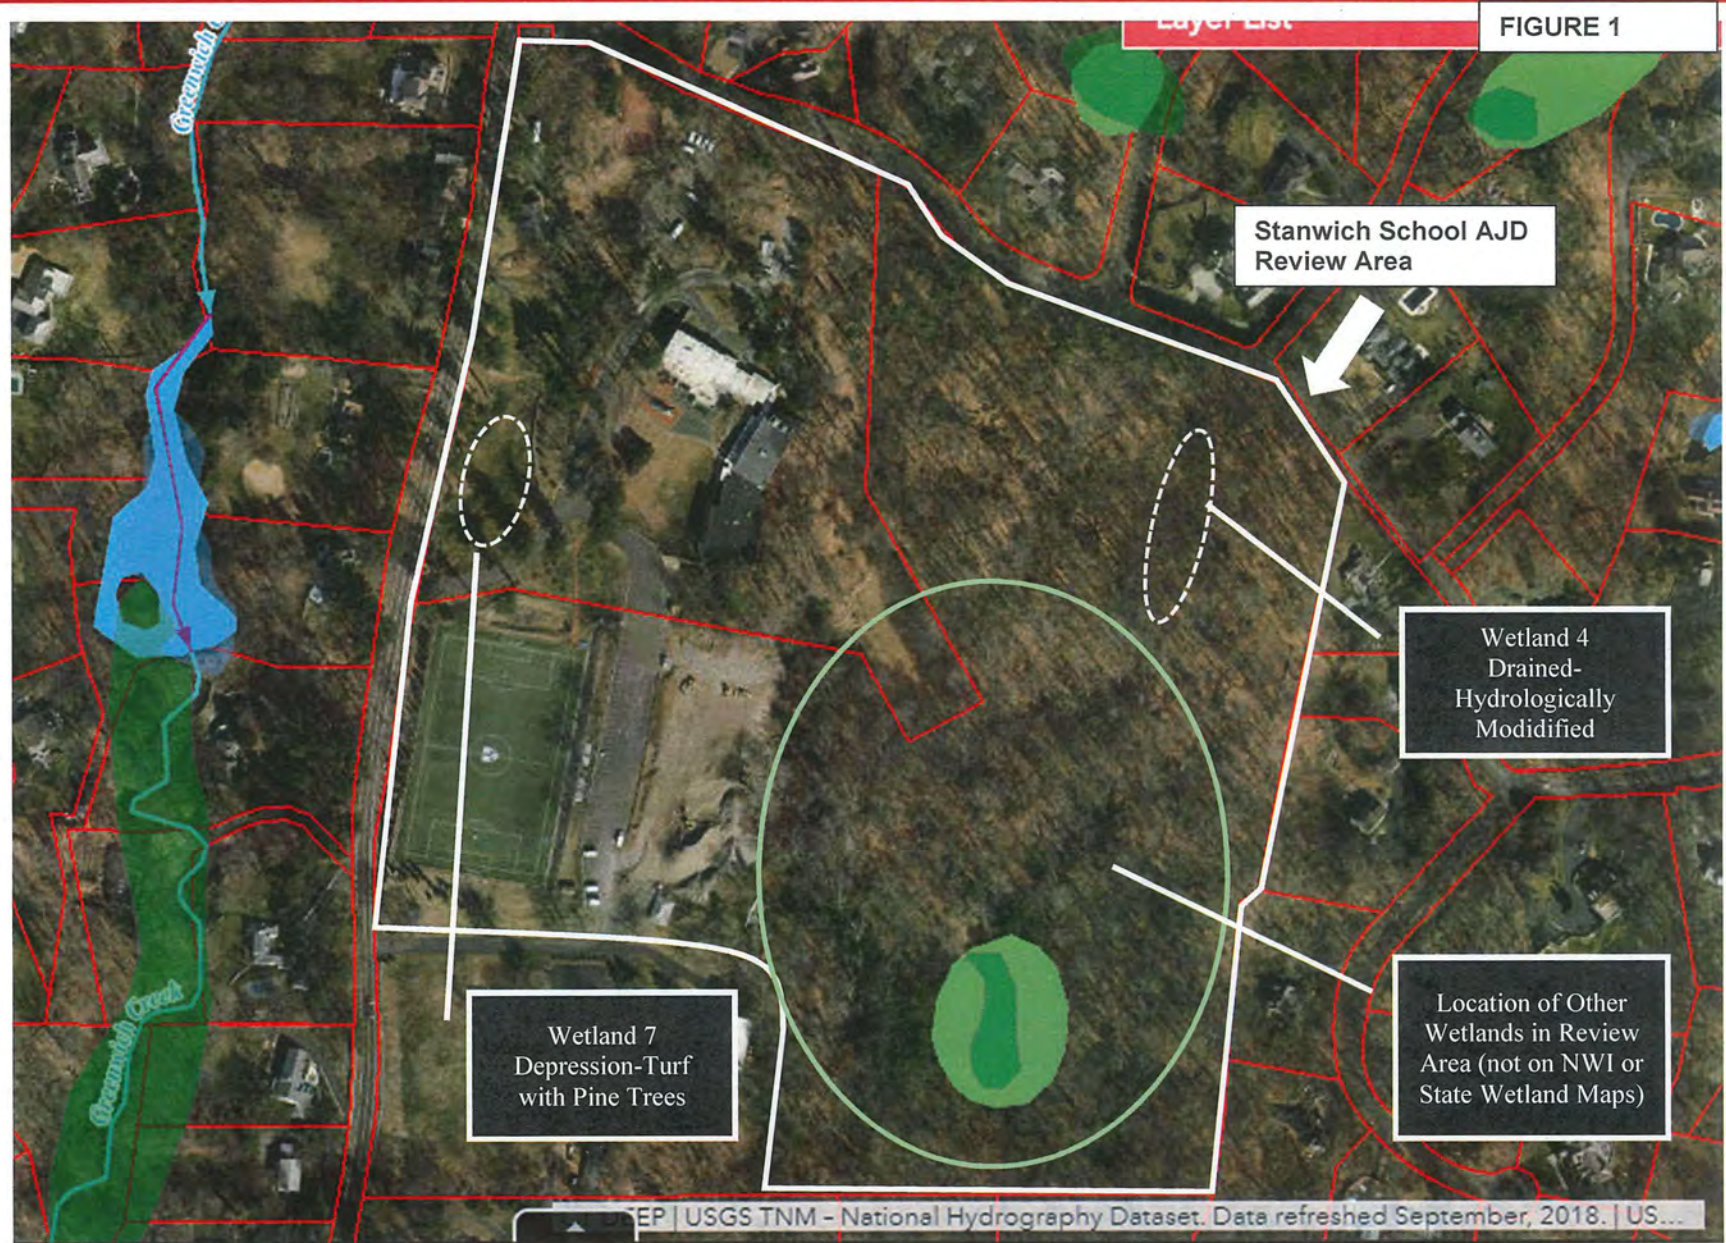
FIGURE 1

STANWICH SCHOOL NAE-2000-01240  
APPROVED JURISDICTIONAL DETERMINATION REVIEW AREA

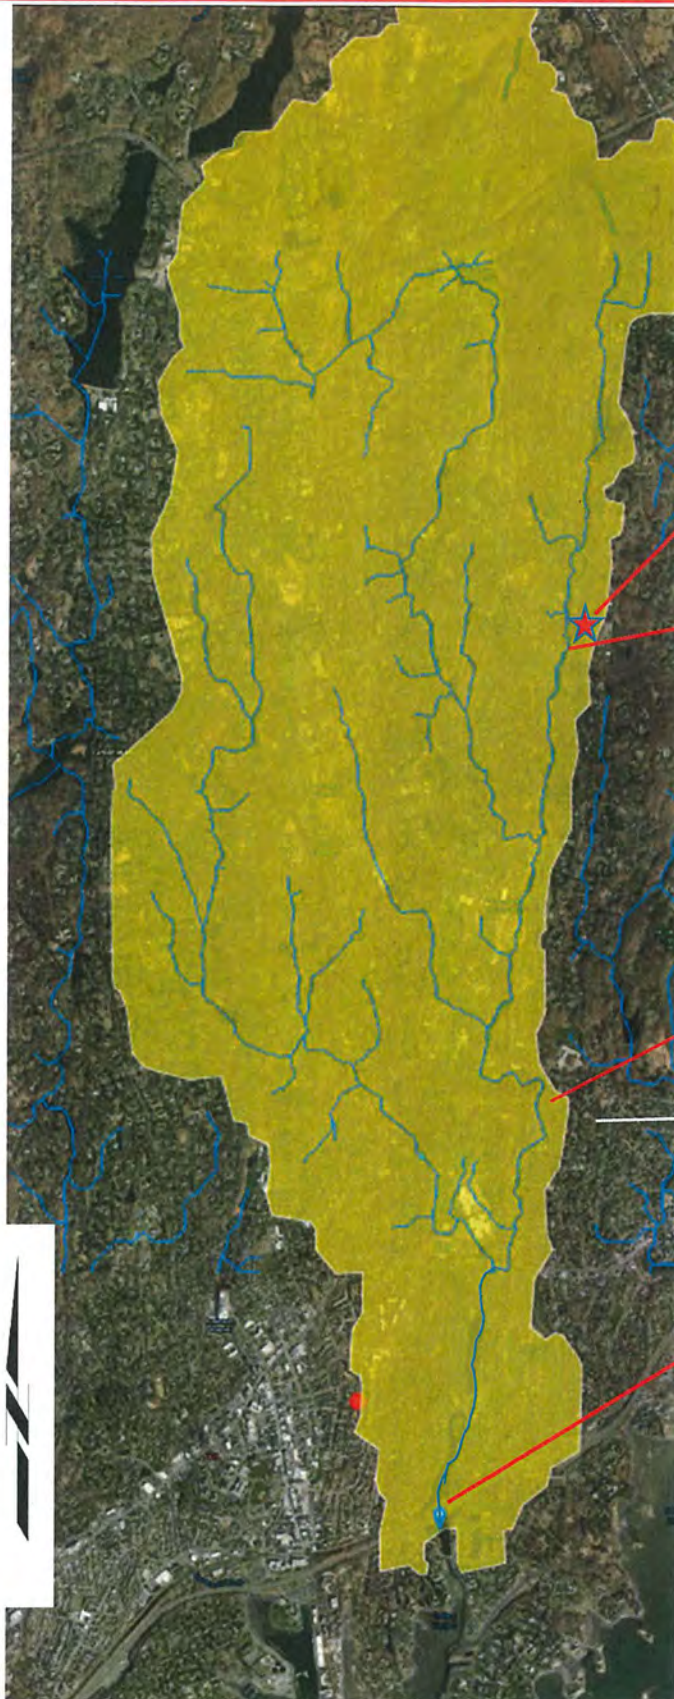
FIGURE X

STANWICH SCHOOL NAE-2000-01240  
AJD SPOE B for (a)(5) STREAM 2 to (a)(1) water – Indian Harbor

NAE-2000-01240  
'AJD REVIEW AREA' including  
W-7

"STREAM 2" – (a)(5) waterway  
Perennial Greenwich Creek  
(outside review area)

"INDIAN HARBOR"  
Section 10 TNW & tidal  
(a)(1) waterway

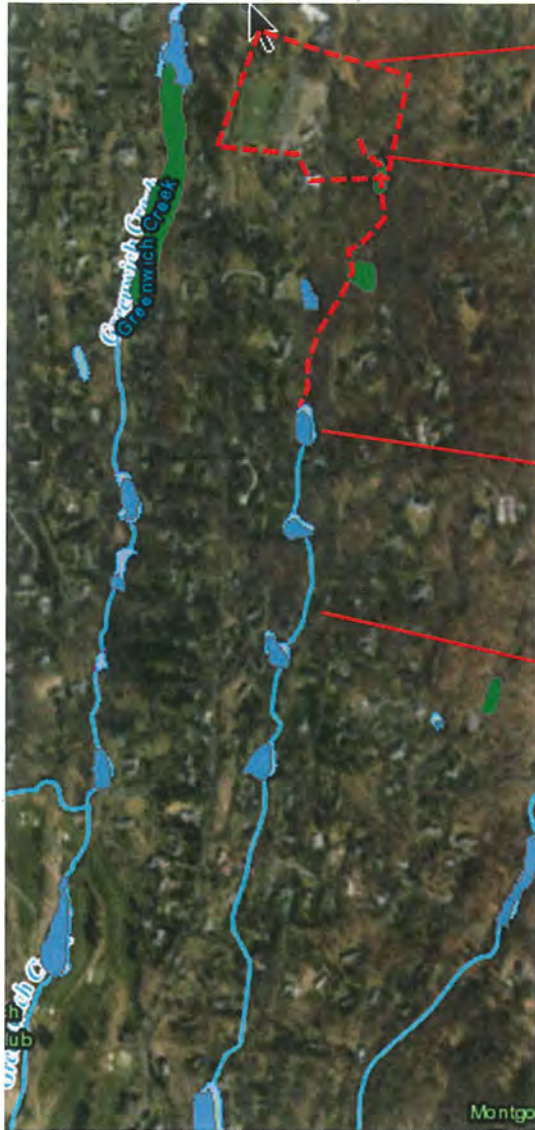
FIGURE X

AJD review area -257 Stanwich Road

AJD (a)(5) STREAM 1 (headwater, Intermittent unnamed tributary of Brothers Brook) at 257 Stanwich Road within the AJD Review Area

AJD (a)(5) STREAM 1 Unnamed tributary transitions to Perennial at 57 Stanwich Road

Travels through 6 impoundments before merging with Brothers Brook at 57 Bible Street, adjacent to Montgomery Pinetum Park

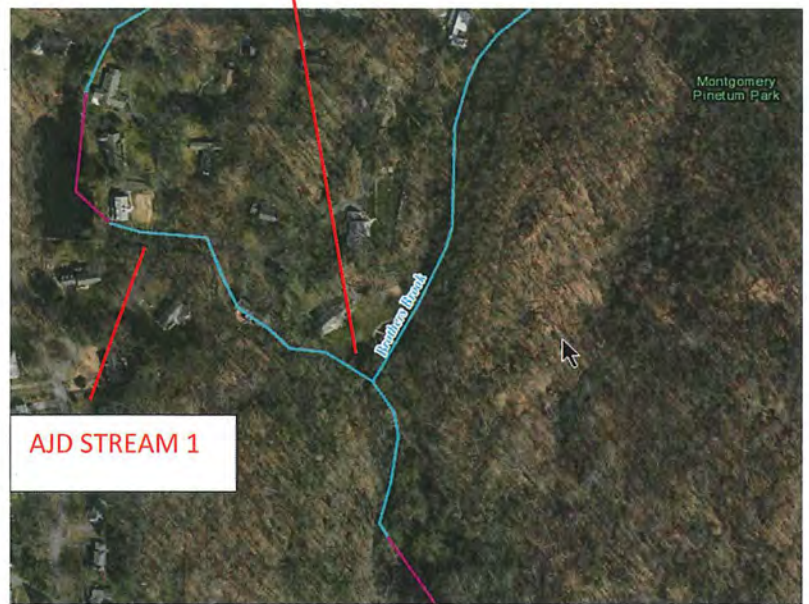
**FIGURE 7**

**CONNECTIVITY TO (A)(1) TO (A)(3) WATERWAY**

AJD STREAM 1 TRAVELS DUE SOUTH 1.06 MILE FROM 257 STANWICH ROAD TO MERGE WITH BROTHERS BROOK IN GREENWICH, CT AT 57 BIBLE STREET, THEN BROTHERS BROOK TRAVELS SOUTH/SOUTHWEST FOR APPROXIMATELY 0.67 MILE BEFORE EMPTYING INTO COS COB HARBOR JUST BELOW EAST PUTNAM AVENUE IN GREENWICH, CONNECTICUT

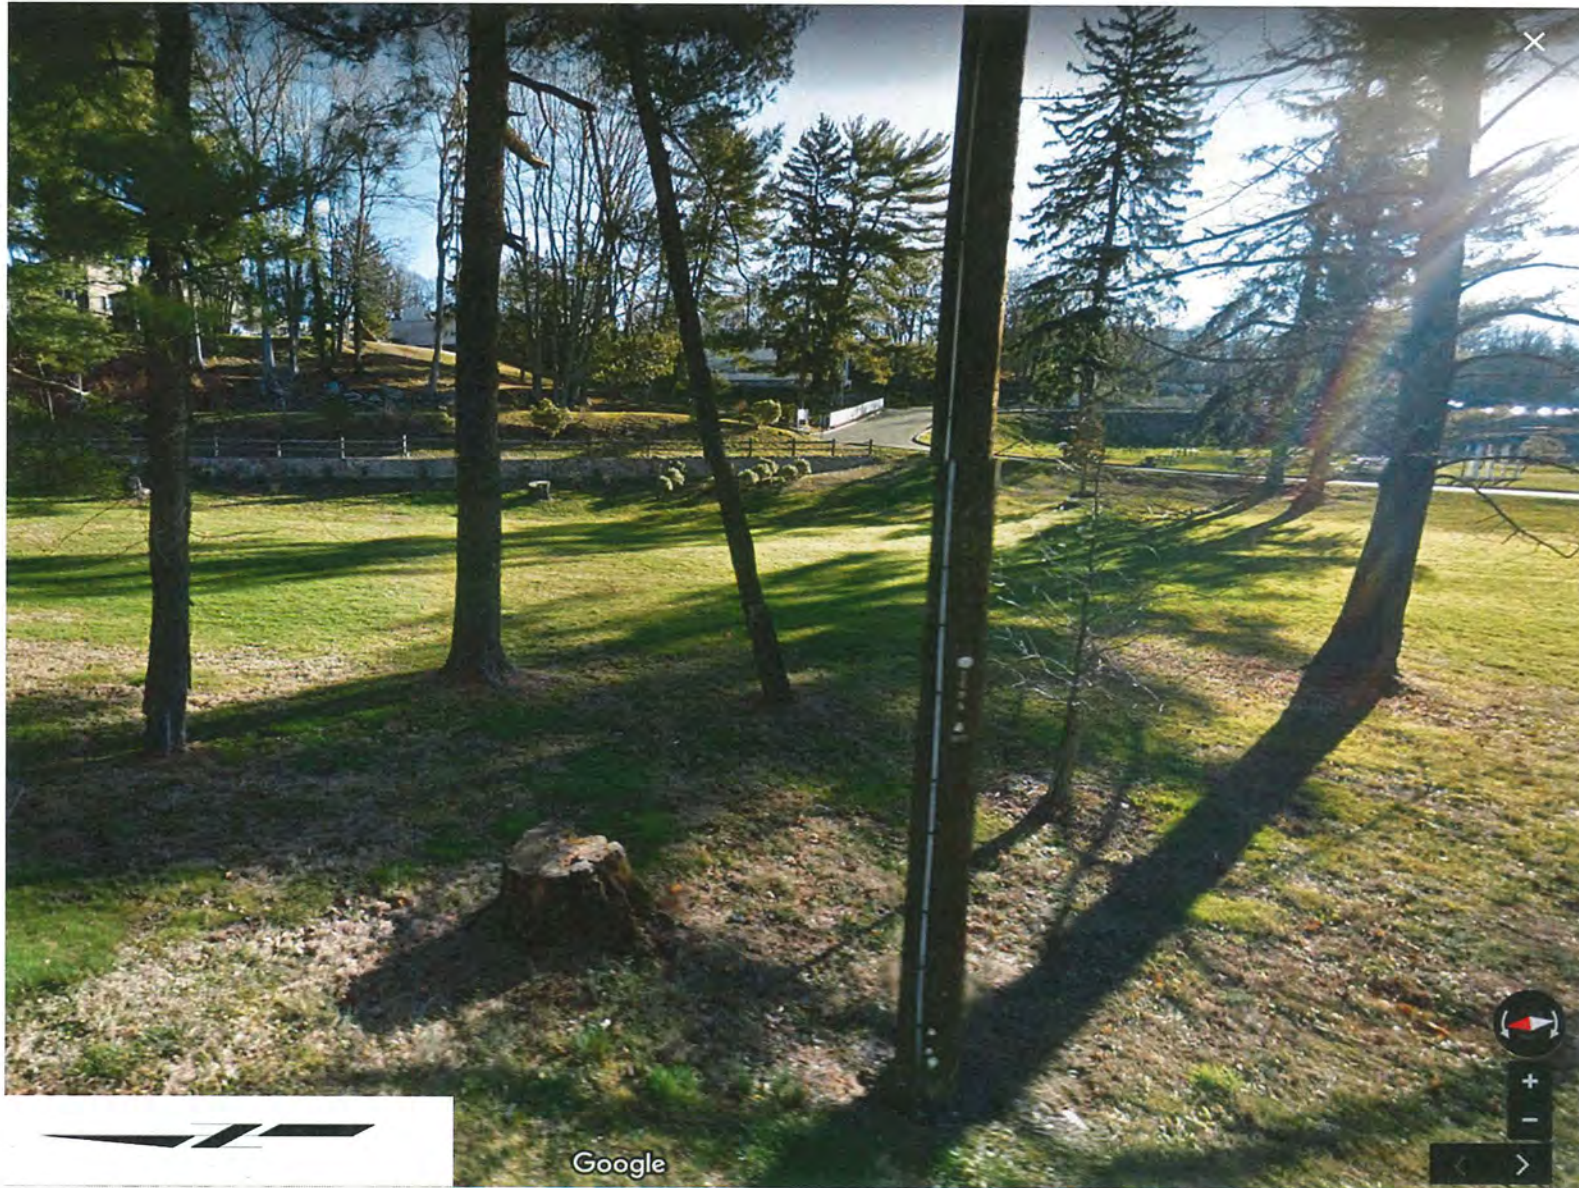
FIGURE 10

STANWICH SCHOOL NAE-2000-01240  
VIEW OF WETLAND 7 FROM 260 STANWICH ROAD

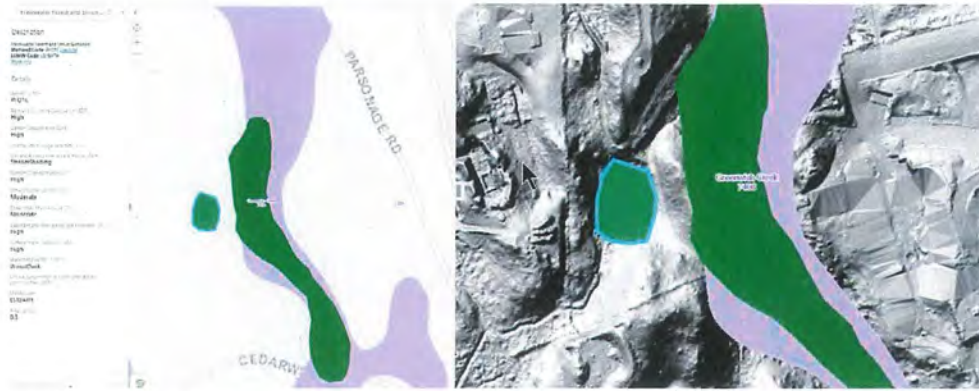
SS-7: Thin till deposits, within proximity to WOTUS but hydrologically connected/part of tributary system

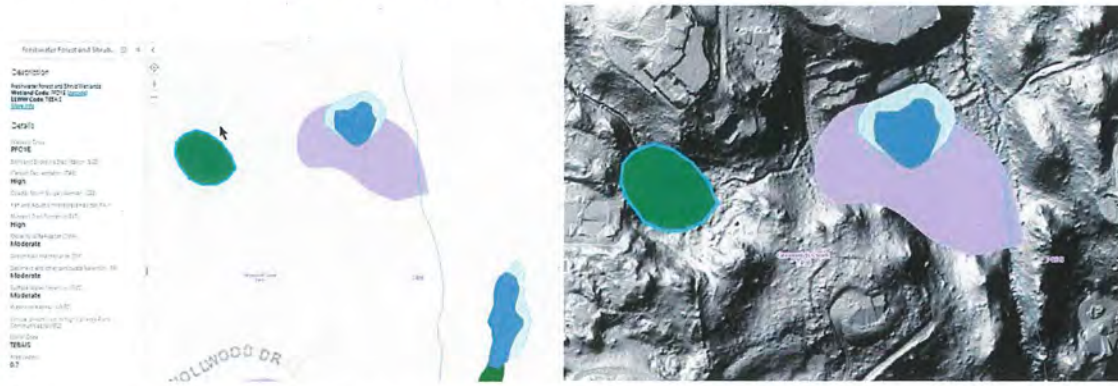
SS-8: Thin till deposits, within proximity to WOTUS but hydrologically connected/part of tributary system

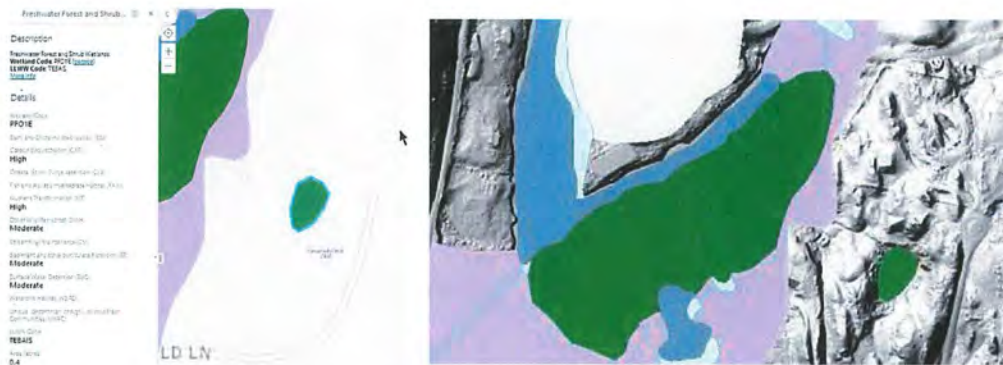
SS-6: Thin till deposits, within proximity to WOTUS but different terrain and landscape setting

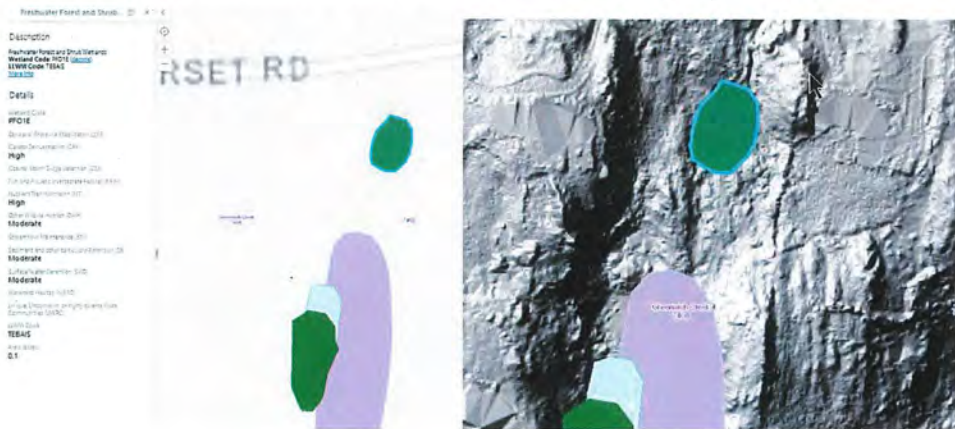
SS-4: Thin till deposits, similar terrain and landscape setting; within proximity of WOTUS but appears hydrologically connected as headwater tributary feature.

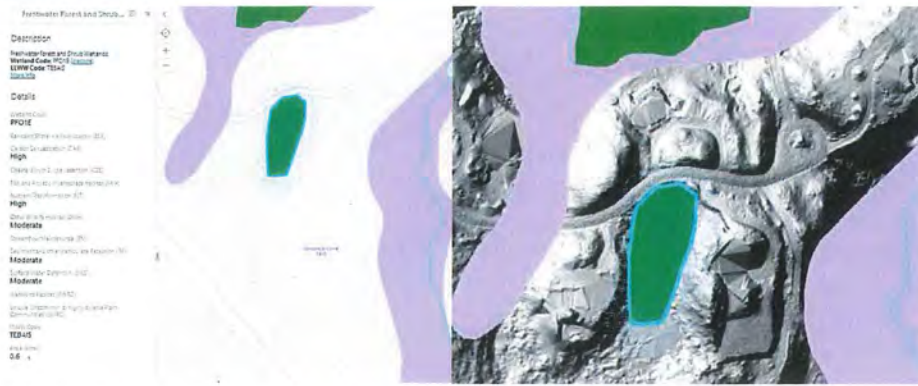
SS-5: Thin till deposits, slightly different terrain; within proximity to WOTUS

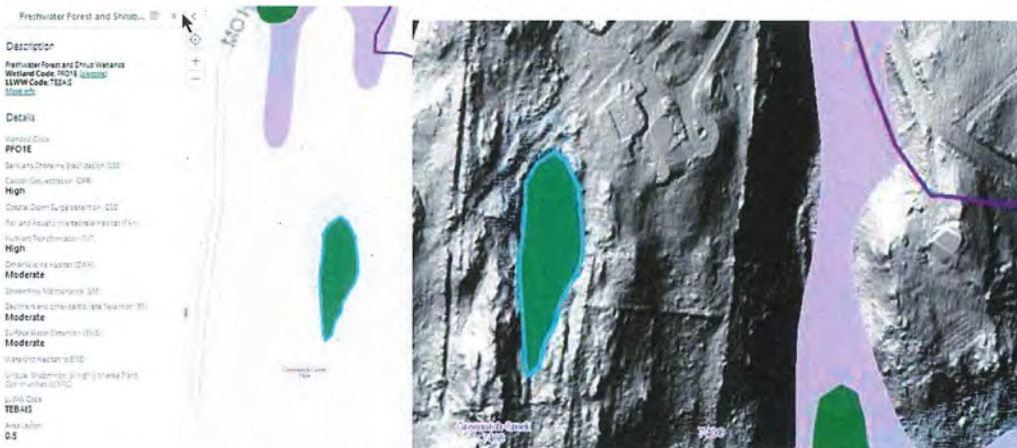
SS-2: Thin till deposits, similar terrain, with proximity distance to WOTUS

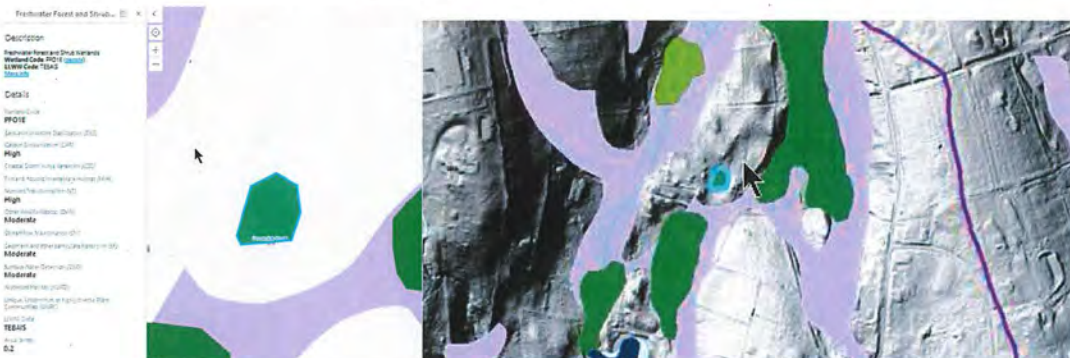
SS-1: Thin till deposits; within proximity distance to WOTUS; similar terrain
