CT DOT – Route 91

File No.: 198800859

MITIGATION SITE FIELD DATA FORM

Site Name: CTDOT Rt. I-91 Widening—Mitigation Site A File No.: 198800859

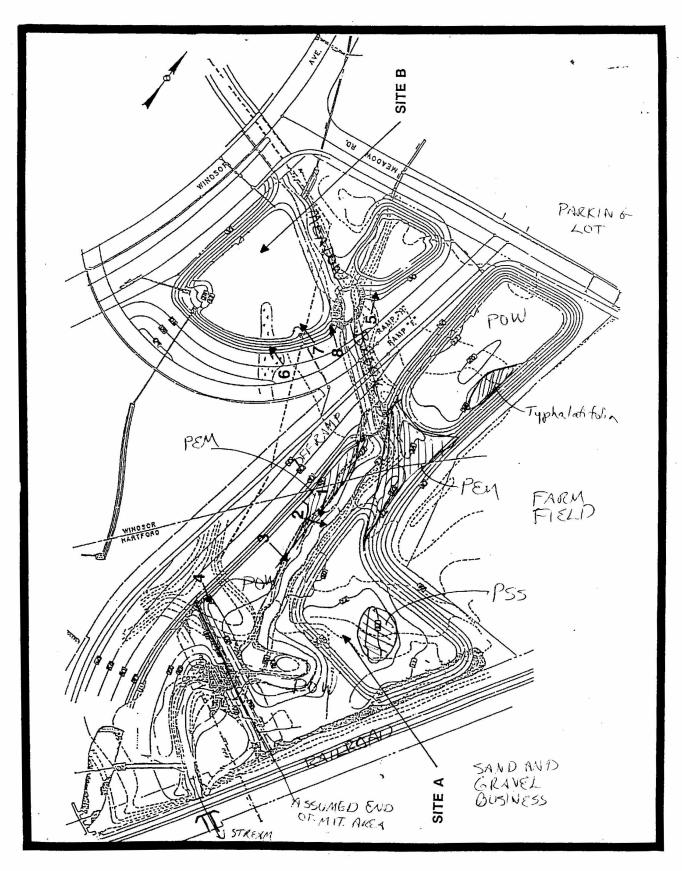
Project #63-358 Site Plan Plate 2

Site is bounded by steep slopes to the highway and the railroad. There is a fringe of forested upland between the site and a farm field to the east. There is a PSS island in the southern ponded area which does not seem to be as shown on the design—it is further east. The stream enters from Mitigation Site B to the west via a culvert, passes through an herbaceous wetland dominated by cattail and loosestrife, is ponded in the southern portion of the site and then discharges through what is an "undisturbed" area to the south before it flows under the railroad bed and eventually joins the Connecticut River.

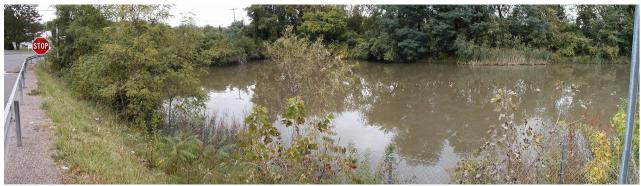
Looking north and east at northern ponded area from west side of site next to I-91 off-ramp

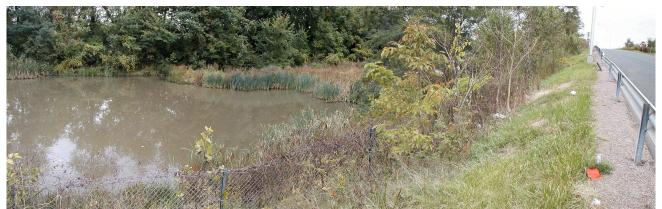
Looking east and south at northern ponded area from west side. Cattail area in center is near where stream enters culvert under I-91 ramp and connects to mitigation site B to the west.

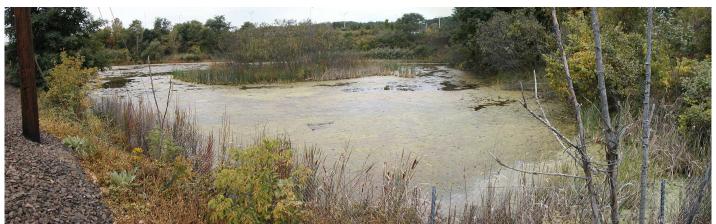
Algal mats are abundant in southern ponded area and are probably indicative of nutrient loading from the stream. The water is very turbid in the northern ponded area but there are no algal mats.

Looking southwest and west from northeast corner of southern lobe. Note island and algae in the water.
