# Huber Resources

**File No.:** 199701542

## MITIGATION SITE FIELD DATA FORM

Site Name: Huber Resources File No. 199701542

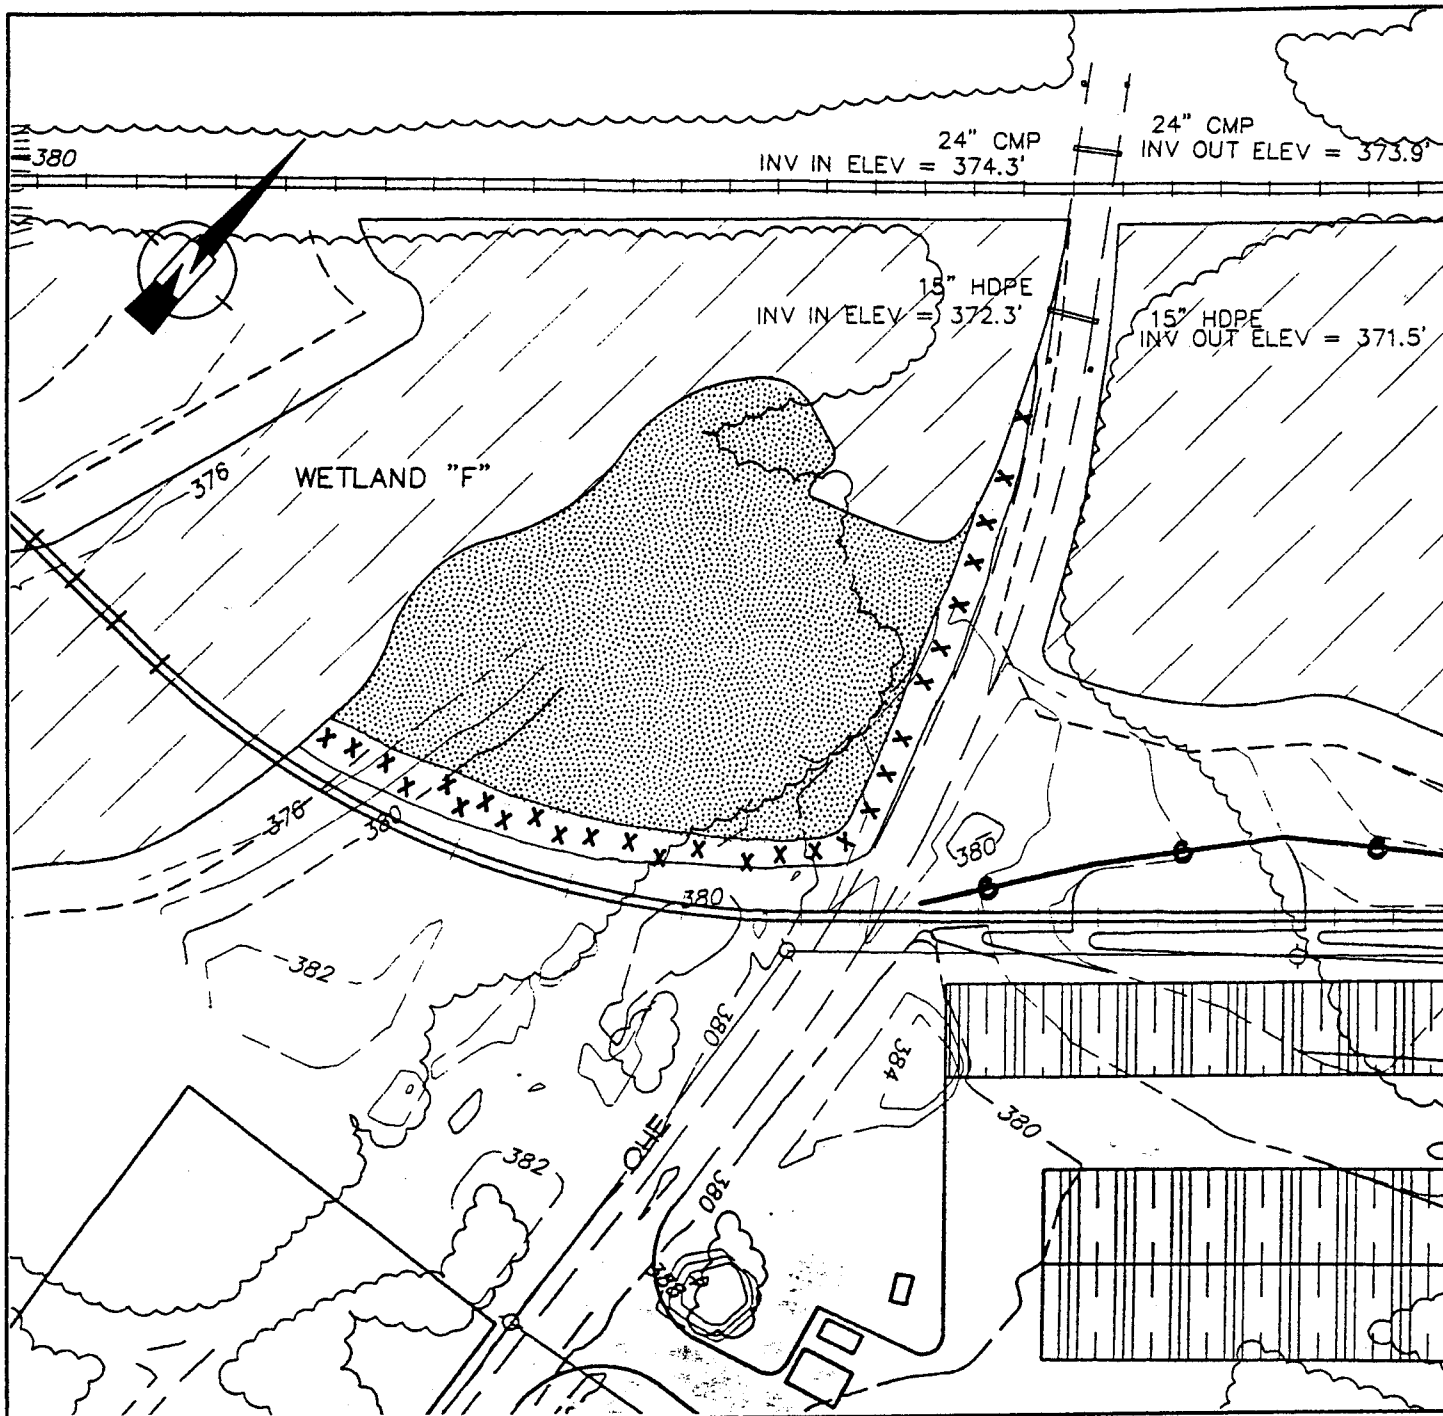
**Figure C-1**

**Huber Property Compensation Areas  
Creation Area C (1.10 ac.)**

Location of fill removal

x x x Denotes sideslopes planted w/shrubs (enhancement, 0.20 ac.)

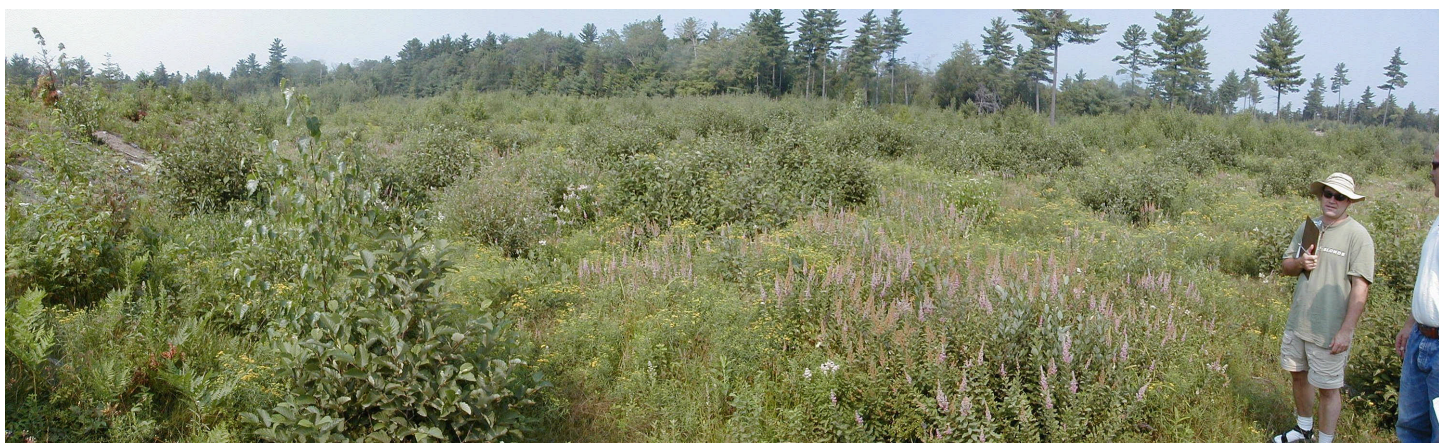
Looking southwest to northwest from slope down to eastern corner of creation area

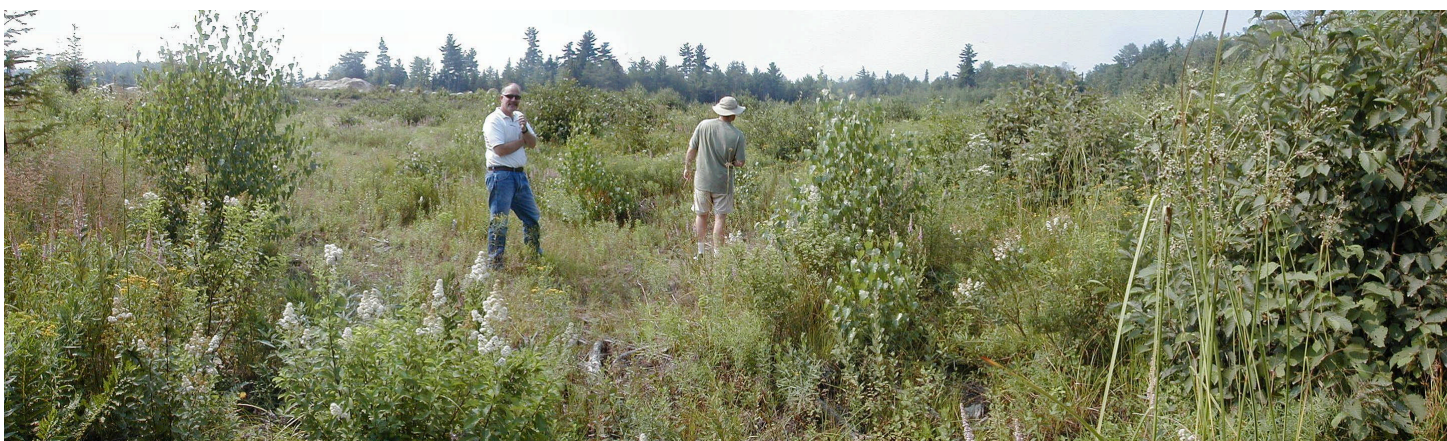
Looking south and west from northeastern corner of creation area

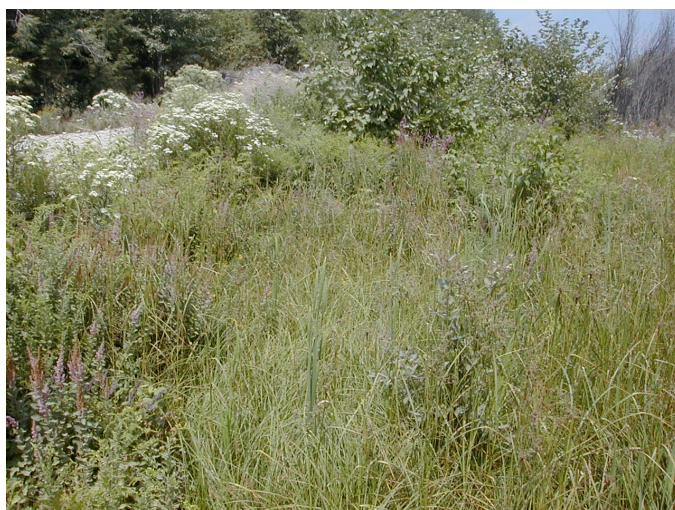
The restoration part consists of a third of an acre in which fill for a road was removed and the area was returned to its previous grade. It is a narrow swath surrounded by forest that slopes down to a stream.

Restoration area. Note logging road on left.

There are still remnants of siltation fence in the restored site that should be removed.
